Archaeological Investigation

SCADBURY MOATED MANOR, LONDON BOROUGH OF BROMLEY: LANDSCAPE INVESTIGATIONS

Research Report Series 012-2021

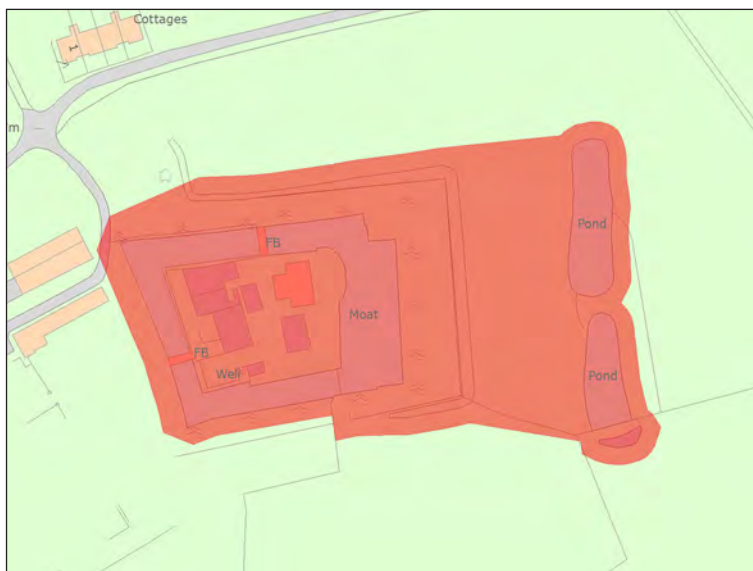
Figure 3 – The currently scheduled area of Scadbury Moated Manor, the western footbridge (FB) no longer survives (© Historic England, Corporate GIS; background mapping © and database right Crown Copyright (All rights reserved 2019) Licence number 000394)

The only scheduled monument in the broad project area is Scadbury Moated Manor itself, listed as 'Scadbury Manor moated site and fishponds' (List Entry Number: 1409786; Figure 3).

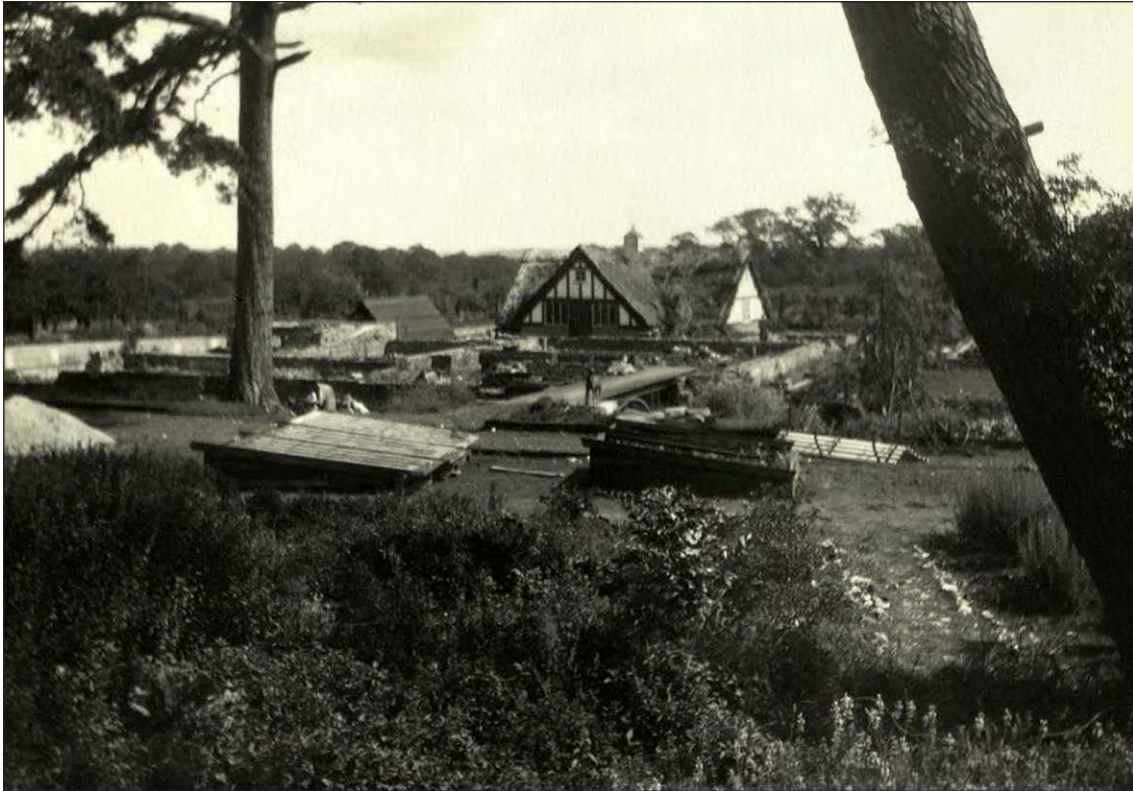
Figure 5 – The moat island towards the end of the Marsham-Townshends' initial works, about 1930, the Apple Store can be seen in the middle distance (BHC, 1080/2/1/17)

In the interwar years, The Marsham-Townshends did significant work in and around the moat and island by clearing vegetation, digging out and filling with water the largely dry moat, building dwarf walls on top of the ruined walls he found (Figure 5). Then between about 1936 and 1938, he had a fantasy 'medieval hall' erected using old timbers, which was known historically as 'Manor Hall' (Figure 6), a project managed by the Kettering architects Gotch and Saunders. Hugh was said by Philip Street, who photographed the work in progress, to believe that the timbers, which were from Manor Farm in St Mary Cray, had originally come from Scadbury, and therefore that he was 'reinstating' them. However, this was incorrect, the timbers had to be cut to fit, and it is unclear why Hugh thought so (ODAS, pers comm).

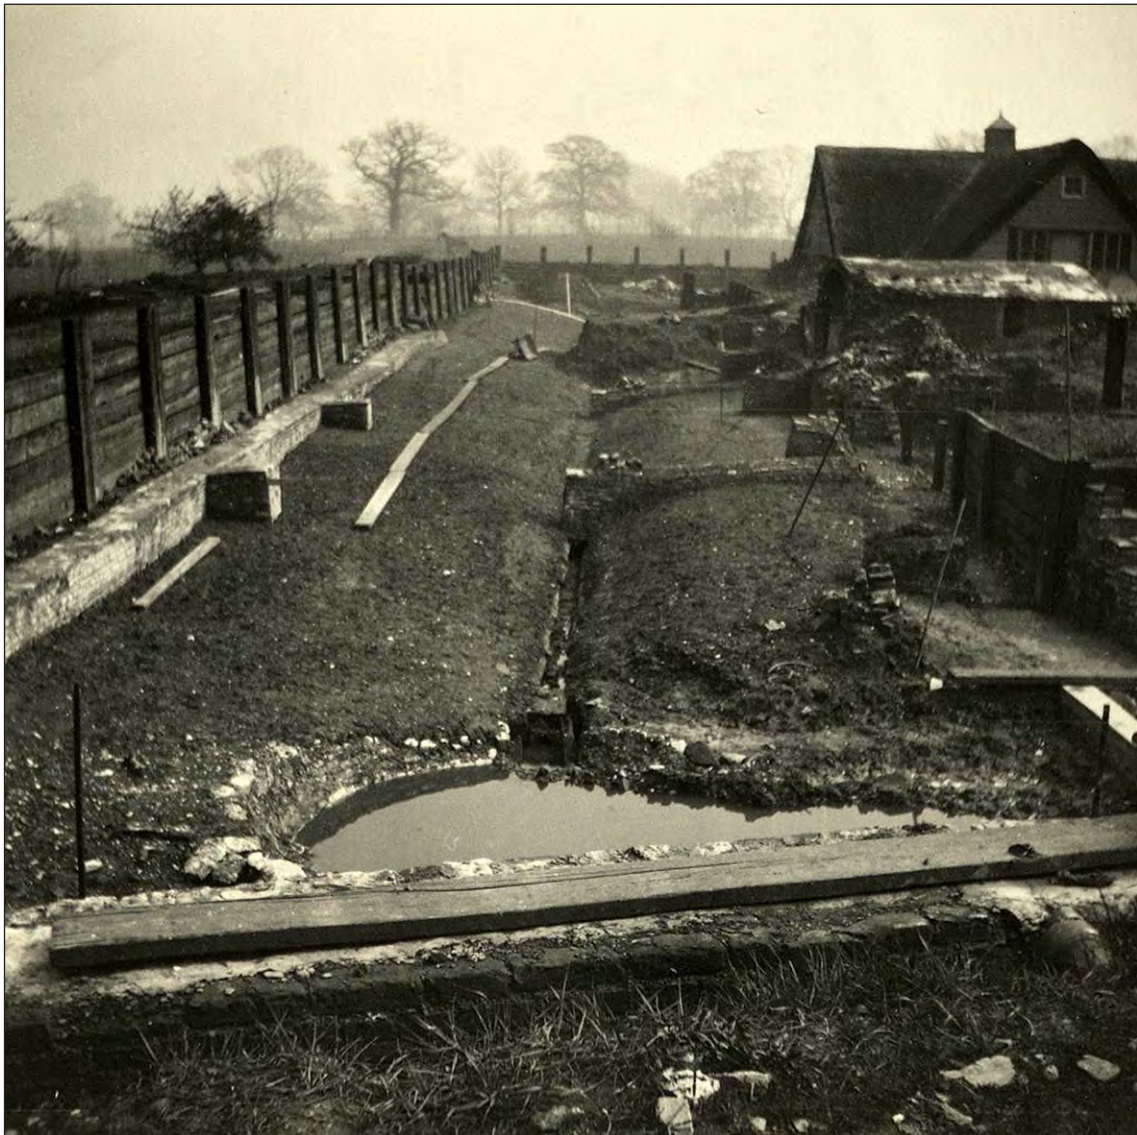
Figure 10 – An example of one of the excavation photographs of the 1920s showing the north moat arm from the west (BHC, 1080/2/1/17)

A number of photographs of the Marsham-Townshends' moat excavations (Figure 10), as well as a few from a little later, survive in BHC (1080/2/1/17). These show

the moat before work commenced (or at least very early in the process) and at several stages during and afterwards and most must date from the 1920s. Several show parts of the moat before any obvious work, with the east and west arms holding water, and with the former drained but almost completely silted up. The earliest stages of excavation were rather untidy with spoil apparently dumped close to where it had been excavated. The later stages involved the use of a small railway and cart to remove spoil. In a few photographs, brick walls can be seen within the on-going works suggestive of the foundations for walls above that had been lost or removed. The photographs then record the construction of timber revetment and reinforcement within the moat arms. The photographs also include a general view across the island from the west showing a decorative pavement approaching the bridge abutments (presumably that dated to about 1700 by ODAS (Hart 2019)), where there was a temporary wooden bridge. Visible in the background is the Apple Store. There is also one showing the initial excavation of the Large Cellar, and another the area south of the Undercroft. Visible in the background of several of these photographs are what may be walls and spills of rubble, hinting at the state of the island and suggesting that they are early images.

island. It is difficult to determine the extent of rebuilding as the lower work is in poor condition and below the water line. The clearest of the excavation photographs (see for example Figure 10) show there to have been several surviving buttresses and suggest that the eastern part of the moat wall itself (from the causeway to a few metres west of the Undercroft) then survived to close to the current height but that the western part had been lost, at least above foundation level. Cast concrete has been used extensively in this latter section, no doubt as a simple and economical repair, and to reinforce existing brickwork in places, such as around the buttresses.

To the west of the Causeway the outer moat walls comprise shuttered concrete above brick, now being undermined where wet. Weathering of the concrete has revealed decayed timber revetment behind, suggesting that it was a secondary fix, which is borne out by the excavation photographs (Figure 10 for example). The upper brickwork is late, though the lowest visible courses appear to be English bond, suggesting they are early, and whilst the buttresses appear to be of entirely late construction they could be based upon early fabric, again supported by the early photographic evidence. East of the causeway the work appears to be entirely late with brick above cast concrete, and there is no photographic evidence for any early work here.

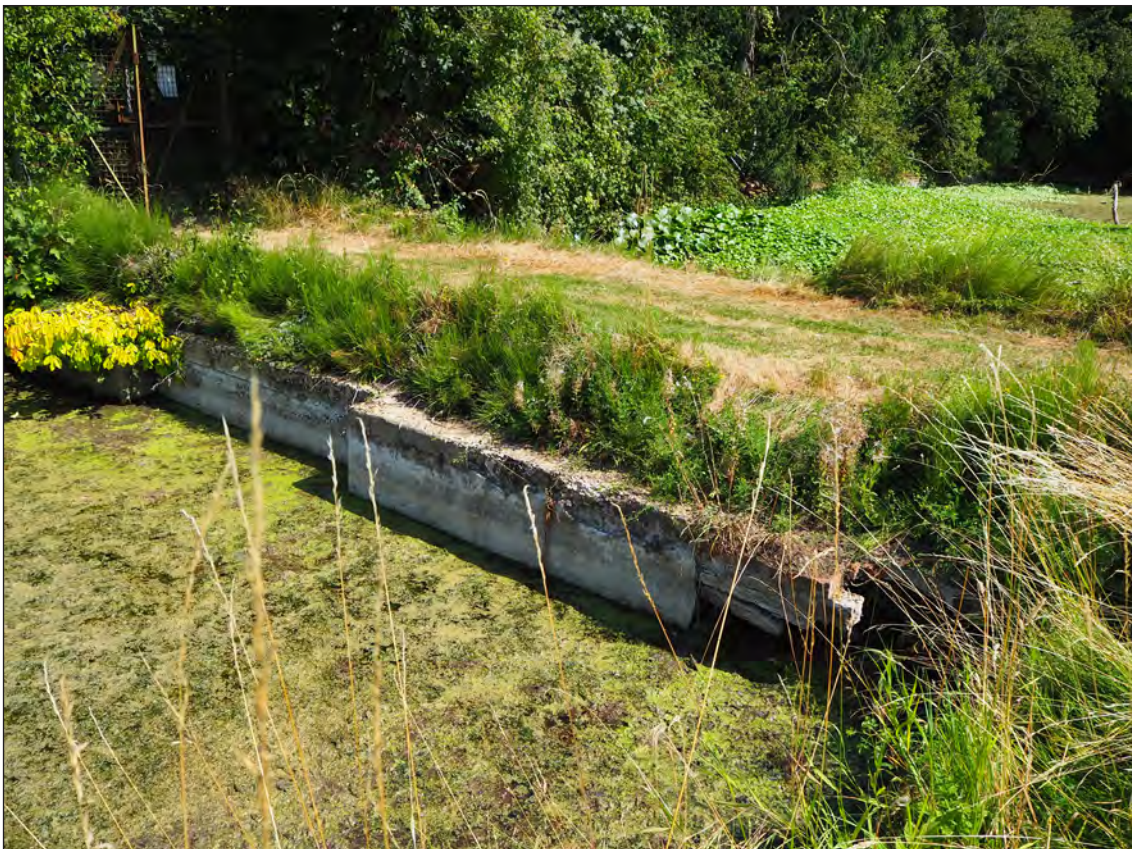
Figure 14 – The Causeway from the south-west, note the cast concrete reinforcement and the brick to the right (Magnus Alexander 11/08/2020 © Historic England)

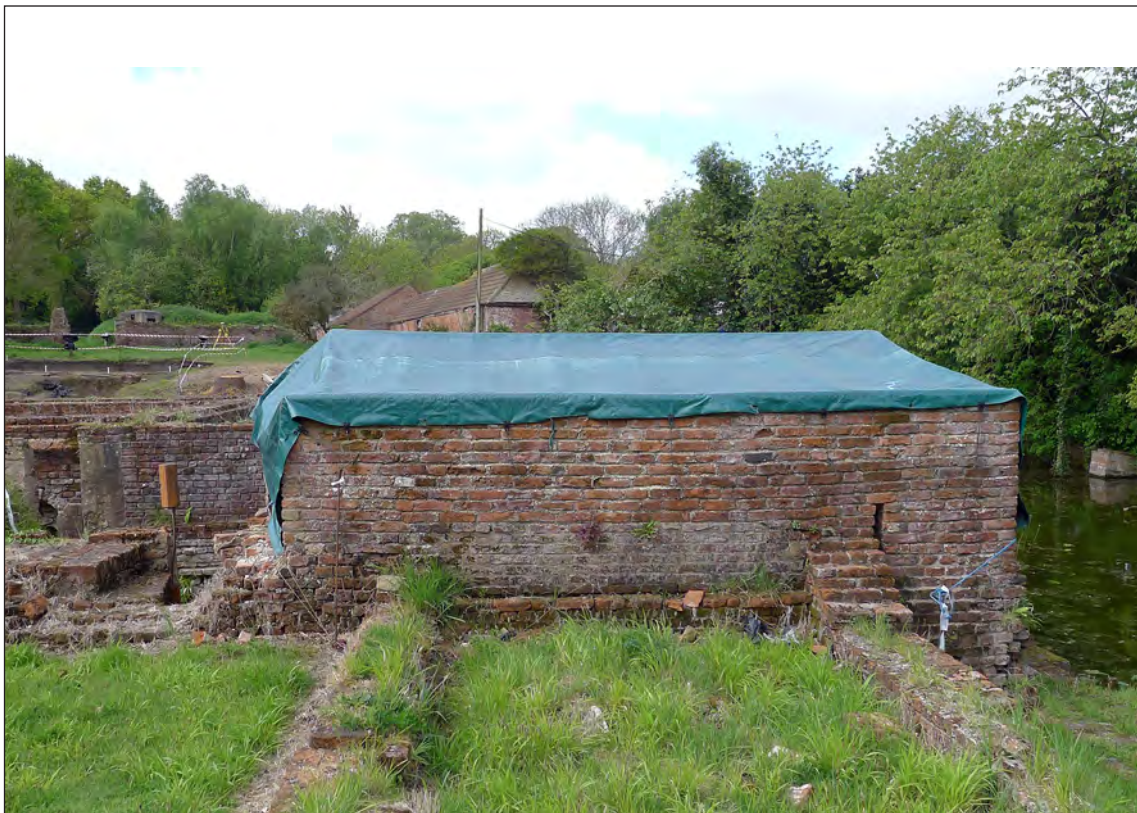
Figure 15 – The Undercroft from the east, the two walls discussed are visible in the foreground (Jonathan Kewley 26/04/2017 © Historic England)

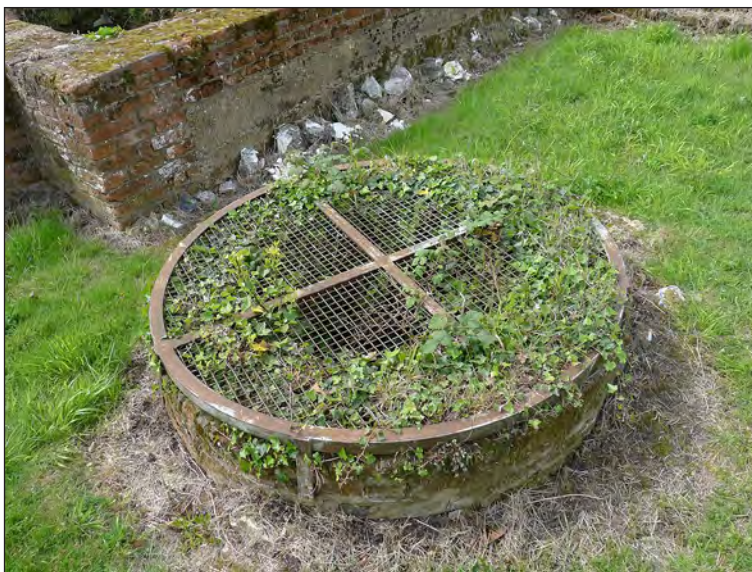
Figure 16 – The north well from the north-east. The late north wall of the Large Cellar can be seen in the background, note the use of concrete (Jonathan Kewley 26/04/2017 © Historic England)

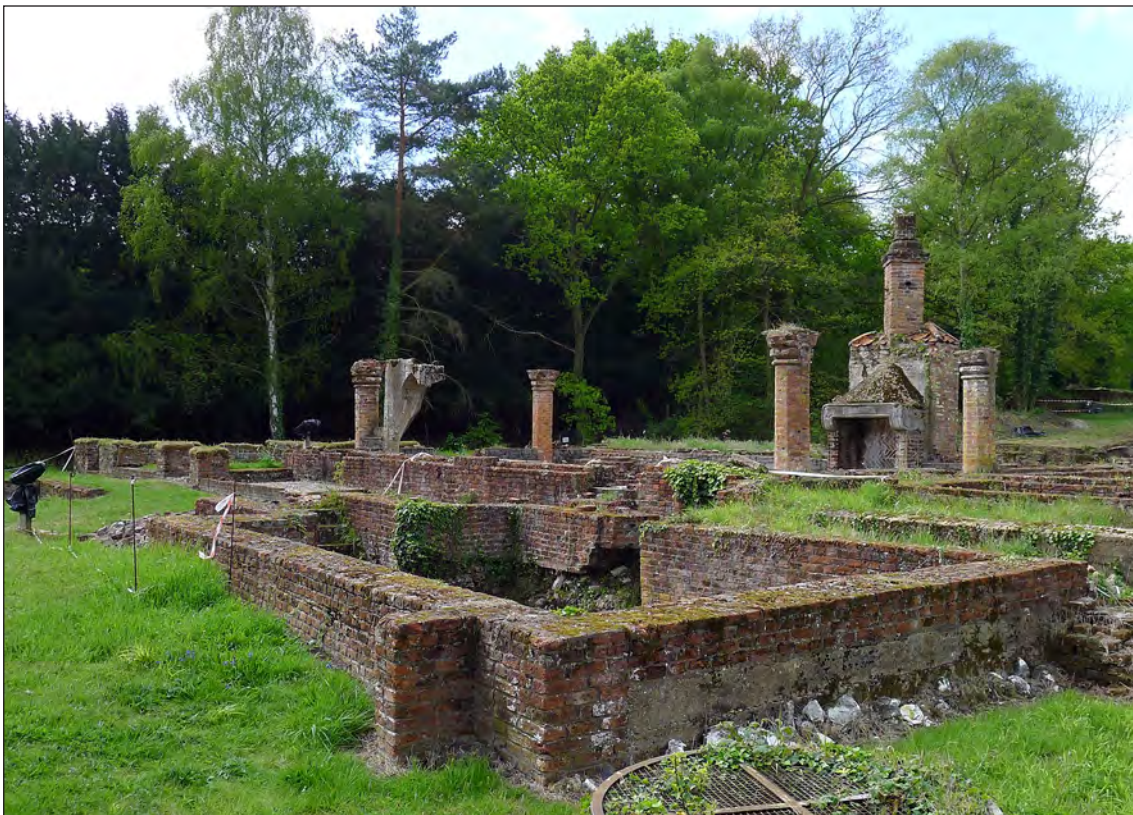
Figure 17 – A general view of the Large Cellar from the north-east with the columns and the fireplace of the Hall behind (Jonathan Kewley 26/04/2017 © Historic England)

The Large Cellar is a flooded, rectangular structure with broad straight stairs to the south and narrow curving stairs to the west (Figure 17). The upper walls, over 20 courses deep in places, are late with early work beneath. The late walls include several decorative features including a relieving arch in the north wall possibly recording the former barrel vault and several niches, some of which may have early work visible behind. The visible southern stair is entirely late and discrepancies between the levels given on the G&S plan and levels recorded during the survey suggest that these stairs were rebuilt after 1928. The lower part of the small stair to the west appears to have been a fairly coherent, if narrow, early stair (0.65-0.80m wide), with a short straight section from the cellar and a rising curve turning 90° to the south, though most of it has collapsed or is underwater. From about halfway up the curving section the steps are late and though some have partially collapsed, the upper steps are in place. The top of the stairs has an awkward relationship with the north-east corner of the Hall and narrow to 0.50m, though this could be a result of the late work rather than original. The early work has decayed in several places leaving the late work above poorly supported (Figure 18). This has led to some shifting en masse of the late brickwork, particularly the west side north of the small stair and to either side of the south stair. At the base, the lower eastern and western walls step in a slightly and at the north-west corner the late work overlies the probably early wall running south from the Undercroft (below) which aligned with lower section of the western cellar wall, suggesting they may have been part of a single structure, though a direct relationship cannot be seen. The interior of the

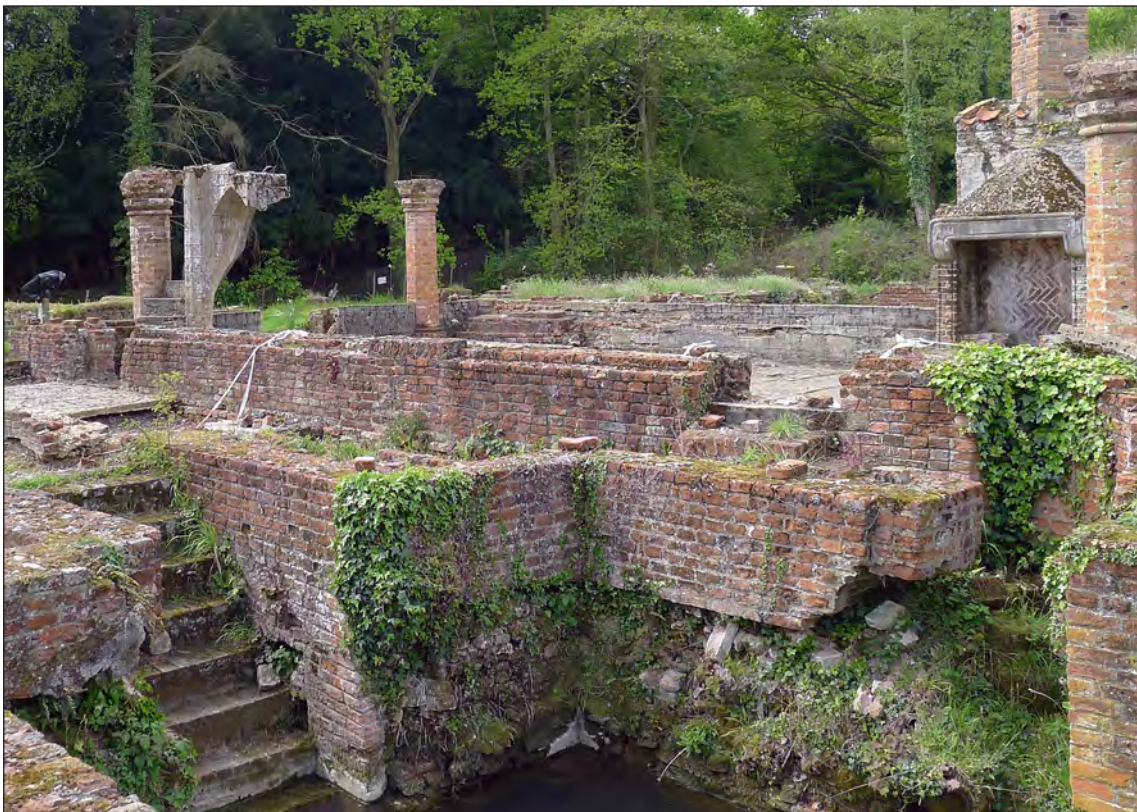
Figure 18 – A view south-west across the south of the Large Cellar with the Hall behind. The south stair is to the left with the small west stair to the right. The extent of decayed early fabric below the late work is clearly visible between the two (Jonathan Kewley 26/04/2017 © Historic England)

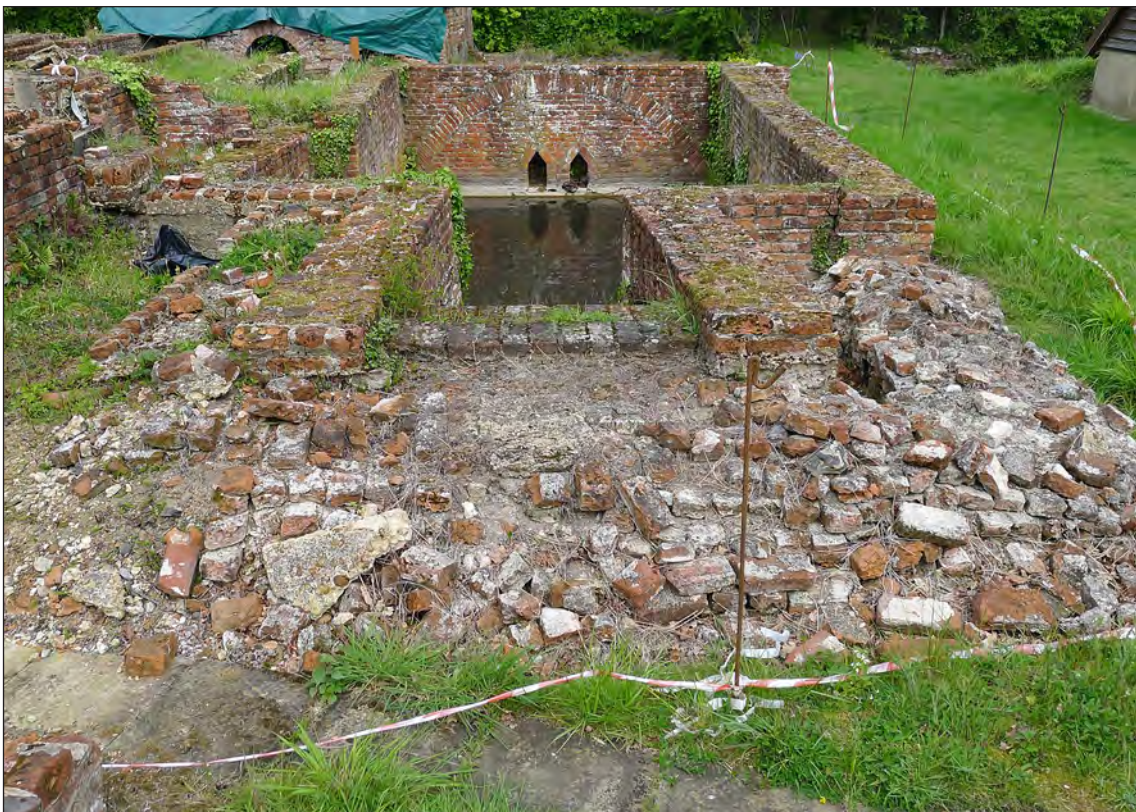
Figure 19 – The Large Cellar from the south with the block of brickwork wrapping around the south stair. Note the possible joint to the lower left, the second joint is obscured by the buff block (Jonathan Kewley 26/04/2017 © Historic England)

To the south and east of the top of the south stair is a large, L shaped block of early brickwork [4] (Figure 19), which ODAS dated to about 1500 (Hart 2011, fig 3, 8) apparently on the form of the bricks, the lime mortar, and evidence from elsewhere. It seems likely that this formed the foundation for a structure, its compact form suggesting something with a relatively small footprint; ODAS suggested a staircase (Hart 2011, 10). It may have blocked the lowest (original?) stairs into the cellar and so have been secondary, perhaps related to a rebuilding of the structure above. The G&S survey noted that at the south-east corner of the cellar were two walls independent of one another, the outer with very shallow footings, so perhaps constructed to visually tie two phases of work together rather than being structural, lending some support to this suggestion. To the west is a late wall or planter that the G&S plan suggests was constructed on a separate wall running south from the cellar. Despite being rather roughly laid there are two fairly neat joints visible within the rather decayed brickwork suggesting the western side wall of the stair continued to the south separating the wall beneath the planter from the rest of the base.

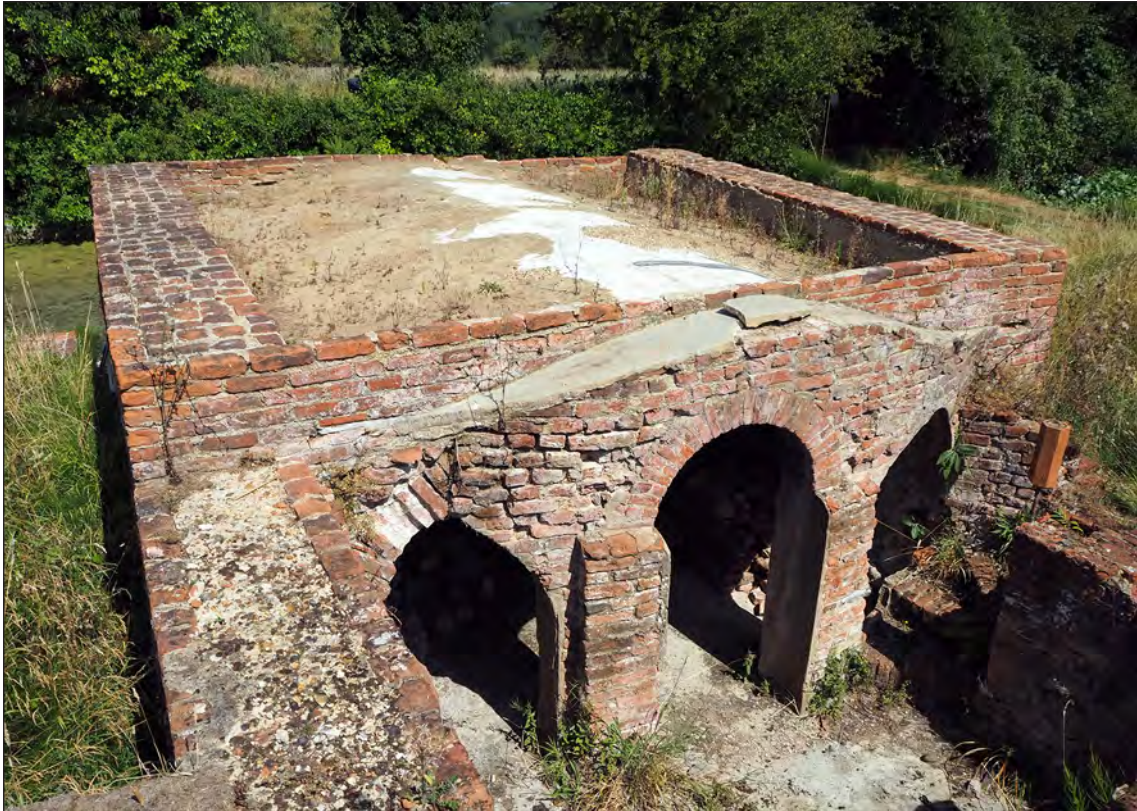
Figure 20 – The Undercroft from the south-west (Magnus Alexander 11/8/2020 © Historic England)

The Undercroft is a substantial brick-built structure with a thick, low, barrel vault (Figure 20). It is the only building to be shown on all detailed early maps and is depicted uniformly suggesting it was always a significant element of the remains on the island, and probably in use; it was labelled 'Boat House' on early OS maps. It was in a poor condition and ODAS have undertaken various repairs to the structure (pers comm). In 2008 they repaired and repointed the northern of the two east-west walls, with a stepped section created against the Undercroft wall. In 2009-10 the west wall was cleared of vegetation and repointed, and repairs were made to the splayed window opening including cutting and insertion of replacement bricks and re-building of the external sill. The work was done using lime mortar and re-used bricks.

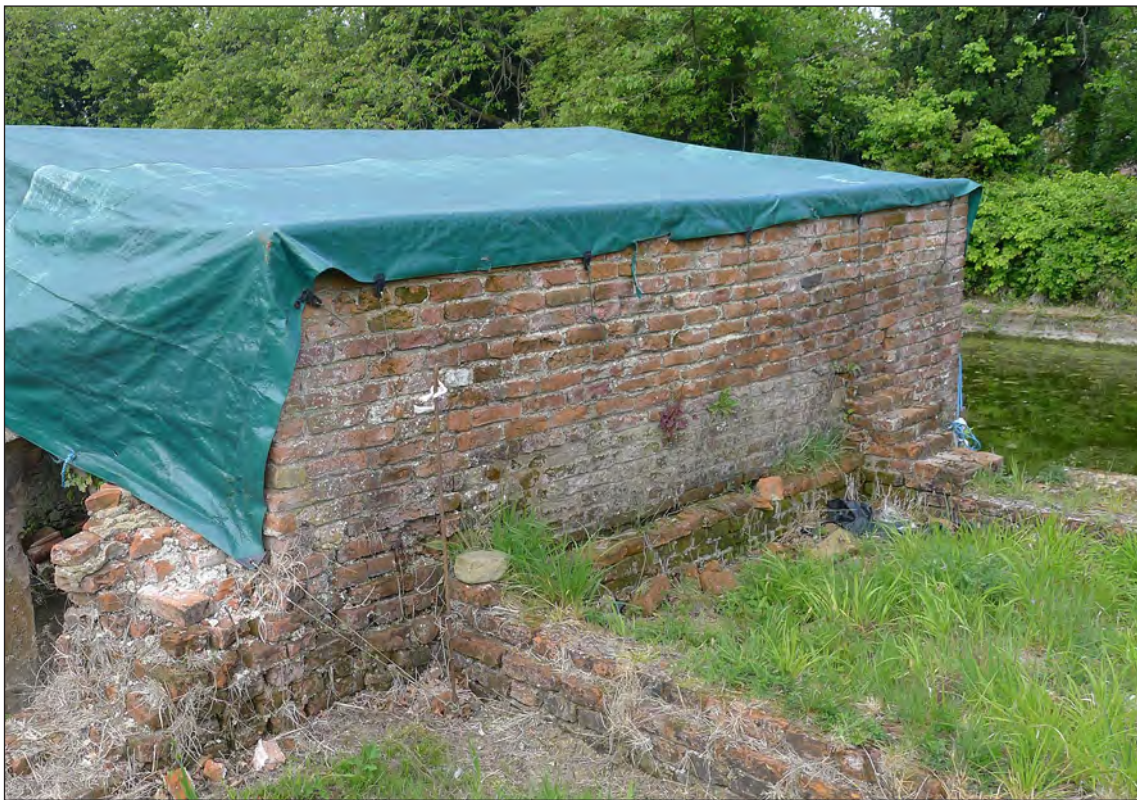
Figure 21 – The east wall of the Undercroft showing the late work above and the stepped-out section below (Jonathan Kewley 26/04/2017 © Historic England)

Internally the structure appears to be of a whole and apart from a concrete floor there is no obvious late work. Externally, the upper 0.7m or so of the eaves, is late with early work below. The base of the east face, between the two walls to the east described above, steps out a little, is on a slightly different angle, and is early, with crude late repointing (Figure 21). The upper part of this wall is on a slightly different alignment, has been refaced and is late. The lower parts of the north-east corner have late repairs, but there are suggestions of degraded English bond and parts project north of the later work above, suggesting it is part of the early wall to the south. In fact much of the earlier brickwork on the north faces of the Undercroft walls and vault is irregular suggesting that they had originally been tied into an end wall on the line of the current moat wall (Figure 22). At its base, the eastern wall is wider than the western and a vertical joint running up to the level of the spring for the vault is visible, suggesting the wall may have been added to along the eastern side and

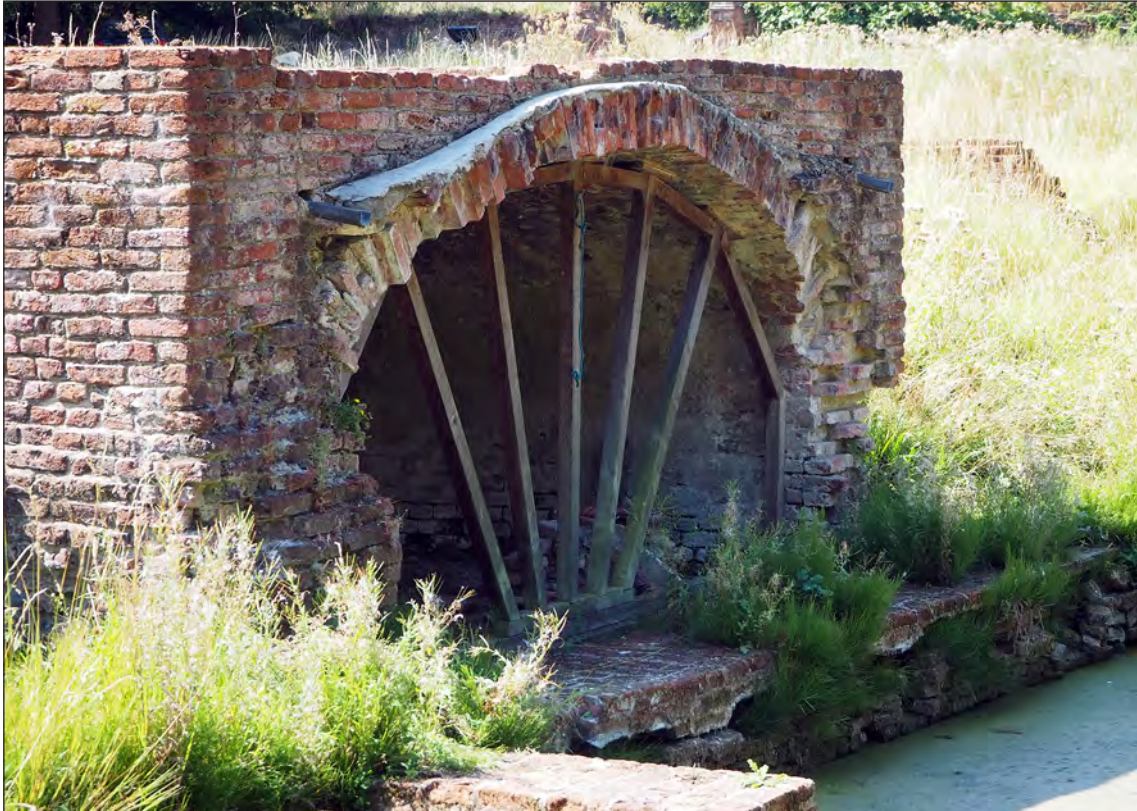
Figure 22 – The north side of the Undercroft from the north-east (Magnus Alexander 11/8/2020 © Historic England)

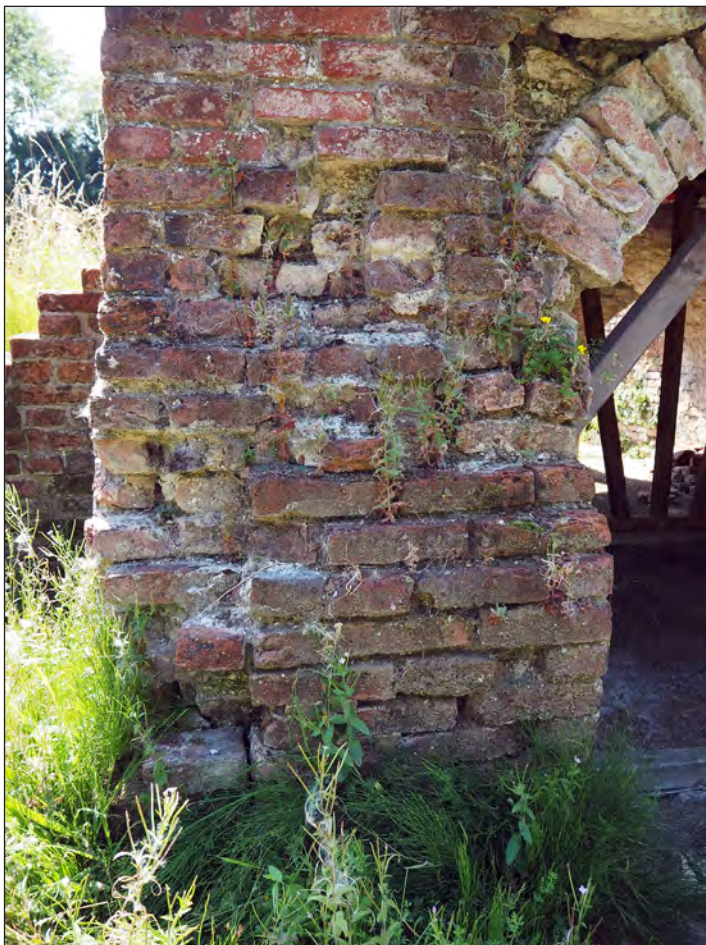
Figure 23 – The north end of the east wall of the Undercroft, note the vertical joint left of centre (Magnus Alexander 11/8/2020 © Historic England)

rebuilt above the vault, where it was structurally simpler to do so (Figure 23). This suggests that the two east-west walls to the east of the Undercroft (above) are only tied into this and so part of a secondary early phase.

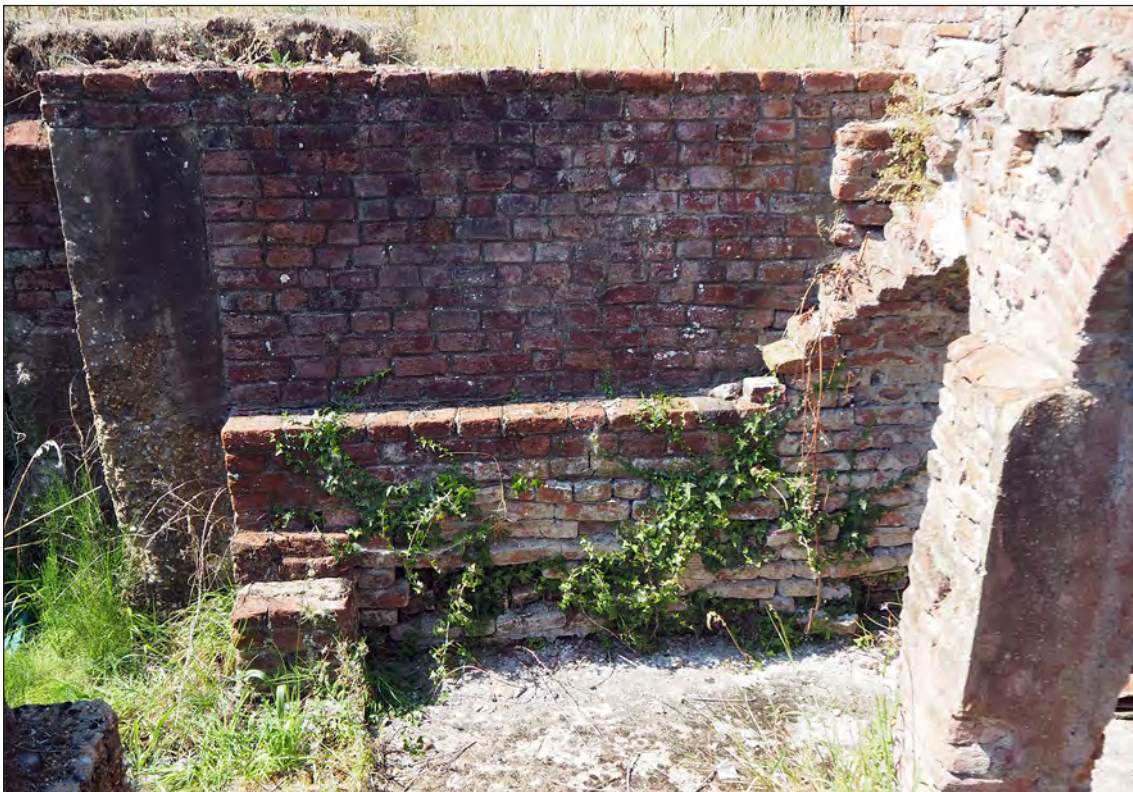
Figure 24 – The west wall of the Undercroft 'area' with the spring for the barrel vault visible to the right. Some early English bond is visible at the bottom of the photograph with clearly late work above the step (Magnus Alexander 11/8/2020 © Historic England)

The lower parts of the walls of the Undercroft extend south beyond the vaulted section creating an 'area' between it and the Small Cellar accessed via a spiral stair set into the east wall. The upper part of the west wall [5] appears late (Figure 24). The lower section looks early and projects eastwards into the 'area' at the same level as the spring for the vault to the north, suggesting it may once have supported the vault which extended further south, also suggested by some irregular brickwork in the south face of the vault, probably all the way to the Small Cellar (and indicated on the G&S survey by a dashed line). The south-west corner of the Undercroft has a slightly awkward relationship to the Parlour; although the west wall of the former is on the same line as the east wall of the latter it is offset to the east and unlikely to have been built at the same time, though which is earlier and which later is not known.

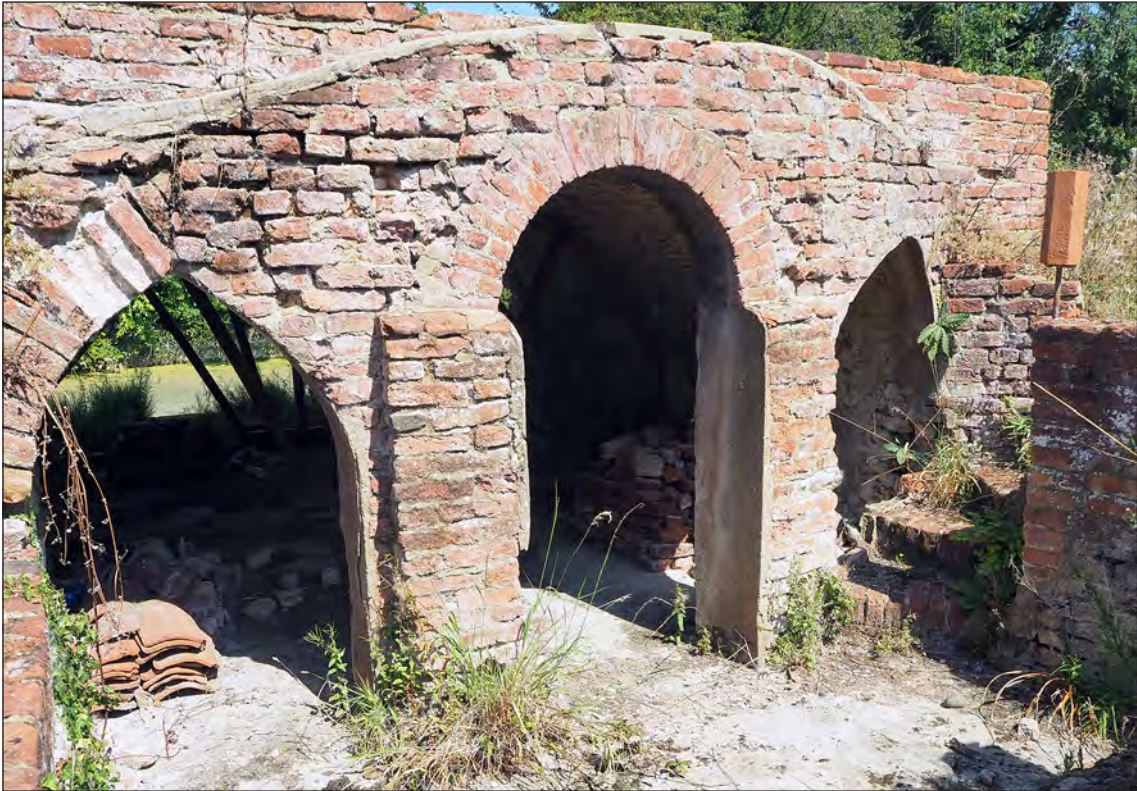
Figure 25 – The south end of the Undercroft with the ‘area’ in the foreground and the spiral stairs visible to the right (Magnus Alexander 11/8/2020 © Historic England)

The south end of the surviving vault is supported by two brick columns (rather crudely reinforced with late work) with a well-built semi-circular arch between and slightly awkward 'gothic' arches to either side, partially making use of the profile of the barrel vault (Figure 25). This supporting work appeared to be secondary to the main structure though this could not be confirmed. If so, then the cellar area might have been a deliberate creation, perhaps associated with the use of the Undercroft as a boat house.

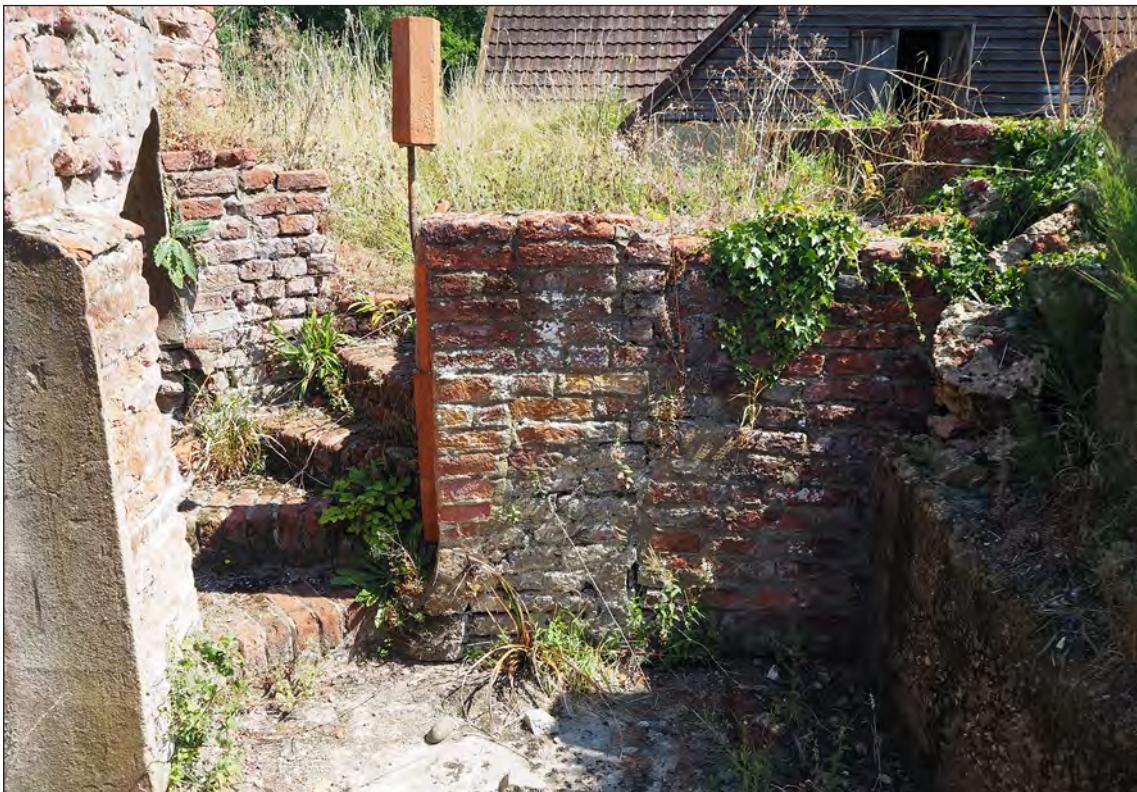
Figure 26 – The east of the Undercroft ‘area’, the area of concrete and rubble to the right is the location of one of the steps noted on the Gotch and Saunders survey plan (Magnus Alexander 11/8/2020 © Historic England)

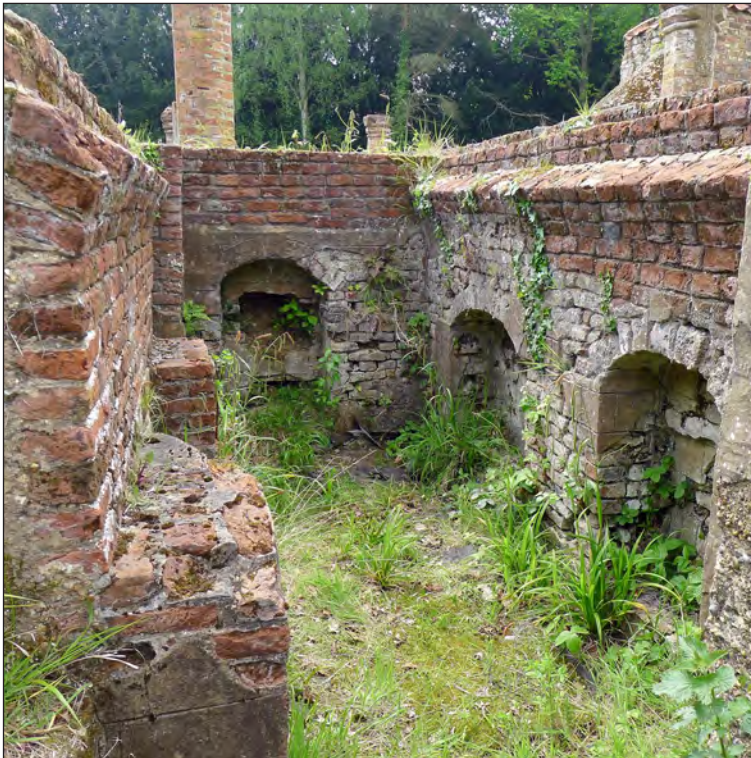
Figure 27 – The Small Cellar from the NNE (Magnus Alexander 11/8/2020 © Historic England)

The Small Cellar is also of brick but here early walling survives to a high level and springs for a small barrel vault remain (Figure 27). There are niches in the south and west walls and two low piers against the east wall, as well as a full height pier in the south-east corner so clearly the cellar (and whatever stood above it) had a relatively complex history for a small structure. The west wall of the Undercroft does not form the west wall of the Small Cellar, which is offset to the west and appears to be integral with the east wall of the Parlour, so the Undercroft and Small Cellar seem not have been constructed as a whole. It has a simple but decorative brick floor which looks very similar to that in the Marsham-Townshends' excavation photograph of the Large Cellar (above) so could also be early, though as the floor in the large cellar was tertiary it is also possible that the Small Cellar was an addition. G&S give a level on the cellar floor of 74.60m OD (calculated) and nearby the actual level is only 0.06m lower, close enough to be due to error, historic or modern, and suggesting that it was not altered post-1928. Late concrete render in several places has been scored to look

like ashlar and probably once covered the whole cellar; this is in keeping with the reconstructed hall so more likely of the 1930s than 1920s.

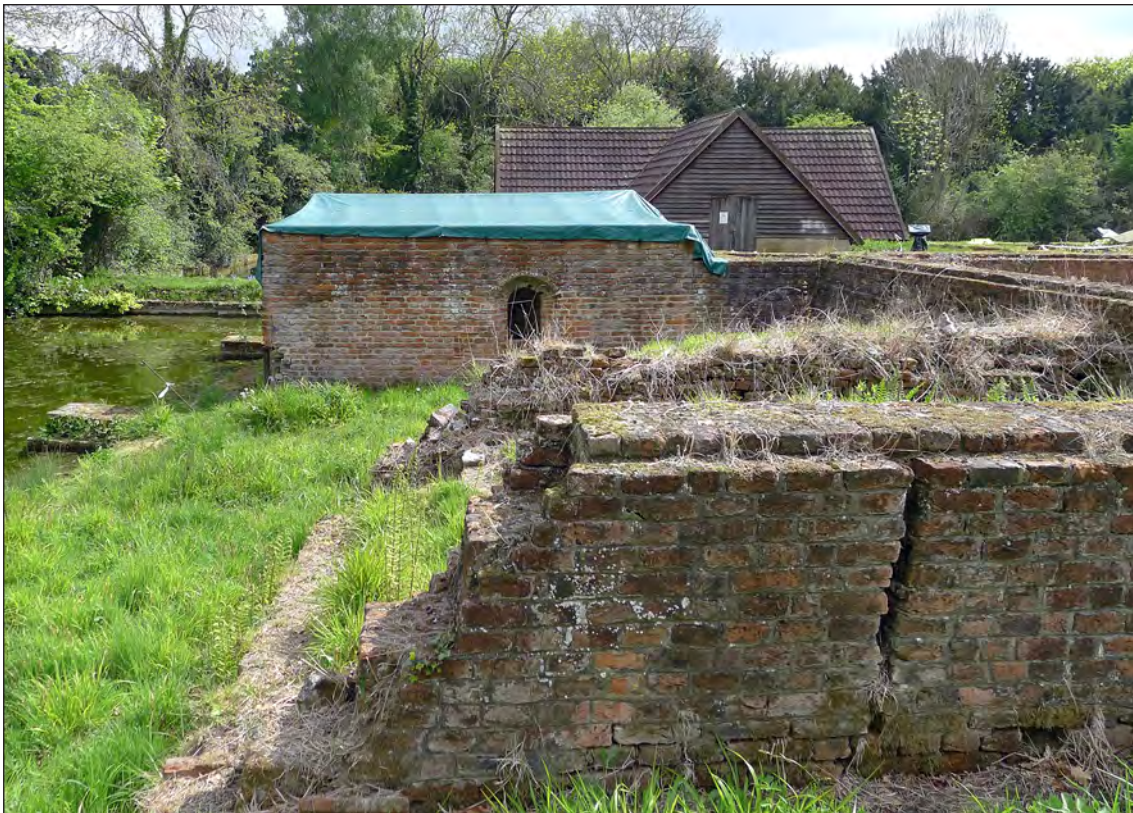
Figure 28 – General view from the west, wall [9] is in the foreground with [7] beyond, the Undercroft and Apple Store are in the background (Jonathan Kewley 26/4/2017 © Historic England)

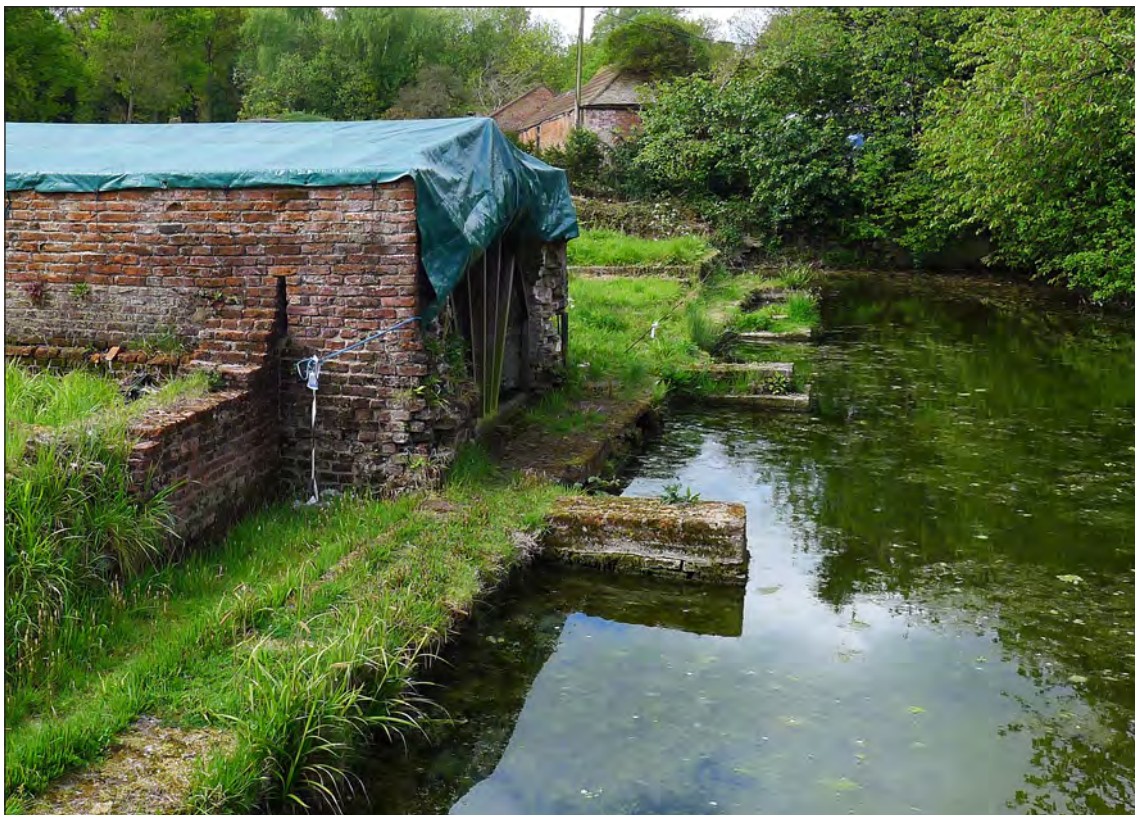
Figure 29 – The north moat wall looking west from the Causeway (Jonathan Kewley 26/4/2017 © Historic England)

The northern wall [1] is broader than the southern and appears to have stepped out at the base though the wall is in poor condition. It retains higher ground to the south, perhaps explaining its relatively substantial form. The upper courses and surviving north face (see Figure 29) are late work though much has been lost; more has survived to the west where the wall is rather crudely tied into the Undercroft. The surviving lower courses appear early.

To the west of the causeway a low wall [10] retains the moat island (Figure 29). The upper, visible brick courses are late and create a narrow walk along this side of the

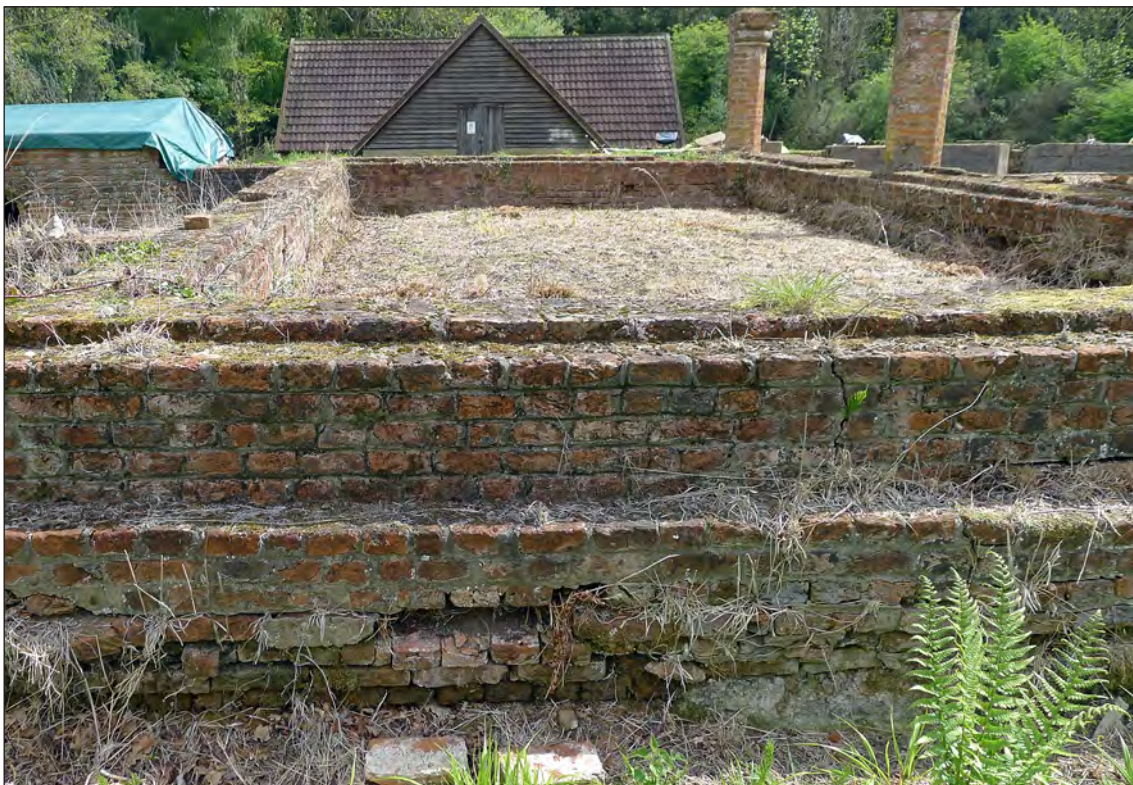
Figure 30 – The Parlour from outside the north-west corner looking east. Note the decaying English bond at the base of the wall with some late concrete to the right (Jonathan Kewley 26/4/2017 © Historic England)

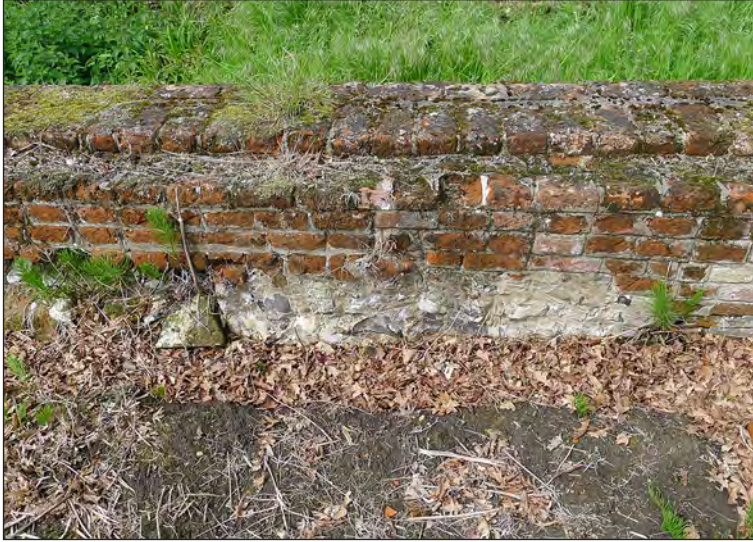
Figure 31 – East face of the Parlour's west wall (the opposite face to that in the foreground of Figure 30) showing the repointed flint (Jonathan Kewley 26/4/2017 © Historic England)
