Archaeological Investigation

SCADBURY MOATED MANOR, LONDON BOROUGH OF BROMLEY: LANDSCAPE INVESTIGATIONS

Research Report Series 012-2021

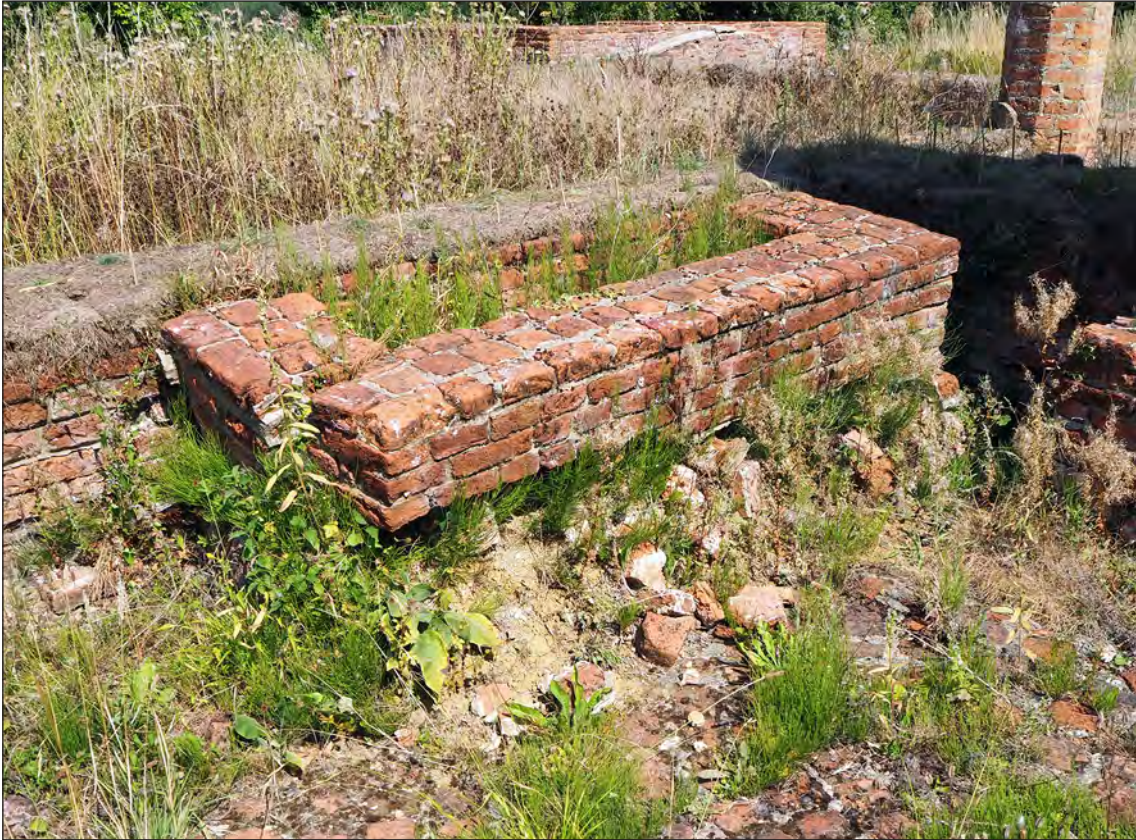
Figure 32 – The collapsing planter built against the south wall of the Parlour and projects into the south of the Herb Garden (Magnus Alexander 11/8/2020 © Historic England)

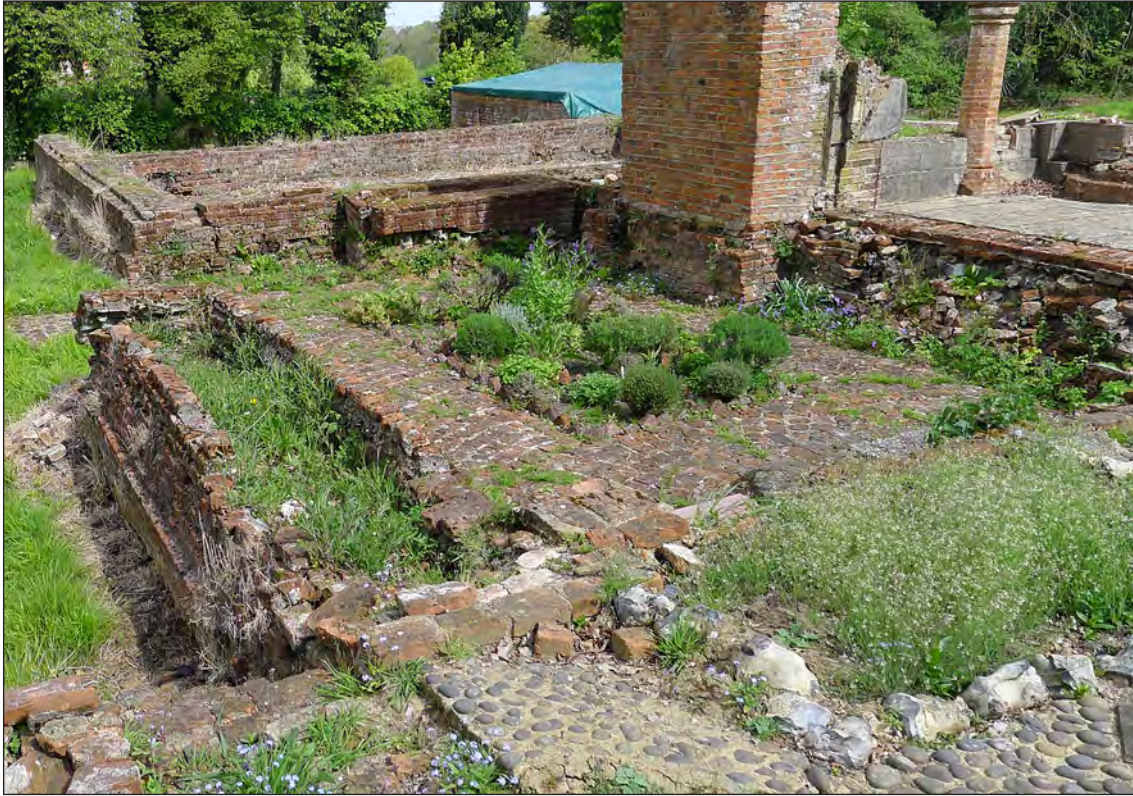
Figure 33 – View of the Herb Garden from the south-west with the Hall to the right and the Parlour beyond (Jonathan Kewley 26/4/2017 © Historic England)

This is the modern use of a small enclosed area that featured a rectangular central bed with smaller beds on all sides, all defined by bricks set vertically but angled at 45-degrees to create saw-toothed edging, with fish scale pattern brick paving between, probably by the Marsham-Townshends (Figure 33). It is defined by the surrounding walls; that to the north was the western half of the south wall of the Parlour and has been described.

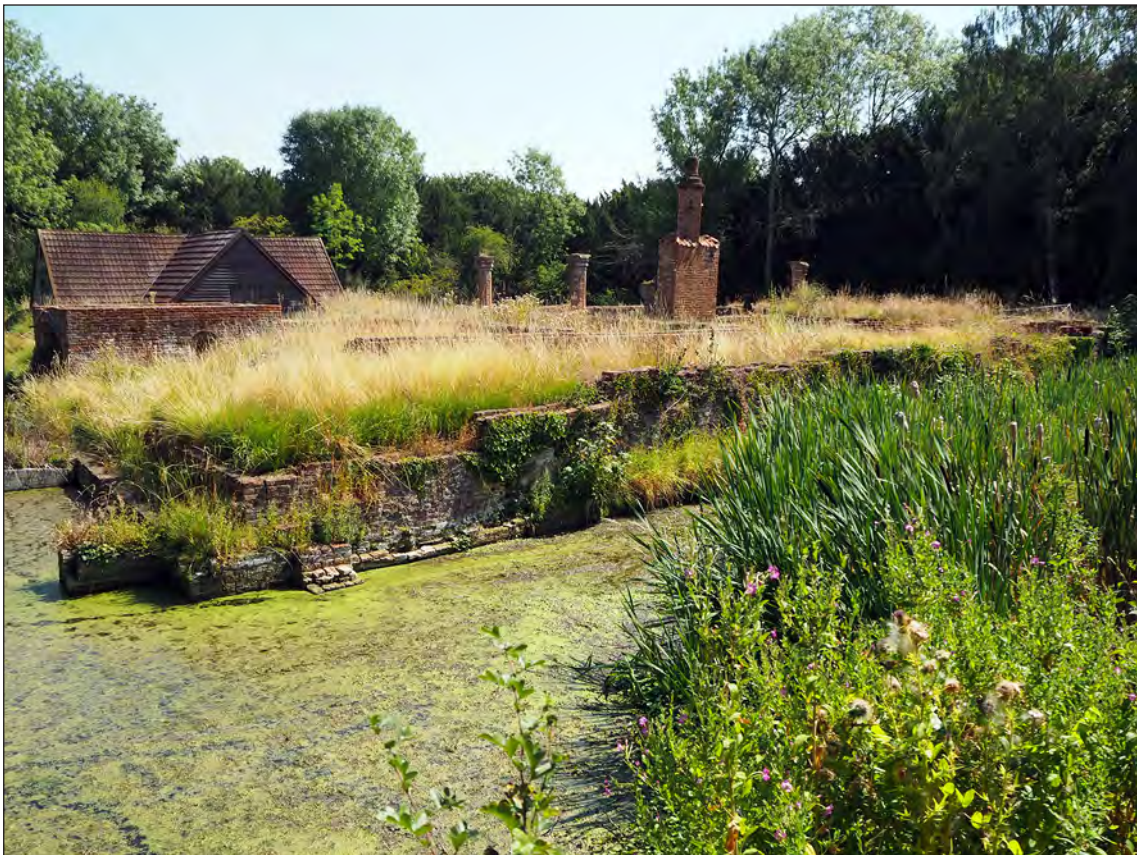
The moat wall [13] drops vertically into the moat (Figure 34) with seven internal buttresses to the east (Figure 35), most being approximately the same size, though the southernmost is larger than the others. The wall is built of bricks in soft mortar with relatively narrow joints laid in English bond and is clearly early. The upper courses are loose but the lower remain in fairly good condition. The west face remains intact in places but there are large areas where the face bricks have been lost. In a plate in Webb et al (1899, opp 106) the wall appears intact, suggesting that this damage occurred during the Marsham-Townshends' works, but perhaps they removed loose material. ODAS noted the use of poor-quality brickbats in most parts of this wall where they were not intended to be visible, including as headers in the face (Hart 2000, 18), which would leave it poorly tied in and explain these areas of loss. To the south is an area of collapse that, whilst restricted, cut back further than just the face. North of the most northerly buttress, the wall [14] is narrower and on a line slightly forward of that to the south, with a retaining wall behind and steps down towards the north-west corner, much as seen on the northern extension of the west Parlour ('Parlour' used here to distinguish the area named by ODAS from the more general 'parlour' used elsewhere) wall to the east (above). This appears to be late work but probably the rebuilding of an early wall, which had collapsed more than that to the south. This length of wall steps out slightly just above the water surface,

Figure 34 – A general view of the moat island from the north-west, with the west moat wall from the north-east corner to the bridge abutment (Magnus Alexander 11/8/2020 © Historic England)

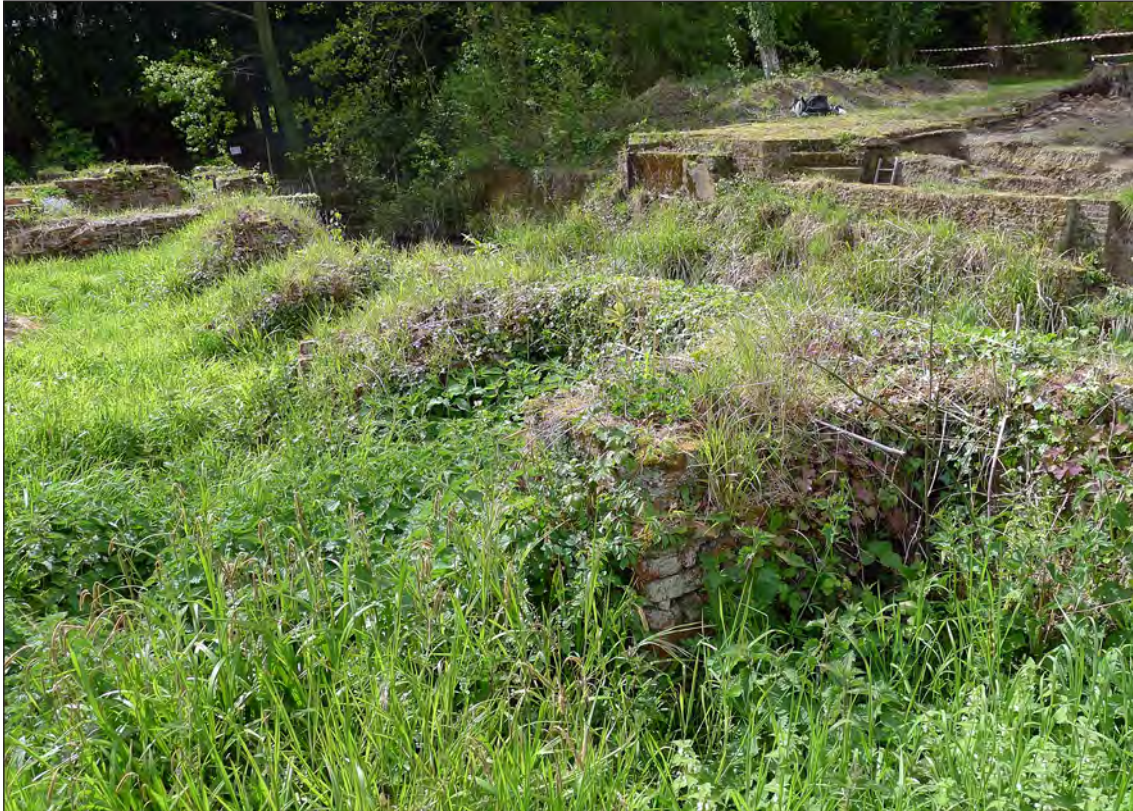
Figure 35 – The west moat wall from the north, despite being rather overgrown, four of the internal buttresses are visible with the bridge abutments on the island (left) and opposite (above right of centre) visible beyond (Jonathan Kewley 26/4/2017 © Historic England)

Between the wall and the Parlour/Herb Garden is a long narrow area, from the north-west corner of the moat island to the bridge abutment (below) (Figure 35). Most of this was excavated by ODAS in the later 1980s and the current fall towards the moat wall is largely the result of this. The ODAS excavation revealed a pavement of large flint cobbles here, not mentioned in the excavation report; this was presumably by the Marsham-Townshends but required a large quantity of good quality flints from somewhere (Michael Meekums, ODAS, pers comm). Immediately beneath this was natural clay at a high level to the east, with a construction trench to the west associated with the building of the moat wall as it contained building debris and dated to the middle of the 15th century (Hart 2000, 9-13). The presence of the buttresses and the construction trench suggests that there was space for them and therefore that there were no existing buildings tight to the edge of the moat here. The south end of this area, immediately north of the bridge abutments (below), is more complex. As mentioned above, G&S recorded a wall where the late planter is, that returned a little to the west, and traces of a wall continuing as far as the end of the buttresses. It also noted that the space between the first and second buttresses 'was arched over one ring of arch remains but not in situ'. A second set of wall traces was also recorded to the south of this, apparently running between the end of the

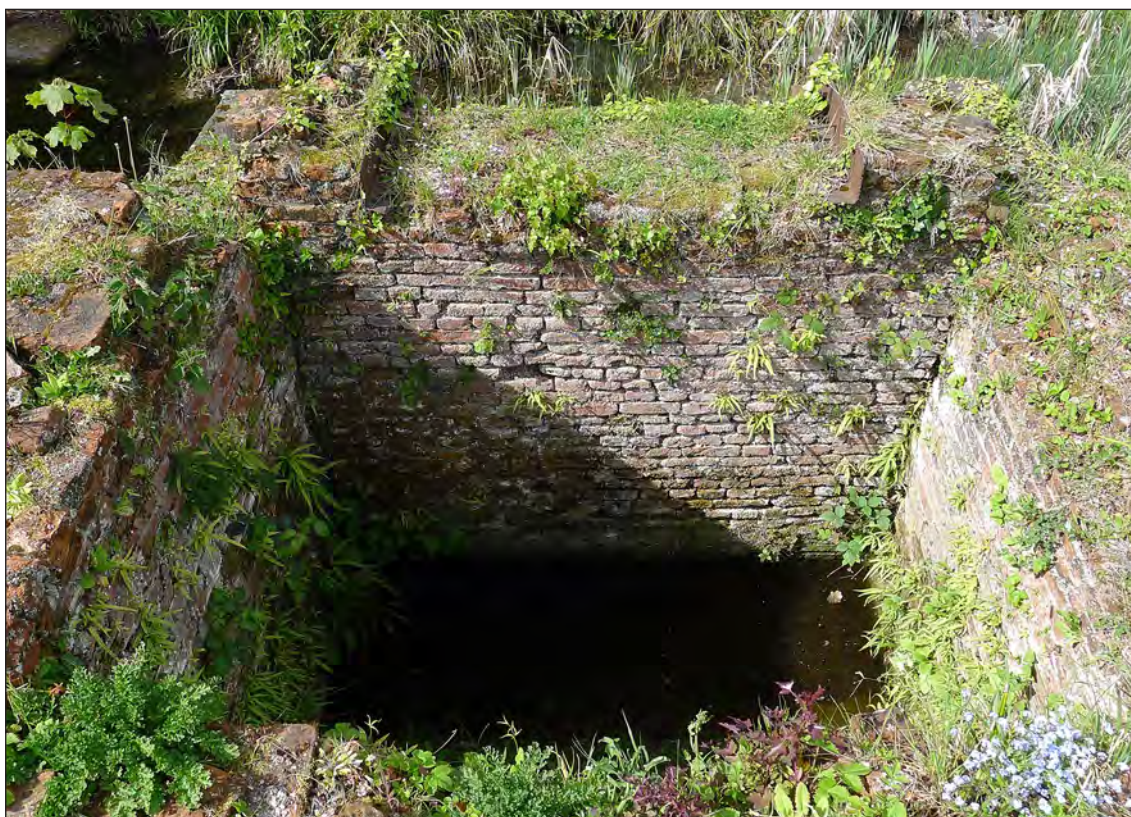
Figure 36 – The eastern bridge abutment and pit from the east, note the poor joints to left and right of the far wall (Jonathan Kewley 26/4/2017 © Historic England)

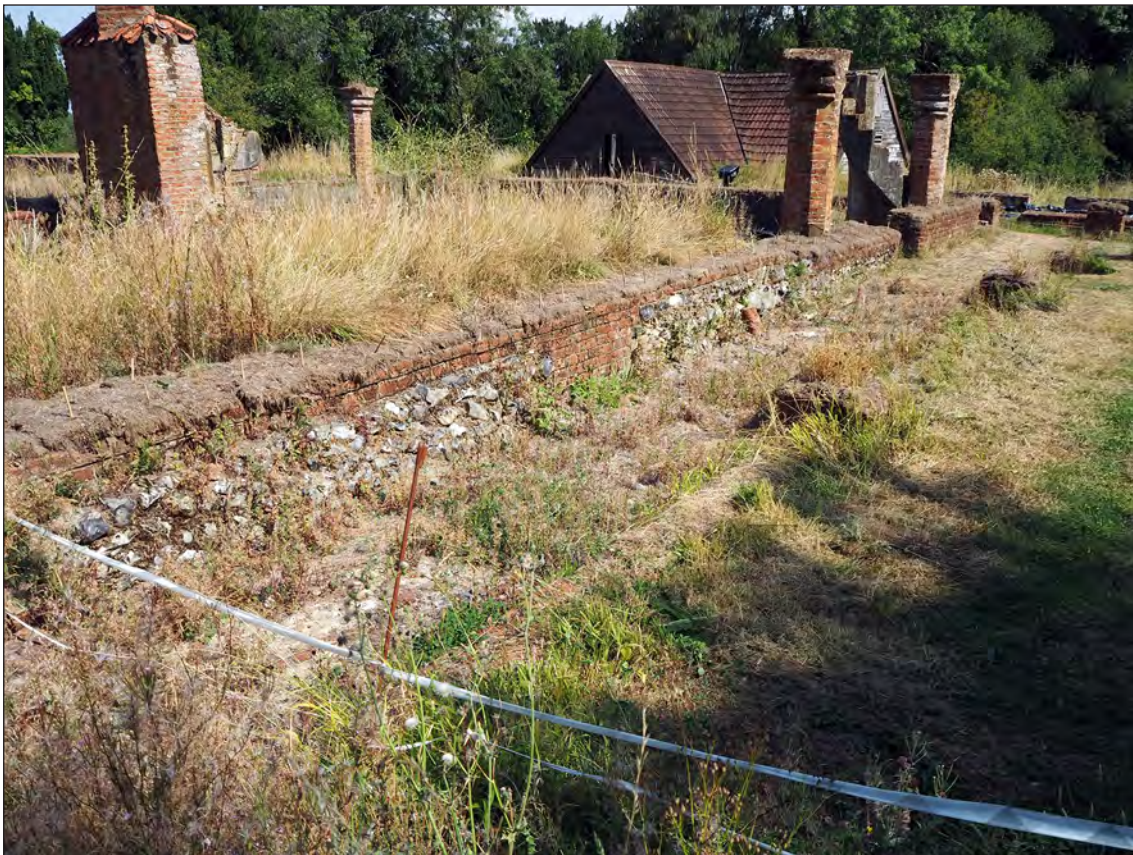
Figure 37 – General view of the flint wall from the WSW, the bricked up section, possibly an entrance, can be seen in the centre of the image (Magnus Alexander 11/8/2020 © Historic England)

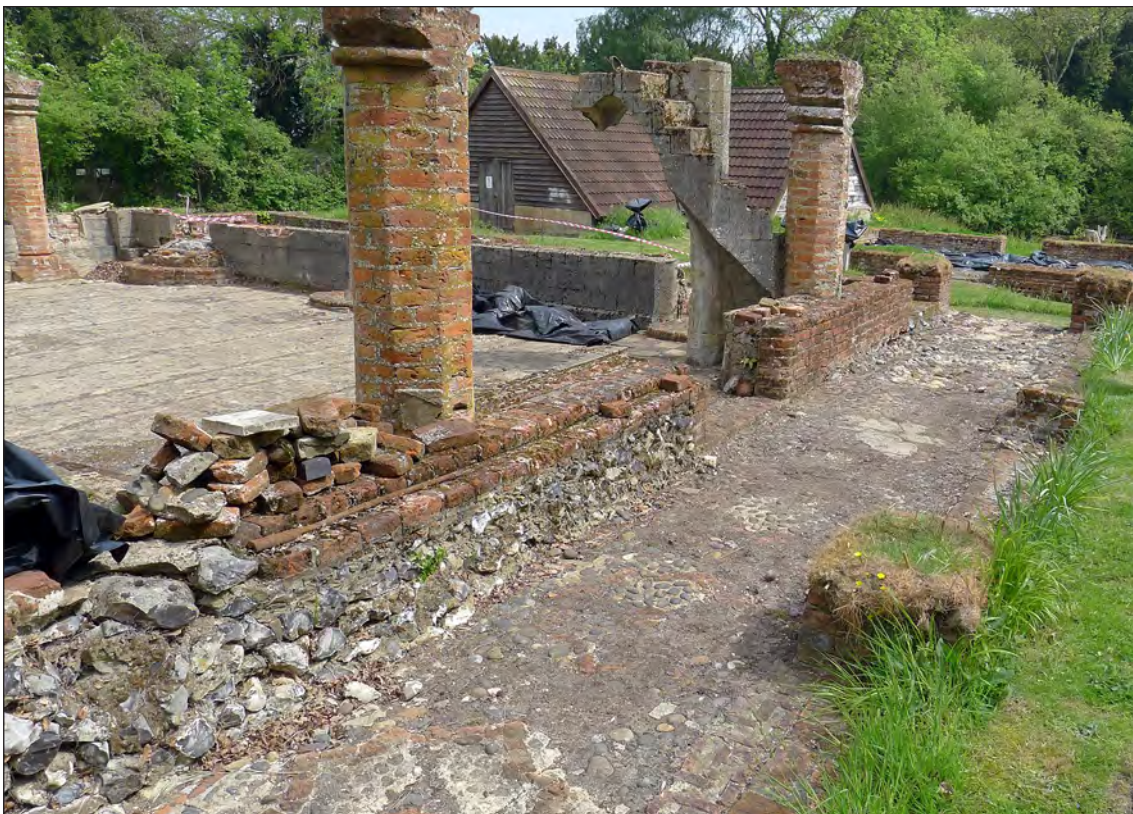
Figure 38 – The eastern parts of the flint wall from the west, further flints probably marking its continuation can just be seen beyond the south entrance to the Hall and continuing beyond its east wall (Jonathan Kewley 26/4/2017 © Historic England)

but is still visible to a height of about 0.30m with late brick and a coping course on top. The flintwork stops abruptly where the reconstructed hall's south entrance has been inserted, but very similar flint is visible 2.00m further east, 0.75m beyond the entrance, though it is lower and in poor condition (Figure 38). The flint wall continues beyond the south-east corner of the Hall for almost 2.00m where flint is also visible in the north face supporting the probability that this was a wall or footing. Although truncated by the late entrance to the reconstructed hall, the flint did not immediately resume, so it is possible that there was a second original gap in this wall, like that to the west, indicating another entrance, though this is uncertain.

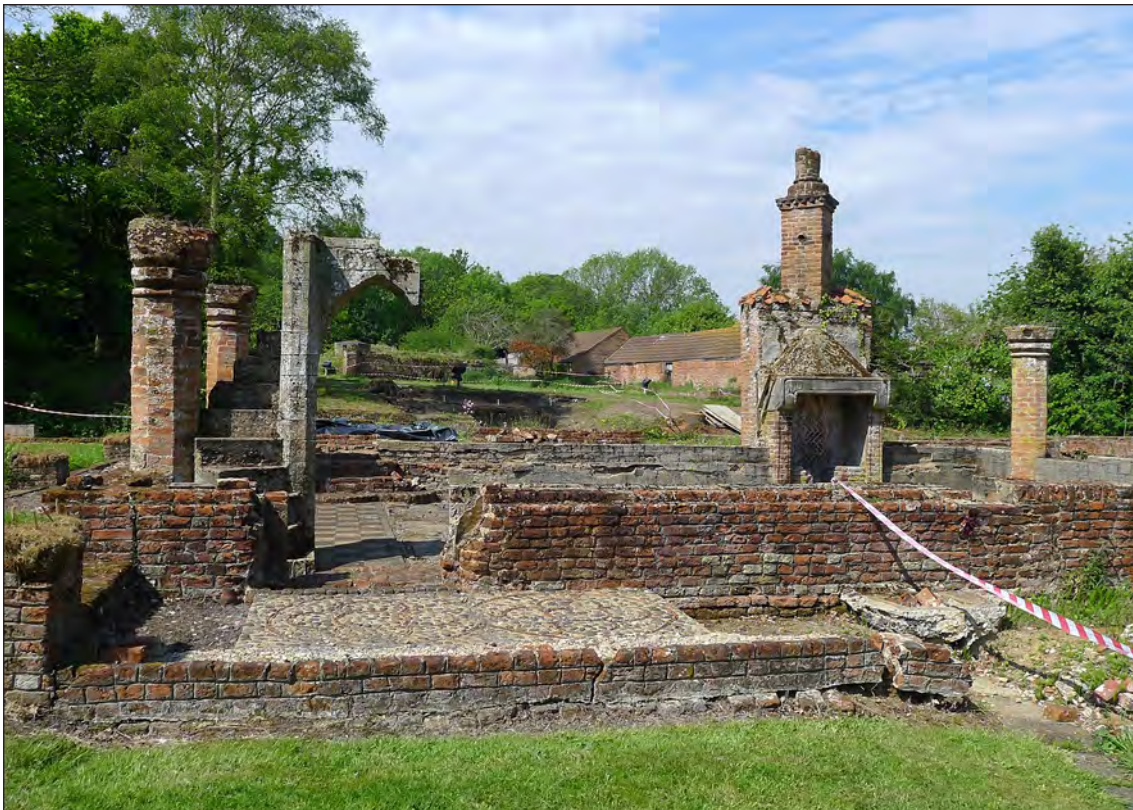
Surviving from the reconstructed hall are two pairs of brick columns to north and south that supported the timber frame and a rising concrete spiral stair that led to a gallery. There is also the substantial fireplace and chimney stack towards the north end of the west wall (mentioned above), and a semi-circular sunken feature in the middle of the east wall of uncertain function (Figure 39). Although a probable drain suggests it contained water, photographs survive showing it to have contained one of the main structural crucks of the reconstructed hall. It is therefore possible that the floor here was lowered to accommodate this and the drain was to prevent the timbers becoming damp (Michael Meekums, ODAS, pers comm). The largest entrance is to the south and there is another entrance at the south end of the east wall; both allow almost level access. Two further entrances step down into the reconstructed hall, one from the entrance causeway at the south end of the west wall and one at the north end of the east wall. As noted, these are all secondary late features not visible on the 1934 APs (Figure 13); the south, south-east and north-east entrances, the semi-circular feature, and possibly the fireplace, were cut through or into existing walls, though the walls probably date, at least in part, from the Marsham-Townshends' earlier work.

Figure 39 – A general view of the Hall area from the south-east. Three of the four brick columns, the concrete stair and the fireplace are visible, the decorative pavement in front of the south-east door (middle foreground) is typical of the other late decorative pavements laid by the Marsham-Townshends seen elsewhere (Jonathan Kewley 11/5/2017 © Historic England)

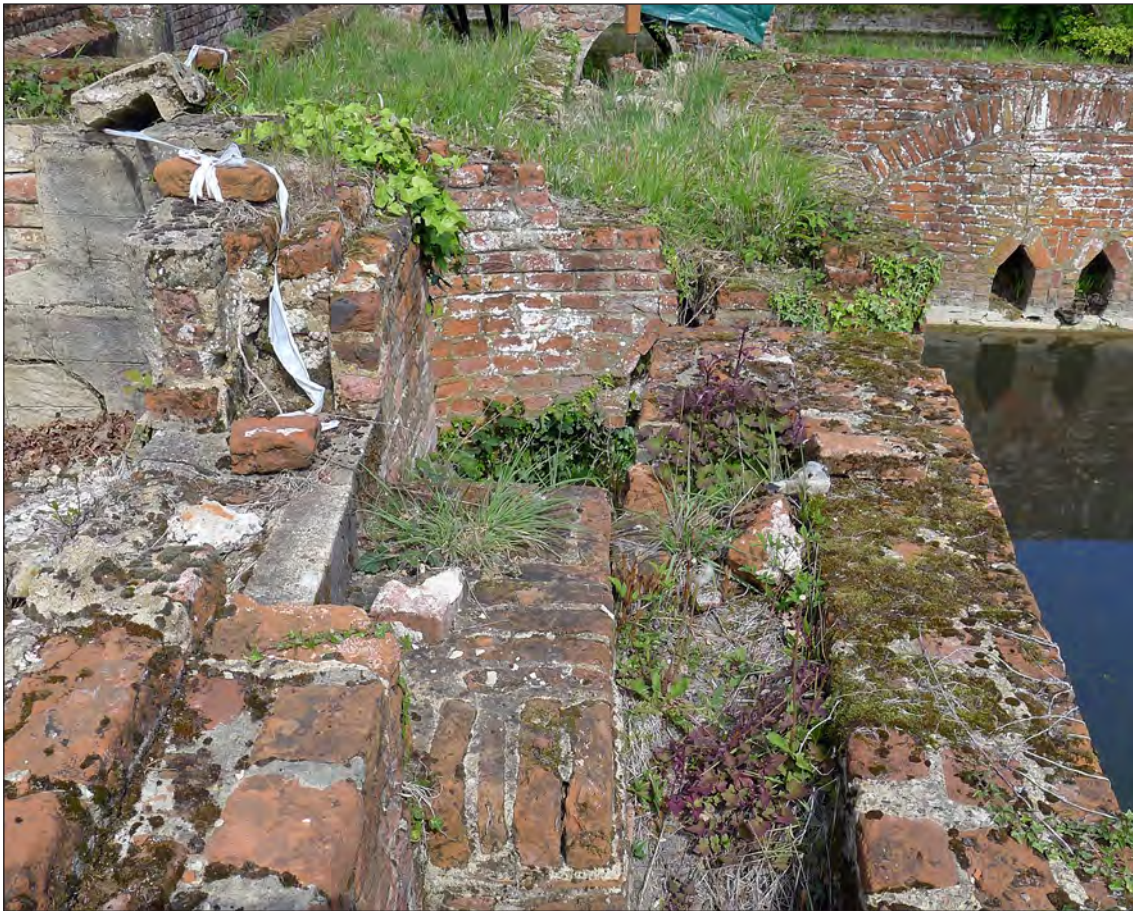
Figure 40 – The awkward relationship between the north-east corner of the Hall (left) and the Large Cellar (right) (Jonathan Kewley 26/4/2017 © Historic England)

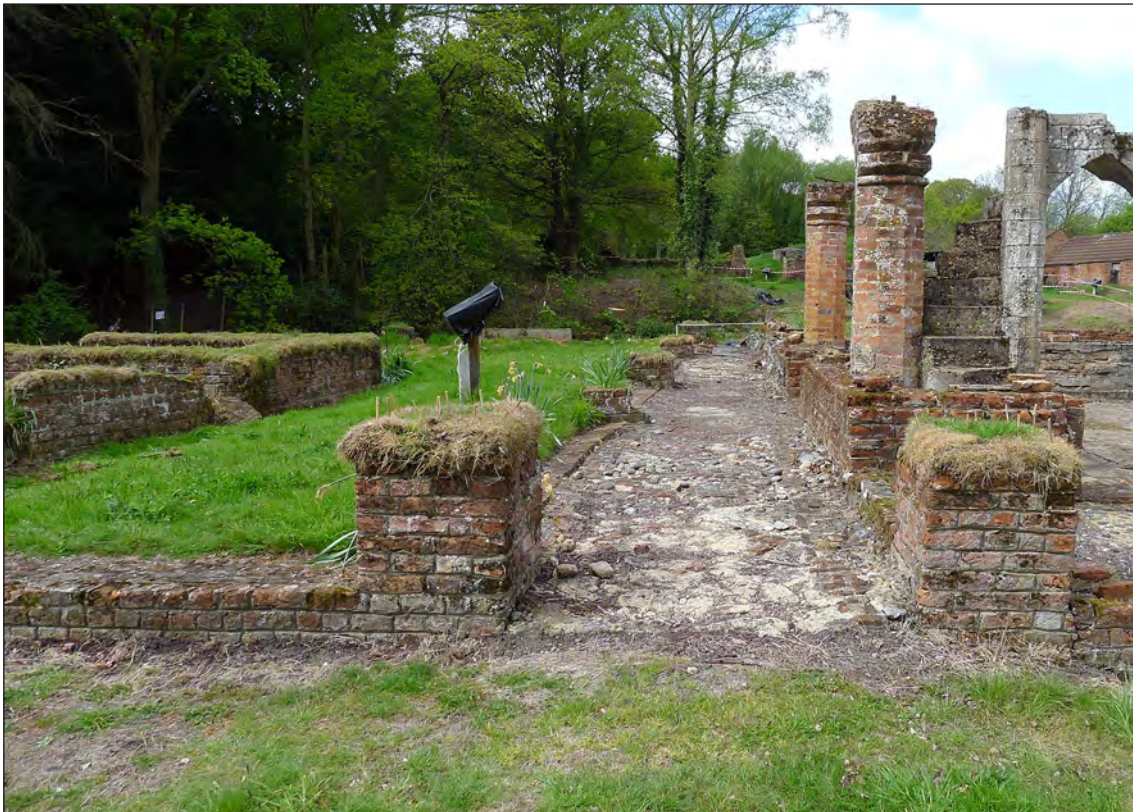
To the immediate south of the flint wall a late decorative pavement [22] of similar pattern to elsewhere, runs for over 16m along the south side of the entrance causeway, Hall and beyond and is about 1.20m wide (Figure 41, centre). To the south this is defined by a late, low, brick wall with five regularly spaced square planters, which turns south on the line of the wall east of the Hall and was in place by 1934 (Figure 13). There is no evidence for any early footings to this wall, though they may have been present; G&S show a narrow wall on this line, pecked in the central section suggesting it was only partially traceable.

Figure 41 – A general view of the area south of the flint wall from the east; the Hall and flint wall can be seen to the right, the turf capped well enclosure to the left (Jonathan Kewley 26/4/2017 © Historic England)

South of this is level grass, retained to the south by a substantial brick enclosure around two wells (Figure 41, left) with very light walls running away from this to the east and west, the latter returning to the north to run parallel to the west moat wall, though their collapse is leading to slumping (see west moat wall above and south moat wall below). East of the well enclosure, at the level of the grassed area to the north, is a rectangular structure [23] that appears superficially like that around the well. The north wall has a similar form with single skin bricks and a concrete core and continues the line of the well enclosure. There is a planter on the corner where it returns south, again on the line of the wall to the east of the Hall and there is an entrance in the approximate centre of this east wall. A cast concrete path runs west from this across most of the enclosure. Although the enclosing walls appear as substantial as those around the well, all are collapsing to some extent, presumably following the collapse of the light wall to the south, so appear to have been built without proper foundations. This structure is clearly secondary to the well, and did not appear on the G&S survey; a narrow wall on the line of the late north wall was indicated with dashed lines which returned to the north where it was shown to be more substantial and went on to meet the wall to the south of the decorative pavement (above). This rather suggests an early building to the north was of more historical significance than the late structure to the south. The G&S survey does though note 'paving of brick laid flat' over a rectangular area like the northern two thirds of the later structure but this may have been a yard surface. The survey gives a

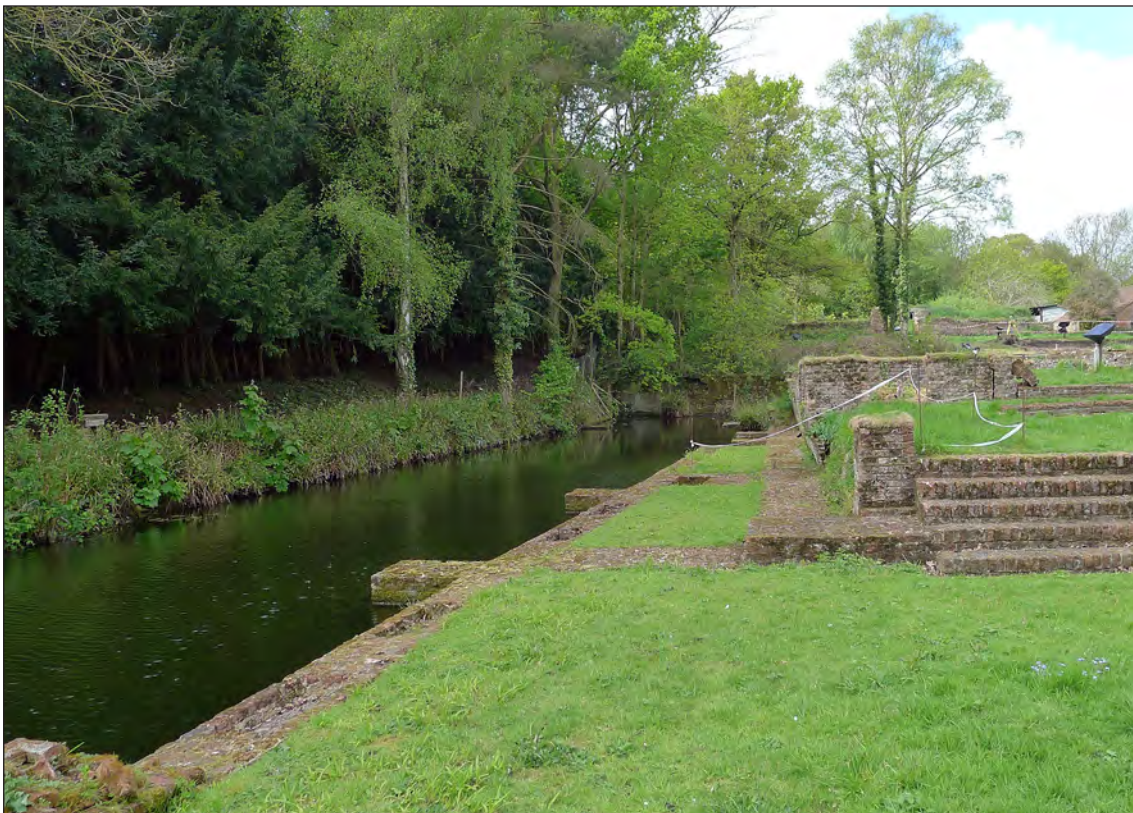
The south moat wall comprises two main elements, the low moat wall (itself made up of two distinct sections), and set back from this, along the western two thirds of the island, a second set of walls retaining the high ground to the north (Figure 42). All visible brickwork is late, and historic OS maps show that this side of the island was realigned to run more to the ENE (note particularly the differences between the 3rd and 4th editions), though the south-west corner seems to be in roughly the same location, and ODAS describe the buttress here as original (Hart 2000, fig 5, 11). The excavation photographs show what appear to be sections of surviving early walls and buttresses apparently in the location of the existing work so it seems that rather than building new walls on new lines, the Marsham-Townshends ‘chased’ the walls along this side of the island and built up from what he found. The previous depiction of the island here might have been the result of material collapsing from the north pushing its apparent line to the south.

Figure 42 – General view of the south moat wall from the SE corner of the island looking west (Jonathan Kewley 26/4/2017 © Historic England)

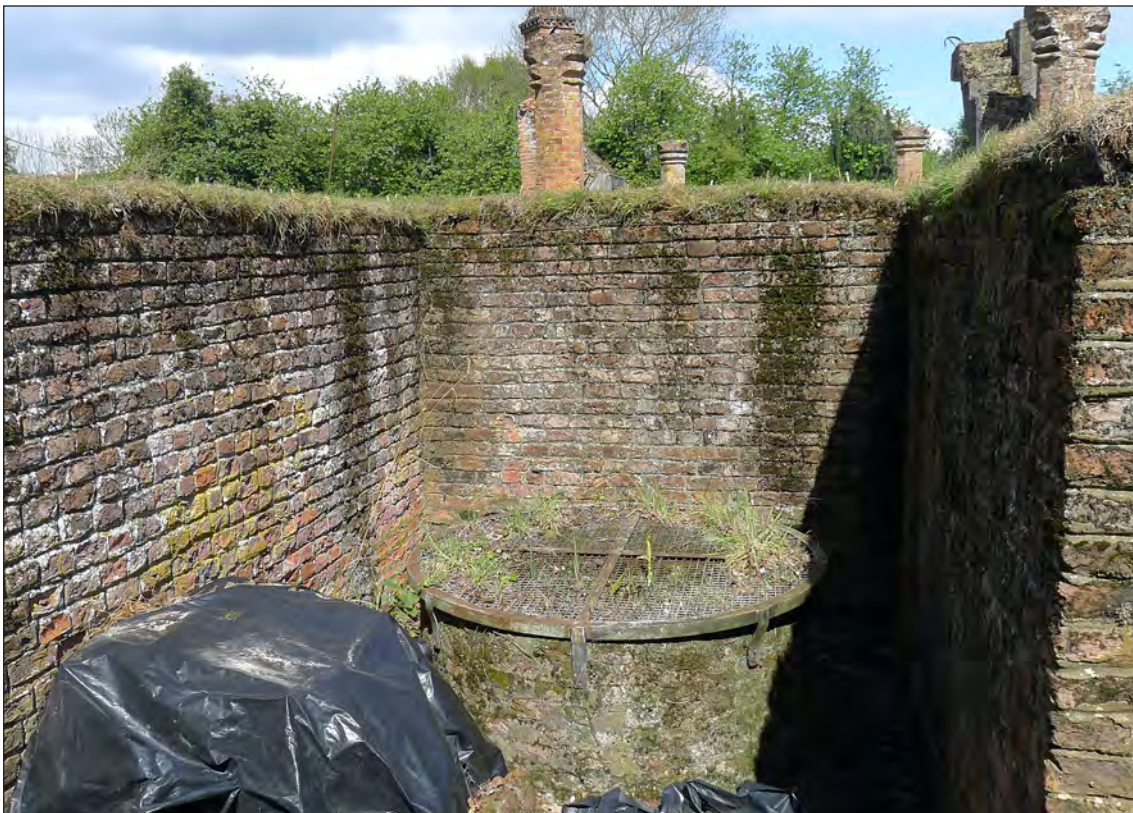
Figure 43 – The south well enclosure from the SSE, the second well is in the back-left corner and cannot be seen (Jonathan Kewley 26/4/2017 © Historic England)

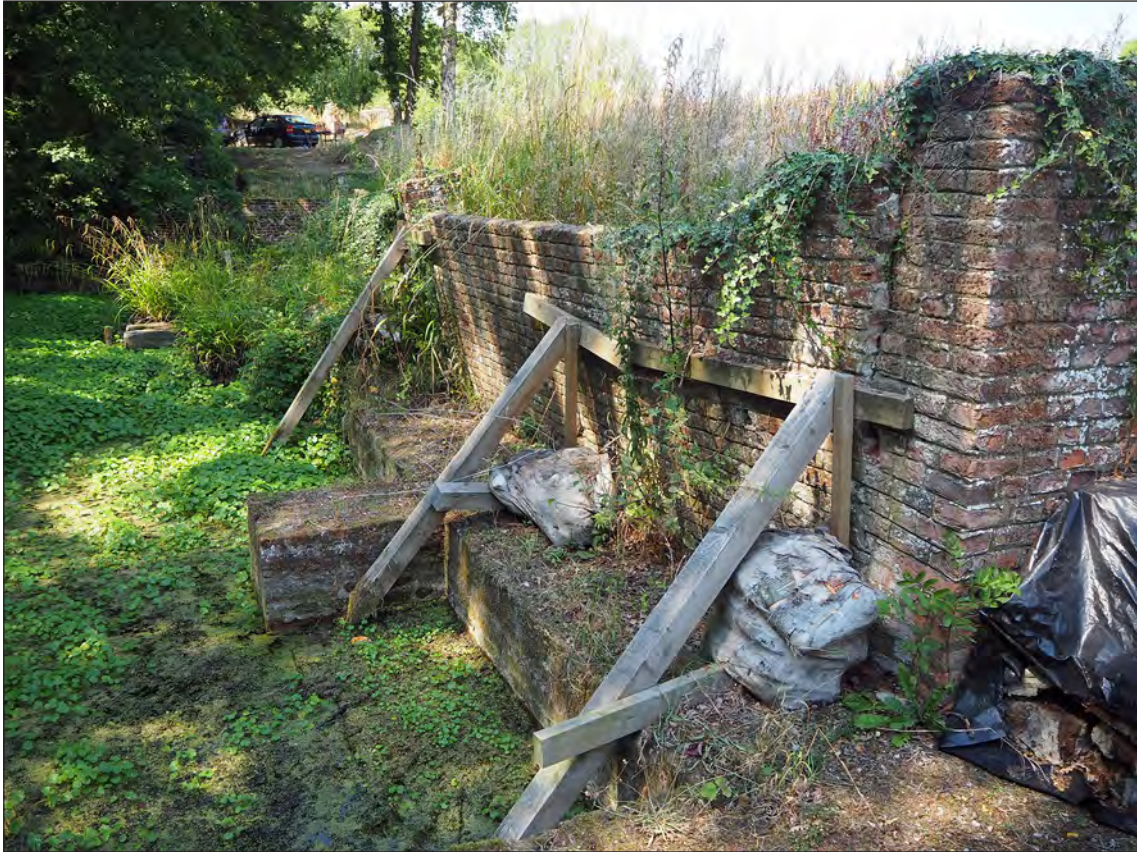
Figure 44 – The collapsing retaining wall to the west of the well enclosure from the east (Magnus Alexander 11/8/2020 © Historic England)

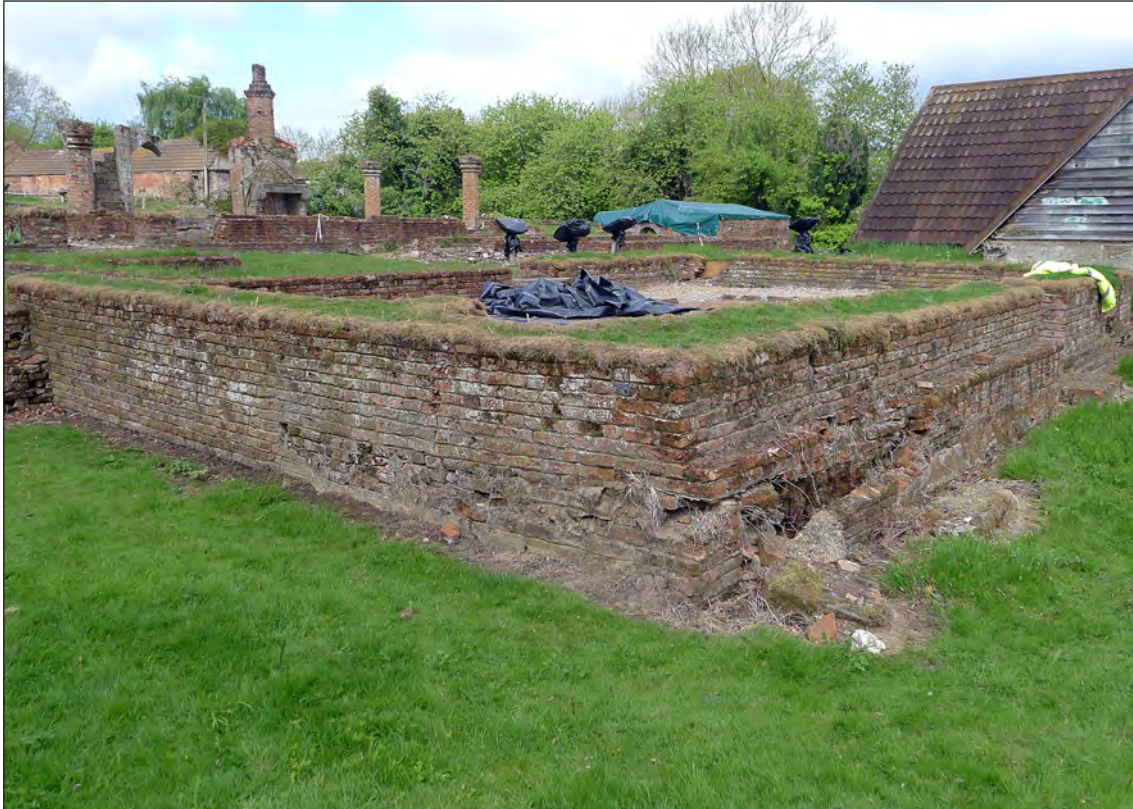
Figure 45 – A general view of the Kitchen from the south-east. Note the slightly decayed early work in the base of the wall to the left of the near corner and the late work spalling away from earlier work to the right (Jonathan Kewley 26/4/2017 © Historic England)

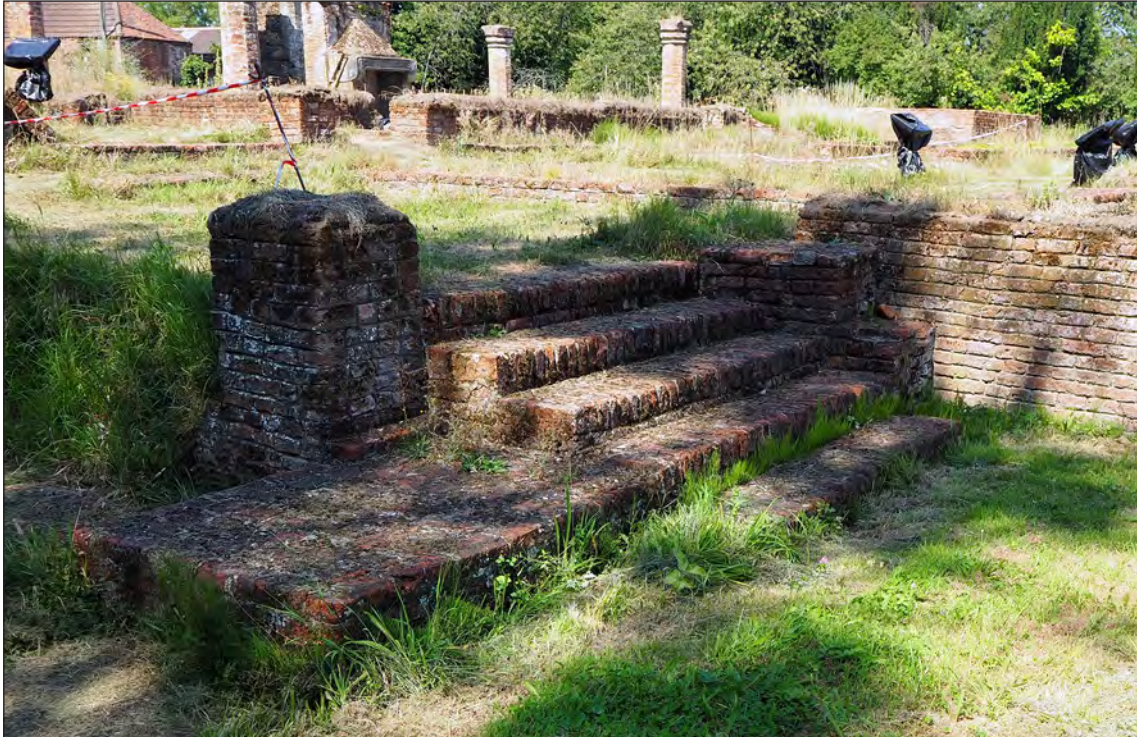
A broad set of brick steps [30] with adjacent brickwork runs SSE for 4.3m or so, from the south-west corner of the Kitchen and on the same line but slightly to the west (Figure 46). As noted above, this retains higher ground to the west, the steps allowing access. The wall to the south also stepped down though this was clearly not intended for access. All this work appeared to be late, but again the G&S survey showed a wall here, so it probably incorporates early work.

Figure 46 – Steps to the south of the Kitchen (Magnus Alexander 11/8/2020 © Historic England)

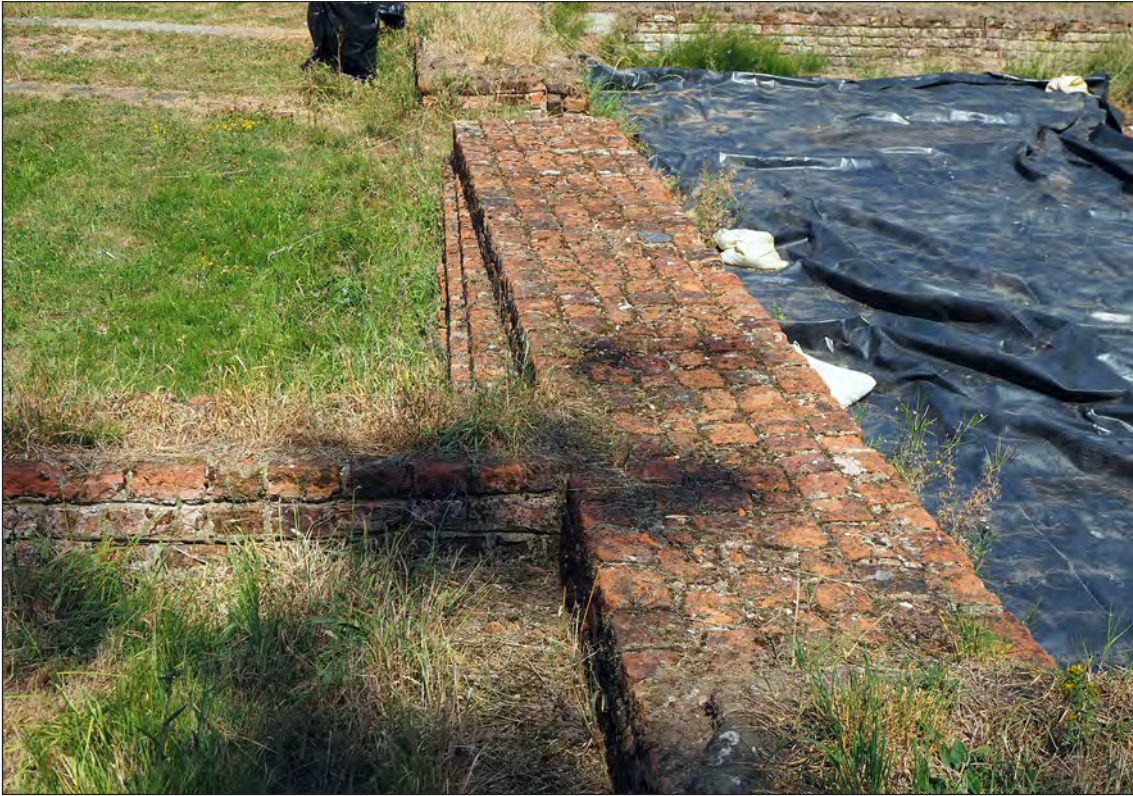
above). Although the existing west wall of the Kitchen runs on much this line, it is straight and a uniform width and although all of the visible brickwork seems late, the alignment of the lowest courses south of the west Kitchen entrance reflect that of the G&S plan, so are probably early (Figure 48).

Figure 48 – The west wall of the Kitchen from the south, showing the markedly different orientation of the lower courses (Magnus Alexander 11/8/2020 © Historic England)

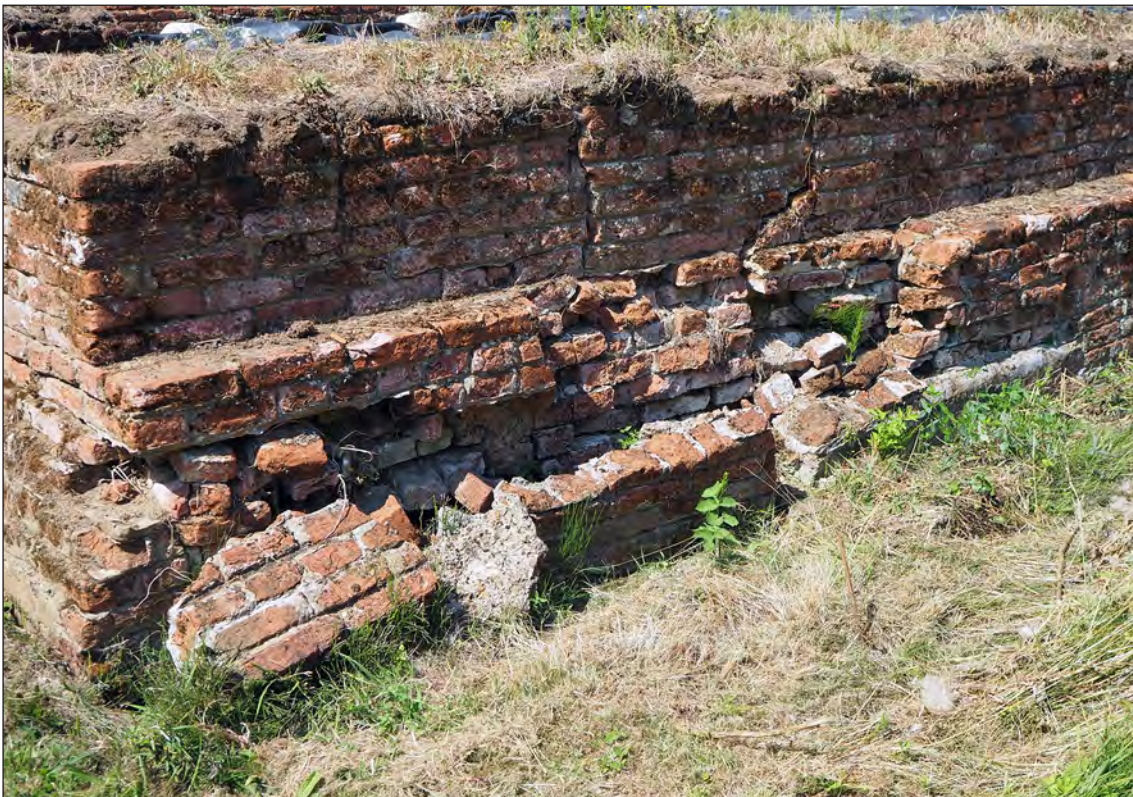
Figure 49 – The south end of the east wall of the Kitchen, from the south-east, showing the late skin falling away from the probably early core (Magnus Alexander 11/8/2020 © Historic England)

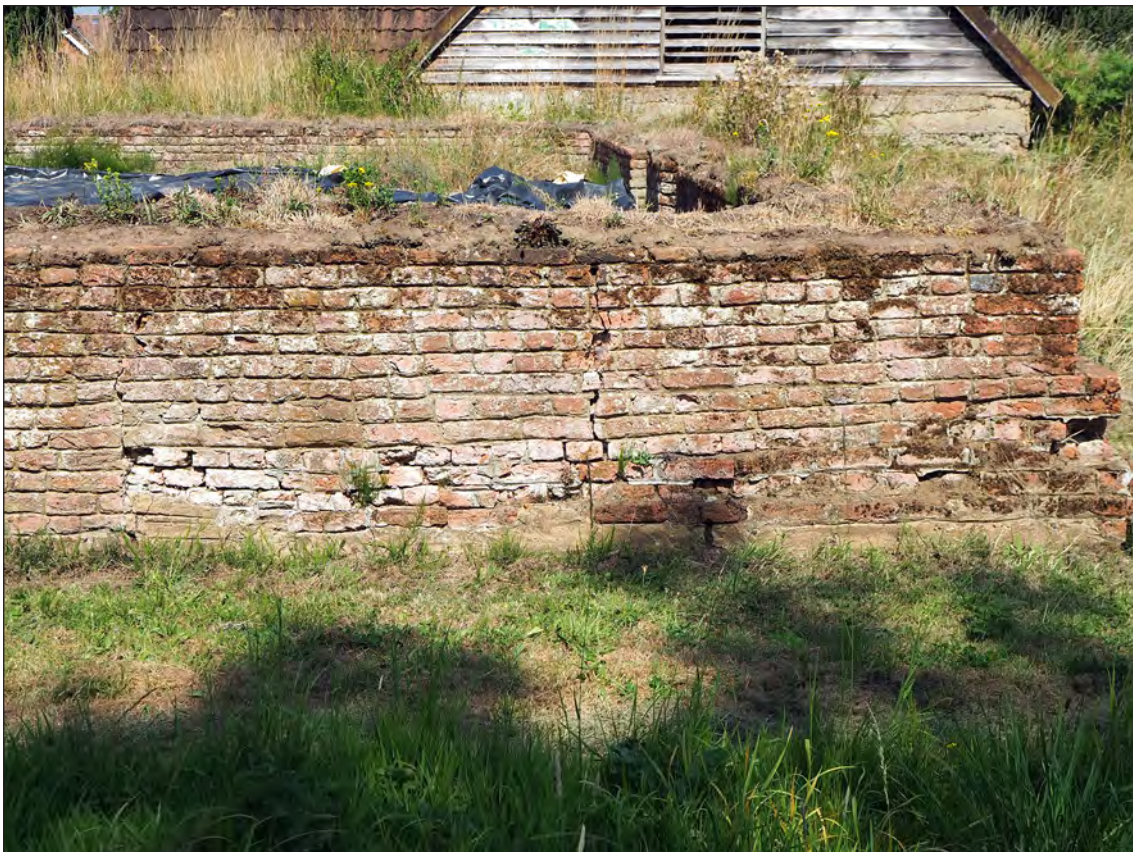
Figure 50 – The east end of the south Kitchen Wall, note the presence of English bond towards the base (Magnus Alexander 11/8/2020 © Historic England)

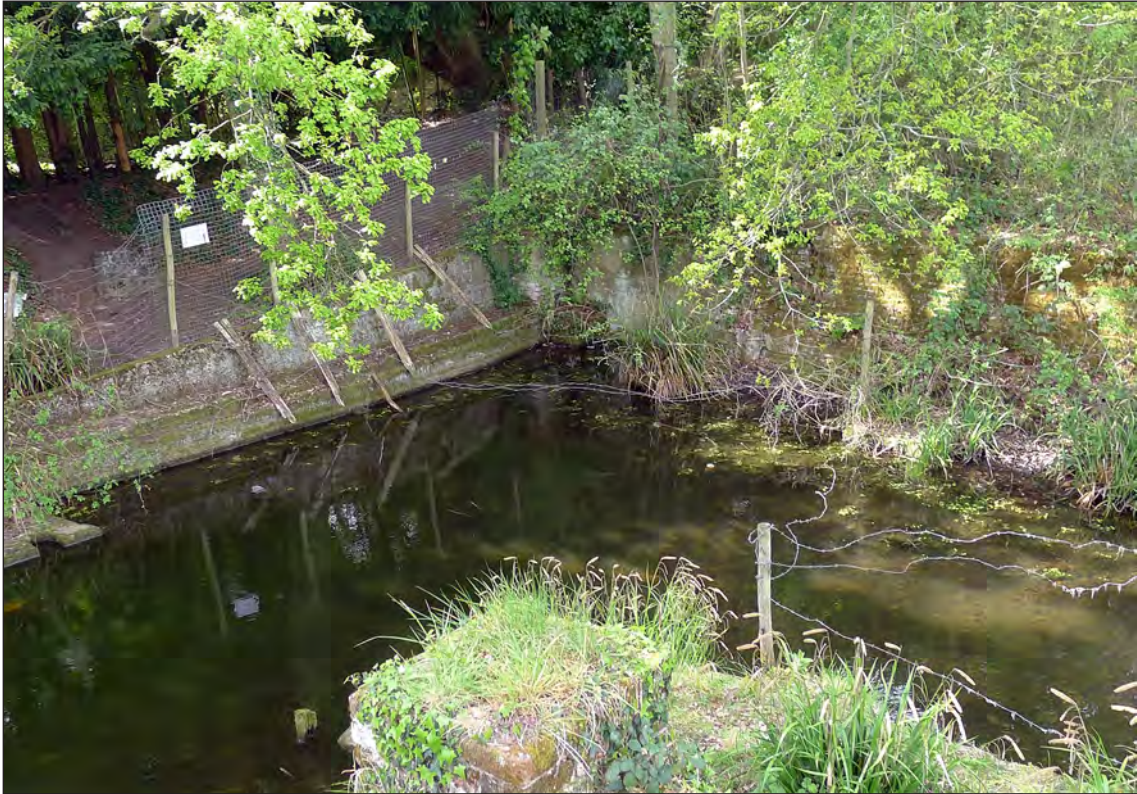
To the south is a section of shutter cast concrete with a single course of brick coping, probably continuing around the corner from the west end of the south moat wall (above), though a brick pier between the two makes this uncertain (Figure 51). Immediately to the north, the wall is of brick which has been heavily repointed and has no coherent form or bonding. Here the wall steps forward at the base, where there were several low buttresses, though most of these were not visible at the time of survey. The upper parts, visible at the time of the survey, appear to be late but, for the reasons given above, are probably early at core. The lower parts and buttresses are more likely to be early, though consolidated by the Marsham-Townshends.

Figure 51 – The south-west corner of the moat from the moat island, south moat wall to the left, west moat wall to the right (Jonathan Kewley 26/4/2017 © Historic England)

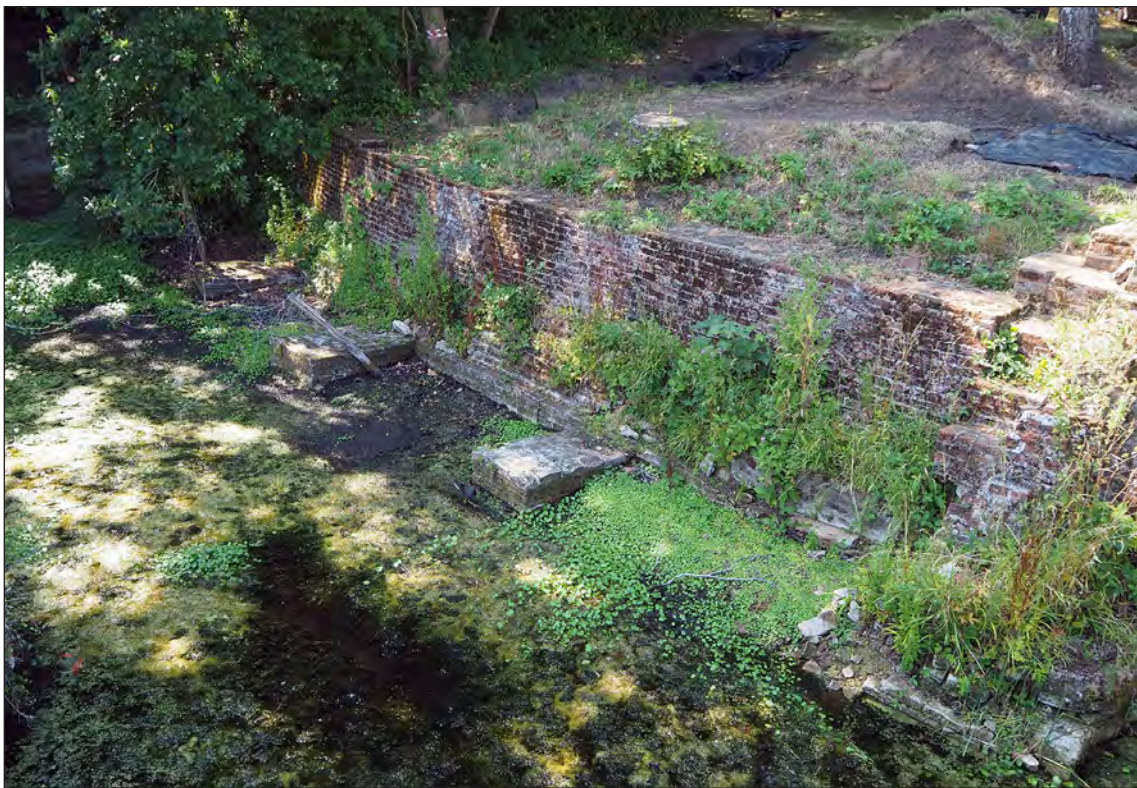
North of this is about 12m of more uniform brickwork extending to the west bridge abutment. This has a near vertical upper section with a stepped-out base and a low buttress. Most is heavily pointed and falling away in some areas, but in places appears to be English bond. Although numerous partial bricks and adjacent courses of headers suggest this was late, the ODAS comments on the use of partial bricks in the west moat island wall (above) may apply here. The lower courses were

Figure 52 – The southern part of the outer west moat wall with particularly low water level, part of the western bridge abutment can be seen to the right (Magnus Alexander 11/8/2020 © Historic England)

underwater at the time of survey so could not be seen clearly, but recent site visits have allowed them to be photographed (above).
