Archaeological Investigation

SCADBURY MOATED MANOR, LONDON BOROUGH OF BROMLEY: LANDSCAPE INVESTIGATIONS

Research Report Series 012-2021

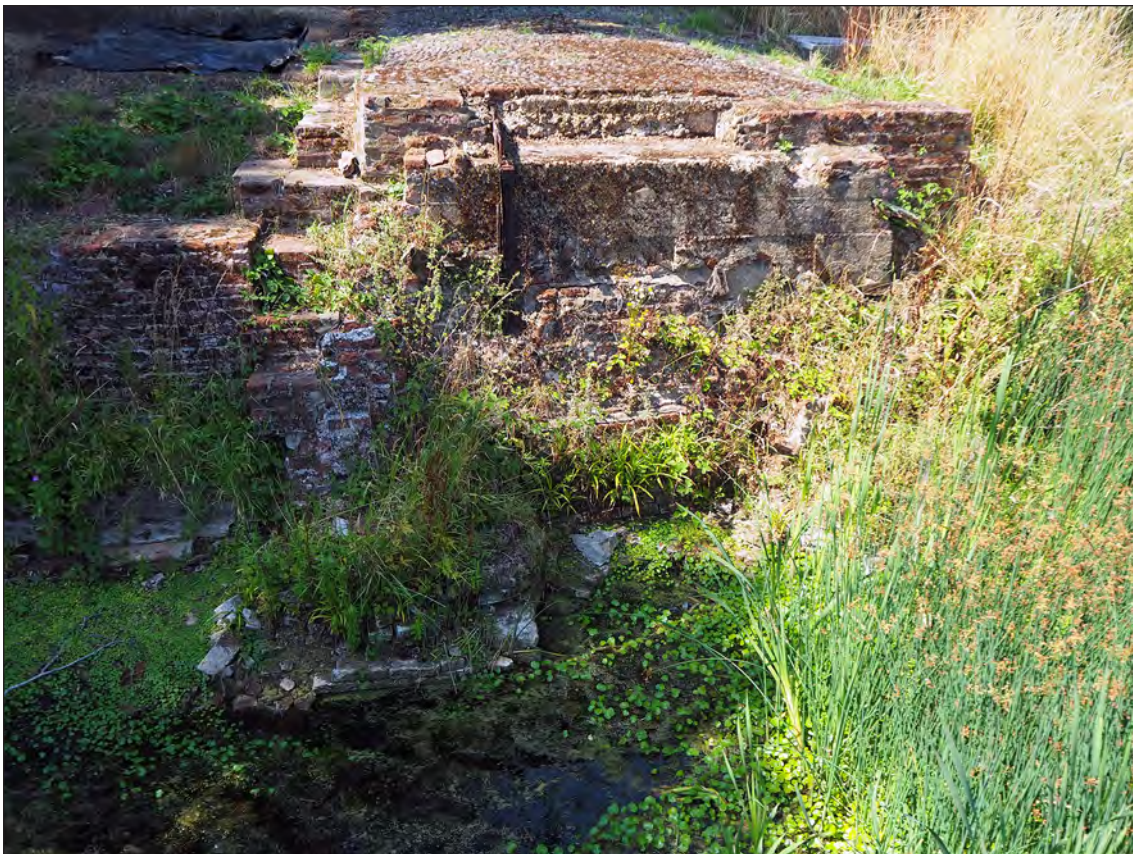
Figure 53 – The western bridge abutment from the east, although overgrown the low water level allows some features not visible during the survey to be seen (Magnus Alexander 11/8/2020 © Historic England)

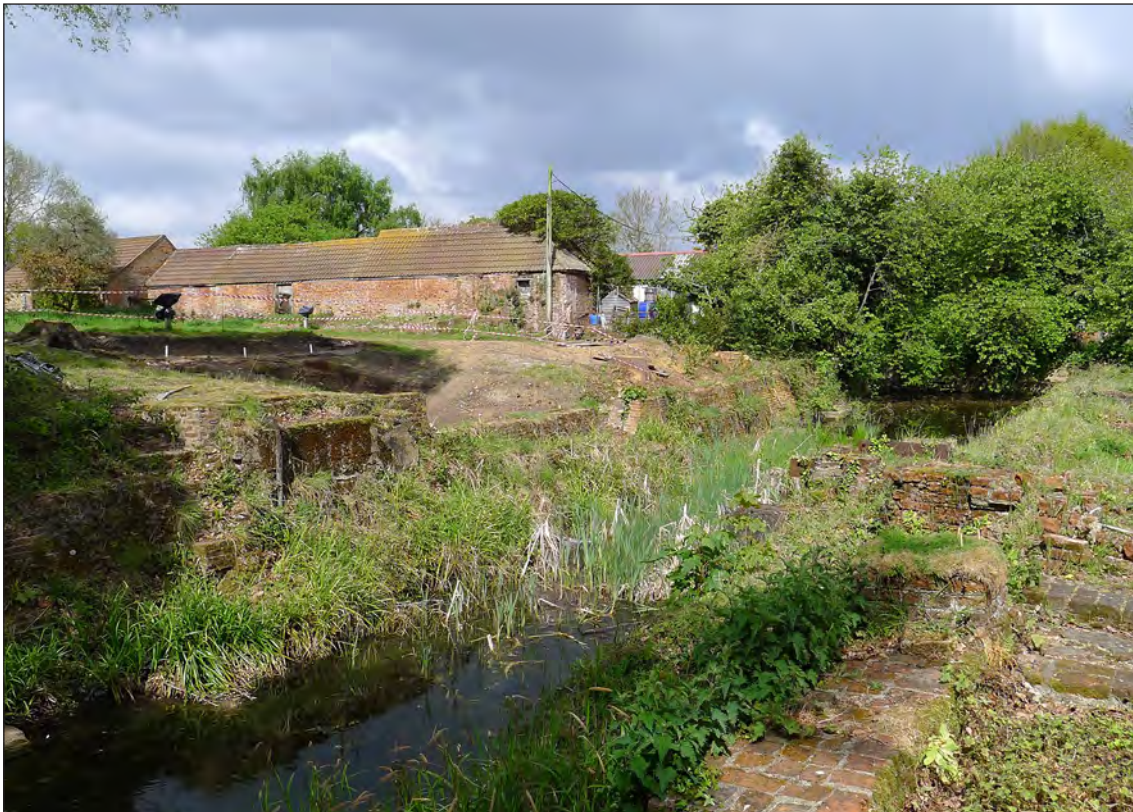
Figure 54 – A general view along the west moat arm looking north (Jonathan Kewley 26/4/2017 © Historic England)

decayed wall running along this side of the moat north of the bridge abutment so this late work (and that described below) was based upon early footings perhaps still visible as the stepped out base, which also suggests that the stepped out base to the south of the bridge abutment was early. The following 4.2m are set back, apparently in order to provide a small area with access to the water level, approached by a set of steep, narrow, late steps similar to several others. The creation of this section may have removed some of the surviving early wall, though some could survive below. At the time of survey ODAS had a trench open behind the sections of moat wall described above (see Figure 54 and 'Discussion' below for their findings).

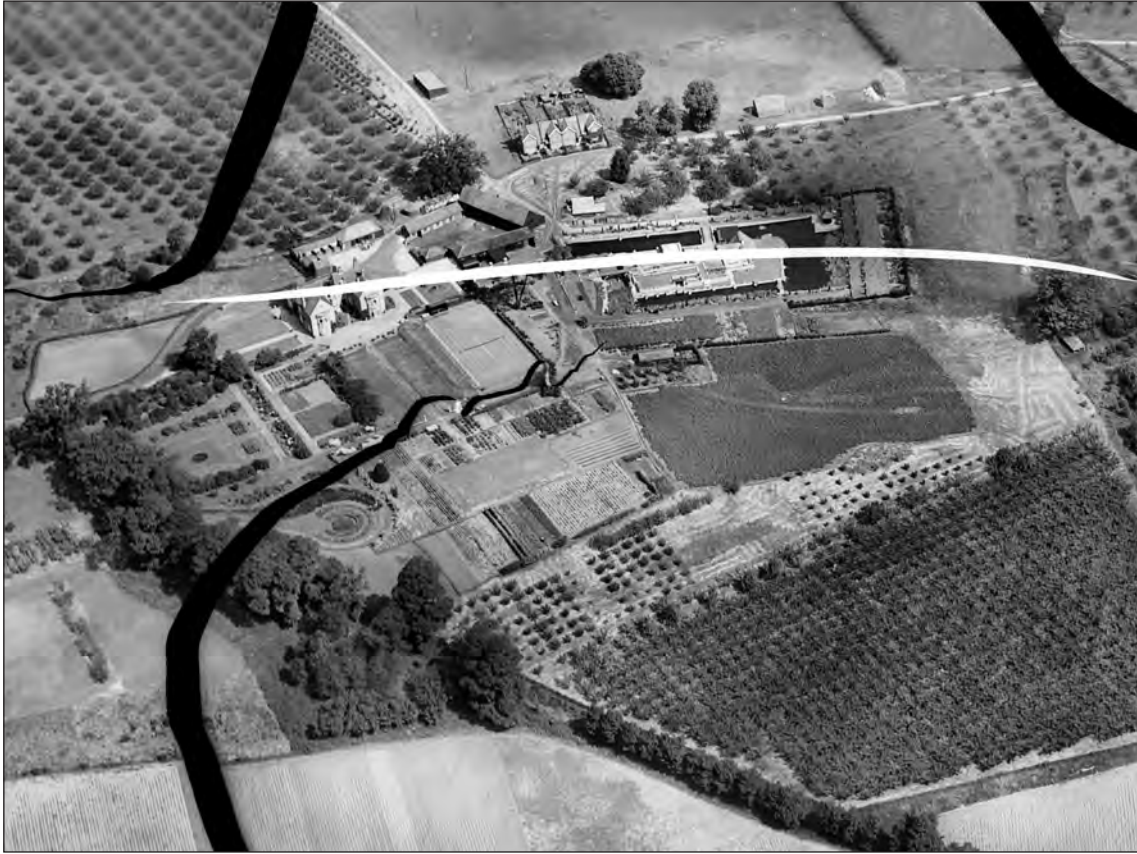
Figure 57 – Detail from a July 1934 aerial photograph of Scadbury Moated Manor from the south. AFL193408/EPW045614 © Historic England (Aerofilms Collection)

Along the bottom of much of scarp [9] are smaller secondary scarps [15]. These are generally rather irregular but around the south-east corner of the dam and along the south side of it there is a clear terrace defined by a lower scarp [16]. The 1934 aerial photographs (Figure 57) shows a faint path running along the base of the dam and these regular scarps suggest that this may have been deliberately constructed rather than simply eroded.

Much of south-west third of the walled garden is given over to a fenced enclosure formerly used by a nursery based on site and was not surveyed. This area appears to have been a productive garden in the 1920s/30s with regular rows of planting visible on an early photograph (Figure 58) and the 1934 APs (Figure 57). A line of trees to the north-east, visible in Figure 57, was probably to screen it from the house. Between this enclosure and the garden walls is an accessible strip 3.0-3.5m wide where a low, inward facing scarp [54] can be seen, which continued along the full length of the south-west wall. It was unclear if this was the remains of old planting beds or a path, or the build-up of debris from the wall, but the raised area was noticeably lower for several metres about halfway along the south-west wall, where there was a section of newer brickwork and the 1934 APs show a gate, which suggests beds. To the south-east of the fenced enclosure is an open area falling

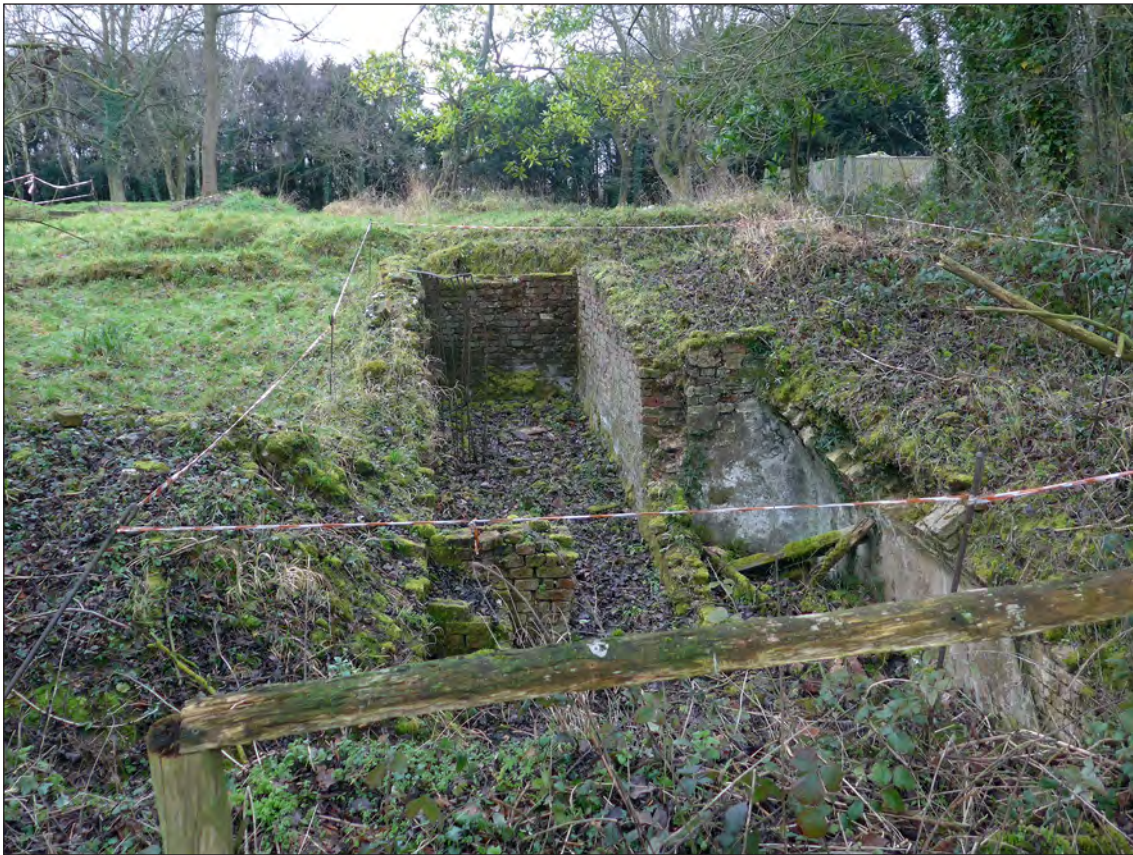
Within the area surveyed are the remains of Scadbury Park Mansion, occupied on and off by Hugh from the early 20th century and extended by him in 1919-20 (see Figure 4 and Figure 58). ODAS have concluded from an examination of the foundations and cellars (Figure 59), that the house had mid-16th-century origins and was originally, perhaps, the gatehouse to the manor (Hart 2008, 23). Various foundations and walls were surveyed [43] and these correlate with the excavated plan published by ODAS (*ibid*, 7), though more recent work by them has exposed additional features, including the footprint of the south-east wing [44], part of the 20th-century expansion. To the west of this area a rectangular hollow was surveyed [45]. Though a spoil heap obscures its full extent, its width and orientation suggest it marks the site of the corresponding west/south-west wing. A scarp falls away to the north, and north of this is an approximately square level area [46] very probably marking another part of Scadbury Park Mansion. ODAS report that the footings here were completely removed during the levelling of the site by LBB in 1984 (Hart 2008, 8).

Figure 59 – The cellar of Scadbury Park Mansion from the north, note the vault spring to the right, English bond brickwork is visible in places (Magnus Alexander 14/2/2018 © Historic England)

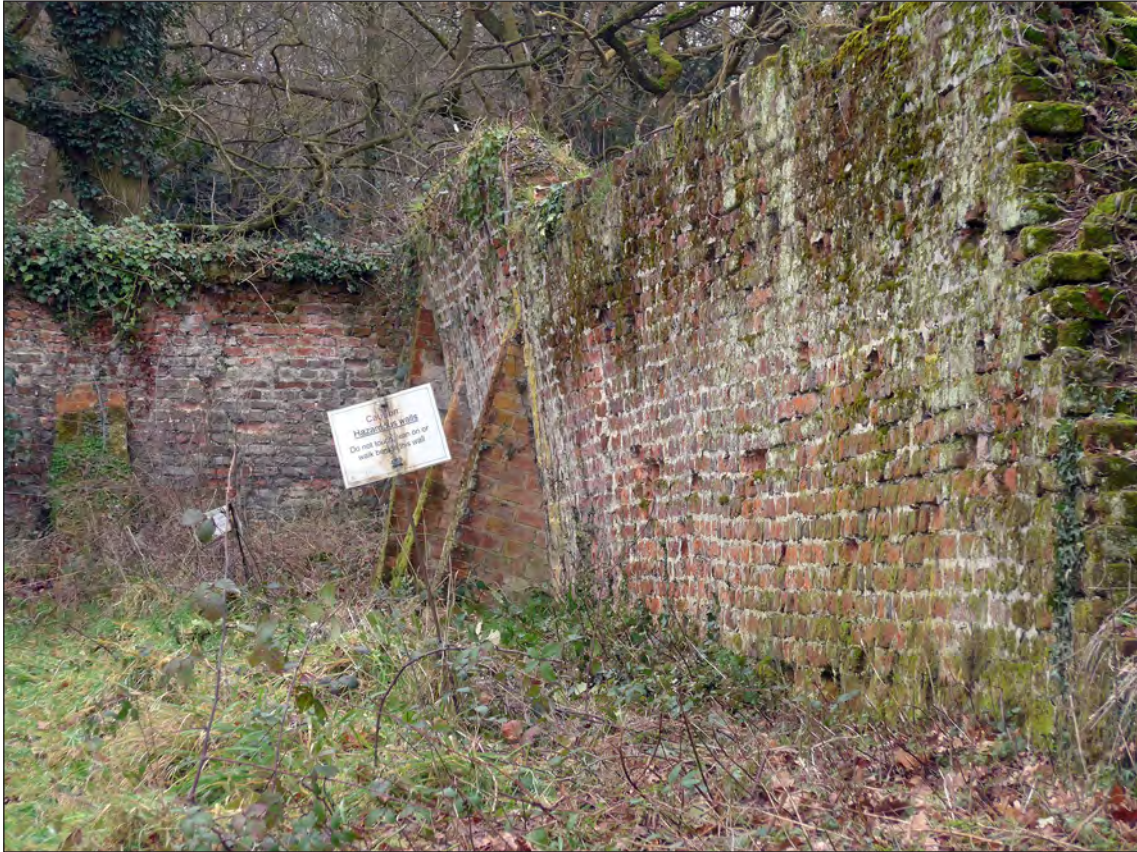
Figure 60 – The western corner of the walled garden from the ENE showing the buttresses supporting the leaning north wall (Magnus Alexander, 14/2/2018, © Historic England)

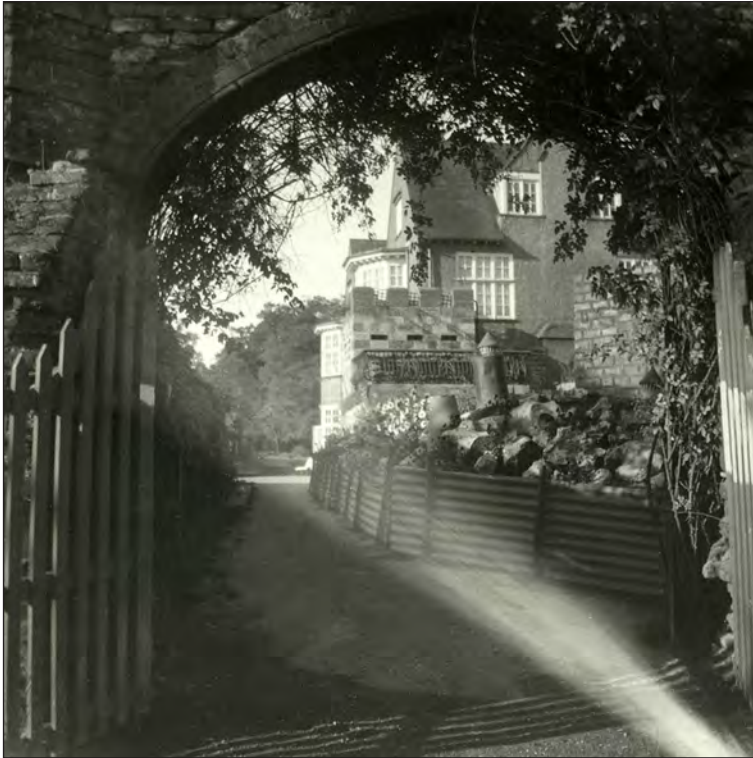
Figure 61 – The Second World War structures in about 1940 viewed through the ‘Tudor’ arch to the south-east, the flare is on several contemporary negatives – clearly a faulty camera (BHC, 1080/2/1/17)

To the north-west of the tennis court is a substantial rectangular structure [61], 14.5m south-east/north-west and 16m south-west/north-east, and typically 1.2m high. This is crudely built of earth and other debris retained to the north-east and most of the north-west side by shuttered concrete, and elsewhere by sheets of corrugated iron, most of which have rusted away, held vertically by what appear to be sections of rail from a light railway, perhaps that used by the Marsham-Townshends during their excavation of the moat (Figure 61, Figure 62; see also

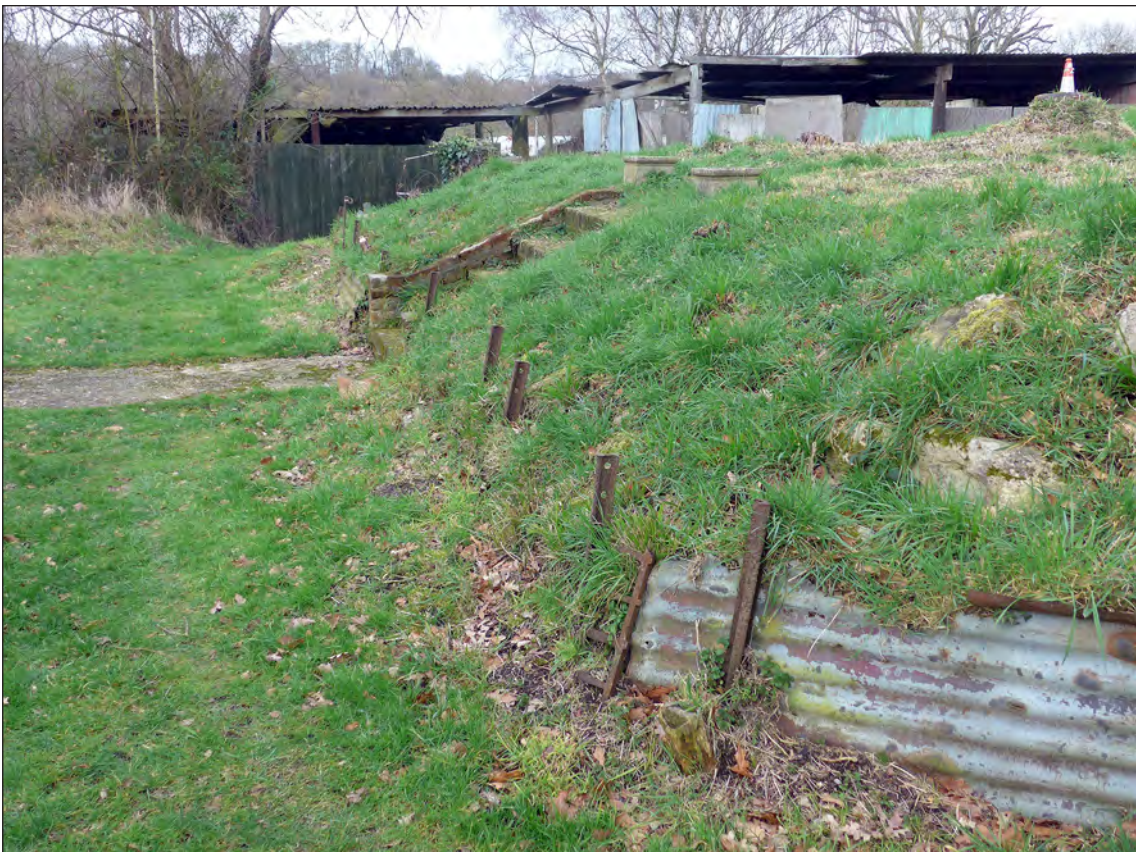
Figure 62 – The south-west side of the same structure from the south showing the metal revetment, garden steps and modern ramshackle sheds behind (Magnus Alexander, 14/2/2018, © Historic England)

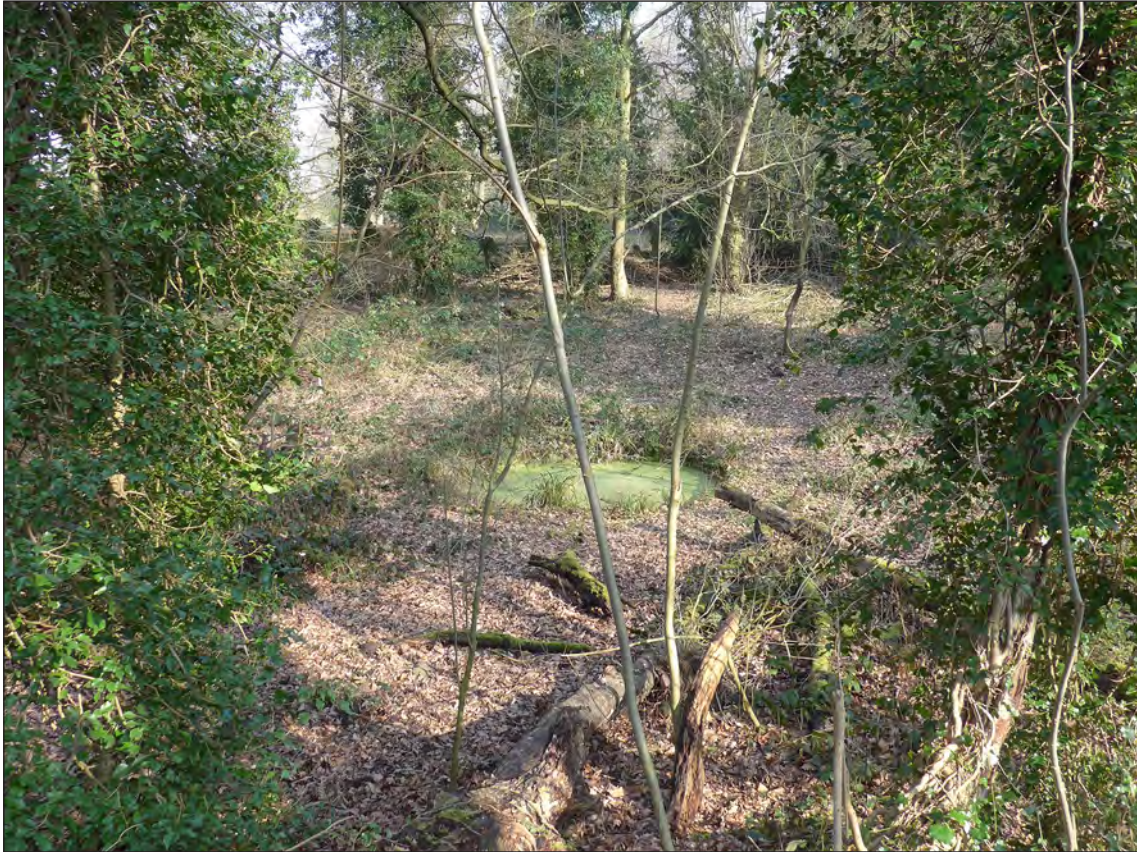
Figure 63 – A general view from the west across the rectangular depression west of the walled garden with the circular pond visible in the centre (Magnus Alexander 22/02/2018 © Historic England)

The area to the immediate south-west of the walled garden is dominated by a large rectangular depression on a similar orientation measuring about 40m north-west/south-east by 31m north-east/south-west (Figure 63). To the north-east, this is defined by a moderate scarp [70] that increases in height as the general topography rises, reaching about 0.6m high towards the north corner. This is separated from the walled garden by a featureless strip of ground with a uniform width of about 7.2m, though this narrows slightly to the north. The 1934 APs show that this housed a deep bed against the garden wall and a broad path to the west of this; an east facing scarp [71] and gully to the north [72] are probably also related to this path. The defining scarps to the north-west [73] and south-west [74] are both higher and steeper, reflecting the topography; in the north-west corner reaching a height of about 1.8m, though rising ground beyond gives the impression of greater height. A gully running to the immediate north of [73] is probably a relatively modern path. The south-east of the depression will be described below. The early OS maps show almost the entirety of this feature to be a slightly irregular sub-rectangular pond, though the 3rd edition of 1909 (Figure 9) suggests the water filled area had reduced in size.

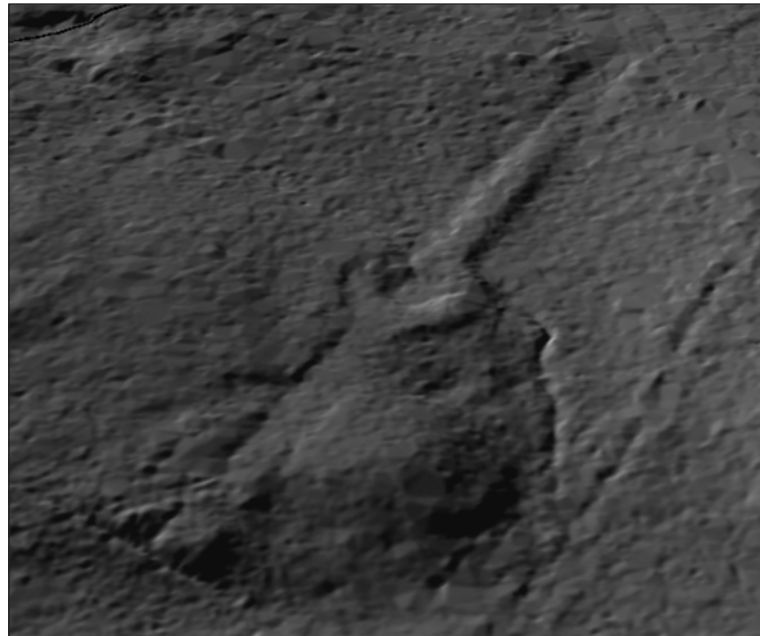
Figure 73 – Oblique view of the causeway seen on lidar. LIDAR TQ4570 © Environment Agency copyright 2017. All rights reserved

The lidar has revealed earthworks within what was the 1890s boundary of Icehouse Wood (Figure 72). These consist of a path aligned north-west/south-east, which extends across uneven ground and is defined by a combination of embankments and cuttings. From the northern end of the wood, a causeway leads downslope creating a level path 6m wide and between 50cm and 1m above the ground. A little over halfway along this path is a pond. This pond is approximately 80cm deep and measures 17m by 13m. The causeway crosses what may be a watercourse, seen on lidar but not marked by the OS. South of this possible watercourse, the ground rises slightly, and it is here that the pond is located. The path divides and passes on both sides of the pond re-joining on the opposite side. The southern continuation of the path is formed by a cutting and then an embankment. The total length of this earthwork is 180m. Based on measurements derived from the lidar, the path ends approximately 2m higher than the ground to the south (Figure 73). The name Icehouse Wood suggests that these earthworks may be associated with the production and storage of ice, but no icehouse site has been identified in this survey,

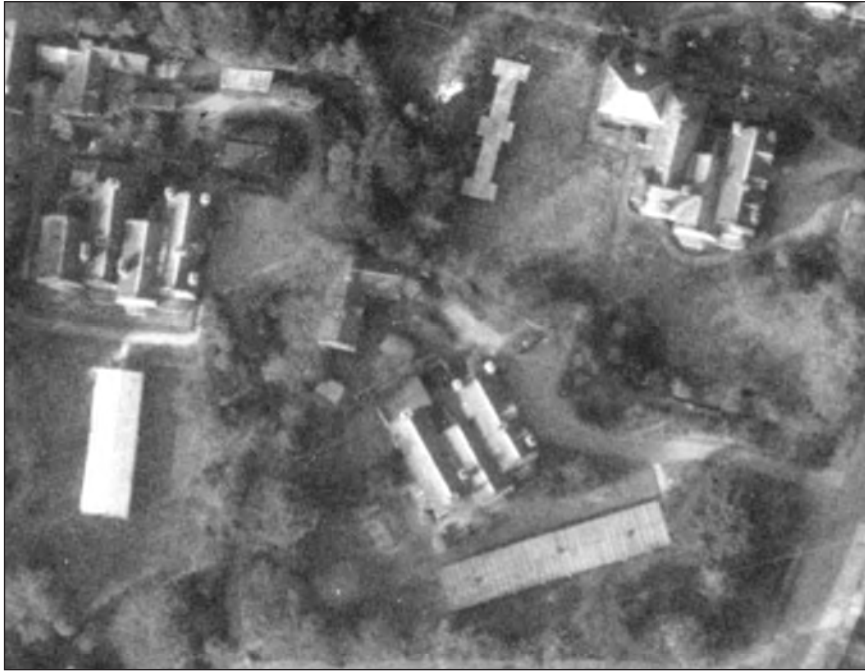
Figure 79 – Manor Park Road Detail of RAF/106G/LA/1339 RV 6142 29-MAR-1946. Historic England Archive (RAF Photography)

A second area of possible wartime activity was identified within the adjoining gardens of three large houses on Manor Park Road, to the west of St Paul's Cray Common. The houses were first named on the 1960 OS maps as Harley, Walpole and Pelham (Pelham was subdivided by 1960 into West, Upper and East Pelham). Three buildings, one in each of the three gardens to these houses, are first seen on the 1944 RAF aerial photographs (Figure 79 and Figure 80). The largest building was at Harley, built to the south of the house. It measured 31m by 6m and had a pitched roof. Immediately to the west was Pelham, in front of which was a building 19.5m by 6.5m, also with a pitched roof. The third building was constructed in the garden to the rear of Walpole, to the north of Harley. This building had a flat roof and followed an unusual plan; the main body was 19m long by 2m wide, but it had three transepts, one at each end and one at the centre, possibly entrances. These increased the width to 4.5m. Hints of interconnecting pathways suggest these buildings formed a single complex.

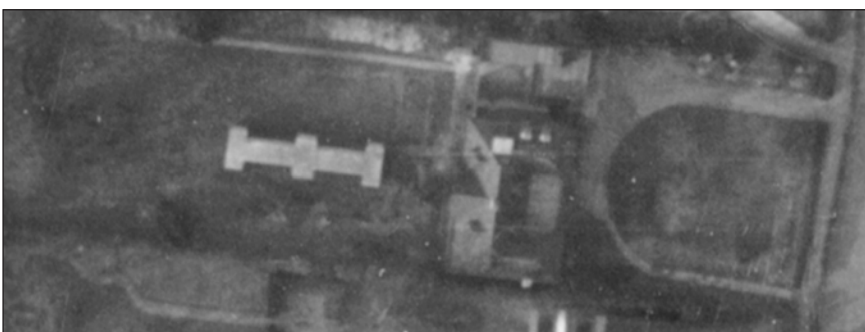
Figure 81 – War-time building in the garden of Chesham House. Detail of RAF/106G/UK/1339 RV 6309 29-MAR-1946. Historic England Archive (RAF Photography)

Road group. This building (Figure 81) was situated in the back garden of Chesham House, Wilderness Road, outside this project area. It had been demolished by 1947.

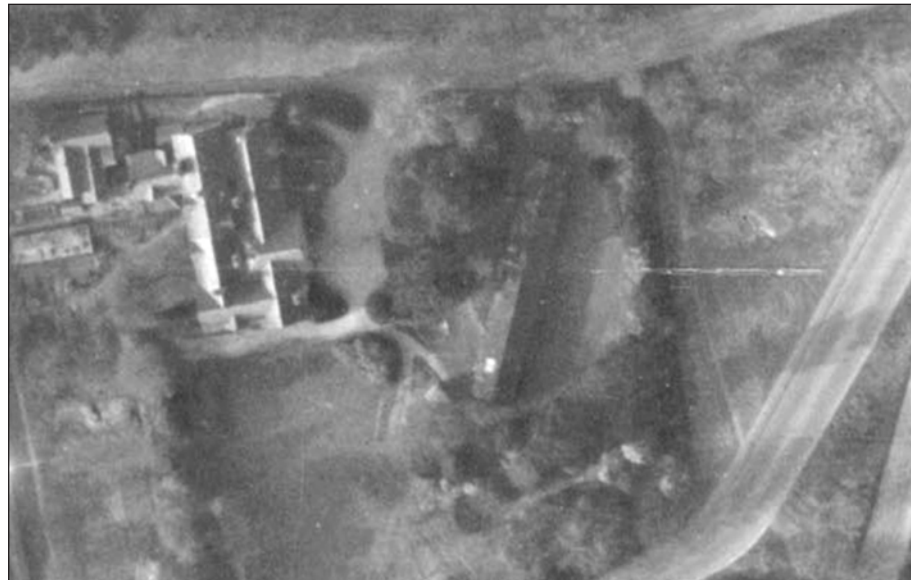
Figure 82 –
Farringtons
Junior School
site. Detail of
RAF/106G/
UK/1339 RV
6304 29-MAR-
1946. Historic
England
Archive (RAF
Photography)

A similar arrangement of a wartime building within a private garden was also seen in 1944 to the north of Manor Park Road. This building was in the garden of a house off Ashfield Lane (unnamed on pre-war OS maps but named Farringtons Junior School on the 1959 edition). It had a pitched roof and measured 34m by 6m. It had been demolished by 1951, perhaps coinciding with the conversion of the house into a school (Figure 82 and Figure 83).

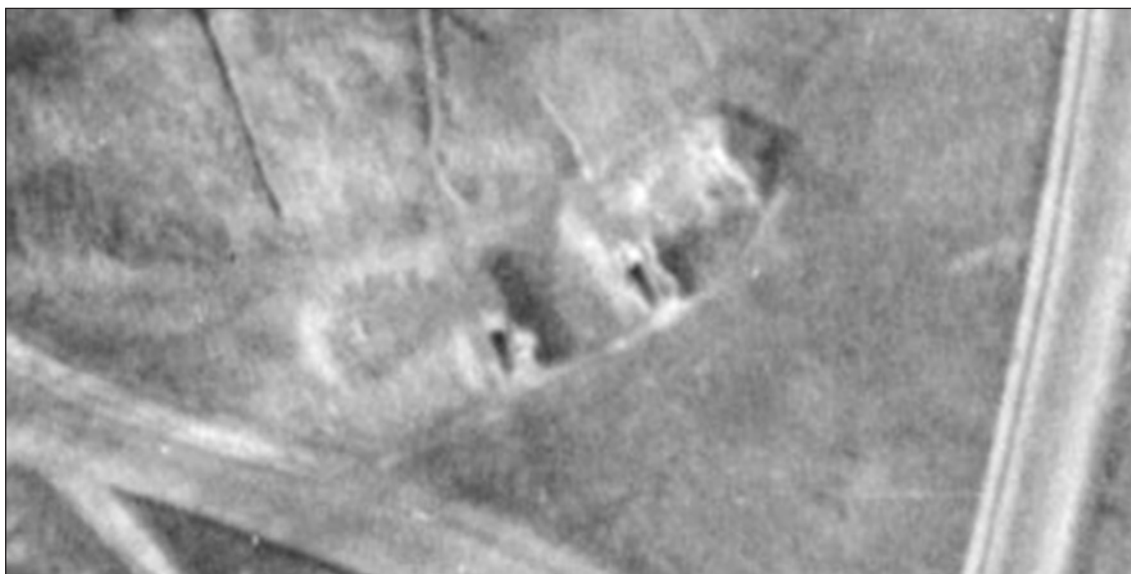
Figure 84 – Air raid shelters on Chislehurst Common. Detail of RAF 106G/LA/1339 RV 6307 29-MAR-1946. Historic England Archive (RAF Photography)

Two earth-covered air raid shelters were located at the northern end of Chislehurst Common, between the High Street and Ashfield Lane, south of the pond (Figure 84). Because these were earth-covered it is not possible to determine their exact size, but they were in the region of 15m by 5m. This matches the approximate dimensions of many of the public surface shelters built from 1939. Those on Chislehurst Common had a single entrance with a projecting porch creating an L-shaped plan. A third public surface shelter was seen on Royal Parade (Figure 85). This also measured approximately 15m by 5m but had no earth-covering or porch.

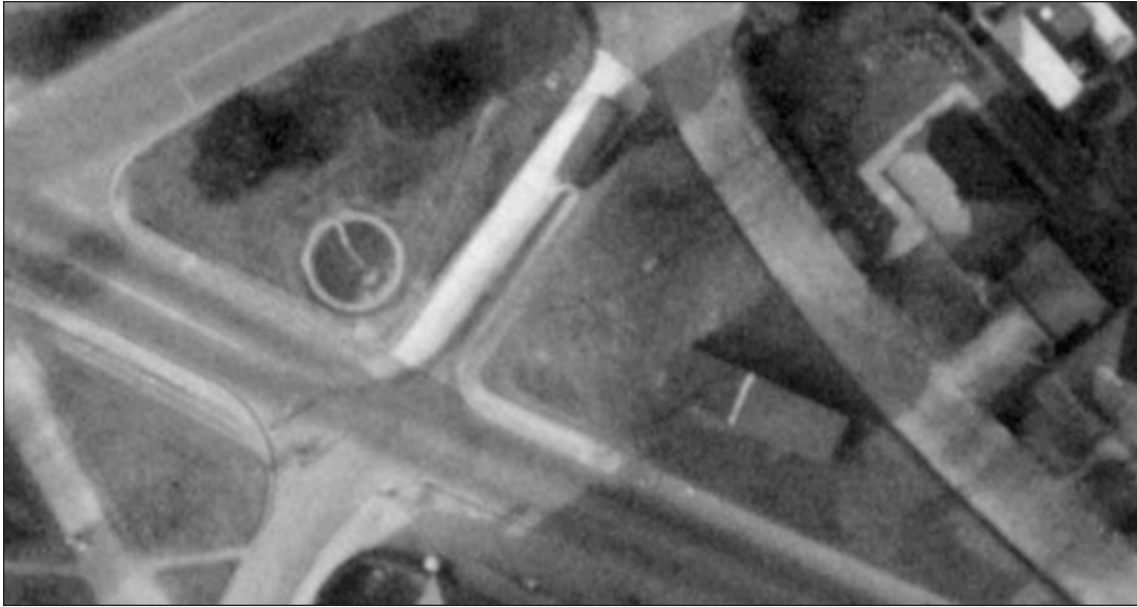
Figure 85 – Rectangular air raid shelter (right) and circular Emergency Water Supply (left) on Royal Parade. Detail of RAF/106G/LA/1339 RV 6264 29-MAR-1946. Historic England Archive (RAF Photography)

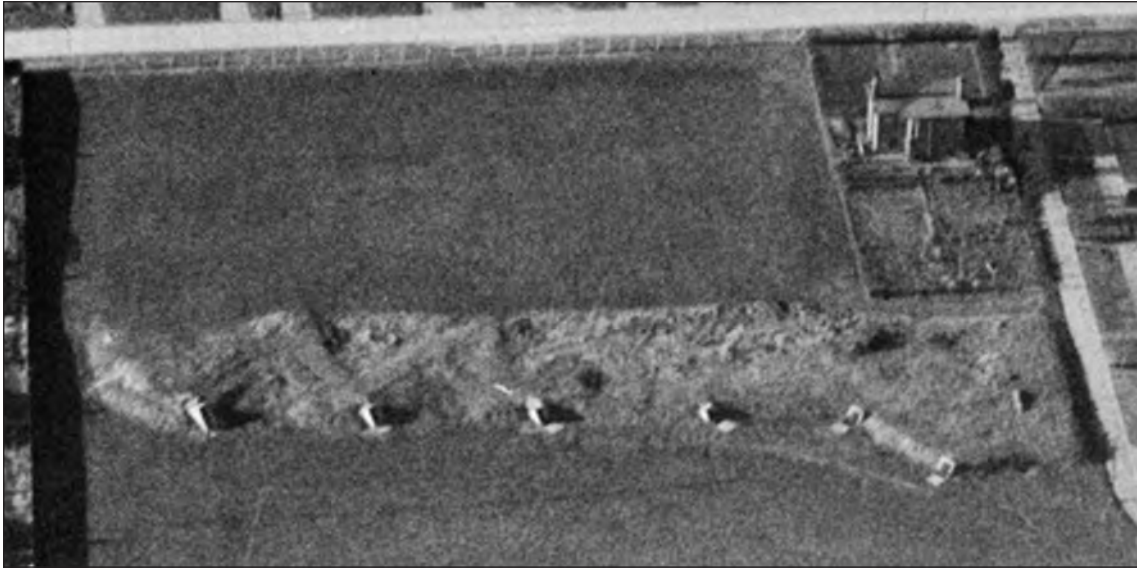
Figure 86 – School air raid shelters in the grounds of what is now Kemnal Technical College. Detail of AFL 61760/EAW020725 24-Dec-1948 © Historic England (Aerofilms Collection)

At Kemnal Technical College (Figure 86) there were six separate entrances to earth-covered air-raid shelters built against a slope to the south-west of the school building. The shelters occupied an area approximately 100m by 30m. The settling of the soil visible on the 1948 aerial photograph suggests that the shelter consisted of a ‘Z’ pattern of structures. Tennis courts now occupy the area of these shelters, which may survive below ground (Figure 87).

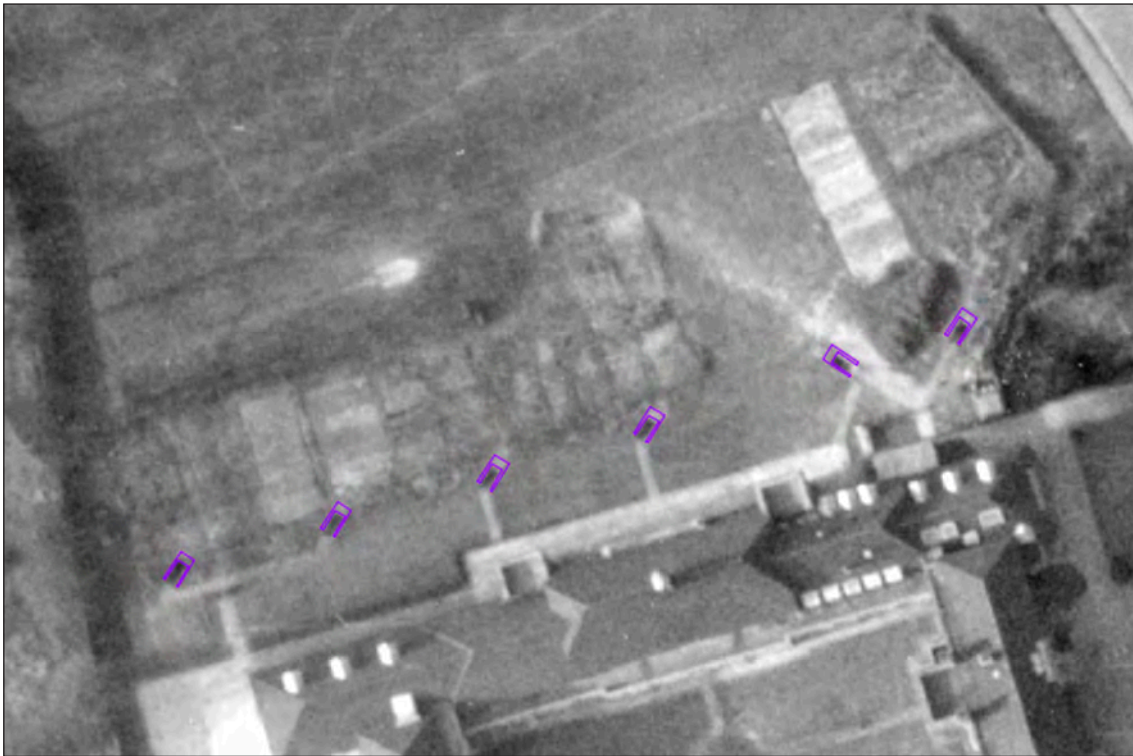
Figure 88 – School air raid shelters in the grounds of what is now Beaverwood School for Girls. The six entrances are outlined in purple. Detail of RAF/106G/LA/1339 RV 6301 29-MAR-1946. Historic England Archive (RAF Photography)

A similar arrangement of shelters was provided for Beaverwood School for Girls (Figure 88). Although they followed a different layout, they too occupied an area approximately 100m by 30m and were accessed via six entrances. Wartime allotments were dug on the earth covering these shelters. This area has since been built over and it is not clear from the aerial photographs if anything survives below ground.

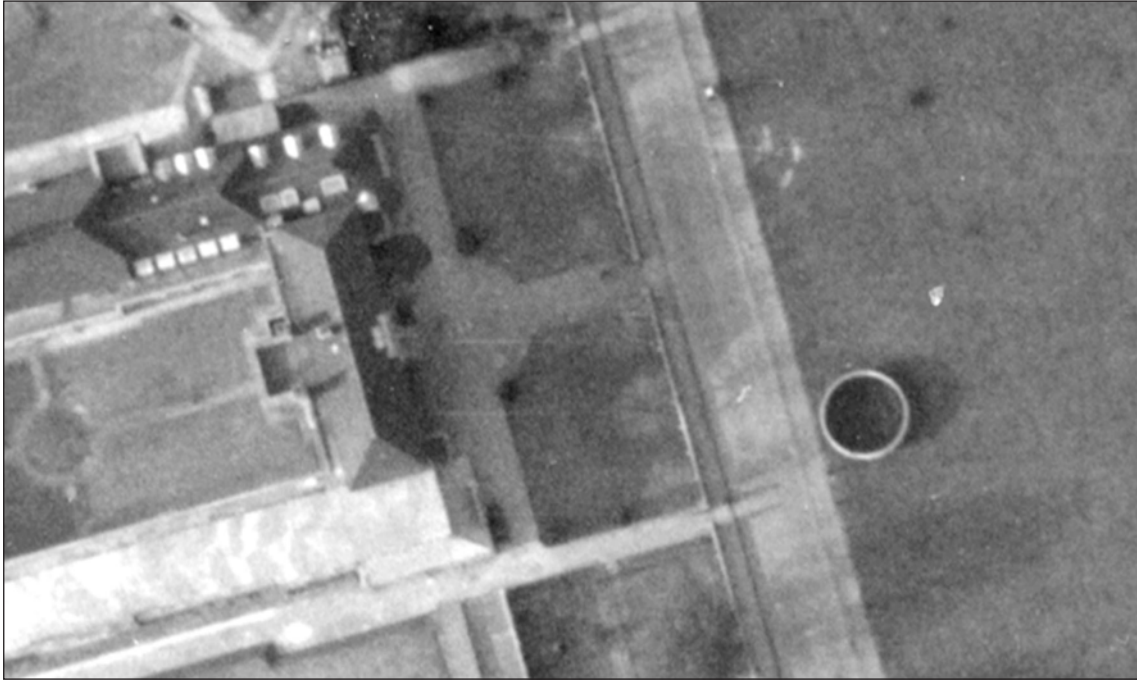
Figure 89 – Circular Emergency Water Supply (EWS) photographed in 1946 opposite what is now Chislehurst School for Girls. Detail of RAF/106G/LA/1339 RV 6301 29-MAR-1946. Historic England Archive (RAF Photography)

Three circular EWS have been identified within the project area. One was located opposite Chislehurst School for Girls and measured 9m in diameter (Figure 89). A second EWS, 8m in diameter, was located within the grounds of Bettington House in Perry Street. The third was also 8m in diameter and located on an area of open ground between Bromley Lane and Centre Common Road/Royal Parade (Figure 85). All three were first seen on the 1944 aerial photographs. The Perry Street EWS had been dismantled by 1946, the other two by 1947.

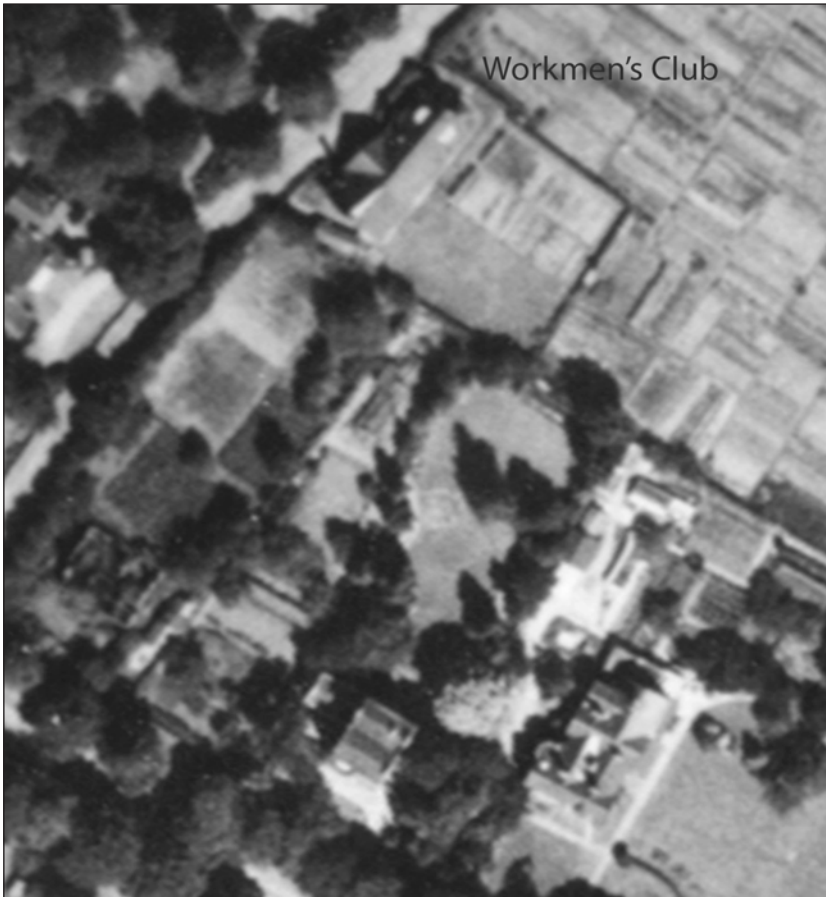
Figure 90 – Workmen's Club in 1944 before air raid. The building bottom left appears to be roofless by this date, perhaps due to enemy action. Detail of RAF/106G/LA/30 RP 3082 07-AUG-1944. Historic England Archive (RAF Photography)

Figure 90 shows buildings on Bull Lane, including the Workmen's Club, and Royal Parade in August 1944. By this date the building on the corner of these two roads

(near bottom left of both Figure 90 and Figure 91) was already roofless, presumably the result of an air raid. Figure 91 shows the same area in 1946 and illustrates the effect of a subsequent raid late in the war. The aerial photograph shows a 15m diameter crater between the garden to a house (now called The Chestnuts) and the roofless Workmen's Club. The most noticeable damage was to the club and this building was eventually demolished. Buildings at the rear of what is now Faulkner House were destroyed as were those within the ground of The Chestnuts. The crater was filled-in by 1951.

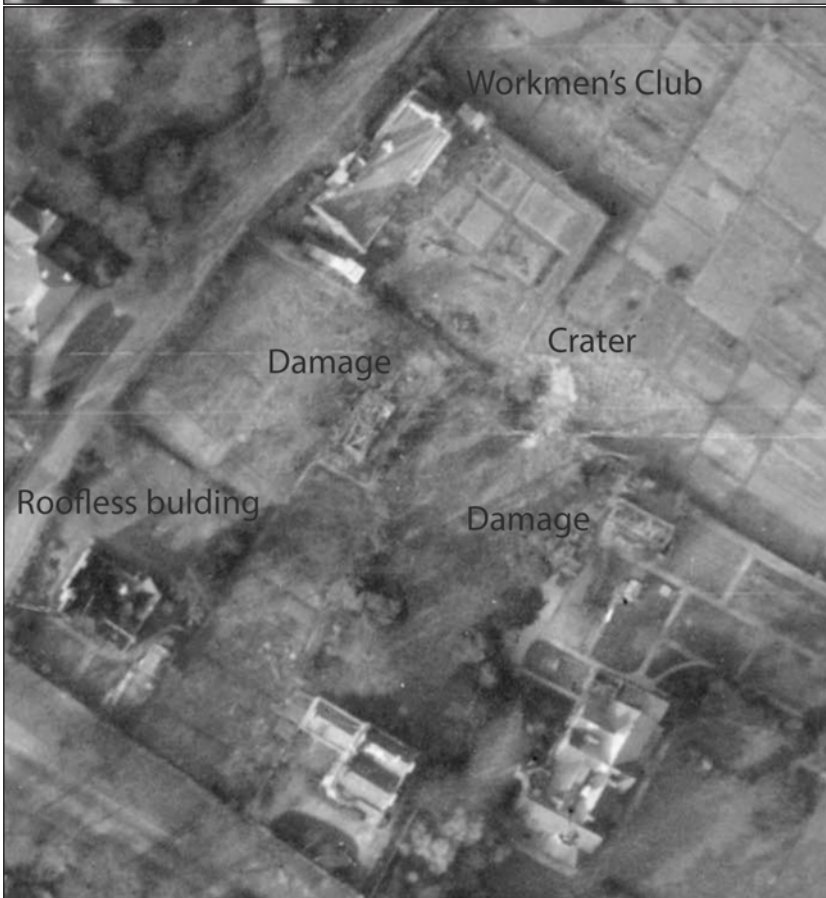
Figure 91 – Workmen's Club and surrounding area after air raid. Detail of RAF/106G/UK/1339 RV 6265 29-MAR-1946. Historic England Archive (RAF Photography)

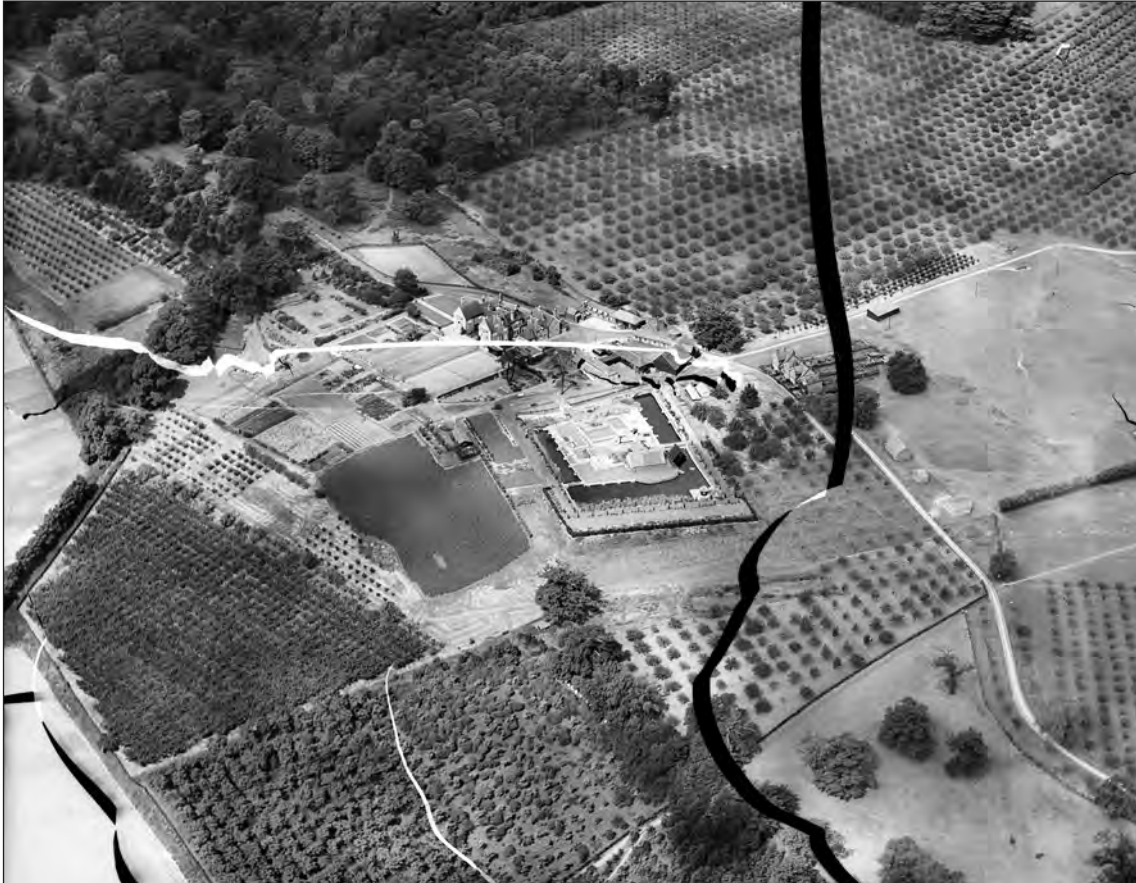
Figure 92 – Scadbury Moated Manor seen from the south-east in 1934. AFL193407/EPW045613 JUL-1934 © Historic England (Aerofilms Collection)

Aerial photographs taken in 1934 illustrate some of the work undertaken by the owners of Scadbury Moated Manor in the early decades of the 20th century (Figure 92; see also Figure 57, Figure 13). They provide detailed views of Scadbury Park Mansion, farm buildings and structures, as well as an overview of the gardens and detail of the planting. These photographs were taken just before the construction of the reconstructed hall on the island in 1936-7 (Archer 2015).

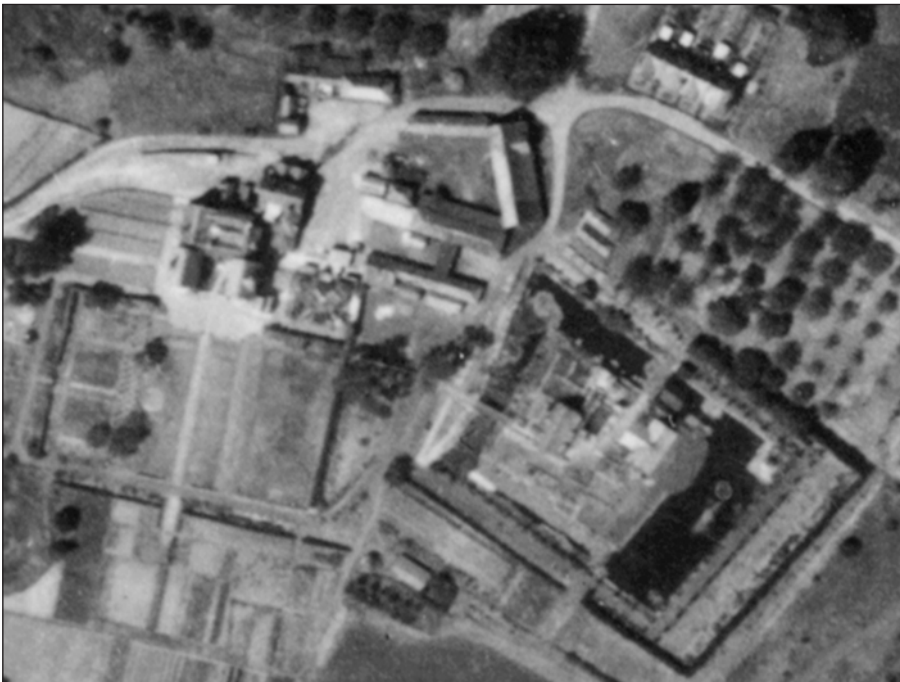
Figure 93 – Scadbury Moated Manor in 1944. Detail of RAF/106G/LA/30 RS 4233 07-AUG-1944. Historic England Archive (RAF Photography)

Scadbury Moated Manor, including the recently reconstructed hall on the moated island can be seen on a vertical aerial photograph taken in 1944 (Figure 93) and the reconstructed hall can be seen in more detail in an oblique aerial photograph taken in 1949 that shows its eastern elevation (Figure 94). However, by this date some of the buildings at Scadbury (notably an estate barn) had been damaged or destroyed as a result of a strike by a V1 flying bomb in March 1945 (Archer 2015).

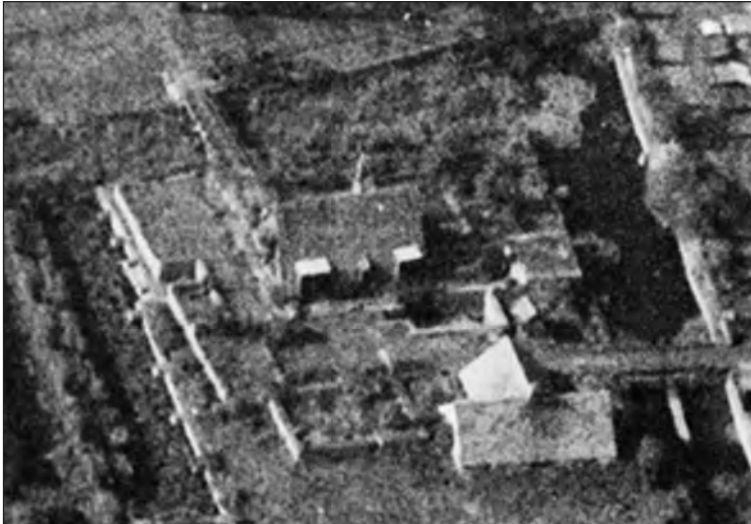
Figure 94 – The reconstructed hall, Scadbury Moated Manor in 1949. Detail of AFL 61921/ EAW026819 03-Oct-1949 © Historic England (Aerofilms Collection)

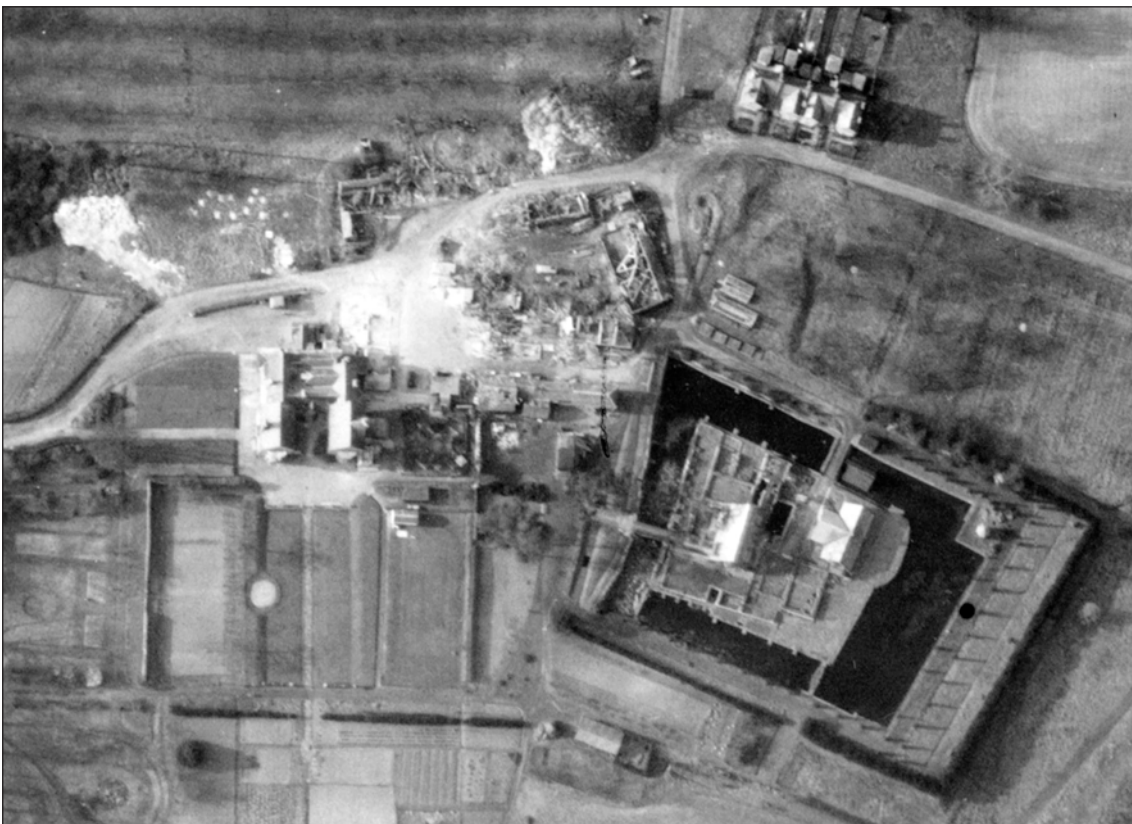
Figure 95 – Scadbury Moated Manor after air raid. Detail of RAF/106G/UK/1339 RV 6148 29-MAR-1946. Historic England Archive (RAF Photography)

The first aerial photographs taken showing the effects of this air raid were taken a year later in March 1946 (Figure 95). Although no obvious crater can be seen on this aerial photograph, the image suggests that the bomb struck a point within the farmyard to the north of Scadbury Park Mansion. This damaged or destroyed the north-eastern part of the house and by 1946 this part of the house appears to have been largely cleared away. The vicinity of the bombsite shows white on the 1946 aerial photograph, which may indicate activity associated with site clearance and

presumably the filling-in of the crater. Blast damage from the explosion can be seen to the north and east and largely destroyed Scadbury Moated Manor's range of farm buildings. The aerial photograph taken in 1946 shows badly damaged but still upstanding elements at the extreme north-west and the extreme eastern side of the range of buildings including the collapsed roof timbers of the estate barn (Figure 96). The site had been partially cleared by 1949, although some ruins remained (Figure 97).

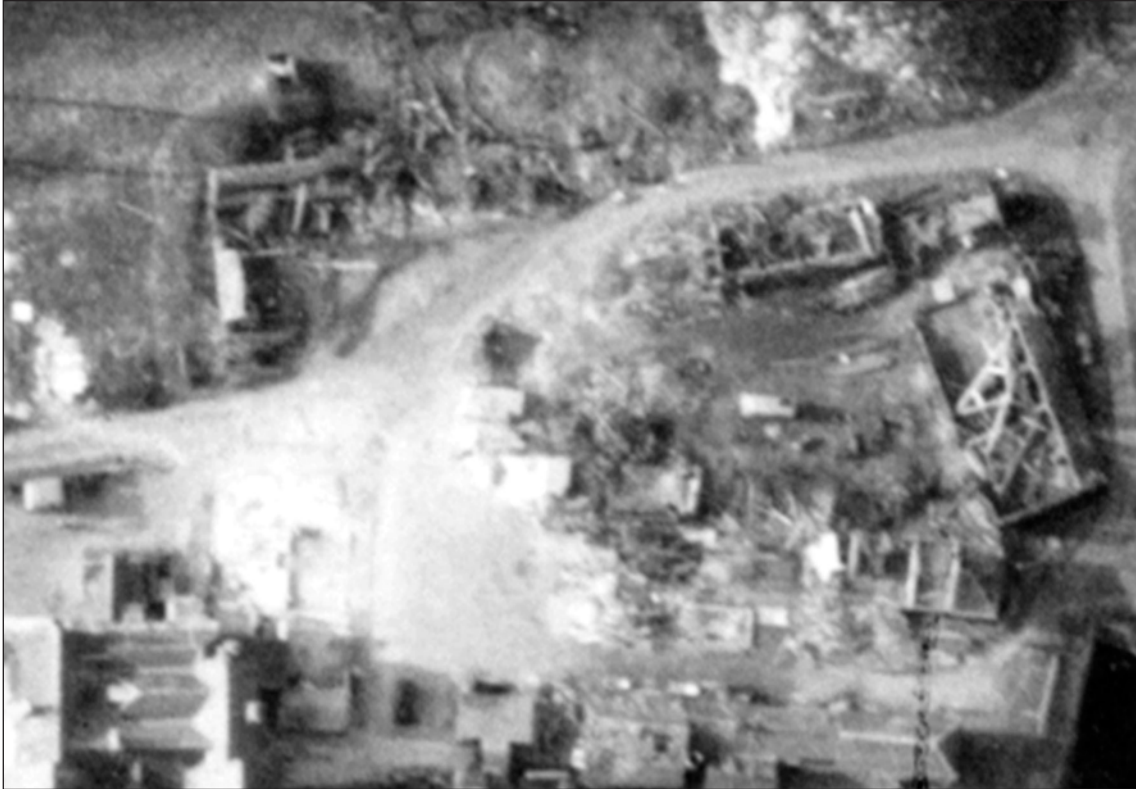
Figure 96 – Detail of Figure 95 showing damaged and destroyed buildings. Detail of RAF/106G/UK/1339 RV 6148 29-MAR-1946. Historic England Archive (RAF Photography)
