Archaeological Investigation

SCADBURY MOATED MANOR, LONDON BOROUGH OF BROMLEY: LANDSCAPE INVESTIGATIONS

Research Report Series 012-2021

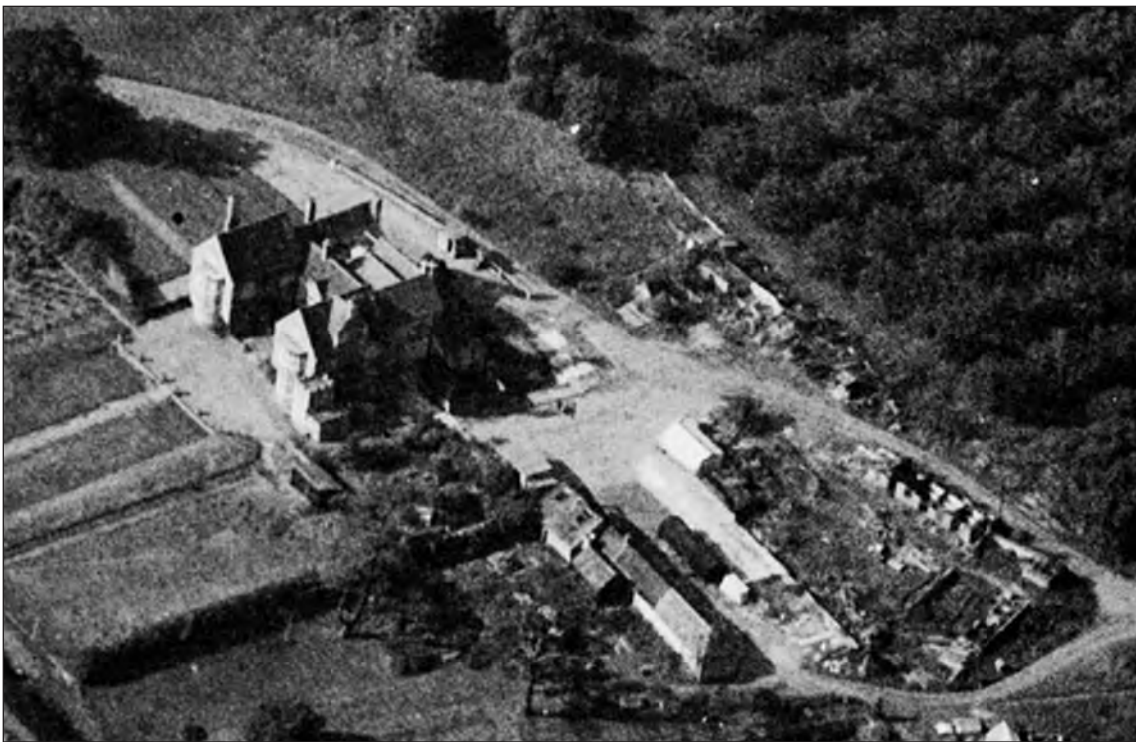
Figure 97 – Some bomb damaged buildings still visible at Scadbury Moated Manor in October 1949. Detail of AFL 61921/EAW026819 03-Oct-1949 © Historic England (Aerofilms Collection)

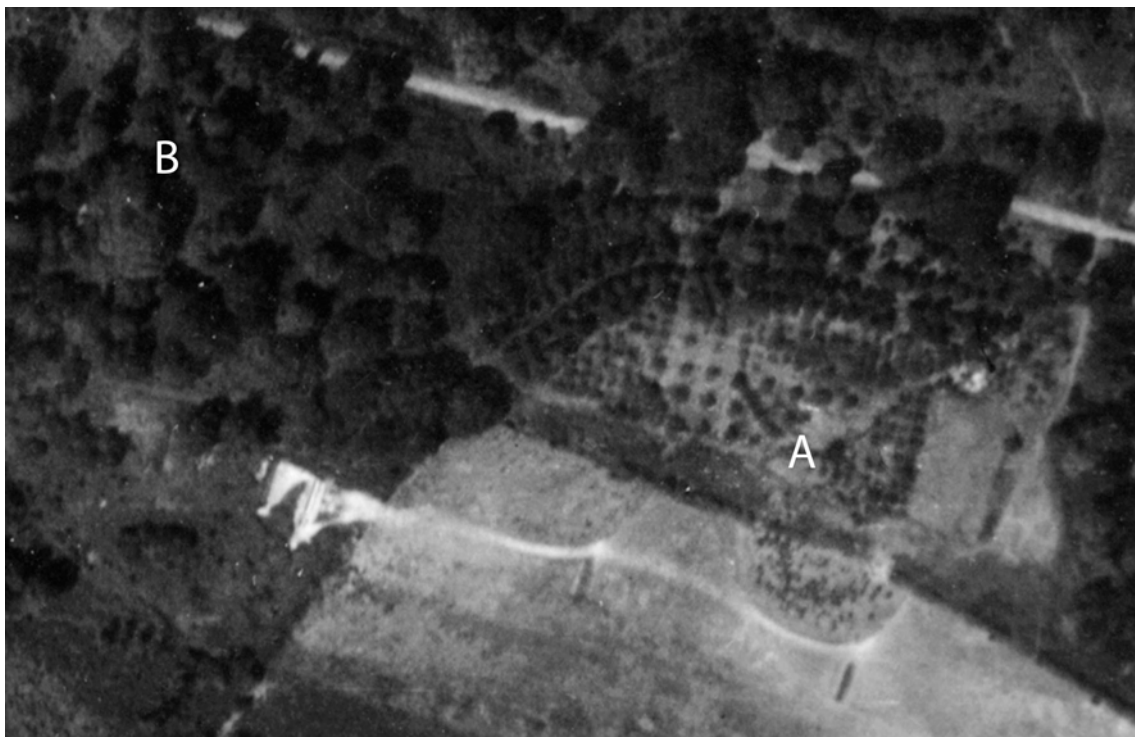
Figure 98 – This 1944 photograph shows a worn path along the length of the firing range. Trees obscure the view of the earthworks seen in Figure 100 and Figure 101 (A and B on this figure). Detail of RAF/106G/LA/30 RS 4235 07-AUG-1944. Historic England Archive (RAF Photography)

A series of possible Second World War trenches located to the south-west of Scadbury Moated Manor can be seen on aerial photographs and lidar. Much of this area is wooded and the only photographs taken during the war are from an August 1944 sortie (Figure 98) when the trees were in full leaf and as a result, very little can

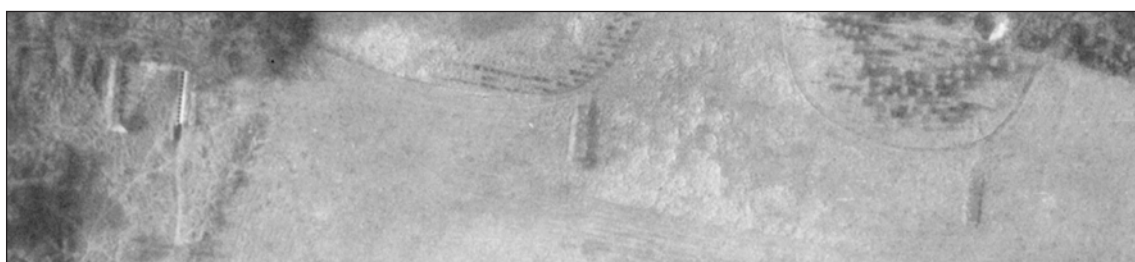
Figure 99 – Firing range to the west of Scadbury Moated Manor, detail of RAF/106G/LA/1339 RV 6148 29-MAR-1946. Historic England Archive (RAF Photography)

be seen. The clearest evidence of wartime activity is the firing range south-west of Scadbury and the single worn pathway along its length. The firing range can be seen in more detail in Figure 99.

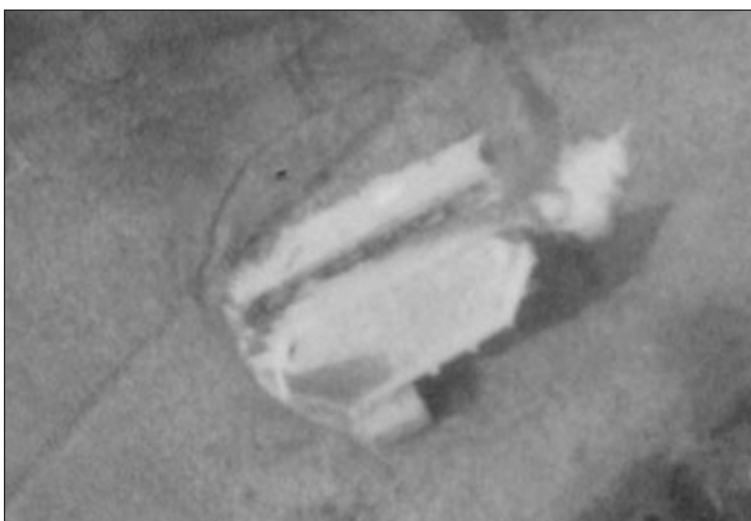
Figure 103 – The butts of a firing range in Hawkwood Estate seen in March 1946. Detail of RAF/106G/LA/1339 RV 6140 29-MAR-1946. Historic England Archive (RAF Photography)

A second firing range was located within Hawkwood Estate. In addition to the firing range there were several slit trenches and other earthworks thought to be associated with military training. Presumably established during the war, these had been demolished by October 1946 (Figure 103).
