The Old Friary, Friars Lane, Beverley, East Riding of Yorkshire

Tree-ring analysis of oak timbers

Alison Arnold, Robert Howard and Cathy Tyers

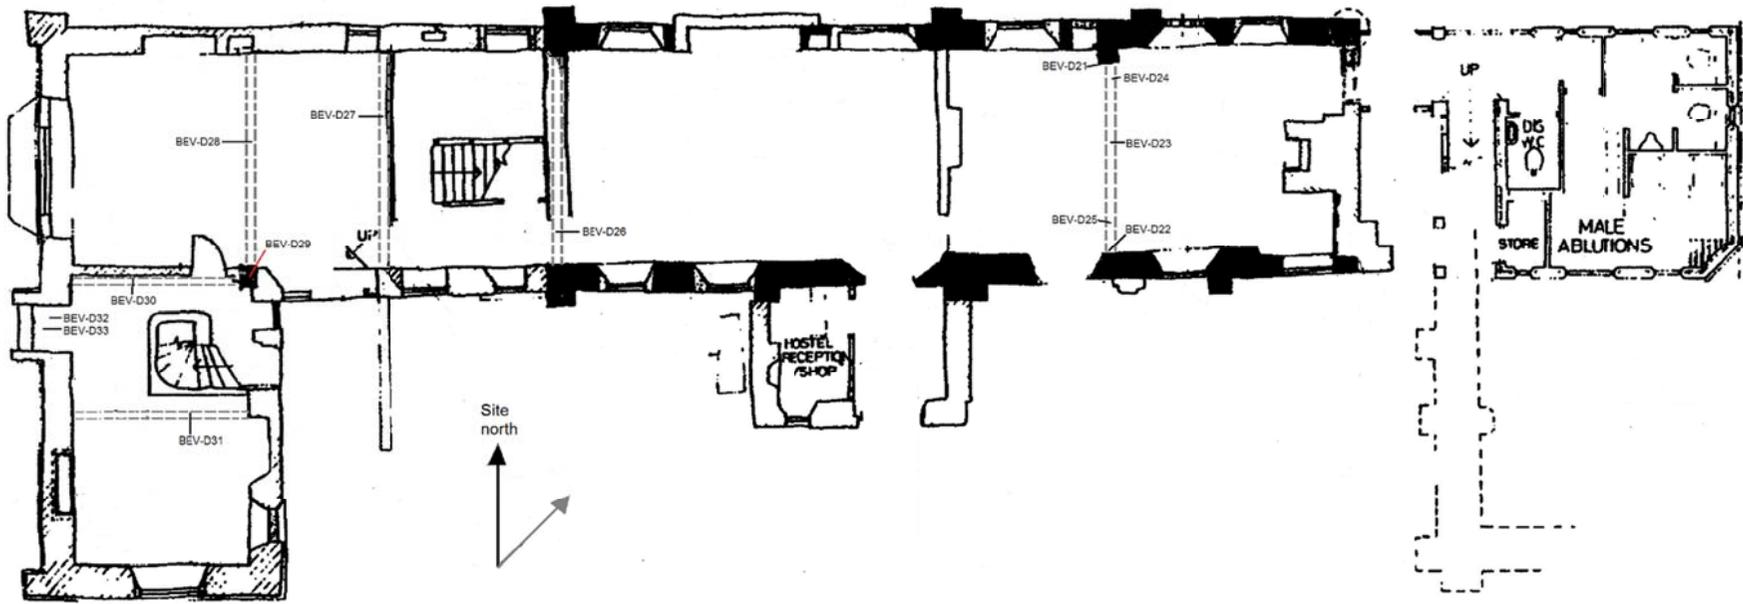
Figure 4: Plan Ground-floor plan, showing the location of samples BEV-D21–33 (after Ingleby and Hobson Architects)

The Old Friary ([List Entry Number 1084062](#)), thought to have been a guest house, library or infirmary, is located on the north-west side of Friars Lane in Beverley (Figs 1–3) and is the only surviving building of the Dominican Friary complex. It is a two-storey linear building, aligned north-east/south-west (east/west for the benefit of this report) with a south-west wing and a two-storey porch (Fig 4).

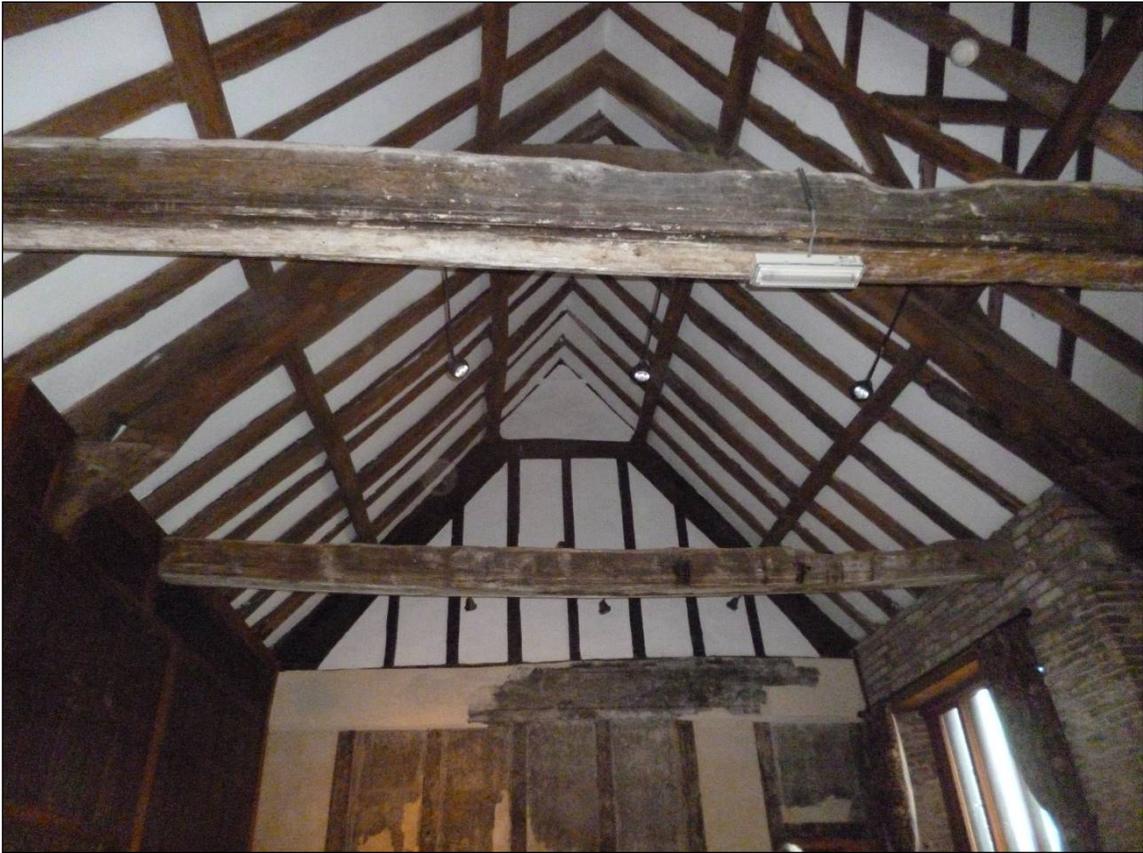
Figure 5: Great Hall, roof with beam 1 in foreground, photograph taken from the east (Robert Howard)

This first-floor hall, open to the roof, consists of three bays and is situated at the western end of the range. The roof over this has three truncated principal rafter trusses and a false hammerbeam truss (Truss 3). The principal rafter trusses have two sets of threaded purlins (Fig 5). Either side of this truss is a reused cross beam, both cross beams are likely to be later insertions incorporated to support a joisted floor above (since removed).

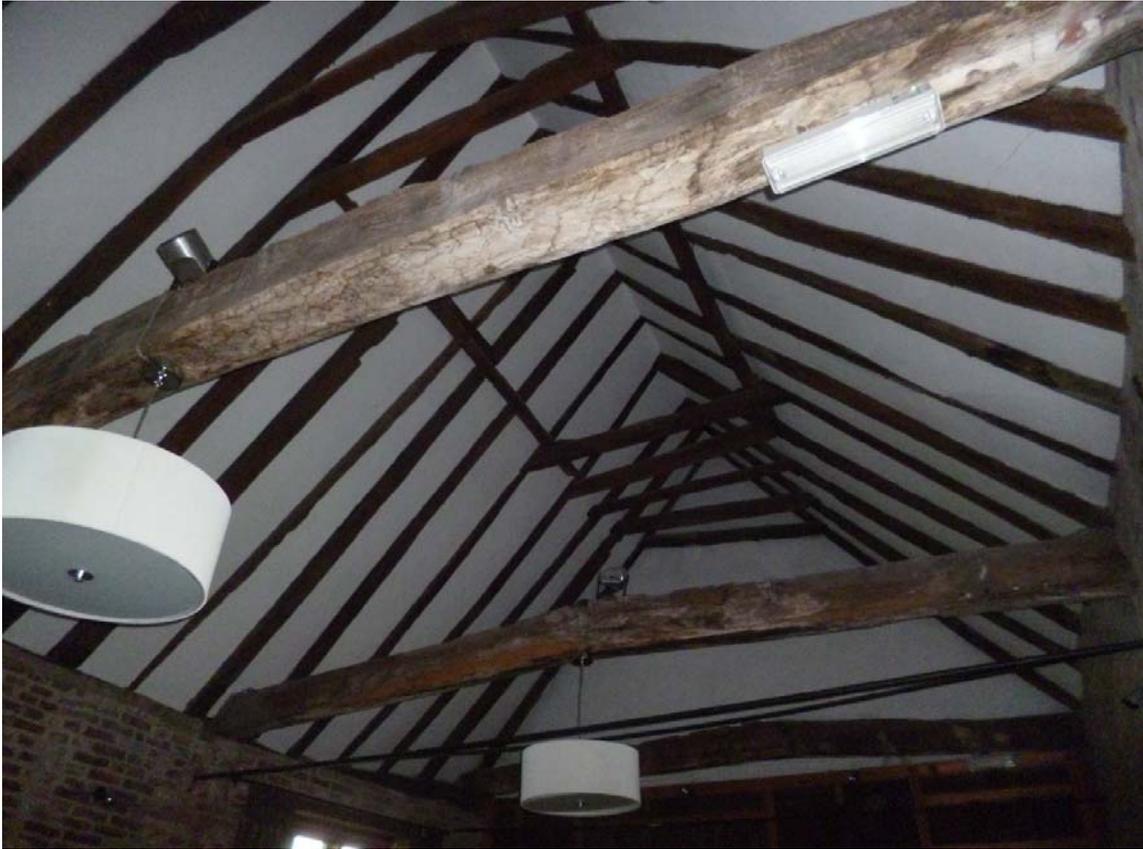
Figure 6: Common Room roof, photograph taken from the west (Robert Howard)

Adjacent to the Great Hall and separated from it by a stud and beam partition is the Common Room; this is again open to the roof. The roof over this area is of common rafter type and utilises a substantial amount of reused timber. It has very high collars and one remaining soulace, cross-beams and a single row of purlins to each slope that run along the back of the rafters, although not along the entire length of the roof (Fig 6).

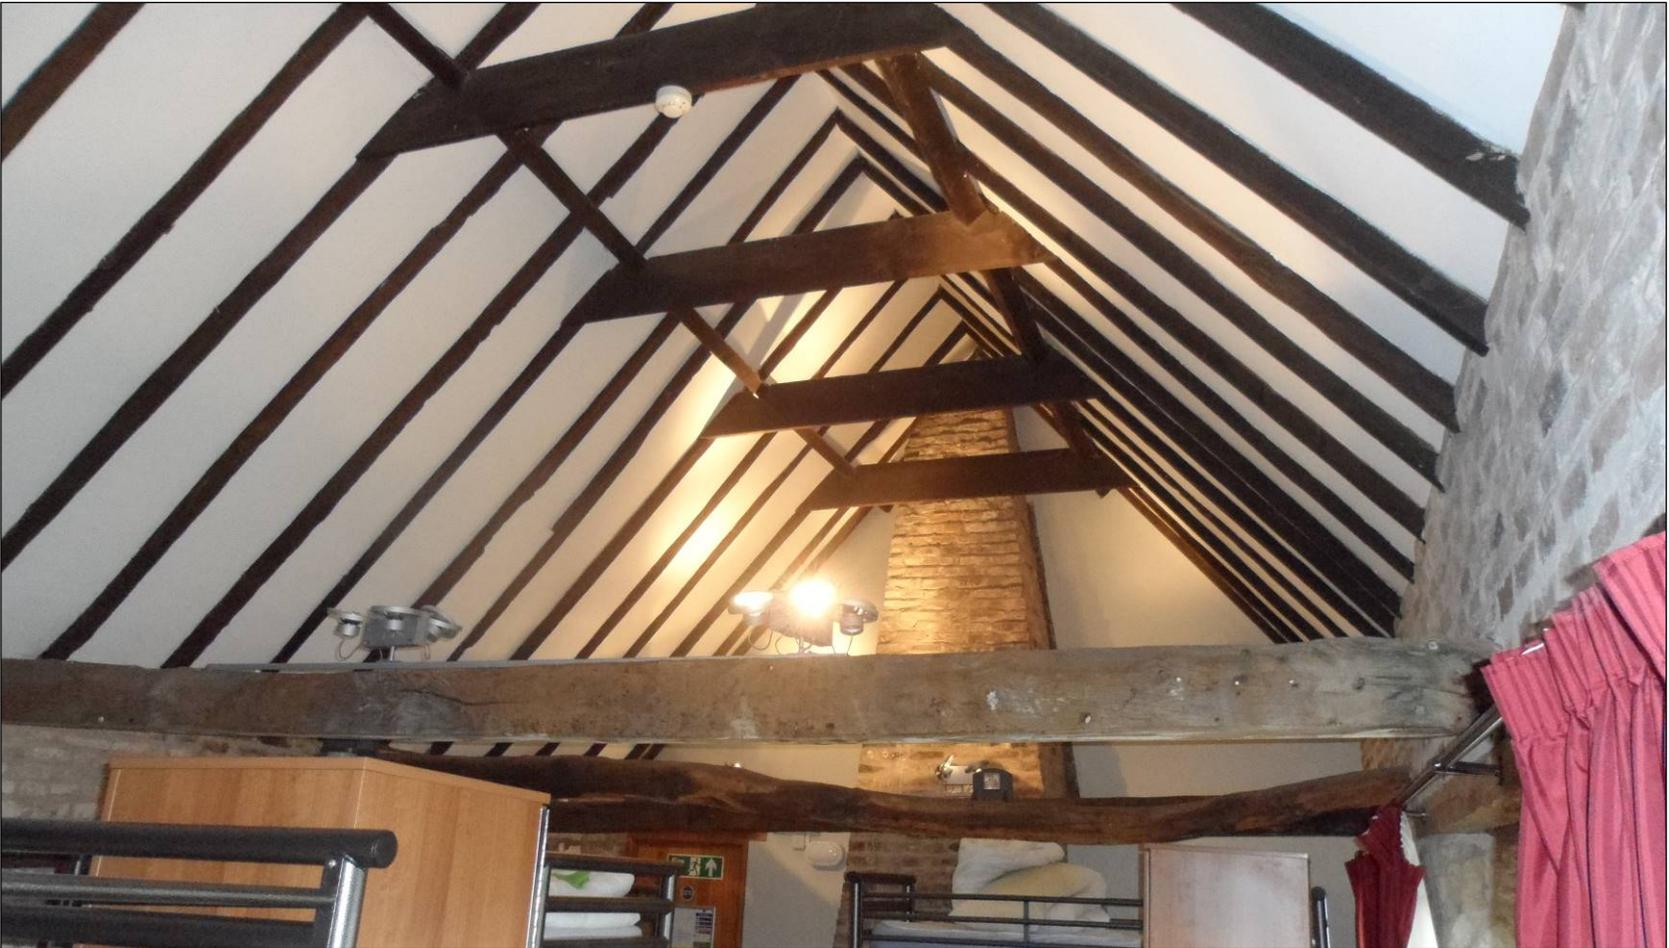
Figure 7: Female Dormitory roof, photograph taken from the west (Robert Howard)

Further east and down a step is the Female Dormitory, also open to the roof and about the same length as the Common Room. This roof is again of common rafter and collar type, with the rafters sitting on the wall tops. Not every rafter frame has a collar, these being distributed about one to every third rafter frame. There is a single row of purlins to each slope, clasped between the collars and the rafters. There are three, irregularly spaced reused cross beams set into the brick walls, just below the tops (Fig 7).

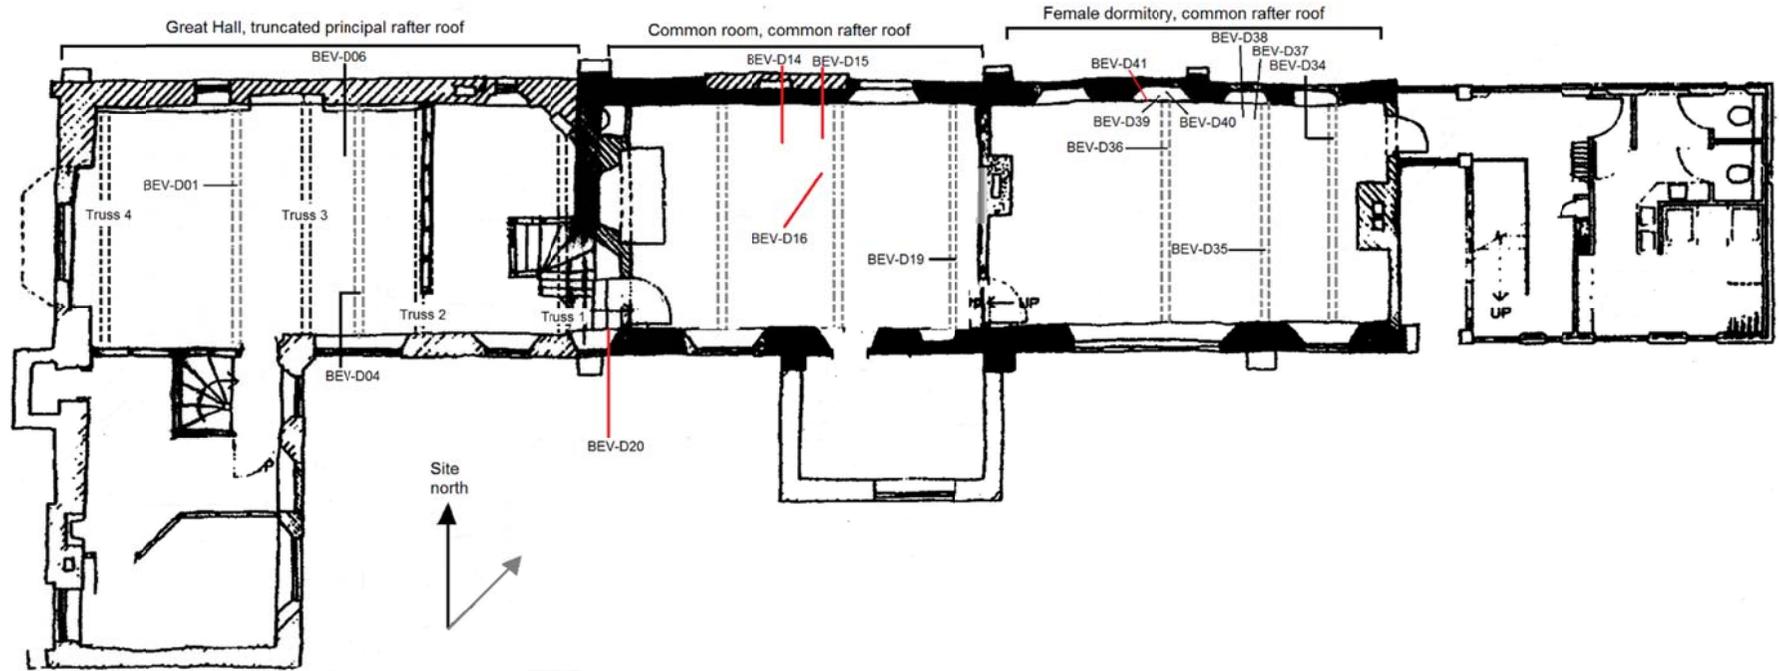
Figure 8: First-floor plan, showing the location of samples BEV-D01, BEV-D04, BEV-D06, BEV-D14–16, BEV-D19–20, and BEV-D34–41 (after Ingleby & Hobson Architects)

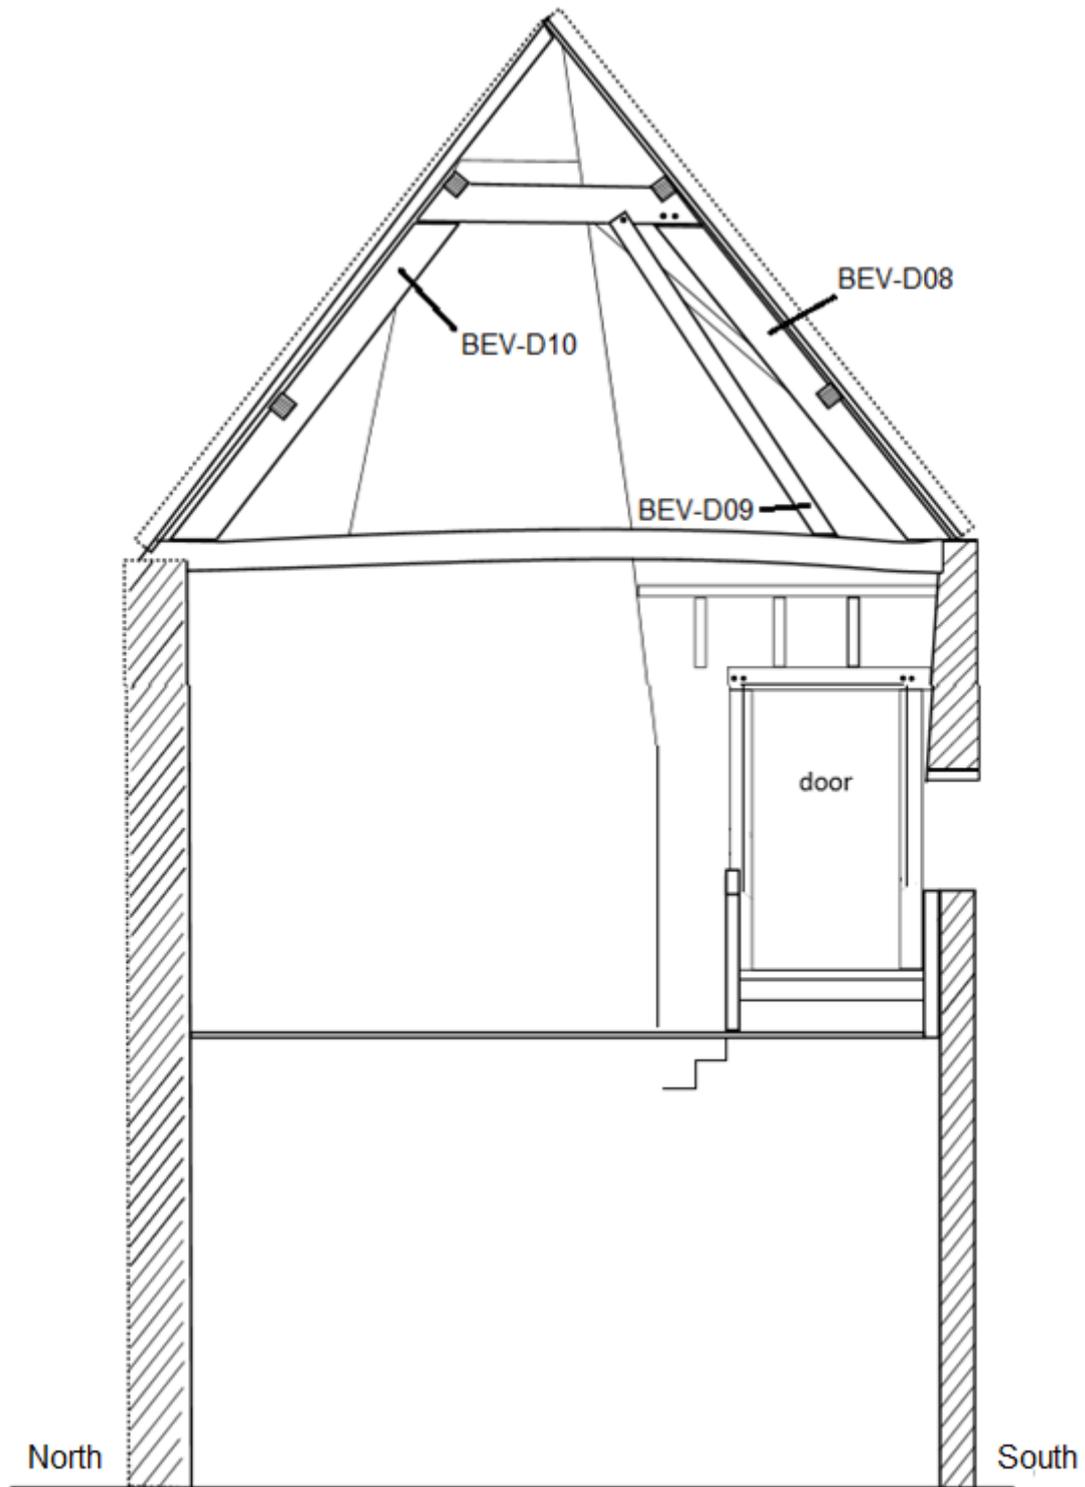
Figure 9: Great Hall, truss 1, showing the location of sample BEV-D08–10 (after YVBSG 2015)

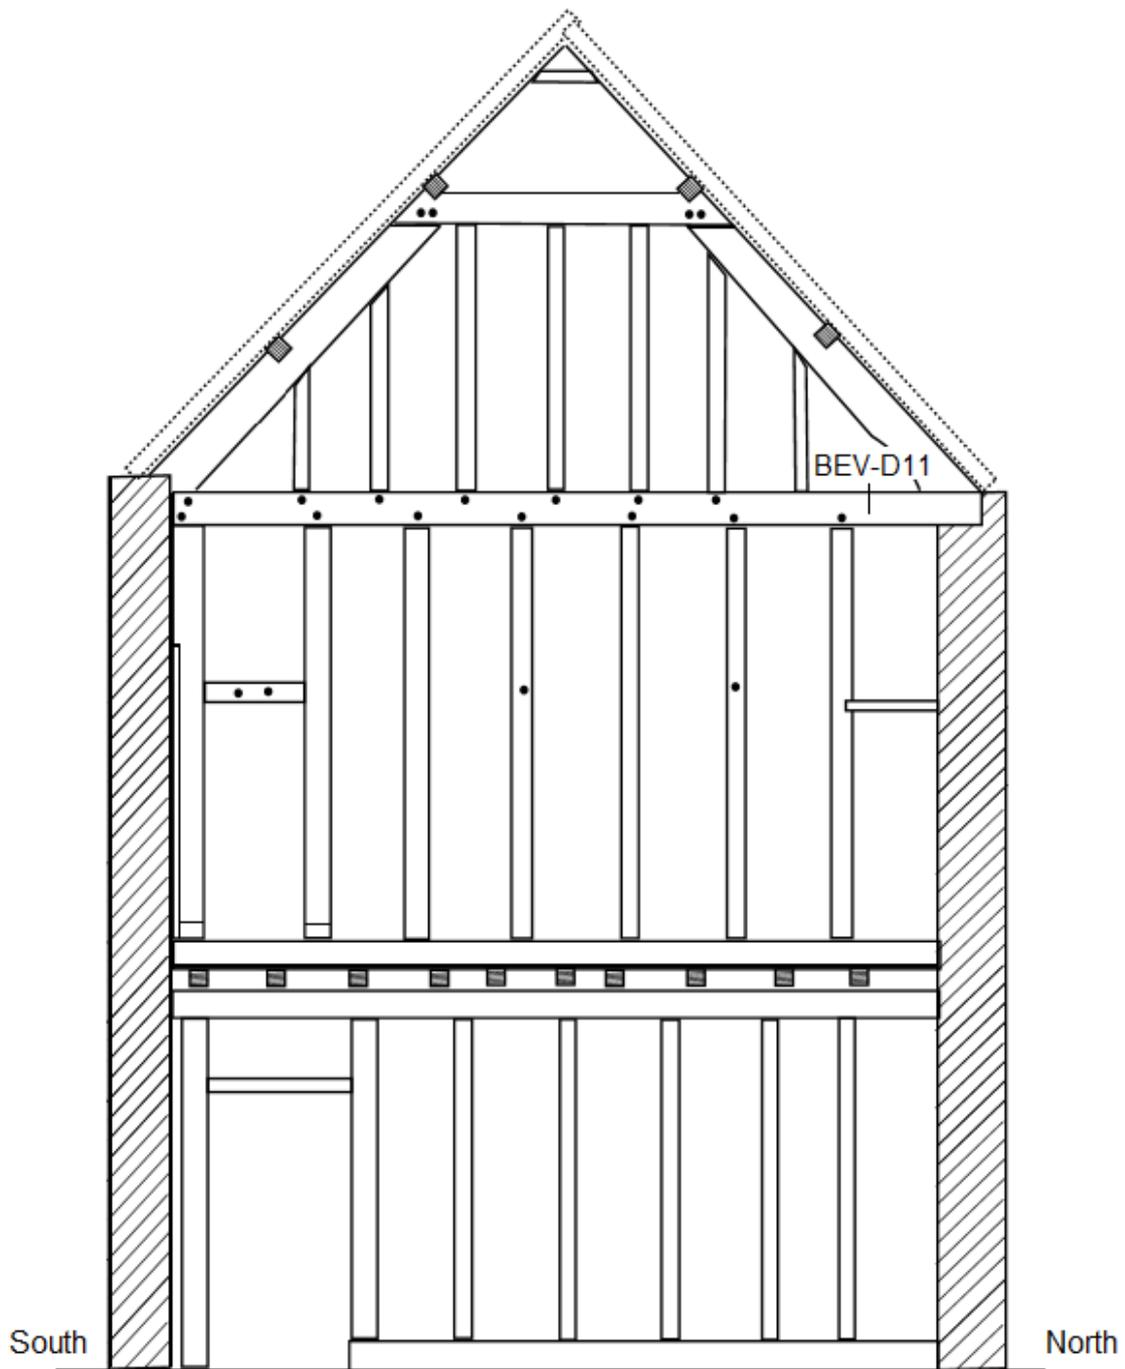
Figure 10: Great Hall, truss 2, showing the location of sample BEV-D11 (after YVBSG 2015)

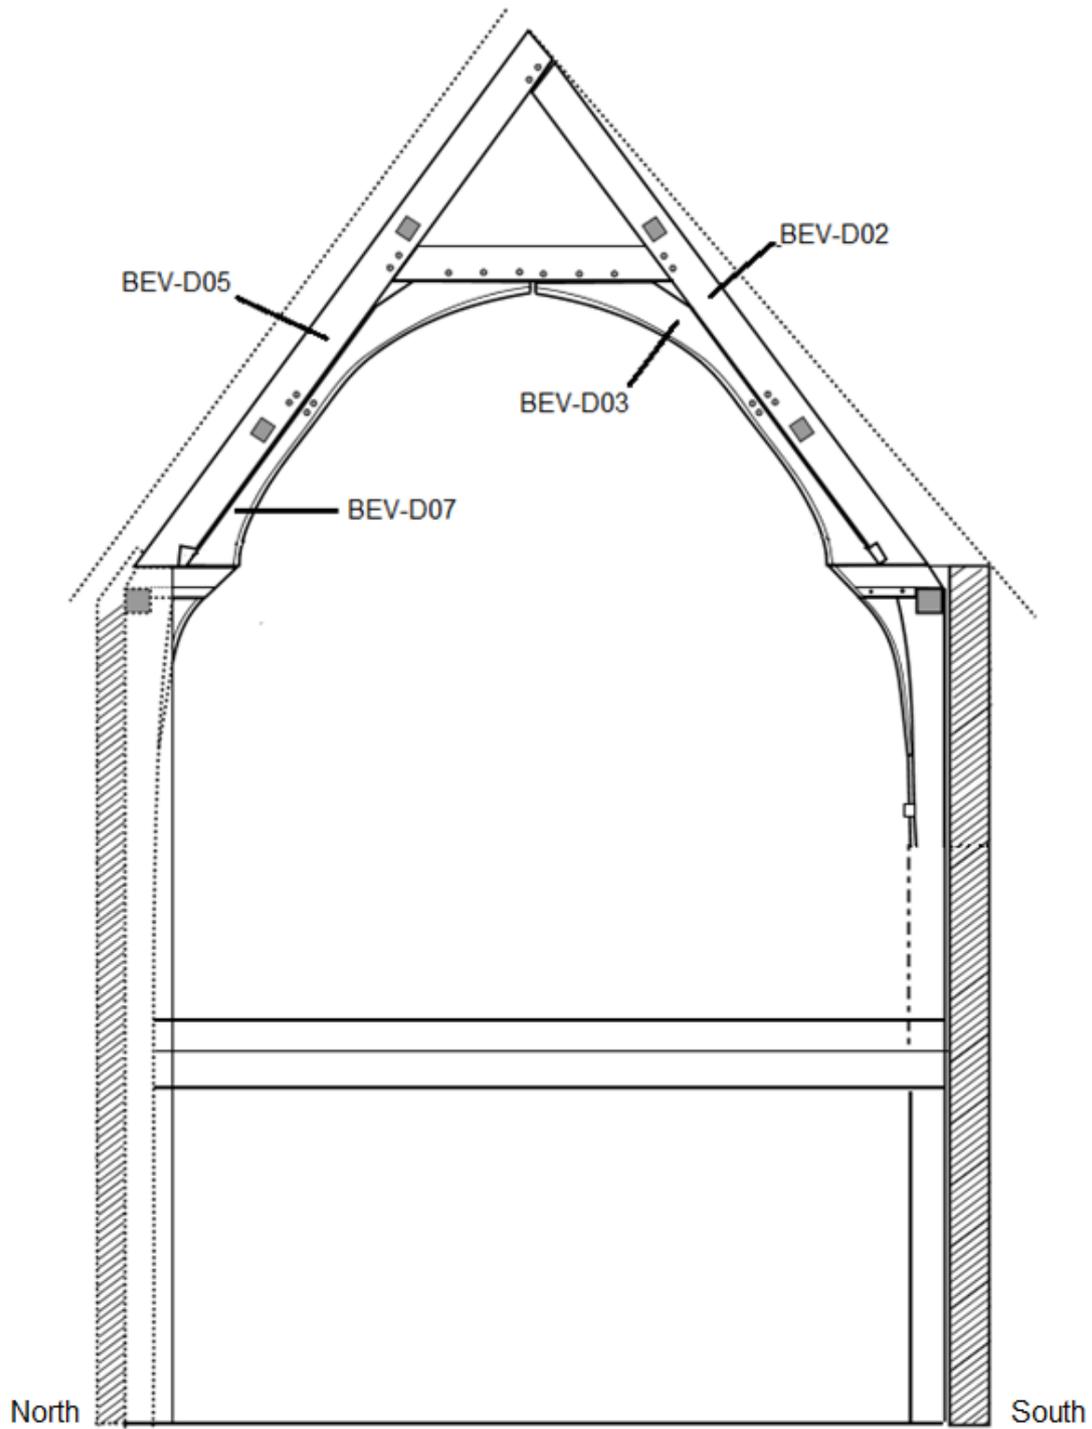
Figure 11: Great Hall, truss 3, showing the location of samples BEV-D02–03, BEV-D05, and BEV-D07 (after YVBSG 2015)

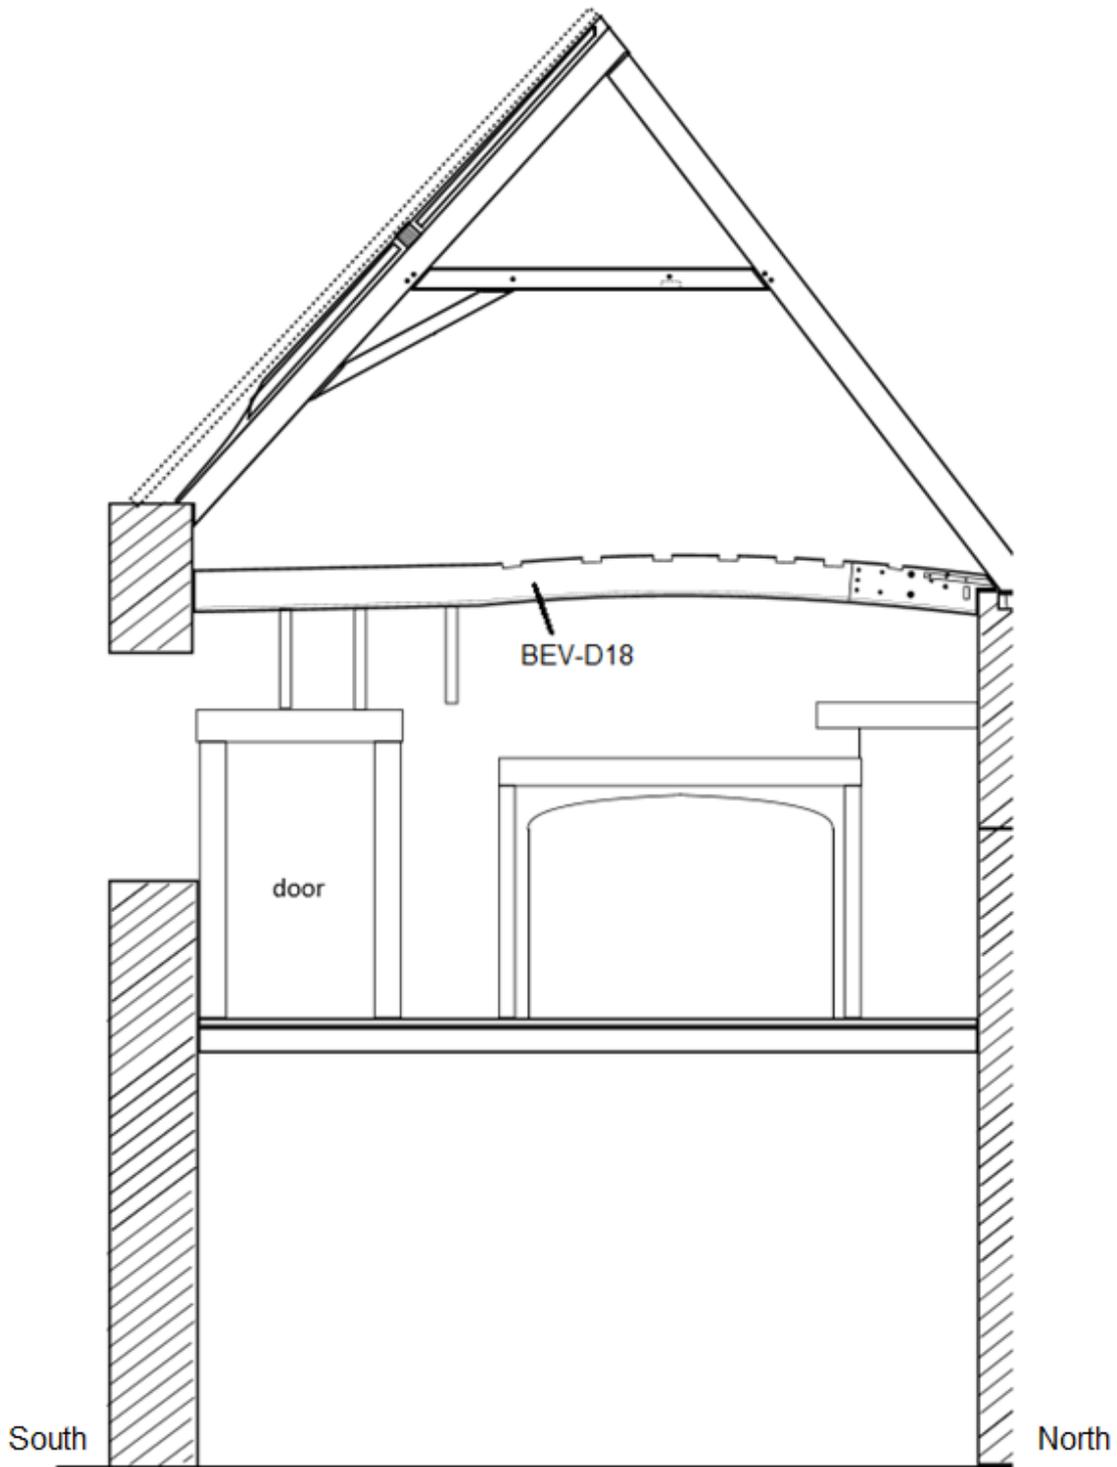
Figure 12: Common room, truss, showing the location of sample BEV-D18 (after YVBSG 2015)

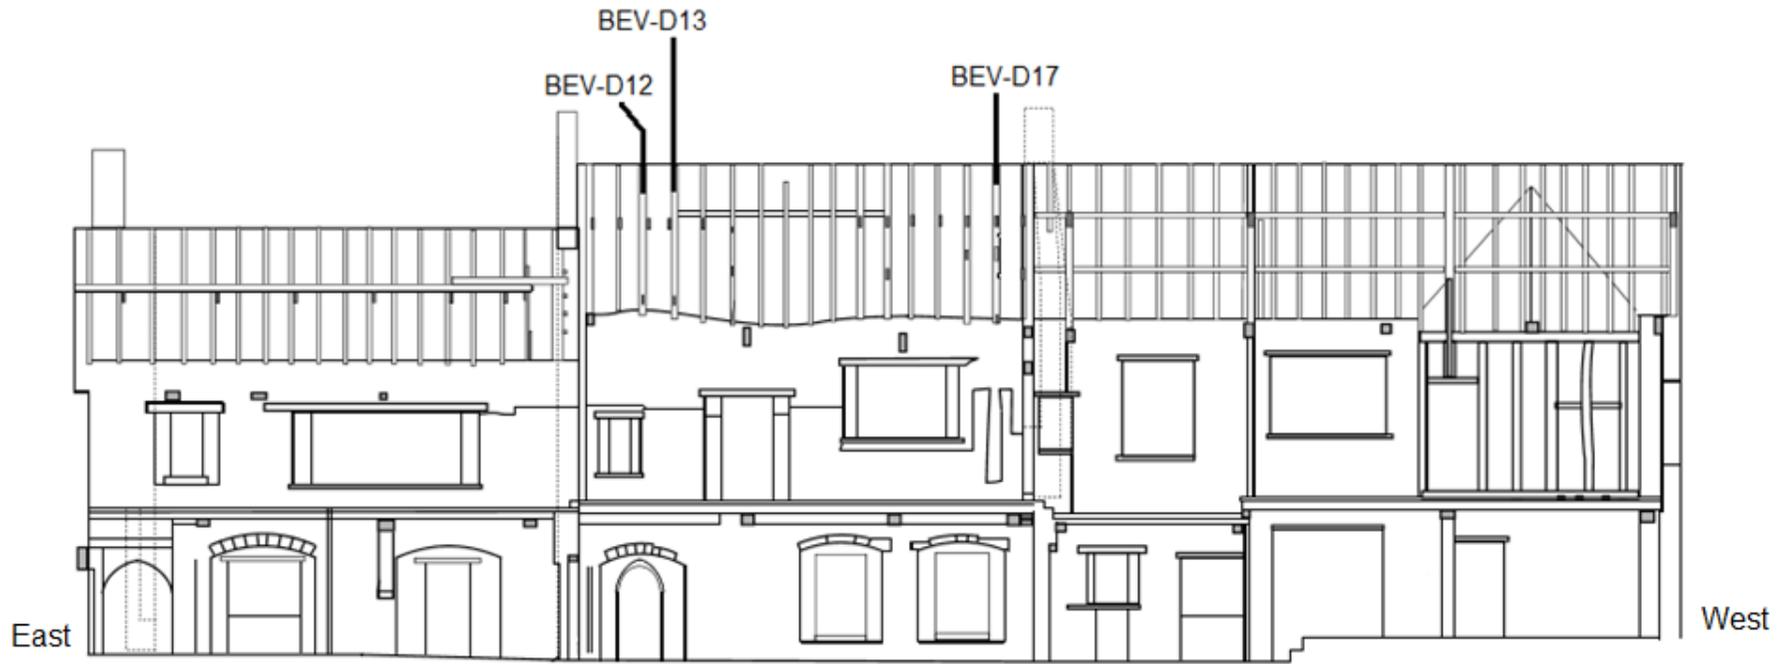
Figure 13: Southern elevation (looking south), showing the location of samples BEV-D12–13 and BEV-D17 (after YVBSG 2015)

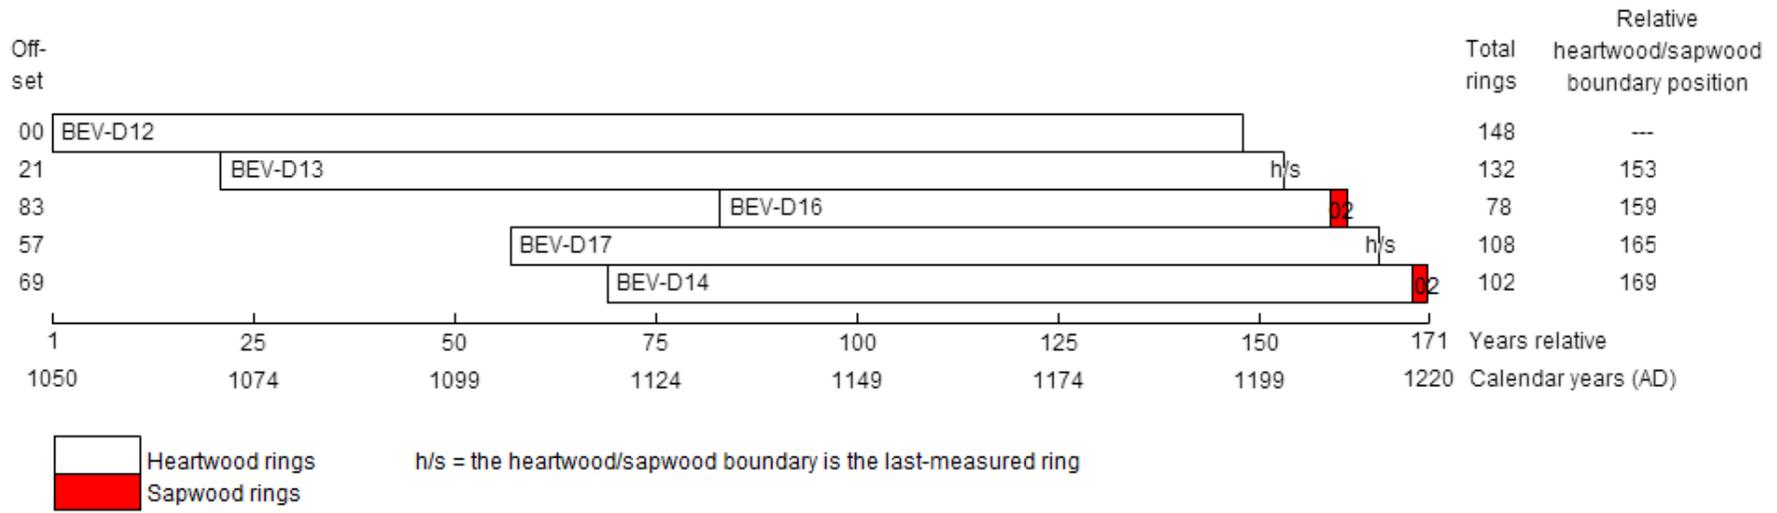
Figure 14: Bar diagram to show the position of samples in site sequence BEVDSQ01

Five samples matched each other at a minimum *t*-value of 5.5 and were combined at the relevant offset positions to form BEVDSQ01, a site sequence of 171 rings (Fig 14). This site sequence was compared against a series of relevant reference chronologies for oak where it was found to match securely and consistently as a

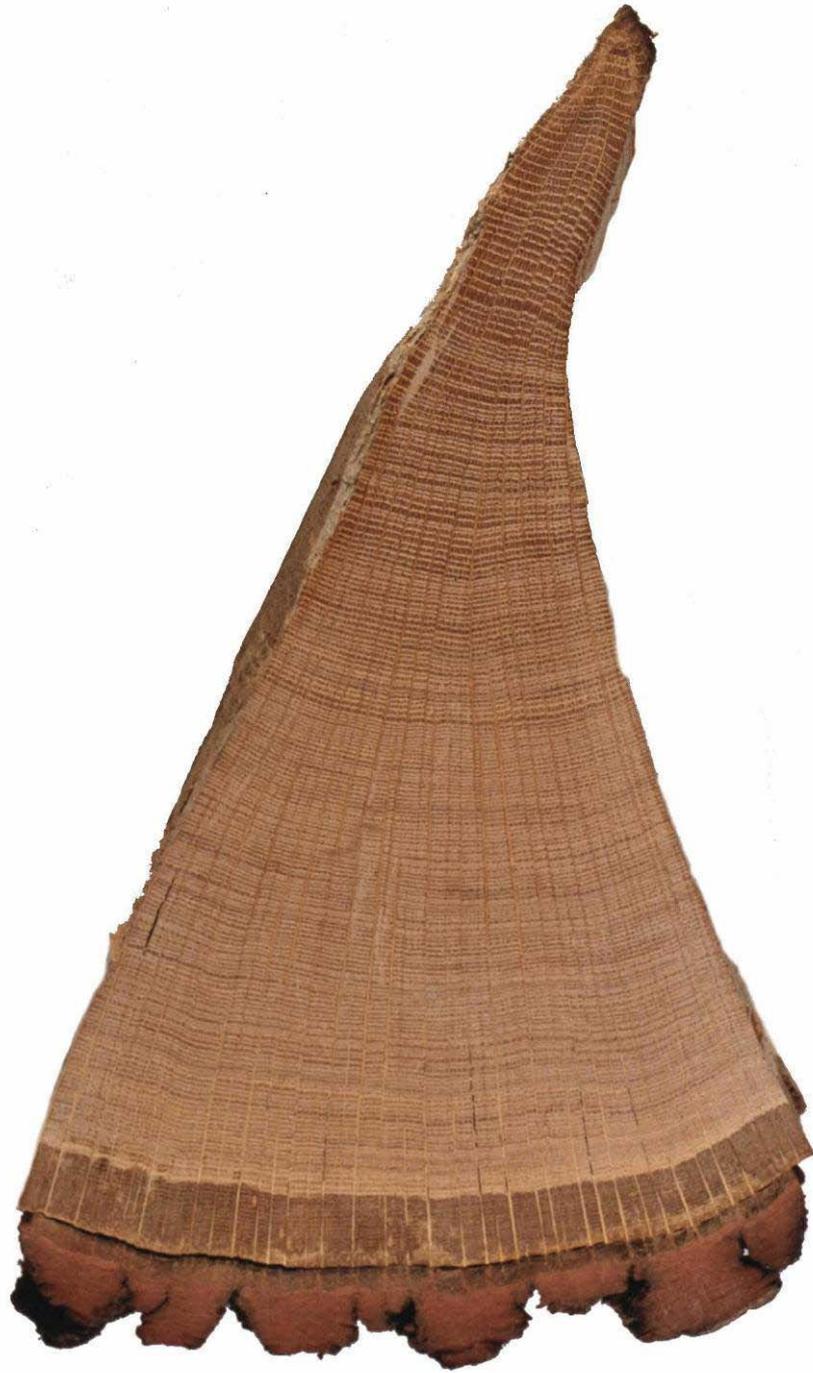
Figure A1: A wedge of oak from a tree felled in 1976. It shows the annual growth rings, one for each year from the innermost ring to the last ring on the outside just inside the bark. The year of each ring can be determined by counting back from the outside ring, which grew in 1976

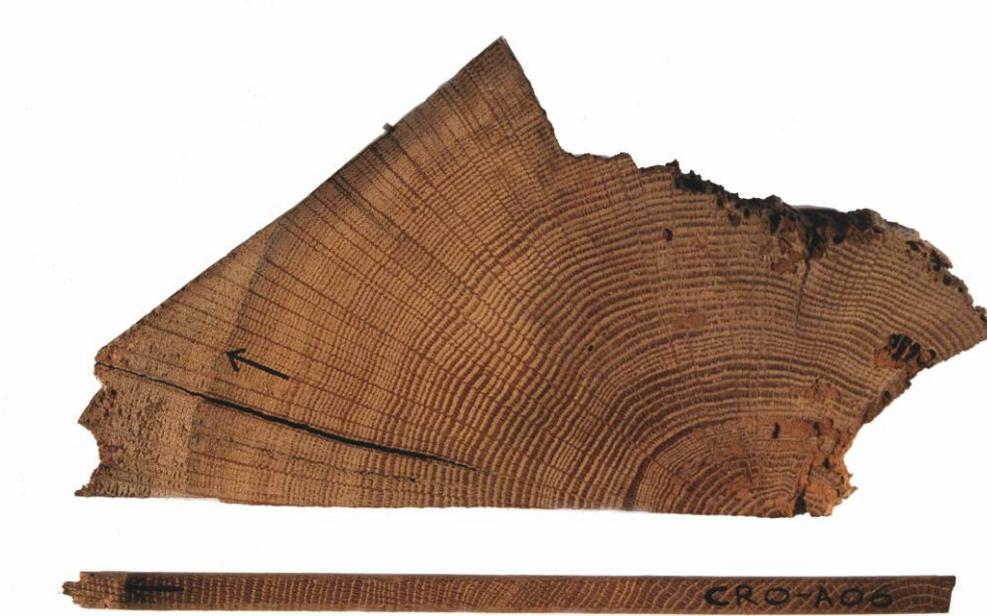
Figure A2: Cross-section of a rafter, showing sapwood rings in the left-hand corner, the arrow points to the heartwood/sapwood boundary (H/S); and a core with sapwood; again the arrow is pointing to the H/S. The core is about the size of a pencil

Quite often some, though not all, of the original outer rings are missing on a timber. The outer rings on an oak, called sapwood rings, are usually lighter than the inner rings, the heartwood, and so are relatively easy to identify. For example, sapwood can be seen in the corner of the rafter and at the outer end of the core in Figure A2, both indicated by arrows. More importantly for dendrochronology, the sapwood is relatively soft and so liable to insect attack and wear and tear. The builder, therefore, may remove some of the sapwood for precisely these reasons. Nevertheless, if at least some of the sapwood rings are left on a sample, we will know that not too many rings have been lost since felling so that the date of the last ring on the sample is only a few years before the date of the original last ring on the tree, and so to the date of felling.

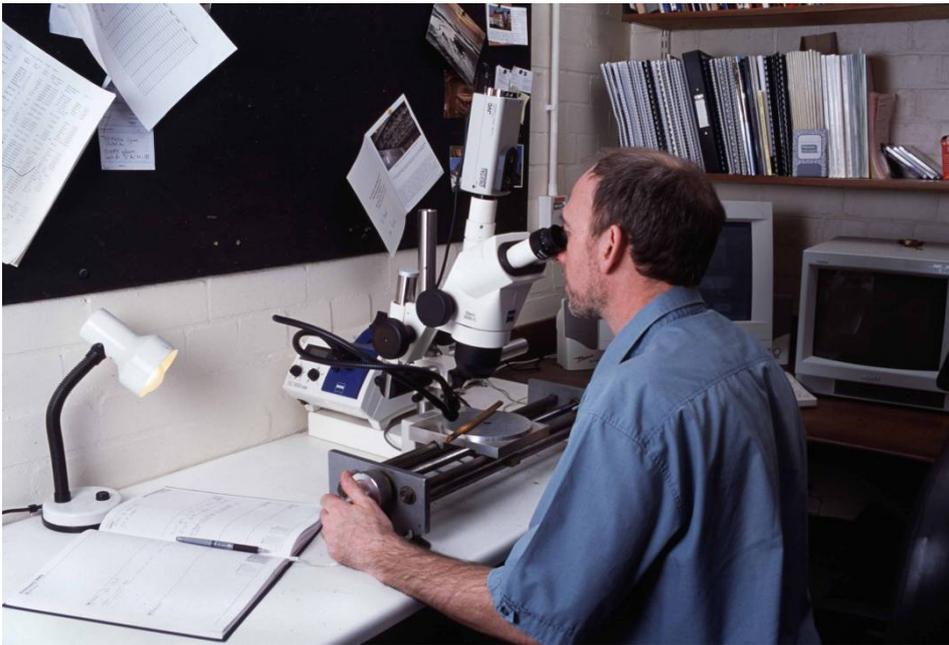
Figure A3: Measuring ring widths under a microscope. The microscope is fixed while the sample is on a moving platform. The total sequence of widths is measured twice to ensure that an error has not been made. This type of apparatus is needed to process a large number of samples on a regular basis

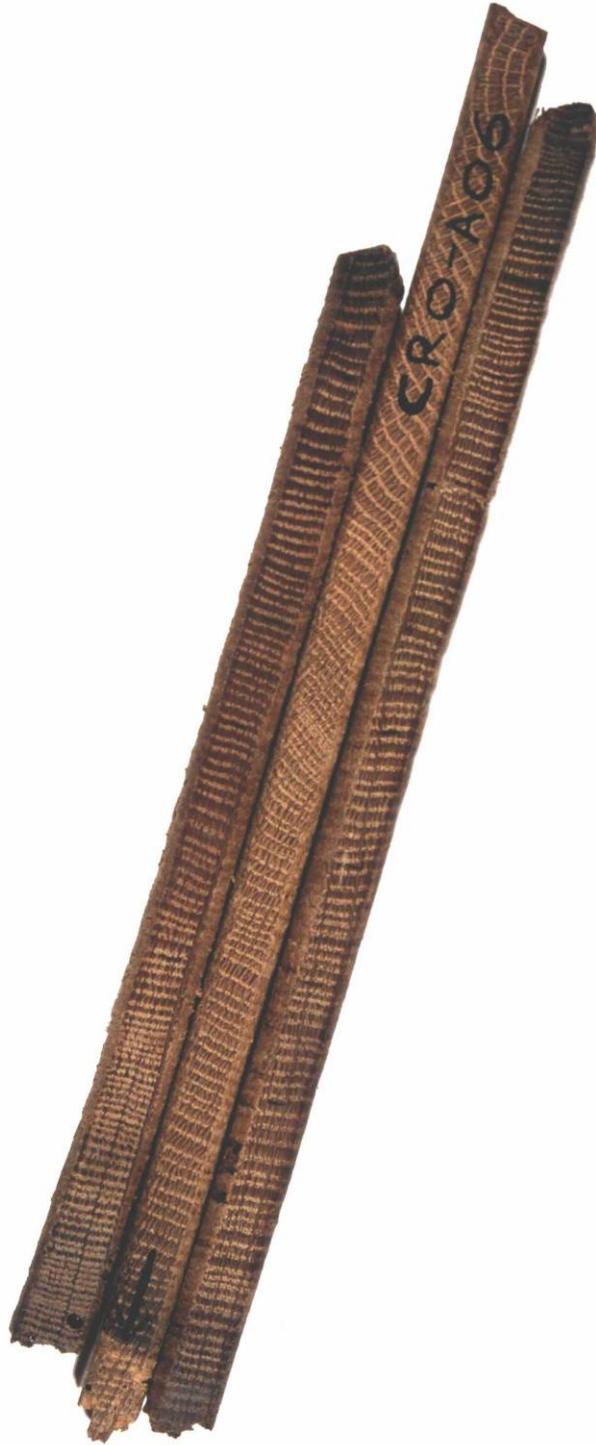
Figure A4: Three cores from timbers in a building. They come from trees growing at the same time. Notice that, although the sequences of widths look similar, they are not identical. This is typical

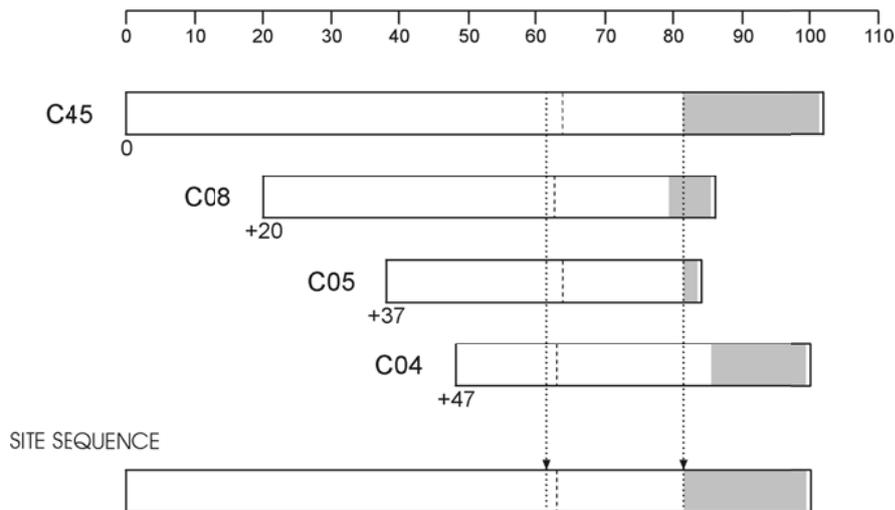
Figure A5: Cross-matching of four sequences from a Lincoln Cathedral roof and the formation of a site sequence from them

The bar diagram represents these sequences without the rings themselves. The length of the bar is proportional to the number of rings in the sequence. Here the four sequences are set at relative positions (offsets) to each other at which they have maximum correlation as measured by the *t*-values. The *t*-value/offset matrix contains the maximum *t*-values below the diagonal and the offsets above it. Thus, the maximum *t*-value between C08 and C45 occurs at the offset of +20 rings and the *t*-value is then 5.6. The site sequence is composed of the average of the corresponding widths, as illustrated with one width.

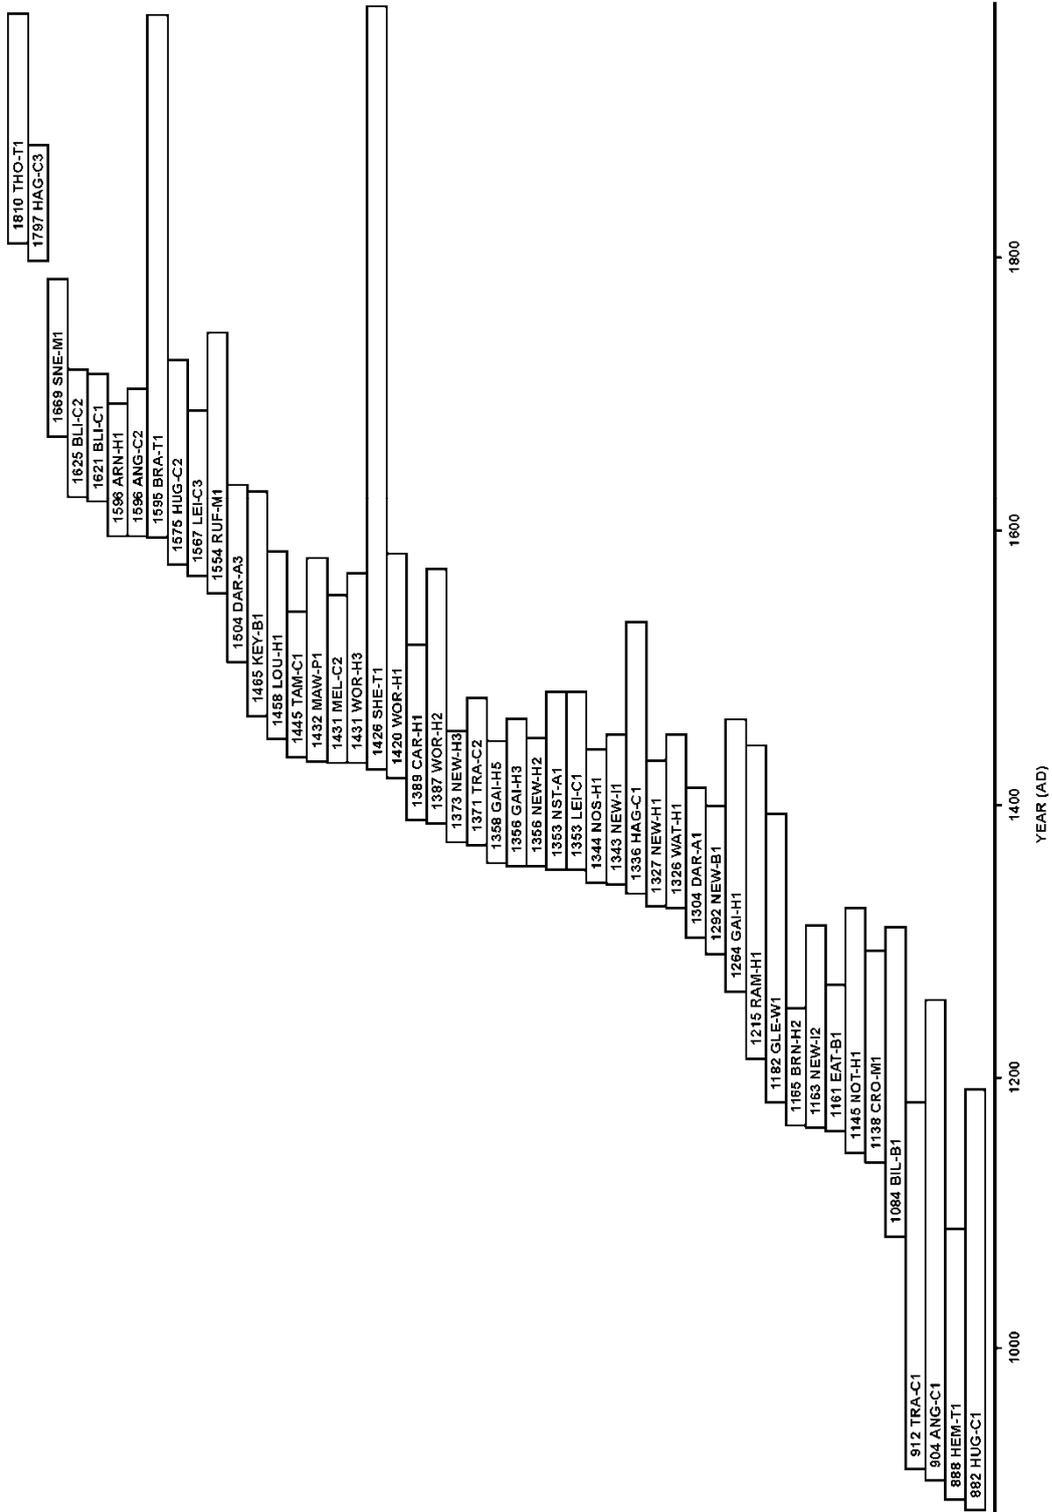
Figure A6: Bar diagram showing the relative positions and dates of the first rings of the component site sequences in the East Midlands Master Dendrochronological Sequence, EM08/87

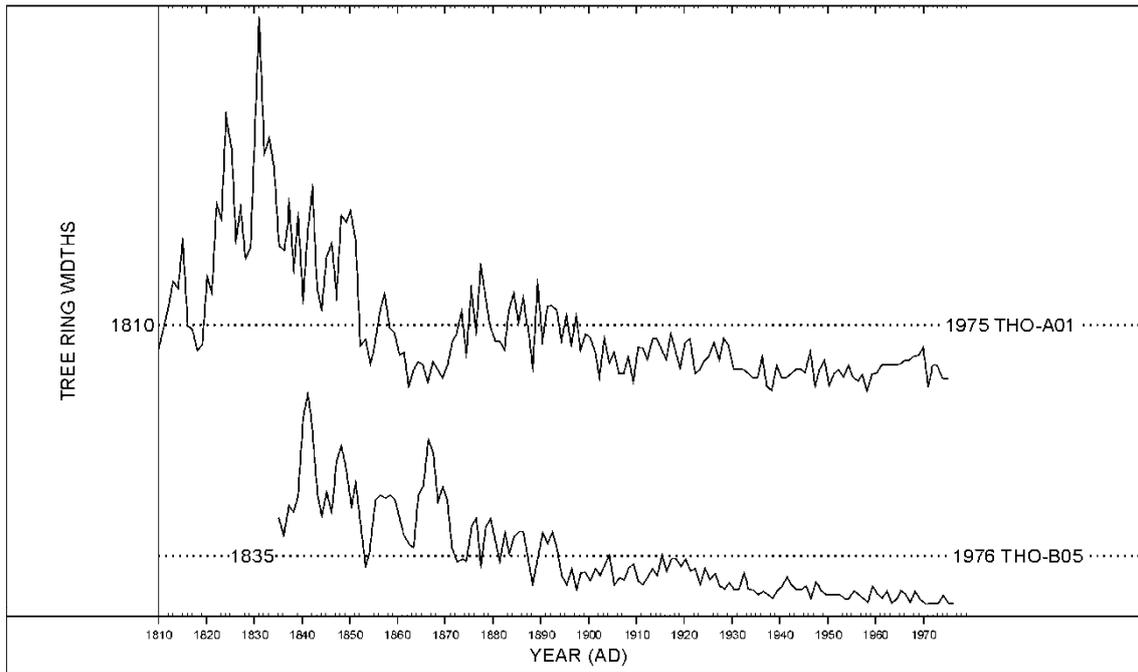
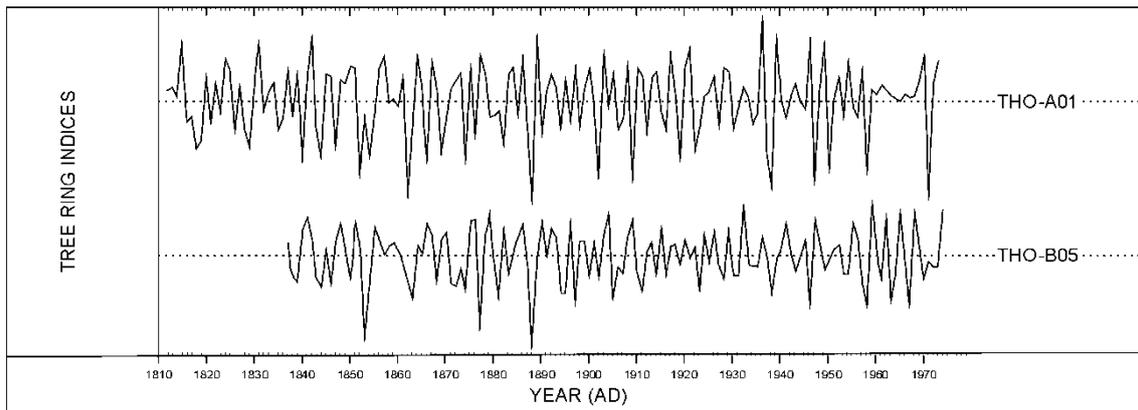
Figure A7 (a): *The raw ring-widths of two samples, THO-A01 and THO-B05, whose felling dates are known*

Here the ring widths are plotted vertically, one for each year, so that peaks represent wide rings and troughs narrow ones. Notice the growth-trends in each; on average the earlier rings of the young tree are wider than the later ones of the older tree in both sequences.
