Historic England

The Stockton & Darlington Railway Goods Depot, Darlington: Historic Building Investigation and Assessment of Significance

S&DR RAILWAY GOODS DEPOT, DARLINGTON

HISTORIC BUILDING INVESTIGATION AND ASSESSMENT OF SIGNIFICANCE

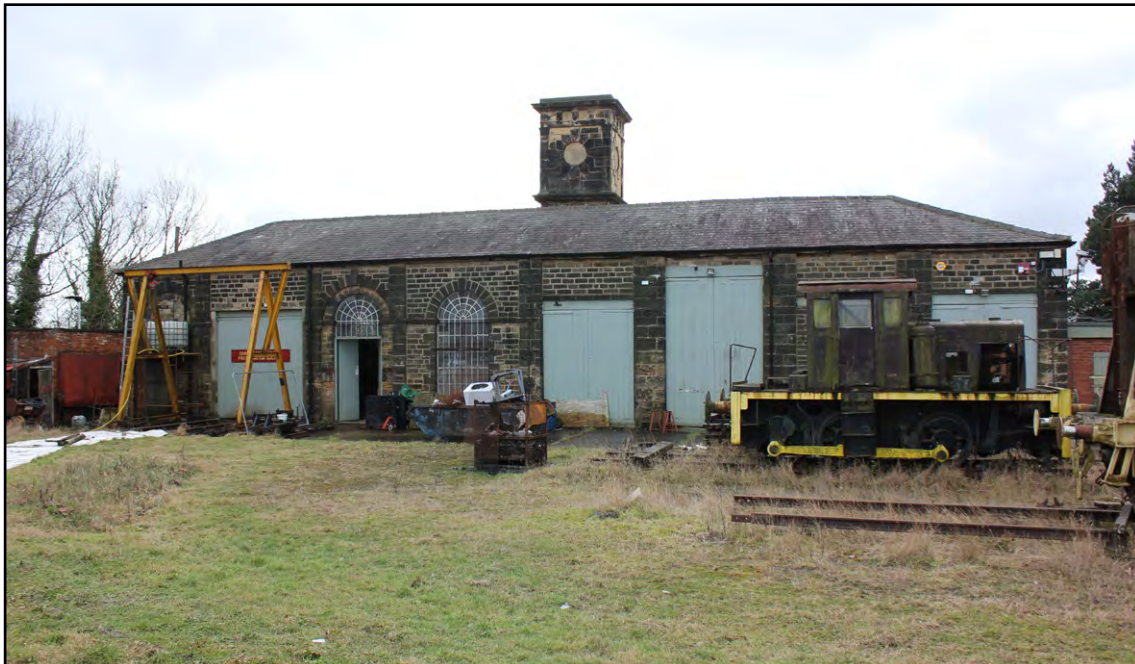
Figure 2: North elevation

In its present form, the Goods Depot comprises eight bays covered by a pair of hipped roofs running roughly east to west (figure 2 and 3). Its corners are articulated by heavy sandstone piers, and its southern elevation (and part of the northern) consists of piers of pilaster strips framing large arched openings. These sometimes contain large arched openings, some with concentric relieving arches with rock-faced voussoirs and keystones. A number of the openings contain metal-framed radial windows, whilst others have been fitted with the square-headed industrial-type windows. The northern elevation has seen various phases of intrusive alteration including the insertion of a number of large timber double doors. Above cornice level there is a functional brick chimney; more notably a clock tower of ashlar articulates the roof. The double hipped roof of Welsh slate has a lead valley gutter. Modern extensions to the west and north are of simple red brick.

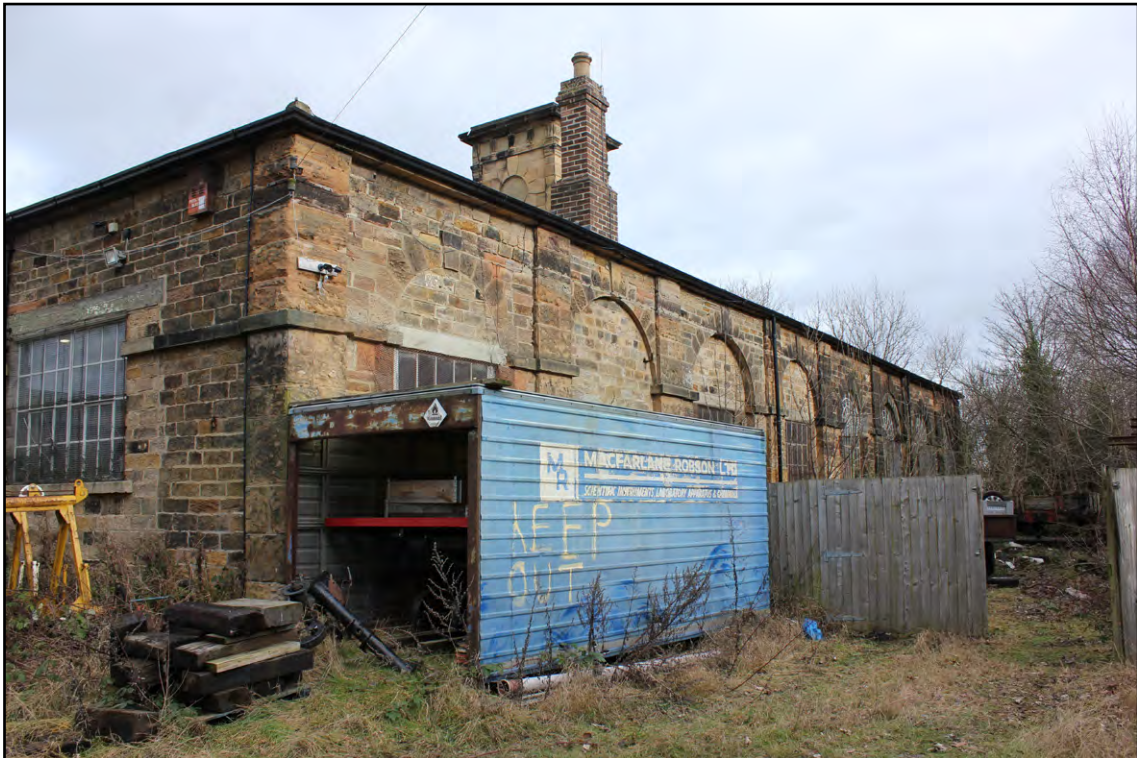
Figure 3. South elevation

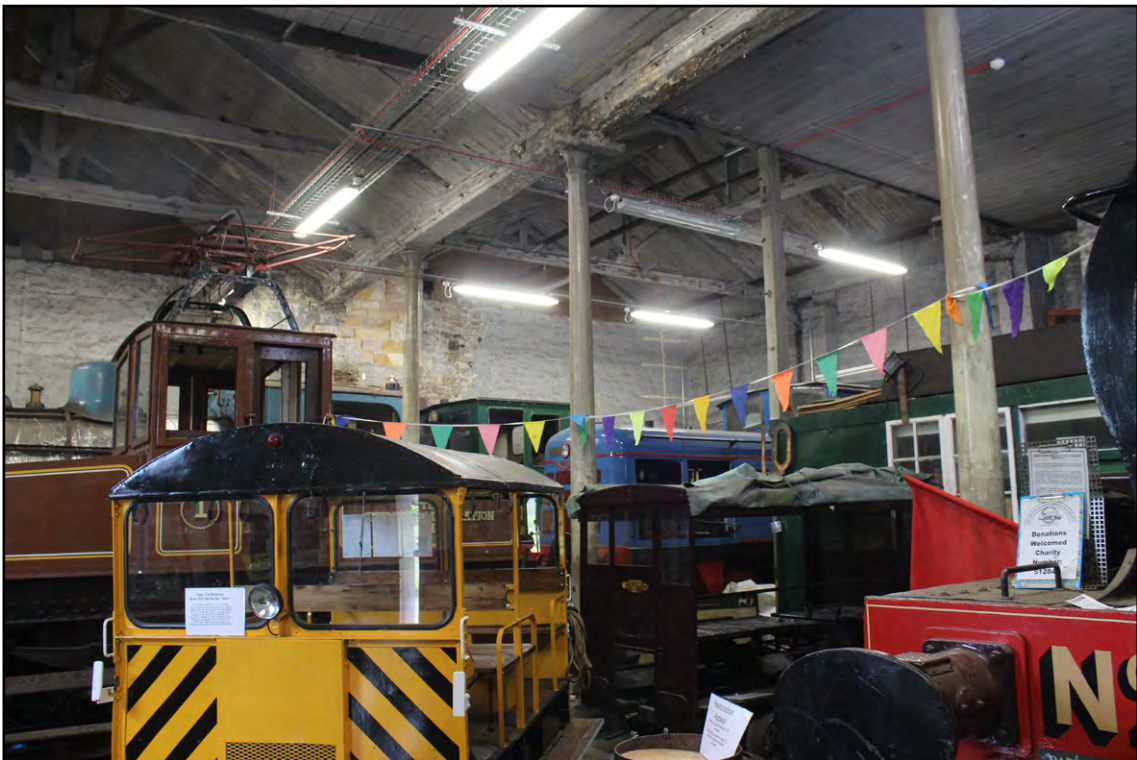
Figure 4. Interior of western cell, looking east

Internally, the building is divided with a north-south spinal wall between its eastern and western halves where there is a modern interconnecting door. These two cells today have a slightly different character and use – the western cell is more open with the roof valley supported on a series of slender cast-iron columns and contains a display of railway vehicles and memorabilia (figure 4). The eastern cell is lit by radial windows and has a more enclosed feel, with part of an original section of north wall with archway within the interior. This half of the building is mainly given over to the maintenance and repair of railway vehicles (figure 5).

The central clock tower is now in a precarious condition. In the western cell it is cantilevered and supported on massive timber beams which have distorted and now rest upon one of the DRPS's locomotives. Survey information demonstrates that the clock tower has a pronounced lean.

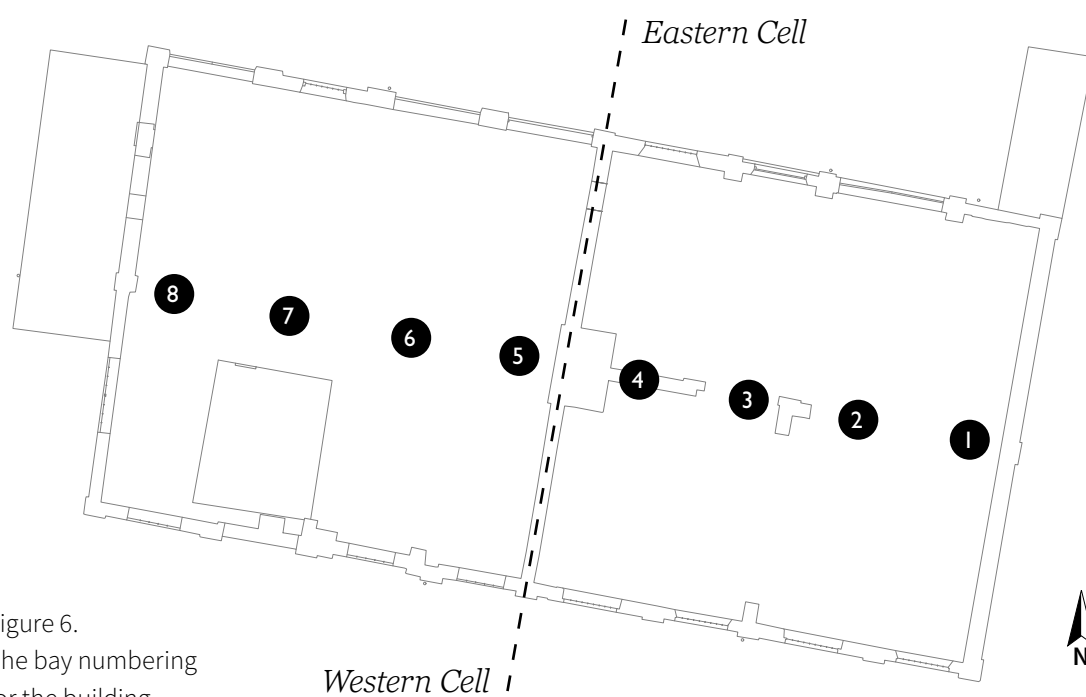
Figure 6.
The bay numbering
for the building

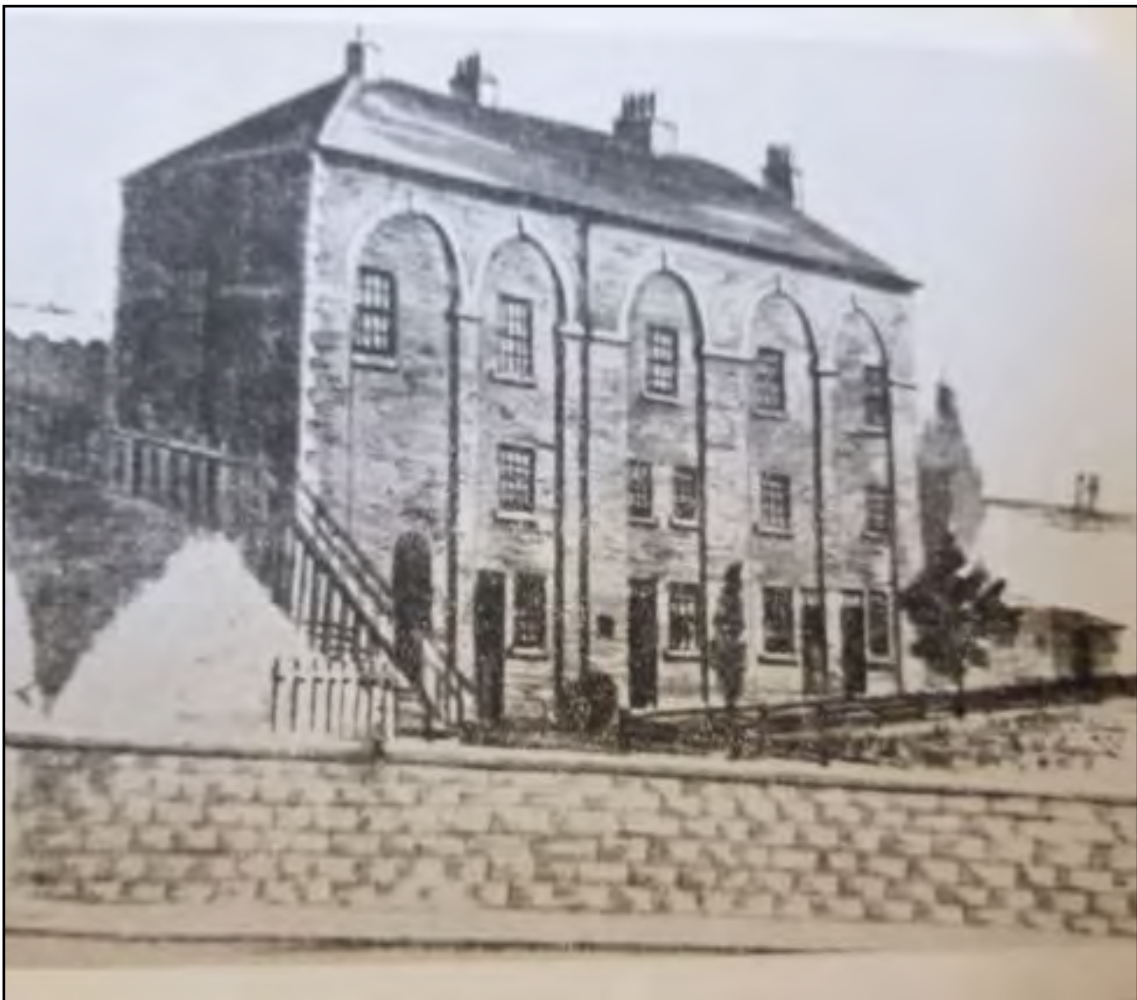
Figure 7: The 1827 Merchandise Station at North Road following its conversion to cottages c.1860 (courtesy of the Ken Hoole Study Centre, Darlington)

The origins of the Goods Depot are closely connected to the earlier S&DR goods depot, or 'Merchandise Station', constructed on the east side of North Road. Built in 1827 it was probably the first in the country designed to handle goods on the newly opened railways. ⁷ The building was not a success as within three years part of the building had been converted to residential use and by 1833 the upper level was given over entirely to rail passengers (figure 7). Its rapid adaptation may have been due to the inadequacies of the site and difficulty of operation. Whatever the reasons, by 1832 the S&DR were planning a new Merchandise Station (referred to in this report as the Goods Depot) on a more spacious site on the opposite side of North Road. Contracts were let in November of that year and it was completed by June of the following year. ⁸

However, the world's earliest known goods shed is the Goods Depot's predecessor at North Road: the 'Merchandise Station'. This building (figure 7) was built by the S&DR in 1827. The Merchandise Station had five arched bays with keystones similar to the Goods Depot. However, it was built against the railway embankment, with road access at ground level and track access at the upper level where goods wagons are thought to have entered the short axis of the building via turntables.⁵³ Internally it was divided into three cells which were rented out to carriers rather than directly operated by the S&DR. The building does not appear to have been particularly successful as by 1830 it was partially converted to cottages, before being used as a passenger station. When the new North Road Station was built in 1841-2, this station function was also abandoned, and the building was demolished some years later.

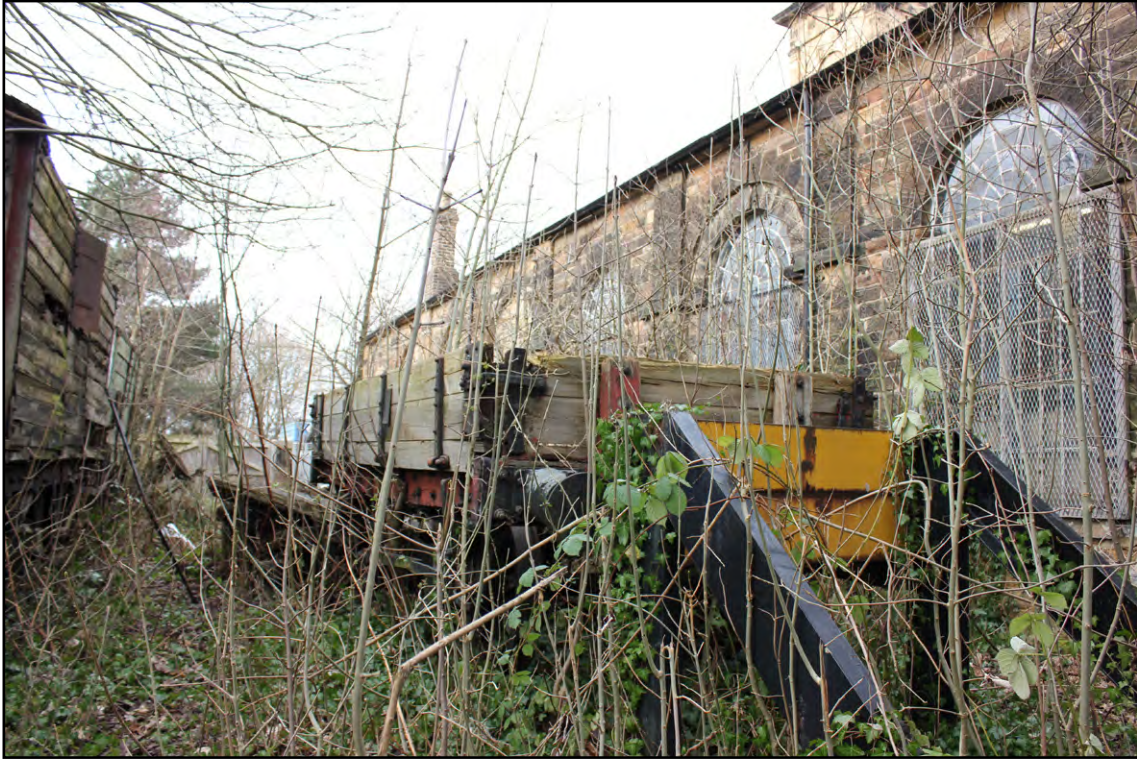
Figure 8: South Elevation, looking north-west

Analysis of the two halves of the southern elevation, however, appears to support a theory of two phases of construction, and several further phases of alteration. Significant differences in both the design and the stonework of the four easternmost and four westernmost bays can be clearly discerned. The four easternmost bays of the south wall have a regular but not symmetrical rhythm of *narrow, wide, narrow, wide* bays as seen from east to west, with correspondingly *thin, thick, thin, thick* wall thicknesses seen internally. The narrow bays are about 2.6m in width between the piers, while the wide bays measure approximately 3.7m. Each bay is divided by a projecting pilaster-like strip of masonry, about 0.75m wide, with the infilling stonework built up against the projections; this can be interpreted as a type of post-and-panel construction. This allows for a taller and wider arch, with voussoirs springing directly from the masonry piers for the arches over the tracks, and a narrower arch with voussoirs springing from an impost moulding for windows. The wider track arches have been altered with the addition of a second, inner arch, as part of a later phase of alteration (figure 9).

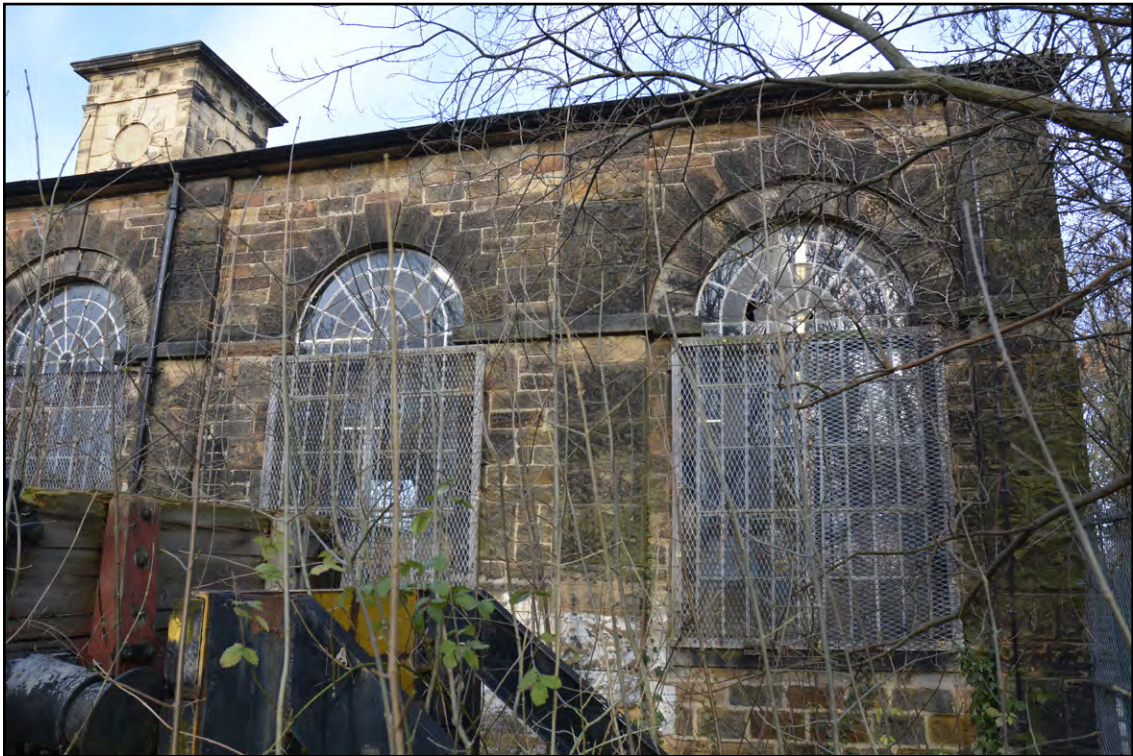
Figure 9: Bay 1 and 2, south elevation

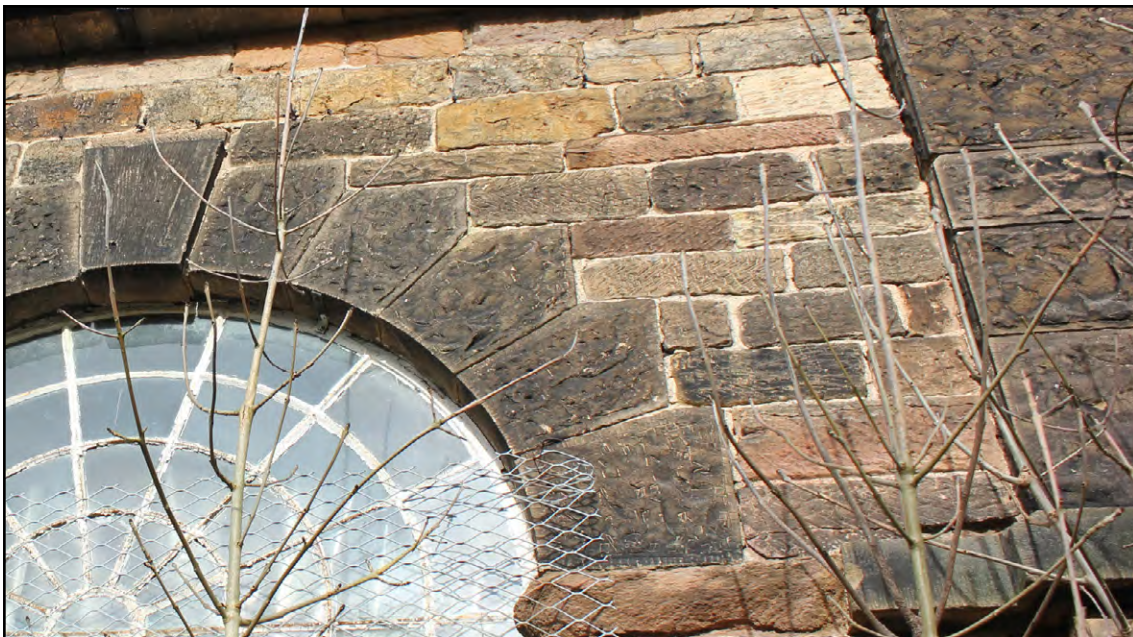
Figure 10: Bay 4 - detail of tooling, south elevation

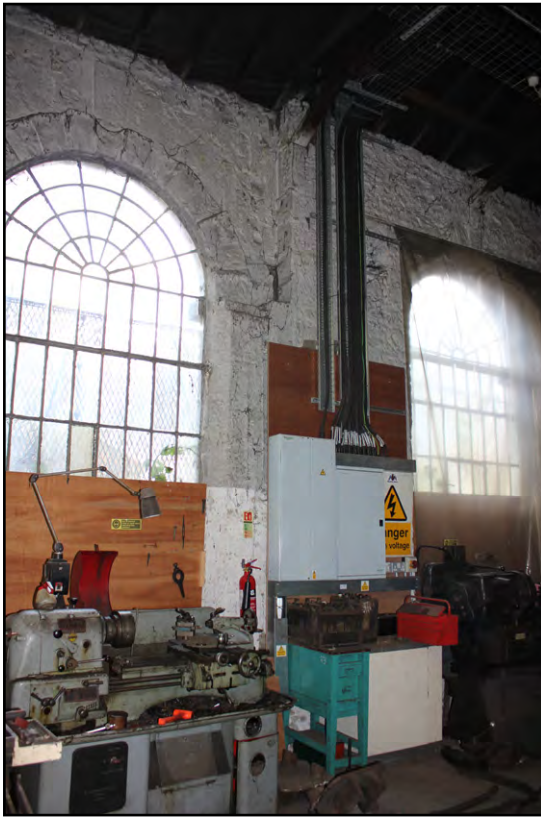
Figure 11: South wall, bays 3 and 4 showing the pattern of thin / thick walls above the arches

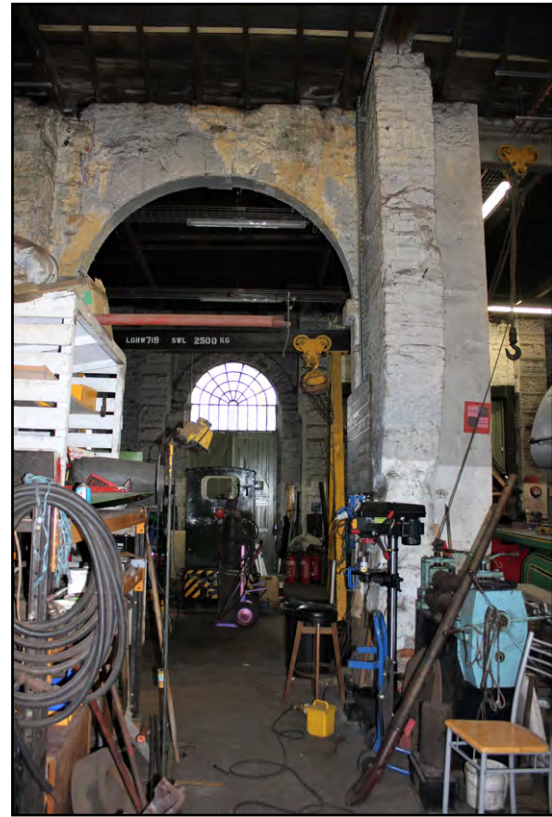
Figure 12: Phase 1 north wall, looking south

Also surviving from the first phase of the Goods Depot is part of the north wall, although this serves now as an internal division (figure 12). The wall is heavily coated in masonry paint and comprises an open archway to bay 3 with voussoirs and keystone, flanked by rusticated piers, identical to those on the southern elevation. Unlike its southern counterpart, it lacks the arched infill, and appears to have been largely unaltered from 1833. Notable features are sockets cut into the soffit of the arch and impost; these may have held some form of timber fitting. It is interesting to note that other similar arches on both the northern and southern elevations (specifically bays 1, 3, 5 and 7 to the south, and bays 1 and 3 to the north) have similar sockets visible above the impost. Their existence on the arch of the former north wall of the phase one building would suggest this feature was part of the earliest phase (potentially for a radial window above the opening). The feature was apparently adopted when the building was extended to the north, but then removed when the arches were infilled after the building went out of use as a goods station.

The former north wall extends into bay 4 but here the arrangement differs from the south elevation; unlike its counterpart, a continuous impost band with stonework above shows no evidence of an archway. The stonework matches the coursing and tooling within the spandrels above the arch in the adjacent bay 3, suggesting the arrangement is original. Below the impost band is a section of wall with a rectangular opening. Issues of access during survey precluded a closer inspection, but the existence of heavily rusticated quoins to its eastern reveal on the north side would suggest this was an original opening. Its height above the current ground level suggests that it served as a window.

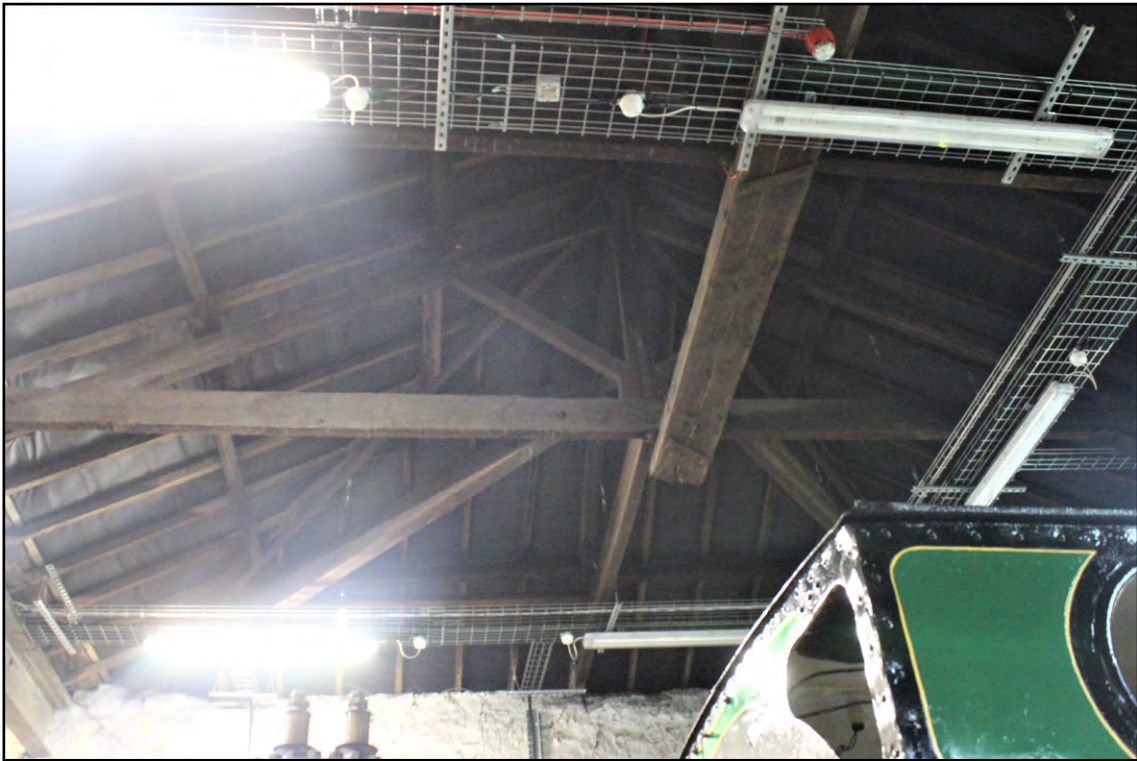
Figure 13: Phase 1 roof truss

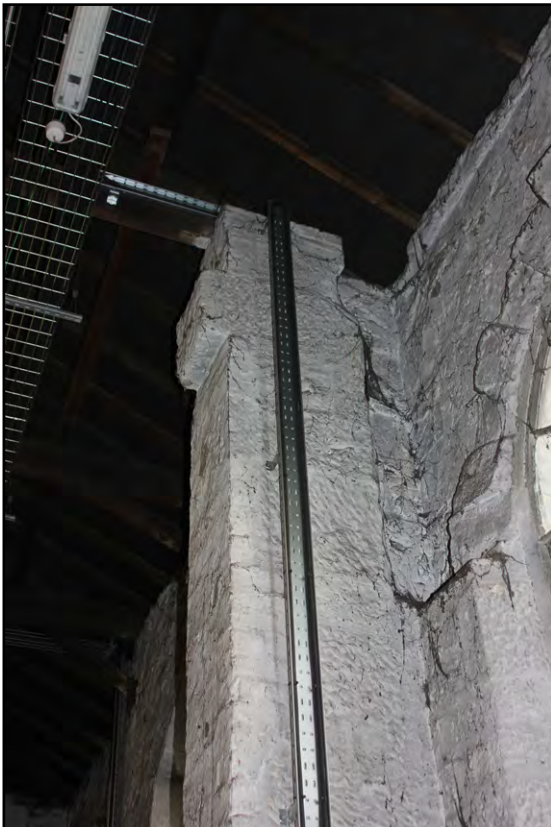
Figure 14: Wall stub, south wall between bays 2 and 3

Within the internal space, there is evidence of a dividing cross wall between bays 2 and 3; this can be seen in the truncated remaining sections in the internal south elevation and mid-section (now internal north wall) (figure 14). The partial north and south walls have projections in the manner of the external rusticated piers, but the remains of the cross wall abut it, showing that the cross wall is a later addition. The date at which this wall was inserted remains unclear, but the stonework appears to be of the same heavily tooled finish as another truncated wall between bays 6 and 7 in the adjacent western cell which suggests they may be contemporary and belong to a later phase of development, possibly phase 2.

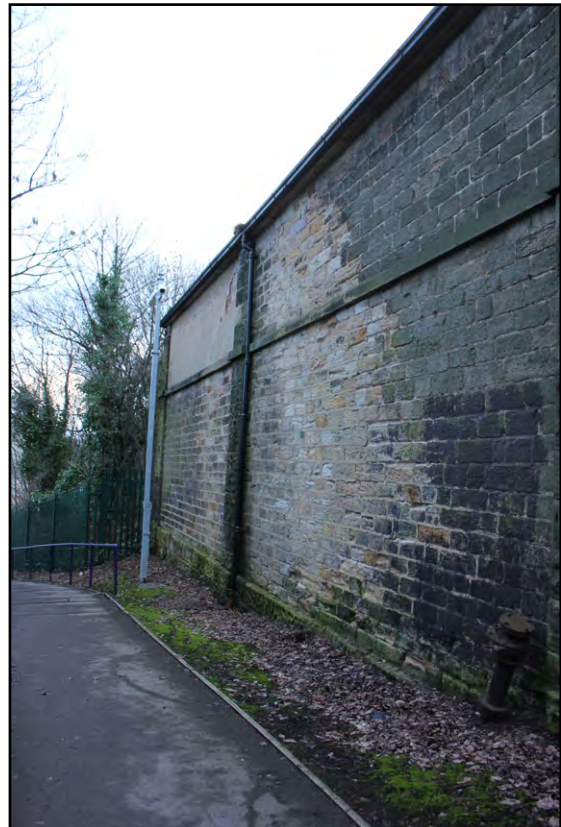
Figure 15: East elevation, looking south

The west wall of the phase 1 building is not extant. The present north-south wall which divides the two halves does not possess the same architectural finish as the eastern elevation (figure 15), with no impost band or apparent coursed stonework or plinth. Instead, the wall abuts the central south wall pier with a straight joint which has required more recent repair due to instability. This wall is therefore of a later phase.

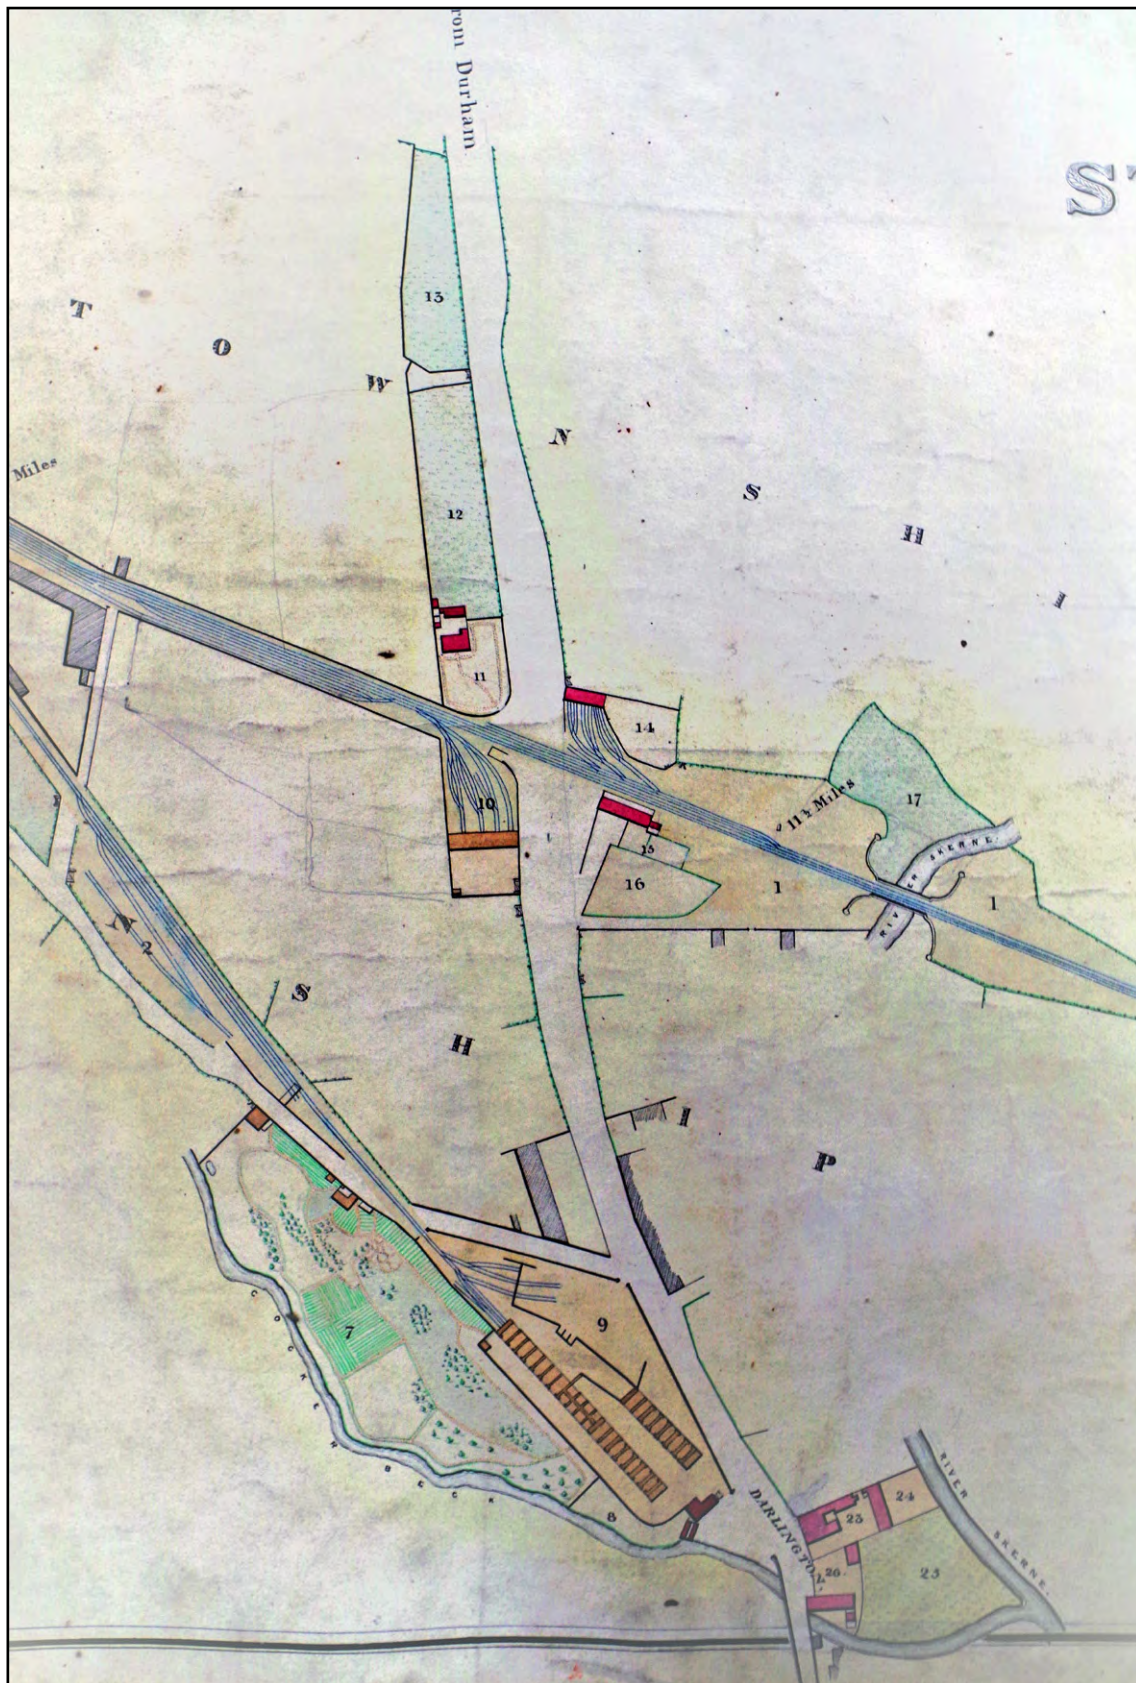
Figure 16: The Dixon plan of 1839 showing the North Road site. Source: Archaeo-Environment Ltd. Reproduced with kind permission of The National Archives, ref. RAIL 1037/456

Dixon's survey of 1839 (figure 16) indicates that by the end of the 1830s, the Goods Depot had been doubled in length to comprise a single range of eight bays. This equates to the southern half of the building as it is today. This map is the earliest cartographic evidence for the site and shows the building (labelled no. 10) with four rail tracks entering from the north through bays 1, 3, 5 and 7. Also worth noting is the enclosed yard to the south, entered from a gate in the south-west corner from North Road, and a small building located in the south-west corner, roughly in the location of the Goods Agent's Office which was built in 1840.¹⁵ This would imply that clients approached the building from the south to deposit or collect goods; the southern elevation was thus the most visible and important, facing as it does both the yard and towards the town.

The cartographic evidence from Dixon's Plan of 1839 (figure 16), indicates that in the earliest two phases the rail tracks did not pass directly through the Goods Depot, probably terminating within the interior where goods were loaded or unloaded. The OS Town Plan of Darlington surveyed 1854 and published 1856 provides further clues of the building's layout and function a decade and a half after Harris extended it (figure 23); although how far this reflects Harris's original design intentions is less clear.

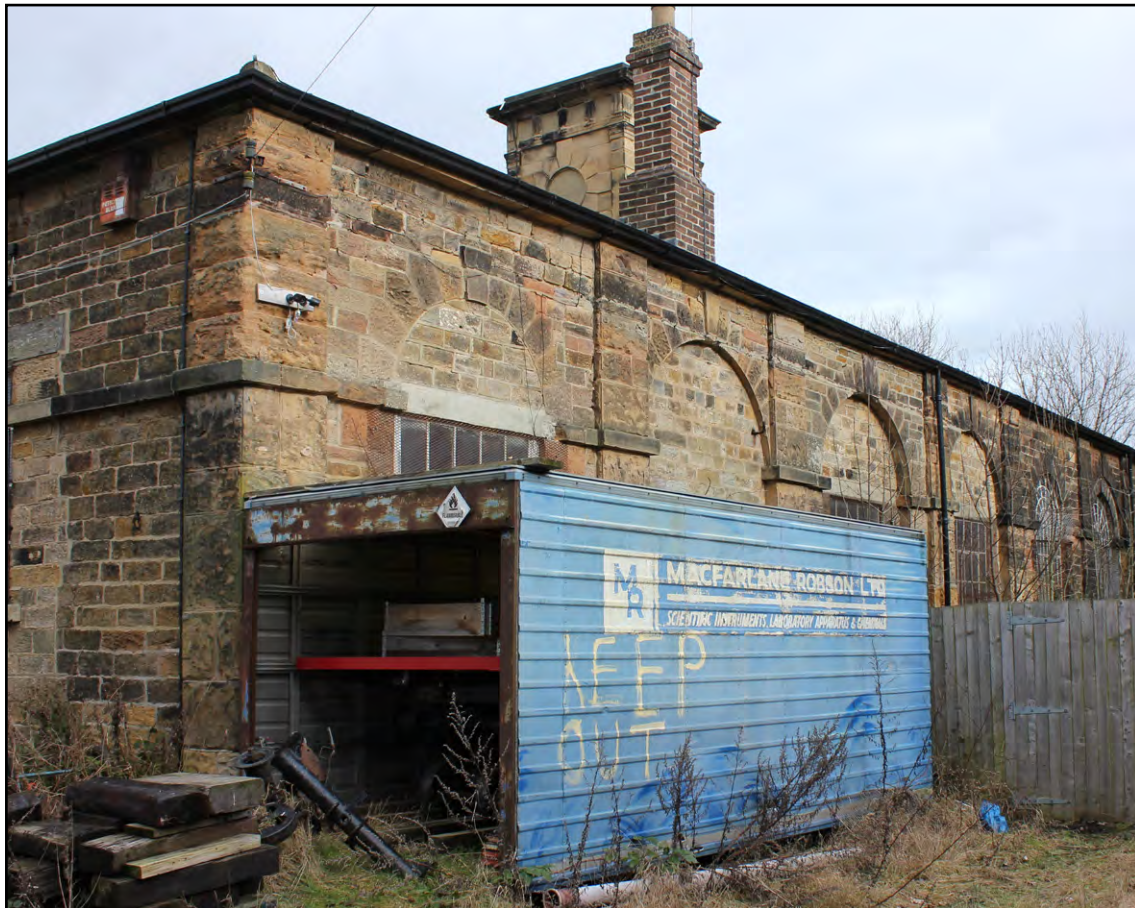
Figure 17: Bays 5 to 8, south elevation

Today, the western half of the south elevation of phase 2 comprises four bays separated by rusticated piers, in a similar manner to the eastern half (figure 17). Each bay contains a rusticated arched voussoir with finely tooled keystones and impost band, and coursed stonework within the spandrels. The western half has been subject to a number of alterations; bays 5, 6 and 7 have been fitted with rectangular metal-framed windows with concrete lintels, whilst bay 6 has been infilled with coursed stone; a brick stack rises above this bay through the slate roof, indicating the reason for its blocking.

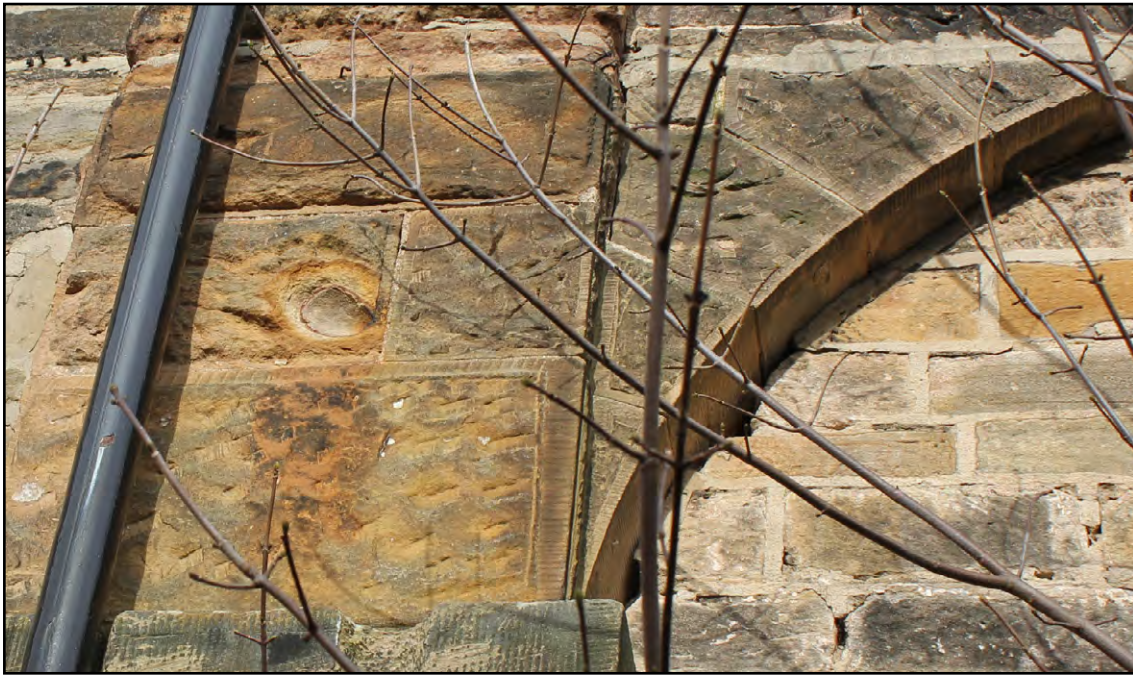
Figure 18: Pier between bay 5 and 6 showing different tooling to that of Phase 1

Other differences are apparent. The tooling of the masonry of the western half of the elevation is quite different to that of phase 1 to the east, with heavier tooling to the voussoirs and more distinct margins (figure 18). The treatment of the stonework is still of high quality, including the distinctive feature of vertical tooling for the reveals of the arches and the sides of the rusticated piers.

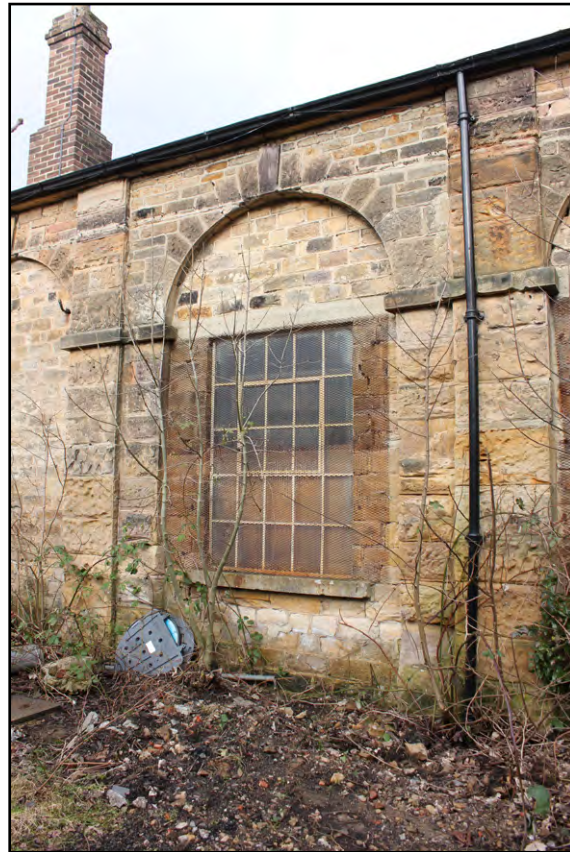
Figure 19: Bay 5. Its different arrangement suggests it may have been for pedestrian or cart access

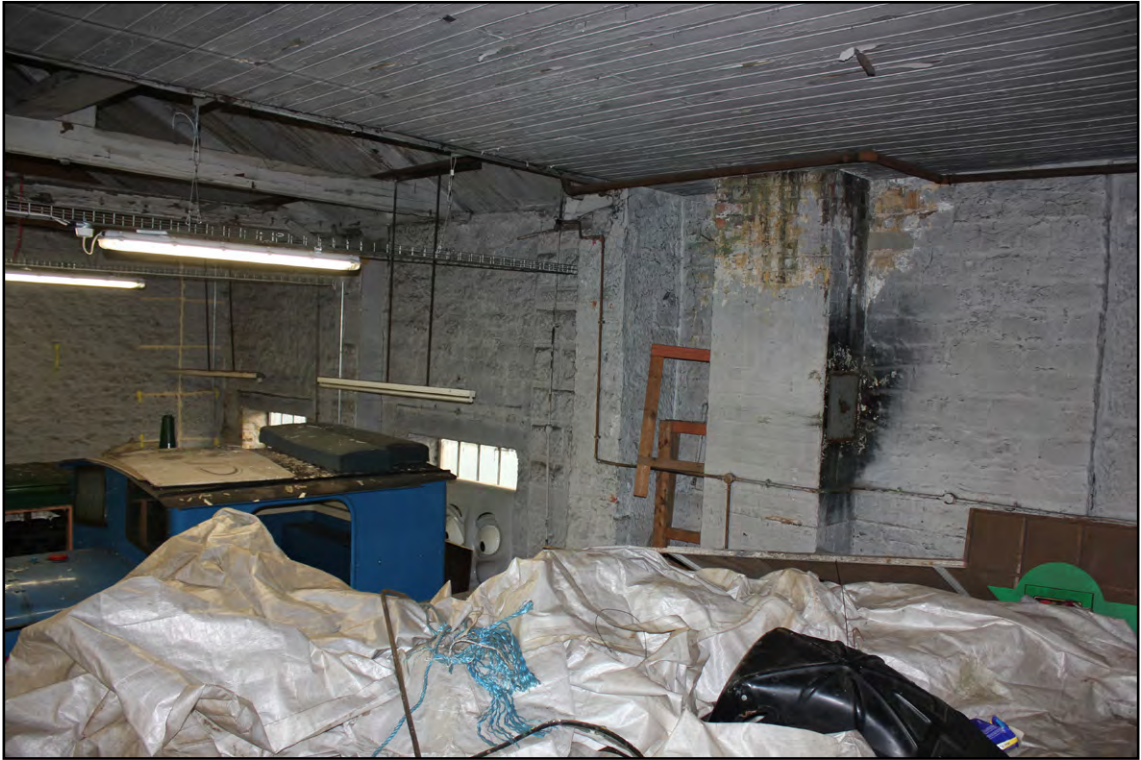
Figure 20: The internal south wall, western wall. The series of rusticated piers, a wall stub with heavy tooling and a chimney flue characterise this elevation

The internal fabric of the south-western wall is difficult to access, and later alterations have obscured much of the evidence (figure 20). The original arches are less easy to discern internally in contrast to the eastern side, although the inside of the original voussoirs and keystone to bay 8 are just visible. However, two rusticated piers which flank bay 6 are prominent. Unlike elsewhere on the southern wall, they project from the surface and although partially obscured by paint, the rustication and wide-tooled margins are still distinctive. These piers were clearly originally designed to be visible internally. As noted above, bay 6 is an anomaly which may have provided access to pedestrian and road users, not rail, which may explain its treatment internally and externally.

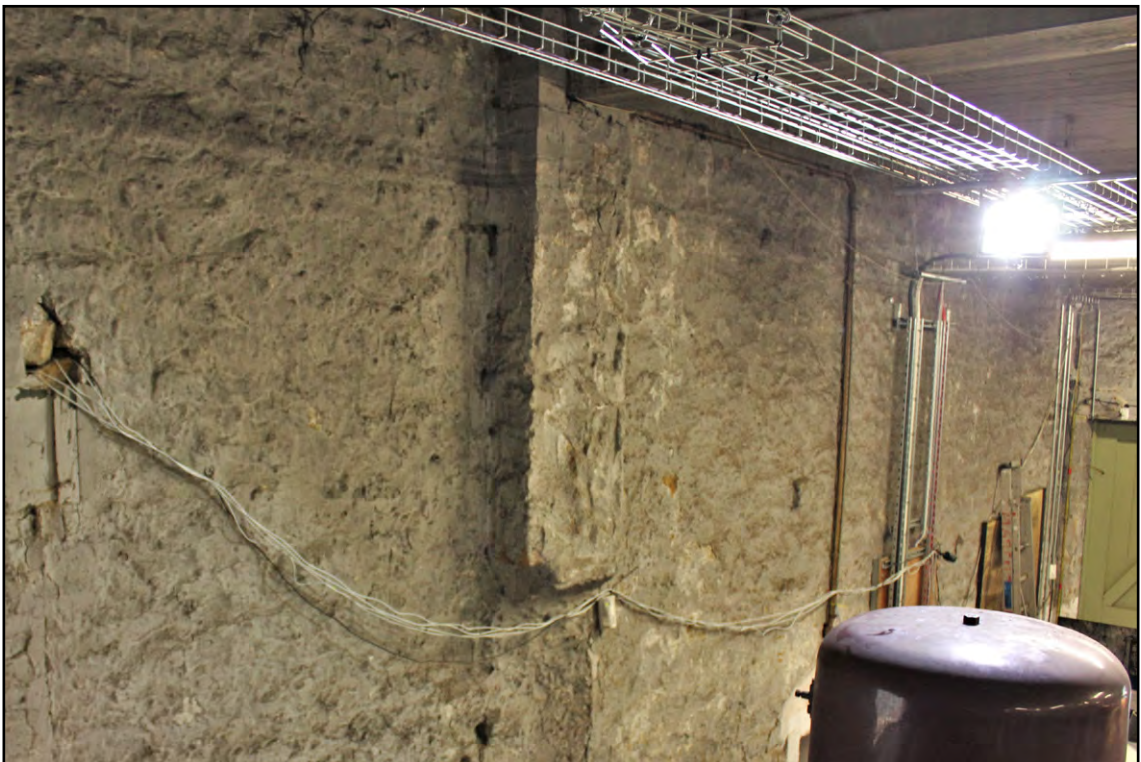
Figure 21: Masonry stub, of what was probably the north wall

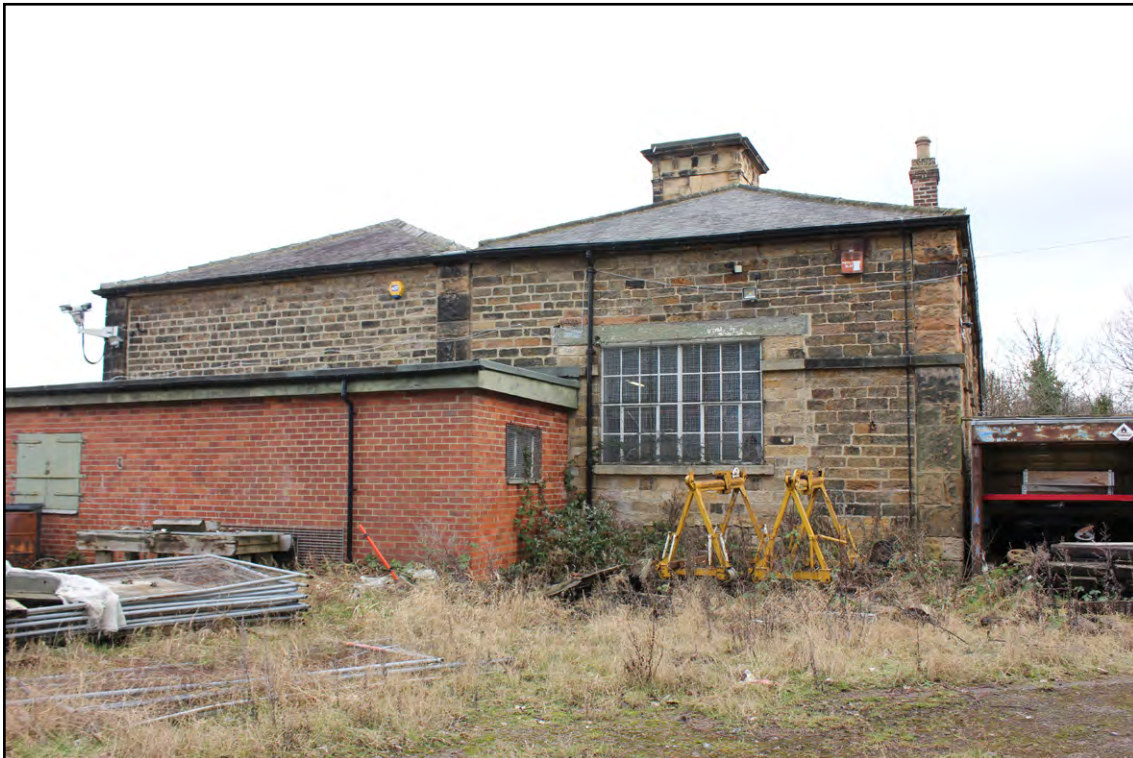
Figure 22: The western elevation - phase 2 is to the right, with later additions and alterations

Also associated with this second phase of construction is the southern half of the west elevation (figure 22). The western elevation is similar in construction to the east elevation, comprising two broad bays of coursed stonework with limited architectural articulation. There is a noticeable difference in the coursing-heights and stone size between the southern and northern portions, also indicating two separate phases. Rusticated piers articulate and define the corners and the two phases converge at the centre of the elevation. A simple string course runs horizontally along the elevation, now partly obscured. No plinth could be discerned, though this may be due to a difference in the ground level between the east and west elevations. The square-headed metal-framed window to the southern half, and the flat-roofed brick extension which conceals much of the northern half of this elevation belong to later phases.

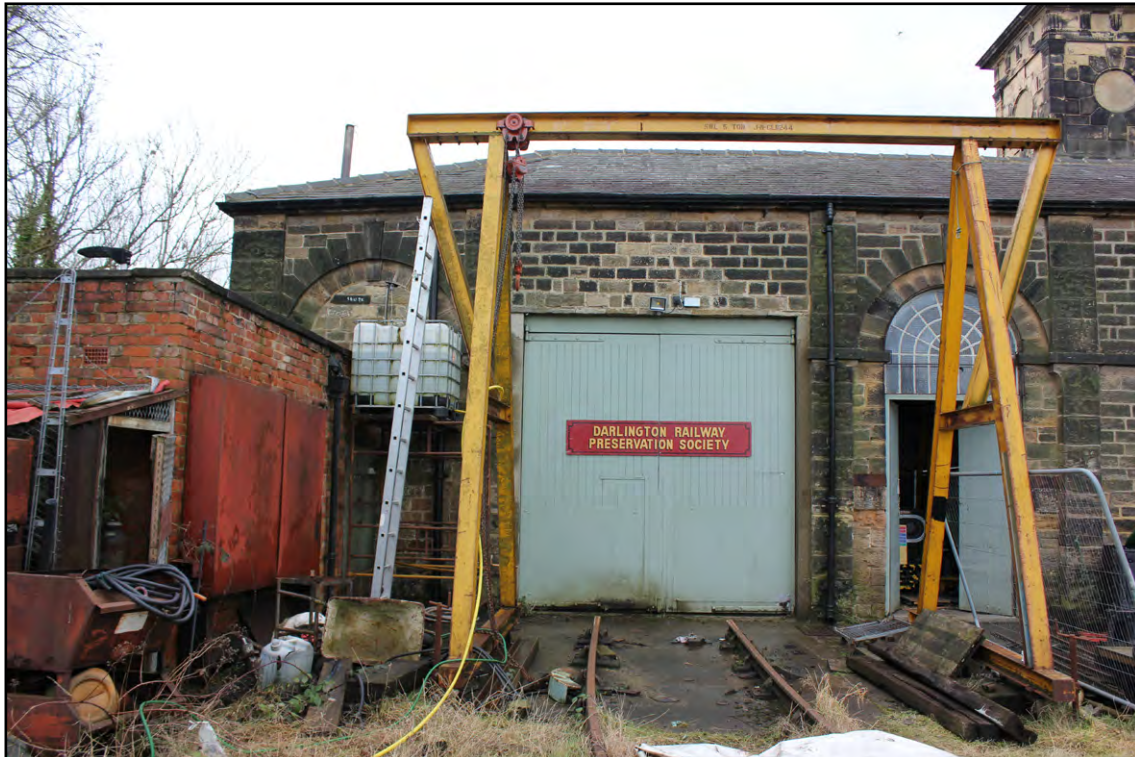
Figure 24: Bays 1 – 3, north elevation

Bays 1 to 4 are partially legible as Harris' 1839-40 extension (figures 24 and 25). Bay 1, although obscured, contains a high arch with rusticated voussoirs and keystone, similar to its corresponding bay to the south. The adjacent wider bay 2 now contains timber double doors but is known up to 1951 to have contained a radial window similar to bay 4.²² A photograph taken in 1948 (figure 47) confirms this evidence, as does the disturbed masonry where the arch once was. Bay 3 is a high opening with rusticated voussoirs and keystone, now containing a door and partial radial window above, whilst bay 4 is a wide opening with voussoirs and a keystone set with a radial window (figure 25). Bays 2 and 4 were thus probably originally similar to each other, as were 1 and 3.

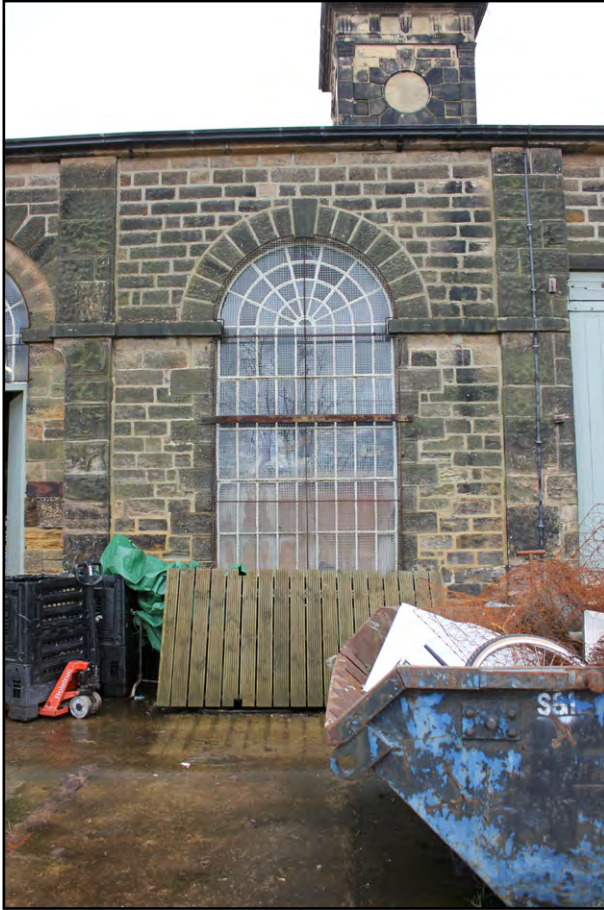
Figure 25: Bay 4 radial window, north elevation

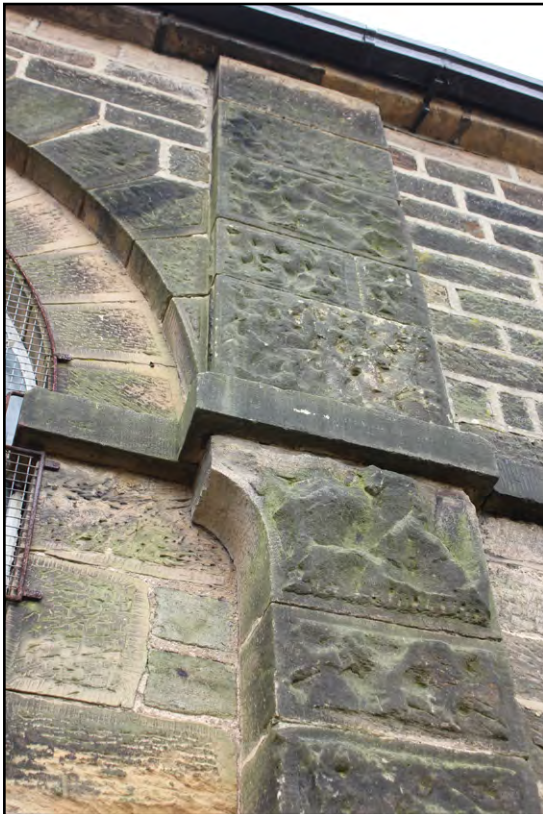
Figure 26: Detail of shouldered arch to bay 3 with later arched infill

The same fine detailing seen on the south elevation is evident within the stonework to the northern elevation of bays 1-4, including the rusticated arched voussoirs with finely tooled keystones and impost band. As observed on the south elevation, the first two courses within the piers above the impost band and the lower stones of the voussoirs to bay 3 are formed from the same stones (figure 26).

Differences are also apparent between the execution of the two elevations. No plinth is apparent, and Harris employed shouldered arches to bays 1 and 3 (figures 26, 28 and 30) which contained tracks. The widths of the piers and widths between bays also differ to the south elevation. The piers between bays 1 - 4 are generally 0.5m in width, in contrast to the south elevation where piers are consistently 0.75m in width. The width of bays 1 and 3 on the north for rail access are 2.7m, reducing to 2.5m above the shoulder, but are 2.6m on the corresponding bays on the south elevation. Bays 2 and 4 (assumed to have originally contained windows) are about 3.9m in width between the piers, but 3.7m to the south. The differences would suggest Harris was responding to a modest increase in wagon gauge, perhaps enough to make their clearance more comfortable between the arched openings. Despite this, Harris appears to have maintained Storey's earlier rhythm of *narrow, wide, narrow, wide* and *high, low, high, low*.
