Historic England

The Stockton & Darlington Railway Goods Depot, Darlington: Historic Building Investigation and Assessment of Significance

S&DR RAILWAY GOODS DEPOT, DARLINGTON

HISTORIC BUILDING INVESTIGATION AND ASSESSMENT OF SIGNIFICANCE

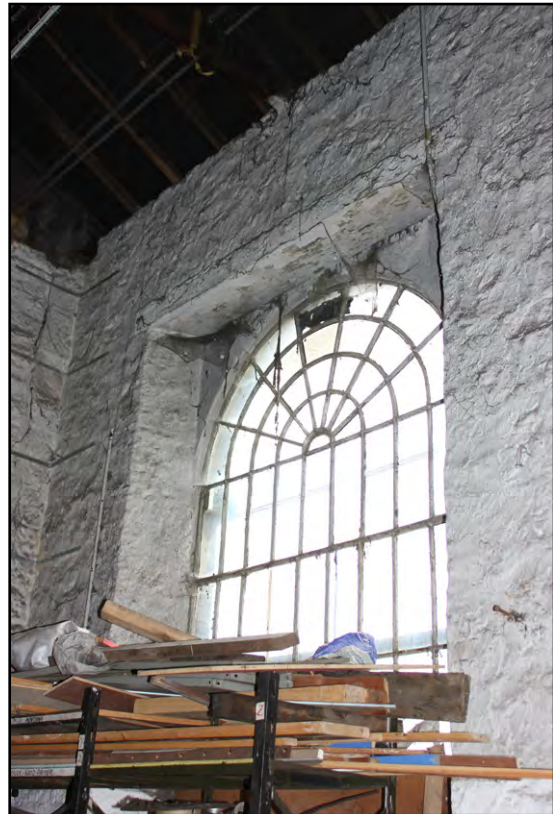
Figure 27: Interior of radial window to bay 4

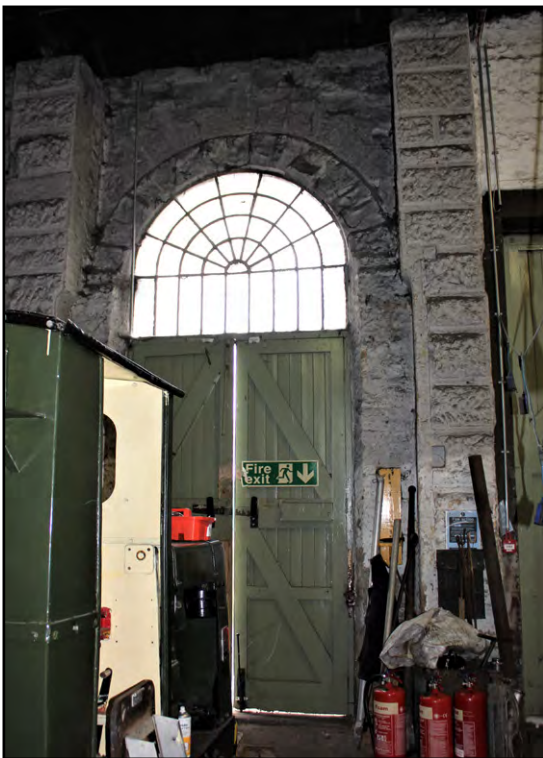
Figure 28: Interior of bay 3 showing rusticated piers

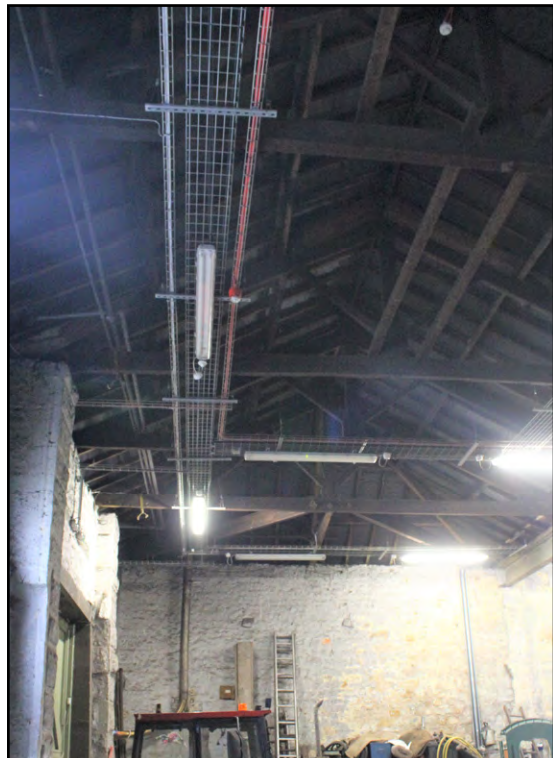
Figure 29: Phase 3 roof structure

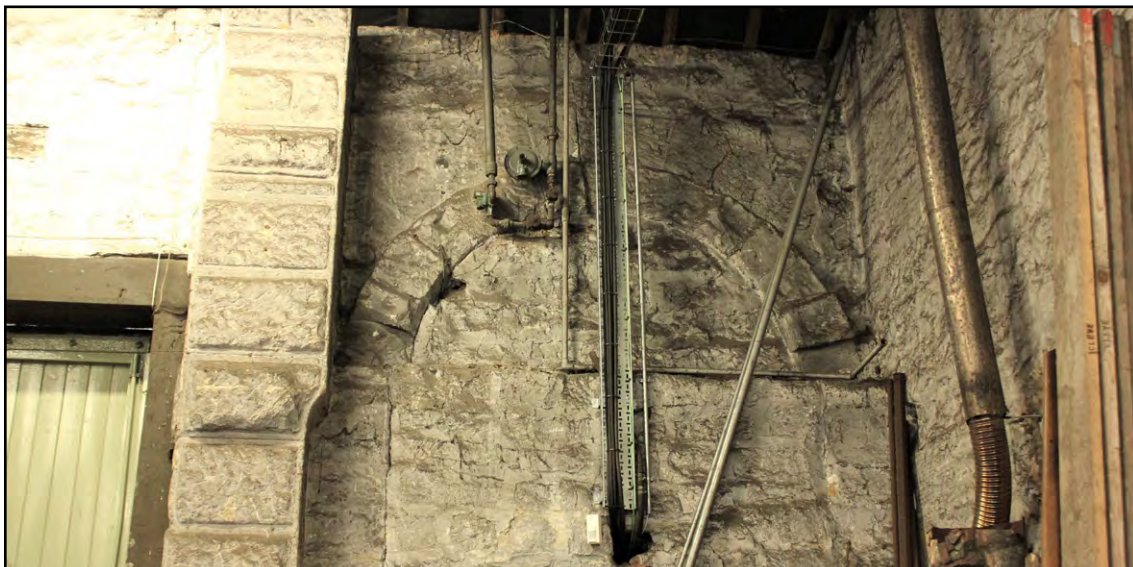
Figure 30: Interior of Bay 1 showing three phases of intervention; Harris' rusticated pier with shouldered internal arch and (just visible) the voussoirs to the wagon opening. Below is the inner arch of a later 19th century alteration, and 1951 blocking of the opening.

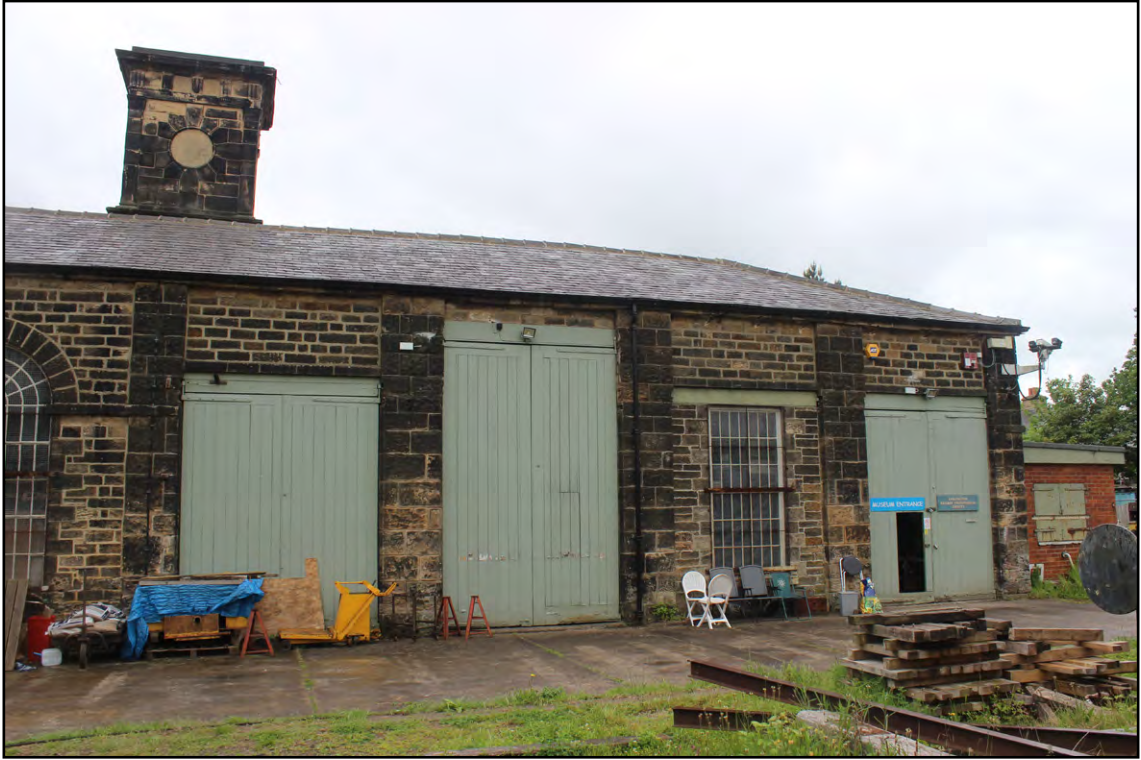
Figure 31. Bays 5 - 8, north elevation

Today, bays 5 to 8 externally are hard to read as a part of Harris' extension, due to later alterations (figure 31). Bays 5 and 8 contain a similar arrangement of timber double doors, beneath a timber lintel and coursed stonework. The impost band has been abandoned. The iron hinges have been carefully cut into the flanking rusticated piers which are also slightly splayed. Bay 6 is similar, containing as it does a set of double doors, but the door is rather higher than those in bays 5 and 8. Bay 7 is infilled with coursed stonework and set with a later industrial-style window with concrete sill, similar to those on the south elevation. These bays, unlike those elsewhere, are of regular widths of approximately 3m, whilst the piers are also wider, measuring about 1m in width.

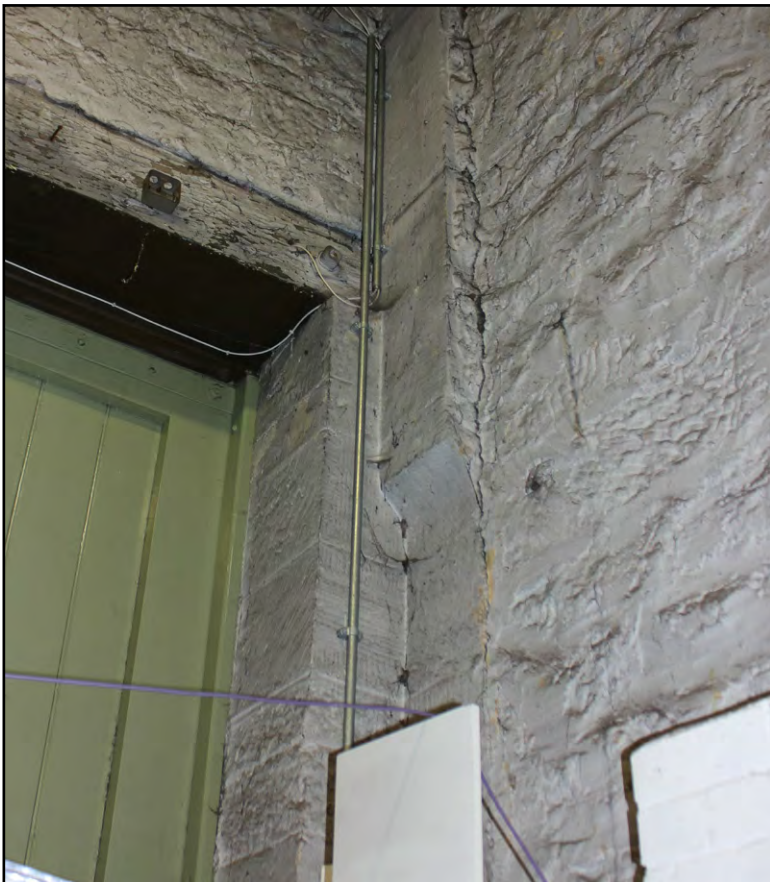
Figure 32. Remnant of shouldered arch to bay 5

However, a fragment of a shouldered arch internally to bay 5 (figure 32) would suggest that this bay was originally of a similar design to bays 1 and 3. In addition, the pier between bays 4 and 5 evidences two phases of stonework, leading to the overall conclusion that bays 5-8 and their piers have been largely rebuilt and belong to a later phase of alteration.

A feature of the northern section of spinal wall appears to suggest that Harris had completed the new north elevation before the spinal wall was constructed; the northern end of the spinal wall abuts the central pier between bays 4 and 5 with a straight joint. Internally, the pier has a shoulder and above the pier has a rusticated finish with distinct margins, similar to others on the north wall. This suggests the pier's inner face was intended to be visible and the spinal wall a later addition (visible in figure 32).

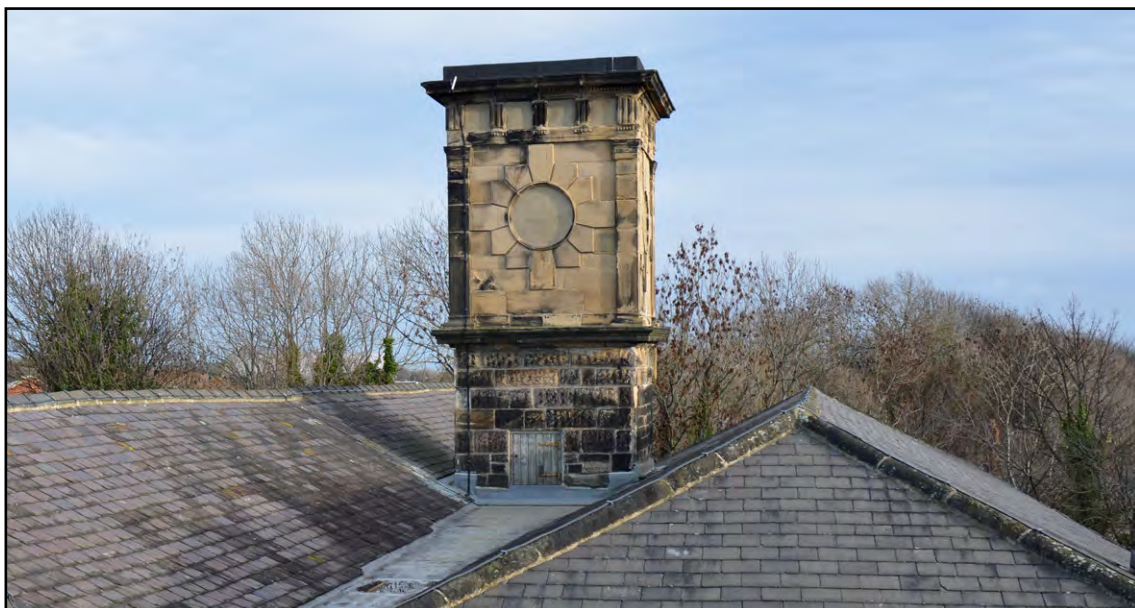
Figure 33: Clock tower (Historic England Geospatial Survey Team)

The square tower which rises from the roof valley is visible from the rail line and from the surrounding area. It is built in smooth, high-quality ashlar with Doric pilasters at the corners and an entablature including a triglyph frieze with guttae. The choice of the Doric order was presumably to give the tower a distinctly Classical architectural flavour of the more austere sort. The roundels which form the clock faces (now infilled) are surrounded by voussoirs similar to those forming the arched openings on the elevations. The cement-rendered metopes between the triglyphs were originally open so that the sound of the clock's bell could be clearly heard. An image taken in the mid-20th century indicates that the clocktower once supported a flagpole (figure 43). Below, the tower is constructed of rusticated stonework with the same heavy tooling seen on the structure within the interior. On the west elevation is a small timber door with strap hinges which provides access into the roof valley. The resulting composition is the strongest Classical feature of the entire building.

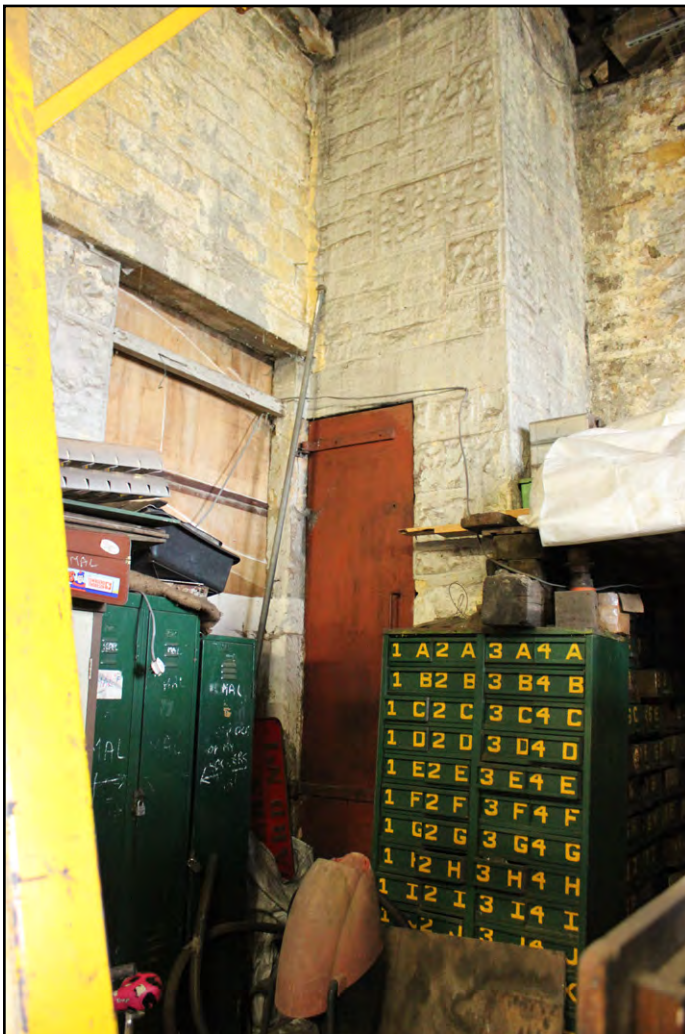
Figure 34: Tower base and door, eastern cell, north side

Internally, the clock tower extends through the building to the ground, with its weight also being taken by the north-south spinal wall, and the former external north wall from phase 1 (figure 34). The insertion of the tower implies that the spinal wall was built at this time to provide stability, from which one can extrapolate that there was no solid division between phases 1 and 2 when the latter was constructed. The tower is constructed with the same attention to detail as the phase 2 stonework, with margined and rusticated quoins. At its base on the north side within the eastern cell is a doorway with stone lintel, approximately 0.67m above the modern floor level. This suggests that the building interior had raised floors. Access into the base of the tower was not possible at the time of investigation, but it is said to be a single space. It is presently used by the DRPS for storage.²⁷

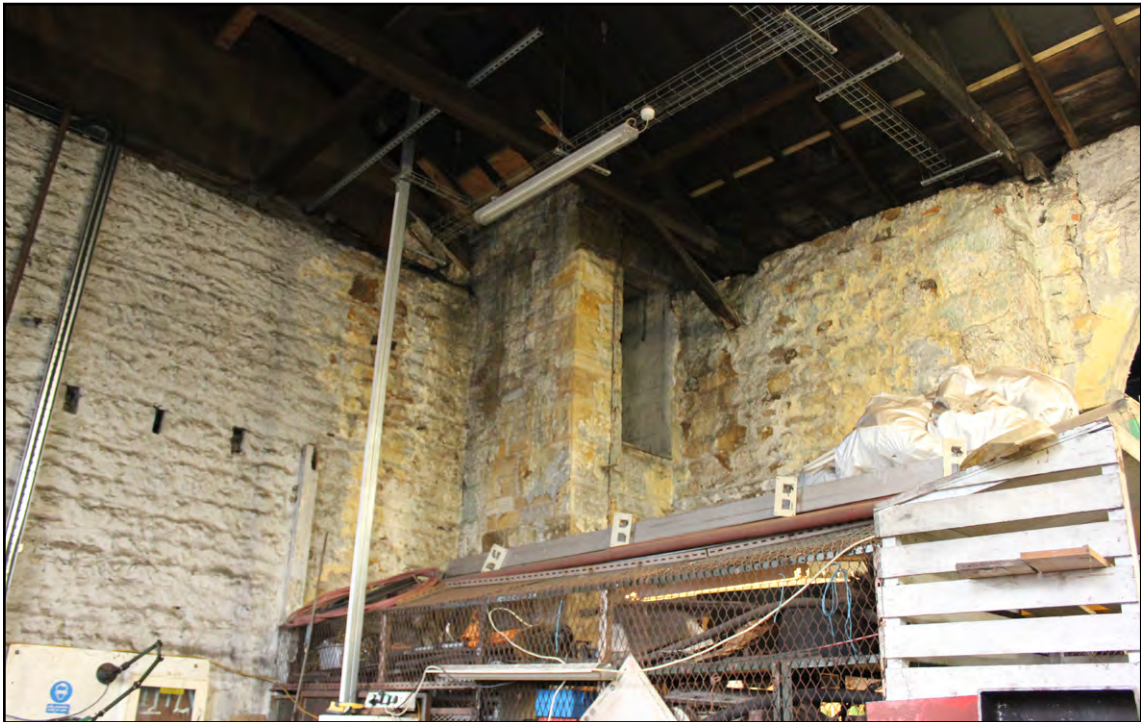
Figure 35: Tower base and high-level door, eastern cell, south side

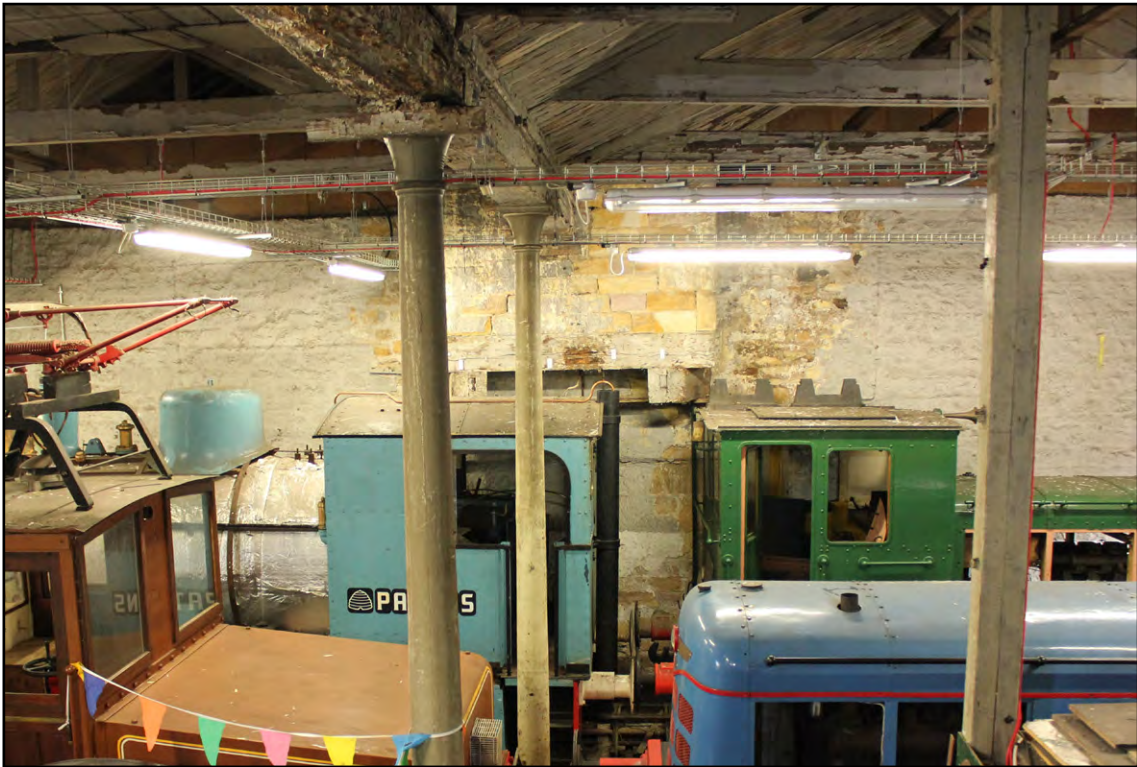
Figure 36: The western cell looking east. Note the slender cast-iron columns, and uppers section of tower cantilevered out on heavy timber beams

The central clock tower is now in a precarious condition. In the western cell it is cantilevered and supported on massive timber beams which have distorted and now rest upon one of the DRPS's locomotives. Survey information demonstrates that the clock tower has a pronounced lean.

A notable feature within the western half of the Goods Depot, separating the phase 2 building from the phase 3 northern extension, is a series of slender cast-iron columns (figure 36). These support the roof, which is carried on a longitudinal timber beam composed of two lengths scarfed together. It is unclear when this work was carried out, and it has been suggested above that they could have been inserted instead of constructing the north wall, leaving the northern half open. However, there is also no reason for this work not to have been by Harris. It has been observed that similar but smaller columns are found within the loggia of the adjacent station built 1840-41.³¹ Interestingly, the columns are raised upon stone plinths of a similar height above ground level as the threshold of the clock tower door, perhaps also evidencing the existence in phases 2 and 3 of a raised floor, or internal platforms running alongside the rail lines to facilitate loading/unloading inside the Depot (figure 37). The interior has a more open character compared to the east, and whilst this may be evidence for a later date of the works, it is also feasible that the open arrangement reflected different functions between the two cells.³²

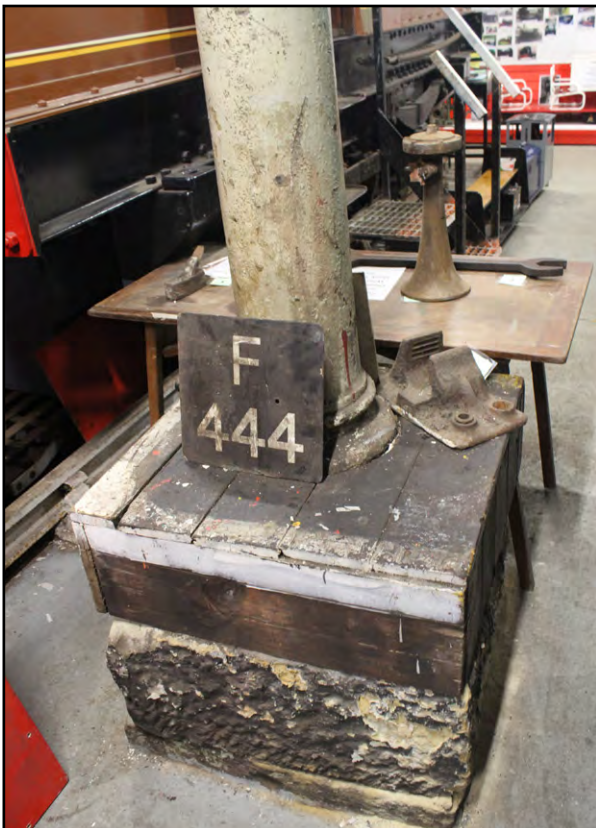
Figure 37: Base of column

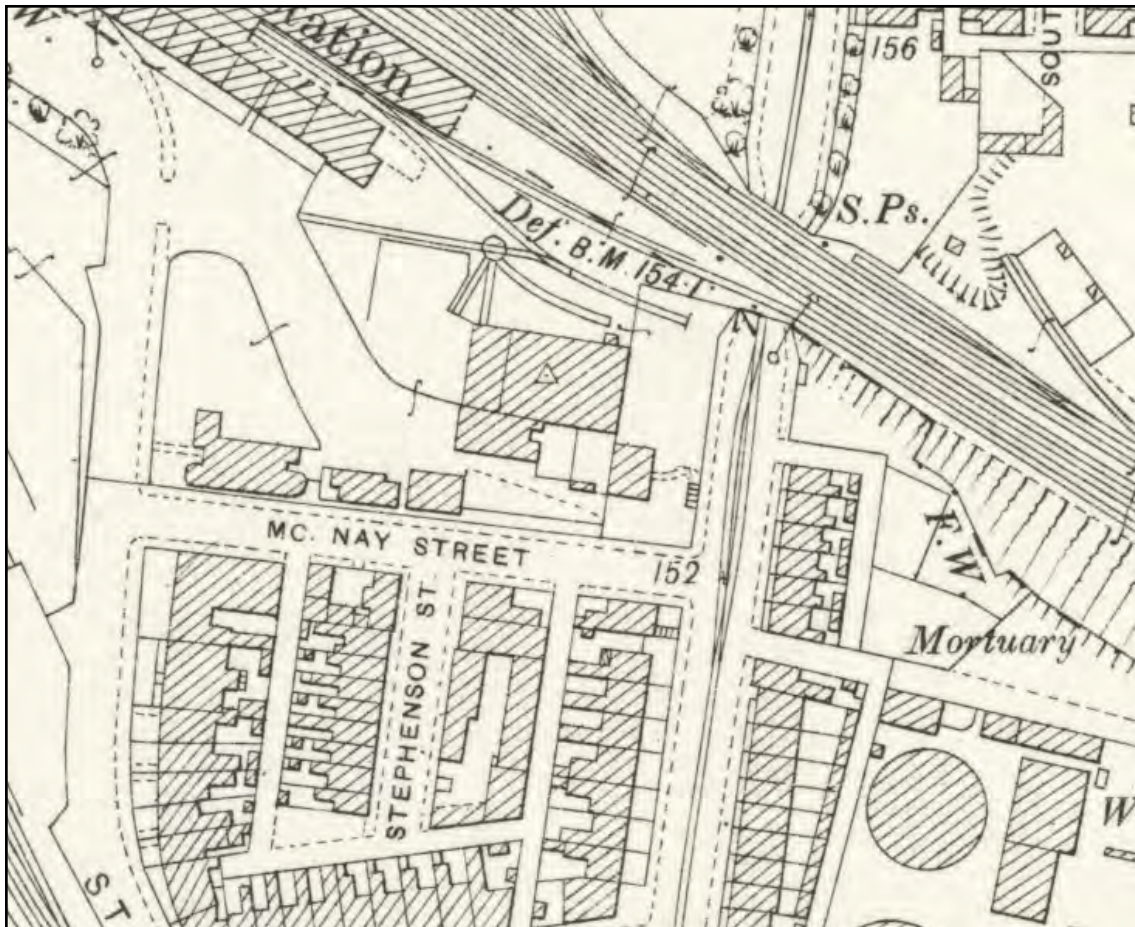
Figure 38: Ordnance Survey County Series 25" (1:2500) revised 1896, published 1898.
Reproduced with the permission of the National Library of Scotland

The 1896 Ordnance Survey map also depicts substantial changes to the Goods Depot in the intervening years and indicates that the building had ceased to function in its earlier form (figure 38). The former track arrangement has been lost – a single track enters the yard from the station, but rather than approaching the Goods Depot directly, it leads to an external siding. The Goods Depot is now only accessible by shunting from this siding via a turntable. Tracks which formerly entered bays 1, 3, 5 and 7 have been lifted, and the sidings substantially truncated. One specific track from the turntable appears to approach, and possibly enter bay 8, whilst two others terminate in the yard of the Goods Depot. During the building's earliest phases of use as a goods station, bay 8 did not have track access, perhaps suggesting not only changes to its use, but also to its internal layout and structure.

Other changes are also apparent: direct access from North Road has been lost and access is now via a wide road leading from the west towards the south of the building. There is now a rectangular building attached to the south elevation (the line of the former roof can still be seen where it was chased into the stonework above bays 4 – 8). The south side appears to have been subdivided into rectangular yards and a building is situated to the south-east with a path leading to North Road. The map also suggests that the interior of Goods Depot has been subdivided between bays 6 and 7.

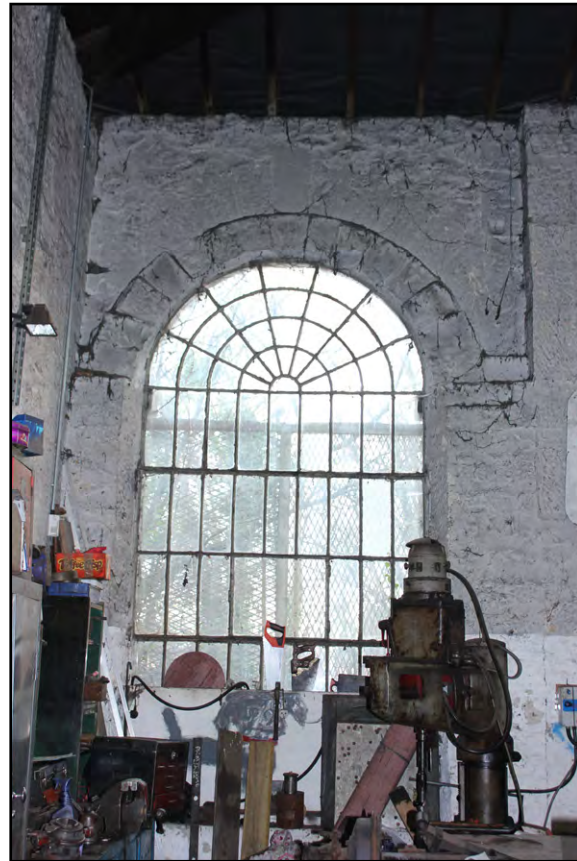
Figure 40: Interior of bay 1, south elevation

The repurposing of the Goods Depot is also reflected in the building's fabric. No longer required for wagon access, the tall arched openings of bays 1 and 3 on both the north and south elevations were infilled with inner arches, presumably to take either doors or windows. The carefully tooled voussoirs and keystones and use of an impost band is respectful of the previous work. Internally, however, the finish was not as well executed, with the inner arches roughly finished and supported on piers which are stepped inwards to take the weight of the new arch (figure 40). The result of the conversion was an enclosed eastern cell, probably lit by radial windows which, like the external stonework, may have been sympathetically copied from bays 3 and 4.

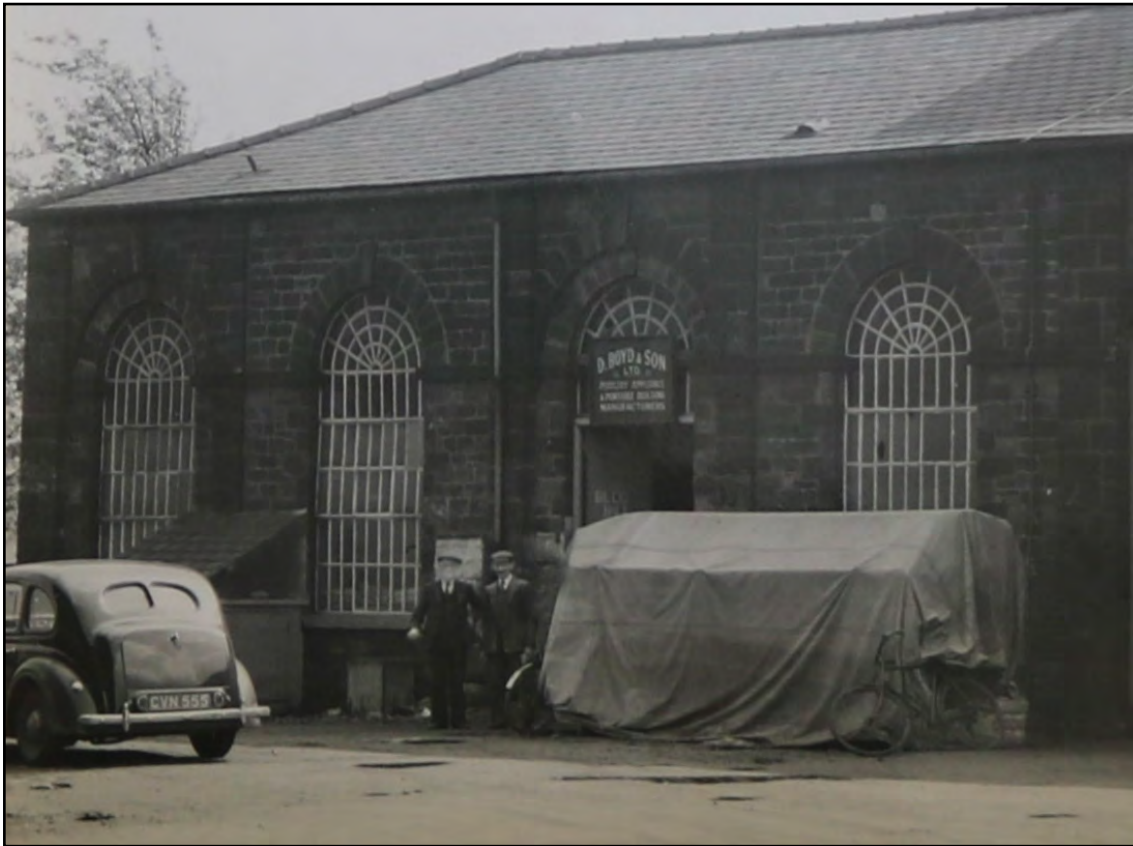
Figure 41: Detail of eastern half of north elevation showing the arrangement of arched openings in 1948 (courtesy of the Ken Hoole Study Centre)

A further difference can be seen in the treatment of the voussoirs to bay 4 (and bay 2 as shown in figure 41). Rather than rusticated voussoirs, stepped towards the keystone, the voussoirs are curved. The tooling, is, however, similar to its companion voussoirs in bays 1 and 3 and therefore is contemporary. Internally, this difference in treatment is also visible as the window is set below a timber lintel (figure 27). A similar lintel at the same height can be seen above the doors in bay 2, suggesting that the internal form of the window was also similar.

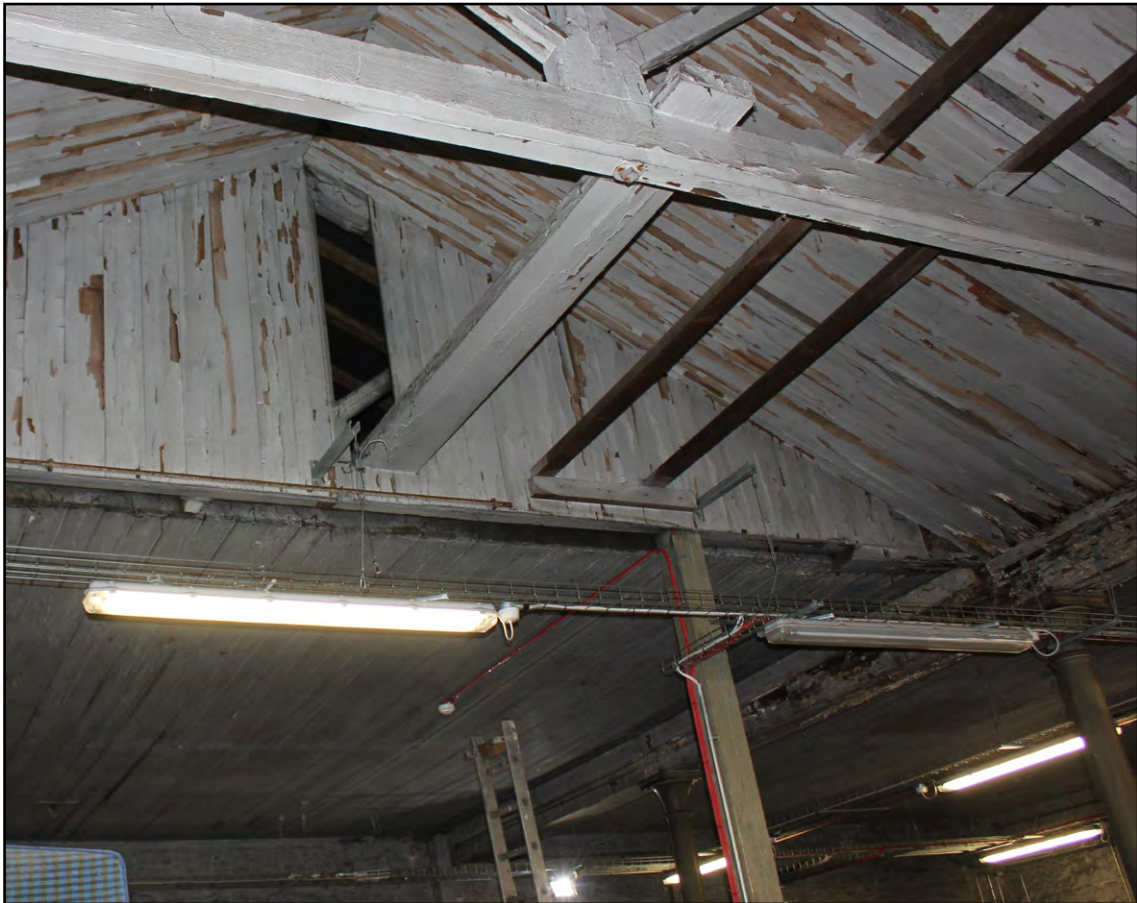
Figure 42: Timber tongue-and-groove ceiling and sarking

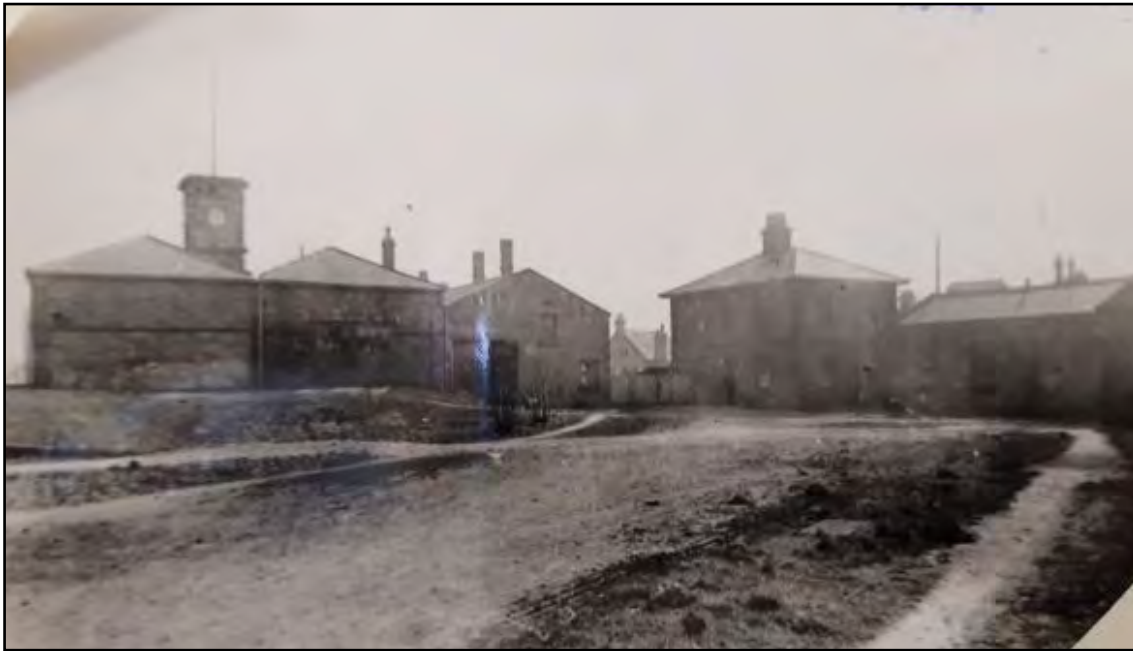
Figure 43: Photograph of the building with extension to the south elevation (date unknown but possibly late 19th century). Note timber door in the west elevation and fire station signage indicating it was the main access into the building

Internally, the western half was probably fitted out at this time with a tongue-and-groove ceiling over bays 7 and 8, whilst sarking boards were installed between the trusses above bays 5 and 6. The cartographic evidence from 1896 indicates an internal division between bays 7 and 6 which is evidenced at the meeting of the suspended ceiling and sarking boards where a gap of approximately 0.51m wide marks the position of a former partition (figure 42). Additionally, a British Rail plan from 1951 instructed the partial removal of 'timber partition sections 17' 0" high' between these two bays.⁴² Doors were also inserted through the west elevation and fitted with partially glazed timber doors.⁴³ These are also visible in an undated photograph of the building along with the extension attached to the southern

elevation (figure 43). The internal finishes of the western half of the building would suggest a slightly higher status than the eastern cell, where internal finishes remained crude, perhaps for a more utilitarian use.

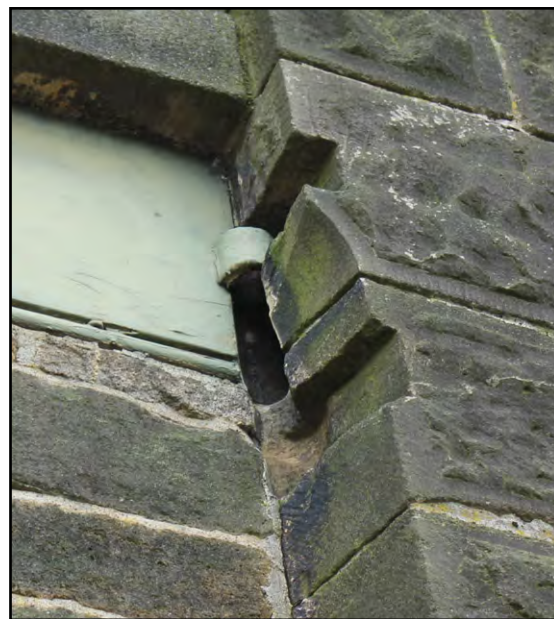
Figure 44: Empty slots and part of a hinge to bay 7. Note the careful tooling

Today, bay 7 contains a 20th-century square-headed metal industrial-style window below a timber lintel. However, the remains of hinges and cut stonework indicate that this was also set with timber doors (figure 44). The doors to bay 6 have been raised as evidenced by the empty hinge slots. The present hinges have been crudely cut-in at some point after 1951.⁴⁵

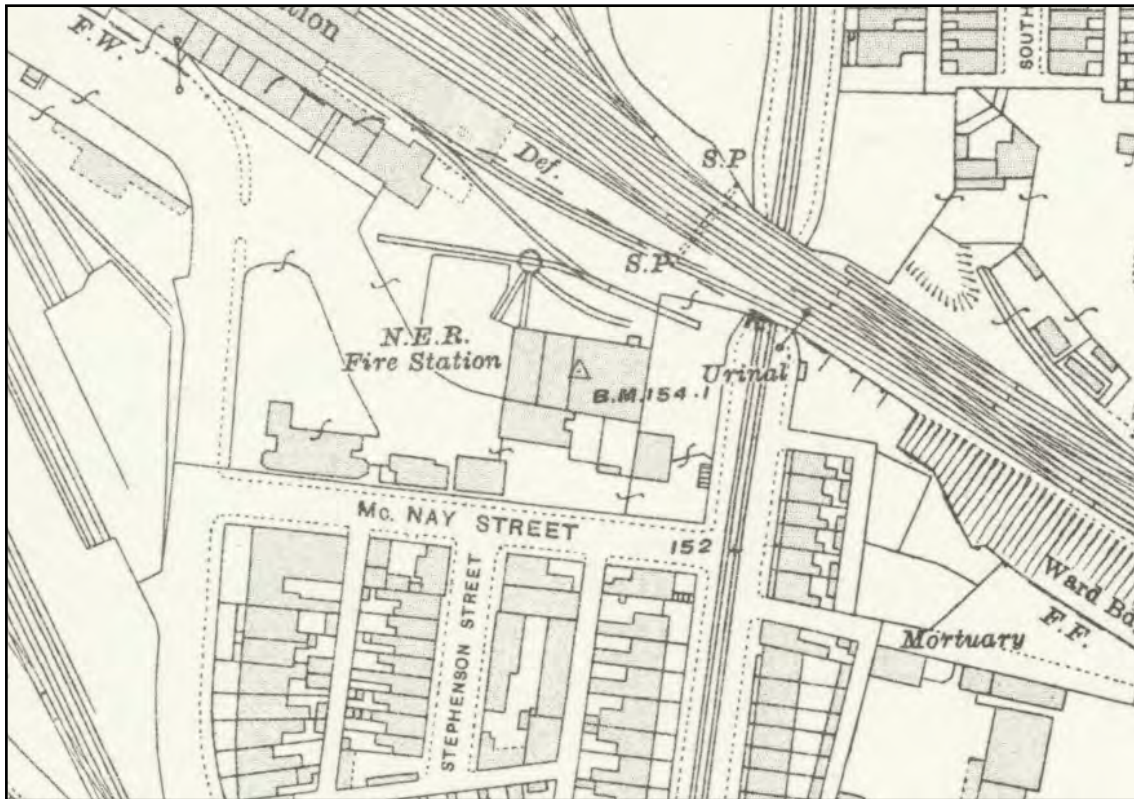
Figure 45: Ordnance Survey County Series 25" (1:2500) revised 1913-14, published 1915.
Reproduced with the permission of the National Library of Scotland

The use of the western side of the building as an NER fire station is first shown on the third edition Ordnance Survey map revised 1913-14 and published 1915 (figure 45). In terms of how the building is depicted, however, there are no significant changes from the 1896 OS map. Less can be evidenced about the use of the east side of the building during the later 19th and earlier part of the 20th centuries. This part of the building may have seen a period of vacancy but is known to have been occupied by D. Boyd & Sons prior to 1951.⁴⁶ While the exact nature of the business and its use of the building cannot be confirmed, the wider business of David Boyd was listed as a portable agricultural building business.⁴⁷

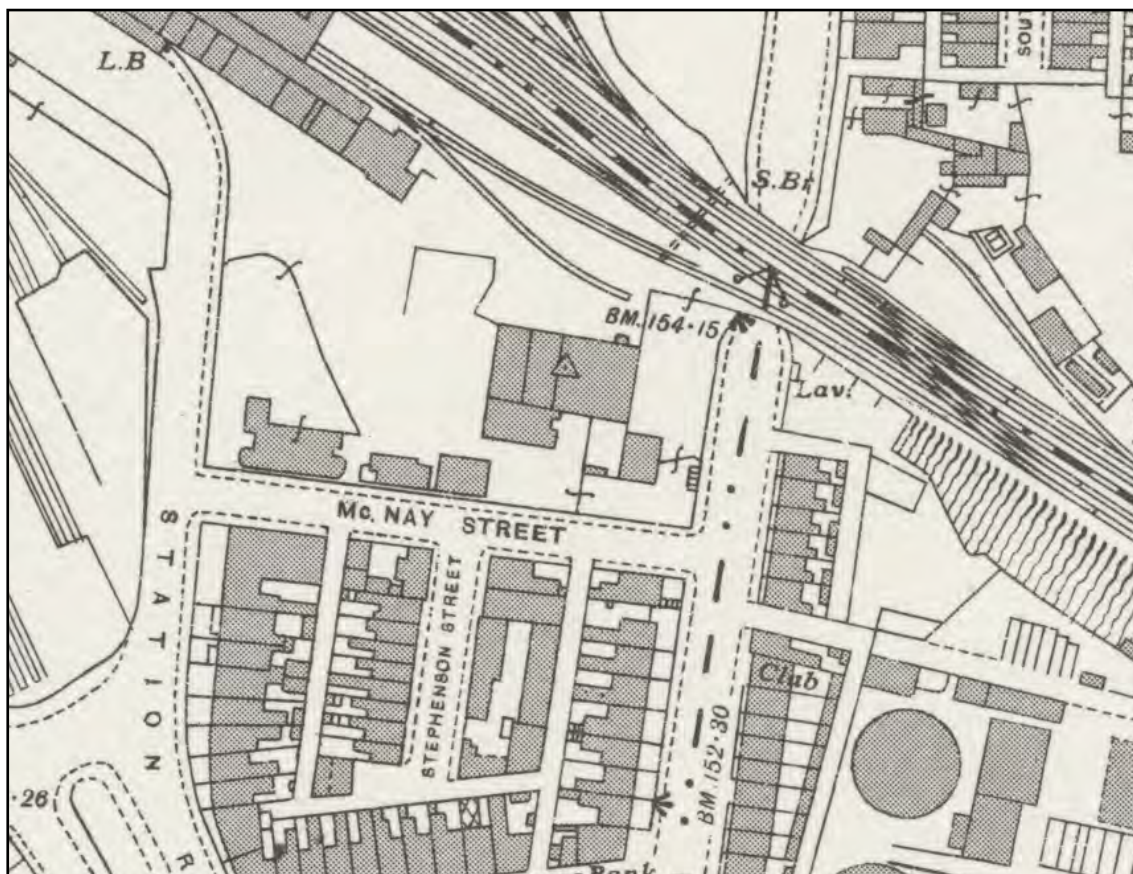
Figure 46: Ordnance Survey County Series 25" (1:2500) revised 1939, published 1947. Reproduced with the permission of the National Library of Scotland

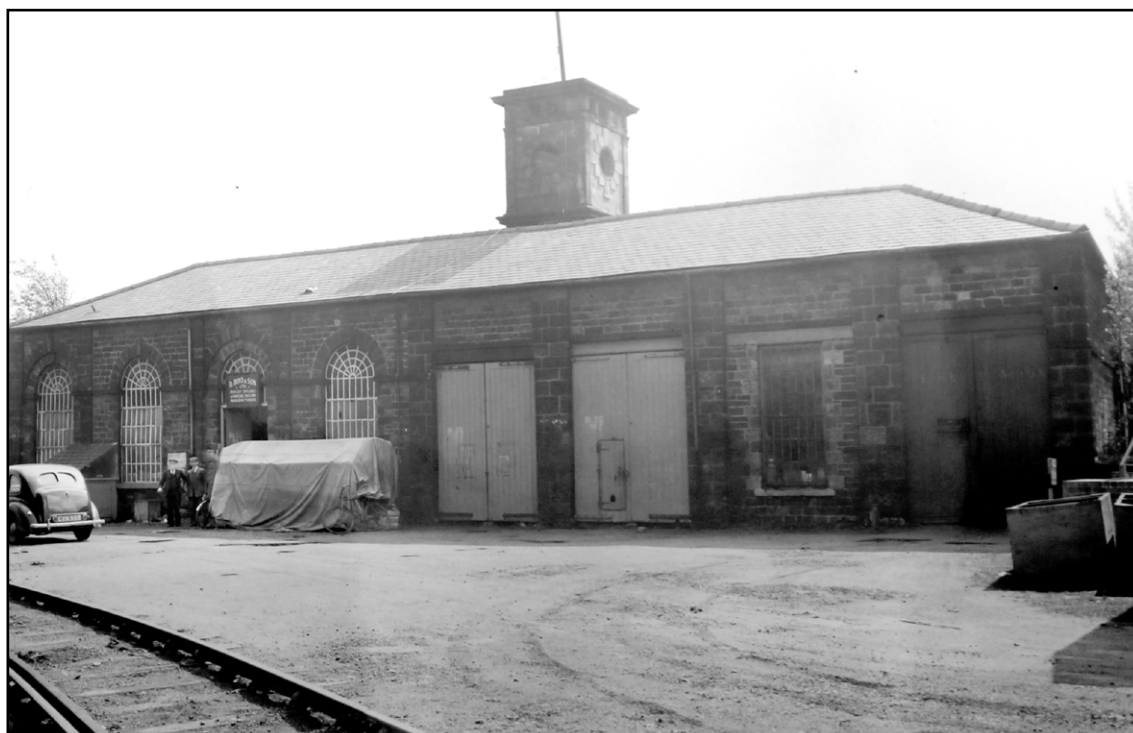
Figure 47. North elevation of the Goods Depot 1948 prior to its conversion in 1951. It is interesting to note that the clock tower roundels are still open on the west and north elevation (courtesy of the Ken Hoole Study Centre)

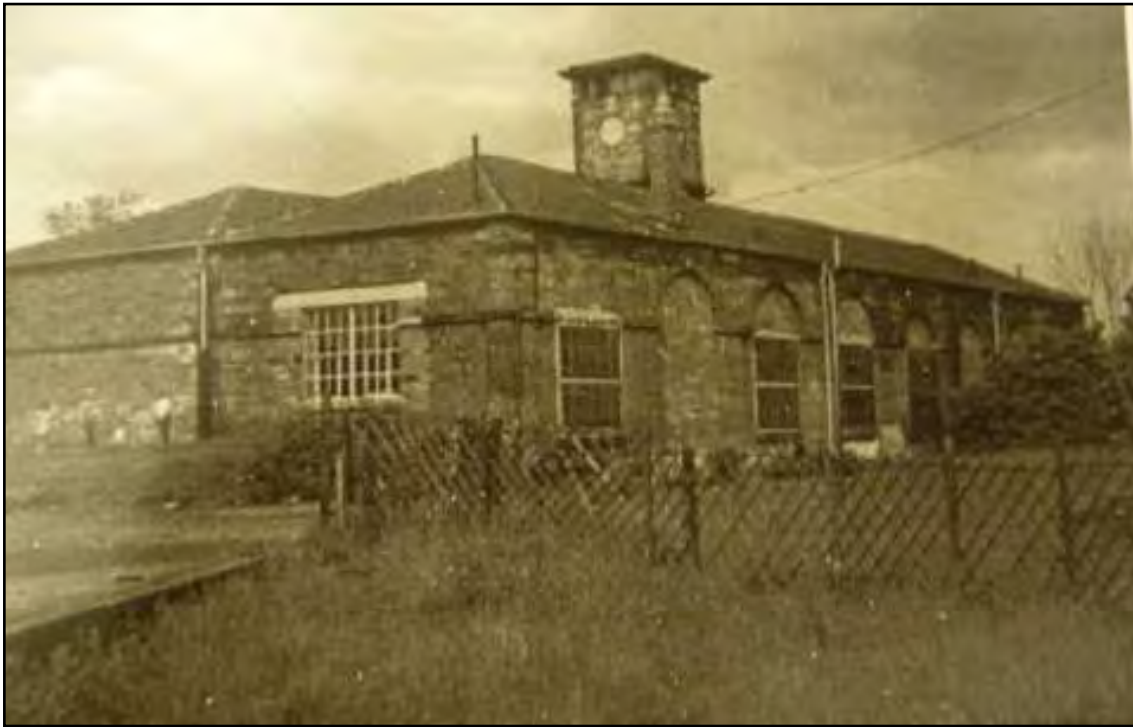
Figure 48. The south elevation of the Goods Depot, c.1951 (courtesy of the Ken Hoole Study Centre)

Many of the alterations proposed in the 1951 plans can be seen in the present-day building – the square-headed industrial-style windows on the south elevation, and window inserted into bay 3, the brick toilet block obscuring bay 1 on the north side, and the timber double doors set in a concrete frame in bay 2. On the west elevation, the blocking of the former doorway is still clearly visible, now set with metal-framed window as proposed in 1951. The 1953-4 1:1,250 OS map, published in 1955 (figure 49), also illustrates changes to the site. No sidings are indicated and significantly a large building is now positioned south-west of the Goods Depot, potentially part of the vehicle-servicing operation.

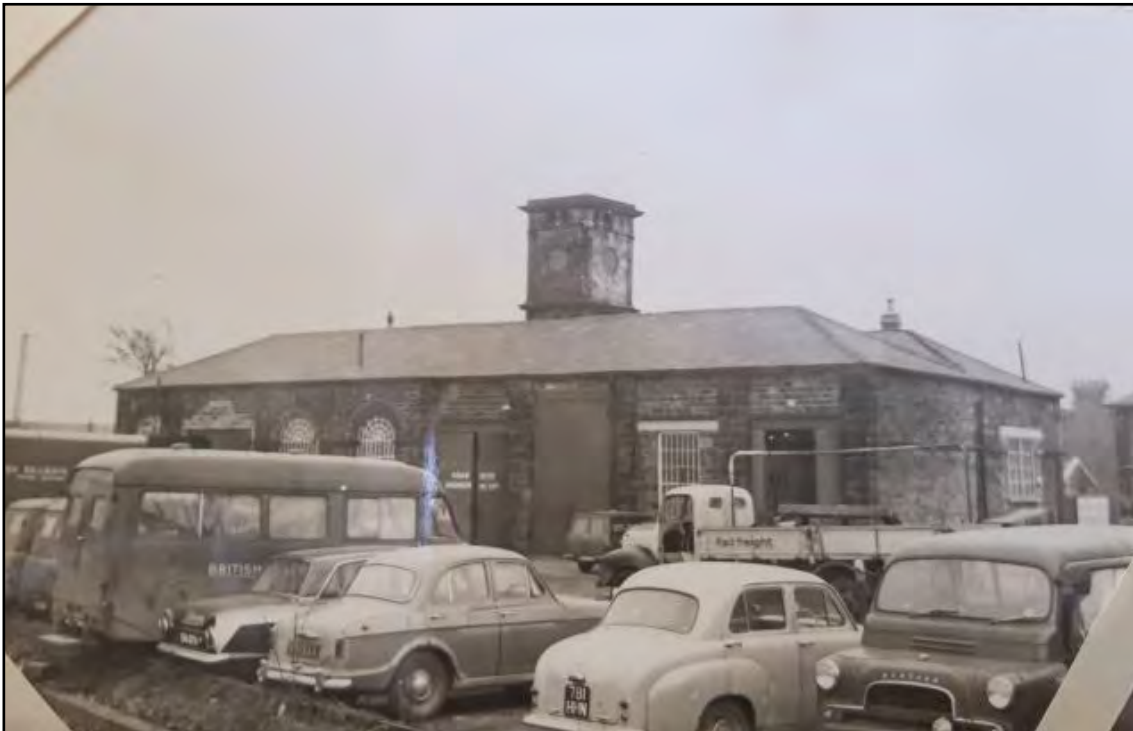
Figure 50: The Goods Depot in 1969 apparently still is use as a vehicle-maintenance depot. Note the doors to bay 6 have been raised, but the extension to the west elevation has yet to be constructed

By 1971, the 1:1,250 OS map (revised 1971, published 1972; not reproduced here) indicates significant changes. The extension attached to the west elevation is shown for the first time, presumed built after 1969 as evidenced from an image taken at this time (figure 50). This is now used as an office and store by the Darlington Railway Preservation Society (DPRS). The map also indicates that buildings shown on the 1953-4 map have been removed. What appears to be an inspection ramp is indicated to the west, which might suggest the building was still in use as a servicing depot at this time. However, by the Second Revision, published 1988 (not reproduced here), the site had been cleared.

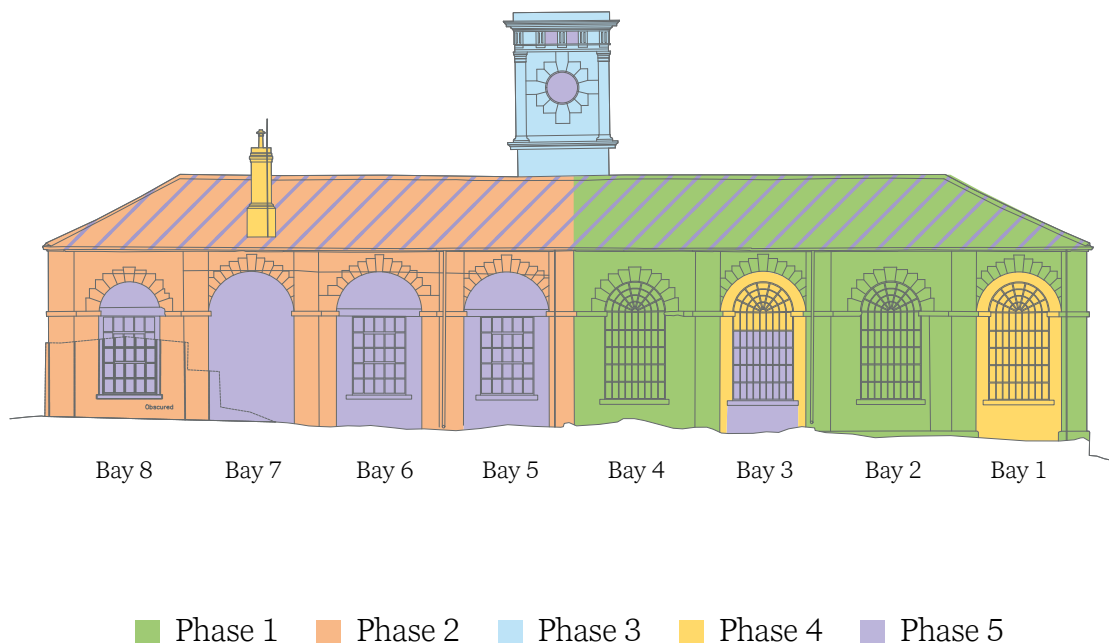
Figure 51. Phased south elevation. Please note hatching with two colours represent several alternative or uncertain phases

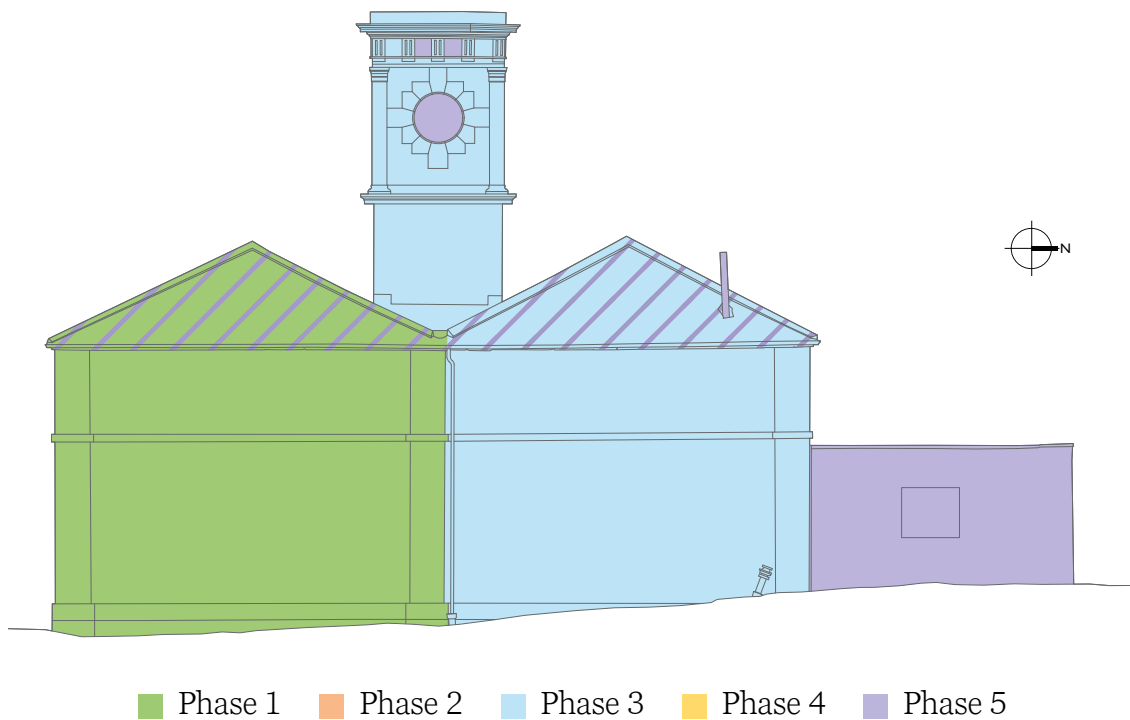
Figure 52. Phased east elevation. Please note hatching with two colours represent several alternative or uncertain phases

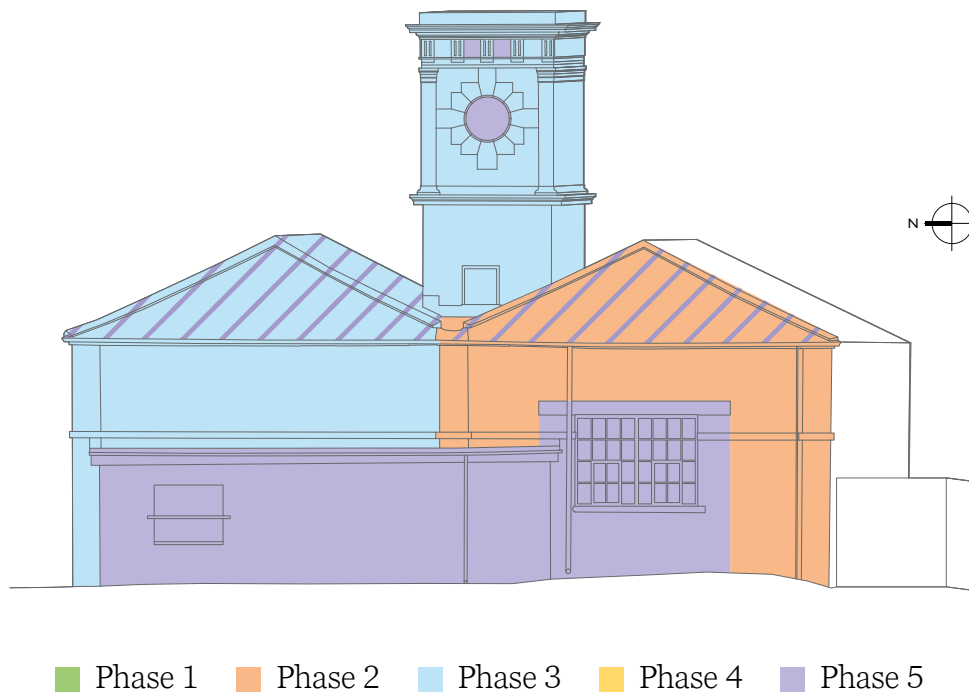
Figure 54. Phased west elevation. Please note hatching with two colours represent several alternative or uncertain phases
