Historic England

The Stockton & Darlington Railway Goods Depot, Darlington: Historic Building Investigation and Assessment of Significance

S&DR RAILWAY GOODS DEPOT, DARLINGTON

HISTORIC BUILDING INVESTIGATION AND ASSESSMENT OF SIGNIFICANCE

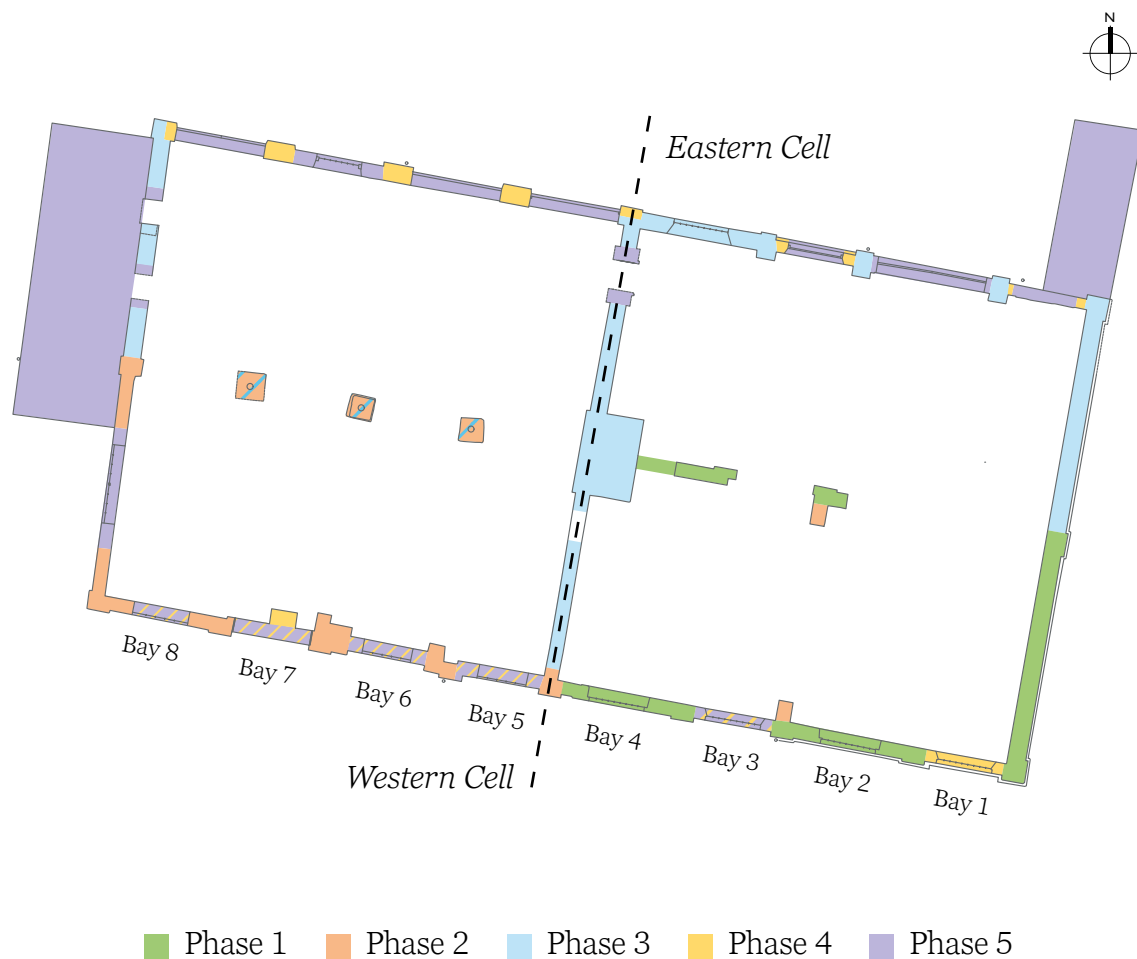
Figure 55. Phased plan of the building. Please note hatching with two colours represent several alternative or uncertain phases

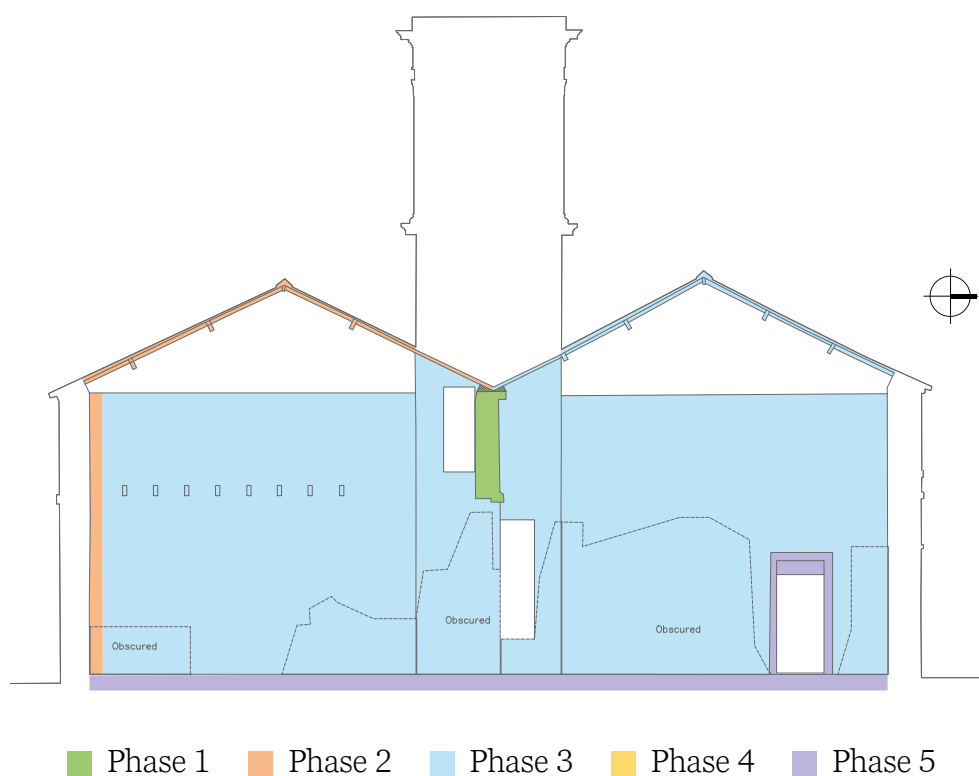
Figure 58. Central spinal wall: east face phasing

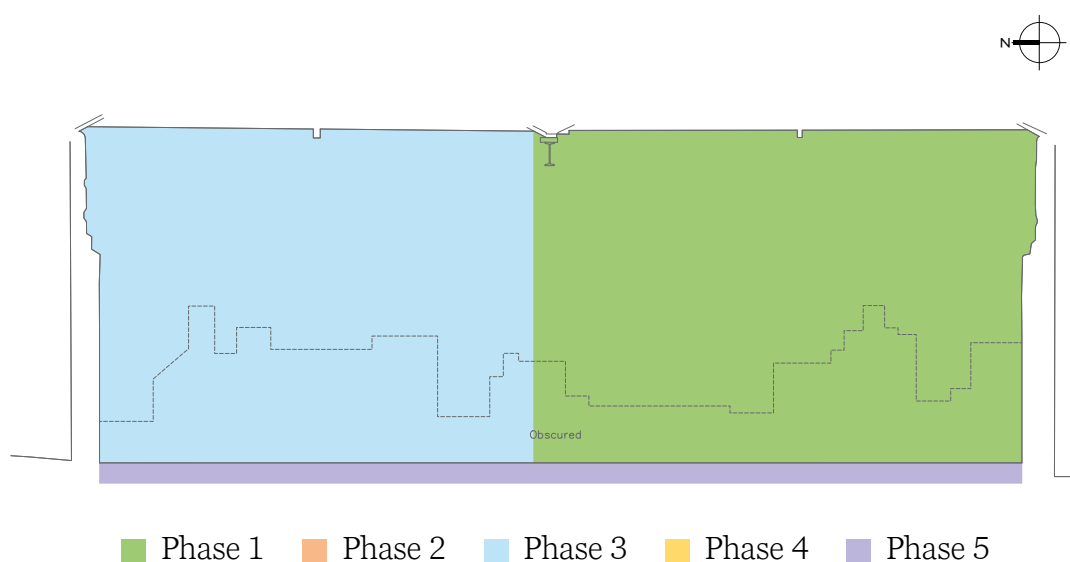
Figure 59. Eastern internal elevation phasing

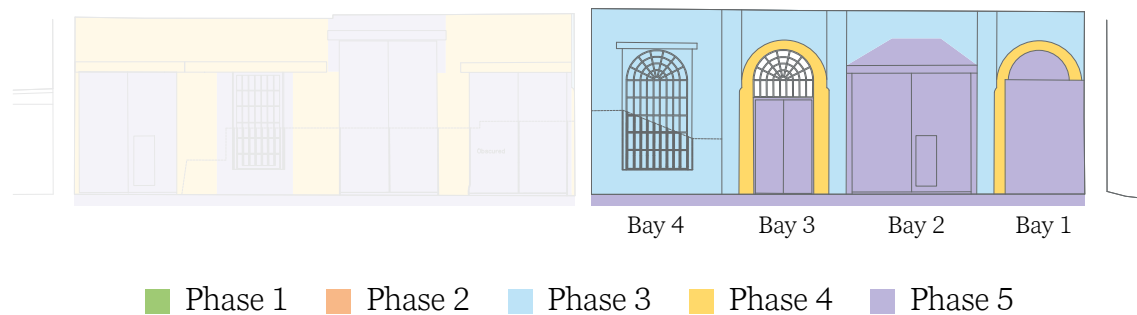
Figure 60. Northern internal elevation: eastern half phasing

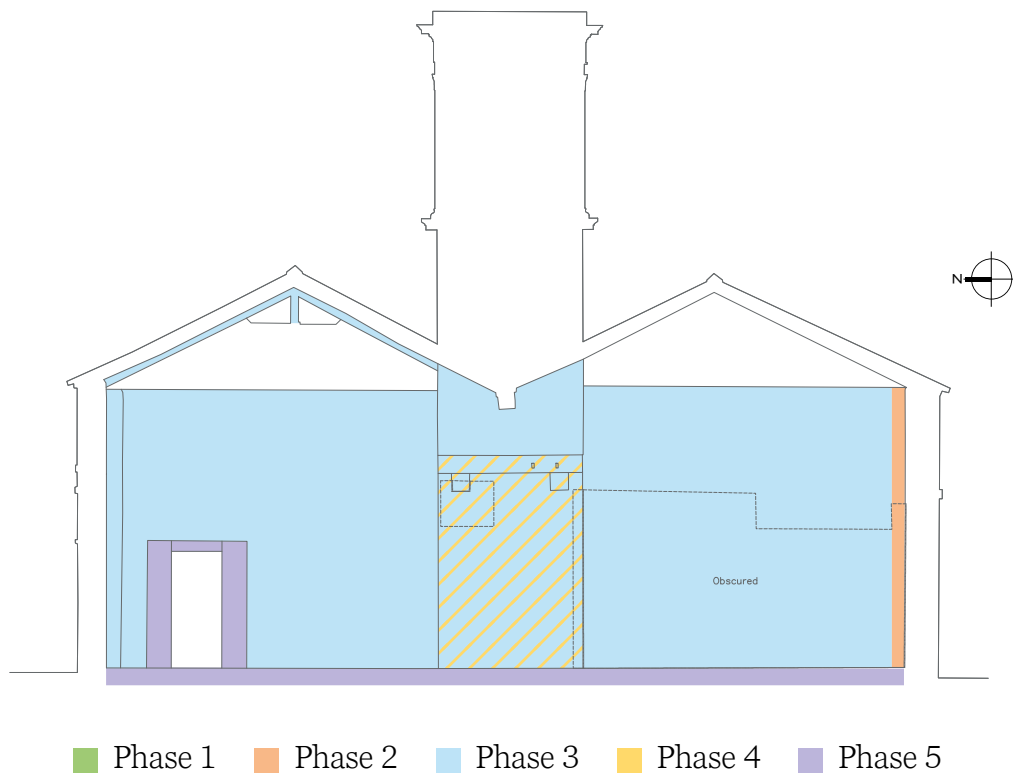
Figure 61. Central spinal wall: west face phasing. Please note hatching with two colours represents several potential alternative or uncertain phases.

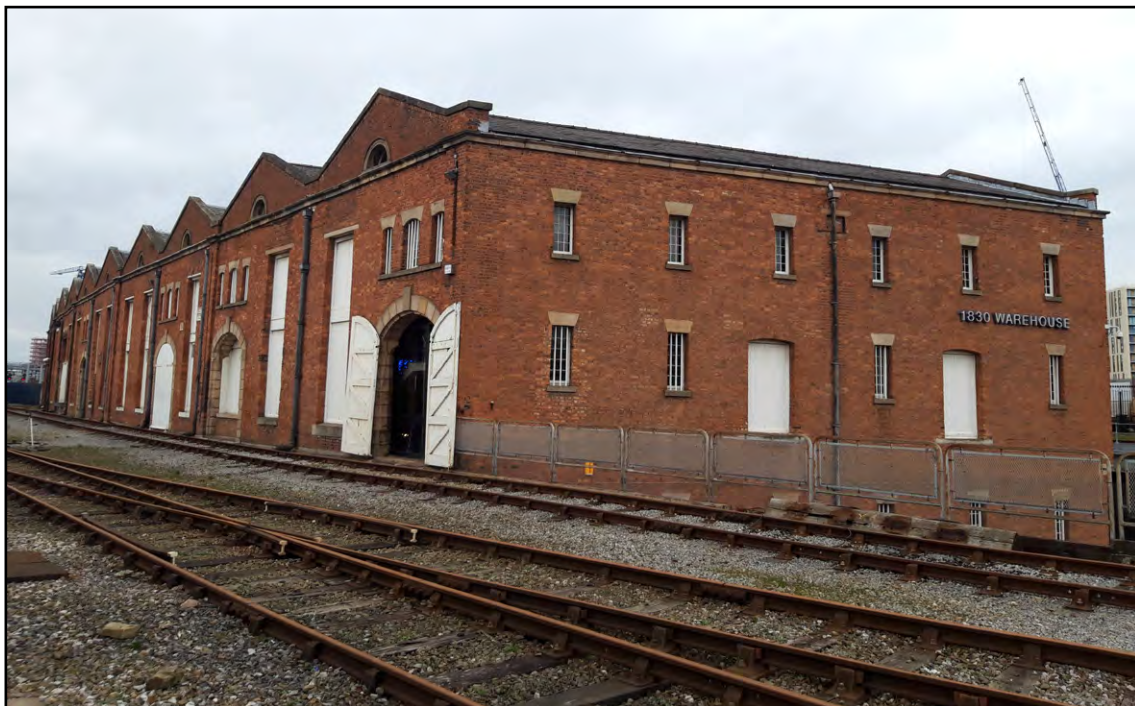
Figure 66. 1830 Railway Warehouse, Manchester

The earliest surviving railway goods trans-shipment building is of the larger urban warehouse type. Manchester's 1830 Liverpool Road Station warehouse (now the Science and Industry Museum) was, like Darlington's Merchandise Station, built against the railway embankment with the first floor accessible from the railway line and set over multiple storeys with short-axis entry. Wagons were turned through ninety-degrees on turntables before being taken into the building through double doors. Goods were transferred through the building (initially) by gravity hoists and finally lowered by external hoists to the road below.⁵⁵ The design of both the 1827 station and 1830 warehouse have much in common with canal warehouses. This building type had developed over many years, and for the railways to utilise existing successful designs is unsurprising.

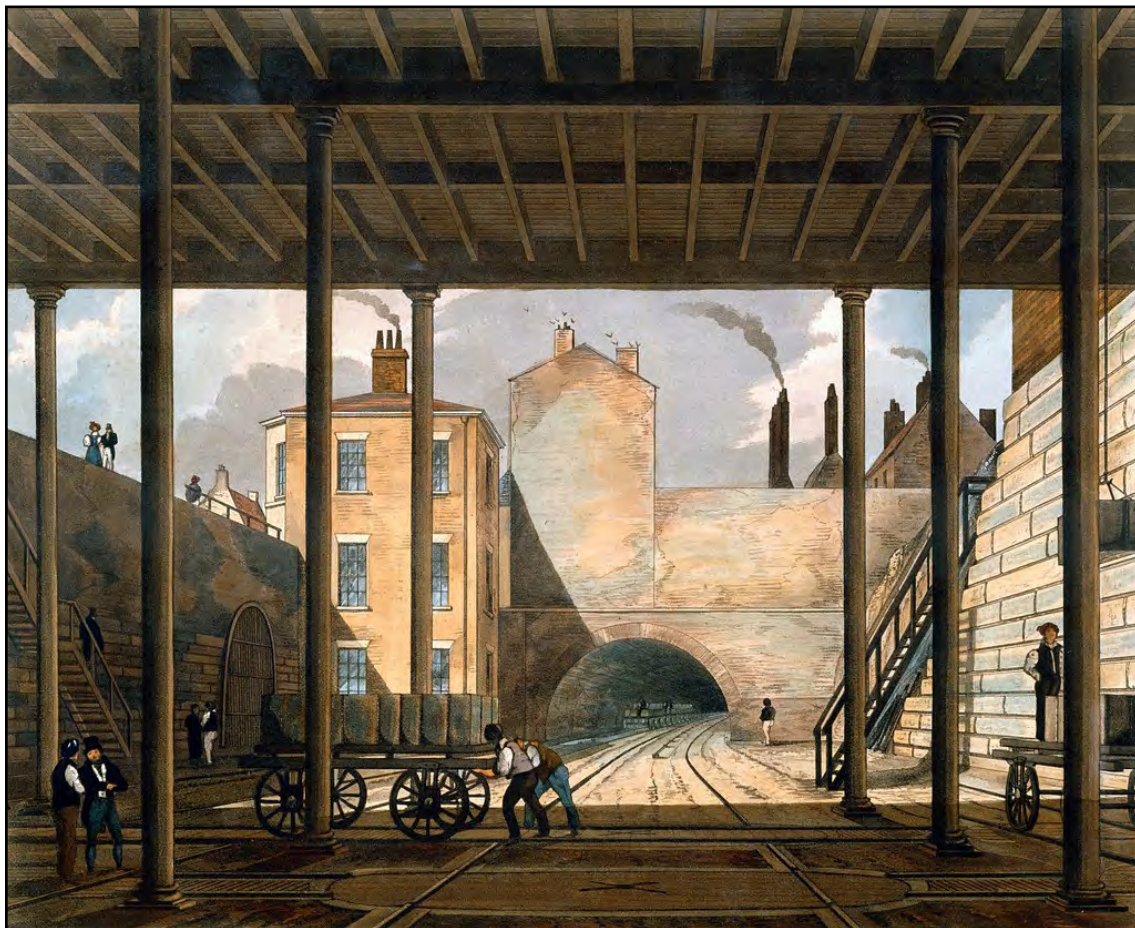
Figure 67: Turnplates at the Park Lane goods station of the Liverpool and Manchester Railway in 1831 by S.G. Hughes. Note the cast-iron columns supporting warehouses above the track where goods could be hoisted for storage. Originally published in *Coloured Views on the Liverpool and Manchester Railway*, 1831. London: Ackermann & Co; plate 9 (Wikimedia Commons)

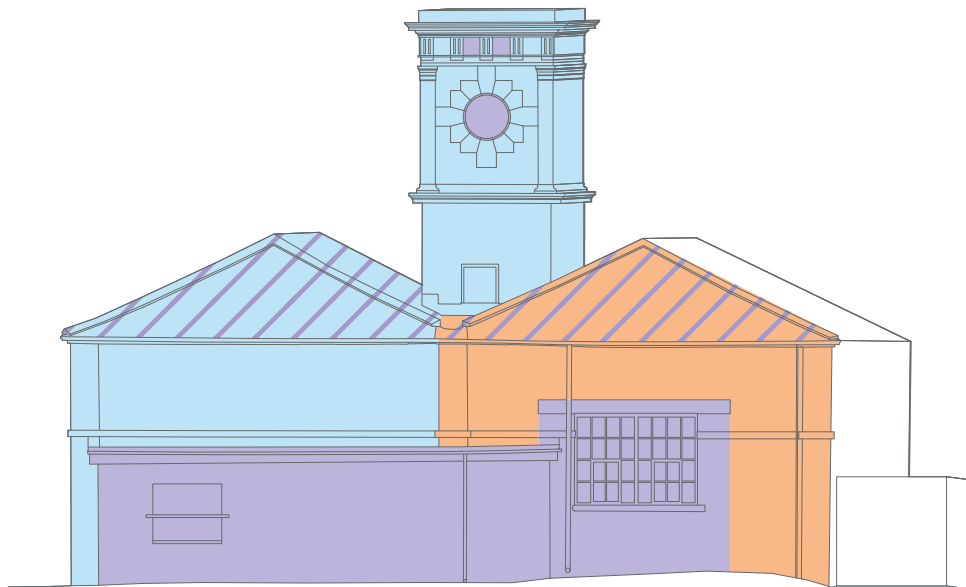
West Elevation

Phase 1
 Phase 2
 Phase 3
 Phase 4
 Phase 5
