The Road, Rail and Parkland Bridges of Bishop Auckland, Co Durham: an assessment of the historical and archaeological evidence

Marcus Jecock

**THE ROAD, RAIL AND PARKLAND BRIDGES OF
BISHOP AUCKLAND, Co DURHAM:**
an assessment of the historical and archaeological evidence

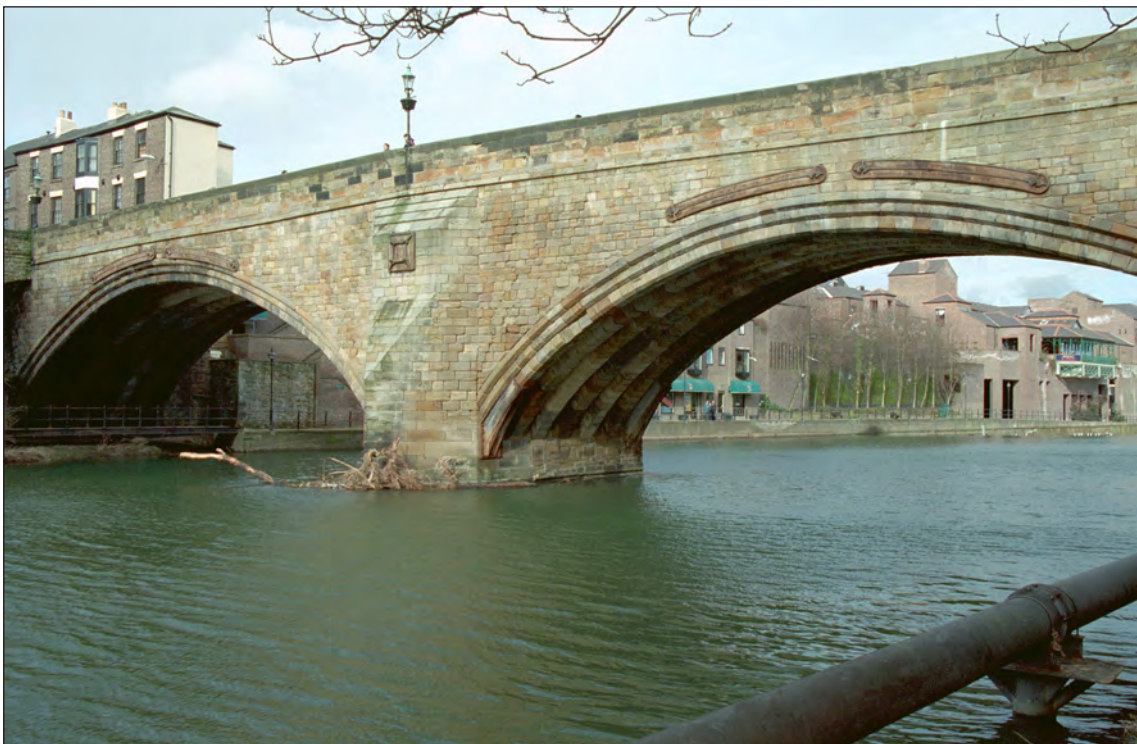
Fig 2. Framwellgate Bridge, Durham. Note the triple arch rings visible on the elevation, with the first ring made up of a series of discrete ribs (visible under the soffit of the arch). © Mr Bob Cottrell. Source: Historic England Archive IOE01_03605_35

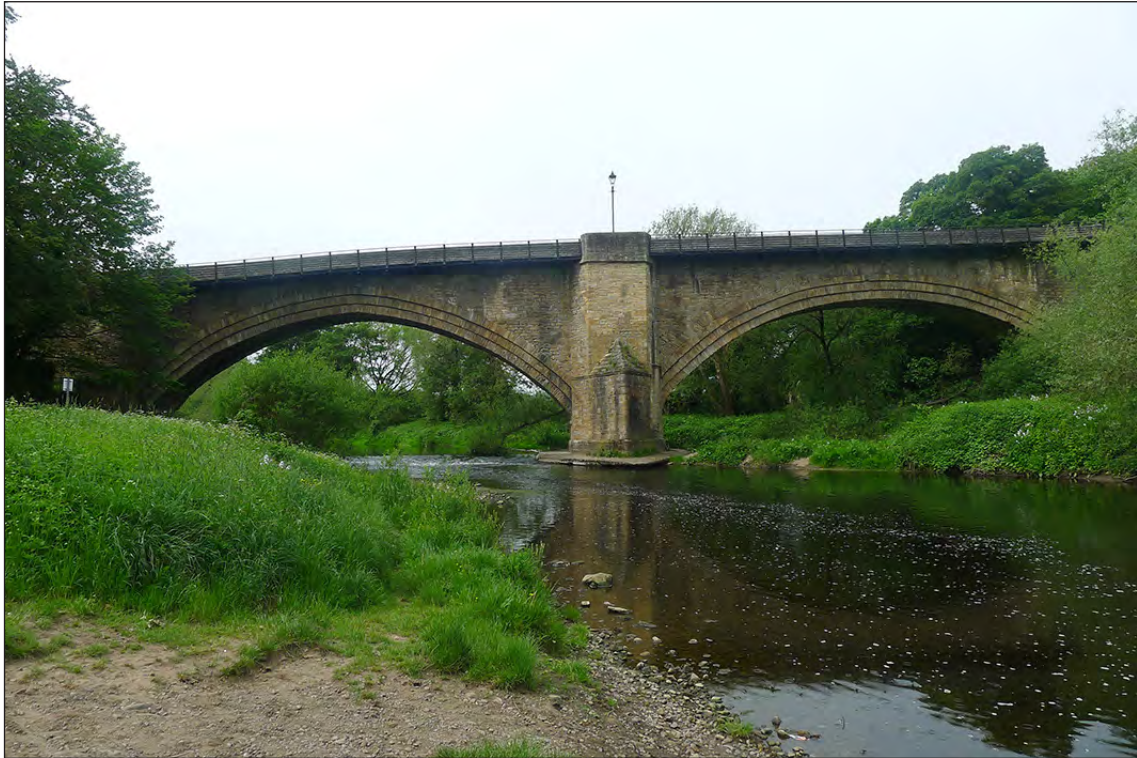
Fig 4. The eastern (downstream) elevation of Newton Cap Bridge. (© Historic England/Marcus Jecock)

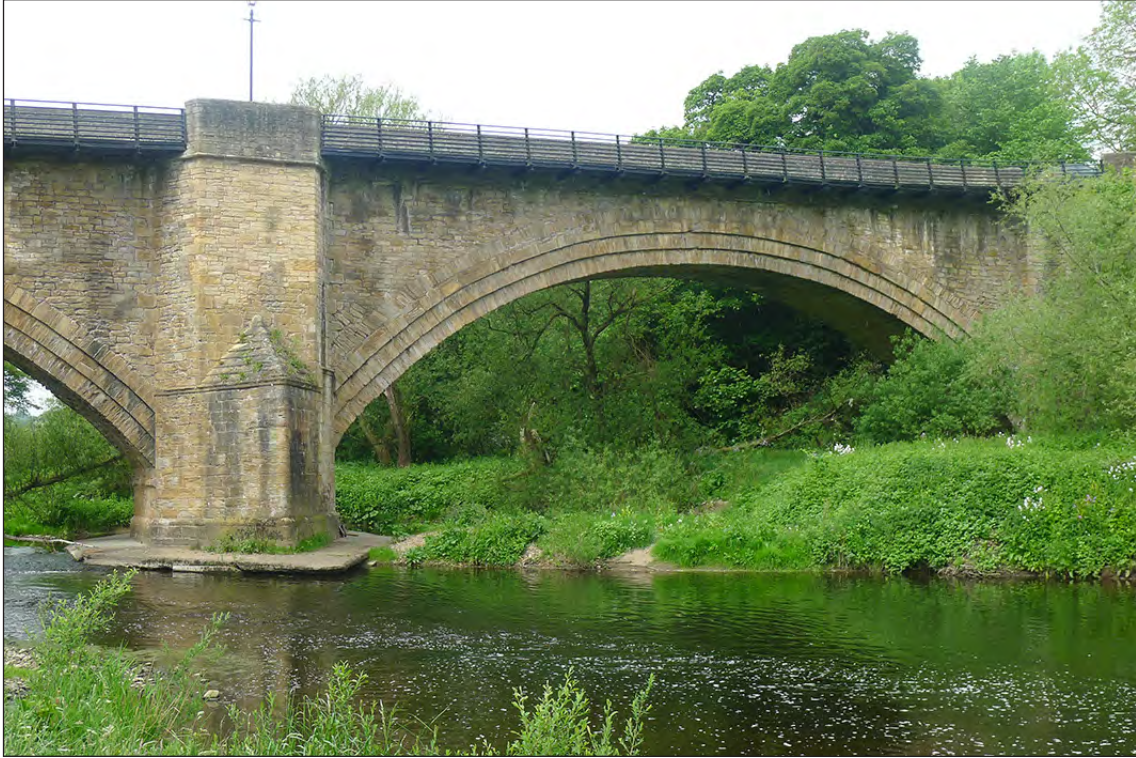
Fig 6. The northern arch of Newton Cap Bridge from the east. Note the fourth arch ring, and the off-centre voussoirs close to the springing from the pier with signs of patching in the spandrel above. (© Historic England/Marcus Jecock)

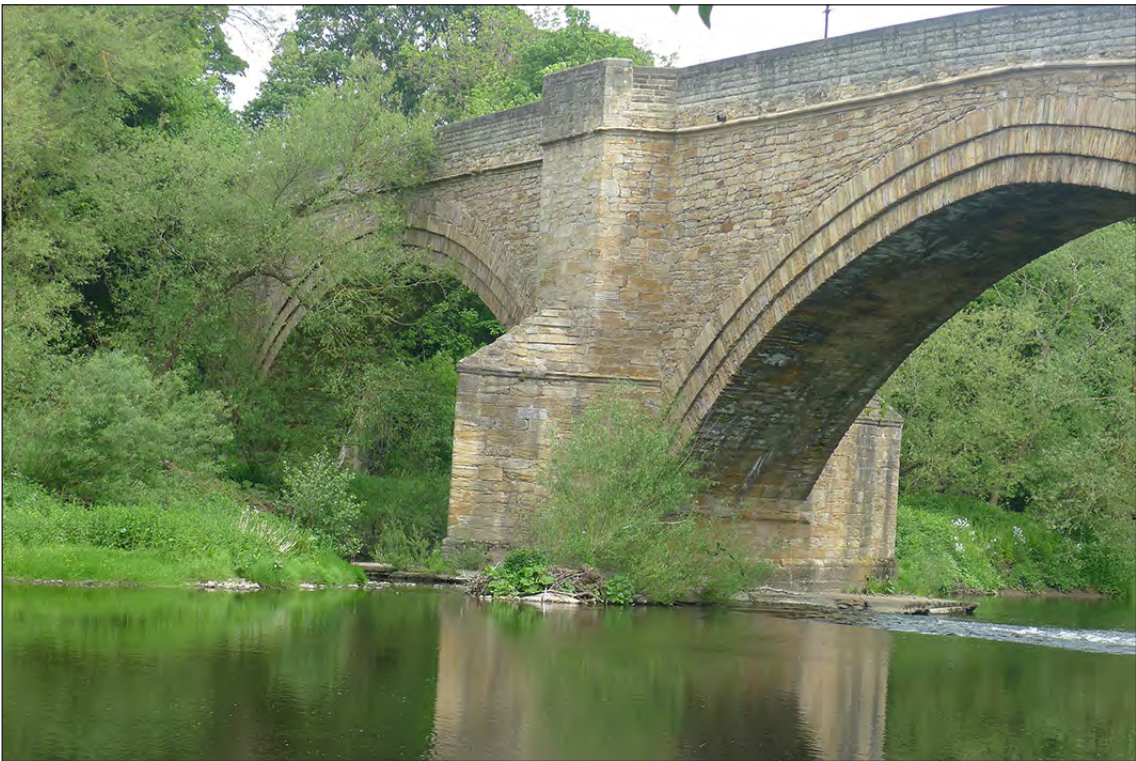
Fig 7. The western (upstream) elevation of Newton Cap Bridge. (© Historic England/Marcus Jecock)

A narrow ashlar string course runs at deck level and separates the spandrels from the parapets above. This is most clearly seen on the western elevation (a modern pedestrian cantilevered walkway obscures the eastern elevation). The string course is horizontal over the northern arch, but rises from the southern abutment towards the crown of the southern arch and less perceptibly drops down again afterwards toward the central pier. This indicates that the southern approach on to the bridge was originally lower than its northern counterpart, and the southern arch slightly humpbacked. It is clear the southern causeway has subsequently been raised in order to level out the deck. Apart from a short section above the western cutwater, the parapets consist of stone of a different colour to the rest of the bridge and must be modern replacements; a course or two of older stonework survives, however, between the string course and the base of the modern parapet (Fig 7). Because the parapets are modern, it is likely the coping is, too, and an inscription cut in to the western parapet recording the leap of one Edward Palfrey from the bridge in to the river below in 1744 - a fall or dive of some 48 feet (14.63m) which he amazingly survived (Surtees 1922, 11) – is therefore likely to be restored (as suggested by the current listing description). The modern pedestrian walkway that obscures the eastern parapet and string course is partly supported on the abutments and central pedestrian refuge - sections of the parapets of which have been cut away to receive it - but is also cantilevered out on girders set in to the top of the spandrels. Straight joins visible in the parapet walling of the western central pedestrian refuge indicate that a similar walkway once existed against the upstream elevation of the bridge (Fig 7; and see below).

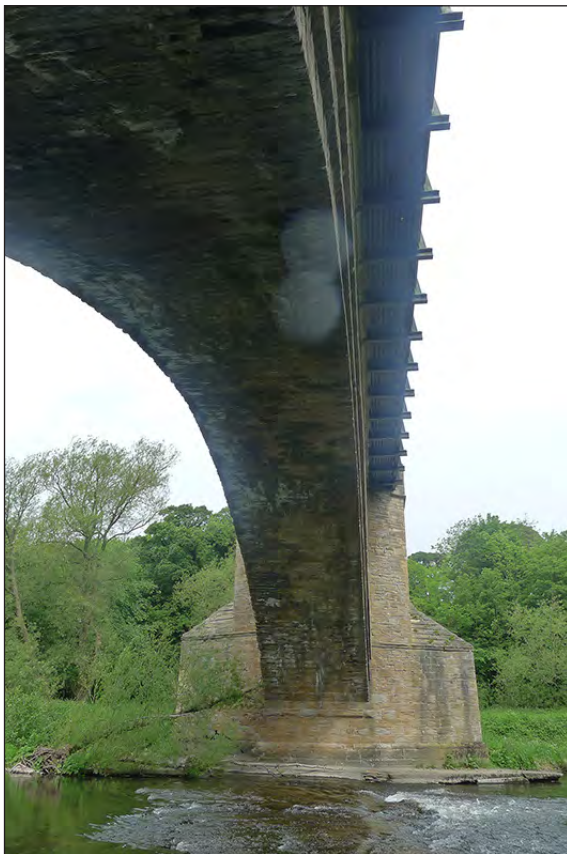
Fig 8. The underside of the southern arch and the central pier of Newton Cap Bridge seen from the south. (© Historic England/Marcus Jecock)

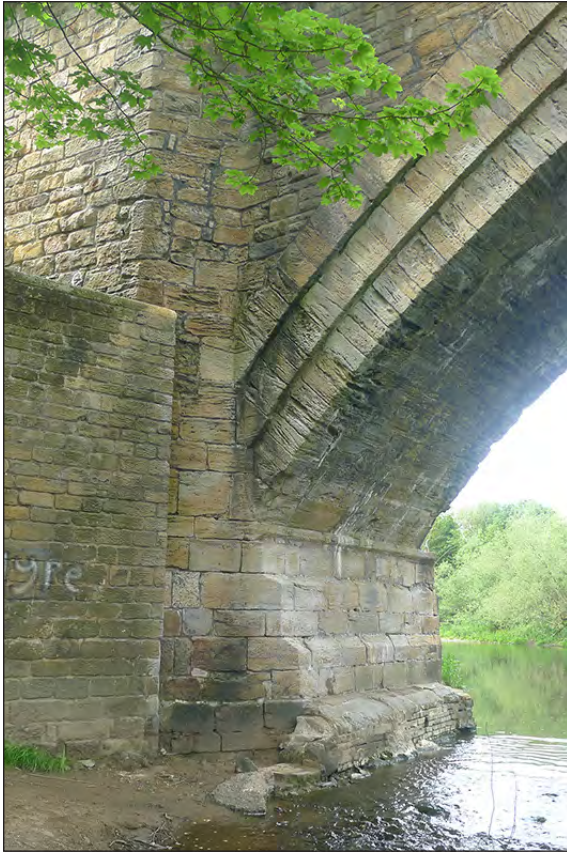
Fig 9. The face of the southern abutment of Newton Cap Bridge. (© Historic England/Marcus Jecock)

arch is probably the support for the timber centring that would have been necessary to construct the arch rings. In contrast, the face of the southern abutment (Fig 9) has three chamfered step-backs, and also exhibits what may be described as a narrow string course (confined to the width of the arch barrel only) at the level of the springing. The reason for these differences, and whether they imply the pier and abutment are of different dates, is again unclear. Since, however, the third step back on the abutment appears to be at the same level as the projecting course on the pier, it likely fulfilled a similar purpose although strangely the upper surface of the projecting course appears horizontal (the pier was only viewable from distance) rather than chamfered as on the abutment. Difficulties in accessing the north bank of the river mean it has not been possible to determine whether similar features exist on the face of the northern abutment and north face of the central pier.

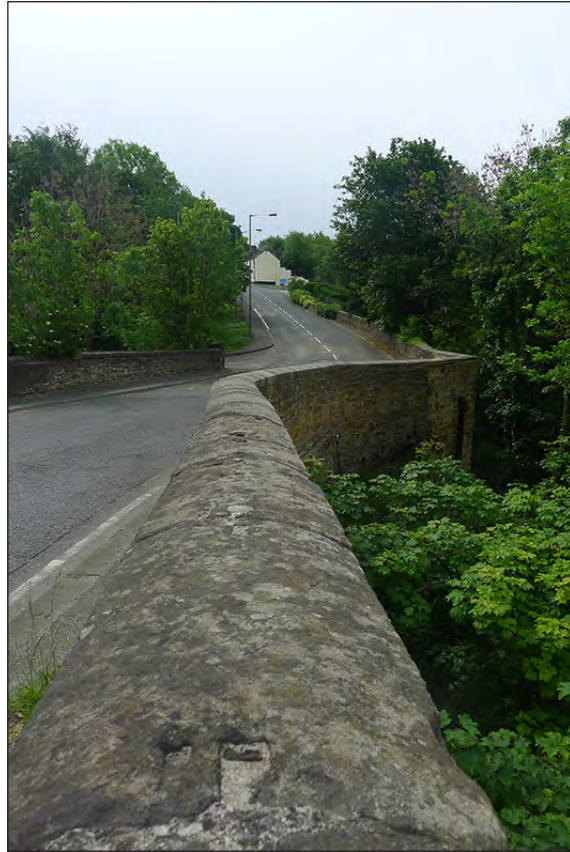
Fig 10. The northern approach to Newton Cap Bridge. (© Historic England/ Marcus Jecock)

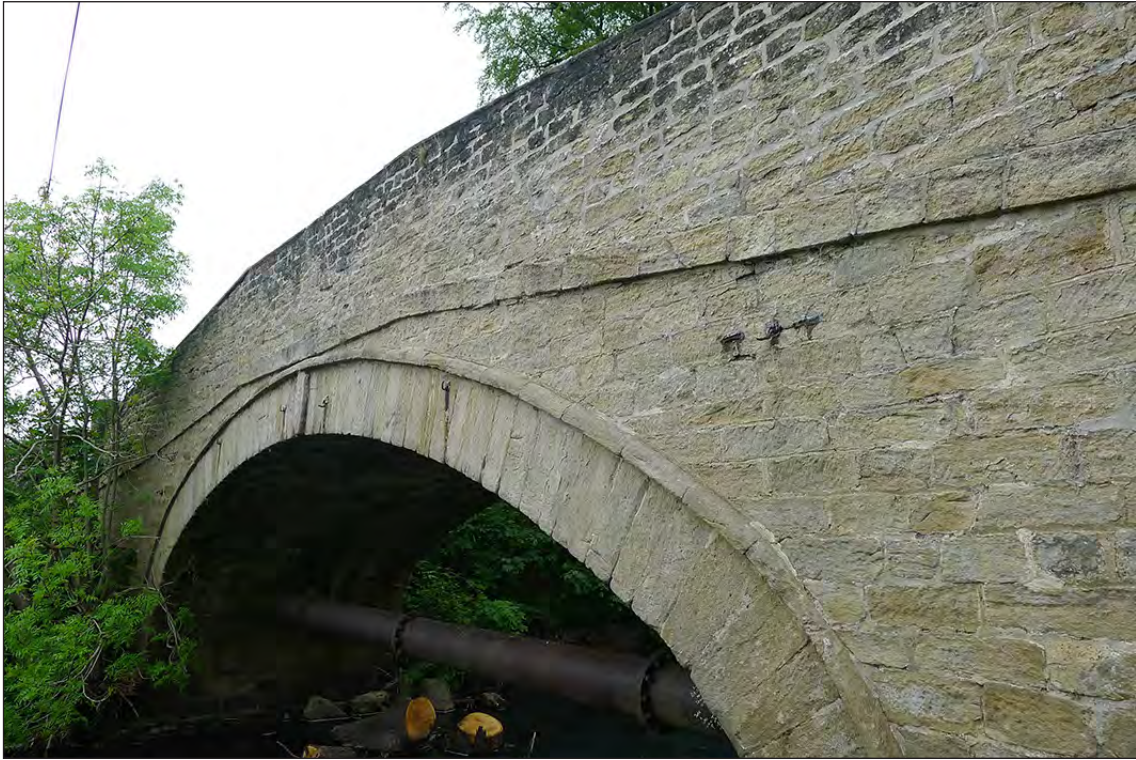
Fig 11. The western (downstream) elevation of Jock's Bridge. Note the humpbacked form of the string course at deck level mirrored by the parapet above. (© Historic England/Marcus Jecock)

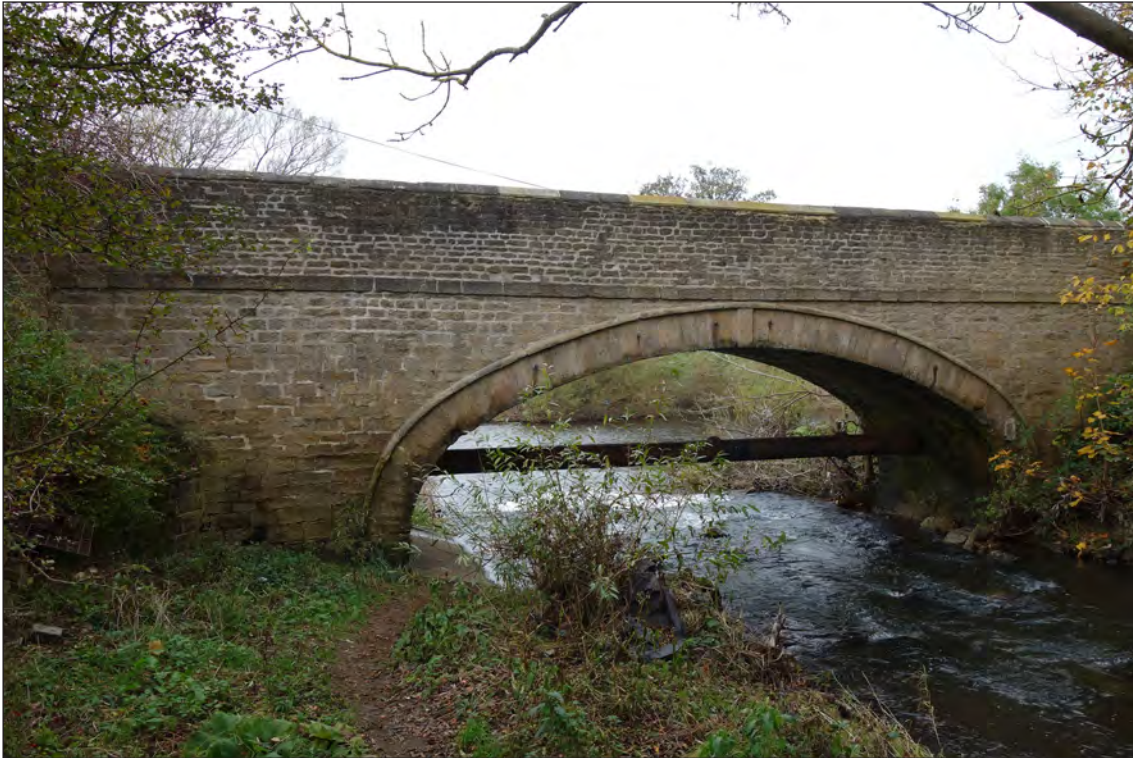
Fig 12. The eastern (upstream) elevation of Jock's Bridge. Note the horizontal string course and parapet, suggesting the elevation has been rebuilt. The date 1819 is inscribed on the keystone of this elevation . (© Historic England/Rebecca Pullen)

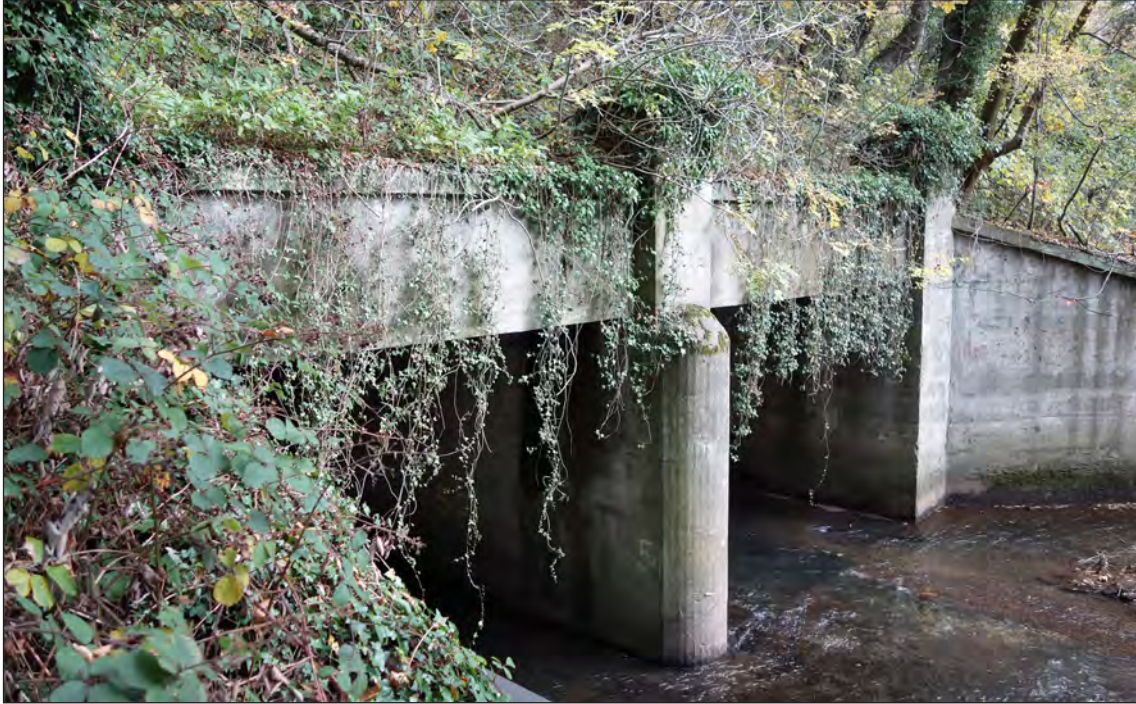
Fig 13. The southern (upstream) elevation of the bridge carrying Durham Road across the River Gaunless. Note the domed top to the bull-nose cutwater and the piers with pyramidal caps that rise through the soffit, which give the bridge a very Art Deco appearance. (© Historic England/Rebecca Pullen)

The bridge comprises two large, square-section, concrete box-culverts, each about 45m long by 5m wide, built side by side at the base of a large earthen road embankment. All concrete is poured, with the marks of the timber shuttering and stages of the pour plainly visible on exposed surfaces. The culverts share a central spine wall, the ends of which have been formed in to bull-nose cutwaters rising to domed summits at the level of the bridge soffit (Fig 13). The soffit itself is formed from riveted, presumably H-section, steel girders with the spaces between infilled with concrete-panel jack arches (Fig 14). On the bridge elevations, the end girders are disguised as concrete beams and continue up as low parapet walls topped by flat coping; in addition, the abutments and spine wall continue through the soffit and parapet walling as short, square-section piers topped by pyramidal caps. Low walls that splay out from the abutments at either end of the bridge terminate in similar piers, again topped by pyramidal caps. The walls act to train the river whilst at the same time retaining the base of the overlying road embankment (Fig 13). The bridge invert is paved or concreted.

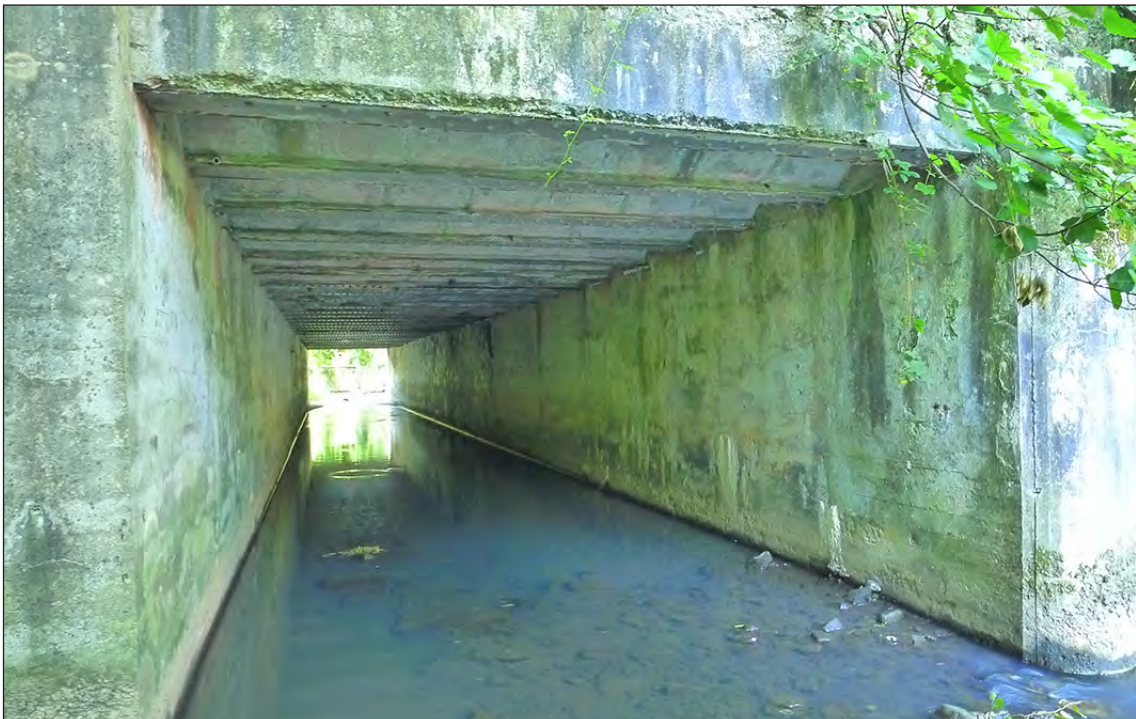
Fig 14. The eastern of the two box conduits of the bridge carrying Durham Road across the River Gaunless., seen from the north. The central spine wall with its bullnose cutwater is at right of frame. Note the soffit formed from steel joists and concrete jack arches. (© Historic England/Marcus Jecock)

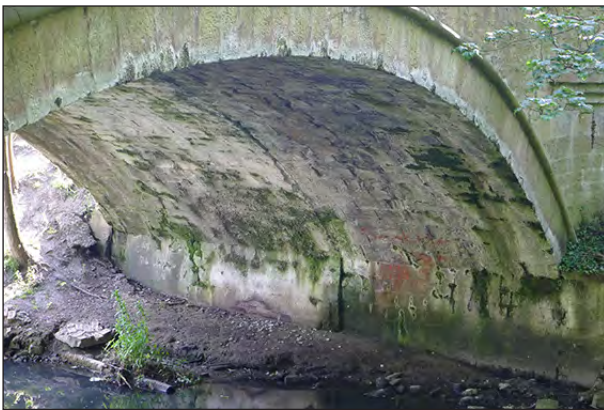
Fig 15. The construction joint visible in the barrel of Gaunless Bridge. (© Historic England/Marcus Jecock)

The bridge comprises a single, segmental arch springing from plain abutments topped by wing walls. However, a very clear construction joint in the barrel of the arch shows that the structure has been widened and effectively comprises two bridges built side by side at different dates (Fig 15). The earlier bridge was originally just 4.48m (about 14½ feet) wide; it was later extended by 3.52m (about 11½ feet) towards the north (downstream).

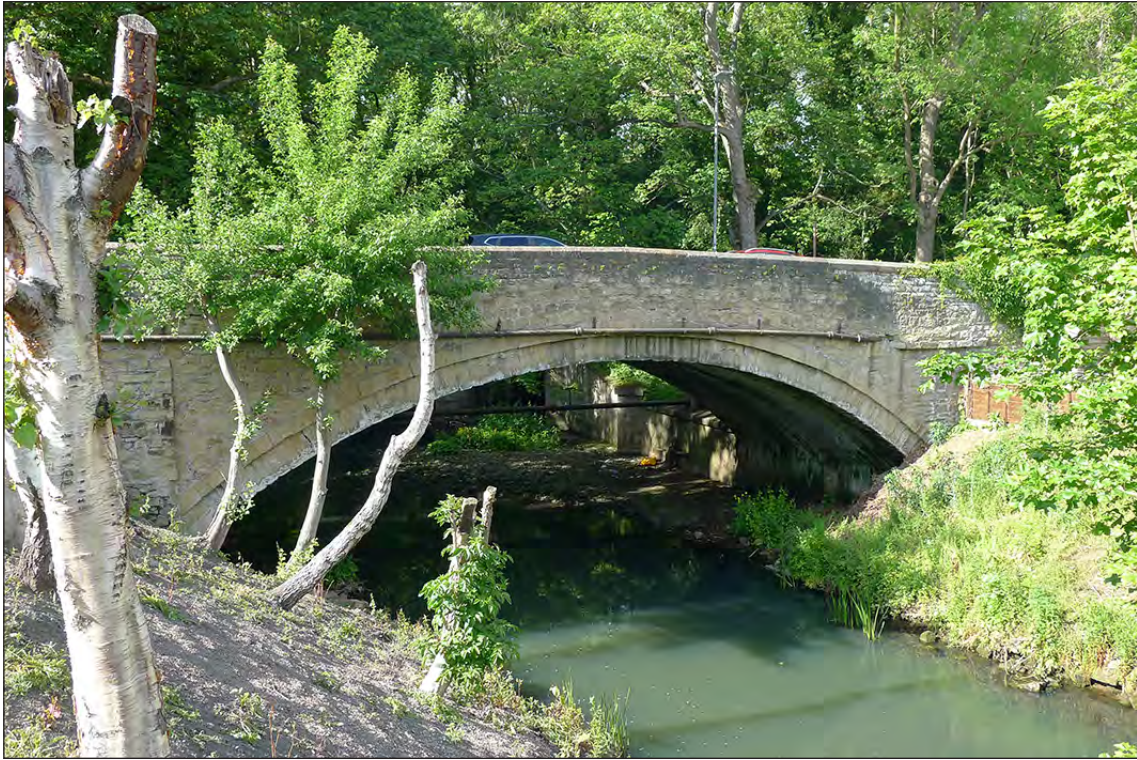
*Fig 16. The southern (upstream) elevation of the phase-1 Gaunless Bridge.
(© Historic England/Marcus Jecock)*

The visible upstream elevation of the southern, phase-1, bridge consists of an arch ring of narrow ashlar voussoirs, longer than they are wide by a ratio of about 4:1, topped by an archivolt of smaller, squarer, ashlar sitting slightly proud of the arch ring. The spandrels and parapets are brought flush with the archivolt and comprise

rubble stone laid for the most part in courses. The western abutment is bolstered by a small buttress (which may be secondary) while in the east the parapet/wing wall is corbelled out slightly immediately above the springing of the arch in order to ease access on to the bridge from Durham Road (Fig 16).

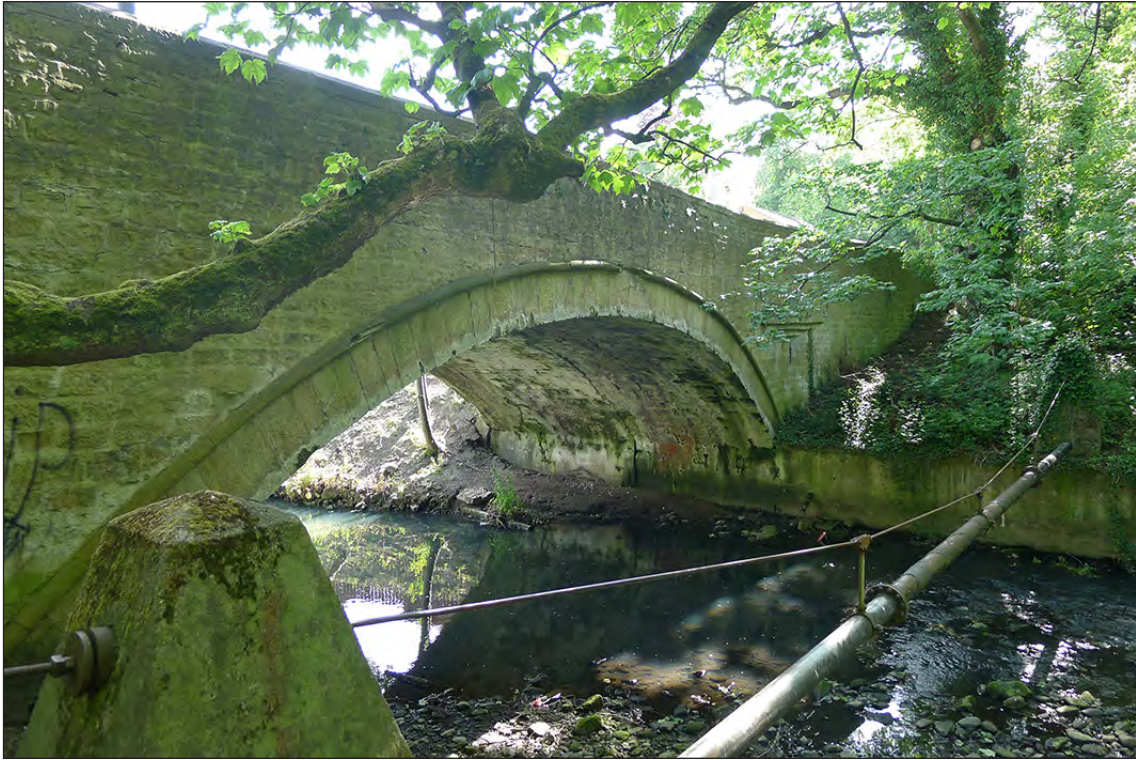
Fig 17. The northern (downstream) elevation of the phase-2 Gaunless Bridge. (© Historic England/Marcus Jecock)

The visible elevation of the second, downstream bridge is similar in form and construction to its upstream predecessor, but has voussoirs that are less well dressed (and also somewhat wider) surmounted by a much finer and more decorative archivolt in the form of a narrow roll-moulding (Fig 17). The approach on to the bridge from Gib Chare is similarly eased slightly by corbelling out of the western parapet (this time in three stages), again immediately above the arch springing, while the short wing wall that continues the parapet westwards ends after some 14m in a drum pillar featuring a flat-topped cap with rounded sides to match the chamfered coping that adorns both sets of parapets and wing walls. The parapets and coping are presumably, therefore, all of one period and contemporary with the date when the bridge was widened (see below).

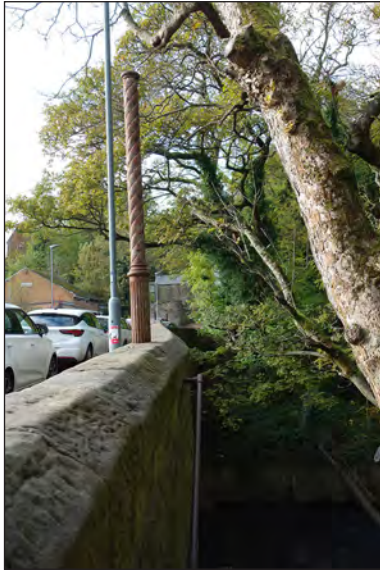
Fig 18. The cast-iron shaft of the old gas lamp on Gaunless Bridge. Note the supply pipe on the outside of the parapet. (© Historic England/Rebecca Pullen)

The shaft of a cylindrical cast-iron street lamp is set into the coping of the northern parapet just east of the crown of the bridge, although the lamp itself is missing (Fig 18). The lamp is clearly secondary to the bridge on which it stands. A fluted pedestal supports the ornamental twisted shaft with its simple base and capital mouldings. The light was gas-fired (the cast-iron supply pipe rises out of the western river bank and is still attached to the outside of the parapet).

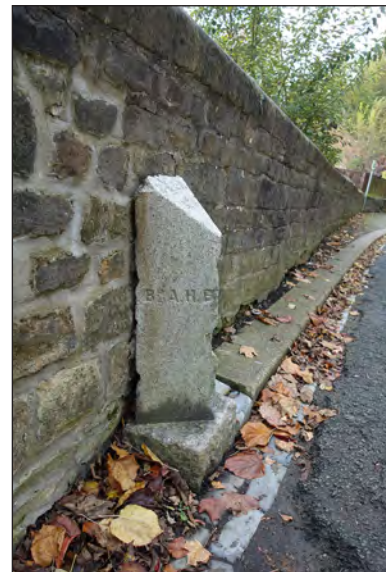
Fig 19. Stone on the crown of Gaunless Bridge, set up by the Bishop Auckland Area Health or Highways Board in 1878. (© Historic England/Rebecca Pullen)

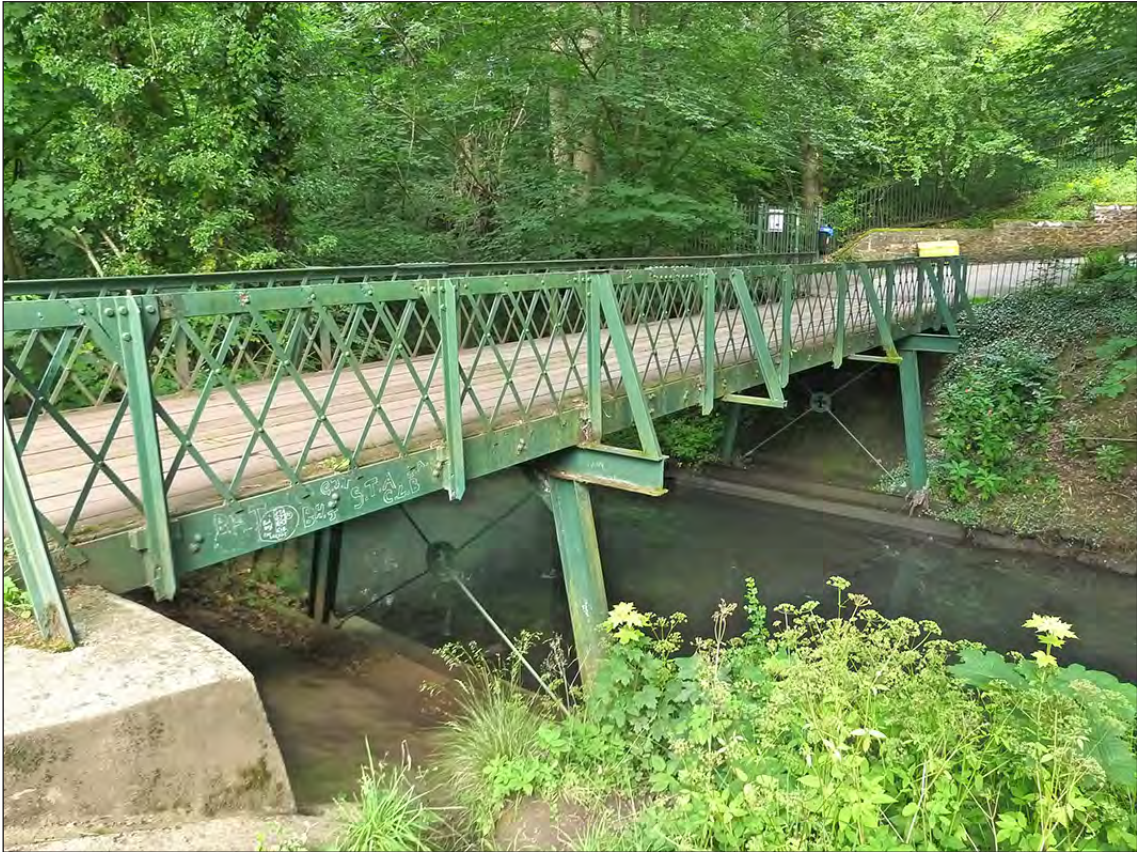
*Fig 20. The pony truss bridge over the River Gaunless in Bishop Auckland Cemetery.
(© Historic England/Marcus Jecock)*

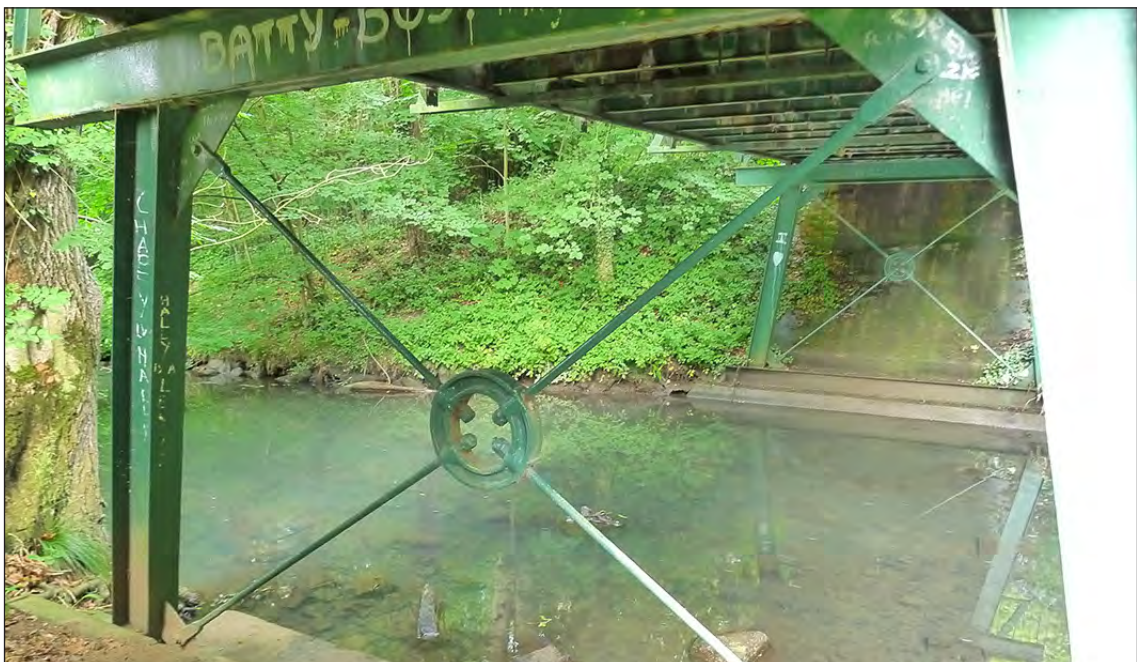
*Fig 21. The support trestles to the pony truss in Bishop Auckland Cemetery
(© Historic England/Marcus Jecock)*

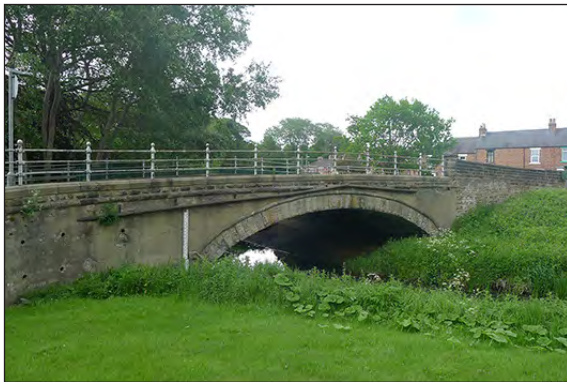
Fig 22. The southern (upstream) elevation of the phase-1 B6282 bridge over the River Gaunless at South Church (© Historic England/Marcus Jecock)

intersections on either river bank. However, a very clear construction joint in the barrel of the arch shows that the structure has been widened and effectively comprises two separate bridges built side by side at different times. The earlier bridge is that on the upstream side which is 5.9m (about 19 feet 4 inches) wide (Fig 22); it was later extended by 4.16m (about 13 feet 6 inches) towards the north (downstream). A late 20th- or early 21st-century steel-girder footbridge on stone abutments now stands immediately alongside the later structure, effectively concealing much of the downstream elevation.

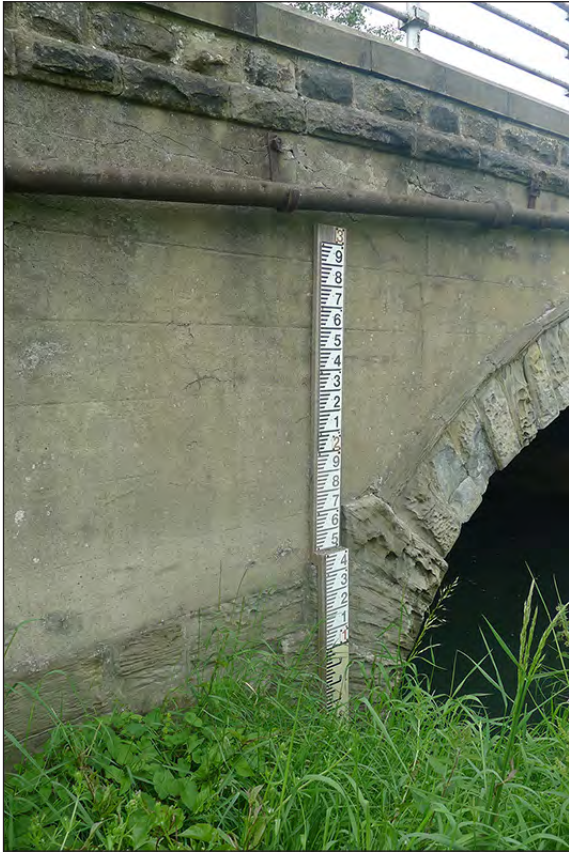
Fig 23. Detail of the western abutment of the phase-1 B6282 bridge over the River Gaunless at South Church, showing the difference in the form of the voussoirs and the exposed masonry in the causeway. (© Historic England/Marcus Jecock)

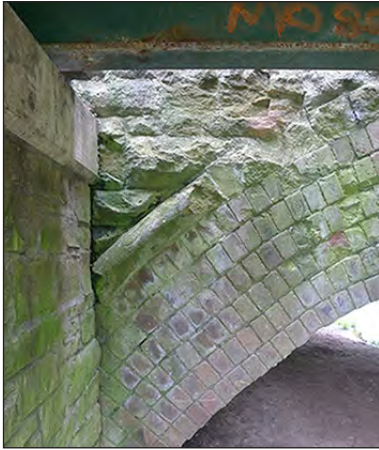
Fig 24. The hacked archivolt close to the eastern springing of the phase-2 B6282 bridge at South Church. (© Historic England/Marcus Jecock)

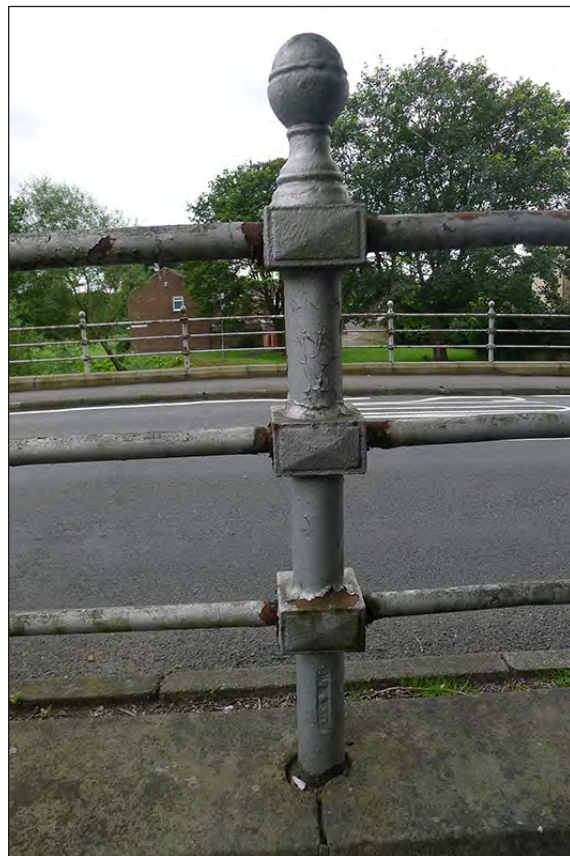
Fig 25. Detail of the Inter-War railings to the B6282 bridge over the River Gaunless at South Church. (© Historic England/Marcus Jecock)

All parapets (except the south-eastern wing wall) consist of iron or steel railings rising from low, stone walls with chamfered, flat-topped, ashlar copings that run between square end piers with flat caps. The stonework is rock-dressed; the edges of the pier caps and the corners of the piers are, in addition, margined. The railings are made up of three sets of horizontal tubular bars, set between tubular uprights with pineapple-shaped finials. The bars are attached to squat, horizontal, cuboid mouldings apparently welded on to each upright; the outer and inner faces of the cuboid mouldings are also raised up as low pyramids (Fig 25). The parapet to the south-eastern wing wall, in contrast, is a solid wall of rock-faced masonry, including the upper surface of the coping course which is margined in keeping with the end pier caps; this wing wall is clearly later than the body of the causeway beneath. Because of the similarity to the stonework visible in the spandrels of

the northern elevation, it is likely that railings, parapets and wing wall are all part of a single scheme and contemporary with the downstream widening, ie they date to between the First and Second World Wars (see below).

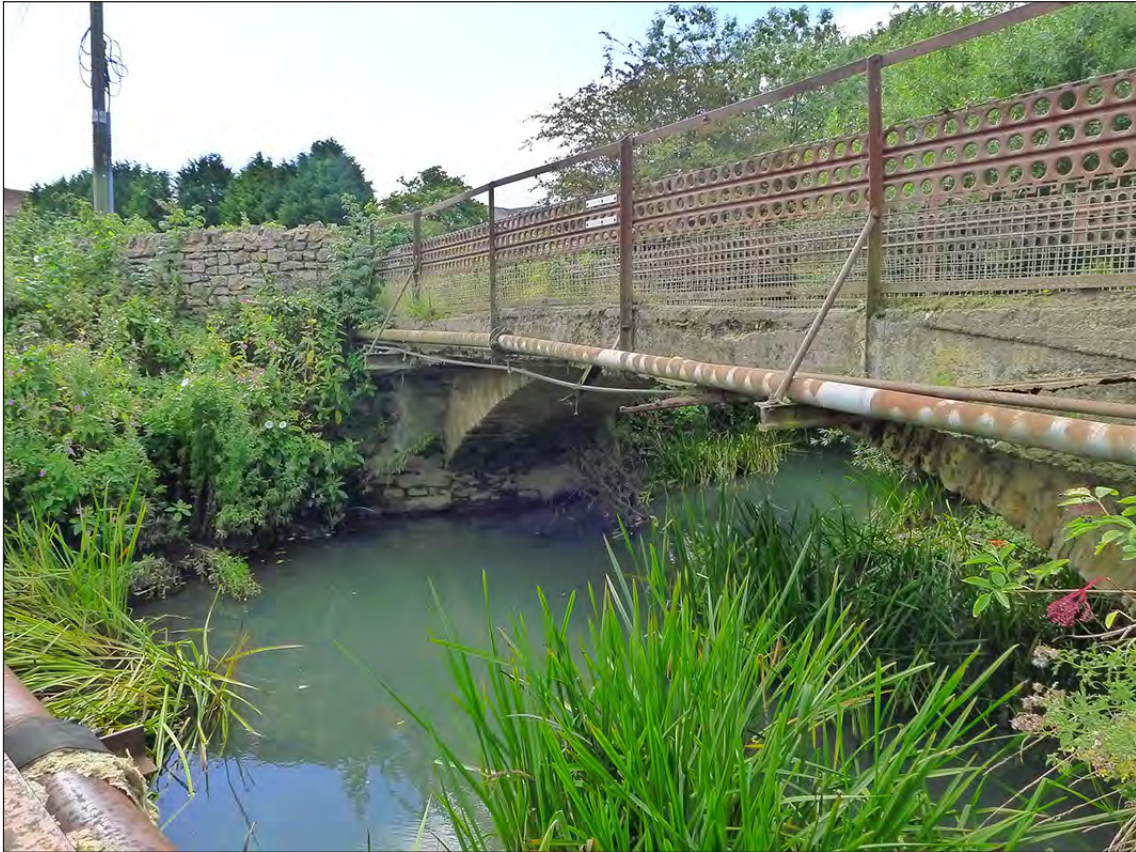
Fig 26. The eastern elevation of the 'Deanery' packhorse bridge across the River Gaunless at South Church. (© Historic England/Marcus Jecock)

The bridge comprises a very narrow, rather flat, segmental stone arch, between stone abutments that are around twice as wide as the arch (Fig 26). The arch rings are formed from roughly shaped blocks of fissile sandstone, while spandrels and abutments seem to comprise a mixture of coursed block work and in places areas of a more rubbly and less regular nature, all somewhat obscured by re-pointing (Fig 27). The modern deck and bankside vegetation prevented close inspection. There is no evidence for the form of the original parapets (assuming there ever were any), because the bridge has been effectively doubled in width by the addition of a poured concrete slab, 3.03m wide, that oversails the arch rings by a considerable margin on each side. The present, rather makeshift, parapets are steel railings, composed of T-section stanchions bolted directly to the sides of the slab or rising from short lengths of old train rail set in to the spandrels, to which are fixed a mixture of flat bars, what appear to be tyre-traction mats, and wire mesh. Diagonal tie bars bolted to the ends of the rails and the midpoint of the stanchion above, add lateral strength to the railings. The rails also help support a pipeline and electricity cable attached to the eastern elevation of the bridge.

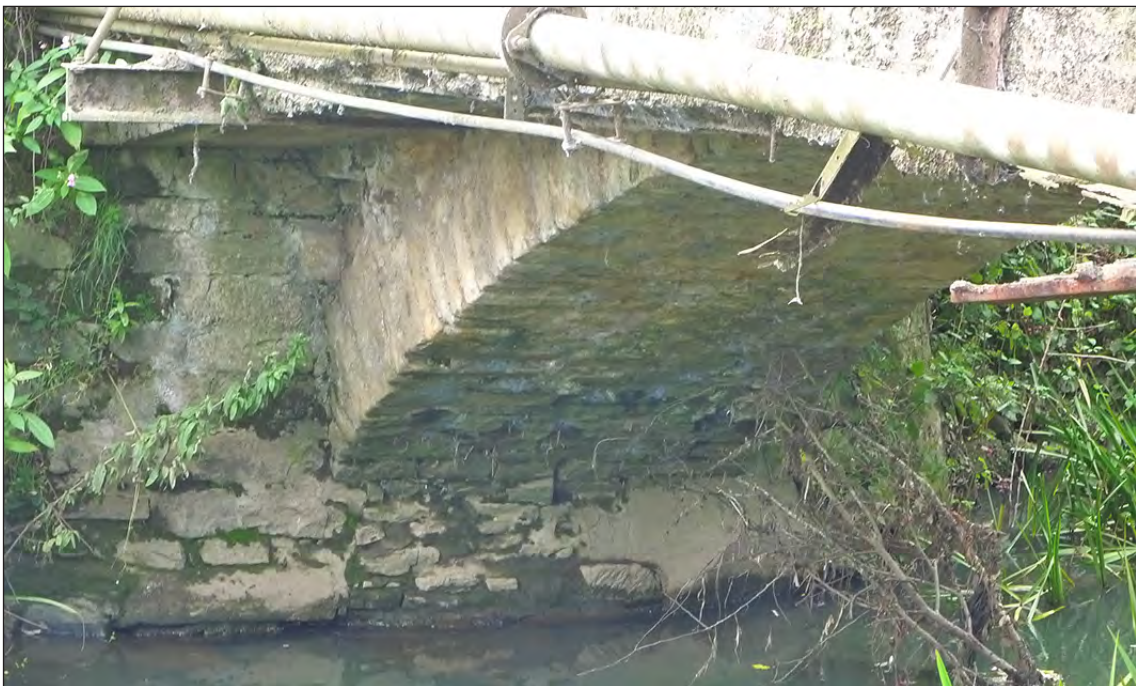
Fig 27. Detail of the southern abutment and arch of the 'Deanery' packhorse bridge across the River Gaunless at South Church. (© Historic England/Marcus Jecock)

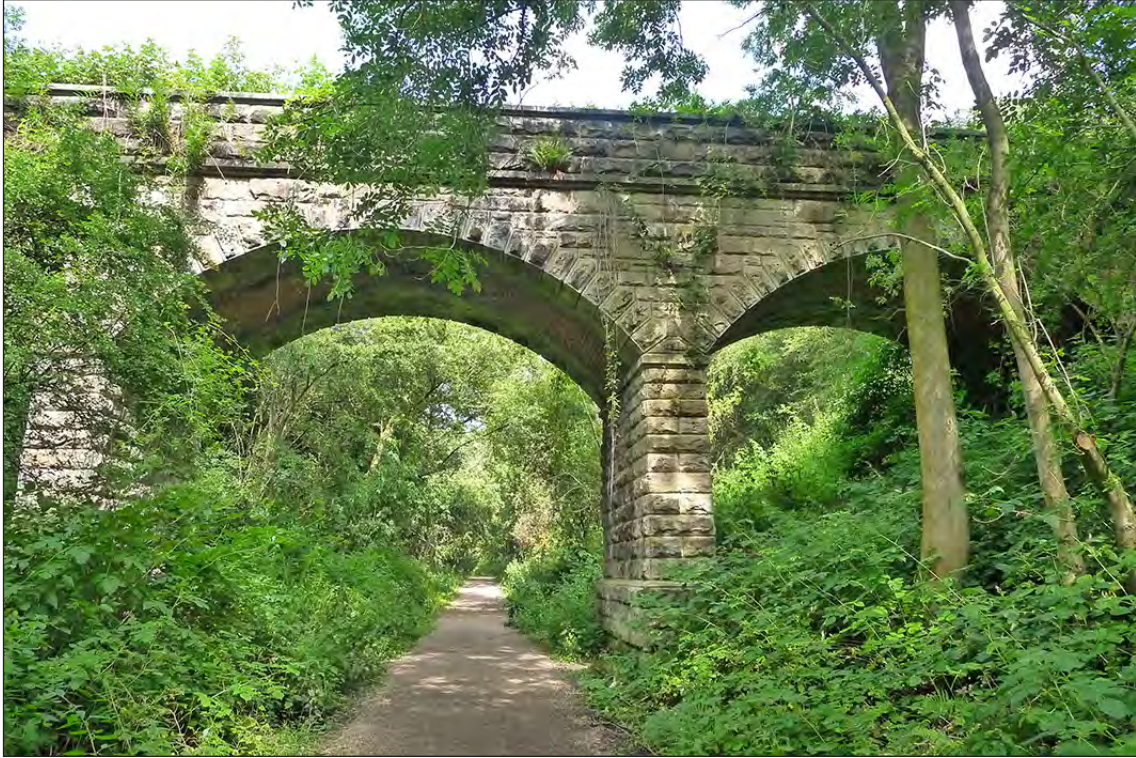
Fig 28. The south-western elevation of railway accommodation bridge BIF/5, showing the central and eastern spans. (© Historic England/Marcus Jecock)

The railway here runs through a cutting, and the bridge, which is oriented south-east to north-west and crosses the railway at right angles, comprises three segmental arches (Fig 28), some 4.52m wide by 7.55m span by 6.5m high at the crown (North Eastern Railway Association 2018), between abutments that rise out of the cutting's sides. Unsurprisingly, the bridge's design draws on a library of architectural treatments common to many if not all bridges on the line.

Apart from the barrels of the arches which are red brick, the bridge is constructed entirely from squared masonry, generally laid in regular horizontal courses and, with the exception of the soffits of the voussoirs in the arch rings, all rock-faced; the faces of the voussoirs plus the corners of the quoins in the piers are, in addition, margined.

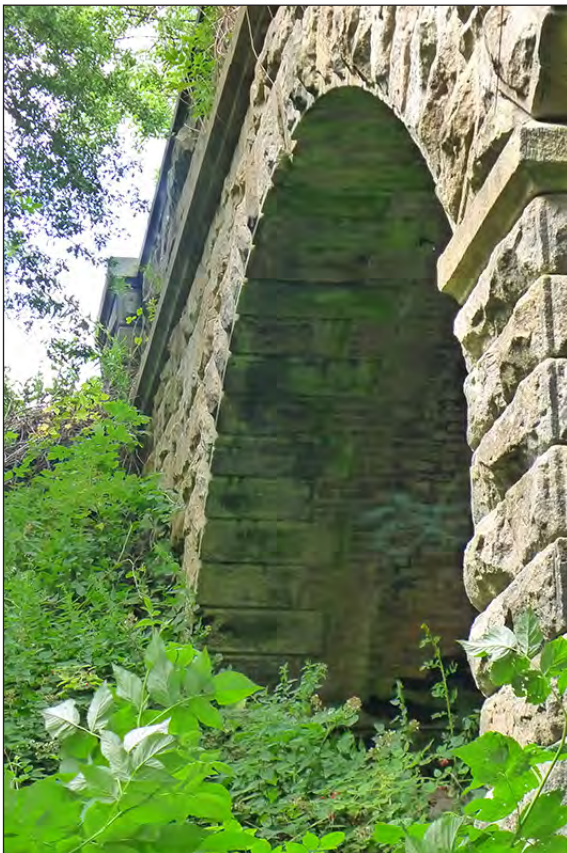
Fig 29. Detail of the western arch and parapet of railway accommodation bridge BIF/5, showing end pier, string course and impost banding. (© Historic England/Marcus Jecock)

The arch rings spring from skewback stones set above ashlar impost bands, and the voussoirs have stepped ends that key directly into the spandrels. Each pier has a slightly enlarged base, differentiated from the pier itself by a narrow ashlar chamfer. A horizontal string course at deck level, again ashlar, divides spandrels from parapets. The latter terminate in rectangular end piers that break forward on the elevations, and have ashlar caps; the coping stones likewise appear to be ashlar although the bridge was only viewed from the floor of the cutting and the precise form of the coping and

end pier caps – plus the treatment of the inner faces of the parapet walls - was not determined. As best as could be seen, however, string course, coping stones and end caps all share the same profile, namely a smooth, concave lower moulding rising to a square middle section and angled top (Fig 29). The bridge is currently in a neglected state, with small trees and other vegetation rooted in its deck and elevations.

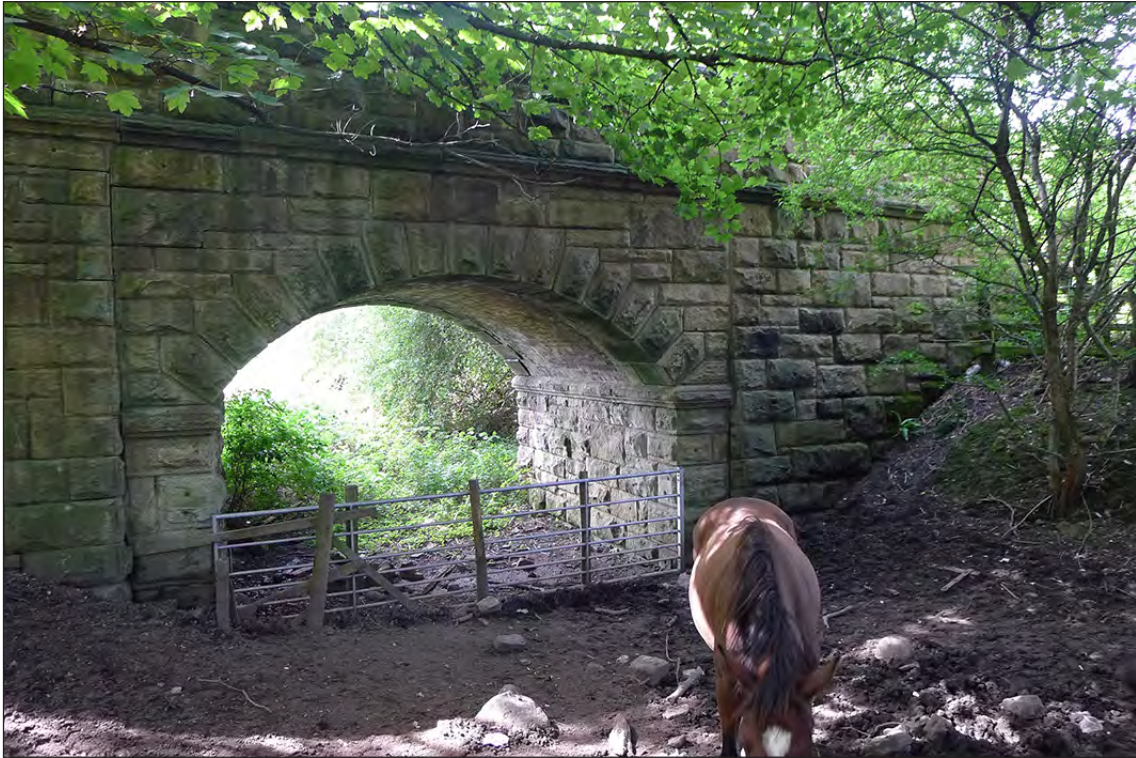
*Fig 30. Eastern elevation of railway accommodation bridge BIF/7.
(© Historic England/Marcus Jecock)*

The bridge comprises a single segmental arch, 4.85m wide by 4.42m span, between abutments approached at either end by earthen embankments (Fig 30). Unsurprisingly, its design draws on a repertoire of architectural treatments shared by many if not all bridges on the branch line.

The sides of the abutments slope out slightly from top to bottom, and are buried within the embankments which wrap round them. Apart from the barrel of the arch which is red brick, the bridge is constructed entirely from squared masonry, laid in irregular horizontal courses and for the most part rock-faced with smooth margins. The rings of the arch – which spring from skewback stones set above impost bands – consist of large stone voussoirs with stepped ends keyed directly in to the
