The Road, Rail and Parkland Bridges of Bishop Auckland, Co Durham: an assessment of the historical and archaeological evidence

Marcus Jecock

**THE ROAD, RAIL AND PARKLAND BRIDGES OF
BISHOP AUCKLAND, Co DURHAM:**
an assessment of the historical and archaeological evidence

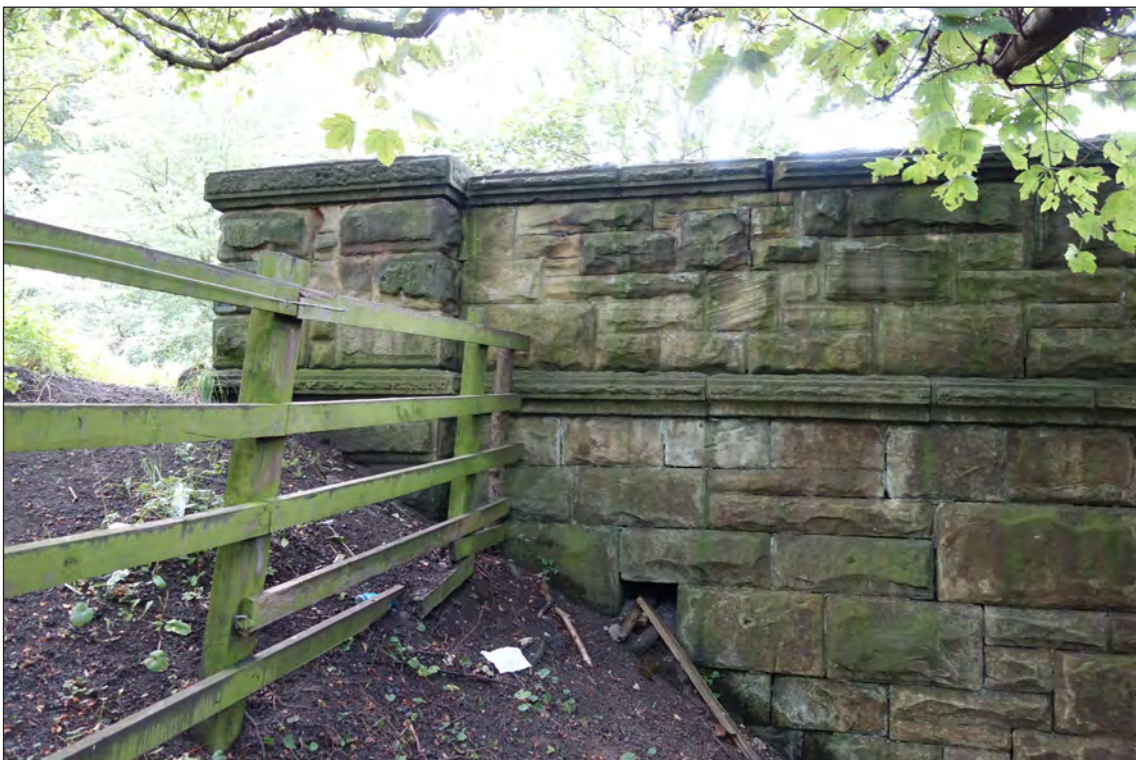
Fig 31. Detail of railway accommodation bridge BIF/7, showing string course, end pier and coping. (© Historic England/Rebecca Pullen)

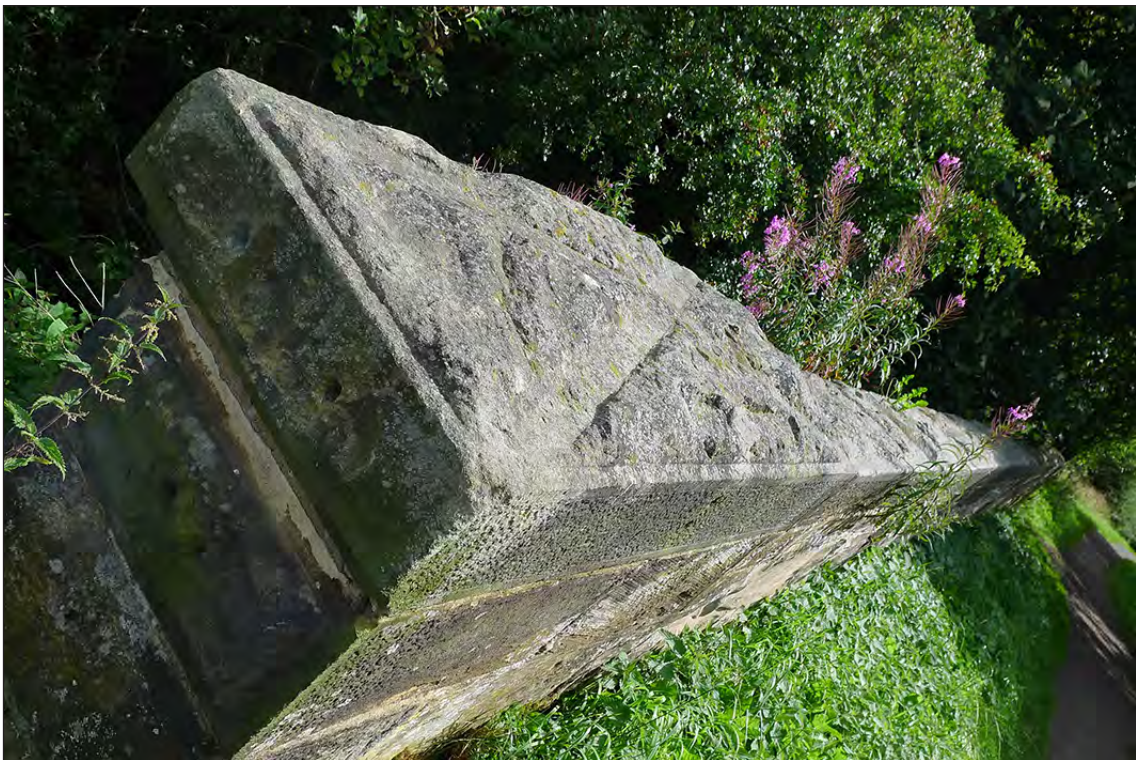
Fig 32. Detail of end pier on accommodation bridge BIF/7, showing the saltire design on the pyramidal cap and the varied treatment of 'public' and 'non-public' surfaces. (© Historic England/Marcus Jecock)

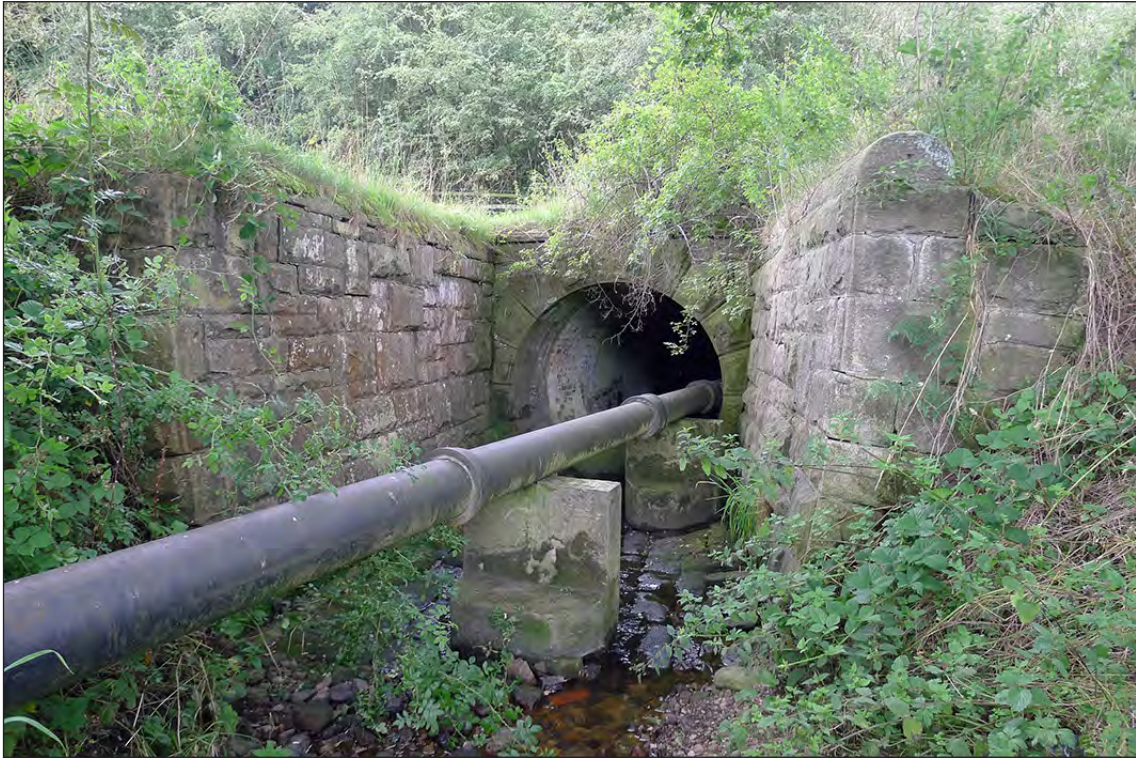
Fig 33. The eastern portal of railway culvert BIF/8. (© Historic England/Marcus Jecock)

The culvert consists of a 2.4m-diameter (8-foot) circular brick tube, approximately 98m long, through the base of a tall earthen embankment that carries the railway across the valley of the Burn (Figs 33 and 34). The headwalls are built in stone, and comprise arch rings composed of large voussoirs with stepped ends to key them in to the small spandrel area above, finished by a course of thin, flat-topped coping stones. Voussoirs and coping stones are rock-faced and margined; the stones in the spandrels are rock-faced only. River-training walls extend out a short distance from each headwall, and double up as revetments to the base of the embankment. They, too, are formed of rock-faced masonry, laid in irregular horizontal courses, with the end quoins margined in addition, all beneath a coping course this time of semi-circular profile. The bed of the Burn between the training walls is paved with stone setts. A secondary, 9-inch (228.6mm) diameter, cast-iron (?) sewer pipe has been

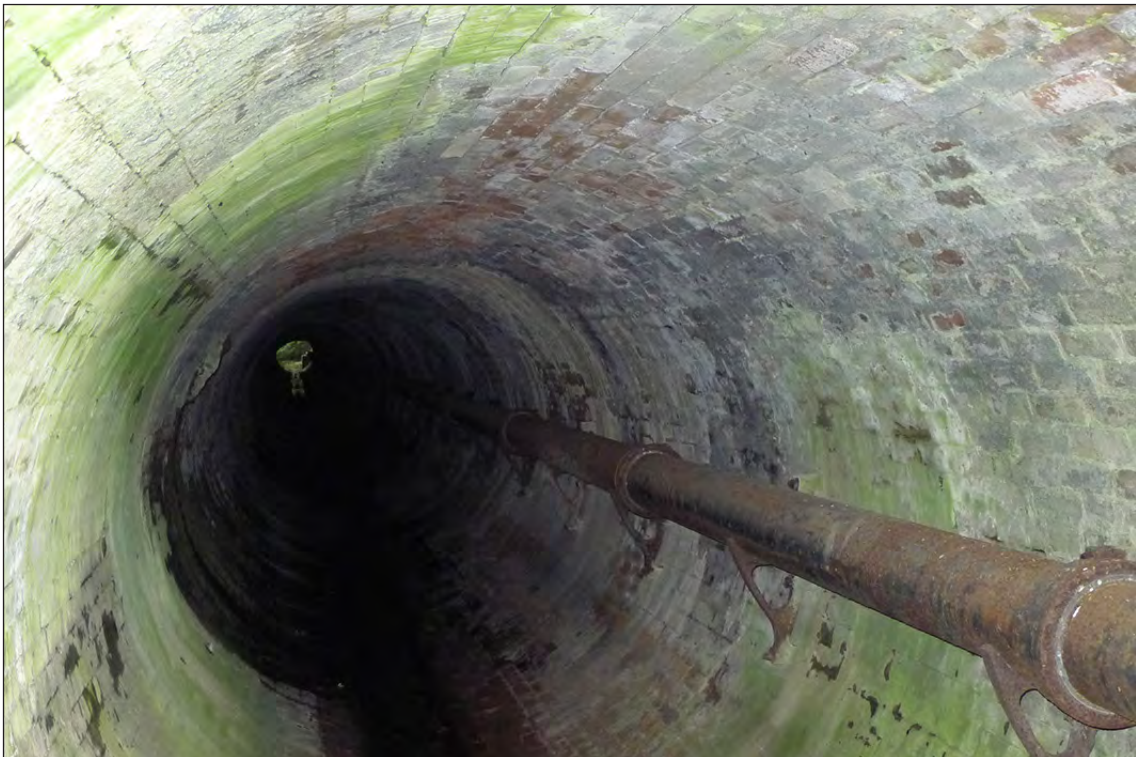
Fig 34. Interior of railway culvert BIF/8. (© Historic England/Marcus Jecock)

laid through the conduit. This sits on concrete supports as it enters the conduit, but is attached to the side of the conduit within the tube; dates cast in to the pipe collars suggests the pipeline was laid in 1939.

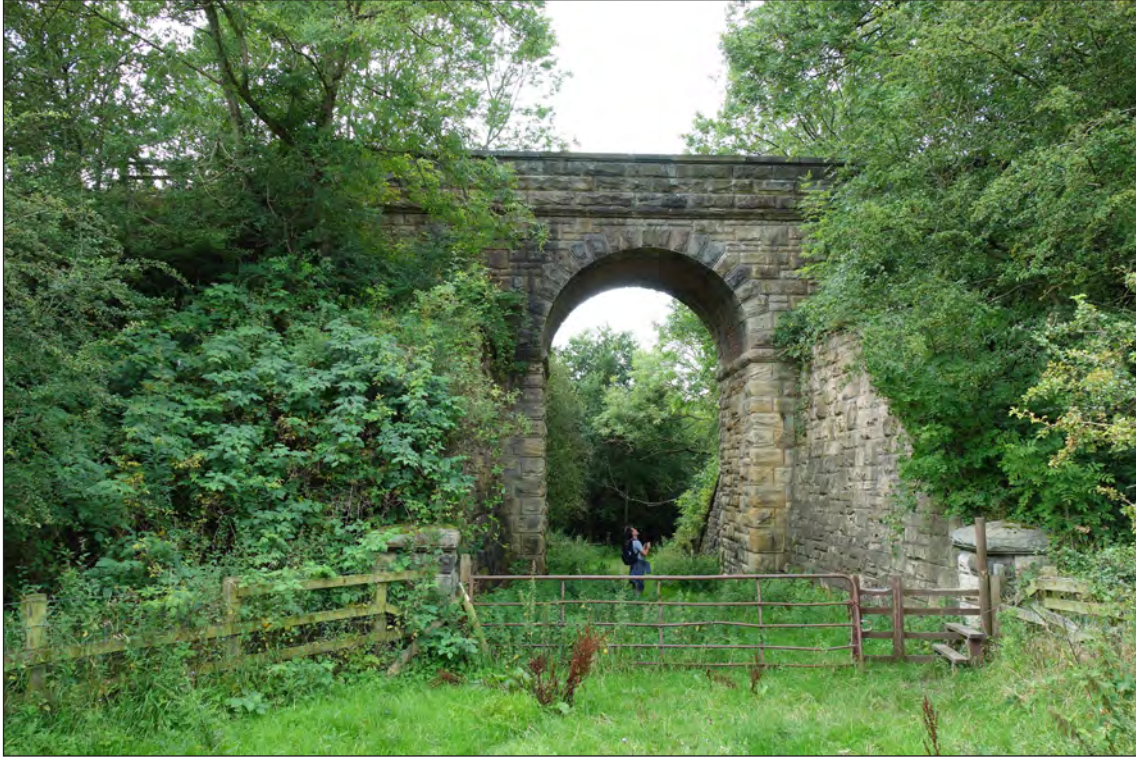
Fig 35. Eastern elevation of railway accommodation bridge BIF/9. (© Historic England/Rebecca Pullen)

The arch lies between abutments approached at either end by earthen embankments held back by retaining walls (Fig 35). Apart from the arch barrel which is red brick, the bridge is constructed entirely from squared sandstone, laid in irregular horizontal courses and for the most part rock-faced with smooth margins, although the detailing is now hard to see on many stones because of pronounced wind abrasion (Fig 36). The rings of the arch - which rise from impost bands - consist of large stone voussoirs with

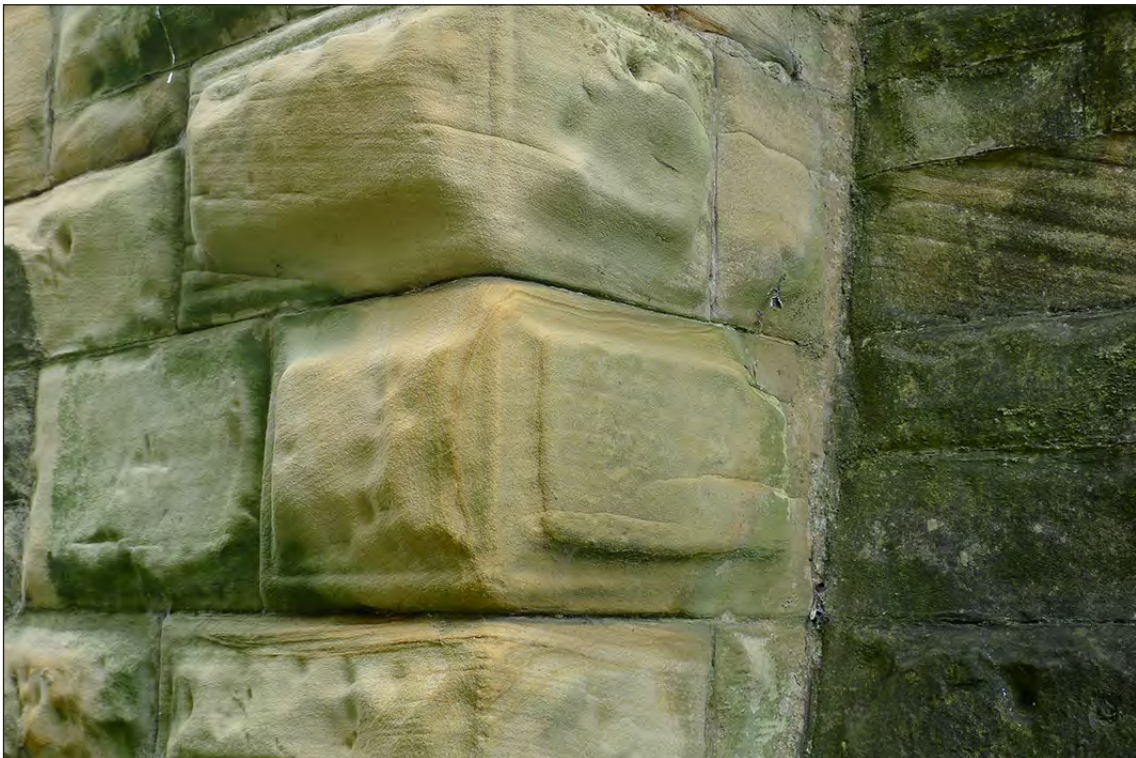
Fig 36. Detail of the weathered stonework on the abutment of railway accommodation bridge BIF/9. (© Historic England/Marcus Jecock)

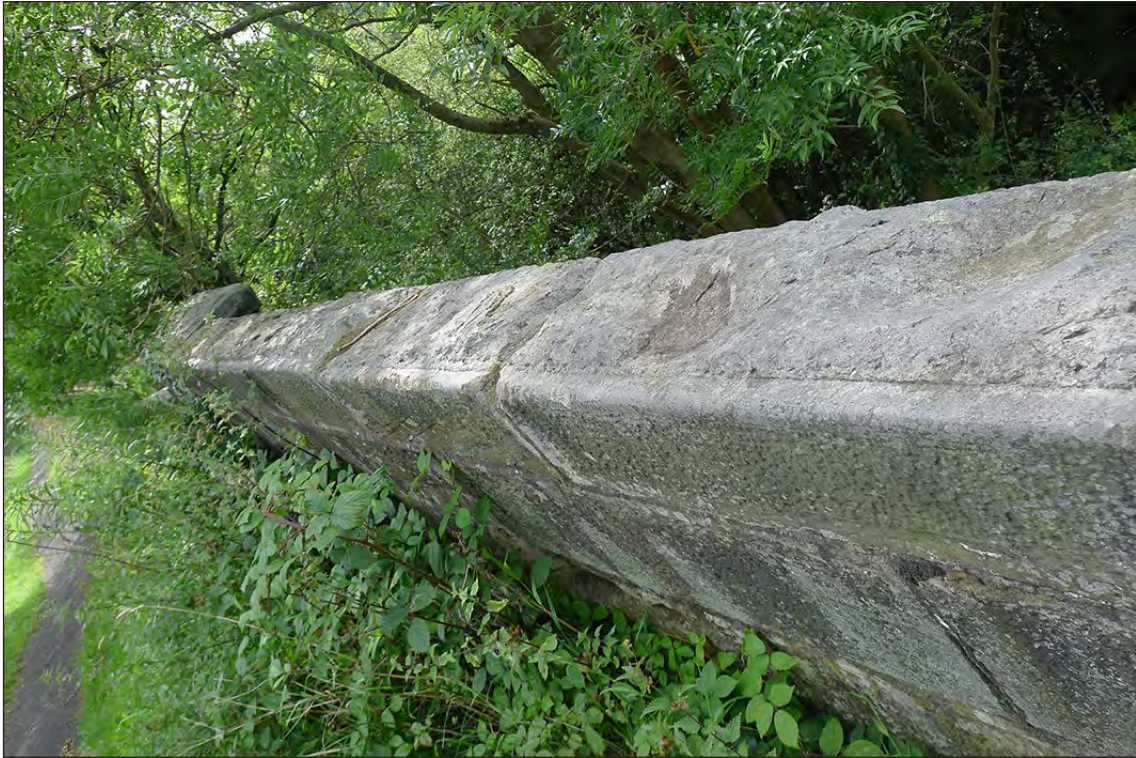
*Fig 37. The (?original) eastern parapet of railway accommodation bridge BIF/9.
(© Historic England/Marcus Jecock)*

stepped ends that key directly in to the spandrels. A horizontal string course at deck level separates spandrels from parapets. Impost bands and string coursing are rock-faced and margined in keeping with the masonry elsewhere, but rise from a smooth, concave lower moulding. The parapets terminate in end piers, emphasised by breaking forward from the parapets slightly (their caps also rise marginally higher than the intervening coping), all formed of large rectangular blocks again rock-faced and margined except for the inner (non-public-fronting) faces which are simply tooled and margined. The coping stones to the eastern parapet and caps to all four piers are rock-faced apart from their internal faces (tooled to match the parapet walls), but the coping stones to the western parapet are tooled in their entirety with lightly chamfered edges, suggesting they are secondary (Figs 37 and 38). The tops of all coping stones slope down slightly towards the external elevations, presumably to shed water. The public-fronting faces of the four caps plus the eastern parapet coping consist of two stages: a first-stage, smooth, concave moulding (as per impost bands and string coursing) succeeded by a rectangular moulding. On the caps this second stage rises in to a low-relief pyramid, with the intersections between the faces of each pyramid picked out by broad channelling so as to form the shape of a saltire when viewed from above. Identical but thinner caps occur on the end piers to the embankment retaining walls, which break both forward and back from the adjacent walling (Fig 39). The walls themselves slope out slightly towards their base, curve down towards the end piers and have coping very similar to that on the eastern parapet, but rock-faced and margined on all surfaces and, like the caps on the adjoining piers, of a much thinner profile. Some of the coping stones are now dislodged and/or missing.

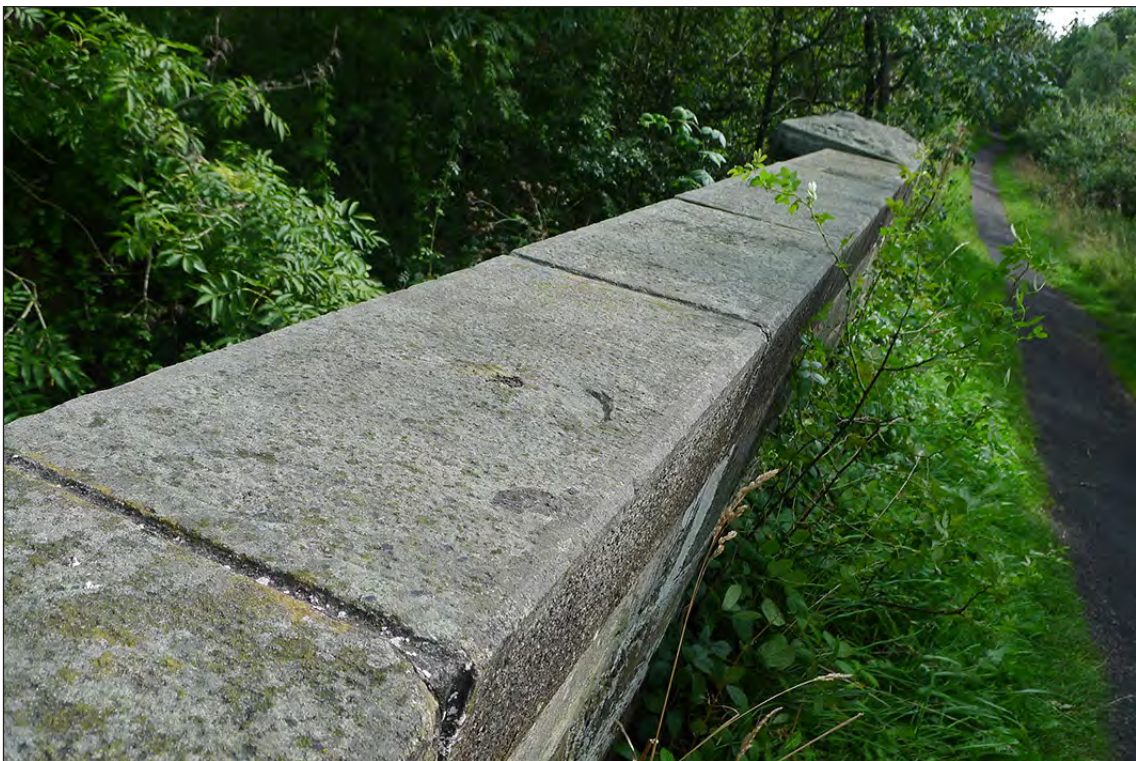
Fig 38. The (?replacement) western parapet of railway accommodation bridge BIF/9. (© Historic England/Marcus Jecock)

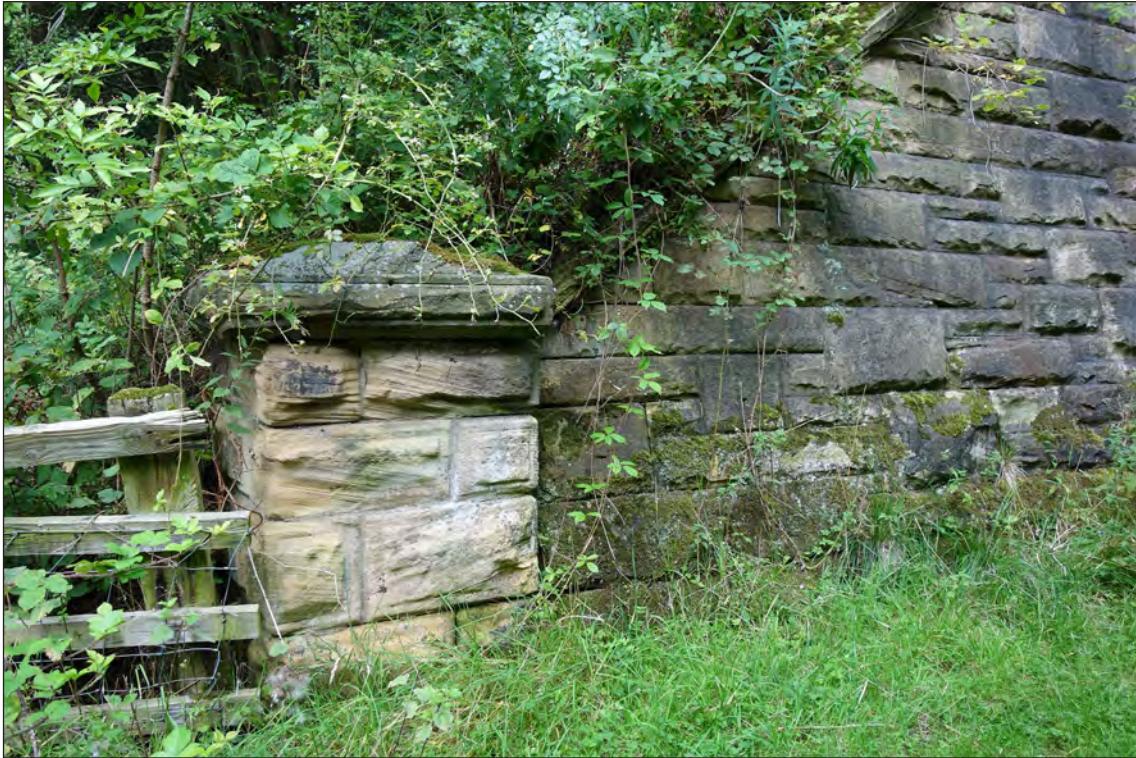
Fig 39. Detail of one of the end piers and part of the embankment retaining walling of railway accommodation bridge BIF/9. (© Historic England/Rebecca Pullen)

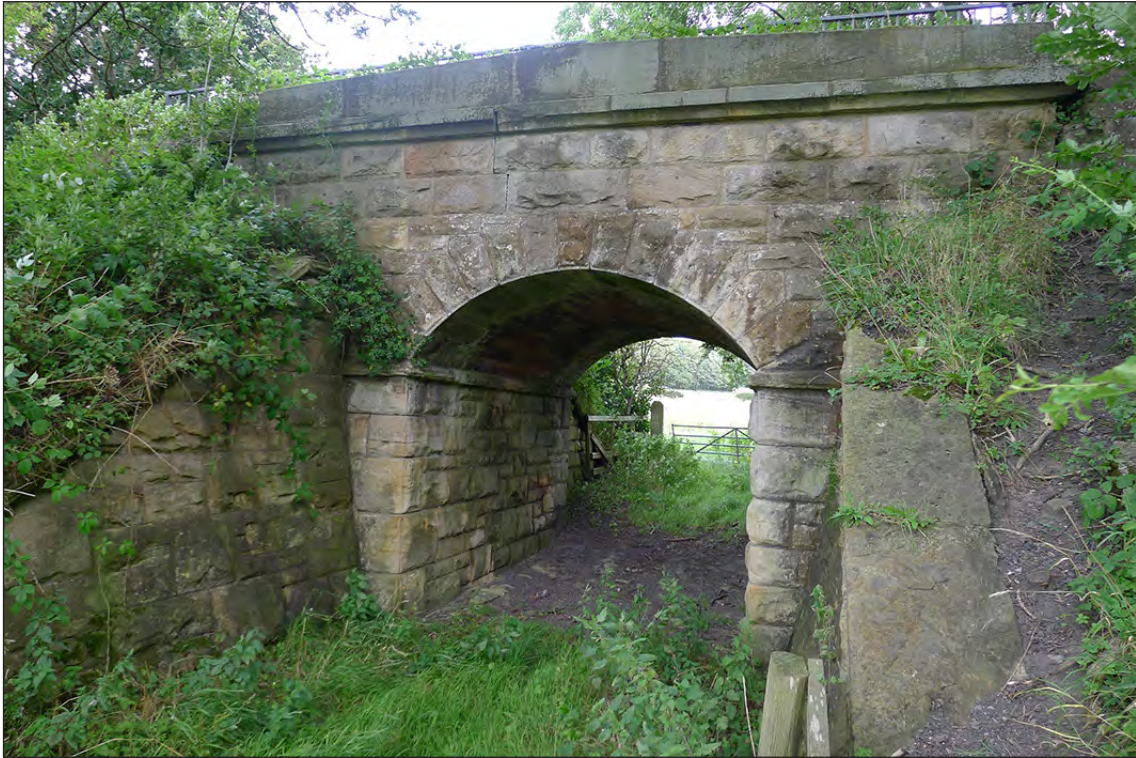
*Fig 40. West elevation of railway accommodation bridge BIF/10.
(© Historic England/Marcus Jecock)*

The bridge comprises a single, low, segmental arch, 4.74m wide by 2.74m span by 2.715m high to the crown of the arch (North Eastern Railway Association 2018), set between abutments approached at either end by earthen embankments (Fig 40). Unsurprisingly, its design draws on a library of architectural treatments shared by many if not all bridges on the branch line, although being a cattle creep some of the finer detailing seen on other bridges is omitted or scaled back.

Apart from the barrel of the arch which is red brick, the bridge is constructed entirely from squared masonry, laid in irregular horizontal courses and for the most part rock-faced with smooth margins. The rings of the arch – which spring from skewback stones set above impost bands – consist of large stone voussoirs with stepped ends

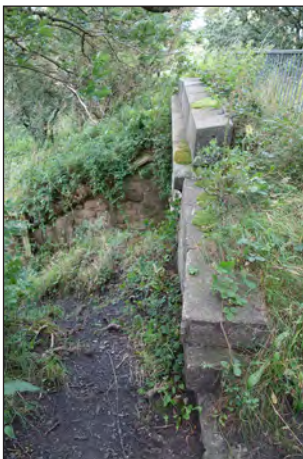
*Fig 41. Detail of dislodged/missing stones in the eastern parapet of railway accommodation bridge BIF/10.
(© Historic England/Rebecca Pullen)*

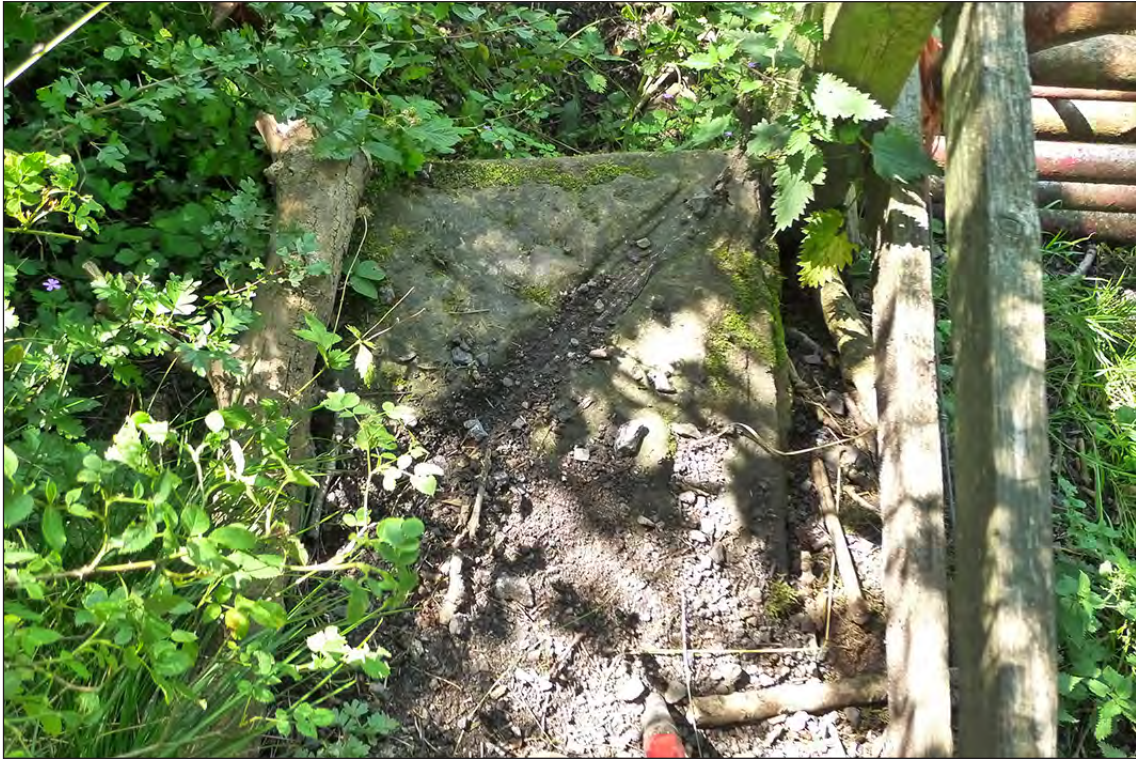
*Fig 42. Detail of one of the end pier caps to the retaining walls of railway accommodation bridge BIF/10, showing the 'half-saltire' channelling.
(© Historic England/Marcus Jecock)*

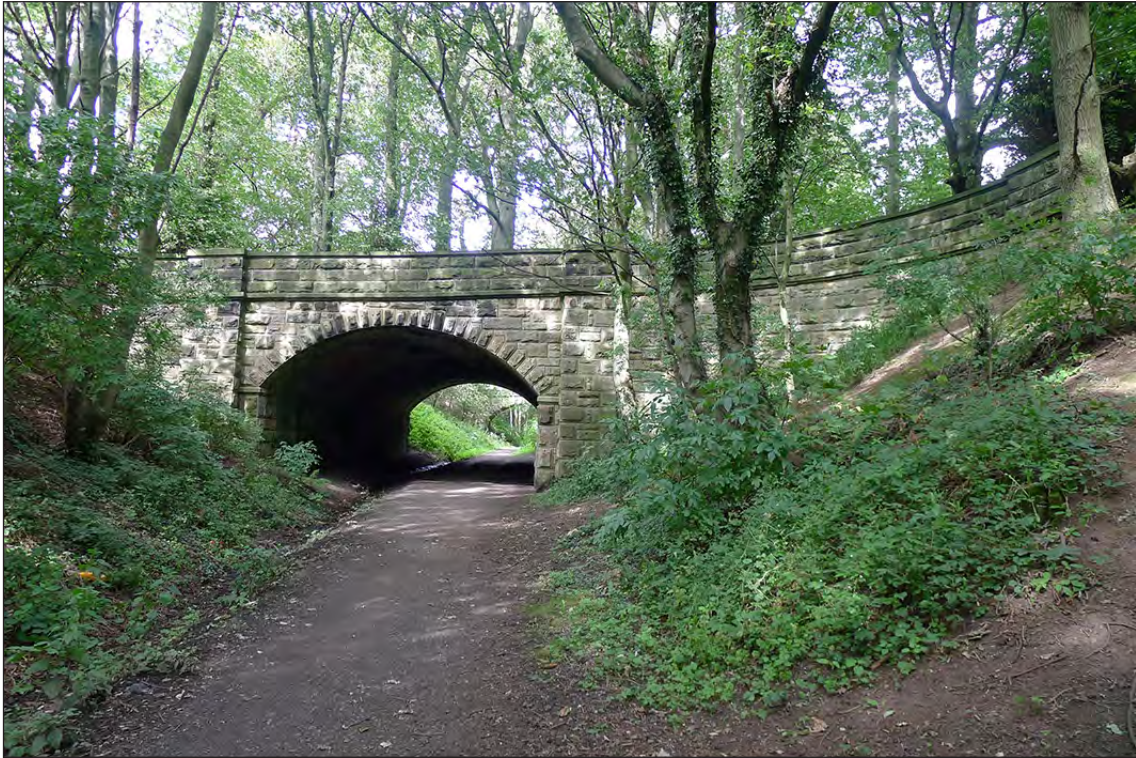
Fig 43. The south elevation of railway accommodation bridge BIF/11 ('Bishop's Bridge'). Note the great width (or length) of the arch barrel. (© Historic England/Marcus Jecock)

The railway here runs through a cutting, and the bridge comprises a single segmental arch, 25.1m wide by 7.9m span by 4.42m high at the crown (North Eastern Railway Association 2018), set between abutments that curve out and disappear in to the cutting's sides. The eastern side of the cutting is marginally higher and in consequence the bridge deck slopes down slightly towards the west. The bridge appears to have been constructed to allow for dualling of the line, although only a single track was ever laid (Fig 43). Unsurprisingly, its design draws on a library of architectural treatments common to many if not all bridges on the branch line, However, this particular bridge is unusual for its excessive width (or length) which is just over three times the span of its arch, making it more akin to a short tunnel.

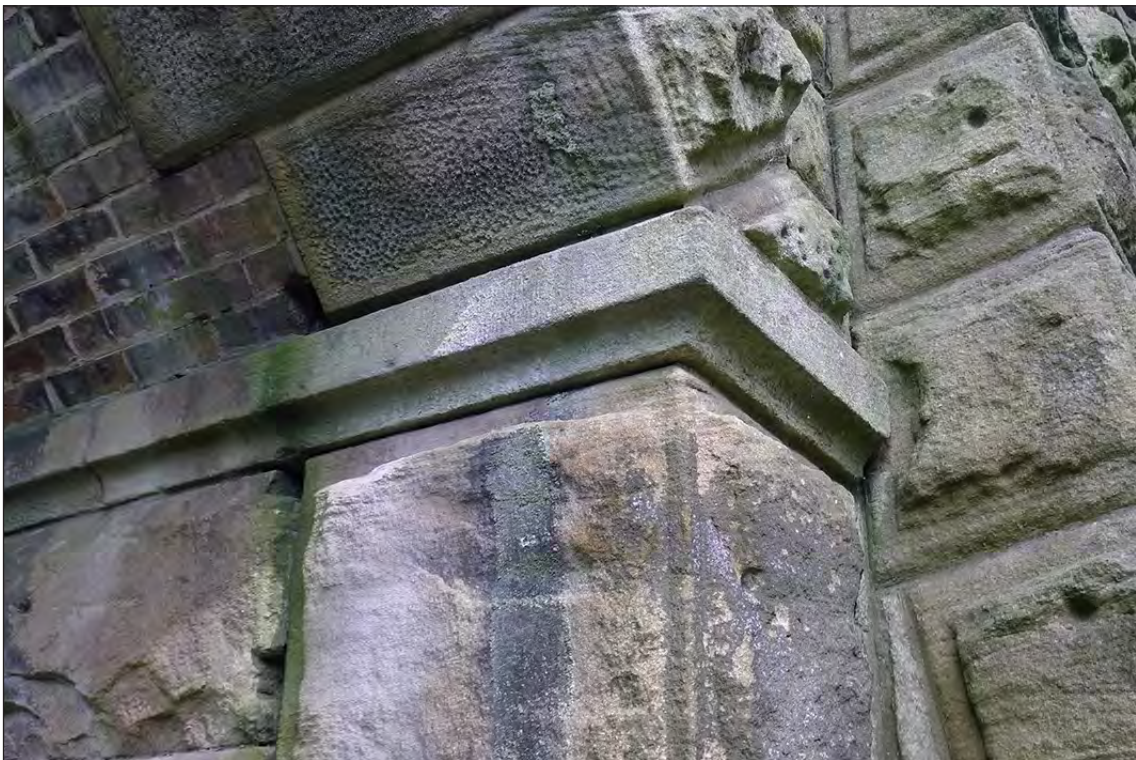
Fig 44. Detail of the springing of railway accommodation bridge BIF/11 ('Bishop's Bridge'), showing impost banding plus the varied finishes applied to the other stonework. (© Historic England/Marcus Jecock)

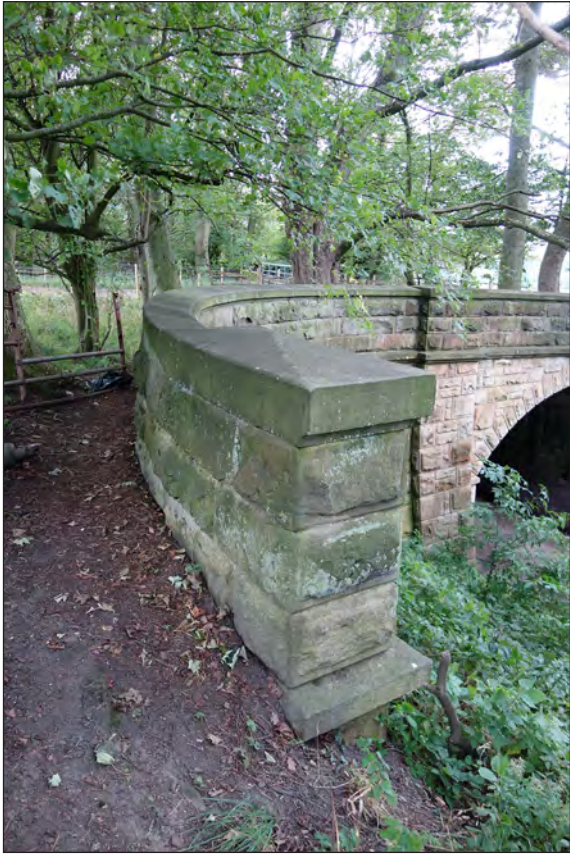
Fig 45. Detail of parapet and curving wing wall to railway accommodation bridge BIF/11 ('Bishop's Bridge'). (© Historic England/Rebecca Pullen)

or the deliberate selection of stone of contrasting colour. Impost bands and string coursing are ashlar in pleasing contrast to the rock-faced stonework elsewhere; both have a similar profile - a smooth, concave lower moulding, rising to a square middle and angled upper section. The pilaster strips on the abutments continue through the parapets as piers, and the parapets continue beyond these piers as curving wing walls that terminate in additional end piers. All piers are identical: rectangular in cross section, breaking forward on their external faces only. All have pyramidal caps that rise slightly proud of the coping stones on the adjoining parapets and wing walls, largely because the upper surfaces of the latter are angled down slightly towards the bridge's external elevations to assist the shedding of rainwater (Fig 45).

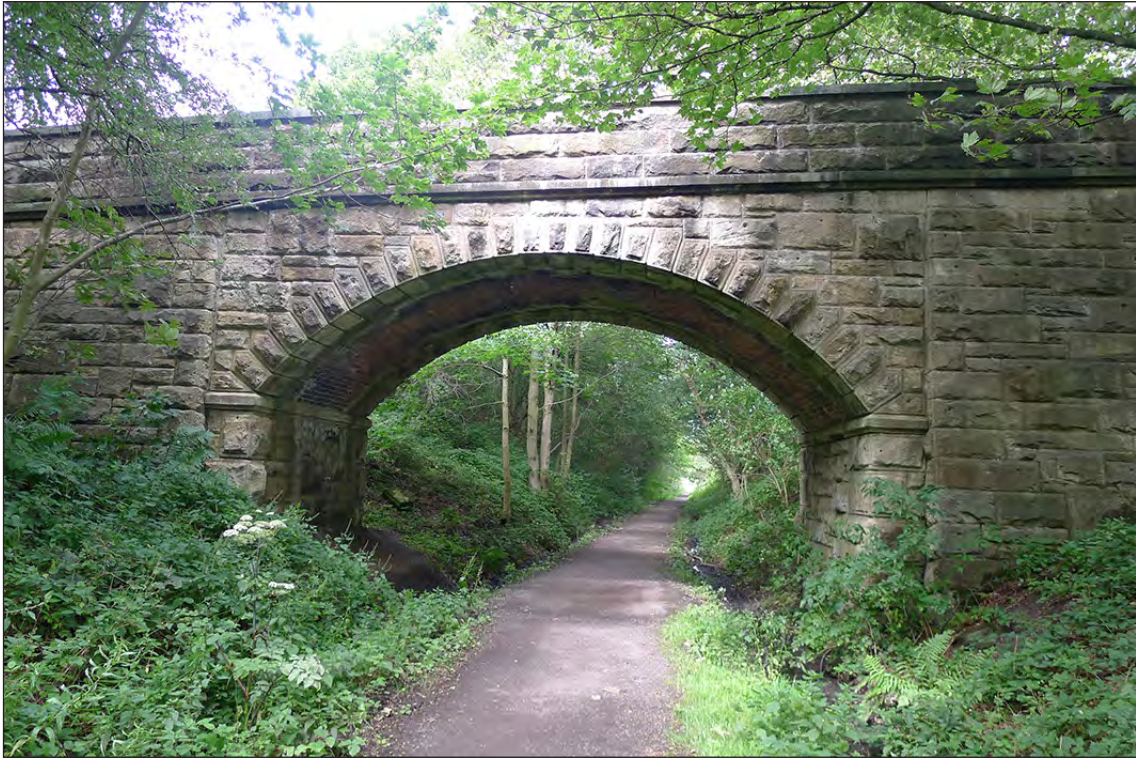
*Fig 46. Southern elevation of railway accommodation bridge BIF/12.
(© Historic England/Marcus Jecock)*

The railway here runs through a cutting, and the bridge comprises a single segmental arch, 4.32m wide by 7.9m span by 4.72m high at the crown (North Eastern Railway Association 2018), set between abutments that rise from the cutting's sides. The eastern side of the cutting is marginally higher and in consequence the bridge deck slopes down slightly from east to west. The bridge appears to have been constructed to allow for dualling of the line, although only a single track was ever laid (Fig 46). Unsurprisingly, its design draws on a library of architectural treatments common to many if not all bridges on the line.

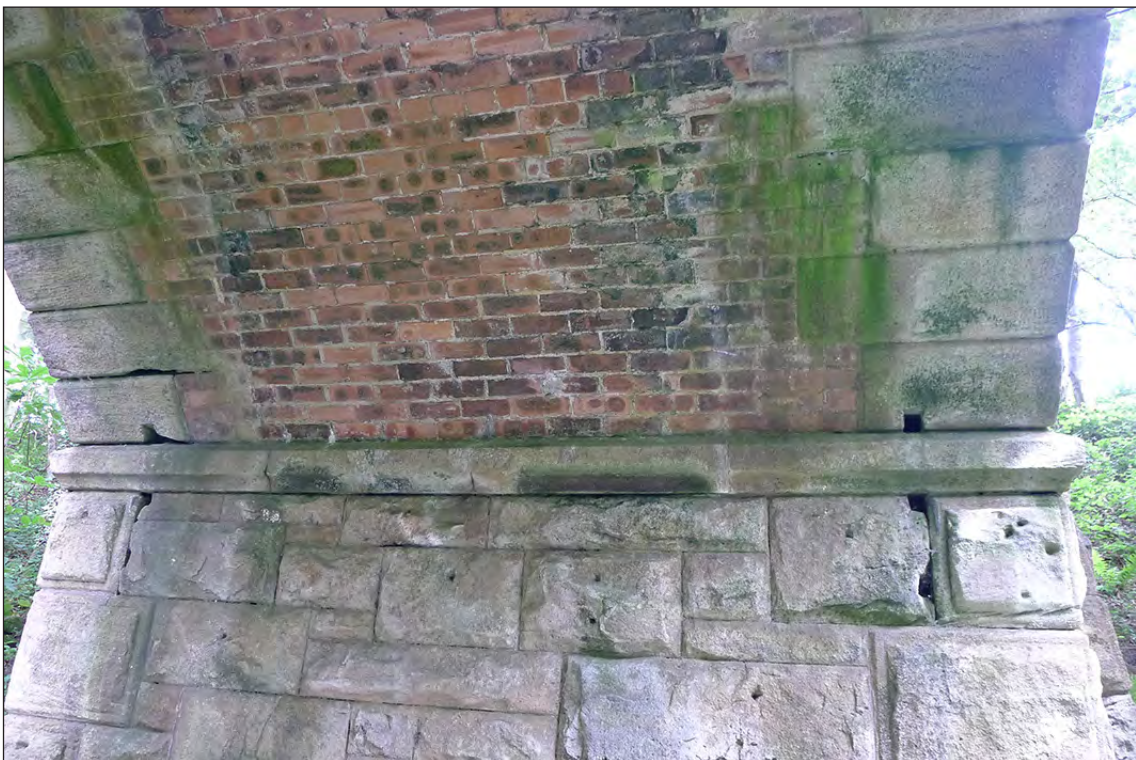
Fig 47. Detail of abutment face and brick arch barrel of railway accommodation bridge BIF/12, showing impost band plus the varied finishes applied to the stonework. (© Historic England/Marcus Jecock)

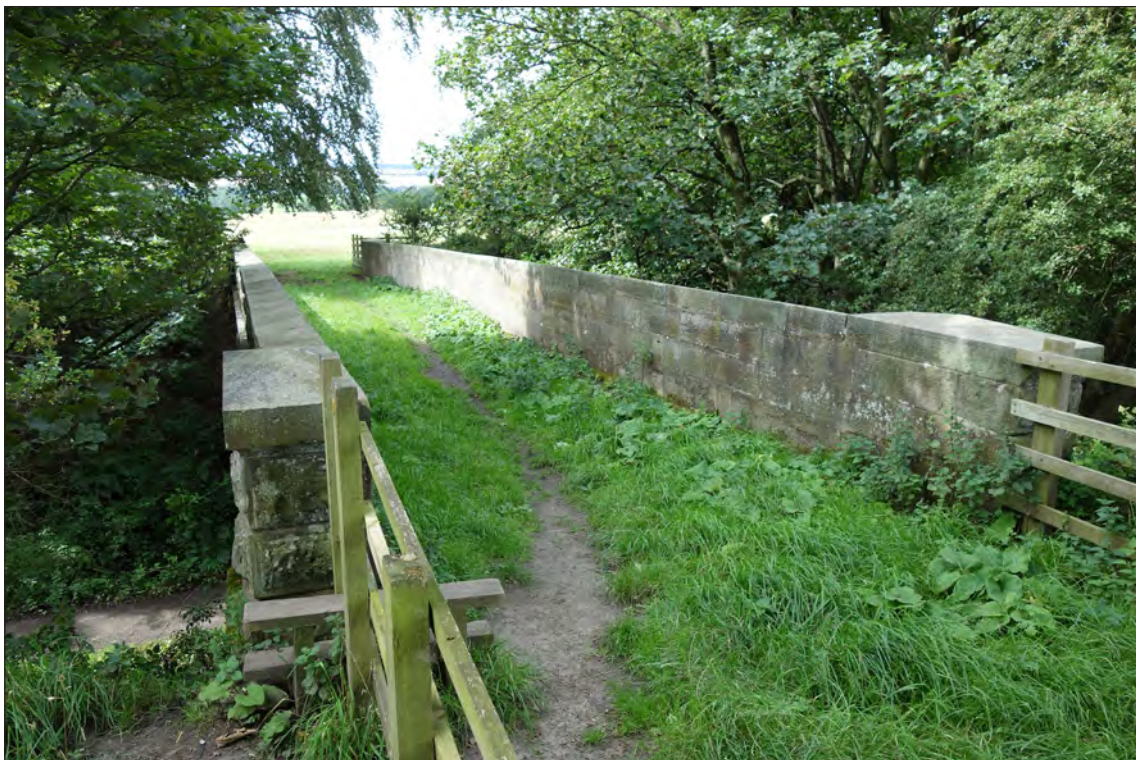
Fig 48. View west along deck of railway accommodation bridge BIF/12, showing parapets and end piers. (© Historic England/Rebecca Pullen)

is mostly rock-faced, margined in addition on the abutment quoins, parapet end piers and elevations of the voussoirs; the inner faces of the parapets and soffits of the voussoirs are in contrast tooled and margined (Fig 47). The arch rings spring from skewback stones set above impost bands, and the voussoirs have stepped ends that key directly in to the spandrels. The parapets are differentiated from the spandrels by a near-horizontal string course at deck level, and are topped by coping stones with a gently sloping upper surface, angled to the outside to help shed rain water. Parapets terminate in rectangular end piers that break forward on the elevations, and have ashlar pyramidal caps (Fig 48). Impost bands and string coursing are also ashlar in contrast to the rock-faced stonework of the main body of the bridge; both have a similar profile - a smooth, concave lower moulding, rising to a square middle and angled third section. All coping stones and end caps rise from a similar concave moulding.

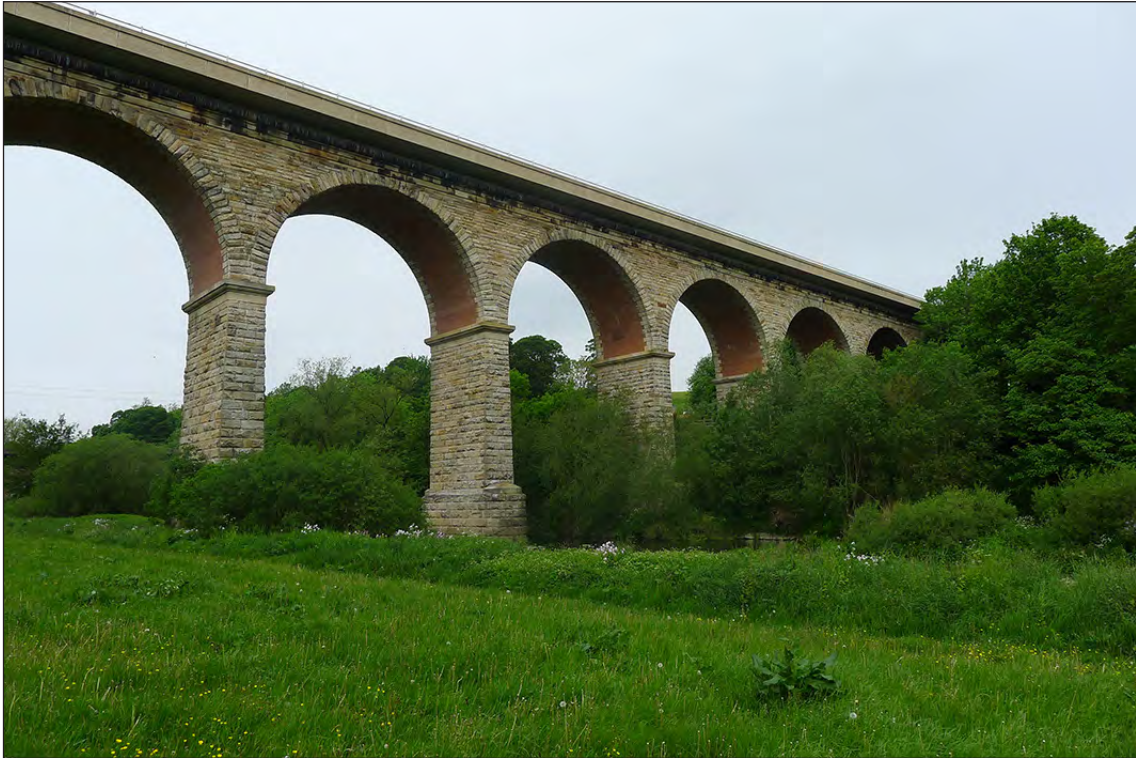
Fig 49. The northern end of Newton Cap Viaduct from the east. Note the modern cantilevered road deck. (© Historic England/Marcus Jecock)

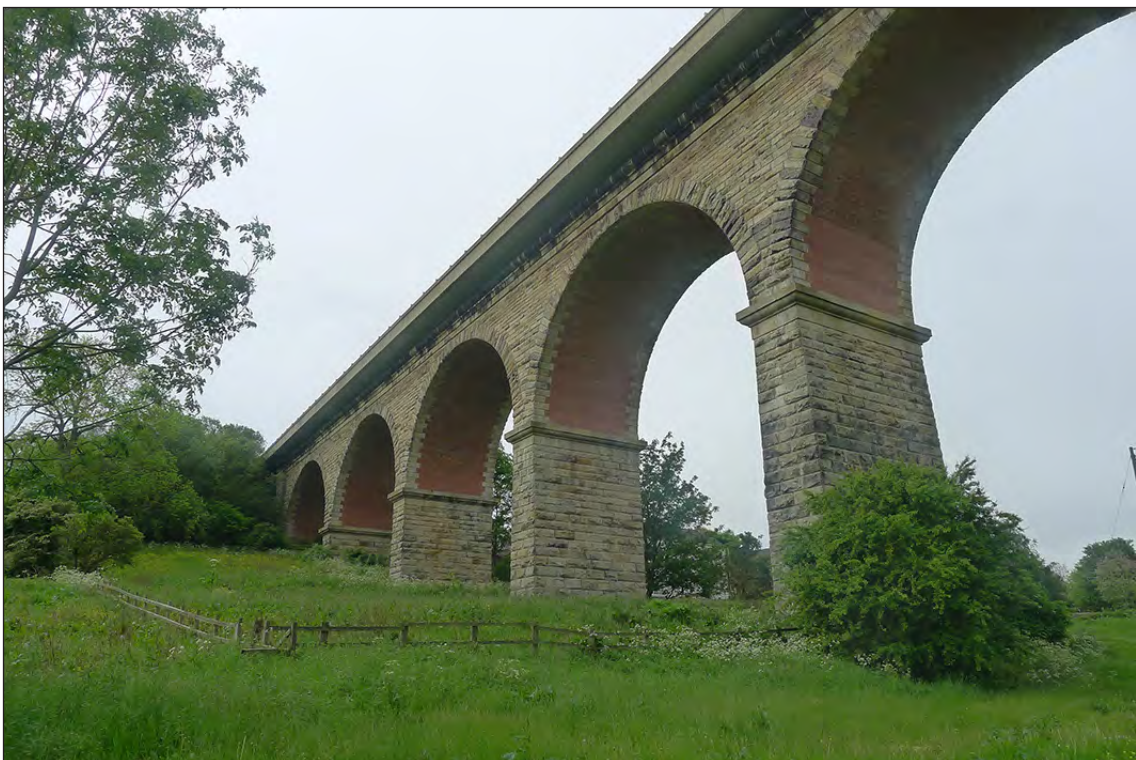
Fig 50. The southern end of Newton Cap Viaduct from the east. Note the modern cantilevered road deck. (© Historic England/Marcus Jecock)

The viaduct is reportedly 828 feet (252.374m) long, and comprises 11 semi-circular arches, each of 60-foot (18.288m) span (CIHT nd), supported on tall masonry piers and abutments which taper upwards to an ashlar impost band (Figs 49 and 50). Counting from the south, the seventh and eighth arches span the river (about 100 feet below), while the ninth spans a local access road. The basal courses of piers 5 to 8 (*ie* the four that stand in the floodplain) are extended forward and back to form boat-shaped cutwaters rising to domed, ashlar tops (Fig 51); all other piers rise straight from the valley sides. The arches have single arch rings formed of large

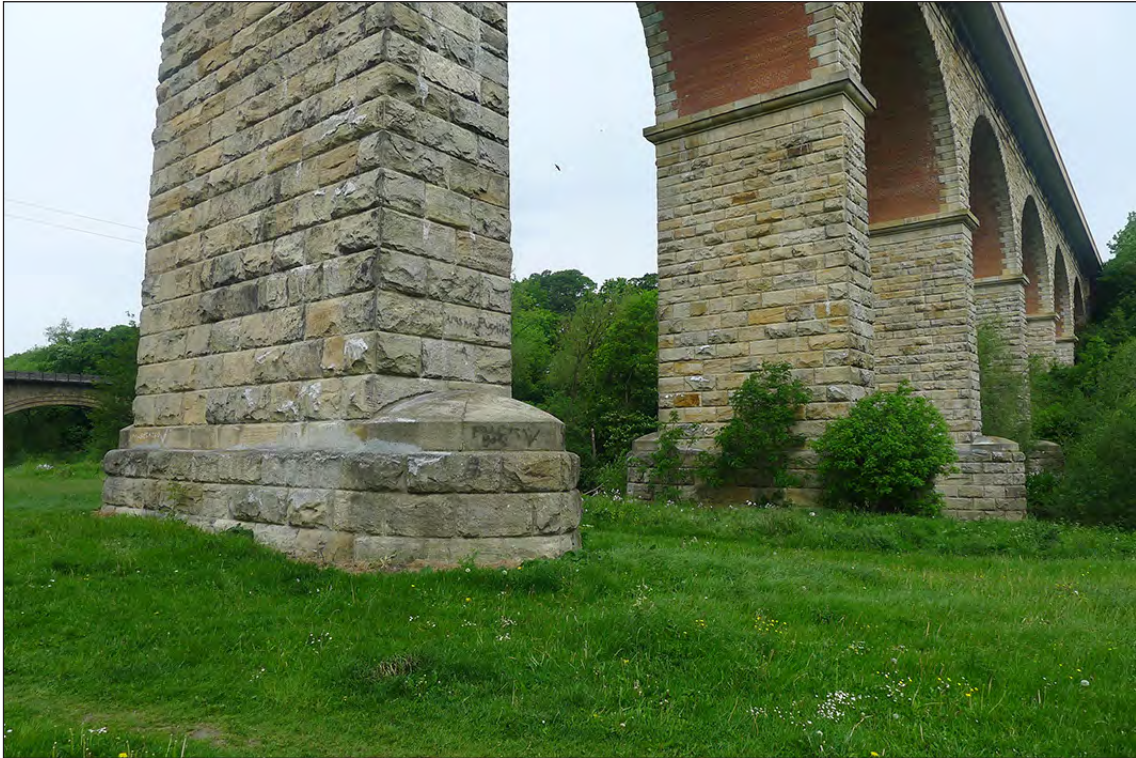
*Fig 51. Detail of the cutwaters against the central piers of Newton Cap Viaduct.
(© Historic England/Marcus Jecock)*

stone voussoirs; the soffit of each arch is, however, executed in red brick making for a pleasing contrast in both colour and material. All stonework is rock-faced apart from the undersides of the arch rings (smooth to match the brickwork) plus the impost bands on the piers and a second band at the level of the cutwater caps on the floodplain piers, which are likewise ashlar. According to the current listing description - written before the conversion of the bridge to carry road traffic - the original parapets were low with flat copings, interrupted at intervals by pilasters surmounted by low pyramidal caps. The original engineering drawings do not survive (*Newcastle Journal* 1995), but a sketch included on the ELR line diagram from the 1920s shows the parapets with four 'pilasters' per elevation: two end piers plus pilasters situated immediately before and after arches 1 and 11 (North Eastern Railway Association 2018). The parapets were removed or have been obscured by the insertion of the current road deck, which is a concrete slab cantilevered out over the viaduct elevations to allow for the inclusion of footpaths either side of the carriageway; the present parapets are crash-proof metal fences affixed to the edges of the road deck. Examination from distance (looking up from the level of the valley floor), shows that the original parapets rose from an ashlar string course laid immediately above the arch rings surmounted by a roll moulding, both of which survive. Similar string course and parapet detailing is recorded on two other viaducts built on the Durham branch: Durham and Belmont (NHLE 1322851 and 1120726).

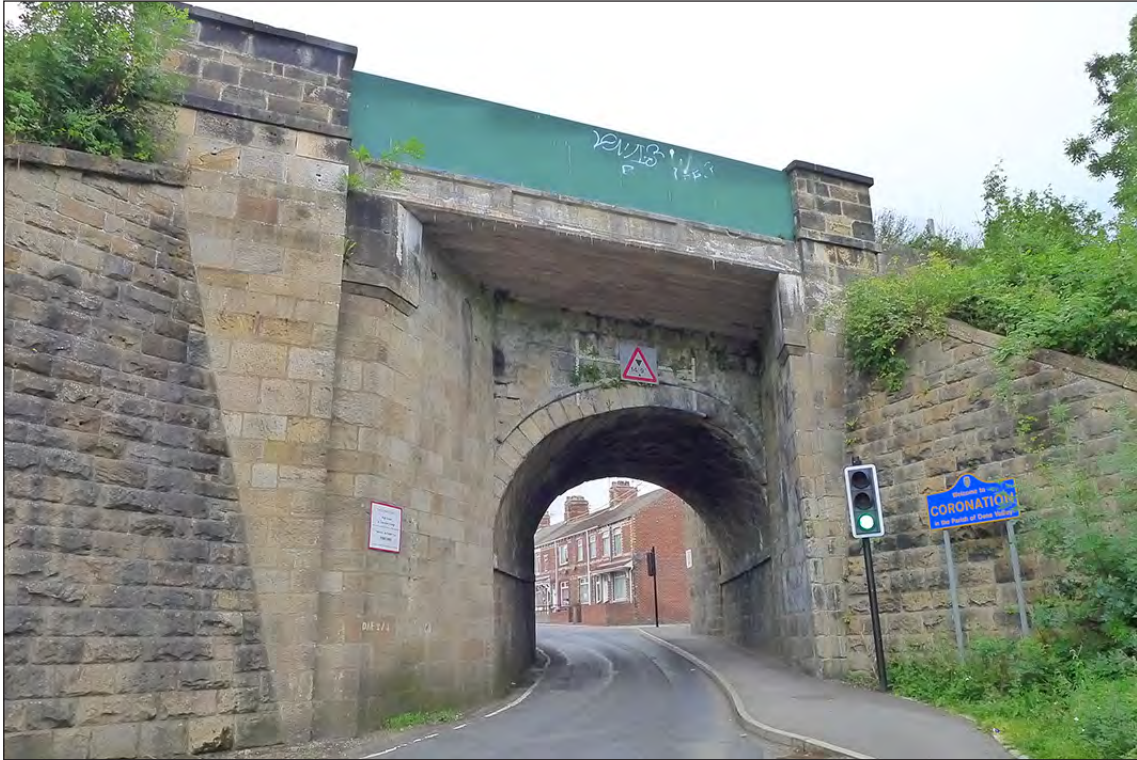
*Fig 52. The eastern elevation of railway underbridge DAE2/4 (High St, Coundon Grange), showing the original skew arch and one half of the later widening.
(© Historic England/Marcus Jecock)*

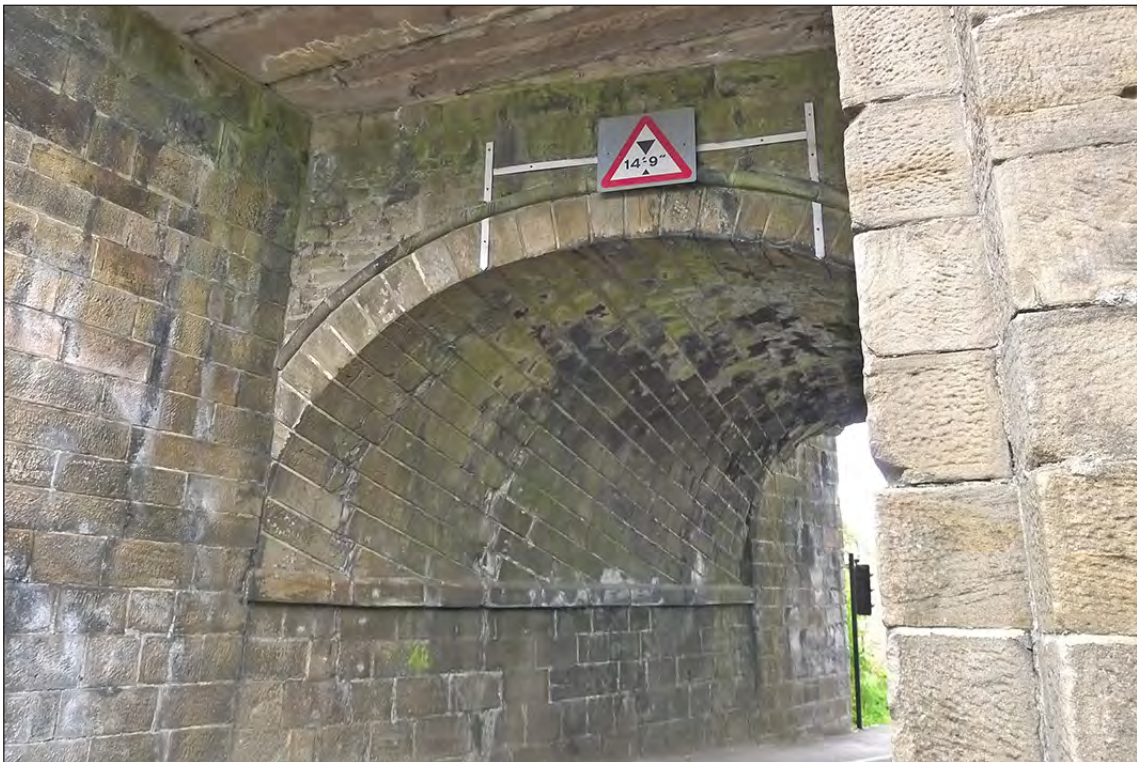
*Fig 53. Detail of the original western elevation of railway underbridge DAE2/4 (High St, Coundon Grange), showing arch ring, archivolt and impost banding.
(© Historic England/Marcus Jecock)*
