The Road, Rail and Parkland Bridges of Bishop Auckland, Co Durham: an assessment of the historical and archaeological evidence

Marcus Jecock

**THE ROAD, RAIL AND PARKLAND BRIDGES OF
BISHOP AUCKLAND, Co DURHAM:**
an assessment of the historical and archaeological evidence

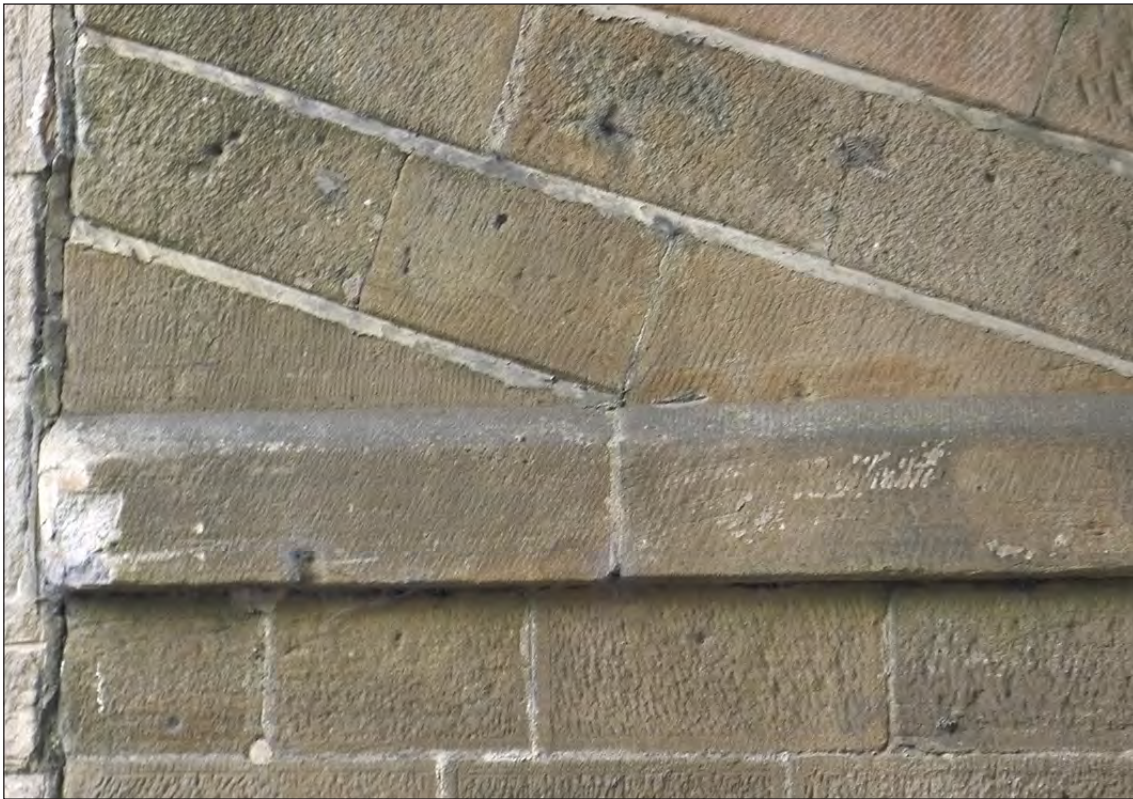
Fig 54. Detail of the impost banding and helicoidal coursing of the phase-1 arch barrel of railway underbridge DAE2/4 (High St, Coundon Grange). Note that the stones forming the first course of the barrel are integral with those in the impost banding beneath. Note also the butt joint with the masonry of the phase-2 widening just visible at left of frame. (© Historic England/Marcus Jecock)

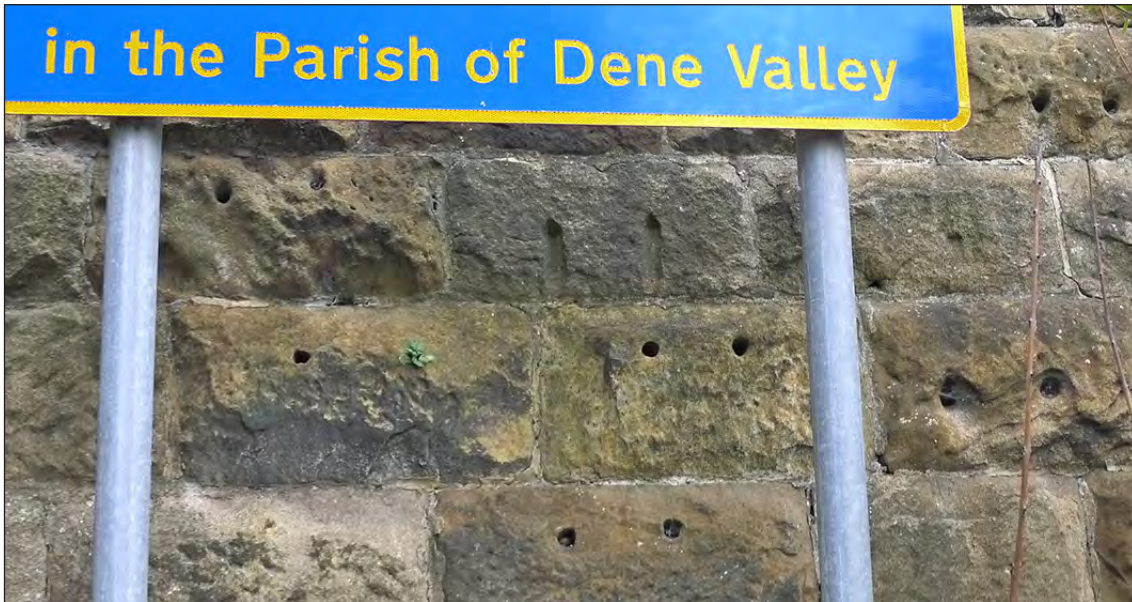
Fig 55. Detail of S&DR stone sleepers re-used in the north-east retaining wall of railway underbridge DAE2/4 (High Street, Coundon Grange). (© Historic England/Marcus Jecock)

regular blockwork that has been tooled and margined, whilst that of the embankment retaining walls, including the faces of the coping stones, is in contrast rock-faced. Some of the blocks in the retaining walls exhibit pairs of drilled holes either in section or plan (Fig 55), suggesting they are re-used S&DR stone sleepers (until *circa* the 1840s, the company anchored its tracks on stone blocks rather than timber sleepers).

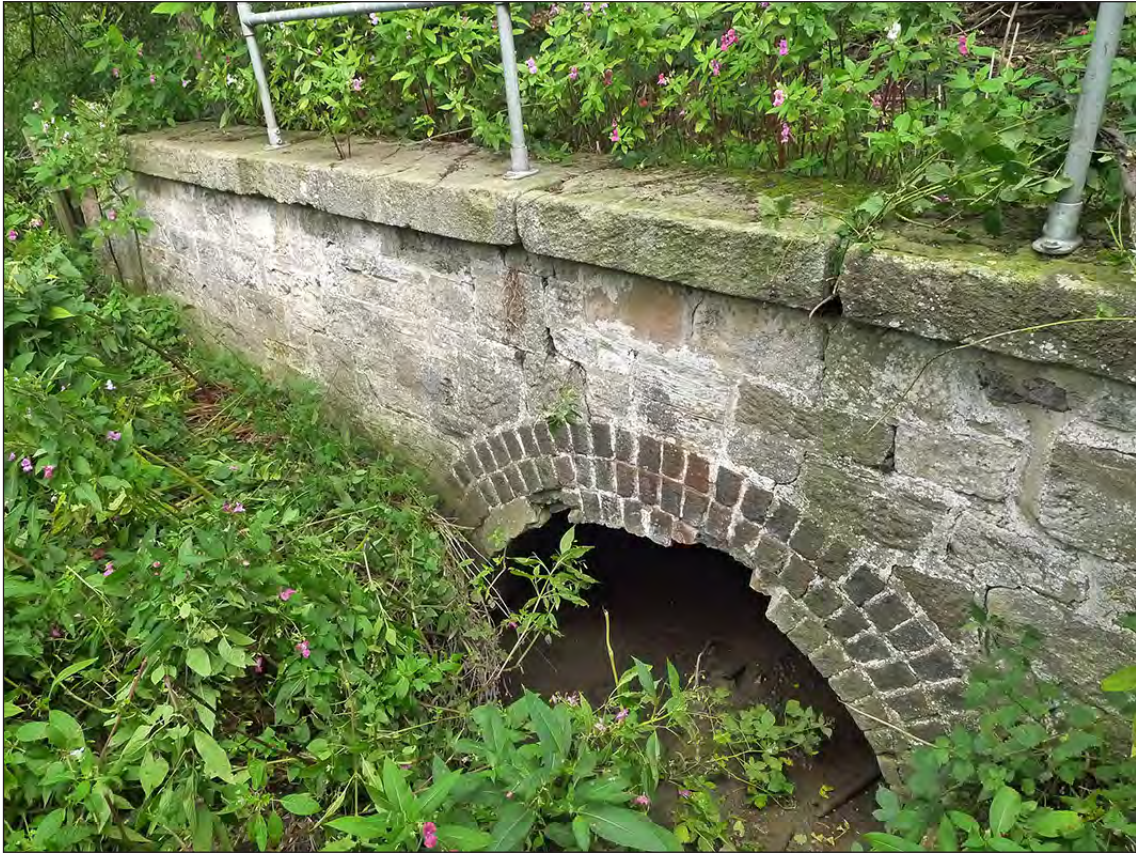
Fig 56. The southern headwall of culvert DAE2/5 taking Dene Beck under what was originally the Bishop Auckland & Weardale Railway, now the Darlington to Bishop Auckland line. (© Historic England/Marcus Jecock)

The culvert lies at the base of a tall earthen embankment that carries the railway across the valley of the Dene Beck. It comprises a 1.8m-wide (6-foot) barrel vault composed of three, brick, arch rings, running between low headwalls set some 66.5m (218 feet) apart (Fig 56). The headwalls in contrast are built of squared stone blocks laid in irregular courses, topped by a course of simple flat coping stones that oversail the external elevation. A modern tubular steel safety fence is bolted to the coping above the centre of each headwall. A drain that runs along the foot of the southern face of the embankment flows in to the beck immediately below the outfall of the culvert; the confluence of drain and beck is formed in concrete.

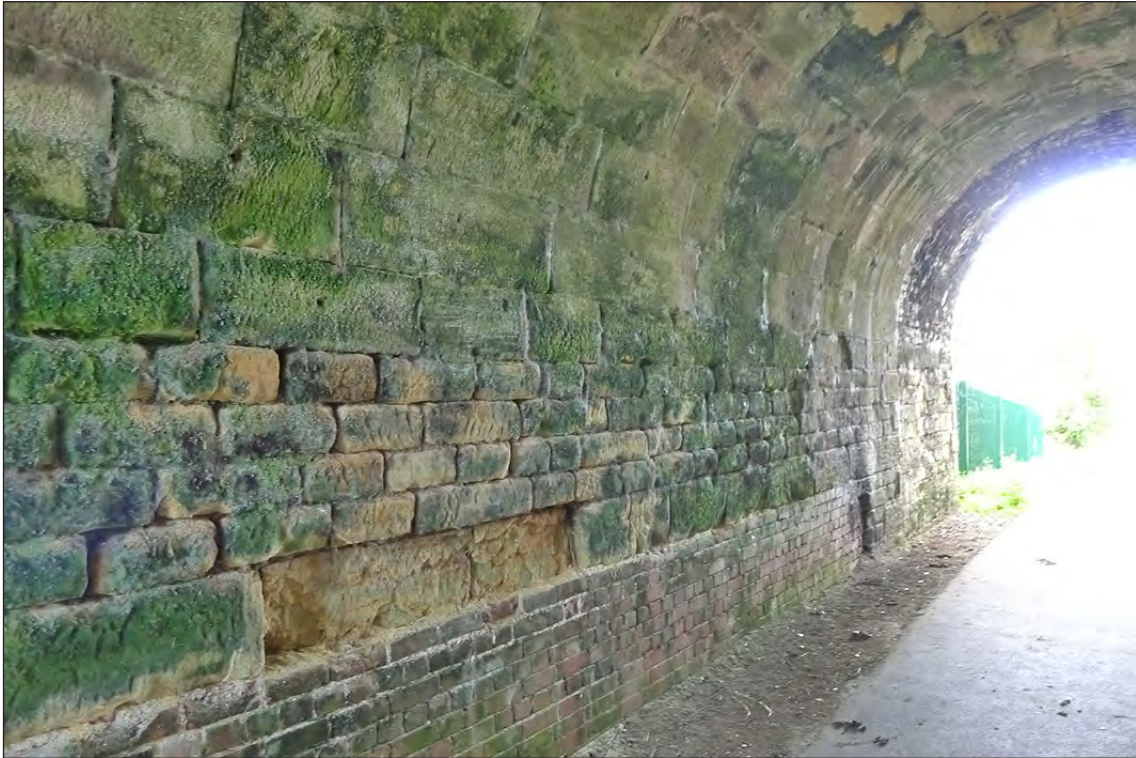
Fig 57. The southern face of the phase-1, abutment of railway accommodation underbridge DAE2/6 ('Shepherds'). Note the repeating rhythm of the original stonework: four narrow courses followed by one course of larger stones, all now deteriorating and heavily patched in brick. The stone arch barrel contrasts with the brick arch barrel of the phase-2 western extension which can just be made out at right of frame. (© Historic England/Marcus Jecock)

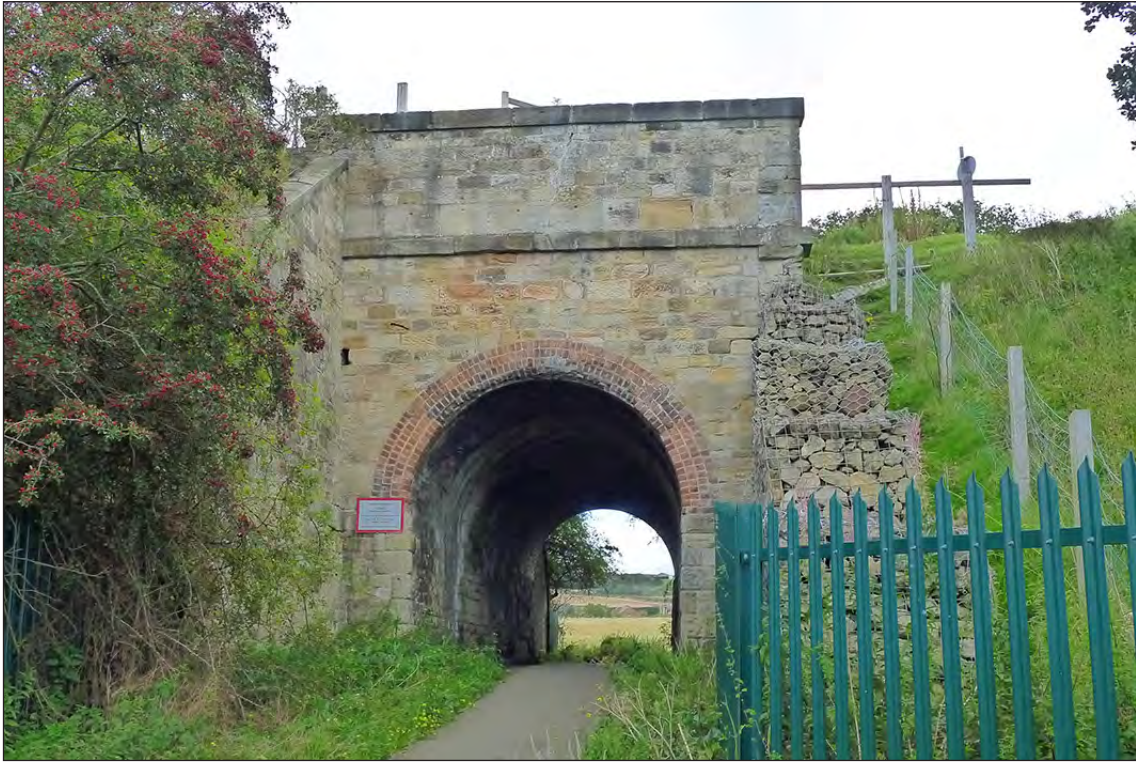
Fig 58. The western, phase-2, elevation of railway accommodation underbridge DAE2/6 ('Shepherds'). (© Historic England/Marcus Jecock)

and red brick: masonry for the abutments, spandrels and parapets, brick for the arch rings of which there are four (Fig 58). The masonry comprises squared blocks, laid mostly in regular courses and undecorated apart from margining on the abutment quoins. There is a square-section, ashlar, string course at deck level on each elevation. The parapets each consist of a basal course of large sandstone blocks followed by several courses of smaller blockwork, topped by flat coping that slightly oversails the external face in a mirror image of the string course below; the upper courses of the eastern parapet in addition incorporate a few rock-faced blocks suggesting parts of it may be rebuilt. The parapets have no end piers, but embankment retaining walls topped with flat coping spring from their ends, emanating from just below the level of the parapet coping and sloping down to low end piers with pyramidal caps. Much of the south-west retaining wall has collapsed or been dismantled in recent years, and been replaced by a modern gabion wall; only a stub of the original retaining wall survives.

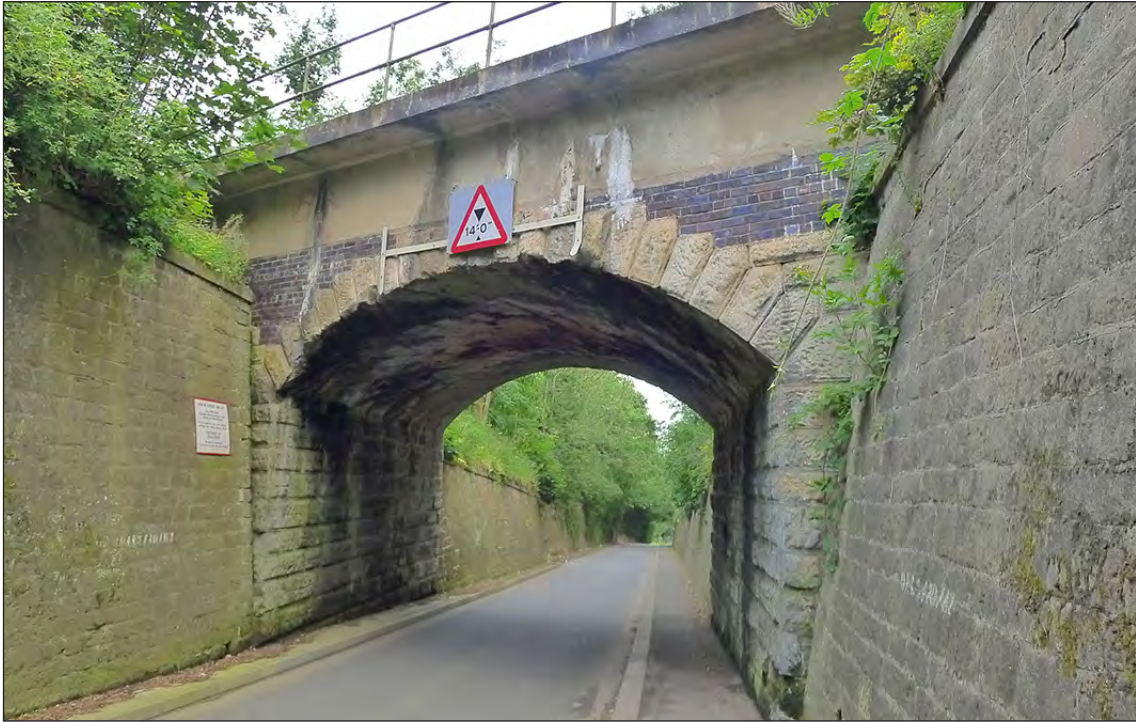
Fig 59. The north-east (uphill) elevation of railway underbridge DAE2/7 (Bone Mill Bank). Note the brick repair to the spandrel and the later concrete parapet. (© Historic England/Marcus Jecock)

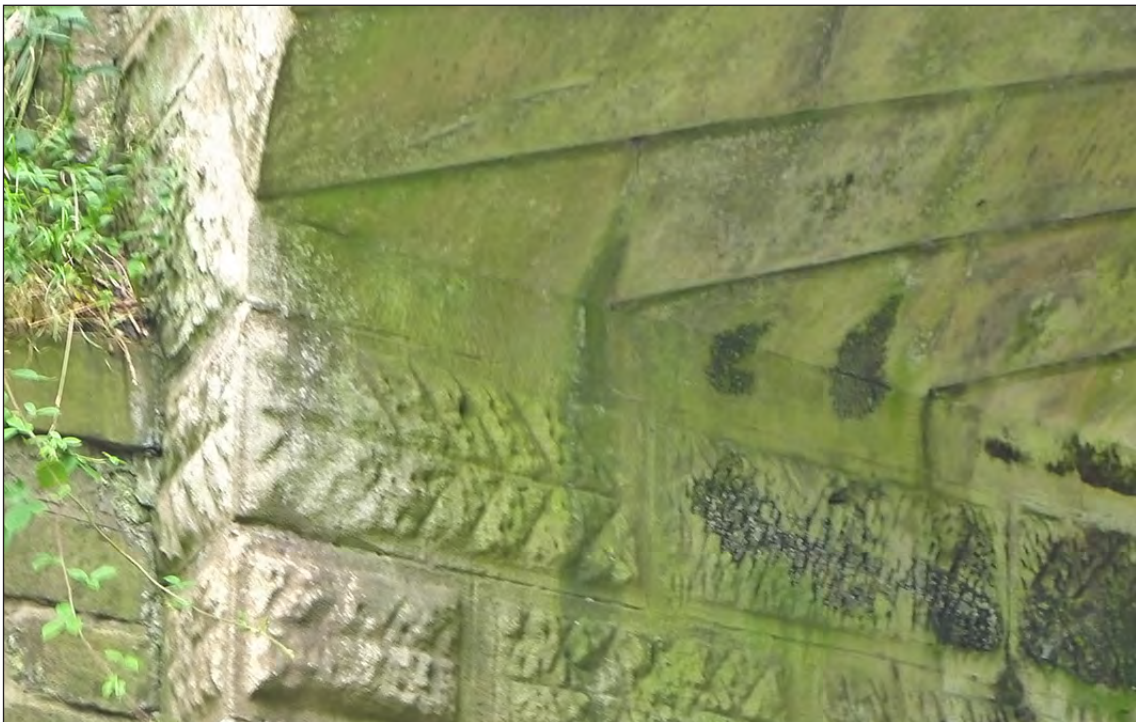
Fig 60. Detail of the arch springing on railway underbridge DAE2/7 (Bone Mill Bank). Note the stones forming the first course of the arch barrel are integral with the abutment coursing, and the distinctive way the stones of the abutment have been dressed using incised chevrons. (© Historic England/Marcus Jecock)

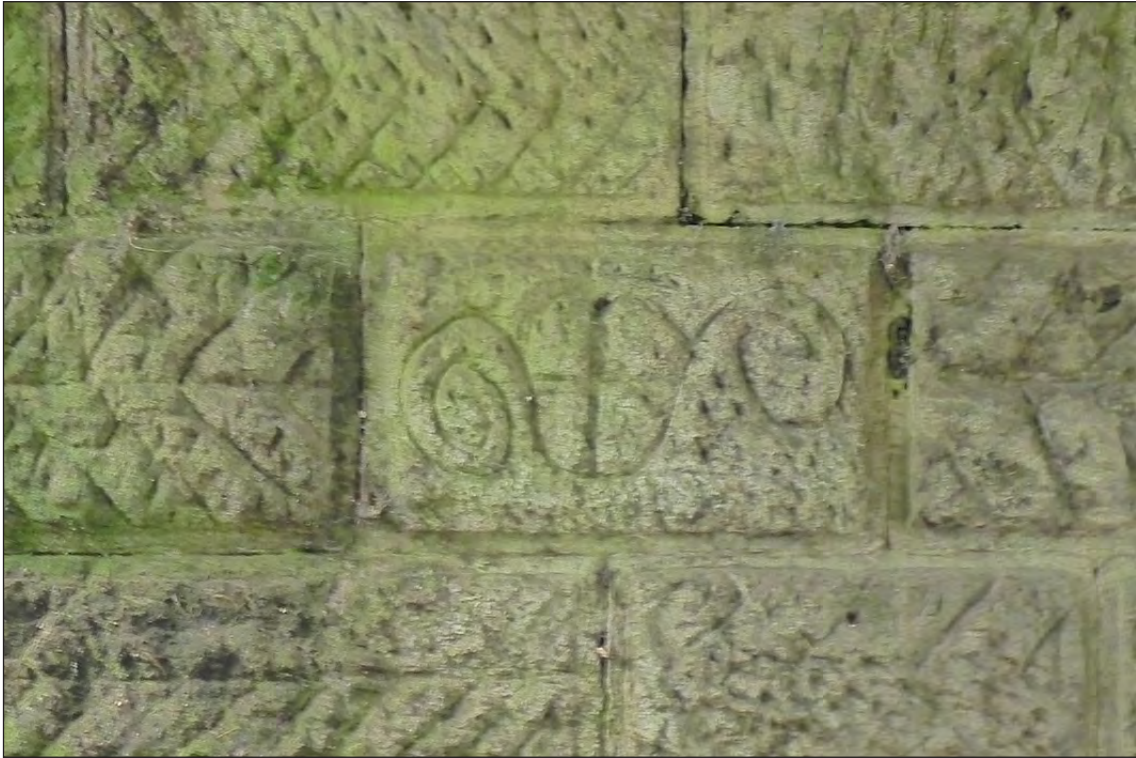
Fig 61. Detail of the cartouche in the centre of each abutment of railway underbridge DAE2/7 (Bone Mill Bank). (© Historic England/Marcus Jecock)

the centre of each abutment bears an incised cross set in a cartouche between spirals (Fig 61). These are probably conceits of the stonemasons and/or contractor who built the bridge. The south-western (downhill) elevation of the bridge is largely original and retains its horizontal ashlar string course at deck level, above which is a stone parapet running between rectangular end piers that break forward from the elevation, all now topped by flat (?concrete) copings and modern tubular-steel safety railings (Fig 62). The spandrels to the north-eastern (uphill) elevation, however, have been repaired or rebuilt: below the level of the arch crown the spandrels have largely been refaced in blue engineering brick, while above the crown, the string course and stone parapet have been replaced by a concrete wall supporting a concrete walkway cantilevered out over the roadway below; modern tubular steel railings have again been installed along its outer edge (Fig 59). Stone retaining walls revet the sides of the road cutting and butt up against the bridge elevations.

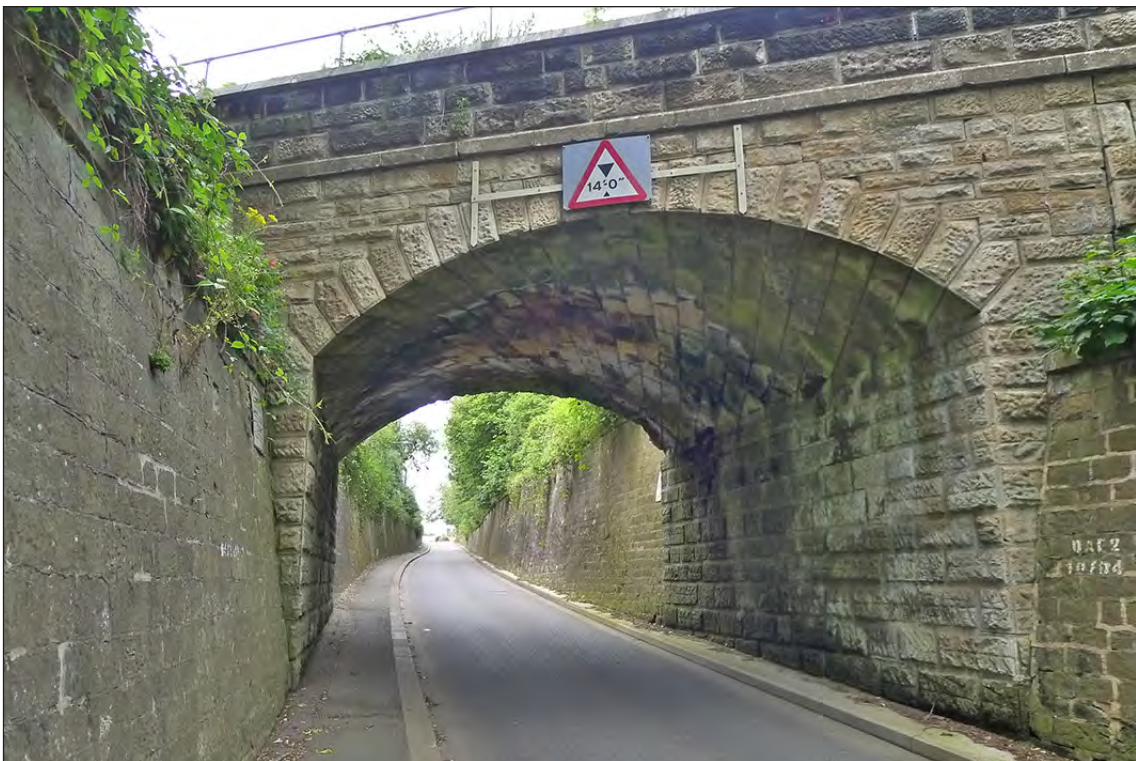
Fig 62. The south-western (downhill) elevation of railway underbridge DAE2/7 (Bone Mill Bank). (© Historic England/Marcus Jecock)

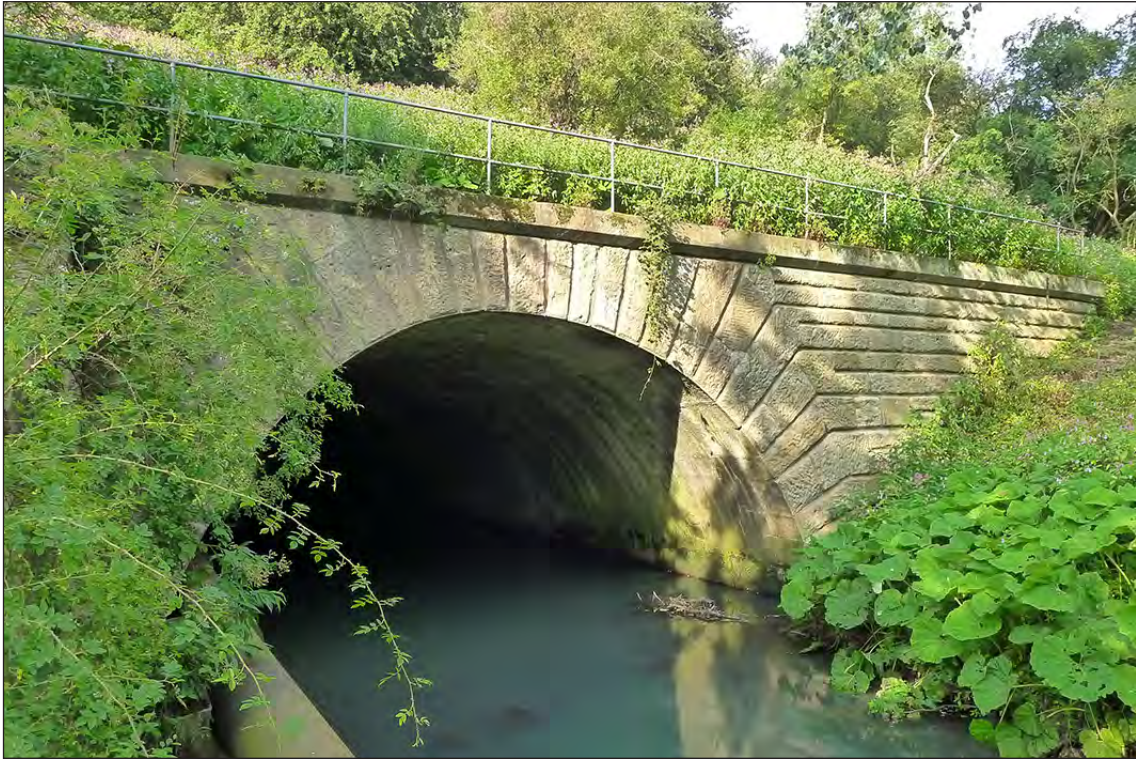
Fig 63. The southern portal of railway bridge DAE2/8 over the River Gaunless. (© Historic England/Marcus Jecock)

The bridge is in reality a large-diameter culvert that passes through the base of a tall earthen embankment; the culvert is semi-circular, about 68.5m (225 feet) long and carries both embankment and railway across the valley of the Gaunless. It is constructed in masonry throughout. The voussoirs in the arch rings are massive, and have angled ends that extend a short distance into the horizontal coursing of the adjoining headwalls: each voussoir is the thickness of two courses of masonry in the headwall. All masonry on the elevations is rock-faced and V-grooved. Through the soffit of the bridge, however, the voussoirs are only tooled (Fig 63). Both headwalls terminate in a course of large, flat, ashlar coping stones laid immediately above the voussoirs of the arch crown; this coping is square section but has a basal chamfer. A low stone wall, only three courses high, sits atop the coping to the northern portal (Fig 64). Modern tubular steel safety fences have been fitted to the coping/parapet wall at both portals. On the east bank of the river, both headwalls extend in line with the portals and the river bank rises to meet them; but on the west bank both headwalls turn through a right angle to create short a retaining wall revetting the

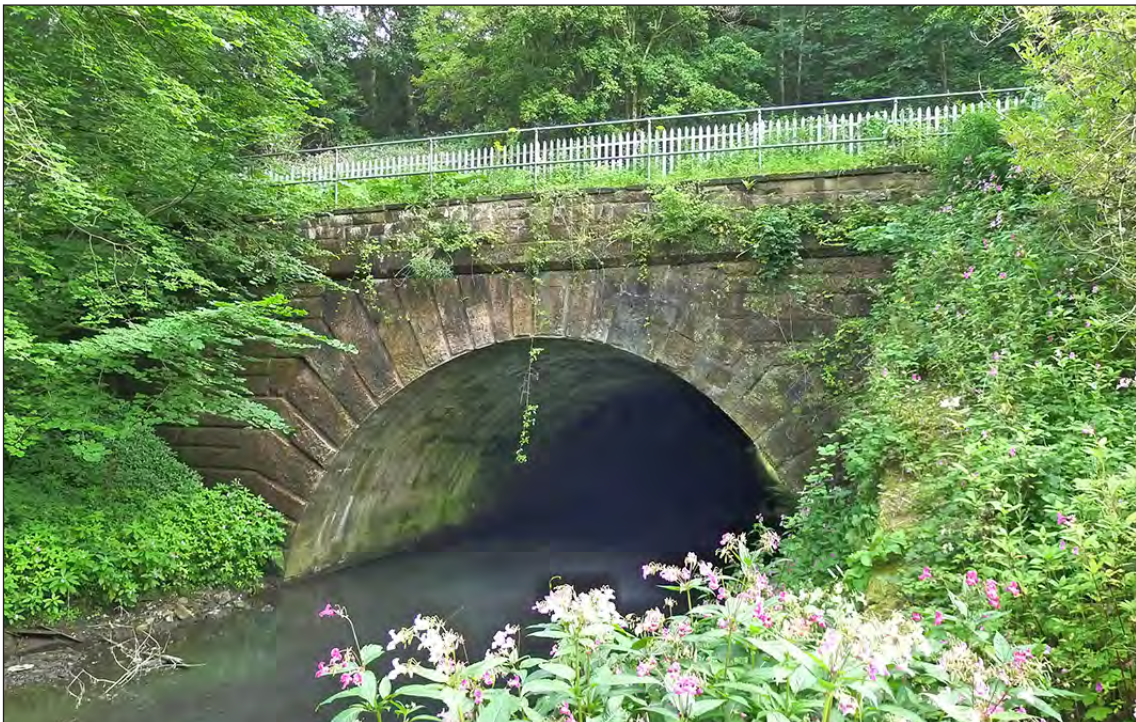
Fig 64. The northern portal of railway bridge DAE2/8 over the River Gaunless. Note the low parapet wall above the coping, probably added before 1896 to retain extra embankment material when the railway was widened. (© Historic England/Marcus Jecock)

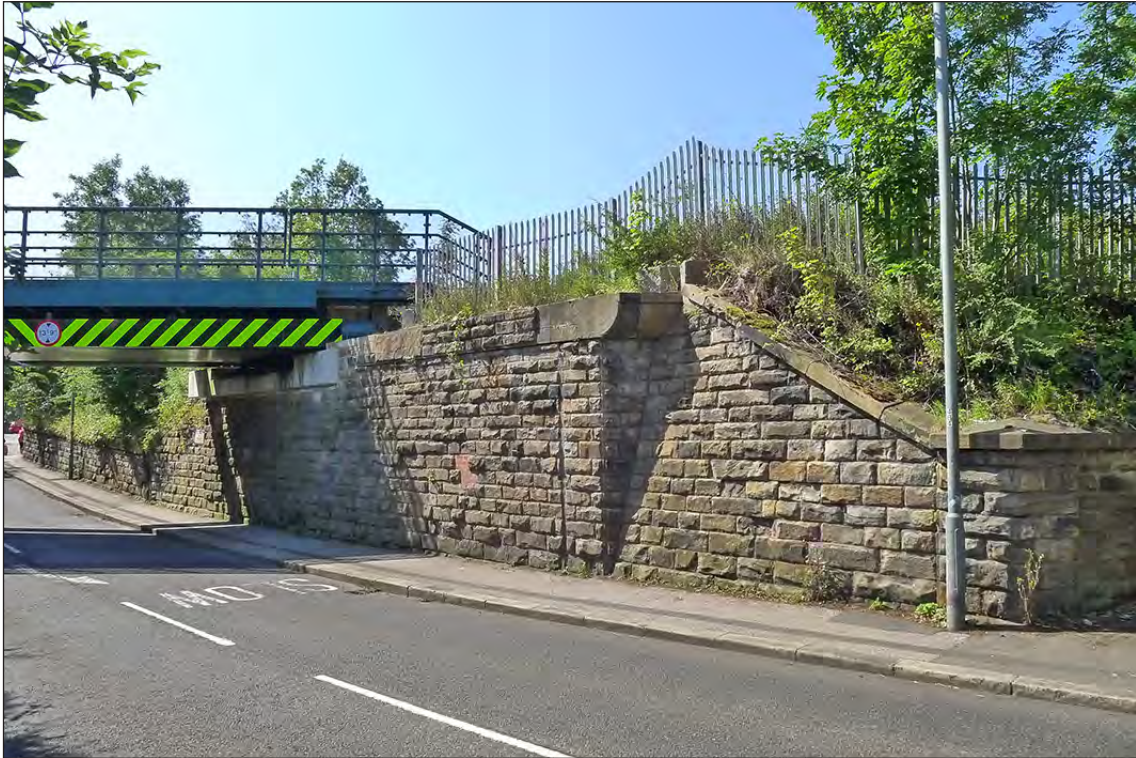
*Fig 65. The north elevation of railway underbridge DAE2/9 (South Church Lane).
(© Historic England/Marcus Jecock)*

The road here lies in a shallow cutting in order to create sufficient headroom beneath the bridge for traffic passing north-south along South Church Road. The sides of the cutting are retained by the bridge's stone abutments and also by short wing walls that flank the abutments and slope down from the level of the bridge deck to square end piers (Fig 65). The abutments are wide enough to carry three railway tracks, but the girders for the two northern lines have been lifted and the single track that remains in use is now carried on modern steel girders with safety railings for parapets. The girders sit on massive concrete bearing blocks set in to the southern end of both abutments; the concrete has effectively replaced the top four and a half courses of original stonework (Fig 66). All masonry is rock-faced (margined in addition on the abutment quoins and corners of the end piers) apart from the flat coping to the wing walls, the pyramidal caps to the end piers and bearing blocks close to the centre and at the northern end of each abutment, which

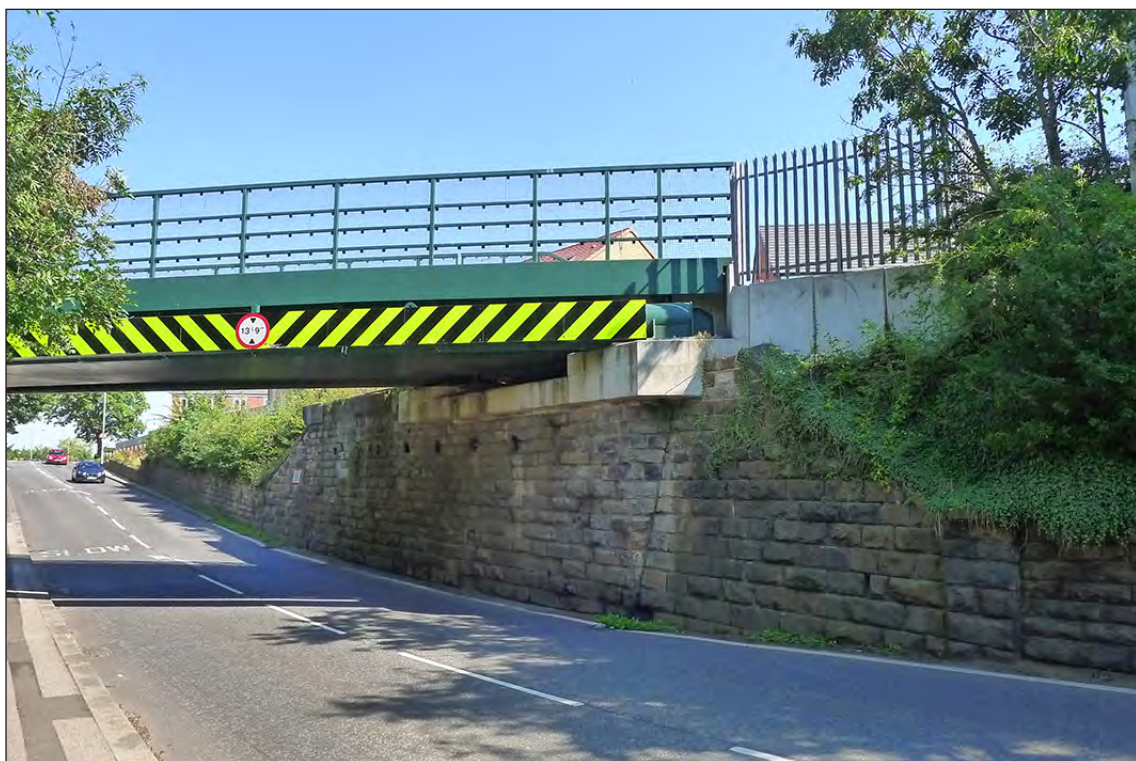
*Fig 66. The south elevation of railway underbridge DAE2/9 (South Church Lane).
Note the modern concrete bearing block which has replaced the topmost courses of
stonework in the abutments. (© Historic England/Marcus Jecock)*

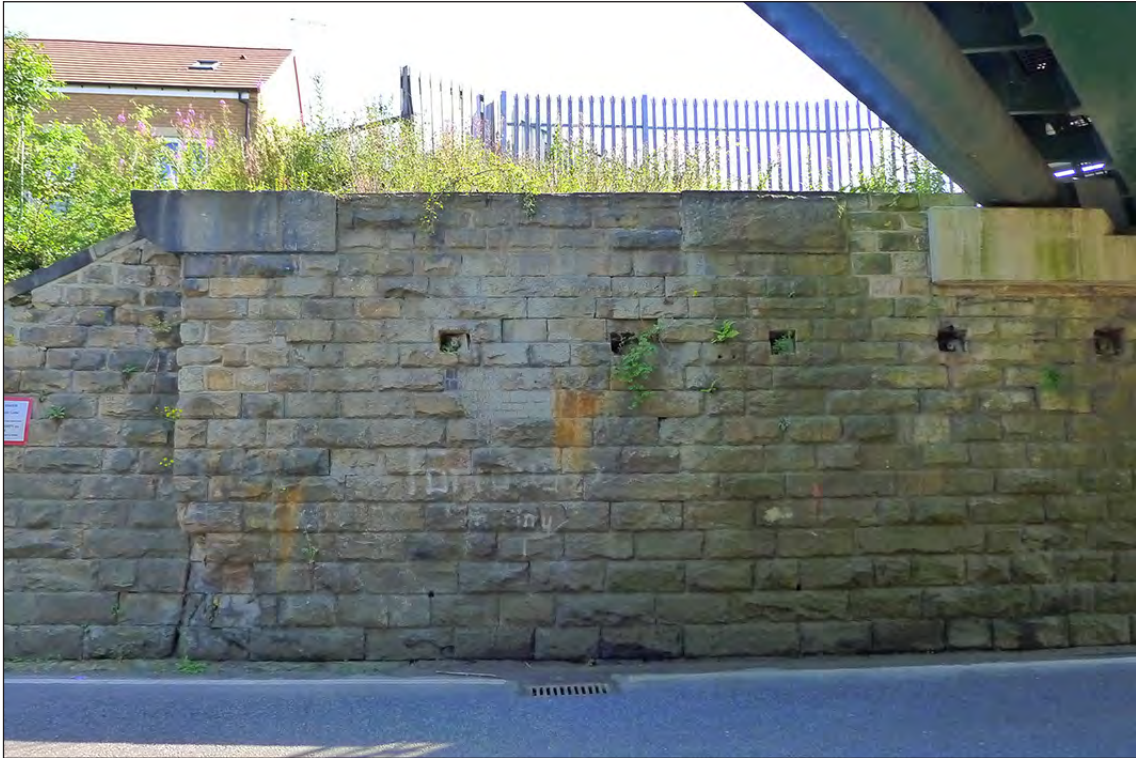
Fig 67. The north end of the east abutment of railway underbridge DAE2/9 (South Church Lane). Note the disused stone bearing blocks towards the centre and at the end of the abutment, and the modern tie rods and anchor plates added to stabilise the structure. (© Historic England/Marcus Jecock)

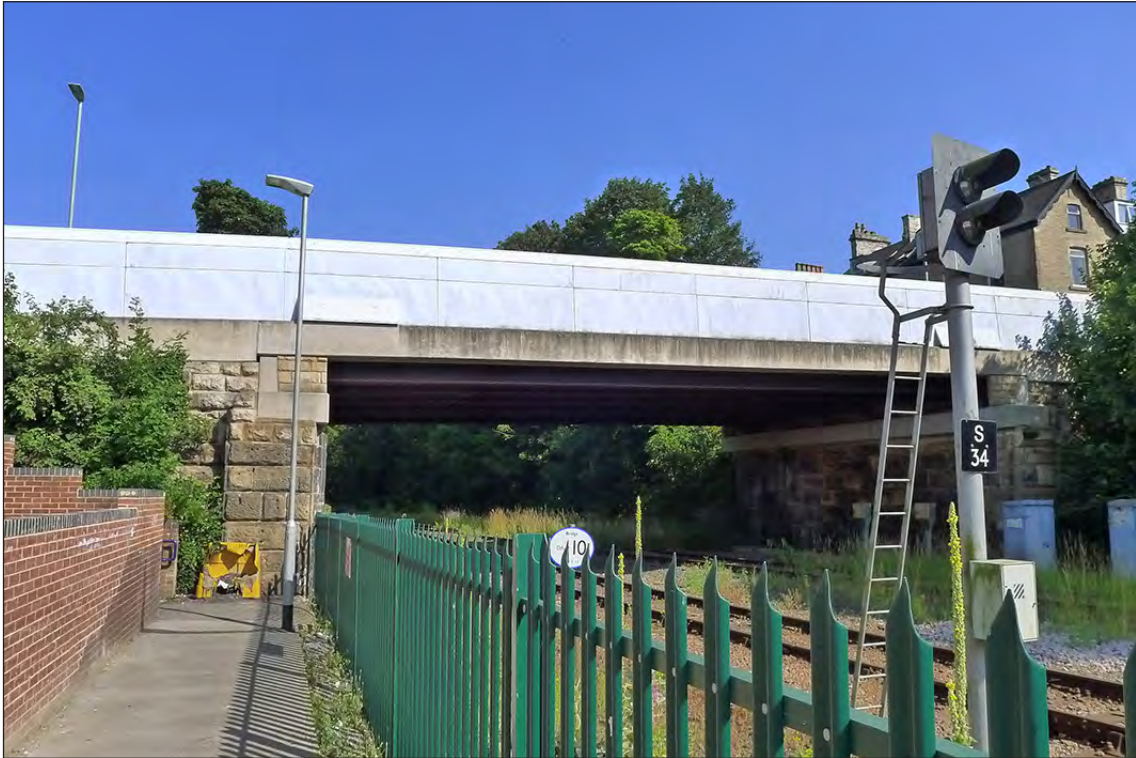
*Fig 68. The west elevation of railway overbridge DAE2/10 (Cockton Hill Road).
(© Historic England/Marcus Jecock)*

The bridge comprises stone abutments supporting a modern steel girder and concrete deck (Fig 68). A sign attached to the parapets states that the bridge was replaced in 2010 by Durham County Council, but this seems to have been a re-decking exercise only, leaving the abutments largely untouched apart from replacing the uppermost few courses of masonry in concrete to take the bearing pads for the new steel girders. Because the bridge lies across live railway, only the south abutment and western elevation of the north abutment were visible for investigation. The south abutment comprises square, stone piers at either end with the space in between walled in (Fig 69). Both piers break forward slightly from the wall and are also surmounted by large ashlar blocks that corbel out to east and west, suggesting the piers were originally free-standing; if so, however, the walling, cut and tooled similarly to the piers, was probably added very soon after. The stonework in the elevations of the piers, including the elevation of the western pier in the northern

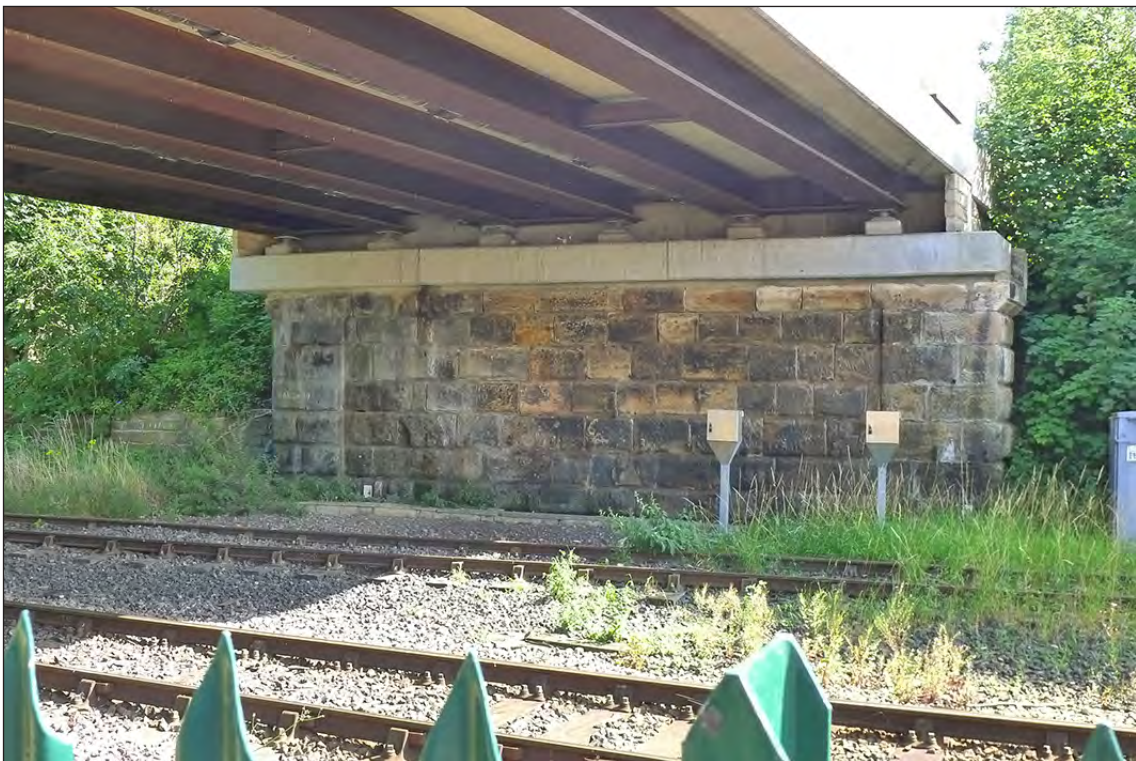
Fig 69. The south abutment of railway overbridge DAE2/10 (Cockton Hill Road). Note the ends of the abutment break forward slightly and are surmounted by large ashlar blocks that corbel out on both sides, suggesting they initially comprised free-standing piers. (© Historic England/Marcus Jecock)

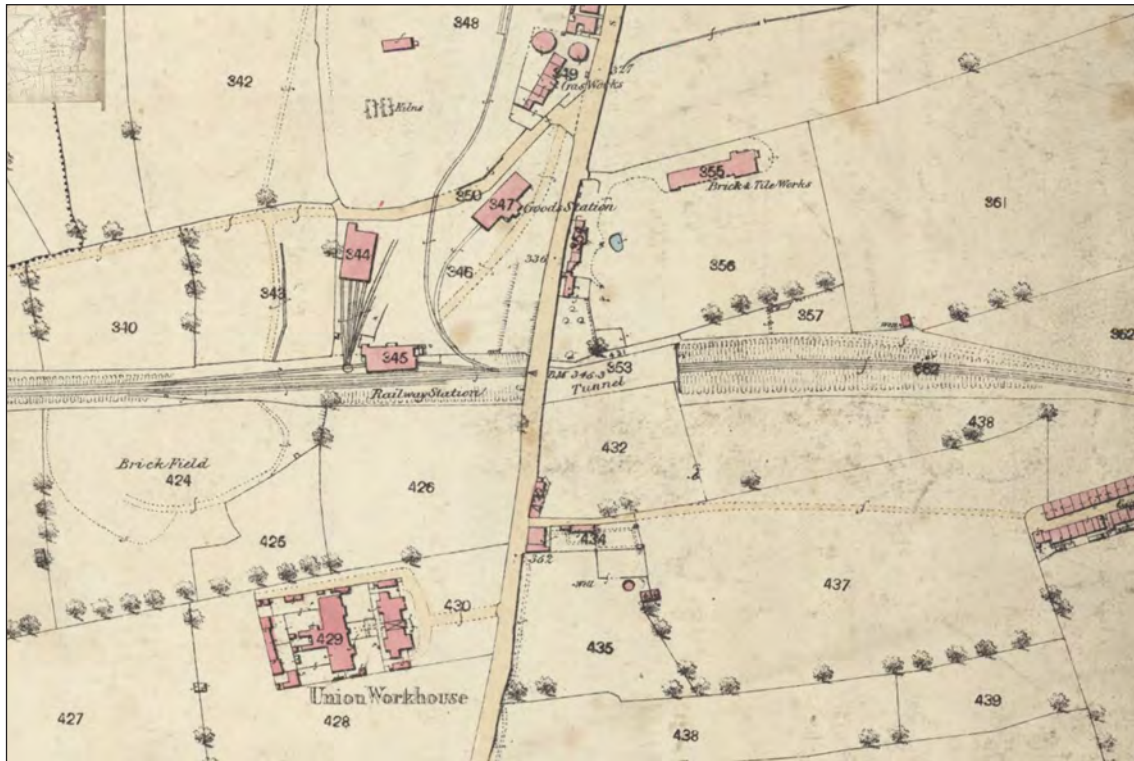
Fig 70. The road and rail layout around Cockton Hill Road, as surveyed by the Ordnance Survey in 1856. (Reproduced from the 1857 County Series 1:2500 Ordnance Survey map, with the permission of the National Library of Scotland under Creative Commons Attribution (CC-BY) licence: <https://maps.nls.uk/index.html>)

Ordnance Survey map evidence shows that the BA&W was laid as double track, and that Cockton Hill Road bridge stood immediately against the western portal of a short tunnel on the eastern approach to Bishop Auckland station (Fig 70). By 1896, however, the tunnel had been opened up into a wide cutting, and the bridge lengthened towards the north in order to span four tracks and accommodate an improved junction between the BA&W and the NER branch line to Durham (Fig 71). The junction improvements are dated 1866-7 (Fawcett 2003, 22-3). On this evidence the extant northern abutment of the bridge cannot be original, but must date to 1866-7, or later.

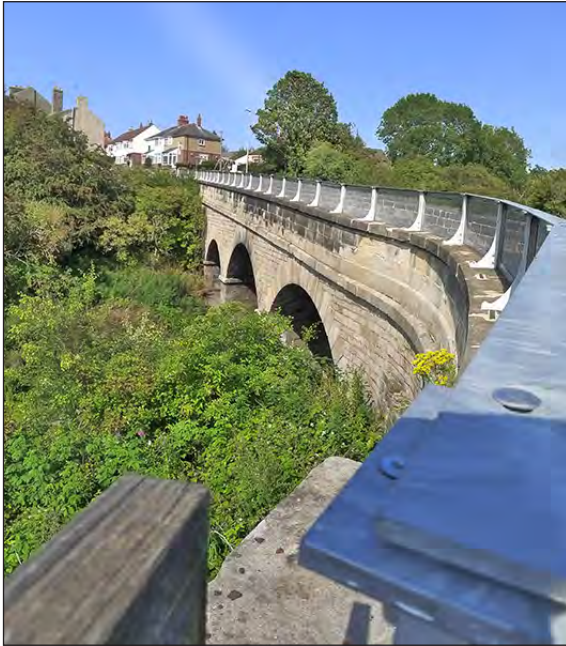
Fig 72. The western elevation of railway overbridge DAE2/11 ('Latherbrush Bridge').
 (© Historic England/Marcus Jecock)

The railway here runs through a cutting, and the bridge comprises three segmental arches between abutments that rise out of the cutting's sides (Fig 72). The bridge is built entirely of stone: ashlar for the abutments, piers, arch barrels and parapets, and squared blocks laid in horizontal courses for the spandrels. The railway here runs east to west, and the bridge crosses it at quite a severe angle. Accordingly, the voussoirs in the arch rings (which rise from skewback stones above rectangular impost bands) are stepped to key in to the spandrels and help counteract the stresses inherent in a skew bridge. The voussoirs and intrados of each arch are laid

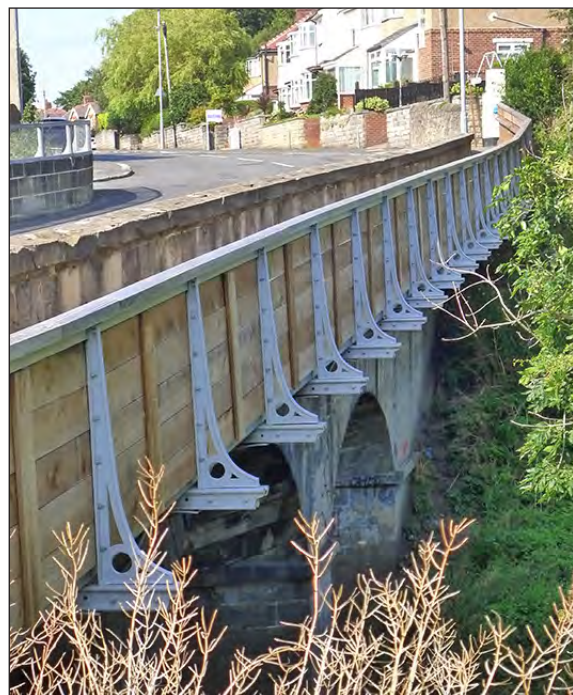
Fig 73. The Victorian pedestrian walkway cantilevered out against the eastern elevation of railway overbridge DAE2/11 ('Latherbrush Bridge').
 (© Historic England/Marcus Jecock)

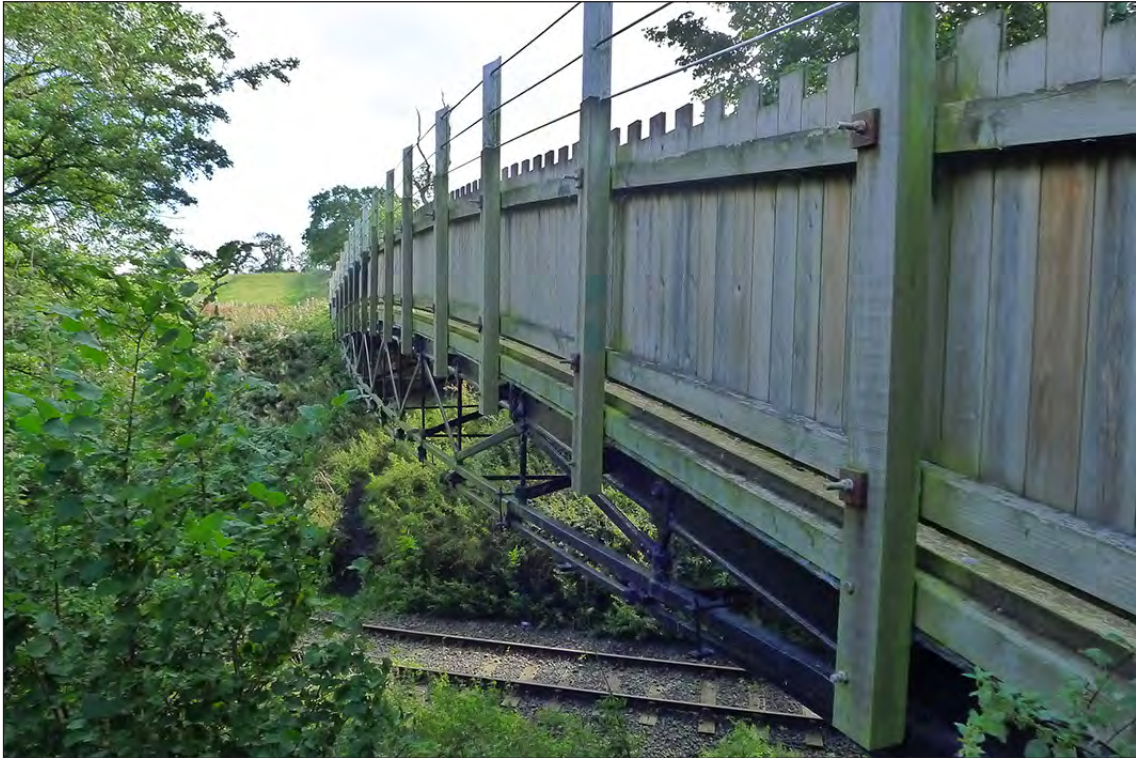
Fig 74. The eastern elevation of railway accommodation overbridge DAE2/12 (lenticular truss), looking south. (© Historic England/Marcus Jecock)

The bridge comprises iron, lattice, side girders carried on stone abutments which rise from the tops of the railway cutting (Fig 74). The girders are tied together to form a lenticular (lens-shaped) truss that acquires its strength from the upper members (or chords) being in compression and the lower in tension, cancelling out the compressive and tensile forces and therefore exerting only vertical forces on the abutments (Rennison 1996, 80). The upper chords

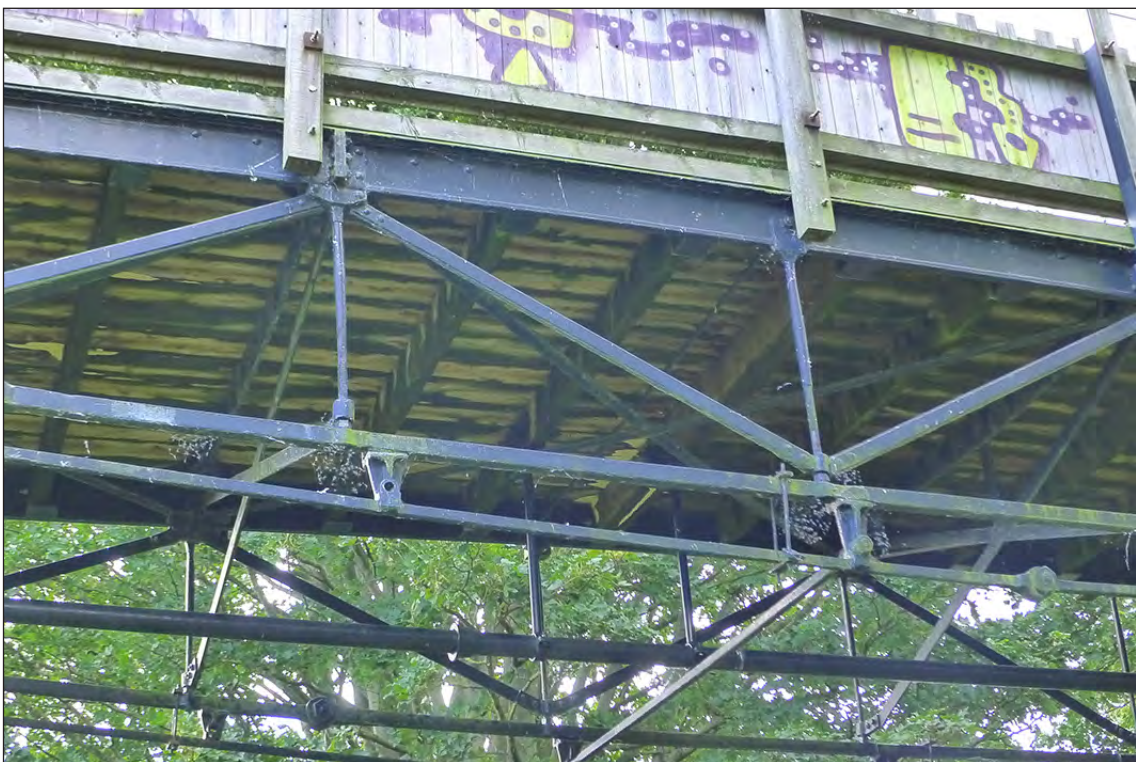
Fig 75. Detail of the chords, truss structure and cross-bracing of railway accommodation overbridge DAE2/12 (lenticular truss). (© Historic England/Marcus Jecock)

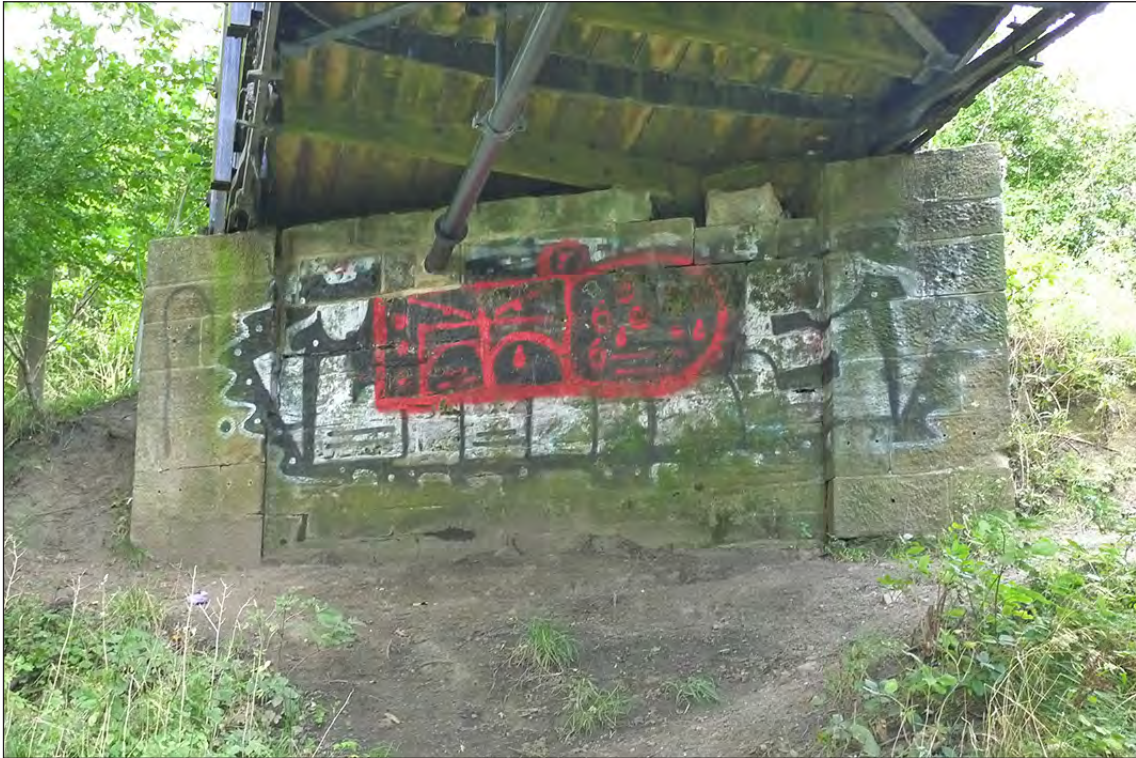
Fig 76. The face of the north abutment of railway accommodation overbridge DAE2/12 (lenticular truss). (© Historic England/Marcus Jecock)

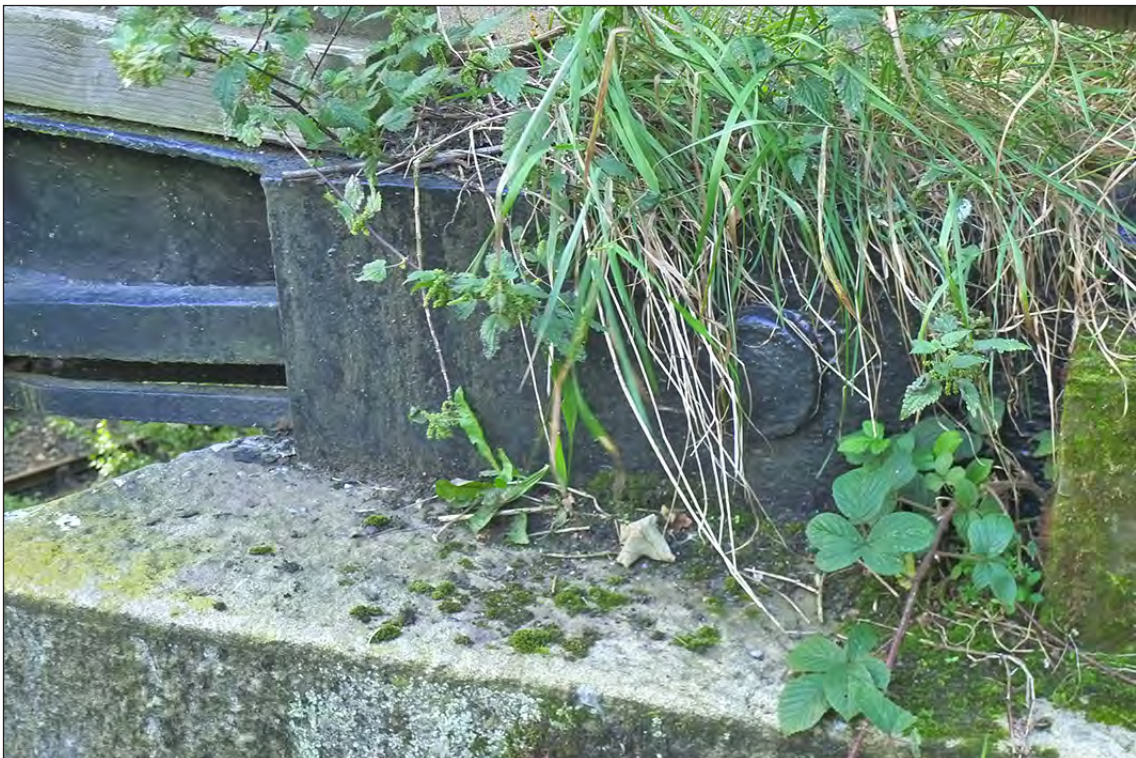
Fig 77. Detail of one of the truss hinges of railway accommodation overbridge DAE2/12 (lenticular truss). (© Historic England/Marcus Jecock)

The bridge superstructure is as described by Rennison (*ibid*, 80). His description is reproduced below, emended to emphasise the fact that the bottom chords are each composed of two separate members. The bridge has ‘a clear skew span of 86ft 3in [26.29m] with the two trusses [side girders] spaced at 11ft [3353mm] centres. It has a timber deck on timber cross joists at 2ft 4in [711mm] centres; every 14ft [4267mm] the cross joist is of iron. The main top member is H-section cast iron and the [upper] bottom [member] is wrought iron flat link chain. There are twelve panels incorporating eleven verticals of round bar with diagonal flats alternately rising and falling ... [An additional] lower bottom member is of square bar [and is] coupled to the chain by cast clamps which carry the cross tie-rods ...; there are horizontal and vertical cross bracings of wrought iron flats’ (Fig 75). The abutments are built from squared, tooled blocks and have faces that break forward slightly beneath each girder (Fig 76). The hinges of the truss rest on stone (or perhaps concrete) blocks, with angled tops, that are set back from the abutment faces (Fig 77). The parapets, which are formed in timber (vertical planking on rails fixed to posts bolted to the side girders, heightened by three courses of horizontal wire), are modern; the timber deck is likewise modern, last replaced in 2009 (John Askwith, pers. comm.).
