The Road, Rail and Parkland Bridges of Bishop Auckland, Co Durham: an assessment of the historical and archaeological evidence

Marcus Jecock

**THE ROAD, RAIL AND PARKLAND BRIDGES OF
BISHOP AUCKLAND, Co DURHAM:**
an assessment of the historical and archaeological evidence

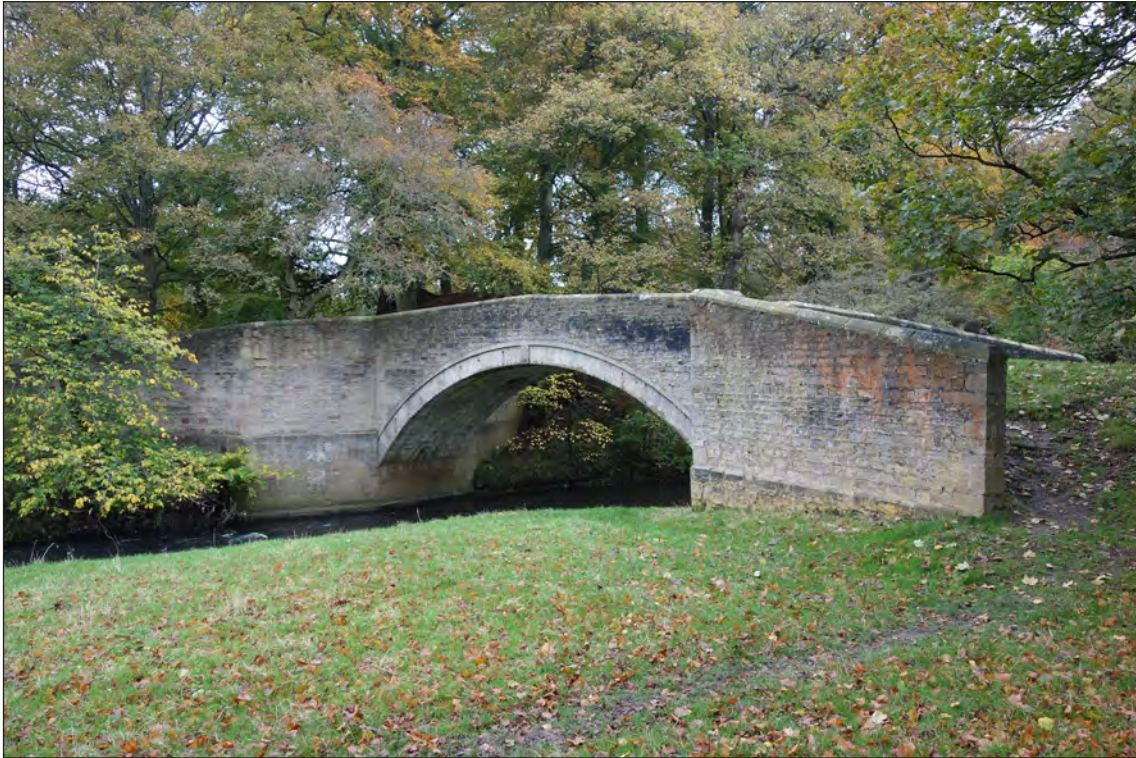
*Fig 78. The west elevation of Bishop Trevor's drive bridge in Auckland Park.
(© Historic England/Rebecca Pullen)*

The bridge comprises a single, segmental arch, 3.62m wide and with a span of about 12m, approached via short, ramped causeways at either end (Fig 78). Each elevation has a single arch ring composed of voussoirs and a raised keystone, all surmounted by a narrow archivolt of square section that sits proud of the ring but flush with the keystone. The spandrels are brought flush with the archivolt and merge with the parapet walling (*ie*, there is no string course to mark the level of the road deck). The parapet copings are flat-topped with chamfered edges. The approach causeways splay out at acute angles in two stages (resulting in the overall plan of the bridge being akin to the shape of a double-headed spanner); they have a chamfered setback at the level of the archivolt springing, but similarly are undifferentiated from the wing walls that surmount them. All masonry comprises squared blocks laid in courses, apart from the voussoirs, archivolt and copings which are finely tooled. The elevations are identical except for the keystone on the western (downstream) face which is inscribed 'RD. | 1757.' (RD standing for Richard Dunelm, or Bishop Richard Trevor of Durham) (Fig 79).

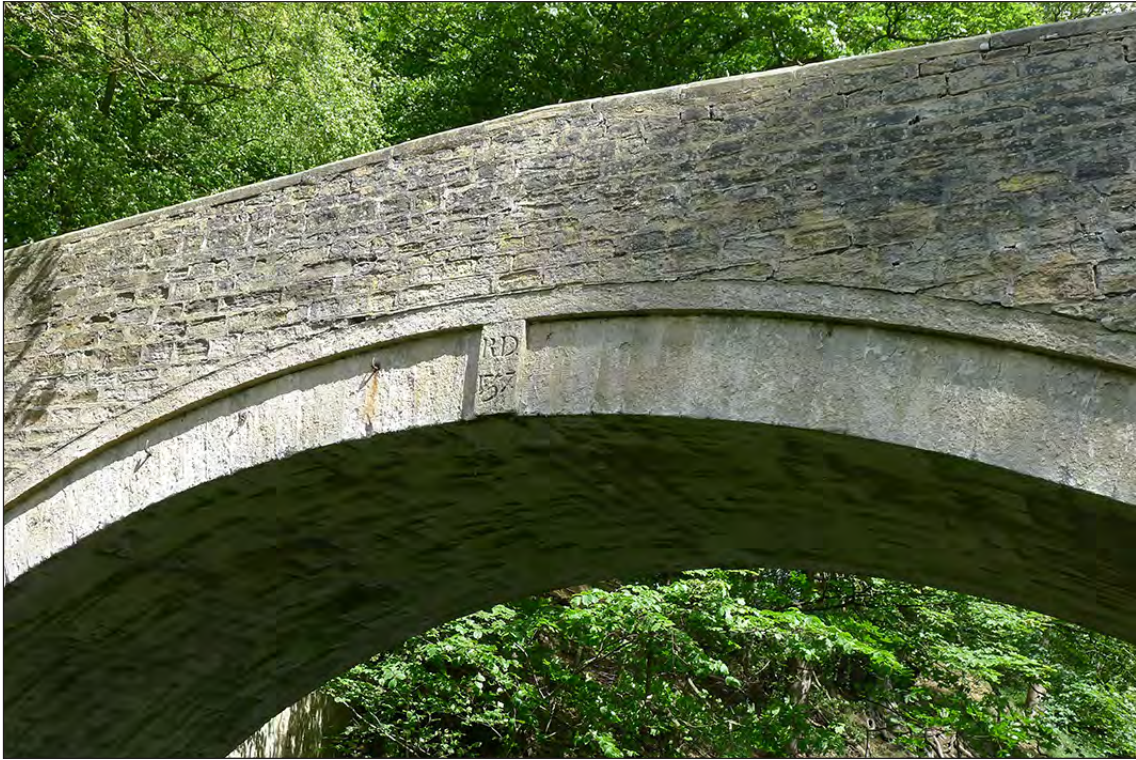
Fig 79. Detail of western arch ring and inscribed keystone of Bishop Trevor's drive bridge in Auckland Park. (© Historic England/Marcus Jecock)

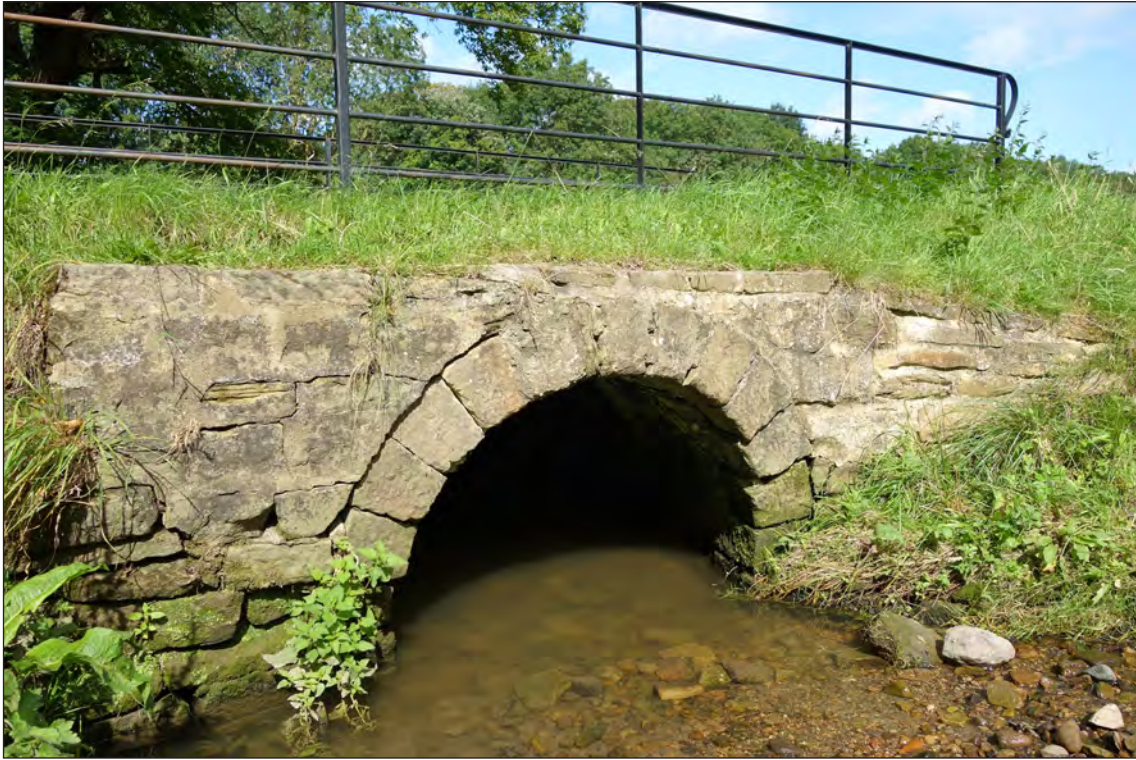
Fig 80. The eastern headwall of 'Bishop Trevor's' culvert for the Coundon Burn in Auckland Park. (© Historic England/Rebecca Pullen)

The culvert originally comprised a masonry barrel vault with a span of 1.3m, running between low headwalls set 6.55m apart (Fig 80), but much of the vault has at some time in the recent past (probably post 1994, see below) been demolished and replaced by vertical walls of breeze block and brick supporting a road deck formed from concrete joists (Fig 81). The original barrel still survives for a short distance in from each headwall, and is visible in each wall as a single ring of coarsely shaped voussoirs. The headwalls themselves are built of roughly squared blocks laid mostly in courses (in places now obscured by cement render or pointing), apart from the north end of the eastern headwall which comprises more fissile material, probably a modern repair. The current listing description, written in 1994, states that the bridge has ‘wrought-iron railings with simple flat principal and intermediate posts’. These have been replaced – presumably at the same time as the culvert barrel - by steel railings comprising four horizontal tubular bars passing through holes in square-section uprights, complemented by a fifth, square-section, top bar that supports a flat handrail tied back on to the end posts by downturned scrolls. At or close

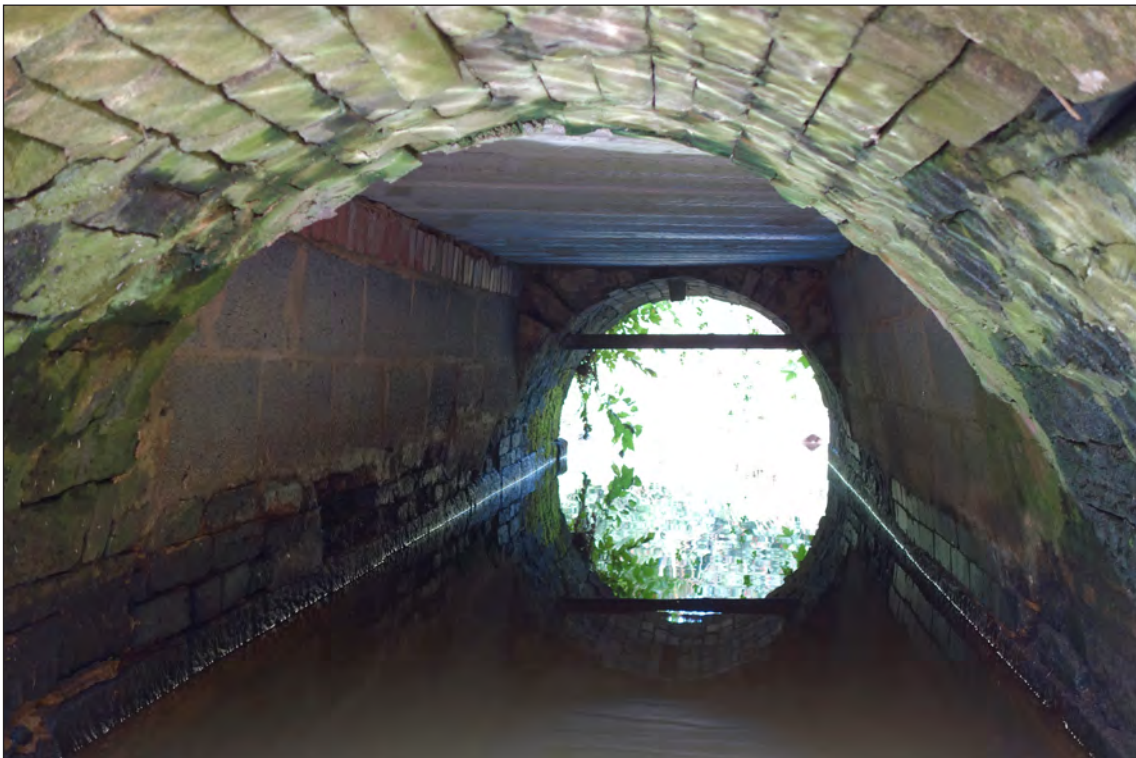
Fig 81. Detail looking through the arch barrel of 'Bishop Trevor's' culvert for the Coundon Burn in Auckland Park, showing the central section rebuilt and re-decked in modern materials. (© Historic England/Rebecca Pullen)

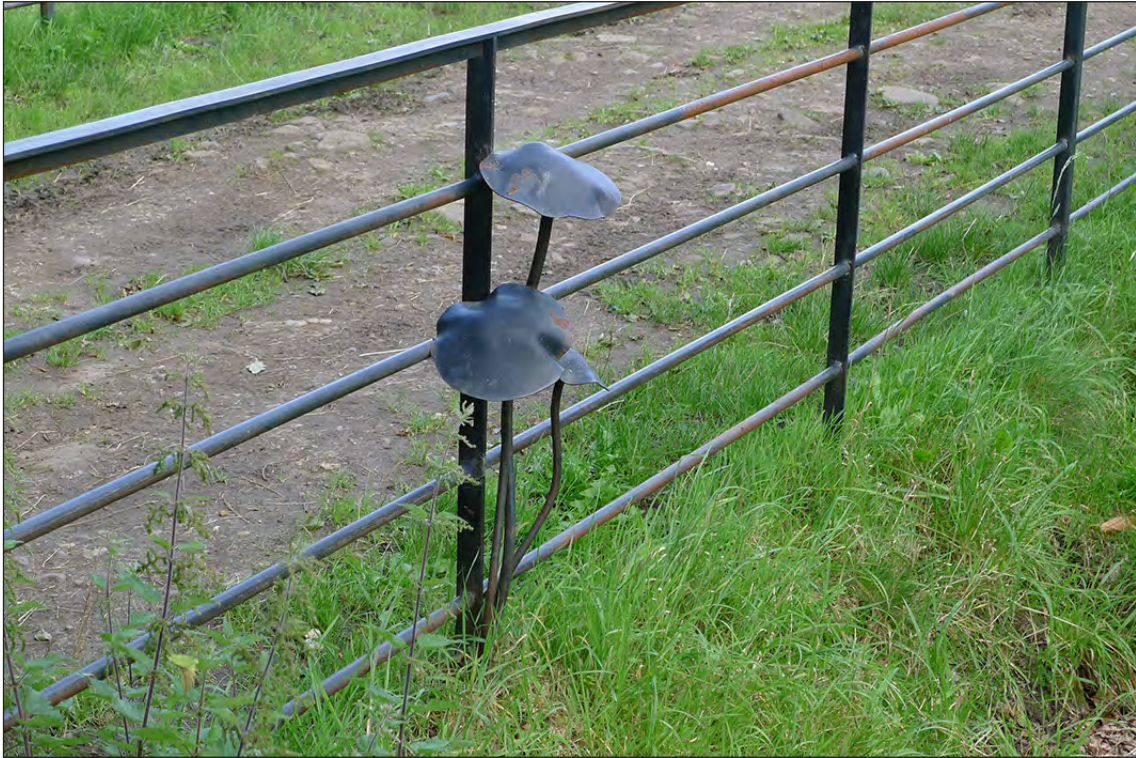
Fig 82. Detail of the modern railings to 'Bishop Trevor's' culvert for the Coundon Burn in Auckland Park. (© Historic England/Marcus Jecock)

to the southern end of the bridge, a clump of ornamental steel mushrooms sprouts from the base of a single stanchion on either set of railings (Fig 82).

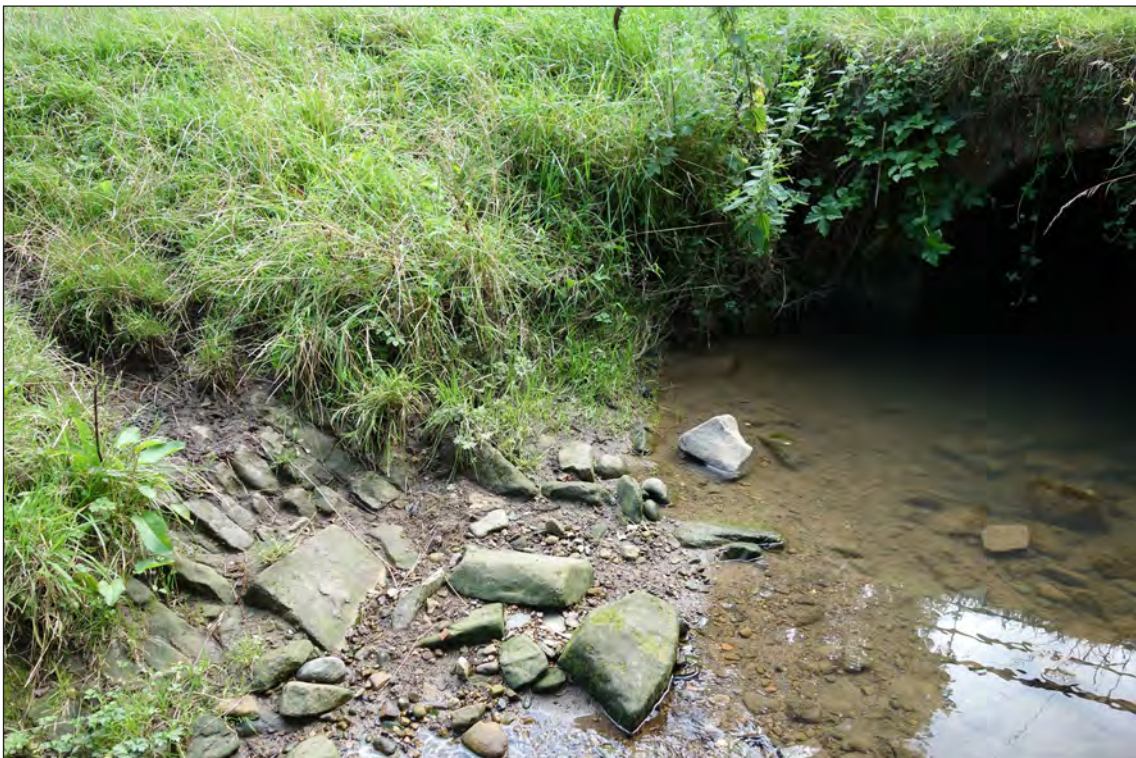
Fig 83. Detail of the paved stream bed or invert of an earlier bridge site immediately downstream of 'Bishop Trevor's' culvert for the Coundon Burn in Auckland Park. (© Historic England/Rebecca Pullen)

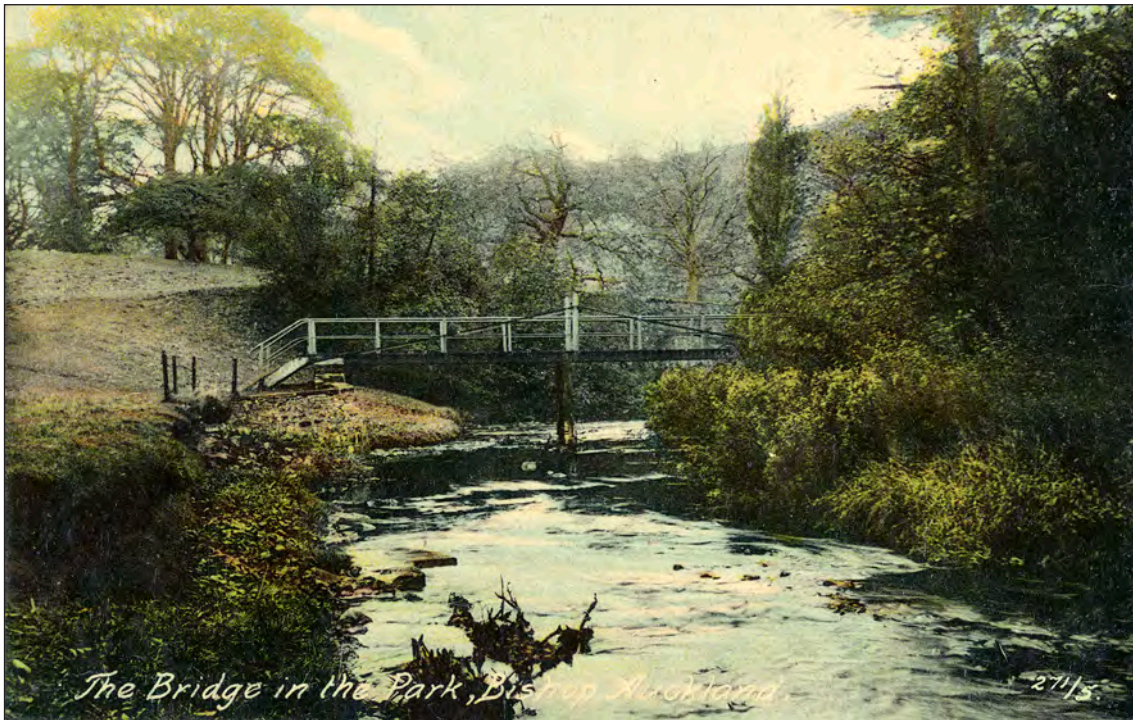
Fig 84. The former Green Bridge in Auckland Park, from a postcard (Nigel Temple Postcard Collection, Historic England Archive pc07445.tif)

All that now remains of the footbridge are its abutments (stone on the east bank but concrete, seemingly remodelled, on the west bank), a fallen set of concrete steps on the west bank and, in the middle of the river bed, the concrete foundation for a central pier with two sawn-off holding-down bolts set in to its surface. The form of the bridge is captured in several late 19th- or early 20th-century photographs or postcards. One of the photographs, undoubtedly the earliest (*The Northern Echo* 2018) shows the bridge as a very simple form of kingpost-truss structure on stone abutments, namely a timber deck on metal girders braced by diagonal bars rising at a low angle from the ends of the girders to the kingposts mid-stream. Simple timber handrails, fixed to a series of uprights plus the kingposts, line both sides of the deck. The structure appears to have subsequently become unsafe, however, for a later postcard (Fig 84) depicts the bridge as before but with the extra support of a metal trestle mid-stream; it is the concrete foundations for this trestle that survive in the river bed. Hutchinson (2015, 46) dates the addition of the trestle to about the time of the First World War. The historic photographs show both abutments were originally constructed of stone and the deck was approached in the west by timber steps, but the evidence on the ground shows the western abutment and steps were later refashioned in concrete.

A bridge at this location probably existed as early as 1810, which is the year The Temple was built (*The Northern Echo* 2018). A bridge (although not necessarily that shown in the photographs) certainly existed here by 1857 (Ordnance Survey 1861) and is depicted on every map edition thereafter up to the outbreak of the Second World War. It had disappeared, however, by 1961 (Ordnance Survey 1967), the year in which The Temple was demolished (*The Northern Echo* 2018). Parkland records from the 1870s indicate the footbridge was then known as Green Bridge (The Landscape Agency 2012, 22), perhaps in reference to the colour it was painted; the modern newspaper account refers to it simply as the Temple Bridge. It is unnamed on Ordnance Survey maps. It was recorded as site 67 in the recent archaeological survey of the Park (Oxford Archaeology North 2012).

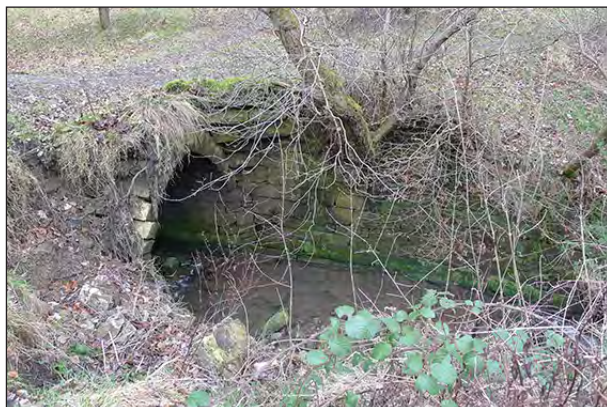
Fig 85. The eastern elevation of 'footbridge no. 1' across the Coundon Burn in Auckland Park. Note the corbelling in the north-east spandrel to ease the passage of the footpath on to the bridge, and the short length of training wall. (© Historic England/Marcus Jecock)

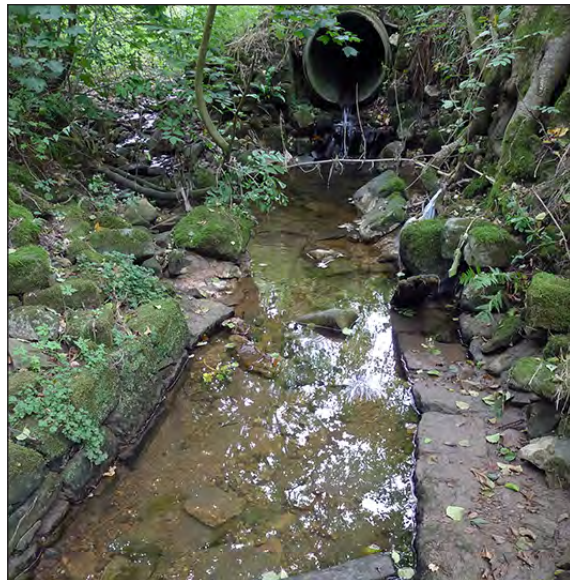
Fig 87. The remains of ‘footbridge no. 2’ across the Coundon Burn within Auckland Park, looking upstream. © Historic England/Marcus Jecock)

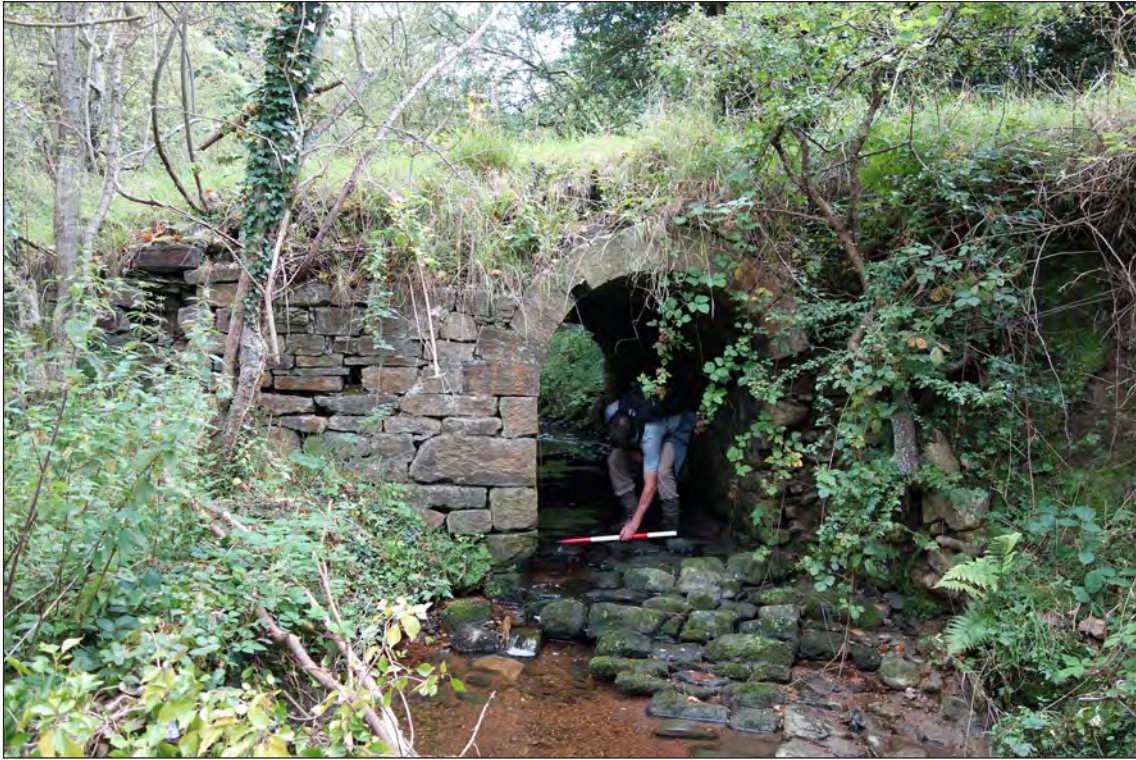
Fig 88. The downstream (western) headwall of 'footbridge no. 3' across the Coundon Burn in Auckland Park. (© Historic England/Rebecca Pullen)

The structure comprises a simple semi-circular barrel vault, some 8.05m long by 1.5m wide, rising from vertical side walls, all capped by earth and gravel. The crown of the arch stands about 1.83m (6 feet) above the floor of the invert (stream bed), which is paved. The arch ring in the western, downstream, headwall (there are no spandrels to speak of, or parapets for that matter) is formed of well-dressed, squared voussoirs (Fig 88), but the upstream headwall (if ever there was one) has collapsed taking the arch ring with it (Fig 89). All other masonry comprises roughly squared stones of various sizes, laid for the most part in horizontal courses. There are short training walls on the upstream side, again ruinous.

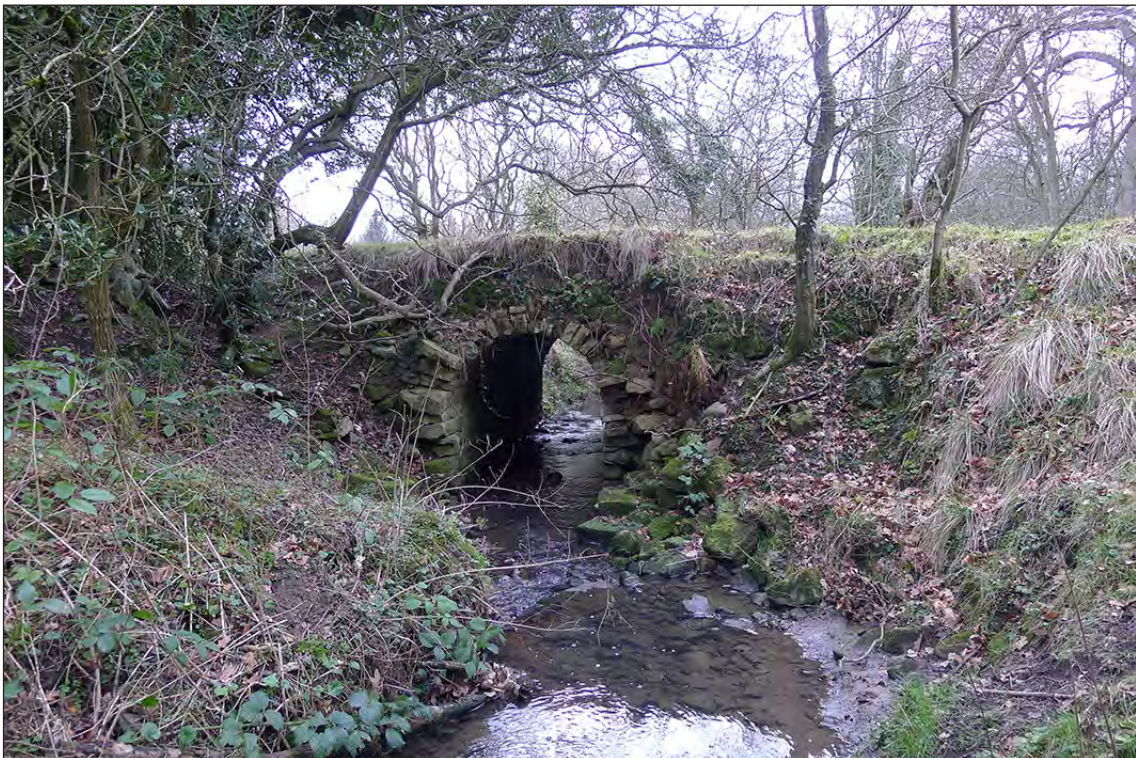
Fig 89. The collapsed, upstream (eastern) arch ring and headwall of 'footbridge no. 3' across the Coundon Burn in Auckland Park. (© Historic England/Marcus Jecock)

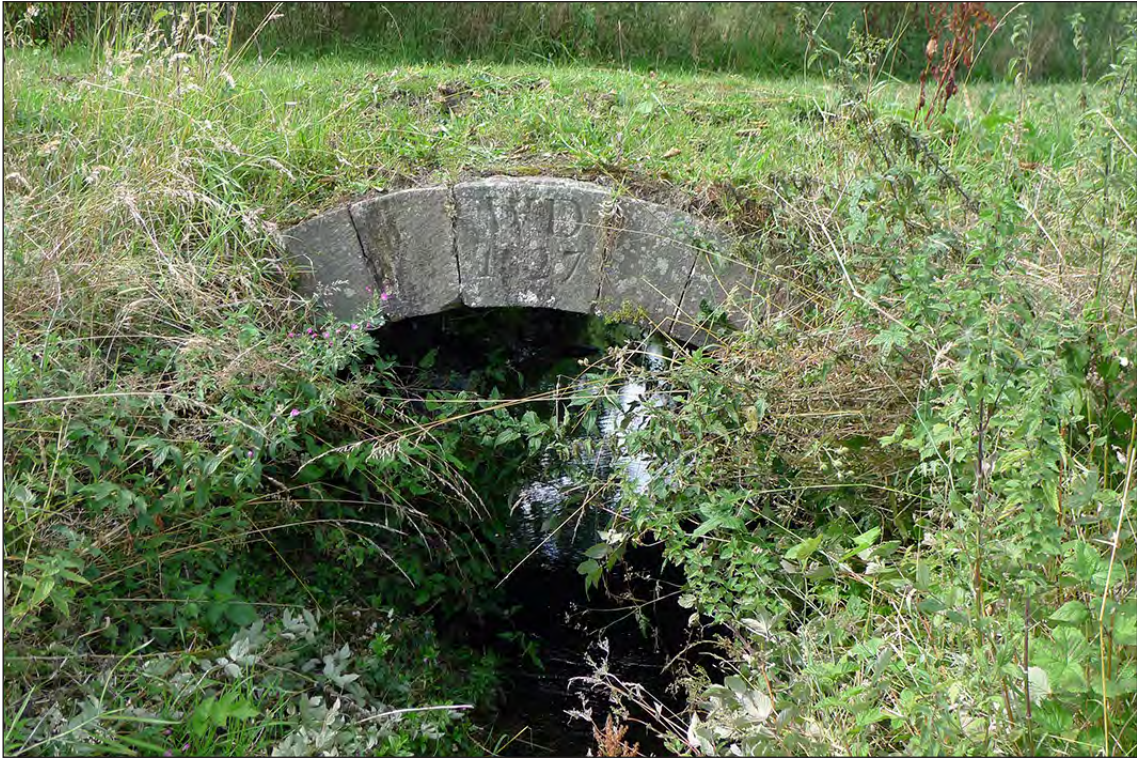
Fig 90. The upstream arch ring and inscribed keystone to Bishop Van Mildert's drive bridge over the Coundon Burn in Auckland Park. (© Historic England/Marcus Jecock)

The structure comprises a simple, elliptical barrel vault some 6.8m long by 2.13m wide, capped by earth and gravel. There are no headwalls or parapets. The eastern (upstream) elevation comprises a single arch ring of fine ashlar voussoirs with the keystone inscribed 'WD | 1827' (Fig 90), but the arch ring in the western elevation (and the vault that connects the elevations) is formed of less well-dressed stone (Fig 91). A training wall continues the line of the north abutment a short distance downstream and the invert is paved. Although described in the List description as a footbridge, traces of splayed stone kerbing in the ground on the northern approach, together with the length of the vault, very much suggests that the structure was built to carry a carriage drive, or at the very least a bridleway (Fig 92), rather than simple footpath.

The evidence of the keystone shows that the culvert is the work of 'William Dunelm' (*ie*, William of Durham, otherwise Willam Van Mildert, Bishop of Durham between 1826 and 1836) and not Bishop Trevor as currently stated in the List description. However, the earliest map evidence for a bridge at this location is Jeremiah Dixon's 1772 plan of Auckland Park (held by The Church Commissioners of England; seen in facsimile courtesy of The Auckland Project), which shows it (unnamed) as part of a

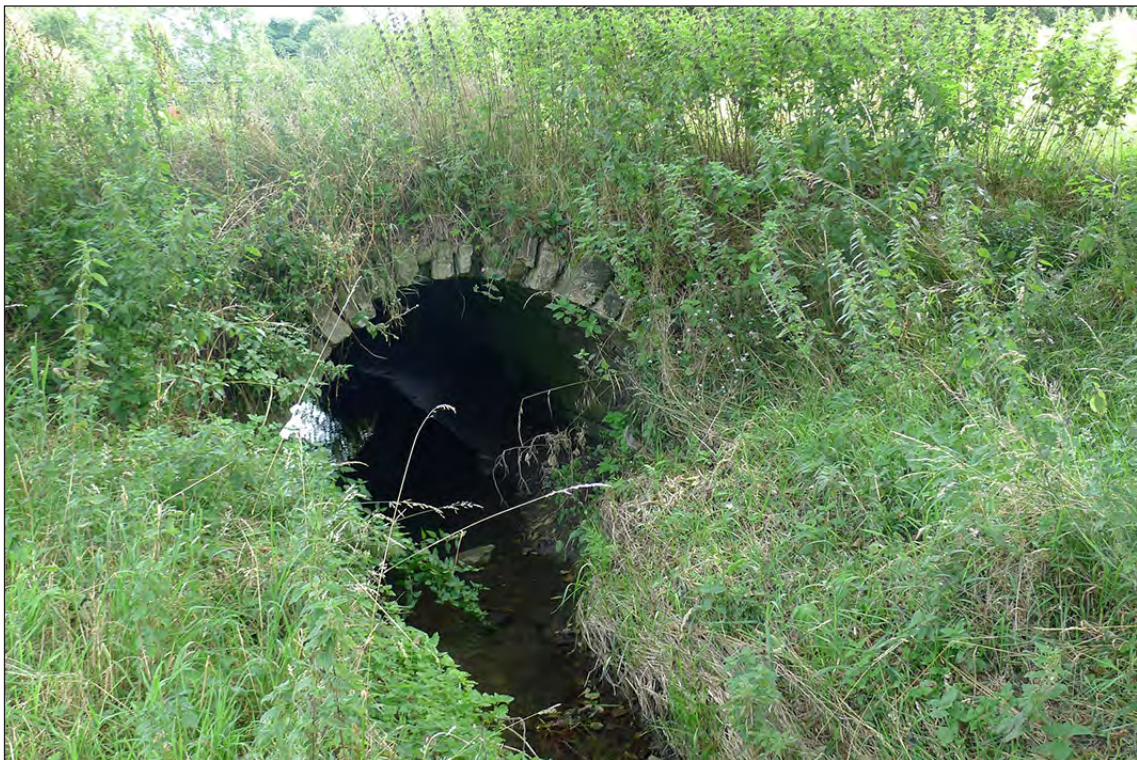
Fig 91. The downstream arch ring to Bishop Van Mildert's drive bridge over the Coundon Burn in Auckland Park. (© Historic England/Marcus Jecock)

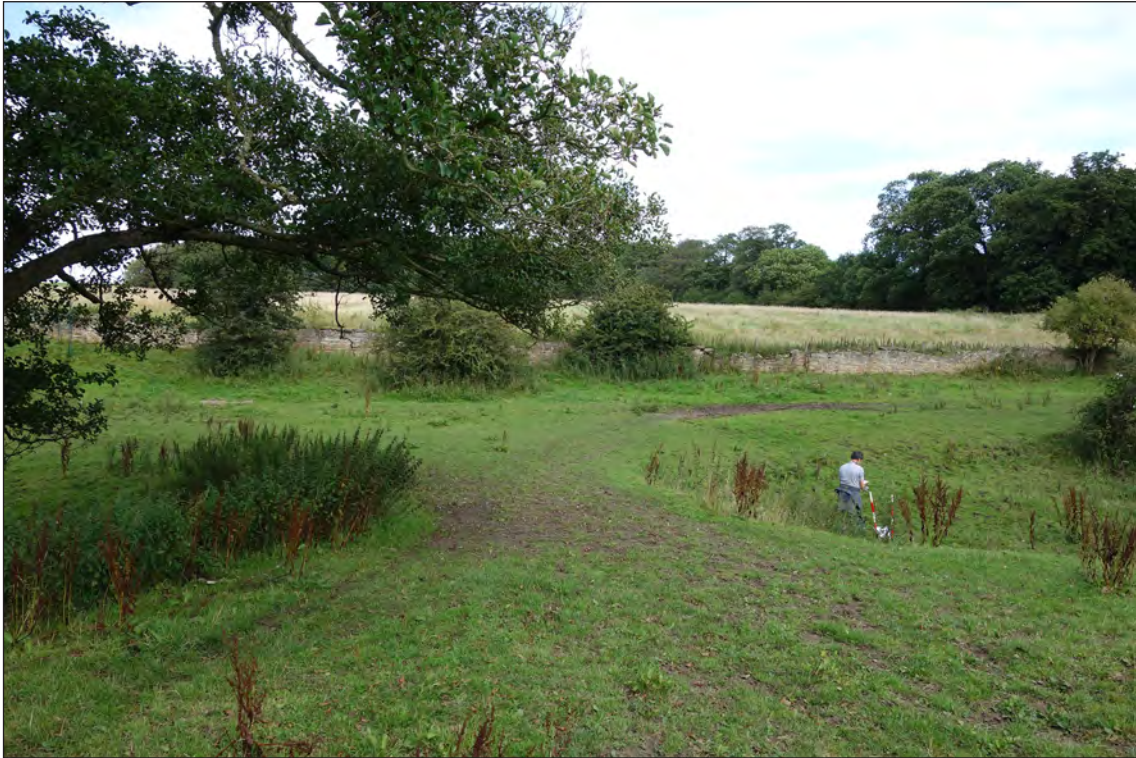
Fig 92. View south across Bishop Van Mildert's drive bridge over the Coundon Burn in Auckland Park, showing the width of the carriage drive. (© Historic England/ Rebecca Pullen)
