Shipley Bridge
China-Clay Works,
South Brent, Devon

An archaeological survey by English Heritage

County:	Devon
District:	South Hams
Parish:	South Brent
NGR:	SX 6800 6290
NMR no:	SX 66 SE 189
Surveyed:	April 2002
Report by:	Phil Newman
Surveyors:	Phil Newman

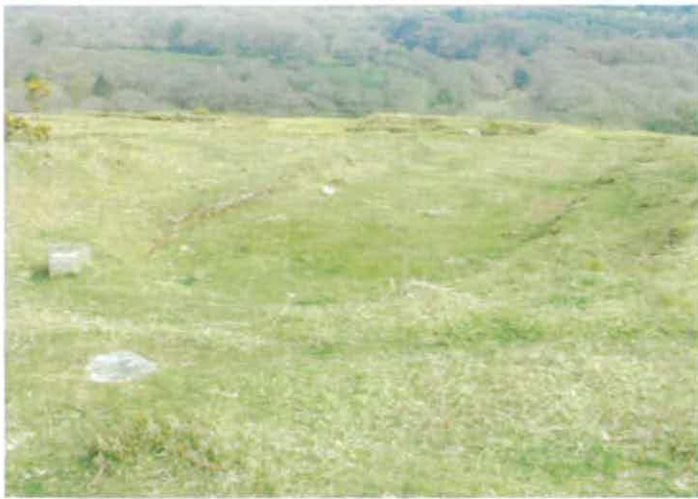
Plate 1. The sand drag.

The position of the pipe and the vestigial channels suggest that the slurry was first deposited into the western 'drag'(10). This consists of a level platform on top of which is a shallow, stone-lined depression of 17m by 4.5m. This is divided into three runs of approximately 1m wide by 20cm deep, two of which have curved terminals with narrow openings on the west end (Pl. 3). There is a manhole opening on the eastern end, from which two channels branch away to the south.

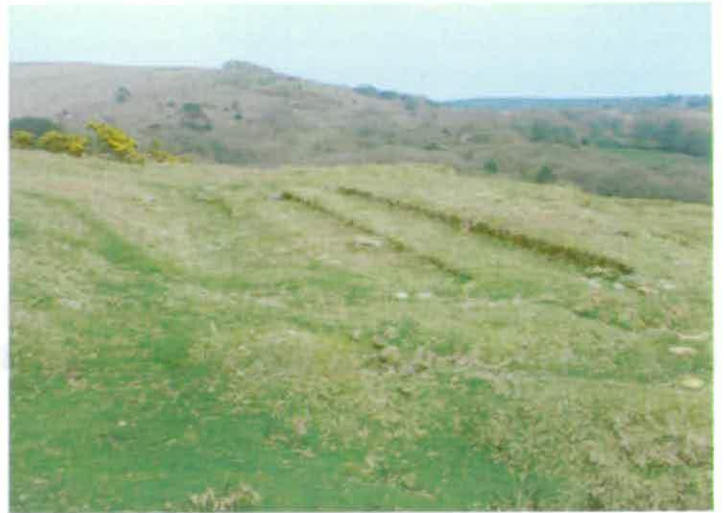
Plate 2. The mica drag.

The larger drag (12) is a shallow pit with parallel sides and a rounded north-west end. Though the pit itself is shallow, the steep gradient of the hillside has meant that a substantial cutting was needed to obtain a level floor and the horseshoe-shaped scarp at the north-west end has a drop of 2.5m. The sides of the pit are lined with stone and brick, some of which has been robbed. Half way along the floor of the pit there is a change in height of 8cm, created by a single course of bricks. The south-east end of the pit is open and any components there were either of timber or have been robbed.

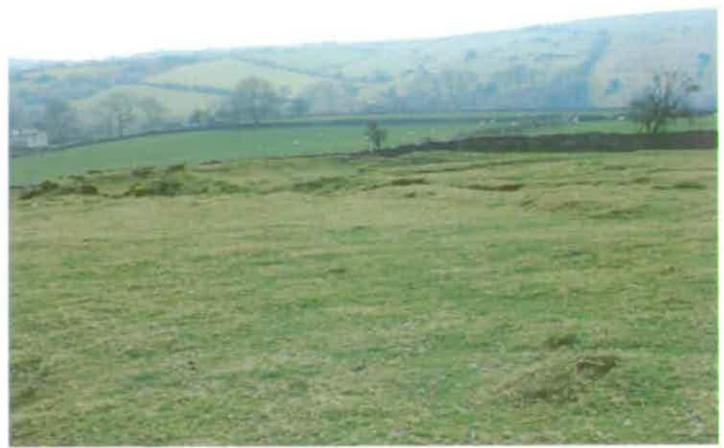
Plate 4. Early sand and mica separating pits

These three pits are aligned descending the hillslope, one below another and were the principal means of separating the sands and mica from the kaolin during the 1850s. The top two pits (1 & 2) consist of roughly rectangular level depressions covering an area of approximately 180 metres² each, with a substantial earthwork retaining bank on the downslope side. Pit 1 has a depth of 0.5m and Pit 2 is 0.7m deep, the floor of the pits have a slight incline of between 0.15m and 0.2m front to back, though it is not known if this is the original gradient. Pit 3 is longer and narrower than 1 and 2 and covers an area of approximately 100metres² with a maximum depth of only 0.2m. The height change between the floors of the three pits is (1-2) 2.64m and (2-3) 2.7m. On all three pits there are vestiges of a granite lining though much of this is likely to have been robbed, leaving only the earthwork remains now visible.

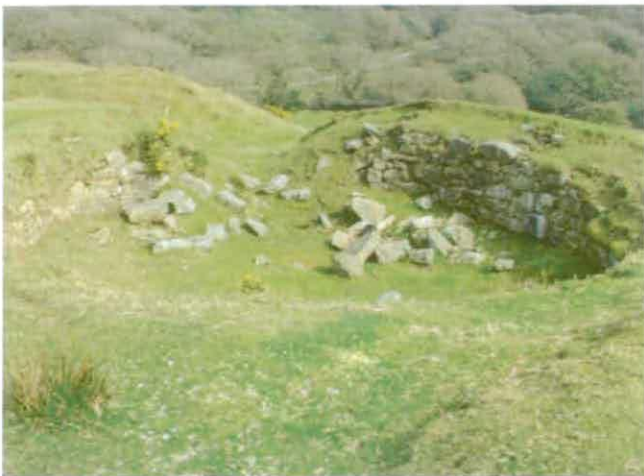
Plate 5. Settling pit (15) with surviving masonry lining.

The floor of Pit 15 (Pl. 5) is 2m lower than that of 14. The diameter of the tank is 8.8m and the granite blocks of the lining still stand to approximately 1m though the overall depth of the pit is 2.4m. The pit has been disturbed on the eastern end where ground has been dug away to rob the stone.

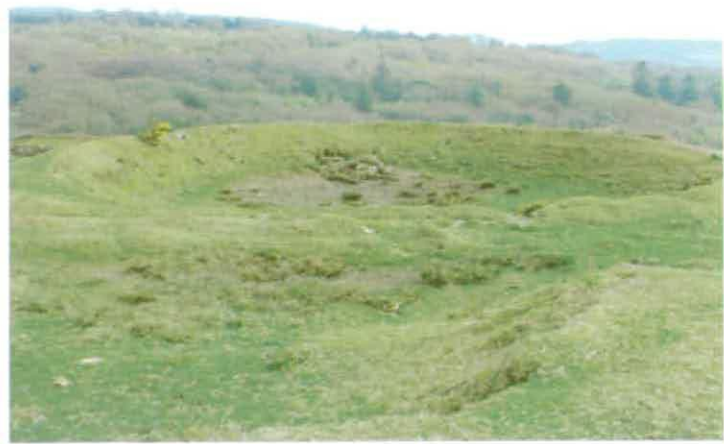
Plate 6. The larger settling pit (14).

Pit 14 (Pl. 6) has an overall diameter of 18m, though the diameter of the stone-lined tank was likely to be nearer 14m, and the depth of the earthwork is 2m. Its depth was established by cutting into the slope and building a semi-circular embankment on the downslope side. On the lip of the bank on the eastern side, two edge-set flat stones mark the position of an overflow sluice from which liquid would flow into the tank(15) below. At the base of the retaining bank is the opening for a ceramic pipe, since robbed, from which the settled slurry could have flowed.

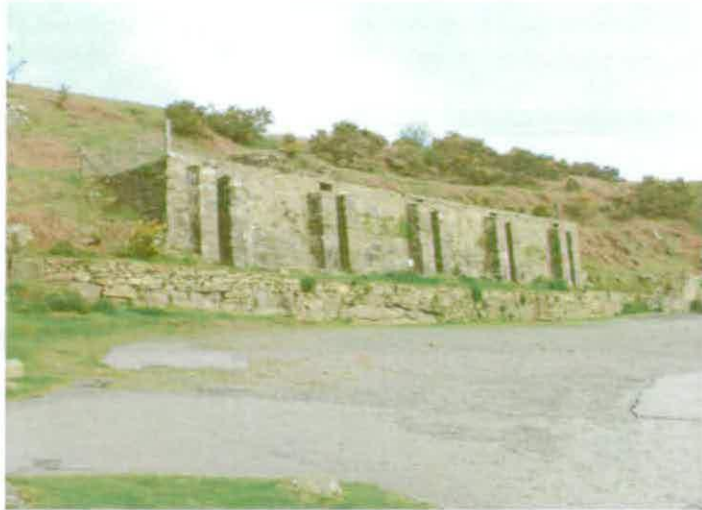
Plate 7. The thickening tank and the site of the drying pan, now used as a car park

The building is cut into the base of the slope, the back wall acting as a revetment and the end walls are partially below surface. The external dimensions are 29m by 7.4m. The reinforced front wall is 2.1m thick giving an internal width to the structure of 5m. The floor is paved with brick and has a slight gradient to allow water to drain off. In the rear wall large pipes set near the top brought the clay into the structure. The eastern, front wall has five evenly spaced vertical openings which stand the full height of the wall and are on average 0.6m wide, with buttresses on the outside. The openings have iron fixings onto which hatches, probably of steel, were fixed so they could be opened to empty the clay, which was by now a moist powder, into the drying pan below. This thickening tank is similar to the example at Shaugh Bridge, which although used in combination with a heated drying pan, is of similar date (Smith and RCHME 1996).

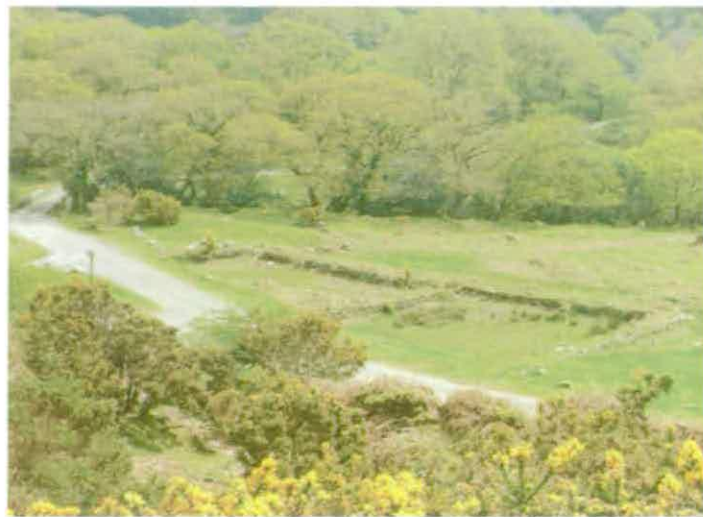
Plate 8. The collecting tanks.

A stone built structure of two cells sited south of the road is referred to by Robinson as a collecting tank (Robinson 1984). Its precise purpose is unclear but it was possibly for the collection of any remaining clay deposits suspended in the water before its return to the River Avon. The walls consist of earth banks with granite facings inside and out, measuring up to 2m thick and up to 0.8m high. The western cell is rectangular and measures 12.7 by 15m; the cell to the east is trapezium shaped with ends measuring 11.5 and 6.3m and an overall length of 20.5m.
