# SURVEY REPORT

## Grand Shaft Barracks, Western Heights, Dover, Kent

**GRAND SHAFT BARRACKS  
WESTERN HEIGHTS  
DOVER, KENT**

**NMR INDEX No: TR 34 SW 464**

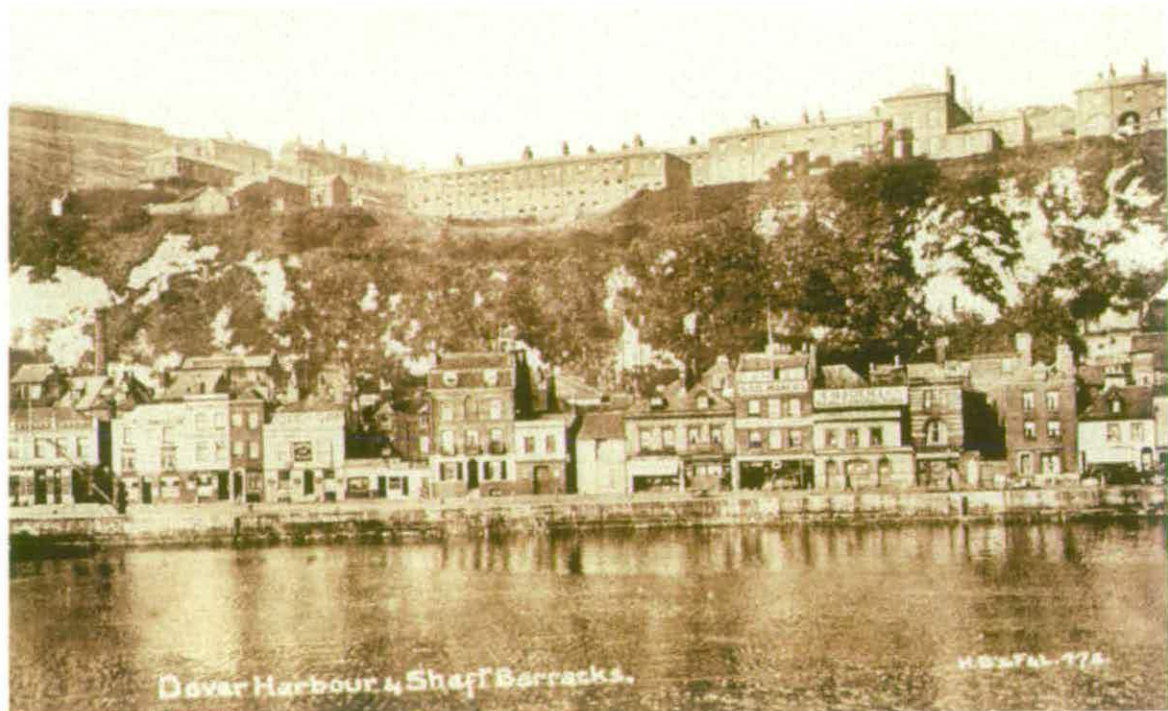
*A view of Grand Shaft Barracks from the harbour, in the late 19th or early 20th century, showing the austere Napoleonic accommodation blocks on the cliff top (d01798; reproduced by kind permission of Dover Museum)*

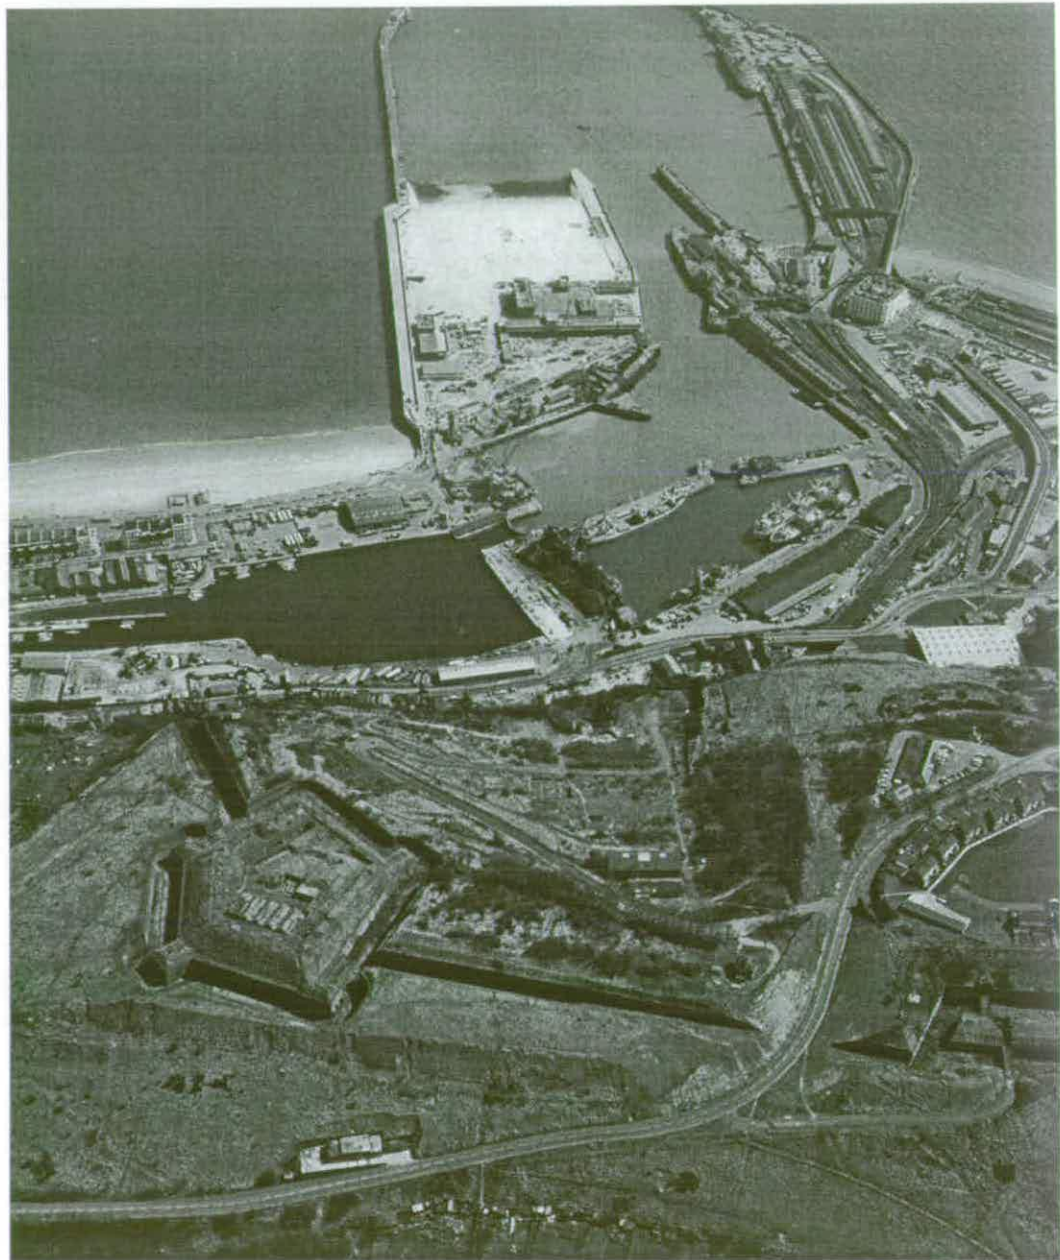
Figure 2  
The site of  
*Grand Shaft  
Barracks* (lower  
centre) from the  
air in 1978: note  
the survival of  
the *Gymnasium*  
and *Troop Stable*  
to the right of  
*Drop Redoubt*  
(NMR AP:  
TR/3140/1/360)

The barracks were decommissioned in 1960 and most of the buildings levelled in 1965, although two buildings were left standing: the Gymnasium survived in 1979 but was removed by 1983, while the Troop Stable/Transport Shed stood until 1997 (Fig 2; NMR APs: MAL/83001/37-9).

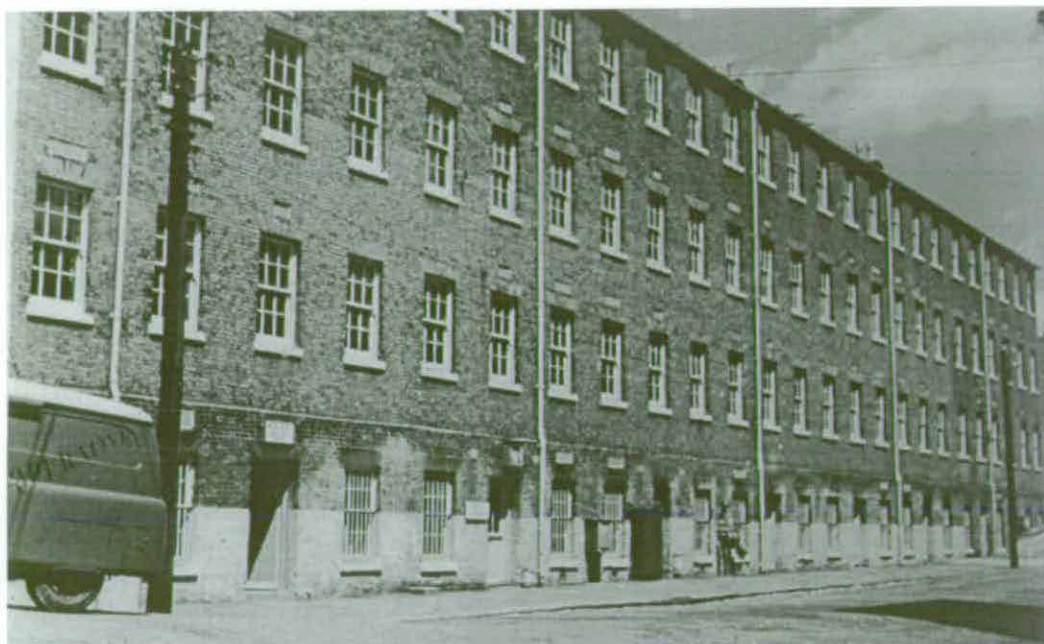
Figure 6  
Soldiers' Quarters  
(Range B), shortly  
before demolition.  
The size and sombre  
nature of the  
barracks is apparent  
(d08611; reproduced  
by kind permission of  
Dover Museum)

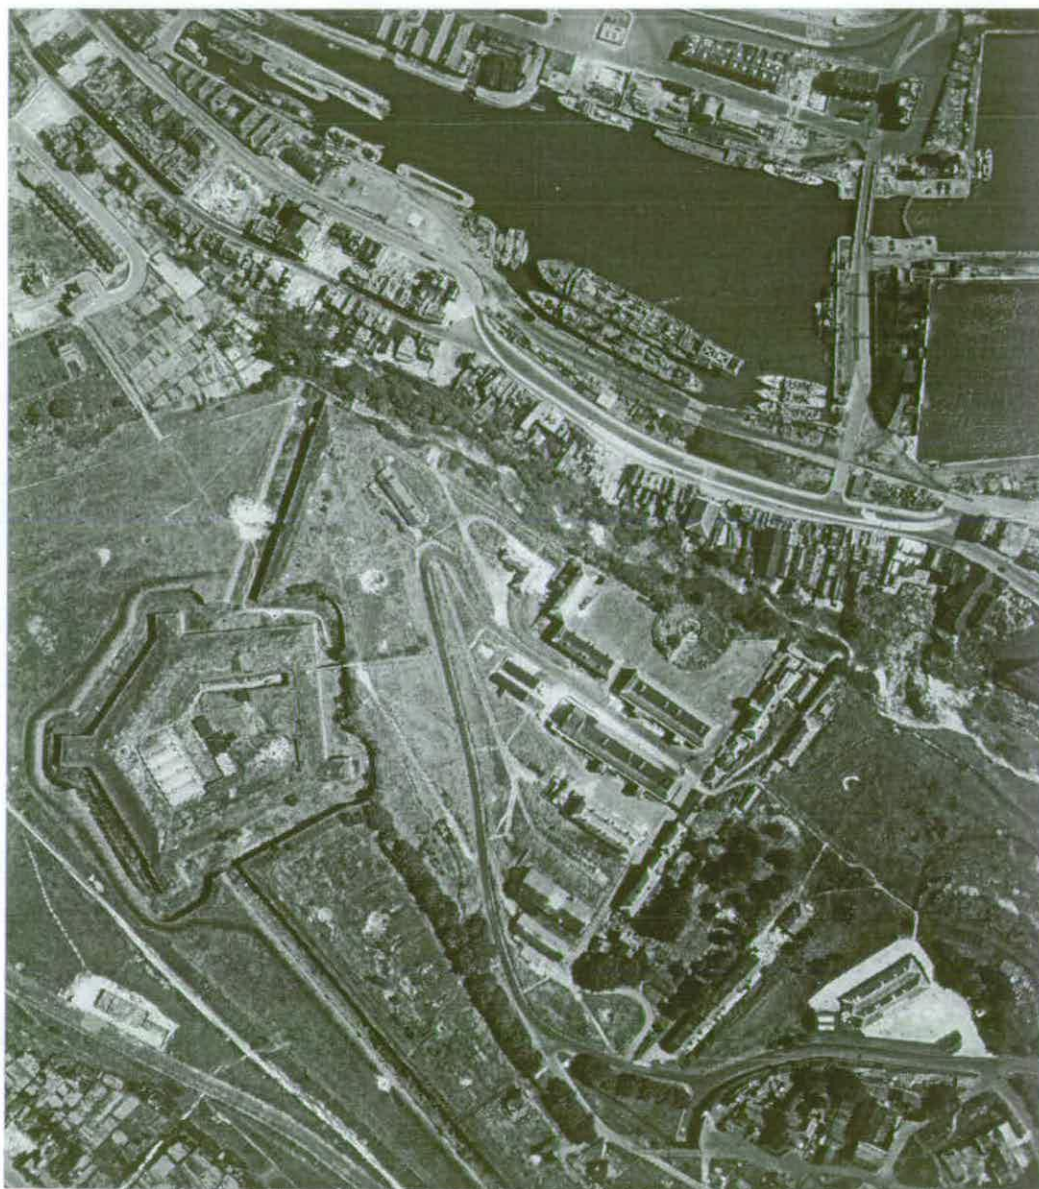
Figure 7  
Grand Shaft  
Barracks from the  
air in 1945 (NMR  
AP:  
106G/UK/610/Part  
IV/6327)

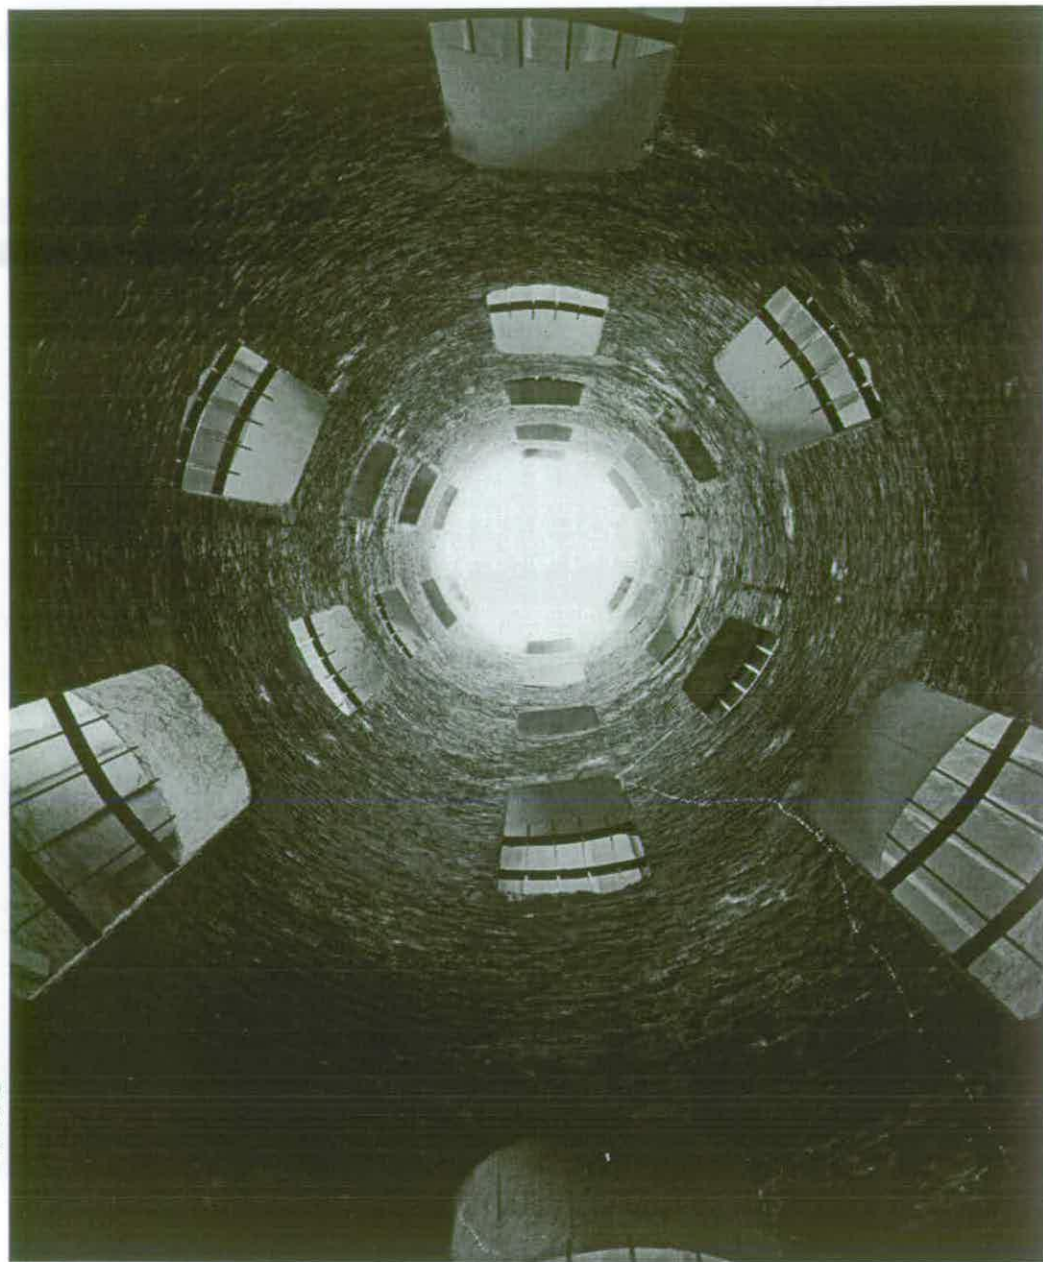
Figure 10  
*A view up the central  
lightwell of the  
Grand Shaft (NMR)*

The Grand Shaft itself is 140ft (42.67m) deep, driven vertically through the chalk cliff and lined with Common-bond brickwork (Fig 10). In the centre of the shaft is a hollow column, in Flemish bond, which serves to support three intertwined spiral staircases, while also acting as a drain and a light well. The three staircases all have stone treads running between the shaft wall and the central column. Four borrowed-lights with semicircular heads, stone lintels and wrought-iron grilles are provided on each staircase. The exact spacing of the lights varies slightly with the geometry of each staircase but the interval between each one is roughly thirty steps. Each borrowed light has an accompanying small landing. The stone sills of the lights are canted into the stairs probably to increase the available light. At the bottom of the shaft, there are low semicircular arches at the rear of each stair: scars in the jambs suggest the position of doors, possibly to small cupboards that probably contained tools and maintenance materials. The shaft leads directly into vaulted gallery, at the end of which was a guard-room and main gate to the town (WD/2352; WD/2354).

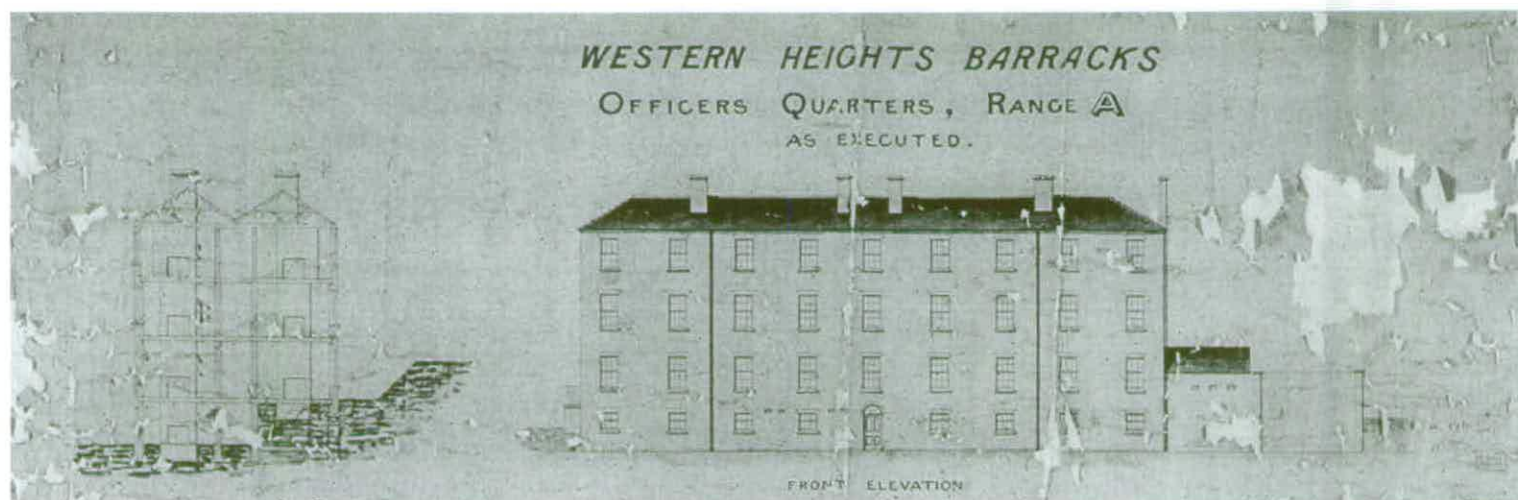
Figure 17 *Field Officers' Quarters: south-eastern elevation and section in 1860 (extract from WD/2445)*

The Field Officers' Quarters occupied the final and highest level of terracing in the original Napoleonic design. This building was virtually identical to the Officers' Quarters Range B although some rooms were combined into suites of three or four, probably for higher ranking occupants. There was a small enclosed yard on the north-eastern end (Fig 17).

The outline of this building can still be seen; the north-western wall at ground floor level is an eroded foundation; the south-western end at basement level stands to 1.1m, rendered internally; a very slight scarp covers the foundation of the south-eastern wall. A steep scarp,

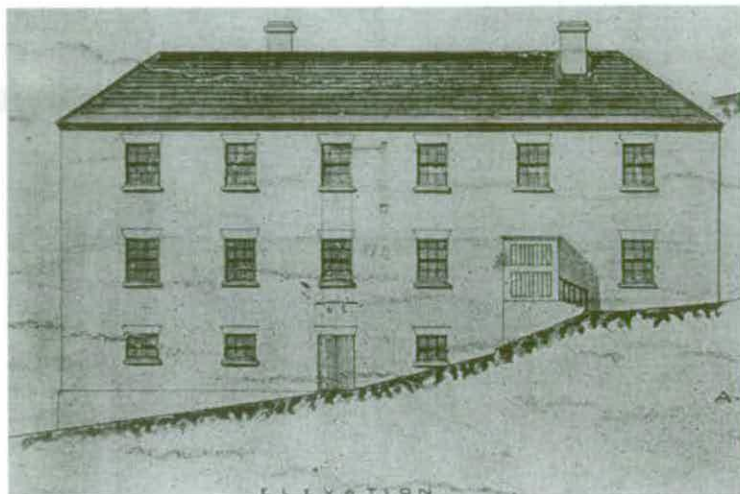
Figure 20  
Barrack Stores and  
Barrack Warden's  
Quarters:  
north-eastern  
elevation in 1856  
(extract from  
WD/2407)

This was a single pile, two-storey building with a three-quarter basement, of 6 by 2 fenestrated bays with a pitched slate roof. The northern half of the building comprised living accommodation, on two floors (Fig 20). There are slight remains, principally part of the south-western and south-eastern walls, in red brick laid to English bond. Much of the

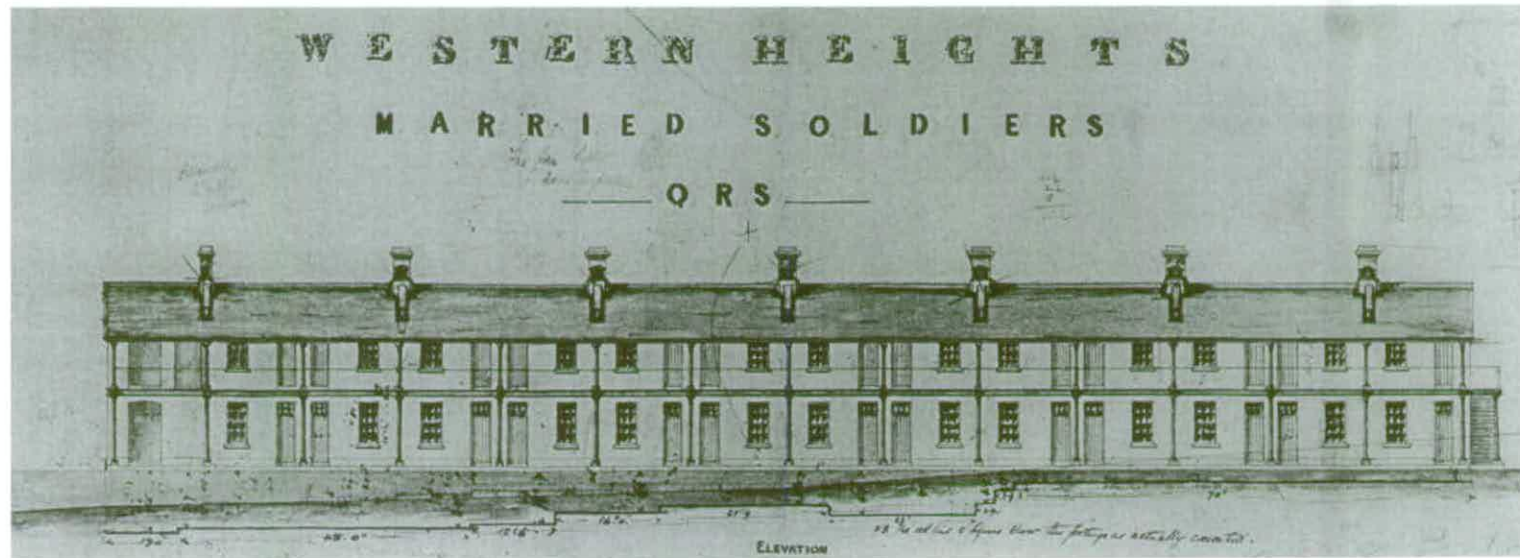
Figure 25 Married Soldiers' Quarters: north-eastern elevation in 1869 (extract from WD/2461)

This building, constructed in 1869, was a brick-built two-storey range with a pitched slate roof, providing quarters for 26 families, each in a one-room apartment with a covered verandah. Each apartment contained a cupboard and a fireplace with a small range. Stairs at the north and south ends of the range reached the first floor apartments and a sink and ash bin were provided in a separate room at the south end of the range (Figs 24 and 25).

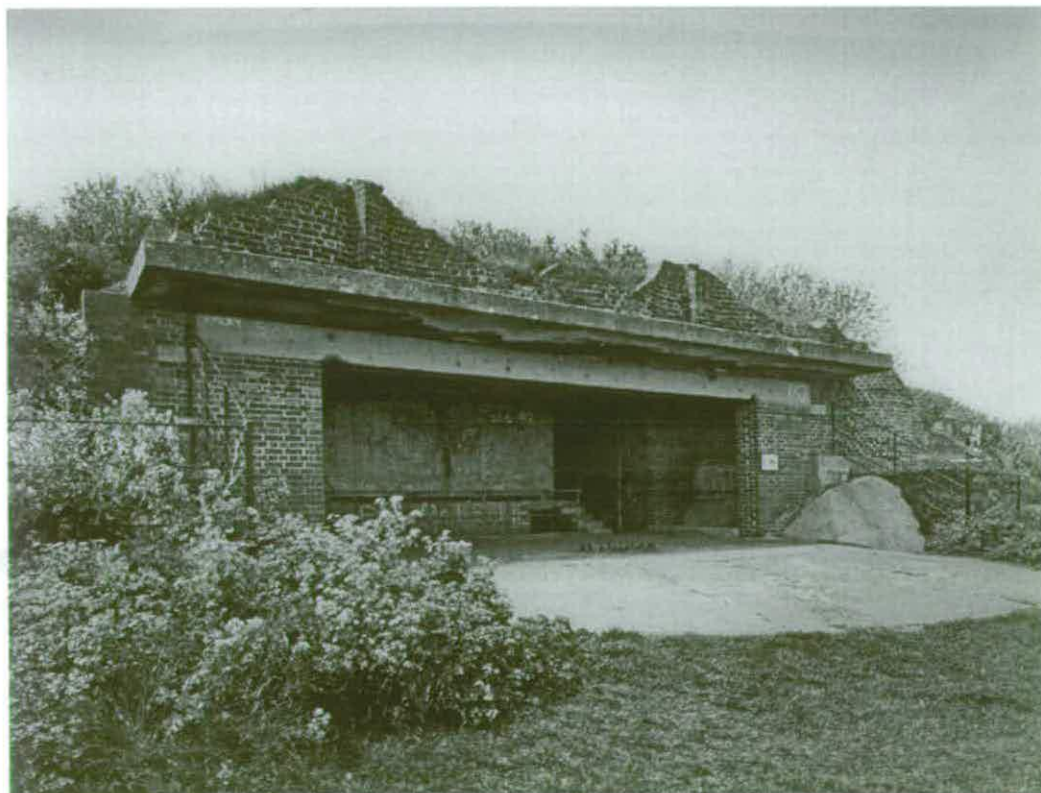
Figure 30  
*St Martin's  
Battery: gunhouse  
for a 6-inch BL  
gun, built in 1940  
(NMR)*

During the Second World War phase, the three 6-inch BL guns were installed in covered gunhouses built in the old open RML emplacements. At the front, the old gun pits were filled with concrete to barbette level as a base for the new guns, which were protected by the brick side walls and reinforced concrete roofs of the gunhouses; broad openings at the front enabled a wide arc of traverse (Fig 30). The roofs continued to the rear over new two-storied structures that filled the back of the old emplacements: their elevations were built flush with the old shell and cartridge stores, creating a continuous range. The upper storeys formed gun
