Ribbesford House
Ribbesford
Bewdley
Worcestershire

Tree-ring Analysis of Oak Timbers

Research Report Series no. 33-2021

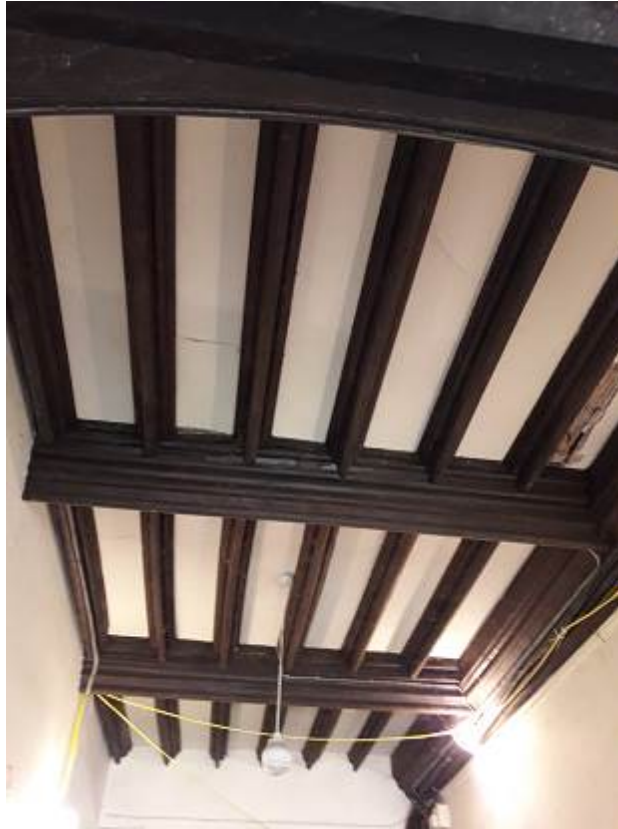
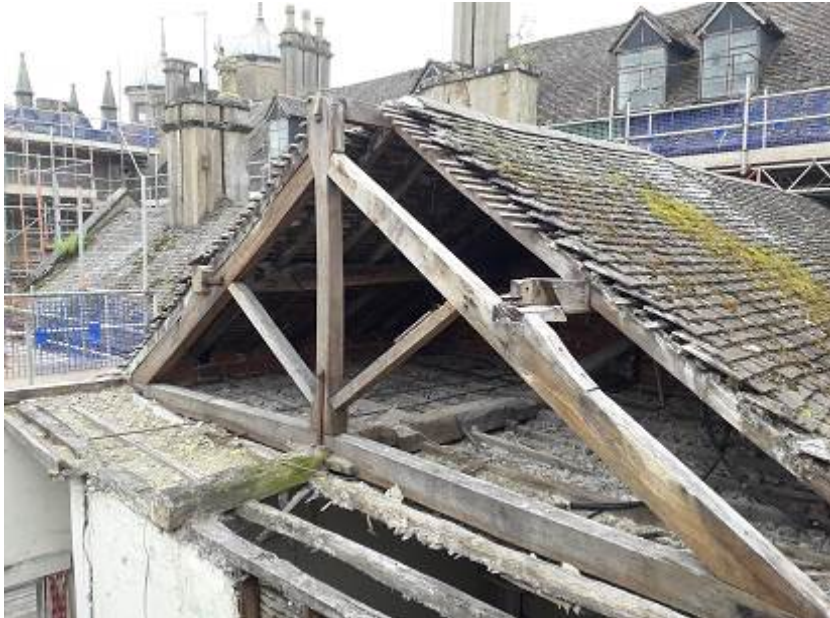
Figure 3a/b: Views of the ground-floor ceiling beams to the (top), and roof truss to the agricultural wing (bottom) (photographs Robert Howard)

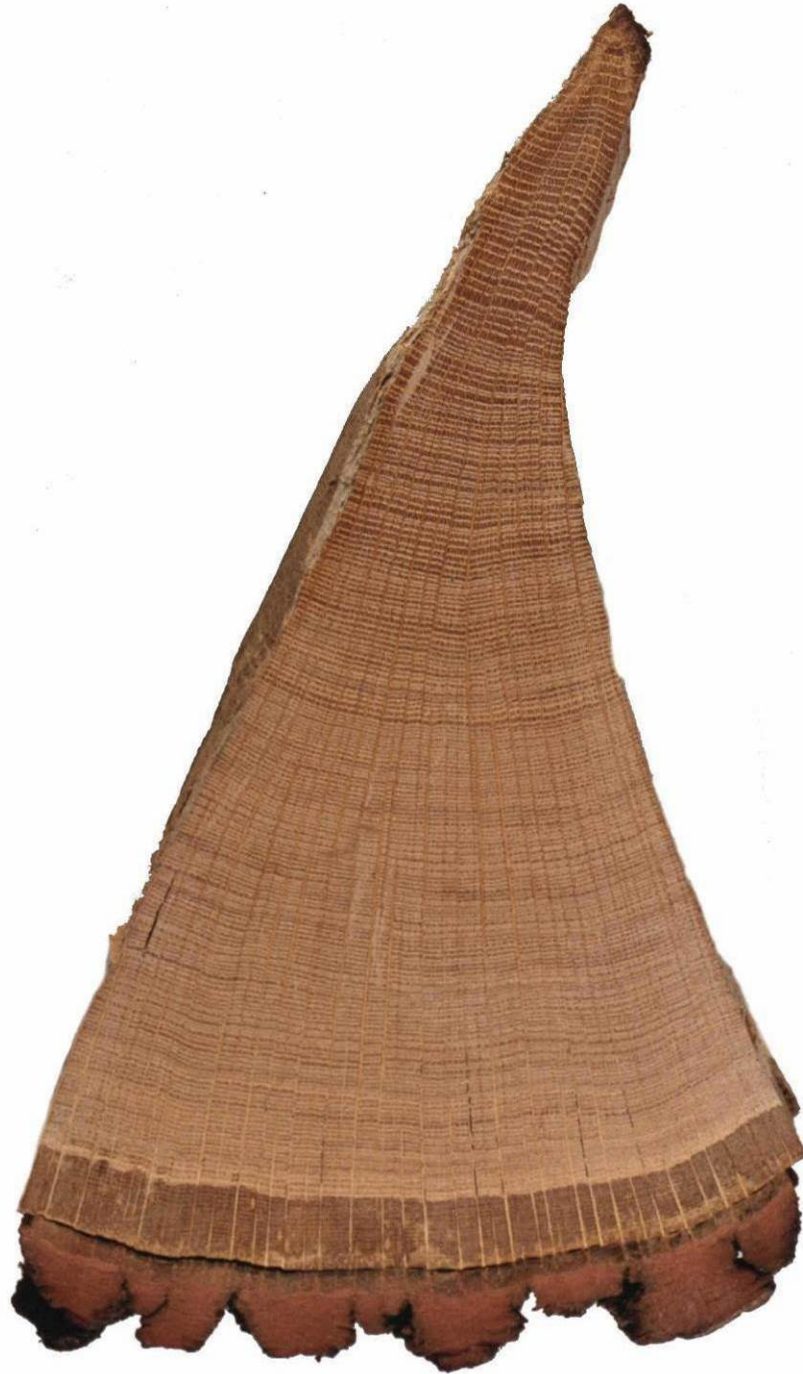
Figure A1: A wedge of oak from a tree felled in 1976. It shows the annual growth rings, one for each year from the innermost ring to the last ring on the outside just inside the bark. The year of each ring can be determined by counting back from the outside ring, which grew in 1976

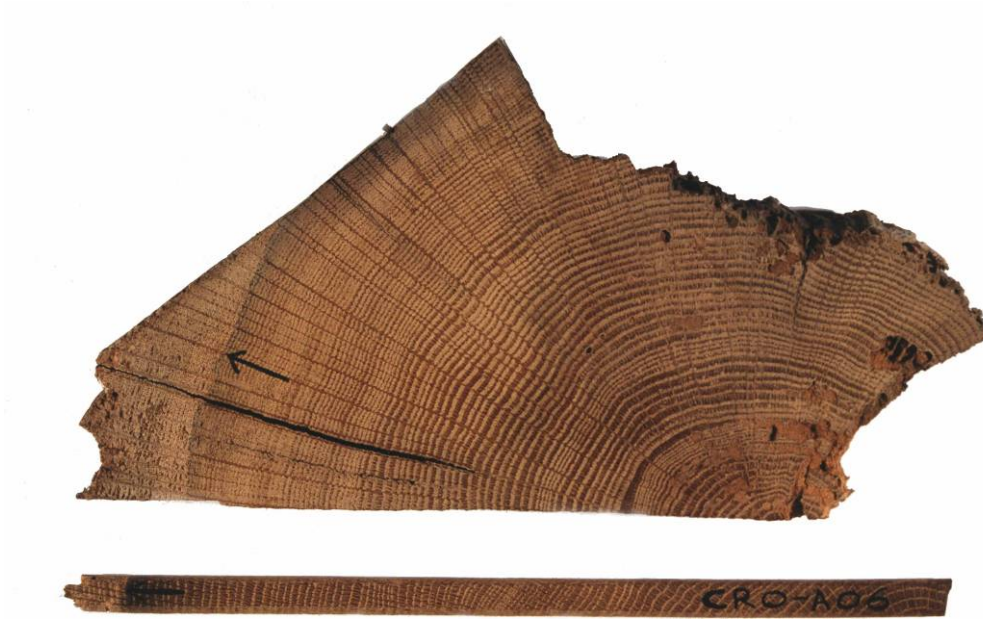
Figure A2: Cross-section of a rafter, showing sapwood rings in the left-hand corner, the arrow points to the heartwood/sapwood boundary (H/S); and a core with sapwood; again the arrow is pointing to the H/S. The core is about the size of a pencil

Quite often some, though not all, of the original outer rings are missing on a timber. The outer rings on an oak, called sapwood rings, are usually lighter than the inner rings, the heartwood, and so are relatively easy to identify. For example, sapwood can be seen in the corner of the rafter and at the outer end of the core in Figure A2, both indicated by arrows. More importantly for dendrochronology, the sapwood is relatively soft and so liable to insect attack and wear and tear. The builder, therefore, may remove some of the sapwood for precisely these reasons. Nevertheless, if at least some of the sapwood rings are left on a sample, we will know that not too many rings have been lost since felling so that the date of the last ring on the sample is only a few years before the date of the original last ring on the tree, and so to the date of felling.

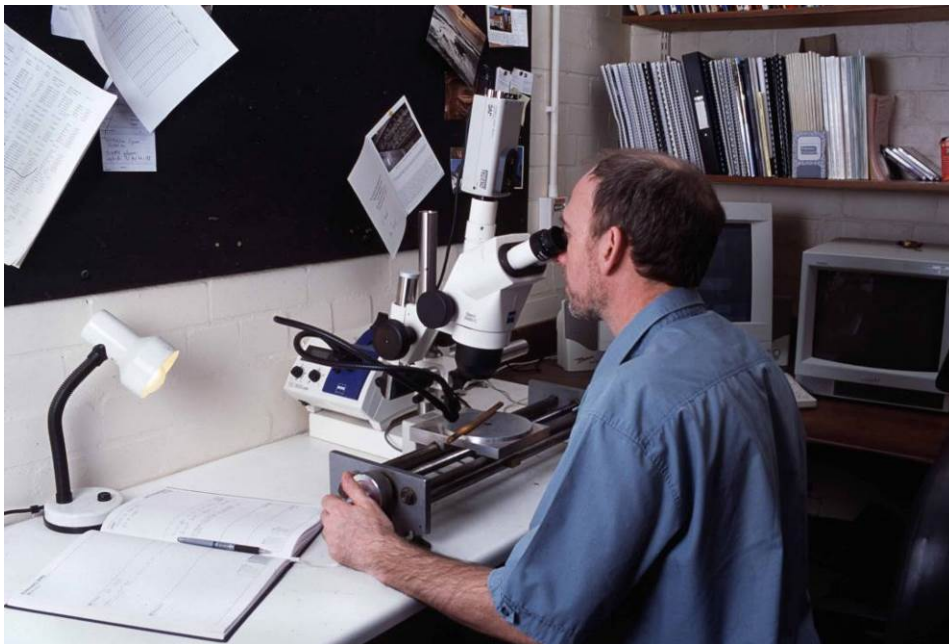
Figure A3: Measuring ring widths under a microscope. The microscope is fixed while the sample is on a moving platform. The total sequence of widths is measured twice to ensure that an error has not been made. This type of apparatus is needed to process a large number of samples on a regular basis

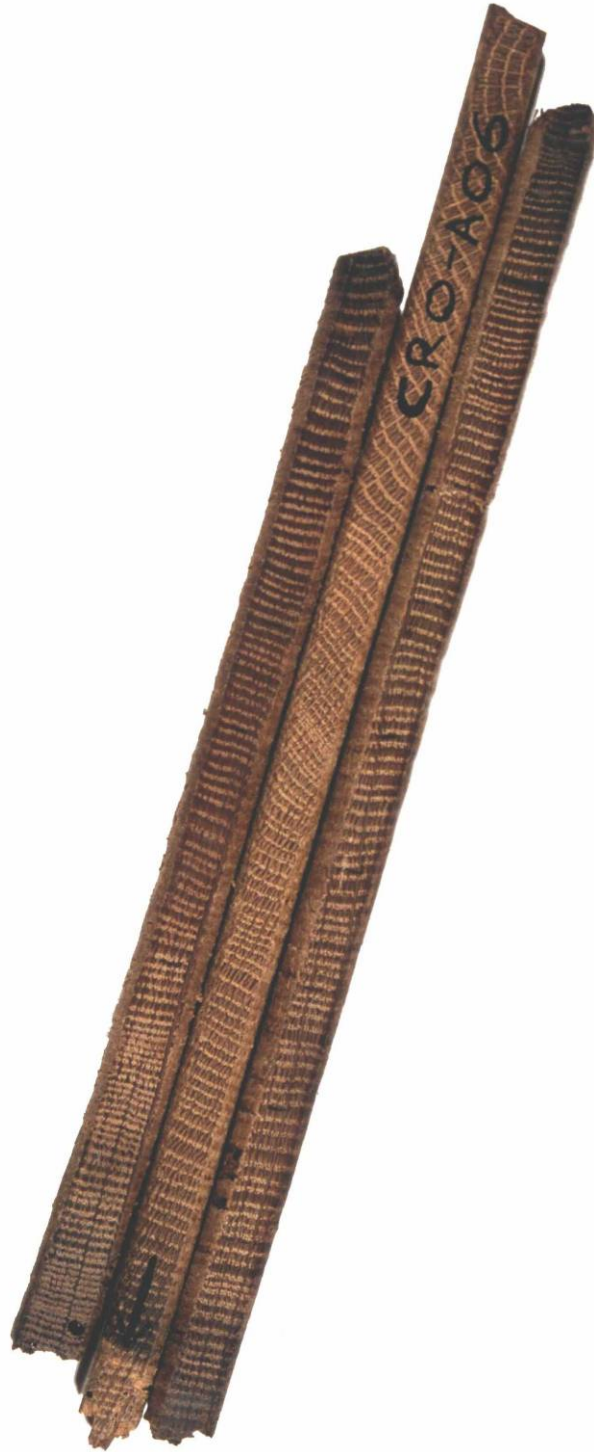
Figure A4: Three cores from timbers in a building. They come from trees growing at the same time. Notice that, although the sequences of widths look similar, they are not identical. This is typical
