Fort Cumberland, Portsmouth  
EXCAVATION ABOVE CASEMATES 36 AND 37

Paddy O'Hara

Fort Cumberland is a bastioned trace fort built between 1782 and 1812 at Eastney Spit. The Fort commands the mouth of Langstone Harbour and is in the care of the Secretary of State, and is managed on her behalf by English Heritage. This note describes the results of work undertaken on the rampart above Casemate 36 and 37, designed to understand the cause of long standing water ingress into the casemates of the curtain wall.

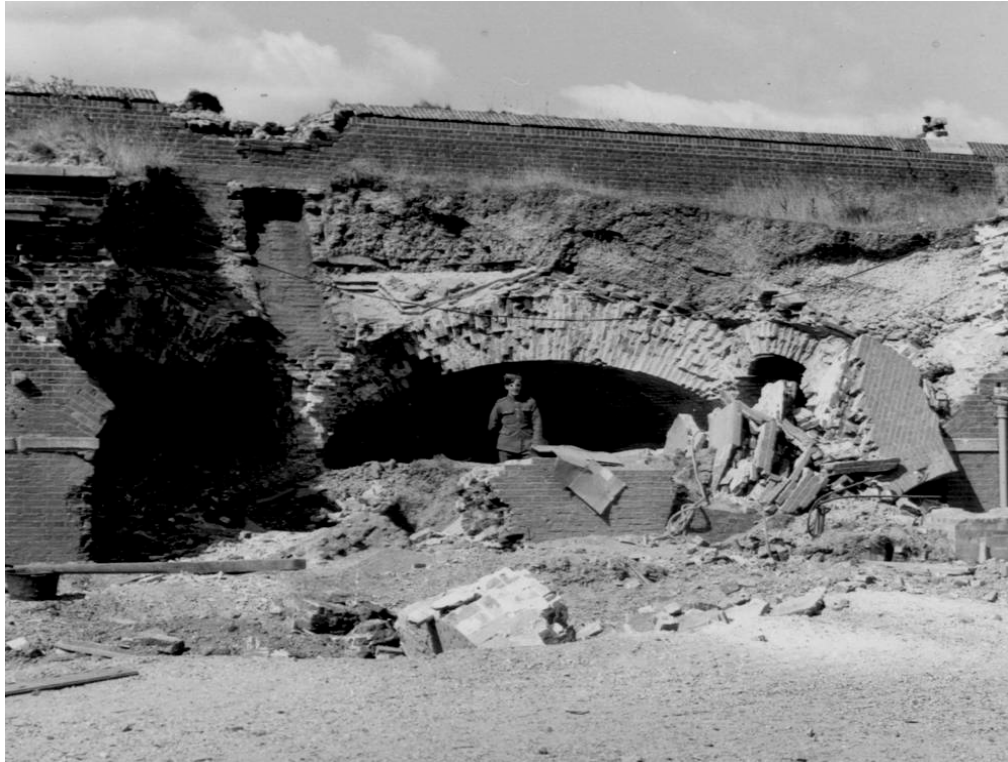
On the 26<sup>th</sup> August 1940 Fort Cumberland was hit by 78 bombs as Luftwaffe bombers headed back across the channel. This resulted in the destruction of two air raid proofed casemates on the Land Curtain with the loss of eight lives and considerable damage to the surrounding ramparts.

The ramparts above casemates 38-43 were similarly damaged and were repaired with concrete slabs capped with a waterproof membrane.

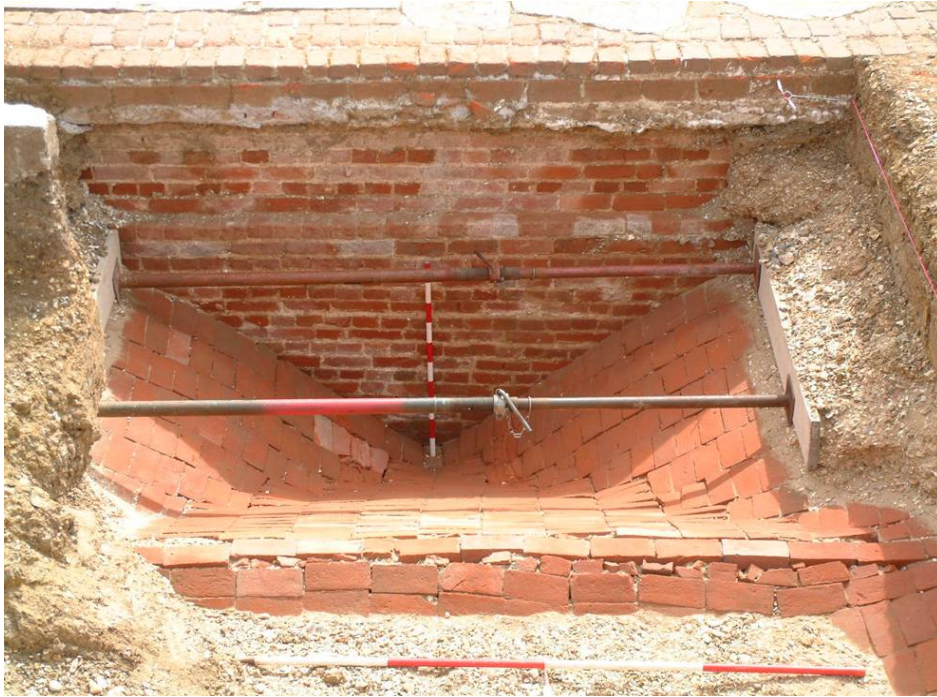
The connecting passageway roof dips south whilst the opposing casemate roofs 36 and 37 dip east and west respectively. The resulting hopper shaped feature is closed off by the brick revetment wall that carries the line of the front face of the casemate. The wall rises from the lowest point of the roof to a height of 1.2m at which point there is a scarcement where the brickwork steps in 0.1m it rises a further 0.37m before stepping out to its original width 1.06m in its final five courses of brickwork. The parade ground face is enhanced a single course of Portland Purbeck Limestone slabs laid flat form a plat that runs the length of the curtain wall. The slabs are tooled to present a decorative milled edge.

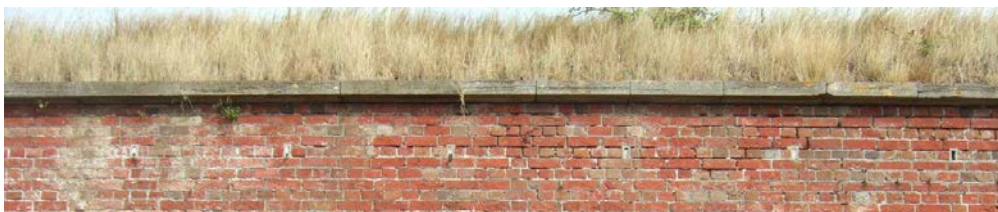
In order to gain access to the drainage run in the valley between the two casemates it was necessary to empty this large hopper shaped structure of its fill of beach shingle. The beach shingle lay directly on top of un-mortared roofs. The roofs were constructed of a bright red soft brick laid on end, their integrity of the structure dependent on the weight of the brick above to key the whole together. The sponsor's agent made a small observation hole in the westerly facing roof of casemate 37 by removing four of the roof bricks. This revealed that the roof was supported on tightly spaced rows of brick on edge of a similar make to those of the roof. These ribs sat on and ran parallel up the sides of a second pitched roof which had been waterproofed with a skim of Portland cement. The valley

gutter associated with this second roof feeds the weep hole which issues into the water hoods on the casemate wall.

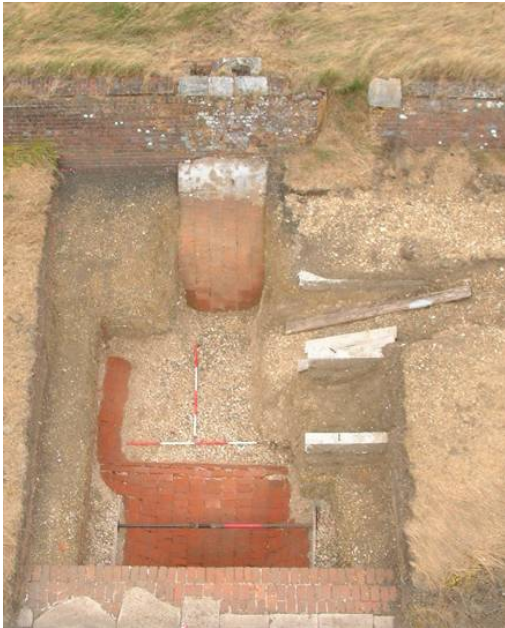
Between each casemate there is an un-mortared brickwork counterfort 1.4m wide which is built against the rampart wall for additional support. As built it terminated below the level of the banquette and is not visible against the rampart. Each casemate has the potential for a fire grate on either side wall and the flues are angled from the grate to enter the counterfort. The flues are then

carried to the top of the counterfort where they angle again into the parapet wall to rise vertically for a further 0.85m within a rectangle of brickwork to the top of the parapet wall. Their position on the parapet wall is picked out by means of three laid chamfered blocks of Purbeck Portland Limestone it is likely that the brickwork box too was covered by Purbeck Portland slabs cut to accommodate the insertion of ceramic chimney pots.

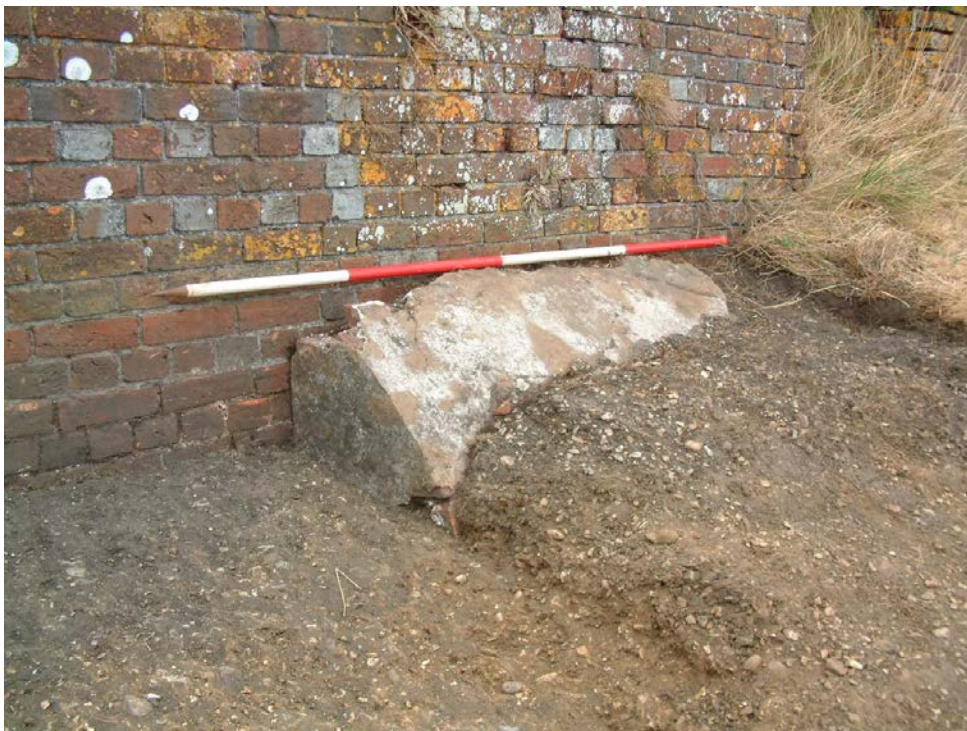
It was clear from excavation that the upper body of the counterfort was skimmed in a protective Portland cement mix, this has deteriorated over time and the brickwork close to the surface is vulnerable to the elements. The limestone capping at the top of the parapet had failed at some point as this had been replaced by a C20 coarse mortar. Sometime after WW2 the chimney pots were removed leaving a scar in the mortar housing. In addition it can be seen that the flue lining has broken away exposing the brickwork. Damage is further exacerbated as plant growth takes hold in the bricks interstices lower down the throat of the flue. The ramparts of the fort are particularly exposed to the prevailing south westerly winds.

This investigation strongly suggests that the problem of water ingress is not one of penetration through the various bombproofing elements above the casemates. Instead it seems highly probable that rainwater runs down the interior of the flue casing, soaking into the porous brick and in time compromising the interior of the casemate.

A simple remedy would be to make waterproof the mortar covered box and to reinstate ceramic pots local Fareham chimney pots (as the original fort would have had) have been used in conservation work elsewhere in the Fort and are still available. A further measure would be to make good the protective skim on the top of the counterfort and to seal off any gaps between it and the rampart. Many of the casemates have been little used since WW2, and a new use would greatly help their conservation it is to be hoped that in part this excavation can help in that endeavour.
