# The Stockton & Darlington Railway Carriage Works, Darlington: Historic Building Investigation and Assessment of Significance

## S&DR CARRIAGE WORKS, DARLINGTON

### HISTORIC BUILDING INVESTIGATION AND ASSESSMENT OF SIGNIFICANCE

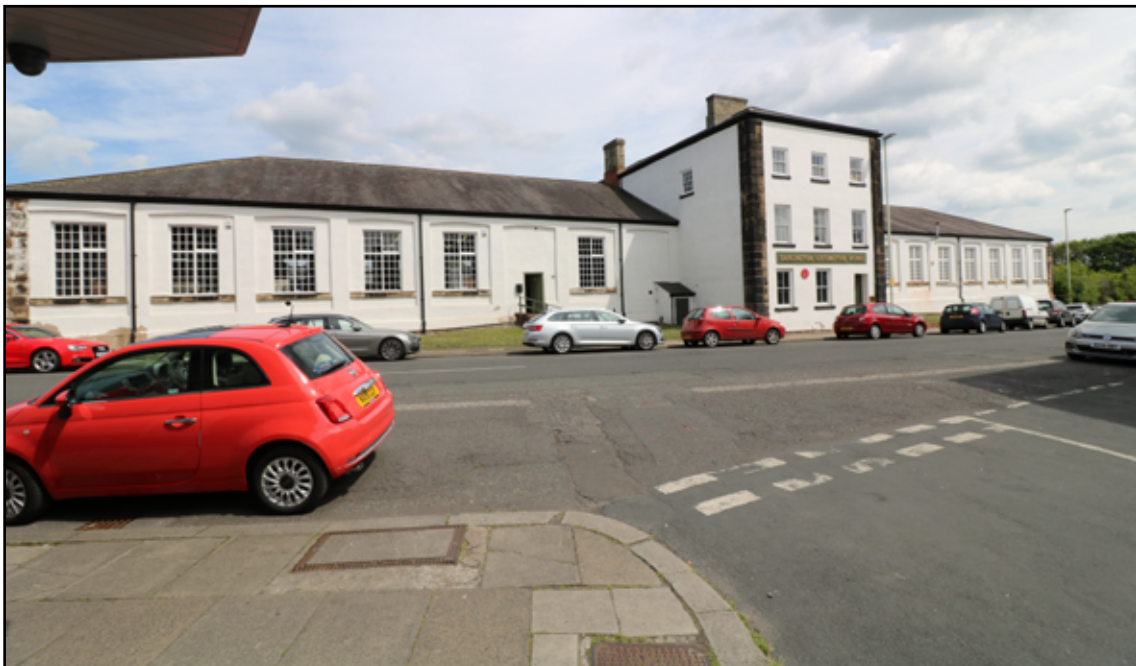
Figure 2. West elevation facing Hopetown Lane.

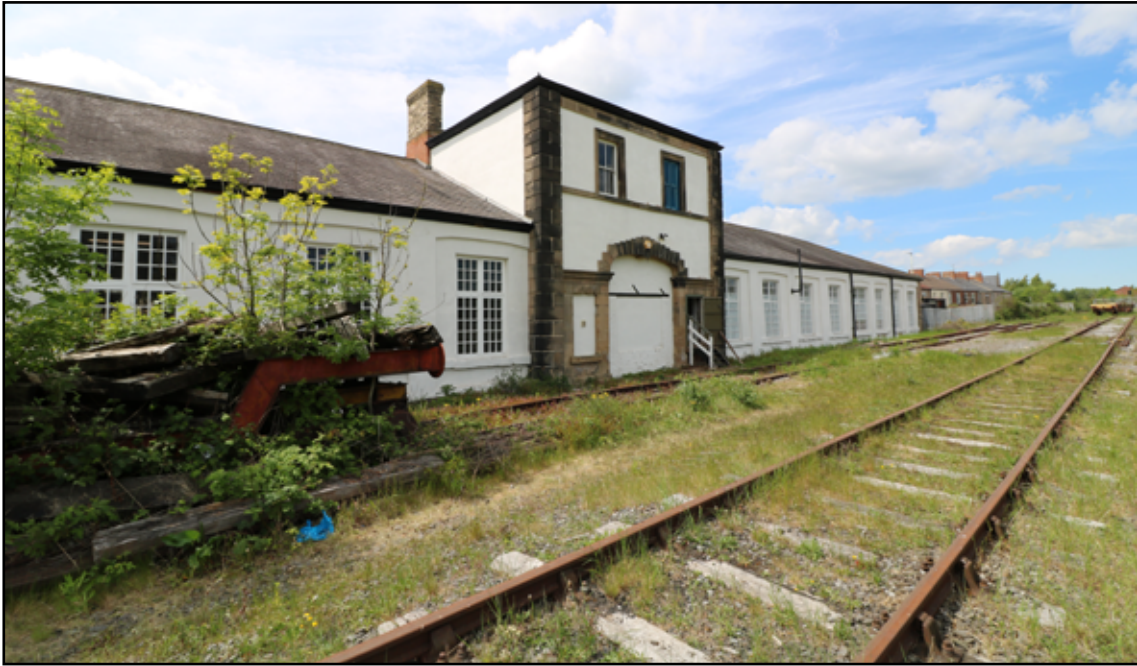
Figure 3. East elevation.

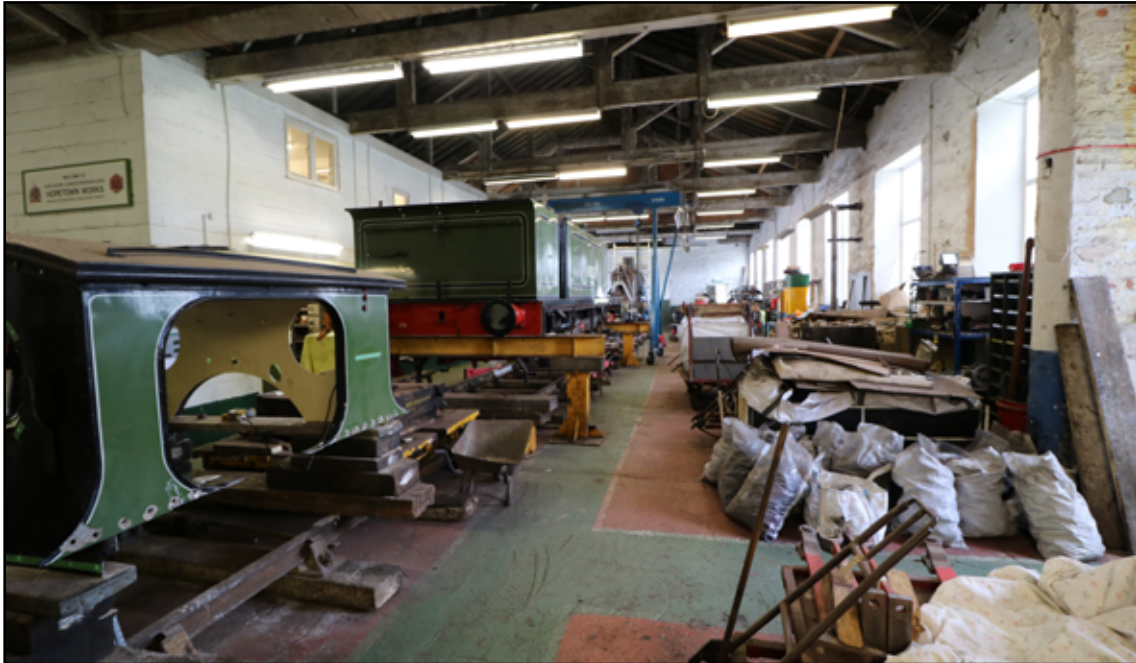
Figure 4. Interior of the north workshop, looking north.

Internally, the two workshops are large open spaces, open to the roof rafters and simply plastered and finished in masonry paint. Both have concrete floors from later phases of adaptation. The units are divided by a modern stud wall, with a lower floor level in the south workshop. Both units possess modern blockwork structures which incorporate facilities and storerooms. The central block within the workshops is of two storeys, with a second floor that was vacant at the time of survey. A disused staircase formerly gave access from the workshop area directly to the first floor. The three-storey element of this block which faces Hopetown Lane has one room per floor accessed via a winding staircase.

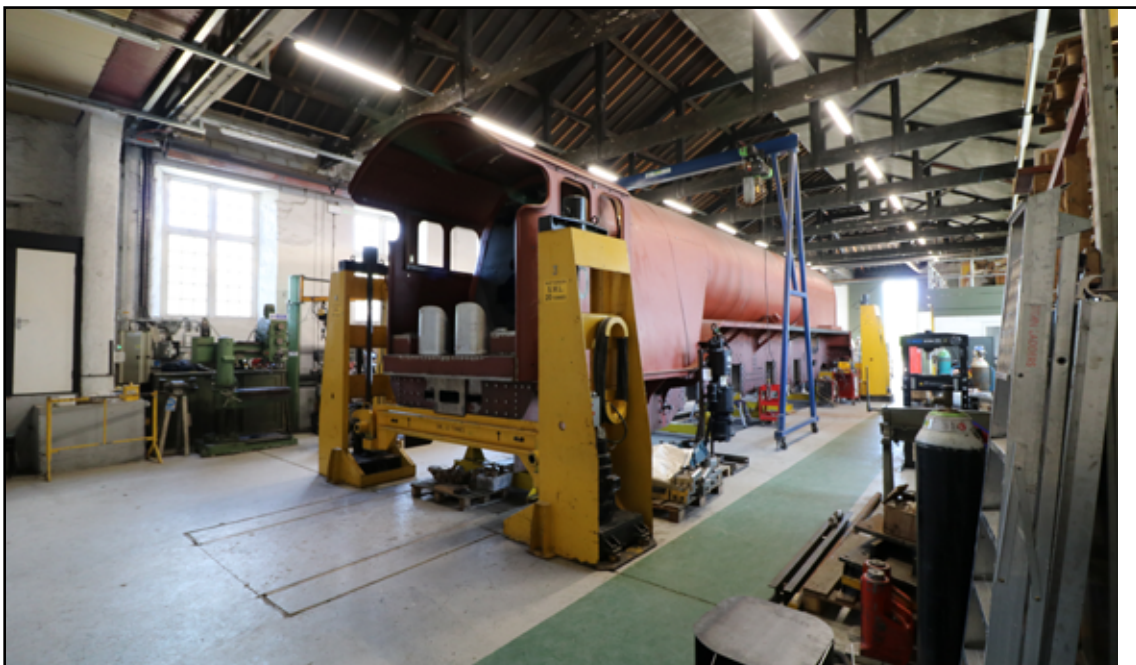
Figure 5. The south workshop, looking south.

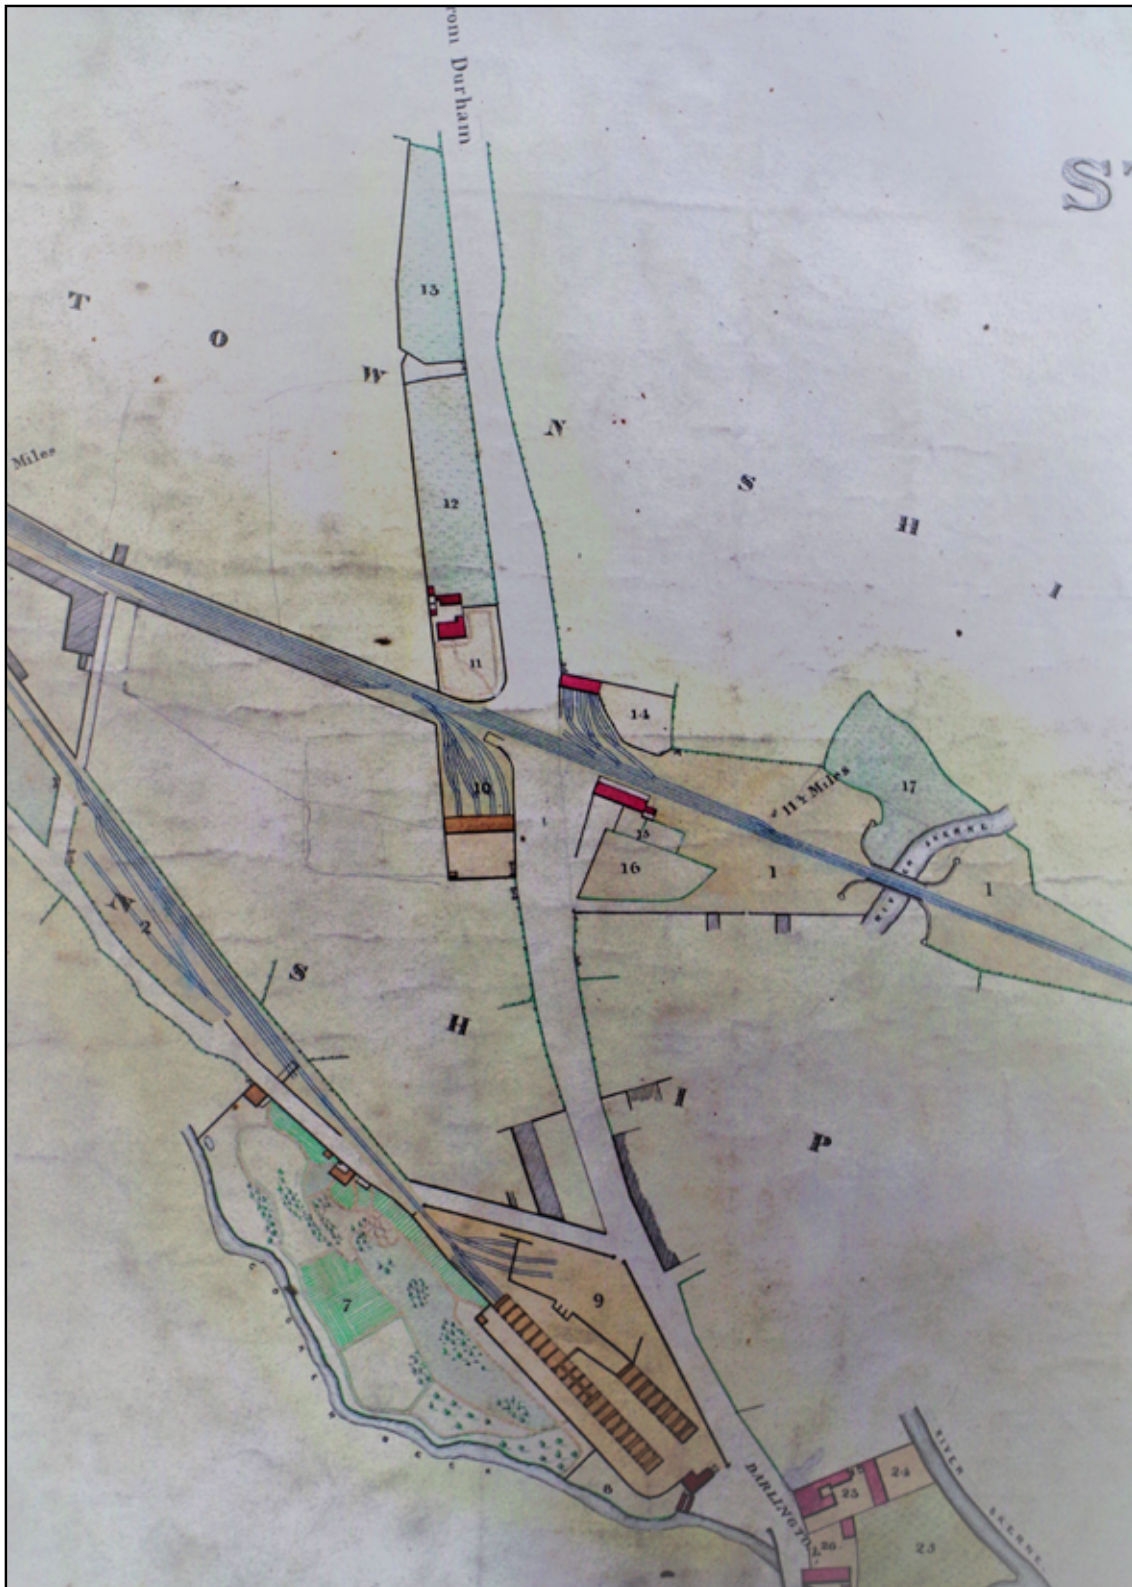
Figure 7. The Dixon plan of 1839 showing the North Road site. The station has yet to be built, but the Goods Depot lies to the west of North Road, and Kitching's Foundry can just be seen further to the west. A rectangular building claimed to have been an early railway works lies to the left of No.14 on the north-west side of North Road. The future site of the Carriage Works lies to the south of the foundry. Source: Archaeo-Environment Ltd. Reproduced by kind permission of The National Archives, ref. RAIL 1037/456.

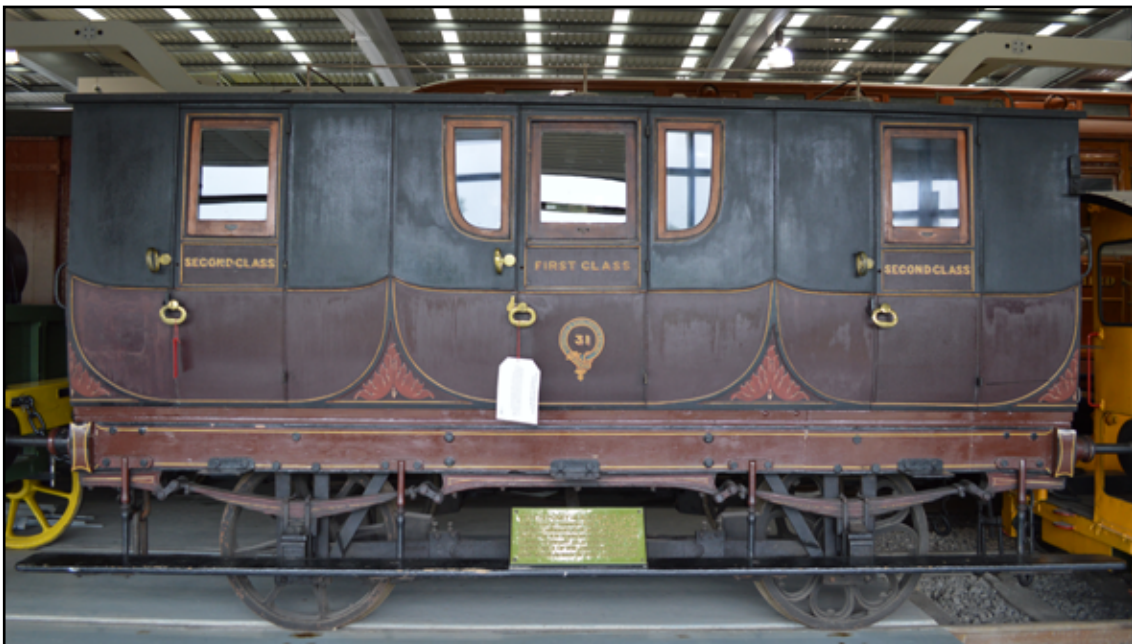
Figure 8. S&DR Passenger Carriage No.31 constructed in 1846 (Draco2008, Wikimedia Commons: CC-by-2.0). [https://commons.wikimedia.org/wiki/File:Stockton\\_and\\_Darlington\\_Railway\\_carriage\\_\(14035032105\).jpg](https://commons.wikimedia.org/wiki/File:Stockton_and_Darlington_Railway_carriage_(14035032105).jpg)

The earliest carriage built for the S&DR to survive from this period was built in 1846 (figure 8). Believed to be the oldest in the world it is preserved in the railway museum 'Locomotion' in Shildon. Built by Messrs Horner and Wilkinson at their works in Commercial Street in Darlington it cost the S&DR £230,<sup>12</sup> and is displayed in the distinctive company livery of dark-red or 'crimson lake'.<sup>13</sup> It is a composite coach with a first-class compartment flanked by two second class compartments. Although a rectangular timber box mounted on a continuous iron under-frame, the compartments are defined by curved gilded mouldings, giving the impression of the familiar stagecoach form; the first-class compartment, however, is both larger, better lit and more luxuriously finished. Metal railings allowed luggage to be carried on the roof, and a seat was provided for a guard who would descend when the train was stationary to apply the brakes.<sup>14</sup>

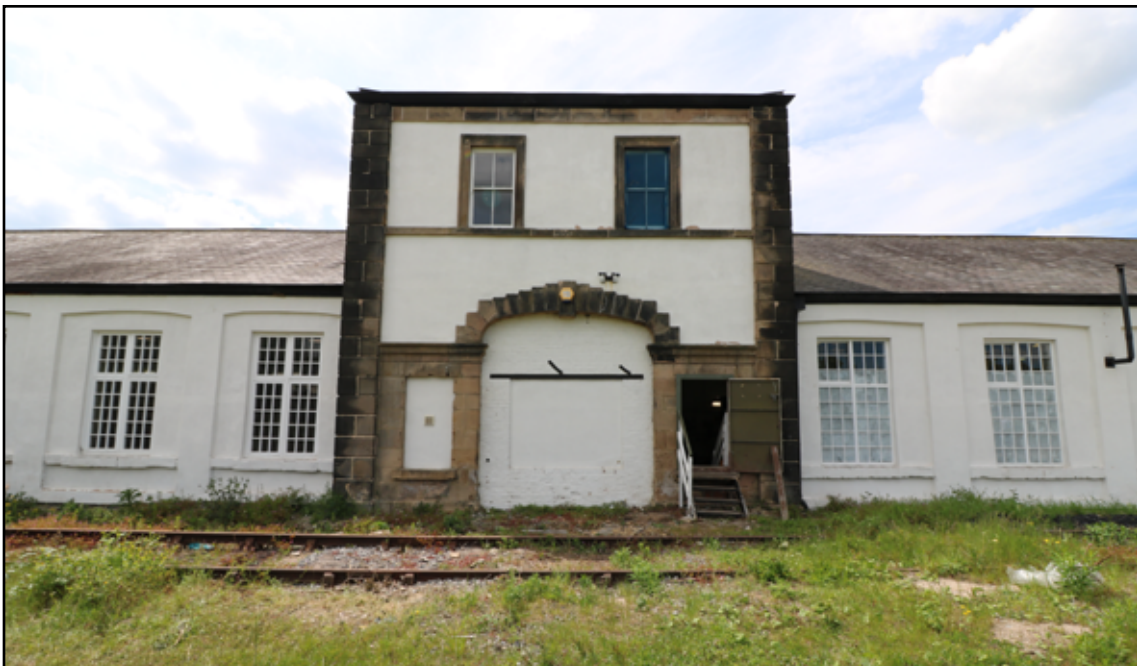
Figure 12. Central block, east elevation today.

The central block of two storeys retains a ground floor of ashlar and comprises a central segmental-arched entrance with stepped voussoirs and a dropped keystone (figure 12). The archway is now bricked up and painted; a central opening within the blocking – presumably once a window - has been filled in more recently with breeze block (visible internally - see figure 13). The archway springs from a finely moulded stone impost band. It is flanked by two former window openings; on the left the opening is legible but blocked – it retains its stone cill - and, on the right, the opening has been converted into a modern doorway accessed by timber steps. Sparkes' drawing of this elevation indicates that the central archway may have contained a pair of timber doors, flanked by windows with multiple lights. Evidence of doors could not be found but the archway is still clearly visible internally.

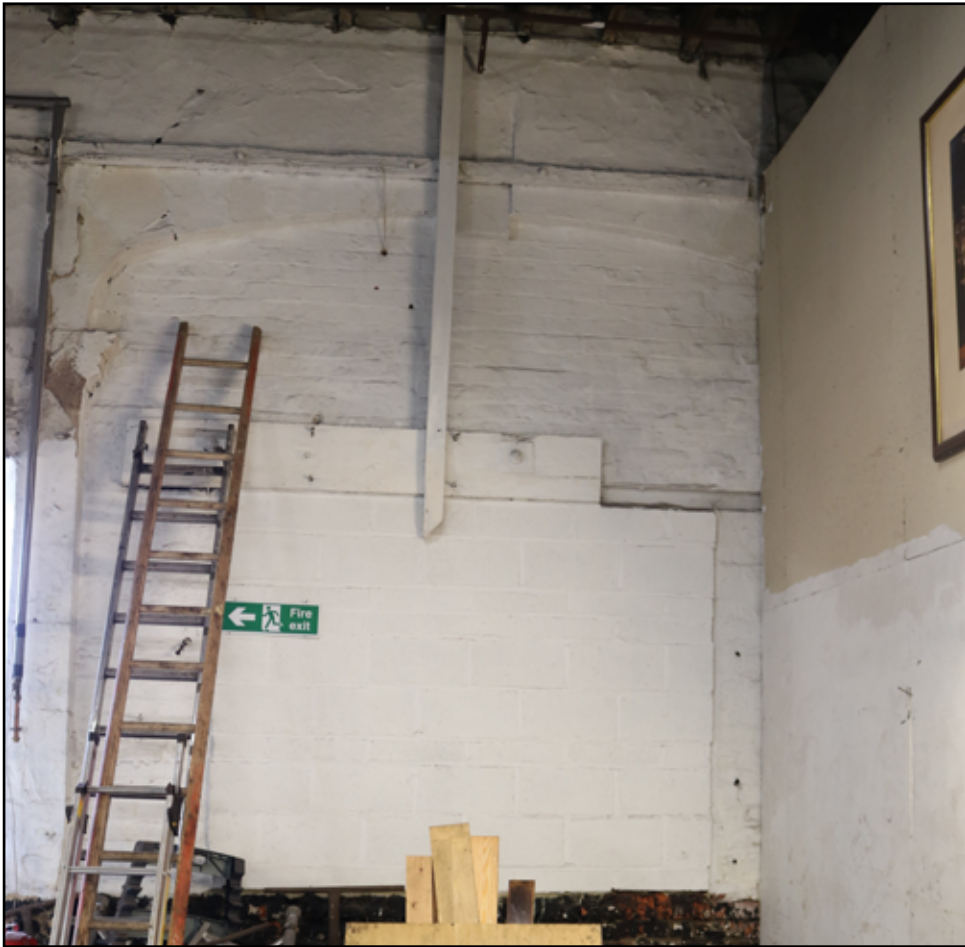
Figure 13. Archway, now blocked, (looking east) as seen in G2.

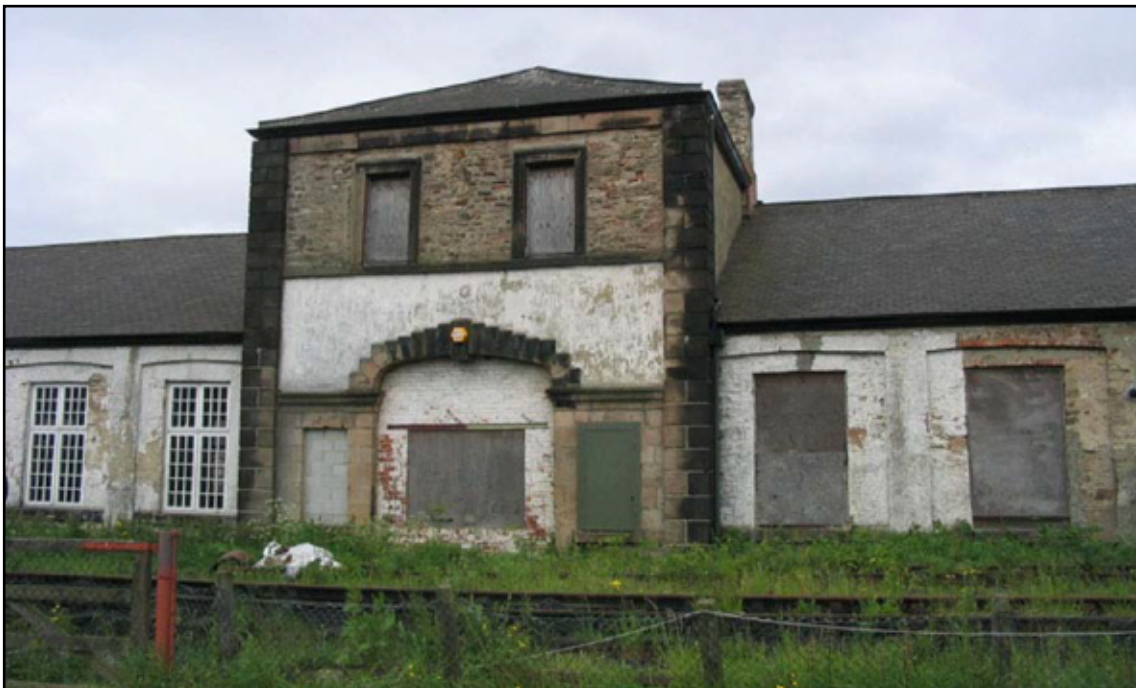
Figure 14. Central block, east elevation in 2004 (Grenville *et al* 2004, Fig.141, 230). Reproduced by kind permission of Department of Archaeology, University of York.

The first-floor windows are modern two-over-two sash windows with moulded stone architraves which rest upon a plain cill band. From the 1853 drawing, it appears the architect may have originally intended them to contain mullions and transoms with multiple panes. No evidence could be found for these, but in the early 2000s Grenville *et al* 2004 recorded the windows as boarded up but probably historically of twelve panes.<sup>26</sup> The first-floor elevation is rendered in cement but images from 2004 show this to be rendered only below the sill band (figure 14).

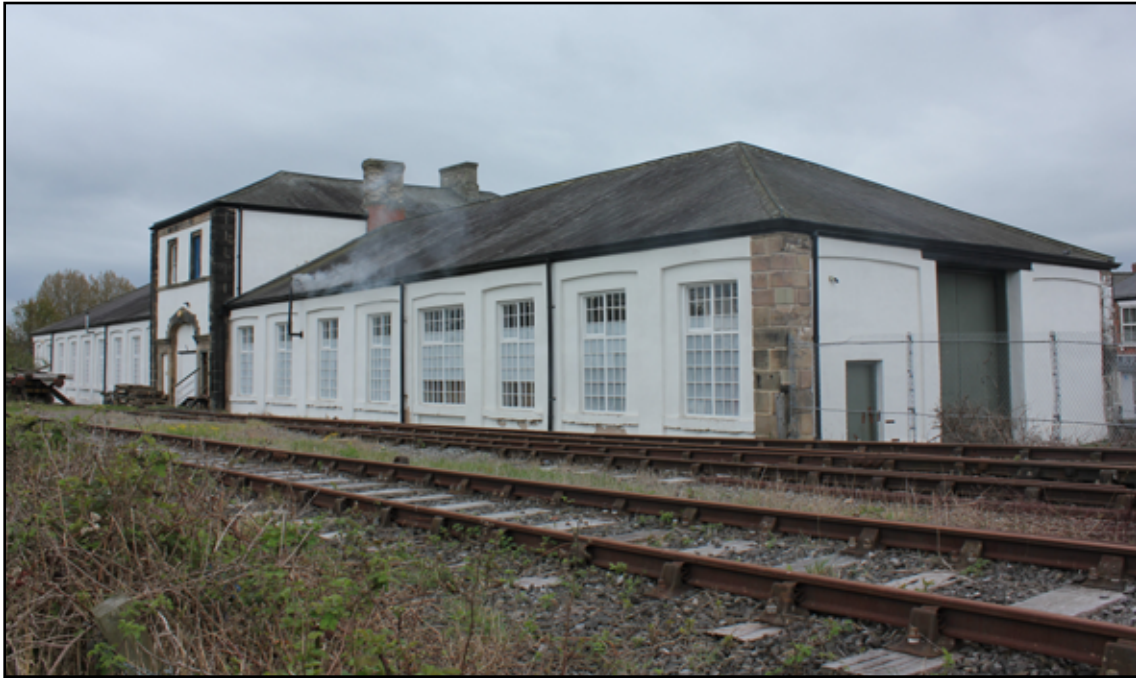
Figure 15. East Elevation

The flanking elevations of the workshop are also recognisable from the 1853 drawing (figure 15). The present arrangement of nine bays to the south and eight bays to the north range corresponds to Sparkes' drawing. Similar to the 1853 drawing, each bay consists of a pier supporting a shallow segmental arch, within which is generally set an opening. Eight of the nine arched recesses to the southern range contain modern multi-paned casement windows with a stone cill. The most southerly bay is blind. Internally, the wall is concealed behind shelving, but in an image from the 1990s an opening in this position is shown to have been blocked in cement breeze (figure 56). This concurs with Sparkes' plan and elevation showing an entrance door within this bay. It is unclear from the fabric evidence if the adjacent bay was always fenestrated as it is today, or originally intended to be blind to take the internal cross wall as shown in the 1853 drawing. Again, no evidence of the cross wall could be traced internally, partly due to the location of modern structures and also because of the layers of plaster and paint.

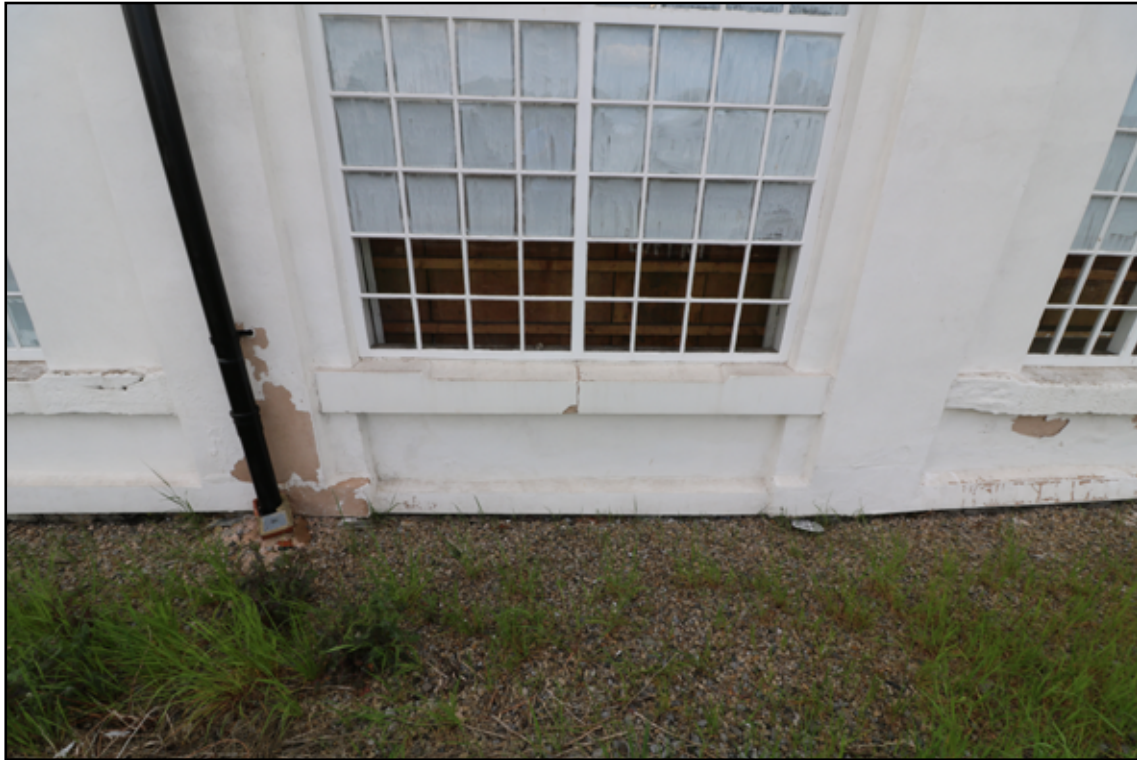
Figure 16. East elevation of the north workshop. Former doorway with modern cill and interrupted plinth below.

A similar external arrangement is found in the eight-bay north range. The fourth bay from the northern end is slightly wider, however, with a modern inserted cill and interrupted plinth below. Internally the window is concealed and could not be inspected, but the evidence concurs with the 1853 elevation and plan suggesting this bay originally contained a door to access the workshop (figure 16).

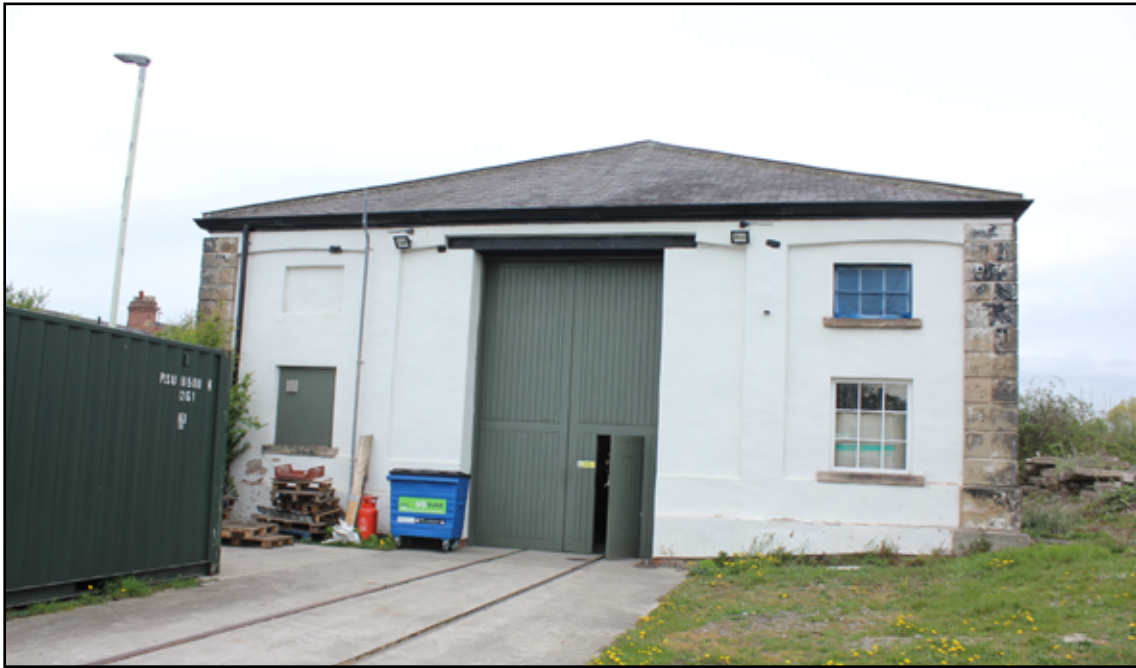
Figure 17. South external elevation.

Elements of the north and south elevations also appear to be from the earliest phase. The south elevation is currently three bays wide with windows set within recessed arches in bays one and three (figure 17). The dressed stone quoins or piers are from the first phase of construction and at some stage appear to have received an application of white paint. The full-height central timber doors are presumed to be the result of several later phases of alteration as they awkwardly cut the curving heads of two arched recesses which can be clearly seen either side of the modern lintel. The widths of the arched recesses and of their piers support the cartographic evidence that this was formerly a four-bay elevation. However, as with the external evidence which has been obscured by cement render, internally the evidence of lost windows could not be traced due to the roughly plastered rubble stone walls and painted finish (figure 17).

On the left of the central doorway is a boarded window with stone cill (behind which a modern timber window frame exists) and above is a smaller blind window, without cill, suggesting it was always intended to be blind. To the right of the central doorway is a timber window with nine panes and a stone cill and above is a smaller window of six panes with a stone cill. The window frames are modern but the cills appear to be historic. The Ordnance Survey of 1854 indicates a doorway was set into the first bay from the left, now set with a boarded-up window. Internally, this section of wall has a modern lining and could not be inspected to confirm the evidence of a former doorway.

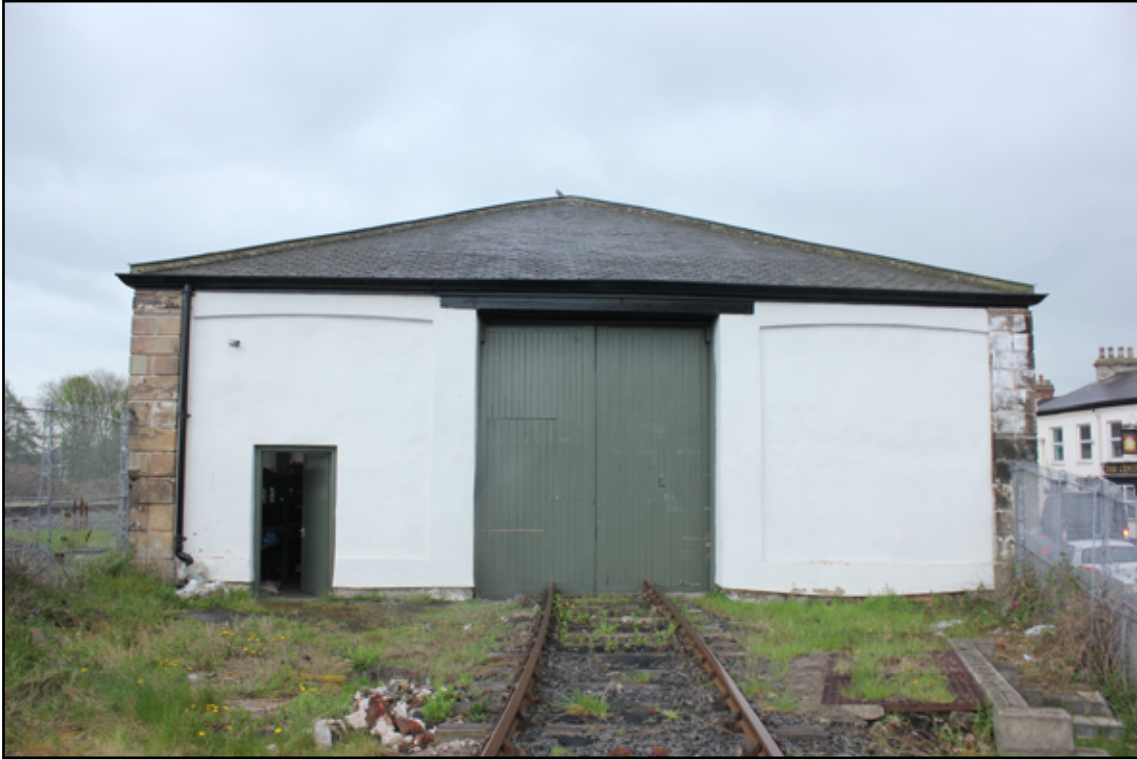
Figure 19. North elevation.

The north elevation is of three arched-recessed bays (figure 18). The central access doorway is the result of a later phase of alteration, but it seems probable that the doorway to its left is from the first phase of construction. A doorway is shown in this location on the 1853 plan, and today has a timber lintel internally and is set with a modern door. An inspection of the internal wall found no other evidence of disturbances to the wall's fabric, and the tall central doorway appears to have been the only major historic intervention to this elevation (figure 19 and figure 20).

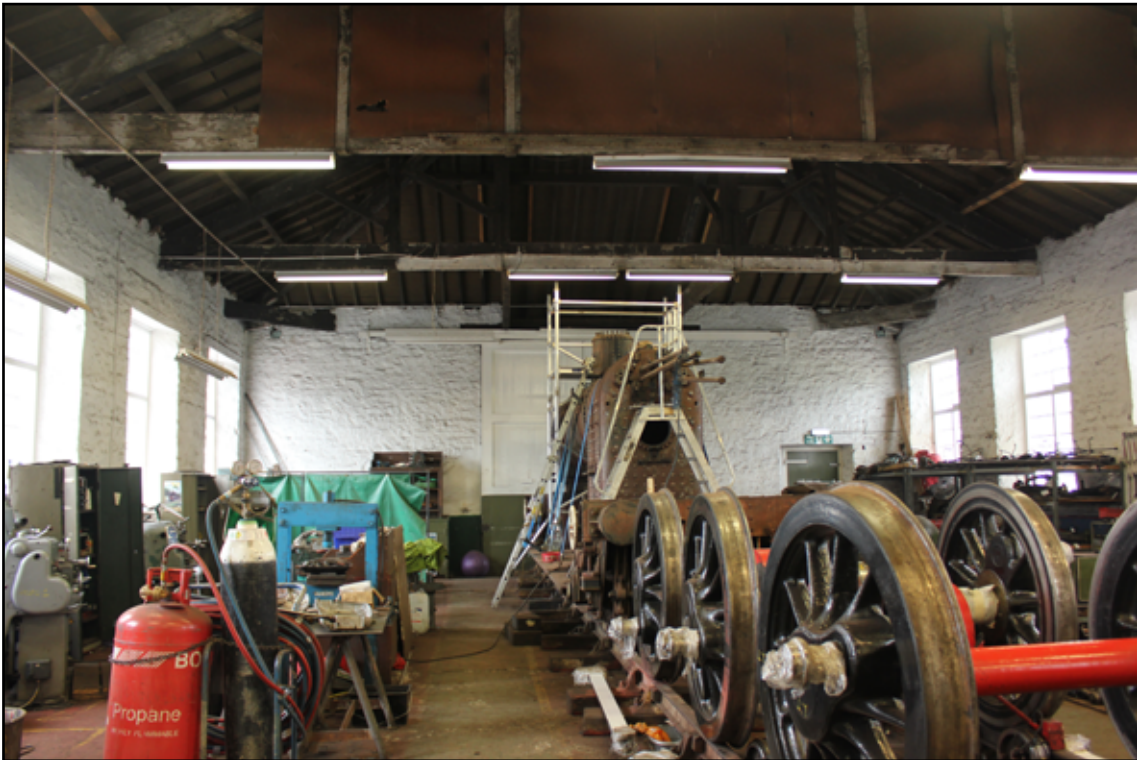
Figure 20. North wall internal elevation.

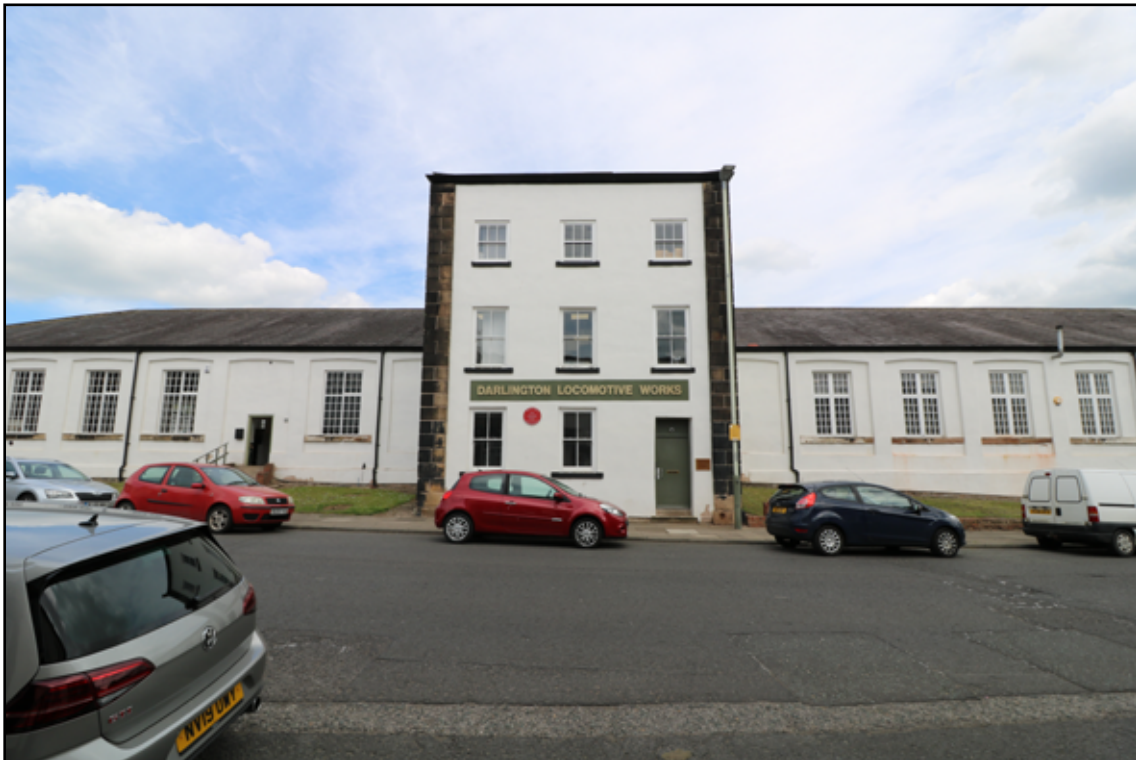
Figure 21. Central block, west elevation seen from Hopetown Lane.

The west elevation faces onto Hopetown Lane and was not depicted on the 1853 drawing. On Sparkes' plan, however, the central block is annotated as the 'Cottage' and presumed to have been living accommodation perhaps for a night watchman.<sup>27</sup> The central block is of three bays set over three storeys; three storeys are possible within this elevation due to the local topography and lower ceiling heights compared to those of the flanking workshops. The modern rendered elevation is plainly finished, with the stone corner piers as the sole embellishment. The modern single-panelled entrance door is offset to the right, as shown on the 1853 and 1854 plans, and may have historically featured an overlight.

Adjacent are a pair of two-over-two modern sashes to the ground floor, three two-over-two modern sashes to the first floor, and three three-over-three to the second floor. All windows have painted stone cills which appear to be original. A further window to the right return elevation (south) is a modern two-over-two sash which lights a staircase, whilst another modern multi-paned sash window on the north-return elevation lights a second-floor room. All timber windows are modern replacements, but all openings appear to be original to the 1853 building. In 2004, Grenville *et al* noted during a survey that the first-floor windows had formerly been fitted with four-over-four sashes, and the second floor six-over-six, which likely corresponds to their original arrangement.<sup>28</sup>

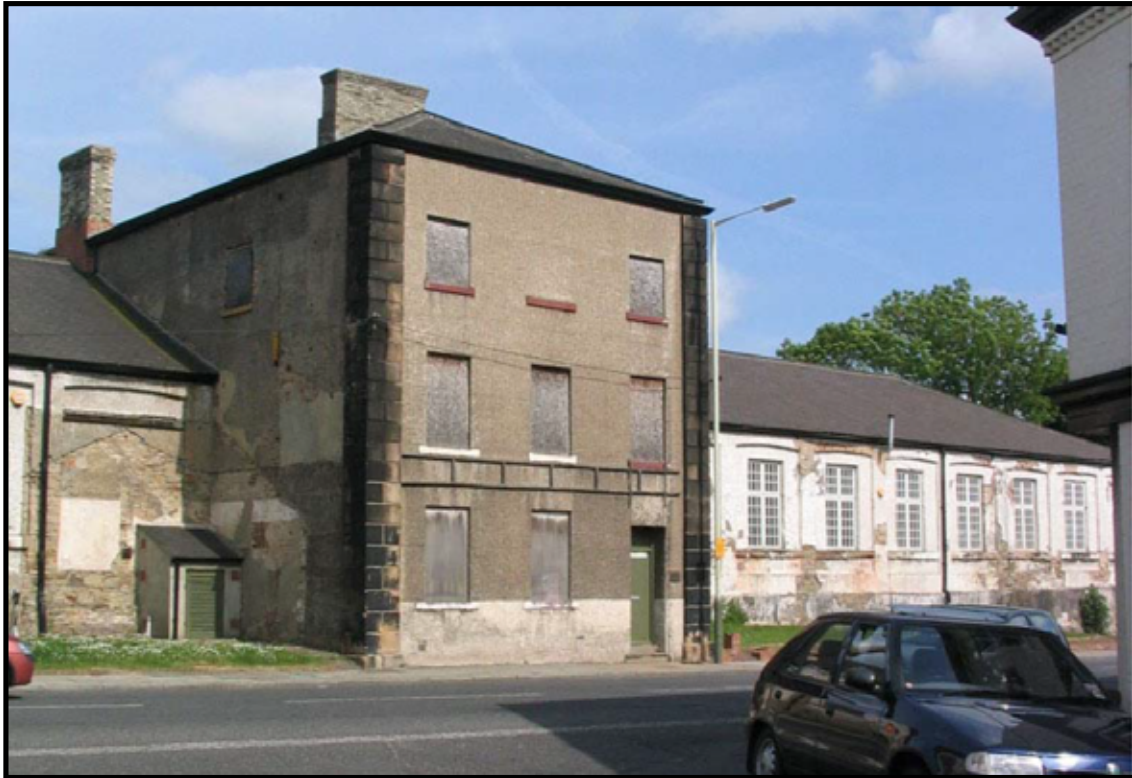
Figure 22. The Hopetown elevation in 2004 . Note to the left are the scars of various outbuildings visible in the rendered walls. (Grenville et al 2004, fig.137, 228). Reproduced by kind permission of Department of Archaeology, University of York.

The central block today is flanked by the two workshop ranges. The arrangement of arched-recessed bays set with windows with stone sills is roughly similar in both the north and south ranges and their eastern elevations, although the arrangement of openings differs slightly; a number contain blind recesses and a doorway is set in the sixth bay from the left (now containing a modern entrance door). This doorway appears to be in its original location, as it corresponds with the 1853 and 1854 OS plan. Both indicate that yards with outbuildings flanked the central block. Although there is little indication of their existence today, photographs taken before the elevations were rendered in 2015-2016 concur with the evidence and show the outline of various phases of structures, with pitched and lean-to roof lines traced in the render on the north and west elevations (figure 22).

The Ordnance Survey 1:1250 map edition of 1956, surveyed in 1953-5, continues to suggest that the building is located in a busy railway yard with a platform shown to the east (figure 52). The building is now annotated as a ‘Warehouse’ with a hoist also shown against the south elevation; hachures running away from the south wall suggest the ground surface here has been lowered, probably to facilitate road access to the gable end of the building from the gateway off Hopetown Lane. The outbuilding which may have contained a scullery and pantry in the 1850s, now appears smaller, corresponding with the evidence that several outbuildings were formerly located in this position (see figure 22). All other outbuildings have been removed.

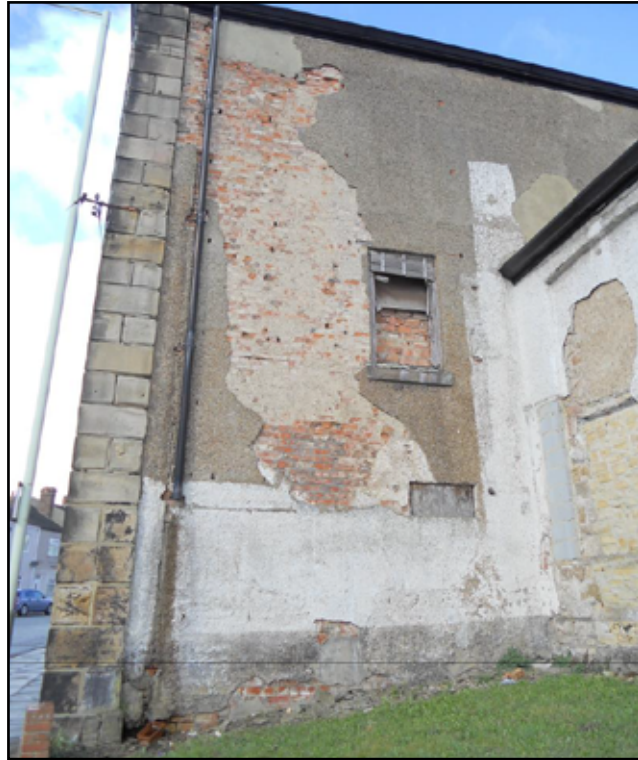
Figure 23. The south elevation of the 'Cottage' with blocked doorway to the right. Reproduced by kind permission of Head of Steam Railway Museum, Darlington.

On the south side of the 'Cottage' the evidence of an earlier service yard is limited to a blocked opening. A photograph taken before the elevation was rendered in 2015-2016 also shows the position of the doorway which had a timber lintel and had been infilled with rubble stone in a later phase of alteration (figure 23). Today, the plinth to the first bay is stepped (figure 24). Internally, however, the wall has been roughly plastered and painted, and evidence for the former doorway is no longer visible.

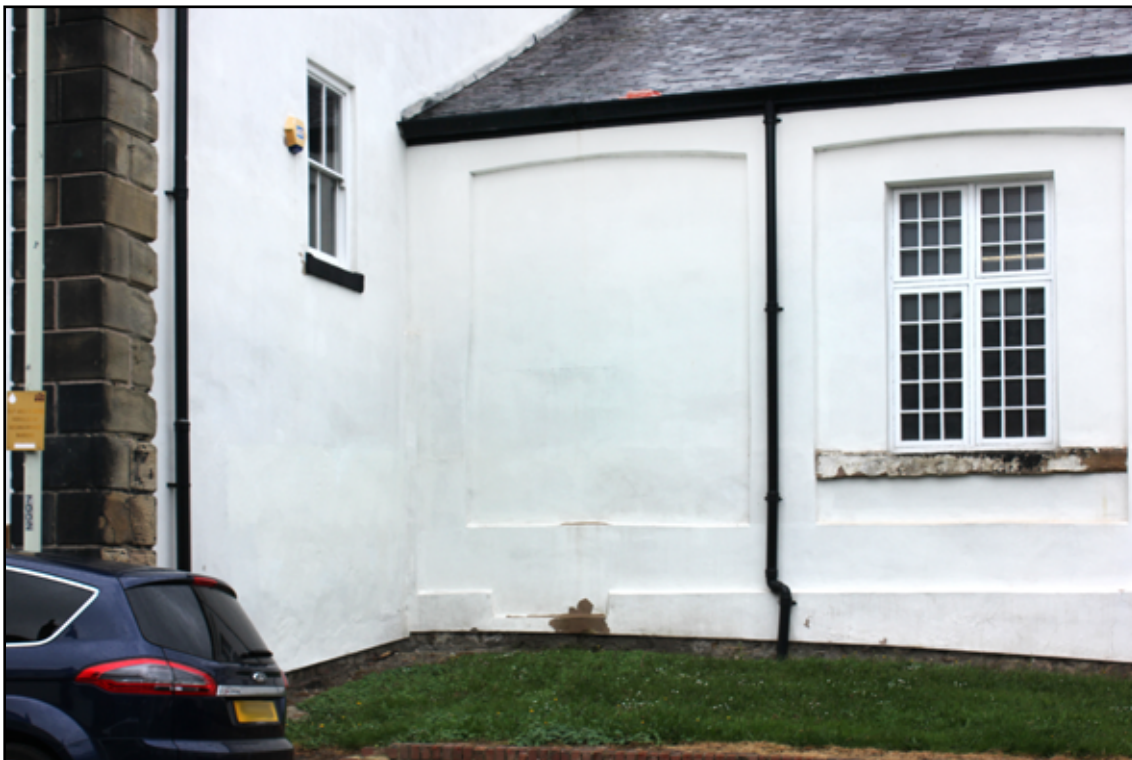
Figure 24. Stepped plinth, west elevation of the southern workshop.

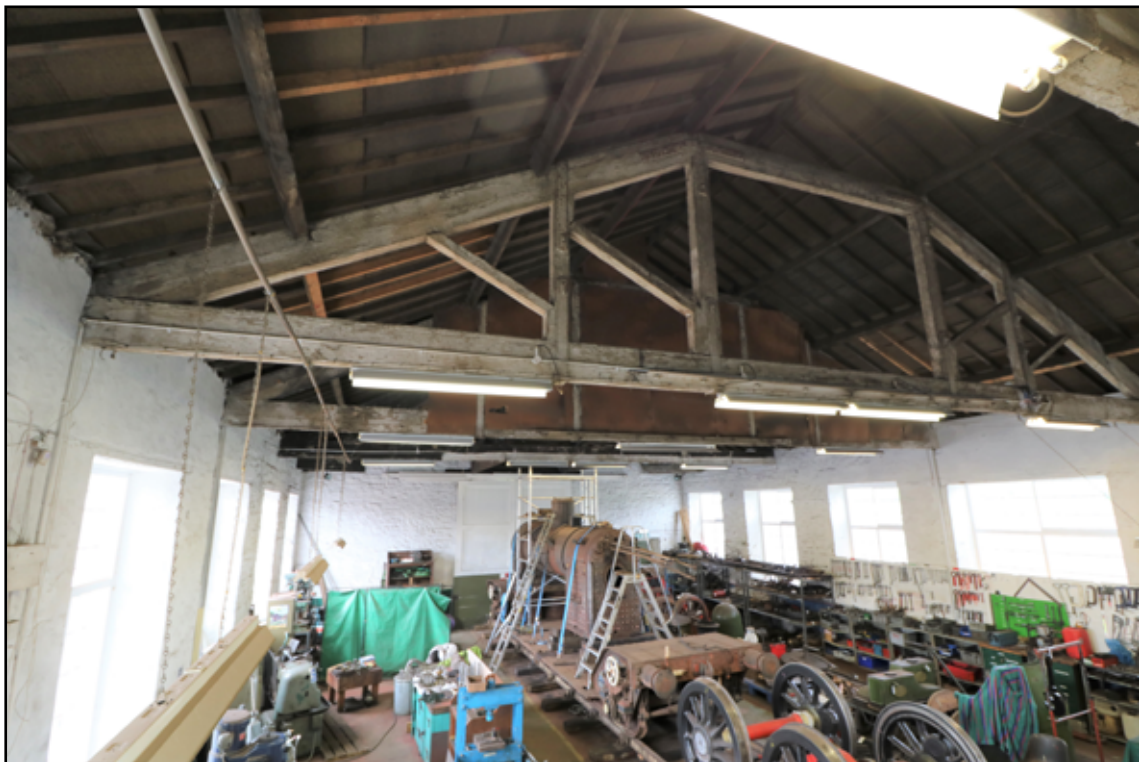
Figure 25. Interior of the north workshop.

The roof structure of the Works largely belongs to phase 1, with later repairs. In the north workshop (G3 - figure 25), the roof comprises seven bays, with the eighth (end) bay supporting the hips. The six queen-post trusses with raking struts, and princess posts also with raking struts have iron strapping and were historically whitewashed.

They support purlins which in turn carry the common rafters. Grenville *et al* 2004 also notes the similarities to the roof structure within the North Road Station train shed, which was extended by Sparkes the same year as the construction of the Carriage Works (figure 28).<sup>30</sup> The roof coverings have been replaced in a later phase of alteration and are finished in slate over sarking felt.

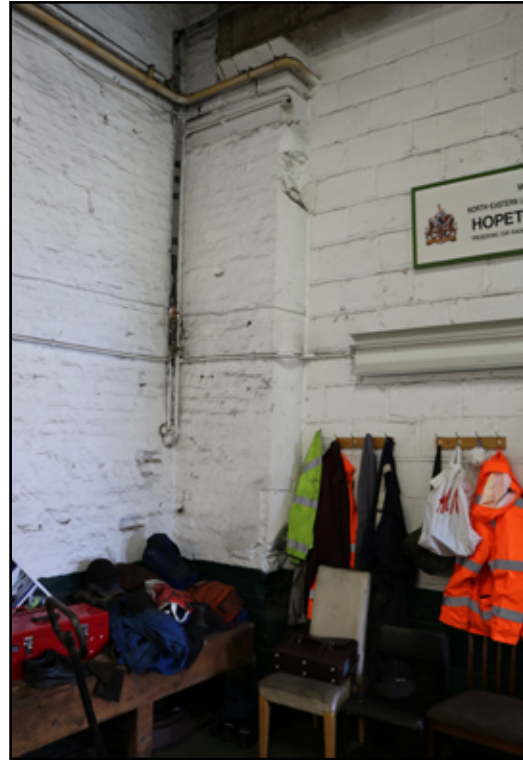
Figure 26. Wall nib with modern wall to the right.

Possible evidence of internal walls which divided the 'Repairing and Lifting Shop' from the workshop ranges, however, do exist. Four projecting brick walls-nibs are located within G2 and G5, now acting as bearings to the iron beams which span the width of the building and support the upper floor and walls (figure 26). The brick faces of the nibs are painted, and the inner faces rendered, presumably to conceal the rough face of the cut brick surface. The 1853 plan shows the brick walls set with fireplaces facing into the workshops. The large size of the chimney stacks above (which today serve two small fireplaces on either side (now blocked) on the second floor) would also support the evidence that this space was formerly subdivided – the rebuilt stacks rest upon the later iron beams, but their width suggests they were sufficient to serve two fireplaces, one within the ground floor workshops and one above (figure 27).

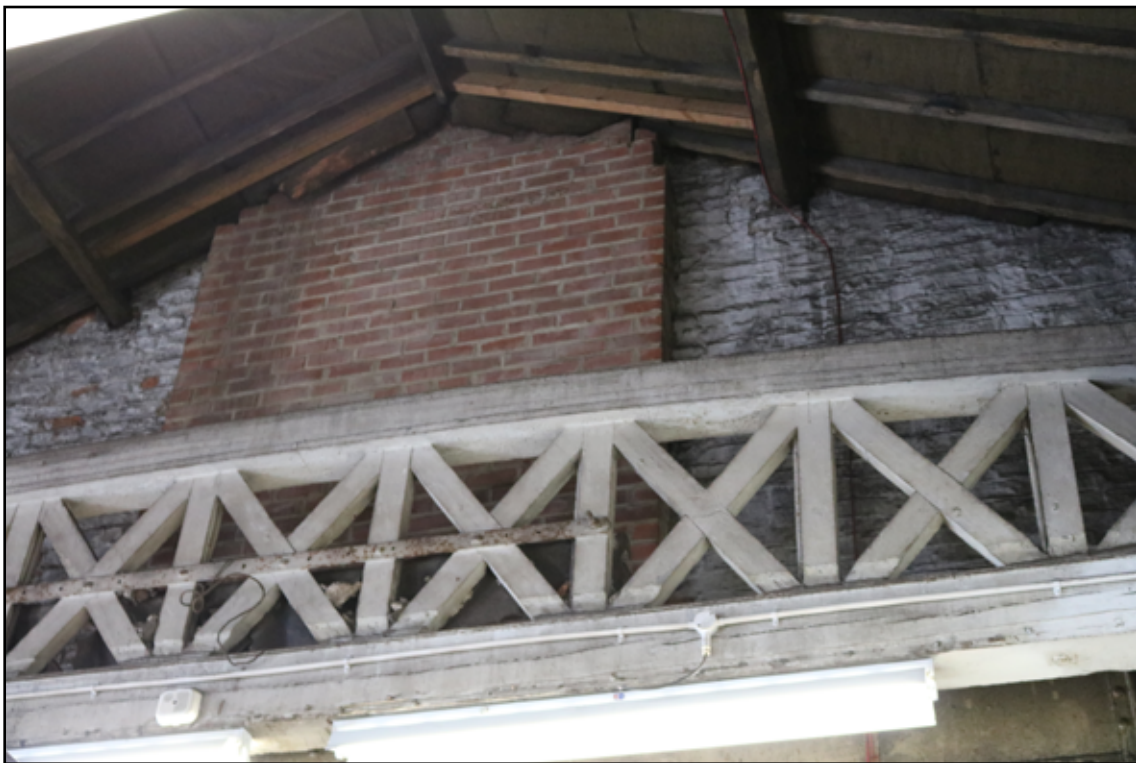
Figure 27. Chimney stack above G2 rebuilt but the original is likely to have served a fireplace to the ground floor workshop and one in S2.

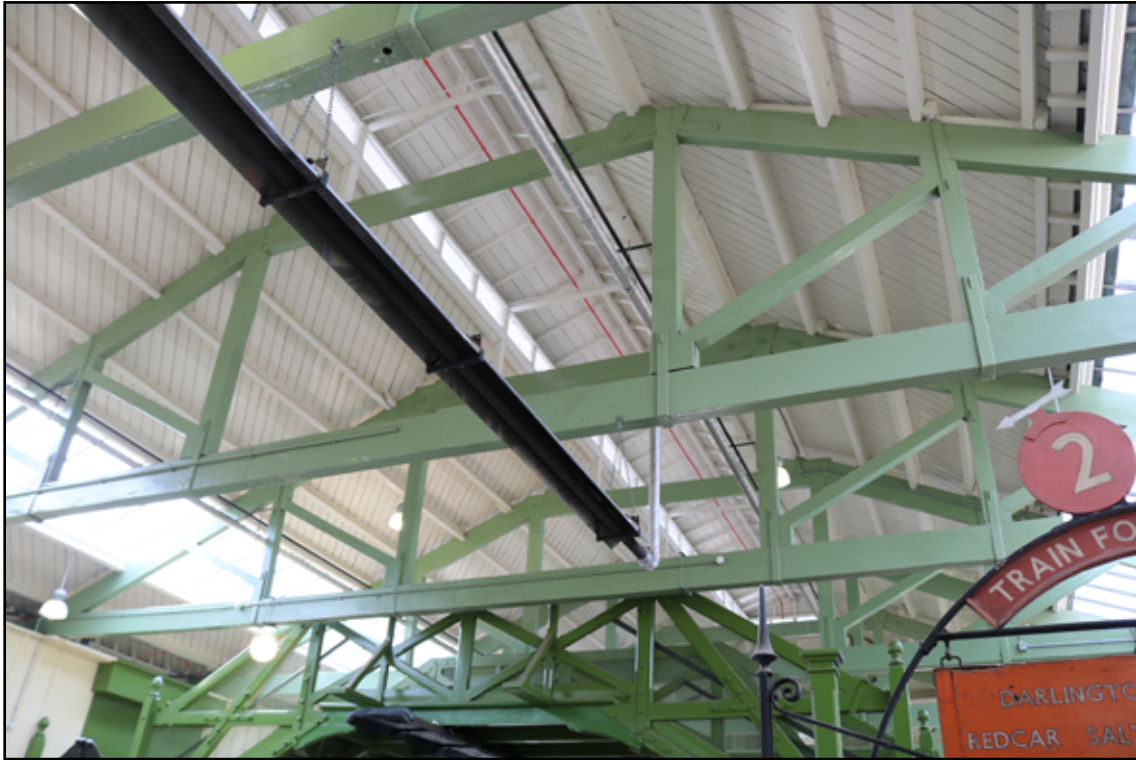
Figure 28. North Road Station roof structure.
