# The Stockton & Darlington Railway Carriage Works, Darlington: Historic Building Investigation and Assessment of Significance

## S&DR CARRIAGE WORKS, DARLINGTON

### HISTORIC BUILDING INVESTIGATION AND ASSESSMENT OF SIGNIFICANCE

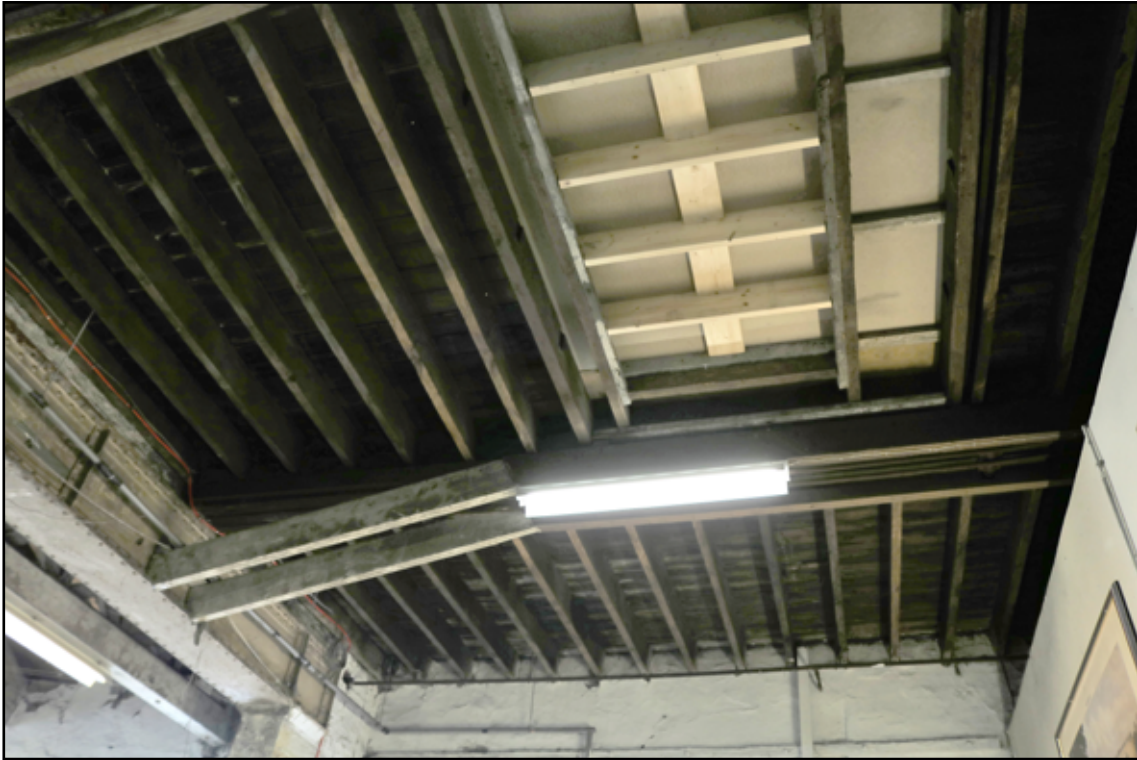
Figure 29. Hatch seen from G2.

Above the 'Repairing and Lifting Shop' in the central block is a room which retains fabric from an early phase of the building's history. Room S2 was unrestored at the time of survey and has lime-washed brick walls with a suspended timber floor, though now largely covered by modern chipboard. The underside of the floor structure shows a former hatch visible from below in room G3 with the floor strengthened by trussed timber girders (figure 28). Curiously, Grenville *et al* 2004 notes that the application of trussed girders was already considered as structurally ineffective by the mid-19th century.<sup>31</sup> Their use appears, therefore, to have been an archaic method, perhaps driven by economy.

It has been presumed that this space formed part of the Carriage Works operation and was a store for the wooden patterns and jigs which joiners used to produce standardised parts.<sup>32</sup> These may have been lowered down through the large floor hatch to the 'Repairing and Lifting shop' below. The hatch is boarded over in S2 but can be seen from G2 below (figure 29). An iron mount attached to the truss above this hole may have formed part of the lifting gear (figure 31). The existence of fireplaces would suggest the space was intended to be in constant use and may have had other uses beside mere storage (figure 32).

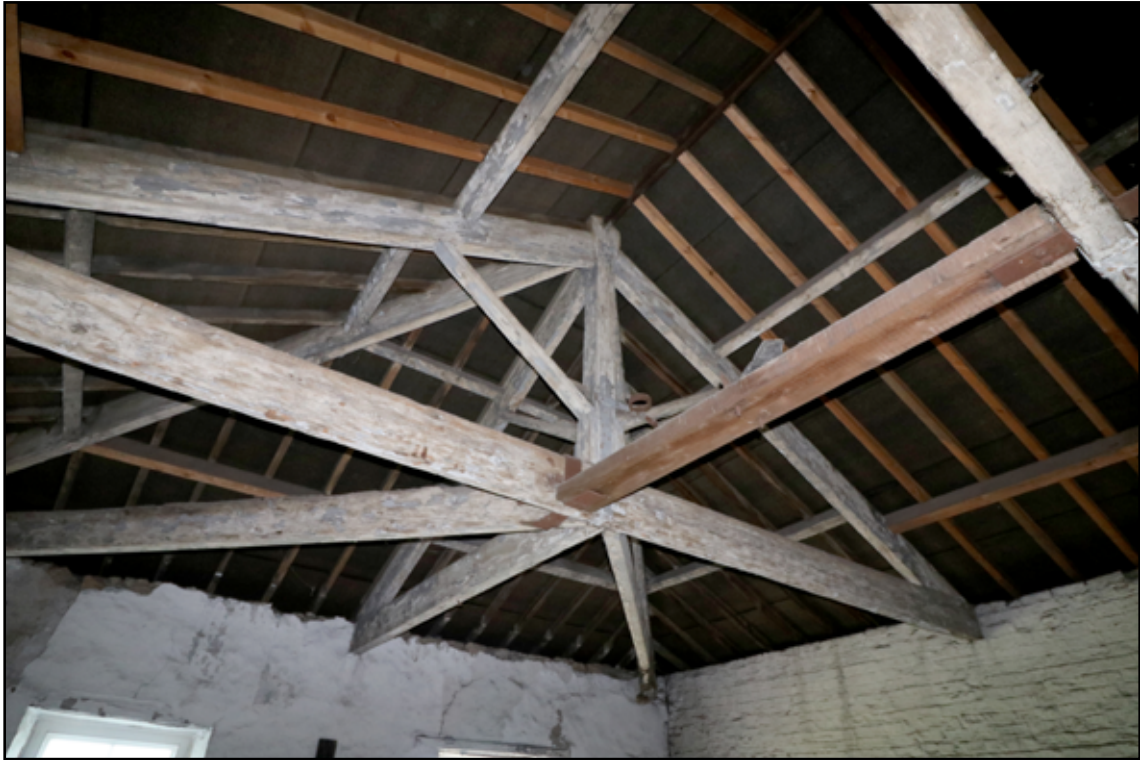
Figure 30. Roof structure in S2.

There is no evidence that room S2 had been fully ceiled; instead, the lime-washed exposed roof comprises king post trusses and hips with modern repairs (figure 30). There is evidence of mortices on the underside of one of the joists suggesting some form of partition may have divided this space, although to which phase it belongs is unclear. There is also a narrow deck formed by boarding spanning a single bay of trusses, possibly used as additional storage space. A 20th-century light fitting is fitted to the underside of the truss, but historic images suggest the space was also lit by rooflights and the two window openings in the east wall (now with modern windows).

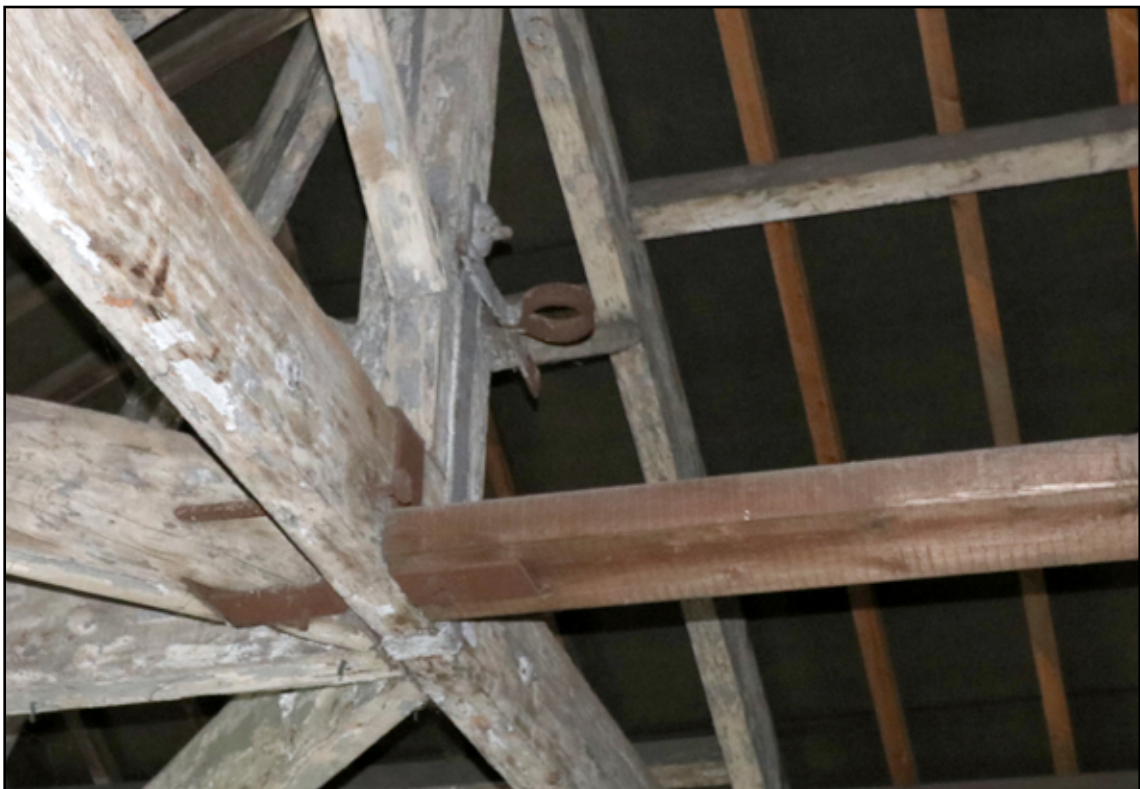
Figure 31. Detail of metal bracket attached to the king post truss which may have formed part of a hoist or lifting gear.

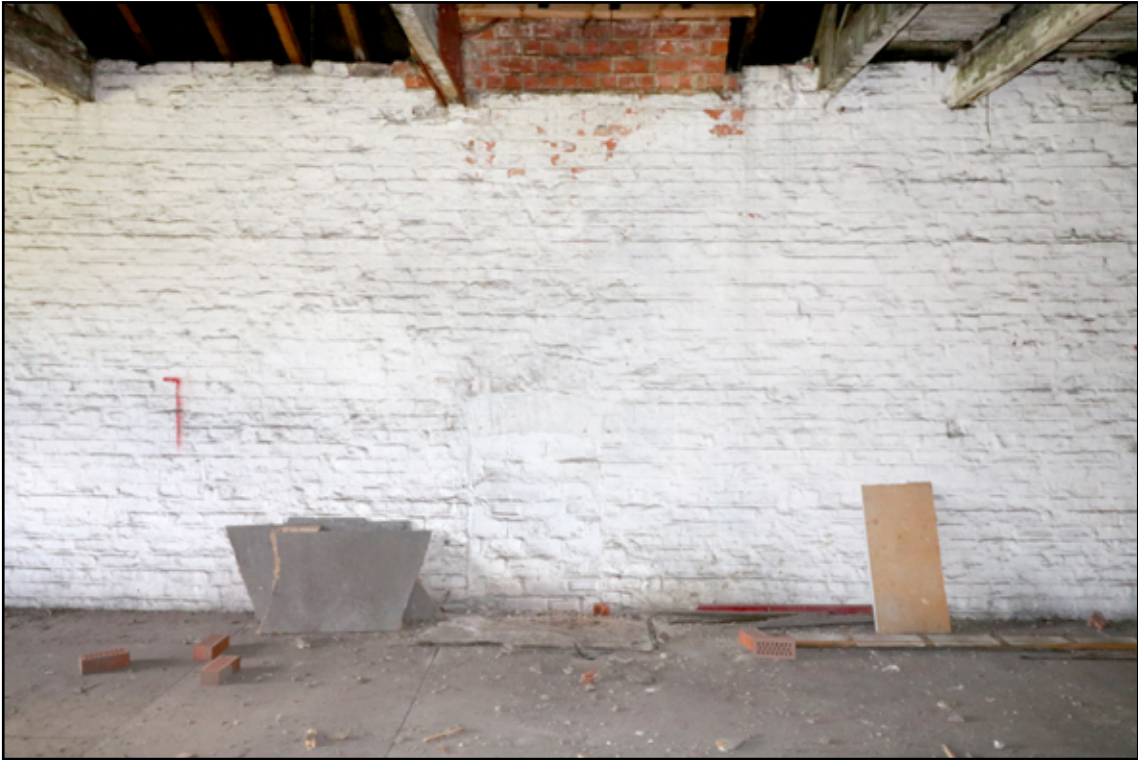
Figure 32. Blocked fireplace with rebuilt stack above.

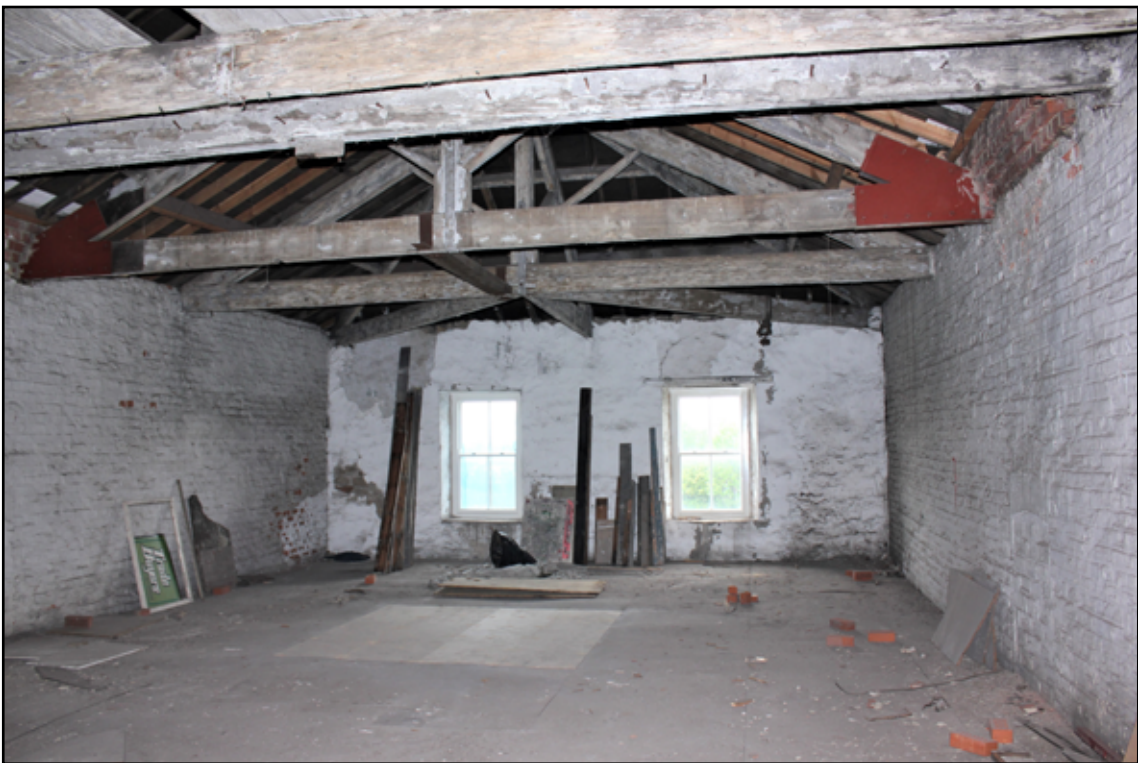
Figure 33. S2 Looking east.

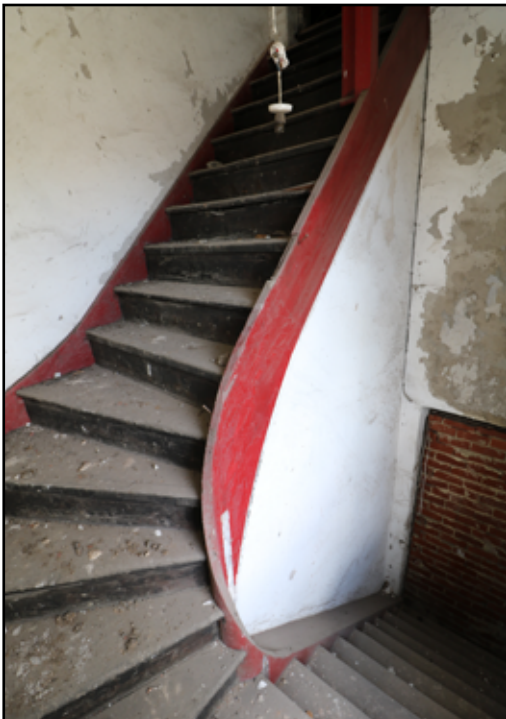
Figure 34. Staircase to workshop and S2.

The staircase is robust with a utilitarian finish (figures 34 and 35). It is formed of timber treads, risers and stringer but no handrail or balusters. Nails and a mortice in the top side of the stringer suggests there may have been a single baluster or post of a simple rectangular section, presumably fixed to a timber handrail, the ghost line of which can still be seen running across the landing joist.

The walls are of brick with a plaster finish, elements of which may be original. A diagonal line on the plasterwork of the external wall suggests some form of boarding or dado rail may have served to protect the wall (figure 36). There is a small landing or gallery over the stairwell with a suspended timber floor behind a handrail accessed by a secondary timber step (figure 37). The original lath and plaster ceiling has been removed leaving the ceiling joists and roof structure exposed to view. The staircase is now redundant, following alterations to the floor level in G5 (discussed below). The closed-string staircase is in contrast to the open-string winding staircase of the 'Cottage' and reflects its secondary status.

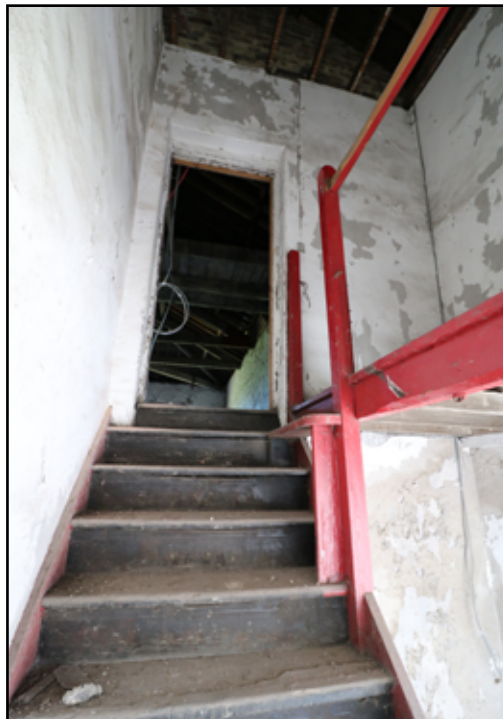
Figure 35. Staircase looking towards S2; the line of a handrail runs across the landing joist to the right with timber step providing access onto the landing.

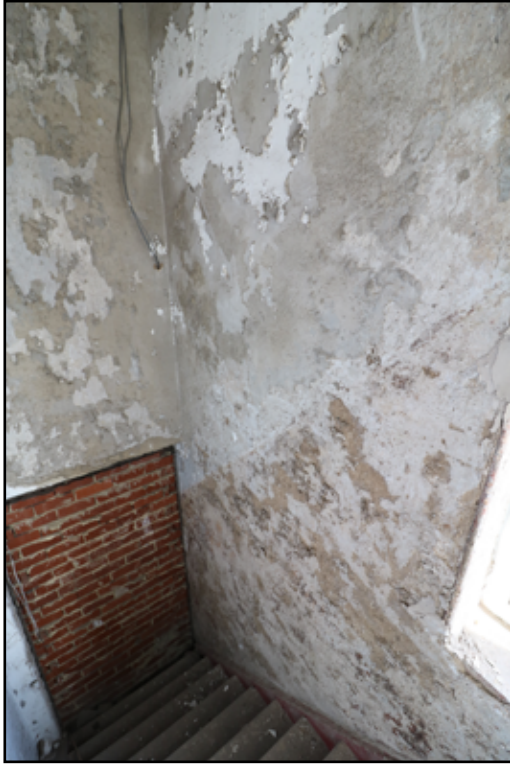
Figure 36. Bricked up doorway which formerly led into the workshops. Note the line of a wainscot or dado to the external wall to the right.

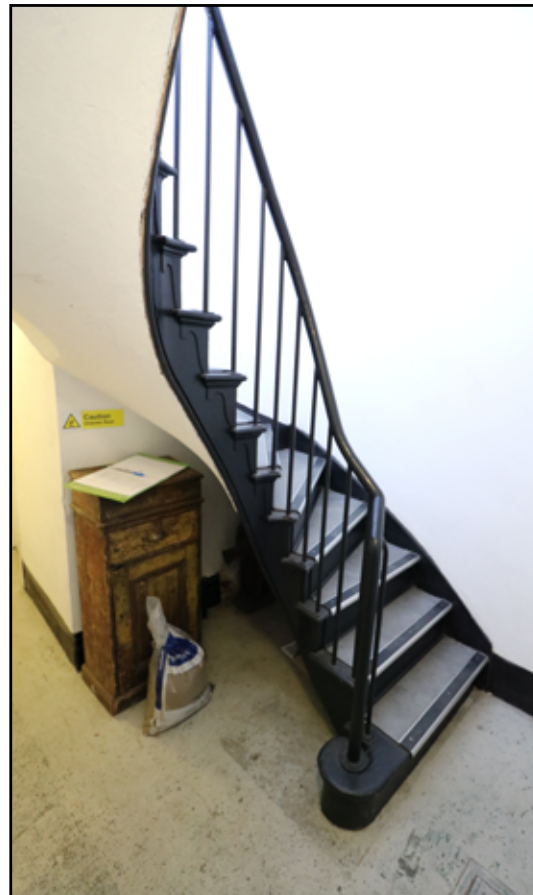
Figure 38. Staircase with modern handrail.

The building was partially restored in 2015-16, when the brick and stone exterior walls were rendered in cement and new sash windows introduced. A new handrail was installed to the main staircase and parts of the central block were restored as offices for the A1 Trust's staff. During this time the walls of G1, F1 and S1 were dry-lined, a modern concrete slab floor installed in G1 and the floors above strengthened by the addition of steel joists.

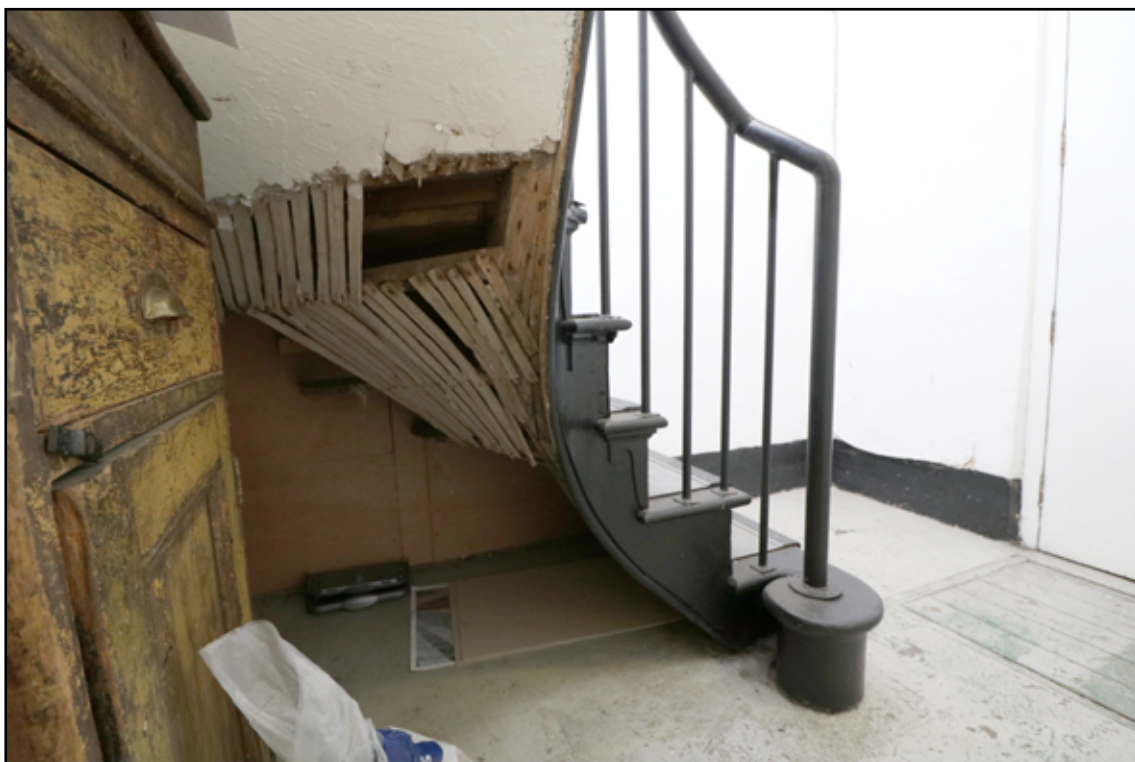
Figure 39. Lath and plaster to underside of staircase.

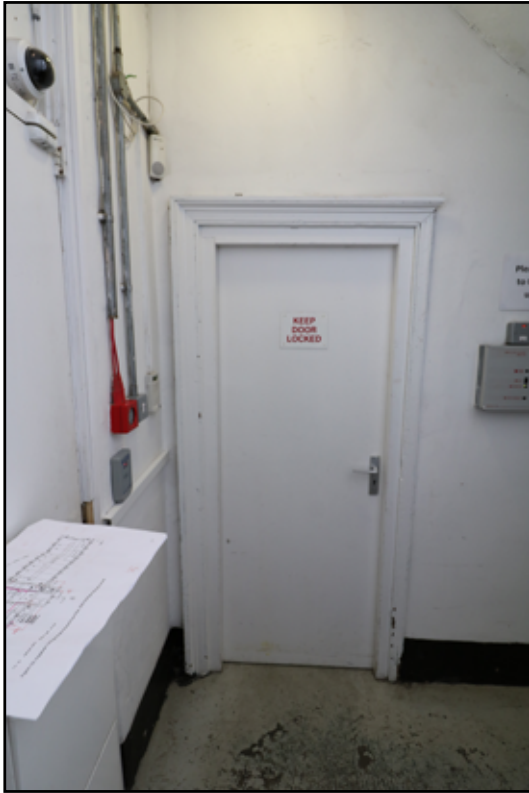
Figure 40. Architrave of door into G1.

fireplace, which was positioned along the east wall, or of the external door opening which provided access to the scullery/pantry extension and yard. Whilst the entrance door is modern, the timber reveals appear to be original but are missing their architrave on the inside (figure 40). The window shutters, boxes and jambs also survive and remain some of the best surviving joinery from the building's first phase (figure 41).

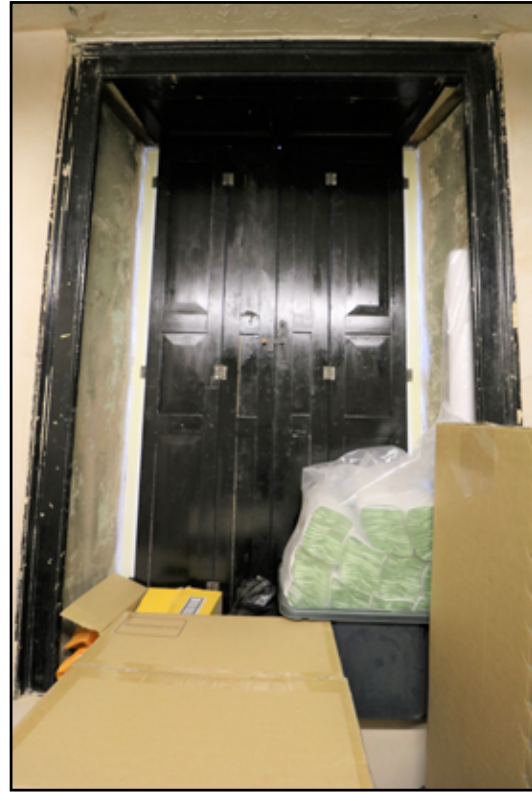
Figure 41. Room G1 window shutters.

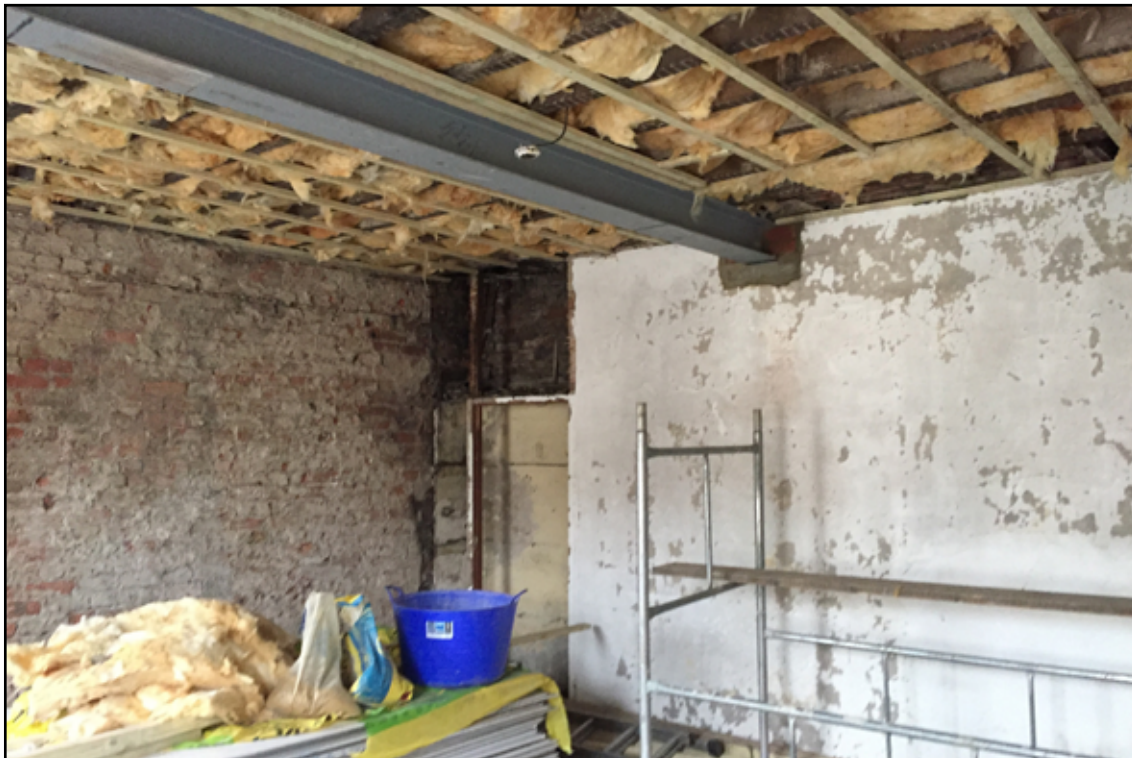
Figure 42. View looking north east into room F1 in 2017 before the walls were plastered and a new ceiling introduced. Signs of the original lath and plaster ceiling are visible on the underside of the ceiling joists, and the faint outline of a blocked fireplace is to the right. The cupboard in the corner has since been plastered over. Reproduced by kind permission of Tony Lord A1/SLT.

Both the first and second floors have been heavily modernised, and no historic features were visible at the time of survey, but the plan form is likely to be faithful to the first phase of construction. Photographs taken prior to restoration works indicate that F1 formerly had a cupboard in its east wall, now boarded over.<sup>33</sup> One image appears to show the outline of a blocked-up fireplace to its right (figure 42). Grenville *et al* 2004 describe S1 as formerly having a lath and plaster ceiling, now either concealed or removed.<sup>34</sup>

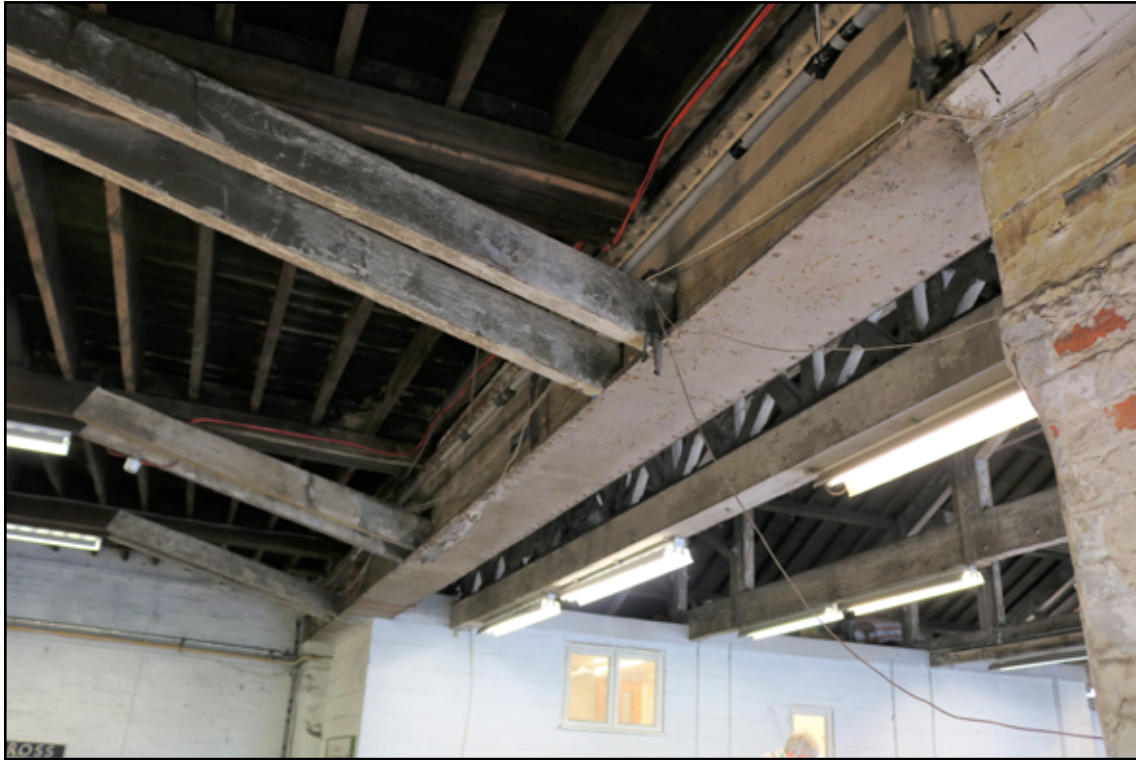
Figure 43. Box-beam in the north workshop. The timber struts support the trussed timber girder of the floor of S2.

An early change within the fabric of the Carriage Works building appears to have been the removal of the ground-floor walls between the workshops and the 'Repair and Lifting Shop'. Today, the original brick cross walls survive as nibs that now provide the bearings for iron beams (figure 26). The rivetted iron box-beams, which rest on timber pads, span the width of the building – a distance of approximately 12.6m (figure 43). Sitting directly on the beams are the walls and flues of the upper storey (S2) which sit on the same alignment (figure 27). The trussed timber girders to the floor above are further strengthened with the addition of timber struts braced against the bottom flange of the box-beams (seen in figure 27). The box-beams have machine-riveted multiple vertical plates, whilst the long horizontal plates appear from inspection to be a single long section, riveted to the vertical plates.

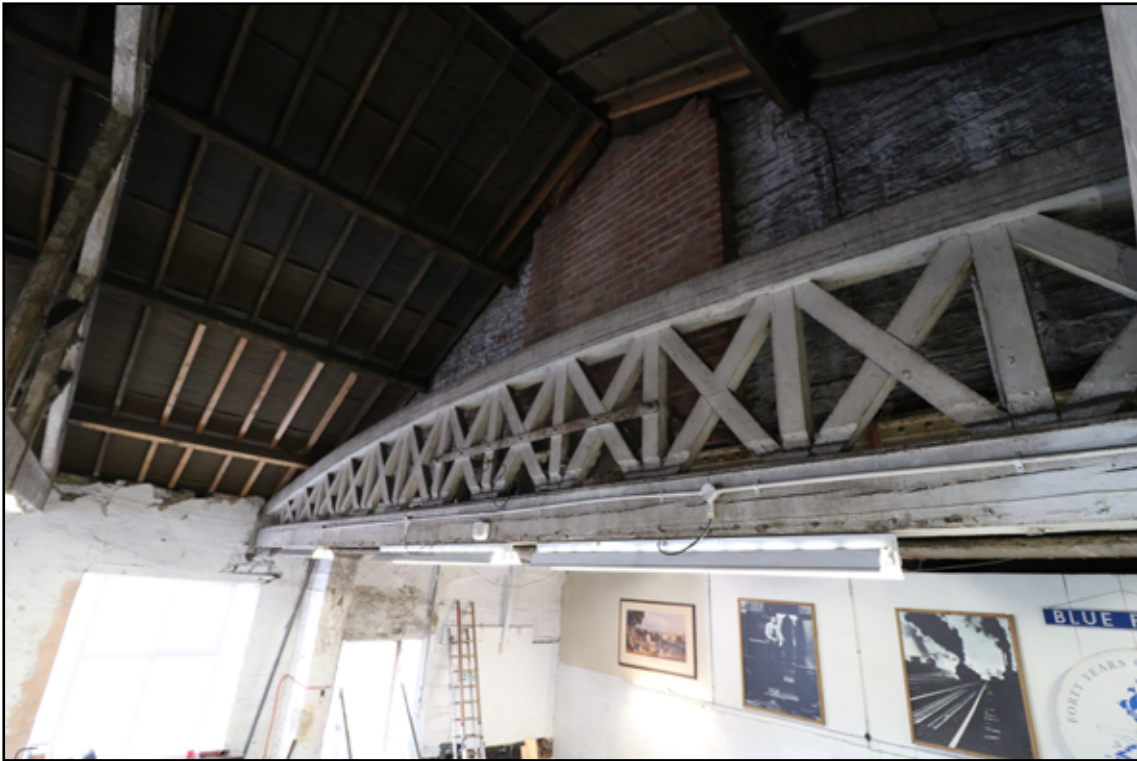
Figure 44. Bow string truss, north workshop.

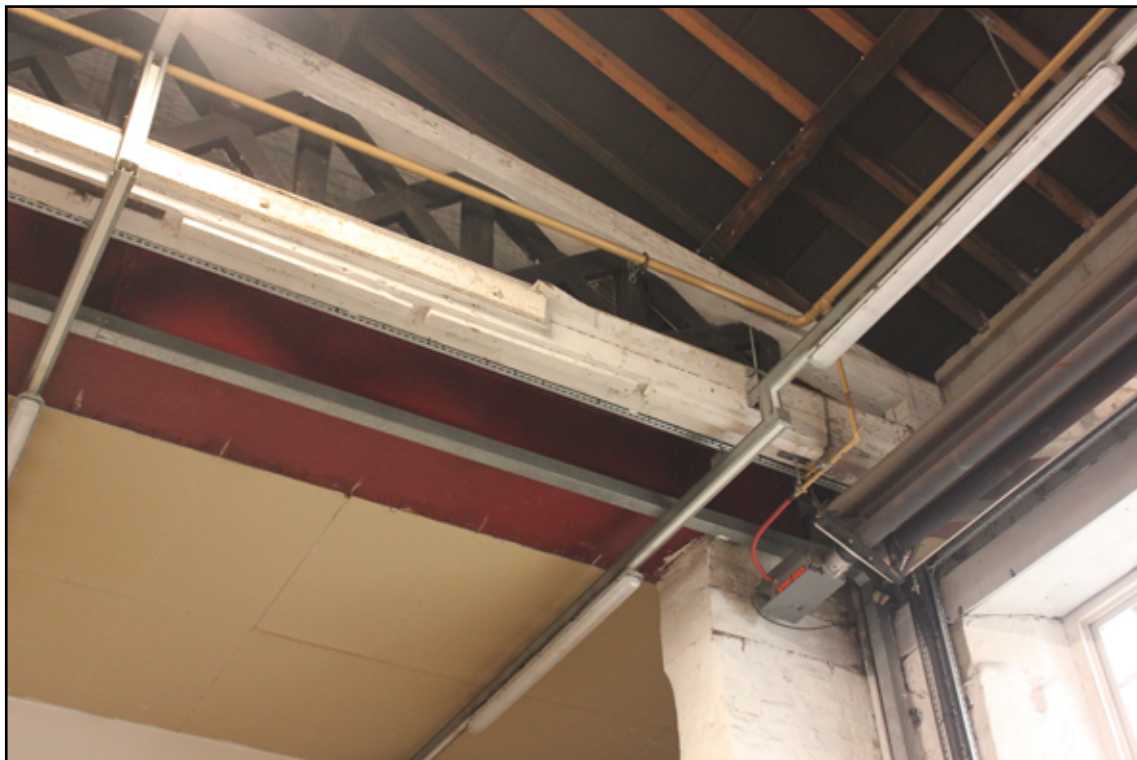
Figure 45. The bow-string truss showing the iron rail and timber stop on its outward face.

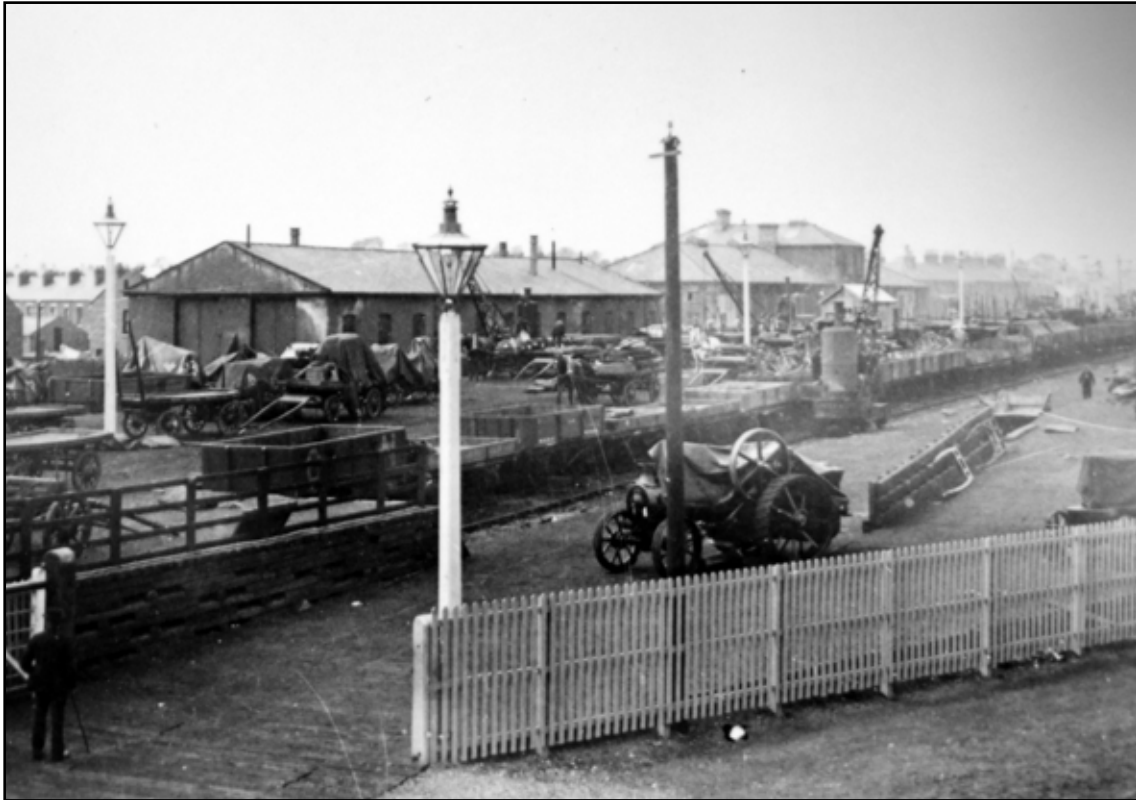
Figure 46. The North Road railway yard taken from Station Road. The Carriage Works can be seen in the background, to the right of a large building. Reproduced courtesy of Ken Hoole Study Centre, Head of Steam Railway Museum, Darlington.

The Carriage Works was captured in an image shortly after closure in 1895 (figure 46). The busy yard is still apparent, and a large rectangular shed-like building is shown adjacent to the Carriage Works to the south - perhaps the 'extension' referred to in a contemporary source? The form of the Carriage Works is recognisable in the background with ventilators to the southern workshop roof. The roof lights to the workshops and over the central block are also clearly shown as are a pair of windows in the south elevation. It is unclear from the image what use, if any, the building had been put to.

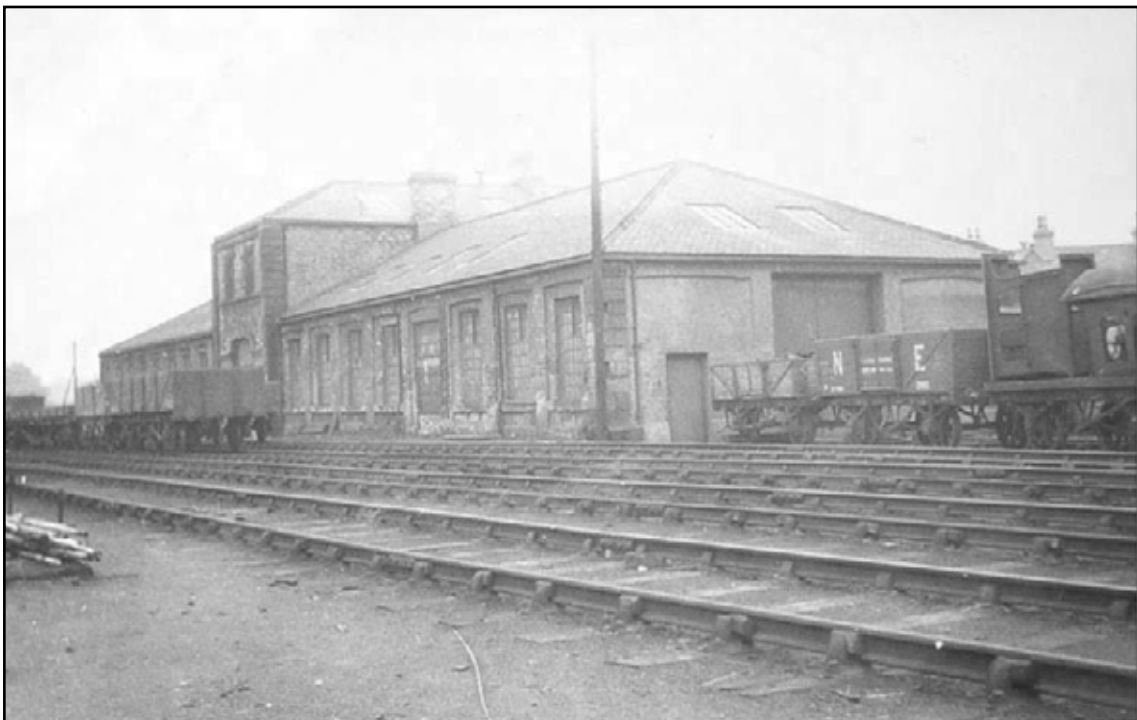
Figure 49. North and east elevations of the Carriage Works in the 1930s Reproduced courtesy of Ken Hoole Study Centre, Head of Steam Railway Museum, Darlington.

The Carriage Works is depicted in a photograph thought to date to the 1930s (figure 49). Prominent is the central timber door in the gable-end, clearly sufficient for the entry of railway vehicles. A siding with parked wagons terminates in front of this elevation beside the pedestrian access door, and four sets of rails run parallel to the east elevation. The slate roof is punctuated with rooflights on the north and east facing roof slopes and the outline of rooflights can just be seen on the roof of the central block. Whilst the present windows to the workshops are all modern and echo the mullion and transom arrangement of the windows shown on the 1853 drawing, this image appears to show the north workshop with multiple-light industrial-style metal framed windows to all eight bays.

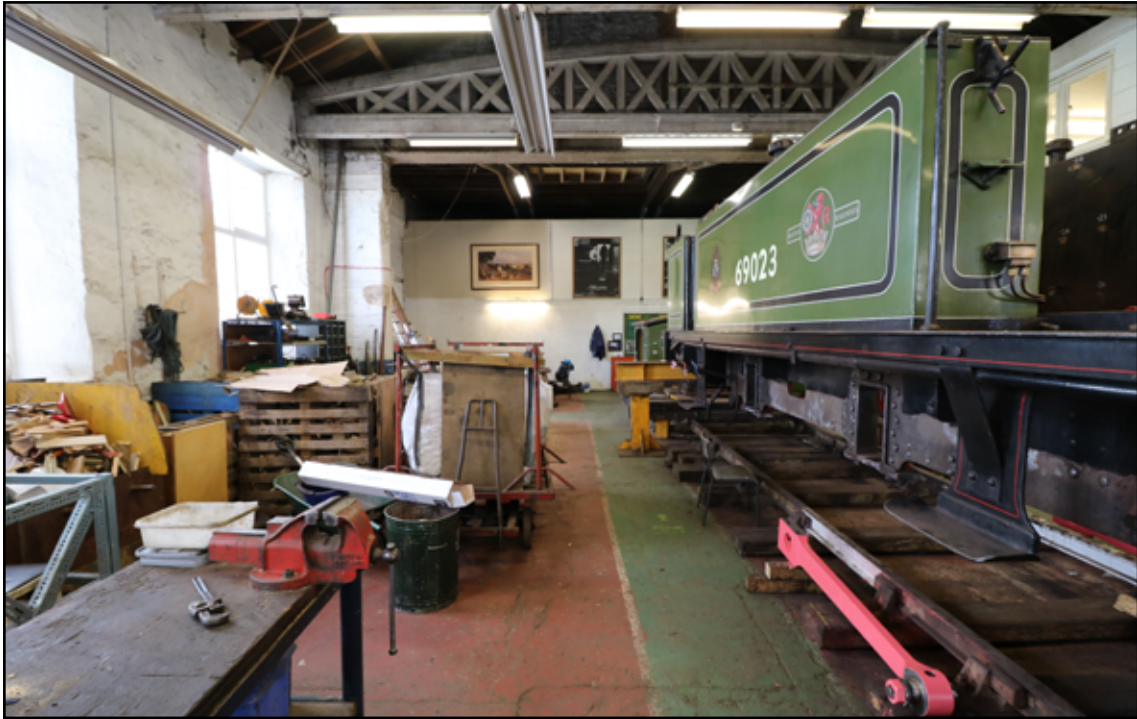
Figure 51. Phase 3 concrete floor to the north workshop

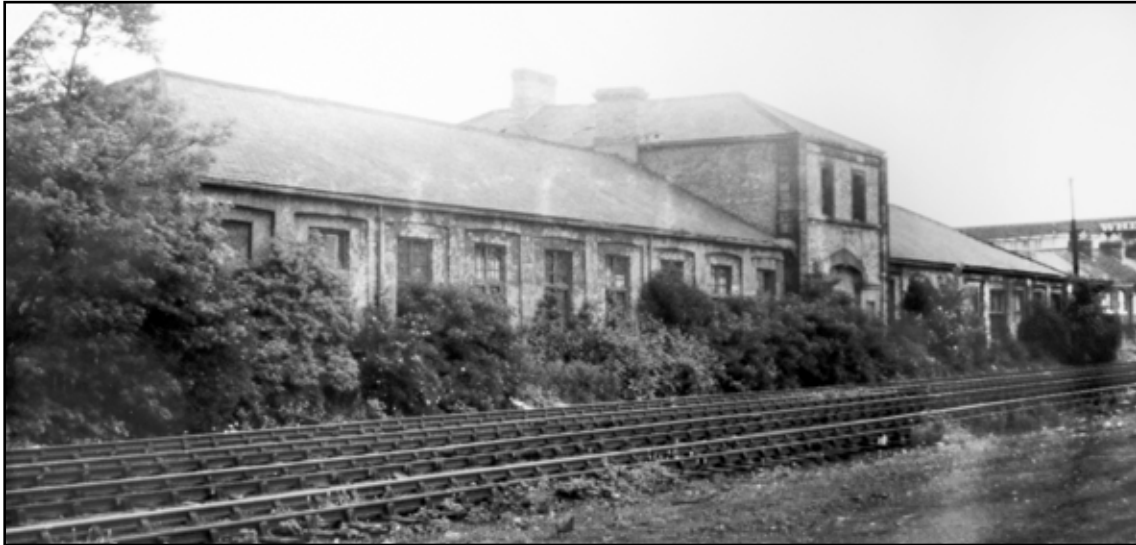
Figure 53. The Carriage Works, circa 1950 to c1970. Reproduced courtesy of Ken Hoole Study Centre, Head of Steam Railway Museum, Darlington.

Around this time, or very soon after, a photograph captures the building's east elevation (figure 53). The photograph can be approximately dated by the Whessoe Engineering building shown in the background of the image which had been extended in the 1950s. The Carriage Works has by this time lost its rooflights and the roof over the central block appears to be in poor condition. The windows are visible, however, and the arrangement of timber mullions can be distinguished in the south workshop. Vegetation has grown up against this elevation and the number of tracks along the elevation has reduced to three pairs with an overall air of dereliction and decline. The Ordnance Survey 1:1250 revision of 1970-78 (not shown here), indicates that the building was by then a 'Garage', presumably for road vehicles as the map also shows the spurs to the north elevation had been removed and the building effectively divorced from the railway network.

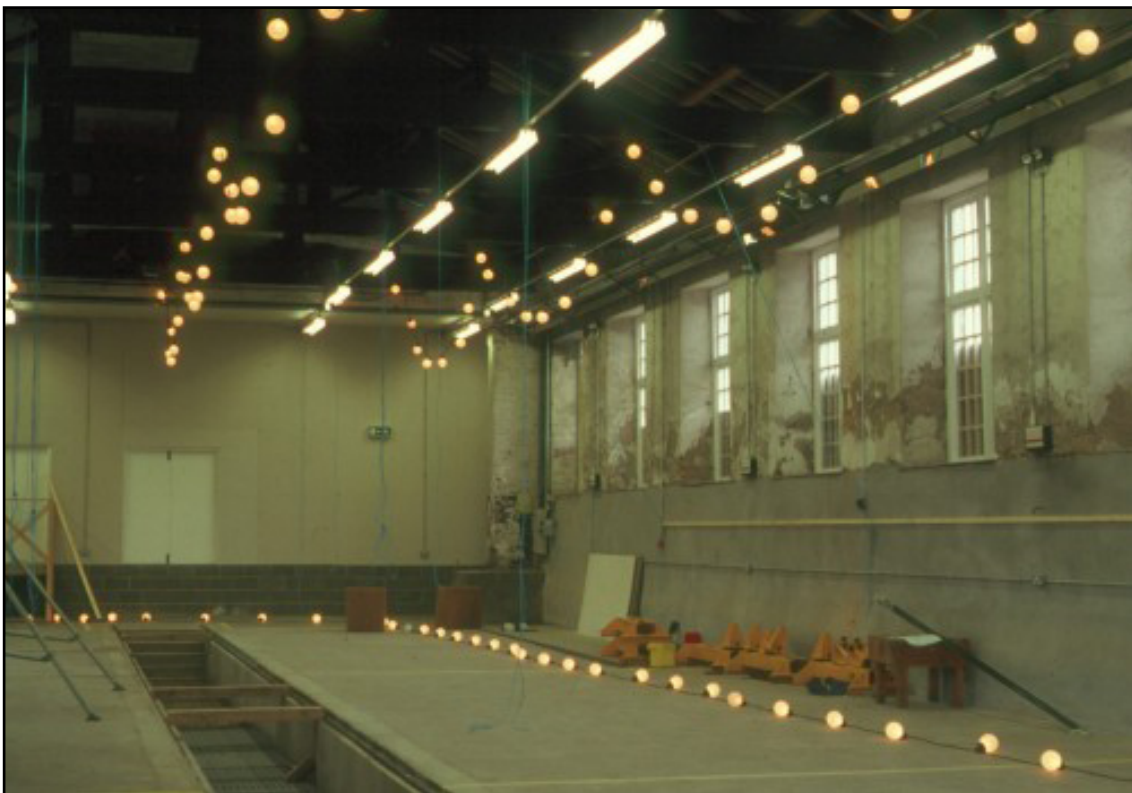
Figure 55. View taken in 1997 of the southern workshop, looking north, showing the new inspection pit. (<https://www.a1steam.com/darlington-locomotive-works/>).

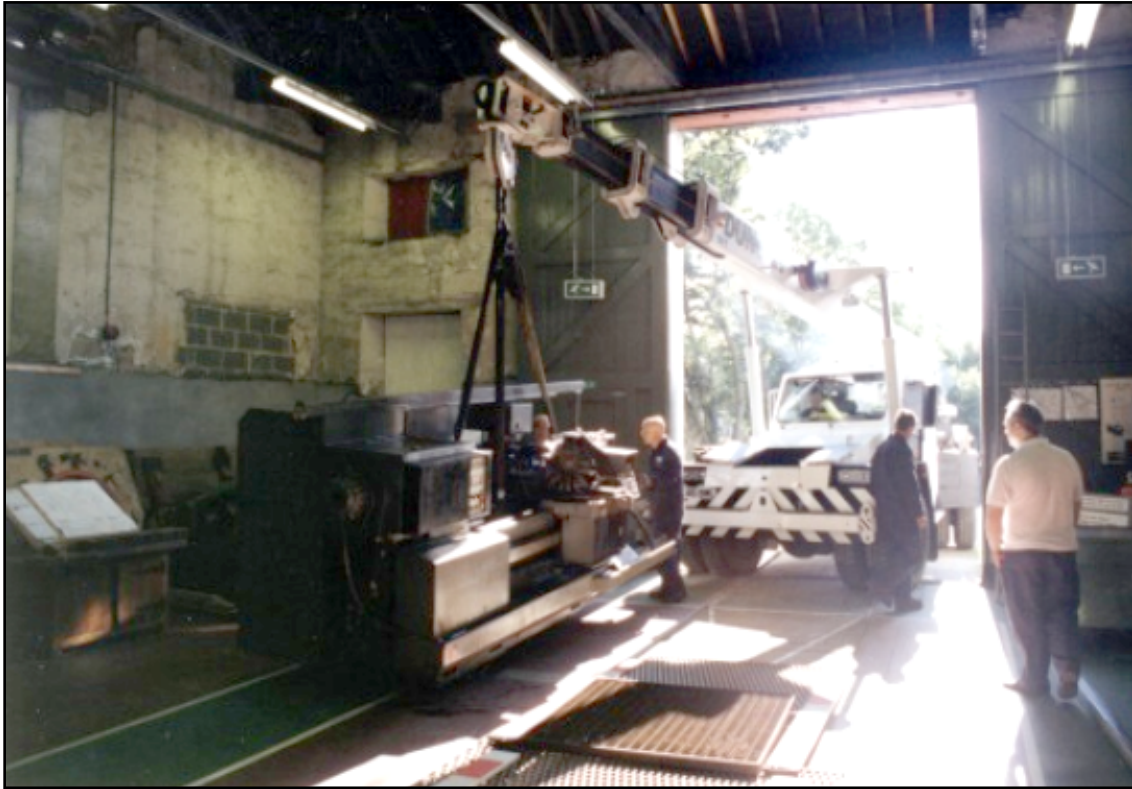
Figure 56: Photograph taken in 1999 of the southern workshop, looking south. Note the top of a blocked opening just visible to the left. (<https://www.a1steam.com/darlington-locomotive-works/>).

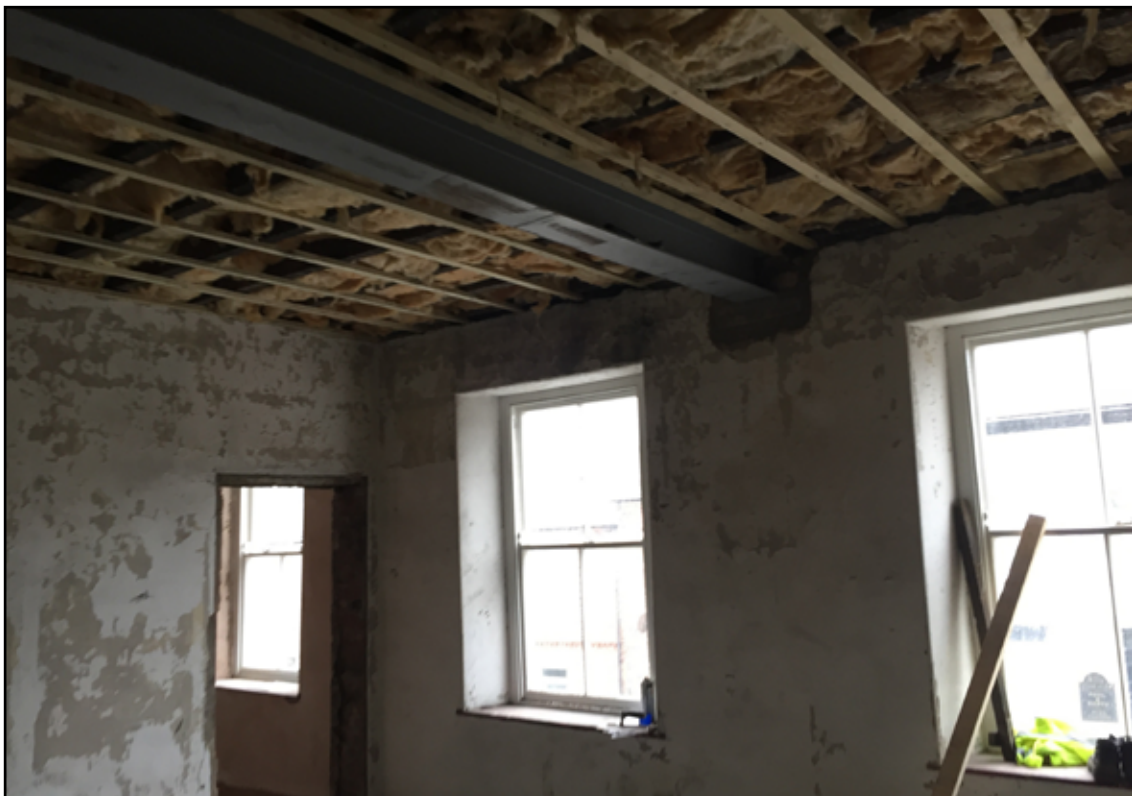
Figure 57. View looking south west in room F1 in 2017 before the walls were plastered and a new ceiling introduced. Reproduced by kind permission of Tony Lord A1/SLT.

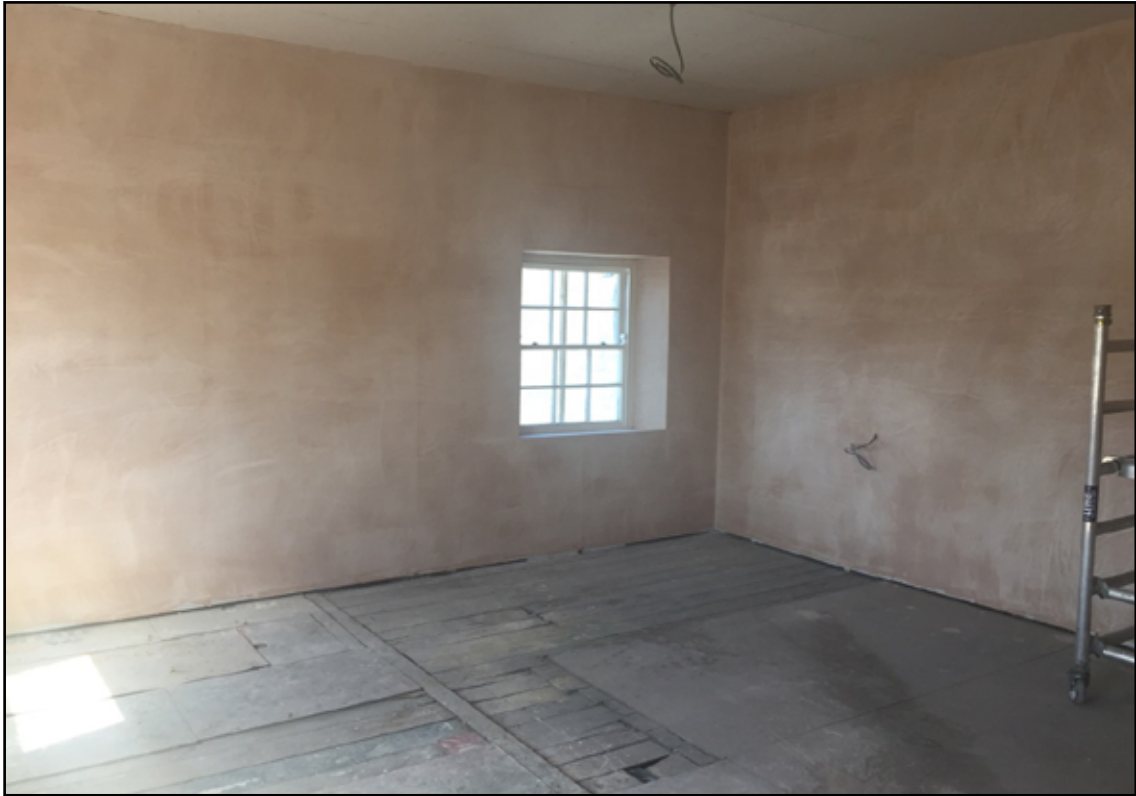
Figure 58. View looking north east in room S1 in 2017 shortly after being replastered. Reproduced by kind permission of Tony Lord A1/SLT.

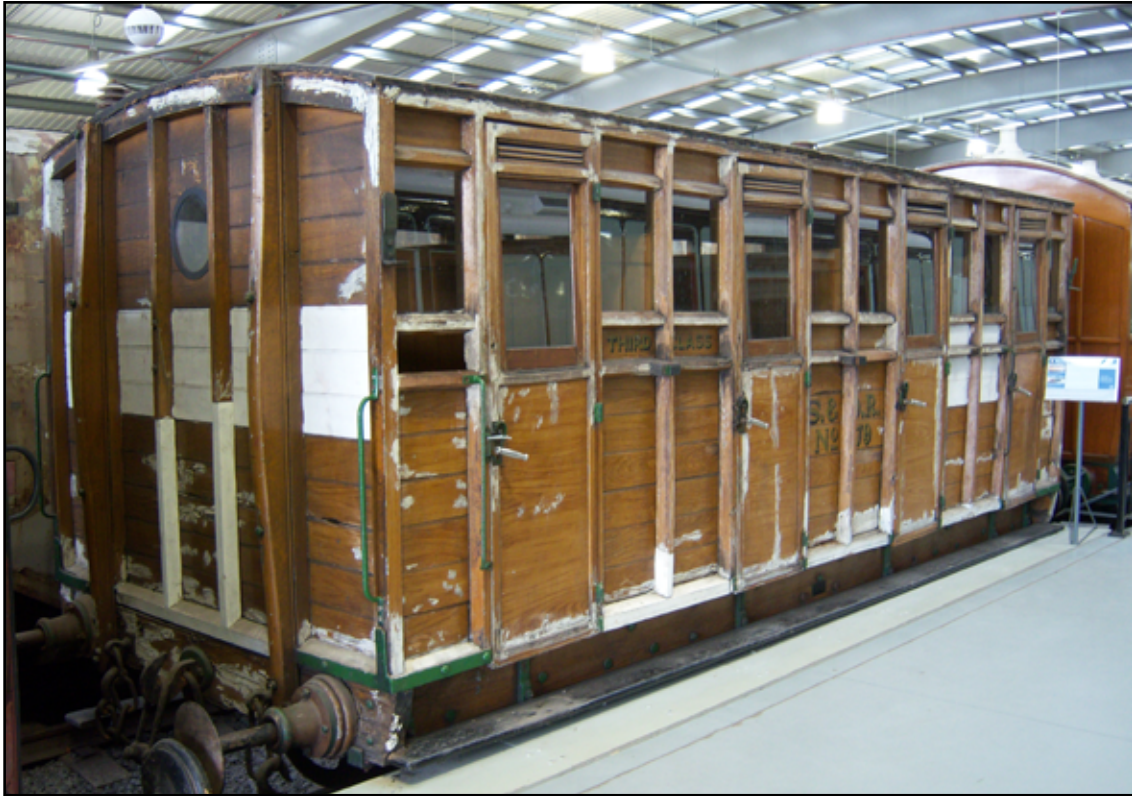
Figure 59. Carriage No.179, thought to have been built in 1865 at the Hopetown Works. Image reproduced under the Creative Commons License courtesy Ultra7.

tracks which ran the length of the building. From start to finish, the whole process of repair and construction was inefficient. The central entry did not promote the production-line process, and it was only possible to move one carriage at a time. As carriage design developed, the ability of the coachworks to cope with longer carriages would have made its antiquated system of side entry and turntables increasingly redundant. An example of the type of carriages produced at the Works during its operation survives today as the 'Forcett Coach', No.179 now restored and on display at the Beamish Museum (see figure 59). Believed to have been constructed in 1865 it was a third-class coach and perhaps the longest carriage the Hopetown Carriage Works could accommodate.<sup>56</sup>
