The Buttermarket, Market Strand, Redruth, Cornwall: Historic building investigation

Research Report Series no. 53-2021

THE BUTTERMARKET, MARKET STRAND, REDRUTH, CORNWALL

HISTORIC BUILDING INVESTIGATION

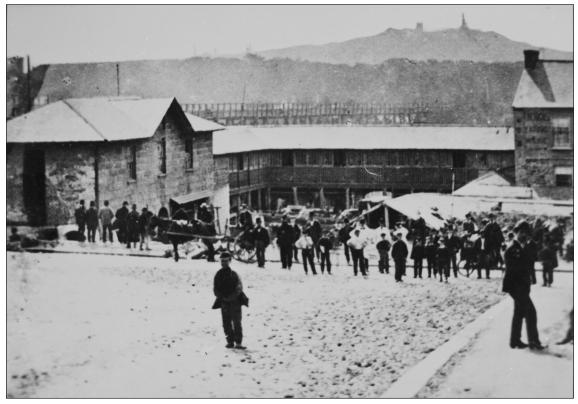
Figure 6: Undated historic photo taken between about 1874 and 1877, showing the southern courtyard and the market house (left), looking south-west from Alma Place. In the background is the old timber railway viaduct, which was replaced in 1884-8. [Kresen Kernow, Corn02860]

The earliest surviving building on the site is the two-storey market house on the south-east side of the courtyard. It formed part of the original L-plan courtyard (see Figures 3 and 4). The building's main (north-west) elevation of ashlar granite faces into the courtyard. The arcade on the ground floor was originally open and all seven arches had projecting keystones and a projecting impost band (Figure 18). The first floor originally had three windows with monolithic lintels, which originally were probably timber sash windows. The original roof is not extant but was hipped with a small cross gable towards the courtyard, whose outline is still discernible in the stonework (see Figures 6 and 18). This cross gable had one small opening, which probably was a louvred vent as now.

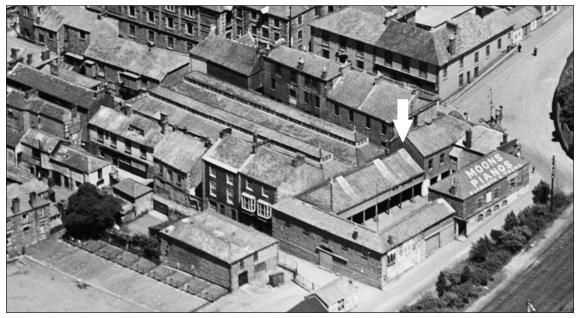
Figure 13: Detail of an oblique aerial photo taken on 24 June 1928, looking north-east. The arrow indicates the north-east end of the north-west range with the inserted first-floor rooms. [© Historic England Archive (Aerofilms Collection), EPW021734]

As these first-floor spaces were built over an area with a wider gap of columns (see Figures 7-9), additional supports were inserted underneath, which were in place by the 1920s (see Figure 13). By the later 20th century, these had become insufficient and were replaced by two large pillars, initially square in plan, then cylindrical, as part of a general strengthening of the floor of this area (see Figures 15 and 46).

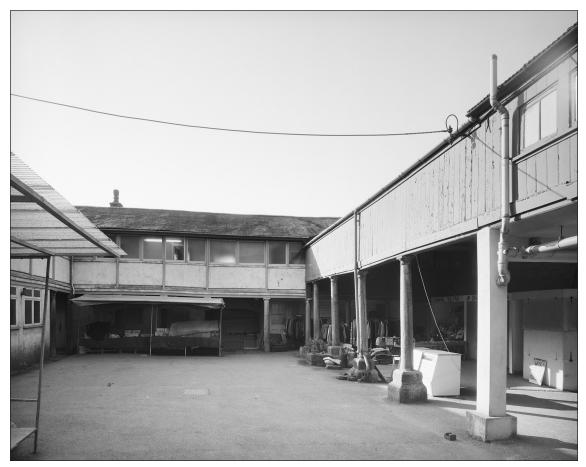
Figure 15: The courtyard in February 1989, looking north-west. [© Crown copyright. Historic England Archive, BB057063]

In February 1989 the Royal Commission on the Historical Monuments of England (RCHME) took a series of photographs of the market courtyard (Figures 15 and 16).¹¹⁴ They show the alterations which had taken place by then. The original windows with narrow, vertical panes survived only above the carriageway to Station Hill (see Figure 16), with horizontal weatherboarding below, and at the north end of the south-west range, with vertical weatherboarding below.¹¹⁵ All other windows in the south-west and south-east courtyard ranges had been altered to plate-glass windows with blank panels below. As the photographs show, some limited commercial activity continued in the courtyard at this time.

The proceeds from the sale of the Fair Meadow in the 1980s enabled the Redruth Market Company to re-pave the courtyard (see Figures 15 and 24), replace the rainwater goods and install new metal gates. The repaving of the courtyard left the historic flagstones in the colonnades and the granite floor drains intact. A few areas of historic cobbles survive in places (see Figure 37). Based on surviving sections, new vertically-glazed windows and boarding were installed on the first floor of the south-east and south-west courtyard ranges (see Figures 15, 16, 24, 30). The current boarding consists of modern, machine-cut tongued-and-grooved boards, which are set back behind the posts, to allow for the installation of railings. By contrast, the older windows and the weatherboarding of the 'bridge' over the carriageway in the southeast range are set further forward in relation to the posts which divide the bays.

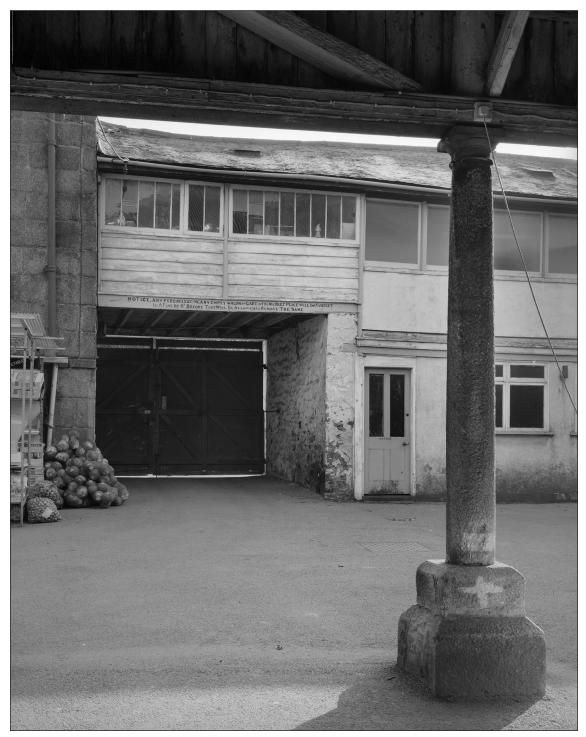
Figure 16: The carriageway to Station Hill in February 1989, seen from inside the courtyard. [© Crown copyright. Historic England Archive, BB057064]

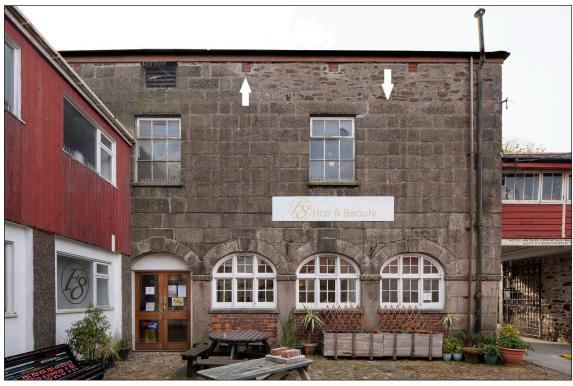
Figure 18: The north-west elevation of the market house, seen from the courtyard. The left arrow indicates the line of the former cross gable, that to the right the line of the original eaves height. [James O. Davies, DP275883]

In 1884 the walls of the two-storey market house were raised by three feet and the roof structure replaced or reconstructed as a hipped roof without the central cross gable (see Figure 18). It is not clear what prompted this and why an increase in the ceiling height of the first-floor spaces had become necessary. It is possible that the 1884 roof alterations referred to another part of the courtyard complex, such as the north-west range (see the section on the late 19th-century improvements). However, at present firm evidence is lacking and it seems most likely that this referred to the market house of 1825-6 whose roof is known to have been remodelled and raised between about 1877 and 1928.

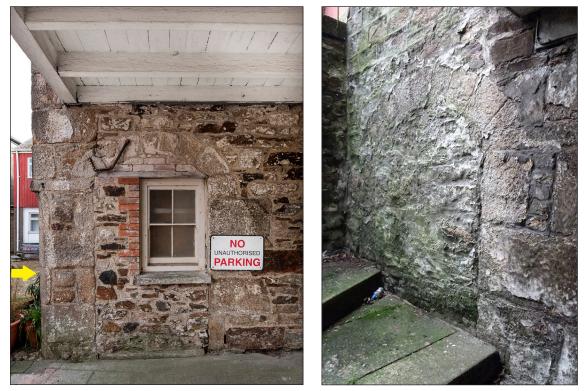
Figure 19: The arches on the south-west elevation (left) and on the north-east elevation (right) of the market house. The arrow in the image to the left indicates a later chamfer. [Left: James O. Davies, DP275887; right: Johanna Roethe]

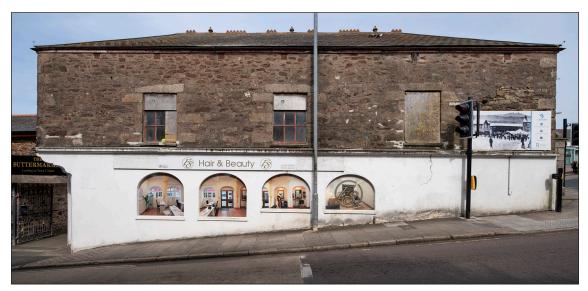
Figure 20: The south-east elevation of the market house in April 2021. [James O. Davies, DP275890]

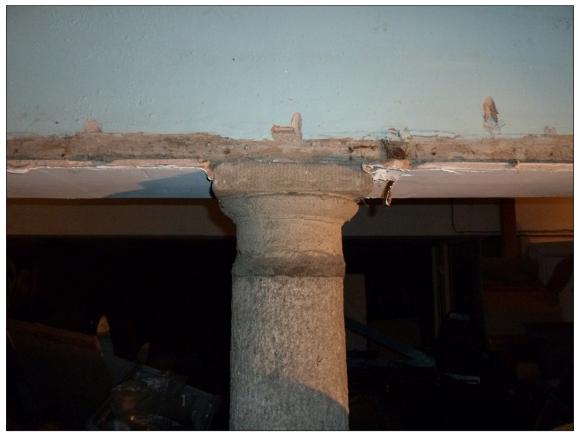
Figure 21: Granite column and capital on the lower ground floor of the Mining Exchange. [Johanna Roethe]

The granite columns are further examples of the reused 1820s columns and they are placed on tall bases to gain the requisite height. It is not clear what kind of capitals they had in the 1870s as most have been replaced in concrete and the remainder are damaged. The photographs of 1989 appear to show similar capitals to that surviving below the Mining Exchange (see Figures 15 and 21). Originally there was a wide gap

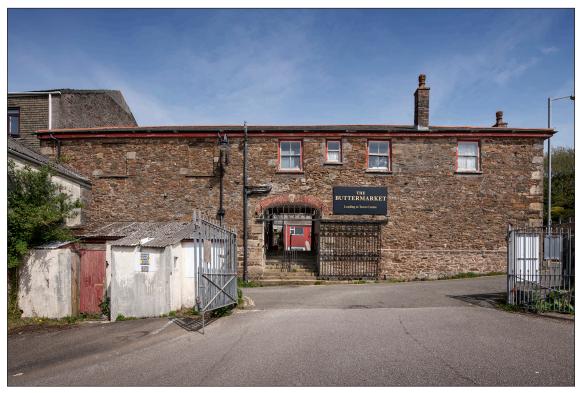
Figure 22: The south-west elevation of the south-west courtyard range, seen from the Fair Meadow carpark. [James O. Davies, DP275878]

survive: a carriageway in the south-east range linked the market to Station Hill and steps under a brick arch in the south-west range provided access to the Fair Meadow (Figures 22 and 23).

Of this phase the south-west and south-east ranges survive, forming a continuous L-shaped building which defines the layout of much of the southern courtyard. The outer walls are of rubble killas stone. The external (south-west) elevation of the south-west range has a shallow projecting plinth, which acts as a retaining wall necessitated by the drop in ground level (see Figure 22). Several first-floor windows in the external elevations provided additional light into the spaces on the upper floor. The south-west range originally had a regular arrangement of five two-over-two sash windows, of which two are now blocked up (see Figures 13 and 22). The south-east range originally had four first-floor windows, of which three have small two-over-two sashes and one is blocked up now (see Figure 23).

At some point before 1976 the first-floor rooms in the south-west and south-east ranges were converted to form a residential flat.¹³⁵ This required the insertion of a bathroom and a kitchen, the latter lit by a new, small window in the south-west elevation of the south-west range (see Figure 22). The current access stair in the south-west range may have been inserted at the same time, replacing an older stair further north in the same range (see Figure 8); however, this stair could not be inspected for this project and its dating needs to be confirmed. The doors to the staircase and to the cupboard below it date from the later 20th century.

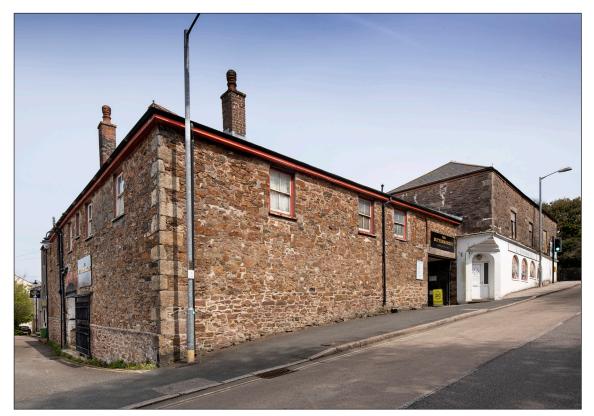
Figure 23: The south-east elevation of the south-east courtyard range from Station Hill. [James O. Davies, DP275877]

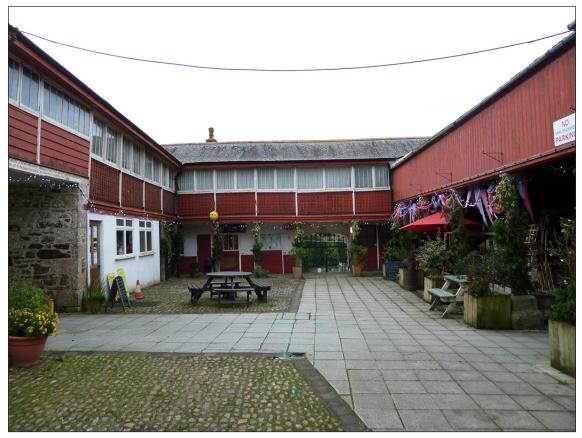
Figure 24: The western half of the courtyard looking at the north-east elevation of the south-west range. [Johanna Roethe]

Inside the courtyard, the two-storey ranges continued the 1820s pattern of groundfloor open colonnades (Figures 24 and 25). The new colonnades probably reused the granite columns of the demolished ranges but with new capitals (Figure 26). Compared to the capital on the lower ground floor of the Mining Exchange these have a fluted neck and an additional torus between neck and shaft.

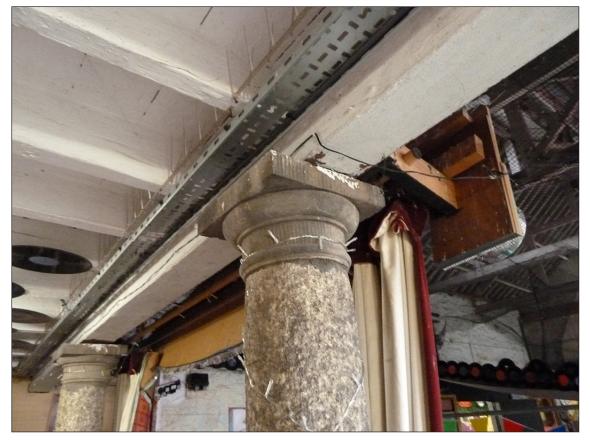
Figure 26: Two 1820s columns with mid-19th-century capitals at the north end of the south-west courtyard range. [Johanna Roethe]

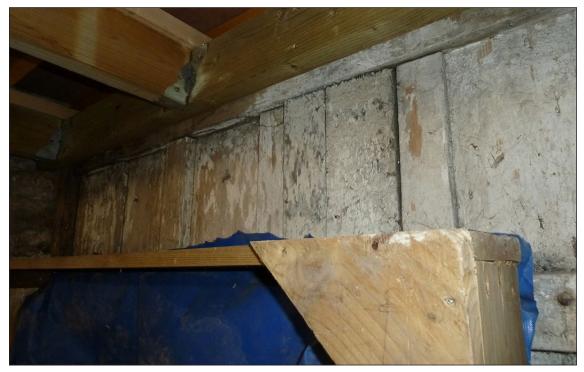
Figure 27: Example of historic boarding between stalls in unit 10 at the north end of the south-west courtyard range. [Johanna Roethe]

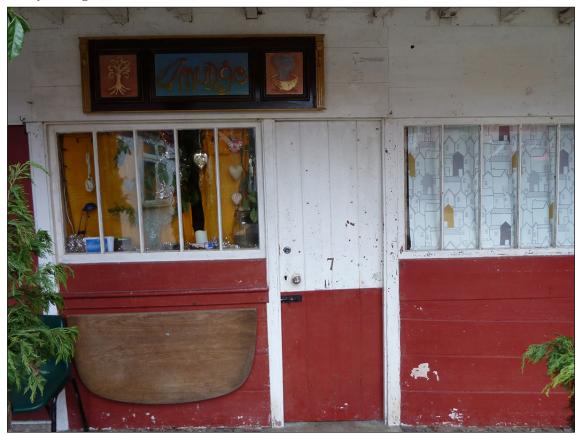
Figure 28: Unit 7 on the ground floor of the south-west courtyard range, with the window of unit 8 to the right. All of the panelling, the window surrounds and the door date from the original date of the building. [Johanna Roethe]

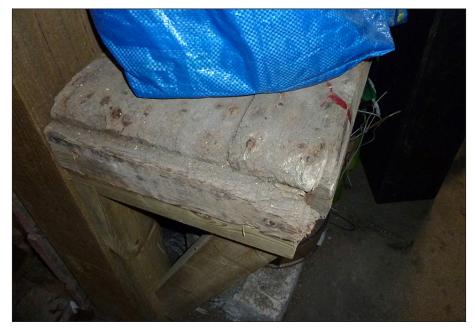
Figure 29: Example of a historic timber work bench (on a modern support) in unit 10 at the north end of the south-west courtyard range. [Johanna Roethe]

Set back behind the colonnades were enclosed market stalls. They were divided by vertically-boarded timber partitions, some of which survive in their original form, for example in units 7 and 10 in the south-west range (Figure 27). Towards the courtyard most of the units have horizontal, beaded boarding under windows with vertical panes. The doors are of vertical boards (Figure 28). In unit 10 at the north end of the south-west range, a wooden workbench survives (Figure 29).

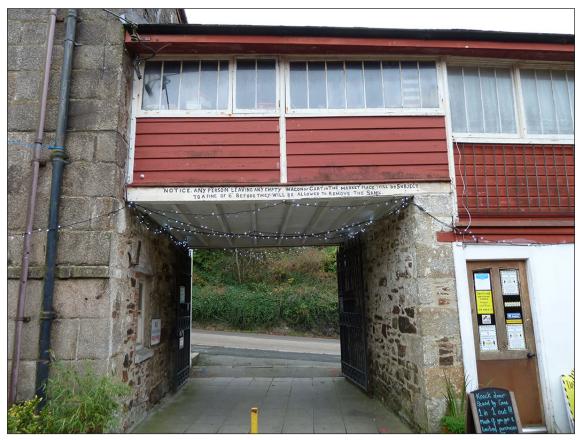
Figure 30: The carriageway in the south-east courtyard range beside the two-storey market house. The weatherboarding is a like-for-like replacement of the previous and possibly of the original arrangement. [Johanna Roethe]

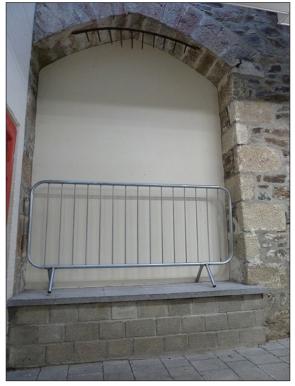
Figure 32: The blocked east arch in the south-east elevation of the meat market. [Johanna Roethe]

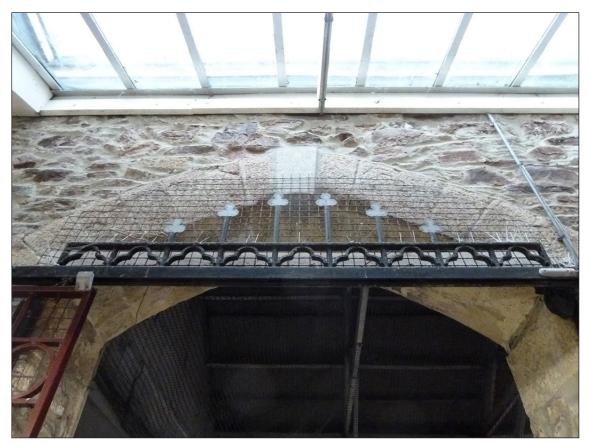
Figure 33: The west arch in the south-east elevation of the meat market. [Johanna Roethe]

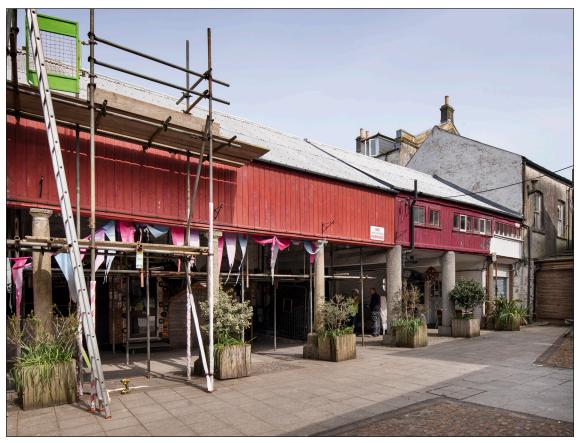
Figure 34: The north-west courtyard range with the rear gable of the Mining Exchange at the far end, April 2021. [James O. Davies, DP275874]

The north-west range takes the form of a roofed area which is open at ground floor level. It was probably originally open to the roof throughout. The roof is hipped at the south-west end and its height matches approximately that of the two-storey southwest and south-east courtyard ranges. To the north-west the range abuts the southeast wall of the meat market and to the south-west the south-west courtyard range. To the north-east the roof of the north-west range now abuts the Mining Exchange, although when first built it extended as far as Alma Place. Towards the courtyard, the roof is supported on columns on stepped pedestals. The roof has queen-post trusses and long struts on the courtyard side which bridge the gap between the wall plate and the top of the columns. Later boarding covers the struts towards the courtyard and provides extra protection from the elements; it is likely that the current boarding replaced a similar original arrangement.

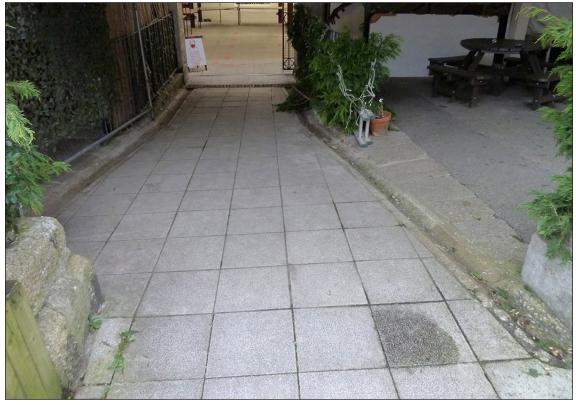
Figure 36: The late 19th-century floor drains lining the remaining (western) entrance from the meat market into the courtyard. The paving between the drains is a modern replacement. [Johanna Roethe]

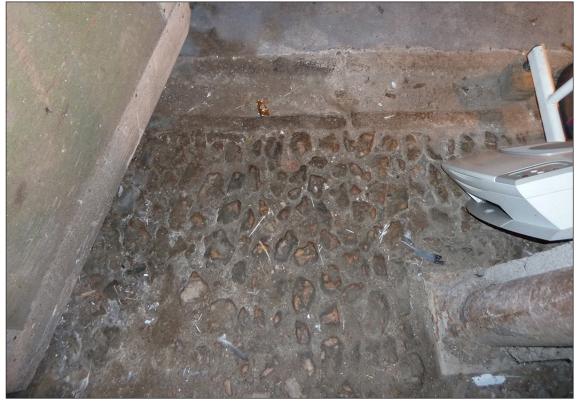
Figure 37: Historic cobbles and granite drain just inside the current entrance to the lower ground floor of the Mining Exchange. [Johanna Roethe]

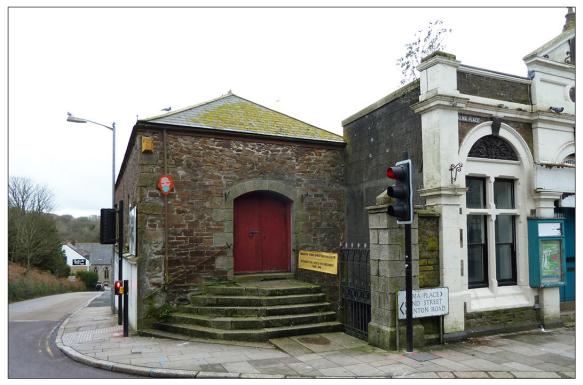
Figure 39: The remodelled north-east end of the market house. The lower stair is behind the modern gate to the right. [Johanna Roethe]

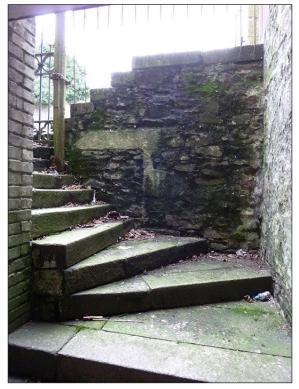
Figure 40: The steps from Alma Place to the lower ground floor of the Wheal Peevor Purser's Office. The blocked arch in the north-east elevation of the market house is to the right. [Johanna Roethe]

Also in the late 1870s and early 1880s the older buildings were altered and improved. Once the Wheal Peevor Purser's Office had been completed, the area to the north-east of the two-storey market house was remodelled. New stairs led from Alma Place down to the lower ground floor of the Purser's Office and another stair led up to a new arched doorway to the first floor of the market house (Figure 39). The doorway replaced a tall, oblong opening (see Figure 6). At the same time, the groundfloor arch in the north-east elevation of the market house must have been blocked up, as the new lower stair was built right up against it (Figure 40, also see Figure 19).

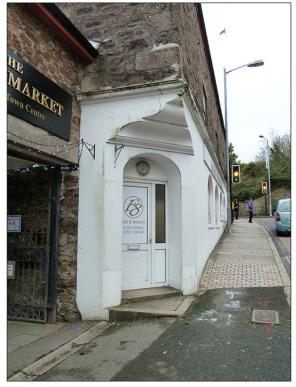
Figure 41: The south corner door from Station Hill. [Johanna Roethe]

Between about 1897 and 1901 the ground floor of the two-storey market house was converted to a printer's workshop, which included a number of alterations. A new entrance was inserted at the south corner, which may have been already canted, so that the workshop could be accessed independently of the market (Figure 41). This entrance took the form of a recessed door while the structural support for the intact upper corner was disguised under a deep moulding. Above this runs a moulded string course which continues along the south-east elevation of the market house; this was probably added at the same time (see Figure 20).

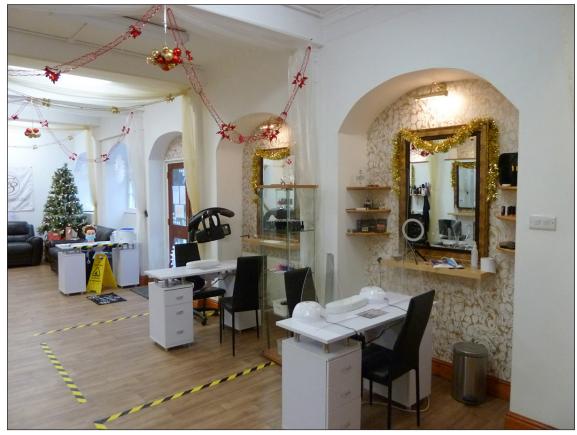
Figure 42: The main ground-floor room of the market house, looking west along the north-west wall. [Johanna Roethe,]

The building was also internally strengthened, possibly against the vibrations of the two printing presses and the gas engine on the ground floor, which were mentioned in the fire insurance documentation of 1901 (see the section on the early 20th century). Five pairs of cast-iron columns were inserted, which support encased ceiling beams (Figures 42 and 43). The cast-iron columns have the maker's inscription 'W. Visick & Sons, Devoran'. Visick & Sons was a foundry established by Walter Visick (*c.* 1852-1934), which moved in 1894 from Veto Works at Bissoe to 'Old Basset's Foundry' near Devoran.¹²⁹ The same firm also supplied ironwork for cattle pens at the Fair Meadow.¹³⁰ At the south-west end of the building a chimney was inserted, probably for the stove mentioned in the 1901 fire insurance document.

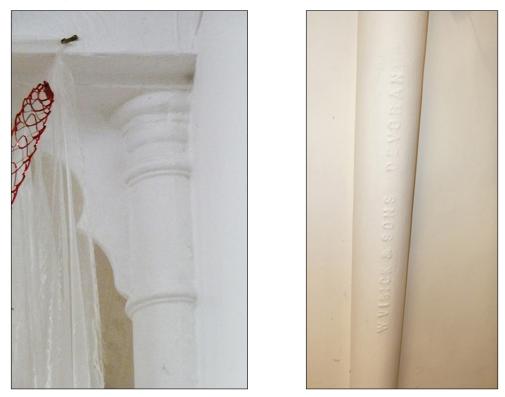
Figure 43: A capital (left) and the maker's mark of the cast-iron columns on the ground floor of the market house. [Johanna Roethe]

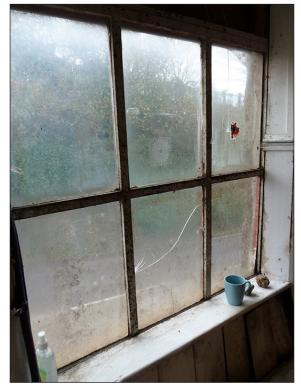
Figure 44: First-floor metal window in the south-east elevation of the market house. [Johanna Roethe]

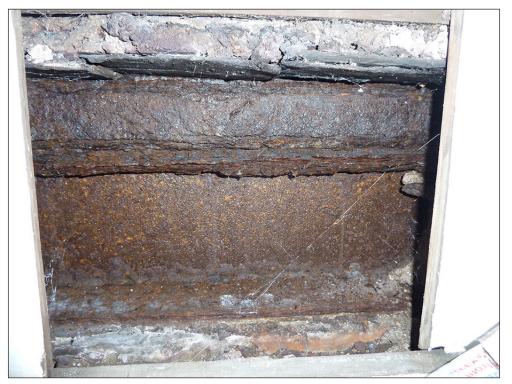
Figure 45: Rusted I-beam under the westernmost first-floor window in the south-east elevation of the market house. [Johanna Roethe]

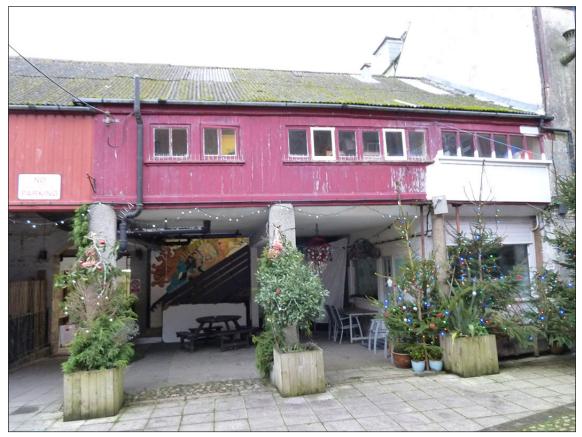
Figure 46: The first-floor offices in the north-west range with the two late-20th-century pillars to the left. [Johanna Roethe]

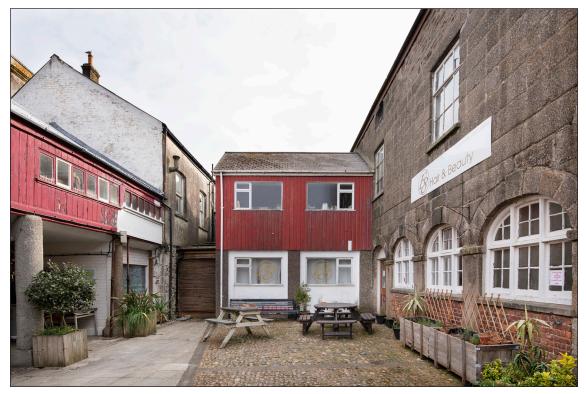
Figure 47: The extension of *c*. 1977 in the angle of the market house (right) and the Wheal Peevor Purser's Office. [James O. Davies, DP275885]

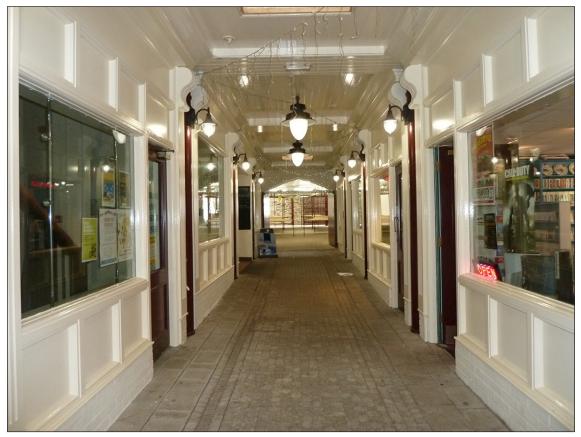
Figure 48: The new arcade of 2000-1 on the site of the former meat market, looking south. [Johanna Roethe]

The most recent major phase of change was the construction in 2000-1 of a new building, reusing the remaining fabric of the former meat market which had been destroyed in the fire of 1982. Designed by architects Hocking & Newton, the new building was constructed inside the historic outer walls, which were retained as far as possible. Instead of copying the form of the 1870s meat market hall, the new building contains a shopping arcade with specialist shops, leading into a wider space at the rear, with first-floor offices above (Figures 48 and 49). A new linear route, called Market Way, leads through the new building to the west archway into the courtyard (see Figure 49).

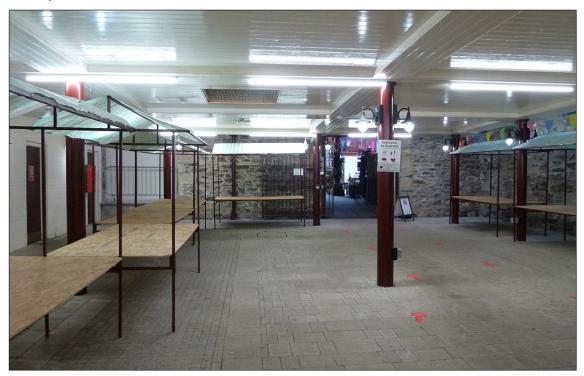
Figure 49: The covered market space at the south end of the 2000-1 building, looking south towards the courtyard. The blocked east arch is just visible to the left, near the corner. [Johanna Roethe]
