**Sawley Abbey, Sawley,  
Lancashire: a Cistercian  
monastic precinct and  
post-medieval landscape**

**SURVEY REPORT**

Archaeological Investigation Report Series AI/17/2005

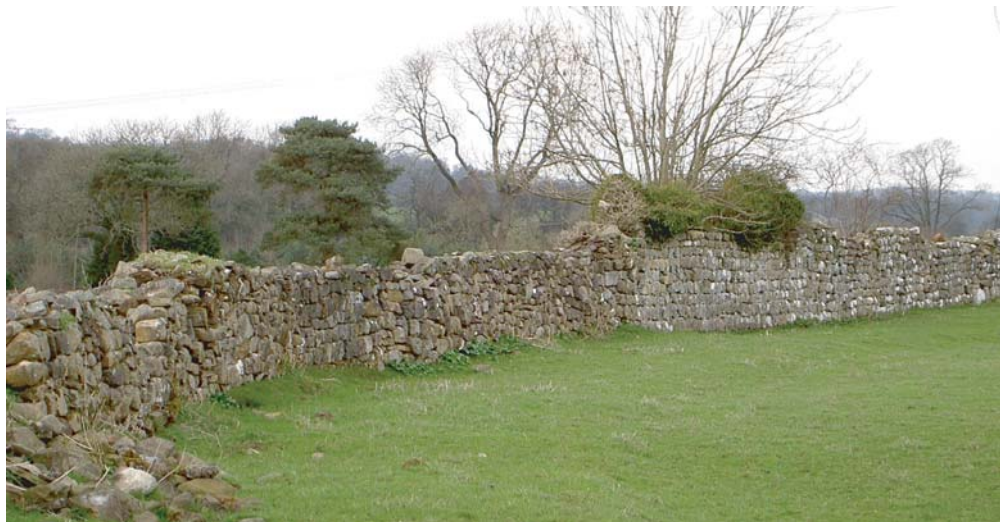
*Figure 8b  
The stone wall  
defining the western  
edge of West Field,  
beieved to originally  
have formed part of  
the monastic precinct  
boundary*

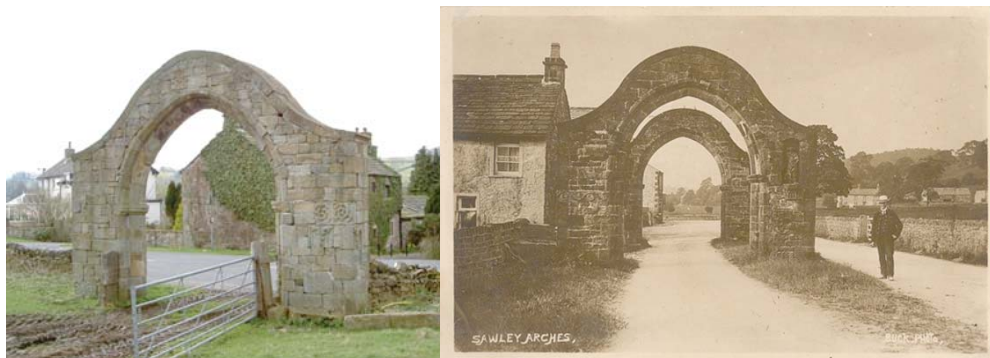
Figure 9a (left)  
The reconstructed arch in the wall of East Field today.  
Figure 9b (right)  
An early twentieth-century photograph of the pair of arches in their previous location, across Village Road. Original print held in Clitheroe Local Studies Library.

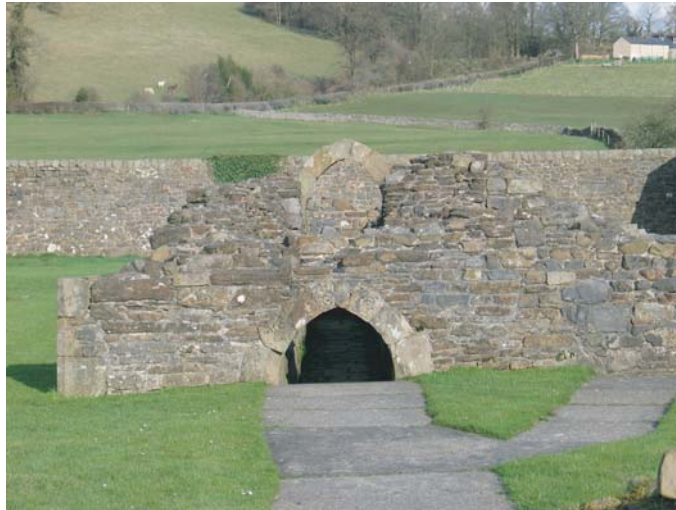
Figure 16  
The main drain to the  
south-east of the  
abbey cloister

and on public display. The stone-lined channel this exposed would have probably been open with the stone arches erected over it, supporting overlying buildings (Figure 16).

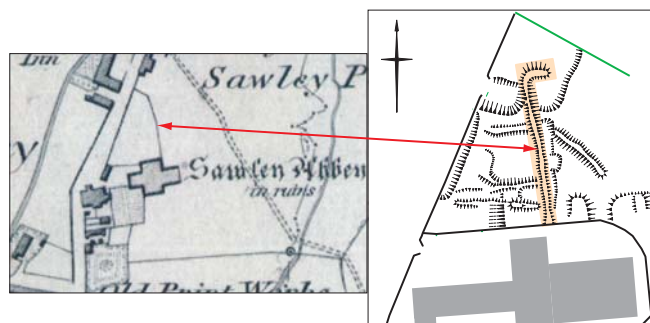
Figure 23  
Extracts from the 1850  
Ordnance Survey  
map and the English  
Heritage survey plan  
allowing a comparison  
of the former wall and  
what remains of it  
today

suggests that the wall adjoined the corner of the abbey church's northern transept and turned west towards the field boundary at its northern end. However, the earthwork evidence indicates that at some stage it turned to the east. This turn may represent a former section of the wall which was no longer in existence when the map was created. As this appears to be a field boundary, the likelihood is that it dates to the post-Dissolution period, when the land around the abbey was divided up for agricultural use.

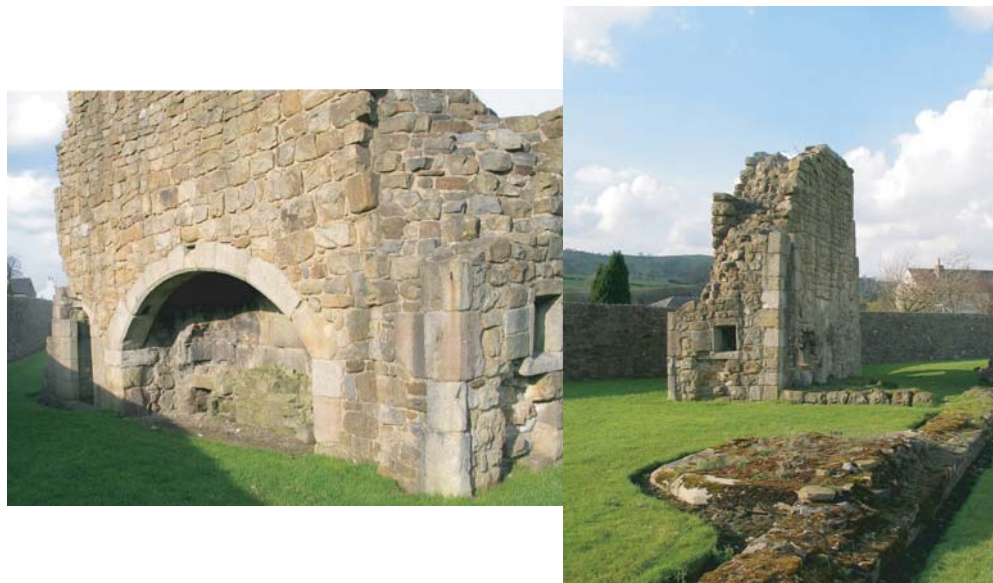
Figure 25  
Photographs showing  
the remains of the  
fireplace and chimney  
adjacent to the  
western range of the  
cloister.

openings in the eastern wall filled in, to create the outer wall of the post-monastic dwelling (Coppack *et al* 2001, 81-2). These remains roughly correspond with the eastern end of a large rectilinear building depicted on the 1847 OS map (Figure 26). Although it is not absolutely clear from this edition of the map, the building was probably still roofed at this date, but had been demolished by 1884, when the next edition of the OS map was surveyed. Presumably it had fallen victim to Earl de Grey's re-modelling of the abbey and its environs in the 1850s.
