Historic England

Parnham House, Beaminster, Dorset: Historic Building Assessment

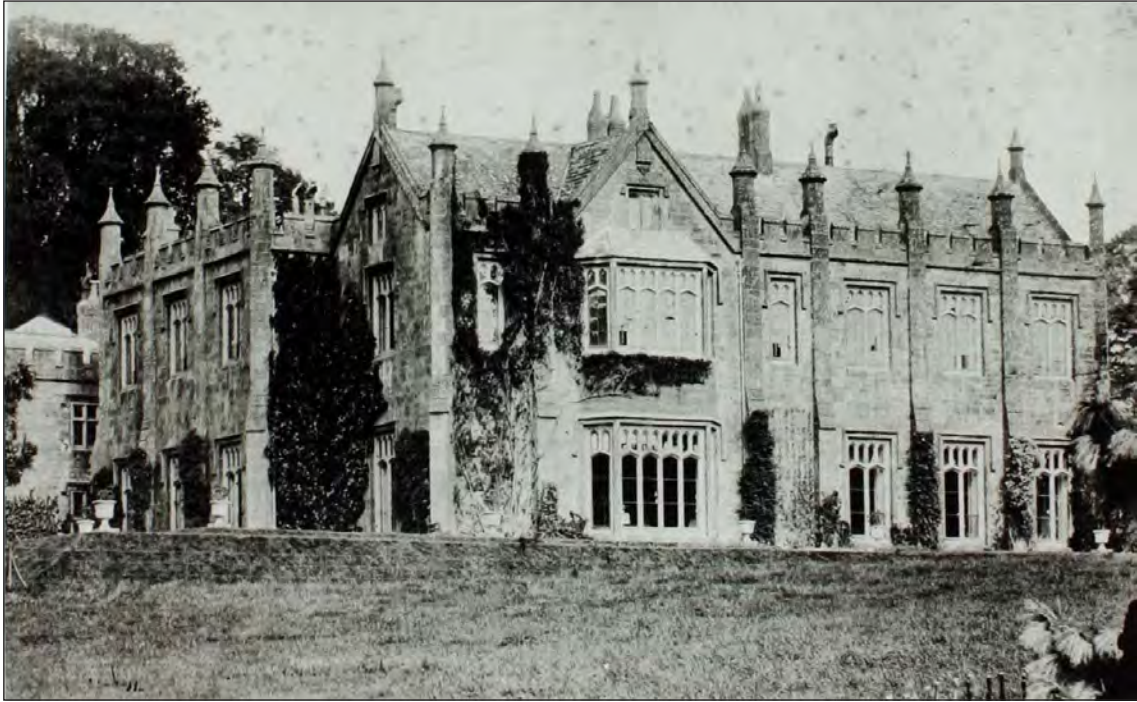
Figure 4 South and west fronts of Parnham in 1874 (HEA BB80/885)

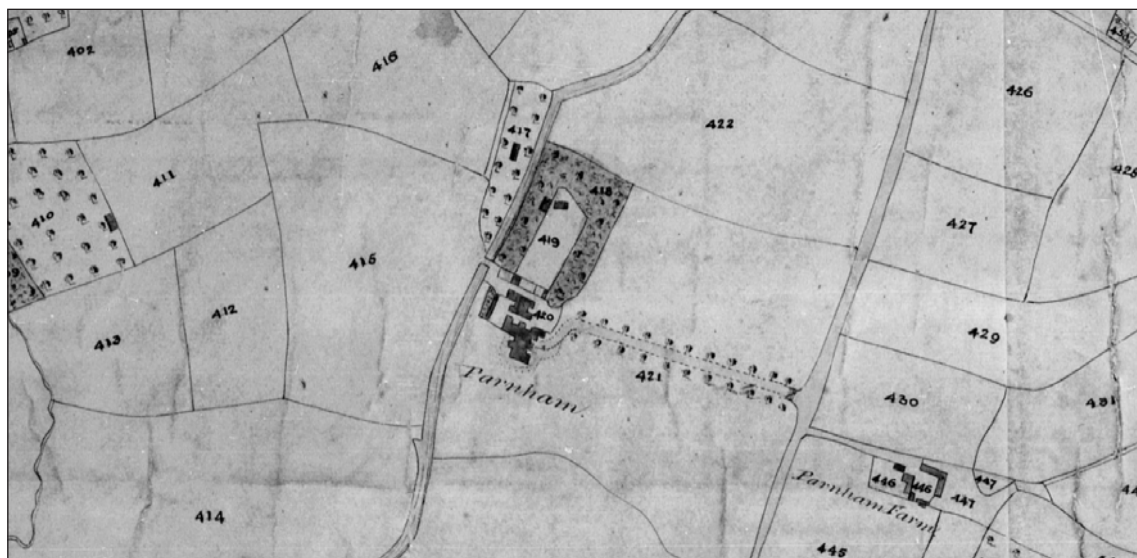
Figure 6 Parnham and its immediate setting depicted on the 1842 Tithe map (The National Archives IR 90/10/13)

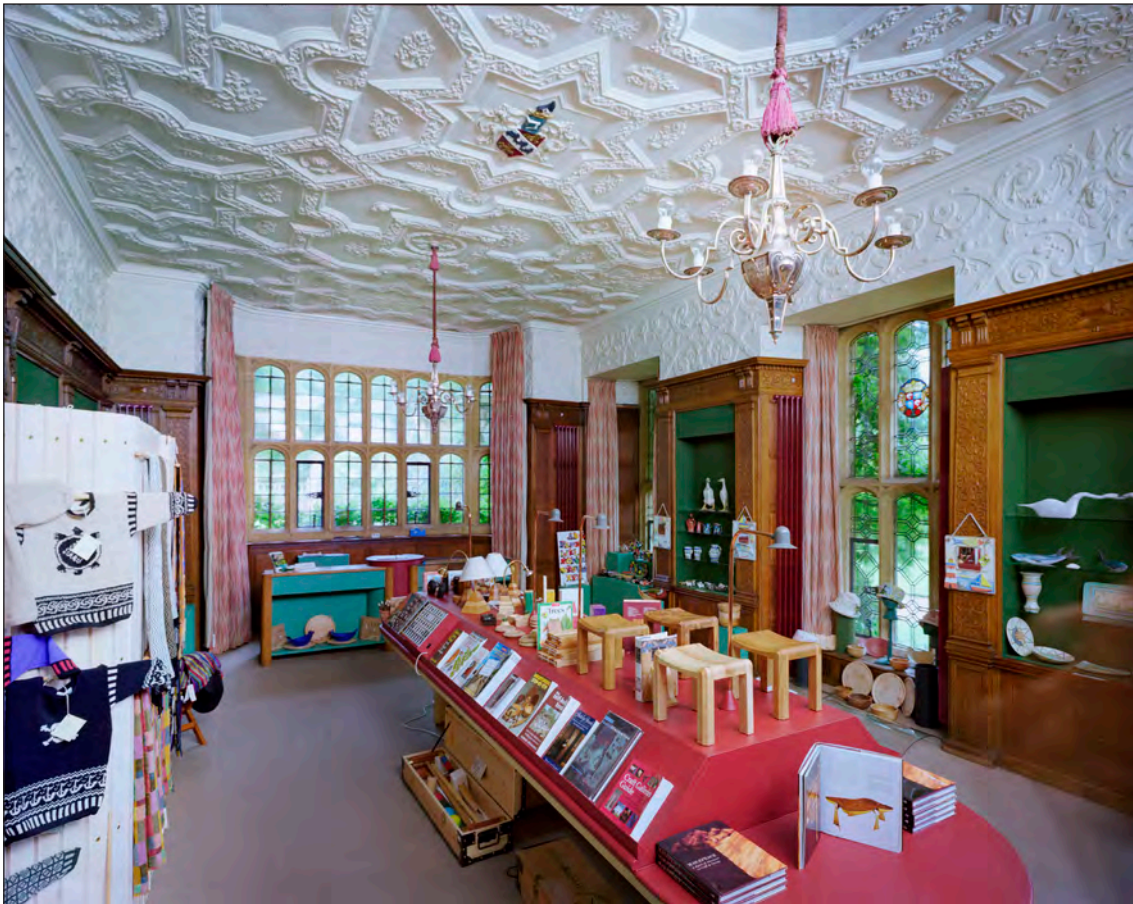
Figure 11 Interior of the library in 1998 (HEA BB99/04447)

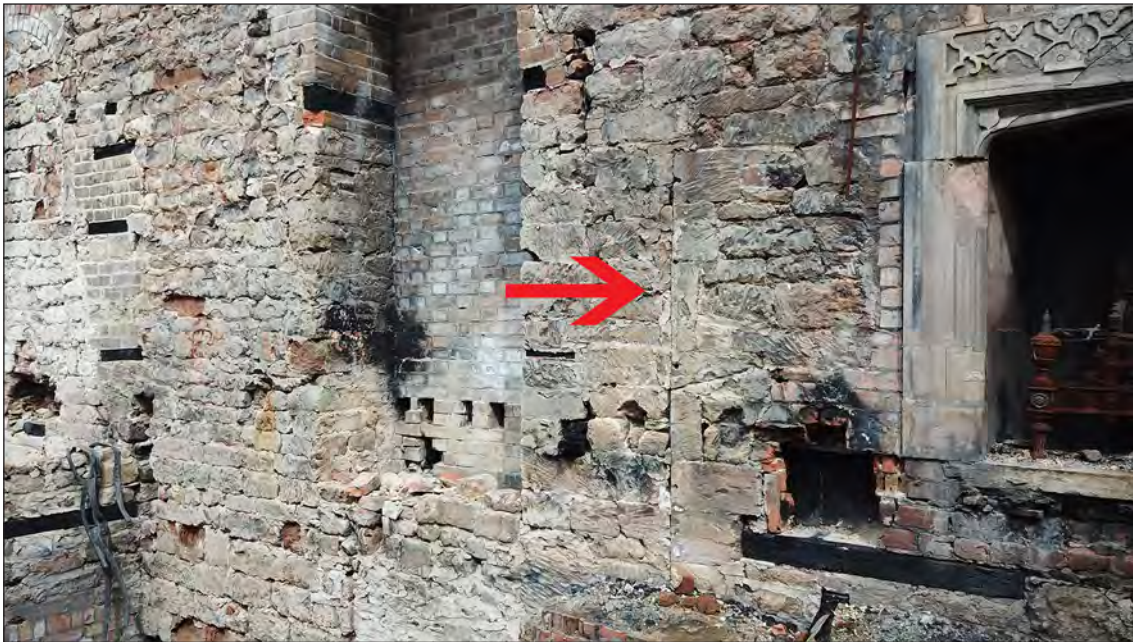
Figure 14 Straight joint visible in the north wall of the south wing, west of the first-floor fireplace (Drone survey image © Historic England)

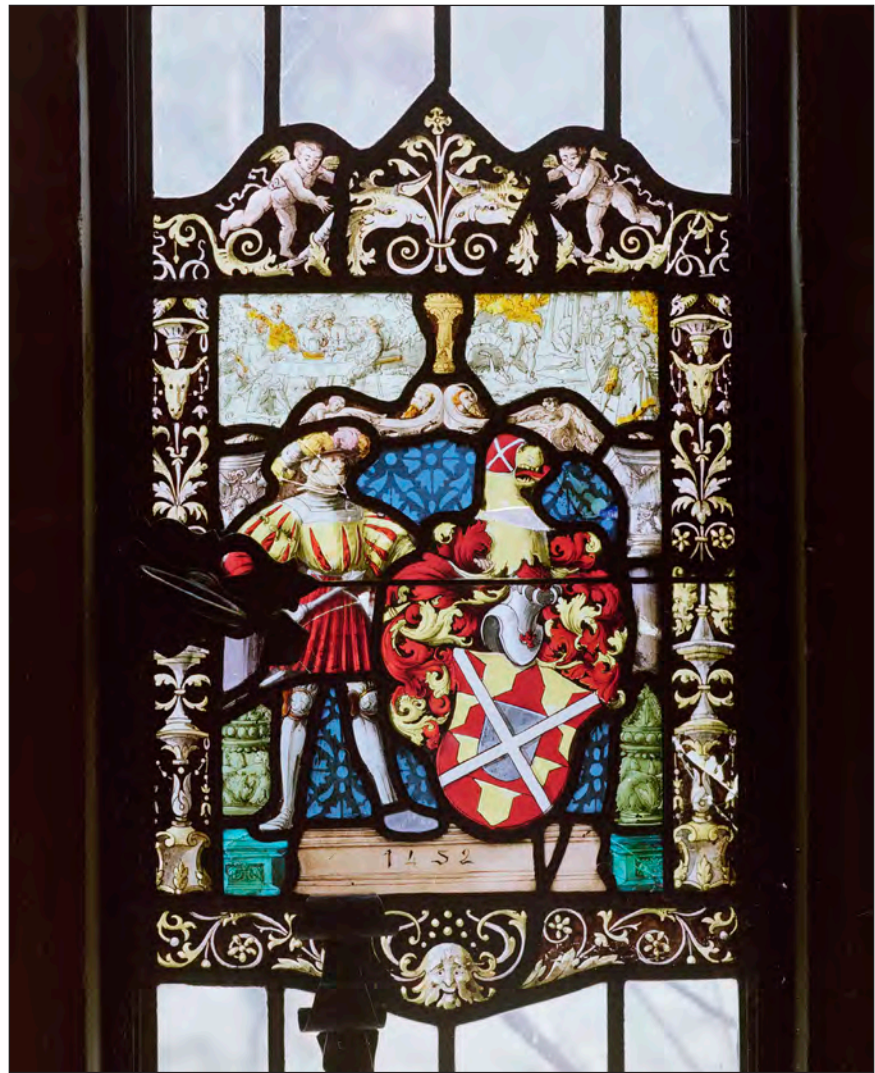
Figure 21 One of stained glass panel in the windows of the ground-floor room of the north wing, possibly of Continental origin, photographed in 1998 (HEA AA99/04684)

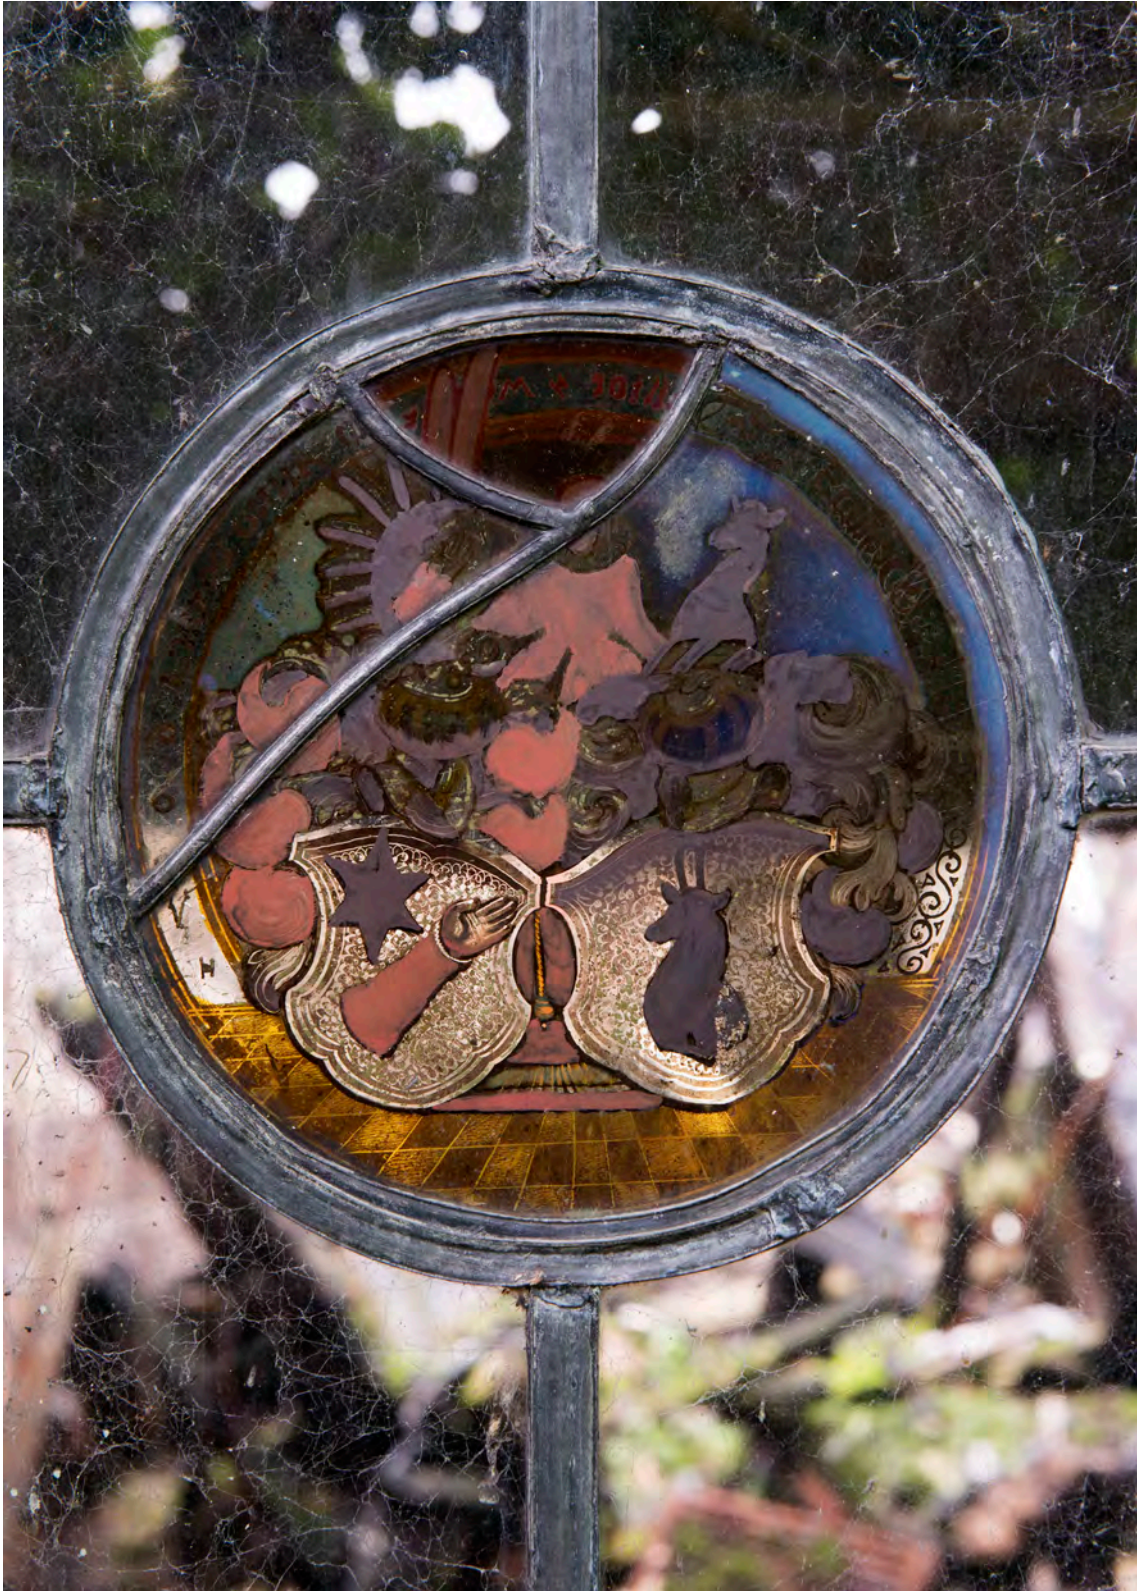
Appendix Two Figure 97: Exterior, north wing, north elevation, detail of stained glass in eastern ground-floor window, looking south (DP275987)

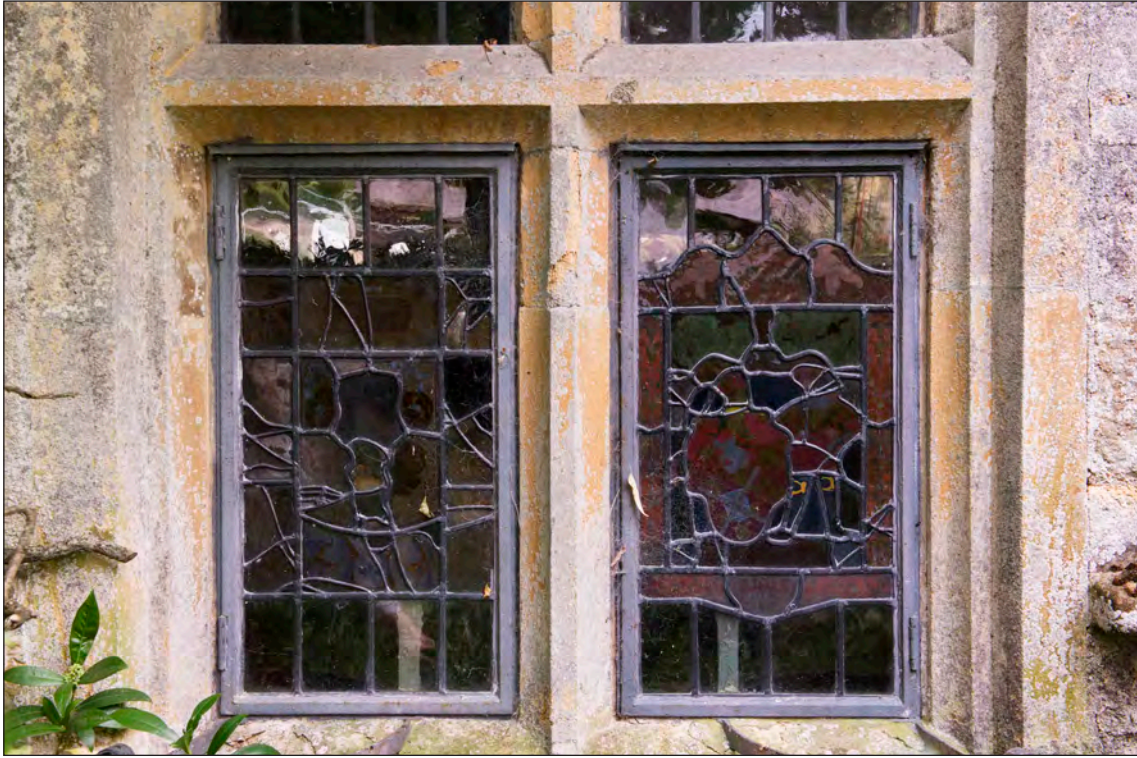
Appendix Two Figure 98: Exterior, north wing, north elevation, detail of stained glass in eastern ground-floor window, looking south (DP275988)

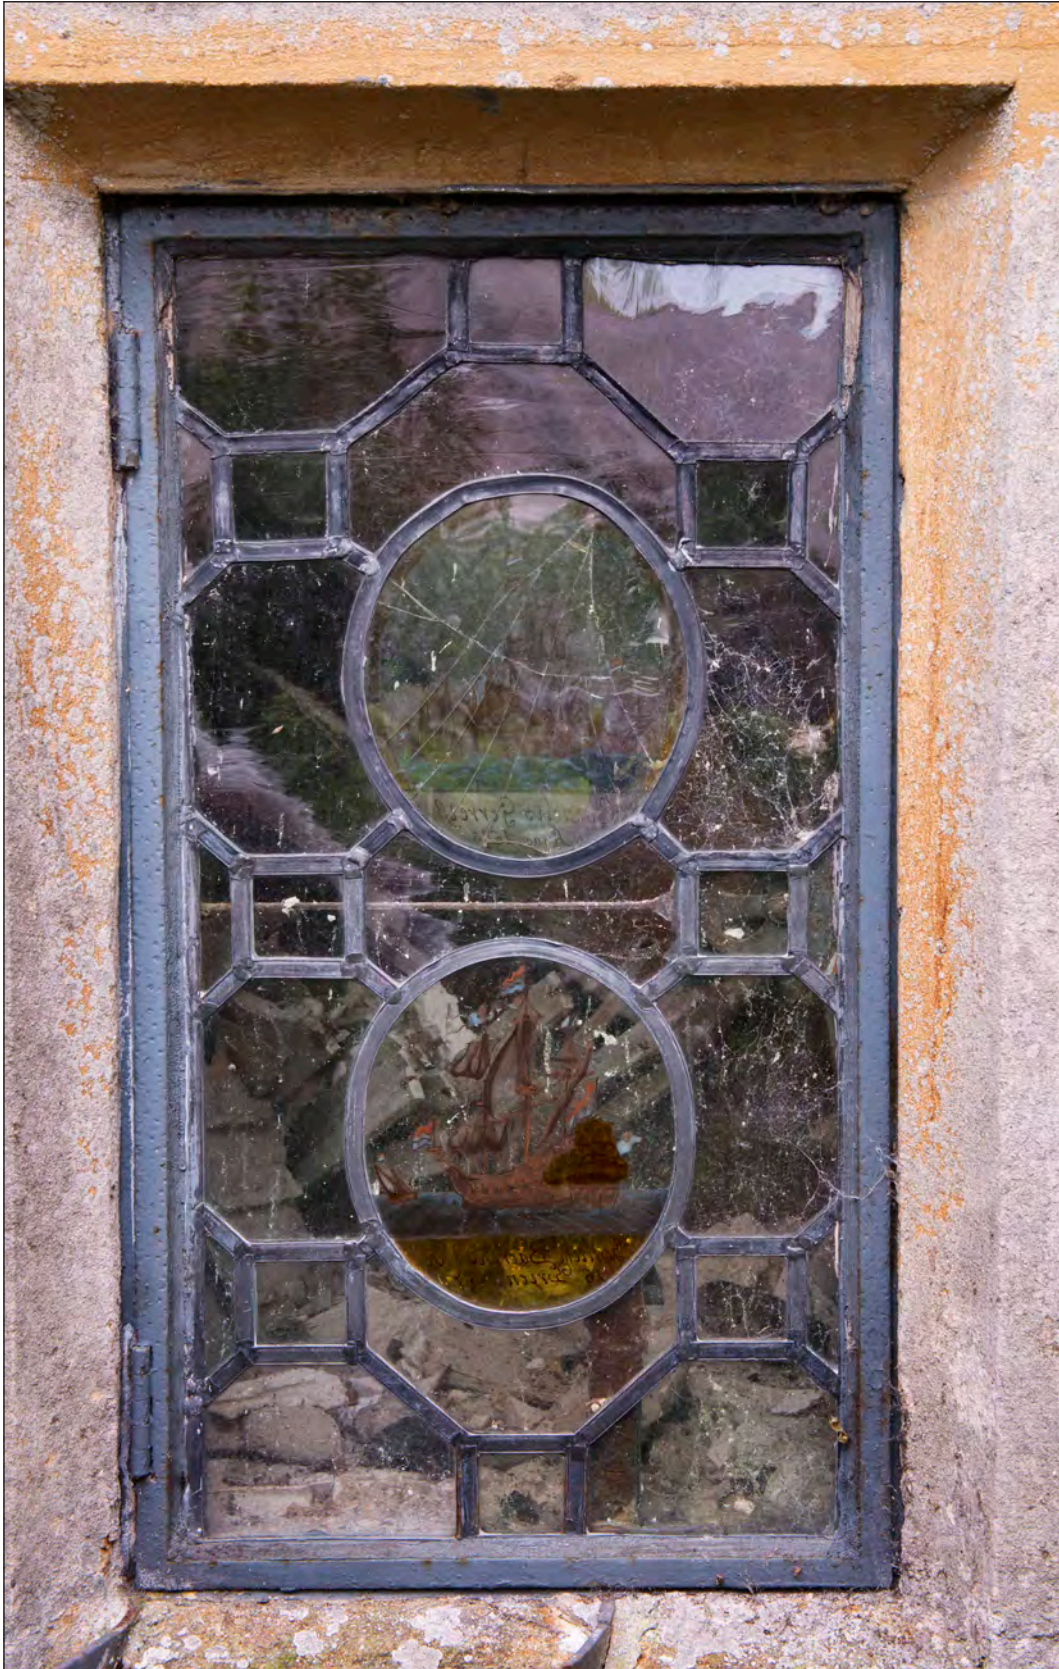
Appendix Two Figure 99: Exterior, north wing, north elevation, detail of stained glass in central ground-floor window, looking south (DP275989)

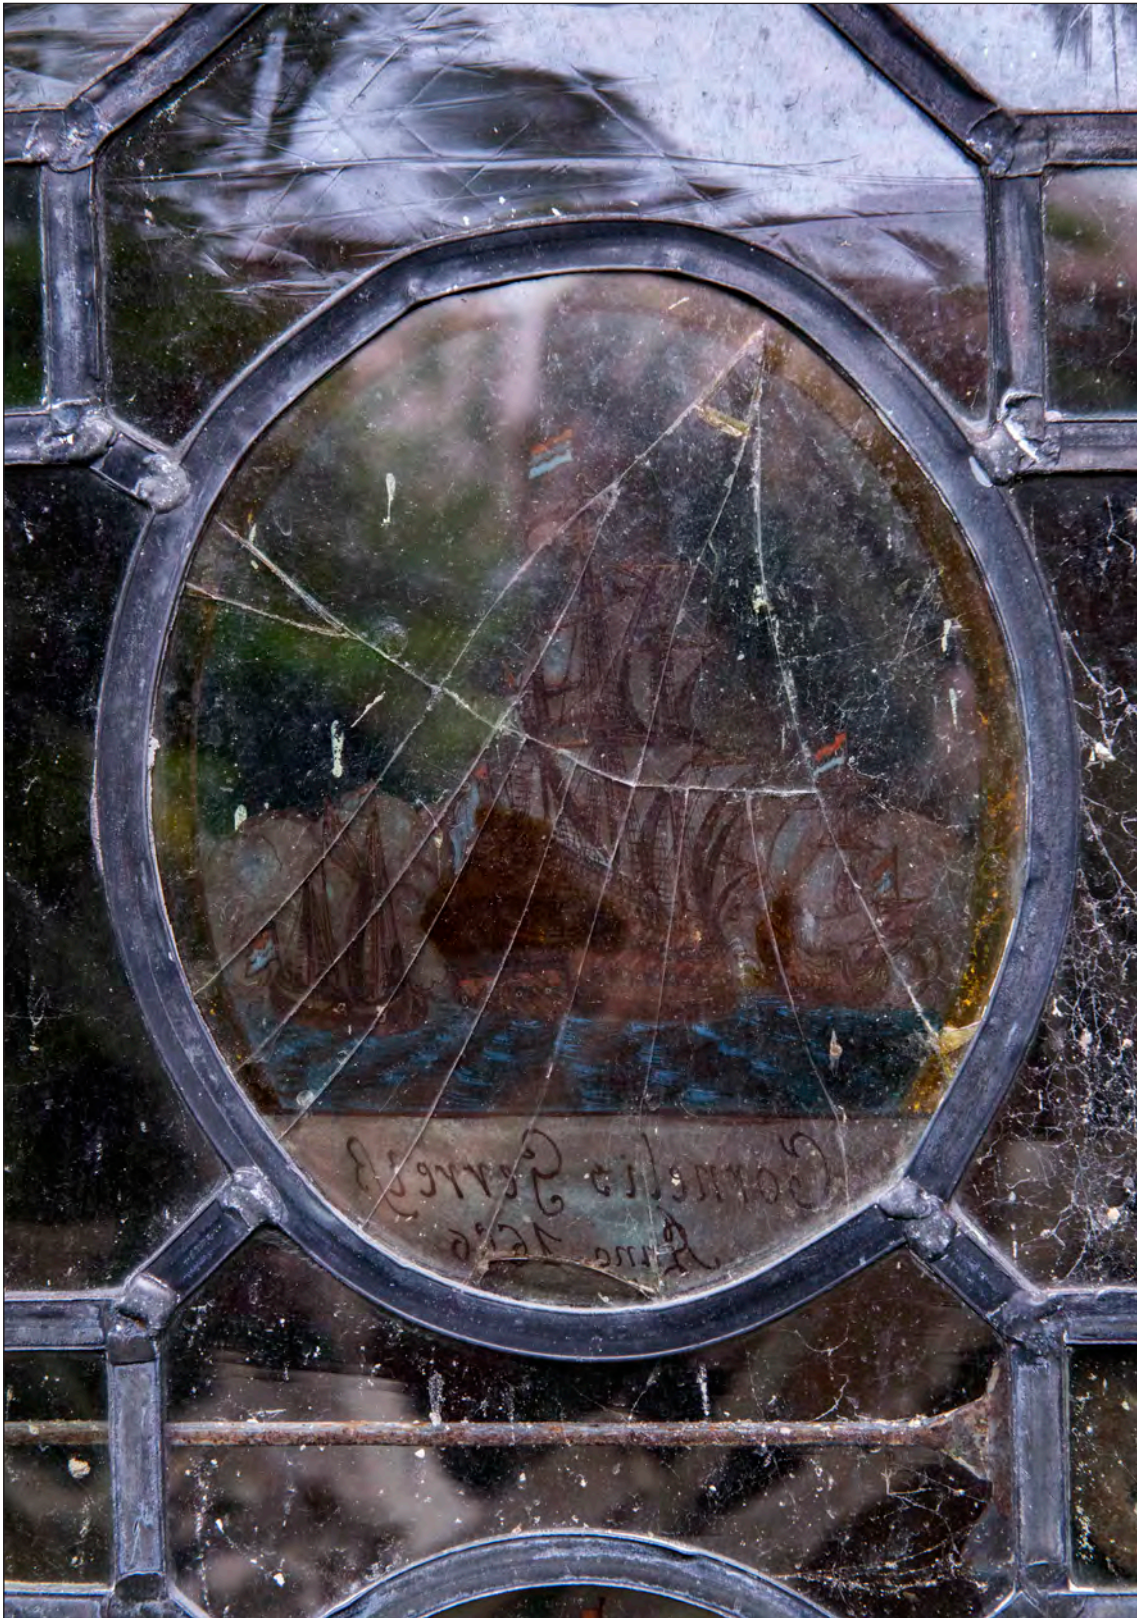
Appendix Two Figure 100: Exterior, north wing, north elevation, detail of stained glass in central ground-floor window, looking south (DP275990)

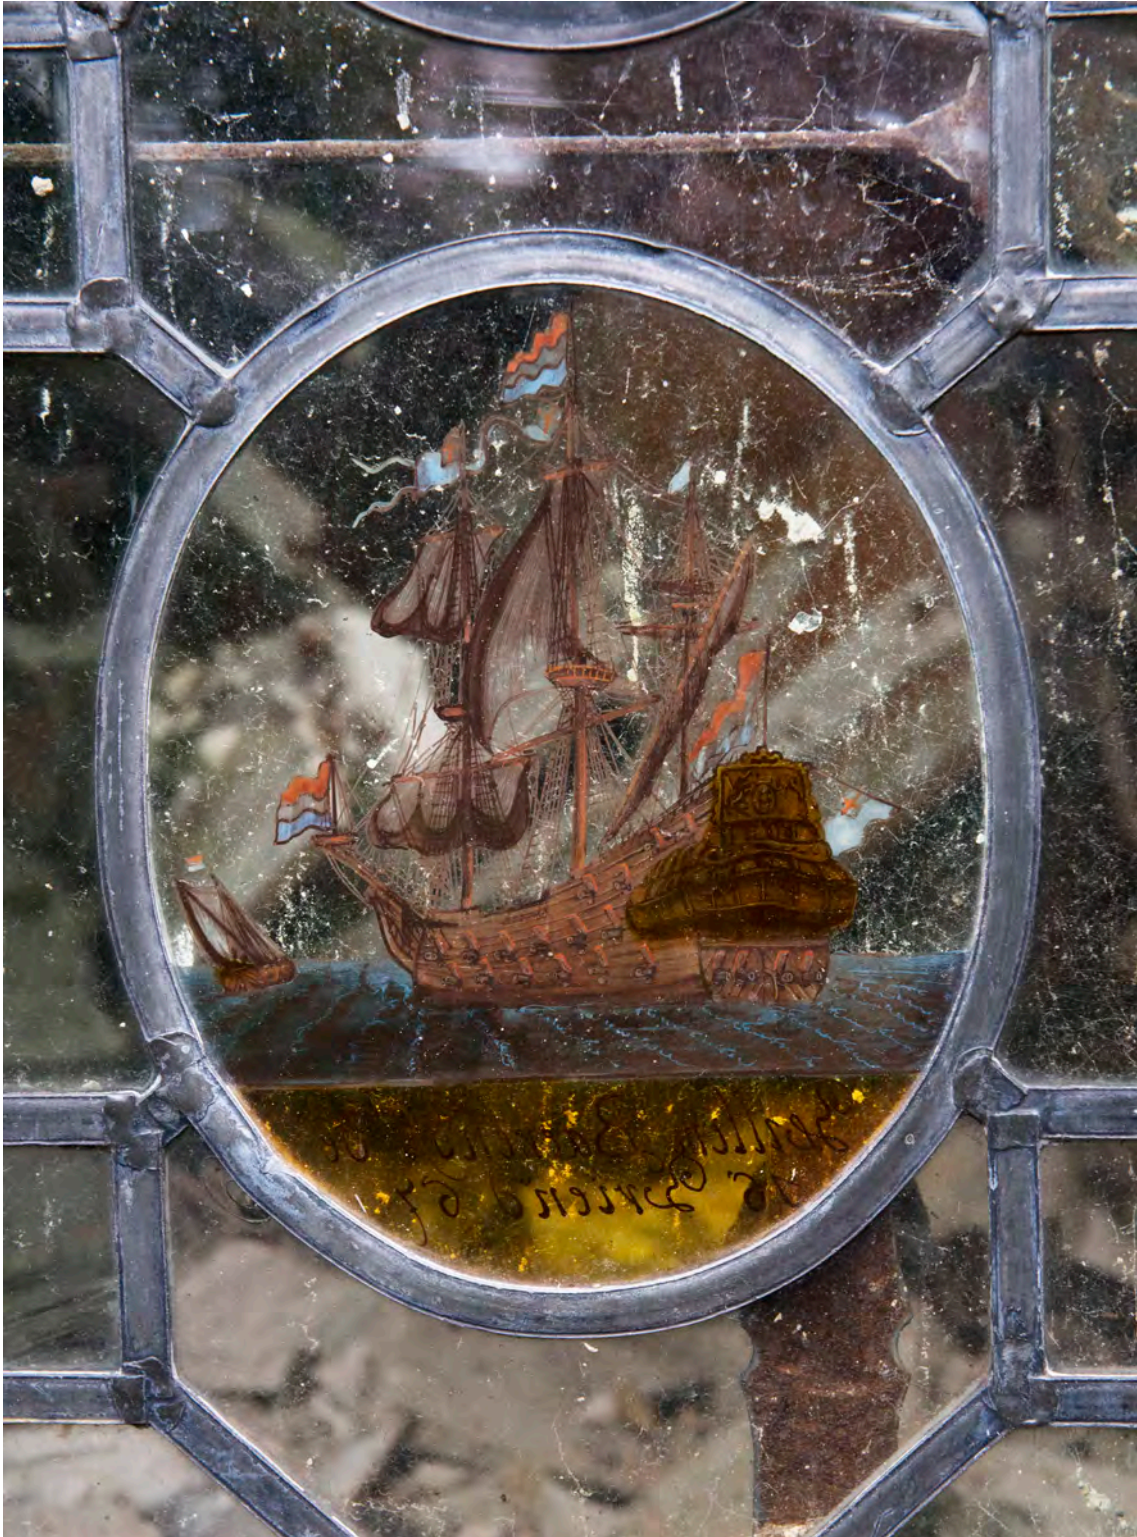
Appendix Two Figure 101: Exterior, north wing, north elevation, detail of stained glass in central ground-floor window, looking south (DP275991)

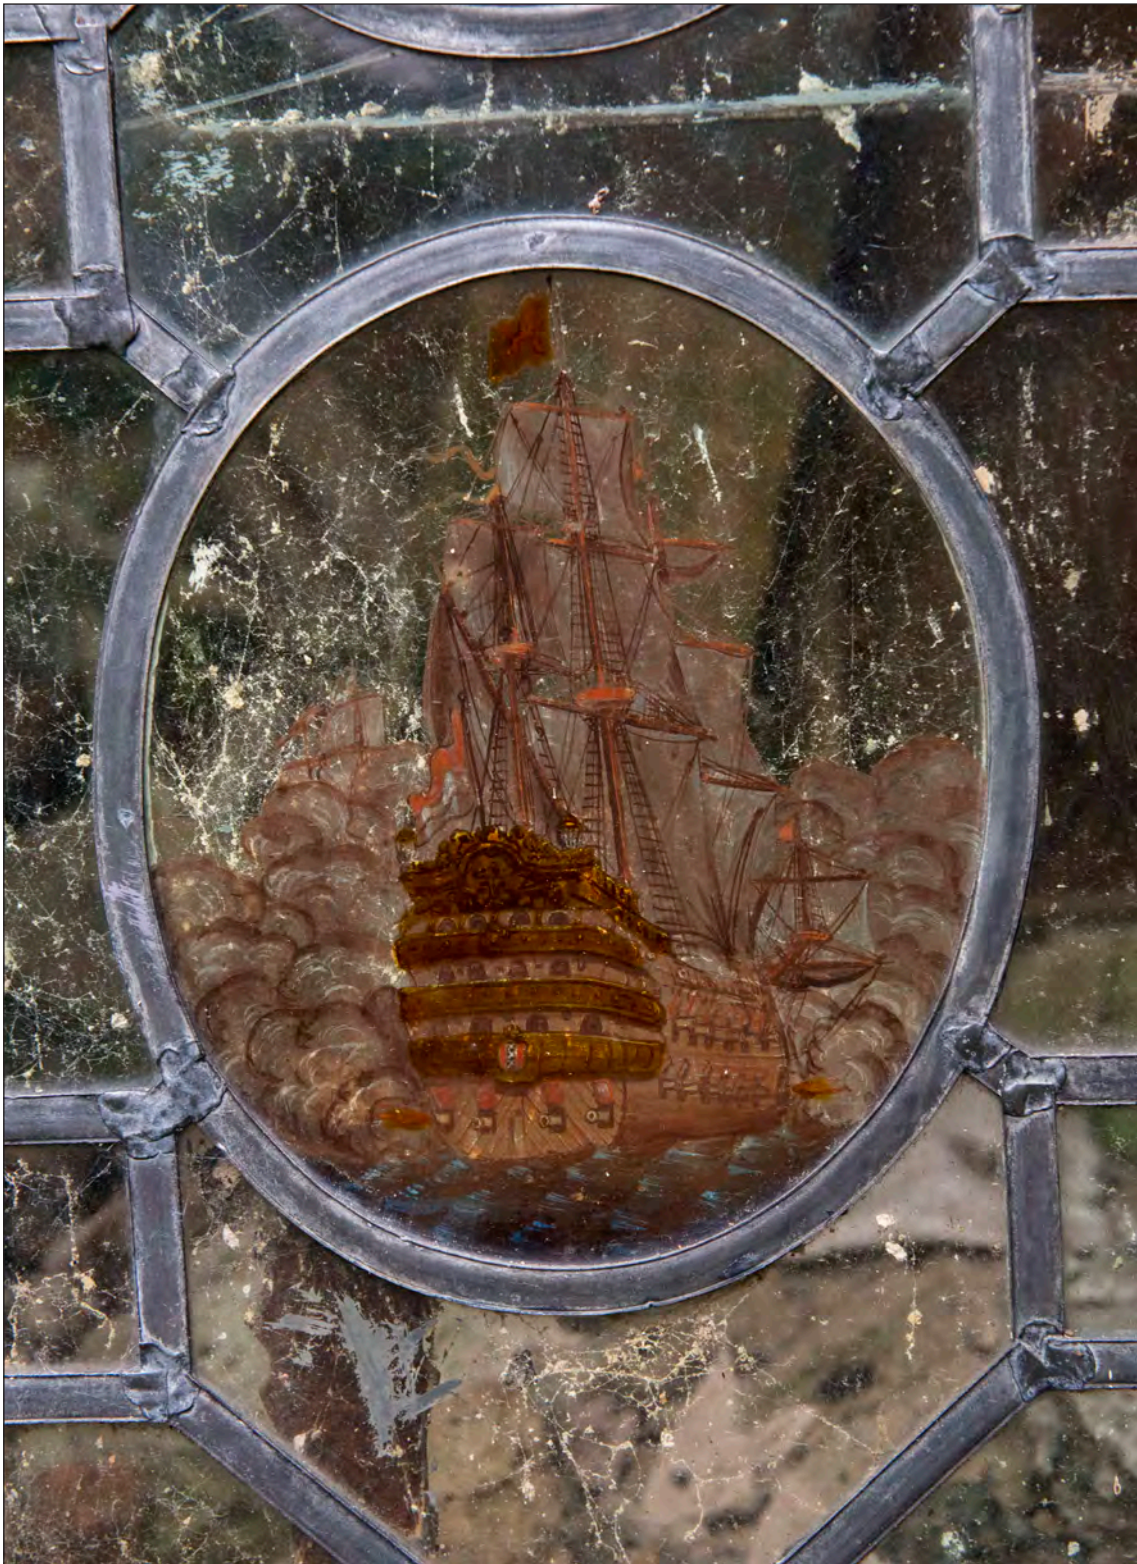
Appendix Two Figure 102: Exterior, north wing, north elevation, detail of stained glass in central ground-floor window, looking south (DP275902)

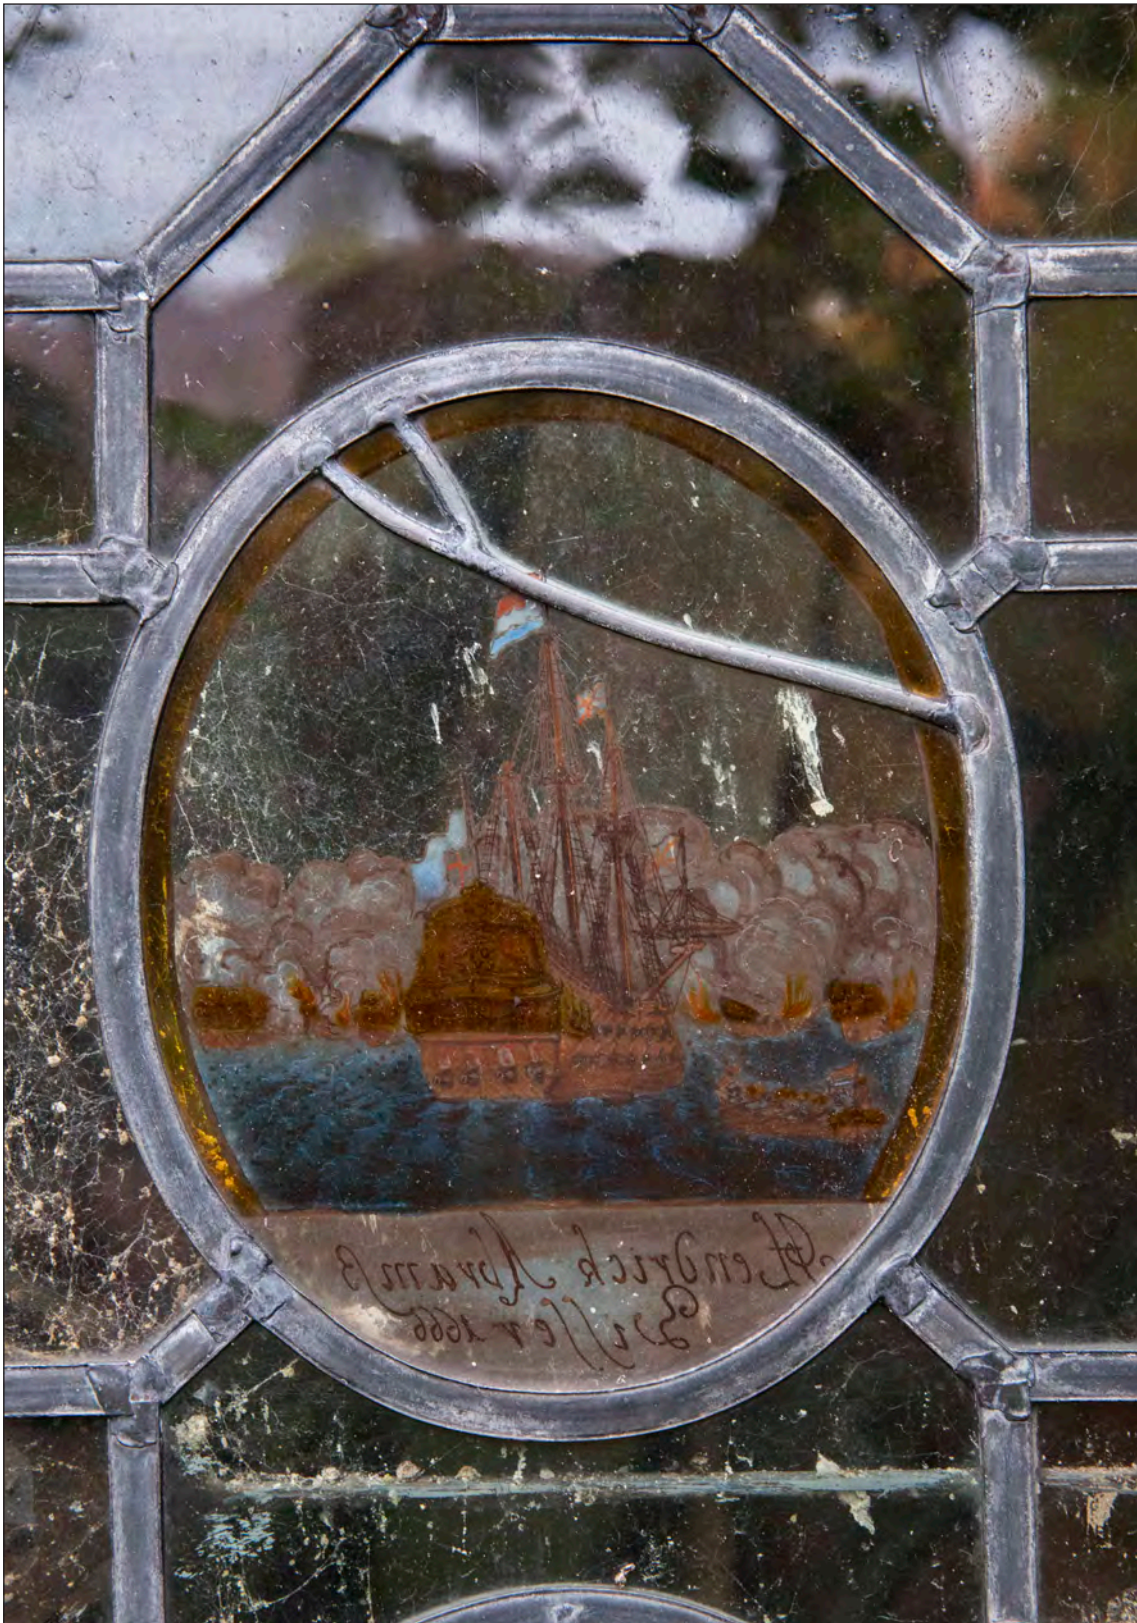
Appendix Two Figure 103: Exterior, north wing, north elevation, detail of stained glass in central ground-floor window, looking south (DP275993)

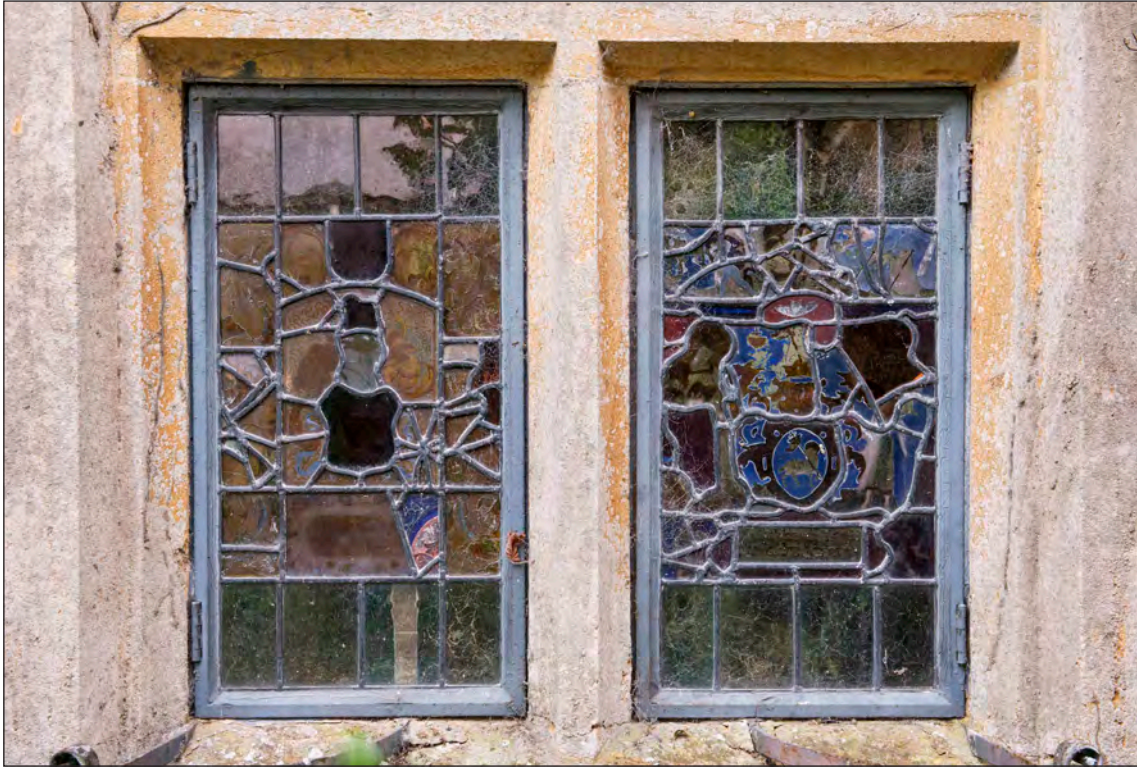
Appendix Two Figure 104: Exterior, north wing, north elevation, detail of stained glass in western ground-floor window, looking south (DP275994)

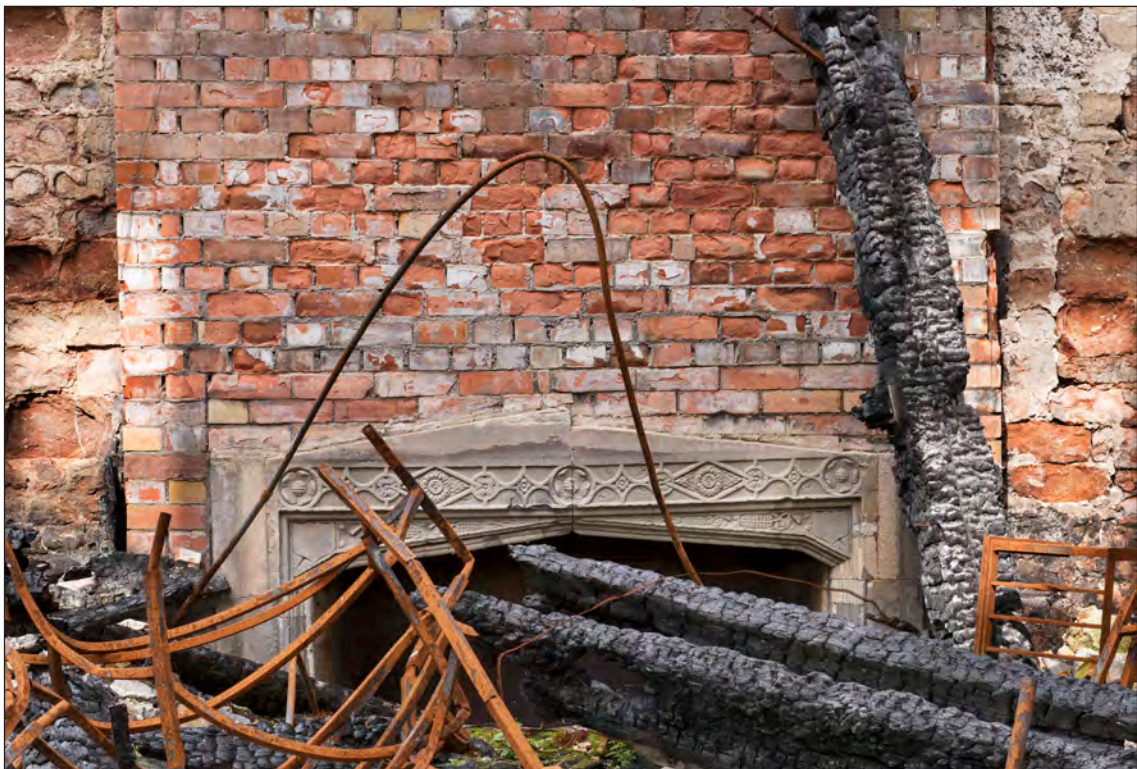
Appendix Two Figure 105: Interior, south wing, north elevation, detail of fireplace, looking north (DP275995)
