# ATOMIC WEAPONS RESEARCH ESTABLISHMENT, ORFORD NESS, SUFFOLK COLD WAR RESEARCH & DEVELOPMENT SITE SURVEY REPORT

# ATOMIC WEAPONS RESEARCH ESTABLISHMENT ORFORD NESS, SUFFOLK

## COLD WAR RESEARCH & DEVELOPMENT SITE

## SUMMARY

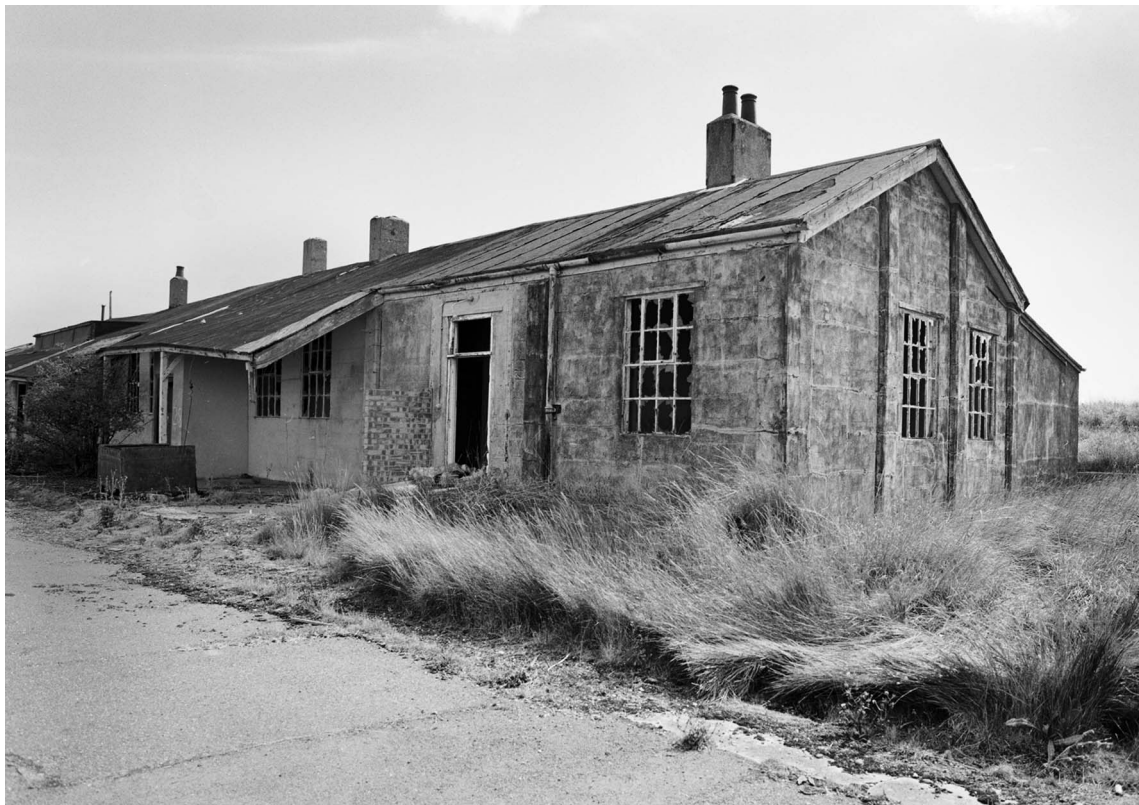
*Figure 3: First World War Royal Flying Corps Headquarters building, note the use of cement block construction. This view was taken in the 1990s, it has since been demolished. (c) English Heritage AA99/08438*

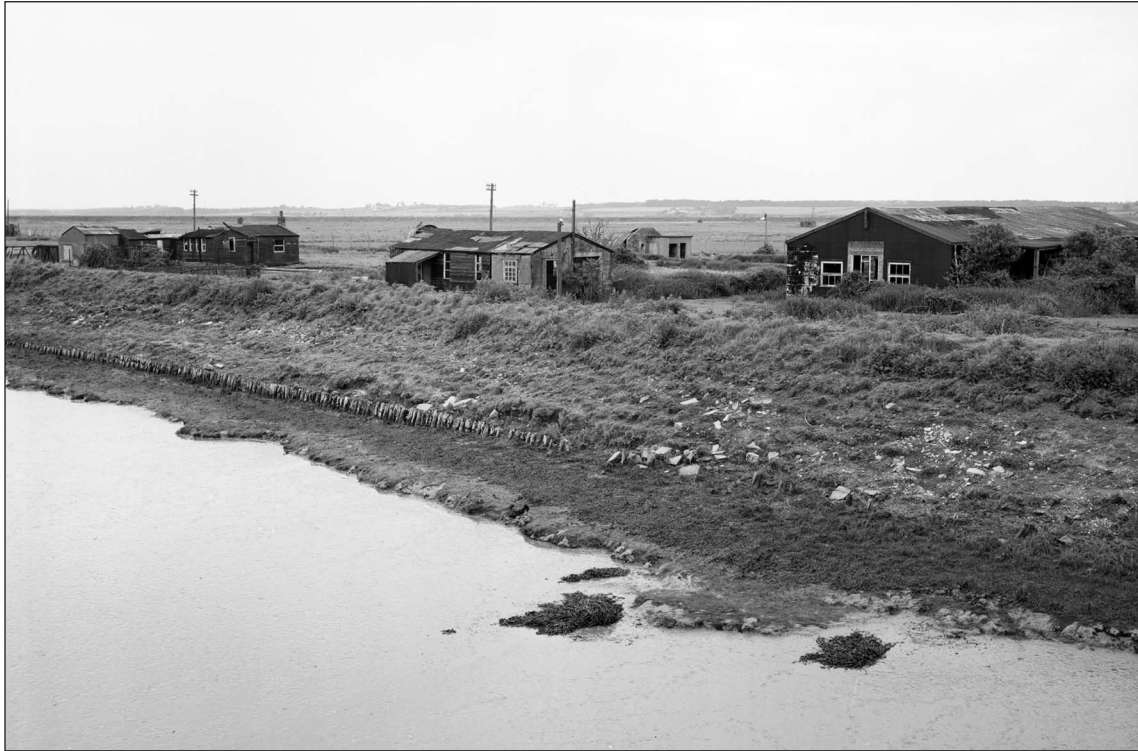
*Figure 4: Photograph taken during the 1990s of the First World War Royal Flying Corps buildings that were used during the 1930s for radar research, to the left is C13 and to the right C8, most of the buildings in the centre have subsequently been demolished (c) English Heritage BB93/09845*

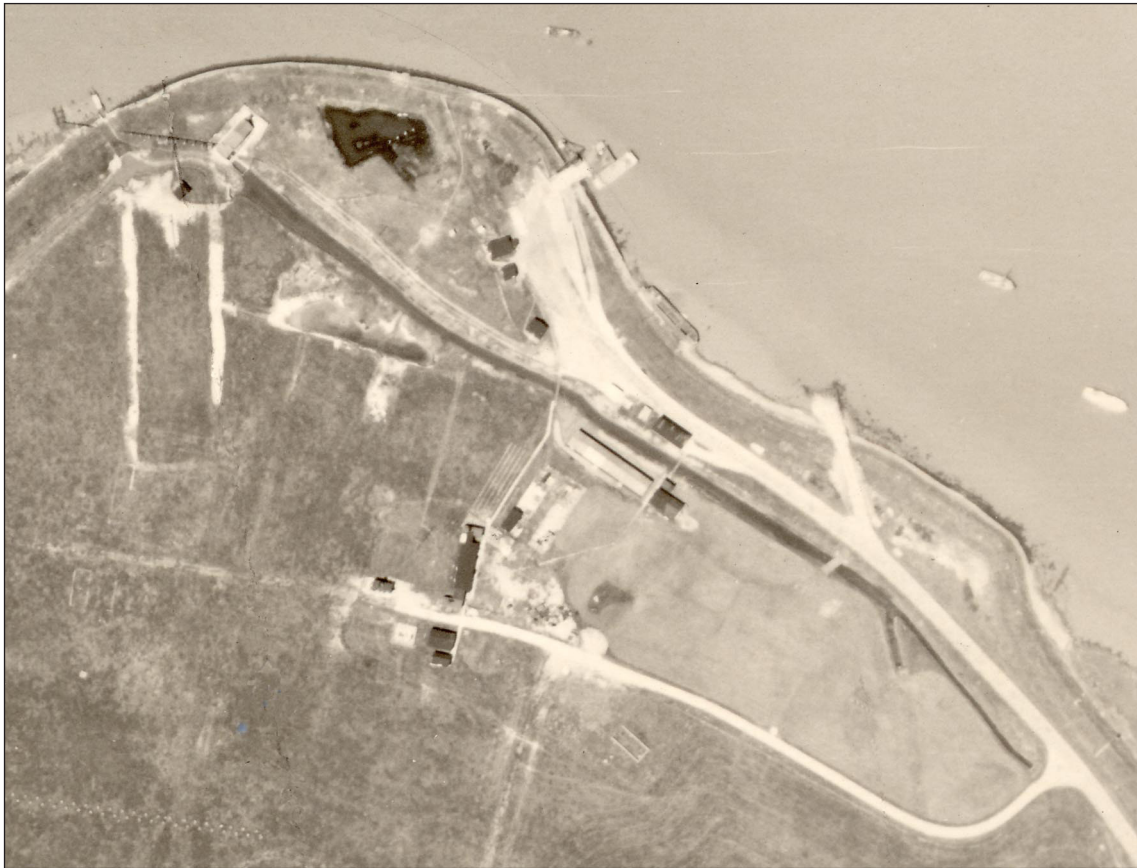
Figure 6: The jetty area in May 1952, at the centre is the long rectangular radar building with SCR 584 radar trailers to either end and a third trailer to the left. RAF58/877 5164 21 May 1952 English Heritage (NMR) RAF Photography

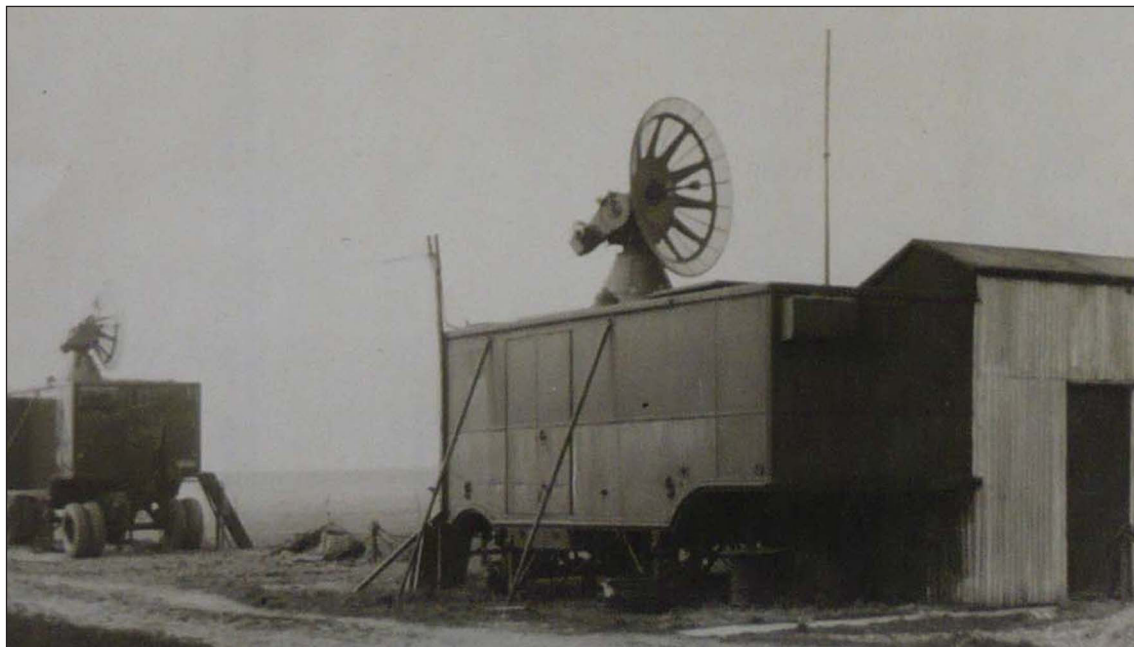
*Figure 7: Early 1950s radar station used during the bomb ballistics trials showing two SCR 584 type radars TNA:PRO AVIA 6/14752*

Ballistics Building and was able to communicate with the aircraft from an adjacent radio transmitter mast. For the trials work, three mobile, wartime American gun-laying SCR 584 radar trailers were set up, along with two mobile trackers equipped with cameras (Figure: 7) (TNA: PRO AVIA6/14752).

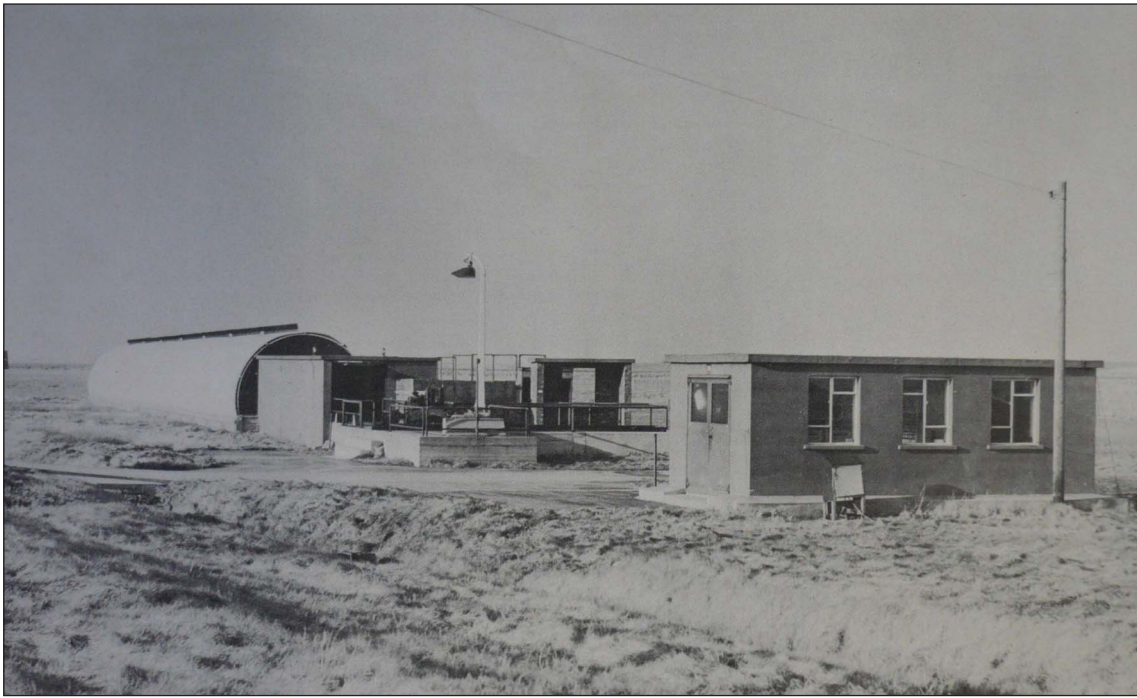
Figure 8: Building C12, was 103, Model ballistics firing range in about 1958. TNA:PRO AVIA6/14752

To further support the bomb ballistics work the RAE also operated a Model Ballistic Firing Range that was built at the southern end of the former RFC area (Figures 8 and 9). Air photographs allow the construction of this facility may be dated to early 1955 (RAF 58/1674 (F21) 0121 4 Mar 55). It comprised a control building with timing and measuring equipment, a platform for a 17-pounder gun and a 50 yard (45.72m) range, covered by a semi-circular corrugated steel sheet roof. In operation models were fired from the gun in a projectile known as a 'sabot' that then fell away to allow the model to travel down the range. Internally, were a series of spark photography stations spaced at 5 ft (1.5m) intervals and for stability mounted on 40 ft (12.2m) piles, which recorded the pitch and

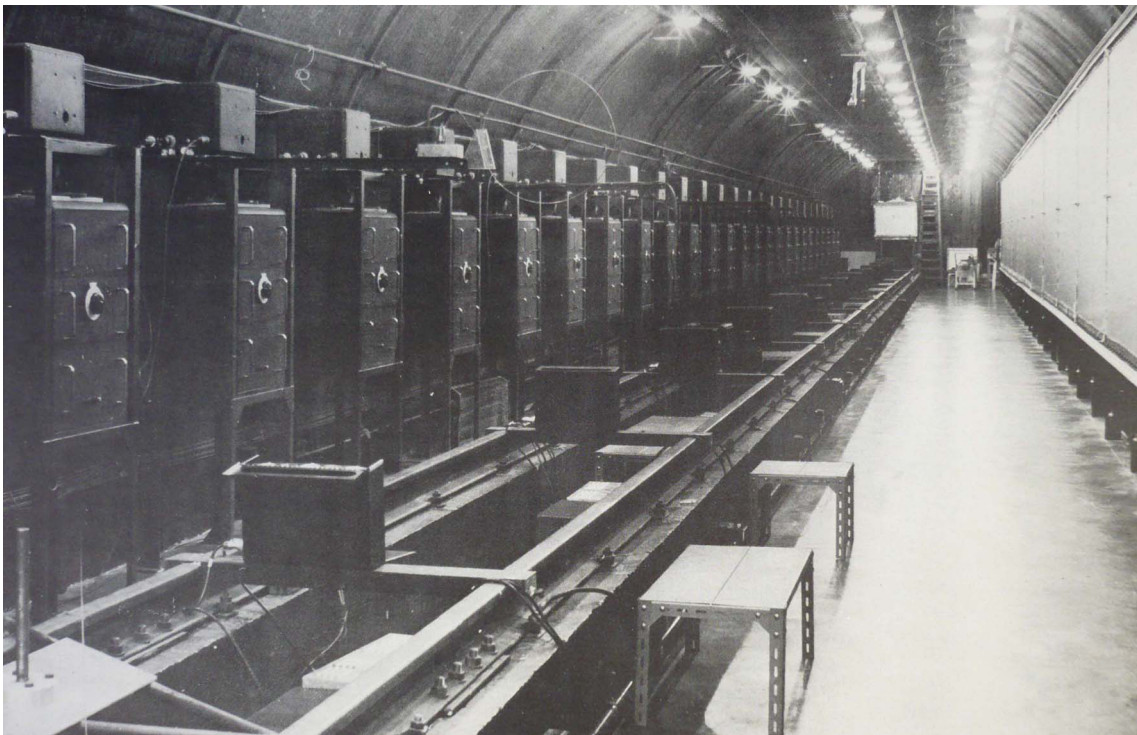
Figure 9: Building C12, model ballistics firing range interior in about 1958 TNA: PRO AVIA6/14752

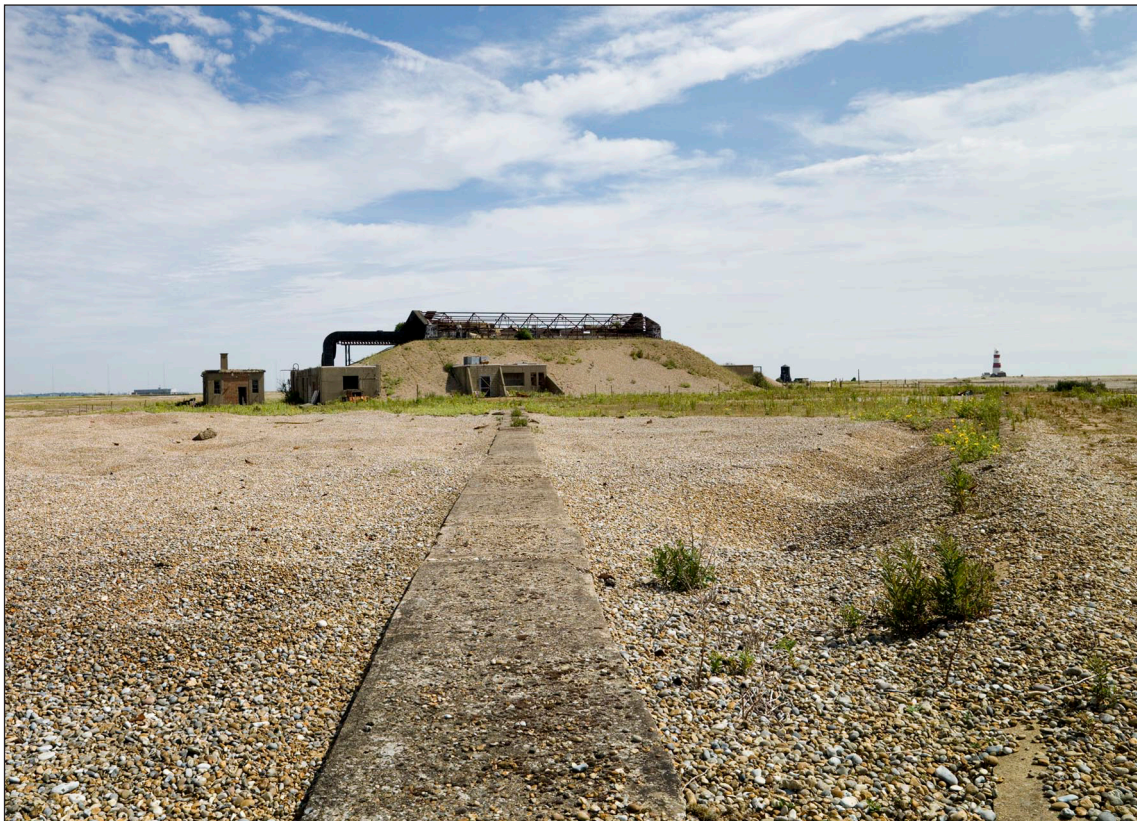
Figure 10: Laboratory 1, building F3, this building was completed by summer 1956 to evaluate weapons prior to the autumn 1956 Buffalo trials (c) English Heritage DP070016

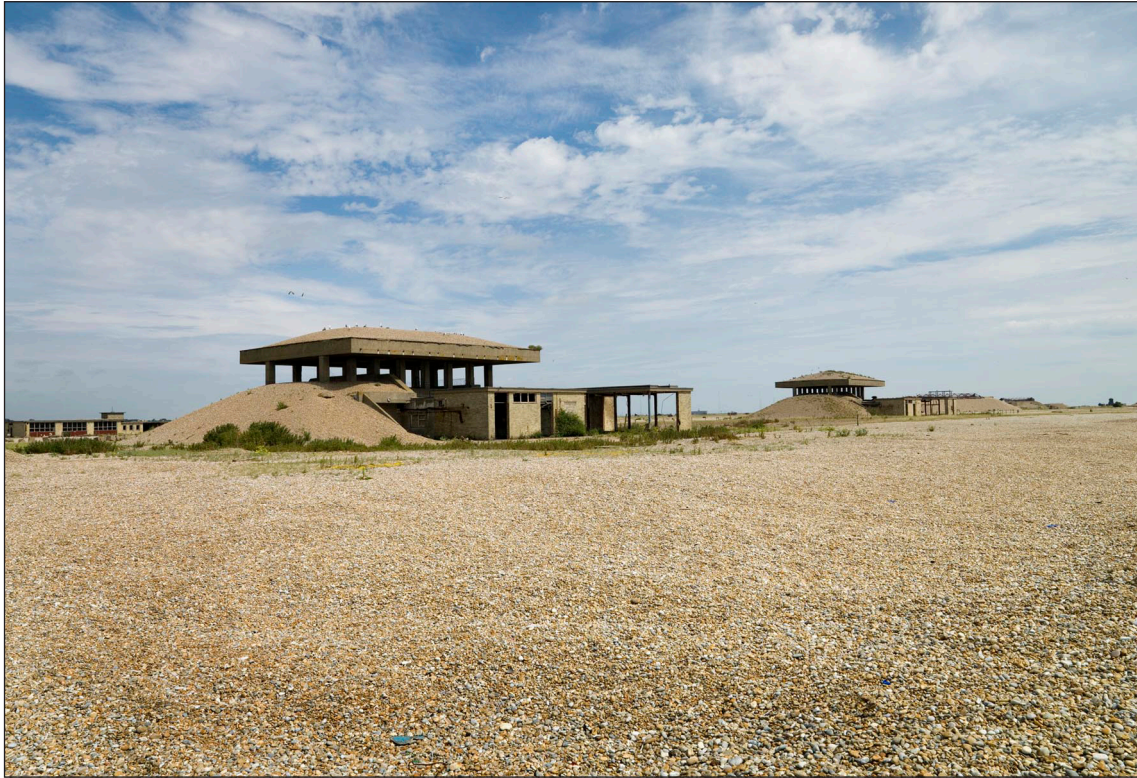
*Figure 11: Vibration Test Buildings E2 and E3, or Pagodas, they were built about 1960 (c) English Heritage DP068510*

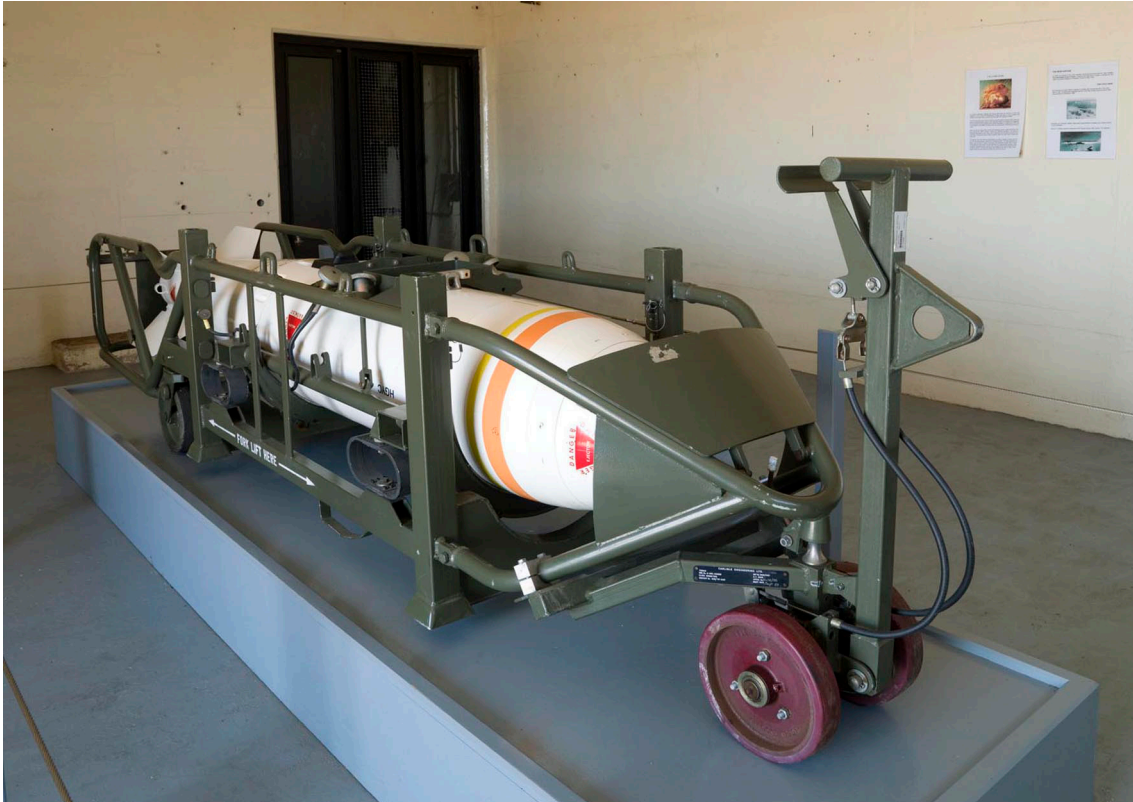
Figure 12: WE177A freefall tactical nuclear weapon (c) English Heritage DP068440

Work was also continued on the WE177 family of freefall bombs (Figure: 12). If success in weapons design is judged by longevity in service it might be regarded as one of the United Kingdom's most successful projects. The series remained in service use from 1966 to 1998. The operational requirement for this weapon was established in the late 1950s to provide a tactical weapon to replace the *Red Beard* bomb, and which was small enough to be carried by a variety of aircraft. The design that emerged was a series of bombs that weighed between 600-900 lb (272-431kg) and measured between 9ft 4in and 11ft 1 in (2.84-3.37m) in length and 16½ in (0.42m) diameter; which was determined by the size of the warhead. It was an extremely sophisticated weapon whose yield could be varied; different variants might be dropped in different roles, for example, as a parachute retarded lay down bomb that was designed to hit the ground before detonating, or as a nuclear depth charge. To simulate falling from a great height the **Impact Facility F5/171** was built in late 1963 or early 1964, in which a weapon, minus its fissile core, was propelled by a rocket powered sled against a concrete wall.

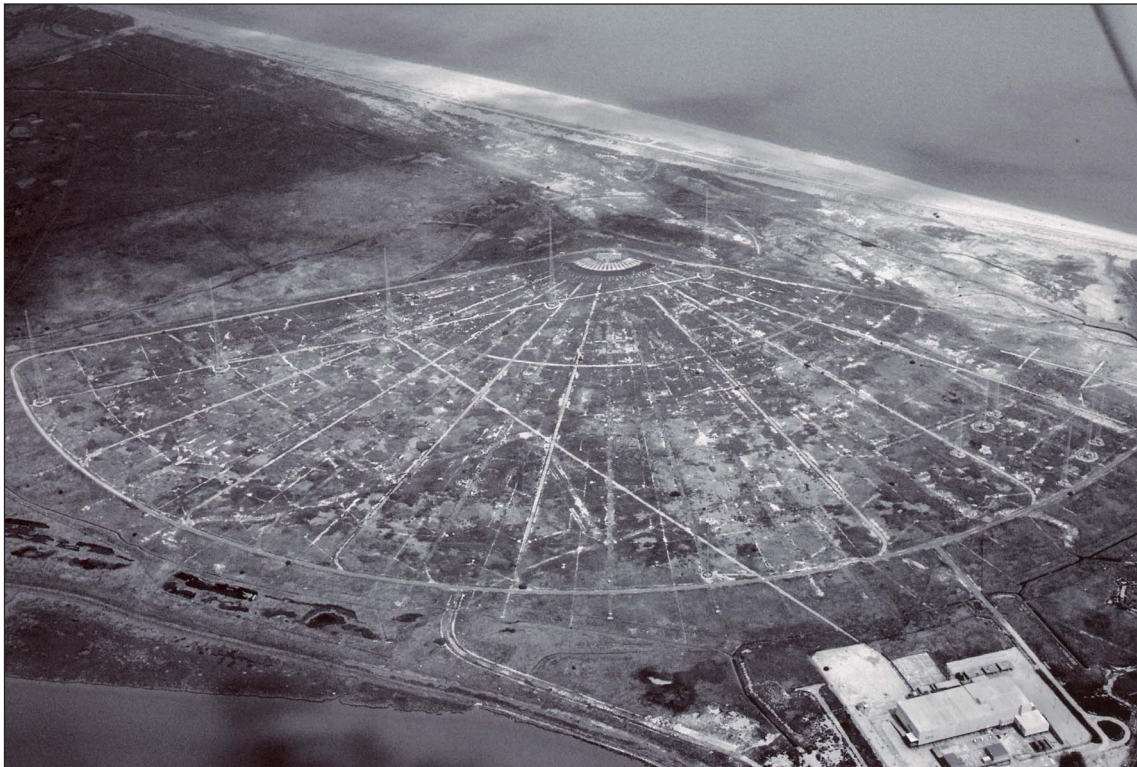
Figure 13: Cobra Mist site 23 July 1997. NMR 15704/25 (c) Crown.copyright.NMR

In the late 1960s, and unconnected with AWRE, Orford Ness was selected as the site for an experimental over the horizon radar system (Figure 13). In essence it was designed to extend the range of conventional radar detection techniques by bouncing radio signals off the ionosphere. In theory it should be possible to detect any disturbance to these signals caused, for example, by the launch of a missile or the passage of an aircraft. The northern end of the spit selected for this installation had been one of the main target areas and was heavily disturbed by practice bombing. Unexploded ordnance clearance began in 1967, by July 1971 most building work was completed and fitting out was finished by February 1972. Testing began almost immediately, it was, however, quickly discovered that there were unsolvable problems with background interference and the project was abandoned in June 1973 (Cocroft and Thomas 2003, 135-9). The facility was later adapted for use by the BBC World Service and since 1997 has been managed by VT Merlin Communications Ltd.

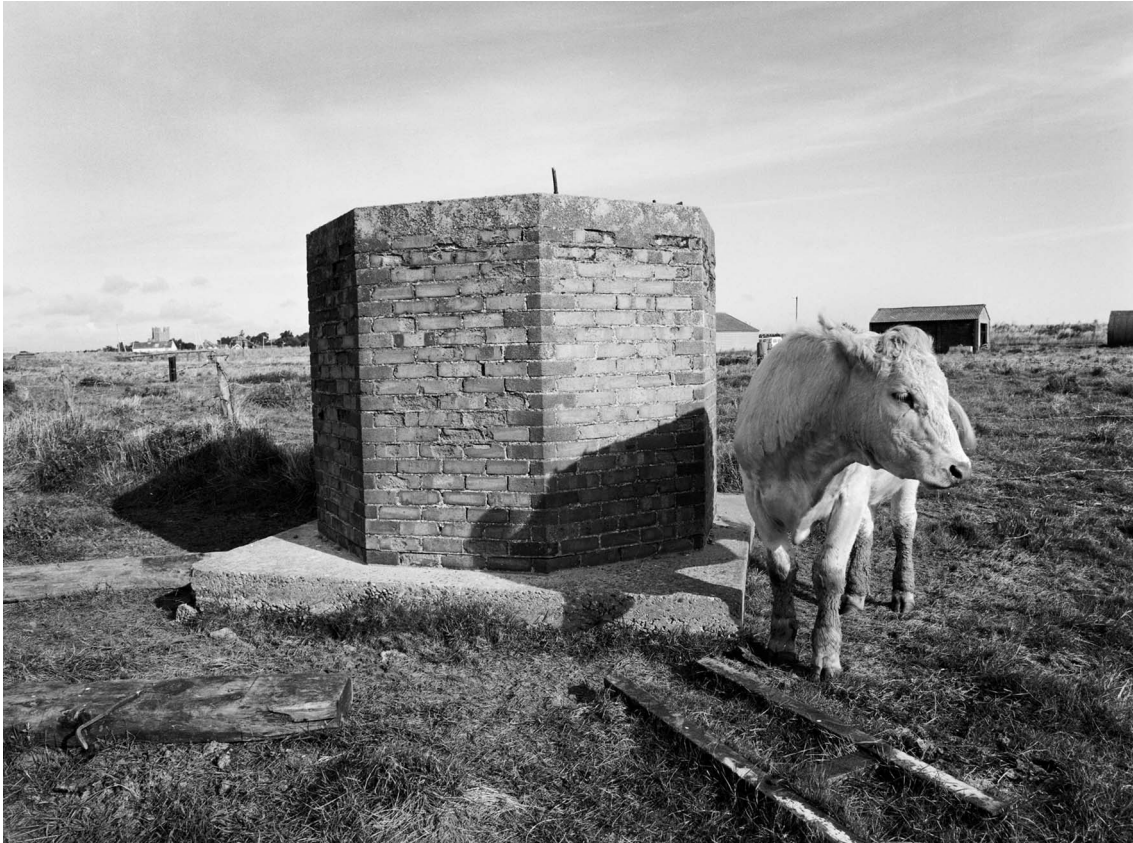
Figure 15: Kinetheodolite base (C) NMR AA99/08401

One of the organisations that were sent a copy of the report on the radar station was ARE/HER (Armament Research Establishment/High Explosives Research), the cover name for the atomic bomb team. One drawback of this location was its vulnerability to flooding and the destruction of valuable equipment and records, which was demonstrated by the February 1953 floods that swept the east coast. Air photographs show that this facility was in operation in 1952, but by early 1955 no mobile radar equipment is shown in place, which may indicate that it was redundant by this date or that it was only occupied during trials work (RAF 58/877 (F14) 5163 21 May 52; RAF 58/1674 (F21) 0122 4 Mar 55). The trials were also recorded by cameras and kinetheodolites, a number of whose mounting plinths still survive; they were not visited during this survey (Figure 15).

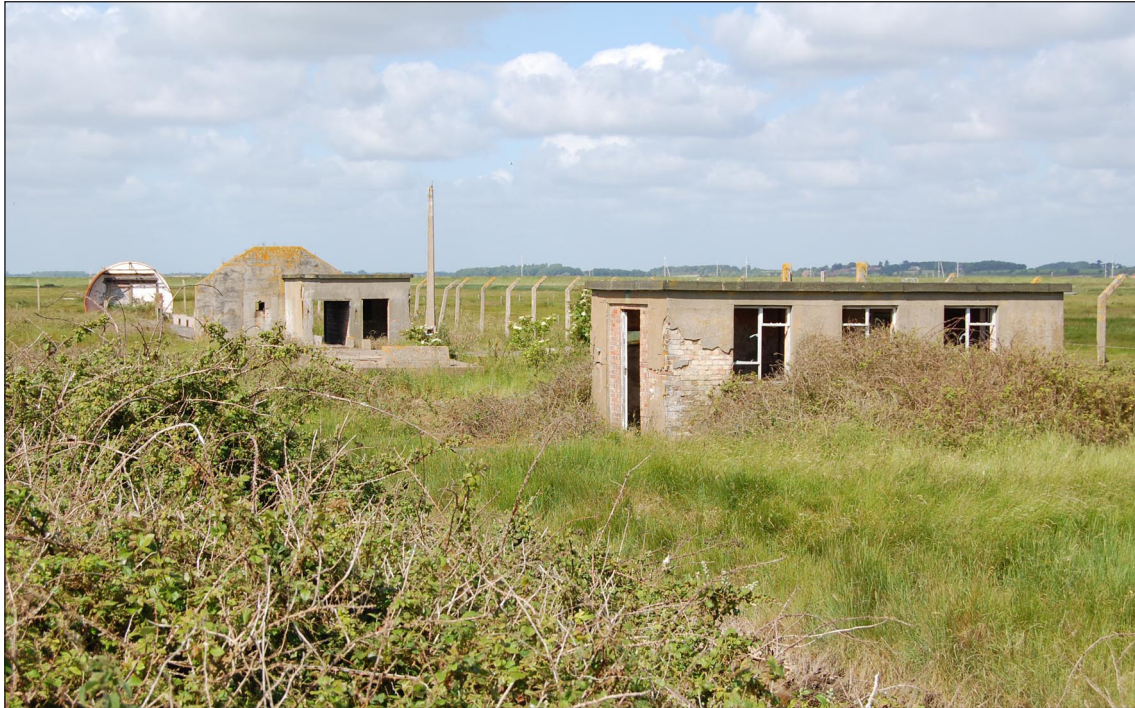
Figure 16: The remains of the Model Bombing Range C12/I03. (c) English Heritage

western end of The Street is the remains of the **Model Bombing Range C12/I03** that was constructed by the Royal Aircraft establishment in about 1954 (Figure 16). This comprises at its eastern end a detached **Control Room I06** and to its west a concrete plinth on which a 17-pounder gun was mounted to fire test models down the range. This was covered by a curved corrugated metal sheet roof, which has been removed, although its profile remains visible in its brick end walls. To its south is the derelict **Canteen C13/3**, which dates from the First World War and is constructed from precast concrete blocks with a pitched timber roof. During the 1950s it was partly refurbished and extended with a brick extension covered by a flat-roofed and was used as a Canteen

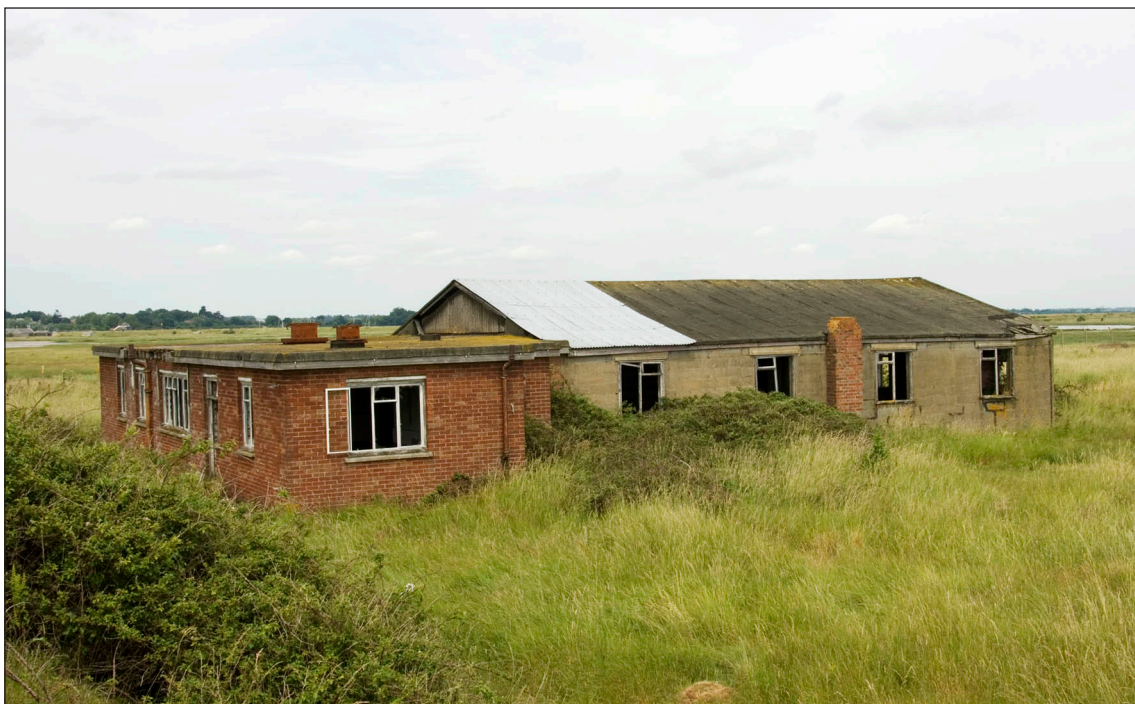
Figure 17: Building C13/3 First World War Officers' mess to right and 1950s AWRE Canteen extension to left. (c) English Heritage DP070030

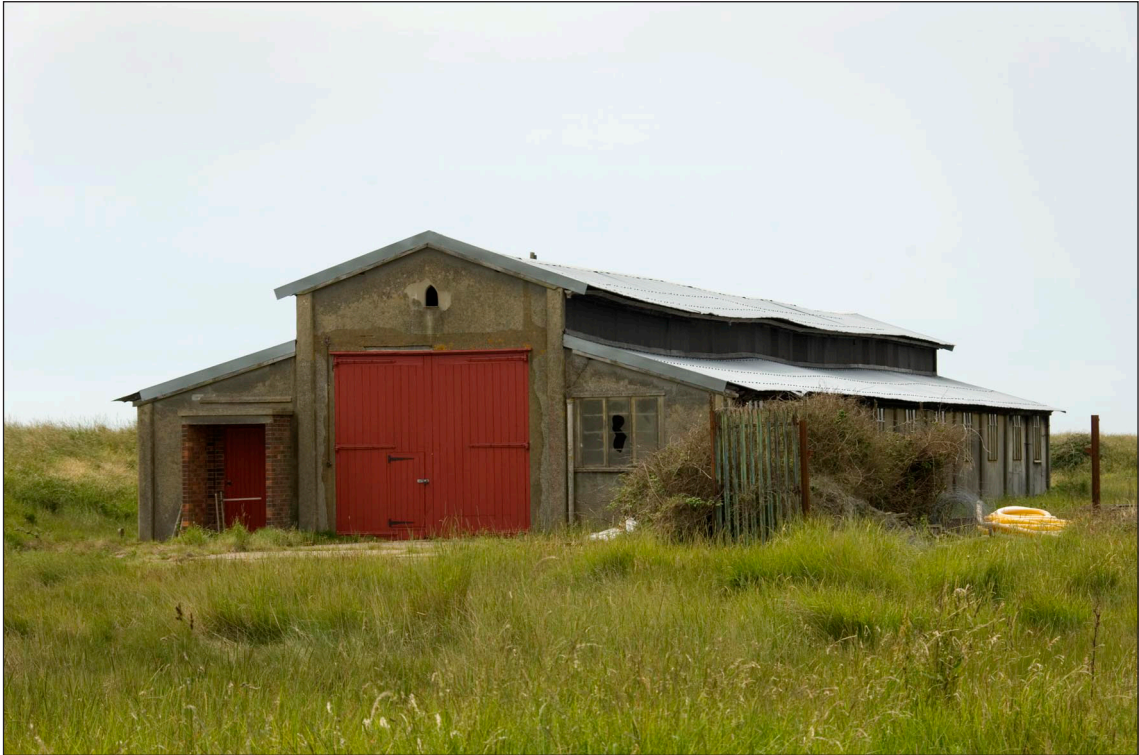
Figure 18: First World War barracks C11/18. (c) English Heritage DP070023

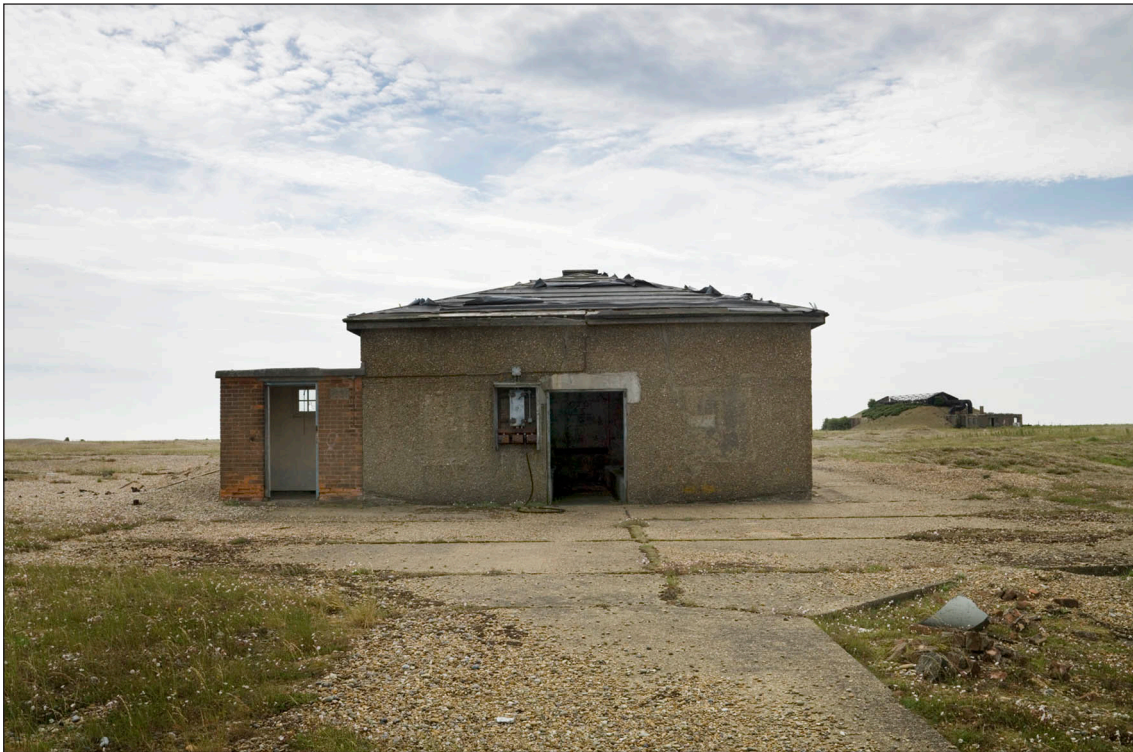
Figure 20: First World War Magazine D2/36/85. (c) English Heritage DP070012

Company Royal Engineers). It too is entered from the north through double doors with windows to either side, which have been blocked. At some point its walls were raised in brick and the whole structure cement rendered to give it a uniform appearance. Internally are two storage platforms and above them a travelling crane by 'Herbert Morris Ltd, Loughborough'. In 1931, the date noted on a concrete plaque, a small brick extension was added to the north east corner of the magazine with a single door to the north and a small 4 light window to the south.

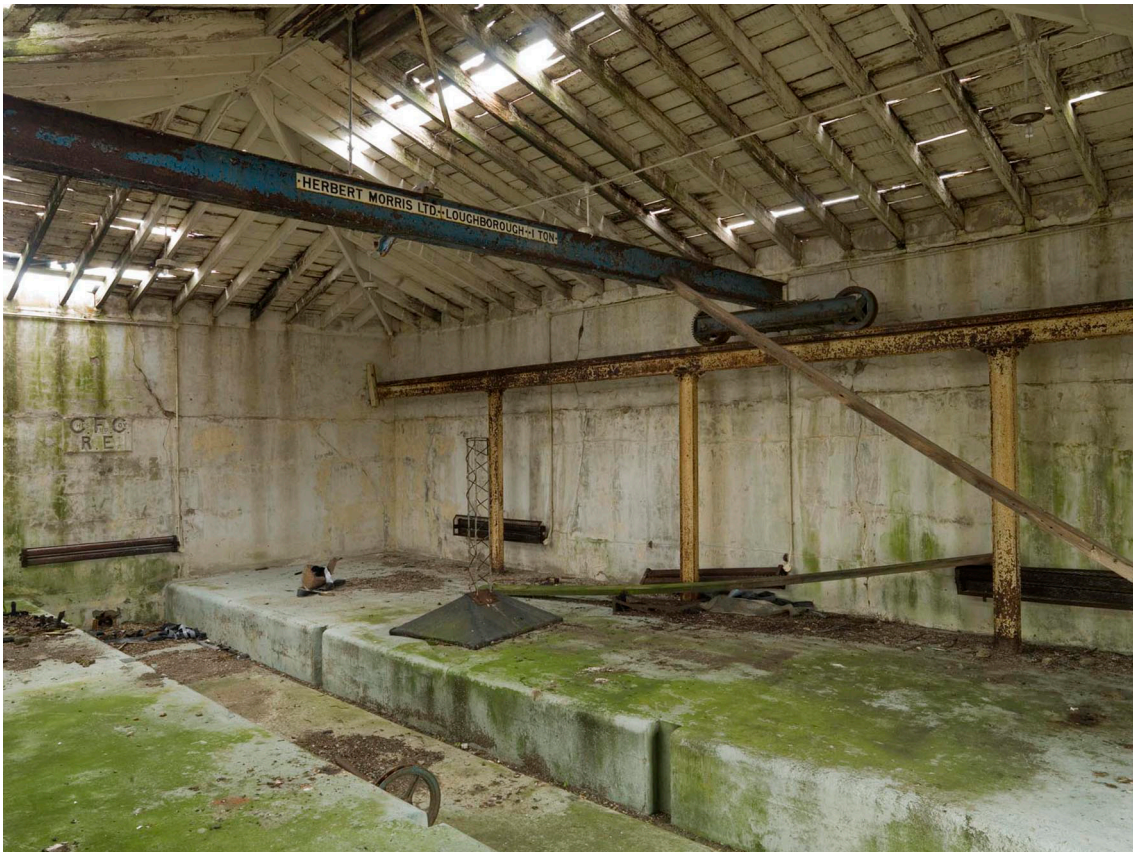
Figure 21: First World War Magazine D2 showing storage platforms and later alterations. (c) English Heritage DP070014

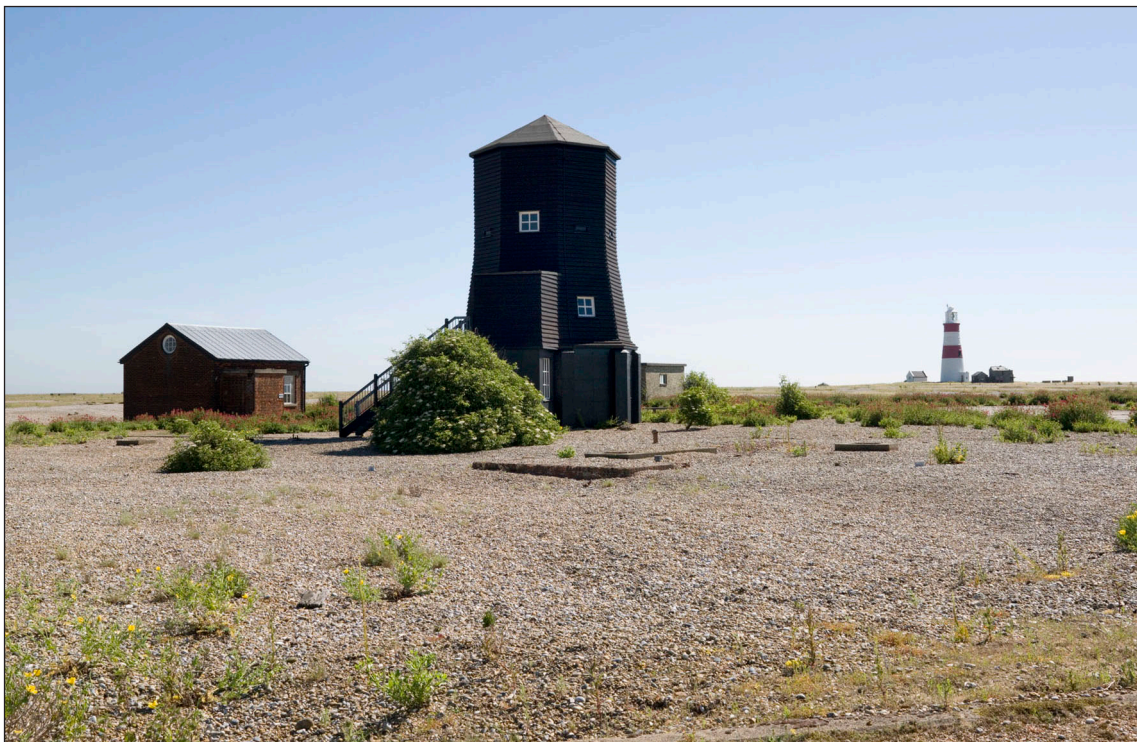
Figure 22: The Black Beacon G1/40 and to the left the Generator House G2/46. (c) English Heritage DP068424

At the eastern end of the AWRE area were a number of structures associated with the bombing range (Figure 44). To the west of the lighthouse is the **Black Beacon G1/40**, constructed in 1928 to house an experimental rotating radio beacon to aid marine navigation. It comprises an octagonal mass concrete base with a wooden superstructure that has recently been re-clad in weatherboards. Adjacent to this building, but perhaps built a few years later is the **Generator House G2/46**. This is a well-built brick structure with gable ends lit by wooden ocular windows, and to the north probably retains its original wooden windows. Later modifications include the addition of a porch, and an outshot to the east that has subsequently been removed.

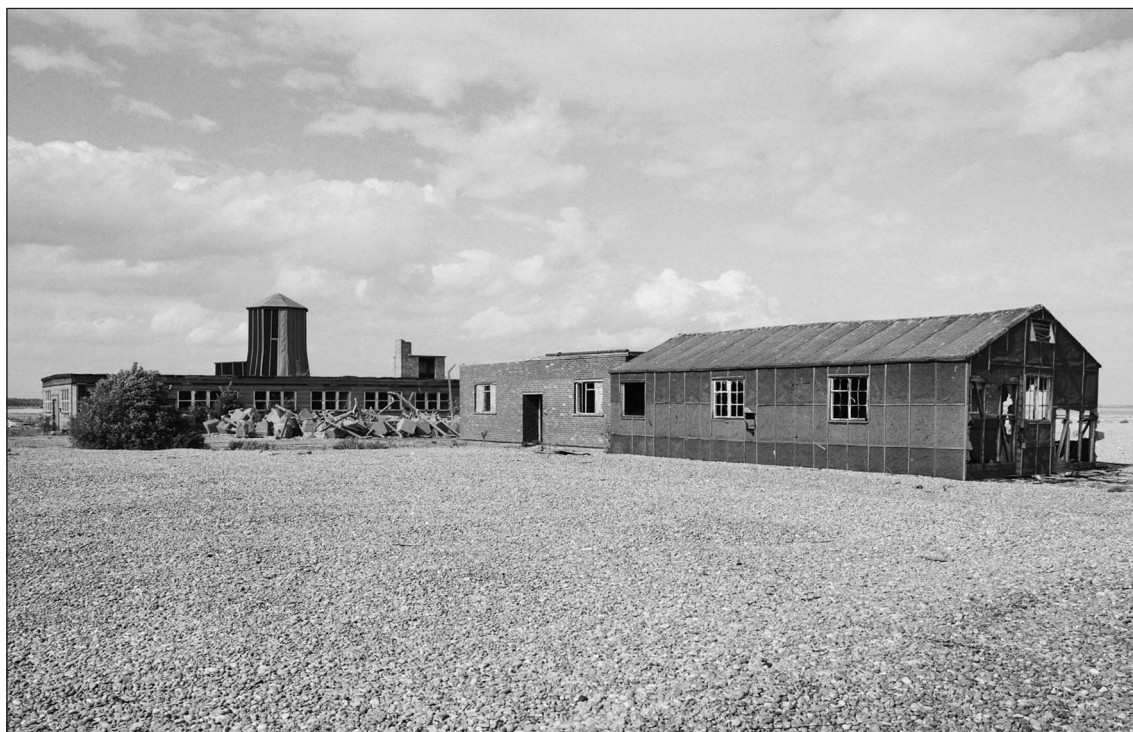
*Figure 23: The headquarters area in the 1990s, to the left is the headquarters building G3 and to its right the Office Annexe G6. (c) NMR AA99/08477*

Adjacent to the **Black Beacon G1/40**, the **Headquarters G3/47** has been demolished but may be traced as a large U-shaped floor slab (Figures 23 and 48). It was built in two phases; originally, around 1956, it comprised a single-storey, L-shaped prefabricated concrete panel building to the north, whose primary function as telemetry recording. Perhaps as part of the 1960 expansion scheme a rectangular brick wing was added to the south. Scars on its slab reveal the internal layout of the building, with offices in the north wing and a probable stores area to the east and south. To the rear are the concrete bases for a metal-framed covered area, possibly a stores area or bicycle shelter. Air photographs show that the building was complete by 1964, but the chronological sequence of air photographs is insufficient to confirm the date of the extension. To its north was a detached brick boiler house finished in Burwell whites, surviving details on its slab mark the position of former walls, door thresholds and plant bases. To its southeast is the concrete floor slab of a timber hut which was the **Office Annexe G6/50**, again scars on its surface reveals its internal layout.

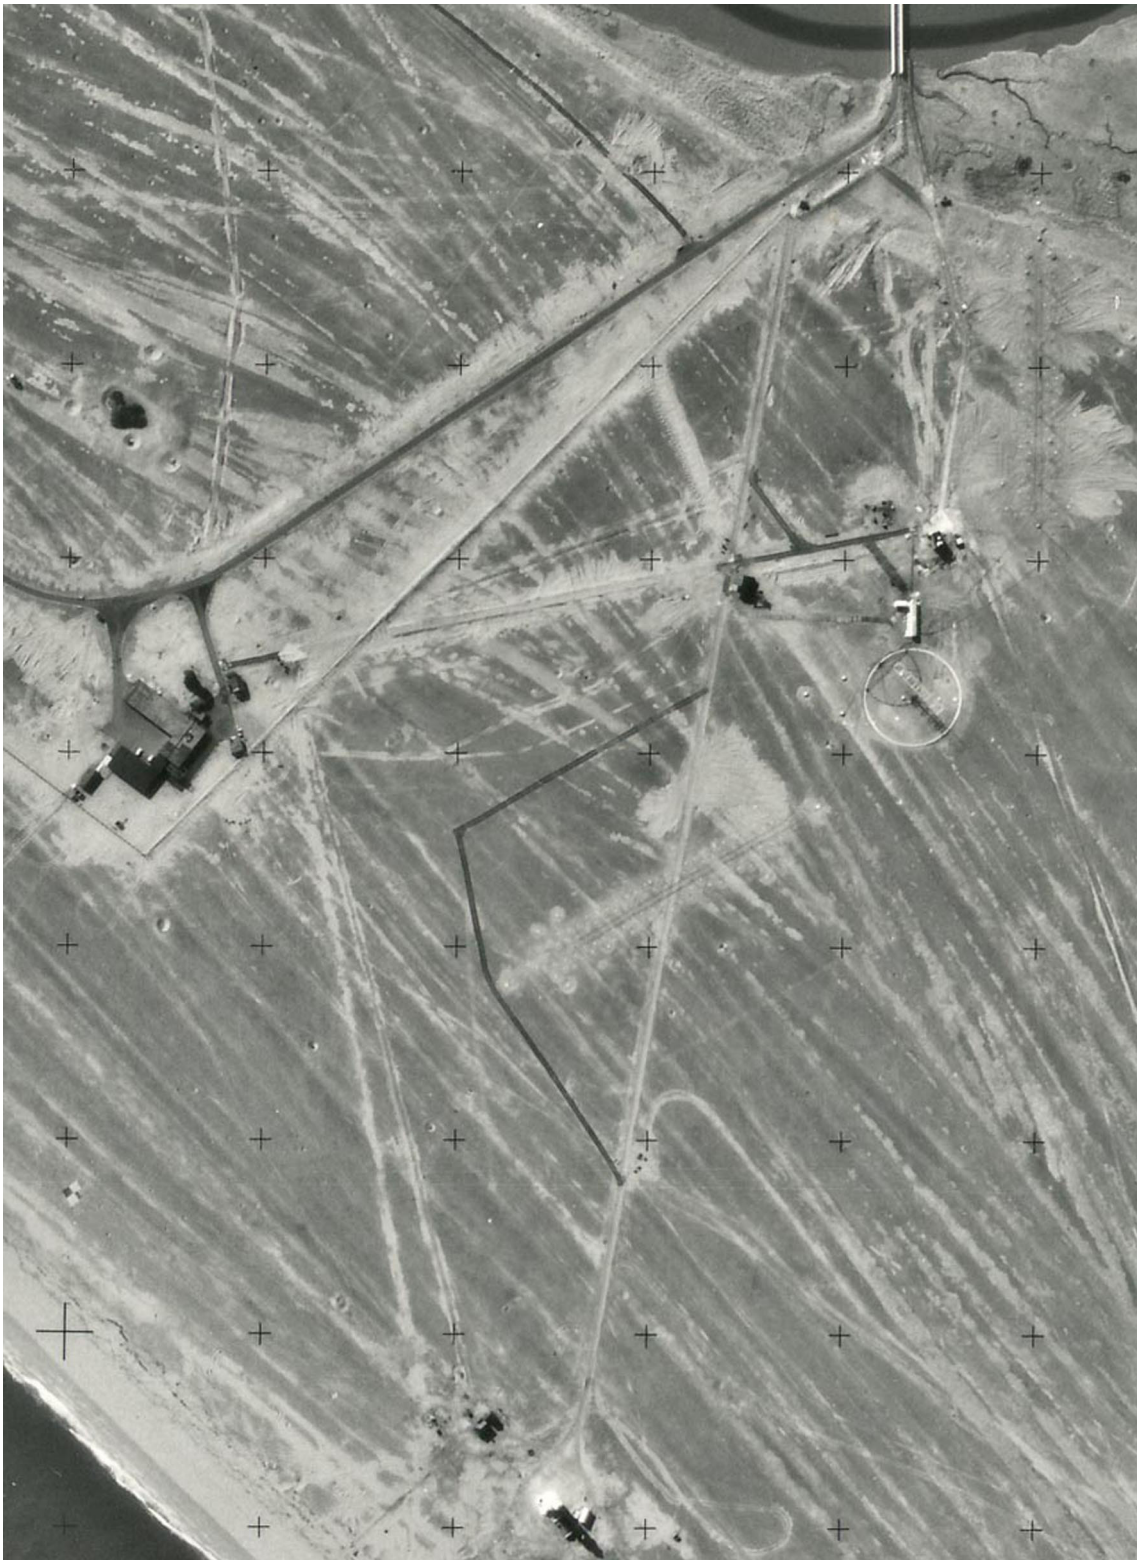
Figure 24: View of the area to the east of the AWRE boundary fence, showing to the top the circular Antenna base H50 and linear arrays to its north and south. The dark section of track marks where it has been diverted around one of the arrays. OS/65054 V029 30 April 1965 (c) Crown Copyright. Ordnance Survey

In about 1964 a series of radio experiments began around the **Bomb Ballistics Building H1/44**. The purpose of these experiments is unknown, but they were probably not part of AWRE's activities (Figure 24). To the southeast of the **Bomb Ballistics Building H1/44** are the remains of an **Antenna H50** base, which comprises at its centre a large 0.42m (1ft 4in) square post that sits within a circular concrete ring 25.37m (83ft 3in) in diameter; this is 1.07m (3ft 6ins) wide and on its surface are fixing bolts. To the northwest of this feature is a rectangular slab that marks the position of associated huts. The circular feature and its hut was in place by August 1964 and by the following April had been joined by two long linear arrays to the south and north, the one to the south causing the road to the lighthouse to be diverted (RAF/58/6492 (F41) 0079 27 Aug 64; OS/65054 V-029 20457 30 Apr 1965).

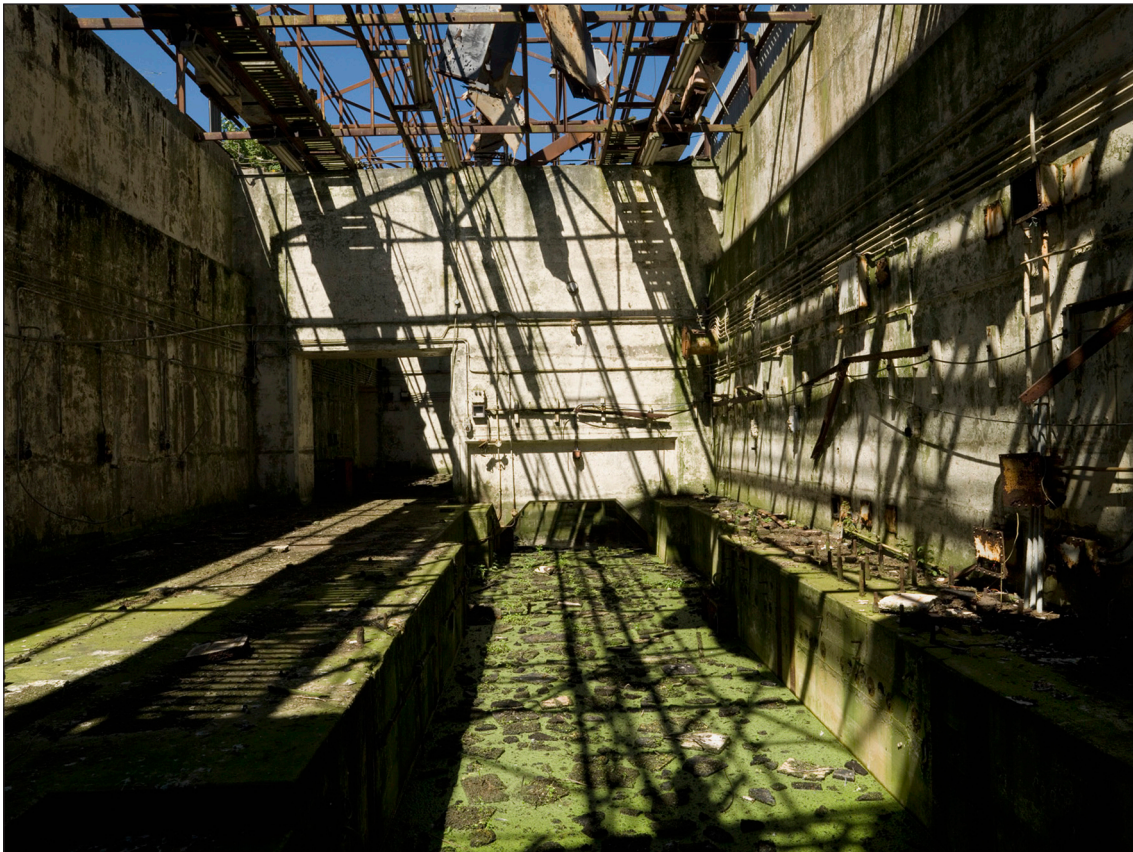
Figure 25: Laboratory I F3/I23 showing the large vibration laboratory to the southeast of the main dividing wall. (c) English Heritage DP068442

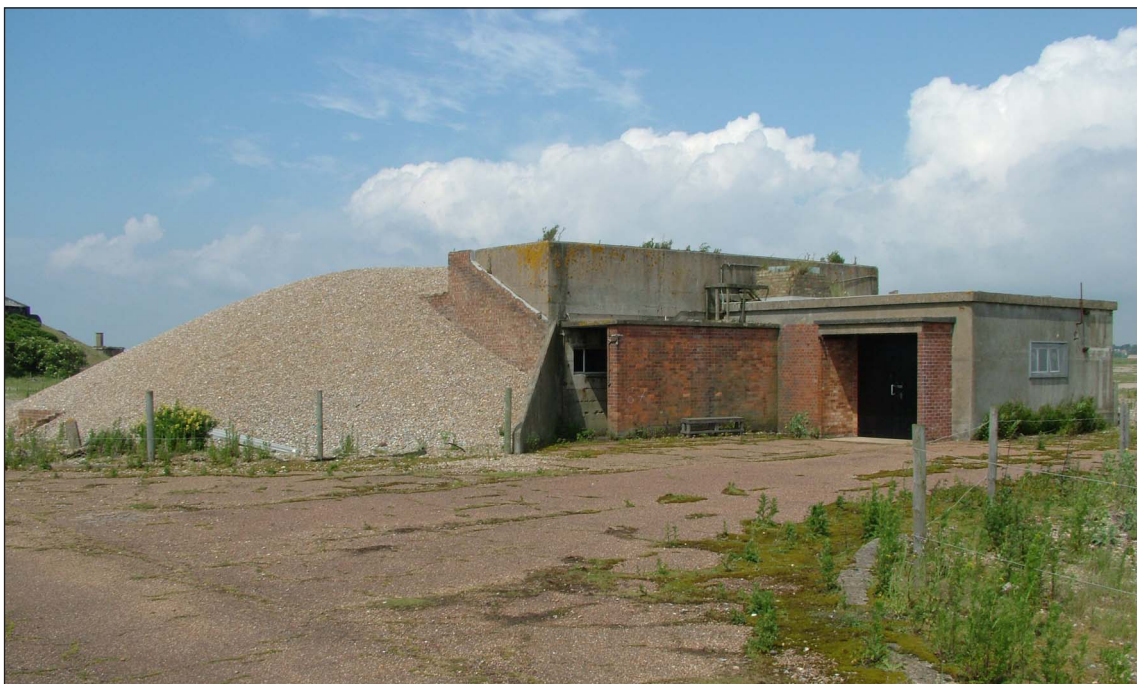
Figure 26: Control Room F4 I27/I67, showing the later brick porch and blast wall. (c) English Heritage

The operations within **Laboratory I** were considered to be so hazardous that it was provided with a detached **Control Room F4/I27/I67** 130m (142yds) to its northeast. This is an L-shaped reinforced concrete structure, originally with an open sided porch

on its northeast side that gave access to the control and monitoring room to the southwest. This comprised two elements; a taller section to the northeast that housed air conditioning plant, some of which survives, an entrance passage; toilet cubicles and to its southwest a large open room with a suspended floor that housed the monitoring equipment, of which a few metal cabinets survive. To protect the building from any accidental explosions in **Laboratory I** its southwest side was protected by a shingle traverse – a protective mound. In late 1963, or early 1964, the **Control Room** was modified to serve the new **Impact Facility F5/I71** (see below) that was being constructed to its northeast, it also suggests that experiments in **Laboratory I** may have ceased by this date (RAF 58/6492 (F41) 0079 27 Aug 64). Alterations to the **Control Room** included the bricking up of the open porch and the insertion of double doors protected by a small projecting brick porch. Due to the change in direction for flying debris a protective brick wall and concrete roof were built to protect the toilet cubicles. Immediately to the northeast is a small brick **Mess Room F8/I30**. This was probably originally designed as a **Store** with a set of double doors facing the **Control Room F4** and windows on its northeast and southeast sides. Later the double door opening was infilled in breeze block and the window opening on the southeast side was used to create a single door. Internally, a white tile splashback survives on its northern wall. Unlike the **Control Room F4** no attempt was made to protect the building from flying debris from **Impact Facility F5**. Similarly, to the south of the **Messroom F8** was an unprotected **Camera Store I72** housed in a timber and asbestos caravan, no trace of which remains.
