# ATOMIC WEAPONS RESEARCH ESTABLISHMENT, ORFORD NESS, SUFFOLK COLD WAR RESEARCH & DEVELOPMENT SITE SURVEY REPORT

# ATOMIC WEAPONS RESEARCH ESTABLISHMENT ORFORD NESS, SUFFOLK

## COLD WAR RESEARCH & DEVELOPMENT SITE

## SUMMARY

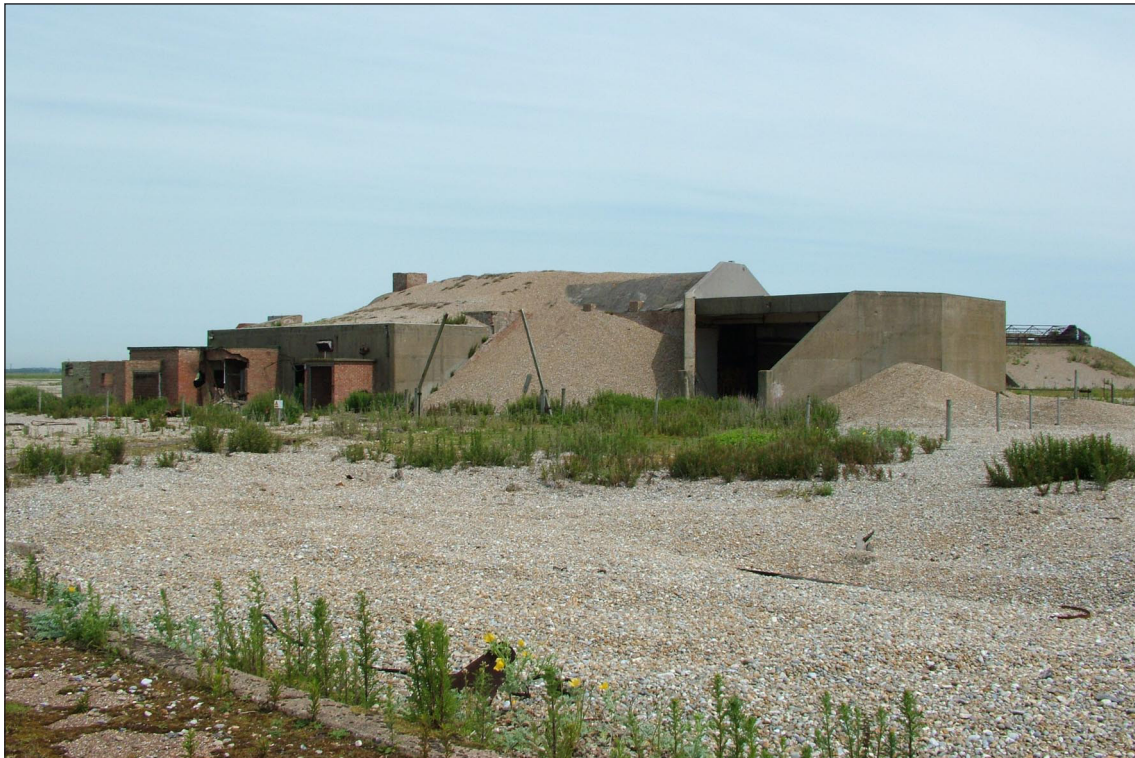
*Figure 27: Laboratory 3, F2 I26/I28, this laboratory was primarily used for the climatic testing of nuclear weapons. (c) English Heritage*

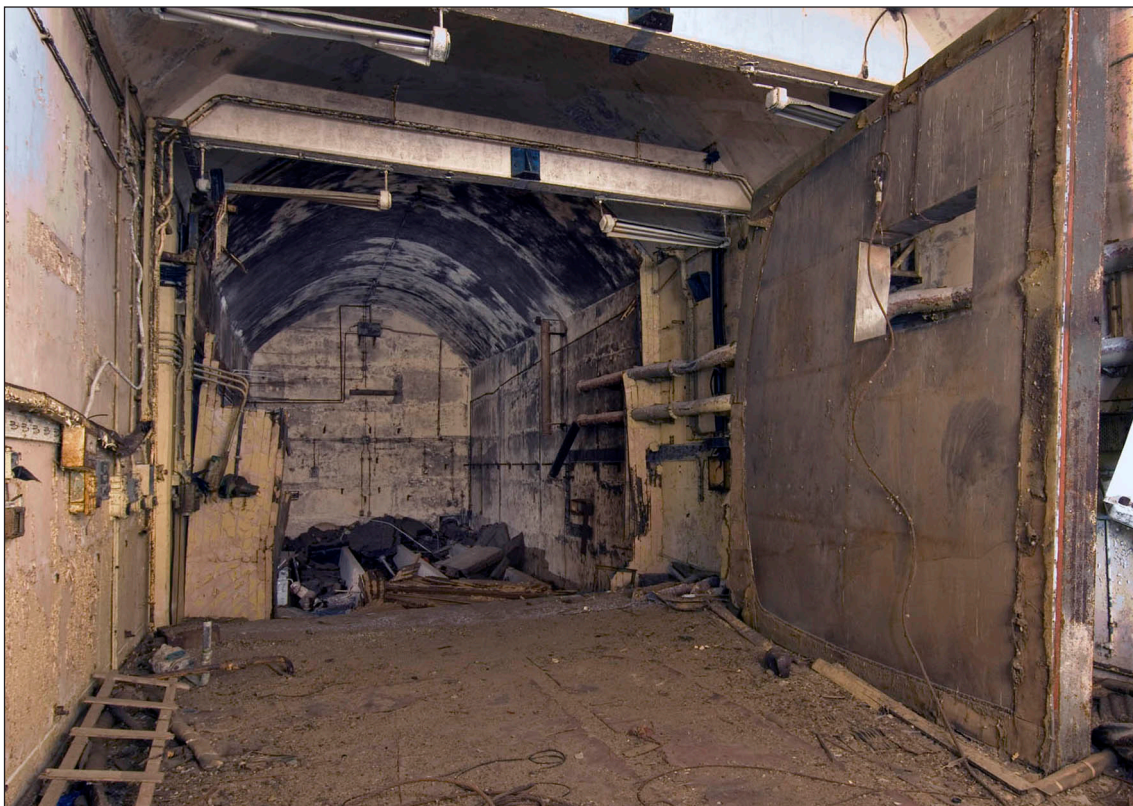
Figure 28: Laboratory 3, interior showing the rear climatic chamber and dismantled sliding door that sealed the chamber. (c) English Heritage DP068471

To support the functions of this building it was equipped with large plant rooms. Set into the western side of the shingle traverse is the **Condense Pump House 128** a large reinforced concrete building 16.98m (55ft 8in) by 6.3m (20ft 8in). It is divided into two rooms. To the south is a small switch room, which may be entered through double external doors as well as from the main chamber along the corridor for the sliding door. The other chamber is larger and housed air conditioning and plant, it too could be entered through external doors or from the main chamber. Outside of its entrance is a support for four gas cylinders that probably held carbon dioxide bottles as part of the building's fire suppressant system. On the northwest corner of the building are a series of small rooms that held various pieces of plant and toilet cubicles.

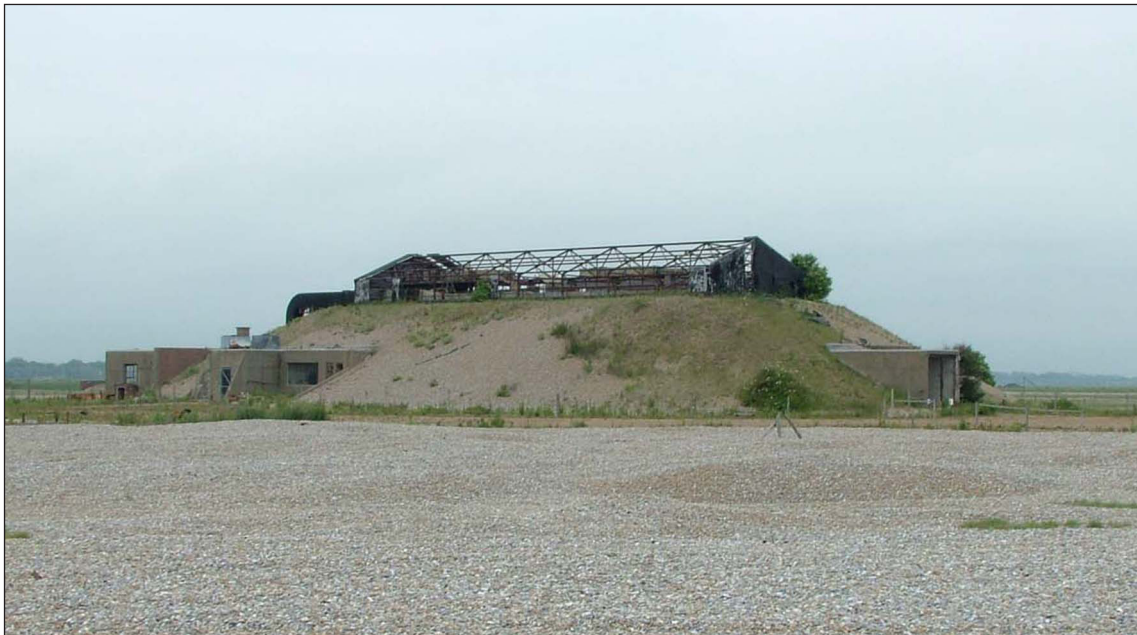
Figure 29: Laboratory I, F3/I23, to the left is the rear plant room and to the right the main entrance passage. (c) English Heritage

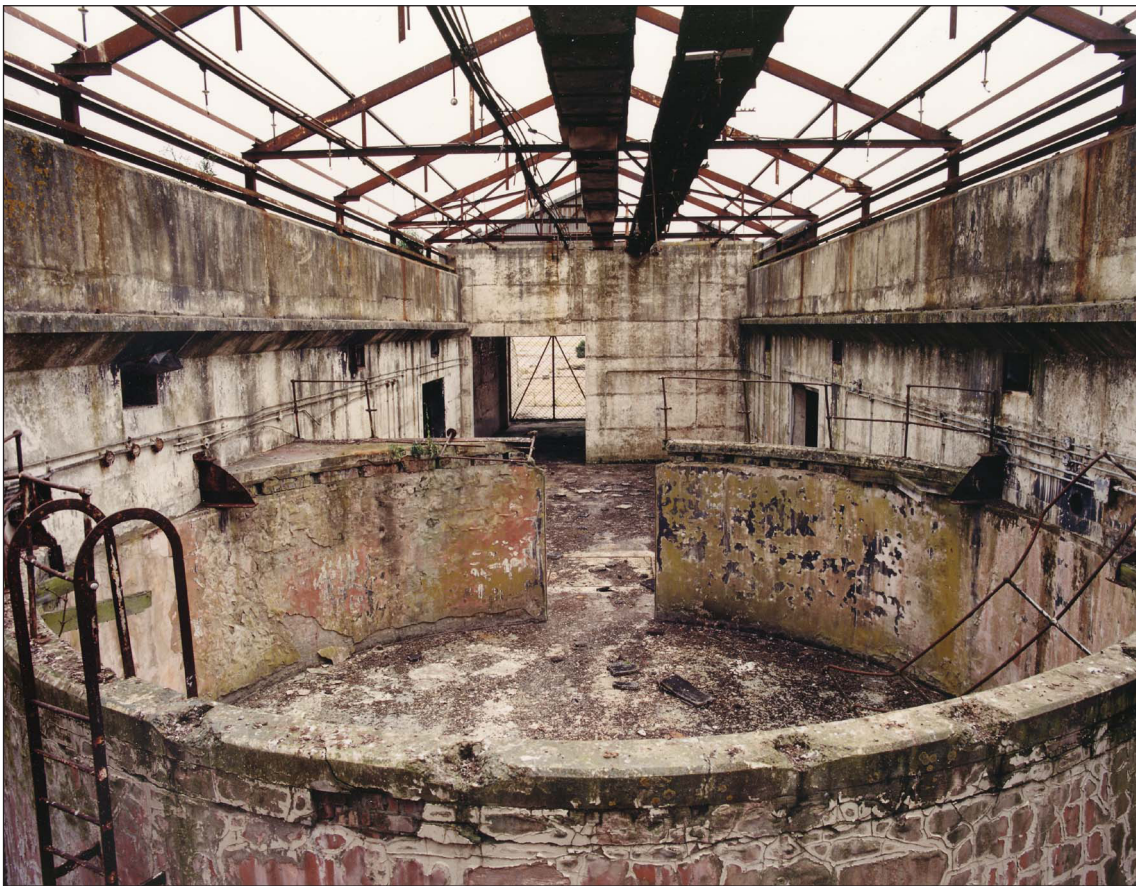
*Figure 30: Laboratory I in June 2000, interior showing the centrifuge pit and above it a section of air conditioning conduit. Below the tops of the walls are projecting ledges that carried rails for a travelling crane. (c) English Heritage*

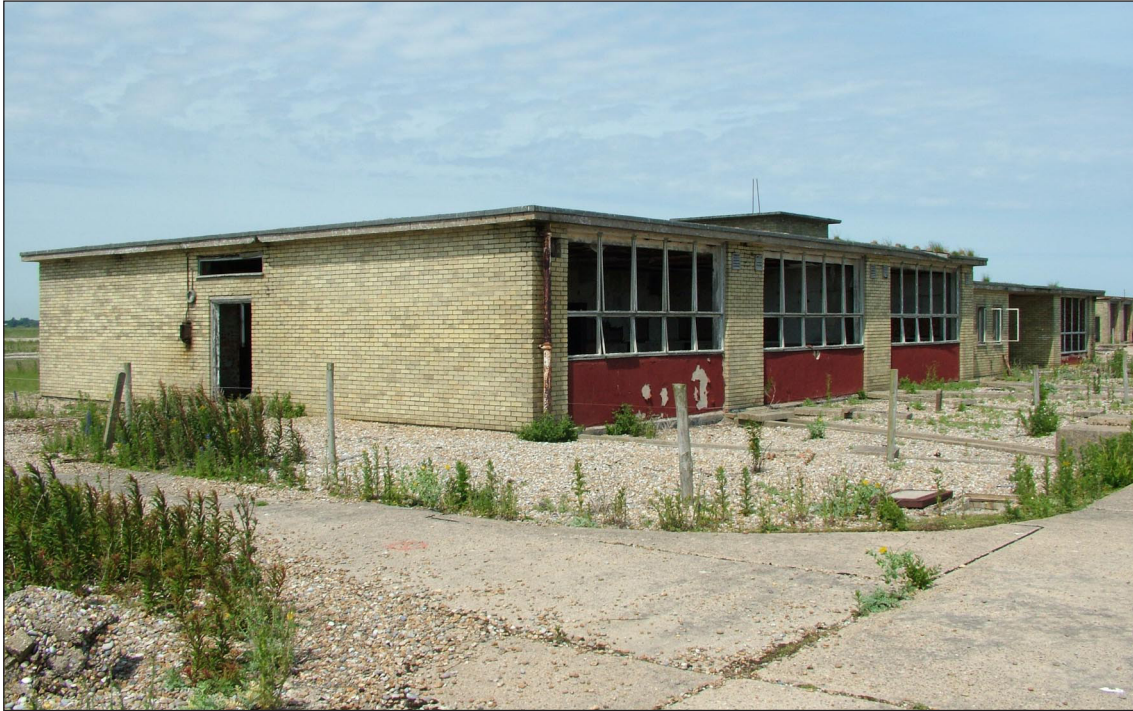
Figure 31: The Control Room E4/I39. (c) English Heritage

At the southern end of the access road is the **Control Room E4/I39**, an **Electrical Sub Station E7/I66**, and the **Pump House E8/I68**. The **Control Room** (Figure 31) was constructed for the remote operation and monitoring of the **Vibration Test Buildings E2/I36** and **E3/I35**, which lie 136m (446ft) to the south. It is constructed in a simple, functional and contemporary style in Burwell White bricks that contrast with the red asphalt covered lower sections of the metal framed bay panels. Littering the ground in front of this building are fragments of yellow Perspex, which was probably used to glaze this building. Although, it has been suggested that the yellow Perspex may have been inserted by a film company. It is divided into two sections, to the west the slightly taller portion housed control and monitoring equipment, and to the east were staff facilities. The building is entered at the eastern end through an inset covered porch, which is surfaced in red and yellow flag stones arranged in a chequer board design. Entry into the building was past the messengers' room, located on the west side of the entrance and to its rear is a windowless switch room. On the opposite side of the entrance was the cloak room. Along the rear wall is a ladies lavatory, cleaners' room and a gents' locker room and lavatory. At the eastern end of the corridor is a small tea room and to its south a large mess room. The taller western section of the building is split into two by a longitudinal east to west corridor. At its eastern end to the south is a store room and on the opposite side of the corridor a dark room. To their west and to either side of the corridor were six almost identical bays, although the two in the southwest corner form a single large room (Figure 32). These rooms were used for housing control and monitoring equipment, which was supported on a raised floor; the under floor void probably accommodated air conditioning pipes and cabling. To reduce noise the upper sections of these rooms and their ceilings are lined with square pierced, plaster-board panels.

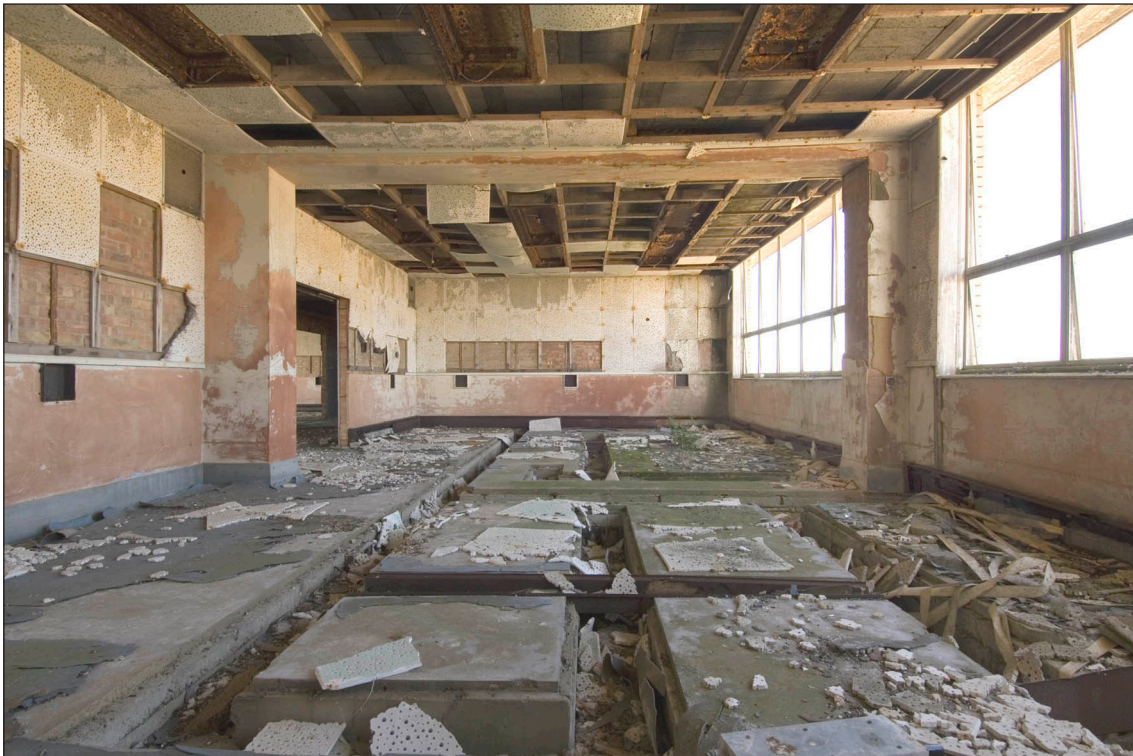
Figure 32: The Control Room E4, showing the large southwestern control room, with subfloor cable ducts and sound proofing boards. (c) English Heritage DP070006

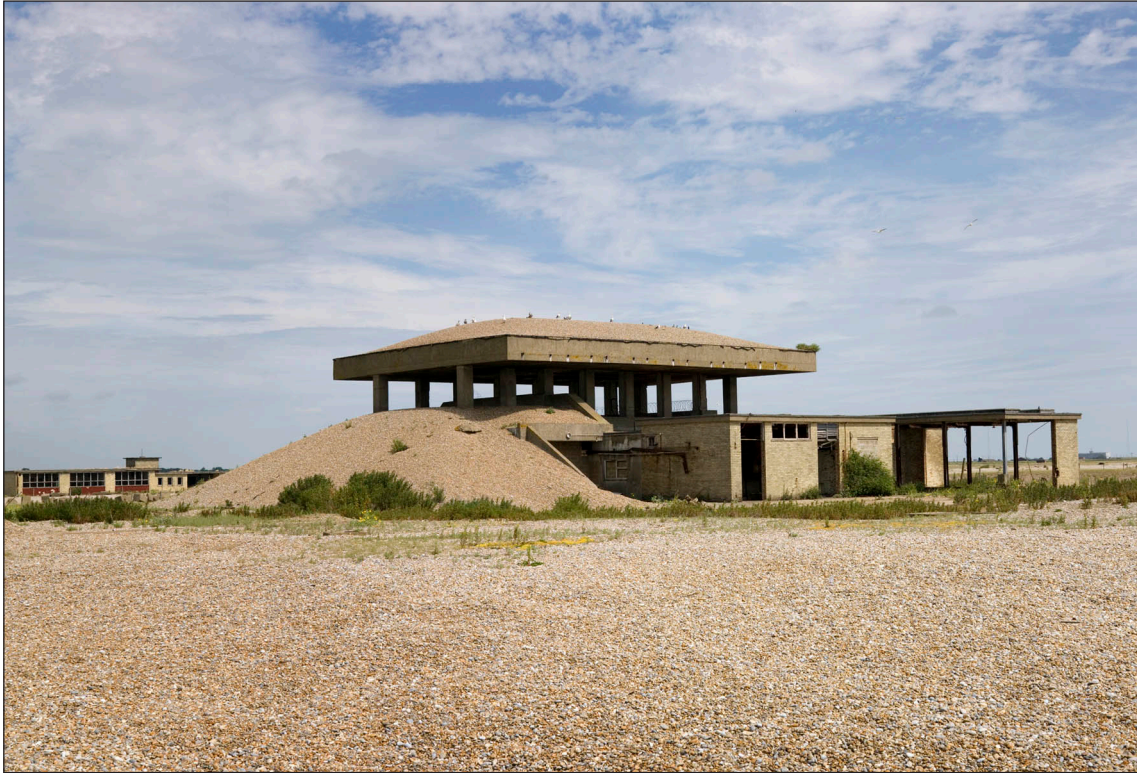
Figure 34: Vibration Laboratory E2, to the right are plant rooms. To the rear is the Control Room E4. (c) English Heritage DP0685509

lowered on to the floor of the main test cell. To assist in manoeuvring heavy objects there are a number of substantial steel eyelets screwed into the underside of the roof. A travelling crane also ran on rails mounted on a ledge beneath the windows, a loose plate on the floor recorded 'Becker twin Lift Maximum Working Load 40 tons serial A-2647-2'.

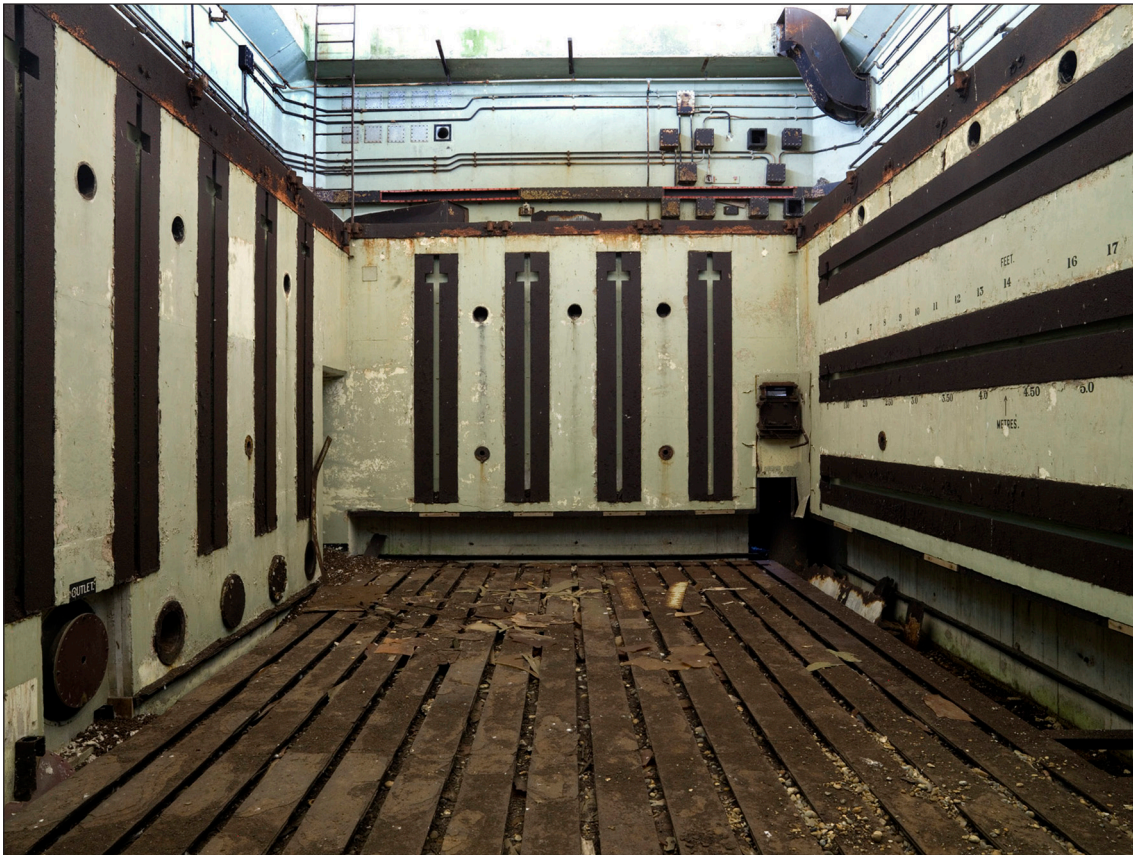
Figure 35: Vibration Laboratory E2 showing the main test chamber with slots for mounting test equipment. (c) English Heritage DP068518

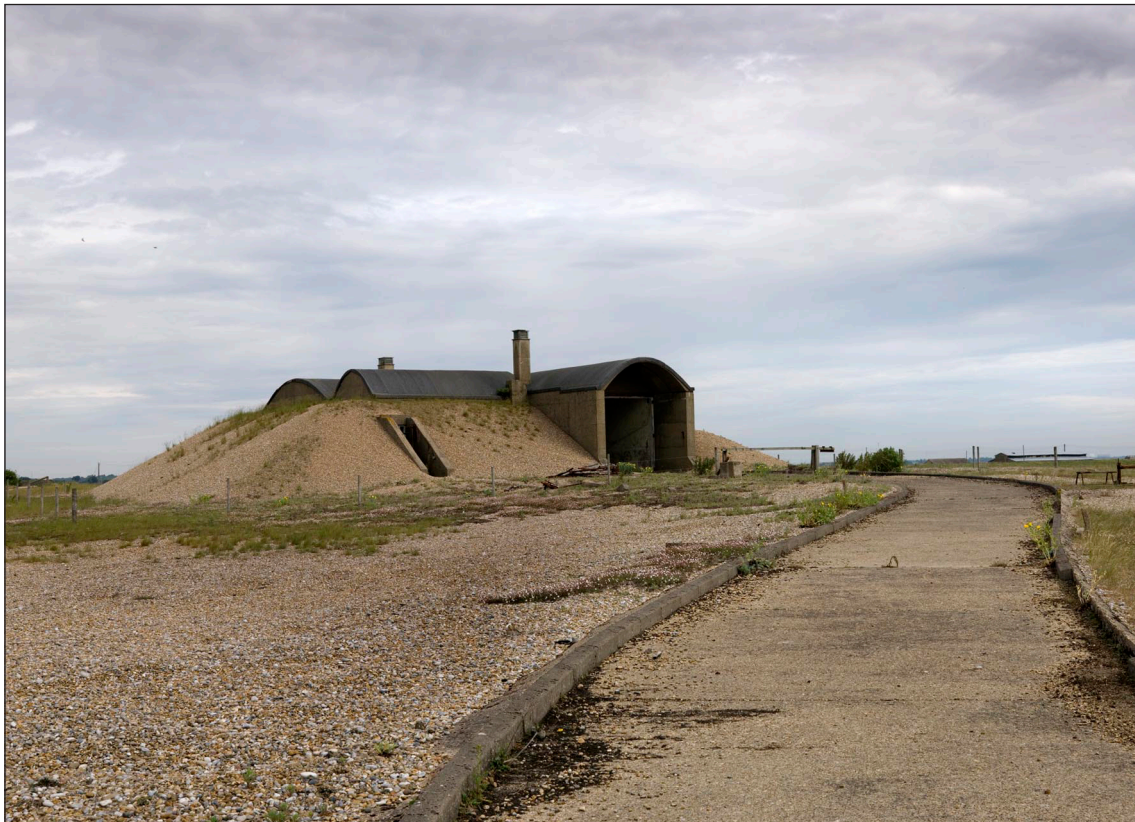
Figure 36: The Magazine E5, to the left is the door to the plant room. (c) English Heritage DP068522

of toeboards, separating an inner clean magazine area from the outer dirty area. The two bays differ slightly in size, the south bay measures 7.45m (24ft 6ins) by 4.55m (15ft), and the north bay measures 9.15m (30ft) by 7.45m (24ft 6in), both are 5.12m (16ft) high. Each was ventilated through a roof vent with a tall vertical stack projecting through the roof, and by a pair of vents leading into a rear air conditioning plant room, which was entered through a single door to the south.

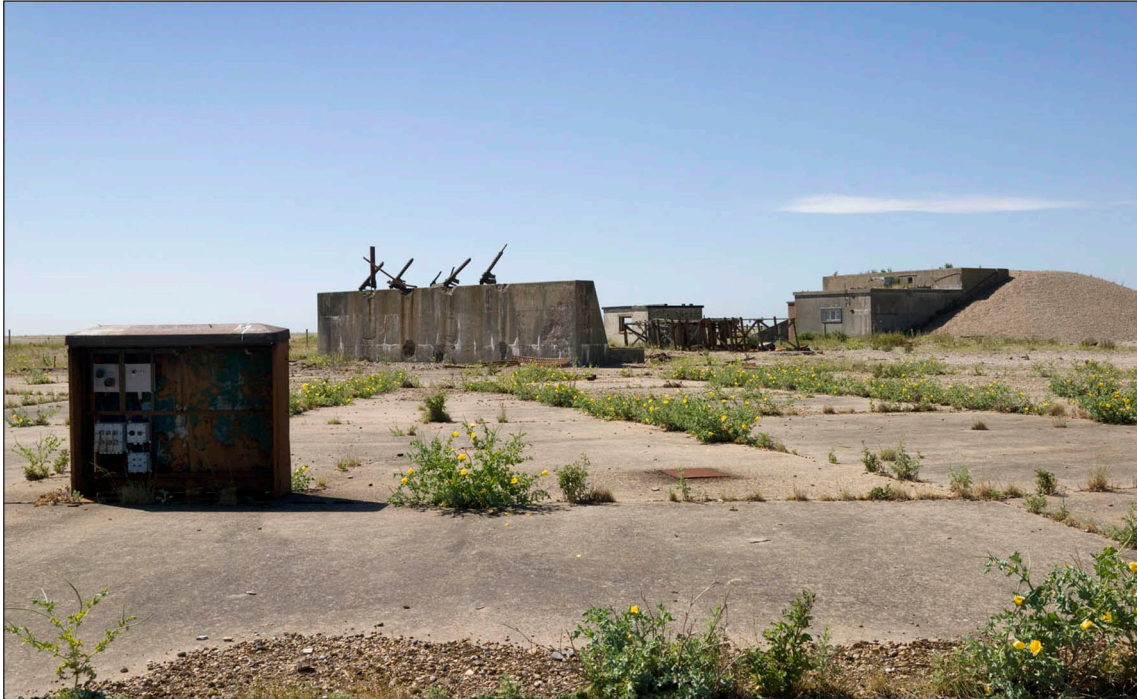
Figure 38: The Impact Facility F5, visible on the wall are the impact spots from firing bomb casings against its surface. To the right is the Control Room F4. (c) English Heritage DP068431

gantry that supported a series of high speed cameras that recorded the impact of the weapon against the wall. During the dismantling of the establishment the wooden gantry was cut down and sections remain where they fell. On the northeast side of the wall are a number of spalled areas that mark the positions of impact. To its south historic photographs show torpedo netting supported on scaffold poles that were designed to catch the weapon, traces of these poles are evident at the side of the concrete surface. To the northeast of the wall is an area of largely featureless concrete on which the tracks for the rocket sleds were placed. These appear to have been semi-movable and were secured to fixing points along the edge of the concrete area. Also on this slab are a number of metal grid covers that probably gave access to control and monitoring cables, and two electrical switch boxes.

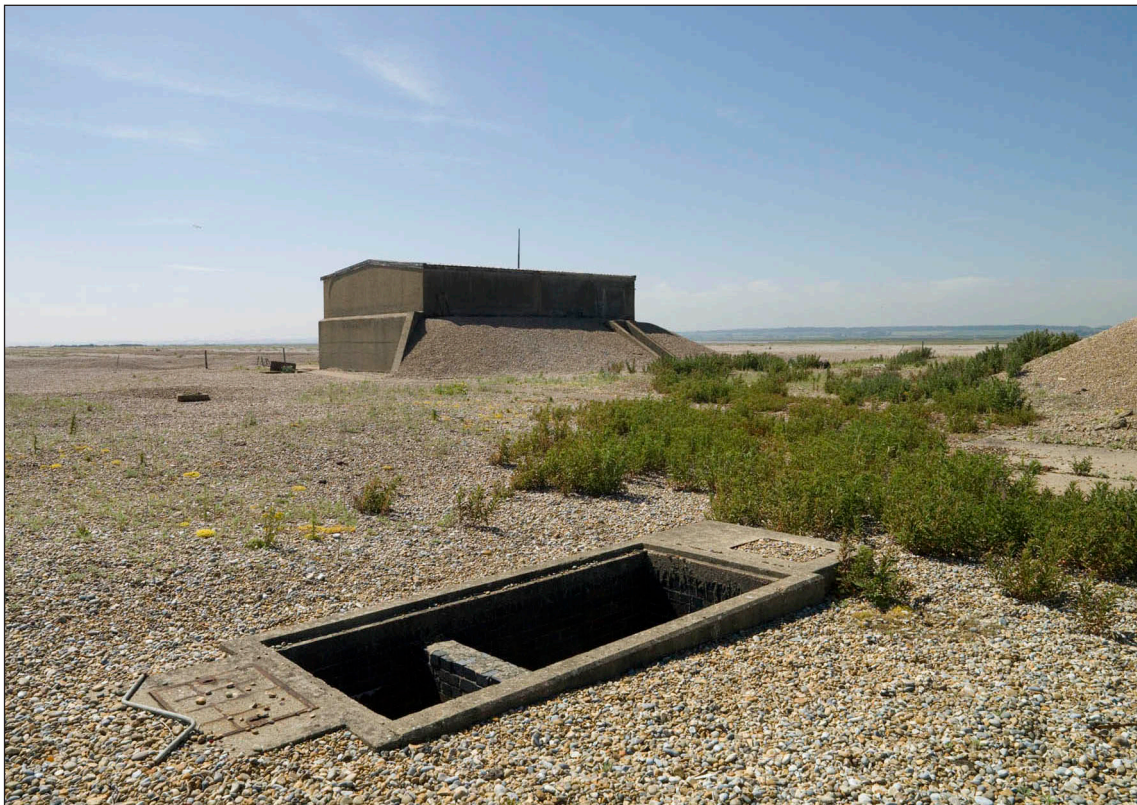
Figure 39: Centrifuge E1 to the right is one of the shingle revetted sides facing the occupied section of the site, also in view is an emergency escape way through the traverse. (C) English Heritage DP068500

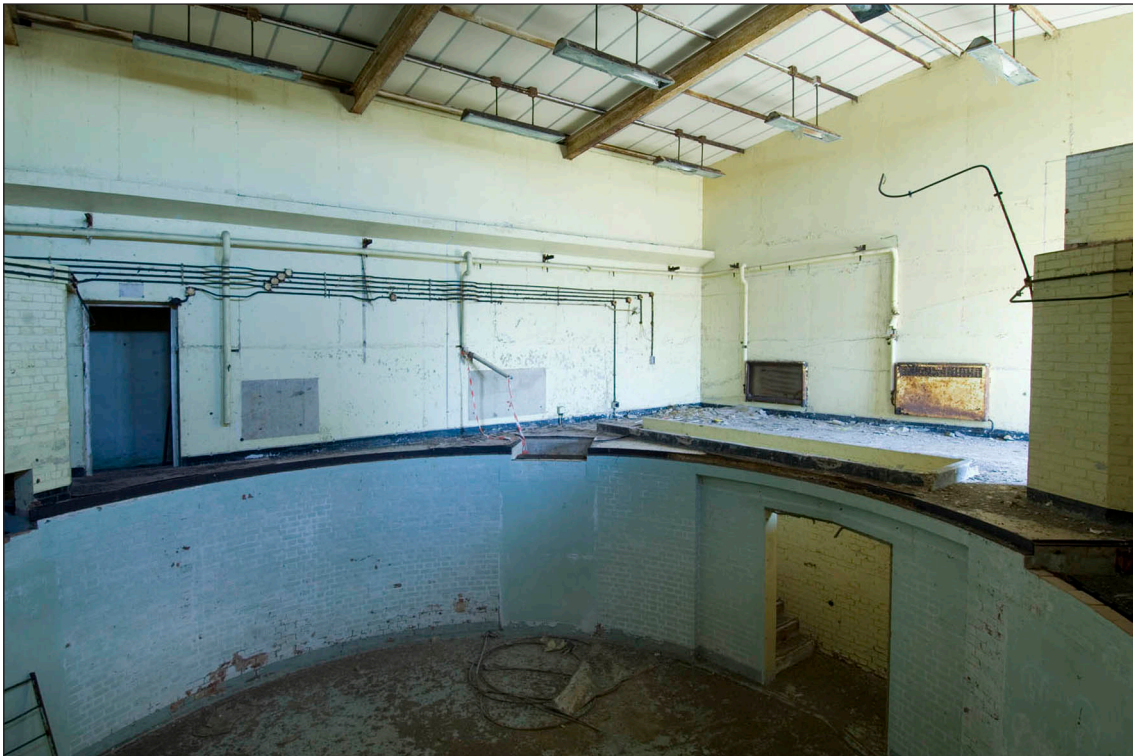
Figure 40: Centrifuge E1, interior showing the main entrance to the right and steps down into the pit. Also visible in this view are three of the four concrete piers that supported the centrifuge's frame. The rear door led to the emergency escape way. (c) English Heritage DP068497

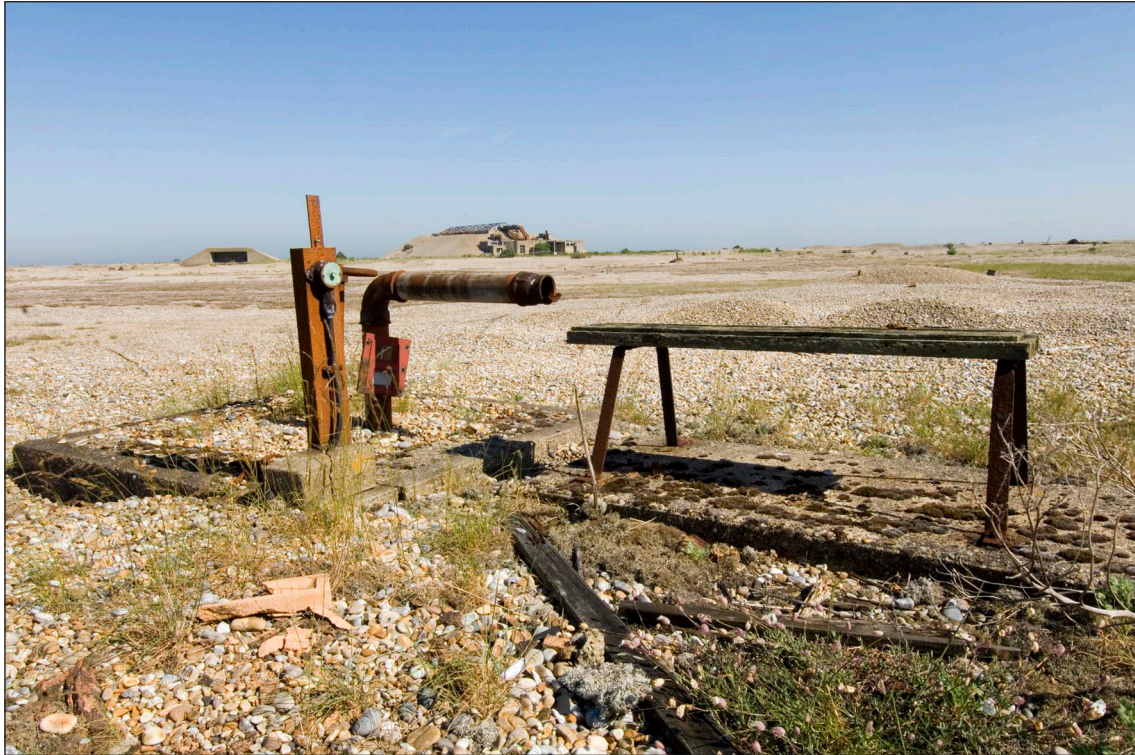
Figure 41: Fire hydrant. (c) English Heritage DP070008

trials and were also lowered while test items were being moved. Some of these may be traced as concrete blocks with a central square hole from where the timber has been removed or rotted. In any area handling explosives fire is a serious hazard. In two of the earliest **Laboratories F2** and **F3** traces of a carbon dioxide fire suppressant system was found, including stands for gas cylinders and red painted pipes. A similar system was found in the later **Electrical Sub Station E7/I66**, although no trace of a carbon dioxide system was in found **Laboratory FI/I25**. Carbon dioxide was probably chosen where there was risk of electrical fires. During the early 1960s development a **Pump House E8/I67** was installed along with storage tanks capable of holding 72,000 gallons (372312 litres). This was connected to a system of pipes and hydrants usually placed close to the test structures (Figure 41). Probably due to the difficulty of digging trenches in the shingle, and for ease of maintenance, water was carried between the buildings in overhead pipes. The metal water pipes have been removed have largely been removed, but their lines may be traced by rows of displaced concrete pipe bases and conduits where they passed beneath the roads.

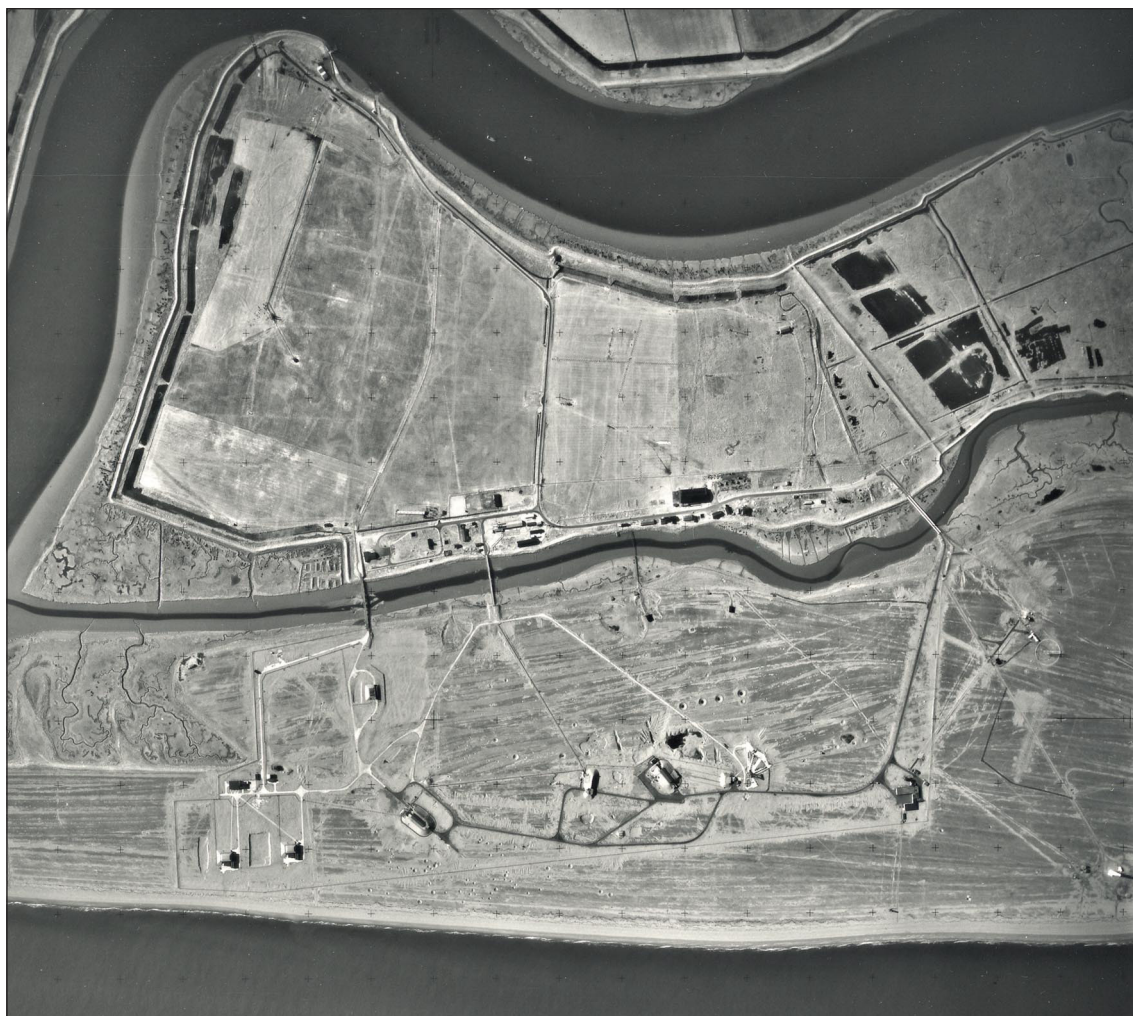
Figure 43: An aerial photograph showing the development of the AWRE area to April 1965. OS/65054 VI08 30 April 1965 (c) Crown Copyright. Ordnance Survey

Initial construction work probably began in summer 1955 and building record drawings completed in June 1956 suggest that the challenging task of building **Laboratory I** was complete by this date (Figure 43). By summer 1956 preparations were already well advanced for the autumn *Buffalo* trials at Maralinga, Australia, which would include an operational air drop of a *Blue Danube* atomic bomb by the RAF (Arnold and Smith 2006, 138-171). By August Bank Holiday of that year, **Laboratory I F3** was ready for its first trial, a live *Blue Danube* round, minus its fissile core (Kinsey 1981, 109). This work was essential to verify that the Bomb's complex systems could withstand the rigours of transport and then operate as intended. The results of these tests would determine whether or not the air drop trial was included in the *Buffalo* programme.

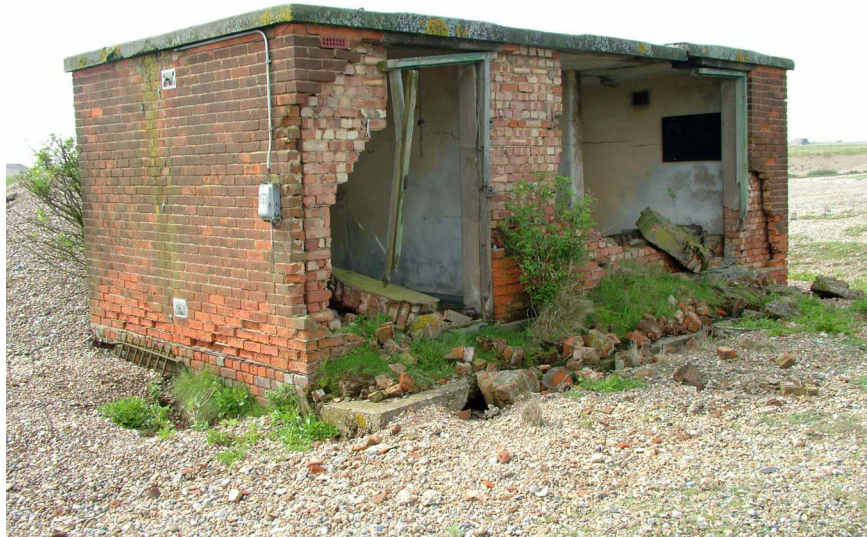
ORIGINAL FUNCTION: Fuze Magazine

The Fuze Magazine is a single storey brick built structure comprising an inner Fletton brick wall laid to English bond, a cavity and an outer red brick cladding wall laid to stretcher bond. The Magazine is set on a foundation course laid to English bond with a double layer Welsh slate damp proof course. The cavity is ventilated by earthenware ventilation bricks, while the bays are ventilated by metal vents set at floor and eaves level. At the east end of the building is self-contained bay formerly accessed from a single outward opening wooden door to the north. To the west are two further bays formerly accessed from a single wooden outward opening door with bronze door furniture, adjacent to the door is a metal boot scraper. This door gave access to a shifting lobby with coat hooks remaining on the east wall and on the west wall is a blackboard. Access to the central bay clean area was over a toeboard, whose position is marked by wooden batons. All the bays were lit by enclosed magazine type lights with wires sealed in metal small bore metal pipes, at the east end of the building is a metal electrical switch box. To the south each bay is lit by a pair of hinged wooden 4 light windows with opaque wired glass. On the west wall are some surviving fixing bands for the copper lightning conductor strap.

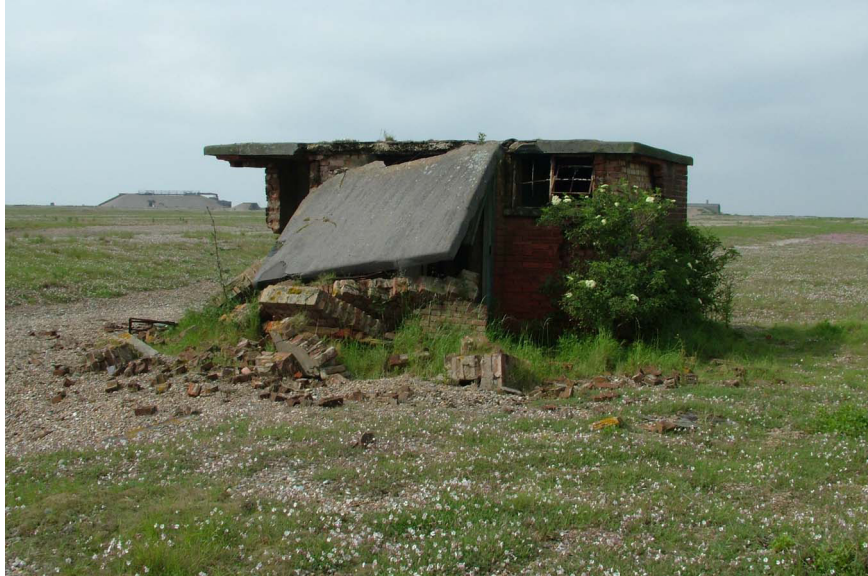
ORIGINAL FUNCTION: Fuze Magazine

The Fuze Magazine is a single storey brick built structure comprising an inner Fletton brick wall laid to English bond, a cavity and an outer cladding in red brick wall laid to stretcher bond, the cavity is ventilated by earthenware vents. It is set on a brick foundation course with a double layer Welsh slate damp proof course and has a flat asphalt covered concrete roof. The Magazine was entered from the northeast through a porch or shifting lobby (now collapsed), access into the magazine area was over a toe board, whose position is marked by surviving wooden batons. Internally the magazine is divided into a longitudinal corridor to the east and to the west are three small self contained magazine bays, each originally closed by a wooden outward opening door with brass door furniture. Each bay was ventilated by a metal vent in its west wall. The magazine corridor was lit by two pairs of 4 light metal framed windows to either side of the porch, which was itself lit by a similar window. The windows are fitted with opaque wired glass. On the southwest corner of the Magazine are a number of surviving fixing points for the lightning conductor earthing strap.

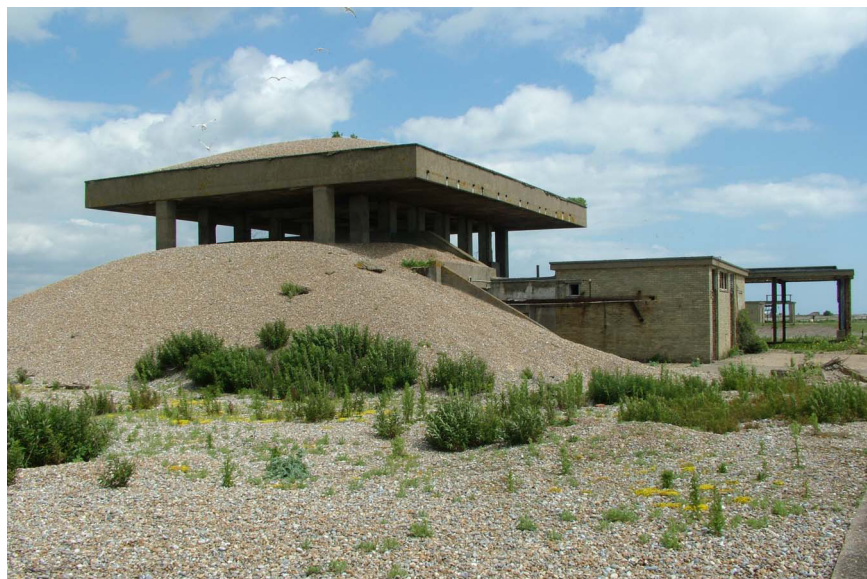
ORIGINAL FUNCTION:Vibration Test Building

Along the base of the north wall are 8 pipe openings, the 2 larger openings are labelled inlet and outlet and 4 are sealed by bolted circular plates. At the south east corner of the chamber a passage leads back to the air-conditioning plant on the east side of the structure. Surrounding the main chamber is an upper walkway which was formerly protected by a moveable handrail, whose fittings survive. Between the walkway and the main wall is a cable duct on the north and south walls, fixed to the main outer walls is a handrail, various electrical pipes switches and junction boxes, a single rectangular cable duct and 4 wooden mounting blocks for pressure gauges, 3 of which survive. On the north and south walls are two pipes are labelled Air and Vac respectively. In the north east corner is a vertical ladder that gave access to the window level and perhaps the overhead travelling crane. Attached to the east wall is a large square section air-conditioning duct leading to the plant room to the south. On the north, east and south walls of the main chamber pipes inserted (4 each for north and south) and (3 on the east wall) which connect back to the cable ducts around the edge of the walkway. Below these on each of the walls are pairs of circular threaded fixings. On the upper west wall of the test cell a sign records, telephone instrument room' below it is a light fitting, another sign reads 'Vac Pump running, Vac Pump Stopped' with light fittings above. Also on this wall are are large screw threaded fixings eyehooks and there is a single eye hook in the centre of the ceiling.

At the northeast corner of the main chamber a doorway gives access to a service corridor running east-west along the north side of the laboratory. For most of its length on its north side are large diameter cork insulated air-conditioning pipes. To the west a flight of stairs provides access to the top of the north lip of the lift pit and to the upper walkway around the main chamber cell this flight of stairs also gives access to a now blocked door in the north wall leading to the escape passage. A second flight of stairs to the east gives access to the plant room attached to the east side of the building.

To the south of the main chamber is a freestanding air-conditioning plant building of brick cavity wall construction faced with Burwell whites laid in stretcher bond with a flat concrete roof supported by RSJs. The building measures 11.62m (38ft 1ins)x 6.04m (19ft 10ins) and is 4m (13ft) tall. The block was divided into 2 by a brick partition wall, the larger bay to the west was entered through two pairs of wooden doors, above the eastern door is a wooden louvred vent which connects back to the air-conditioning plant and above the western door there is a wooden 2 light window. Between the two sets of doors there is a large 3 light window at eaves height. Internally are 3 large concrete machinery mounting plinths and 1 smaller plinth, sections of metal air-ducts also survive and a metal switch cabinet to the west seems to be associated with a compressor for the lift in the main passage way. In the north wall is a larger square opening formerly with a wooden louvred vent and to the west a small square opening which carried the ducting back towards the entrance passage. An opening in the partition wall carries the ducting into the smaller and now sealed eastern bay. The main west bay was lit by 8 lamps and on its east wall is a metal water tank. The east bay was lit by a 3 light metal framed window at eaves height (now blocked). On the north wall a square section duct connects back to the main chamber.

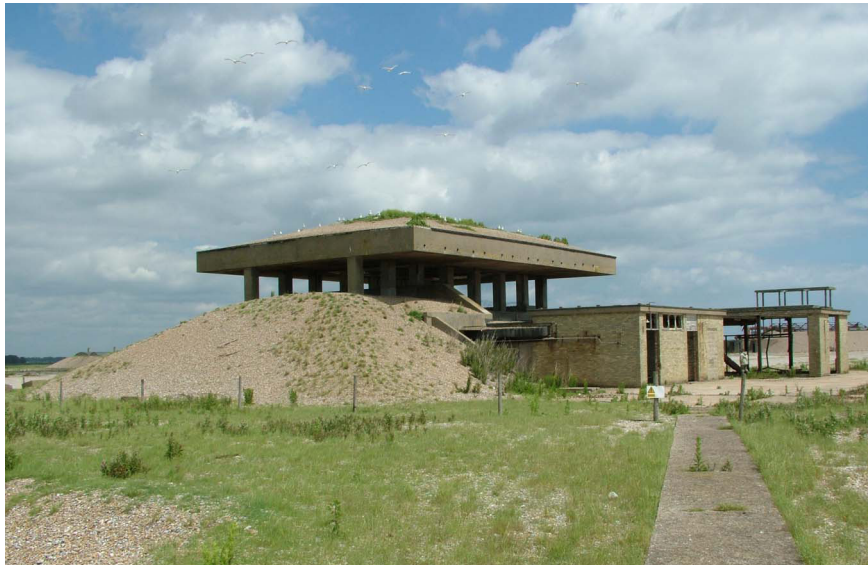
ORIGINAL FUNCTION:Vibration Test Building

To either side of the chamber are cable ducts infilled with shingle, along the base of the north wall are 8 pipe openings, 3 of which are sealed by bolted circular plates. Along the base of the east wall is the remains of an air-conditioning system (not in-situ), at the southeast corner a passage leads back to the air-conditioning plant on the east side of the building. Surrounding the test chamber is an upper walkway which was formerly protected by a moveable handrail, whose fittings survive. Between the walkway and the outer wall is a cable duct on the north and south walls. There is also a fixed handrail and on the south, east and north walls along with various electrical pipes switches and junction boxes and a single rectangular cable duct. In the north east corner is a vertical ladder that gave access to the window level. Attached to the east wall is a large square section air-conditioning duct leading to the plant room to the south. On the north, east and south walls of the test chamber are inserted pipes, 4 each on the north and south walls and 3 on the east which connect back to the cable ducts around the edge of the walkway. Below these on each of the walls are pairs of circular threaded fixings.

The openings between the columns were originally filled with wooden framed windows and glazed with perspex sheets. A ledge along the south and north walls of the main chamber carried rails for an overhead travelling crane. At the northeast corner of the main test chamber a doorway gives access to a service corridor running east-west along the north side of the building. For most of its length mounted on its north wall were large cork insulated air conditioning pipes. To the west a flight of stairs provides access to the top of the north lip of the lift pit and to the upper walkway around the test chamber this flight of stairs also gives access to a now blocked door to the emergency exit in the north wall. To the east a second flight of stairs gives access to the plant room attached to the eastern side of the building, a sign on one of the switches records 'Minerva cell DC supply isolation relay'. On the upper west wall of the test chamber a sign records 'telephone instrument room' below it is a light fitting, to the south are the remains of light fittings and wooden batons for a sign.

To the south and detached from the main test chamber is an air conditioning plant of brick cavity wall construction faced with Burwell whites laid to stretcher bond with a flat concrete roof supported on RSJs. This building measures 11.62m (38ft 1ins) by 6.04m (19ft 10ins) and is 4m (13ft). The block is divided into two by a brick partition wall the larger bay to the west was entered through two pairs of wooden doors, above the eastern opening is a wooden louvred vent which connects back to the air-conditioning plant and above the western door there is a wooden 2 light window. Between the two sets of door openings there is a large 3 light window at eaves height. Internally

Along the eastern side of the complex is another freestanding plant room of brick cavity wall construction and faced with Burwell whites and also has a flat concrete roof. It is divided into 3 bays, at the northeast corner the eastern wall of this bay is rebated back from the main elevation and was formerly entered through double door (now sealed), its northern side is lit by a 4 light steel framed window set at eaves height. To its west is a large rectangular opening housing 2 large diameter air-conditioning pipes that connect back to the pipes in the northern service corridor. To the northeast of these openings is a low concrete plinth. An historic photograph (Kinsey 1981, 108) shows a mobile air conditioning unit connected to the two large air conditioning pipes, and cables leading back to the north wall of the building. Returning to the main eastern side, there are 4 bay openings, the southern bay, which housed a transformer, is now sealed in breeze block. The remainder of the bays have metal concertina doors, internally there was a suspended floor whose concrete piers remain, to the rear is a cable or pipe duct one arm connects back to the main test chamber and also to the bays to the north and south. The roof is supported on steel RSJs and is lit by 3 roof lights and 18 pendant lights. A number of junction boxes, air-conditioning ducts and small-bore electrical ducts remain.

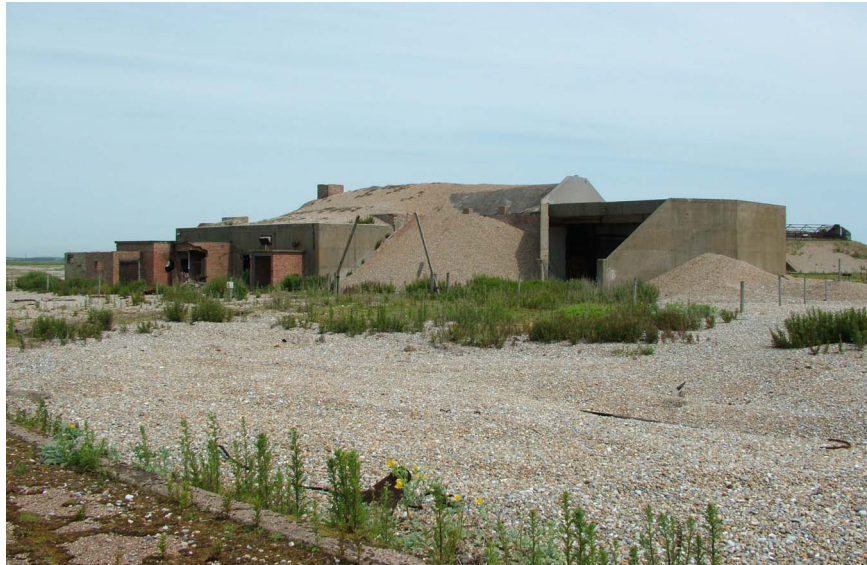
ORIGINAL FUNCTION: Laboratory 3 Climatic Testing

The main chamber is 24.50m (80ft 5ins) long and 6.0m (19ft 6ins) wide and is divided into two uneven cells, to the rear the north cell is 13.50 m (44ft 4ins) long. At the southern end of the chamber where the concrete floor is at the entrance level the chamber is 6.25m (20ft 6ins) high to its apex. Separating the two cells is a large step, 15.30m (50ft) from the rear, north wall, and the floor level drops by about 0.90m (3ft) in the north part of the chamber to the foundation level.

To the northwest of the plant room is an originally freestanding small rectangular building (3.52m (11ft 6ins) × 2.45 (8ft 0ins) and 2.45 (8ft 0ins) high) constructed of Burwell white bricks laid to English bond, which was formerly covered with a flat, steel framed, felted roof (now missing). It is entered from the east through a single wooden door opening with a concrete lintel. To the west is a wooden louvred vent and to the east originally was a small rectangular window subsequently blocked with red bricks. In the north wall are 5 pipe openings of various diameters. Internally are the remains of a switch and fuse box. The building might have been used to house a compressor.

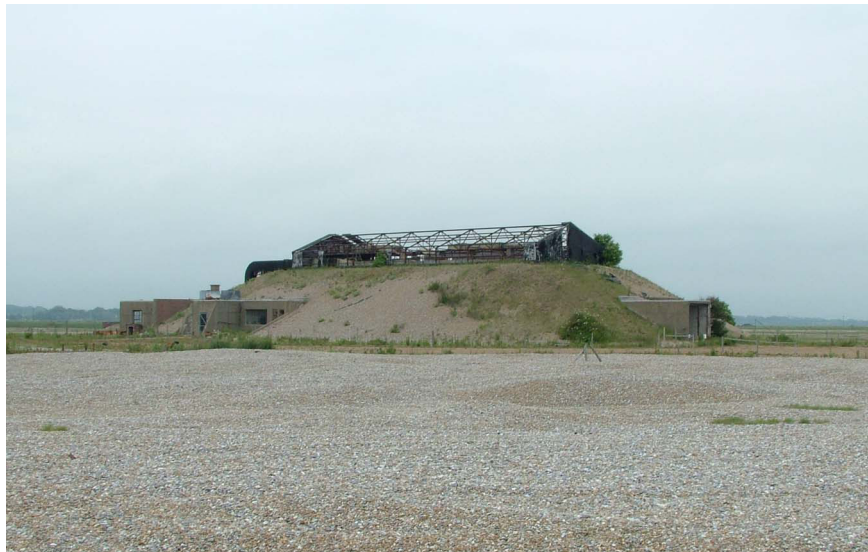
ORIGINAL FUNCTION: Laboratory I Large Vibration

and running along the north wall. The pit passes beneath the dividing wall and fittings on its surface indicate that both openings had some form of sliding screen closures. Coupled with the separate entrances it probably indicates that discrete tests could be carried out in either bay. At the southern end of the pit is a flight of concrete steps leading down into the pit and a steel ladder. On the pit walls there are numerous mounting plates, rings and electrical switch boxes. In the north east corner is the remains of an air-conditioning type duct which may have connected to ducts above that run through the east wall and out of the bay. Roughly centrally placed within the pit, just to the E of the dividing wall, are two small projecting platforms about 1.1m (4ft) below the main floor level. Immediately to their east on the main floor, on either side of the pit, are numerous large mounting bolts. Attached to the walls of the bay are numerous small bore pipes that contained the electrical wiring for lights and wall mounted sockets. Also mounted on the walls are slightly larger bore pipes with occasional gauges and glass bulbs perhaps for the delivery of hydraulic fluids. Painted signs on the walls 'VAC AND AIR' mark the position of removed pipes. There are also painted 'EMERGENCY STOP' and 'CO2 STOP' signs with associated switches by the southern entrance. At the eastern end of the north wall are numerous openings leading into the plant room to the north. On wall of the bay there is an iron ladder leading up to overhead walkways allowing access to air conditioning ducts and lighting. The shallow pitched roof is constructed from angle iron and comprises nine W-shaped trusses, raised slightly above the wall top, forming 7 roof bays. The roof was clad in pressed aluminum sheeting and externally insulated with 0.05m (2ins) cork panels stuck to the cladding with bitumen and covered by felt sheeting, the raised vertical sides were similarly treated. From the northwest plant room two large square ducts enter the main bay through the northwest gable. One of these runs along the centre of the roof space supported within the trusses and had 4 vertical square ducts dropping down from it, two of which survive. The other duct entering the main chamber divides into two and these then run along the sides of the chamber also supported within the roof space. These lateral ducts had regular rectangular downward facing vents. These two systems presumably combined to circulate air within the bay. On the north wall of the main chamber, just to the east of the dividing wall is a large diameter, heavy gauge iron pipe, which has been closed off by a similar gauge end plate. This ran outside and the other end is open, but covered by a circular baffle plate.

The south eastern entrance comprises a main entrance passage 15.50m long (51ft) by 3.35m (11ft) wide and 3.19m (10ft 6ins) high. Originally it was closed by two hinged externally opening wooden doors (the inner having counterweights), giving a central bay of 10.10m (33ft) which was lit by three lights set in ceiling recesses. On its north side are two rooms which may have contained switch and monitoring equipment. The western of these two rooms had double wooden doors, now missing.
