# ATOMIC WEAPONS RESEARCH ESTABLISHMENT, ORFORD NESS, SUFFOLK COLD WAR RESEARCH & DEVELOPMENT SITE SURVEY REPORT

# ATOMIC WEAPONS RESEARCH ESTABLISHMENT ORFORD NESS, SUFFOLK

## COLD WAR RESEARCH & DEVELOPMENT SITE

## SUMMARY

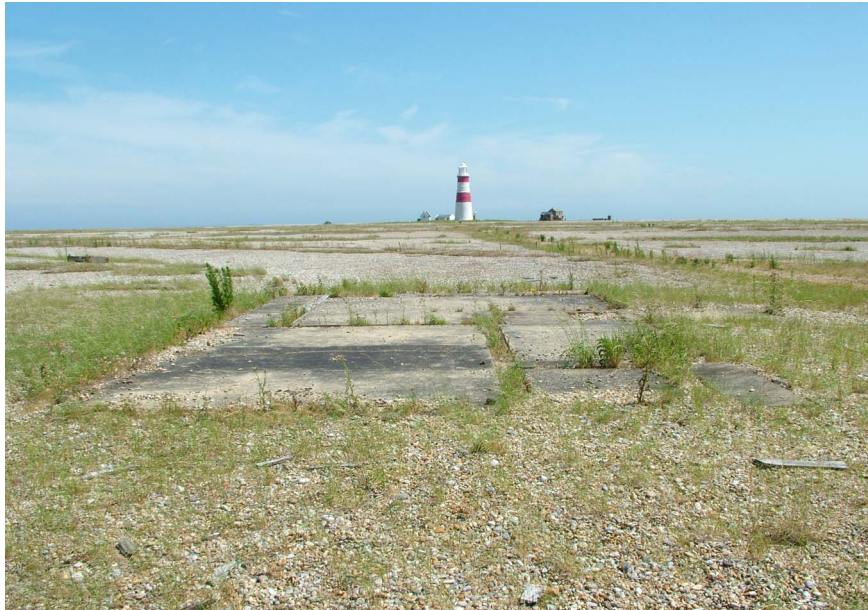
ORIGINAL FUNCTION: Electrical Transformer

The remains of the Transformer compound comprise a foundation wall 6.1m (20ft) x 3.2m (10ft 6ins), at its north end are three ceramic cable pipes, one of which retains a cut- off High Voltage
