# Scarborough Castle, North Yorkshire

# SURVEY REPORT

Archaeological Investigation Report Series AI/11/1999

Surveyed October - November 1998

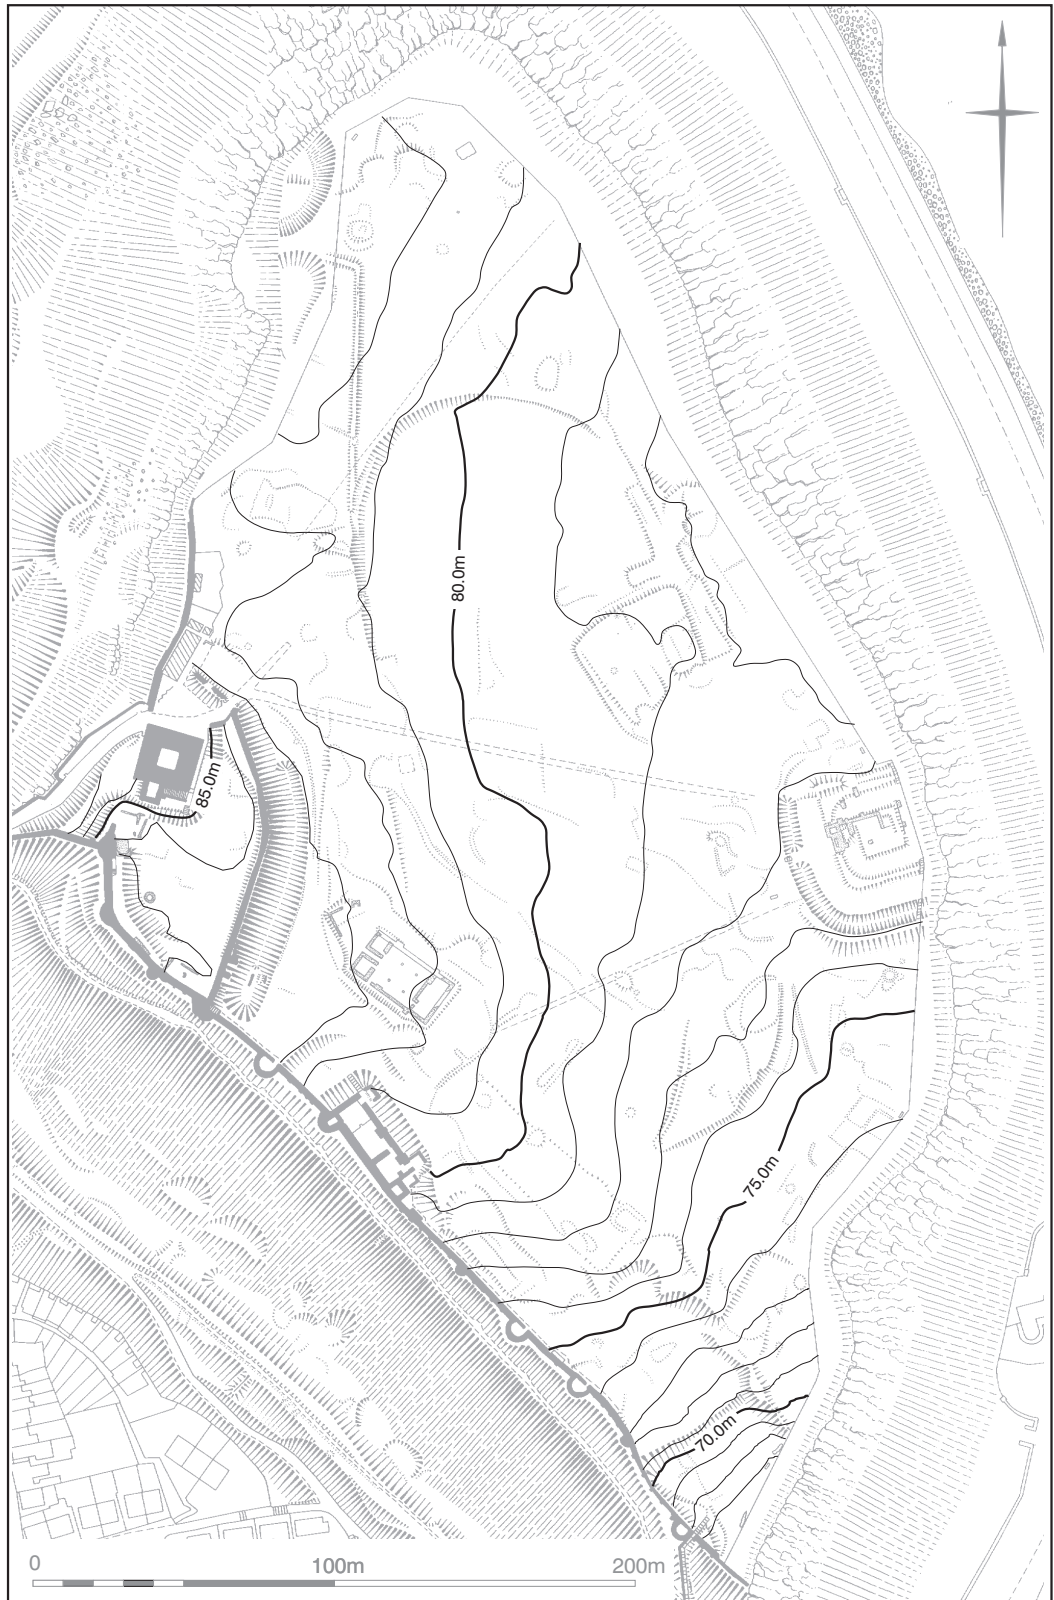
Figure 3. The castle headland showing contours at 1m intervals

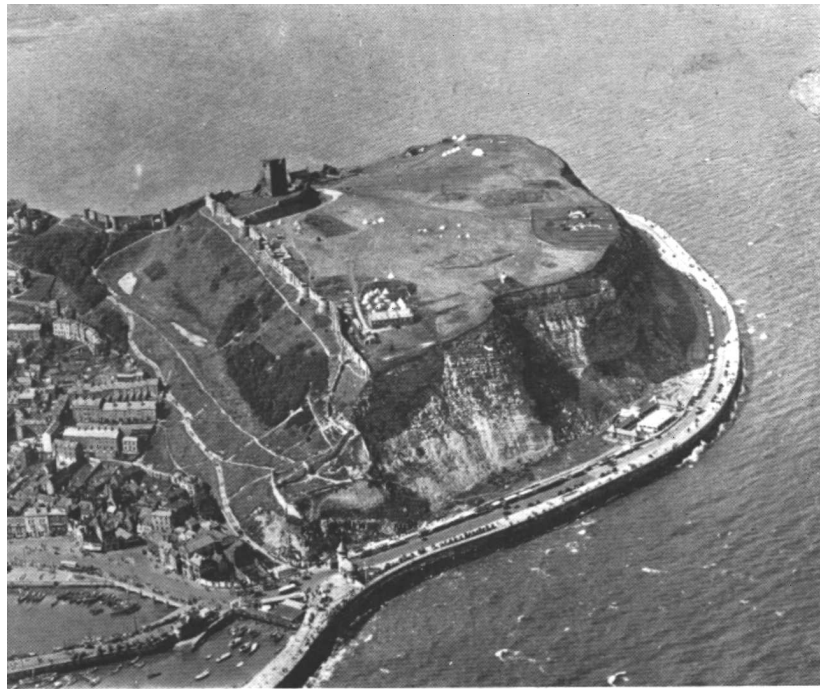
*Figure 5.  
Aerial photograph  
of the castle from  
before 1938  
(Adshead and  
Overfield 1938,  
facing page 80)*

The open space of the outer bailey has also lent itself to a variety of non-military uses during this century. It was the site of an historical pageant in 1912 for which a large stand was erected (Rowntree 1931, 309-11) and in the 1920s work started to construct a football ground across the centre of the headland. The outer bailey also made a useful temporary camp site as is evident on an aerial photograph (Figure 5) taken

before 1938 which shows several clusters of bell tents dotted around the inside of the castle (Adshead and Overfield 1938, facing page 80).

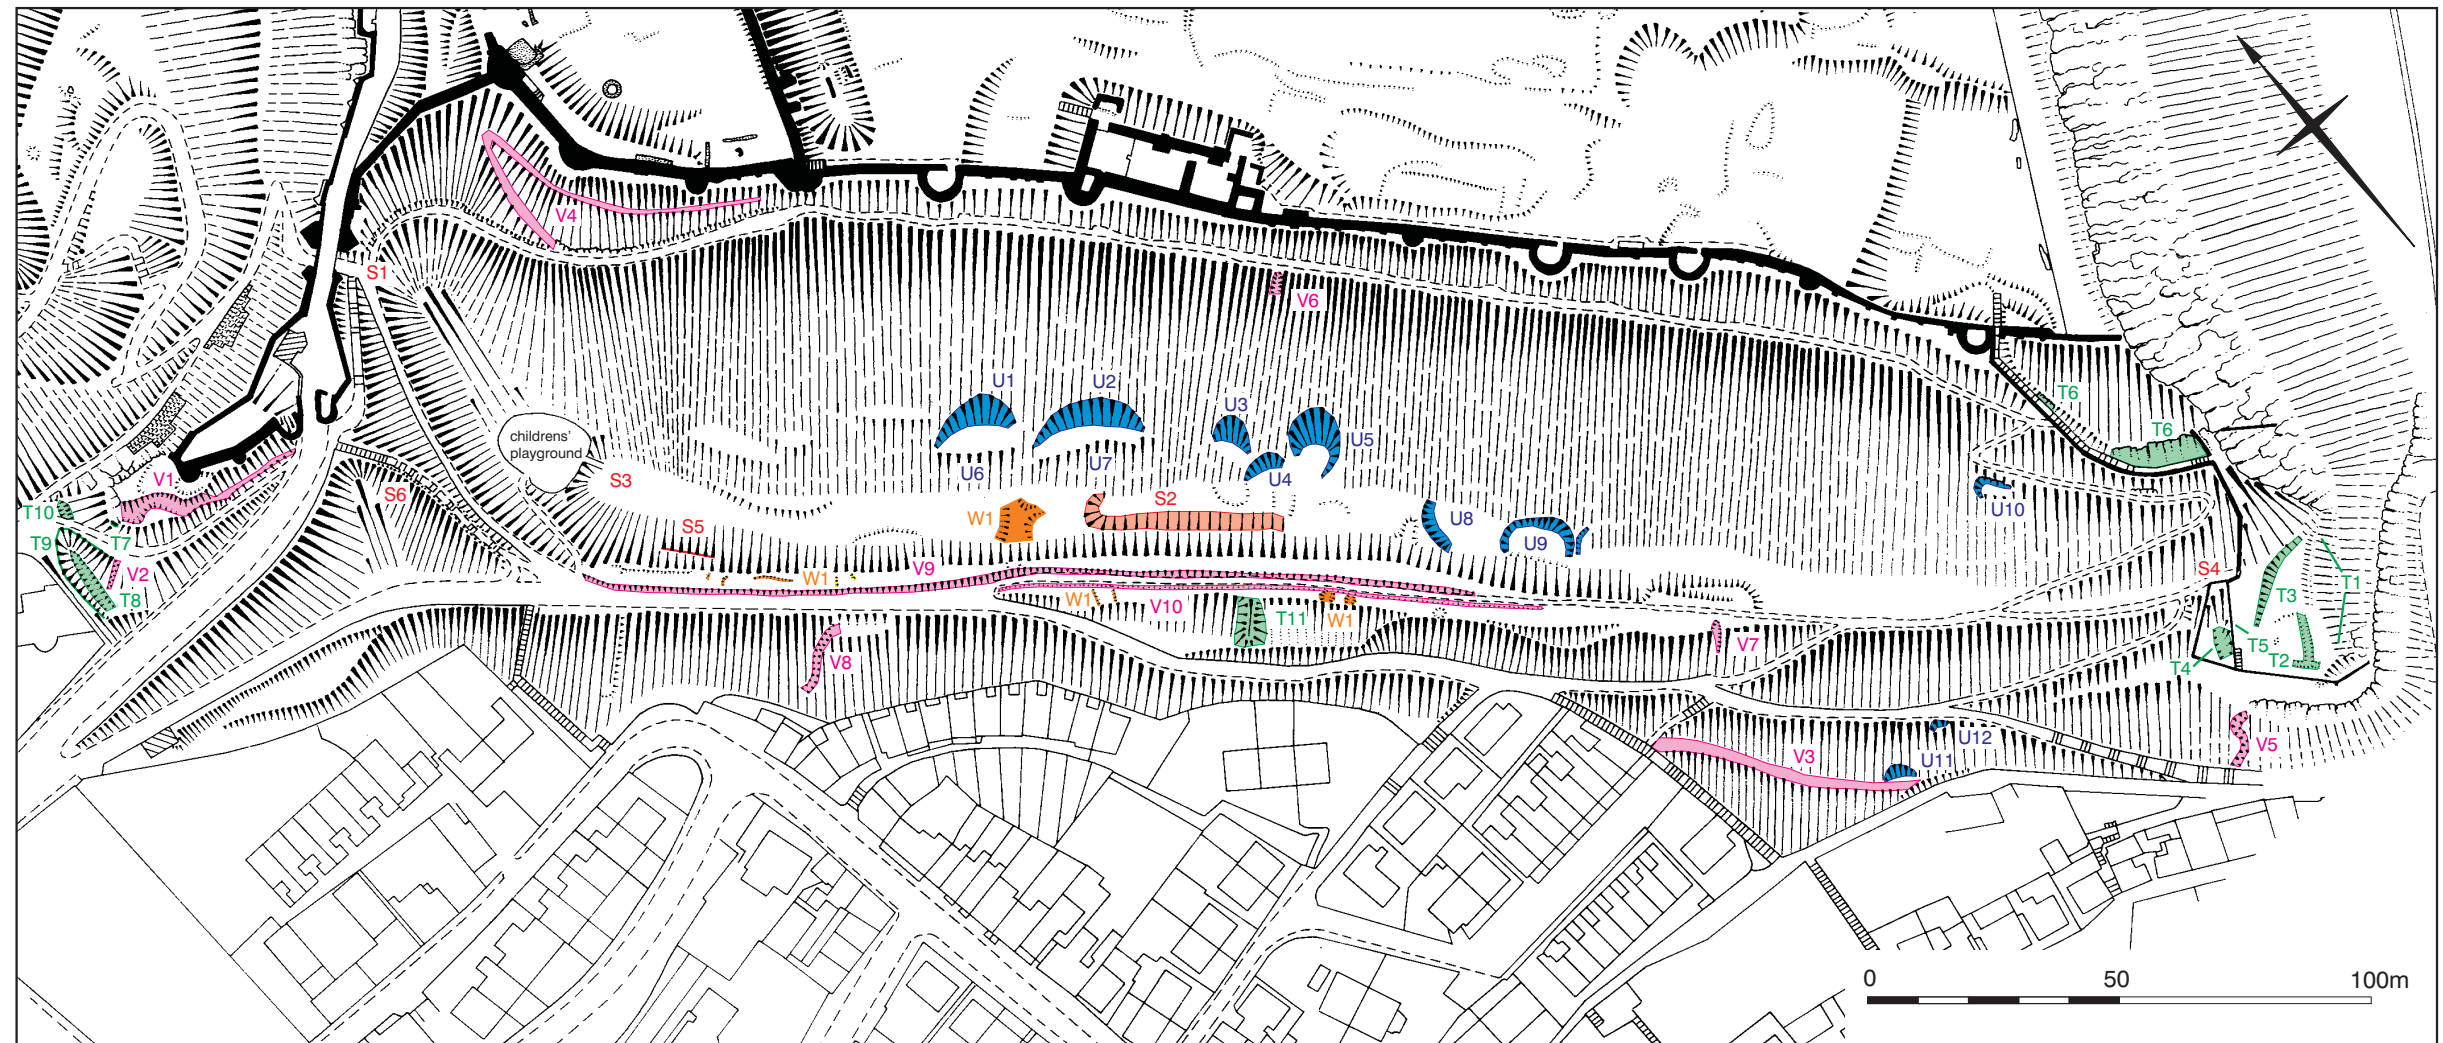
Figure 18. Interpretative plan of the Castle Dykes at 1:1500 scale showing features described in the text

- S1-S6 defences
- T1-T11 outworks
- U1-U12 quarries
- V1-V10 paths and tracks
- W1-W2 miscellaneous features

There is more evidence for a ditch at the north-west end of the Castle Dykes, in the way the rounded end is cut into the hillside below the castle barbican (S3), although it is now partially obscured by the children's playground first constructed in the late 1940s. The excavation of a ditch here would have enhanced the security of the south side of the barbican and deterred attackers from reaching the defile (S1) separating the barbican from the rest of the castle.

At the opposite end of the Castle Dykes the entrance to the South Steel battery from the Castle Dykes is gained along a narrow defile at the foot of the upper escarpment (S4). On the opposite, south side, the defile is formed by a 2.7m high stone wall which revets the highest part of the plateau occupied by the South Steel Battery. Although

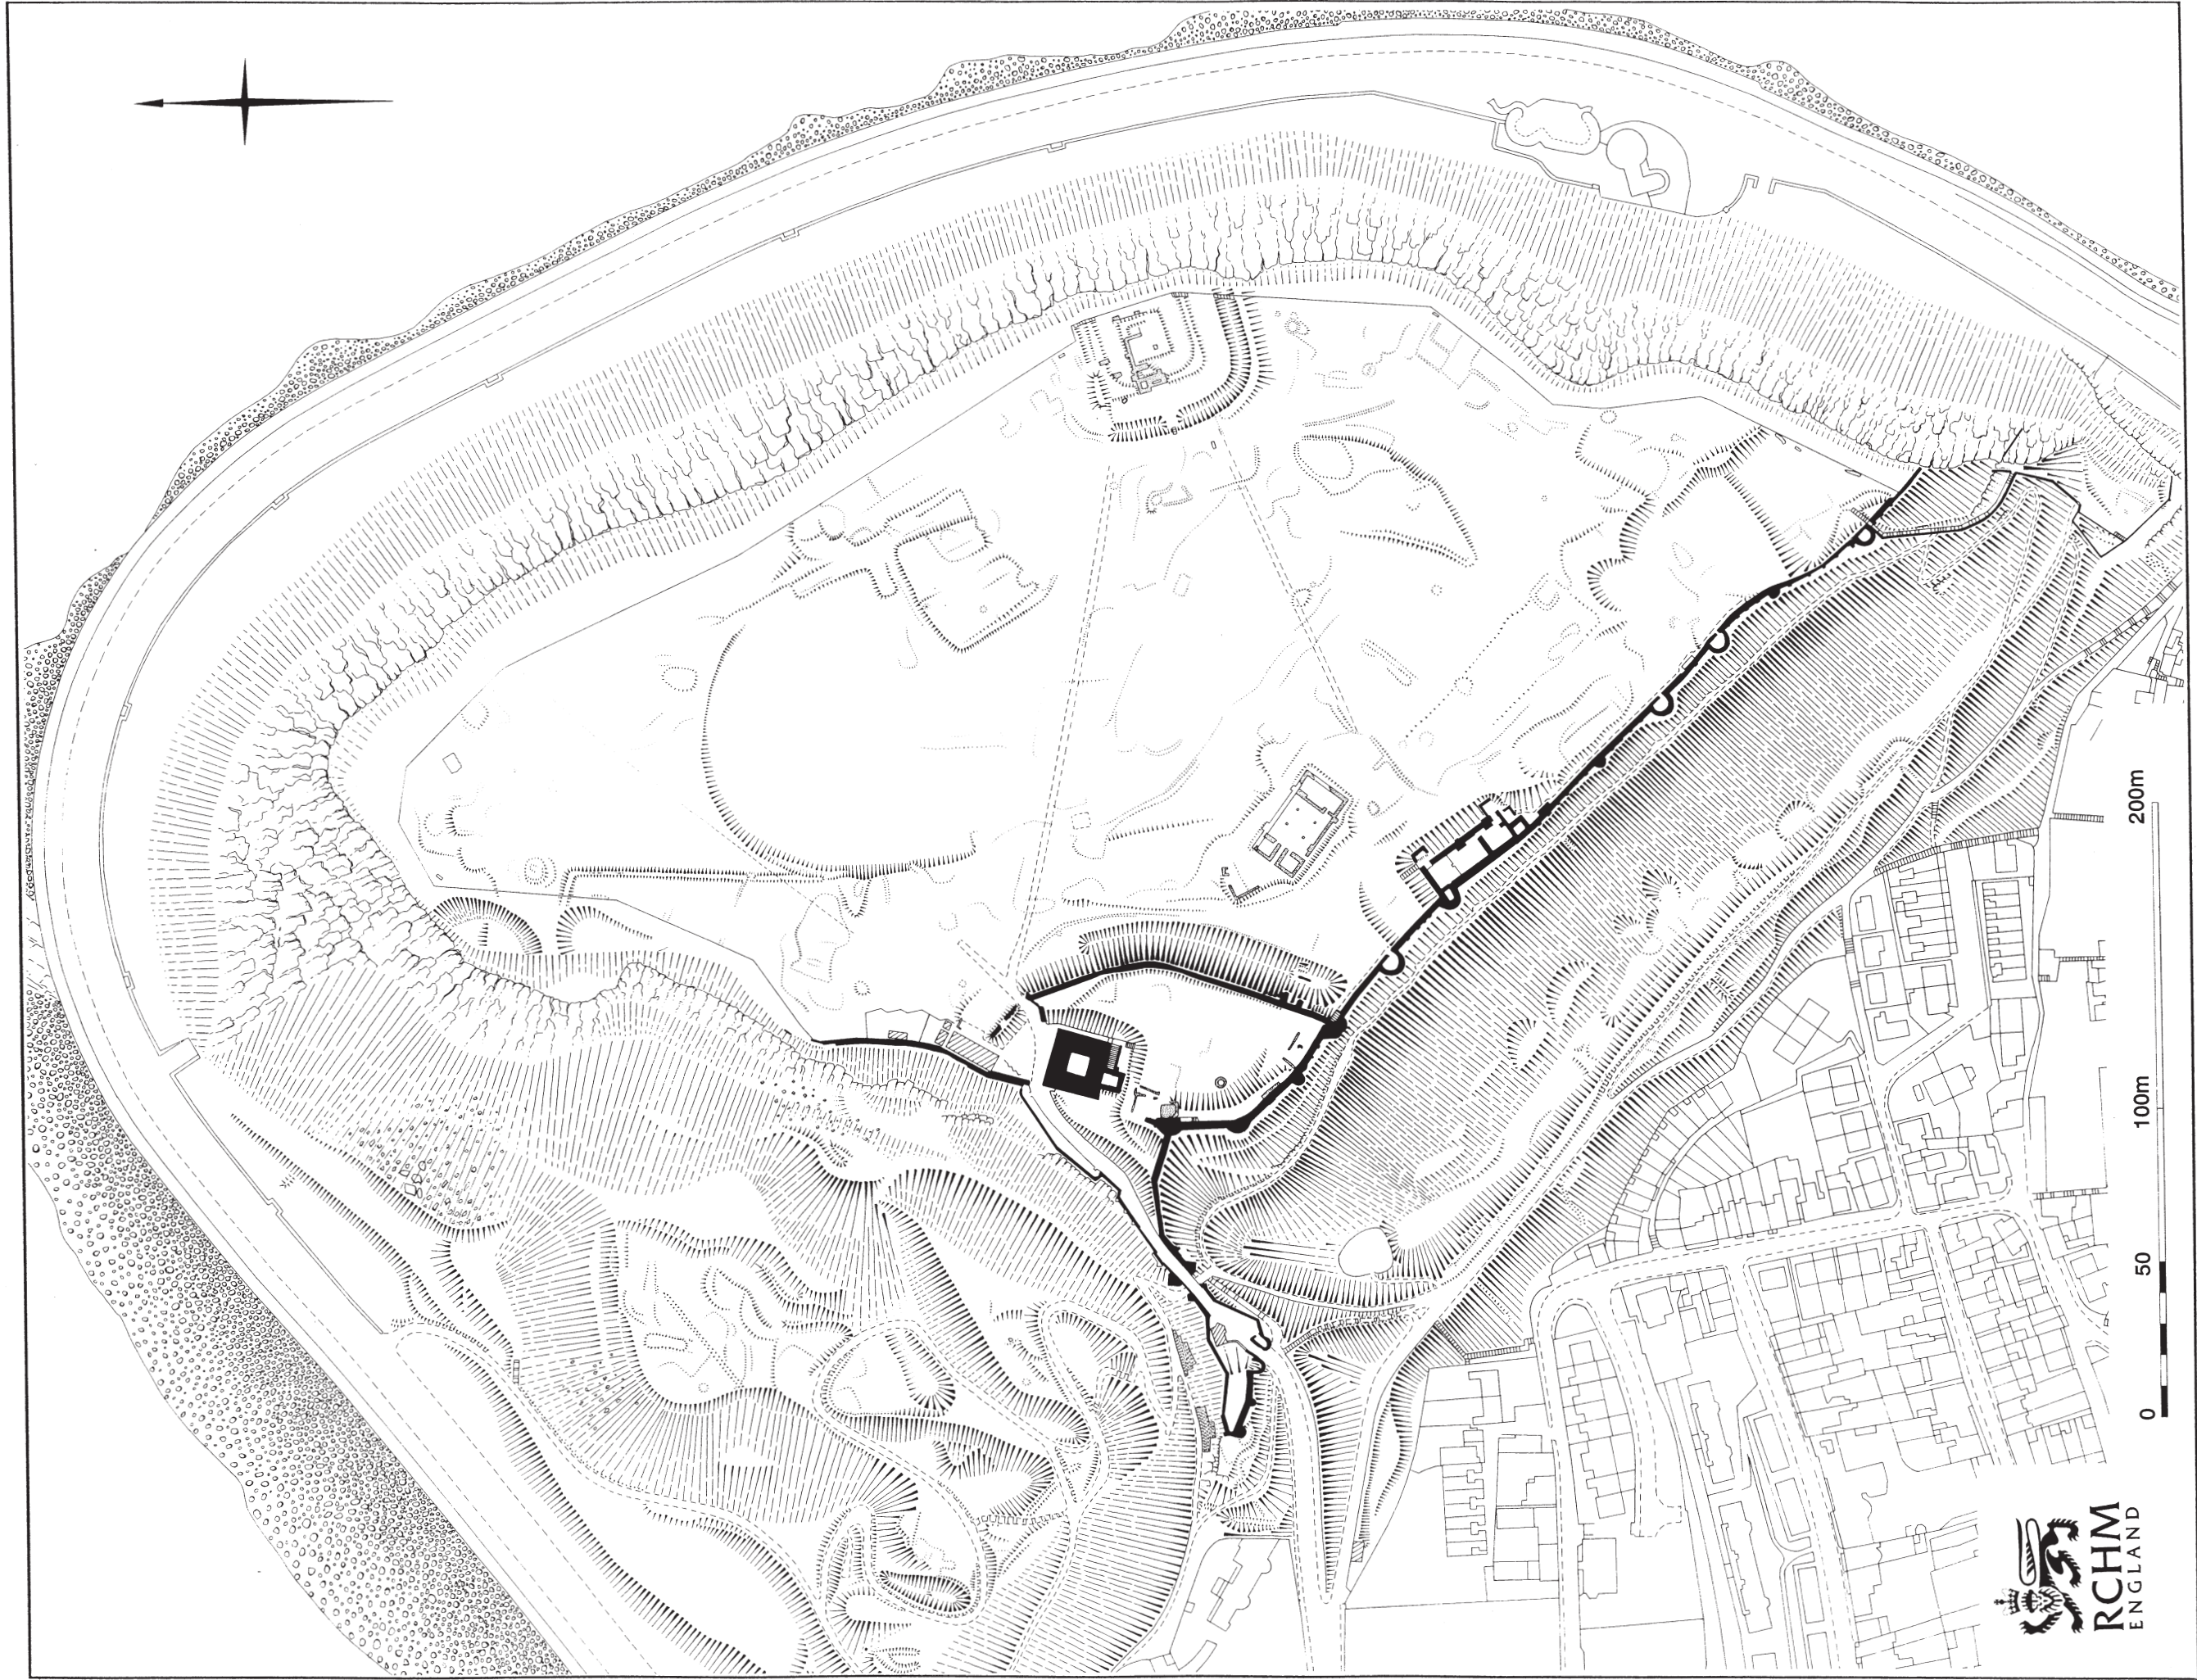
Figure 6. RCHME plan of Scarborough Castle surveyed at 1:1000 scale (reduced to 1:2000)
