ENGLISH HERITAGE

# Loftus Alum Works, Redcar and Cleveland, Cleveland: an archaeological and historical survey

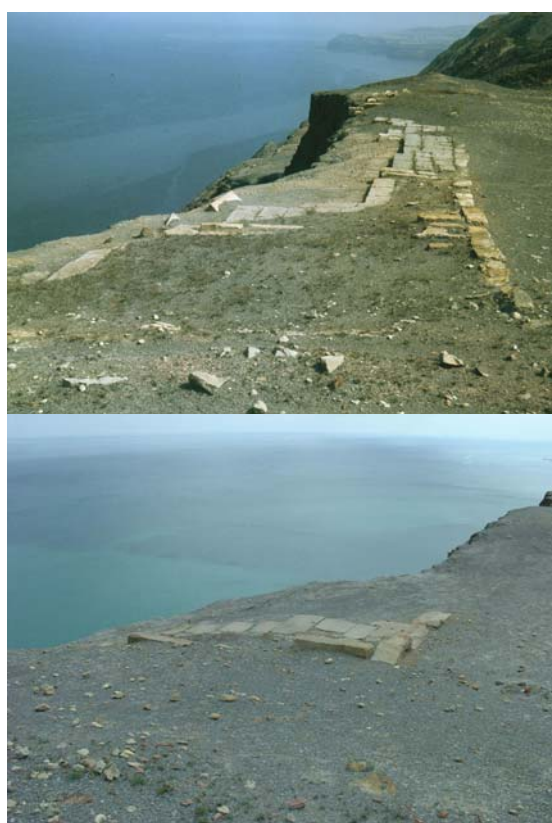
**Figure 5.**  
*Photographs of a steeping pit in area 1; the upper one was taken in 1975, the lower in 2003. This demonstrates the rate at which stone has disappeared from the site in relatively recent times. 1975 photograph reproduced by kind permission of Mr K Chapman.*

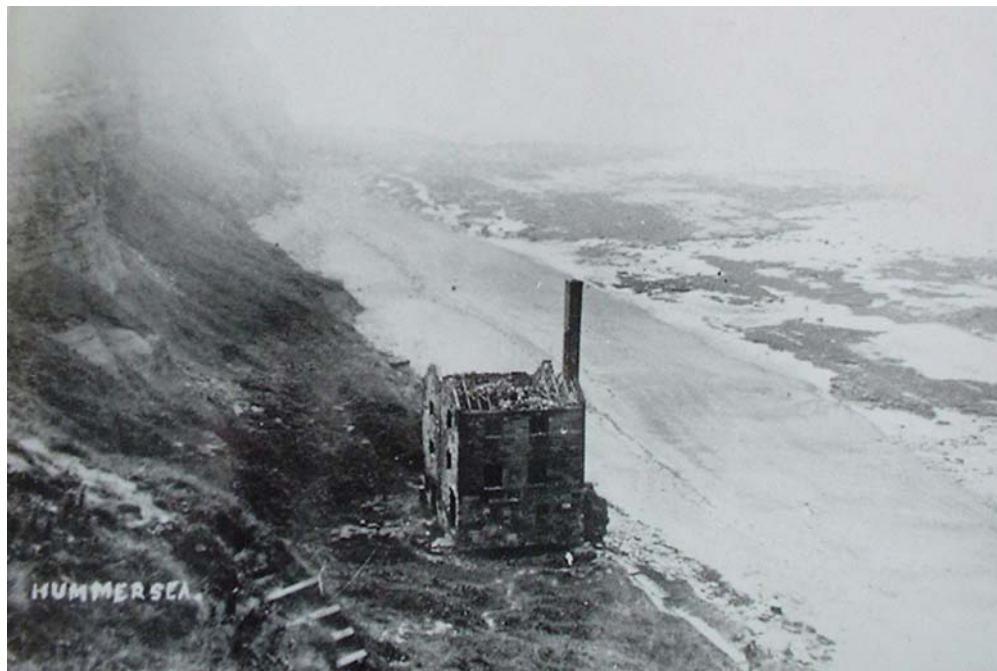
**Figure 10.**  
*Photograph of the  
alum house at  
Hummersea, believed  
to date to the 1890s.  
Reproduced by kind  
permission of Mr K  
Chapman.*

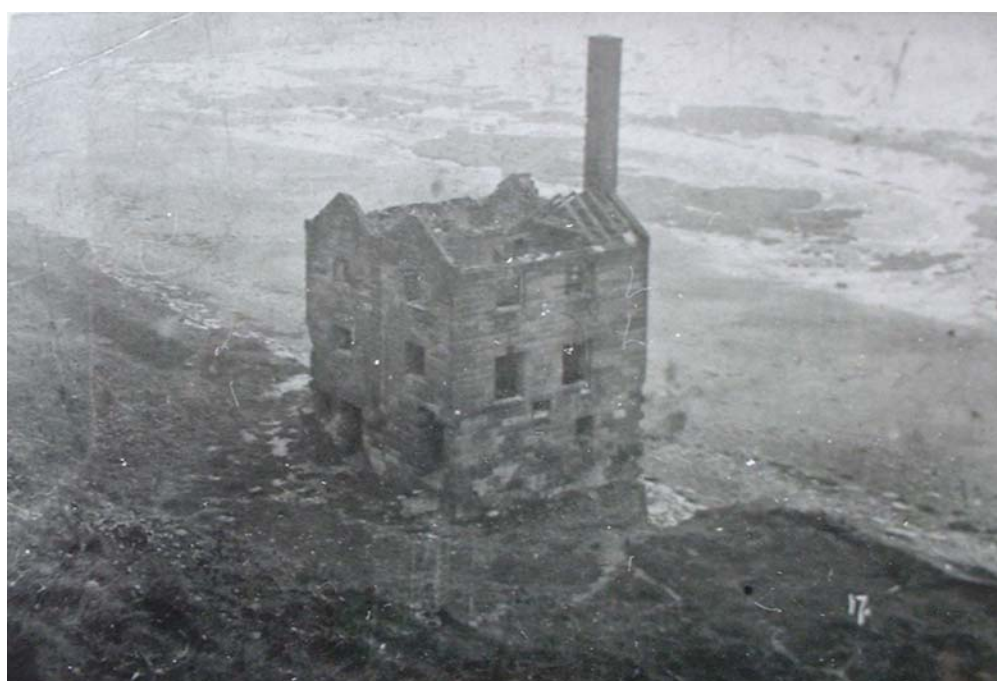
difficult to be sure of exactly what they are or what they represent. What is clear from the image is that the structure illustrated was situated on a flat area that seems to have been cut back into the cliff, apparently for the specific purpose of accommodating the building.

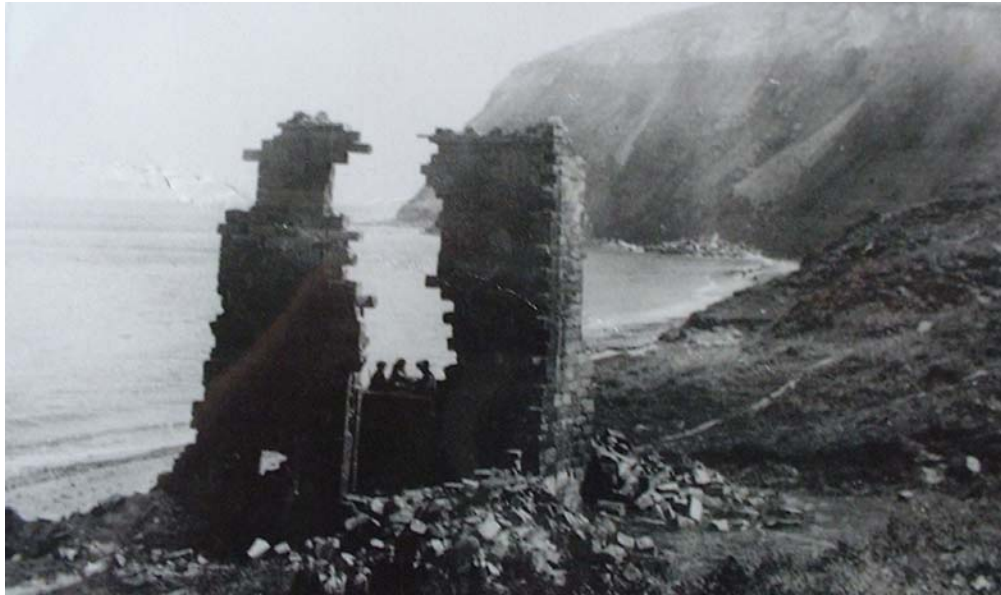
**Figure 13.**  
*Photograph of the  
alum house at  
Hummersea, possibly  
dating to c1910.  
Reproduced by kind  
permission of Mr K  
Chapman.*

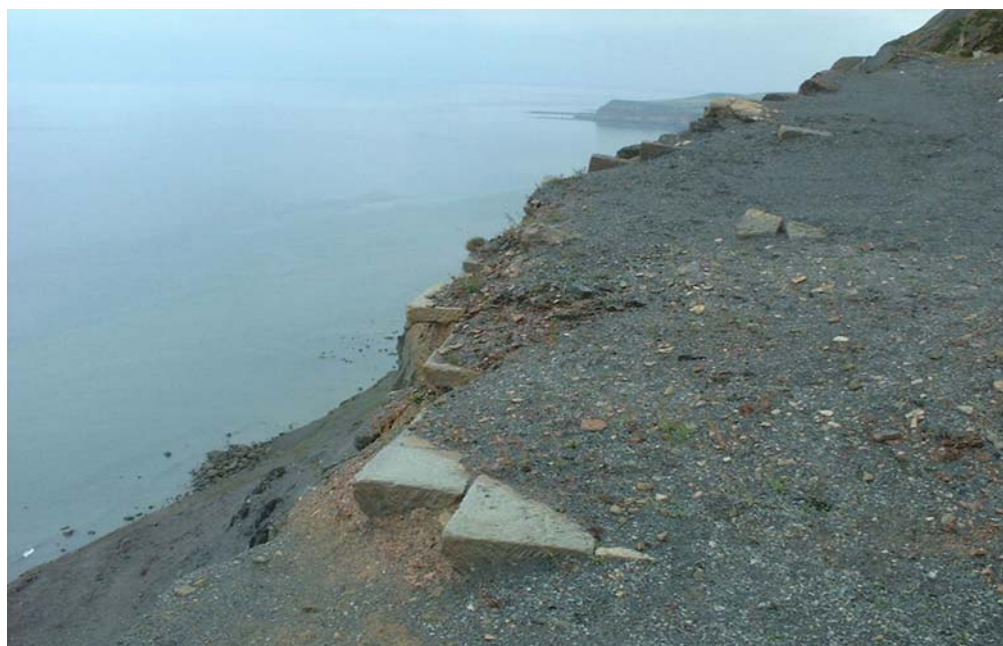
**Figure 16.** Stone slabs, originally part of a steeping pit floor, protruding from the cliff edge at the eastern end of area 1

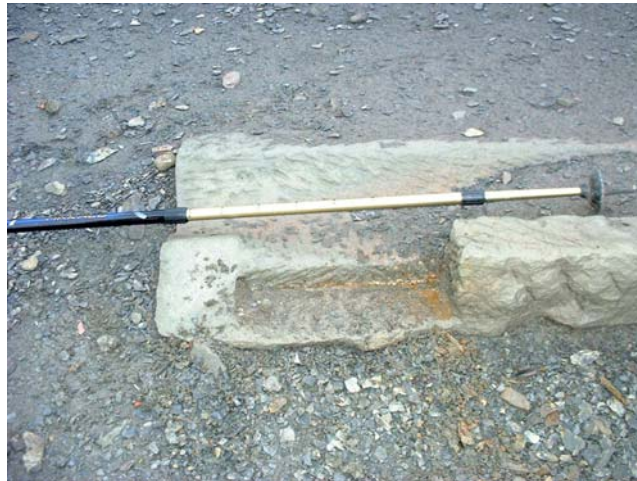
**Figure 17.** Section of stone liquor trough with square-cut notch

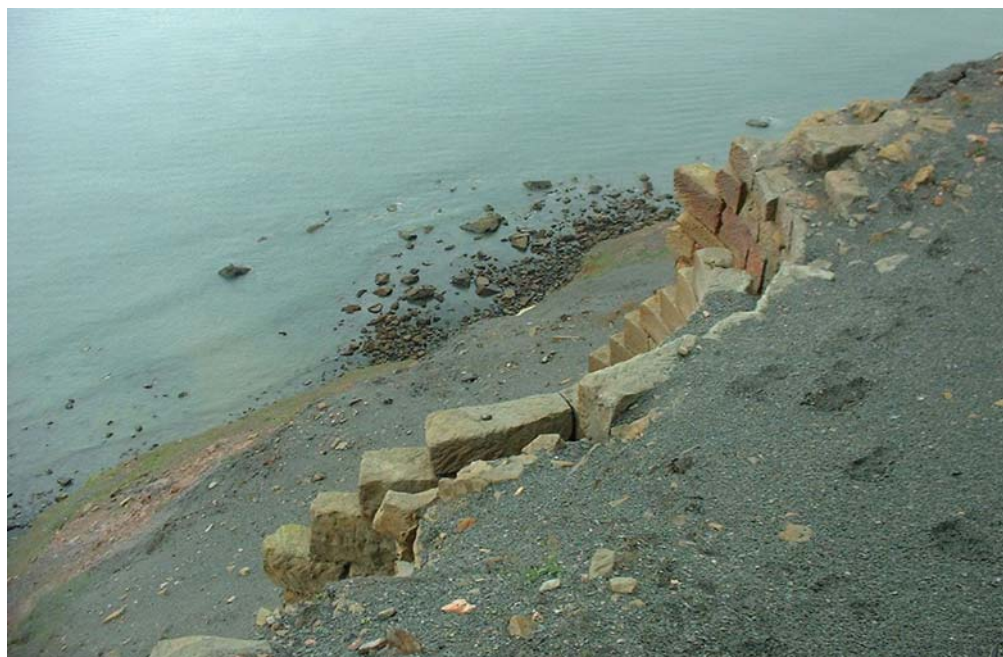
**Figure 18.** Remains of a circular cistern in the cliff edge. A gap can be seen between the two walls of the structure.

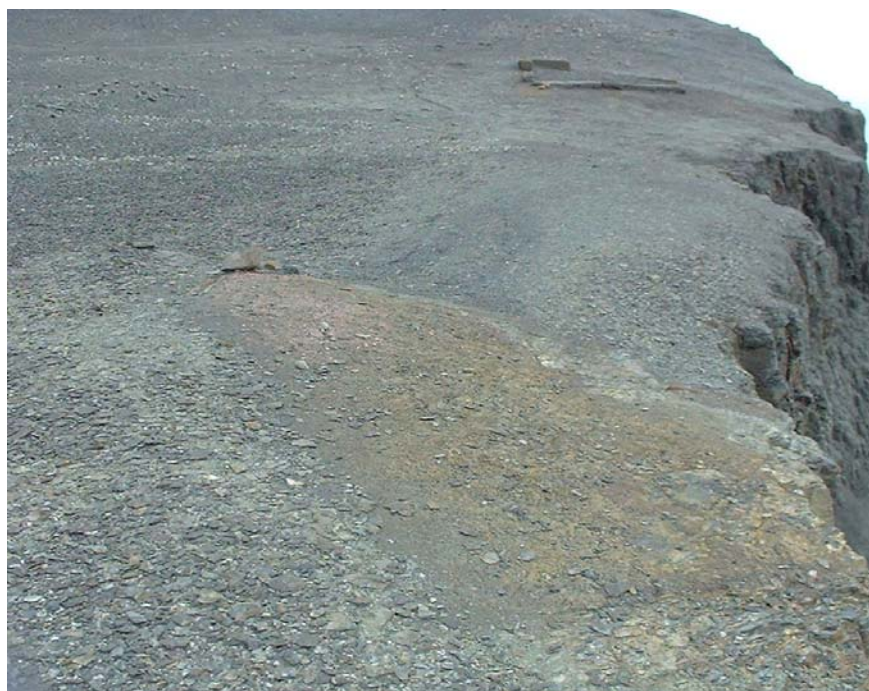
**Figure 20.** *Clay base upon which a steeping pit would have stood. In the distance the structural remains of a steeping pit can be seen, which was probably part of the same range.*

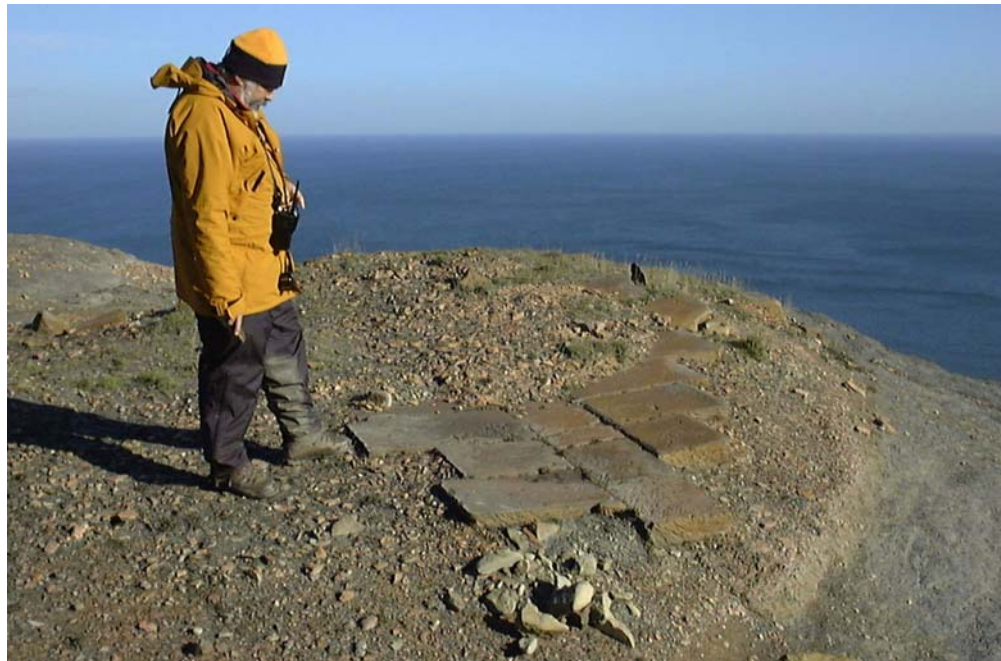
**Figure 23.**  
Photograph showing  
the surviving  
sandstone slab floor  
of a steeping pit in  
area 2

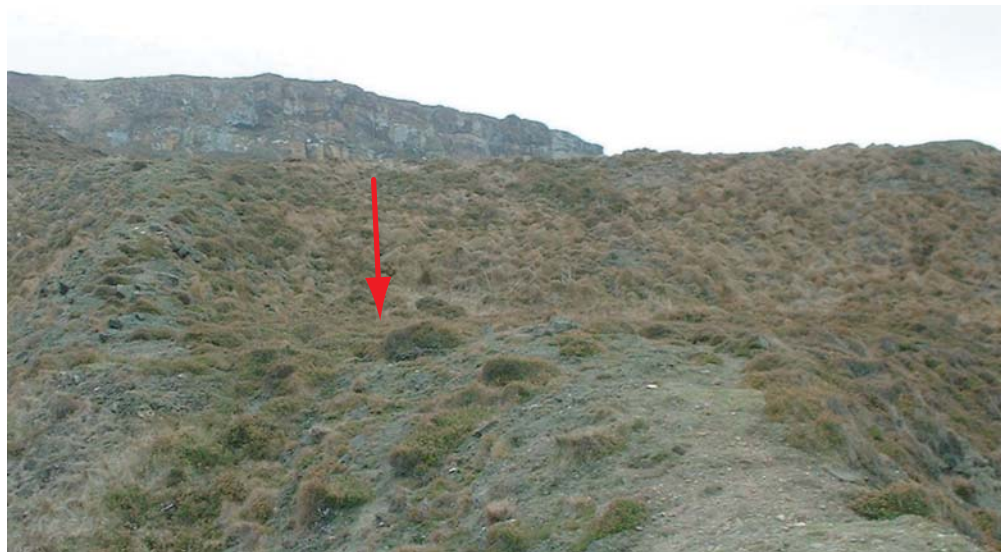
**Figure 27.** Platform (indicated by the arrow) within area 4

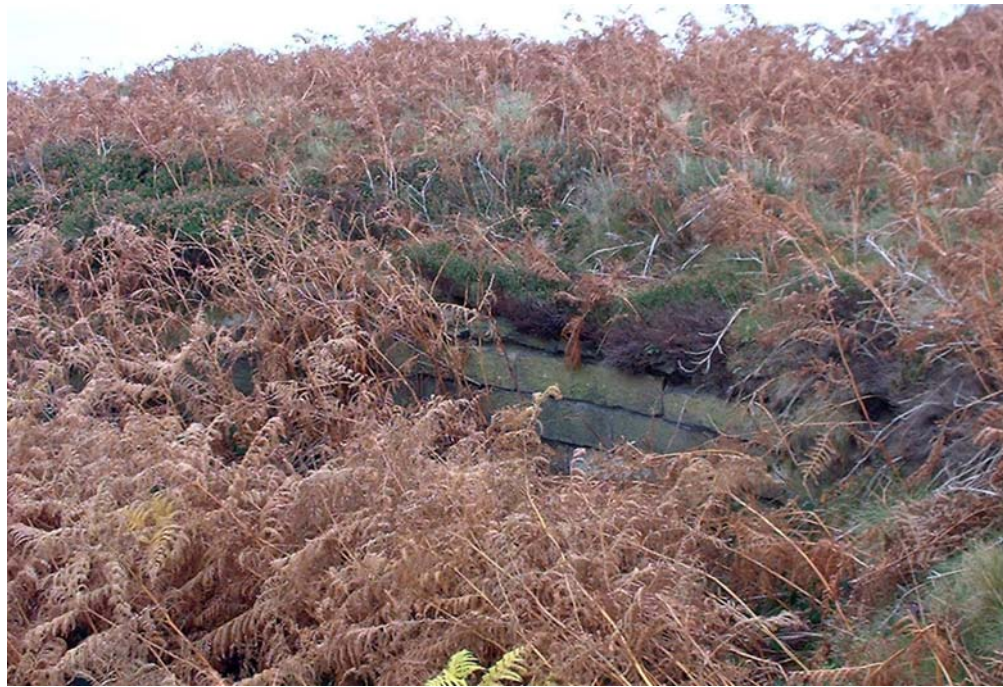
building at this location annotated 'Cistern' (Ordnance Survey 1856a). By the early 20th-century, the building is known to have lost its roof, and two of the walls had disappeared. To the west, the top edge of a scarp seems to define a path leading towards the cisterns. These covered cisterns would have been used to allow the alum liquor to settle before being transferred on to the alum house. The liquor would have carried to the latter via a trough, but no traces of this now survive in the vicinity of the cisterns.

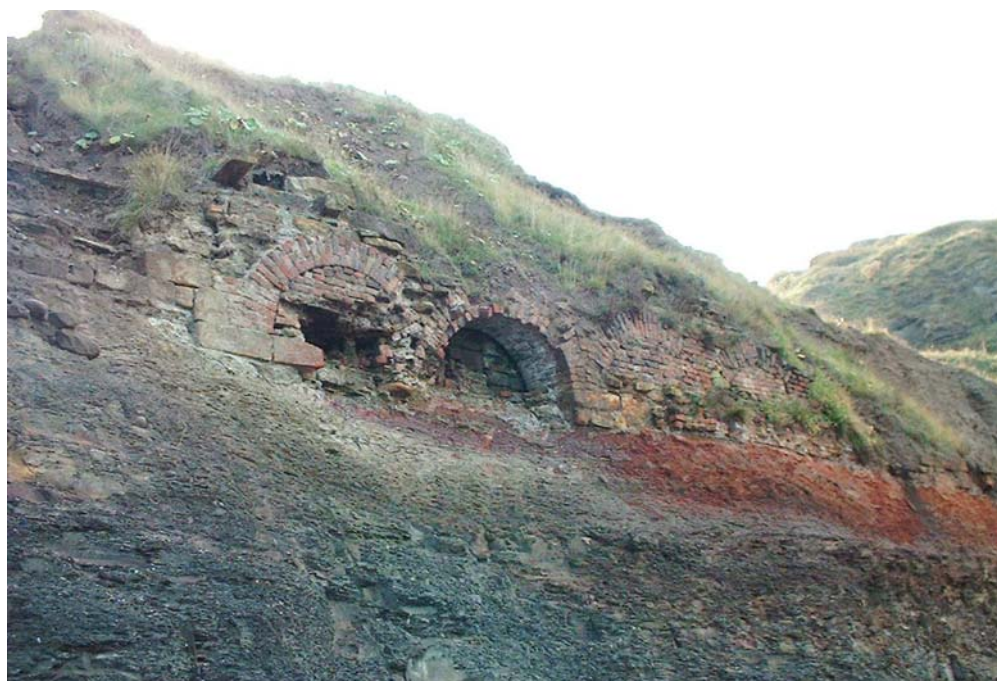
**Figure 34.** The remains of bricked-up arches in the cliff face at Hummersea, formerly part of the alum house complex

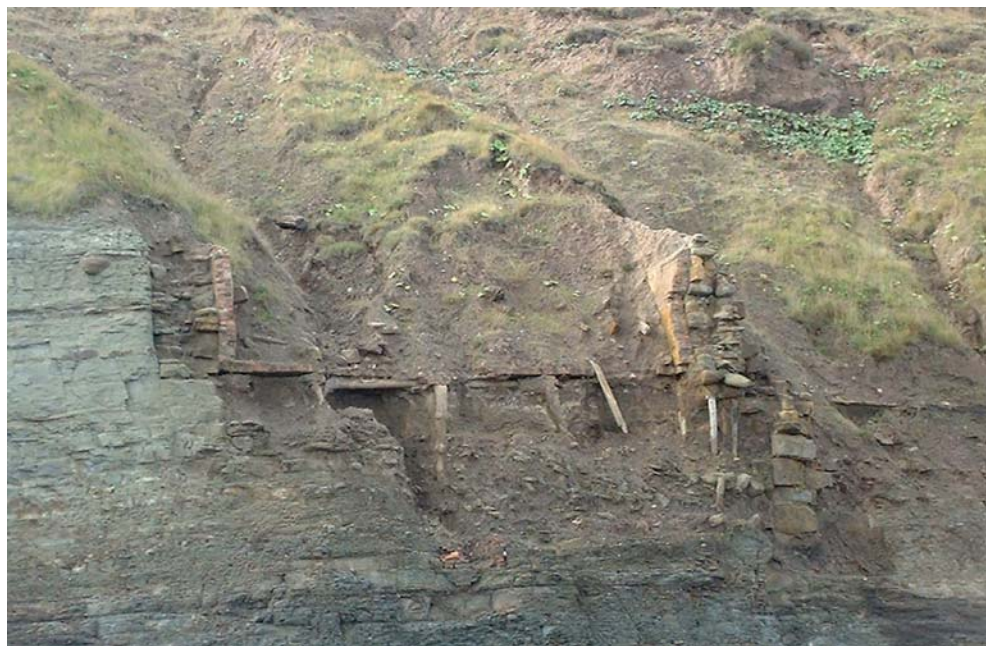
**Figure 35.** Further structural remains of the alum house complex

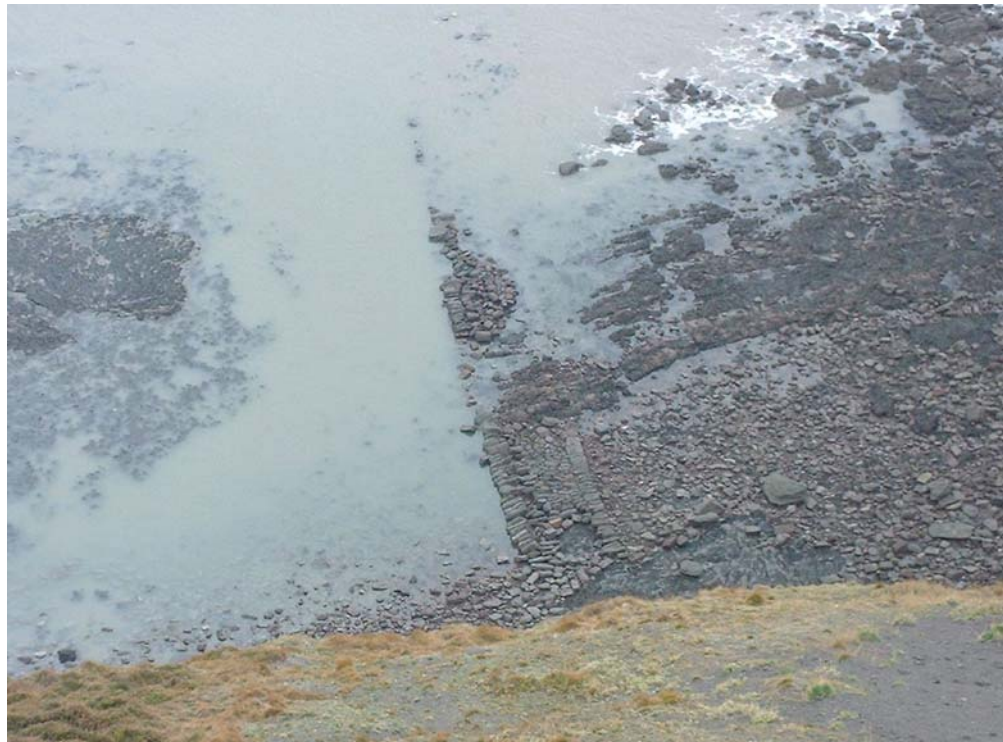
**Figure 36.** The Old Gut as seen from the cliff above. Large stone blocks clearly define the eastern side of the dock.

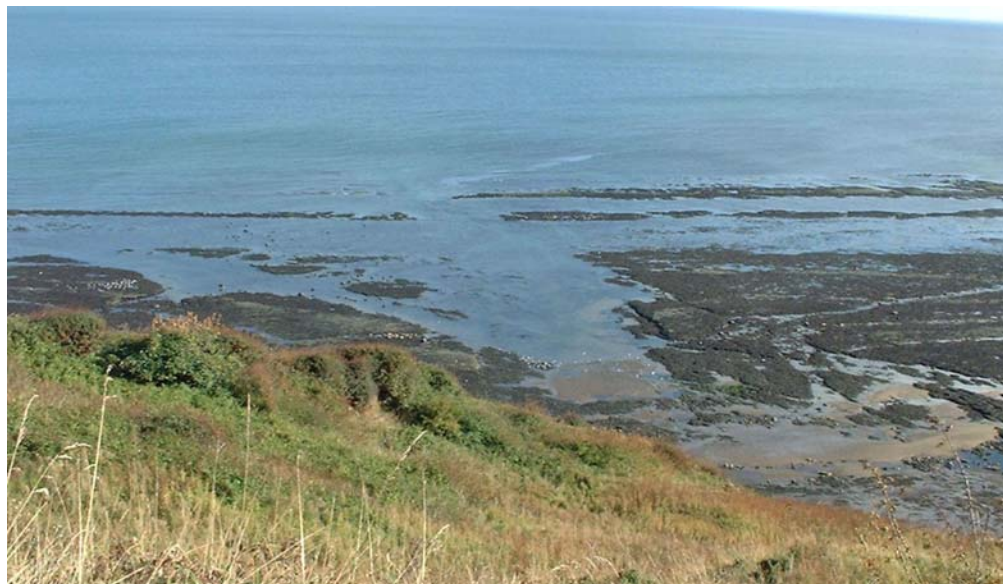
**Figure 37.** *The New Gut is less clearly defined than the Old Gut, but the incoming tide shows the general extent of the dock*

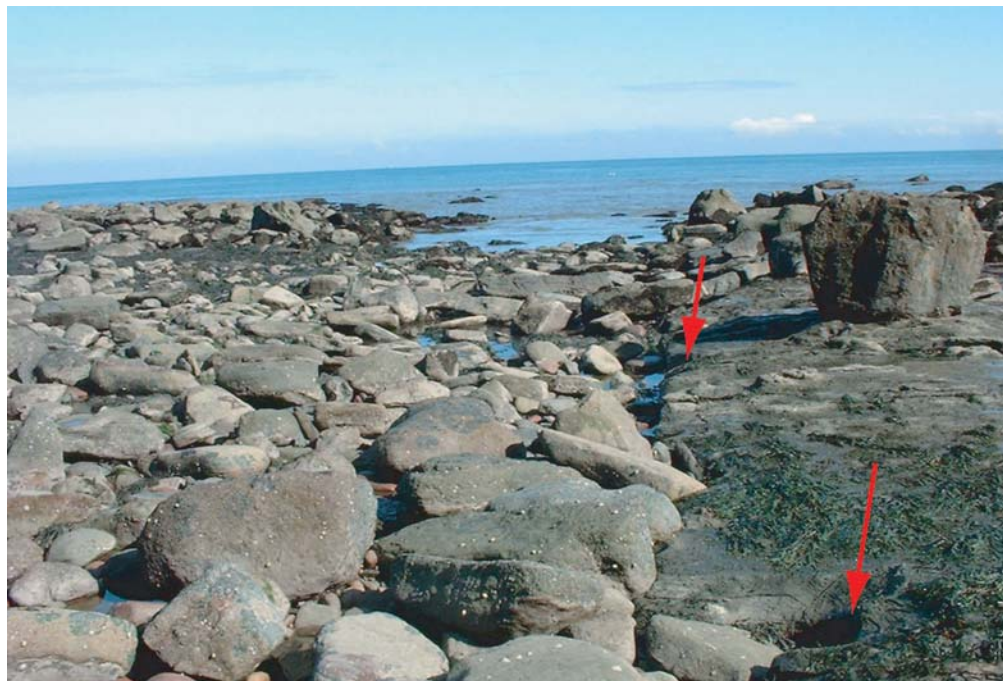
**Figure 38.** Post holes (indicated by arrows) along the eastern side of a probable third dock associated with Loftus Alum Works. The line of the cut for the main dock access, now filled with boulders, can just be seen as a straight line towards the right of the photograph.

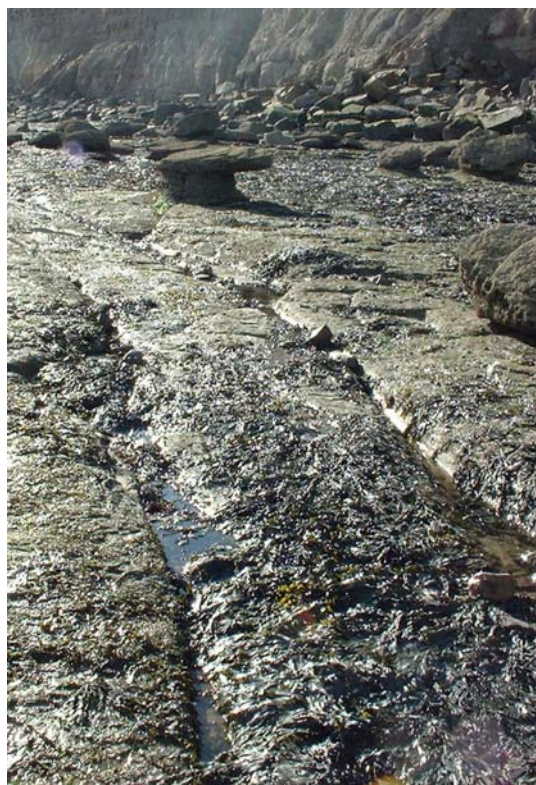
**Figure 39.** Example of a rutway observed on the foreshore near Hummersea Beach

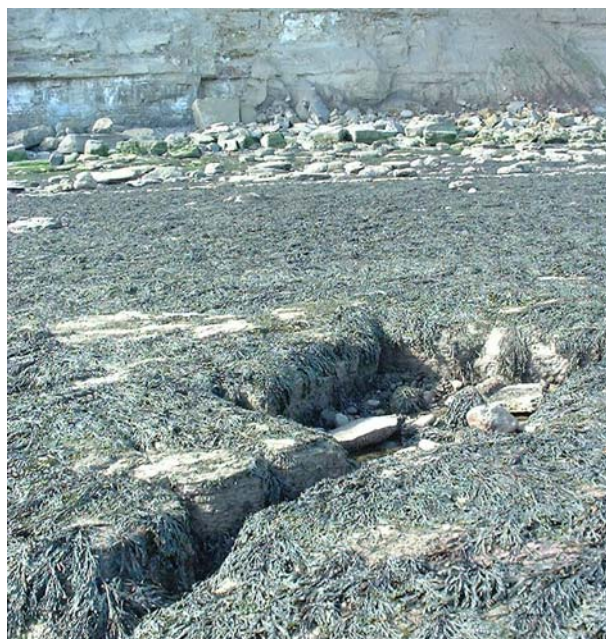
rising or subsiding. The location of the pit suggests that it is unlikely to be closely connected with the Loftus Alum Works, it may even be a more recent creation, possibly associated with the local fishing industry, in particular shellfish.
