The Royal Hotel, Kettering: Historic Building Assessment

Research Report Series 01-2021

**THE ROYAL HOTEL
MARKET PLACE, KETTERING
NORTHAMPTONSHIRE**

Historic Building Assessment

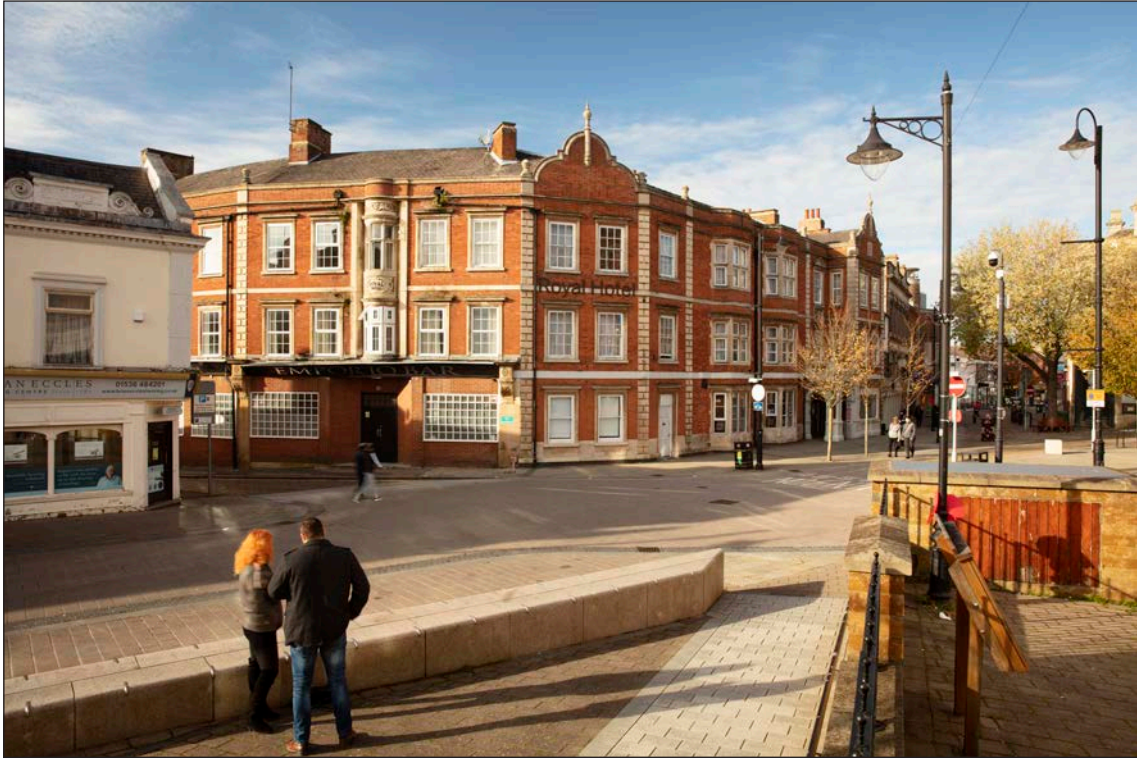
Figure 2: The Royal Hotel, viewed from Market Place [DP300956]

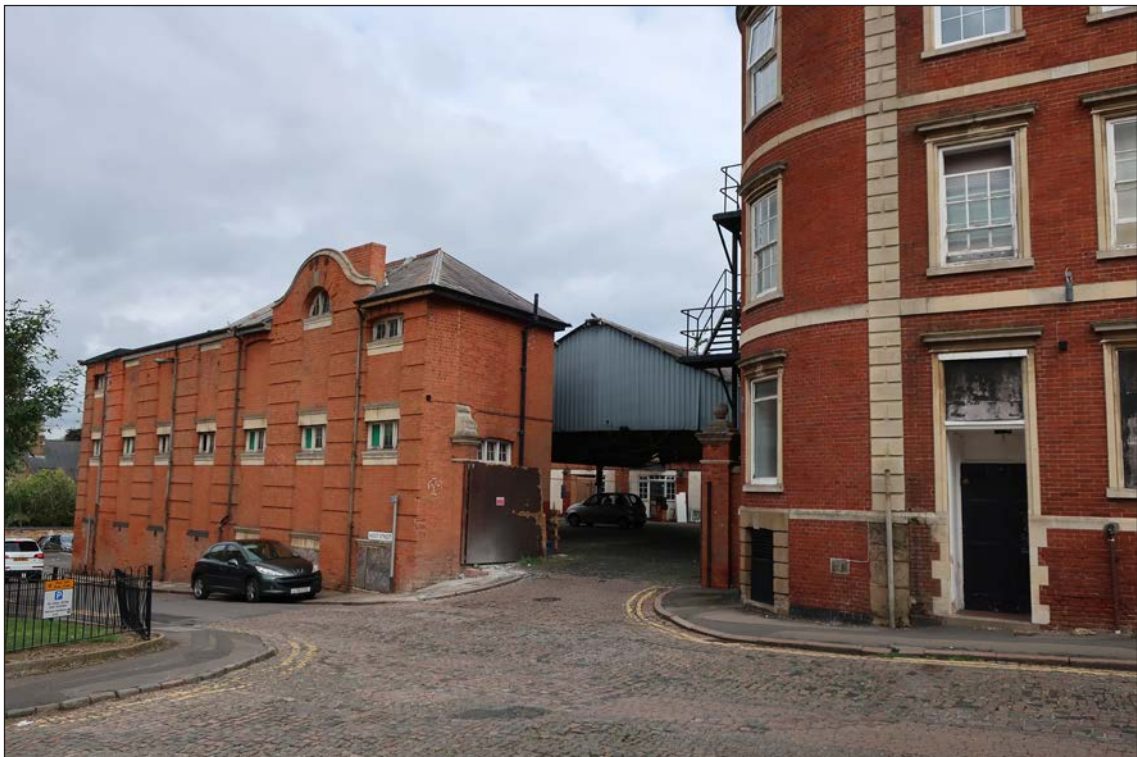
Figure 3: Rear stable block (south elevation) and courtyard entrance [© Historic England, Aimee Henderson]

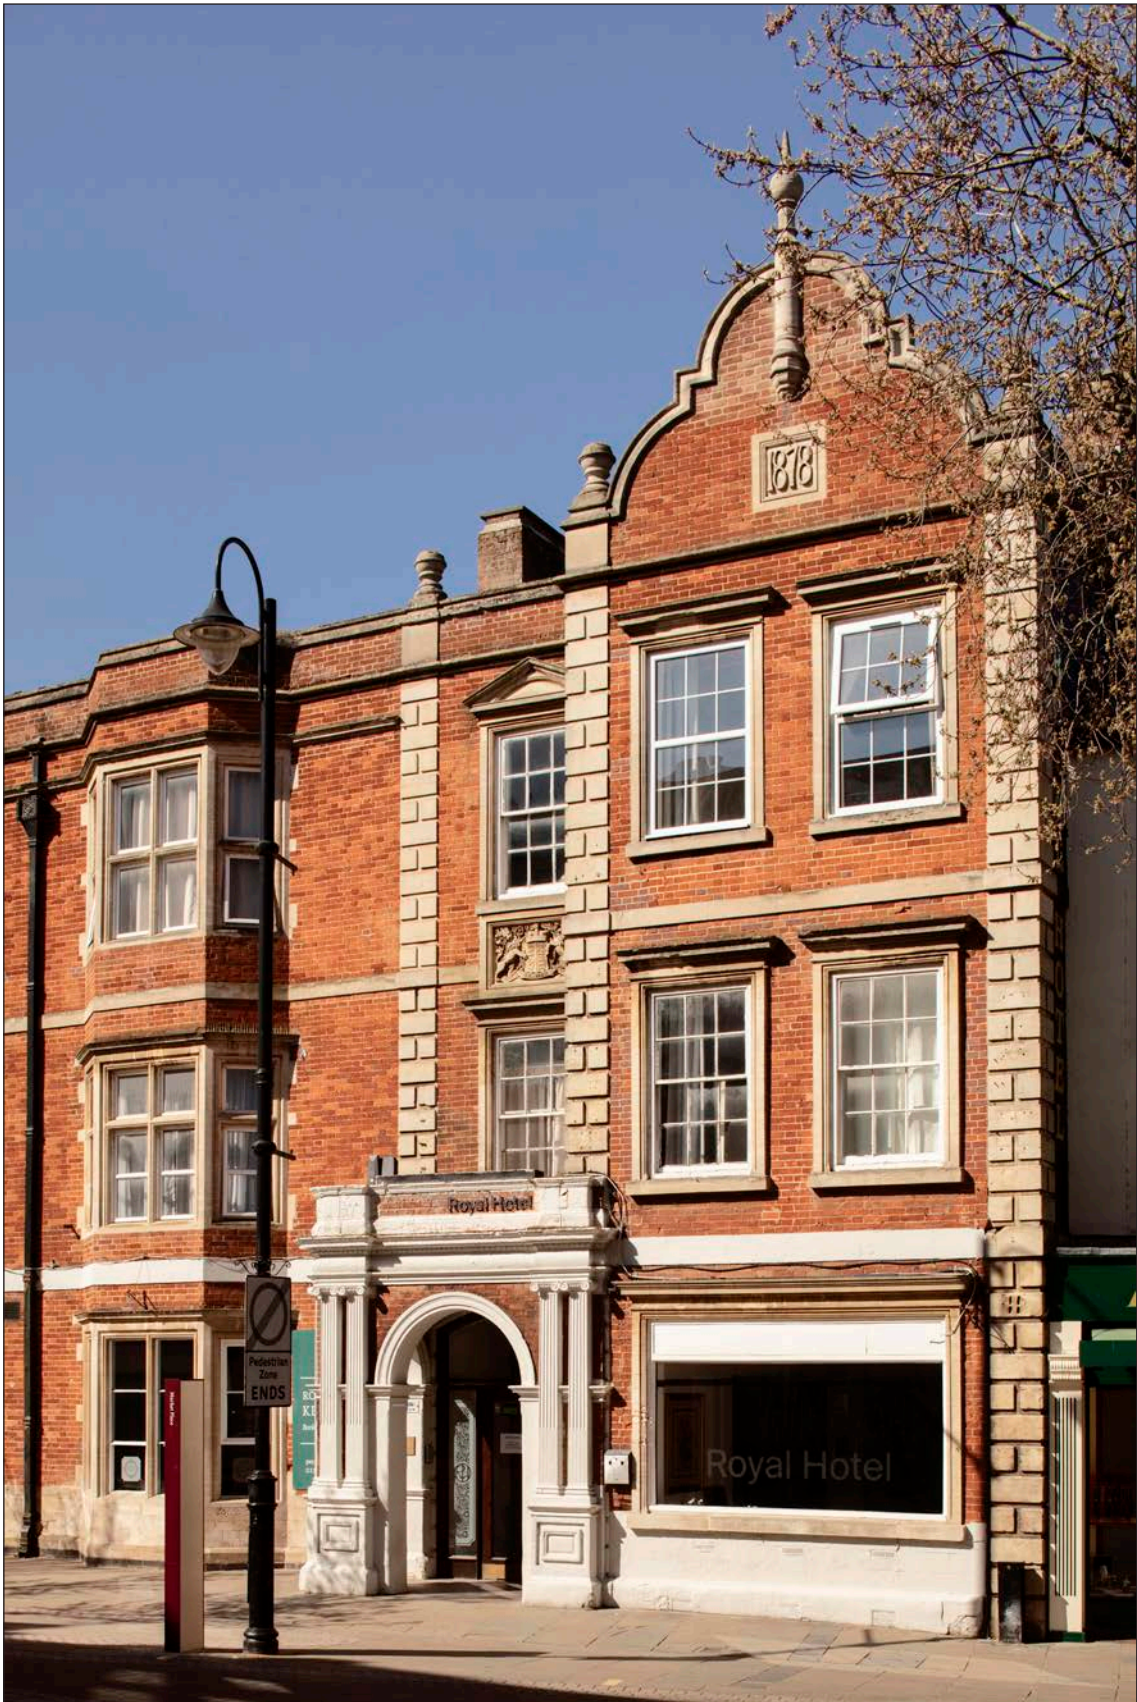
Figure 4: Northern gable with date stone and entrance porch [DP300771]

It is assumed that it was the fifth Duke of Buccleuch who prompted the extension of the hotel in 1878, although to date no plans or other documents have yet been found in association with the rebuilding works. The date of 1878 is provided on a date stone located on the northern-most gable of the hotel.

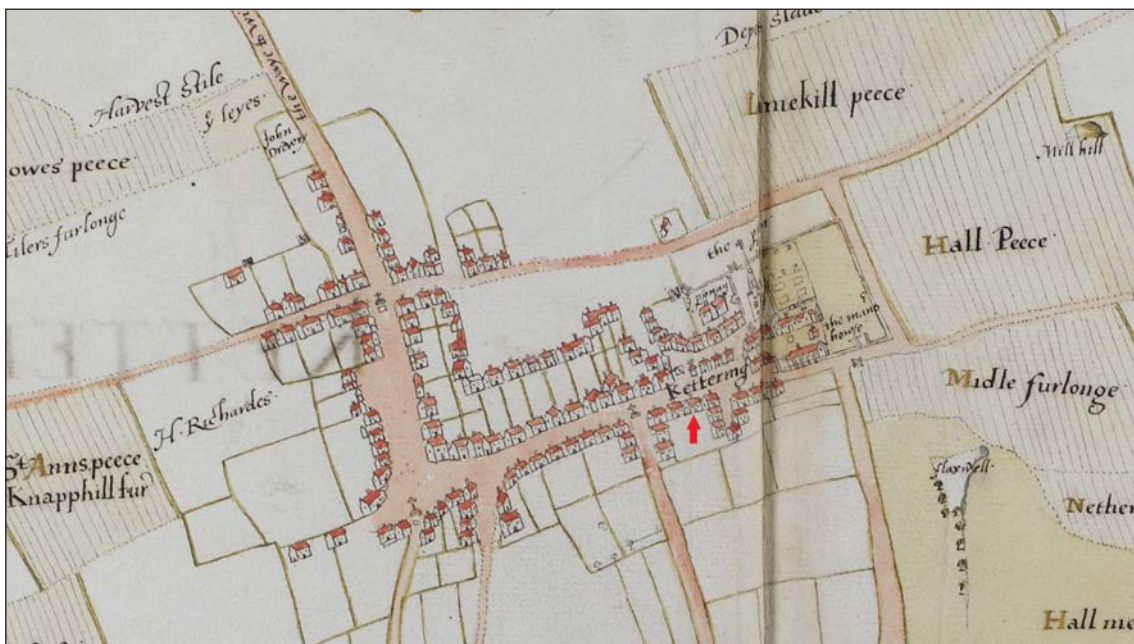
Figure 6: Finch Hatton map of Kettering, 1587. [Northamptonshire Archives FH272-7]. Approximate location of the Royal Hotel indicated by the red arrow.

The earliest available map of Kettering is the Finch Hatton map of 1587, which was produced as part of a survey of the 'Manor howse of Ketteringe [sic]' (Figure 6).³⁹ Although the map is illustrative in character, the principal landmarks such as St Peter and St Paul's Church and the manor house broadly correspond to their physical locations, and the street pattern is discernible against modern Ordnance Survey (OS) mapping.

The arrangement of buildings which make up Market Place broadly corresponds to later, more accurate maps of the area, though there are some key differences. Most notably, the Finch Hatton map depicts the row of houses which occupied the centre of Market Place until the late 18th century. This row of houses was known as Rotten Row and divided the sheep market from Butcher Row.⁴⁰ Butcher Row occupied the upper (eastern) half and the sheep market was located in the lower (western) half. The sheep market is preserved in the name of Sheep Street which led to it from the south; presumably this is where sheep were driven into the market. Rotten Row

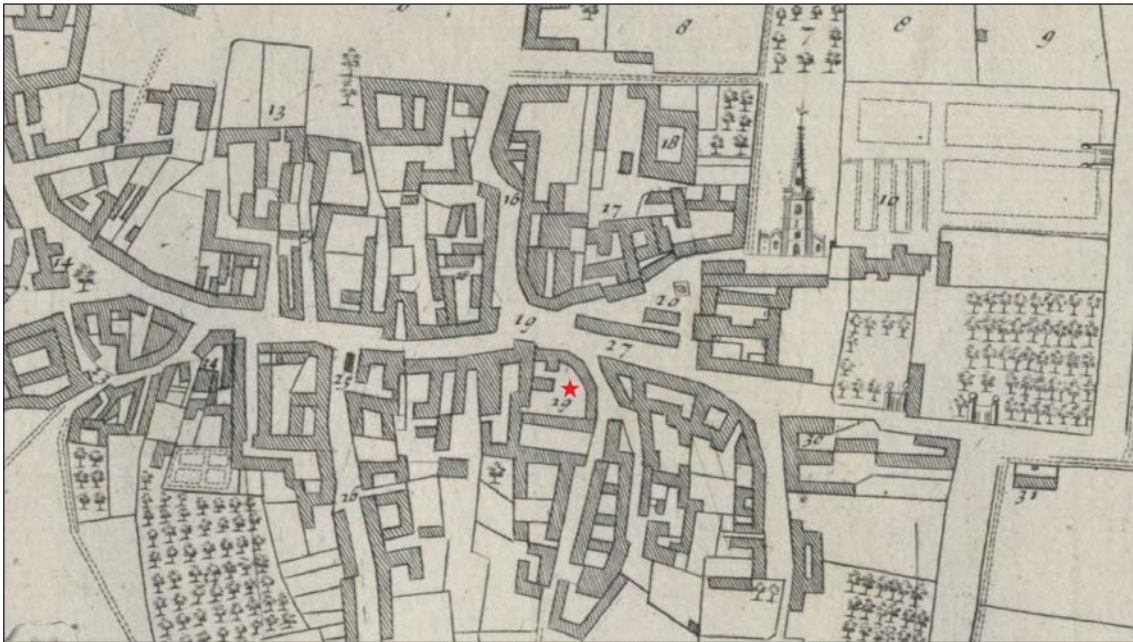
Figure 9: Detail from Thomas Eayre's Plan of the town of Kettering, 1791 [British Library BL01005013961]. No. 29 – White Hart Yard, indicated by a red marker.

The White Hart is again recorded on Thomas Eayre's Town Plan of Kettering, published in 1791 (Figure 9). This plan was clearly surveyed before the removal of Rotten Row in around 1789, as this is still depicted alongside the market hall building. It identifies plot number 29 as 'White Hart Yard' which incorporates all the buildings which front Market Place and which follow the line of the road into Nags Head Lane/West Street. This may indicate that these buildings are all within single ownership, albeit occupied by separate tenant shopkeepers as shown on the 1785 plan. The footprint of the building is not entirely dissimilar from the existing building. The building ranges depicted behind the main frontage are presumably stabling associated with the hotel.

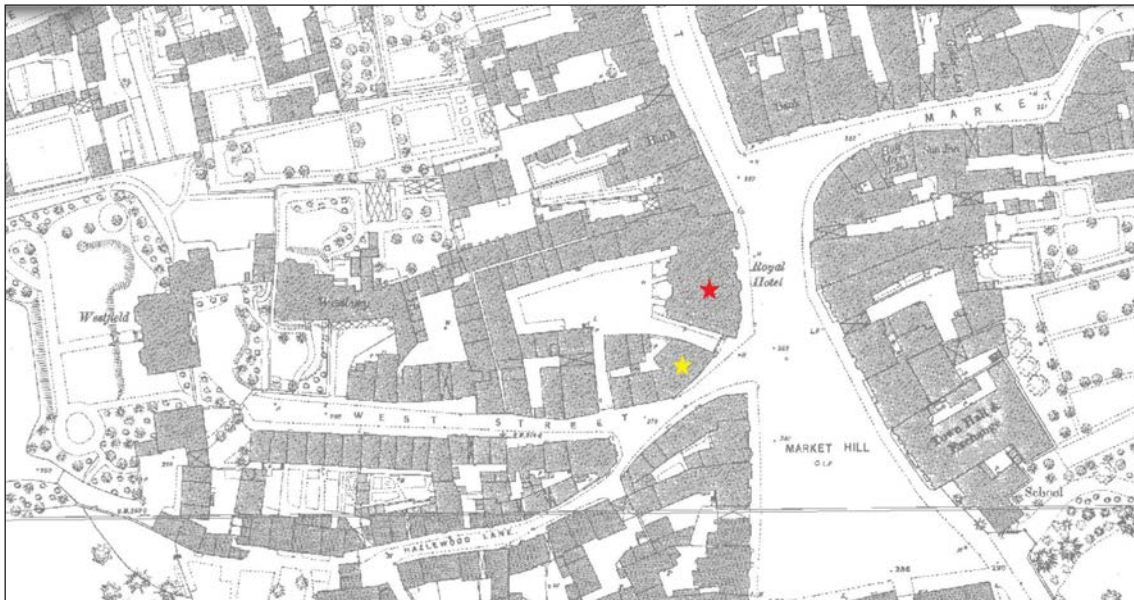
Figure 11: 1886 Town Plan of Kettering 1:500 scale (detail) [© and database right Crown Copyright and Landmark Information Group Ltd (All rights reserved 2022) Licence numbers 000394 and TP0024]. Red marker indicates the hotel, yellow marker relates to Mr Brewer's shop premises.

Smith's map of 1826 suggests that the extent to which the building was extended in 1878 is less than has previously been suggested.⁶¹ Comparison between the 1826 plan and the 1886 Town Plan of Kettering does not suggest substantial changes to the footprint of the building (Figure 11 and see Figure 10). The main changes seem to have been located in the courtyard where there appears to have been new stabling constructed. It also appears that the hotel was extended backwards from the corner fronting Market Place, perhaps adding the angled gable and the long room behind. This also presumably added the Neo-Jacobean front elevation, including the Dutch gables and covered porch. While the extent of any demolition of the older buildings cannot be established from the map record alone, it would appear that the 1878 works either re-fronted or rebuilt the hotel largely on its existing footprint.

It is noteworthy that at this date, part of the site now occupied by the Royal Hotel remained in use as a separate shop unit. Specifically the building fronting West Street (see Figure 11), which census records indicate was occupied by Mr Brewer, a fishmonger.⁶² The same census returns for 1881 records that at the time the Royal Hotel was occupied by its proprietor Thomas Richardson (53), along with his much younger wife Eliza (31), their five sons and one daughter. Other occupants of the hotel identified included a cook, a waiter, a housemaid, a chambermaid, a head nurse and under-nurse, and a parcel's boy.⁶³

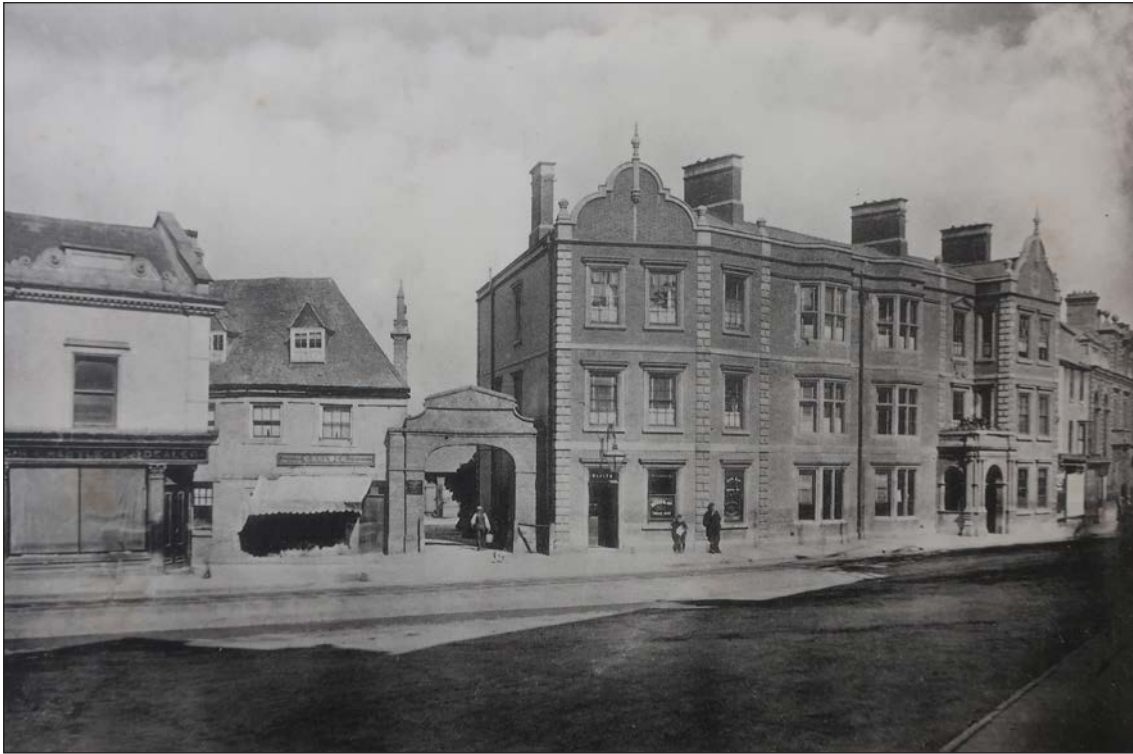
Figure 17: 1896 sales particulars, detail of the elevation to the Market Place, showing Mr Brewer's fishmonger's shop to the left-hand side of the archway. [Boughton House Archive, uncatalogued sales particulars. Used with kind permission of the Duke of Buccleuch and Queensberry KT]

The photographs which accompanied the plans show the only known image of Mr Brewer's shop (Figure 17). Although only partially visible, the shop, which was rendered with a steeply pitched roof, appears to be stylistically earlier in date than the hotel, and possibly represented an 18th century building. No images were provided of the stables but given the extent to which these were rebuilt so soon after the sale, it is possible that they too were remnants of the earlier hotel. This is, however, purely speculative.

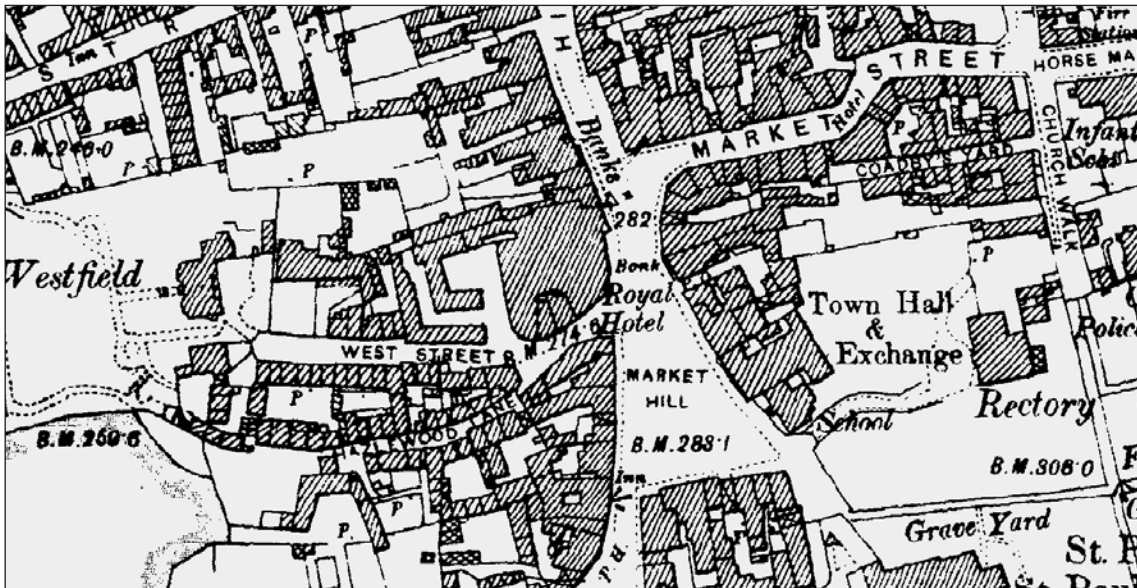
Figure 18: 1900 1:2,500 scale OS mapping (surveyed 1899). [© and database right Crown Copyright and Landmark Information Group Ltd (All rights reserved 2022) Licence numbers 000394 and TP0024].

Soon after the sale, the new owners started extensive works to extend the hotel and stables. This demolished Mr Brewer's shop and extended the hotel around the corner onto West Street. This is shown on the 1900 OS map of Kettering which was surveyed in 1899 (Figure 18).

By the time of the 1900 OS map (surveyed 1899), the hotel is shown to have been extended and the stables to the rear have been altered to include a further range of buildings to the west of the older stable ranges (*see* Figure 18). The hotel extensions occupied the former site of Mr Brewer's shop and the former carriage entrance to the stables. No more detailed plans have been found, so broad conclusions can only be drawn from the map record. It would appear that the extensions included the addition of the former billiard room (now restaurant) and what is now the conference room at the rear of the building.

The existing brick-built stable ranges were added to the hotel after the sale to Phipps Brewery in 1896. As evidenced by the map record, it seems that Phipps bought additional land to the west in order for them to extend the western wing of the stables. This range is two storeys in height when viewed from inside the courtyard, but when viewed from outside of the site it become clear how much the building had to be built up to compensate for the change in ground level (*see* Figures 51 - 54). At this time the earlier L-shaped 1878 stable block was retained inside the courtyard. An entry in the *Stamford Mercury* records that in June 1899 'the tender of Mr W J Payne of Kettering has been accepted for the new stables at the Royal Hotel.'⁸⁵ Construction must have commenced very soon after this, as the new building is recorded on the 1900 OS map (*see* Figure 18).

Examination of the fabric of the stables was, as discussed above, limited by lack of safe access to the building. However the evidence of alterations to existing openings indicates that the building was adapted after its construction. In addition, examination of the 1900 OS map (*see* Figure 18) would suggest that before the demolition of the earlier stable block in the centre of the courtyard, there would simply not be enough space to accommodate the early motorcars. The reference to W J Paynes tender for 'new stables' in 1899 rather than for 'motor stabling' also strongly suggests that this building was intended for stabling for horses.⁹³

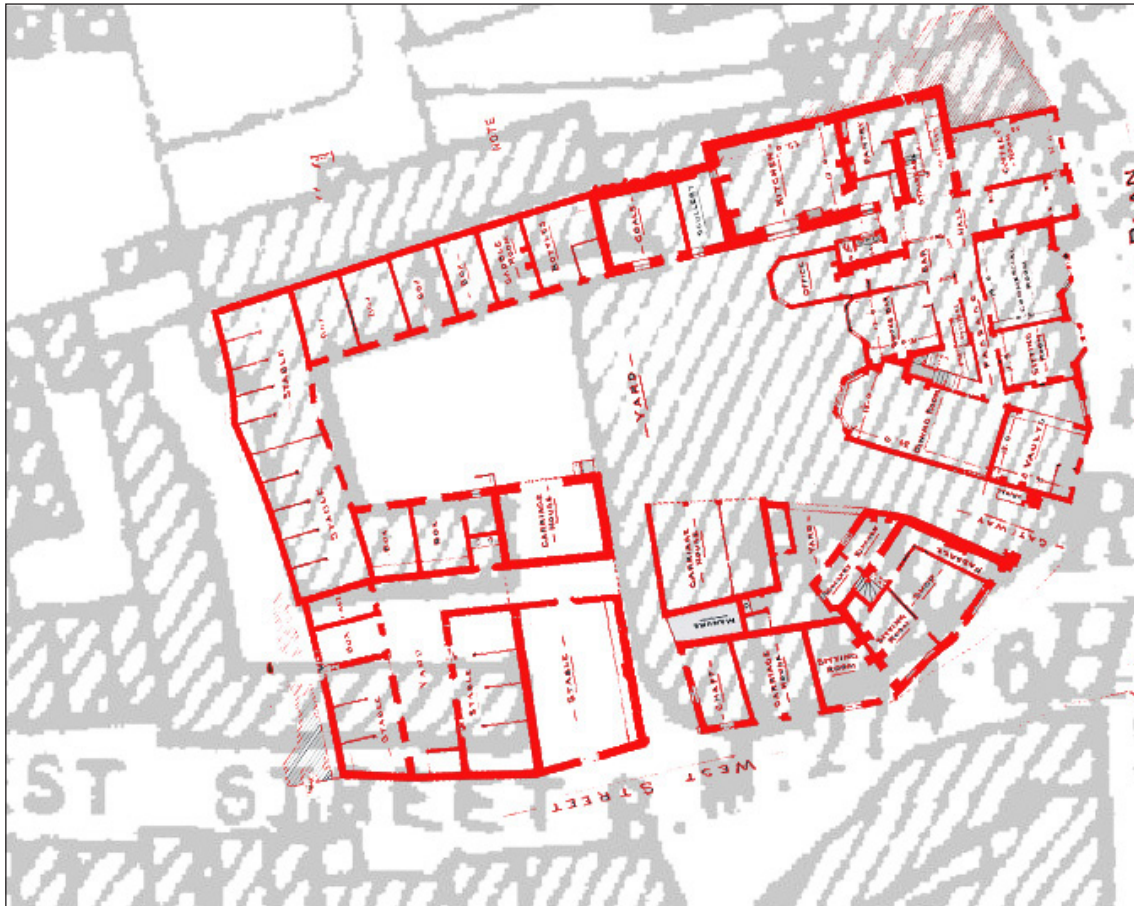
Figure 19: 1896 plan overlain onto 1900 1:2500 scale OS mapping, showing the new stable block added c. 1898 to the west of the site [© and database right Crown Copyright and Landmark Information Group Ltd (All rights reserved 2022) Licence numbers 000394 and TP0024]. Note, not to scale.

Comparison of the 1896 sales plan and the 1900 OS map, shows the extent of the changes to the rear of the hotel (Figure 19). Much of the old yard had been filled in by the addition of the billiard room and conference room at the back of the hotel. Mr Brewer's shop had been demolished, along with the stable block fronting onto West Street and the carriage house behind to accommodate the new wing of the hotel. Part of the stable ranges, albeit minus the old carriage house, remained in place at this date in the centre of the courtyard.

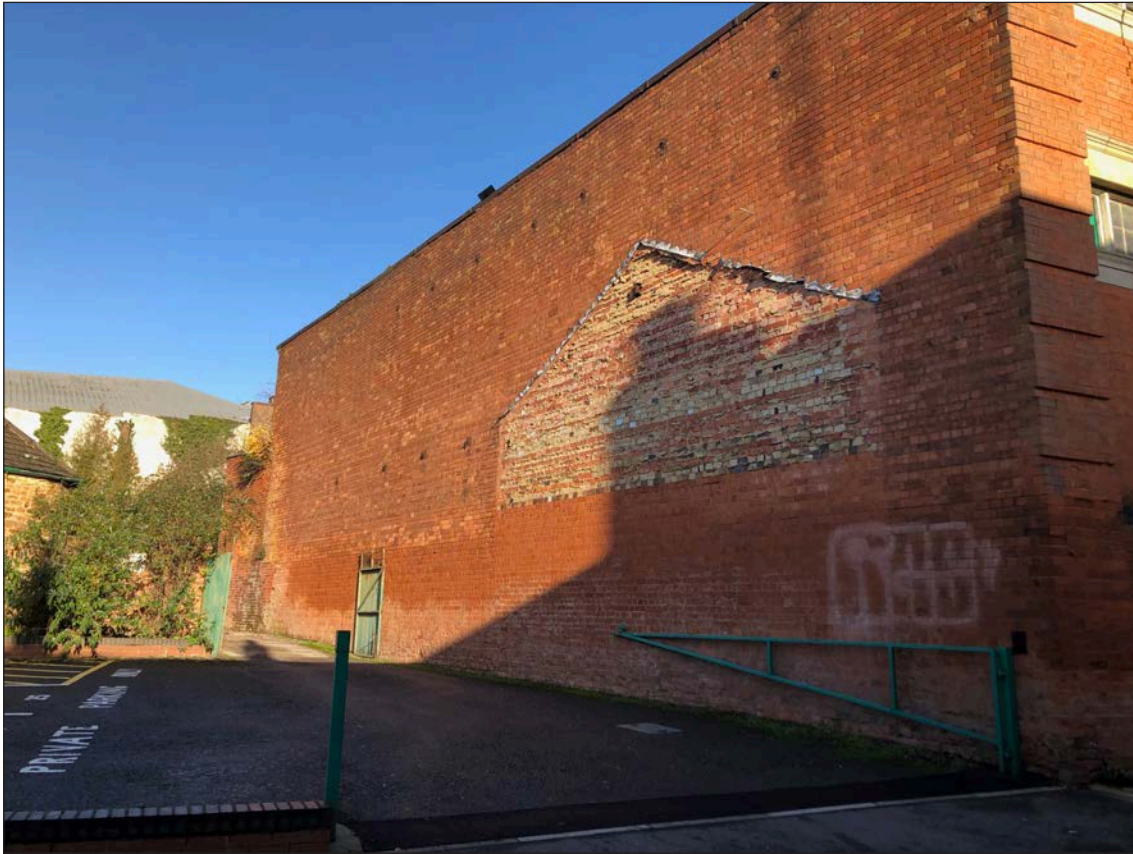
Figure 20: Scar from demolished building on the western elevation of the existing stable block, Dec. 2019
[© Historic England, Hannah Good]

A stable block had been added to the site adjacent to the older L-shaped stable block. It was constructed onto land previously occupied by stalls and stables belonging to the hotel (south range), but also a collection of smaller buildings which are shown on earlier maps to have been previously outside of the hotel's plot (west range). This suggests that Phipps & Co. had purchased additional land to the west and had replaced the buildings on that site in order to building the existing stable block. This new block was abutted by a range of buildings on its western elevation and this corresponds to the building scar still visible on this elevation today (Figure 20).

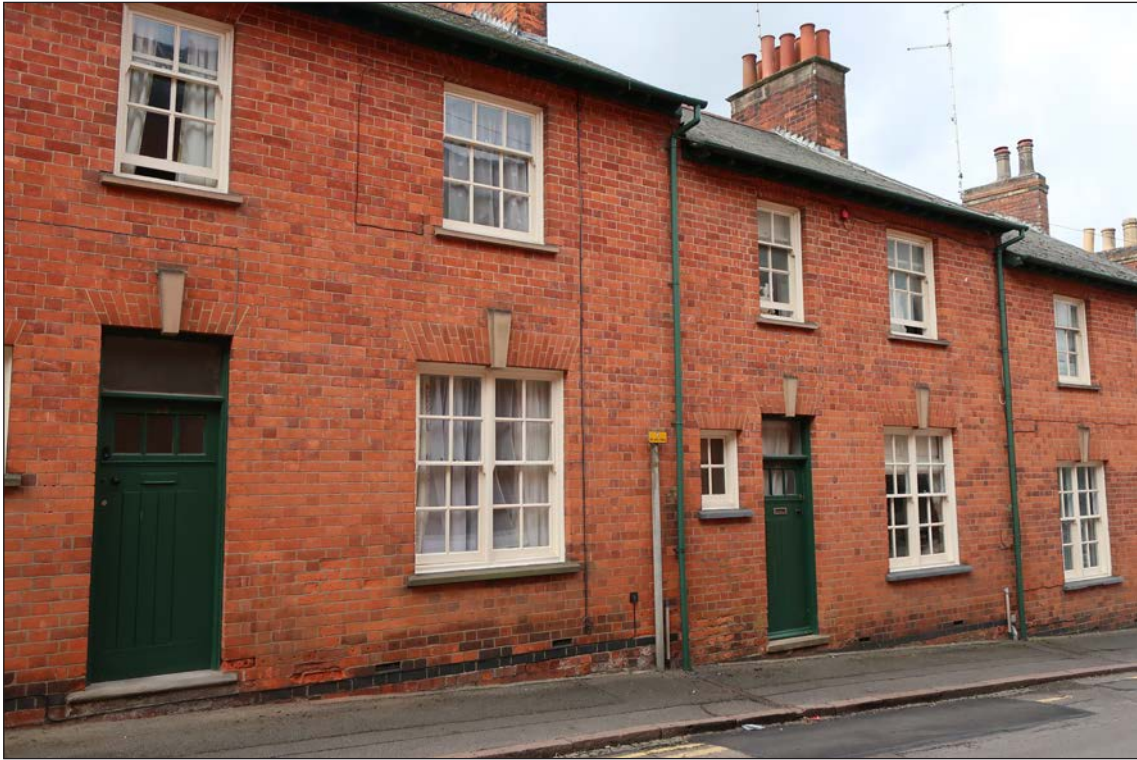
Figure 21: Numbers 23-25 West Street [© Historic England, Aimee Henderson]

It is clear from the 1900 OS map that the demolition of the old stable ranges and Mr Brewer's shop allowed for West Street to be widened and improved from the narrow lane seen on earlier mapping. Examination of the houses opposite the existing stable block reveals the bricks on the front elevations of numbers 23-25 West Street appear to be of similar size, colour, date and brick bond to those on the stable range (Figure 21). Sills and keystones are also made from the same pale coloured stone used on the stable block. This could indicate that these buildings were re-fronted at around the same date as the new stable range was being built, perhaps as part of wider improvements to the street.

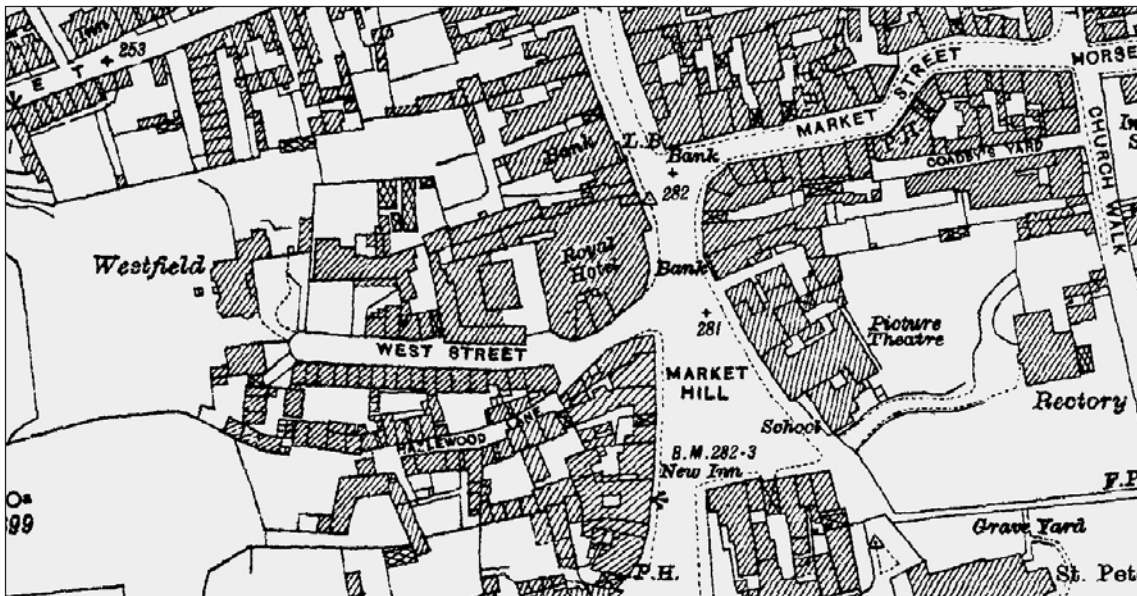
Figure 22: 1926 OS map of Kettering revised 1924 OS 25in (detail) [© and database right Crown Copyright and Landmark Information Group Ltd (All rights reserved 2022) Licence numbers 000394 and TP0024].

By the time of the 1926 OS map (surveyed 1924), further demolition had taken place to the rear of the hotel (Figure 22). The older L-shaped stable block had been removed and replaced with a rectangular building in the centre of the yard. This was seemingly attached to the existing c. 1898 stable block by an open-sided, roofed structure. This is illustrated more clearly on an image of Market Place taken in 1952 (Figures 23 and 24) which shows these buildings behind the hotel.

The addition of the glazed roof structure necessitated the removal of the older, smaller range of stable buildings which remained from before the 1896 sale. This, it seems, was replaced with a small building in the centre of the courtyard, which is shown on OS maps from 1926 (*see* Figure 22). The glazed roof is somewhat strange in that its design incorporated a single skin brick wall at first-floor level, supported on what appears from ground level to be an iron or steel girder, which links the roof to the eastern elevation of the west stable block.

It is almost certain then, that the stables were added by Phipp's Brewery by 1899, but then were very quickly converted for use for motorcars. This had clearly taken place by the publication of the 1926 OS map (*see* Figure 22), and perhaps before 1909, when adverts for the Royal Hotel's garaging began to appear.⁹⁴

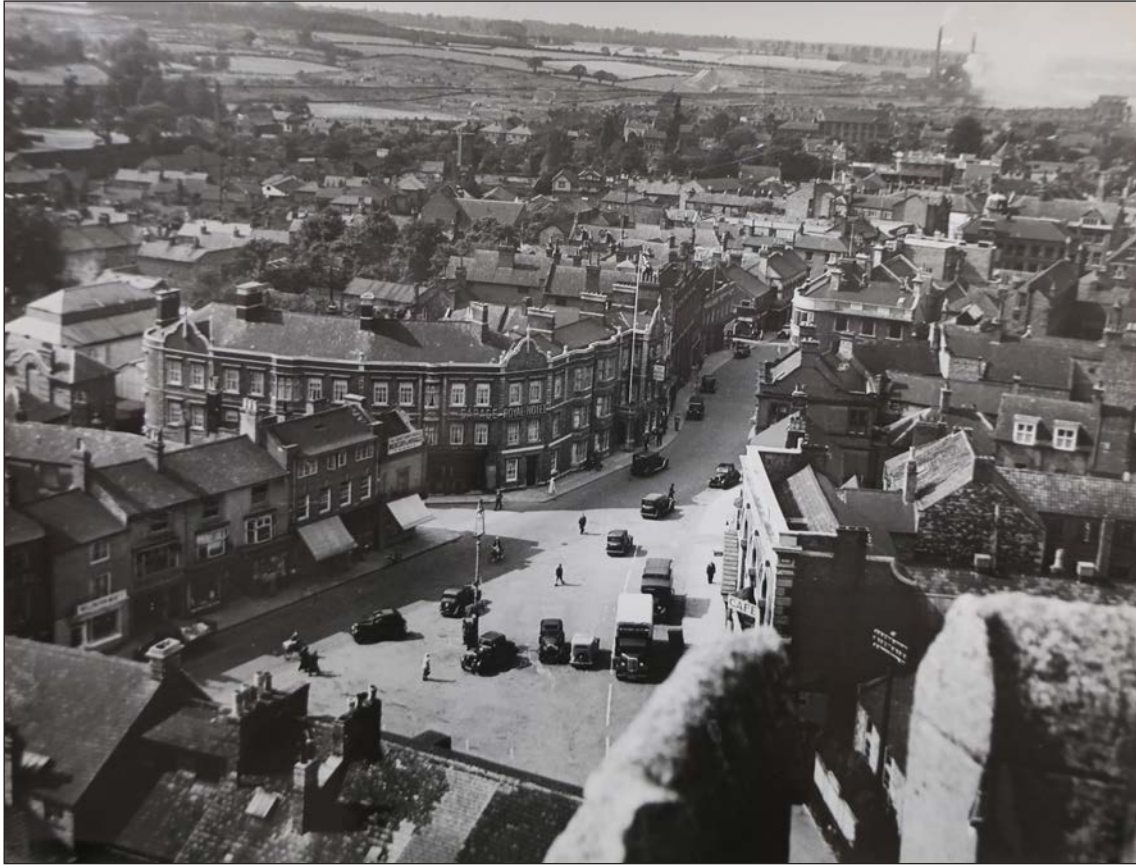
Figure 23: Market Place and the Royal Hotel (c. 1952). [Northamptonshire Record Office ACC-1972-218-P-6172]

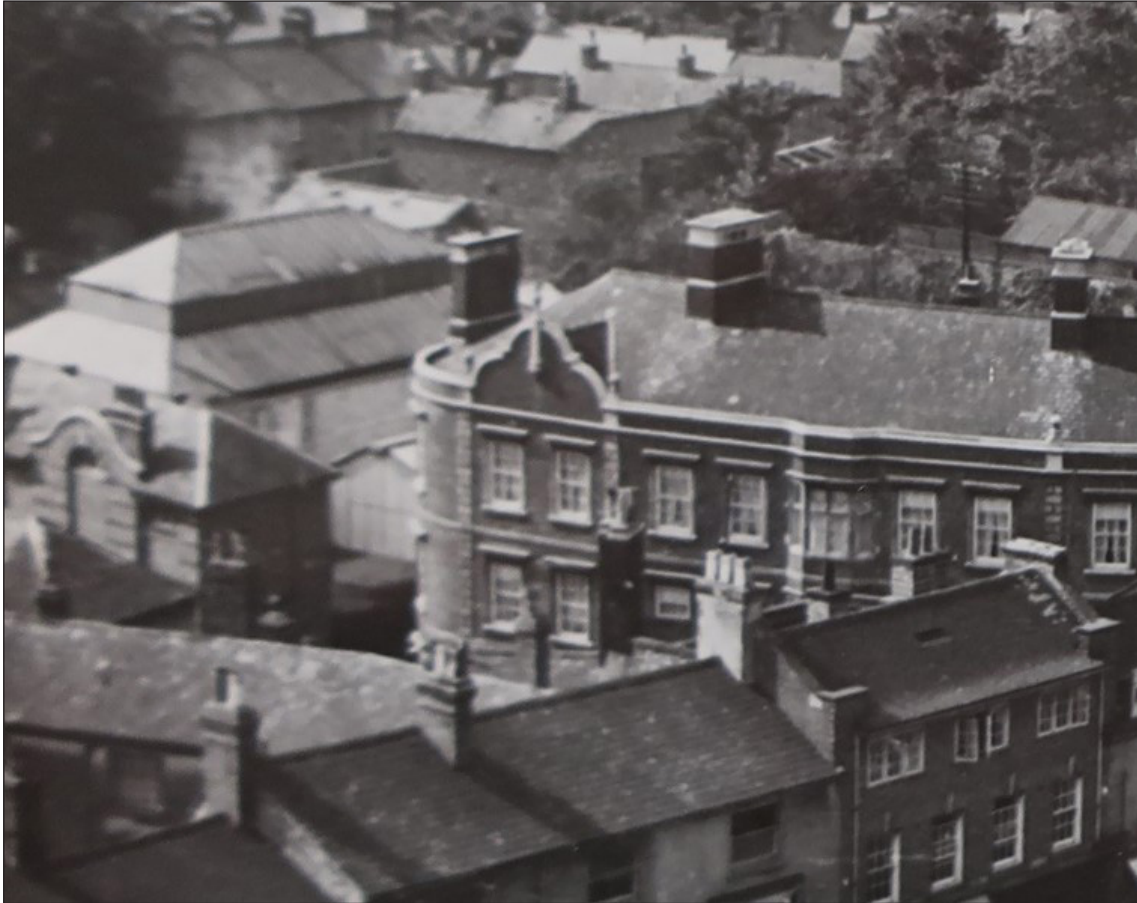
Figure 24: Detail showing metal roofed buildings to the rear of the Royal Hotel viewed from the tower of the Church of St Peter and St Paul (c. 1952). [Northamptonshire Record Office ACC-1972-218-P-6172]

These metal roofed structures were likely added to create garaging at the rear of the hotel and marked a shift from horses to cars as the primary mode of transport for visitors and guests. It is notable that the hotel was being advertised by the RAC for its good provision of garaging from as early as 1913.⁷³

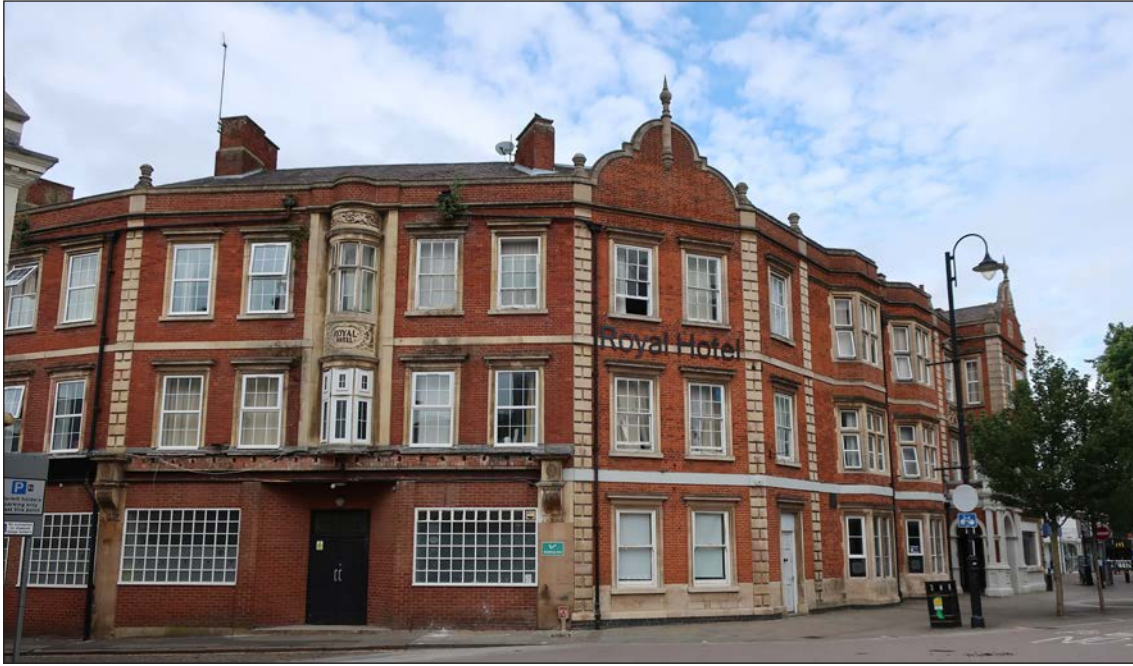
Figure 26: Location of lost shopfront (now nightclub entrance), replaced with multi-paned windows and recessed entrance door post-1982 [© Historic England, Aimee Henderson]

A further alteration took place sometime after 1982, when the ornate late 19th-century shopfront was removed from the West Street elevation to allow the creation of a nightclub in the ground floor and cellar of the hotel (Figure 26). A small fraction of the stained glass of this shopfront has been preserved, albeit in an altered state in the existing bar area.

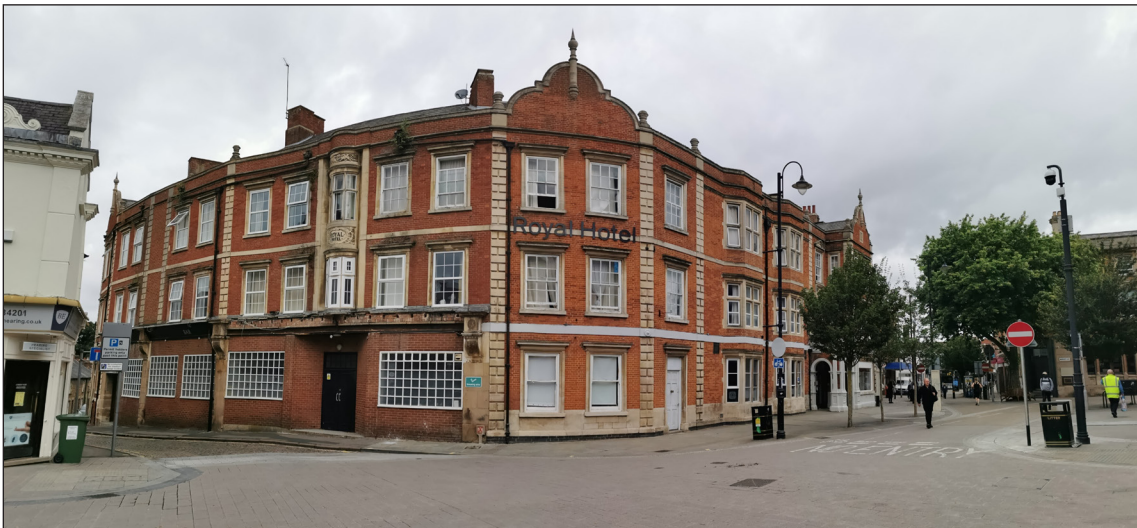
Figure 27: The Royal Hotel [© Historic England, Aimee Henderson]

The main hotel building was constructed in multiple phases, and has undergone substantial extensions since its construction, particularly to the side and rear. The earliest externally visible phase of the existing building dates from 1878, as identified by a date stone on the northernmost gable. Internally, inspection of the built fabric suggests the remains of an earlier building is preserved within the 1878 building.

More recently modern uPVC windows have been inserted into the West Street elevation, including in the lower portion of the oriel window.

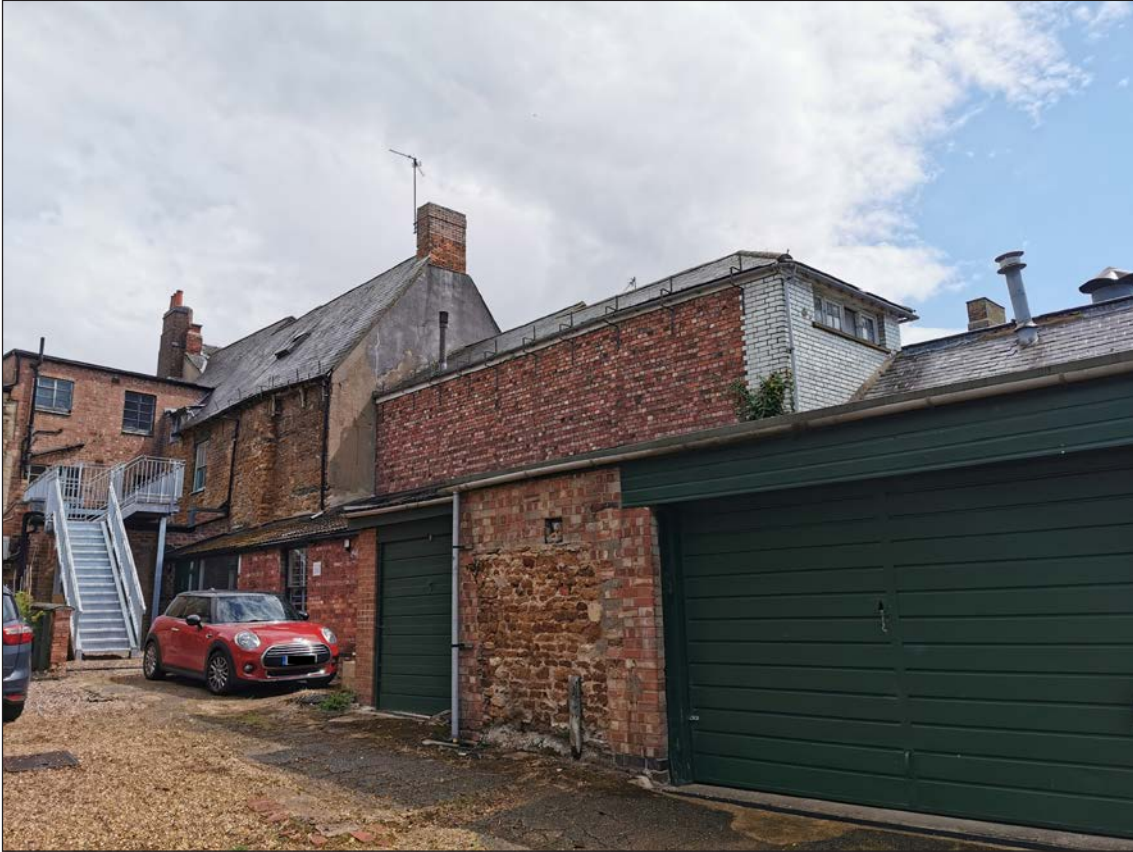
Figure 28: North elevation as seen from the courtyard of numbers 1-7 High Street [© Historic England, Aimee Henderson]

Externally, when viewed from the private courtyard to the rear of numbers 1-7 High Street, the northern elevation of the hotel is partially visible (Figure 28). The three-storey former service range is constructed from ironstone rubble, with some visible timber beams. This extends as far as the former kitchen, which contained a fireplace (that subsequently has been broken out into a pair of double doors). This fireplace would have been serviced by the chimney which remains in place on the gable end of the three-storey section.

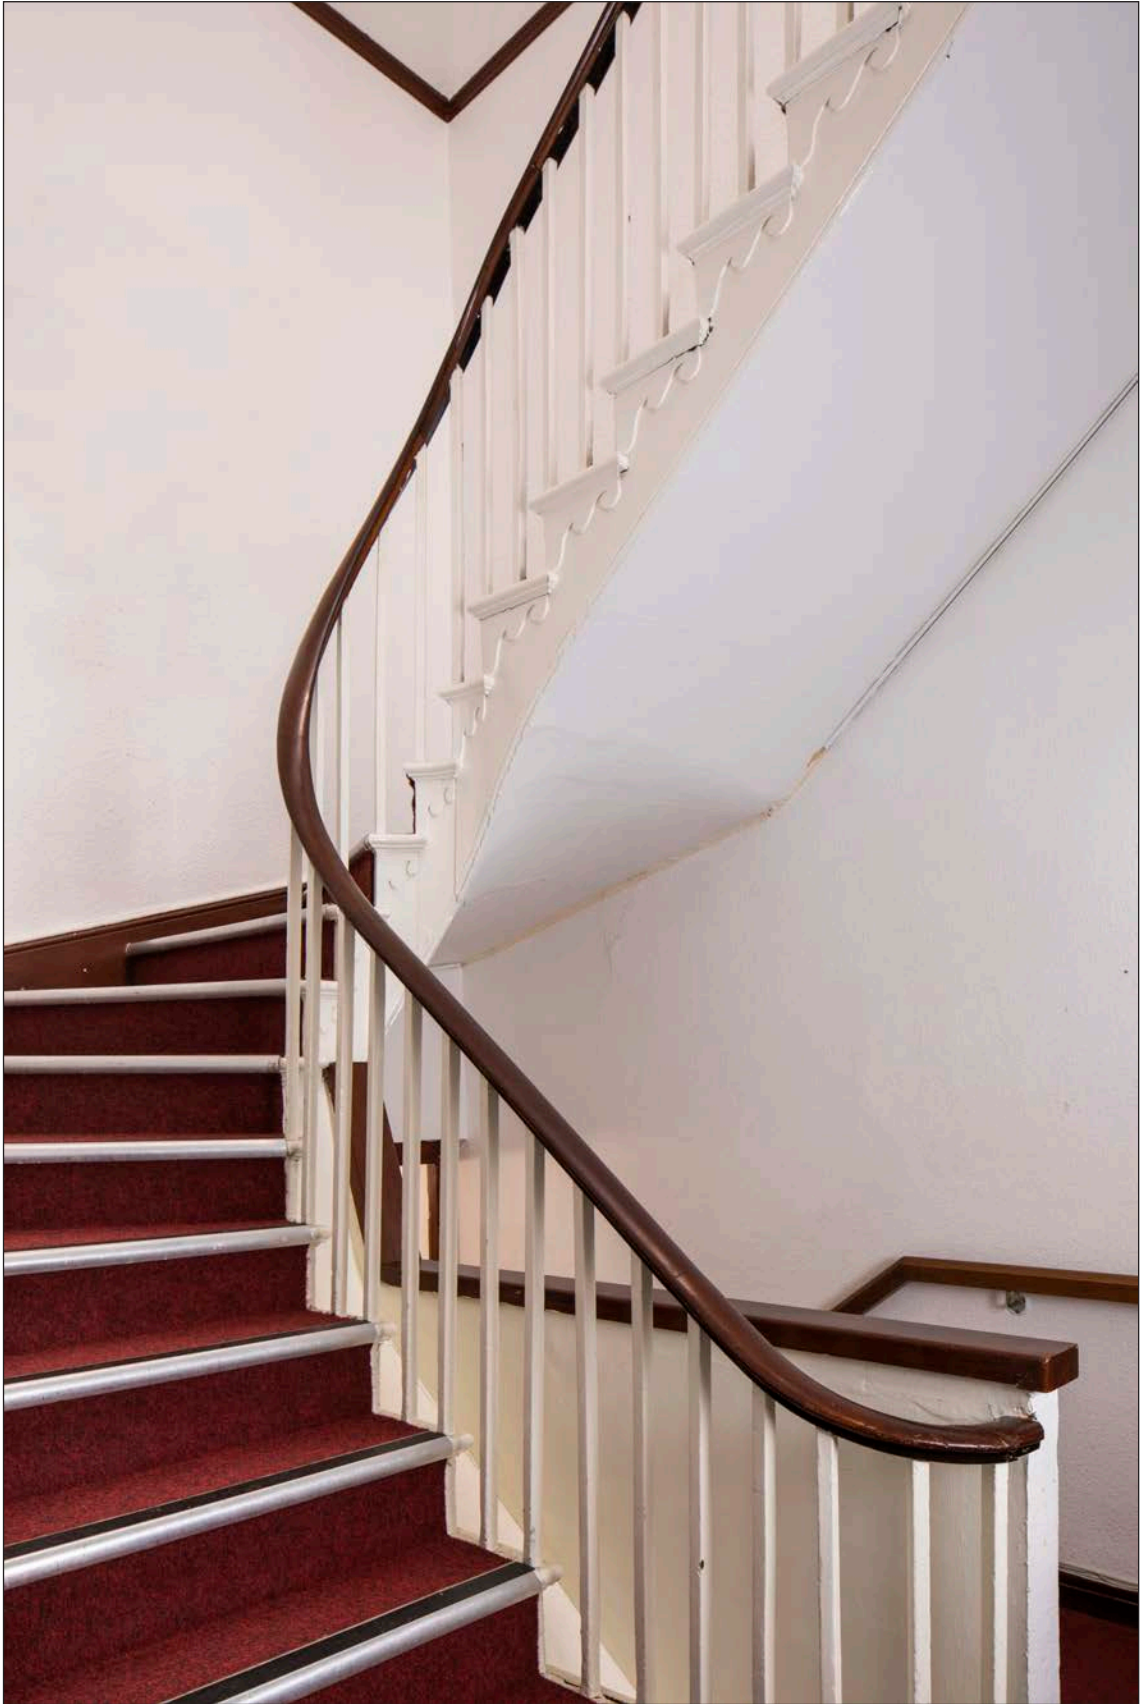
Figure 29: North staircase [DP311984]

Other than the stone walling, very little visible evidence of this earlier phase of the building survives. With one exception. The northern staircase of the hotel, where it runs from first- to second-floor level, is clearly earlier in date than other internal fixtures and fittings (Figures 29 and 30). It should be noted that the staircase has been truncated and altered to meet a much later solid handrail which leads from the first to the ground floor.

The staircase is of modest design but is well executed, particularly in the mahogany handrail which has been carefully carved and fitted together. The handrail is damaged at its lowest end, where it terminates and meets the later handrail. Presumably in its original form the staircase continued down to ground floor level, where it may have originally terminated in what is known as a curtail step; where the handrail turns around on itself to end in a spiral. This arrangement is suggested by the 1896 plans.

The assumed date of this staircase is significantly earlier than the date of 1878, which is given on the datestone on the exterior of this section of the building but is too late to be associated with the suggested earliest iteration of the building around the mid-18th century. Therefore, it is most likely to be a remnant of the alterations which took place between the 1785 and 1826 plans of Kettering, when the building was still known as the White Hart. By the time of the 1878 reordering of the building, this area was given over to services and housing for the proprietor and staff, which is likely why this earlier staircase was not replaced.

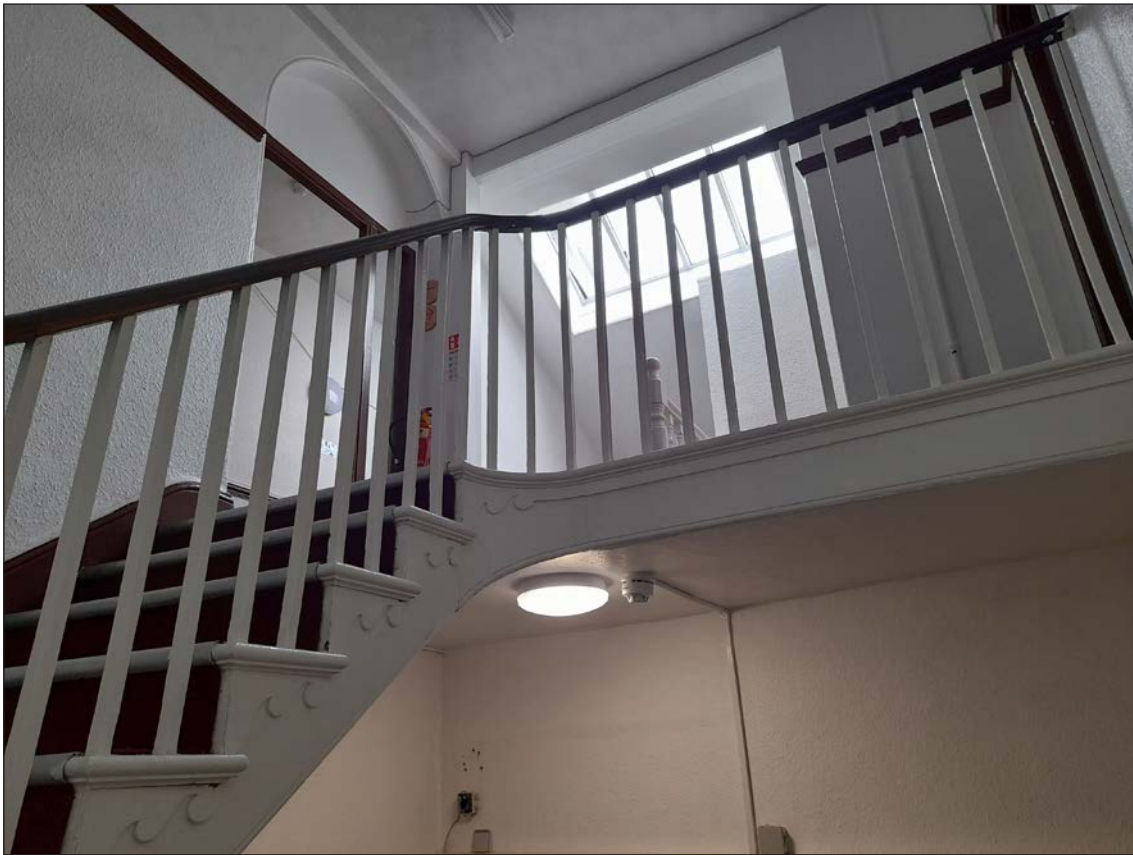
Figure 30: North stair, second-floor landing when viewed from below [© Historic England, Aimee Henderson]
