The Royal Hotel, Kettering: Historic Building Assessment

Research Report Series 01-2021

**THE ROYAL HOTEL
MARKET PLACE, KETTERING
NORTHAMPTONSHIRE**

Historic Building Assessment

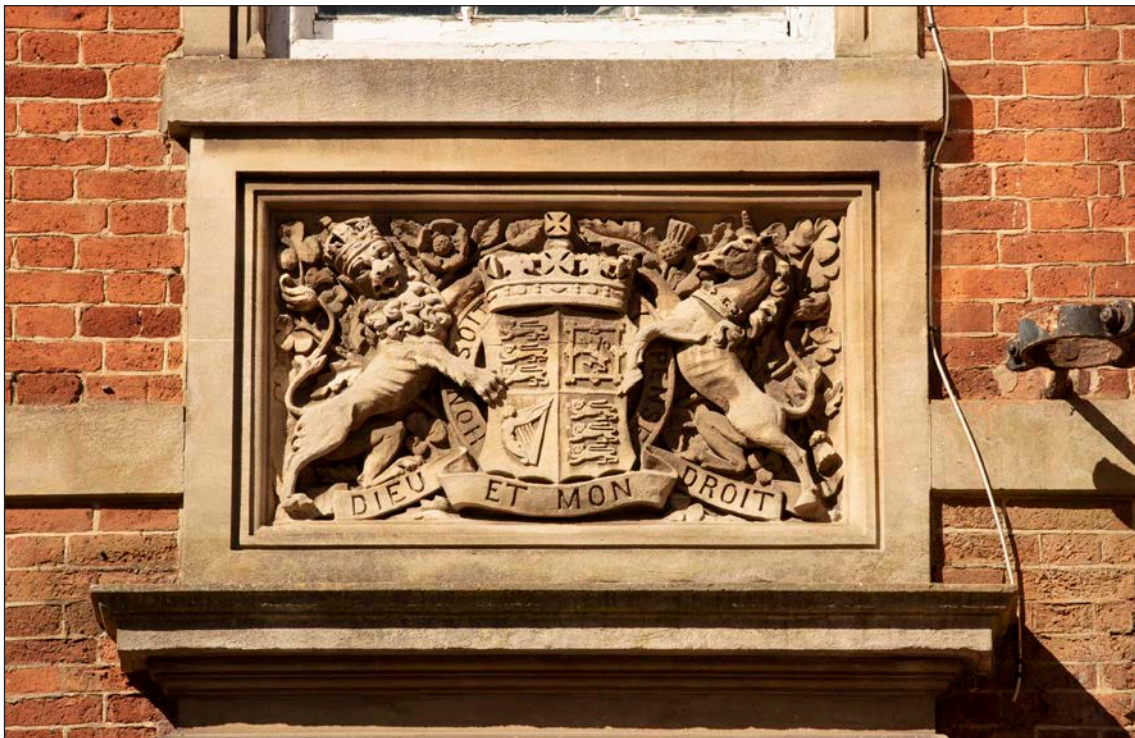
Figure 31: Carved coat of arms above the entrance porch [DP300772]

The date of the alteration is preserved in a date stone on the northern gable of the hotel (see Figure 4). A further relief stone carving above the porch bears the royal coat of arms of the United Kingdom, a reference to the name of the hotel (Figure 31). The porch is executed with paired ionic pilasters on each corner with round arches in between. The pilasters support a simple entablature with plain frieze and dentil cornice. The roofs are pitched and are set slightly back behind parapets to reduce their visibility from ground level.

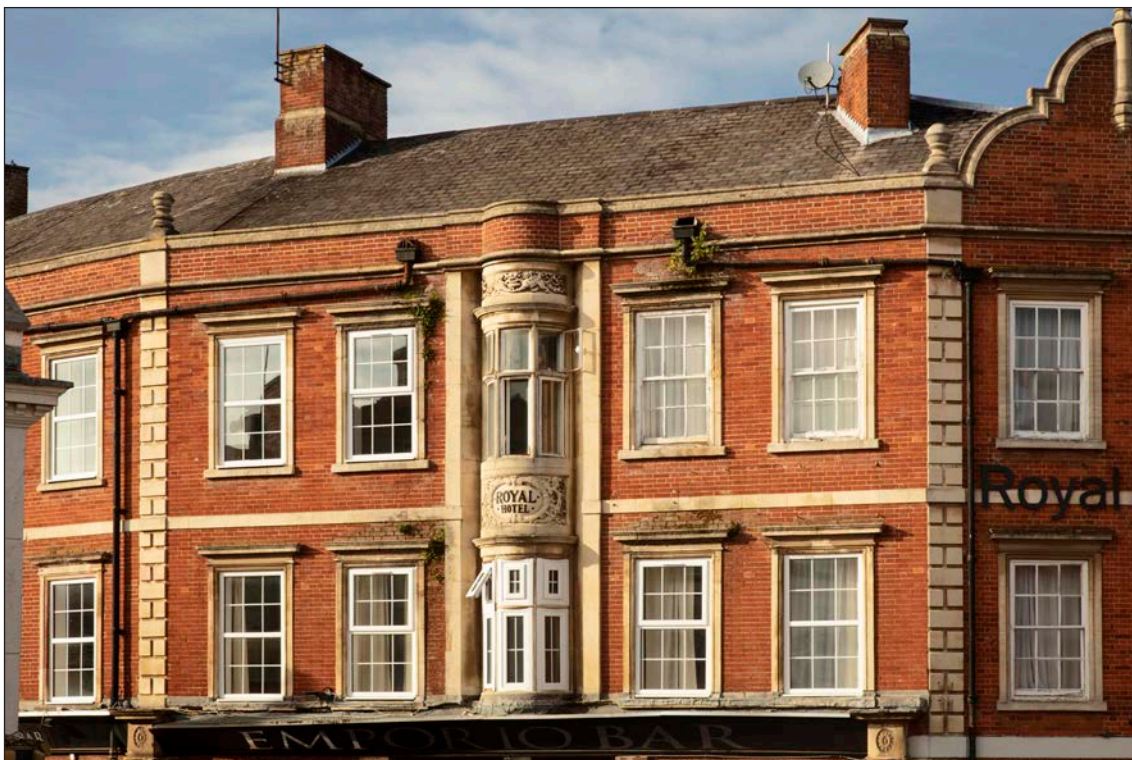
Figure 33: Oriel window on the west street elevation [DP300995]

More recently modern uPVC windows have been inserted into the West Street elevation, including in the lower portion of the oriel window.

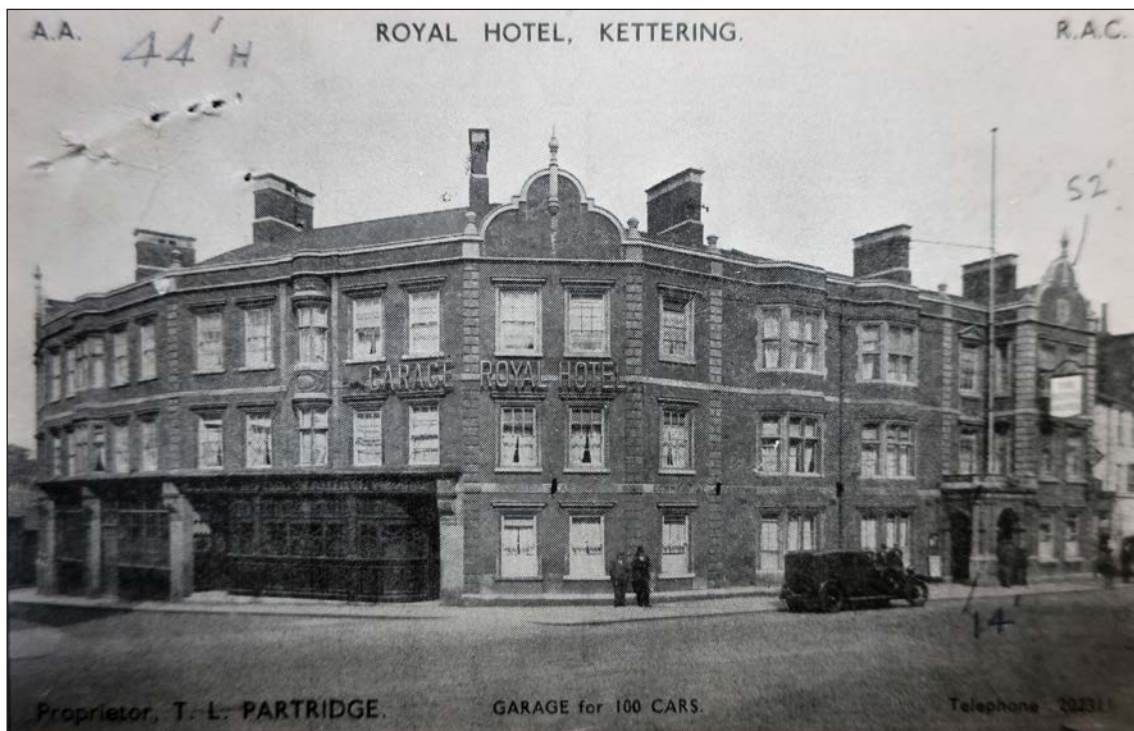
Figure 34: RAC Postcard showing The Royal Hotel, 1913. [Northamptonshire Record Office, Phipps Brewery Photos/1913]

Historic images indicate that the shopfront had a tiled stallriser and bow-fronted, stained glass windows (Figures 34 and 35). A recessed entrance door provided access to 'the vaults' without having to go through the main hotel building. Stone pilasters with moulded corbels to either side of the timber shopfront supported a painted fascia giving the name of the hotel, 'the vaults' and in later images, this carried the branding for 'Phipps Ales'. It appears the shopfront continued further along the elevation to West Street, with simpler, multi-paned windows and the same tiled stallrisers. Since the shopfront was removed, only the stone corbels and pilasters remain.

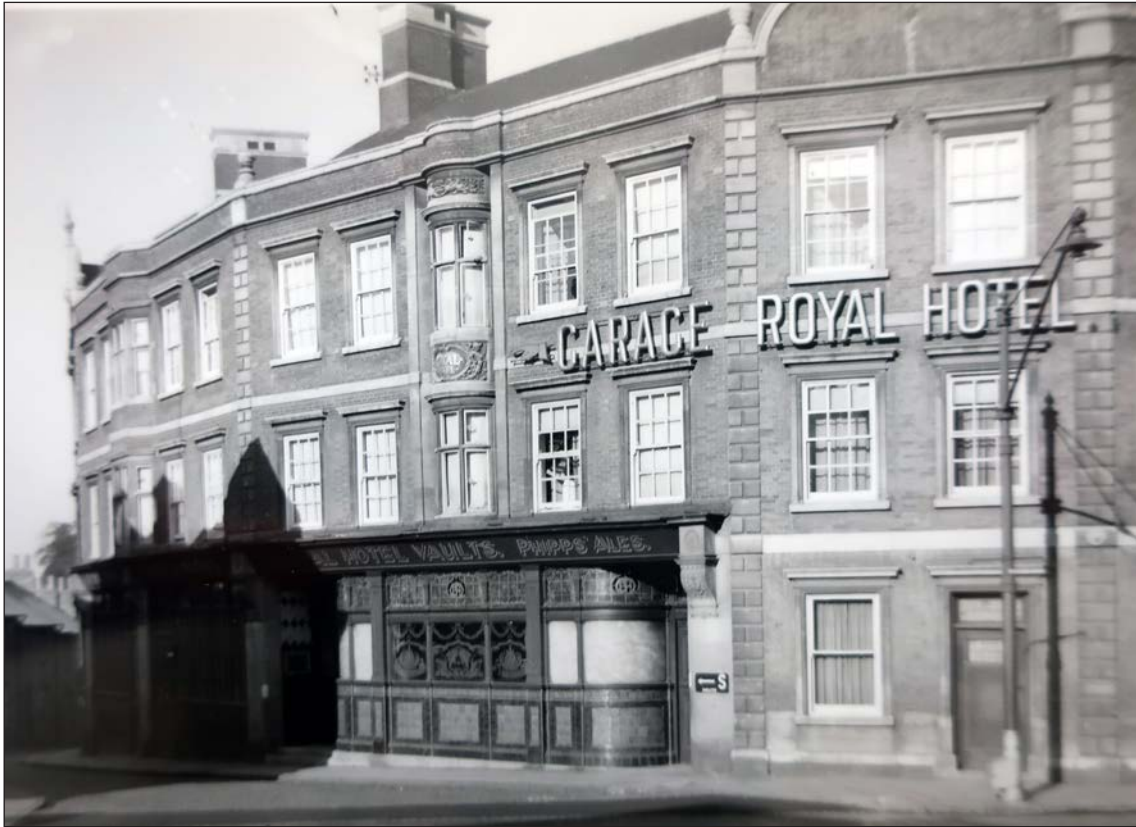
Figure 35: Photograph of c. 1940 showing the former shopfront. Note the blocked side windows compared to the 1913 image above. Note also the alteration of the ground floor window in the gabled bay into a door by 1940. [Northamptonshire Record Office, Phipps Brewery Photos/364-372]

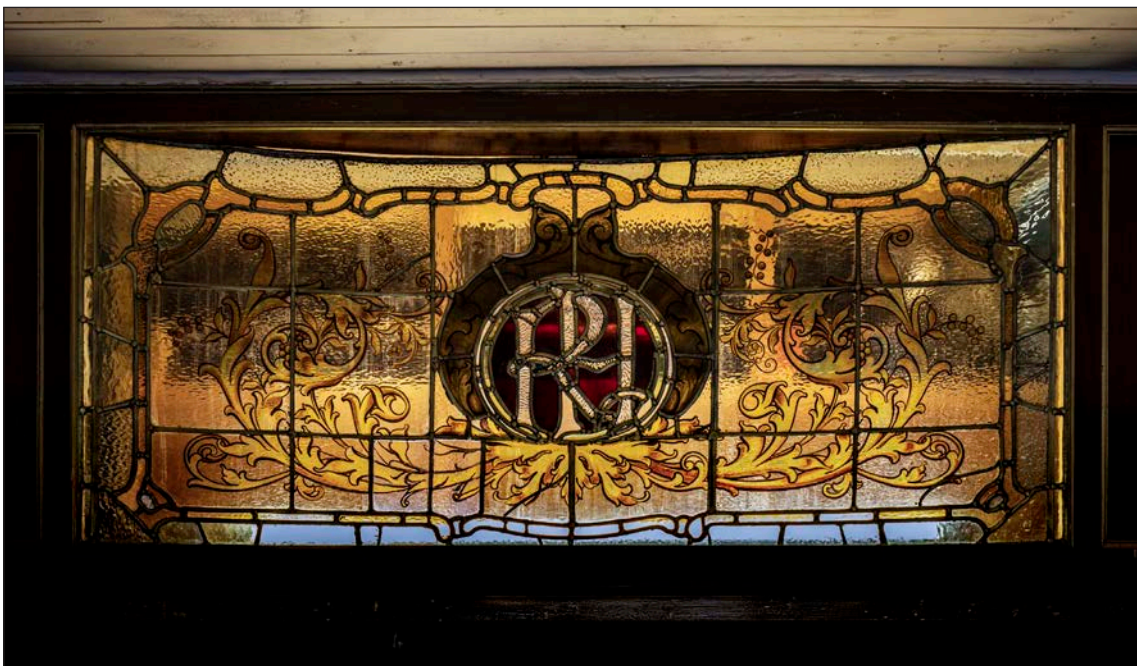
Figure 37: Salvaged stained glass, note the monogram has been reversed from its original position. Some sections of painted glass have been lost. [DP311979]

The existing bar area itself is fitted out with a late 20th-century bar. However, it does incorporate two fragments of the old external shopfront. These have been altered to reverse the RH monogram so that it is inward facing. The windows have lost some sections of painted glass and have also been fixed with extra lead comes to repair broken sections.

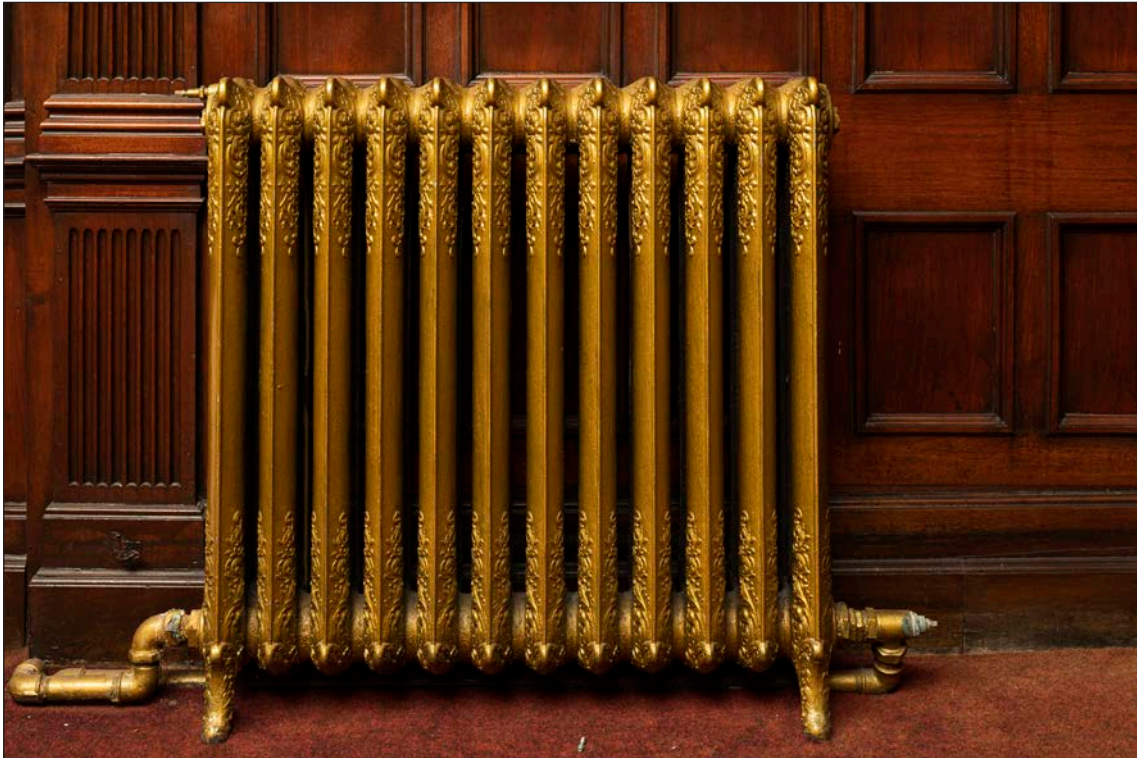
Figure 38: Cast iron 'Beeston Decorated' radiator, example from the restaurant, [DP311973]

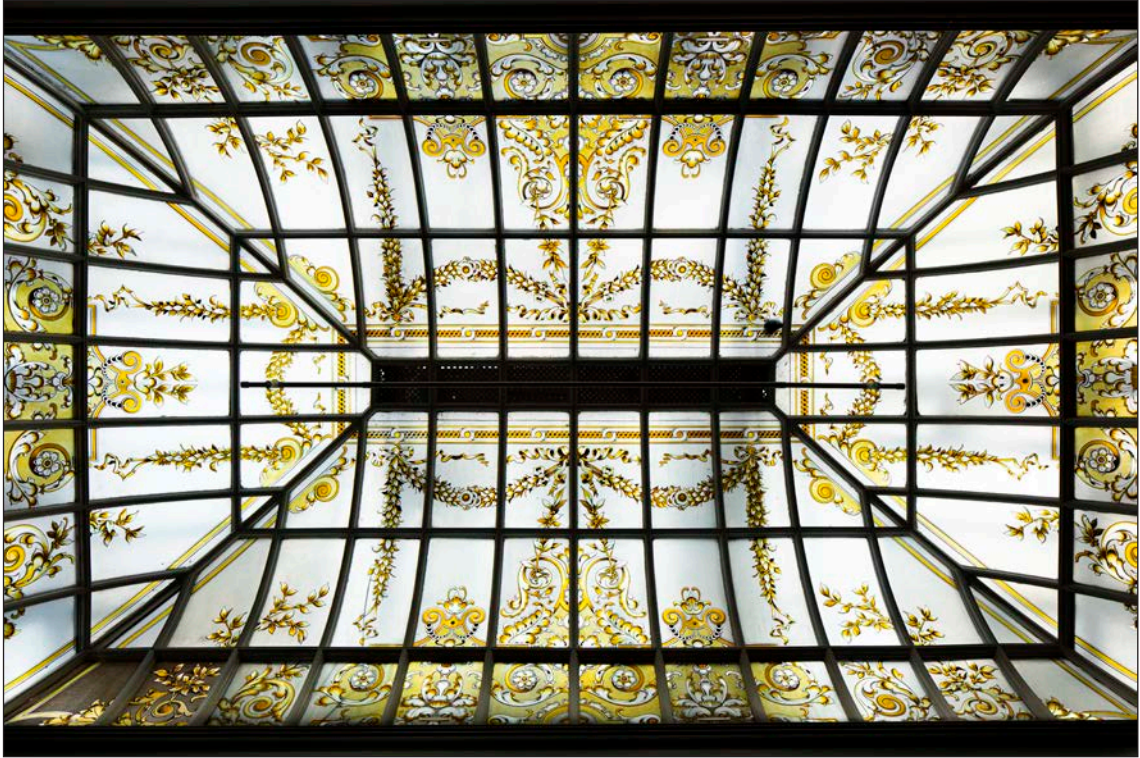
Figure 41: Glazed roof above the restaurant [DP311850]

The former billiard room, which now functions as the hotel's main restaurant area, features a striking, vaulted glass ceiling lantern (Figure 41). The glazing on the lantern is transfer printed rather than painted glass as is seen on the glazing salvaged from the shopfront. Externally the glazed lantern has been enclosed within a later roof to prevent rainwater leaking into the interior.

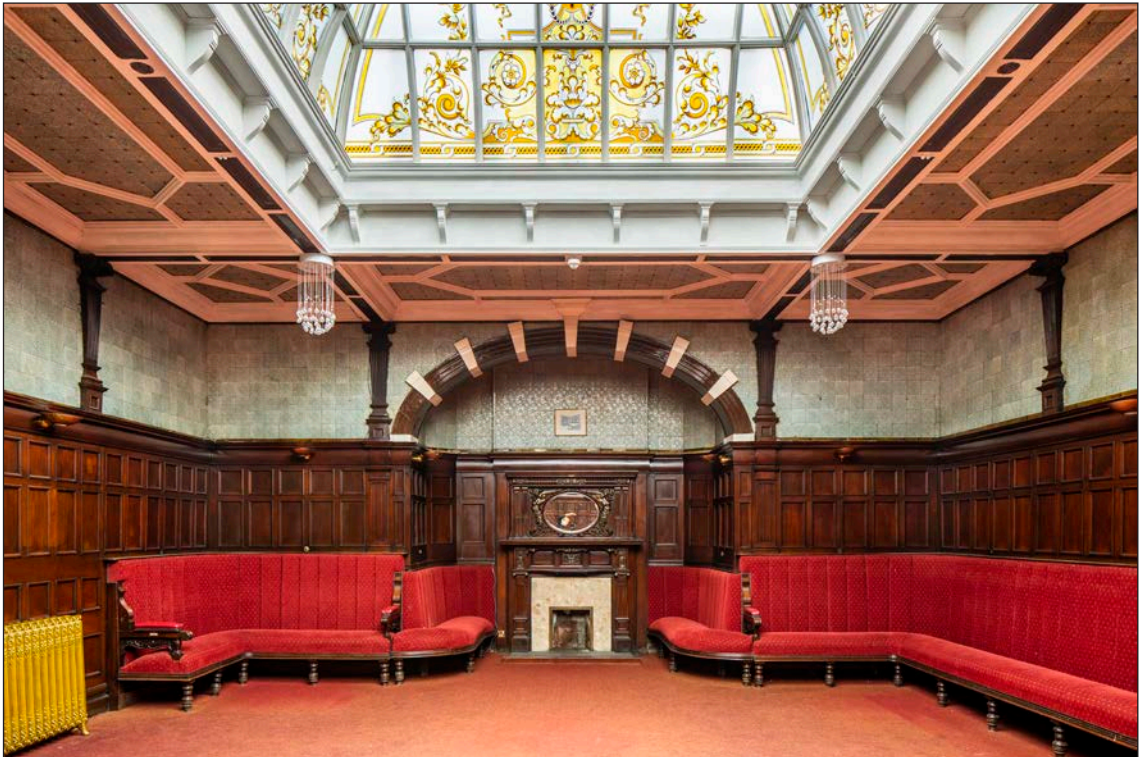
Figure 42: Restaurant (former billiard room) [DP311846]

The restaurant is also notable as it contains a nearly complete fit out by Birmingham bar fitters, Gaskell and Chambers (Figures 42-45). Gaskell and Chambers were probably the largest firm of bar fitters operating during the late 19th century. Unfortunately, their Birmingham premises were destroyed in the Second World War and most of their early records were lost, so specific records relating to the Royal Hotel have not been found. Gaskell and Chambers may also have been responsible for the lost shopfront, as this shared design elements such as tiling with the interior fit out.

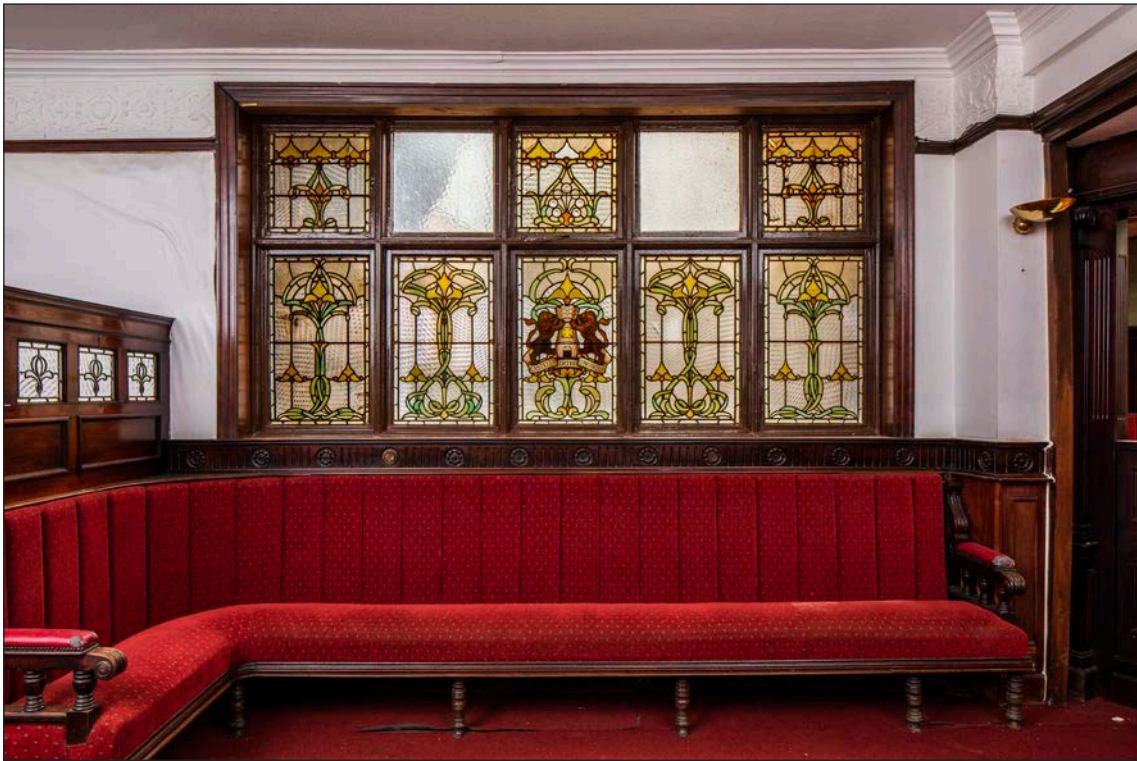
Figure 43: Benches in the east end of the restaurant [DP311855]

The benches and panelling are continued in the eastern half of the restaurant, closest to the bar/servery area. The bar itself is a later replacement. Almost identical benches were located in the Grade II* listed Red Lion pub in Handsworth (now closed).⁸¹

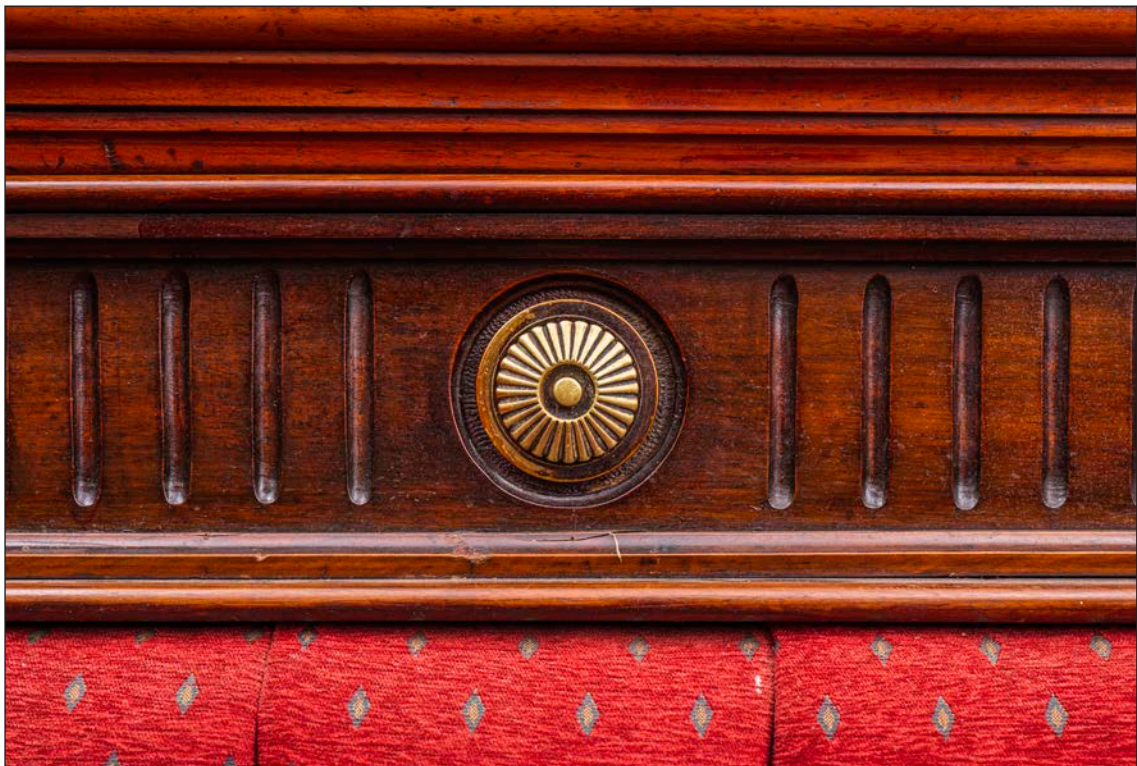
Figure 44: Service button in the restaurant [DP311863]

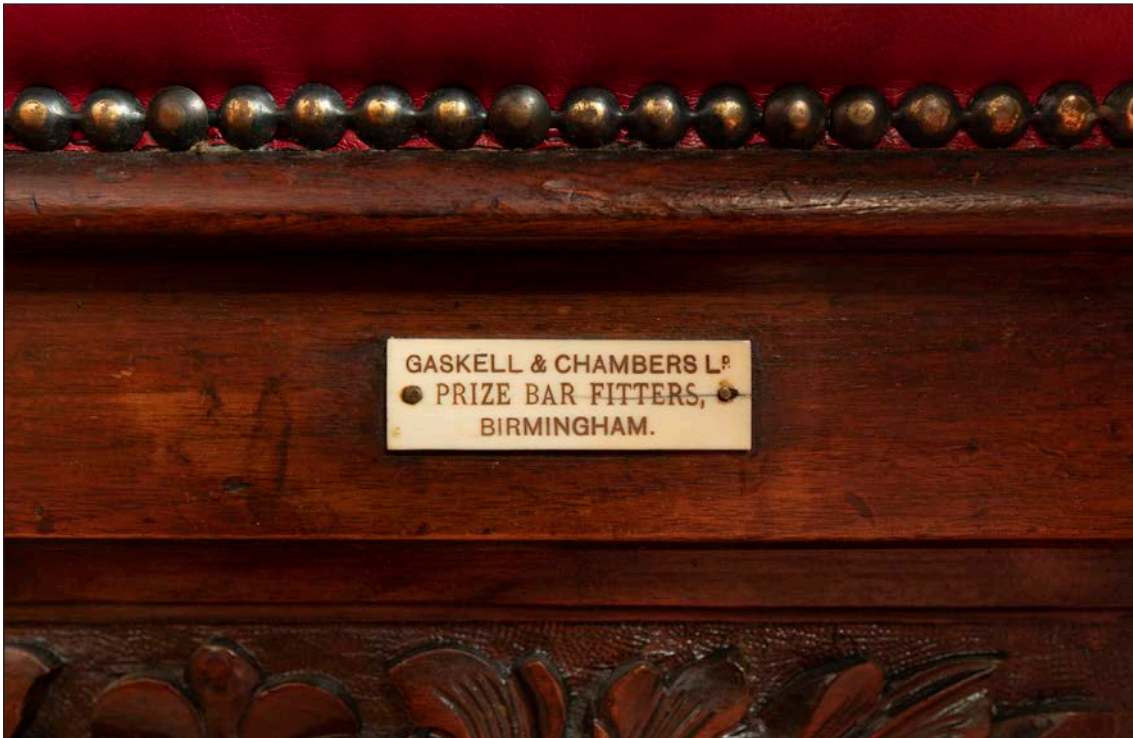
Figure 45: Gaskell and Chambers Ltd, label on restaurant benches [DP311972]

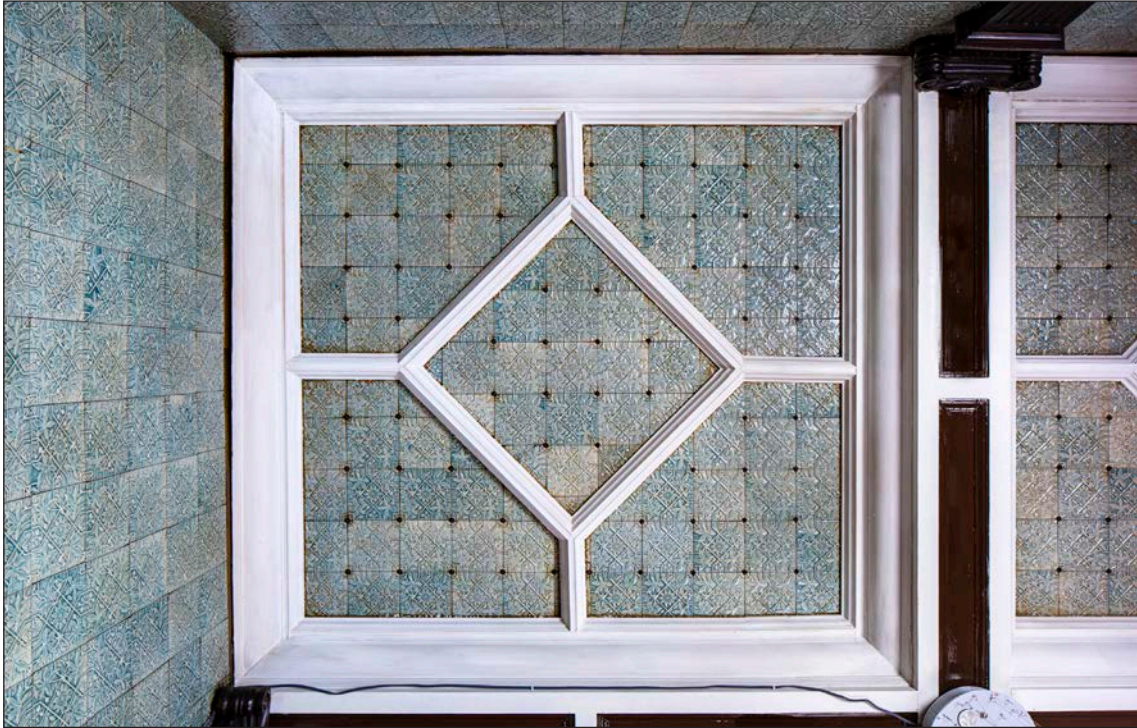
Figure 46: Majolica tiles on the walls and ceiling in the restaurant [DP311971]

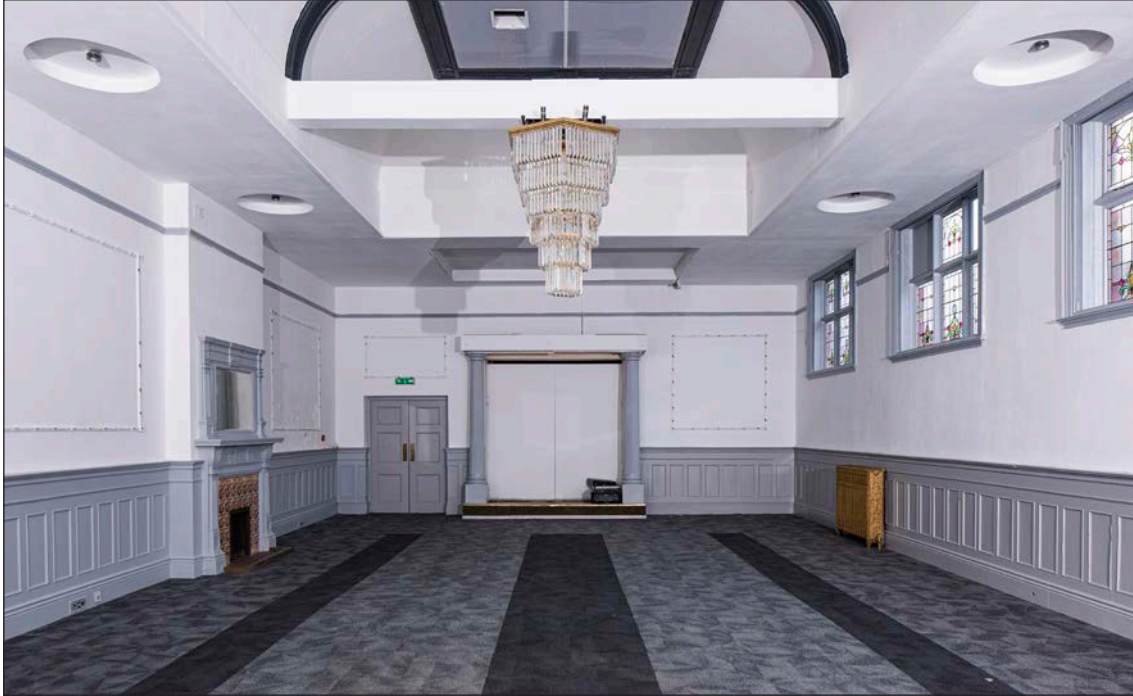
Figure 48: Conference room [DP311871]

The 1896-1899 extensions also included the addition of the large conference room to the rear of the building (Figures 48 and 49). It seems likely that this originally functioned as a ballroom or as a space for assemblies. Like the adjoining restaurant the conference room originally had a central glazed roof light, but this has been covered over internally with plastic sheeting and its exact form is unknown.

The decorative scheme in the conference room is lighter than that used in the restaurant. This is likely because the restaurant, as a former billiard room, was originally viewed as a more masculine space, whereas a ballroom would have been open to female guests and therefore was suitable for lighter, more feminine décor. Nevertheless, the historic panelling and two fireplaces in the conference room make use of the same classical designs seen elsewhere in the hotel. The timberwork has been painted over with emulsion paint, so the original colours are not known. The

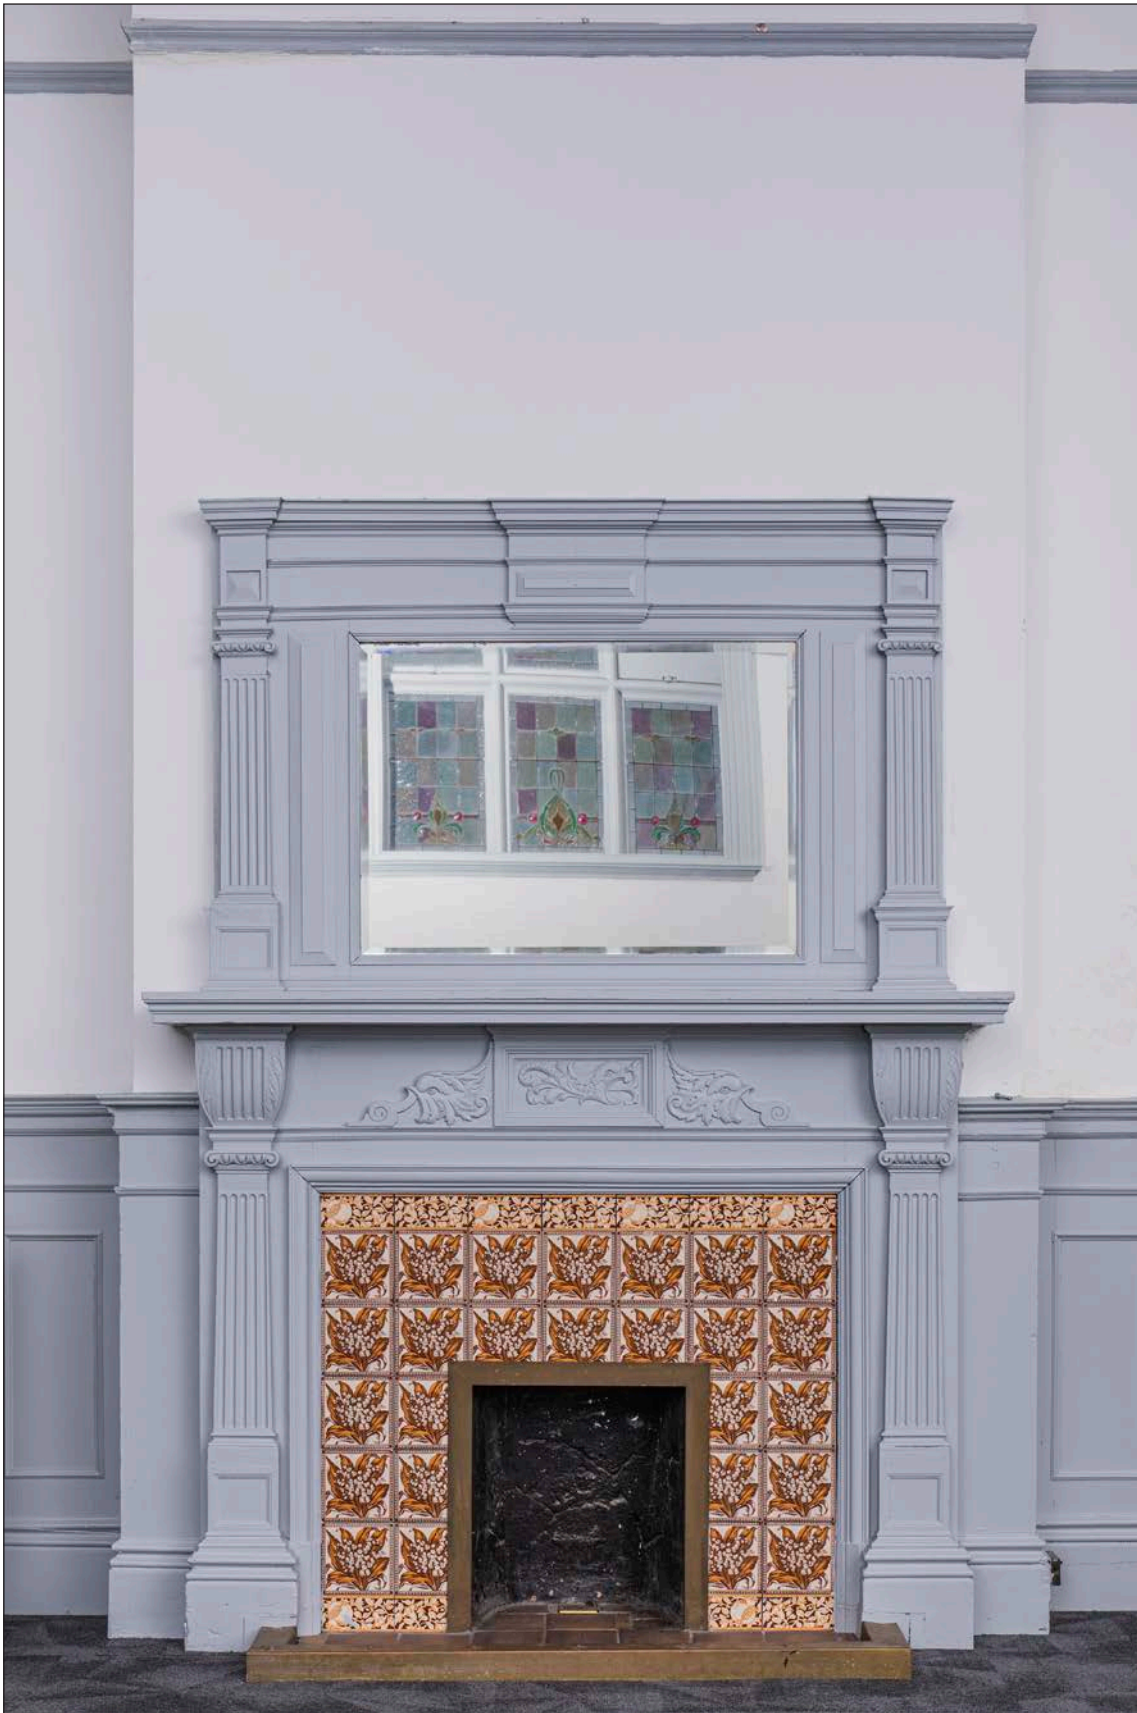
Figure 49: Fireplace from the conference room [DP311876]

fireplaces incorporate mirrored over-mantels and tiled surrounds. Unlike the tiles used elsewhere in the hotel, these tiles are not Majolica but instead are transfer printed with floral designs depicting lily of the valley.

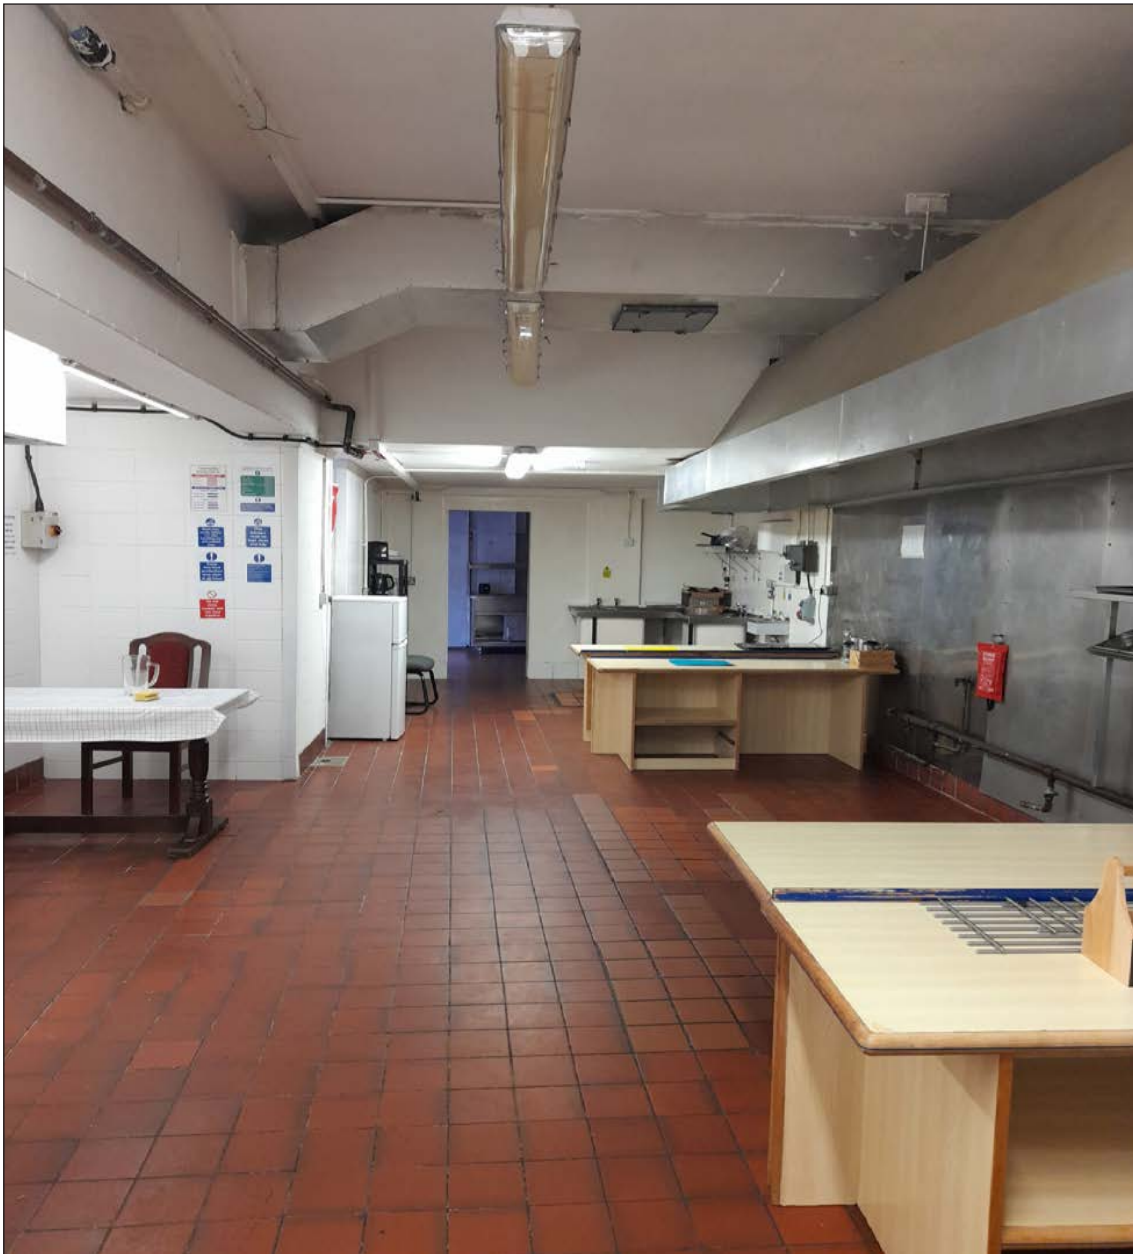
Figure 50: Existing kitchen [© Historic England, Dale Dishon]

By the 1970s the existing kitchen, which was still, at that time, located in the oldest part of the building, was no longer suitable to meet the needs of a modern hotel. Drawings by Gotch, Saunders and Surridge and held in the Northamptonshire Record Office reveal that changes were made to relocate the kitchen from its historic location (now a meeting/storeroom) into its existing location in the rear wing of the hotel (Figure 50).

This not only installed a much larger walk-in freezer in place of the old laundry, which required the removal of the historic copper and sink, but also converted the historic kitchen into a small dining room. This room is now used for meetings and storage. The earlier kitchen in the north wing had originally contained two substantial fireplaces on the east and west walls. These presumably would have once housed large cooking ranges. Both of these were knocked through; the west fireplace to create a double doorway leading between the new kitchen and dining area, and the east fireplace and chimney breast were completely removed to open up the room making it more suitable for a dining area.

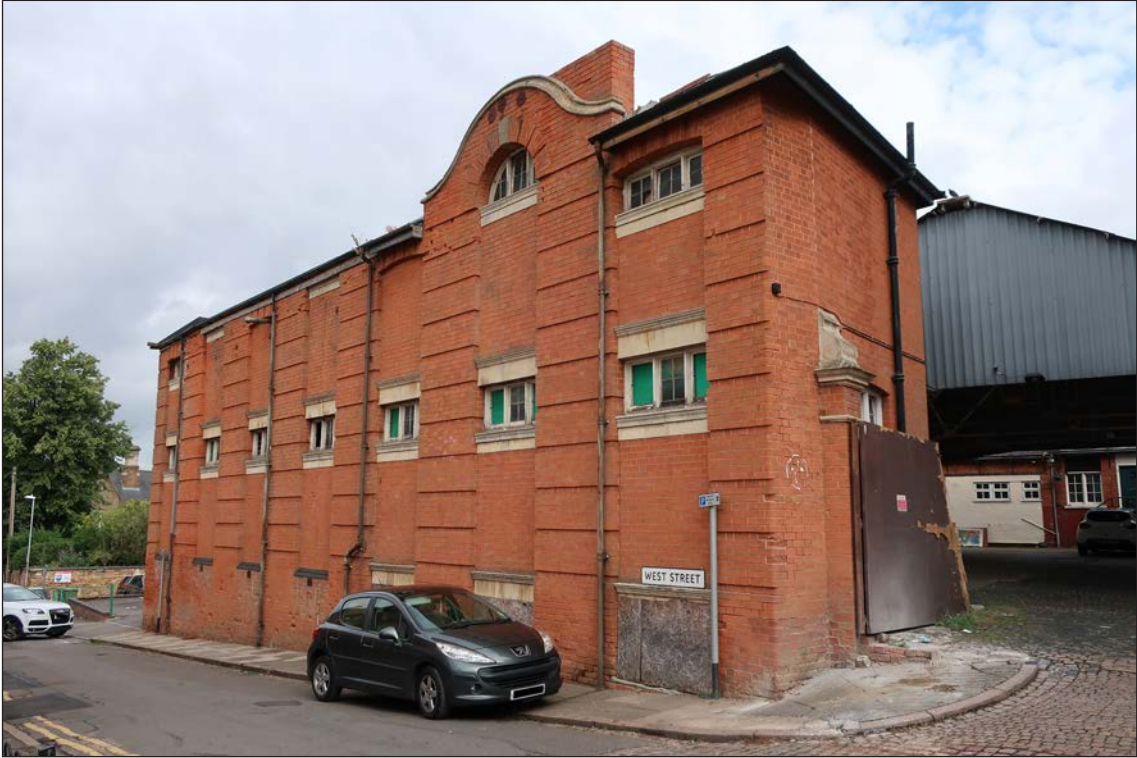
Figure 51: Stable block to the rear of the hotel (south elevation), July 2021 [© Historic England, Aimee Henderson]

The building referred to in this report as a stable block is located to the rear of the main building (Figure 51). It is linked to the rear elevation of the hotel by a suspended metal roof which covers the central courtyard space.

The south elevation of the stable block is constructed from red brick with stone dressings and is two storeys in height, with an additional level under the western end of the building, where the ground slopes away towards the street, and seven bays long. The stable block echoes the main hotel range in the use of banded brick pilasters to demarcate the bays of the building, replicating the stone pilasters on the main building. The design of the external elevation of the stable block also makes use of Dutch gables similar to the main building. Historically there were three gables on the stable block (Figure 52), but due to concerns about public safety arising from unstable masonry, two of these were taken down in 2017 under local authority supervision.

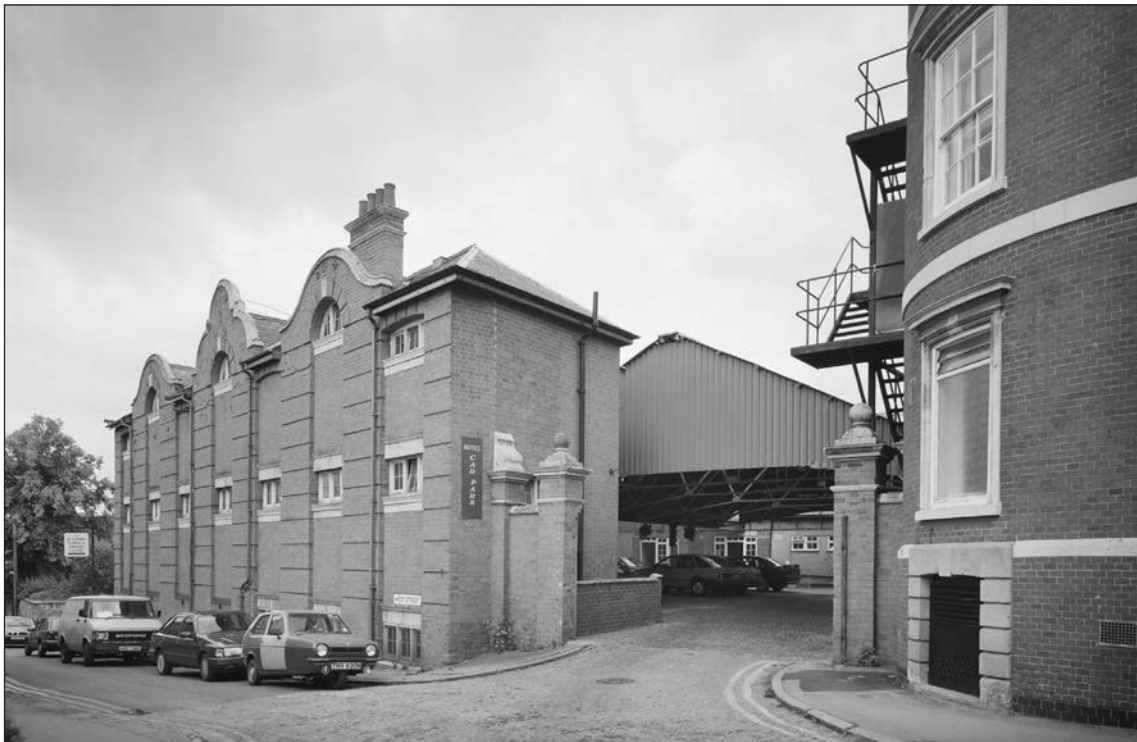
Figure 52: Courtyard from West Street showing the lost gatepost and removed gables, 1991, RCHME [Historic England Archive ref. AA91/03877]

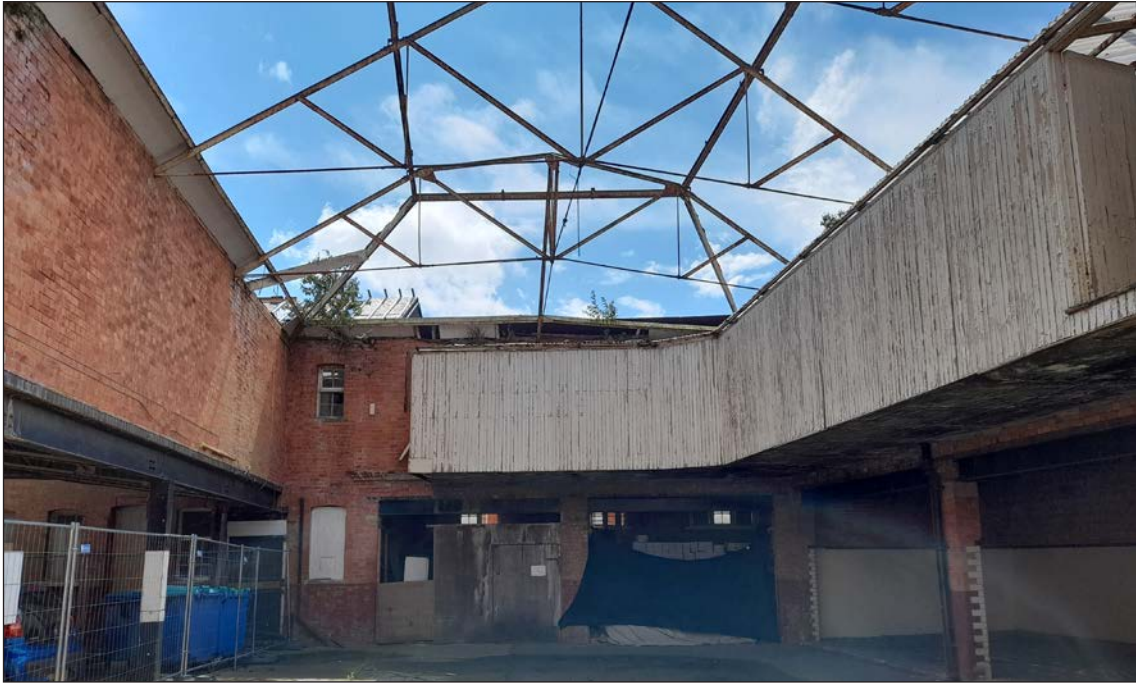
Figure 53: Stable, interior courtyard [© Historic England Dale Dishon]

The views of the internal elevation are obscured by heras fencing and also later alterations to install timber cladding at first floor level. This covers the entire south and western elevations above first floor level when viewed from inside the courtyard (Figure 53). It is not known whether this cladding covers over historic openings associated with the use of the building as a stable, for example openings for taking in hay. At ground floor level, older openings appear to have been substantially widened, particularly in the south and west ranges where steel beams have been inserted to support the wider openings. Otherwise, those few window and door openings which can be viewed from inside the courtyard do not appear to have undergone substantial alteration, though some have been covered over with plywood.

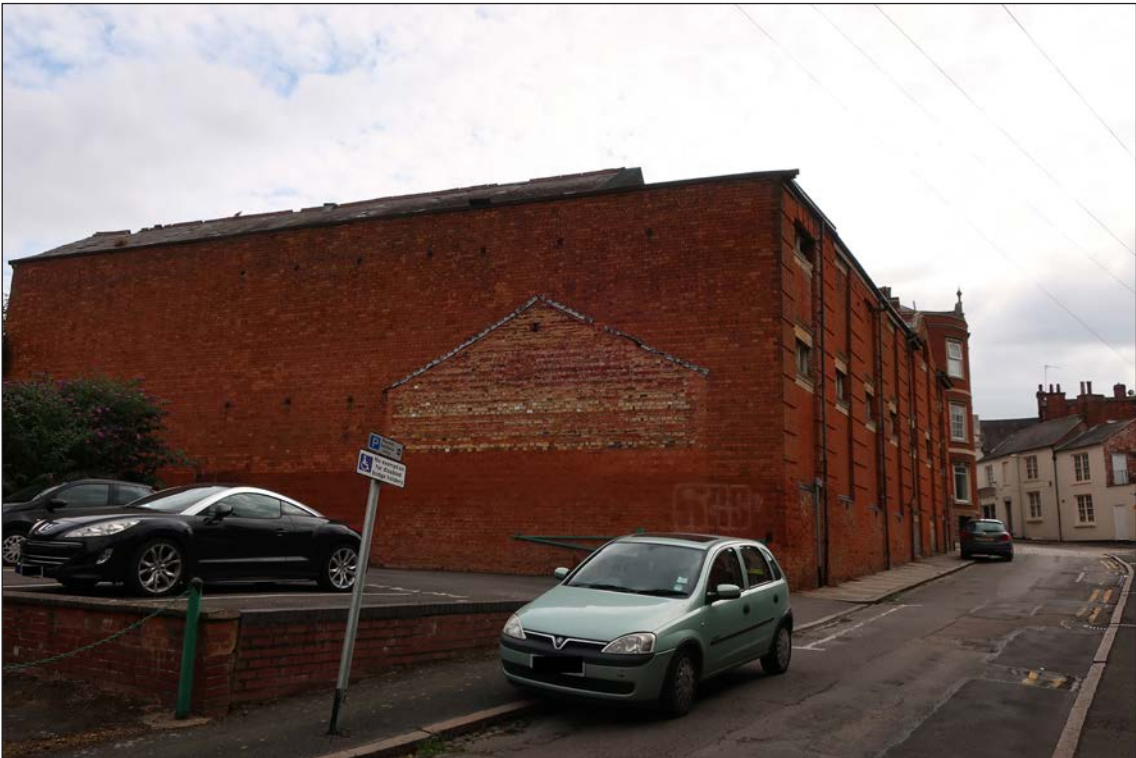
Figure 54: Stable block, west elevation, July 2021 [© Historic England, Aimee Henderson]

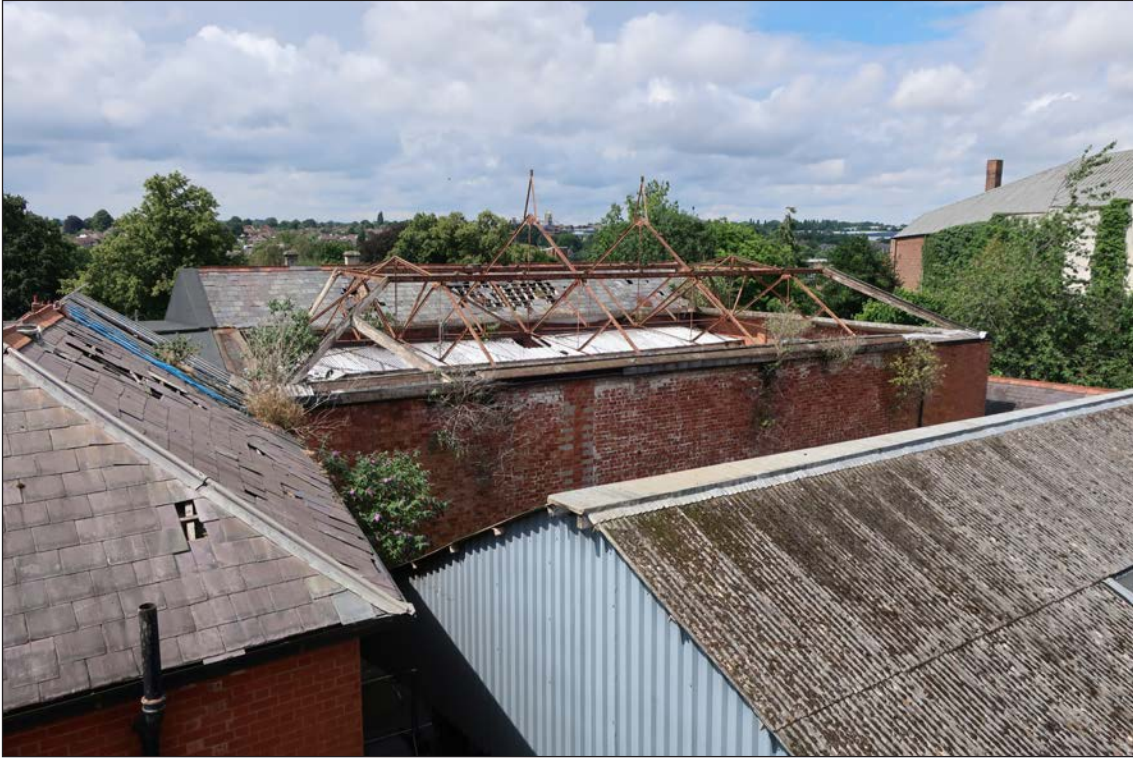
Figure 55: Roofs over the courtyard, viewed from the hotel fire escape.[© Historic England, Aimee Henderson]

At some point between 1950 and 1967 the building in the centre of the courtyard was demolished, and the courtyard was covered over by a further metal roof (Figure 55). This roof abutted the rear wall of the main hotel and enclosed the majority of the courtyard under metal or glazed roofs. This roof remains in place today.
