# The Shambles 6 Market Street North Walsham Norfolk

Tree-ring Dating of Oak Timbers

Research Report Series 3-2022

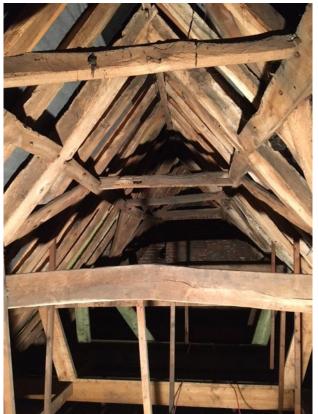
Figure 2: Truss 3, photograph taken from the east (Alison Arnold)

The roof over this part of the building has three principal-rafter and slightly cranked collar trusses, between which are two sets of purlins, windbraces, and common rafters; the truss in the gable end also has a tiebeam (Fig 2).

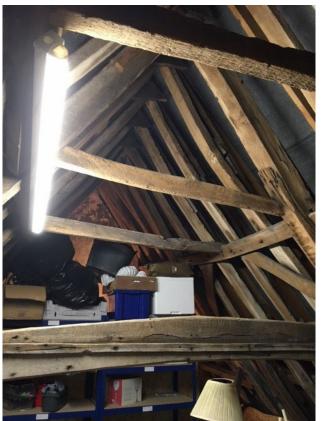
Figure 3: Rear range; truss 3, photograph taken from the north (Alison Arnold)

The roof over this part of the building consists of six principal-rafter and collar trusses, between which are two sets of purlins, windbraces, and common rafters (Fig 3). At first-floor level there is an exposed ceiling frame with main beams and common joists (Fig 4); those in bays 3 and 4 are chamfered and stopped (Fig 5), whilst those in bays 1 and 2 are plain. During renovation works some of the cellar ceiling timbers were removed.

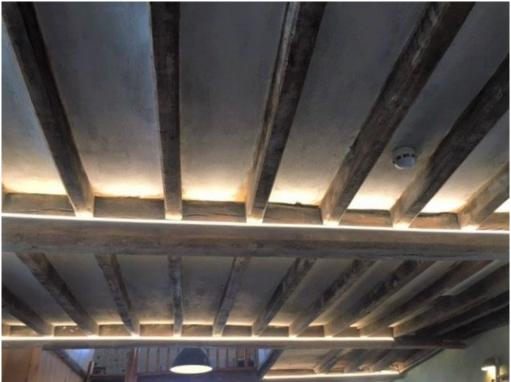
*Figure 4: Rear range; ceiling structure, photograph taken from the south (Alison Arnold)*

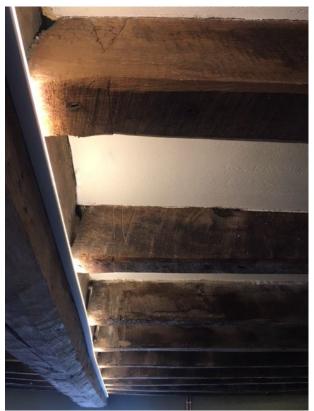
Figure 5: Chamfered and stopped joists in bay 3, photograph taken from the east (Alison Arnold)

It had been speculated that the first-floor ceiling of the rear range was the result to two separate building phases but there is no discernible difference in date of these timbers regardless of which part of the ceiling they came from. It may be that the two bays with chamfered and stopped joists were a room of higher status than those served by the other two bays.

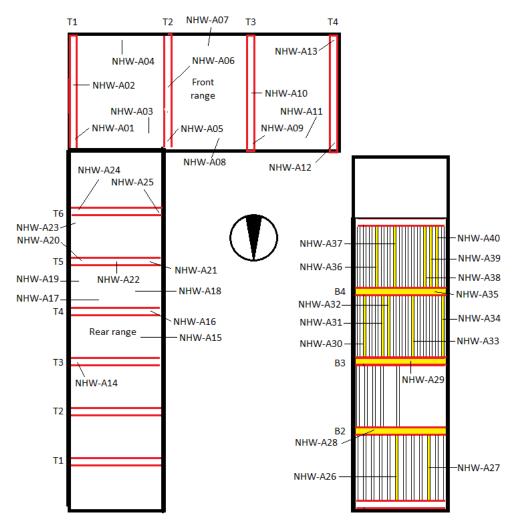
Figure 6: Sketch plan at roof and first-floor level (rear range), showing the location of sampled timbers

*situ* sampled timbers are indicated on Figure 6. Sampled trusses and main beams/bays have been numbered from east to west (front range) and north to south (rear range).

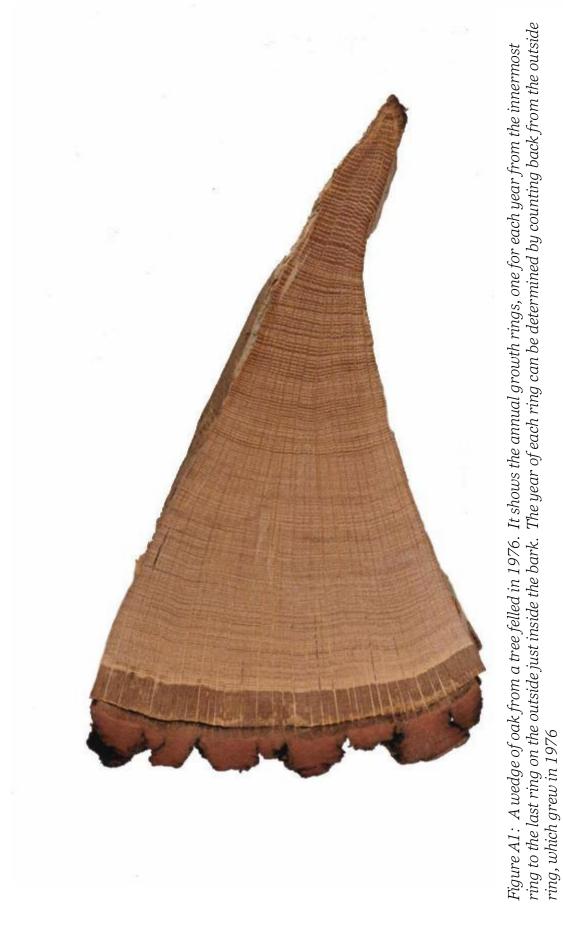
Figure A2: Cross-section of a rafter, showing sapwood rings in the left-hand corner, the arrow points to the heartwood/sapwood boundary (H/S); and a core with sapwood; again the arrow is pointing to the H/S. The core is about the size of a pencil

Quite often some, though not all, of the original outer rings are missing on a timber. The outer rings on an oak, called sapwood rings, are usually lighter than the inner rings, the heartwood, and so are relatively easy to identify. For example, sapwood can be seen in the corner of the rafter and at the outer end of the core in Figure A2, both indicated by arrows. More importantly for dendrochronology, the sapwood is relatively soft and so liable to insect attack and wear and tear. The builder, therefore, may remove some of the sapwood for precisely these reasons. Nevertheless, if at least some of the sapwood rings are left on a sample, we will know that not too many rings have been lost since felling so that the date of the last ring on the sample is only a few years before the date of the original last ring on the tree, and so to the date of felling.

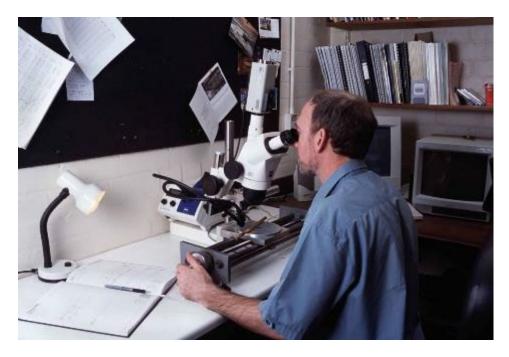
Figure A3: Measuring ring widths under a microscope. The microscope is fixed while the sample is on a moving platform. The total sequence of widths is measured twice to ensure that an error has not been made. This type of apparatus is needed to process a large number of samples on a regular basis

Each core is sanded down with a belt sander using medium-grit paper and then finished by hand with flourgrade-grit paper. The rings are then clearly visible and differentiated from each other with a result very much like that shown in Figure A2. The core is then mounted on a movable table below a microscope and the ring-widths measured individually from the innermost ring to the outermost. The widths are automatically recorded in a computer file as they are measured (see Fig A3).

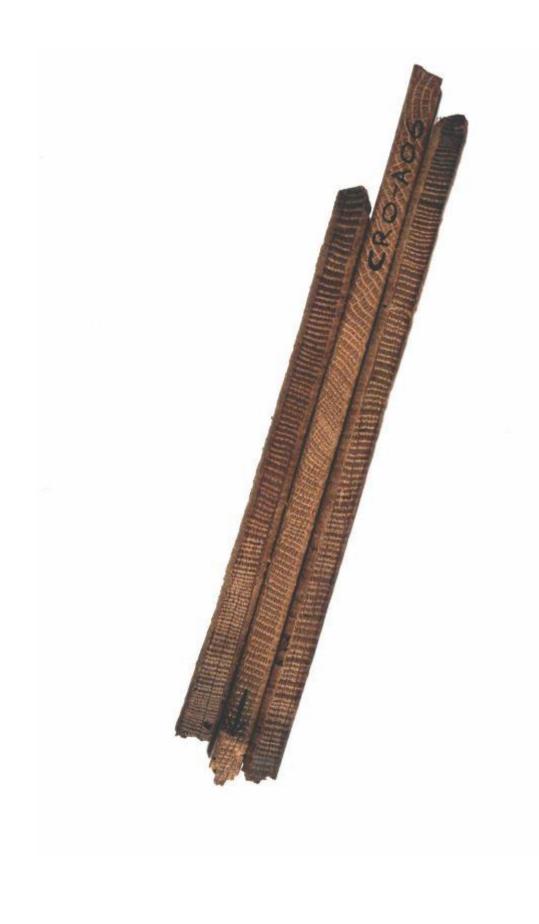
Figure A4: Three cores from timbers in a building. They come from trees growing at the same time. Notice that, although the sequences of widths look similar, they are not identical. This is typical

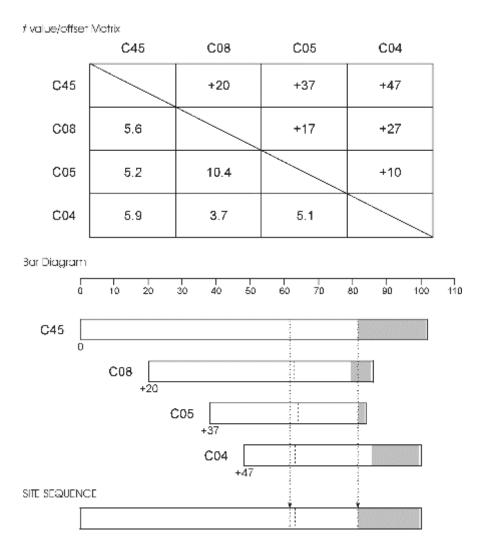
*Figure A5: Cross-matching of four sequences from a Lincoln Cathedral roof and the formation of a site sequence from them*

The bar diagram represents these sequences without the rings themselves. The length of the bar is proportional to the number of rings in the sequence. Here the four sequences are set at relative positions (offsets) to each other at which they have maximum correlation as measured by the *t*-values. The *t*-value/offset matrix contains the maximum *t*-values below the diagonal and the offsets above it. Thus, the maximum *t*-value between C08 and C45 occurs at the offset of +20 rings and the *t*-value is then 5.6. The site sequence is composed of the average of the corresponding widths, as illustrated with one width.

This is illustrated in Figure A5 with timbers from one of the roofs of Lincoln Cathedral. Here four sequences of ring widths, LIN-C04, 05, 08, and 45, have been cross-matched with each other. The ring widths themselves have been omitted in the bar diagram, as is usual, but the offsets at which they best cross-match each other are shown; eg the sequence of ring widths of C08 matches the sequence of ring widths of C45 best when it is at a position starting 20 rings after the first ring of C45, and similarly for the others. The actual *t*-values between the four at these offsets of best correlations are in the matrix. Thus at the offset of +20 rings, the *t*-value between C45 and C08 is 5.6 and is the maximum found between these two among all the positions of one sequence relative to the other.

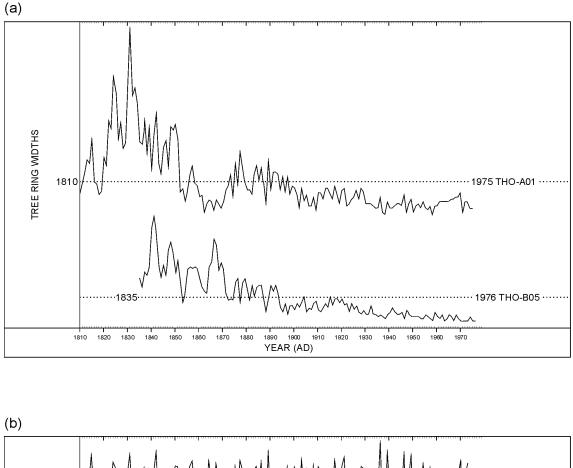
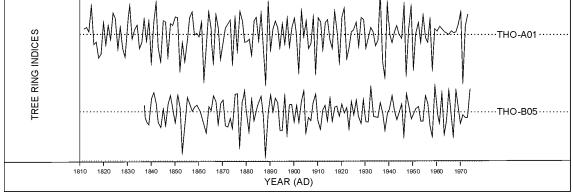
Figure A7 (a): The raw ring-widths of two samples, THO-A01 and THO-B05, whose felling dates are known

Here the ring widths are plotted vertically, one for each year, so that peaks represent wide rings and troughs narrow ones. Notice the growth-trends in each; on average the earlier rings of the young tree are wider than the later ones of the older tree in both sequences

Figure A7 (b): The Baillie-Pilcher indices of the above widths

The growth trends have been removed completely

Tree-ring dating can be done by cross-matching the ring widths themselves, as described above. However, it is advantageous to modify the widths first. Because different trees grow at different rates and because a young oak grows in a different way from an older oak, irrespective of the climate, the widths are first standardized before any matching between them is attempted. These standard widths are known as ring-width indices and were first used in dendrochronology by Baillie and Pilcher (1973). The exact form they take is explained in this paper and in the appendix of Laxton and Litton (1988) and is illustrated in the graphs in Figure A7. Here ringwidths are plotted vertically, one for each year of growth. In the upper sequence of (a), the generally large early growth after 1810 is very apparent as is the smaller later growth from about 1900 onwards when the tree is maturing. A similar phenomenon can be observed in the lower sequence of (a) starting in 1835. In both the widths are also changing rapidly from year to year. The peaks are the wide rings and the troughs are the narrow rings corresponding to good and poor growing seasons, respectively. The two corresponding sequence of Baillie-Pilcher indices are plotted in (b) where the differences in the immature and mature growths have been removed and only the rapidly changing peaks and troughs remain, that are associated with the common climatic signal. This makes cross-matching easier.
