26-27 Market Place North Walsham Norfolk

Tree-ring Analysis of Oak and Elm Timbers

Research Report Series 22-2022

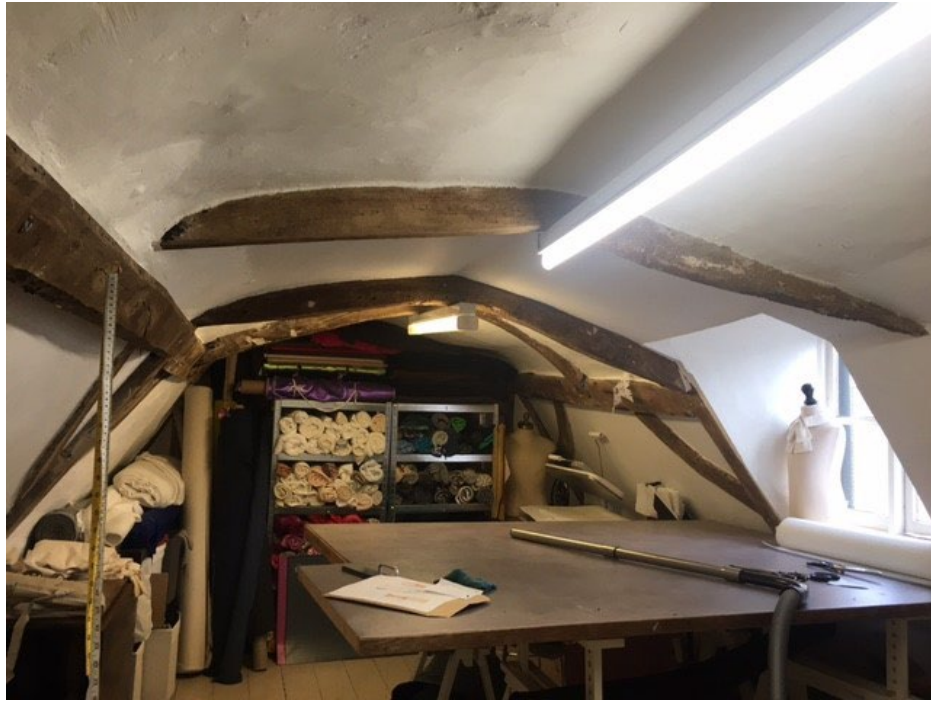
Figure 2: Roof (No 26), truss 5 and one of the intermediary collars in the foreground, photograph taken from the south (Alison Arnold)

The roof of the main, north–south, range consists of six principal rafter and collar trusses, although only the east principal of truss 3 remains, with some additional collars and rafters located within the central bays. Between these are common rafters and butt purlins (Figs 2 and 3).

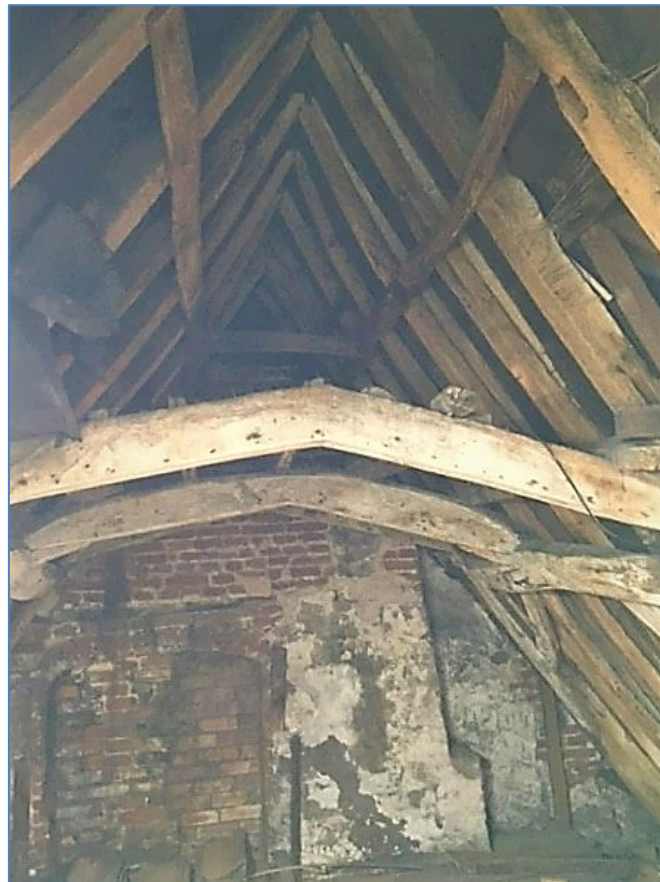
Figure 3: Roof (No 27), truss 2 in foreground, photograph taken from the south (Alison Arnold)

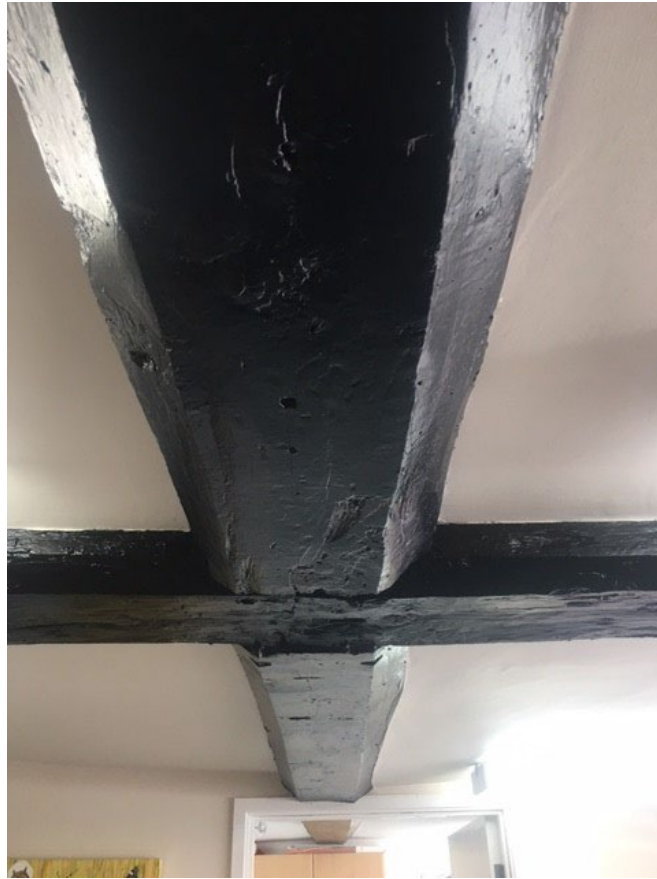
Figure 4: Ground-floor ceiling (No 27), photograph taken from the south (Alison Arnold)

At ground-floor level, within the main, primary range of the building, are some large, chamfered ceiling beams (Fig 4); also visible within this range, at first-floor level, are three main ceiling beams (Fig 5). Two other ground-floor ceiling beams are located towards the rear of the building (Fig 6). Timbers of the cellar ceiling frame are visible beneath both number 26 (Fig 7) and number 27 (Fig 8).

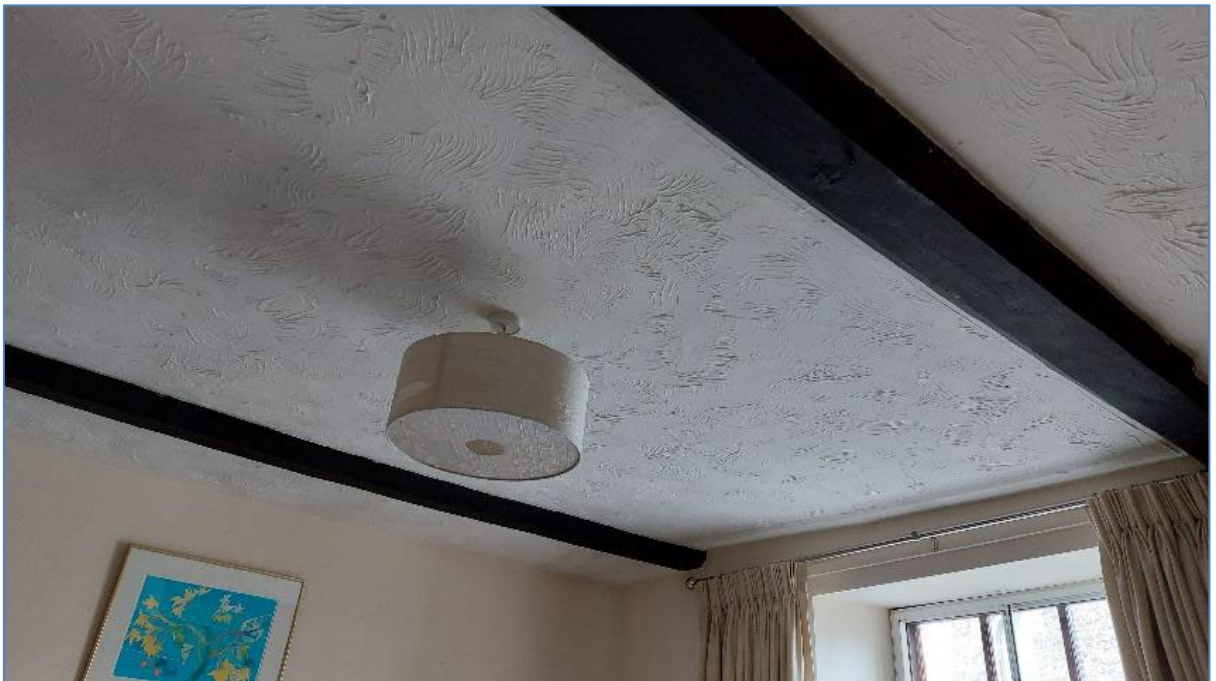
Figure 5: Two of the first-floor ceiling beams (No 27), photograph taken from the south-west (Alison Arnold)

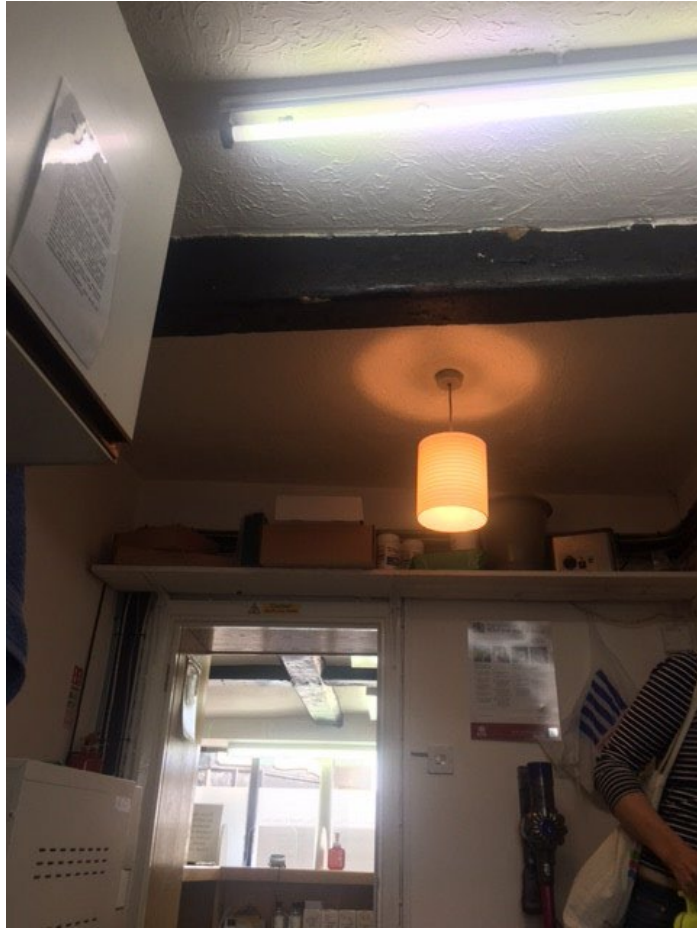
Figure 6: Ground-floor ceiling beam (No 27), the chamfered beams can be seen in the background, photograph taken from the west (Alison Arnold)

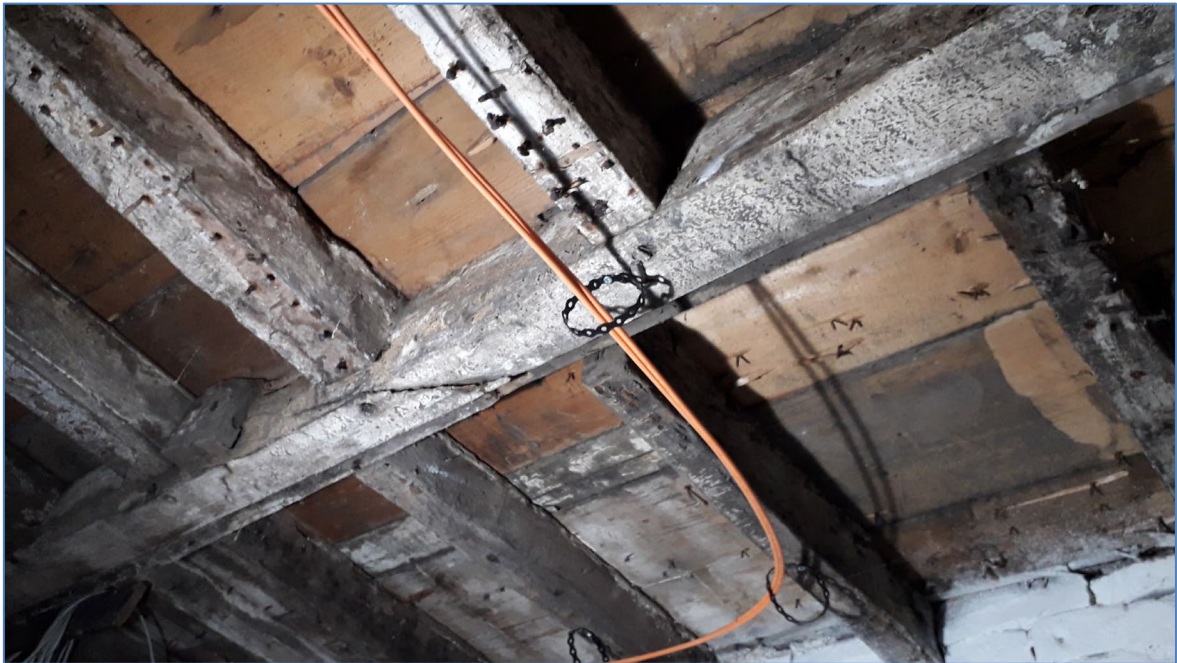
Figure 7: Cellar ceiling (No 26), photograph taken from the north-west (Alison Arnold)

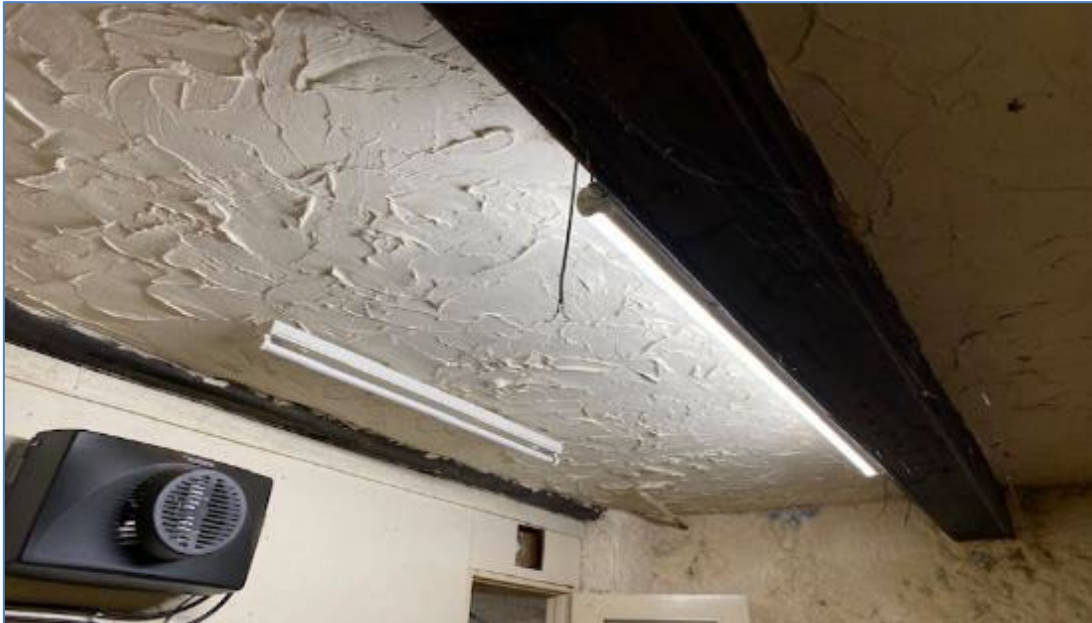
Figure 8: Cellar ceiling (No 27), photograph taken from the south-west (Alison Arnold)

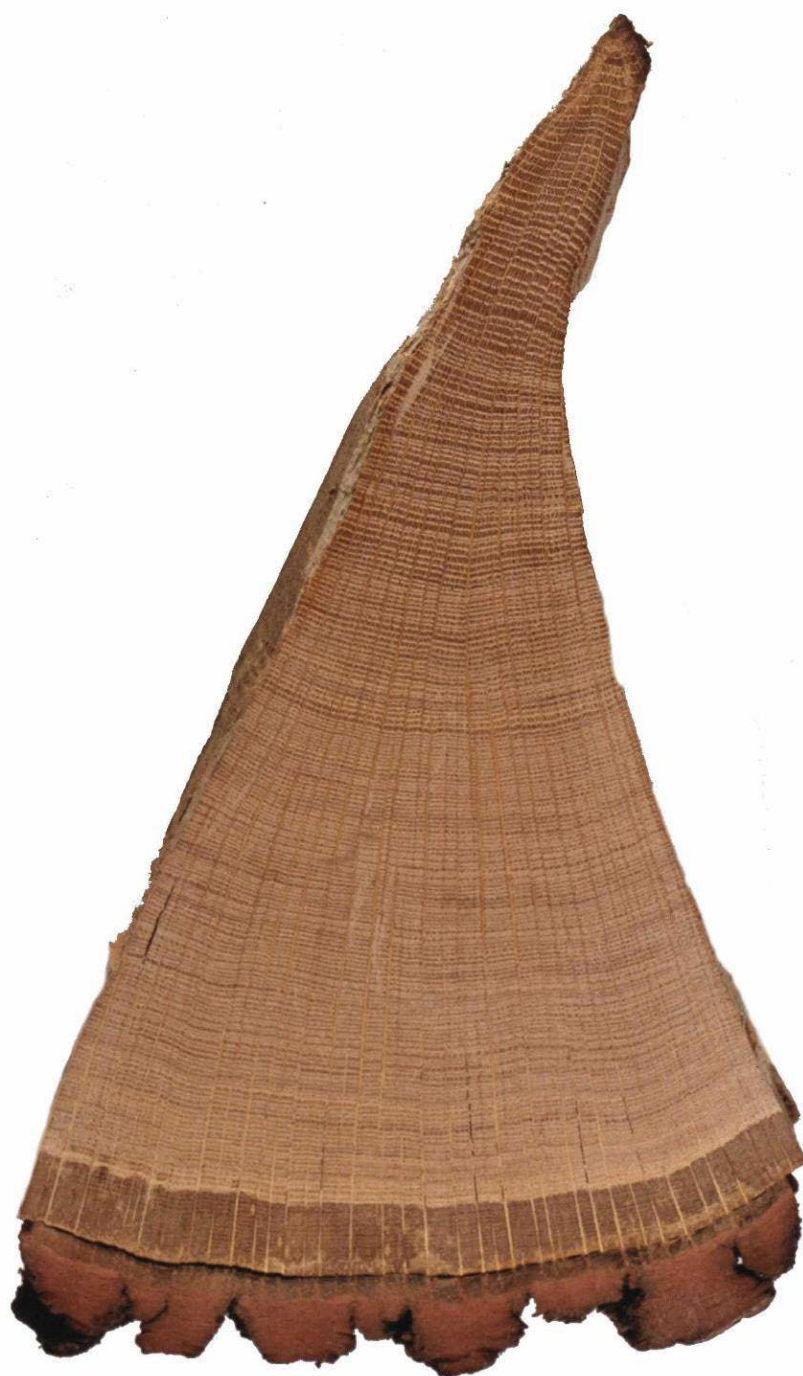
Figure A1: A wedge of oak from a tree felled in 1976. It shows the annual growth rings, one for each year from the innermost ring to the last ring on the outside, just inside the bark. The year of each ring can be determined by counting back from the outside ring, which grew in 1976

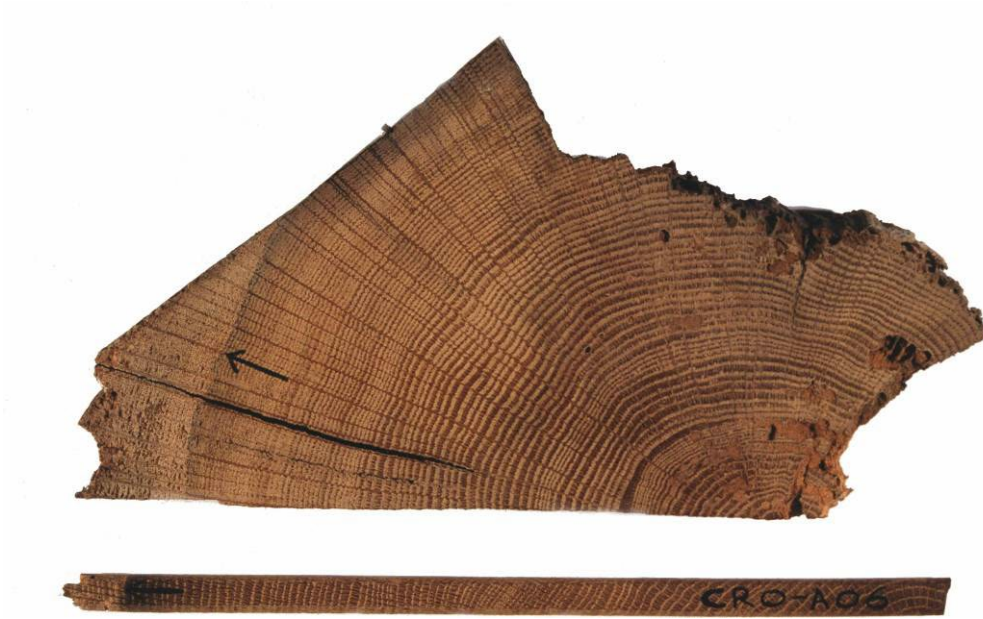
Figure A2: Cross-section of a rafter, showing sapwood rings in the left-hand corner, the arrow points to the heartwood/sapwood boundary (H/S); and a core with sapwood; again the arrow is pointing to the H/S. The core is about the size of a pencil

Quite often some, though not all, of the original outer rings are missing on a timber. The outer rings on an oak, called sapwood rings, are usually lighter than the inner rings, the heartwood, and so are relatively easy to identify. For example, sapwood can be seen in the corner of the rafter and at the outer end of the core in Figure A2, both indicated by arrows. More importantly for dendrochronology, the sapwood is relatively soft and so liable to insect attack and wear and tear. The builder, therefore, may remove some of the sapwood for precisely these reasons. Nevertheless, if at least some of the sapwood rings are left on a sample, we will know that not too many rings have been lost since felling so that the date of the last ring on the sample is only a few years before the date of the original last ring on the tree, and so to the date of felling.

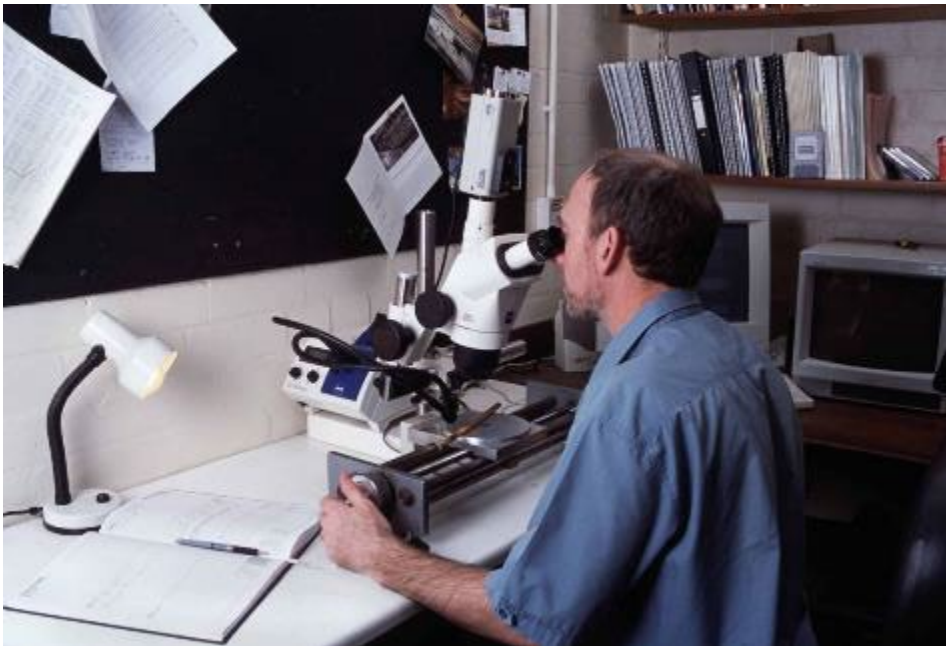
Figure A3: Measuring ring widths under a microscope. The microscope is fixed while the sample is on a moving platform. The total sequence of widths is measured twice to ensure that an error has not been made. This type of apparatus is needed to process a large number of samples on a regular basis

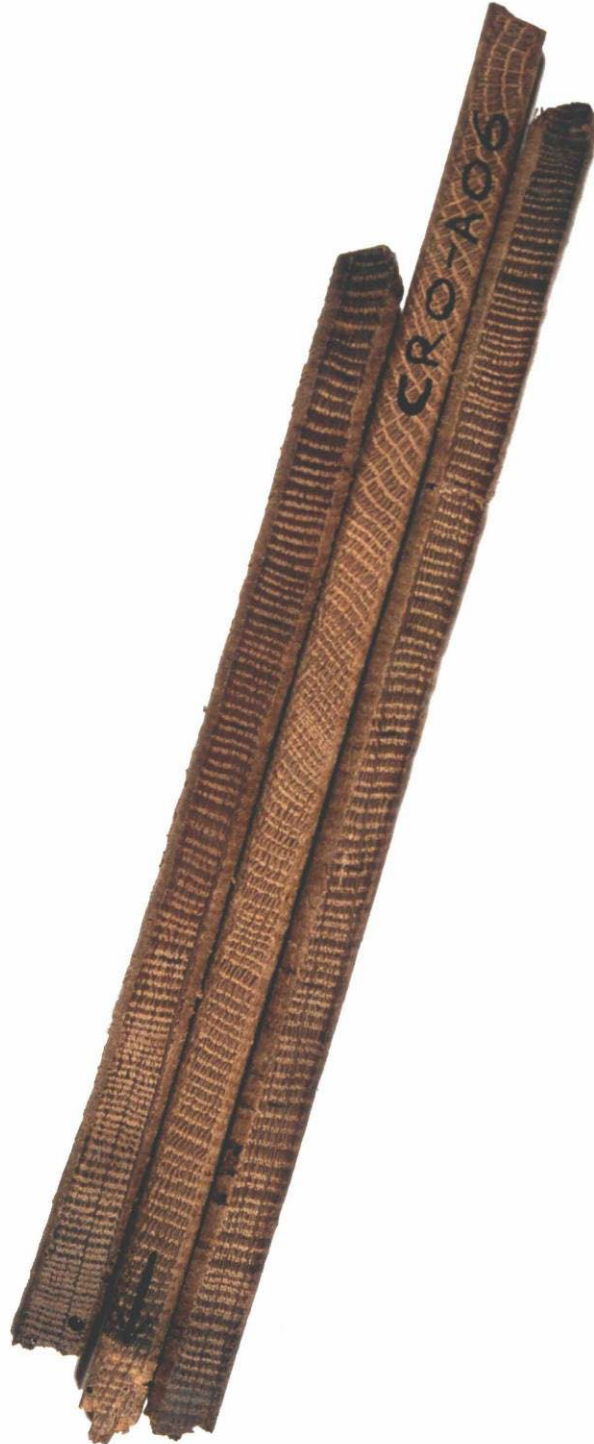
Figure A4: Three cores from timbers in a building. They come from trees growing at the same time. Notice that, although the sequences of widths look similar, they are not identical. This is typical
