Whitefriars Gate, 36-37 Much Park Street, Coventry: Historic Building Assessment

Research Report Series 021-2022

HISTORIC BUILDING ASSESSMENT

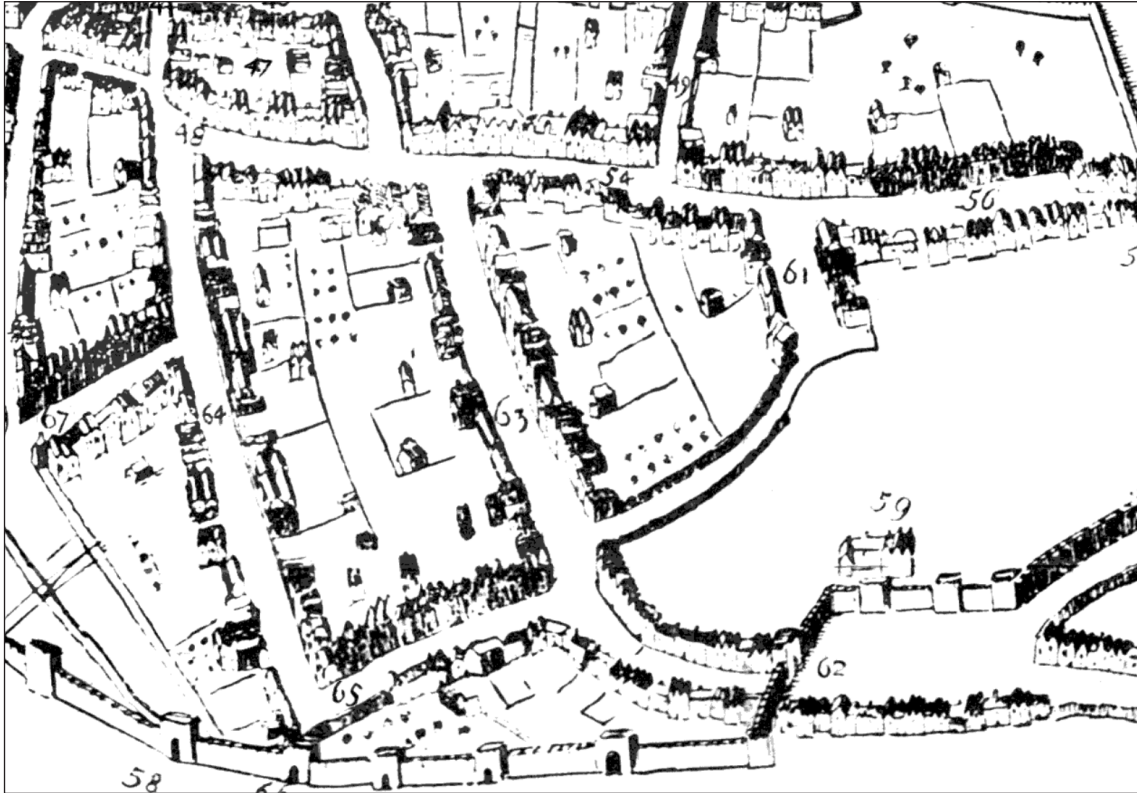
Figure 4 Extract from Speed's 1610 map of Coventry. Whitefriars Lane (61) is shown running from Much Park Street (63), but the gatehouse is not depicted.

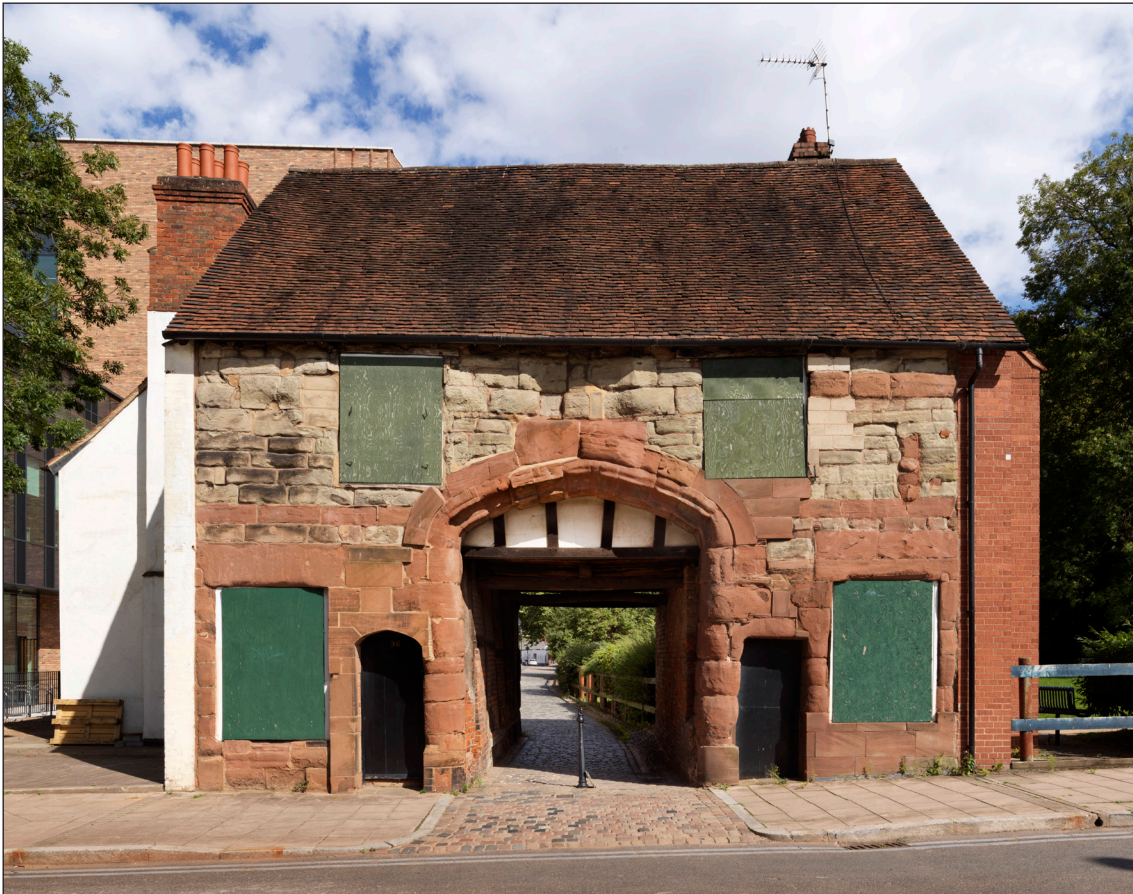
Figure 9 West elevation. [DP219812]

The west (front) elevation appears to have originally comprised the large gateway arch, flanked by the two secondary doors, and by window openings beyond this (Figure 9). The gateway arch is the principal feature which dates the building stylistically. It is formed of red sandstone with a depressed four-centred arch with a deep cavetto moulding typical of the late 14th or early 15th century. The doorway and window openings flanking the archway are formed of the same red sandstone and form part of the same phase, their lintels being carefully accommodated in the jamb stones of the main arch. The southern doorway has a square head with a large sandstone lintel. The lintel is relatively worn, but enough survives to indicate that there appears to have been no moulding around the opening. The northern doorway is of later stone externally, but internally the stonework around the entrance appears to indicate it is an original opening, matching the corresponding stonework of the southern doorway. It now has a depressed four-centred head, differing from that to the south, although it is not clear whether this corresponds to its original form.

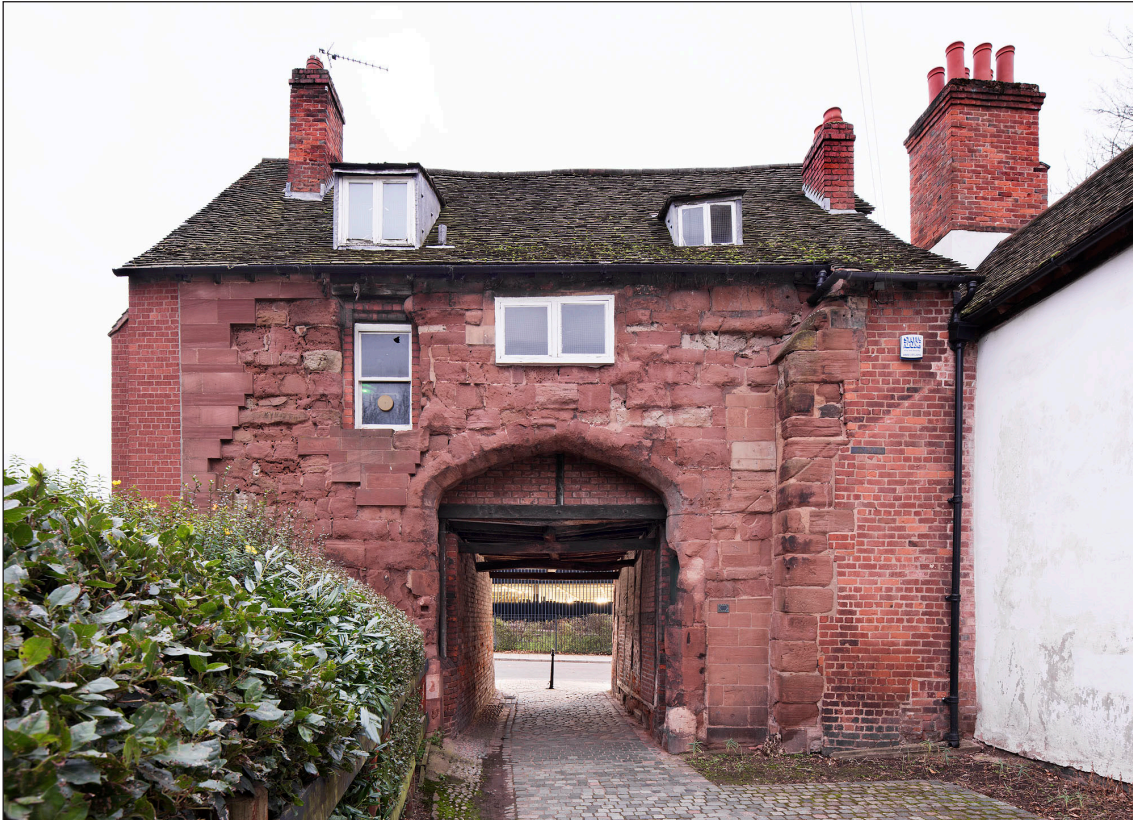
Figure 10 East elevation showing the main archway, the blocked north doorway and the truncated chimney stack. The south doorway is obscured. [DP219945]

The east (rear) elevation of the gatehouse is formed almost entirely of squared red sandstone, with occasional green sandstone blocks, although these two stone types have not been used in any organised way as in the front elevation (Figure 10). The difference in the use of stone types between the east and west elevations has given rise to suggestions that the two elevations may in fact be different dates (Singlehurst 2000). However internal evidence, particularly from the west elevation, indicates that the gateway always functioned with a building behind it, and thus it seems more likely that it is in fact of the same date. The elevation comprises the principal archway with a simple chamfer moulding to its outer and inner faces. As with the west elevation the principal arch is flanked by two smaller doorway arches, which are thus directly in line with their counterparts on the front. That to the south has a four-centred arched head with a simple chamfer profile on its outer face (Figure 11). That to the north appears to have a square head, although it may have been altered by later blocking.

Immediately adjacent to the northern doorway are the truncated remains of a projecting chimney stack. This now mostly comprises later brickwork, but a series of stone quoins have survived as its southern edge. Immediately below the current roof level the stack narrows, with stone coping used on the slope of the top edge. These large coping stones appear to course through into the stone of the main elevation, indicating that the stack is in fact an original feature, although much modified. The

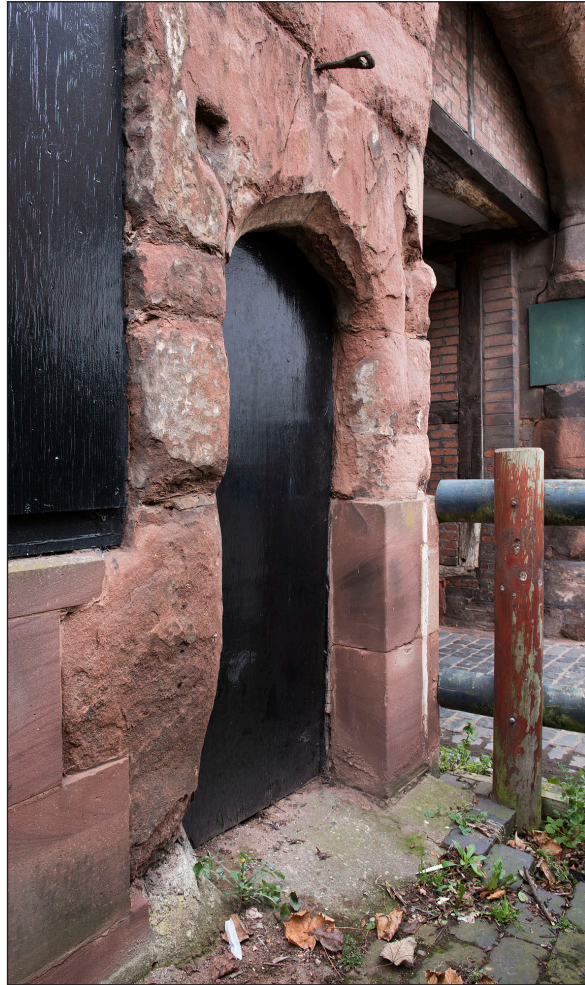
Figure 11 East elevation, south doorway.
[DP219941]

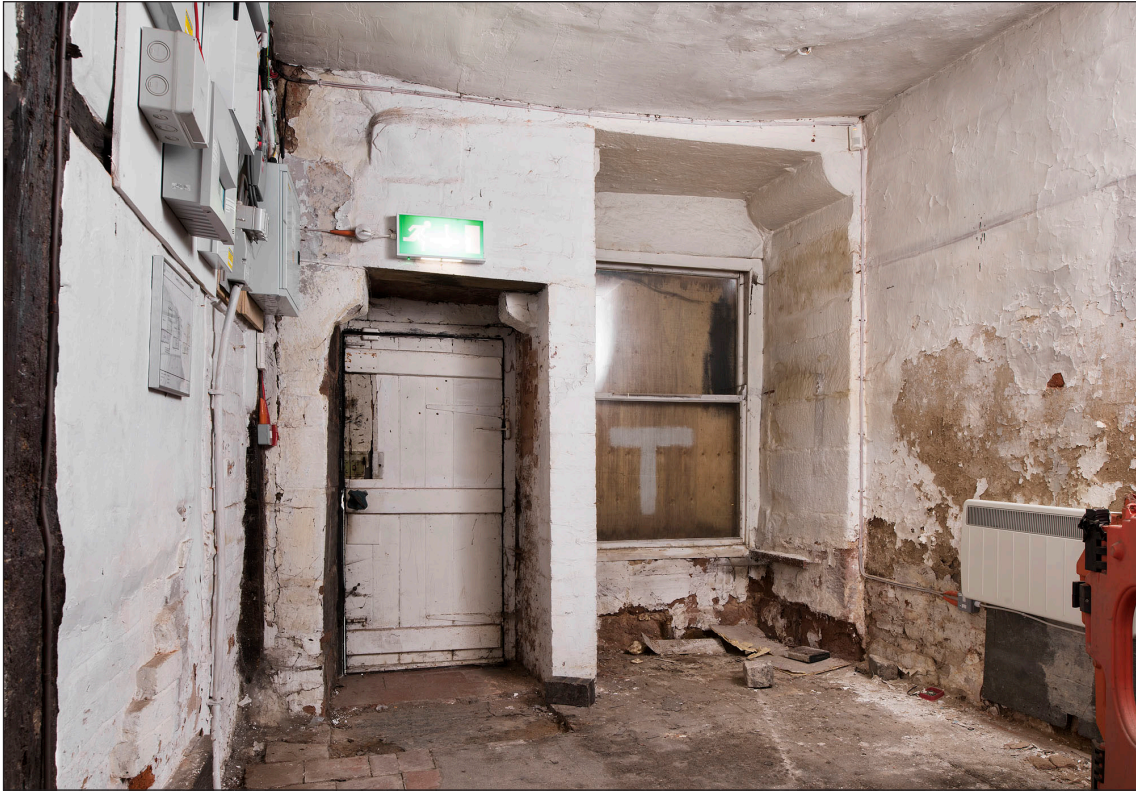
Figure 12 Interior, west elevation, ground floor, north room showing north doorway arrangement. [DP219917]

Internally, later alterations have obscured much of the original detail in the west and east walls. At ground-floor level the openings in the west elevation have been heavily rebuilt (*see below*). However, the inner jambs of both doorways flanking the main archway are of similar form and may represent original fabric (Figures 12 and 13). These have a distinctive form. The head of the doorway curves inwards to form the spandrel of a shouldered arch, but the soffit of the arch curves upwards again in the centre to form what in effect appears like a small vaulted opening over the doorway. The example on the southern jamb of the north doorway is more pronounced

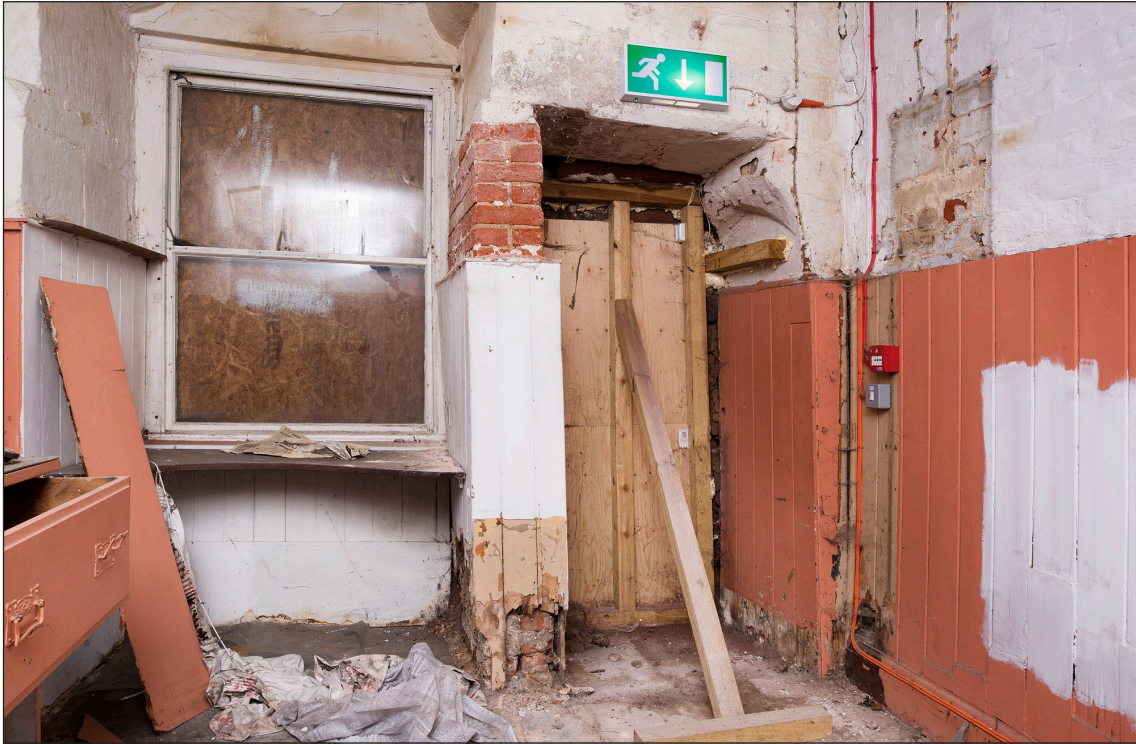
Figure 13 Interior, west elevation, ground floor, south room showing southern doorway arrangement. [DP219913]

Both flanking windows also take a similar form. That to the south represents a better survival (*see Figure 13*). The original south splay of the window opening appears to survive intact, as does perhaps the lintel. The splay is of ashlar stonework. The most distinctive element of the opening is the rounded corbels which project out from the splays to support the lintel. These have a simple chamfer decoration to their outer face. The lintel itself is concealed by the later ceiling, although it is presumed that the chamfer profile would have continued along the outer edge of the lintel. It is likely that the window openings have been altered and widened at a later date, so it is unclear how much of the rest of the internal window arrangement is original. Further investigation of the upper part of the windows may clarify this.

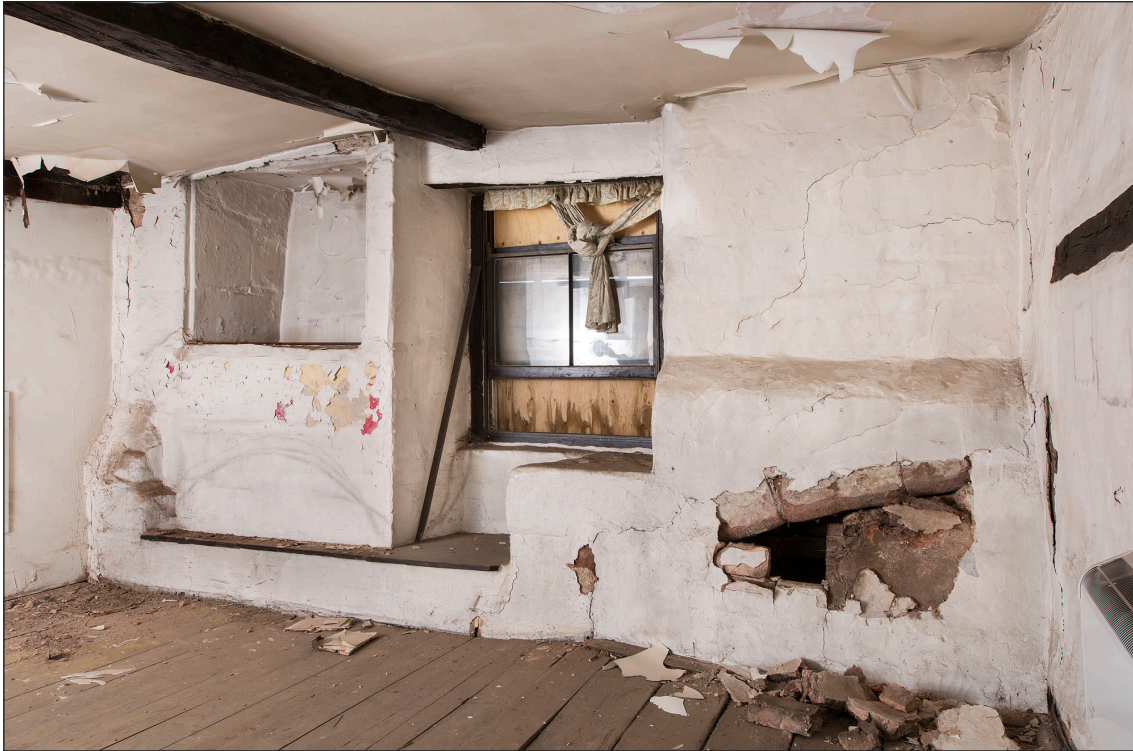
Figure 14 Interior, west elevation, first floor, south room. Note the remains of the eastern side of the principal arch exposed on the right-hand side of the photograph. [DP219907]

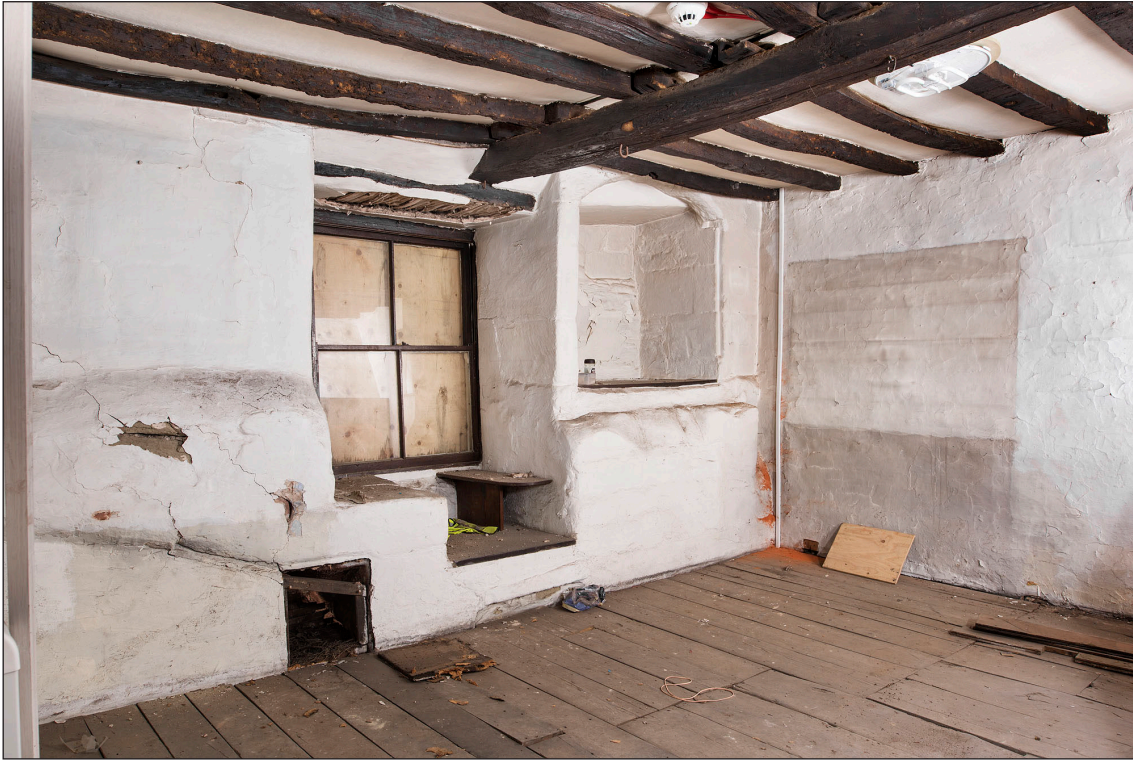
North of the main archway the interior of the west elevation has a similar form as that to the south, although with some small differences (Figure 15). Again there is an off-set running along the elevation at a lower level than that over the principal arch, and the off-set survives as a more consistent feature in this section, although altered around the window opening. As to the south, the outer (in this case the north) jamb of the window opening appears original, and probably indicates the position

Figure 15 Interior, west elevation, first floor, north room. [DP219900].

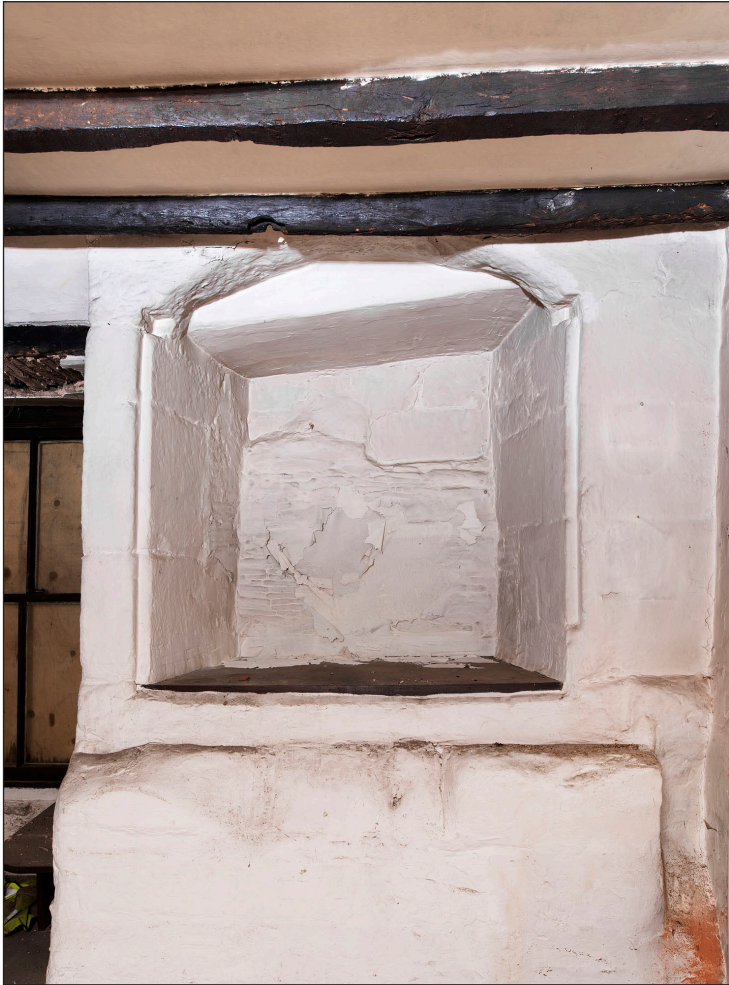
Figure 16 Interior, west elevation, first floor, north room, detail of cupboard. [DP19904]

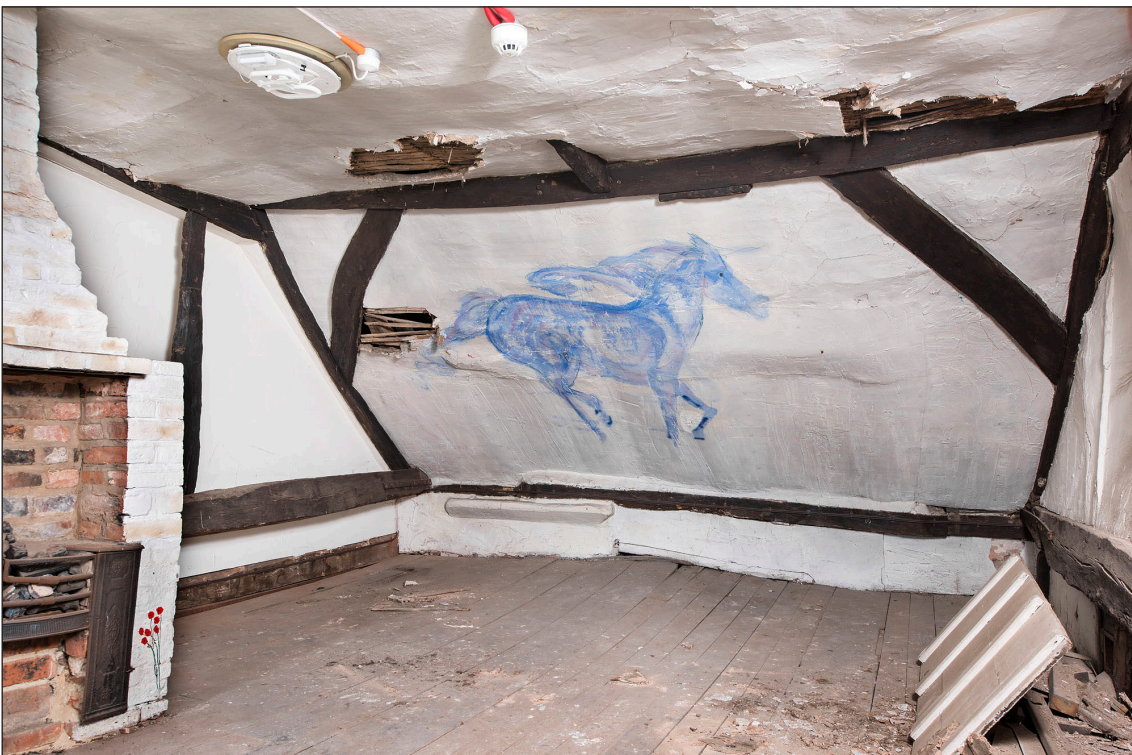
Figure 17 Interior, west elevation, second floor, south room showing projecting stonework towards the southern end of the elevation. [DP219891]

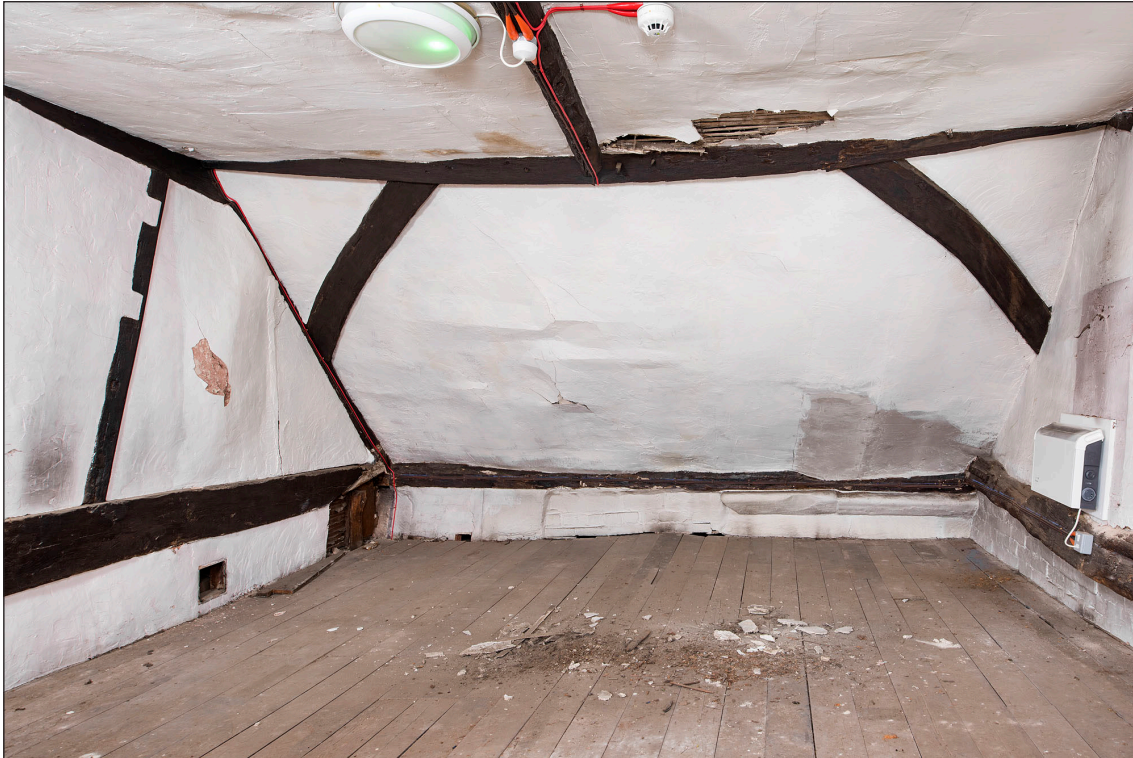
Figure 18 Interior, west elevation, second floor, north room, showing projecting stonework towards the north of the elevation. [DP219893]

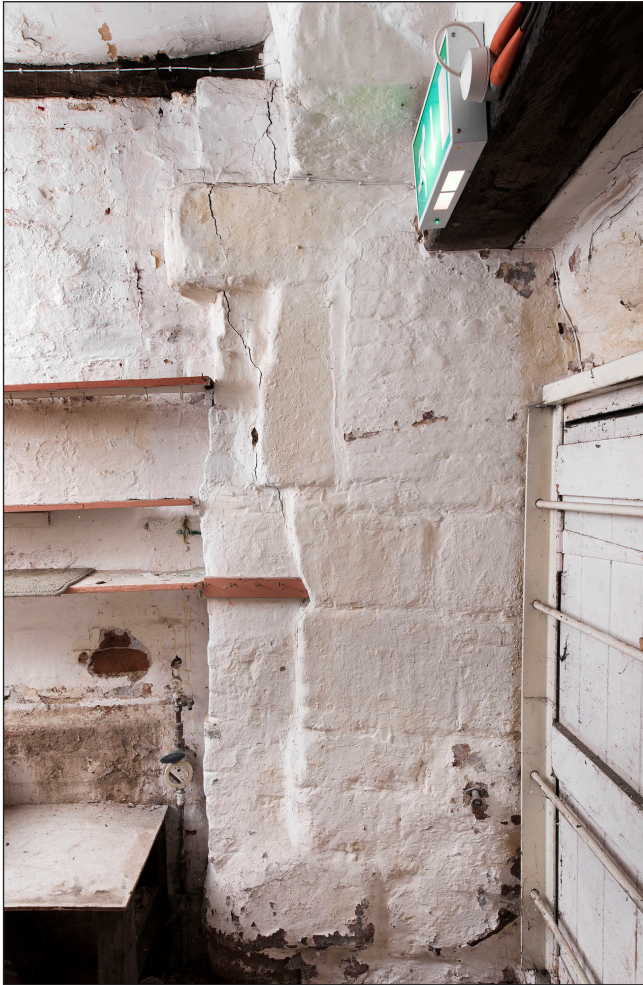
Figure 19 Interior, east elevation, ground floor, south room, showing jamb of doorway and brick blocking. [DP219915]

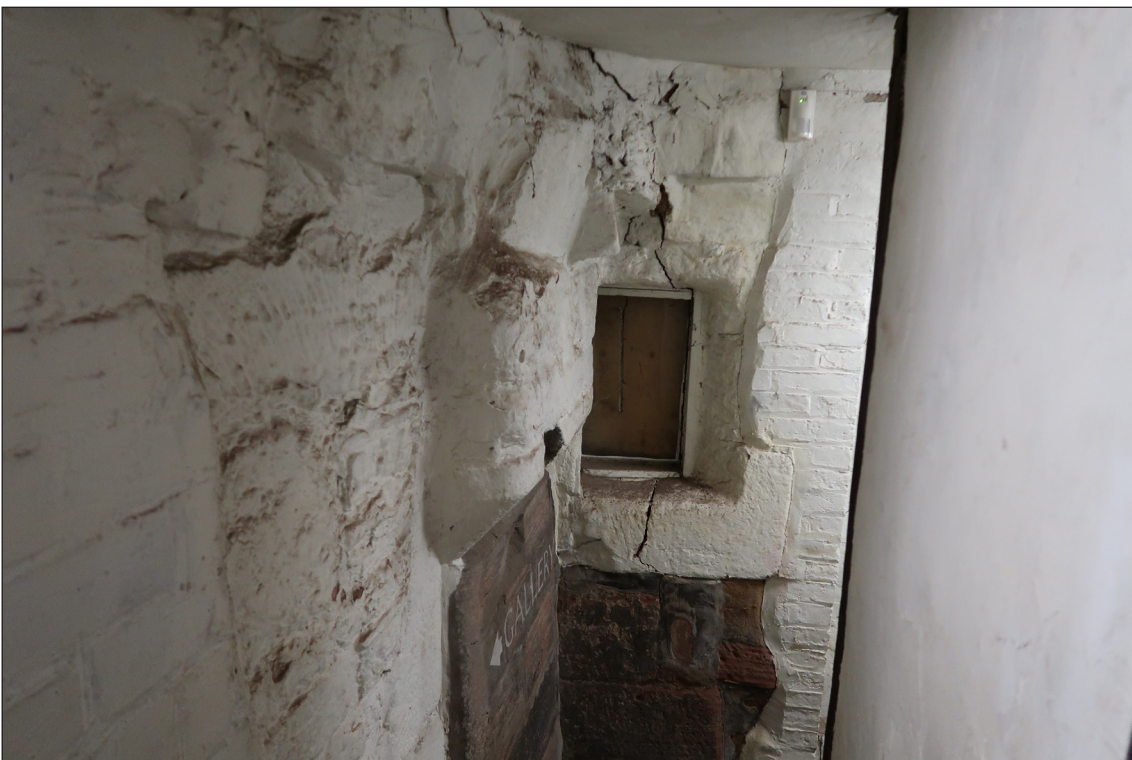
Figure 20 Interior, east elevation, ground floor, north room, showing jamb of doorway and stonework around the high level window feature. [Rebecca Lane © Historic England]

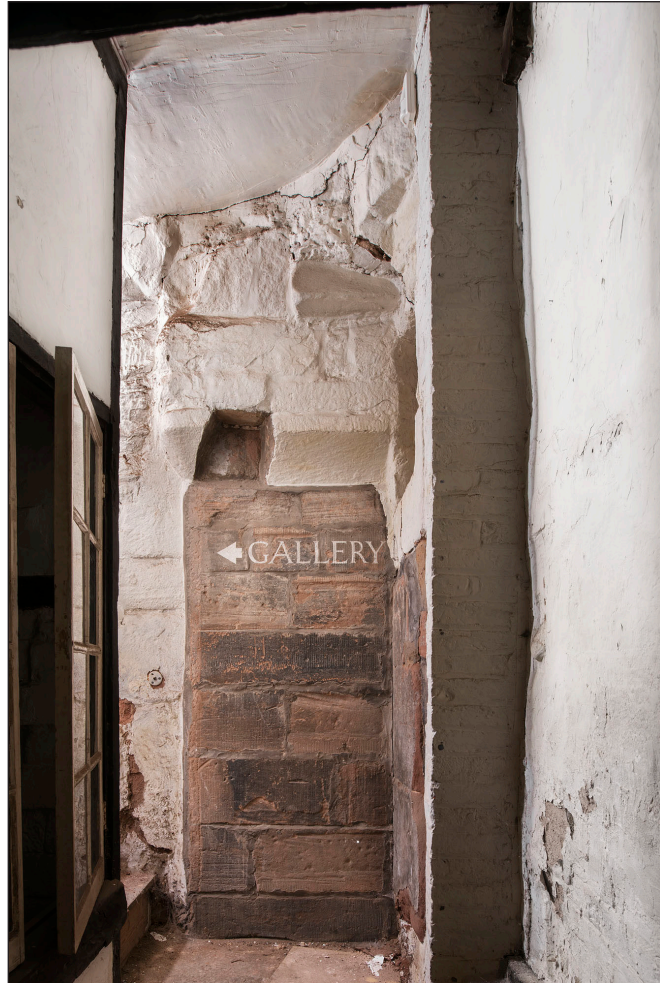
Above the square-headed northern doorway a carefully shaped stone corbels out from the internal wall face (Figure 21). This has a chamfered lower edge and apparently a flat top, which supports a series of projecting stones. Immediately above the corbel this forms two rows of regular, coursed stonework, and then above this, rising towards the current ceiling level, are a series of more irregular stones which have clearly been cut back at a later date. What these stones originally related to is unclear. On the basis of comparison with other gatehouse structures of similar date,

Figure 21 Interior, east elevation, ground floor, north room, detail of projecting stonework over blocked doorway. [DP219919]

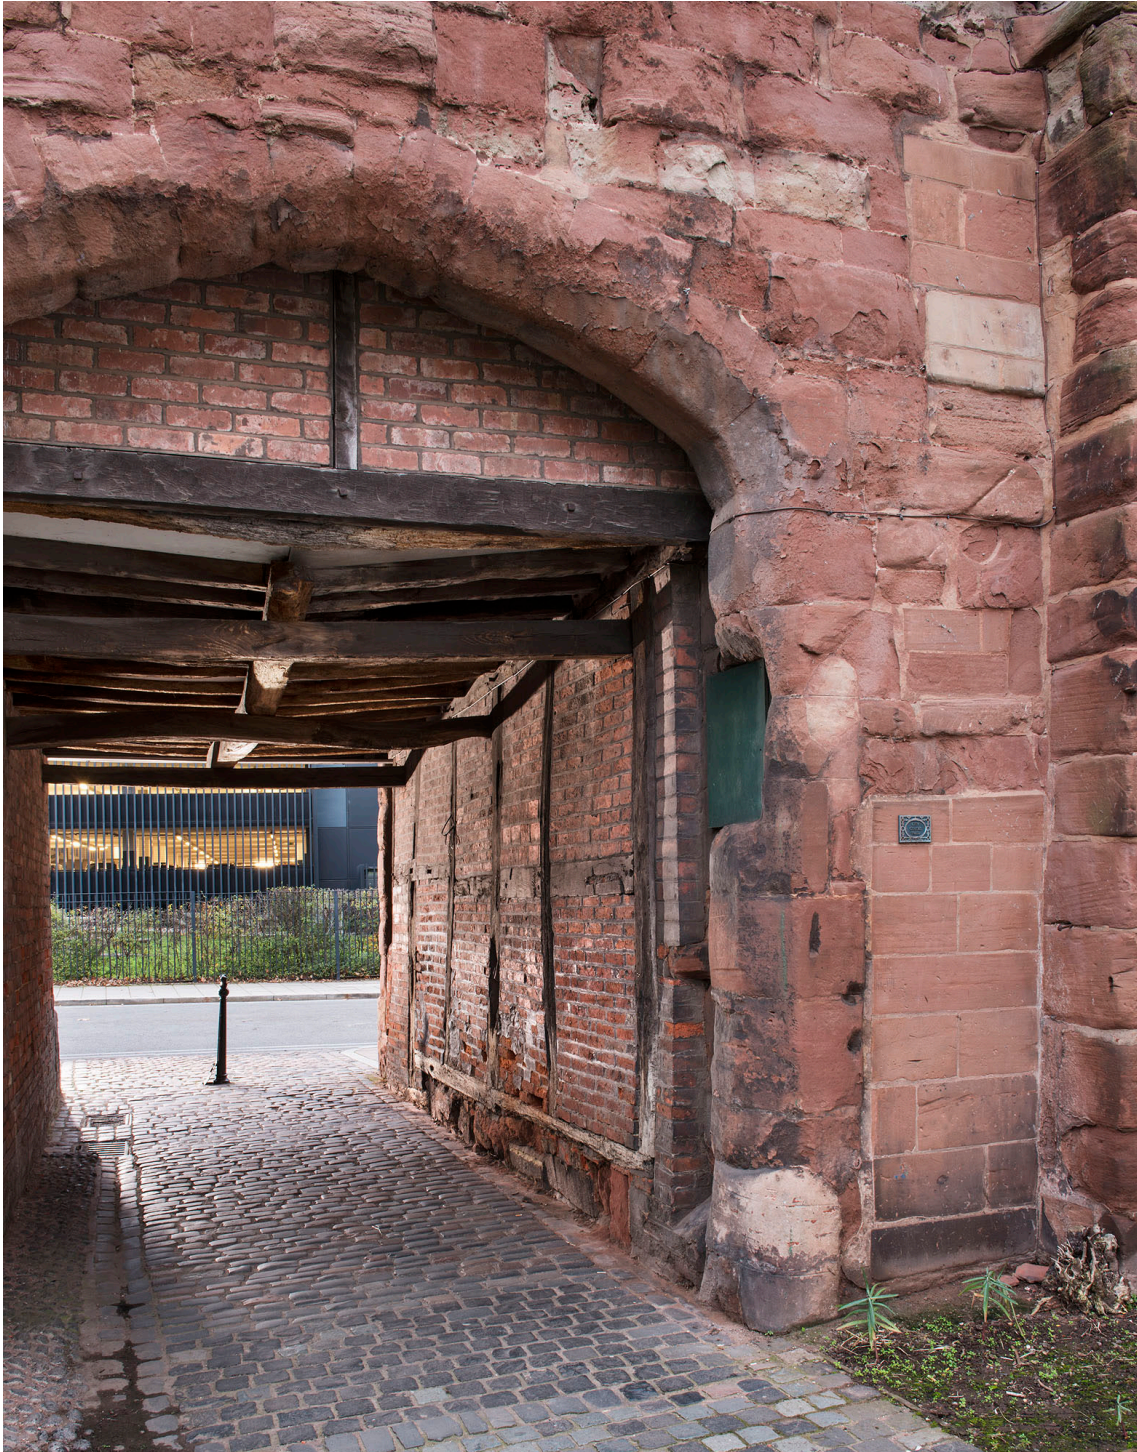
Figure 22 Exterior, east elevation, showing window opening cut through gateway arch jamb and the blocked doorway opening and intermediate window opening above. [DP219942]

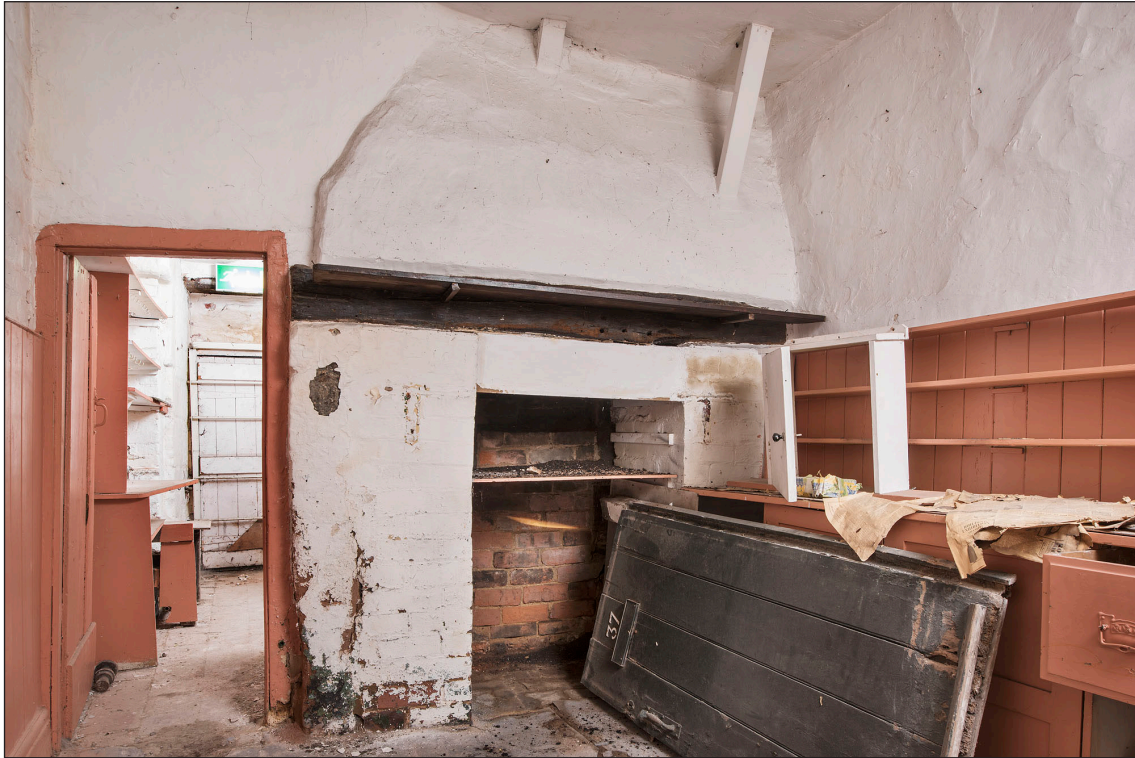
Figure 28 Interior, ground floor, south room showing inserted fireplace. [DP219912]

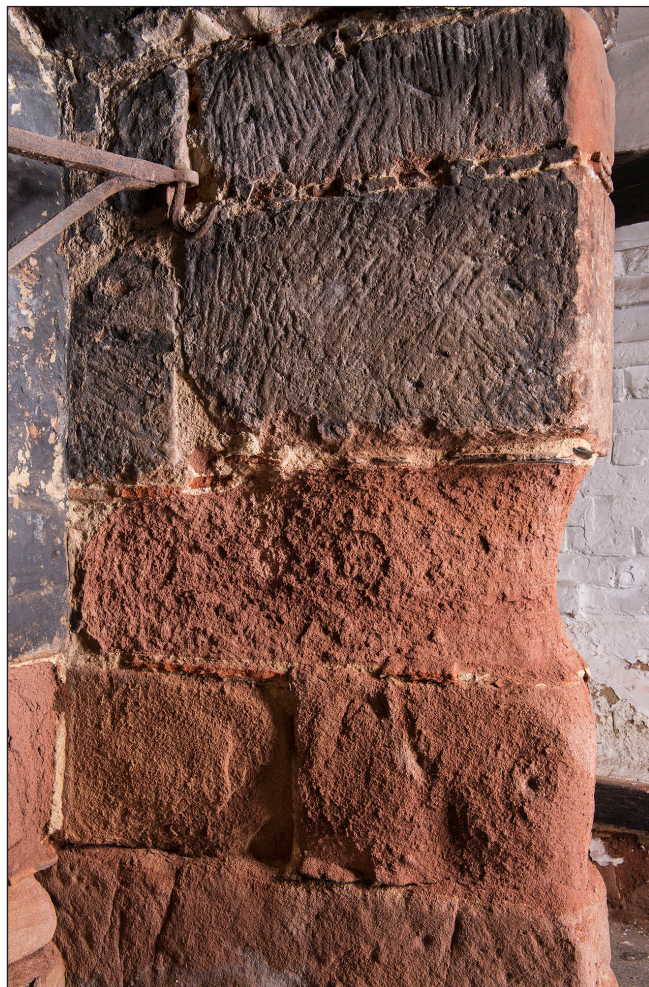
Figure 29 Interior, ground floor, north room, detail of south jamb showing small sections of brick and other ceramic building material used during construction. [DP219922]

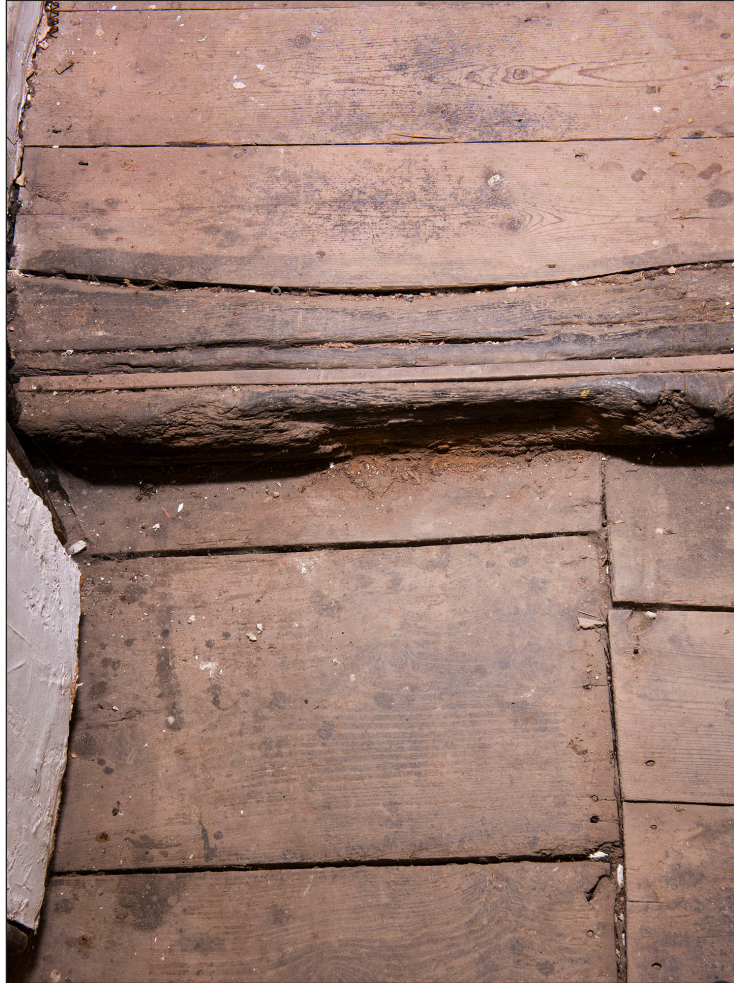
Figure 31 Interior, first floor, north room, detail of transverse partition running through the building. [DP219902]

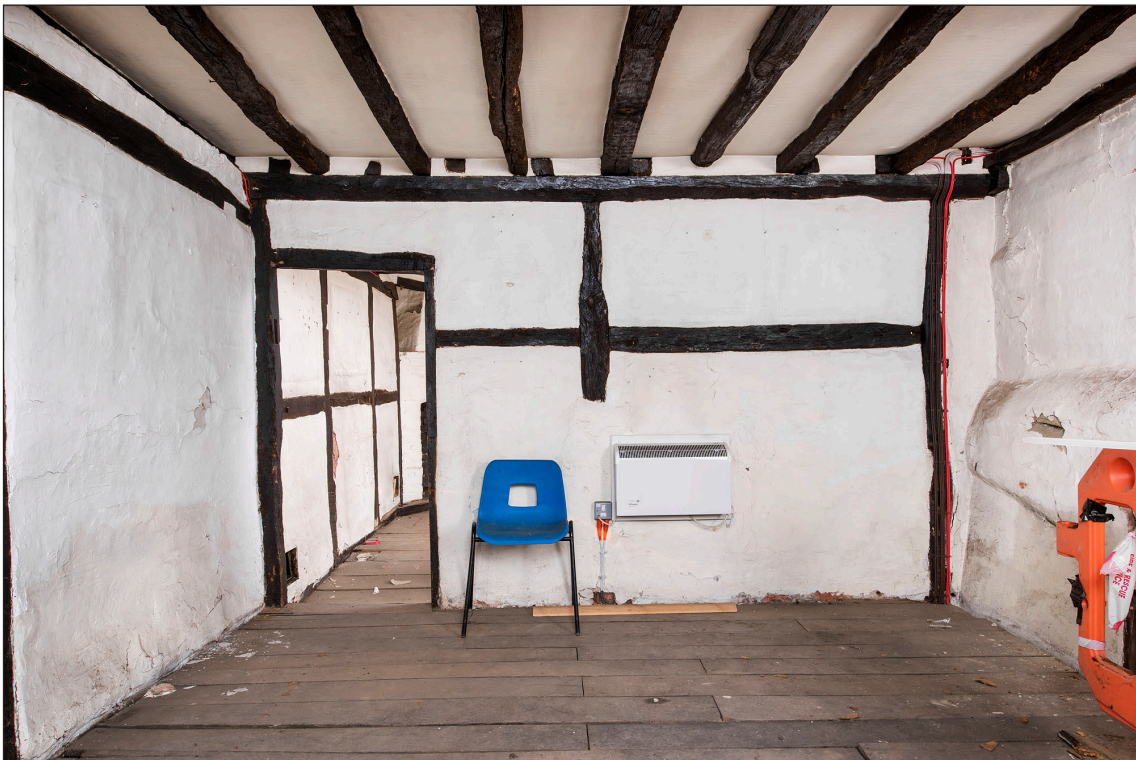
Figure 32 Interior, second floor, north room showing detail of central truss. [DP219895]

These first-floor rooms were also open to the roof structure above. The roof structure itself is formed again of reused timber. Originally it comprised three trusses, with end trusses over the north and south walls, and a central truss, which is structurally part of the transverse timber-framed subdivision running through the building at first-floor level. Both the north and south trusses have subsequently been altered, but the central truss represents a better survival (Figure 32). It is of a simple framed form, with a tie beam and slightly raking struts supporting the collar. There are also further smaller struts providing support for the partition and suggesting that the truss was always closed. All of the timbers show signs of reuse, with the struts clearly showing residual notches or lap joints, for example. The tie beam has a large scarf joint towards its western end, a structurally problematic position, which strongly suggests that the timber was not originally cut to span this space. The tie beam is attached to the wall plates which run along the east and west elevations of the building by metal straps, a further sign that the timbers do not form part of a medieval phase, when they would be much more likely to be properly jointed.

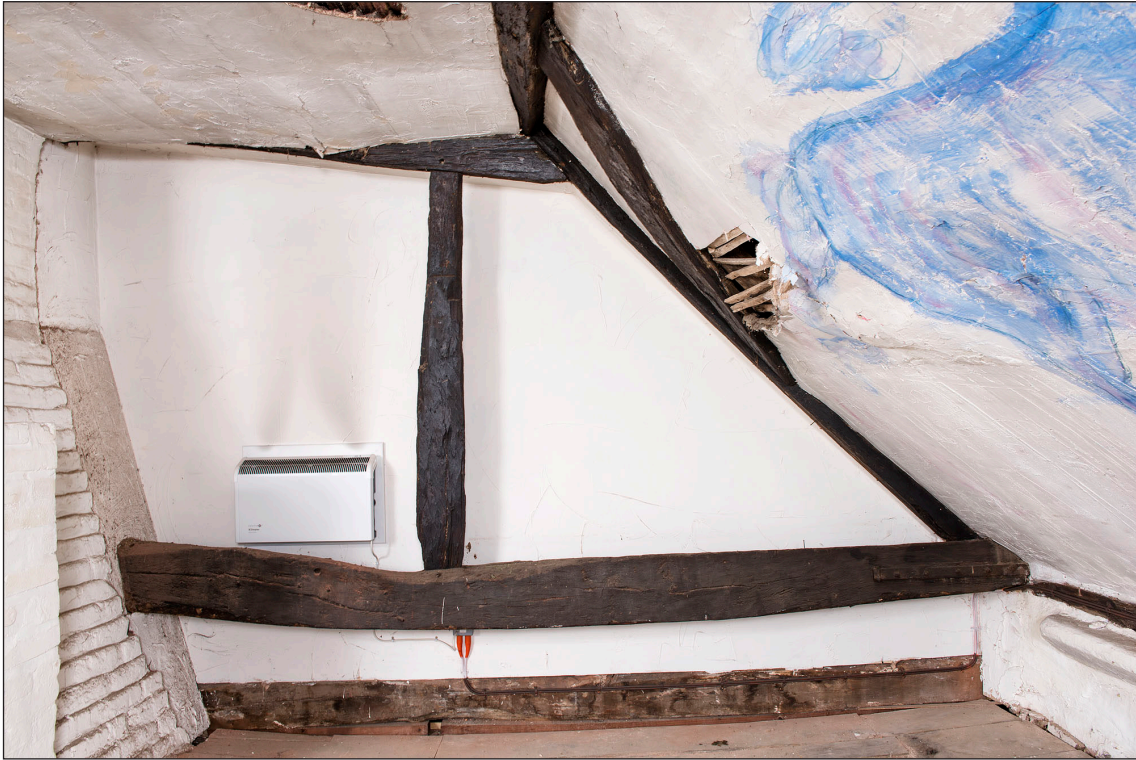
The southern truss now comprises a tie beam and collar, both of which sit slightly inwards from the later south wall (Figure 33). The north truss similarly comprises a tie beam and collar (Figure 34). The trusses support a single purlin to both the east and west, resting on the back of the trusses at collar height. Wind braces rise from each truss to the purlins, and there are residual holes for further braces at

Figure 33 Interior, second floor, south room, showing detail of south truss. [DP219887]

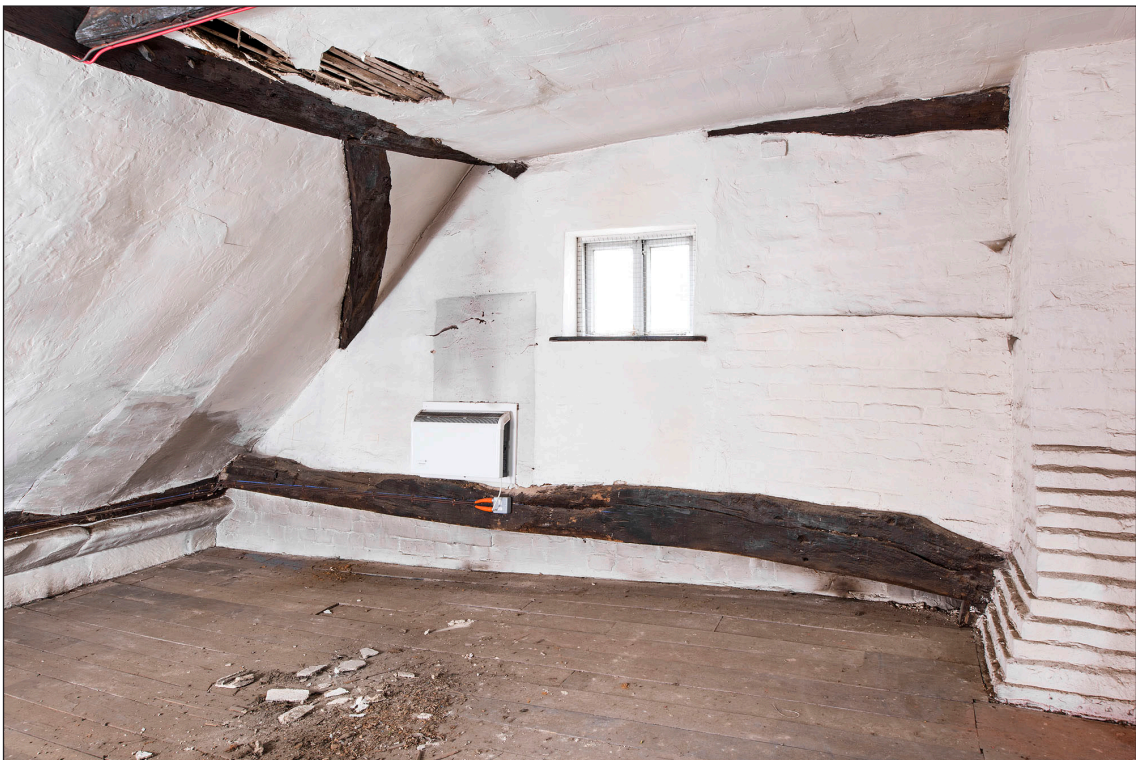
Figure 34 Interior, second floor, north room, showing northern truss. [DP219896]

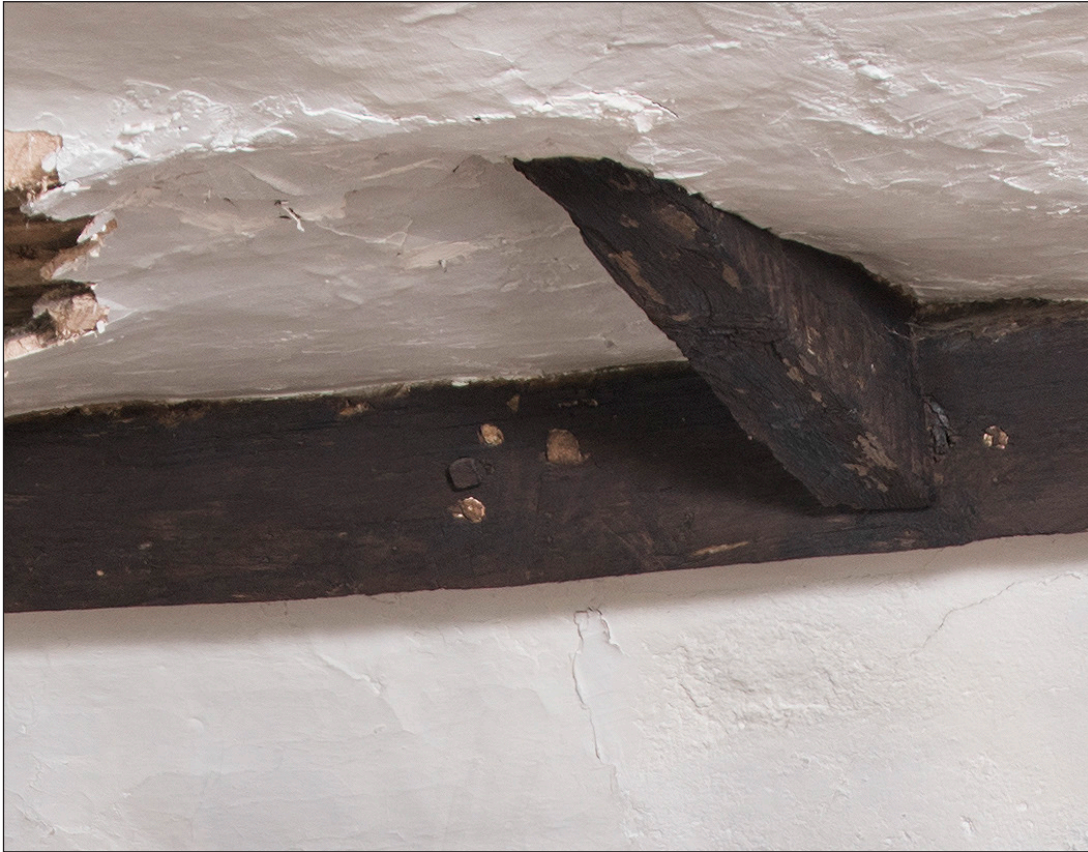
Figure 35 Interior, second floor, detail of purlin on south side, showing redundant peg holes. [DP219891 crop]

intermediate points on the purlins (Figure 35 and *see* Figure 17). Wind braces in these intermediate positions could not have worked with the present roof structure, however, as there is no timber for them to have risen from (unless they ran all the way from the wall plate, which is an extremely unlikely arrangement). Thus it seems probable that the purlins and extant wind braces are reused from an earlier roof. Whether this roof was part of the gatehouse or came from elsewhere is unclear.

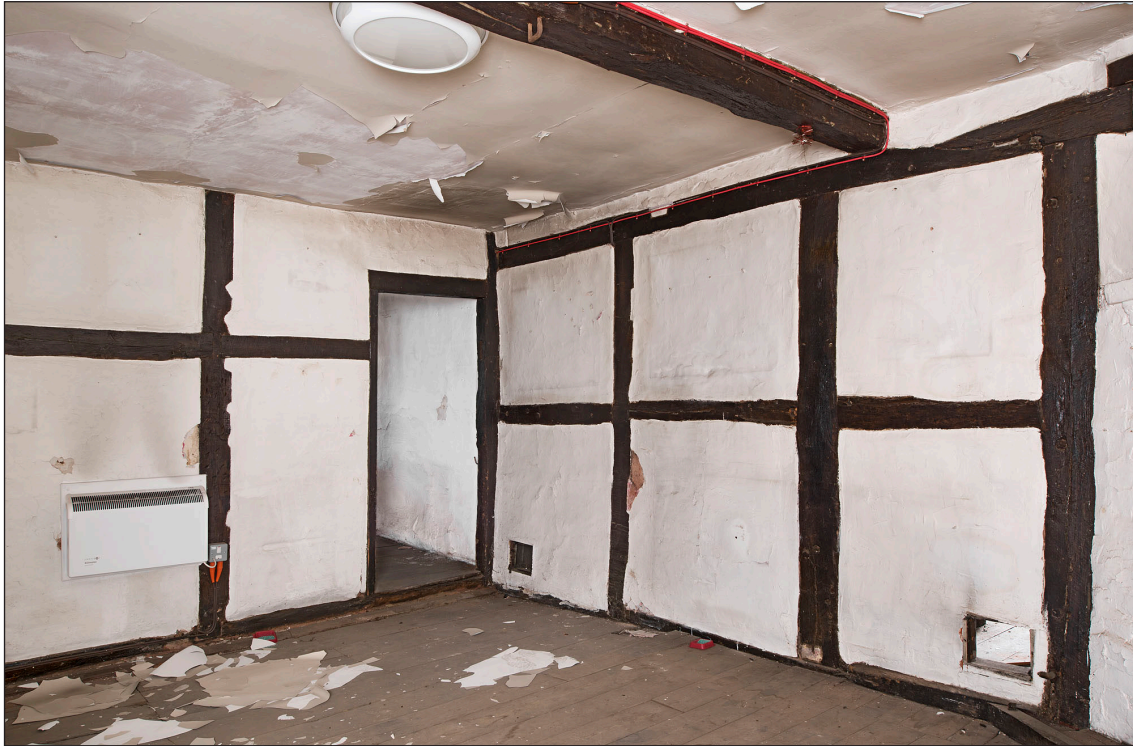
Figure 36 Interior, first floor, south room, showing detail of lateral partition running east to west through the building on the right, with later framing in the left-hand wall. [DP219909]
