Whitefriars Gate, 36-37 Much Park Street, Coventry: Historic Building Assessment

Research Report Series 021-2022

HISTORIC BUILDING ASSESSMENT

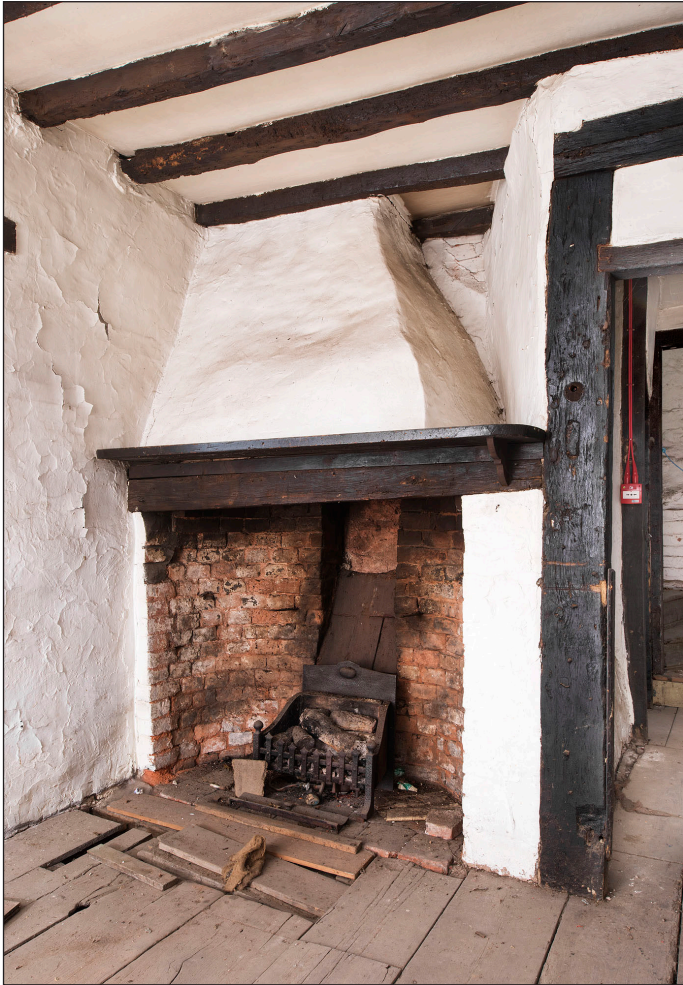
Figure 37 Interior, first floor, north room, detail of inserted fireplace. [DP219903]

This subdivision corresponds to (and therefore is likely to be the same date or slightly later than) the first-floor fireplaces. These are of similar form with hearth backs formed of bricks placed in a continuous curve, although that in the southern unit is located in a different position, angled in the corner of the west room, whereas that in the northern unit sits straight on (Figures 37 and 38). This may be to do with the chimney arrangement; possibly the southern fireplaces had a combined flue with the chimney in the next-door unit necessitating some compromise. The lateral subdivision also supports the inserted second floor, which sits below tie beam level of the Phase Two trusses. Instead the principal transverse beams for this floor are supported on the lateral subdivision, suggesting that the creation of the attic rooms happened at the same time as the creation of the first-floor partition. The subdivision of the first-floor and attic space would also have required a more substantial stair and it is probable that in this phase the present arrangement of stairs to the rear of the chimney stacks was established. Although later renewed, it is also likely that the dormer windows in the eastern part of the roof space were added at this time, as otherwise there would have been no means of lighting the second-floor rooms.

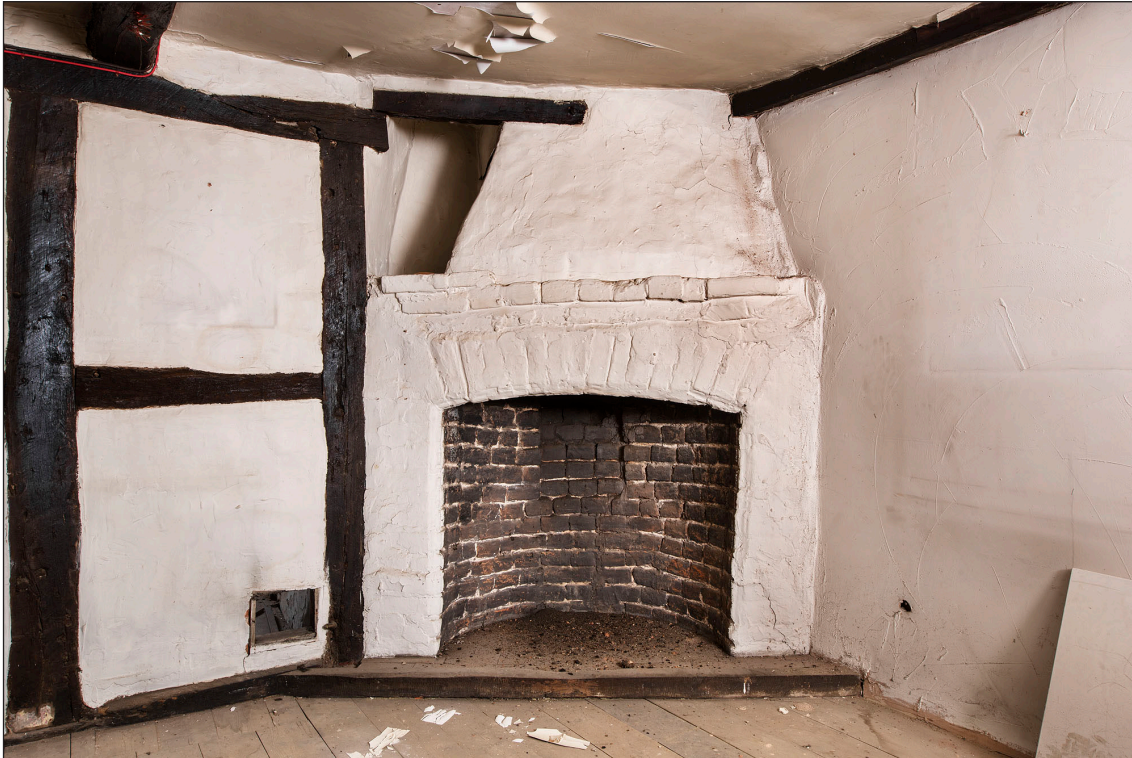
Figure 38 Interior, first floor, south room, showing inserted fireplace. [DP219903]

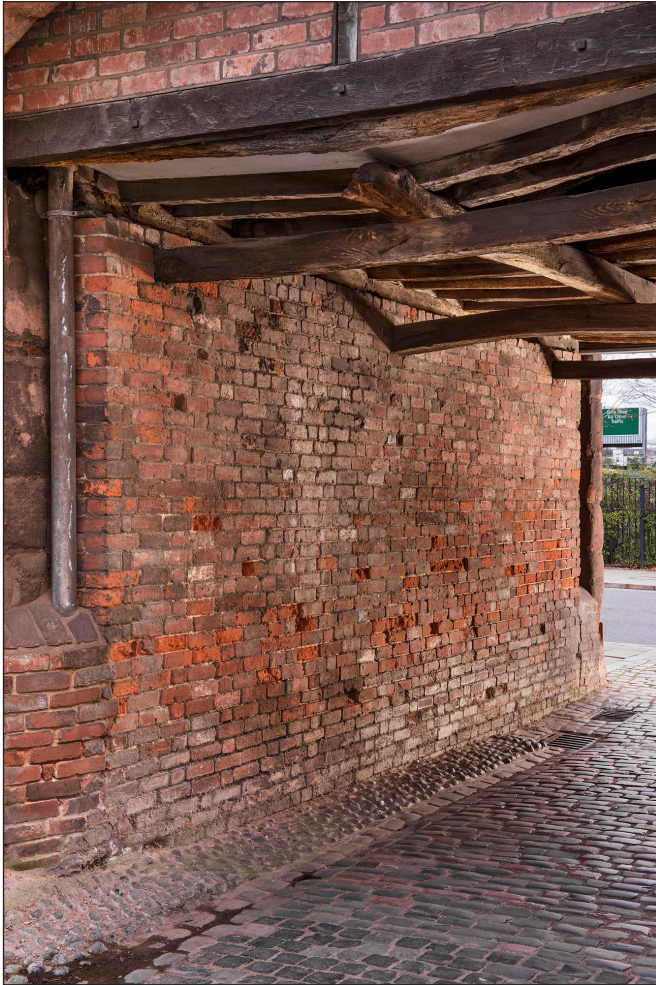
Figure 39 Exterior, south wall of passageway showing brick reconstruction. [DP219944]

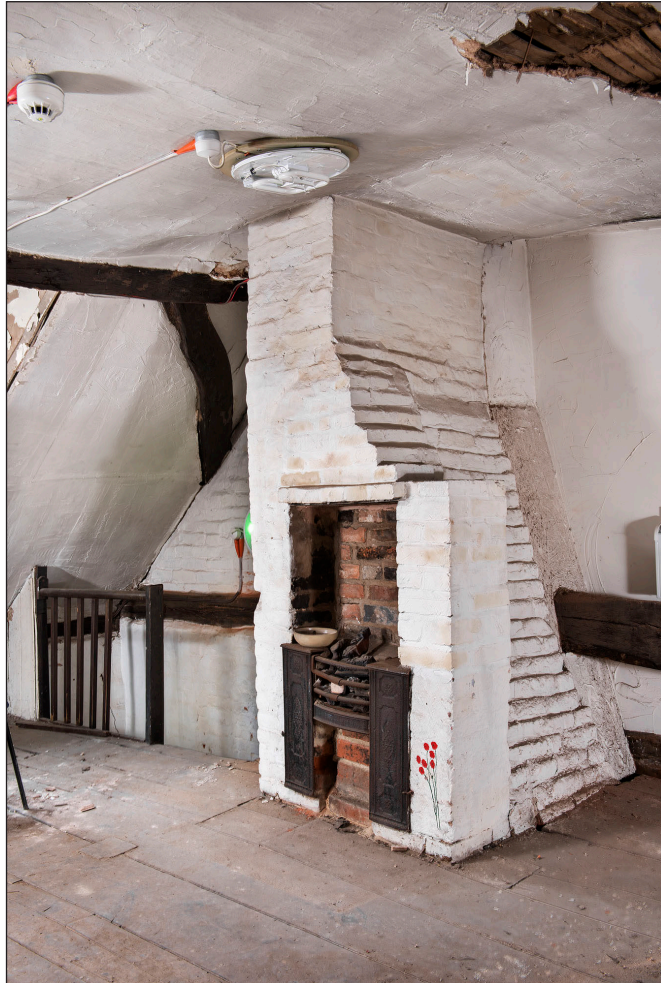
Figure 40 Interior, second floor, south room, inserted fireplace. [DP219886]

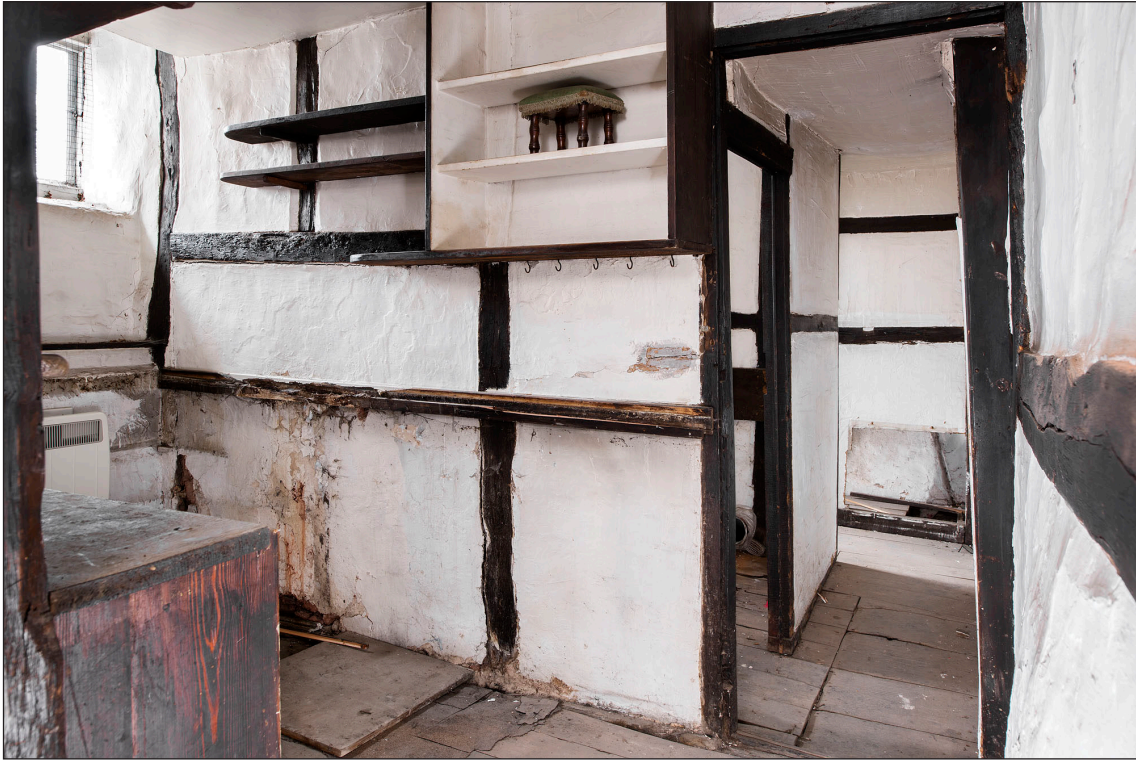
Figure 41 Interior, first floor, 20th century partitioning. [DP219898]
