Historic England

# Rain Noise: Acoustic Tests on Terne-Coated Stainless-Steel Roofing

Roberts Consulting

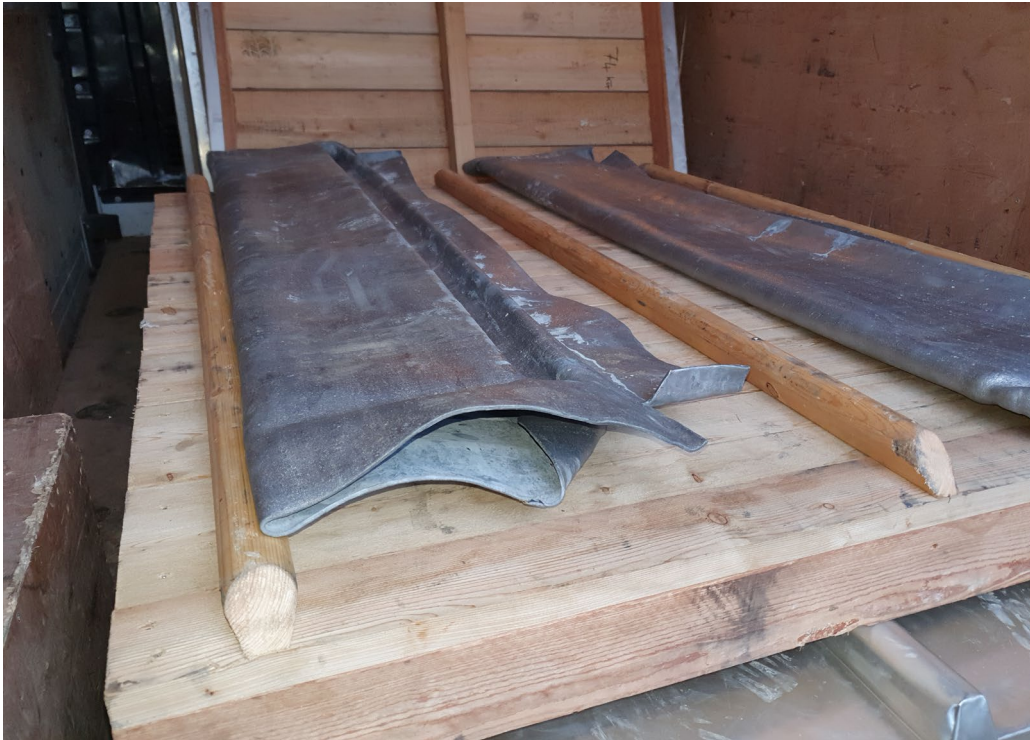
*Photo A1: Sample 1 – lead batten roll, no underlay*

3.4 Lead sample 1 was included as a reference to compare the basic acoustic performance of fully supported lead and TCSS roofing. Once assembled, the sample would be too heavy to transport to the laboratory. Consequently, JTC Roofing Contractors installed the lead at the laboratory.

3.6 Historic England prefers batten roll seams for church roofs as they more closely match historic detailing. The capped batten roll detail adopted in samples 1, 3, 4 and 5 was similar to detail D30 in the FTMRC good practice guide.

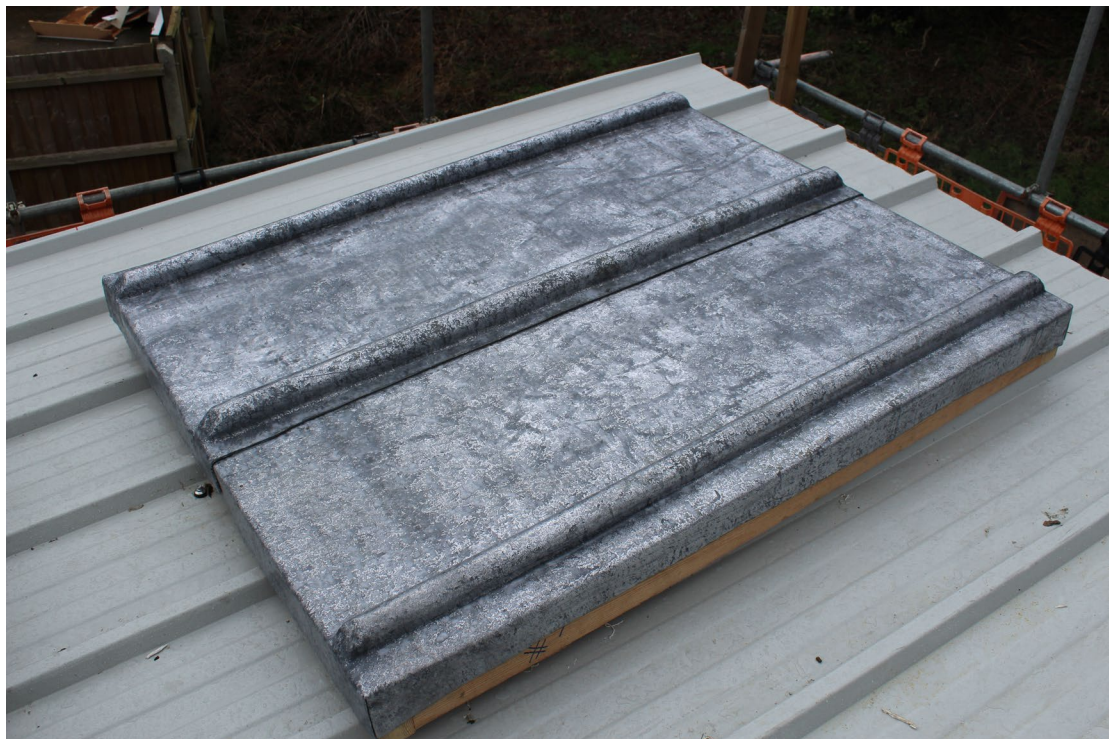
*Photo A2: Sample 1 – as laid on top of test roof*

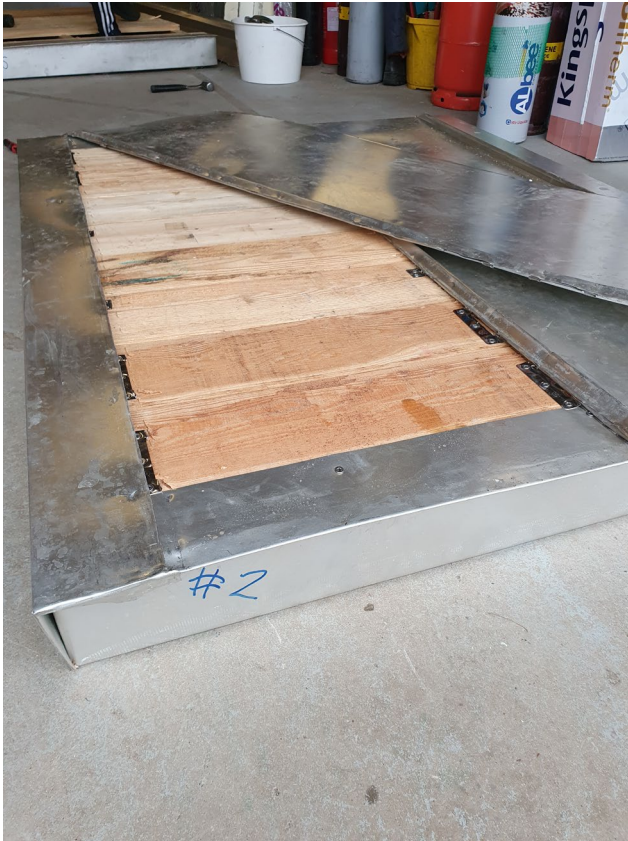
***Photo A3: Sample 2 – TCSS standing seam, no underlay***

3.5 Standing seam joints are often used in TCSS roofing. The double-locked seams (25mm high) for sample 2 were formed in accordance with detail D25 in the FTMRC UK Guide to Good Practice in Fully Supported Metal Roofing and Cladding, 3 edition, FTMRC (2018).

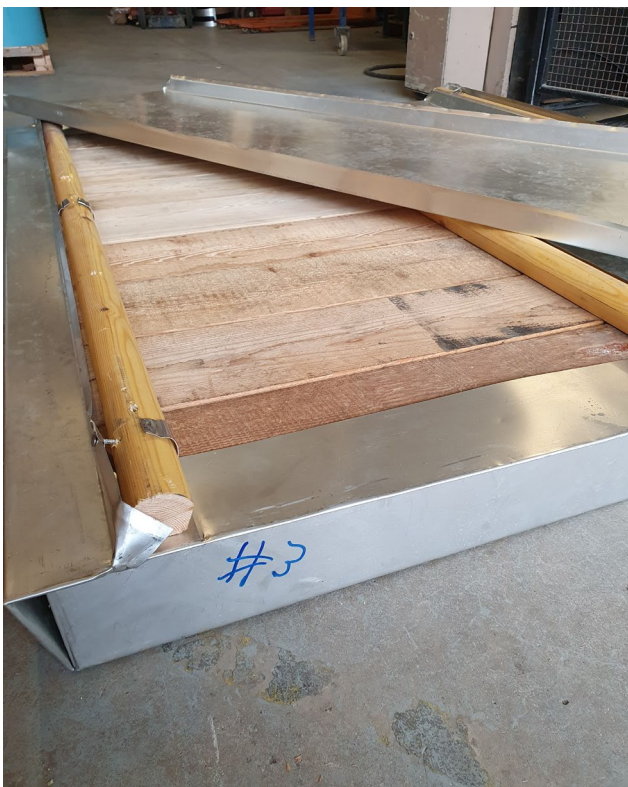
***Photo A4: Sample 3 – TCSS batten roll, no underlay***

- 6.3 For fully supported TCSS roofing, changing from standing seam to batten roll joints, with no underlay, reduces rain noise by 1.3dB. The recorded sound intensity for the batten roll construction was 70.9dB.

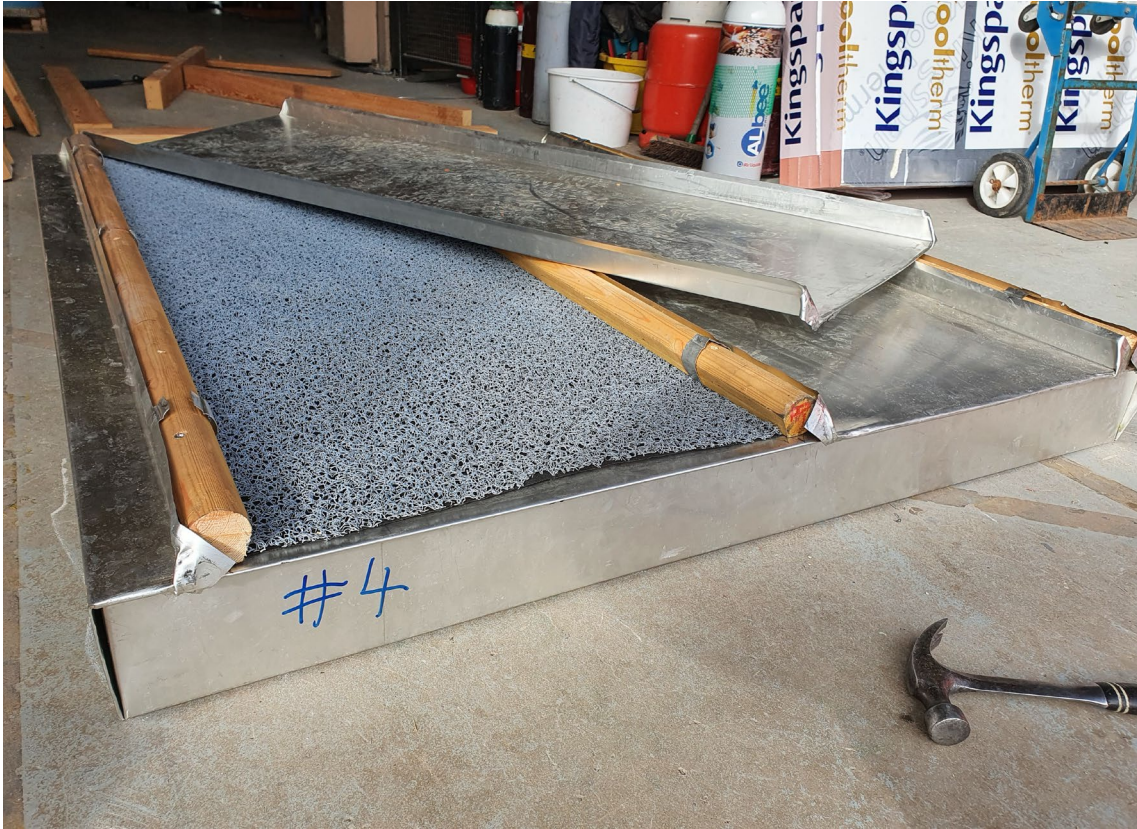
*Photo A5: Sample 4 – TCSS batten roll, spiral mesh underlay*

- 1.5 To address the noise issue, the metal roofing industry has developed several different products that can be laid below TCSS roofing. One option is to use a spiral mesh underlay, placed on top of the wooden deck and directly below the TCSS sheet. This comprises an open fibre mat, up to 8mm thick, with a breather membrane underneath. Concerns have been raised that the air within the mesh can act as a sound box, potentially amplifying the drumming noise.

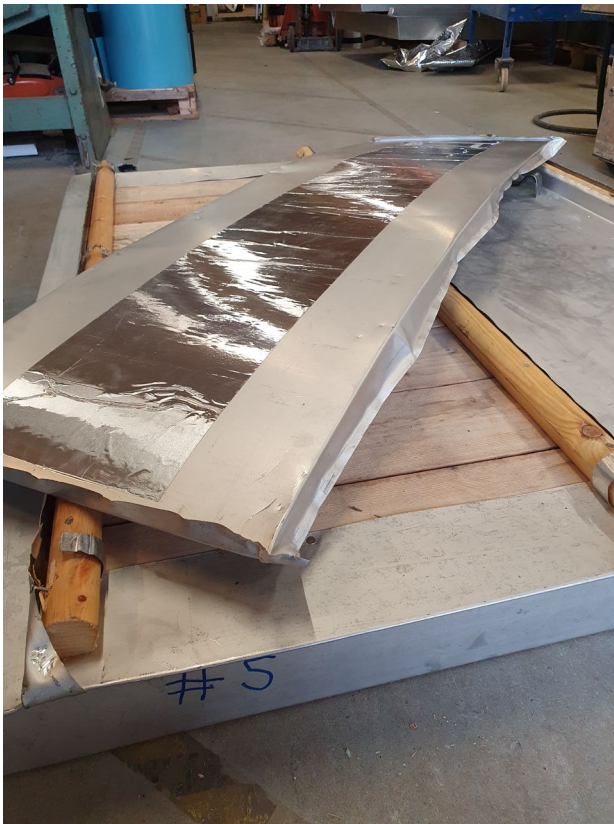
*Photo A6: Sample 5 – TCSS batten roll, adhered acoustic mat*

- 1.6 An alternative is to use a thick acoustic mat that is adhered to the underside of the flat pan of the roofing. The bonded mat increases the stiffness of the metal, thus reducing the rain noise.

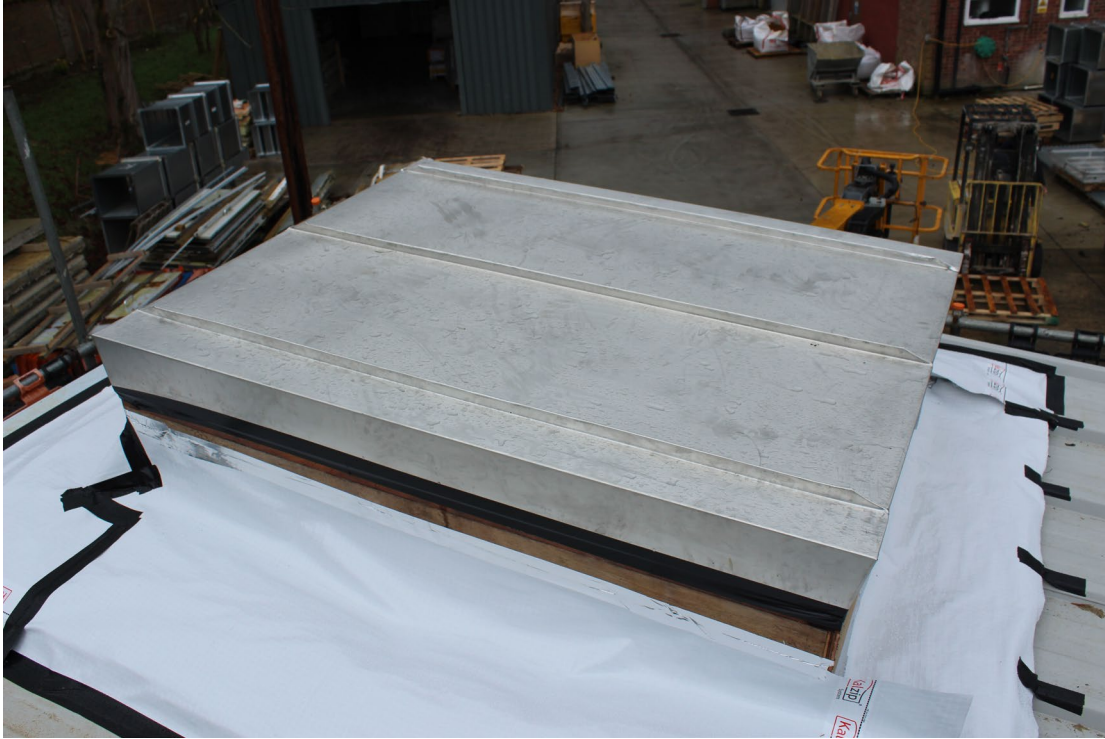
***Photo B1: TCSS roof sample mounted on roof of acoustic test room***

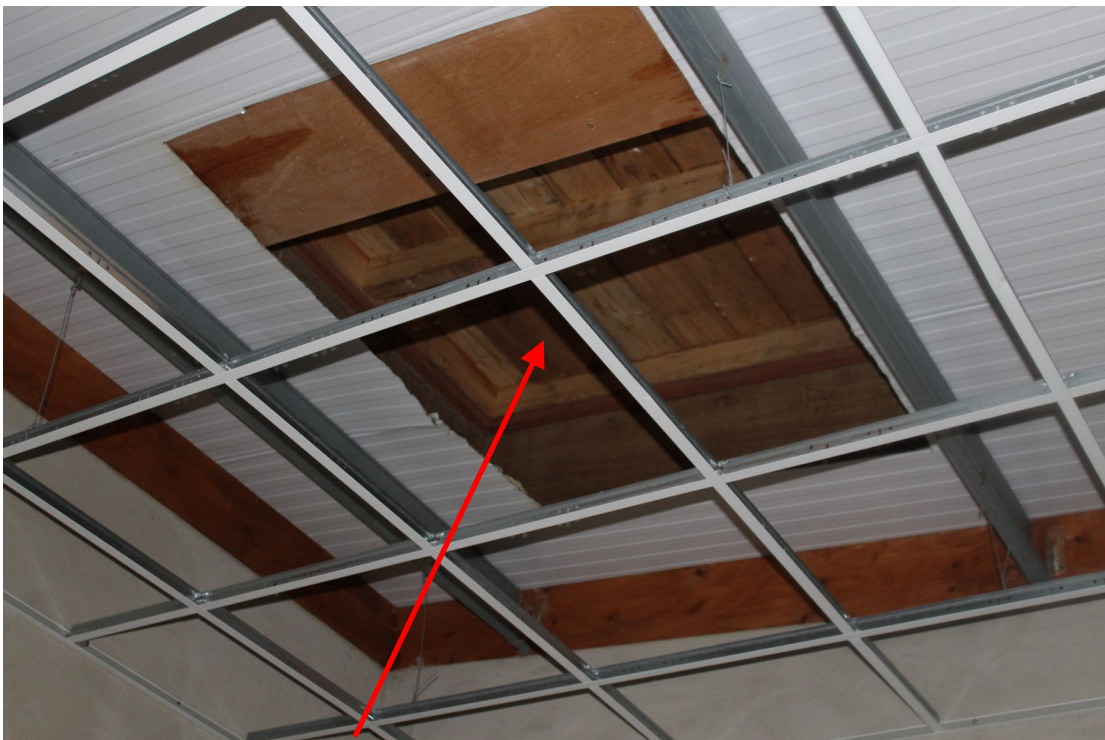
**Photo B2: Underside of roof sample with timber deck, seen from within acoustic test room**

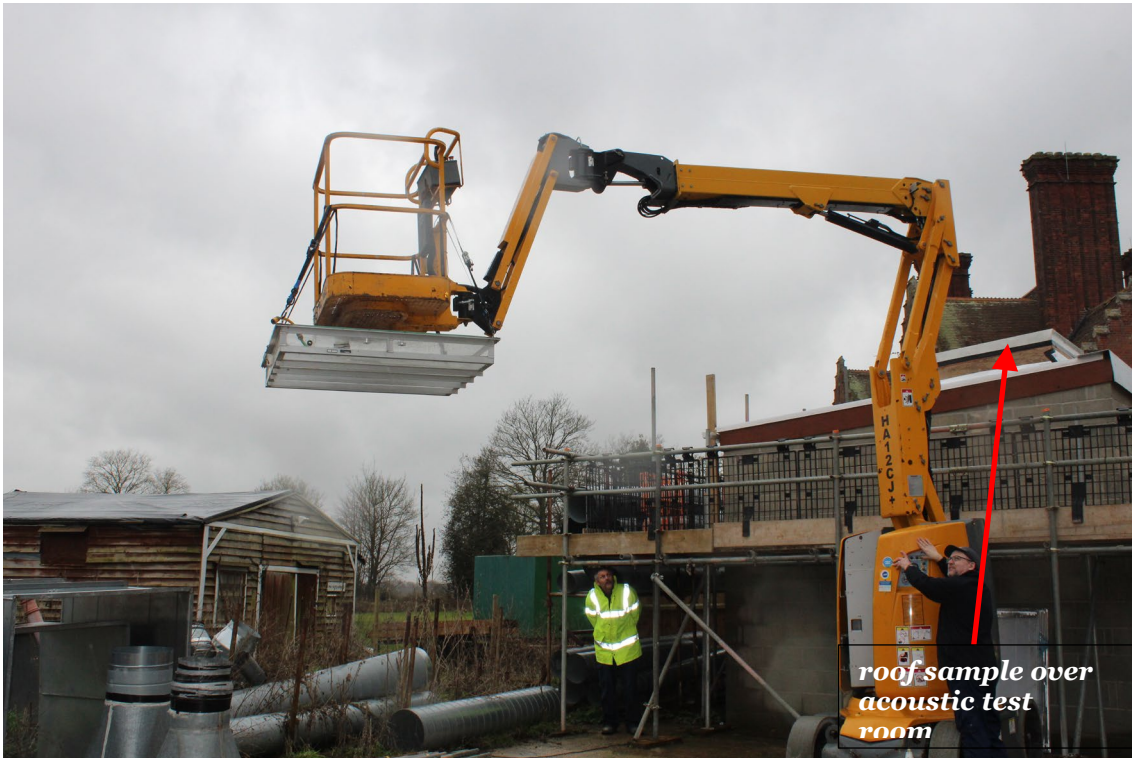
**Photo B3: Water tank suspended below mobile platform before being put in position**

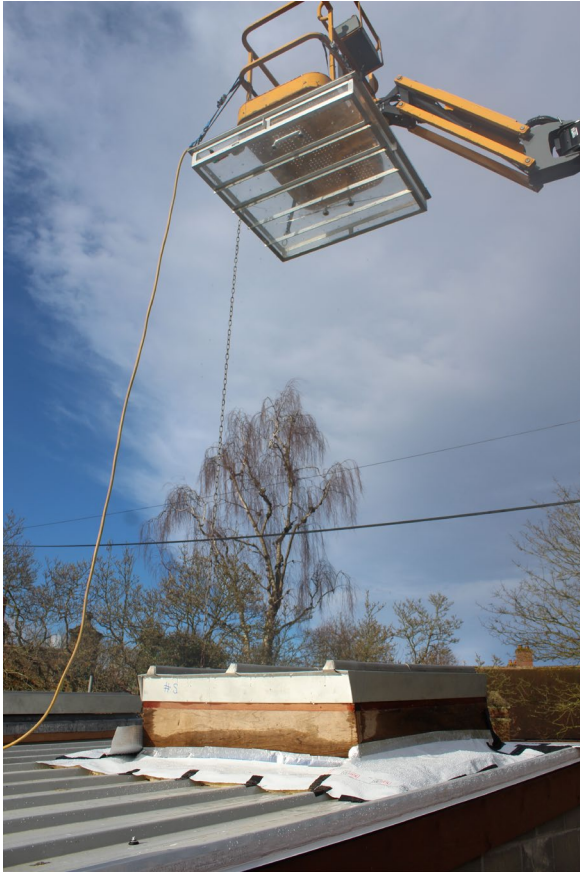
***Photo B5: Water tank suspended 3.5m above roof sample, water supplied by hosepipe***

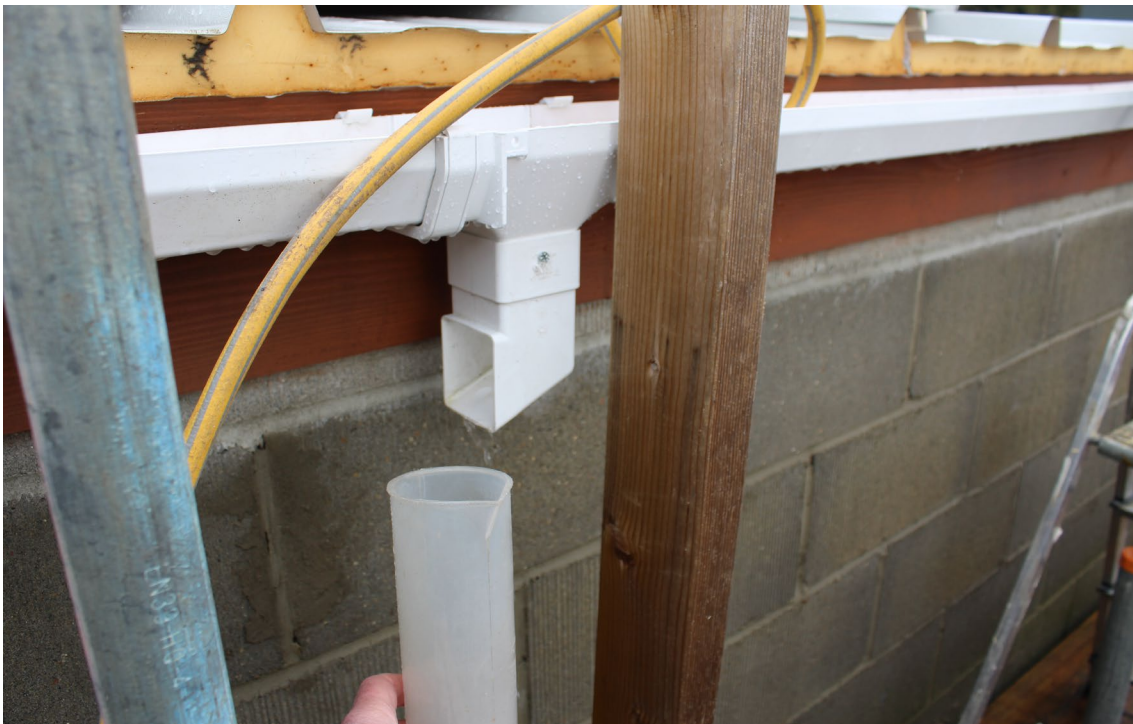
***Photo B6: Rate of water flow is checked by collecting water as it drains from test room gutter***

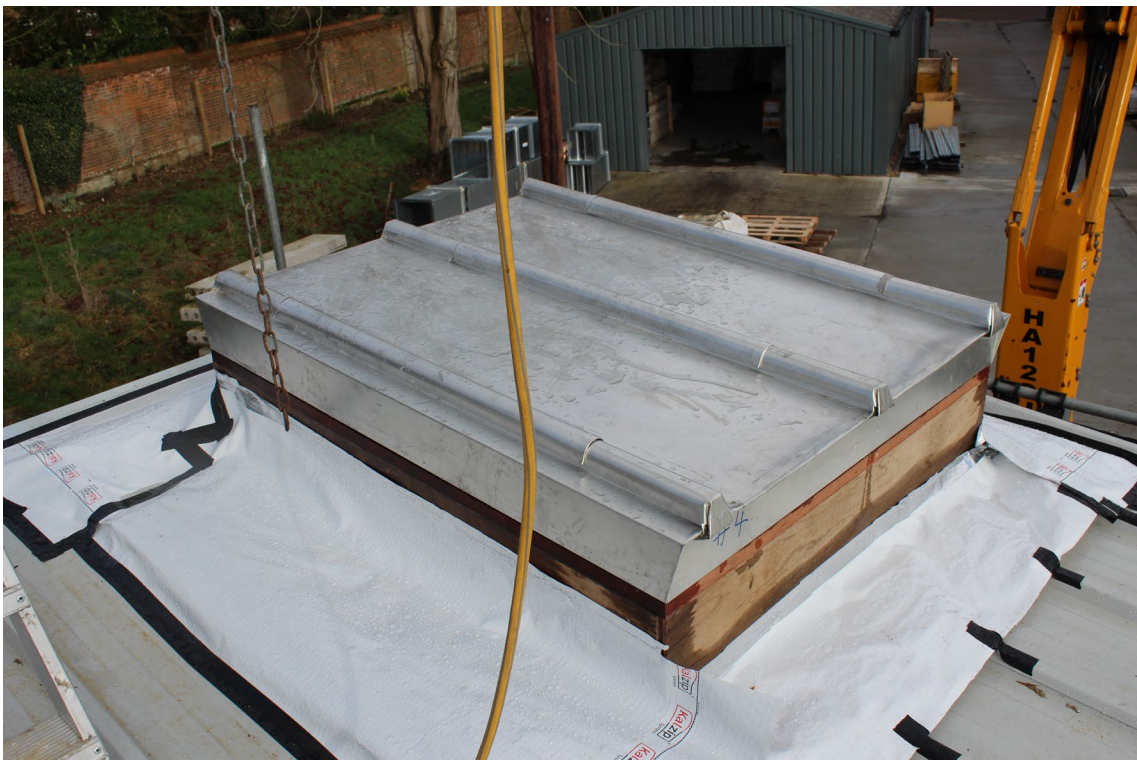
***Photo B8: Follow-on roof sample, ready for testing on 19 February 2021***

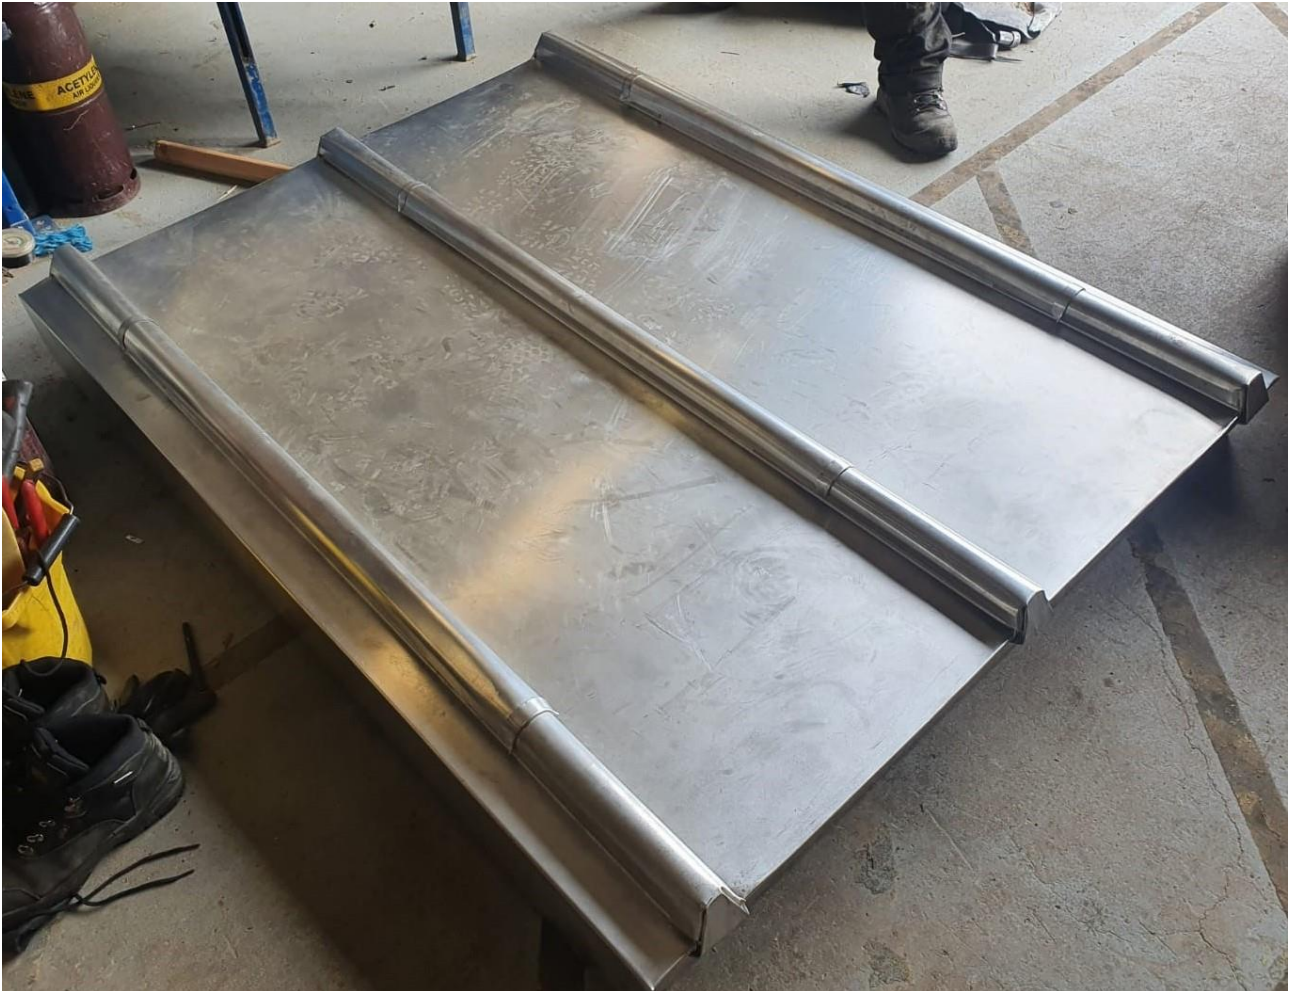
## Photograph 1

**View of 0.5mm TCSS Batten Roll Seam sample**

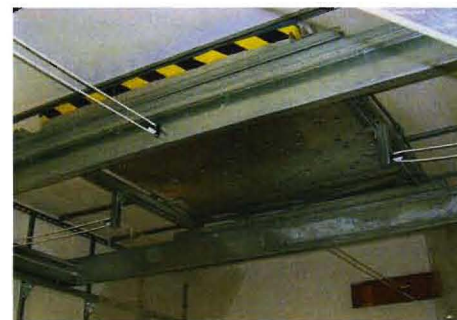
Photo: Underside of water tank with perforated base of the new BRE rain noise measurement rig. (Source: BRE)

A water tank with 25 or 60 holes in the base is suspended at a height of up to 3.5m above the test specimen. Water is supplied to the tank such that there is a constant head of water flowing in a steady state condition. The BRE rig allows for the water tank to be moved to at least three different areas of the test specimen.
