# COLDHARBOUR MILL

### HISTORIC BUILDINGS REPORT

## COLDHARBOUR MILL UFFCULME DEVON

**OCTOBER 2001**

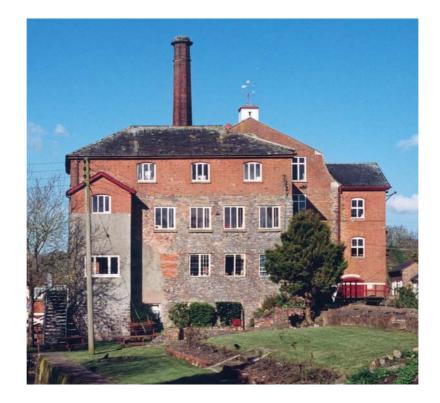
Fig 2. The grist mill from the east. Parts of the lower walls and the north end probably date from before c1800.

The grist mill contains structural evidence of extensive alterations and some rebuilding, and it is likely that substantial parts of the building date from after it ceased to be used as a grist mill in the 1790s. The earlier parts are of stone rubble and the late 19th-century additions of red brick (Fig 2, p6). Internally the building has inserted ceilings and plastered walls which probably obscure other evidence. Externally the fenestration is divided into six window bays, but internally the timber floor structure comprises four wider bays. Most of the timber floor beams have been re-used and do not match the spacing of the windows, indicating that the floors are probably of later date than the walls. The building is of four storeys, the top storey and the roof having been added in the late 19th century.

The north end and the adjoining part of the east elevation may be the earliest parts of the building. In the north end wall, the segmental head of a blocked opening is located just above the footpath along the embankment of the adjoining head race, indicating that this part of the building pre-dates the present form of the race. The four north end bays of the east side wall, below the top storey, appear to be contemporary with the end wall. These bays have small square windows with internal splays and some retain opening wooden casements which could date from before c1800.

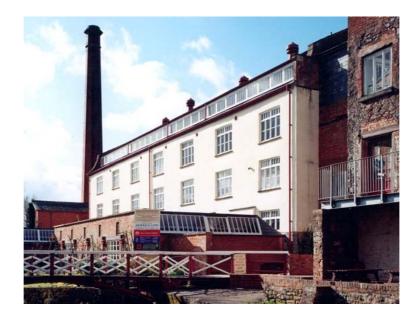
Fig 3. The main mill from the south east. The lower three storeys date from c1800.

The main mill is of four storeys including the attic and is built to a long rectangular plan of fourteen bays (Fig 3, p8). It is entered by a wide door in the base of the stair tower attached to the east end of the north side. Each of the storeys may originally have been open from end-to-end, but a brick cross-wall of mid- or late 19th-century date now segregates the east end bay of the lower two storeys. A two-storeyed extension is attached to the north side and

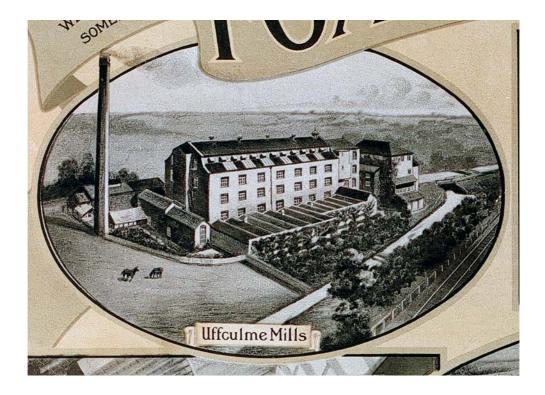
Fig 5. Illustration of Coldharbour Mill in c1900, from a Fox Brothers' advertisement.

A Fox Brothers poster of early 20th-century date includes an illustration of Coldharbour Mill as it appeared in c1900 (Fig 5).<sup>18</sup> This shows an extension added to the south end of the beam-engine house and the extant free-standing chimney. The Second Edition 25" plan, revised in 1903, shows both features and indicates that the boiler house was similar in plan to that shown on the 1887 plan. The c1900 illustration also shows the boiler house roof extending eastwards up to the end wall of the mill. The horizontal engine house, which replaces part of the original east end of the boiler house, was added in 1910.<sup>19</sup> The nature of the other alterations which were carried out when it was built is indicated by physical evidence (see Buildings Report). The 25" plans also show a small greenhouse attached to the south side of the boiler house, the foundations of which were exposed at the site in June 2001.

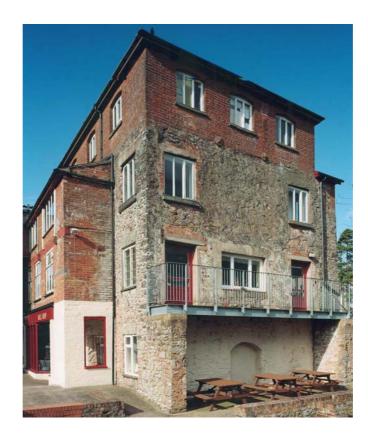
Fig 7. South end of the grist mill.

The south end of the building shows more evidence of reconstruction, but may include the site of one or more waterwheels. The south end of the east elevation comprises a projecting tower which appears to be a later addition. The tower is shown on the 1887 25" plan but not on the 1841 Tithe Map. Its width matches the spacing of the inserted floor beams. The adjoining south end wall seems to be contemporary with the tower, and includes a central blocked arched opening which may indicate the position of a former wheel shaft.

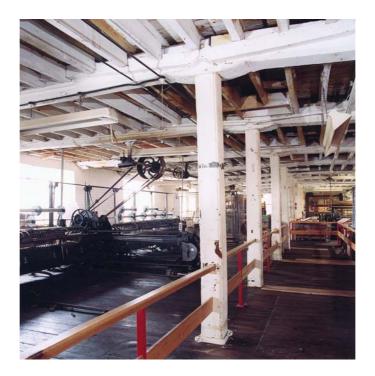
Fig 8. The first floor, showing original timber props and top pads with later reinforcement to beams and joists.

The floors are of joisted timber construction and retain most of the original beams and joists, although the floor structure was extensively reinforced in the late 19th century. The modifications included the replacement if the original boards. The spacing of the floor beams alternates between about 9 feet 6 inches in the wide bays and 7 feet 10 inches in the narrow bays (typical measurements). The two-piece beams are scarfe-jointed in the centre<sup>29</sup> and in the upper floors are still supported by a central row of square timber props with rectangular wooden top pads. The props have a beaded edge moulding and appear to date from c1800. The beams in the ground floor and the east end of the first floor are supported by cast-iron columns of late 19th- or early 20th-century date. The former use of timber props in these areas is indicated by the chamfers on the beams, which stop to either side of the position of the former wooden top pads. Some of the beams in the ground floor are also supported by additional square timber props which are probably not original.

Most of the original beams and joists show evidence of significant warping and all have been reinforced at a later date. The method of strengthening is unusual and may have been carried out when heavier machinery was installed in the mill. The beams have been strengthened with the bolting of long angled square-section timbers to each side, extending from the soffits at the outer ends of the beams to the top edge of the beams in the centre of each span. The ends of the angled side pieces are located in small cast-iron brackets bolted to the beams. The intention seems to have been to create a shallow truss structure to counter the downward warping of the beams. One possible advantage of this technique was that it retained the original headroom in the mill. Contrasting methods of floor strengthening have been noted in textile mills elsewhere, usually coinciding with the installation of new machinery.<sup>30</sup> In many cases, however, beams were strengthened by the addition of a system of trussed iron tension rods beneath the soffits, resulting in a reduction of headroom. The outer ends of the beams at Coldharbour are supported by cast-iron soffit plates fixed into the walls; these appear to part of the modification, since they also support the cast-iron brackets which locate the ends of the angled side pieces. The original joists have been cut-back to give clearance to the side pieces but were not removed. The floorboards are now supported by a second layer of joists which have been inserted above the level of the original beams.

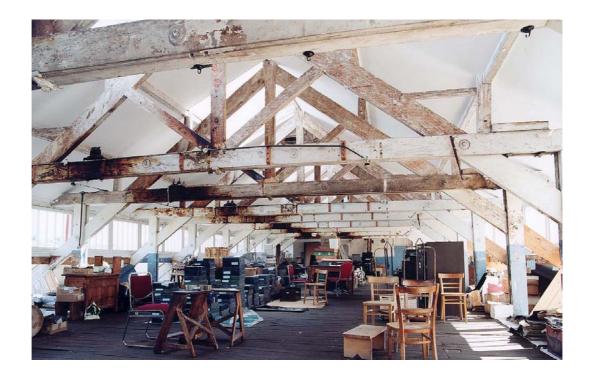
Fig 9. The attic from the west end.

The attic storey was probably added in the late 19th century, in the period when other extensions and the steam-power system were also being added. The raised sections of the end walls take the form of a Dutch gable and are built in a lighter red brick than that used in the ends of the lower storeys. The attic floor is supported by timber beams which have been bolted directly on top of the earlier beams in the third storey ceiling. The roof trusses are of

an unusual design which creates a spacious attic while supporting full-length dormer windows. They are of bolted construction comprising deep principals with a bolted-on collar supporting a short king-post with angled struts. The collars project outwards beyond the principals to support the full-length dormers. The outer ends of the collars are supported by paired queen-posts, which are bolted onto both faces of the principals. The rafters run from the tops of the dormers to the roof apex and are supported on two ranks of purlins on short vertical posts mounted on the principals. Although the design of the trusses is unusual, the method of assembly, and the use of tie-beams bolted directly on top of the original third-storey ceiling beams, indicates that the roof was probably added in the late 19th century.

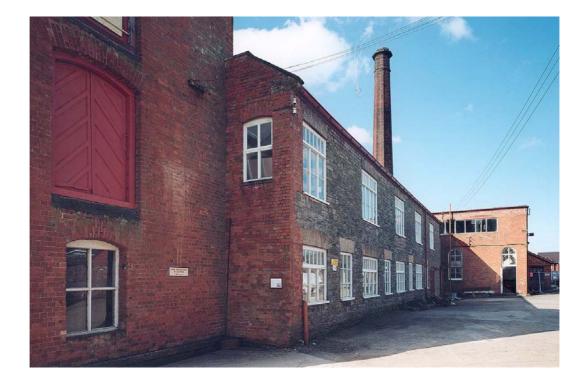
Fig 10. The north side extension added to the corner of the stair tower. 1910 engine house in the background.

The north side extension is of two storeys and was originally adjoined the twelve bays from the stair tower to the west end of the mill. Its west end bay was later replaced by part of the 1910 engine house. At the east end, a straight joint indicates that the extension was added to the stair tower, suggesting that the top storey and the attic were built before the extension. The external wall is of coursed rubble, obtained from a different source to that used in the wall of the main mill. Like the combing shed, the north extension also seems to have been built in two phases of similar date. A slight change in the angle of the coursing can be discerned between the fifth and sixth bays from the east end, indicating the presence of a structural joint. Internal, the joint is reflected in differences in the first floor beams. Those to the east of the joint are probably slightly earlier, comprising one-piece beams which have bolted-on side-pieces to support the joists. To the west of the joint, paired beams are used which are bolted to central metal flitch plates.

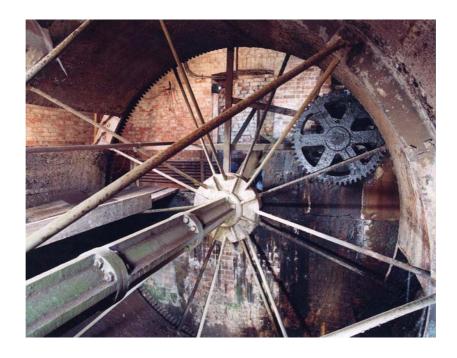
Fig 11. Interior of the waterwheel, showing the ring gear and pinion wheel.

The *in situ* power transmission system comprises a ring gear with internal teeth bolted to the western shroud of the wheel, with a four-foot diameter pinion wheel taking the drive to a small gear chamber inside the mill. This use of a ring gear and pinion was common to all suspension wheels, but in this case the components of the power transmission are later replacements. The ring gear has been obtained from another wheel and the shroud was modified to accept it.<sup>34</sup> The cast-iron pinion has H-section arms and probably dates from the very late 19th or the early 20th century.

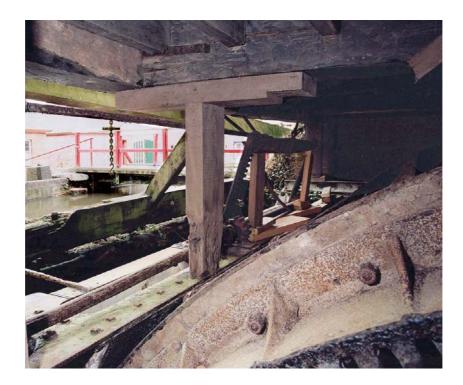
Fig 12. West shroud of the wheel, showing the rack and pinion mechanism of the penstock.

The penstock which controlled the flow of water in to the wheel also appears to be wellpreserved, although most of it is inaccessible below the water level in the headrace.<sup>33</sup> It spans the full width of the wheel, comprising a rack-and-pinion sluice mechanism mounted on a heavy timber beam. The mechanism appears to be intact, and was operated from a small lean-to brick building in the angle between the wheel house and the mill. An additional control for the sluice mechanism was located inside the mill. This is also intact, comprising a system of horizontal shafts which were bevel-geared to the penstock from the ground-floor room adjacent to the south end of the wheel chamber; this room may have been the site of a governor to maintain a constant power output from the wheel. The entrance to the penstock is protected by a curved iron grill in the headrace. A similar grill in this position is shown on the 1834 map.

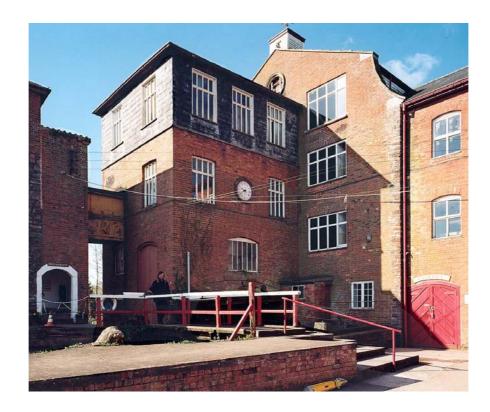
Fig 13. The wheelhouse from the north east.

The wheelhouse is of Flemish-bond red brick. It comprises two storeys above the wheel chamber itself, with joisted floors supported by pairs of heavy north-south timber beams. Structural evidence confirms the documentary evidence that it has been added to the end wall of the mill. The south side wall abuts the mill wall and the north side wall cuts across a former opening, possibly a window, in the mill wall. The walls in the upper part of the central storey are of a lighter red brick and appear to have been raised or rebuilt at a later date. The top storey has slate-hung walls, which could also be an addition.<sup>35</sup> The wheel chamber contains evidence of an earlier structure pre-dating the wheelhouse. The adjoining end wall of the mill includes an angled cement mark which probably indicates the former position of a pitched roof above the southern half of the wheel pit. At the north end of the wheel chamber, the brickwork of the extant walls is built against the brickwork of an internal plinth, which may also be a remnant of an earlier structure.

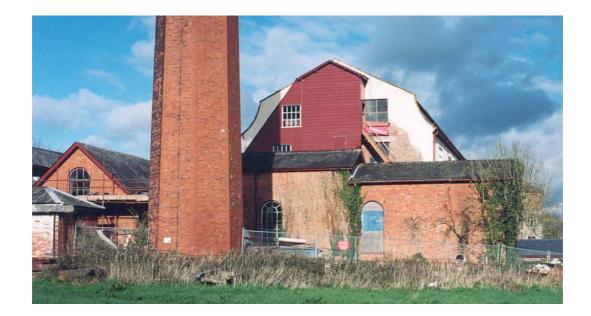
Fig 14. The west end of the site, showing (L - R) the economiser, boiler house, chimney, beam-engine house, rope race and beam-engine house extension.

The beam-engine house was later doubled in length by the addition of a full-height extension to its south end (Fig 14). The brickwork of the extension probably dates from the 1890s. The extant chimney was probably contemporary with the engine house extension. It is a typical free-standing octagonal design for the 1890s, built in brick and well-preserved with its original corbelled top. The 1904 25" plan and the c1900 illustration indicate that the chimney pre-dated the construction of the 1910 engine house, and physical evidence suggests that the flue of the 1865 boiler house was connected to another chimney which does not survive. The extant economiser house may also have originated in this period (J). A building of similar proportions is marked on the 1904 map, and it was later stated that the economiser at Coldharbour Mill dated from c1890 and was replaced in 1931-2.<sup>36</sup>

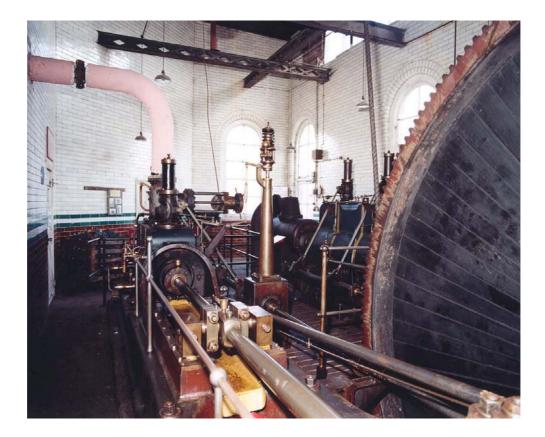
Fig 15. The 1910 engine from the south.

The final major alteration to the steam-power system was the addition in 1910 of a horizontal cross-compound engine and rope-drive system to replace the beam engine and upright shaft drive. The engine house and its 320 hp engine, by Pollit and Wigzell, have been preserved in working order (Fig 15).<sup>37</sup> The main components of the engine are arranged in a typical layout for the period, although new-built in other regions were often equipped with larger tandem cross-compound engines. The high-pressure cylinder and the governor are on the west side of the engine house and the low-pressure cylinder and condenser on the east side. The engine was positioned so that the central flywheel, which contains the grooves for the drive ropes, was in-line with the west end wall of the mill. As a result both the boiler house and the north side extension of the mill had to be modified when the new engine house was built.

The red brick engine house itself appears to be completely intact. The north end and east side are lit by the original sash-opening windows and the south end is open to the rope race. The internal walls are of glazed white brick. The pitched wooden roof is supported by steel trellis beams. The rope race is a sloping wooden structure attached to the west end of the mill, the south end of which is a separately-framed structure which may be the remains of the former upright shaft tower (K). The rope race still contains the rope pulleys attached to the ends of the line shafts on each floor of the mill, although most of the ropes have been removed. The shaft boxes supporting the pulleys appear to have been inserted when the rope race was built, and probably replaced the earlier supports for the upright shaft drive. In 1962 a system of 13 ropes was in use to drive all four storeys of the mill, the combing shed and an overhead line shaft passing from the engine house to the boiler house.<sup>38</sup> The latter drove the water feed pump for the boilers and the cleaning mechanism for the water tubes of the economiser, both of which remain *in situ*. The combing shed was driven from a second rope pulley on the mill's ground-floor line shaft. This remains *in situ* in a boxed-in rope race built into the west-end bay of the mill, with a drive rope running southwards to a pulley on the combing sheds main line shaft.

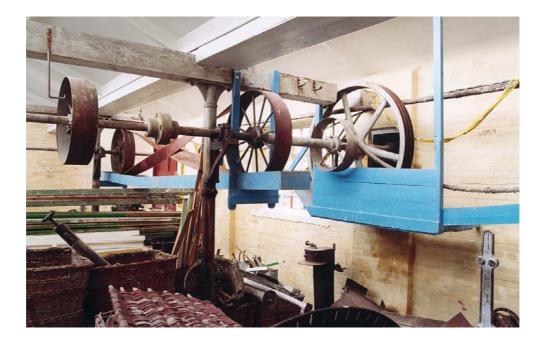
Fig 17. Rope drive system at the west end of the combing shed line shaft.

At the west end of the mill, steam power was transmitted via the rope race to the line shafting in all four storeys, and via a smaller rope race in the ground floor to the west end of the main line shaft in the combing shed. It is not clear why rope drive was used to transmit steam power and belt drives for water power. Museum staff claim that the relative proportion of steam and water power transmitted to the line shafts could be judged by observing the amount of slack in the drive ropes and belts.

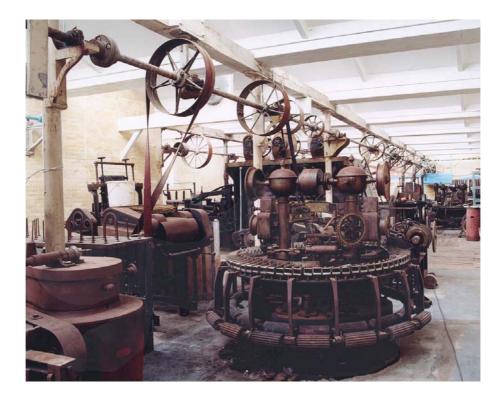
Fig 18. Gill box (left) and Noble comber powered by line shafting in the combing shed.

The initial cleaning and combing of the unwashed wool involved eight early 20th century opener gills made by Taylor Wordsworth and Co. The machines are currently stored in the north-west corner of the shed but were formerly powered by the two line shafts in the wider west half of the shed (see drawing 1/4 and 2/4). The wool was then transferred to a large backwasher located in the centre of the shed, in which it was cleaned further by passing it through a series of steam-heated rollers. This was followed by further gill boxes arranged to produce successively finer degrees of combing, after which the slivers of fibre were transferred to a Noble comber. This is a large circular machine in which a system of rotating inner and outer combs is used to separate the shorter fibres which are not wanted in worsted spinning. A final series of gill boxes and related machines in the east end of the shed involves further fine combing and the drawing and doubling of the slivers of fibre to produce the slubbing.

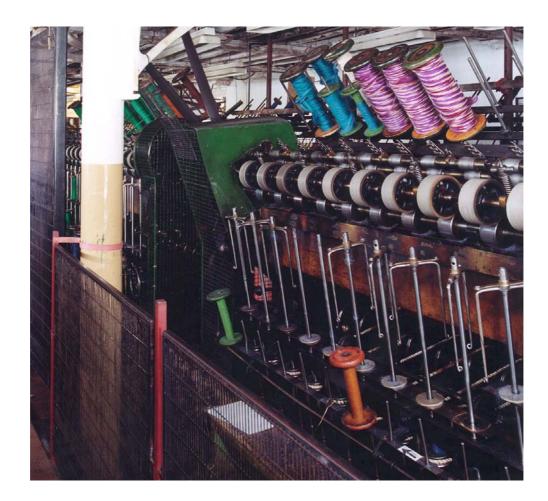
Fig 19. Part of a roving frame in the main mill.

The ground floor of the main mill retains many of the roving machines which were in use up to the mid-20th century. Most are of early 20th century date but one near the west end dates from 1898. The roving was gradually improved as it was passed through a succession of machines starting at the west end of the mill. The roving frames are arranged longitudinally, with two rows flanking the central row of columns and two more along each side wall.<sup>44</sup> They were formerly driven by belts from the central line shaft, with secondary line shafts suspended from the beam soffits to drive the outer rows of machines. The *in situ* machines are now driven by electric motors, in some cases with short line shafts which have been installed by museum staff. It is likely that in the late 19th century the whole of the ground floor of the main mill and the north extension was used solely for roving. In the late 1950s, however, a modern auto-levelling gill box and auto-levelling draw box were installed near the west end of the ground floor and other machines were later installed by museum staff near the east end. Some of the roving frames in the ground floor have recently been adapted for use as spinning frames.

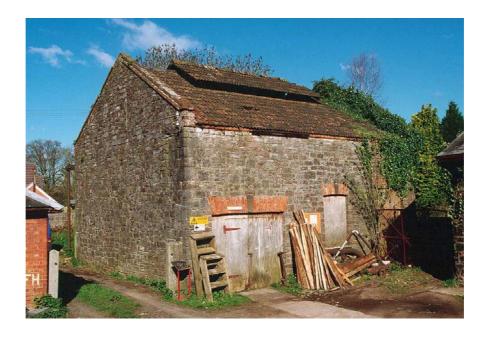
Fig 20. The gas retort house.

#### Gas Retort House (M, Drawing 1/4)
