North Walsham High Street Heritage Action Zone Aerial Investigation

Edward Carpenter

North Walsham
Norfolk

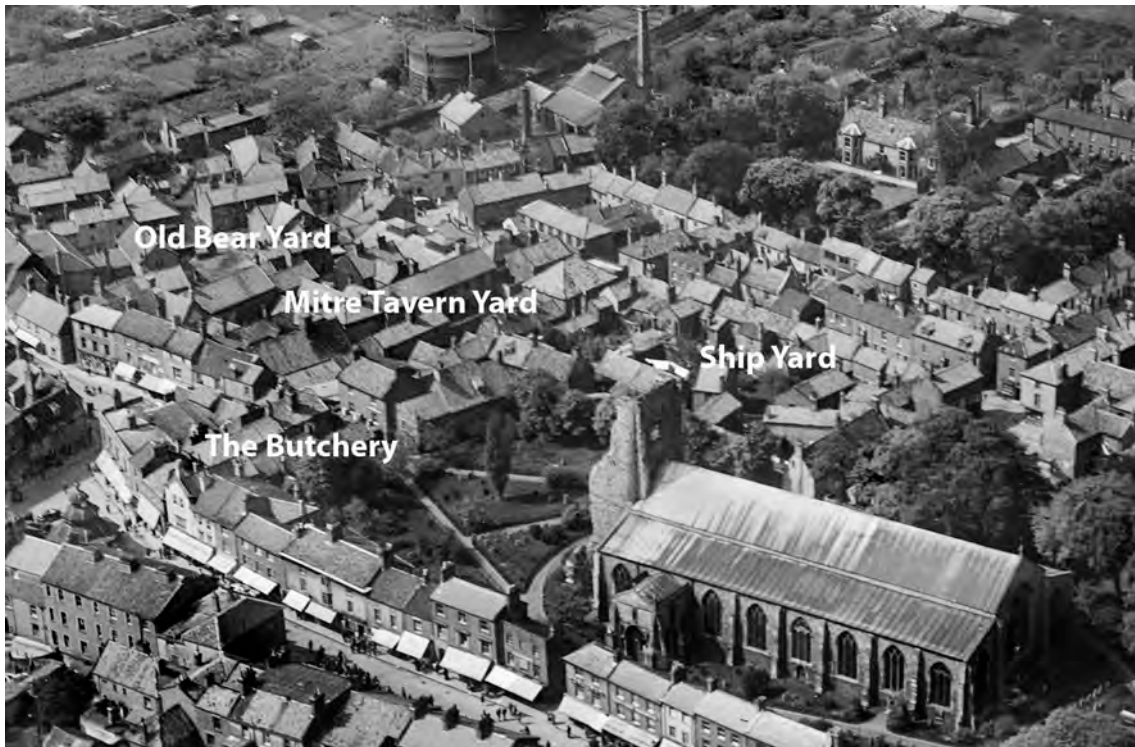
Fig 2: The area to the north and west of the church seen in 1928. The places named are discussed below. Detail of EPW21289 MAY 1928 © Historic England (Aerofilms Collection).

This part of the report covers the area to the north and west of the church defined by Market Street and the Market Place to the south, Mundesley Road to the west, Church Street in the east and Vicarage Street to the north. The historic aerial photographs show a densely packed group of shops, houses, and other buildings. It included the areas known as Ship Yard and The Butchery and was subdivided by Mitre Tavern Yard and Old Bear Yard both of which linked Market Street to Vicarage Street (Fig 2). Several of the buildings seen on the historic aerial photographs have since been demolished and the area centred on Ship Yard was cleared to make way for the St Nicholas Court precinct development built in the early 1970s.

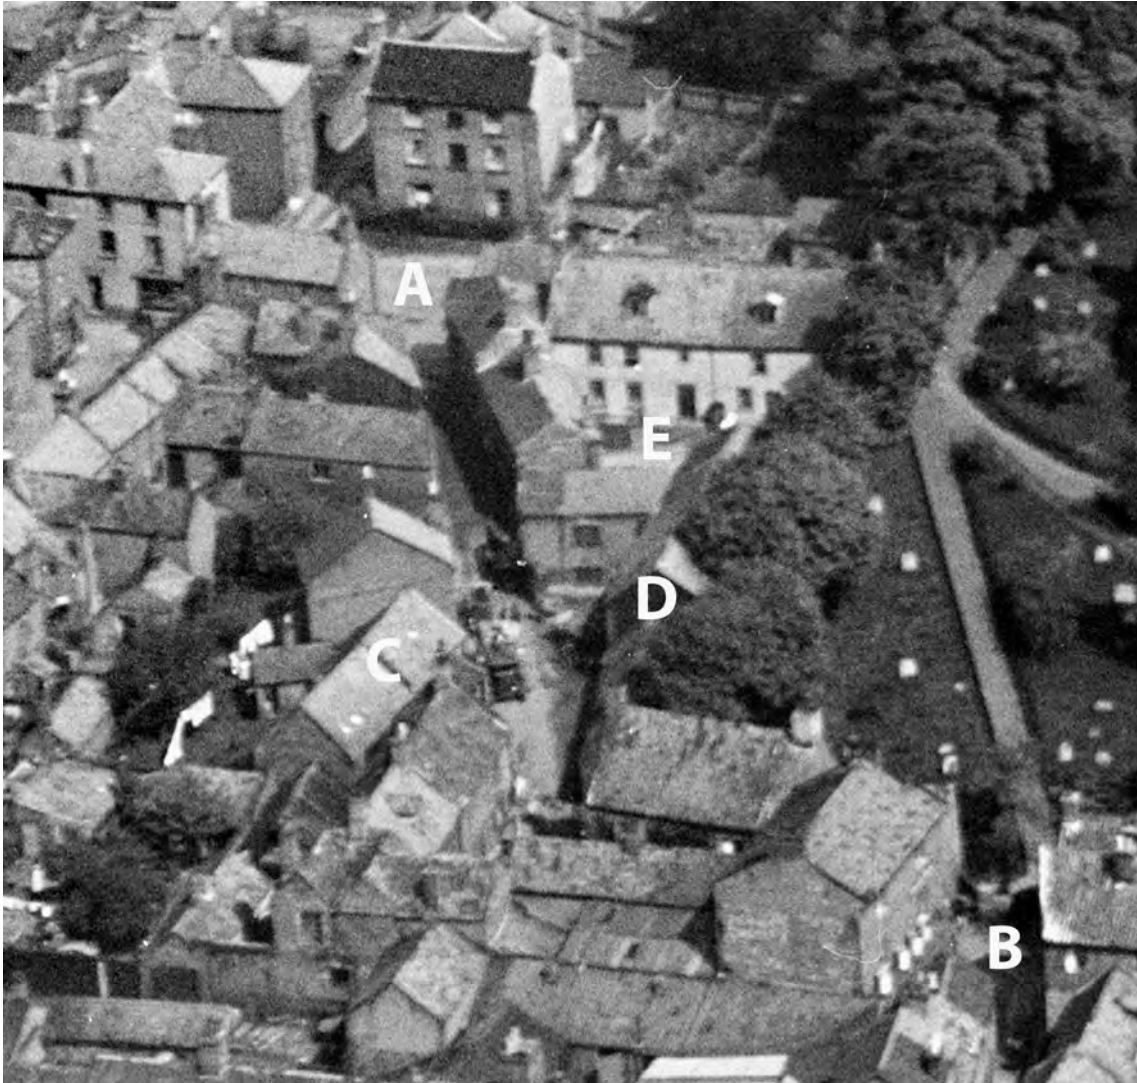
Fig 3: The diagonal road running through Ship Yard seen from the west with Vicarage Street to the left and the churchyard to the right. The letter A marks the north-eastern entrance, B marks the southern entrance. The letters C and D mark some non-residential buildings. The letter E marks the yard accessed via the churchyard. Detail of EPW021294 MAY-1928 © Historic England (Aerofilms Collection).

The Ship Yard area was located to the north-west of the church. Buildings on its northern side faced Vicarage Street, to the west Mitre Tavern Yard, the churchyard to the south and the eastern boundary was defined by an unnamed lane that led from Vicarage Street to the church. A diagonal road headed south-west from this lane and subdivided the area (Figs 3 and 4). The road was defined by buildings at its eastern end, but it then opened out into irregular shaped yards before turning south to join The Butchery. The properties on the north side of the road included a short terrace of houses, and non-residential buildings which, according to the tithe map apportionment were barns in the 1840s. These were adjacent to the rear yards and outbuildings belonging to the buildings facing Vicarage Street. This road was wide enough for vehicles, as shown in Figure 3, but at its southern end it had narrowed to a small, covered alleyway which joined The Butchery (Fig 5). South of this road were buildings along the boundary with the churchyard that were described in the tithe map apportionment as workshops and stables (D in Fig 3). There was also a group of buildings (including houses and shops) arranged around a yard that appears to have been accessed via the churchyard (E in Fig 3). The 1945 aerial photographs show that some buildings seen in the 1928 and 1932 photographs had been demolished and based on the evidence from the Ordnance Survey map, this had happened by 1938. The demolition included the removal of two out of three houses in a short terrace (A in Figs 6 and 7) and a semi-detached property (B in Figs 6 and 7).

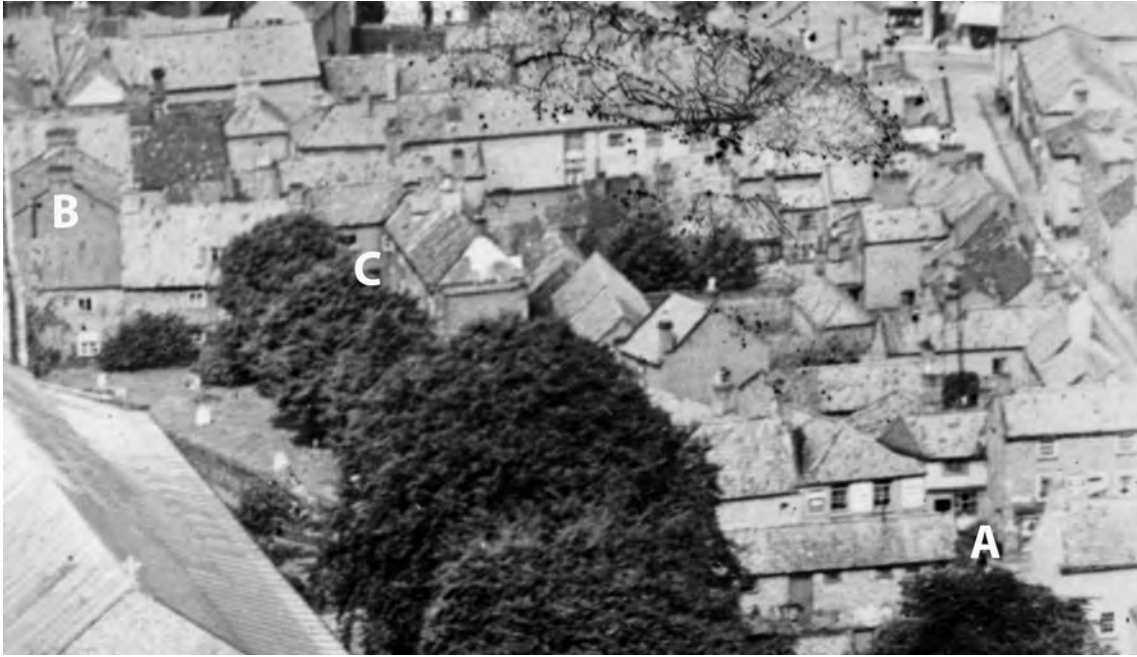
Fig 4: The diagonal road running through Ship Yard from the east with Vicarage Street to the right and the churchyard to the left. The letter A marks the north-eastern entrance, B marks (the location of the southern entrance. The letter C marks the approximate location where the road turns south. Detail of EPW039256 JUL-1932 © Historic England (Aerofilms Collection).

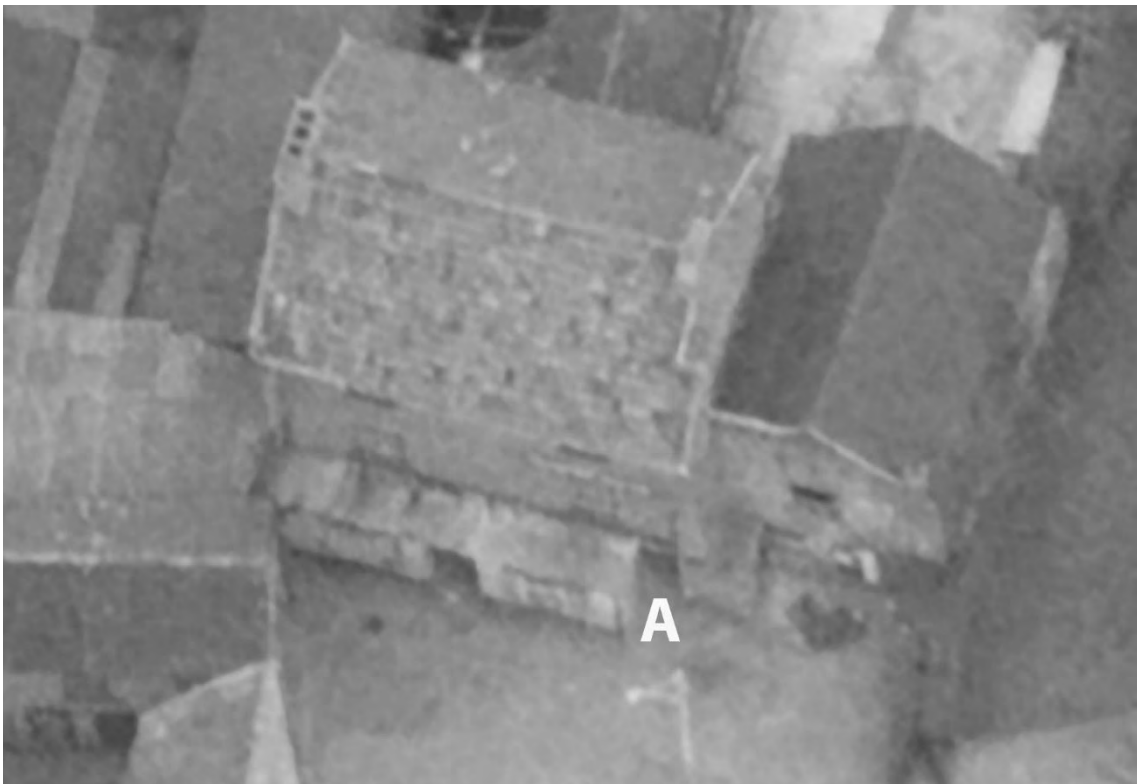
Fig 5: The letter A marks the covered alleyway at the northern end of The Butchery. This led to a rear yard and from there to the diagonal road that ran through the Ship Yard area. Detail of MAL/68006 158 24-FEB-1968. Photo by Meridian Airmaps Ltd. Copyright Norfolk County Council.

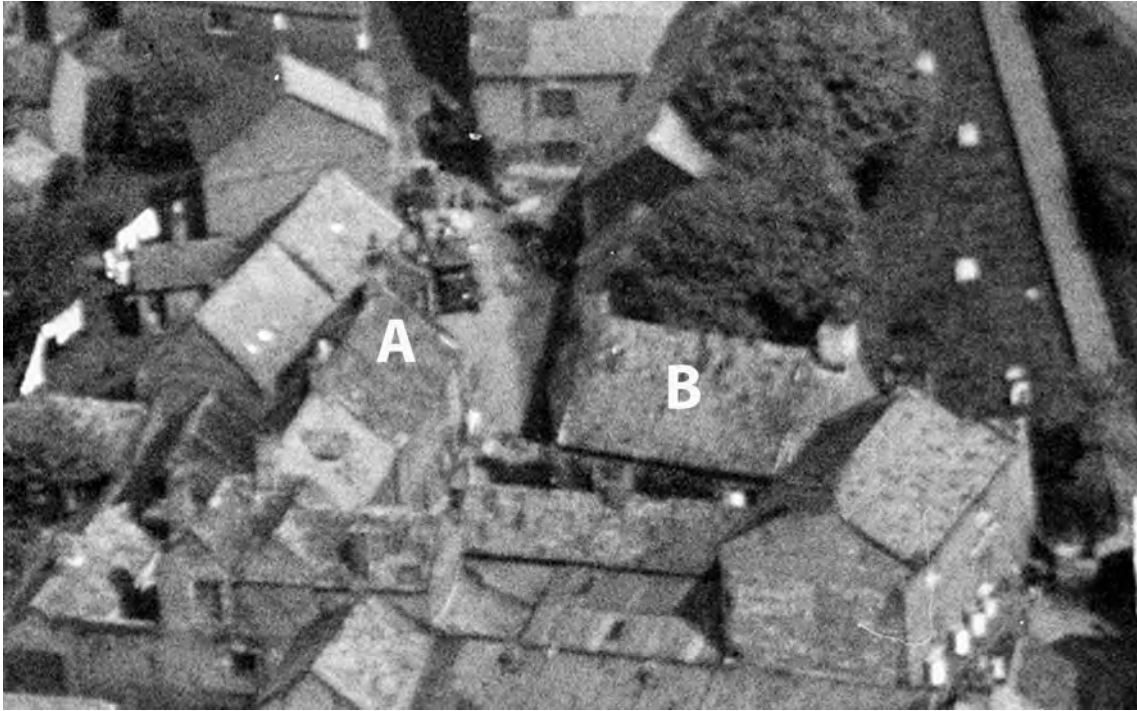
Fig 6: Buildings demolished in the 1930s, marked by the letters A and B seen from the west in 1928. Detail of EPW021294 MAY-1928 © Historic England (Aerofilms Collection).

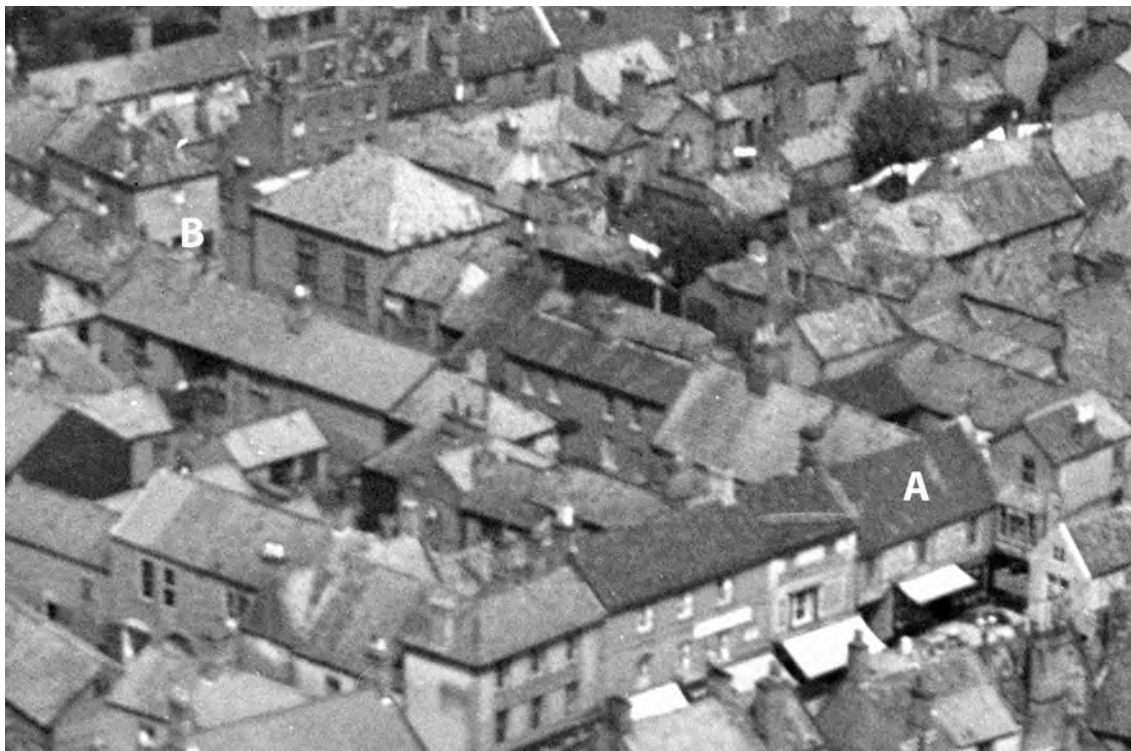
Fig 8: Mitre Tavern Yard seen from the south-west in 1928. The letter A is 6 Market Place and the entrance to the yard is below the A and to the left of the awning. The yard extended to a junction with Vicarage Street marked B. Detail of EPW021295 MAY-1928 © Historic England (Aerofilms Collection).

Mitre Tavern Yard joins Vicarage Street in the north to Market Street in the south (Fig 8). Access to Market Street is via an archway that forms part of 6 Market Street (currently the Shambles Café). Although Mitre Tavern Yard survives as a road name most of the buildings that once defined this area have been demolished.

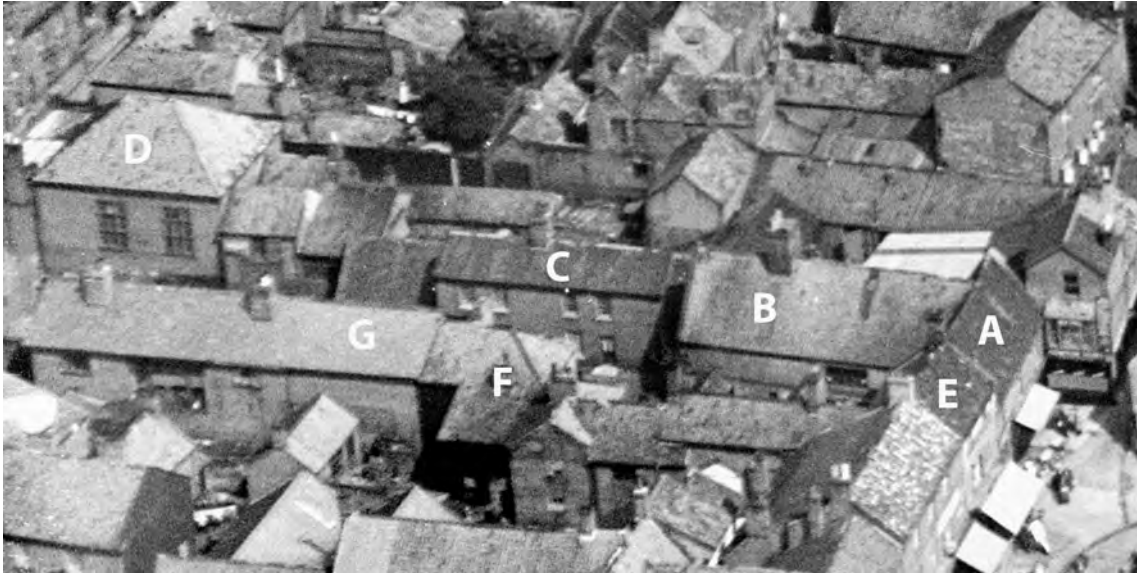
Fig 9: Mitre Tavern Yard looking east in 1928. Market Street to the right, Vicarage Street to the left. The letter A marks 6 Market Place and the entrance to the yard, B is the pub, C the terrace built after 1886 on the former site of the second pub, and D the former chapel and school. On the western side, the buildings between E-F included a house, office, and warehouses. A long barn is marked G and to left (not shown) were cottages facing Vicarage Street (see Fig 10). Detail of EPW021294 MAY-1928 © Historic England (Aerofilms Collection).

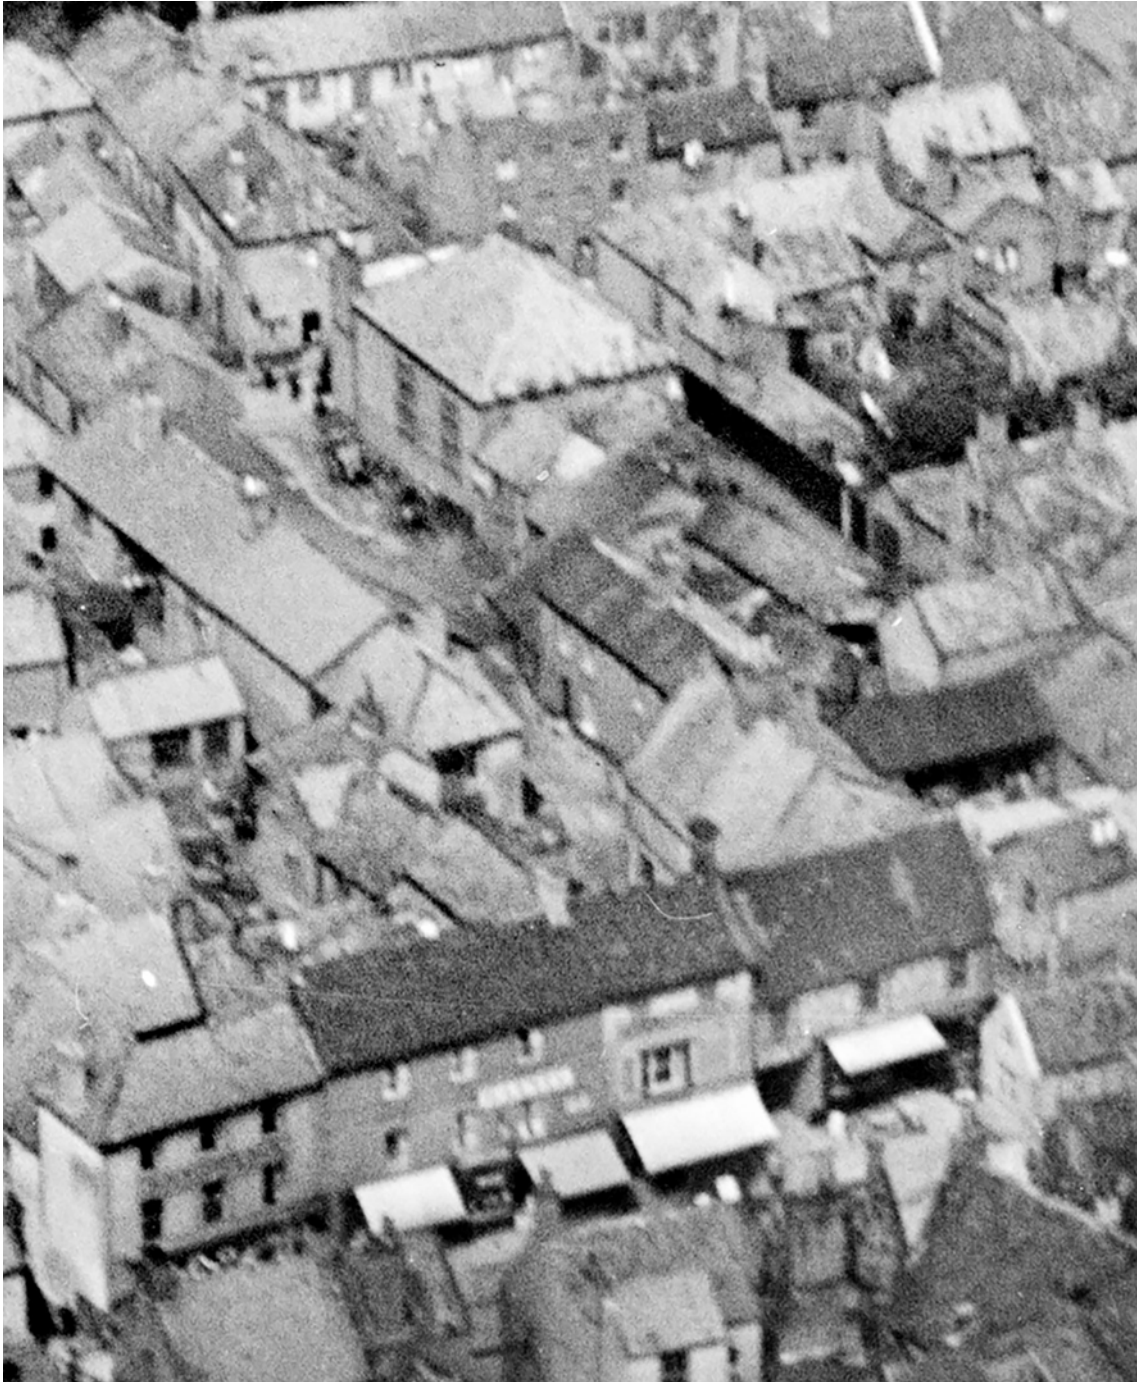
Fig 11: Mitre Tavern Yard from the south in 1928 with Market Street in foreground. Detail of EPW021293 MAY-1928 © Historic England (Aerofilms Collection).

The 1886 Ordnance Survey map shows two pubs separated by a covered passageway along the eastern side of the yard. By 1906 the northern pub appears to have been demolished and replaced with a terrace of two houses and this is what is shown in the 1928 aerial photographs. The large building at the northern of the yard facing Vicarage Street was listed in the tithe apportionment as a Chapel and School, but not on the later 19th-century Ordnance Survey maps. The western side of Mitre Tavern Yard was defined by a row of buildings that were listed as a house, office, barns, and warehouses (Figs 9 and 10). Also taken in 1928, Figure 11 provides an alternative view of the buildings along Mitre Tavern Yard.

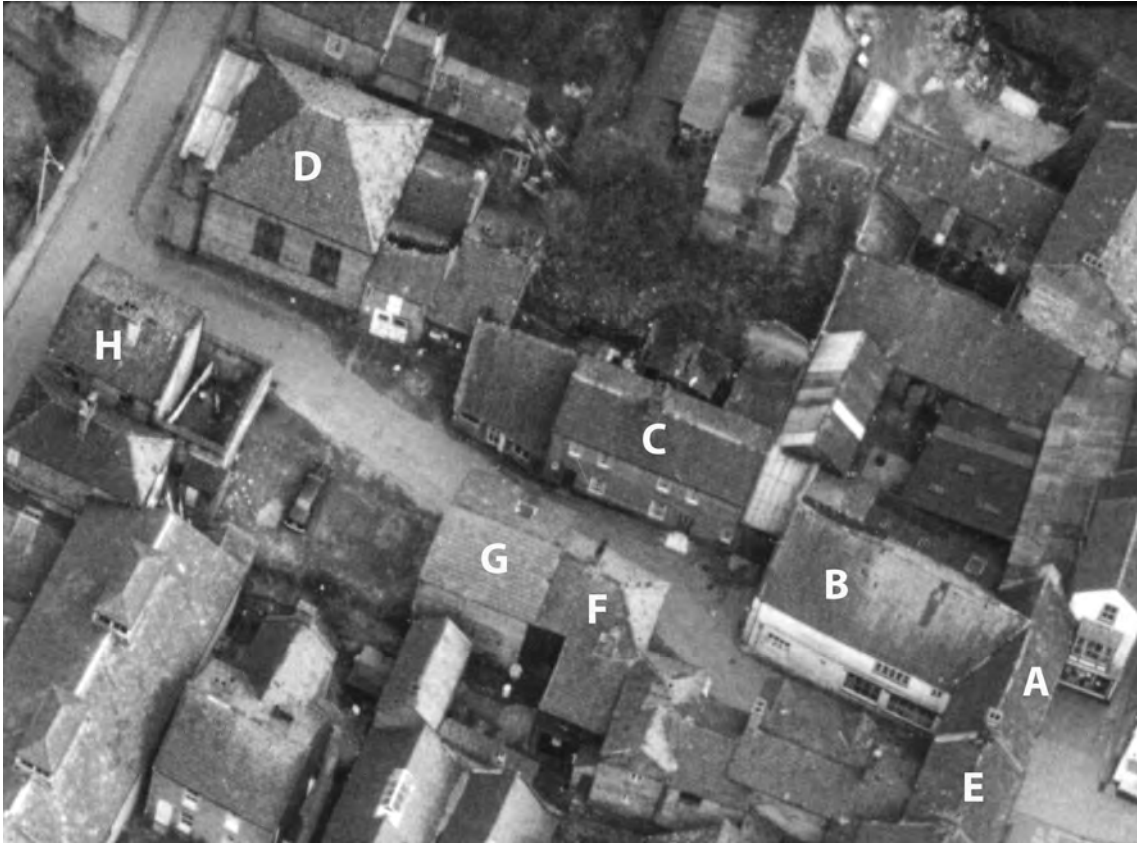
Fig 12: Mitre Tavern Yard looking east in 1968. Vicarage Street is to the left, Market Street is to the right. The buildings marked A-H are the same as those in the Figures 9 and 10. An alley alongside D led from Vicarage Street and provided access to the yards behind C. The long barn marked G in previous figures had been partially demolished (between 1945 and 1955) leaving an open area between the remains of the barn (G) and the cottages (H). Detail of MAL/68006 146 24-FEB-1968. Photo by Meridian Airmaps Ltd. Copyright Norfolk County Council.

Figures 12 and 13 are details of vertical aerial photographs taken in 1968. Although verticals, they were taken in such a way that only the centre of each photographic frame is truly vertical and oblique views of buildings can be seen nearer the edge of each photograph. These show the elevations of the buildings along either side of the yard, which are annotated to allow comparison with Figures 9 and 10. They also show evidence of demolition on the western side which had been carried out between 1945 and 1955.

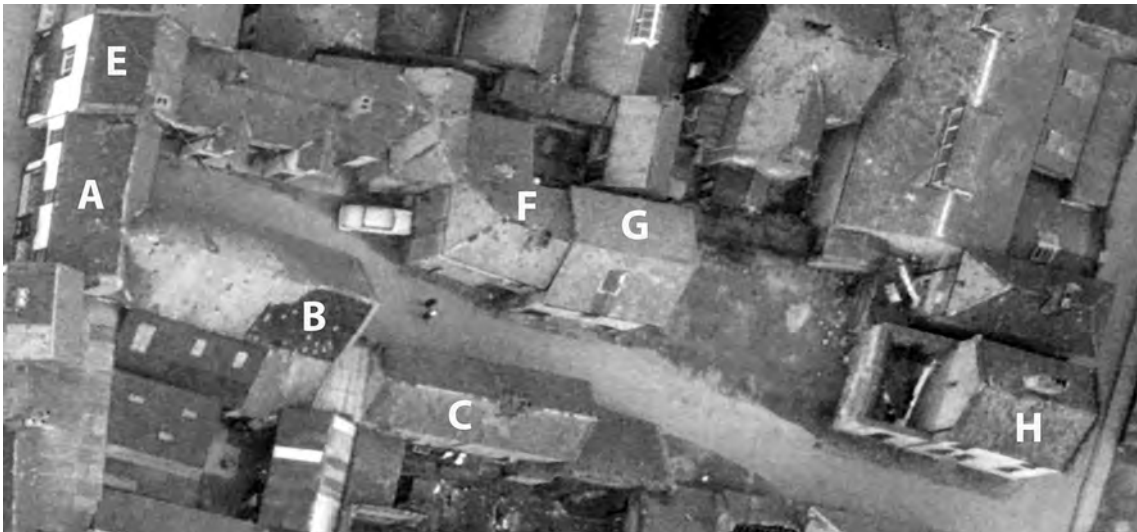
Fig 13: Mitre Tavern Yard looking west in 1968. Market Street to the left and Vicarage Street to the right. The buildings marked A-H are the same as those in the Figures 9, 10 and 12, although the former chapel (D) is off the edge of the frame. Detail of MAL/68006 158 24-FEB-1968. Photo by Meridian Airmaps Ltd. Copyright Norfolk County Council.

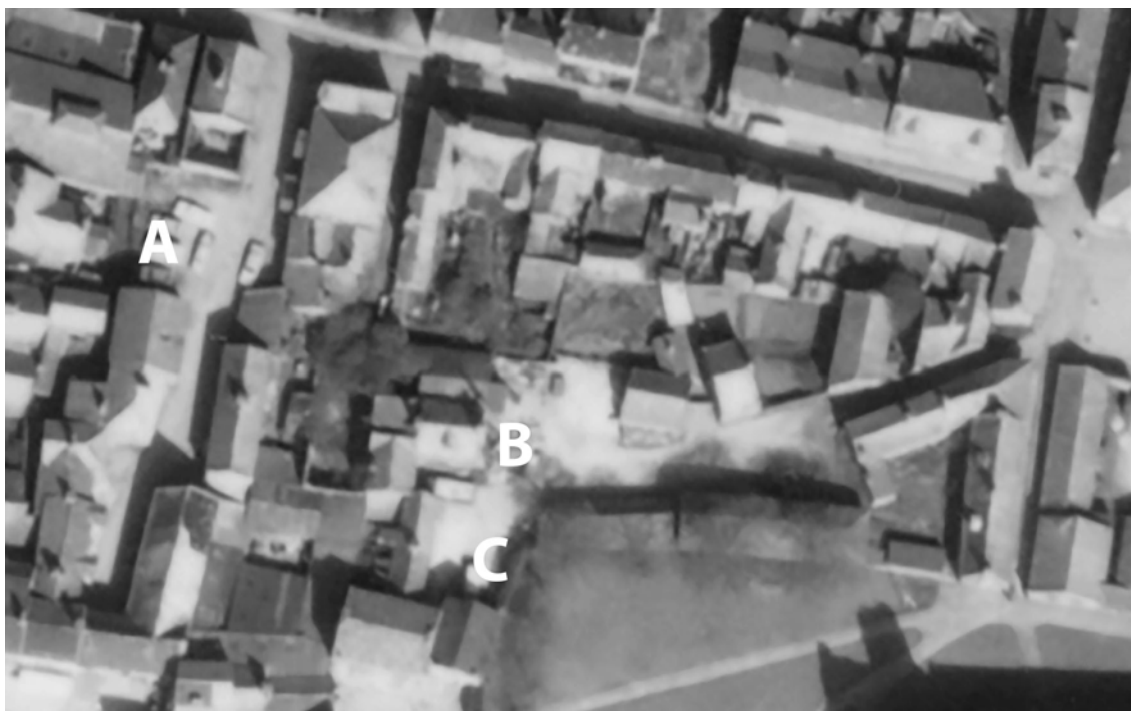
Fig 14: A vertical view taken in 1967, Vicarage Street passes across the top (north) of the photograph, the church is bottom right. By this date some demolition had taken place on Mitre Tavern Yard between 1945 and 1955 (A) and in the Ship Yard area in the 1930s (B-C). Detail of OS/67053 11 24-APR-1967 © Crown Copyright Ordnance Survey.

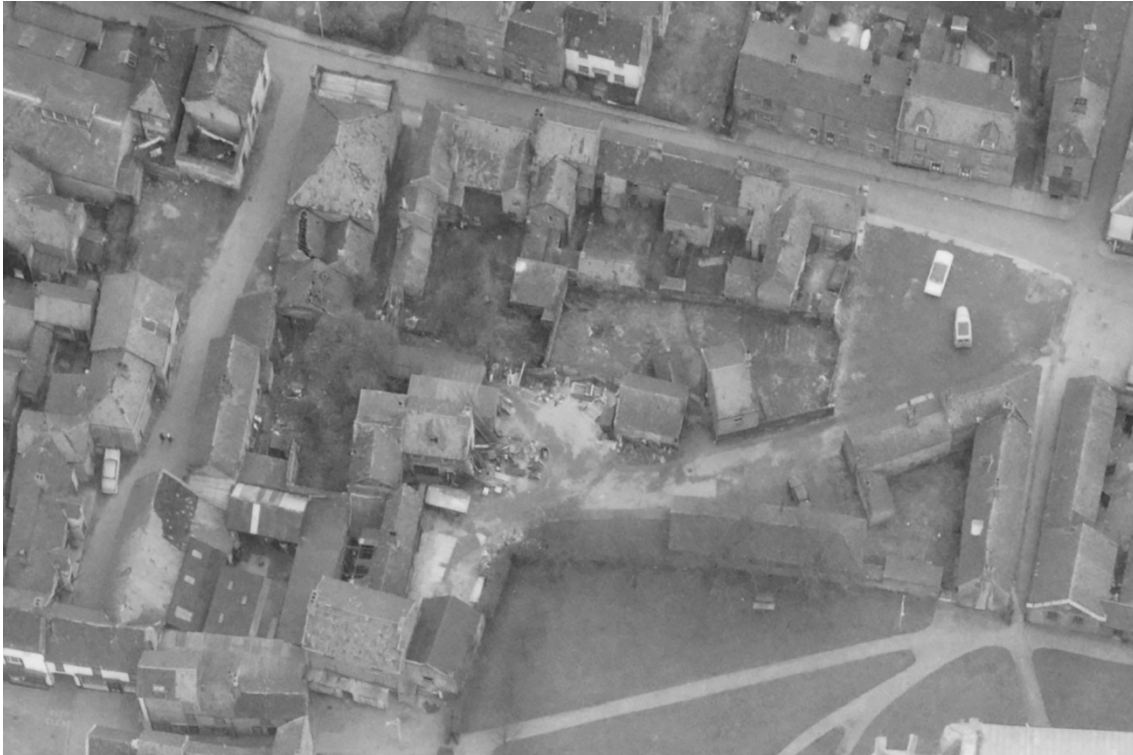
Fig 15: By 1968 the eastern end of the site had been demolished (the open area towards top right with two parked cars). This photograph also shows more clearly the derelict state of some of the buildings with some missing roof tiles. Detail of MAL/60068 158 24-FEB-1968. Photo by Meridian Airmaps Ltd. Copyright Norfolk County Council.

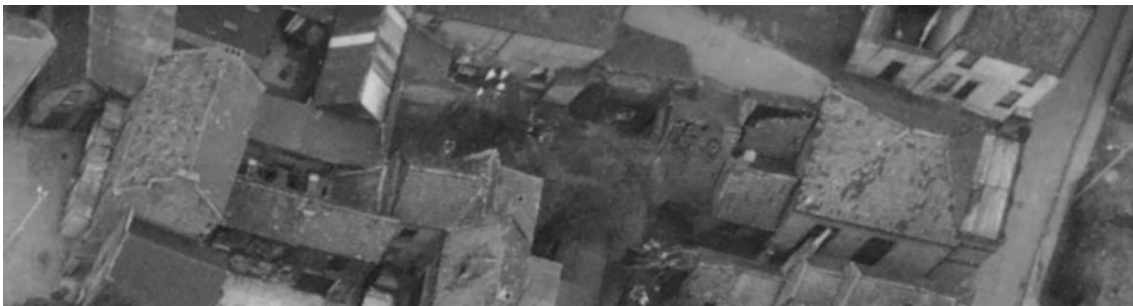
Fig 16: Part of Mitre Tavern Yard running approximately left-right across the top of image and the western edge of the Ship Yard area. This was taken in 1968 and shows some dereliction. Detail of MAL/60068 159 24-FEB-1968. Photo by Meridian Airmaps Ltd. Copyright Norfolk County Council.

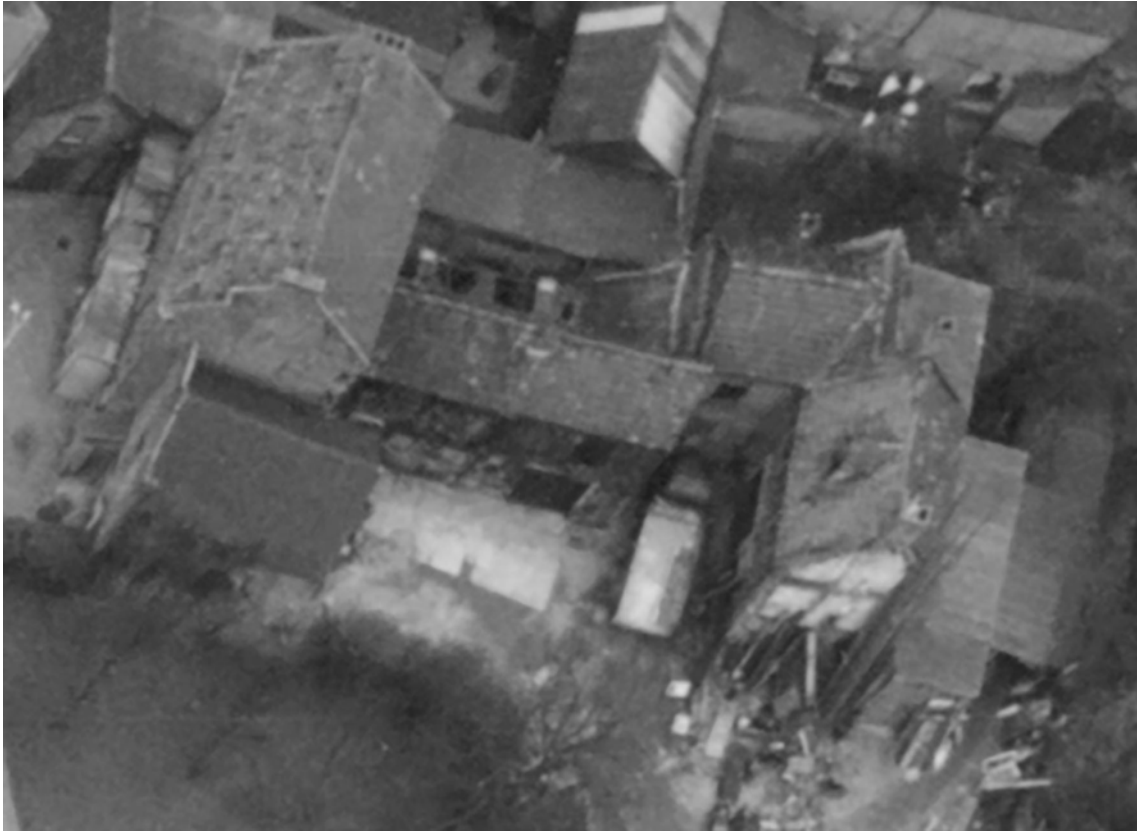
Fig 17: A view taken in 1968. The northern end of The Butchery is on the left of this image. The former interior wall of the terrace partially demolished in the 1930s can be seen showing white on the lower right side of the image. Detail of MAL/60068 159 24-FEB-1968. Photo by Meridian Airmaps Ltd. Copyright Norfolk County Council.

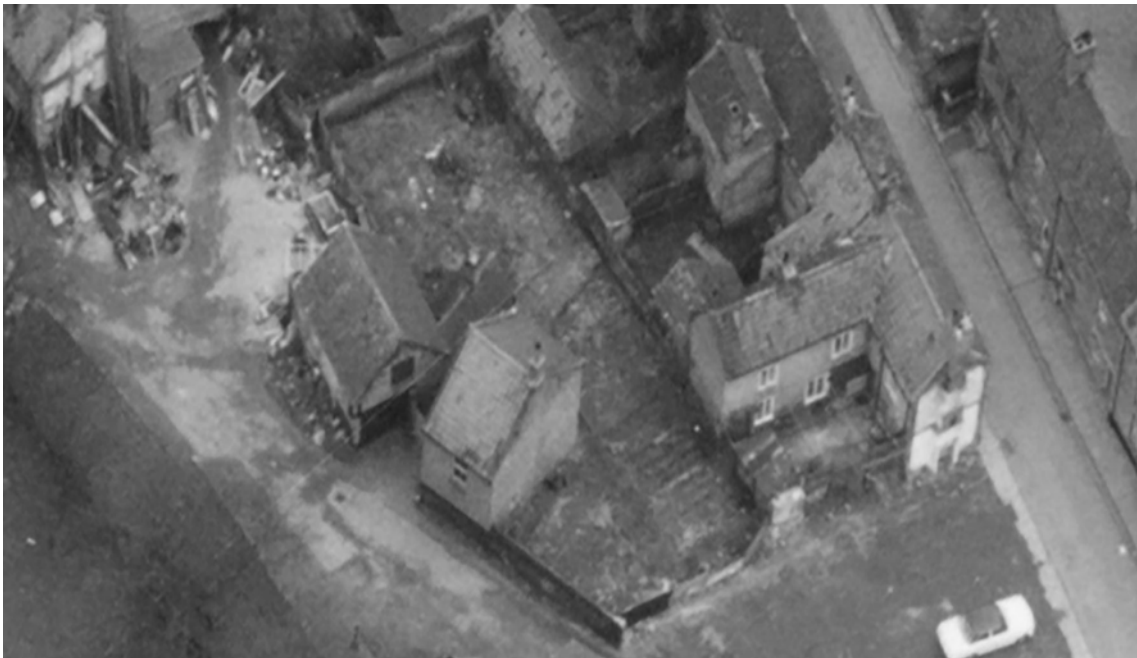
Fig 18: Part of the Ship Yard area in 1968 showing evidence of demolition and dereliction. The former interior wall of a house on Vicarage Street (showing white) can be seen bottom right of the image. Detail of MAL/60068 159 24-FEB-1968. Photo by Meridian Airmaps Ltd. Copyright Norfolk County Council.

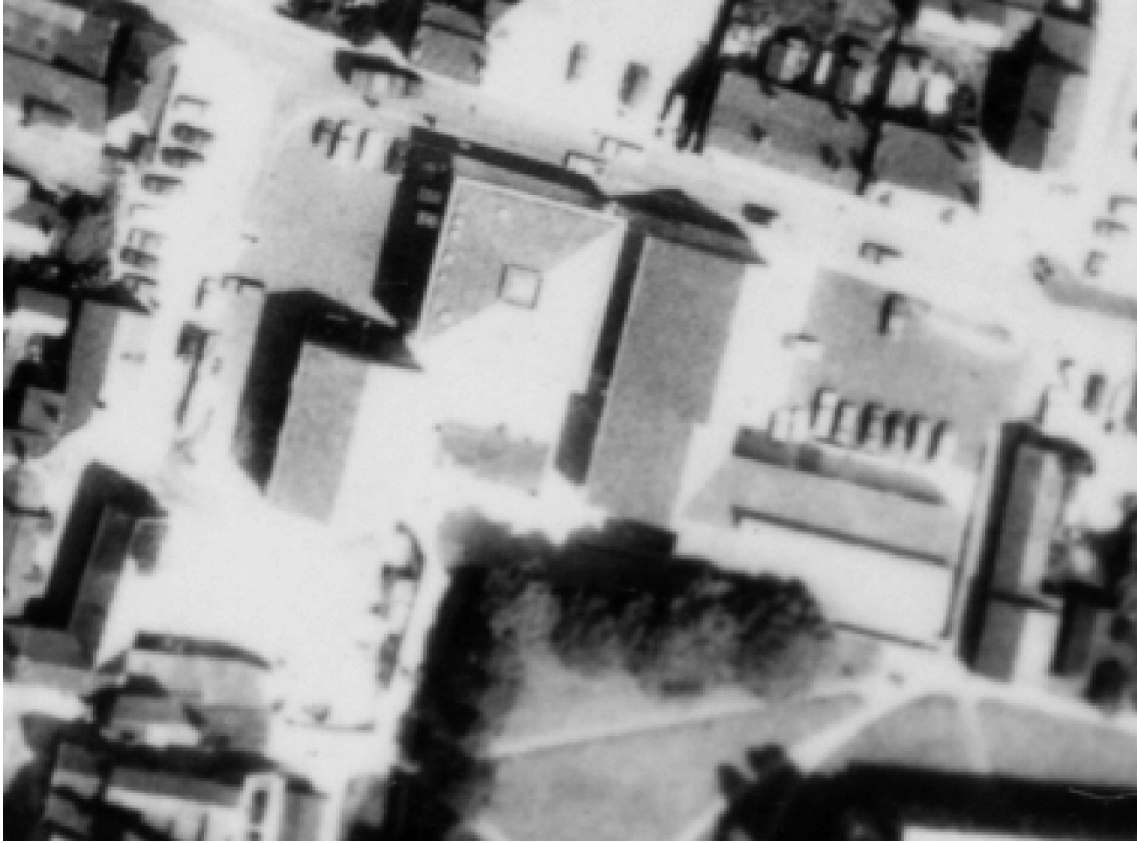
Fig 19: St Nicholas Court precinct in 1972. Compare with the same area in 1967 and 1968 (Figs 14 and 15). MAL/72052 204 22-JUN-1972. Reproduced by Permission of Historic England.

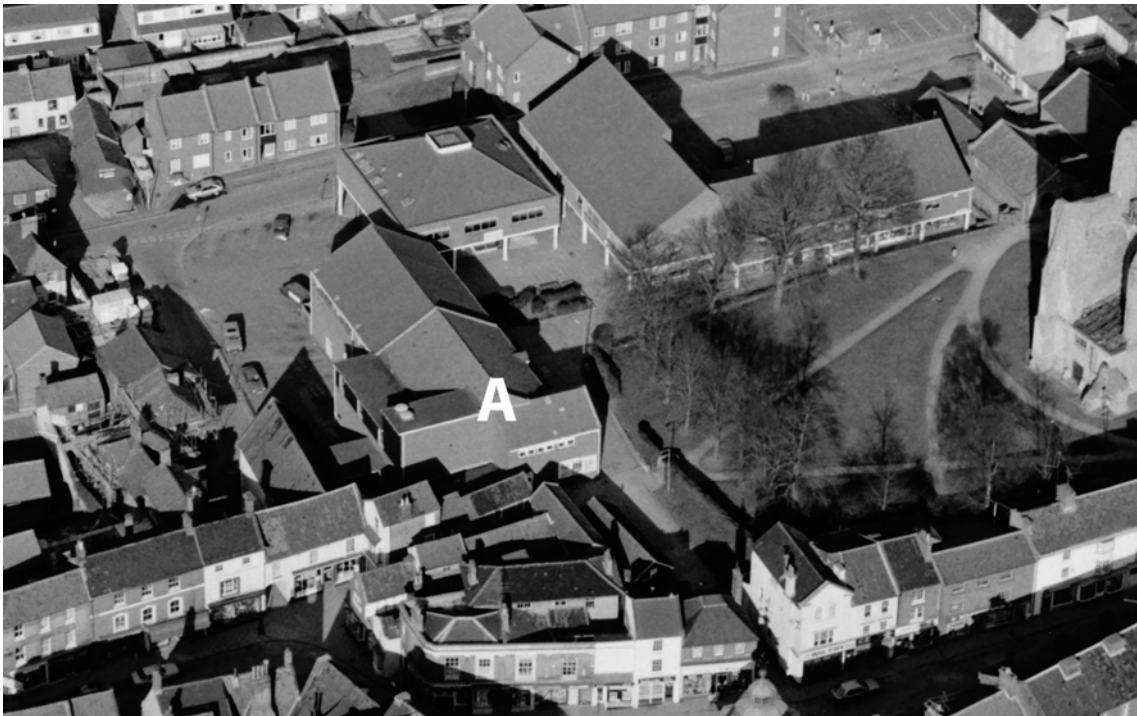
Fig 20: St Nicholas Court precinct in 1986. The buildings centred on A were built after 1972 (compare with Fig 19). Detail of TG2830/C/AZQ8 02-MAR-1986. Photo by D. Edwards Copyright Norfolk County Council.

Despite the demolition that was carried out in the 1930s in the Ship Yard and in the late 1940s/early 1950s in Mitre Tavern Yard, the vertical aerial photographs taken in 1967 show the area largely unchanged from the early 20th-century maps, although some buildings appear in poor repair (Fig 14). By 1968 more demolition had taken place (Fig 15). Some of the buildings in the Ship Yard shortly before their demolition are shown in more detail in Figures 16-18. Presumably this was the beginning of the clearance of the area in preparation for the construction of St Nicholas Court precinct, although there are no later photographs that show this demolition progressing. The 1970 1:2,500 Ordnance Survey map shows the centre of this area cleared of buildings, although those along the eastern side of Mitre Tavern Yard remain as do some on the western side of Ship Yard. Most of these buildings were subsequently demolished and the 1972 aerial photographs show the near completed precinct in place, with one open area to the south-west of the site yet to be developed (Fig 19). The 1975 Ordnance Survey map shows this had been built on by that date (building number 1a) and the whole complex was next photographed from the air in 1986 (Fig 20) and is also shown in 2020 (Fig 21).

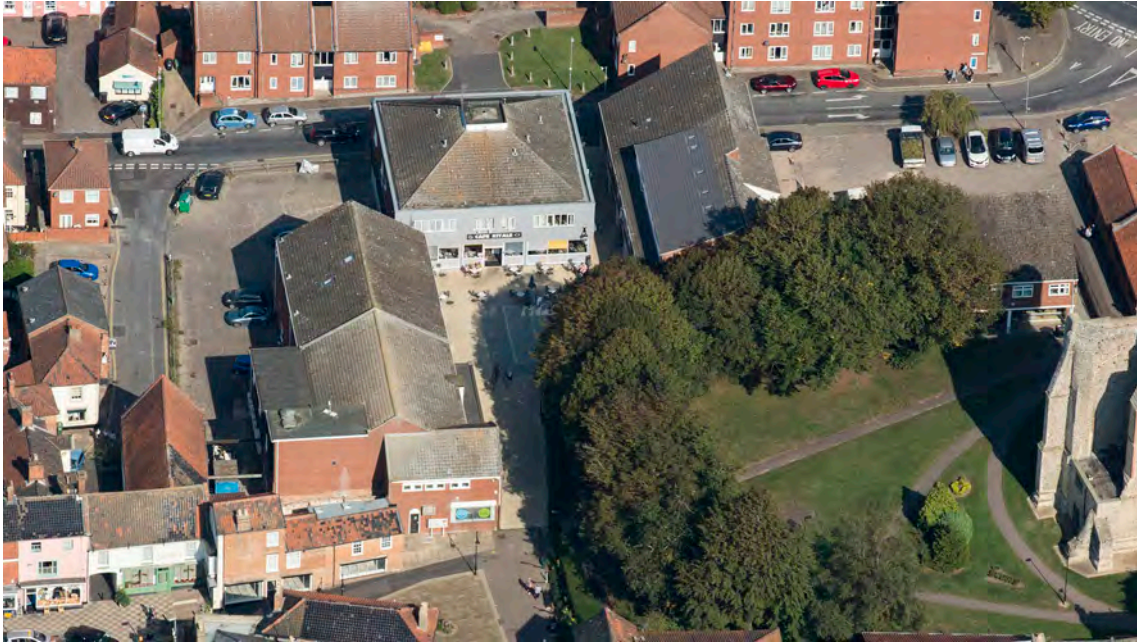
Fig 21: St Nicholas Court precinct in 2020. Detail of 33932_032 22-SEP-2020 © Historic England Archive.

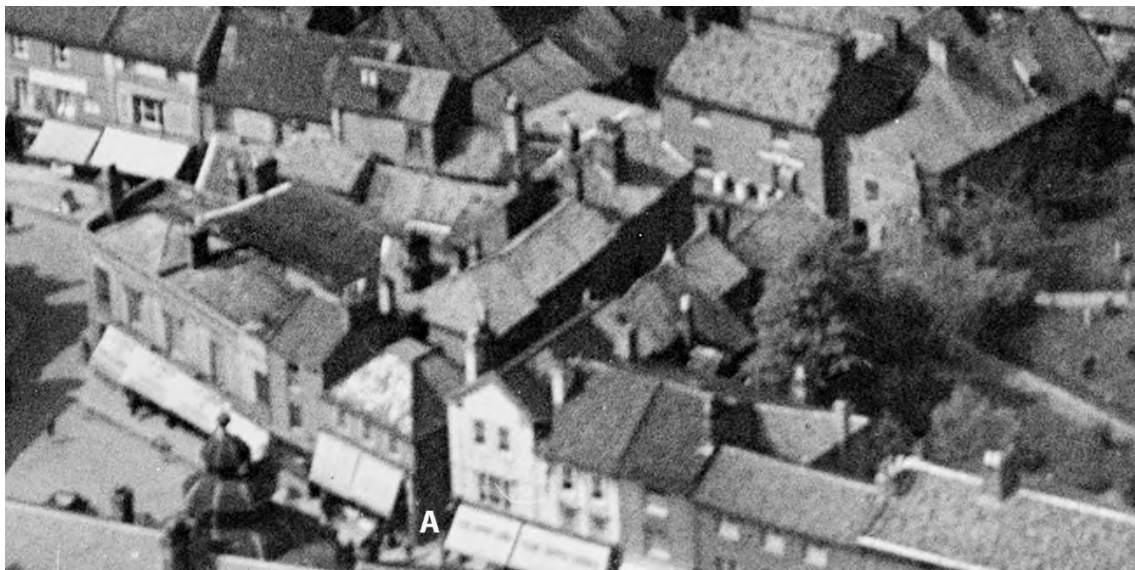
Fig 23: The Butchery from the south-east, the entrance marked by the letter A. Detail of EPW021290 MAY-1928 © Historic England (Aerofilms Collection).

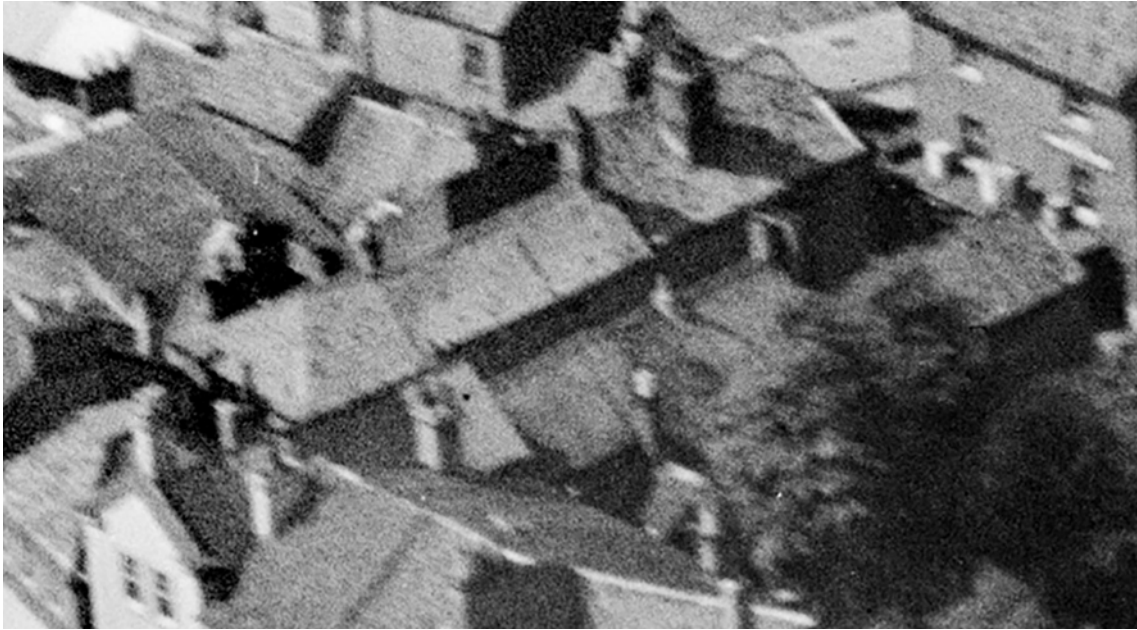
Fig 25: A closer view of The Butchery from the south-east. Detail of EPW021289 MAY-1928 © Historic England (Aerofilms Collection).

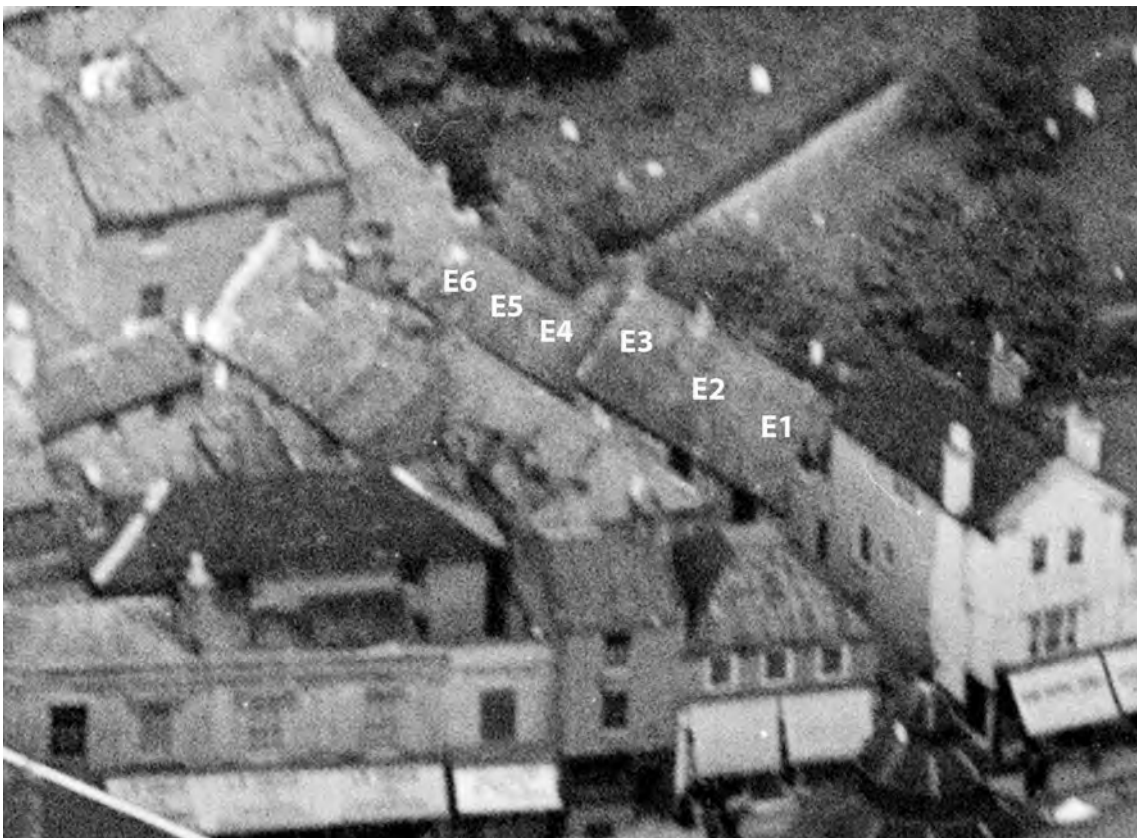
Fig 26: The Butchery seen from the south-west in 1928 providing a glimpse of the front elevation of the eastern side. Approximate locations of individual properties are marked E1-E6 (E for east). Compare with Fig 24. Detail of EPW021293 MAY-1928 © Historic England (Aerofilms Collection).

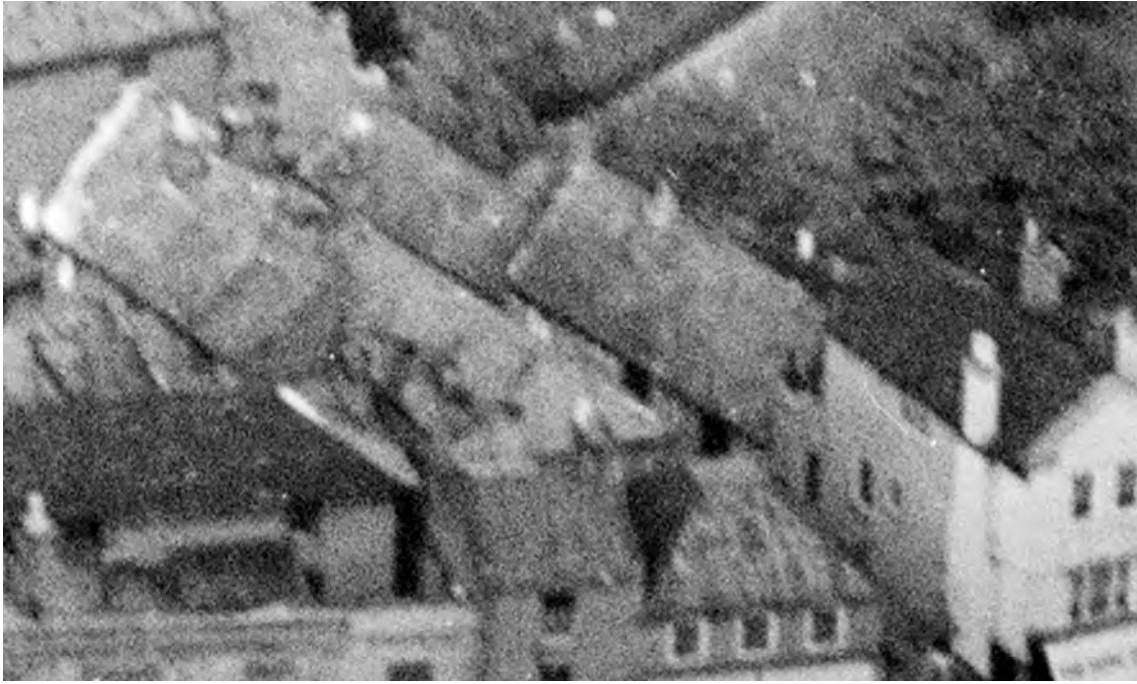
Fig 27: A closer view of The Butchery from the south-west. Detail of EPW021293 MAY-1928 © Historic England (Aerofilms Collection).

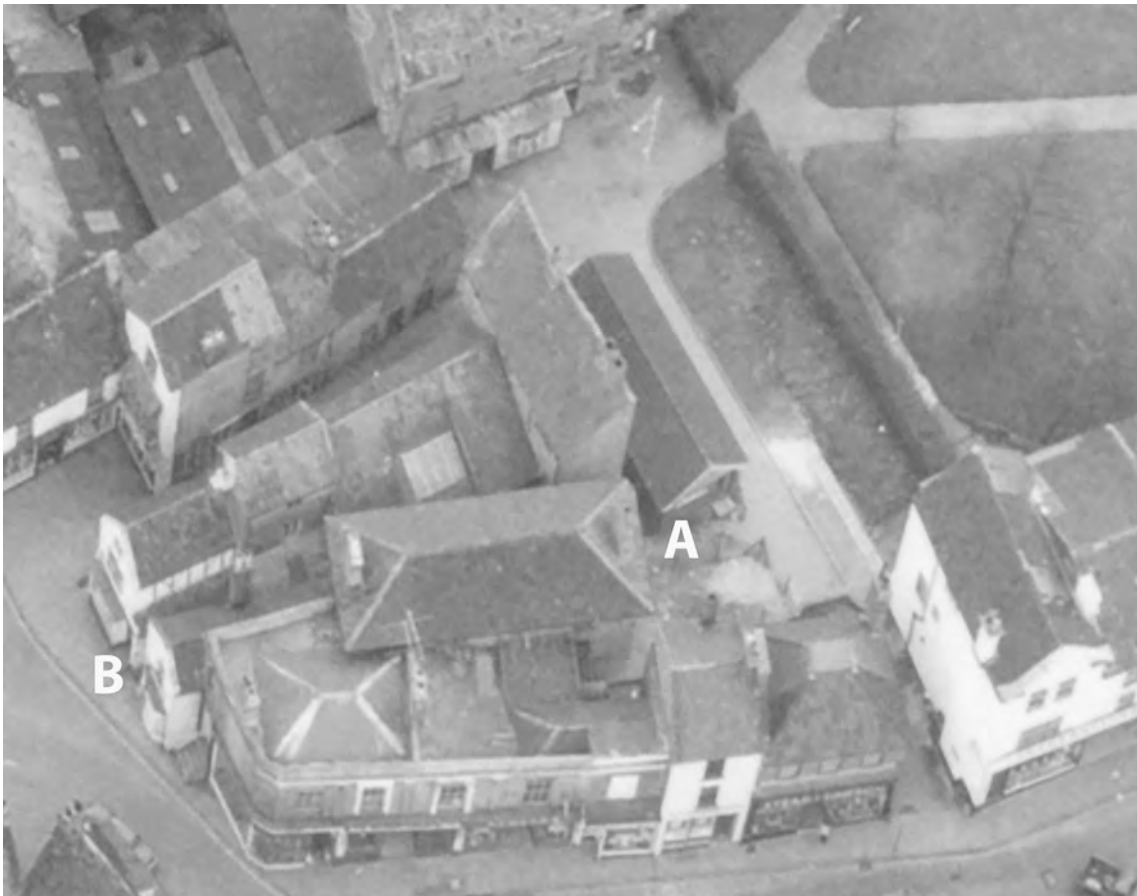
Fig 28: The Butchery in 1968. Letters A and B mark either end of the former blind alley that was opened-up (at A) after the demolition work. The new public toilets are above the letter A. Detail of MAL/68006 157 24-FEB-1968. Photo by Meridian Airmaps Ltd. Copyright Norfolk County Council.

The first edition 1886 Ordnance Survey map shows a row of five buildings on the western side of The Butchery and a row of six on the eastern side. The original house numbers are not known, but for ease of explanation, each building has been given a number in this report and prefixed W for west (W1-W5) or E for east (E1-E6), (Figs 24 and 26). Figures 25 and 27 provide closer views of The Butchery from the same photographs but without this numbering. These buildings are also depicted on the 1928 Ordnance Survey map, but the following map edition (dated 1938) shows that E4-E6 had been demolished. The properties E1-E3 were presumably demolished soon after and cannot be seen on the 1945 aerial photographs. By 1967 properties W1-W5 had been demolished which opened the blind alley that led from Market Street. Public toilets had been built on part of this newly cleared area while the eastern side of The Butchery was left open after demolition, although a pavement was created. These changes can be best seen in a 1968 photograph (Fig 28).
