North Walsham High Street Heritage Action Zone Aerial Investigation

Edward Carpenter

North Walsham
Norfolk

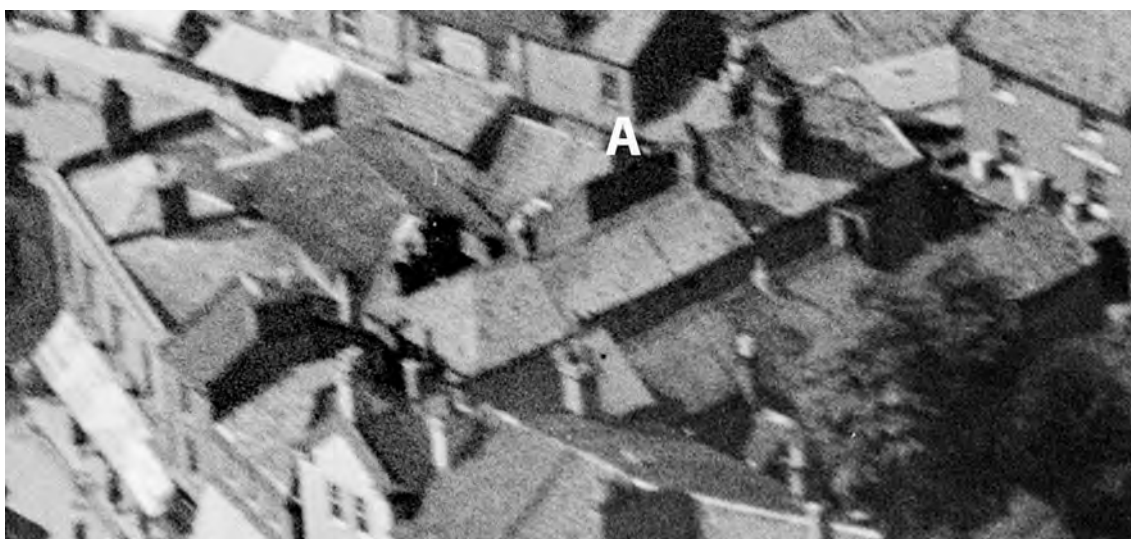
Fig 30: The same property shown in the previous Figure marked A and seen from the south-east. The rear wall cast in shadow is below the letter A. Detail of EPW021289 MAY-1928 © Historic England (Aerofilms Collection).

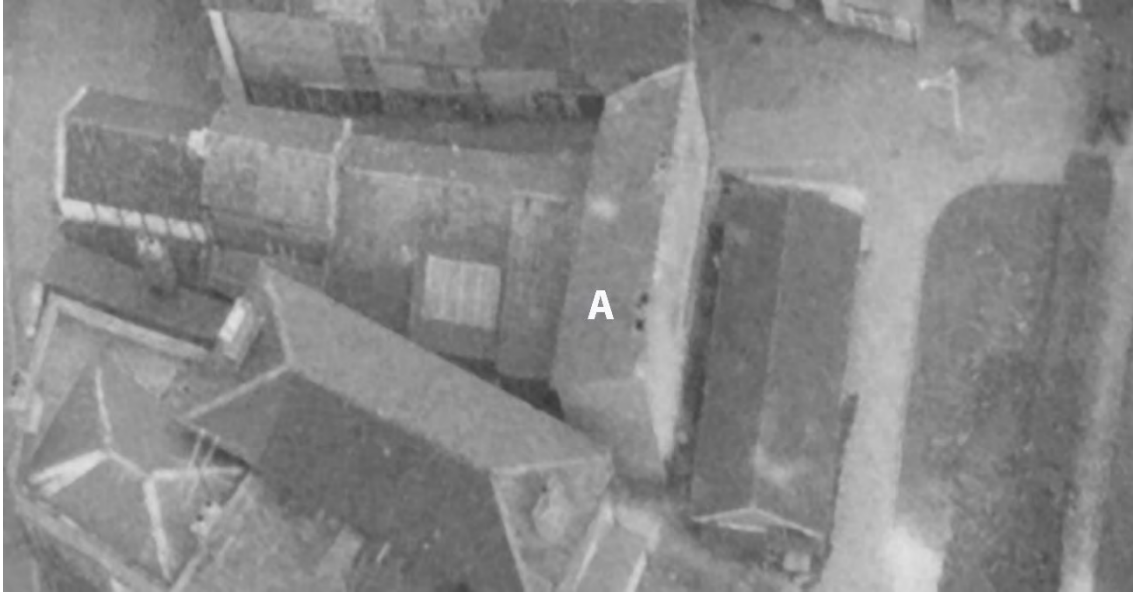
Fig 31: The same property as in the previous two Figures marked A. Seen in 1968 after the properties facing the The Butchery had been demolished. Detail of MAL/68006 158 24-FEB-1968. Photo by Meridian Airmaps Ltd. Copyright Norfolk County Council.

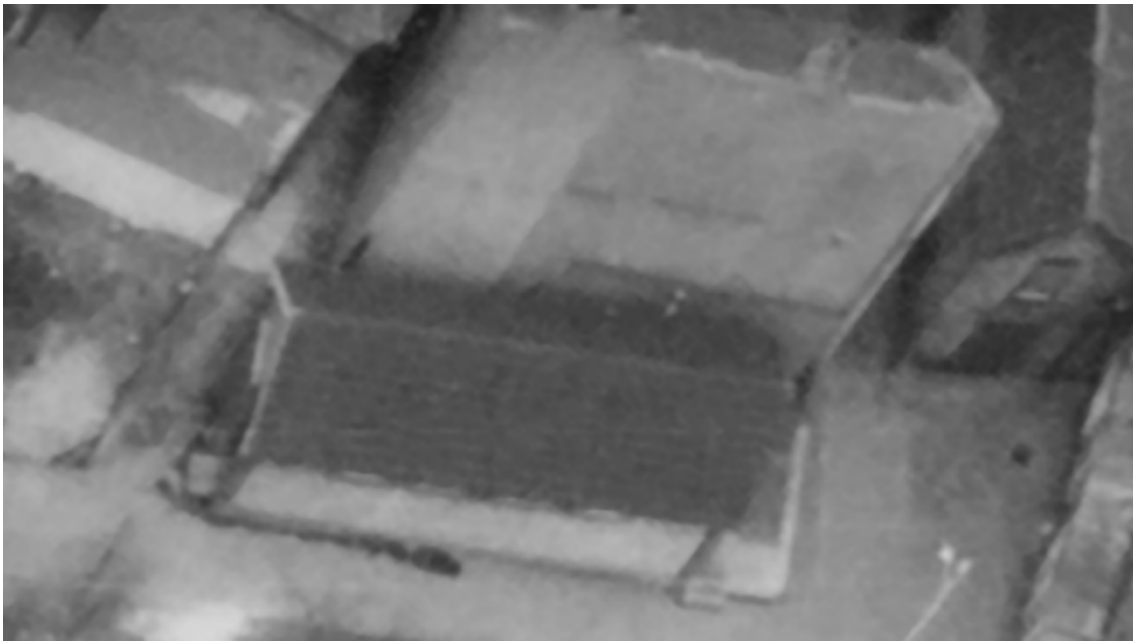
Fig 32: The Butchery in 1968 seen from the east. This is a detail from the edge of a vertical photograph which although slightly distorted, provides a view of the elevation of the building seen in the previous figures. The public toilets are in the foreground. Detail of MAL/68006 159 24-FEB-1968. Photo by Meridian Airmaps Ltd. Copyright Norfolk County Council.

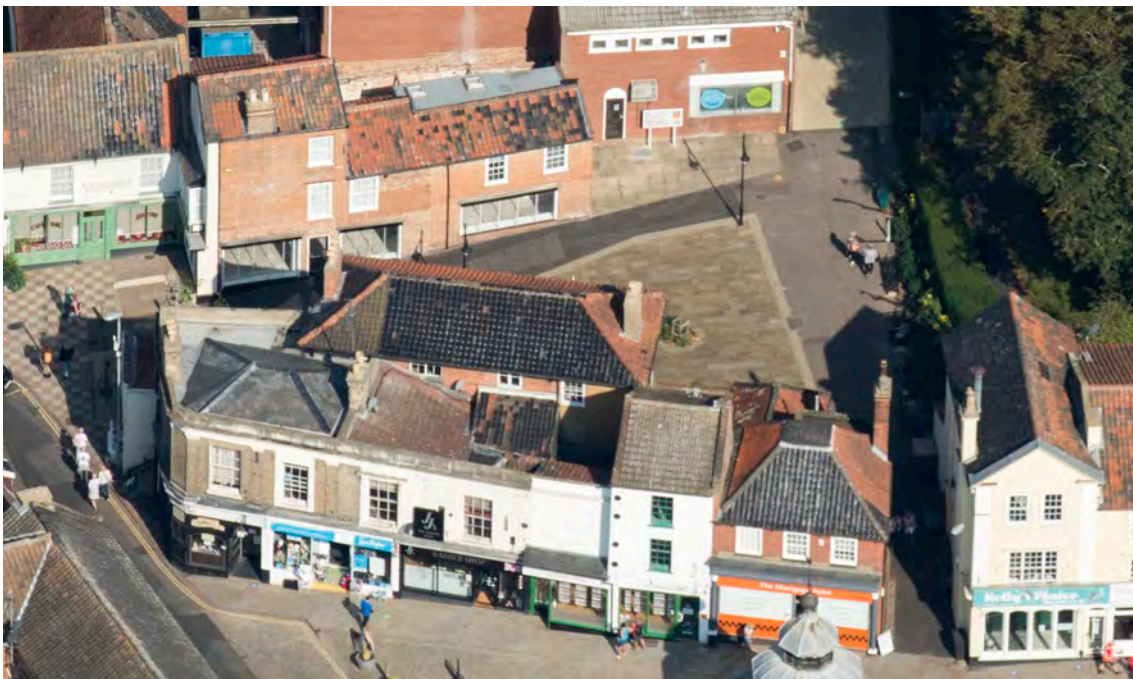
Fig 34; The open area created after demolition of some of the buildings to the west of The Butchery in 2020. Detail of 33932_032 22-SEP-2020 © Historic England Archive.

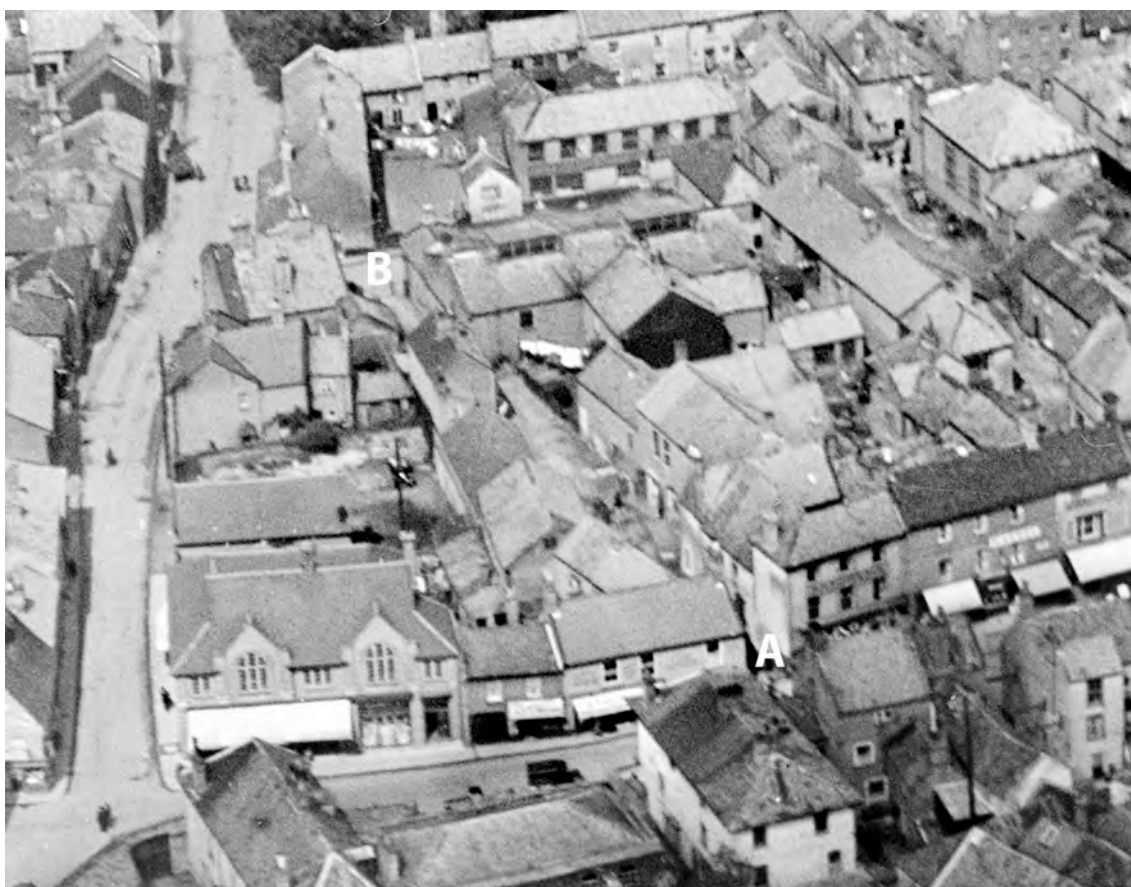
Fig 35: Old Bear Yard seen from the south in 1928. Market Street runs left to right along the bottom of the photograph and the entrance to the yard is at A. The letter B marks the entrance from Vicarage Street. Detail of EPW021293 MAY 1928 © Historic England (Aerofilms Collection).

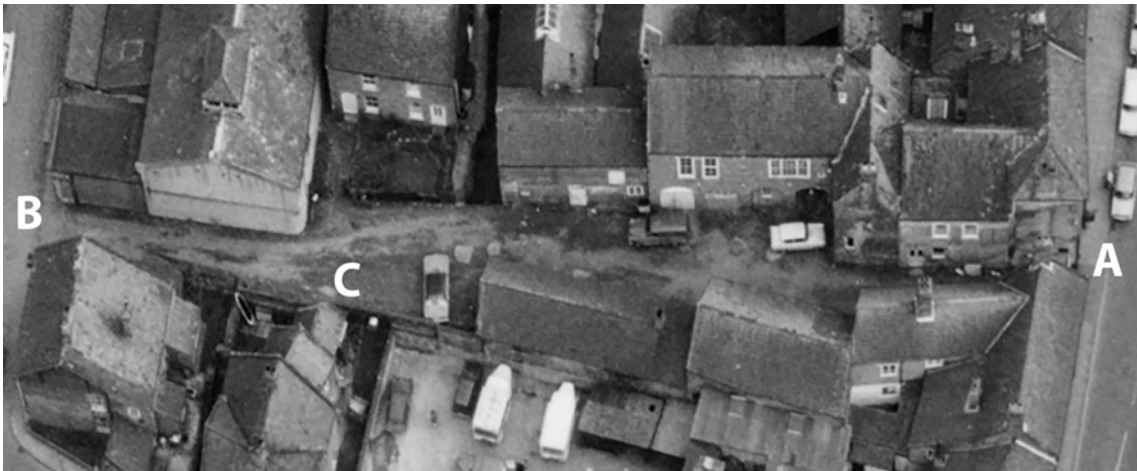
Fig 37: Old Bear Yard looking east in 1968. The letter A marks the entrance from Market Street, B the entrance from Vicarage Street. C marks an area of demolition; compare with Fig 35. Detail of MAL/68006 146 24-FEB-1968. Photo by Meridian Airmaps Ltd. Copyright Norfolk County Council.

The 1968 and 1972 aerial photographs (Figs 37-39) show that little demolition had taken place around Old Bear Yard since 1928. This is also reflected in the 1975 Ordnance Survey map, but the 1984 edition shows much of the central area had by then been demolished. The area was then redeveloped, and the 1986 aerial photographs show a small housing development within what appears to be a communal garden called Old Bear Court. This development cuts across the former line of Old Bear Yard and so closed the throughfare between Market Street and Vicarage Street (Figs 40 and 41).

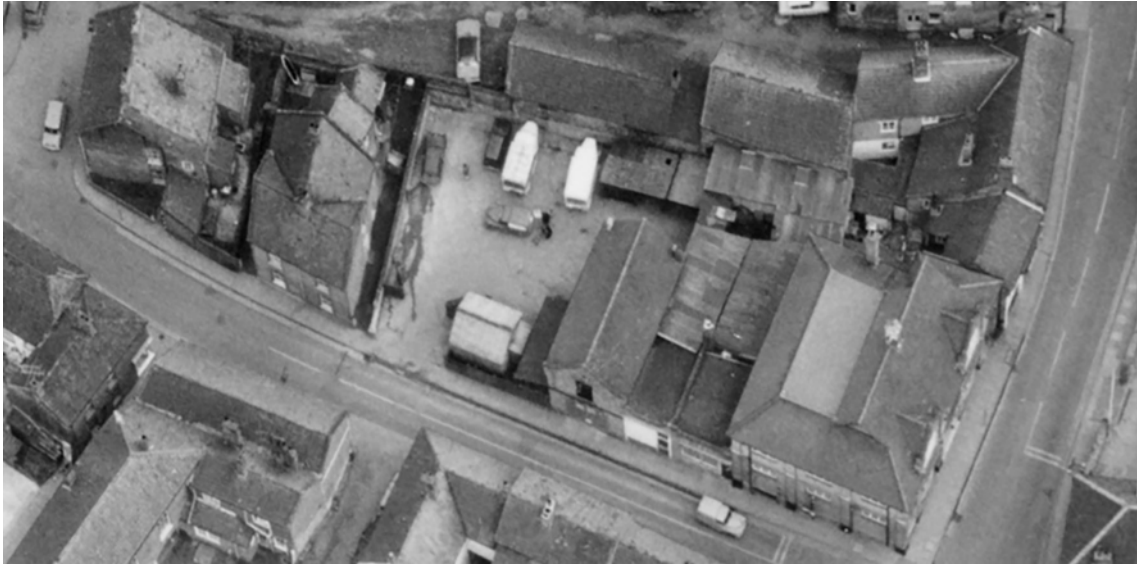
Fig 38: The area to the west of Old Bear Yard. Market Street is to the right, Vicarage Street to the left and Mundesley Road along the bottom of the image. Detail of MAL/68006 146 24-FEB-1968. Photo by Meridian Airmaps Ltd. Copyright Norfolk County Council.

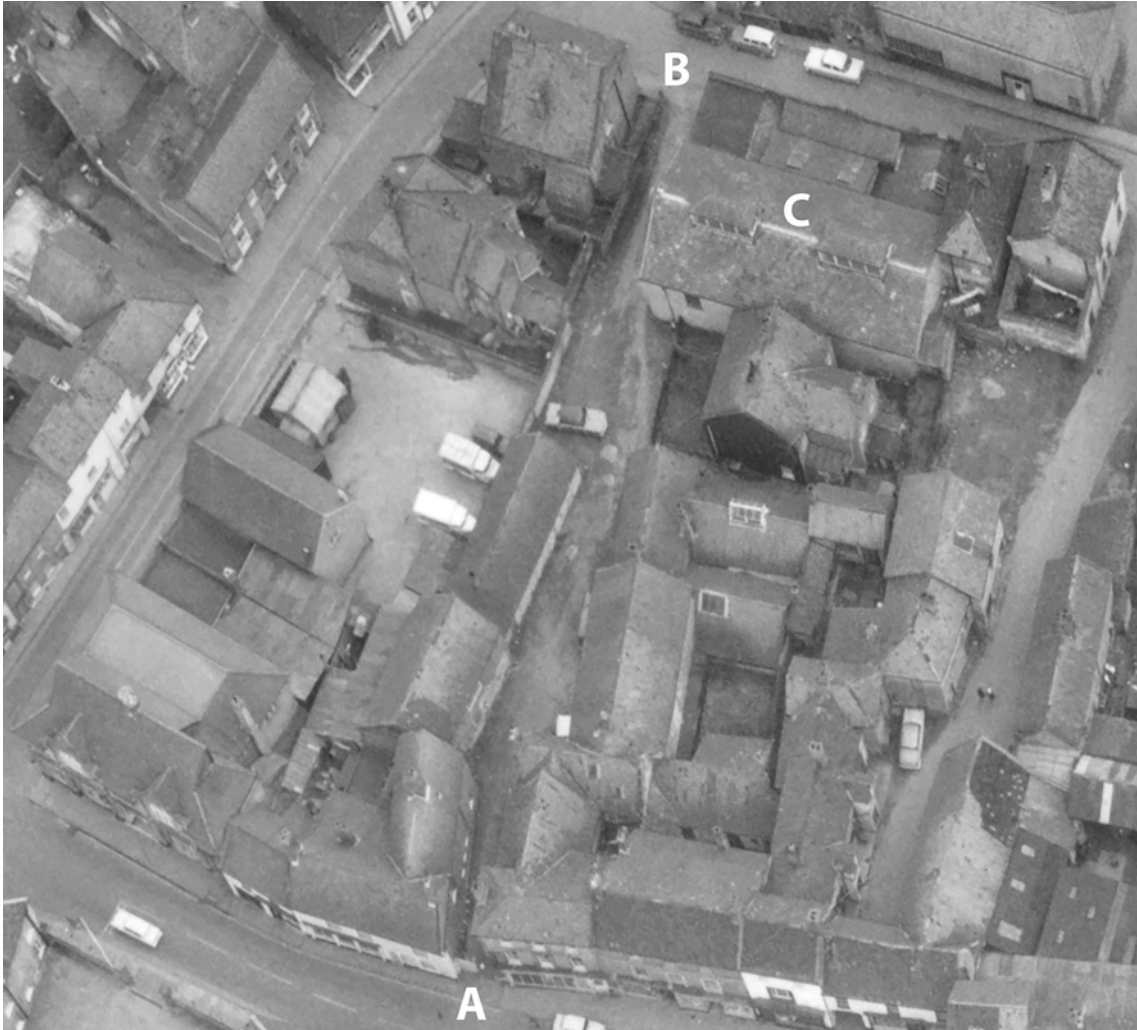
Fig 39: The area centred on Old Bear Yard in 1968. A is the entrance from Market Street, B the entrance from Vicarage Street. C is the Church Rooms. MAL/68006 158 24-FEB-1968. Photo by Meridian Airmaps Ltd. Copyright Norfolk County Council.

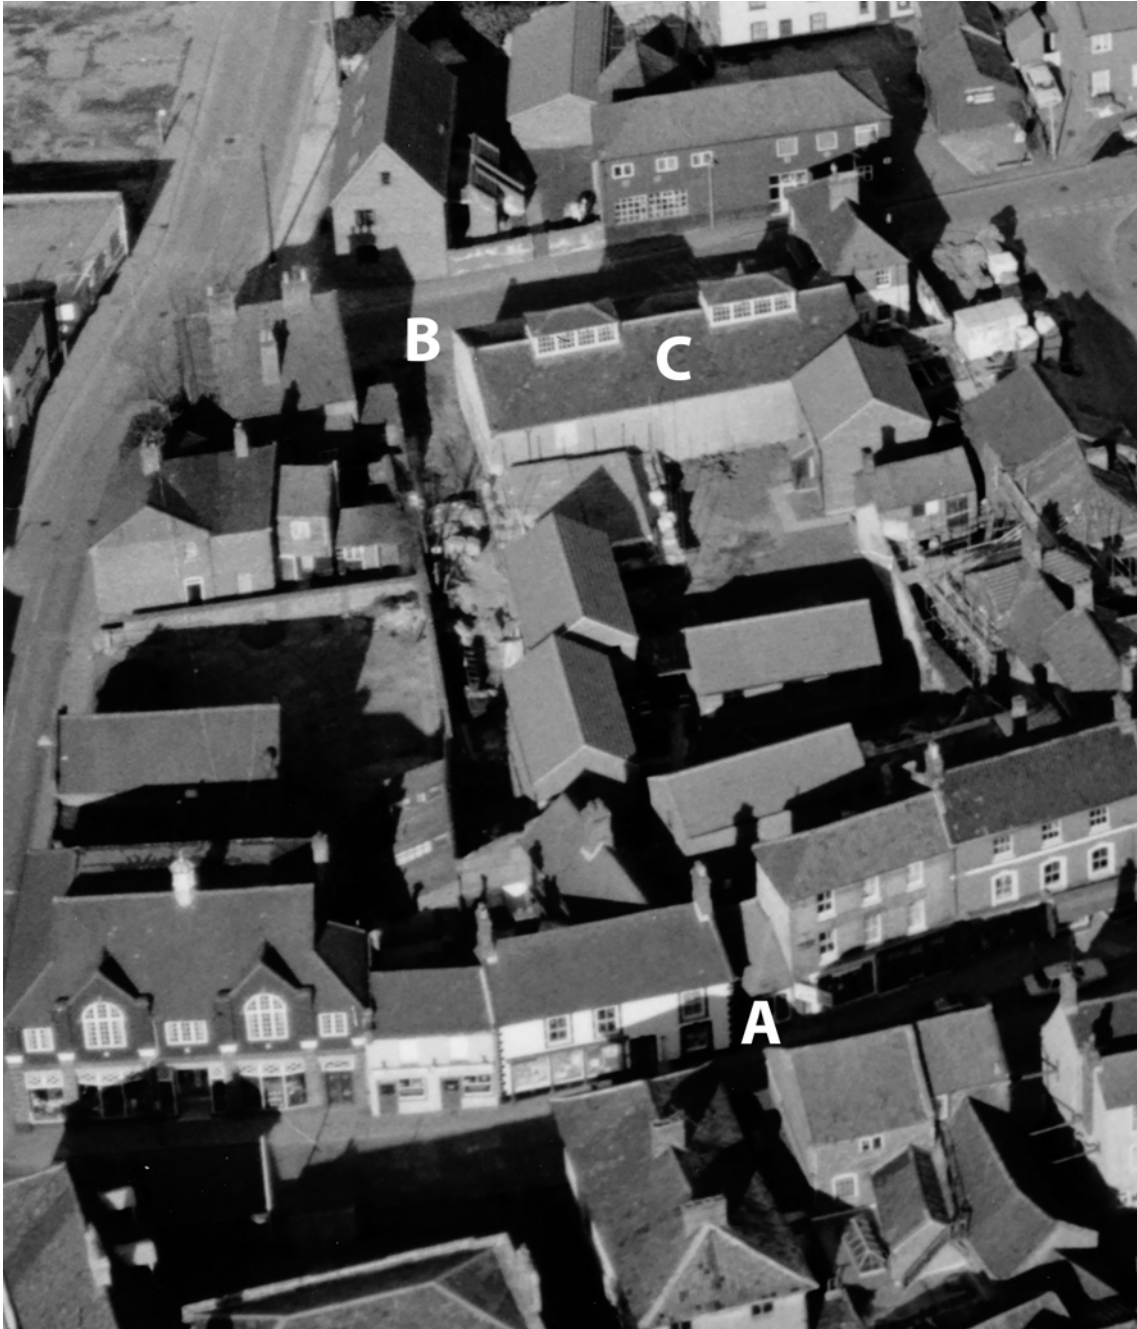
Fig 40: Old Bear Court housing development seen in 1986. The letter A marks the former entrance to Old Bear Yard from Market Street, B the former entrance from Vicarage Street. C marks the Church Rooms. Detail of TG2830/C/AZQ8 2-MAR-1986. Photo by D. Edwards Copyright Norfolk County Council.

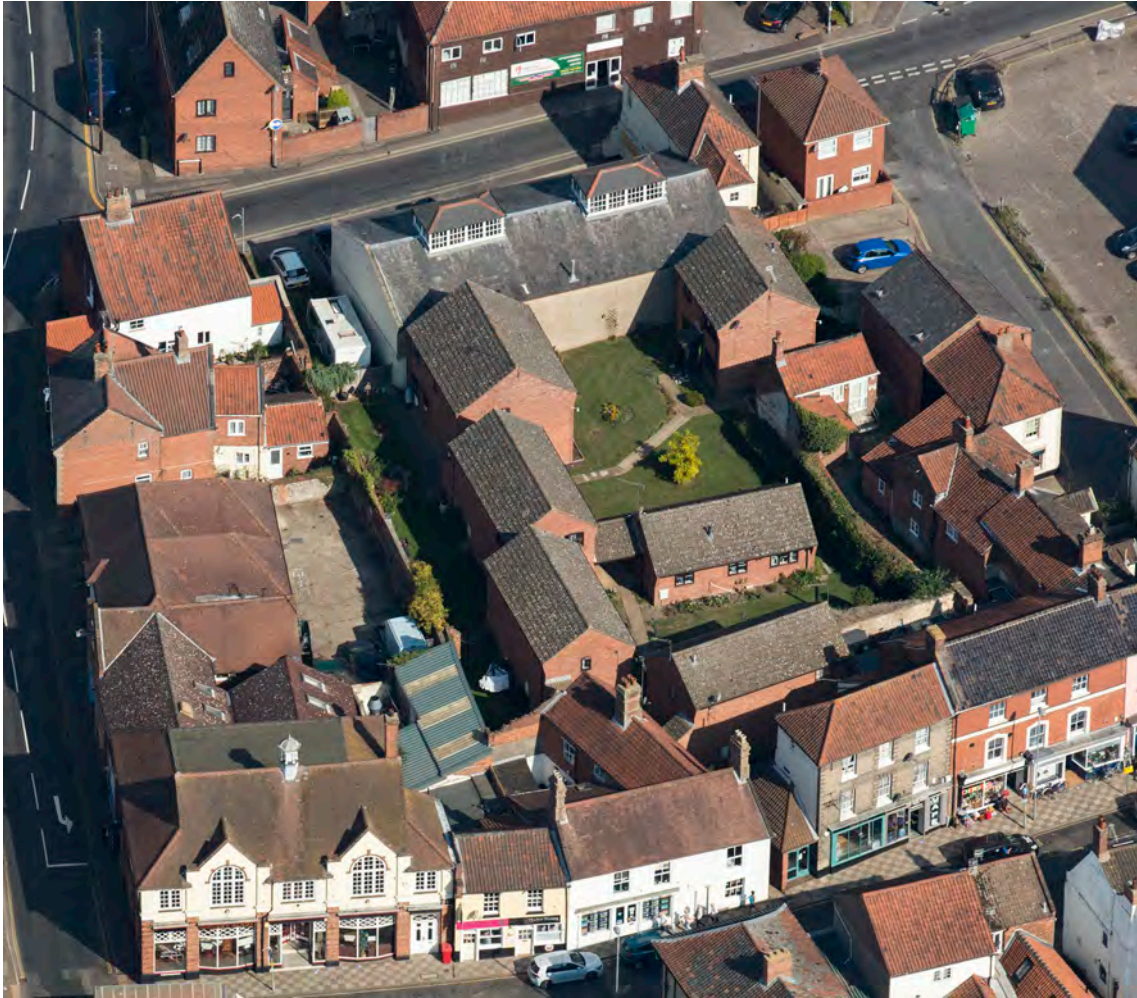
Fig 41: Old Bear Court on the site of Old Bear Yard seen in 2020. Detail of 33933_002 22-SEP-2020 © Historic England Archive.

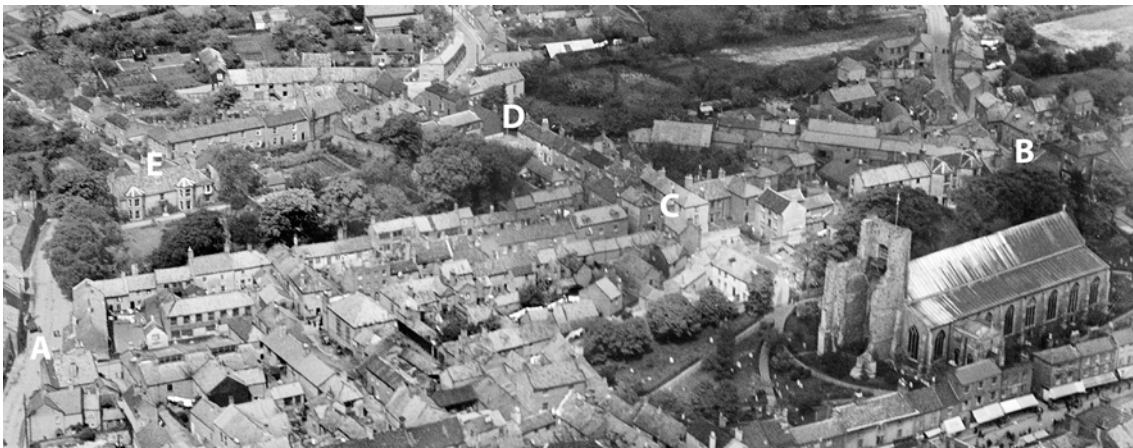
Fig 42: North of the town centre seen from the south-west. Vicarage Street runs from A to B and is joined by North Street at C. Back Street ran from B to D. The letter E marks Lower House. Detail of EPW021293 MAY-1928 © Historic England (Aerofilms Collection).

Vicarage Street is situated to the north of the town centre (Fig 42) and runs from Mundesley Road in the west (A in Fig 42) to Church Street in the east (B in Fig 42) and it forms the northern boundary of the Conservation Area. It is joined roughly halfway along by North Street (C in Fig 42) dividing it into two parts. The western end of Vicarage Street equates to Theatre Street as shown on the 1886 Ordnance Survey map. Some of the buildings along the southern side of the street alongside Old Bear Yard, Mitre Tavern Yard and Ship Yard and are included in the relevant sections above. The buildings seen on historic aerial photographs on the remainder of the southern side of Vicarage Street (north of the church) and along the northern side of the street are discussed below.

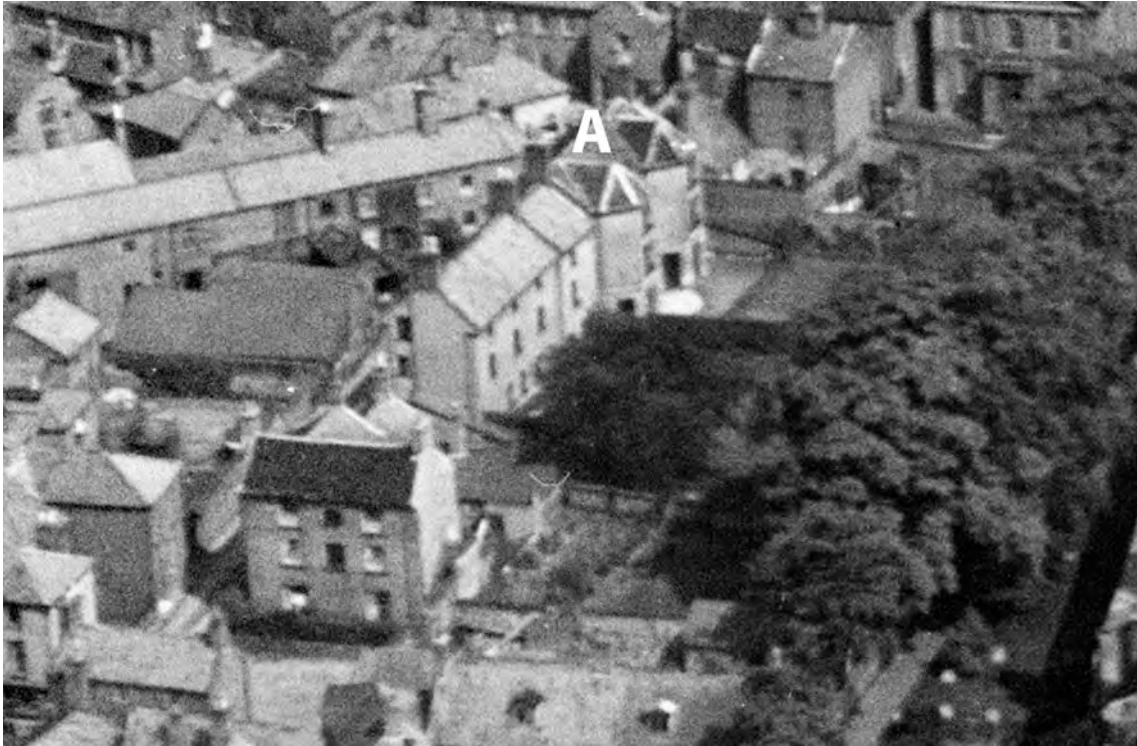
Fig 43: The vicarage and associated houses to the north of the church seen from the west in 1928. The vicarage is marked A, Vicarage Street runs diagonally from the bottom left, the churchyard is to the right. Detail of EPW021294 MAY 1928 © Historic England (Aerofilms Collection).

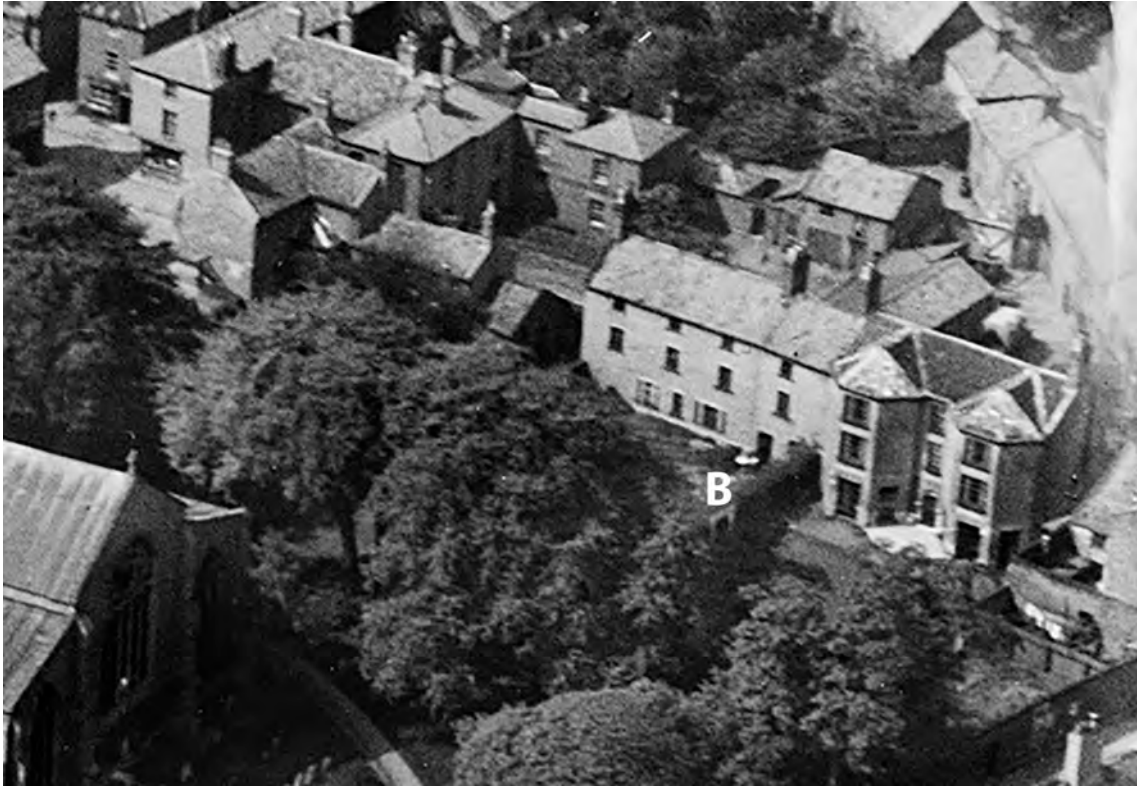
Fig 45: Buildings to the north of the church seen from the south-east in 1928. The letter B marks a gateway through the hedge apparently associated with a path leading from the church to the vicarage (see Fig 44). Detail of EPW021289 MAY 1928 © Historic England (Aerofilms Collection).

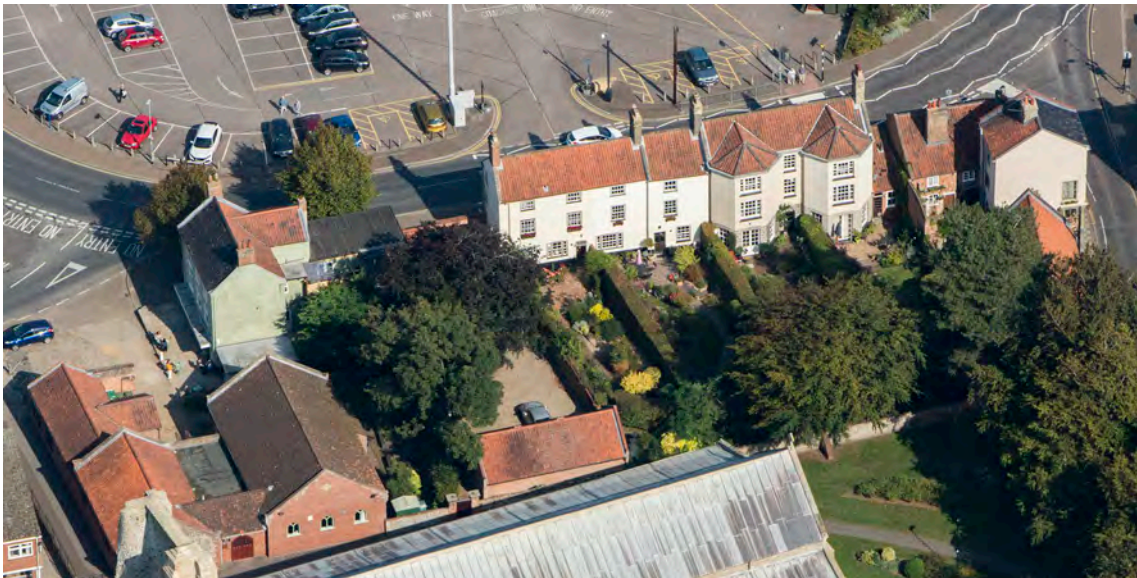
Fig 46: The area to the north of the church, including the former vicarage, in 2020. Detail of 33932_013 22-SEP-2020 © Historic England Archive.

Figure 43 shows the area north of the church in 1928. This area consists of properties facing Vicarage Street, including the former vicarage with large rear gardens extending to the churchyard. Subsequent development has included some new building and the subdivision of the large gardens to the rear presumably reflecting the subdivision of the adjacent properties. A 1968 aerial photograph shows the faint trace of a path that linked the vicarage to the churchyard (Figs 44 and 45). This appears to cut across the adjoining property suggesting that the western boundary to the vicarage's garden is later. Figure 46 shows the site in 2020.

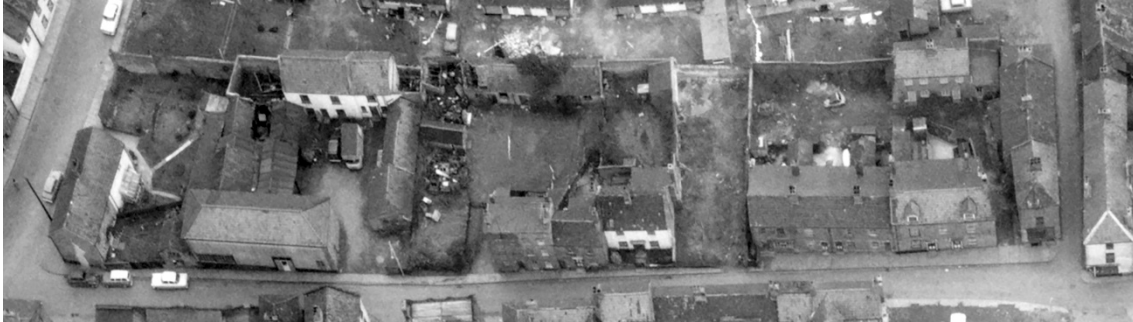
Fig 47: Properties on the western part of Vicarage Street in 1968. South is to the bottom of the photo. The following three figures provide detailed views of this image. Detail of MAL/68006 158 24-FEB-1968. Photo by Meridian Airmaps Ltd. Copyright Norfolk County Council.

The historic aerial photographs show several buildings and yards occupying a 25m deep strip along the north side of Vicarage Street (Fig 47) and these are seen in more detail in Figures 48-50. These properties backed onto largely open ground, much of which was the garden to Lower House, the remainder belonging to smaller properties and their gardens (Fig 51).

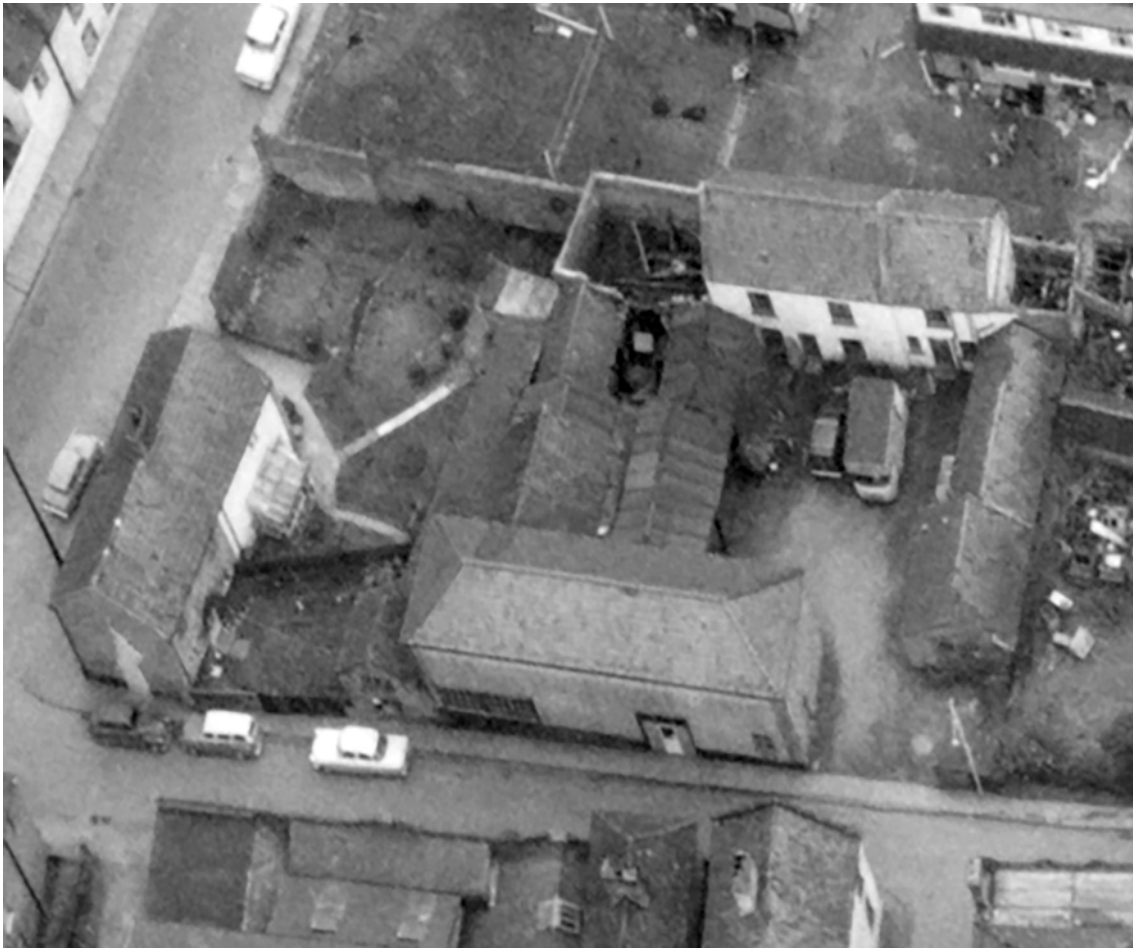
Fig 48: The western end of Vicarage Street (north side) in 1968. Detail of MAL/68006 158 24-FEB-1968. Photo by Meridian Airmaps Ltd. Copyright Norfolk County Council.

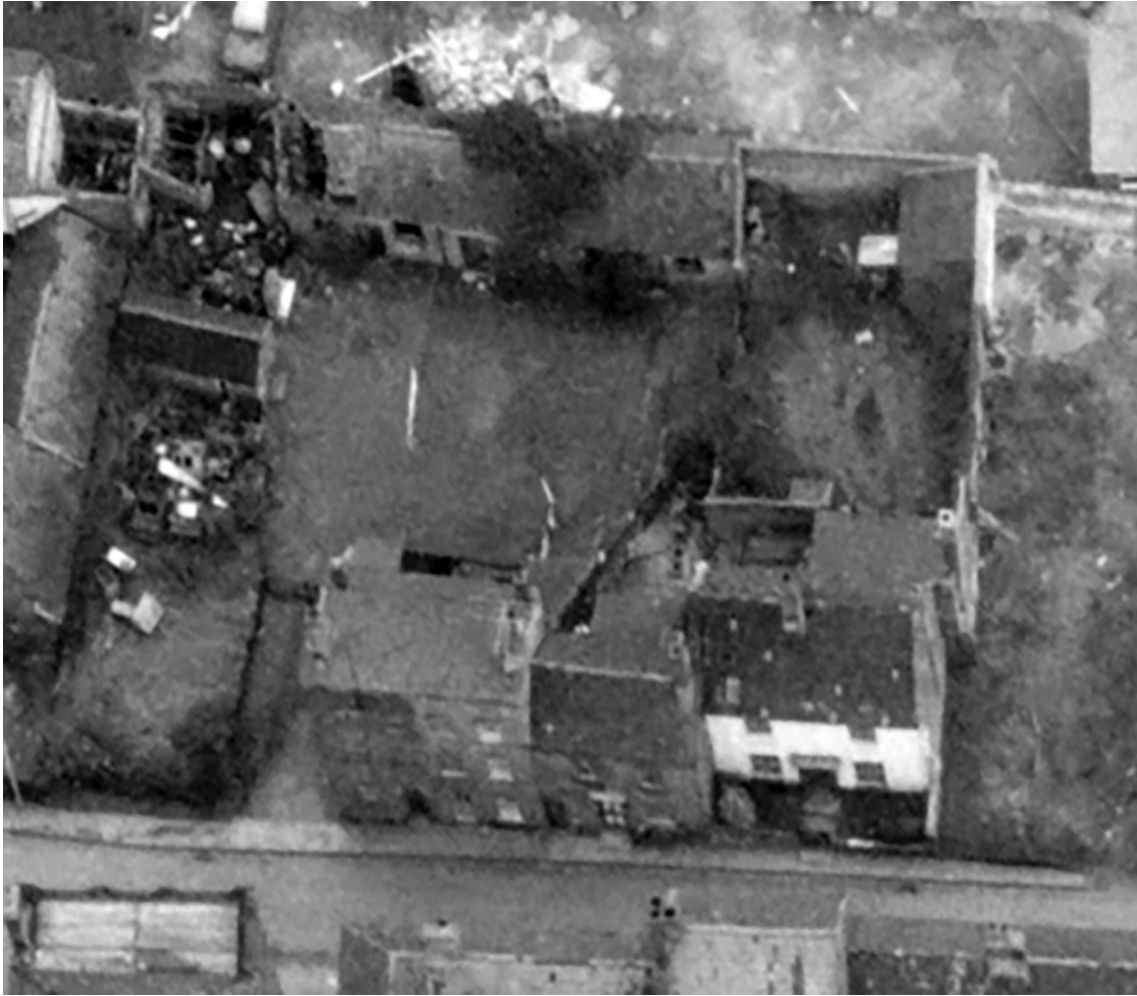
Fig 49: Part of Vicarage Street (north side) in 1968. Detail of MAL/68006 158 24-FEB-1968. Photo by Meridian Airmaps Ltd. Copyright Norfolk County Council.

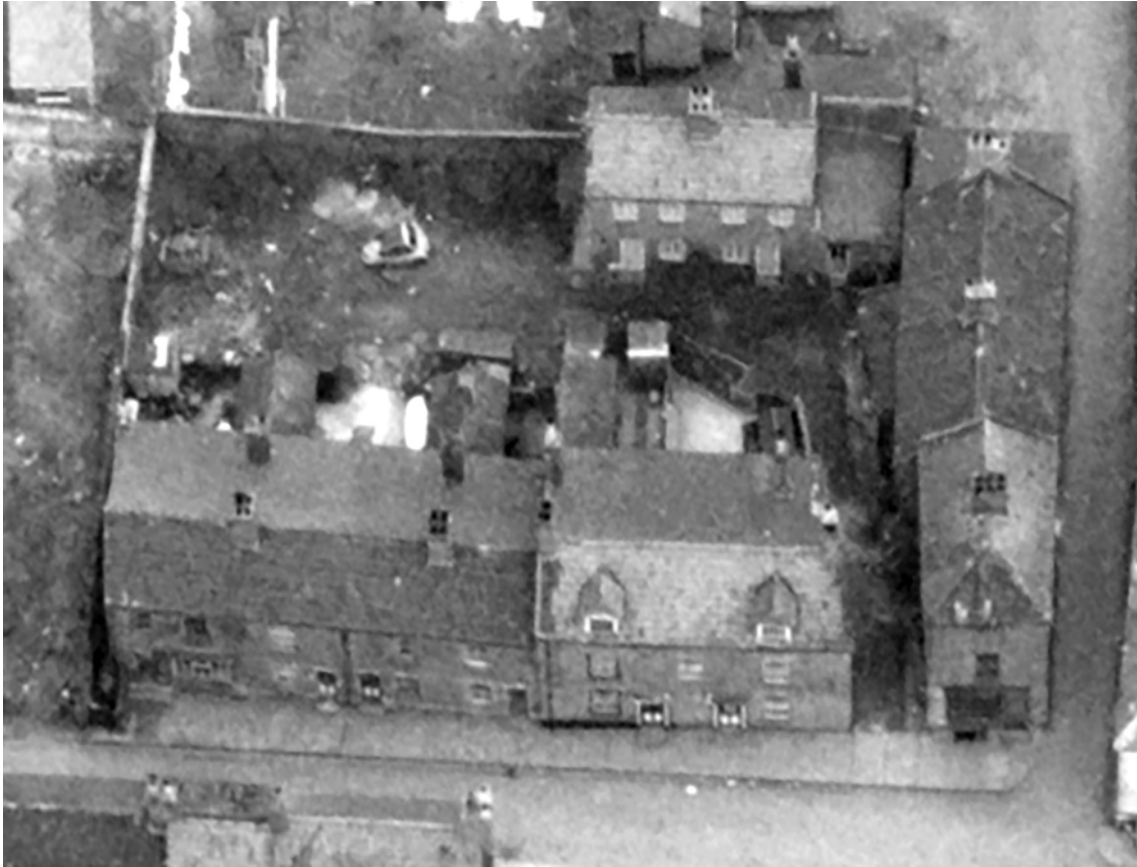
Fig 50: Part of Vicarage Street (north side) in 1968. North Street is to the right. Detail of MAL/68006 158 24-FEB-1968. Photo by Meridian Airmaps Ltd. Copyright Norfolk County Council.

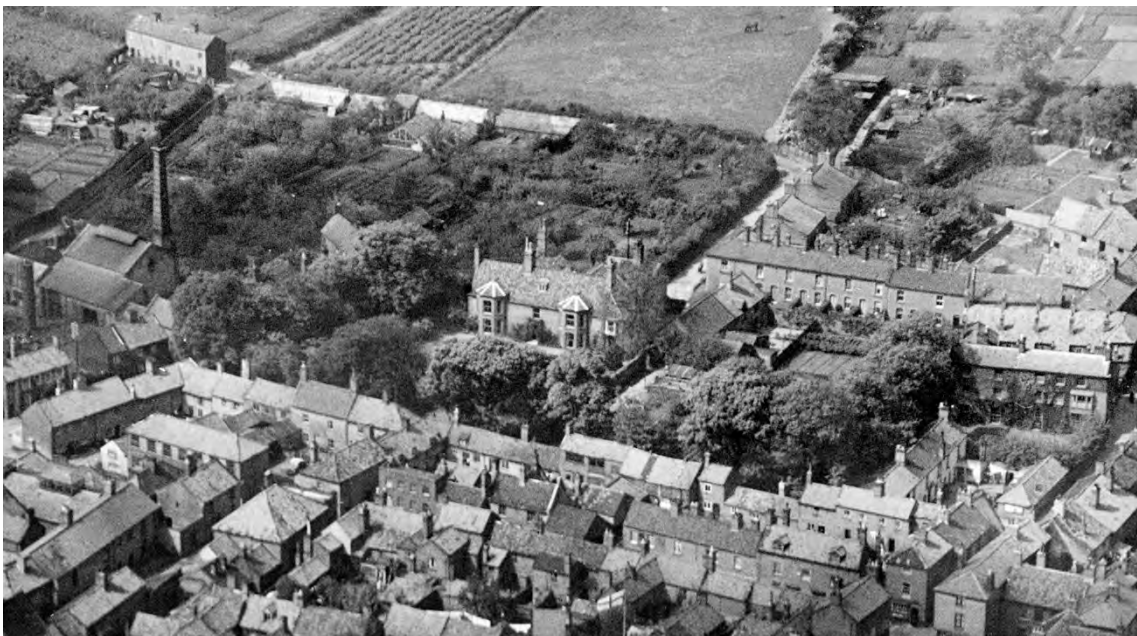
Fig 51: A view taken in 1928 from the south-east. Vicarage Street runs diagonally from the bottom right of the photograph. Lower House, with two bay windows, is at the centre of the image. Detail of EPW021290 MAY-1928 © Historic England (Aerofilms Collection).

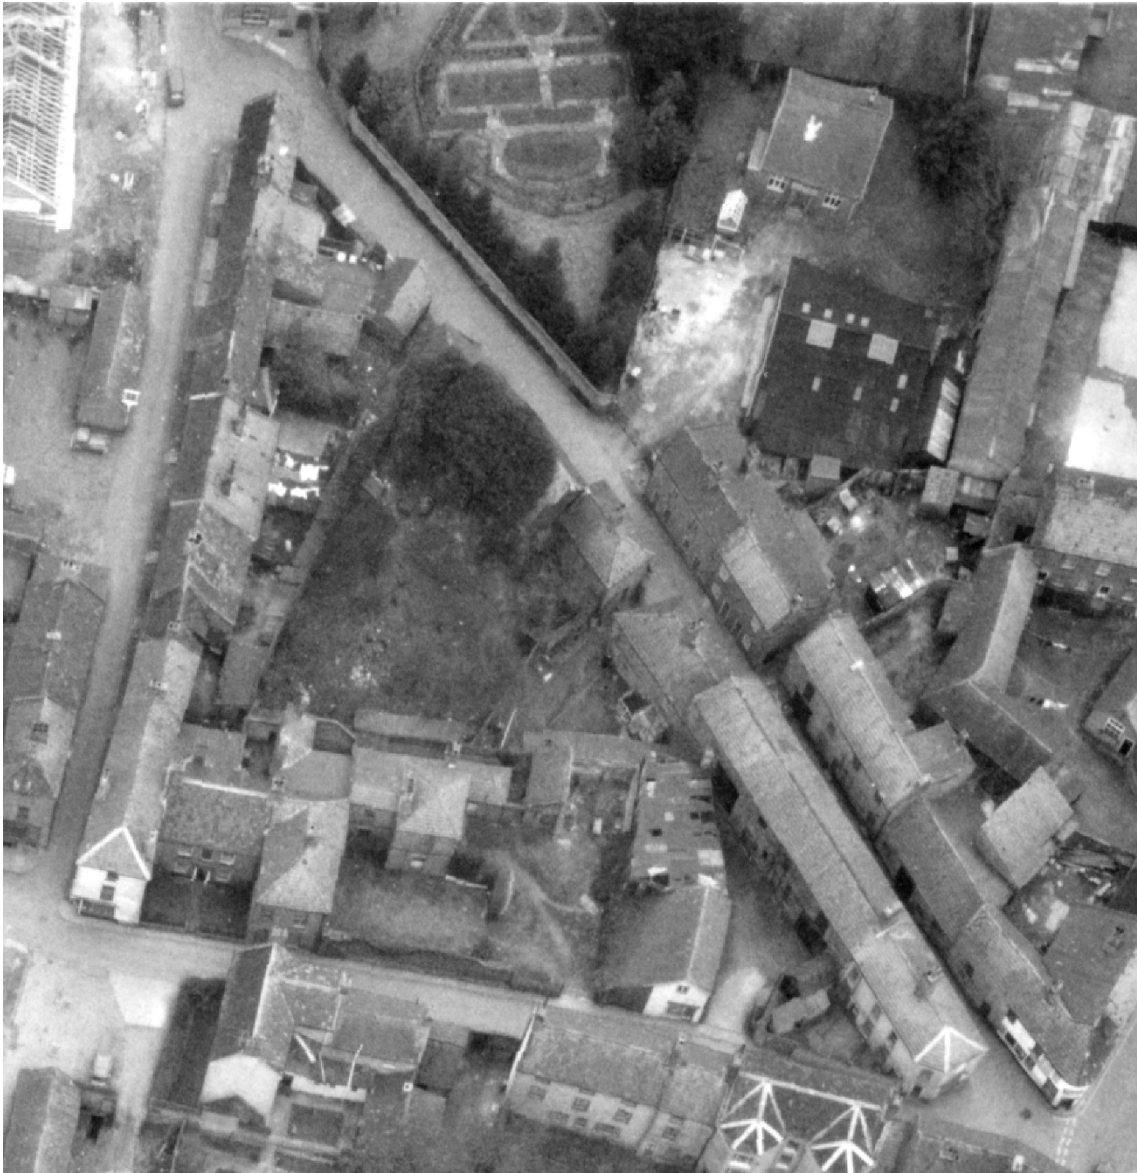
Fig 52: Vicarage Street runs left to right along the bottom of the image, North Street is on the left, Back Street running diagonally bottom right to top left. This view taken in 1968. Detail of MAL/68006 158 24-FEB-1968. Photo by Meridian Airmaps Ltd. Copyright Norfolk County Council.

The eastern end of Vicarage Street extends from North Street in the west to the junction with Church Street in the east. Back Street ran diagonally from this junction north-west to join North Street and formed a triangular street plan (Fig 52). A mixture of buildings and open yards faced Vicarage Street at the southern end of this triangle and two adjoining aerial photographs in this run of images taken in 1968 offer slightly different views of these, one providing a better view of the front (southern) elevations (Fig 53), the second showing some of the side (eastern) elevations (Fig 54). Figures 55-57 provided three views of some of the buildings on Back Street taken in 1928 and 1968.

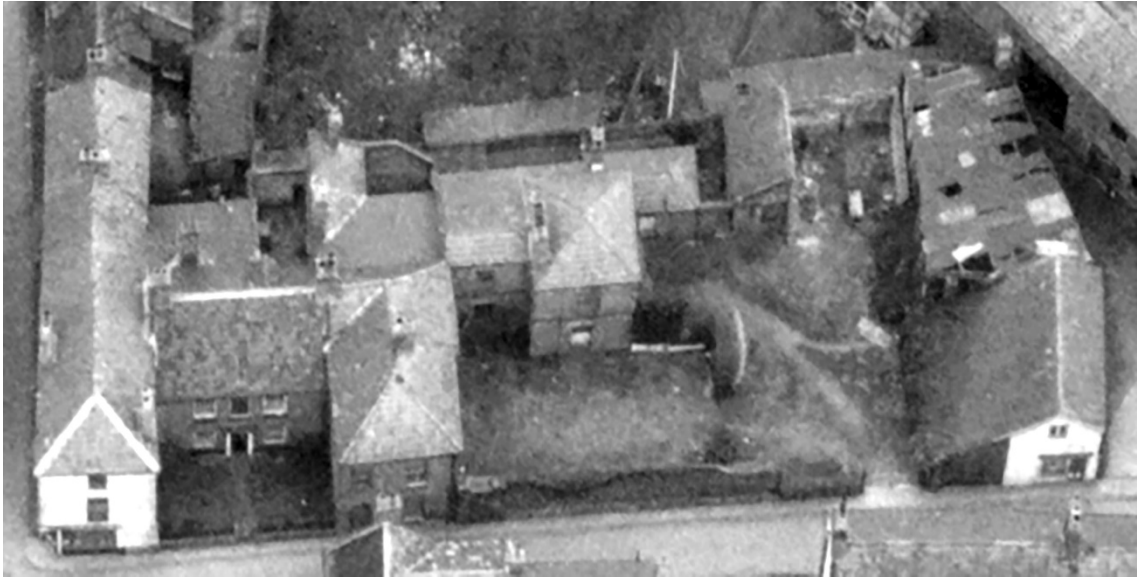
Fig 53: The eastern end of Vicarage Street in 1968. Detail of MAL/68006 158 24-FEB-1968. Photo by Meridian Airmaps Ltd. Copyright Norfolk County Council.

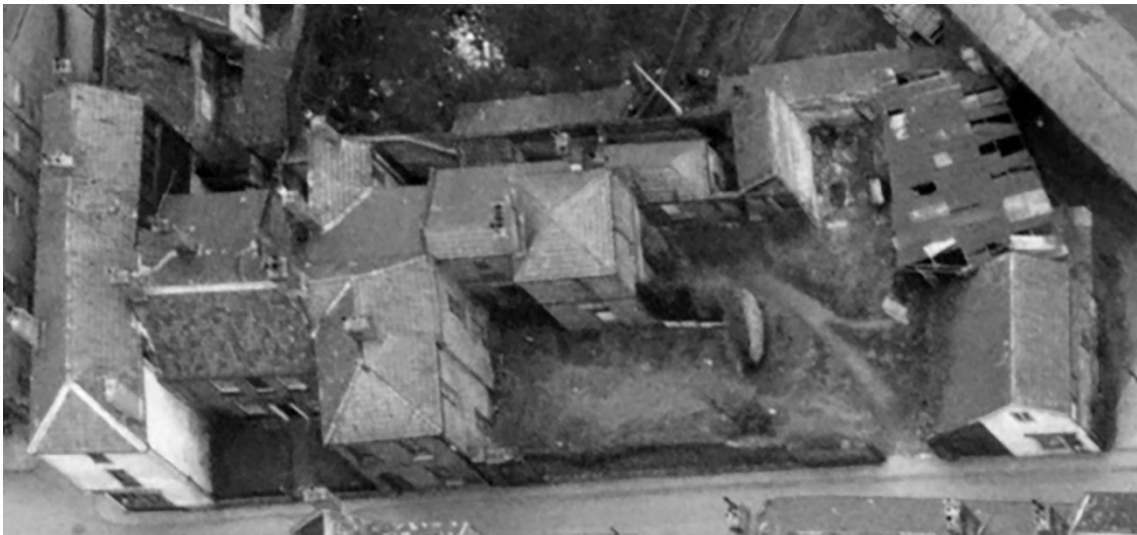
Fig 54: A slightly different view of the same area in Fig 53 showing parts of the side (eastern) elevations. Detail of MAL/68006 159 24-FEB-1968. Photo by Meridian Airmaps Ltd. Copyright Norfolk County Council.

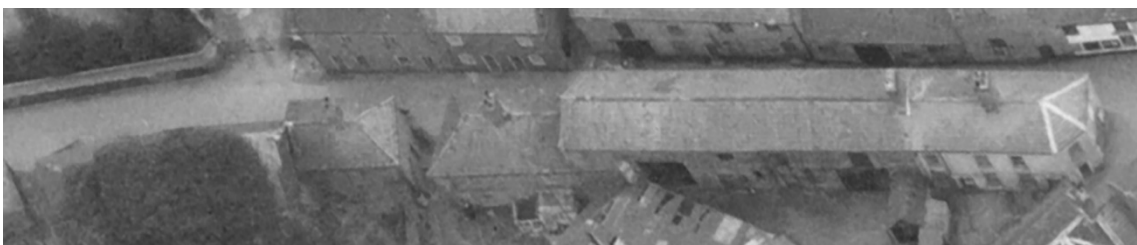
Fig 55: Buildings along the western side of Back Street seen from the west in 1968. Detail of MAL/68006 158 24-FEB-1968. Photo by Meridian Airmaps Ltd. Copyright Norfolk County Council.

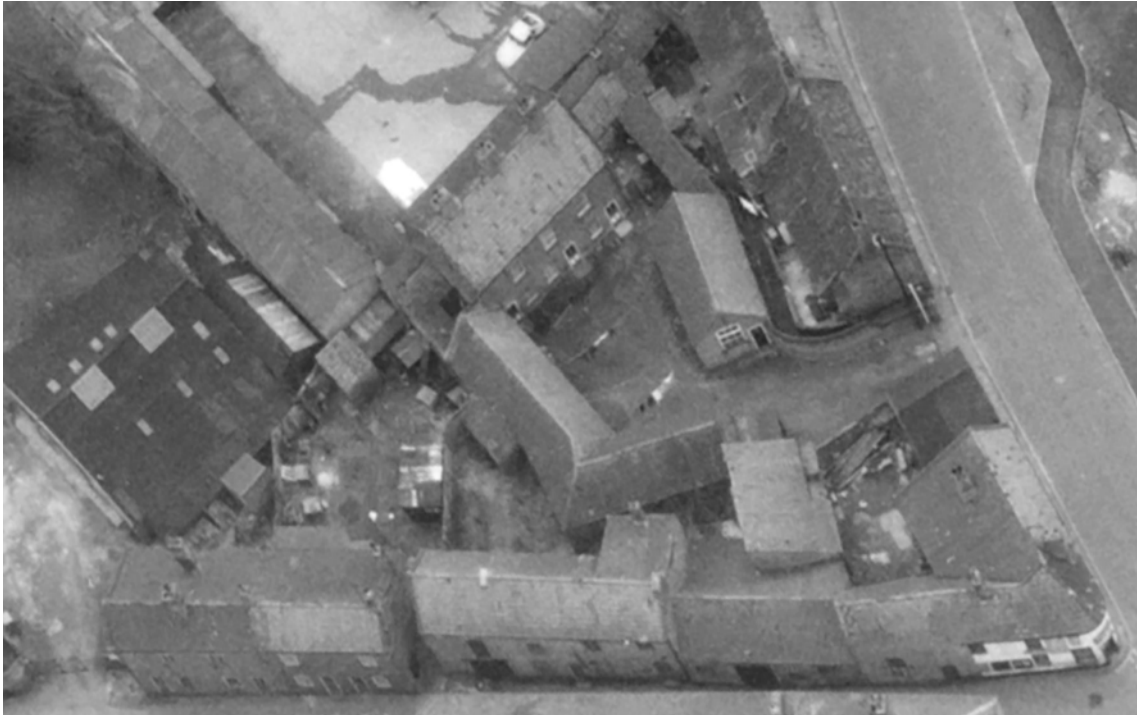
Fig 56: Back Street runs along the bottom of the photograph, Bacton Road on the right, viewed from the south-west in 1968. Detail of MAL/68006 158 24-FEB-1968. Photo by Meridian Airmaps Ltd. Copyright Norfolk County Council.

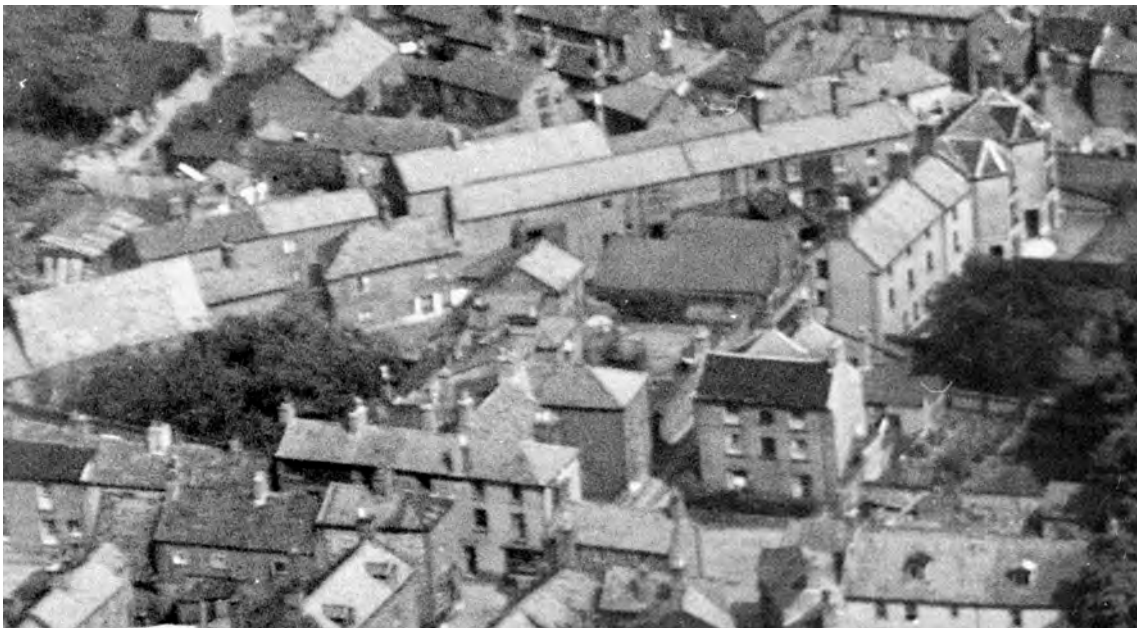
Fig 57: Back Street seen in 1928 from the south-west. Detail of EPW021294 MAY-1928 © Historic England (Aerofilms Collection).
