North Walsham High Street Heritage Action Zone Aerial Investigation

Edward Carpenter

North Walsham
Norfolk

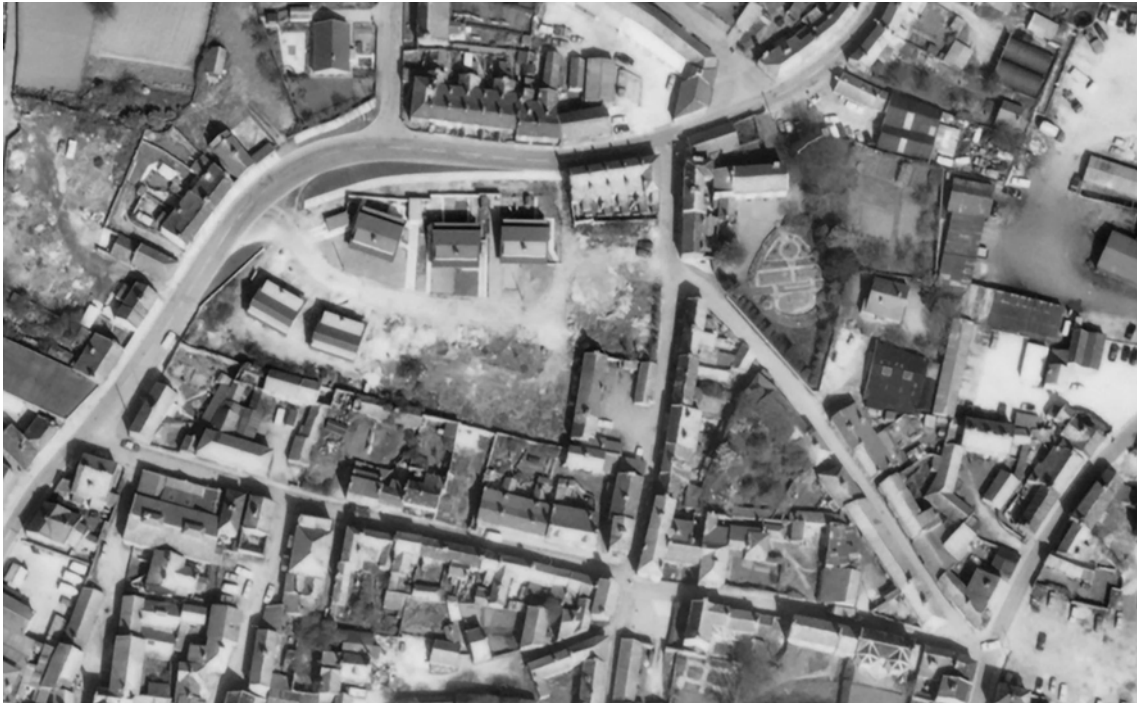
Fig 58: North of Vicarage Street in 1967. Detail of OS/67053 11 24-APR-1967 © Crown Copyright Ordnance Survey.

The 1967 aerial photographs show the new housing development of Greenway Close across the area previously occupied by Lower House, garden and neighbouring properties (Fig 58). This 1967 view largely matches what is depicted on the 1970 Ordnance Survey map. After 1970, several of the buildings on the northern side of Vicarage Street (also shown above, Figs 47-57) had been demolished including the complete clearance of those within the triangular area formed by Back Street, Vicarage Street and North Street. This area was converted to

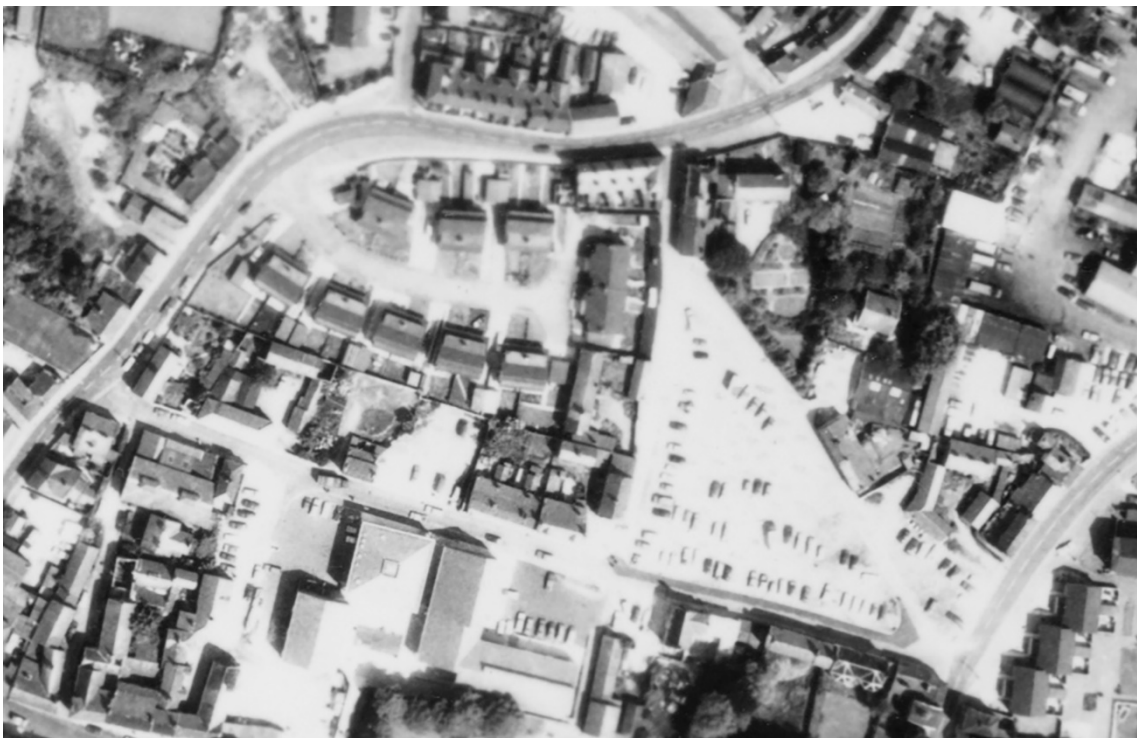
Fig 59: North of Vicarage Street in 1972. Detail of MAL/72052 204 22-JUN-1972. Reproduced by Permission of Historic England.

a car park, perhaps to serve the new St Nicholas Court precinct (Fig 59). The 1975 Ordnance Survey map shows further demolition towards the western end of Vicarage Street. New houses along this half of the street had been built by the early 1980s and seen on 1986 aerial photographs (Fig 60). Figure 61 shows the area in 2020.

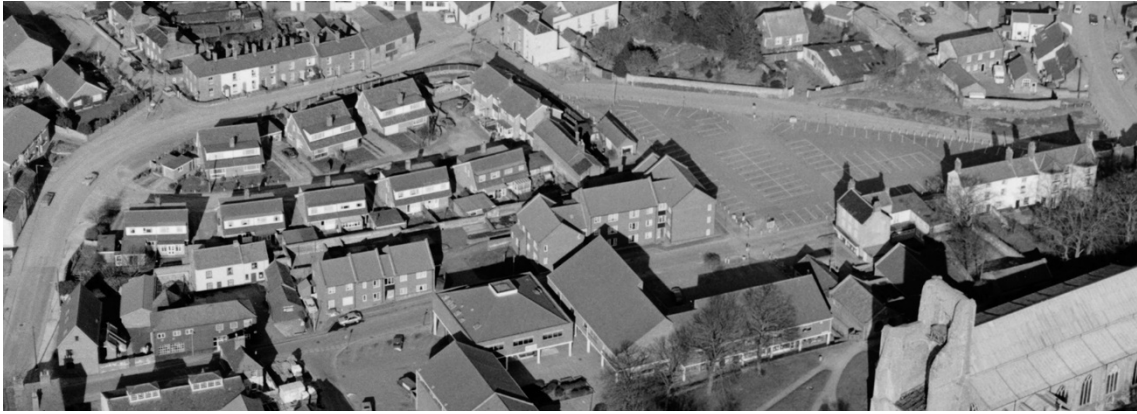
Fig 60: North of Vicarage Street in 1986. Vicarage Street runs diagonally from bottom left of the photograph. The diagonal boundary to the car park on the right follows the line of Back Street. TG2830/C/AZQ8 02-MAR-1986. Photo by D. Edwards Copyright Norfolk County Council.

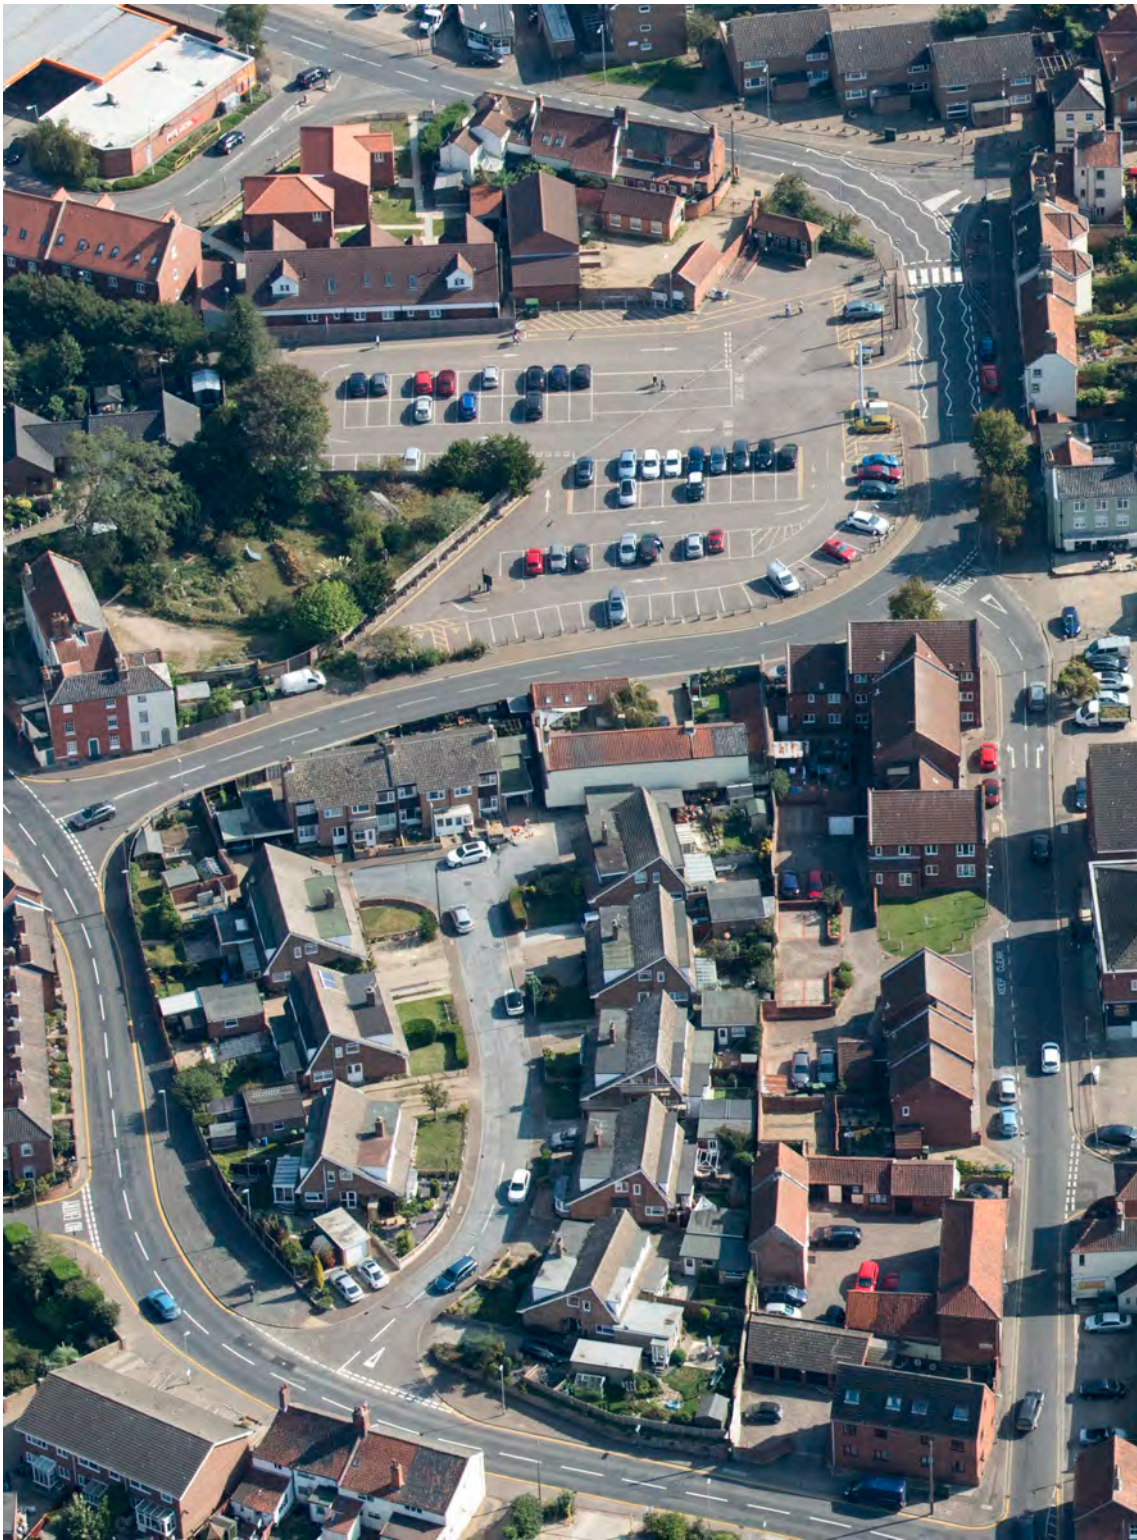
Fig 61: The area to the north of Vicarage Street looking east in 2020. Vicarage Street is on the right, the 1960s Greenway Close development in the foreground, with the car park beyond separated by North Street running left to right in the middle of the image. Detail of 33933_015 22-SEP-2020 © Historic England Archive.

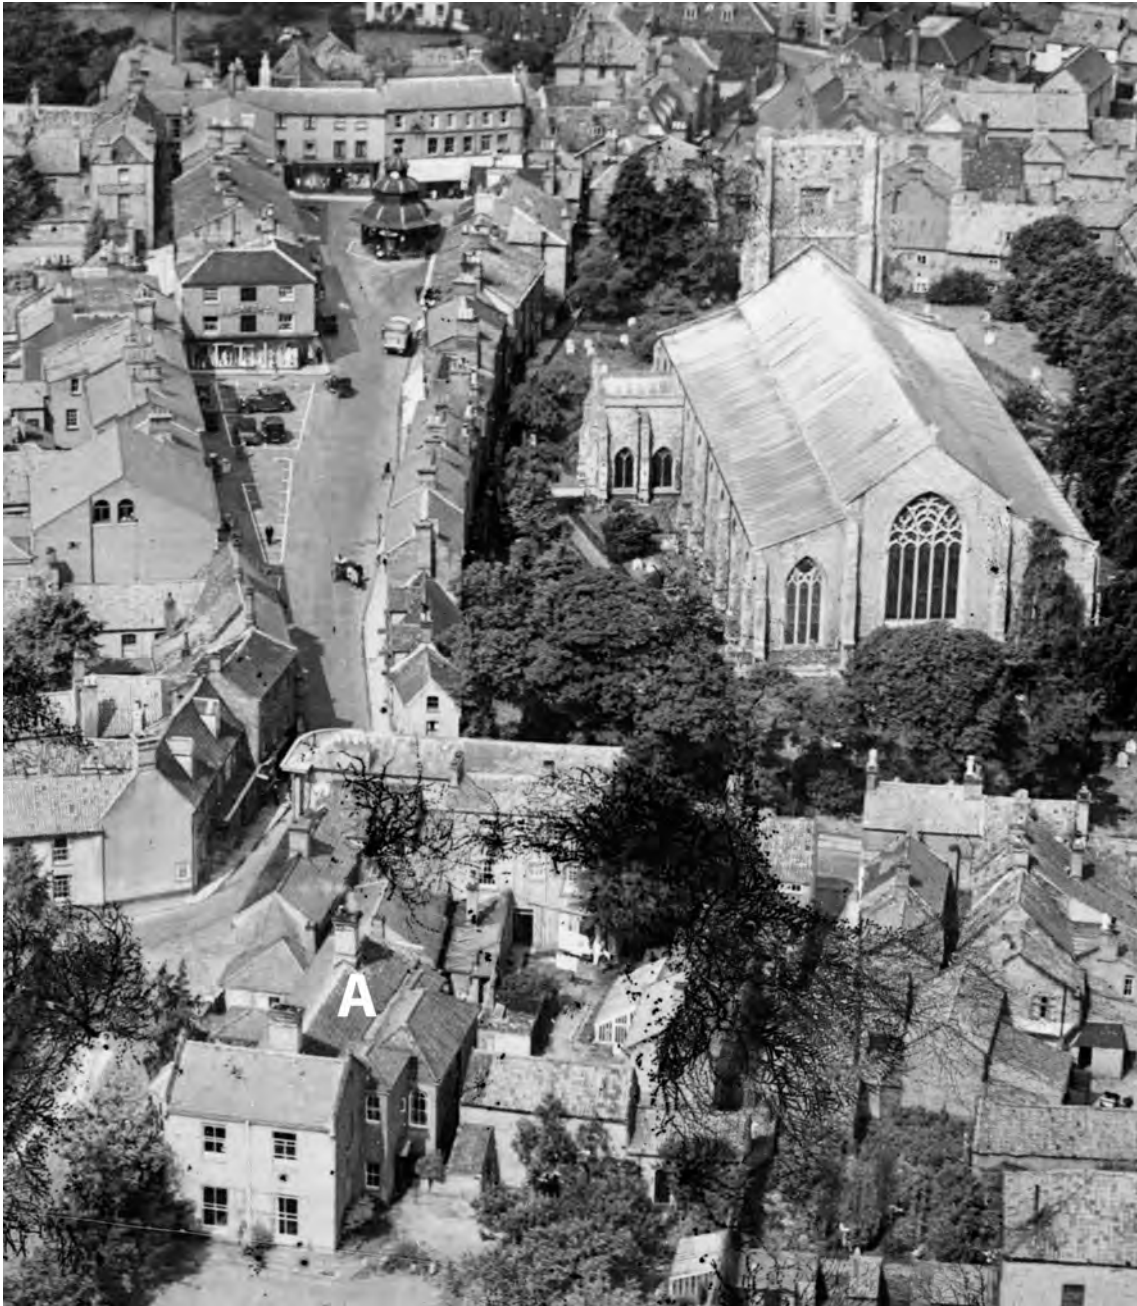
Fig 62: The Cedars (A) and its location in the town at the eastern entrance to the Market place. Detail of EPW039256 JUL-1932 © Historic England (Aerofilms Collection).

The Cedars is situated on New Road at the eastern end of the Market Place (Fig 62). The 1928 and 1932 aerial photographs show the house, its outbuildings, and grounds. This property was later converted to council offices and these are seen in Figure 67. Several of the earliest aerial photographs of The Cedars suffer from light damage or have deteriorated but some details of the building's earlier appearance can be seen.

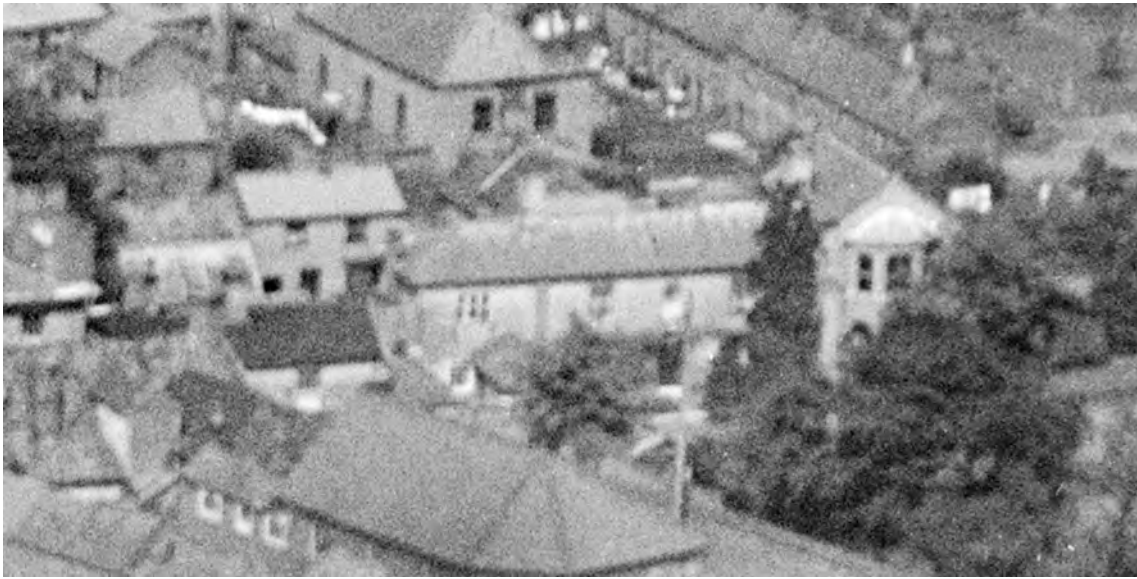
Fig 63: Southern elevation of The Cedars from the south-west in 1928. Detail of EPW021292 MAY 1928 © Historic England (Aerofilms Collection).

The front elevation of The Cedars faces south opposite Yarmouth Road. It cannot be clearly seen in a single 1928 aerial photograph, but Figures 63 and 64 show most of

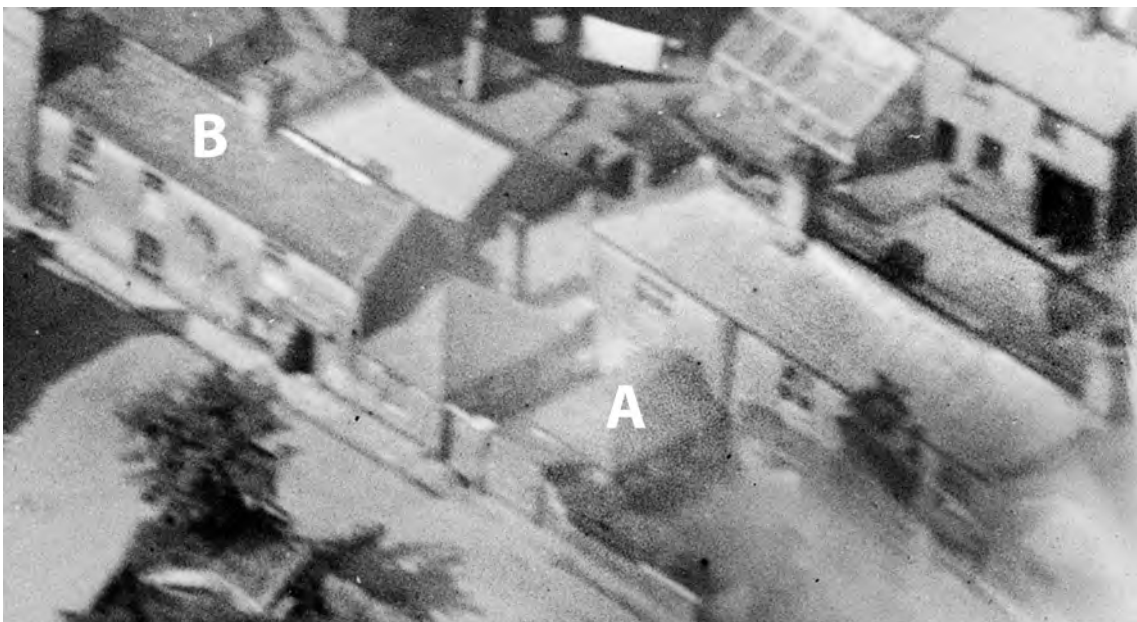
Fig 64: Southern elevation of The Cedars from the south-east in 1928. A and B discussed below. Detail of EPW021289 MAY 1928 © Historic England (Aerofilms Collection).

Figure 64 shows a since demolished ground floor extension to The Cedars (A). This extension is also first depicted on the 1928 Ordnance Survey map. Although the pitched roof structure did not extend as far as the front wall (as suggested by the map) the photograph shows what may be a flat roof crossing the gap between the building and the wall. The wall appears uneven and may possibly have incorporated a former gatepost suggesting it may show a blocked entrance. This may have been wide enough for vehicles and a dropped kerb or no kerb is suggested by the lack of a shadow at this point. However, the quality of the photograph is poor, and it is

difficult to identify some features with certainty. Equally difficult to interpret due to the graininess of the image is the dark line extending up the front elevation of The Cedars by the extension (A) to the eaves of the main house, but it may be evidence of a pilaster. The building to the left of The Cedars (B in Fig 64) survives but the 1928 aerial photograph shows some differences including windows on the ground floor that have since been blocked.

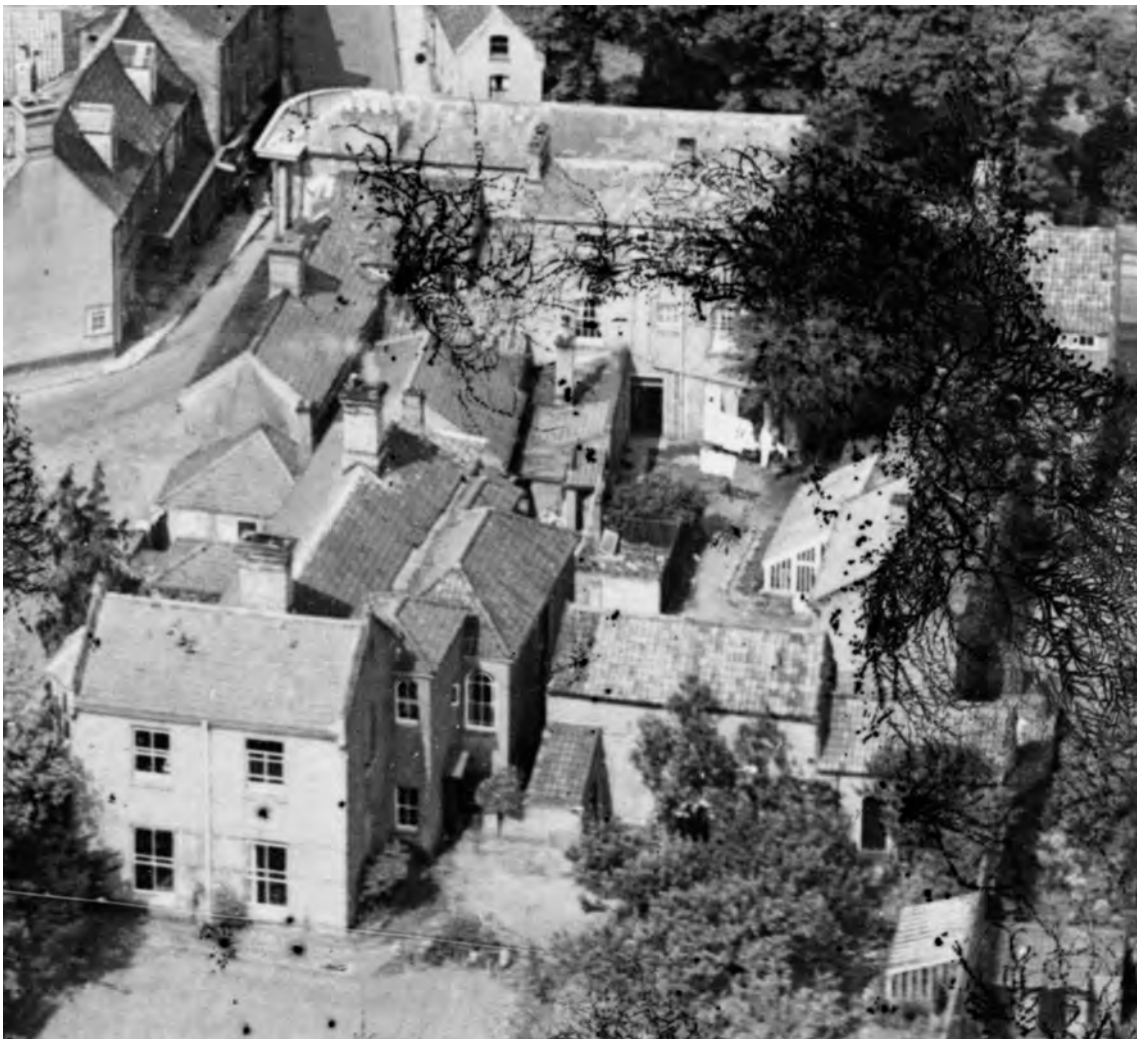
Fig 65: The eastern elevation and rear of The Cedars and adjoining properties seen in 1932. Deterioration of the negative has obscured parts of this image. Detail of EPW039256 JUL 1932 © Historic England (Aerofilms Collection).

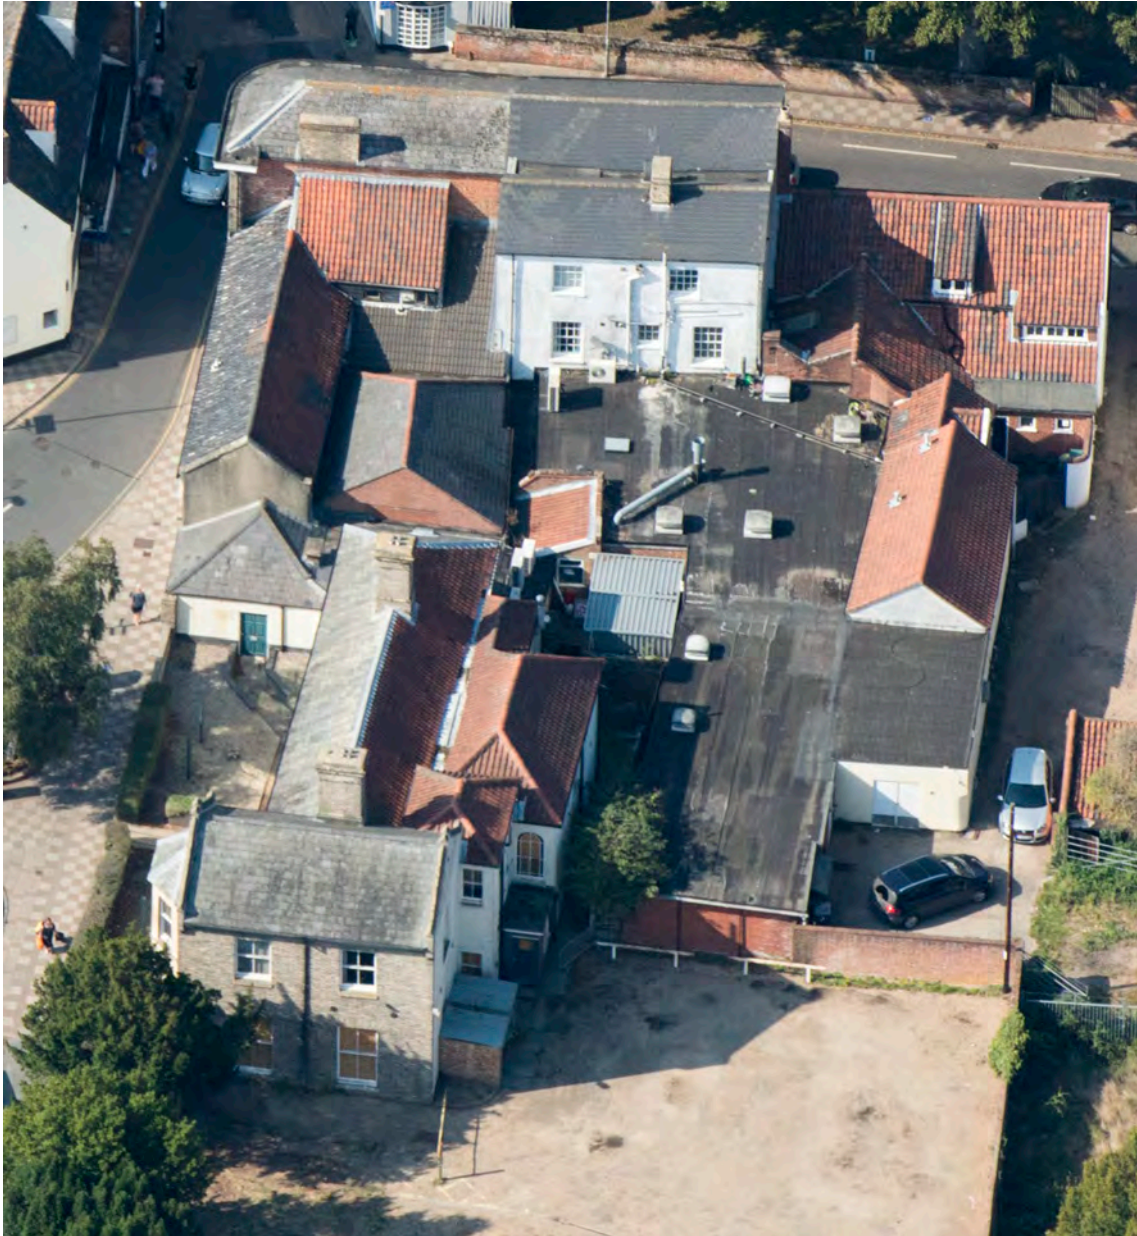
Fig 66: The eastern elevation and rear of The Cedars seen in 2020. Detail of 33932_041 22-SEP-2020 © Historic England Archive.

A partial view of the side and rear of The Cedars and the buildings to the west can be seen in a 1932 aerial photograph (Fig 65). This can be compared with the same view in 2020 (Fig 66). There has been minimal demolition, but The Cedars garden was cleared for a car park and the garden to the north built over with a flat roofed structure. Some of this work was presumably carried out as part of the conversion to council offices (Fig 67).

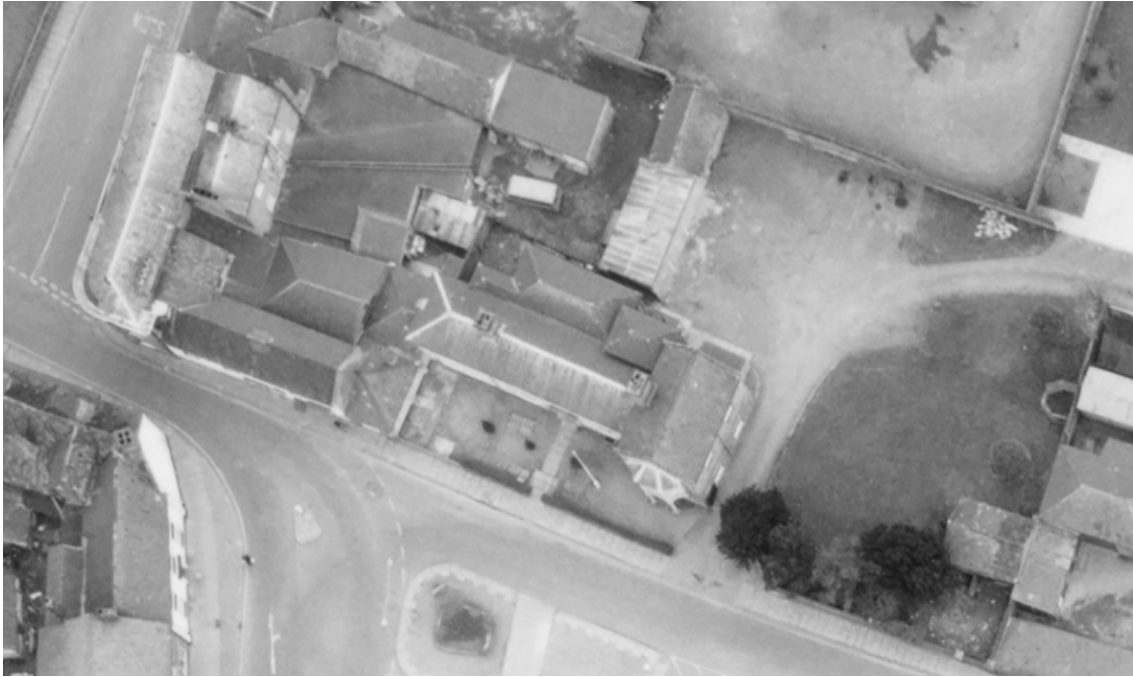
Fig 67: The Cedars in 1968 after conversion to Council Offices. By this date several trees had been felled and the garden cleared. New Road runs diagonally across the bottom of the image. Detail of MAL/68006 159 24-FEB-1968. Photo by Meridian Airmaps Ltd. Copyright Norfolk County Council.

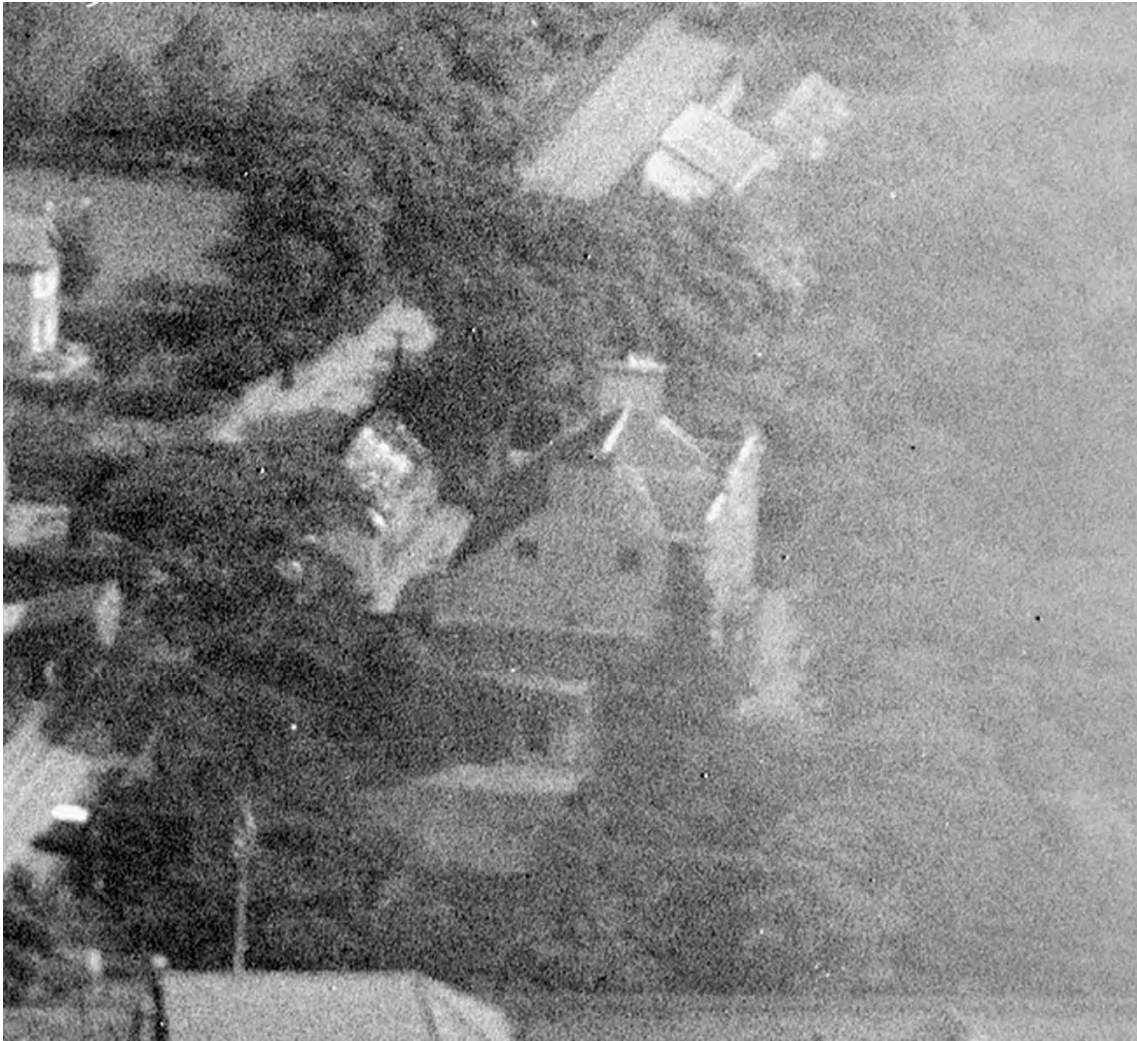
Fig 68: The Oaks seen from the west in 1928. Detail of EPW021294 MAY 1928 © Historic England (Aerofilms Collection).

The Oaks was a large house in extensive grounds on the south side of New Road diagonally opposite The Cedars. The Oaks was demolished in the 1930s and unfortunately the aerial photographic coverage of this house and its gardens is poor. The house only appears in one grainy photograph taken in 1928 (Fig 68). Fragments of the western end of the grounds are captured on the edge of other photos including what may be a garden building at one corner of the grounds seen bottom left of Figure 64.

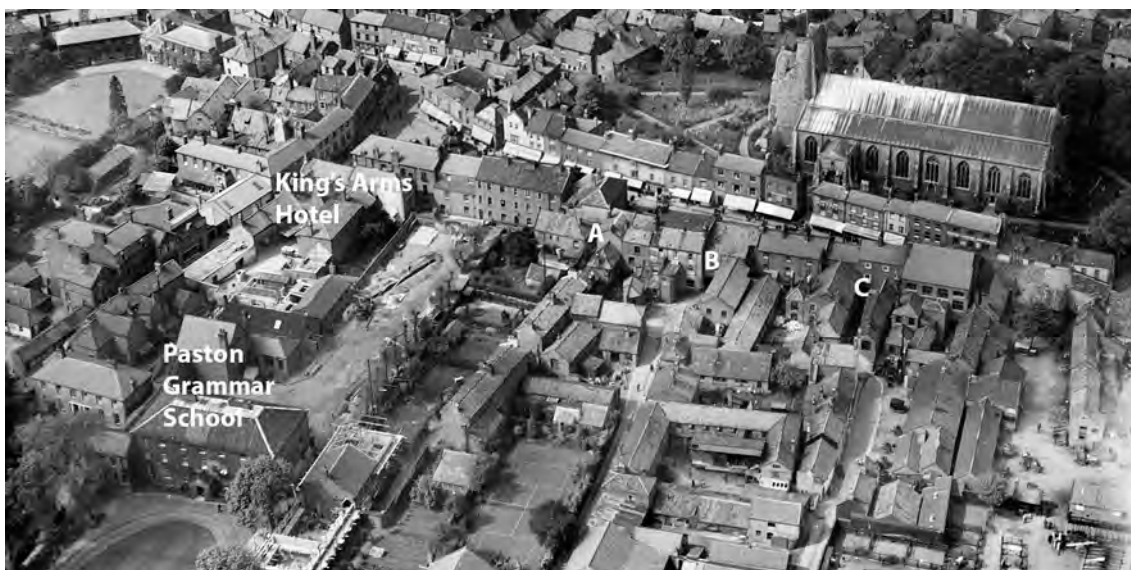
Fig 69: The area to the south of the Market Place. The letter A marks the entrance to The Terrace, B to Bank Loke and C to Black Swan Loke. Detail of EPW021290 MAY 1928 © Historic England (Aerofilms Collection).

This part of the report covers the area to the south of the Market Place defined on its western side by King's Arms Street, by Yarmouth Road to the east and by Grammar School Road to the south. The area is subdivided by narrow lanes (known locally as lokes) that run approximately north-south. These are, from west to east, a blind lane called The Terrace, Bank Loke and Black Swan Loke. Both Bank Loke and Black Swan Loke join the Market Place to Grammar School Road (Fig 69). This area includes the King's Arms Hotel and the former Paston Grammar School (now part of Paston College) all of which are discussed below.

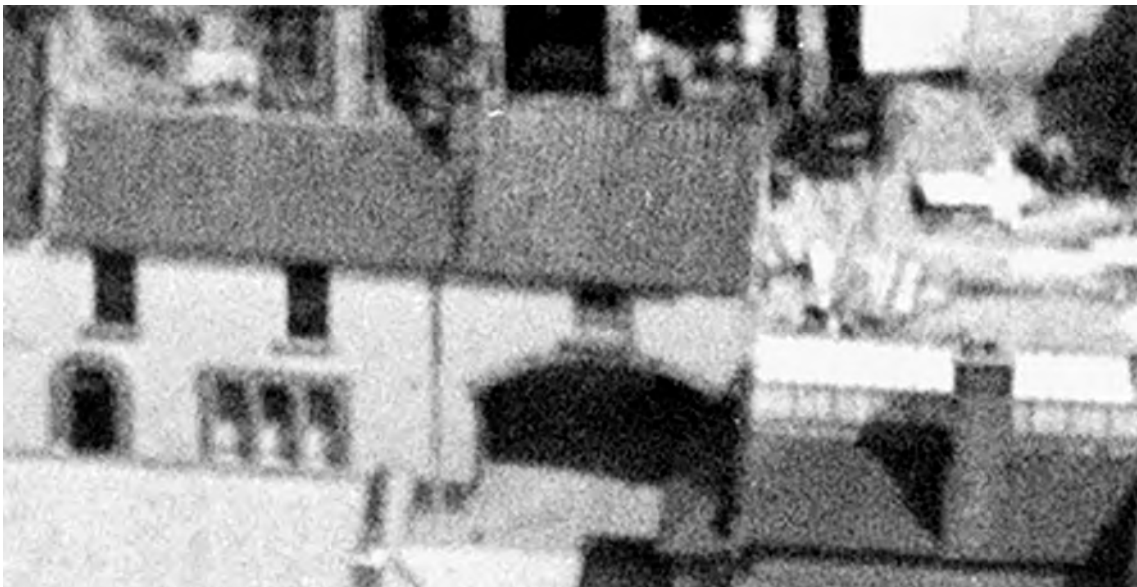
Fig 71: The archway into the King's Arms Hotel yard seen from the west. Detail of EPW021294 MAY 1928 © Historic England (Aerofilms Collection).

King's Arms Hotel faces the Market Place and extends south along King's Arm Street. None of the aerial photographs show the hotel from the north, but views from the west, south-west, and south-east show the rear of the hotel buildings and yard (Fig 70). The hotel yard was entered from King's Arms Street through an archway in the western range of buildings. This is seen from the street in Figure 71 and from the hotel yard in Figure 72.

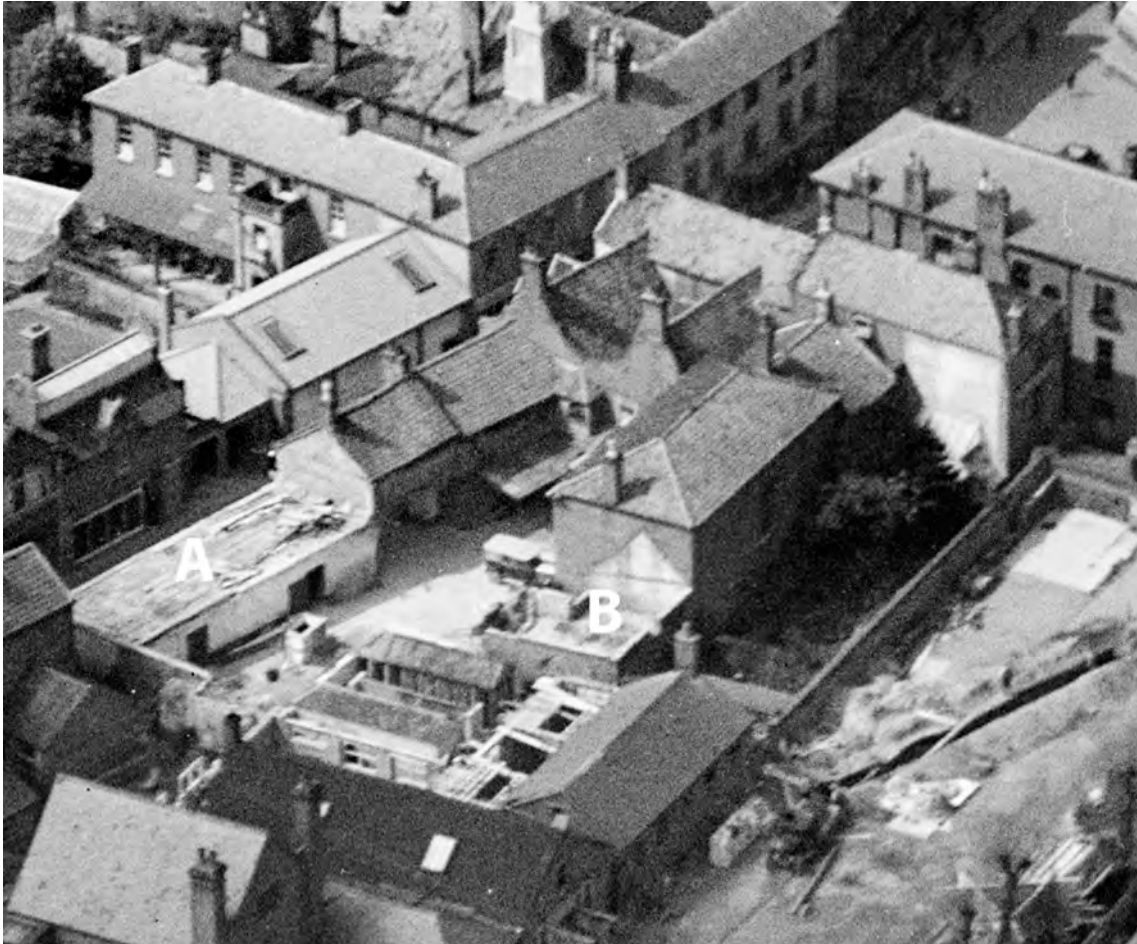
Fig 72: King's Arms Hotel from the south-east in 1928. King's Arms Street runs diagonally from bottom left to top right where it joins the Market place. Buildings undergoing demolition are labelled A and B. Detail of EPW021290 MAY 1928 © Historic England (Aerofilms Collection).

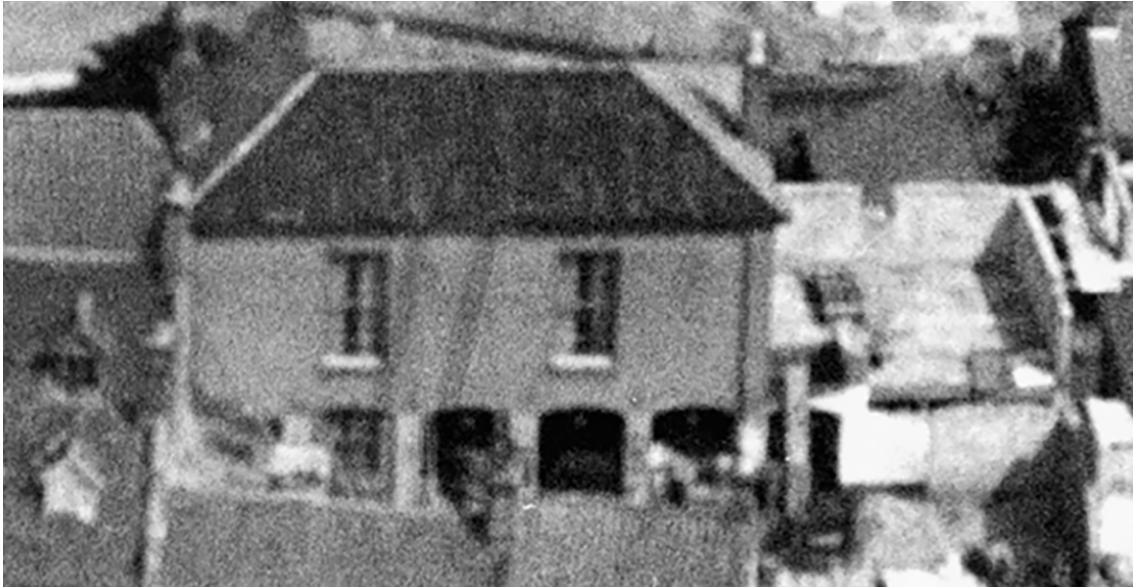
Fig 73: The assembly room with possible coach house below and a partially demolished building on the right. Detail of EPW021294 MAY 1928 © Historic England (Aerofilms Collection).

Building B in Figure 72 was built against a larger building which housed the assembly room on the first floor. On the ground floor were three wide entrances (and two windows) suggesting this was used as a coach house. The photograph shows that the adjoining building under demolition had a similar entranceway and may have served as an extension to the coach house (Fig 73).

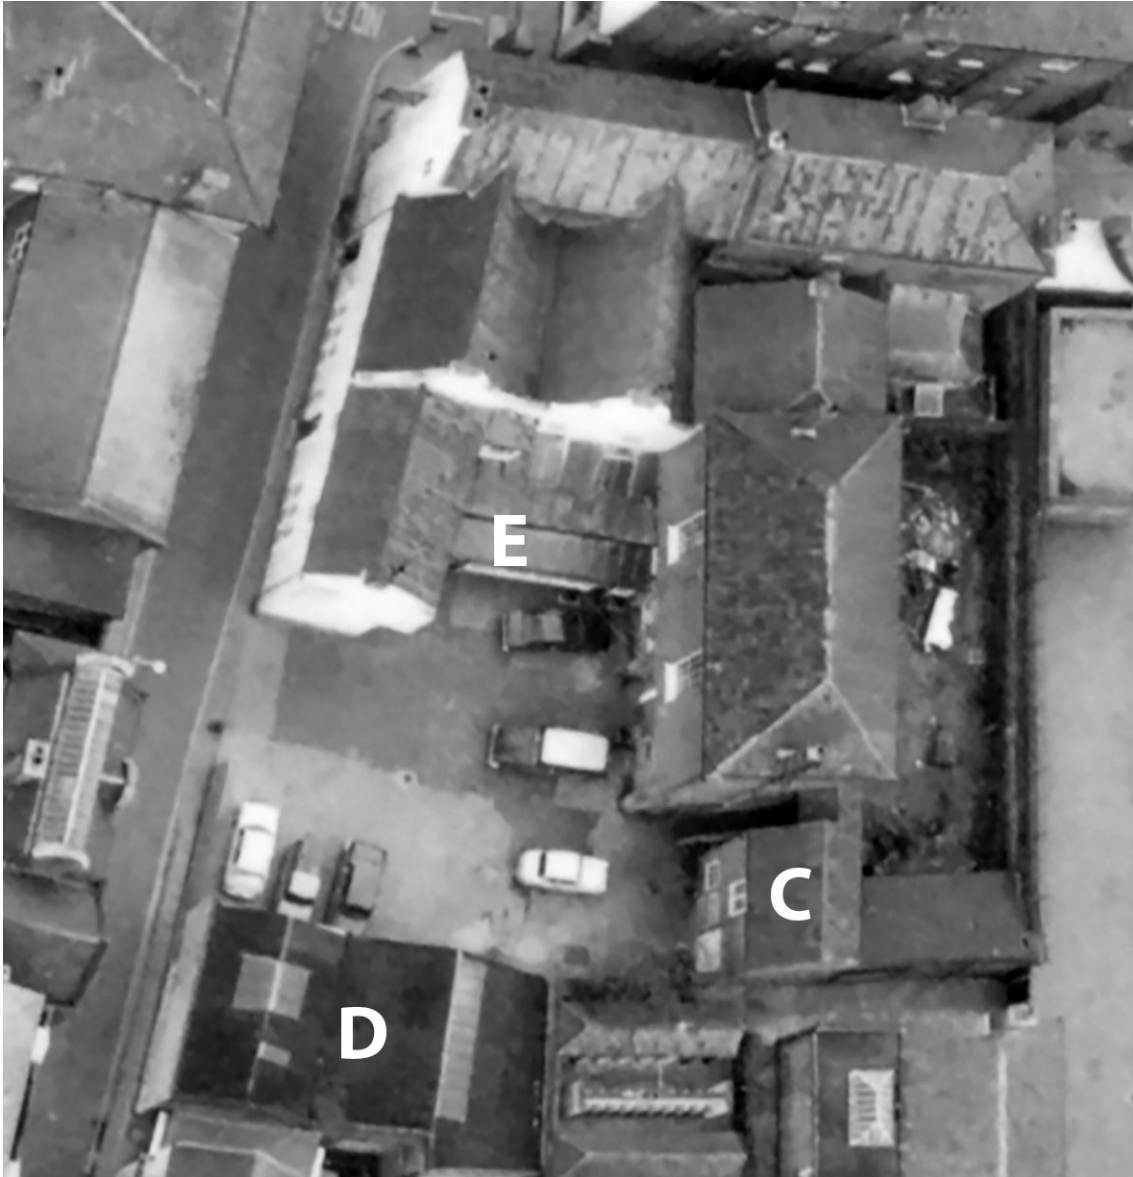
Fig 74: The King's Arms Hotel in 1968 showing the opened-out yard creating a car park and the new buildings (C and D) and the extension (E). Detail of MAL/68006 157 02-FEB-1968. Photo by Meridian Airmaps Ltd. Copyright Norfolk County Council.

The 1945 aerial photographs also show new buildings. A small building had been built to replace building B. This is shown in Figure 74 (C) and is linked to the coach house by a narrow structure, perhaps a corridor. Other new building work included two new structures with pitched roofs and skylights erected at the southern end of the yard (D in Fig 74). The demolition carried out in 1928 is not reflected in the contemporary Ordnance Survey mapping and the Ordnance Survey continued to depict the enclosed yard with covered entranceway until 1970. Although these changes are visible in the 1945 photographs, the results of this demolition and new building in the late 1920s is better seen in this 1968 vertical aerial photograph that is the subject of Figure 74. The 1968 photograph also shows that the single storey extension to the rear of the hotel between the western and eastern ranges had been extended south blocking the second of the five openings to the former coach house (E in Fig 74).

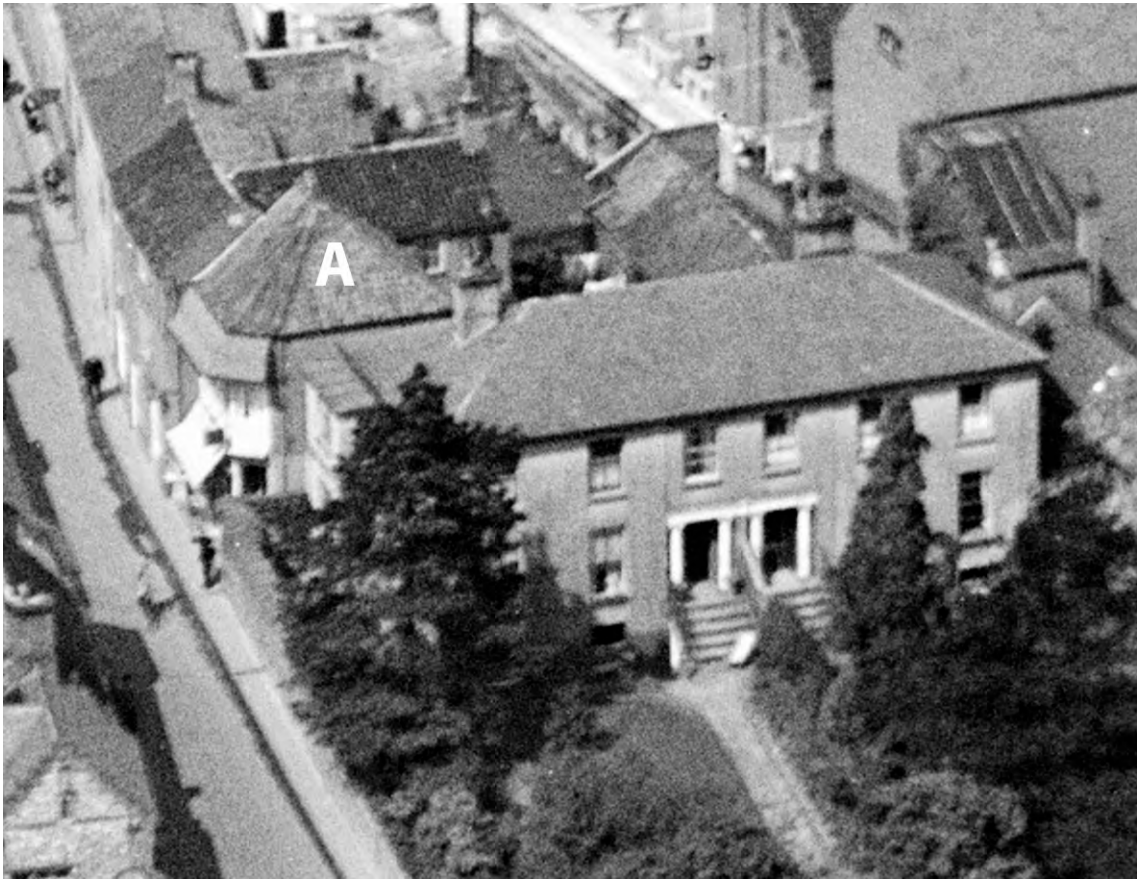
Fig 75: Houses on King's Arms Street in 1928. Of these only A has been demolished. Detail of EPW021292 MAY 1928 © Historic England (Aerofilms Collection).

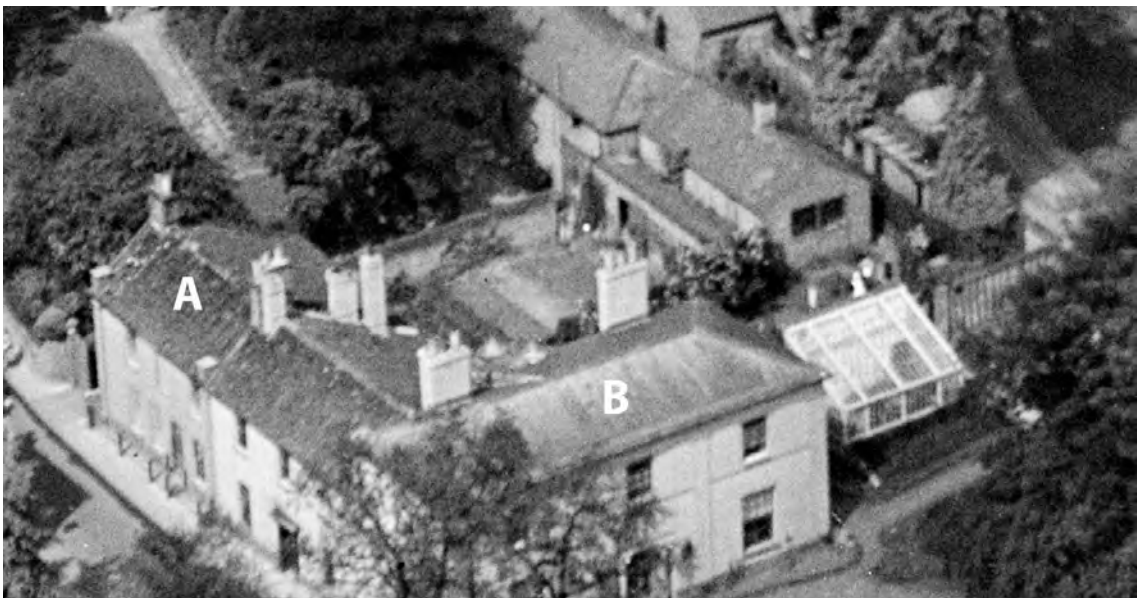
Fig 76: Buildings on King's Arms Street in 1928. Of these 15 Kings Arm's Street survives (A), its neighbour and the larger house at right angles to the road (B) and its greenhouse have since been demolished. Detail of EPW021292 MAY 1928 © Historic England (Aerofilms Collection).

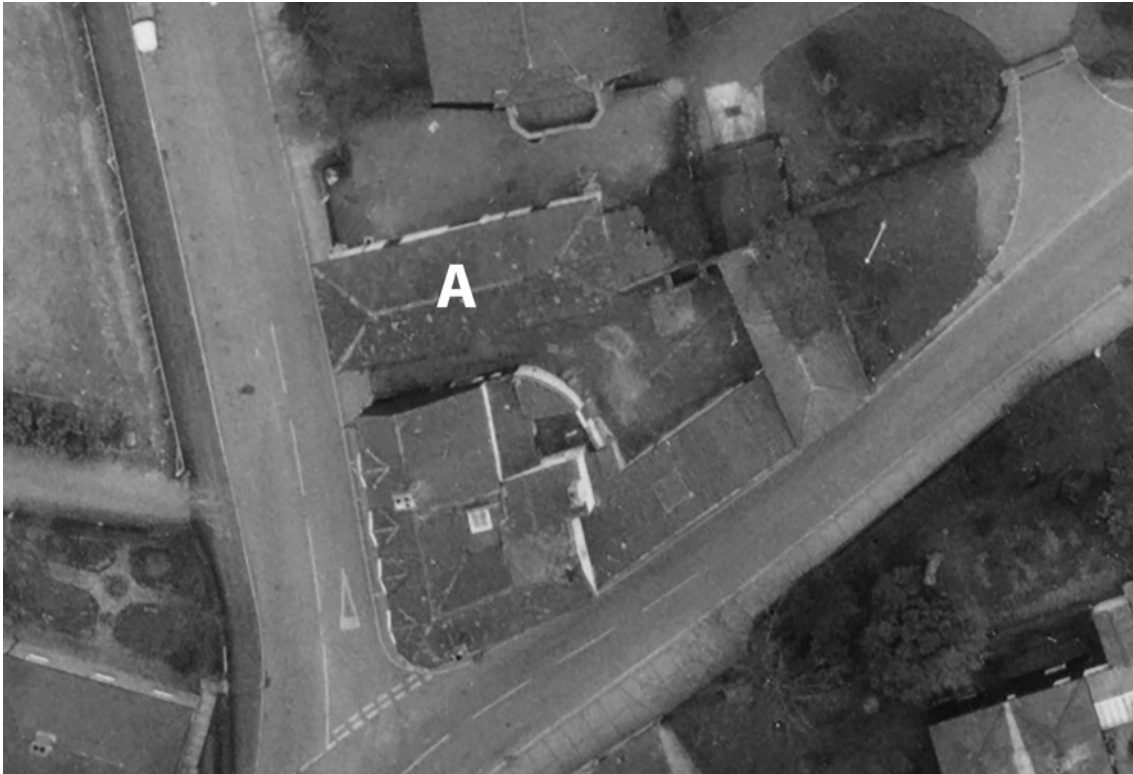
Fig 77: The Bull Inn on the corner of King's Arms Street (left) and Grammar School Road (right) seen in 1968. All the buildings except for A were demolished and the road widened, and a roundabout replaced the T-junction. Detail of MAL/68006 158 24-FEB-1968. Photo by Meridian Airmaps Ltd. Copyright Norfolk County Council.

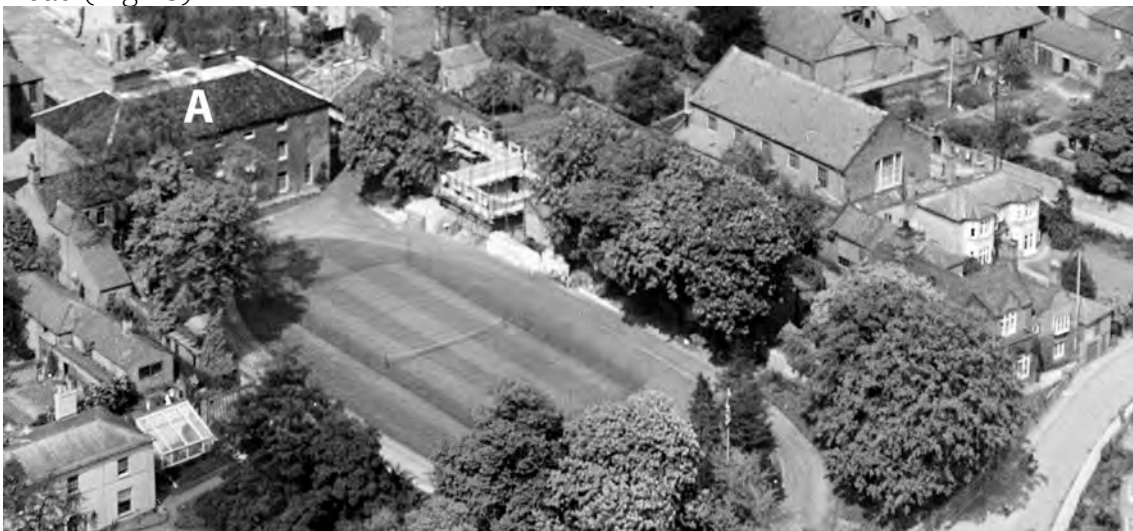
Fig 78: The southern part of Paston Grammar School site seen in 1928 from the south-west, with Grammar School Road bottom right. The letter A marks the main school building (the Nelson Building). Detail of EPW021292 MAY 1928 © Historic England (Aerofilms Collection).

The Paston Grammar School site now forms the eastern campus of Paston College, called The Griffons. The site extends from the Market Place to Grammar School Road (Fig 78).

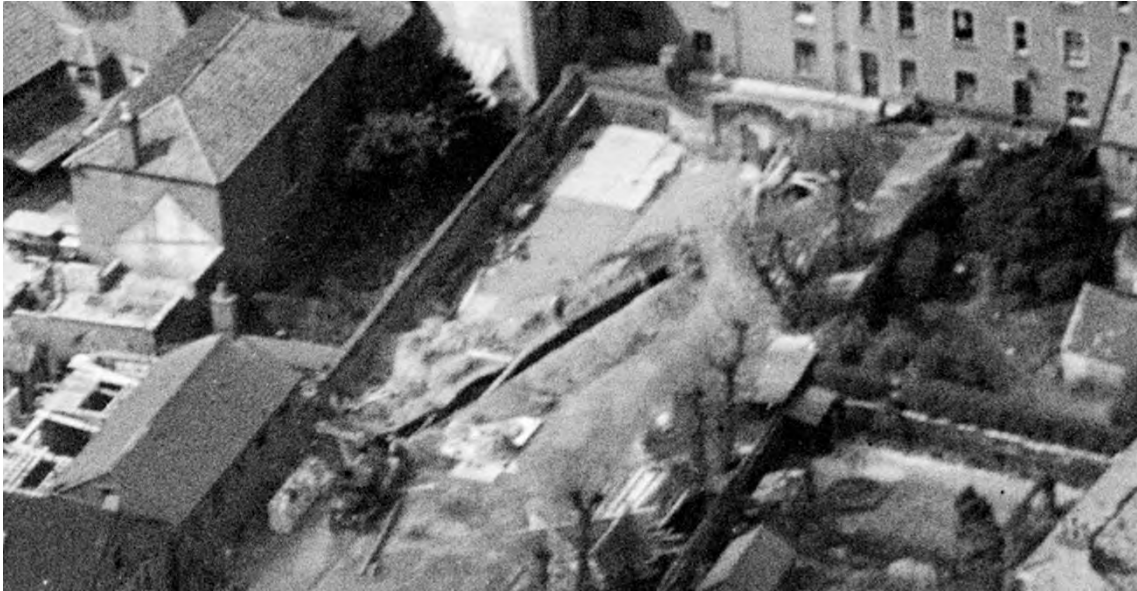
Fig 79: Building work at the northern end of Paston Grammar School grounds in 1928. Detail of EPW021290 MAY 1928 © Historic England (Aerofilms Collection).

The 1928 aerial photographs show at least three areas of building work underway at the school. To the north of the main school building, an area now used as a car park, can be seen a possible service trench (Fig 79). Some of this work was presumably associated with the new buildings that were being erected on part of the school site adjacent to the King's Arms Hotel (Fig 80). The northern end of the school site was also being used to store building materials and these can be seen arranged along the school's eastern boundary (Fig 81).
