North Walsham High Street Heritage Action Zone Aerial Investigation

Edward Carpenter

North Walsham
Norfolk

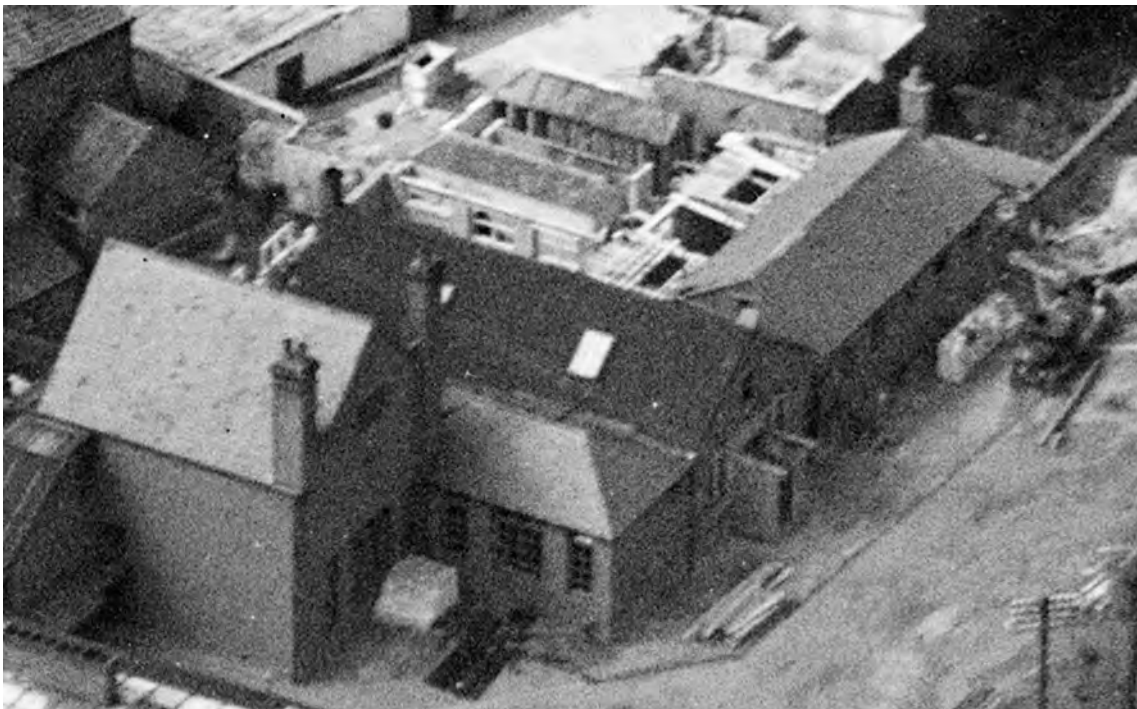
Fig 80: Building work at the northern end of the school grounds (top centre) adjacent to the King's Arms Hotel. Detail of EPW021290 MAY 1928 © Historic England (Aerofilms Collection).

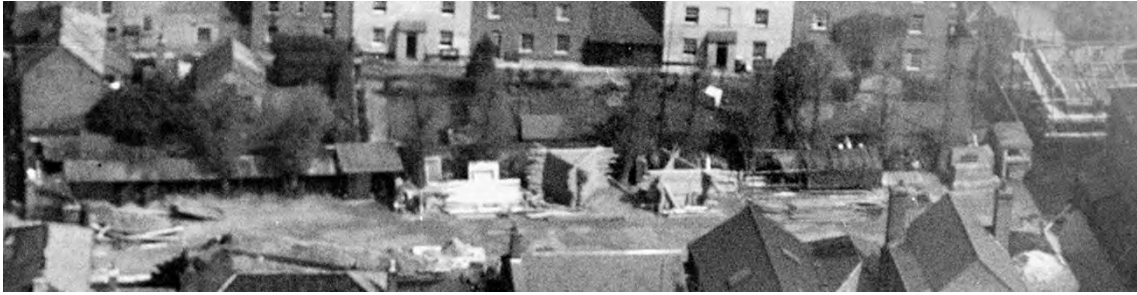
Fig 81: Building materials stored in the school grounds. Seen from the west in 1928. Detail of EPW021294 MAY 1928 © Historic England (Aerofilms Collection).

The 1928 aerial photographs show at least three areas of building work underway at the school. To the north of the main school building, an area now used as a car park, can be seen a possible service trench (Fig 79). Some of this work was presumably associated with the new buildings that were being erected on part of the school site adjacent to the King's Arms Hotel (Fig 80). The northern end of the school site was also being used to store building materials and these can be seen arranged along the school's eastern boundary (Fig 81).

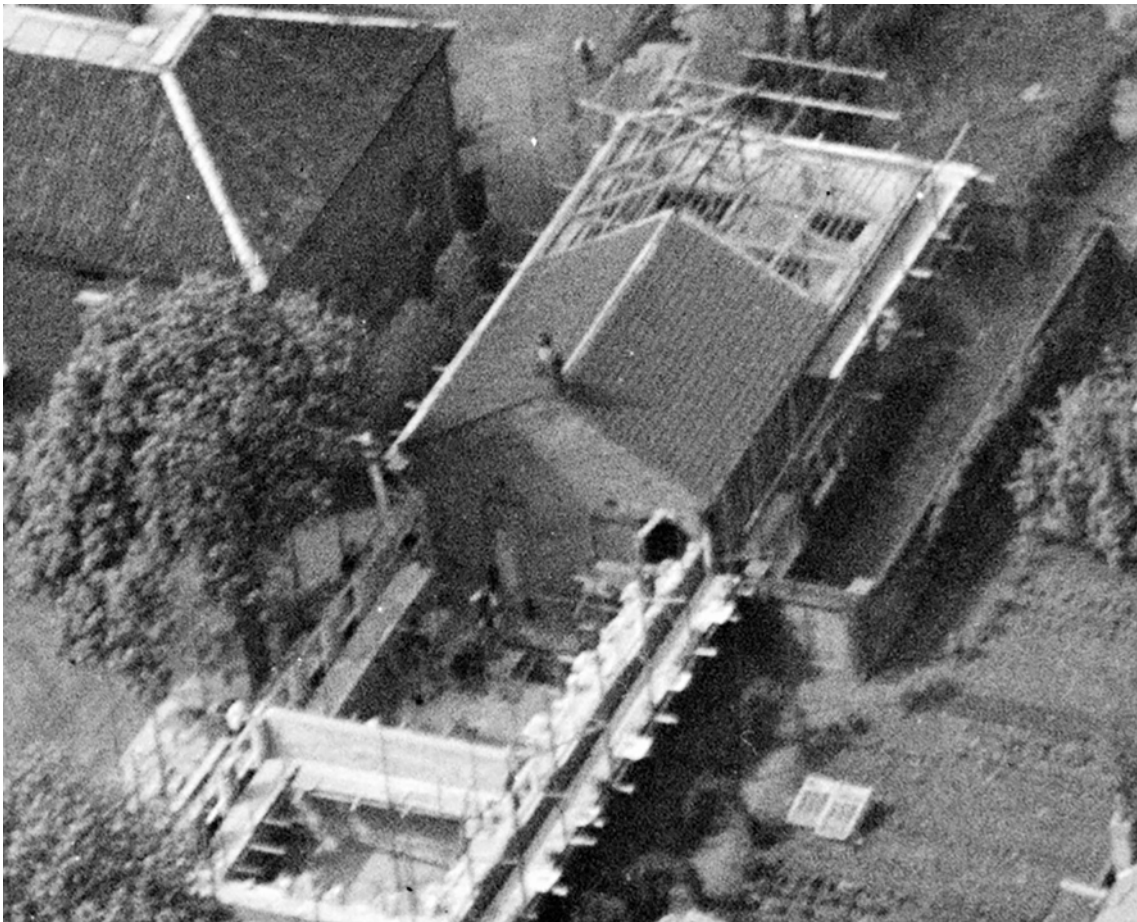
Fig 82: Extensions to a school building, seen from the south-east in 1928. Detail of EPW021290 MAY 1928 © Historic England (Aerofilms Collection).

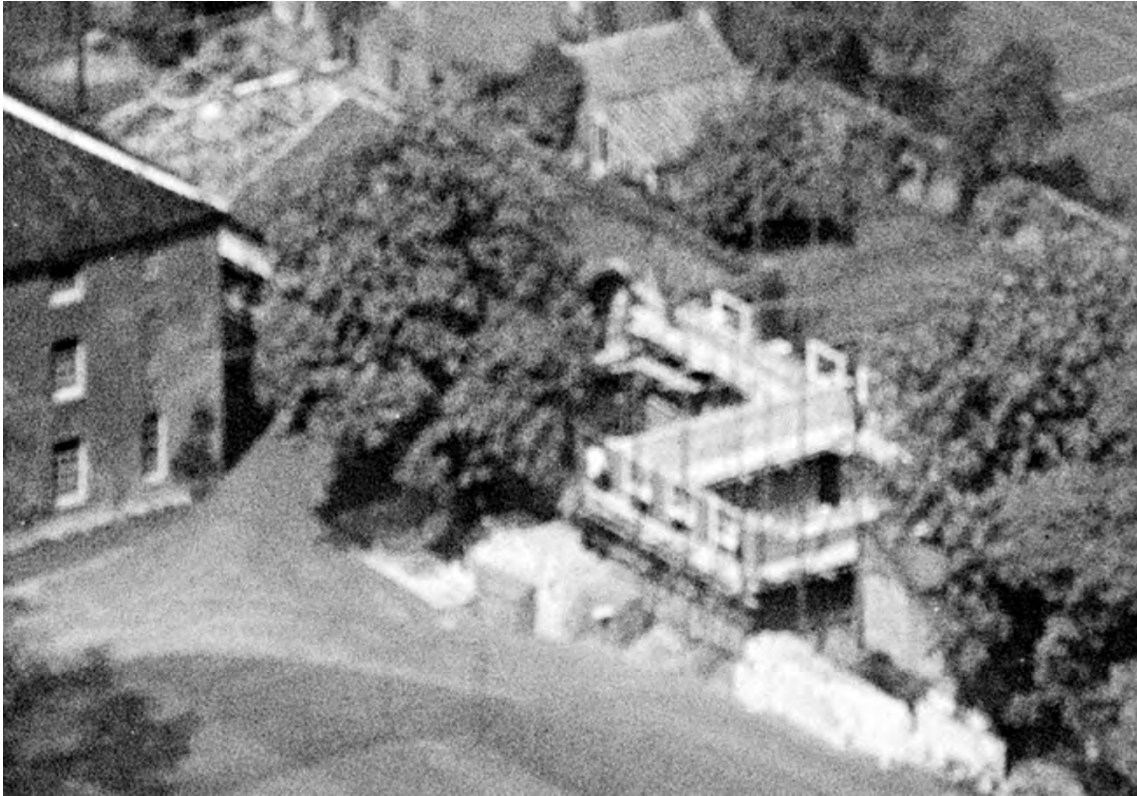
Fig 83: Extensions to a school building, seen from the south-west in 1928. Detail of EPW021292 MAY 1928 © Historic England (Aerofilms Collection).

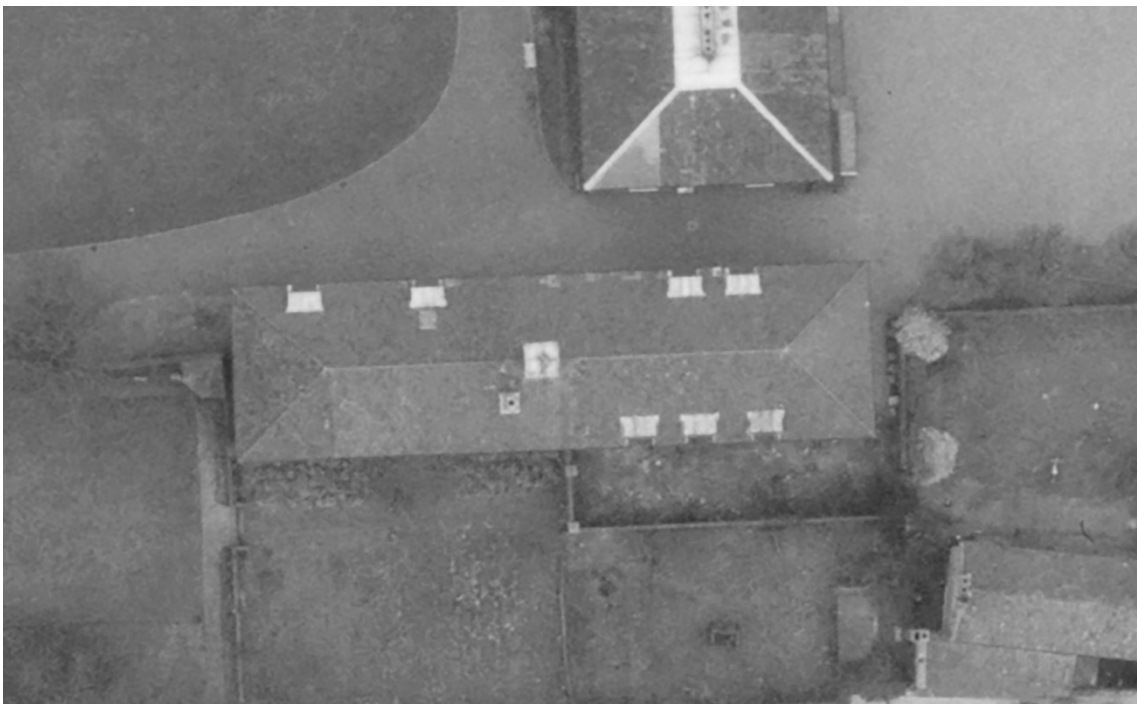
Fig 84: The extended school building seen in 1968. North is to the right. The short wall that joins the building about halfway along the bottom side marks the southern end of the original building; compare with Fig 82. Detail of MAL/60068 158 24-FEB-1968. Photo by Meridian Airmaps Ltd. Copyright Norfolk County Council.

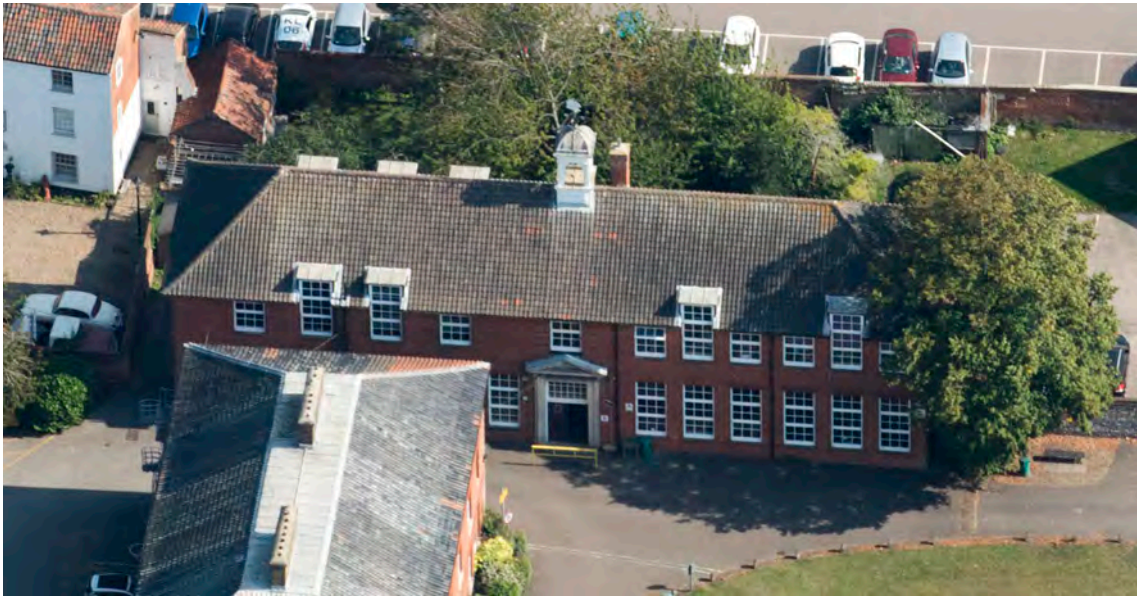
Fig 85: The school building extended in 1928 seen here in 2020. Detail of 33932_027 22-SEP-2020 © Historic England Archive.

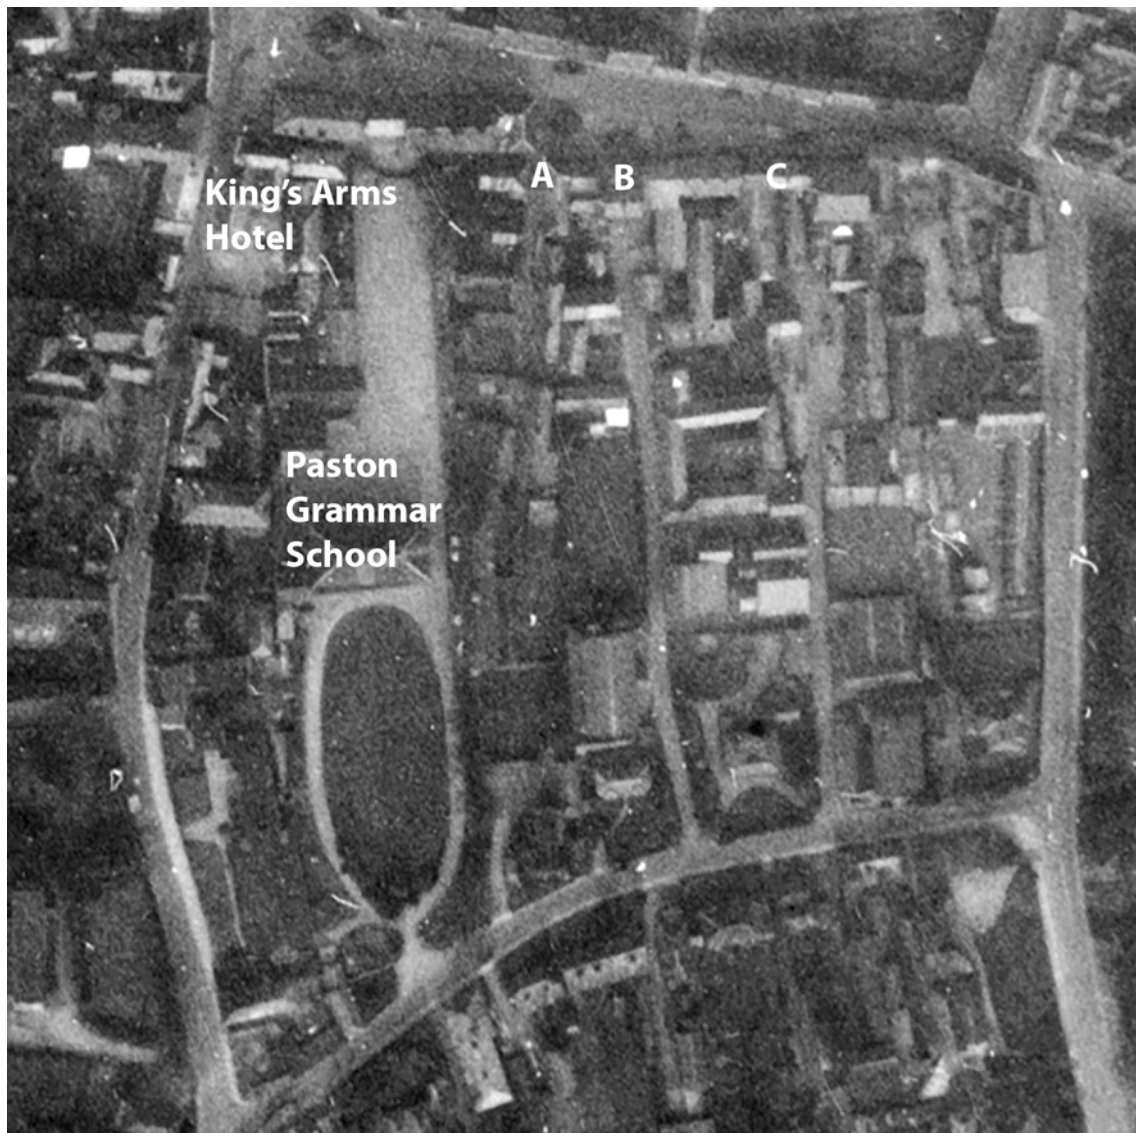
Fig 86: The area to the south of the Market Place seen in 1945. The letter A marks the entrance to The Terrace, B to Bank Loke and C to Black Swan Loke. King's Arms Street is on the left, Yarmouth Road on the right and Grammar School Road along the bottom. Compare with Figure 69. Detail of RAF/106G/LA/177 1090 13-MAR-1945 Historic England Archive RAF Photography.

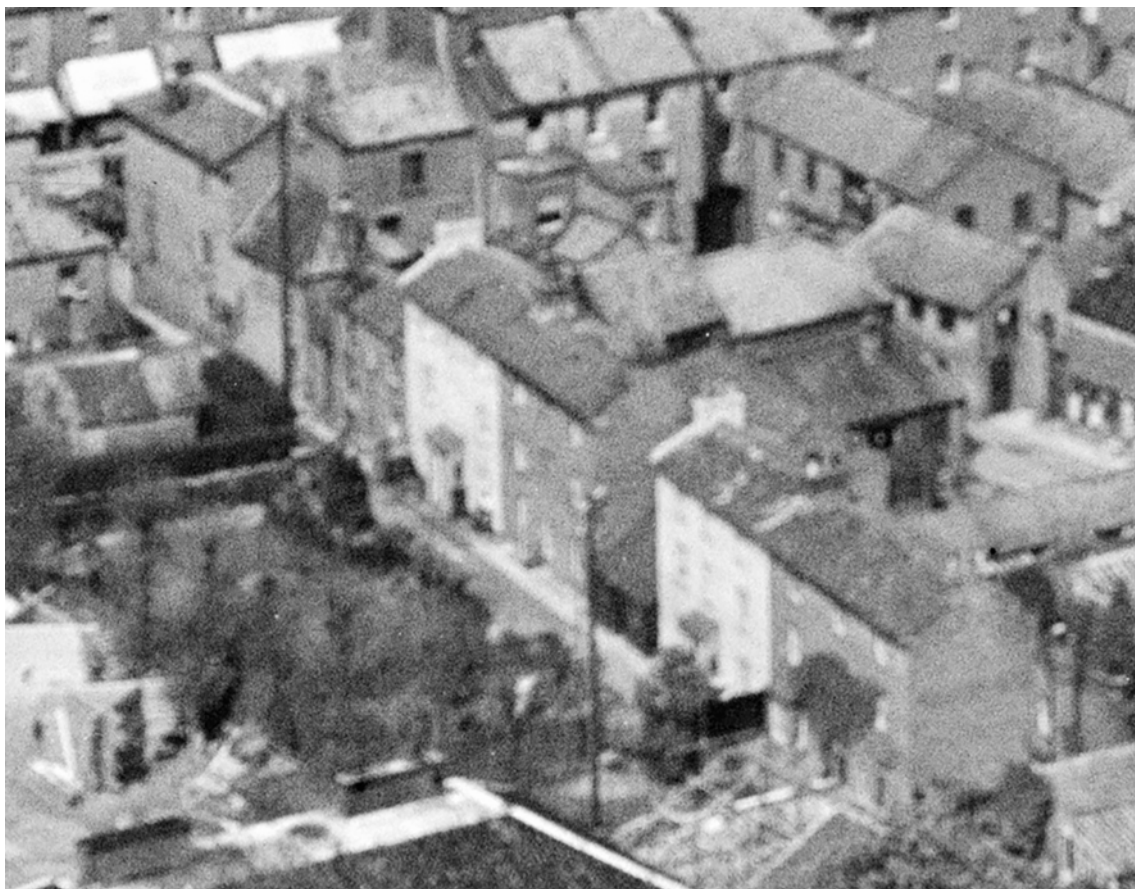
Fig 87: The Terrace from the south-west in 1928. The Market Place is top left. Detail of EPW021292 MAY 1928 © Historic England (Aerofilms Collection).

The Terrace is accessed from the Market Place. This row of buildings is located on the east side of the lane with gardens on the opposite side. Some of the properties to the east were built against the back walls of The Terrace (Figs 87 and 88).

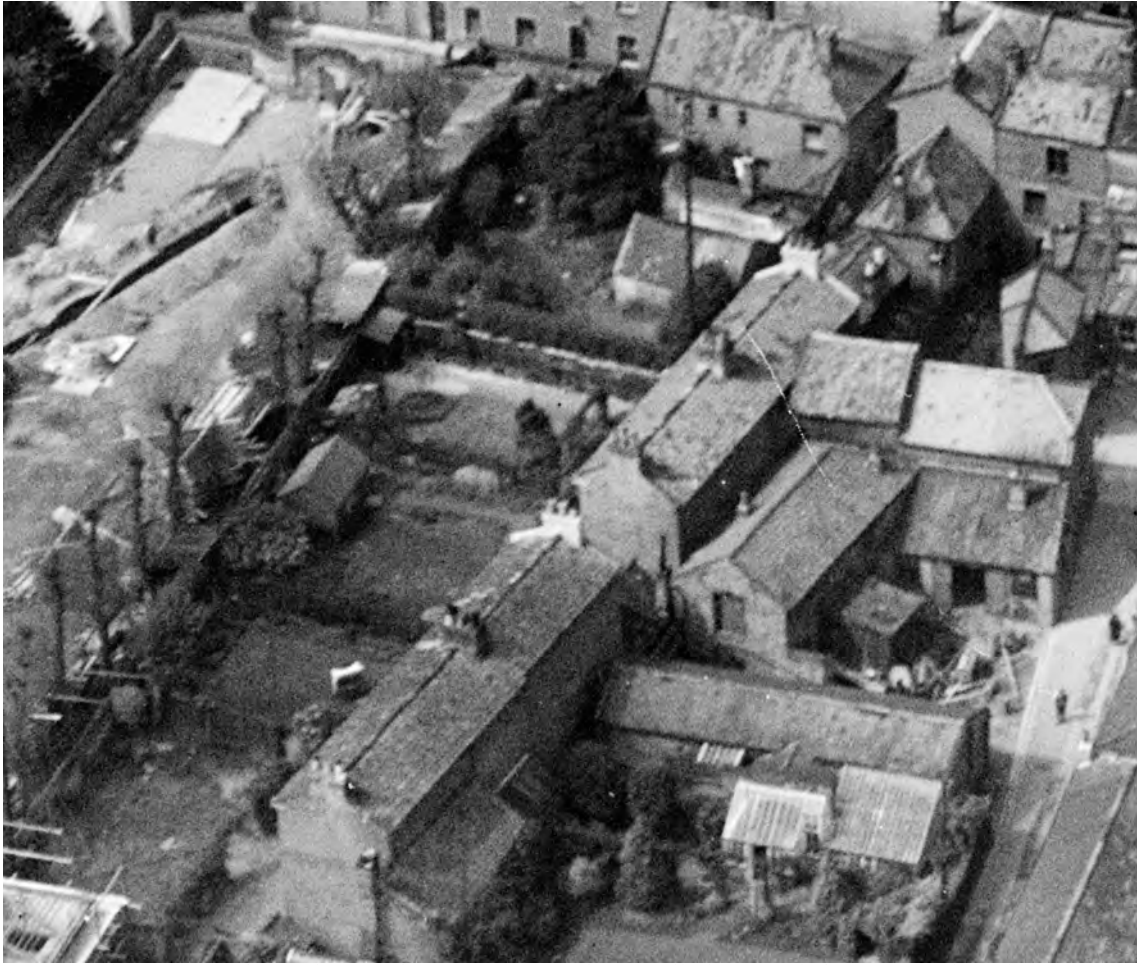
Fig 88: The Terrace from the south in 1928 runs diagonally bottom left to top right. Their gardens are to the left, neighbouring properties to the right. Detail of EPW021290 MAY 1928 © Historic England (Aerofilms Collection).

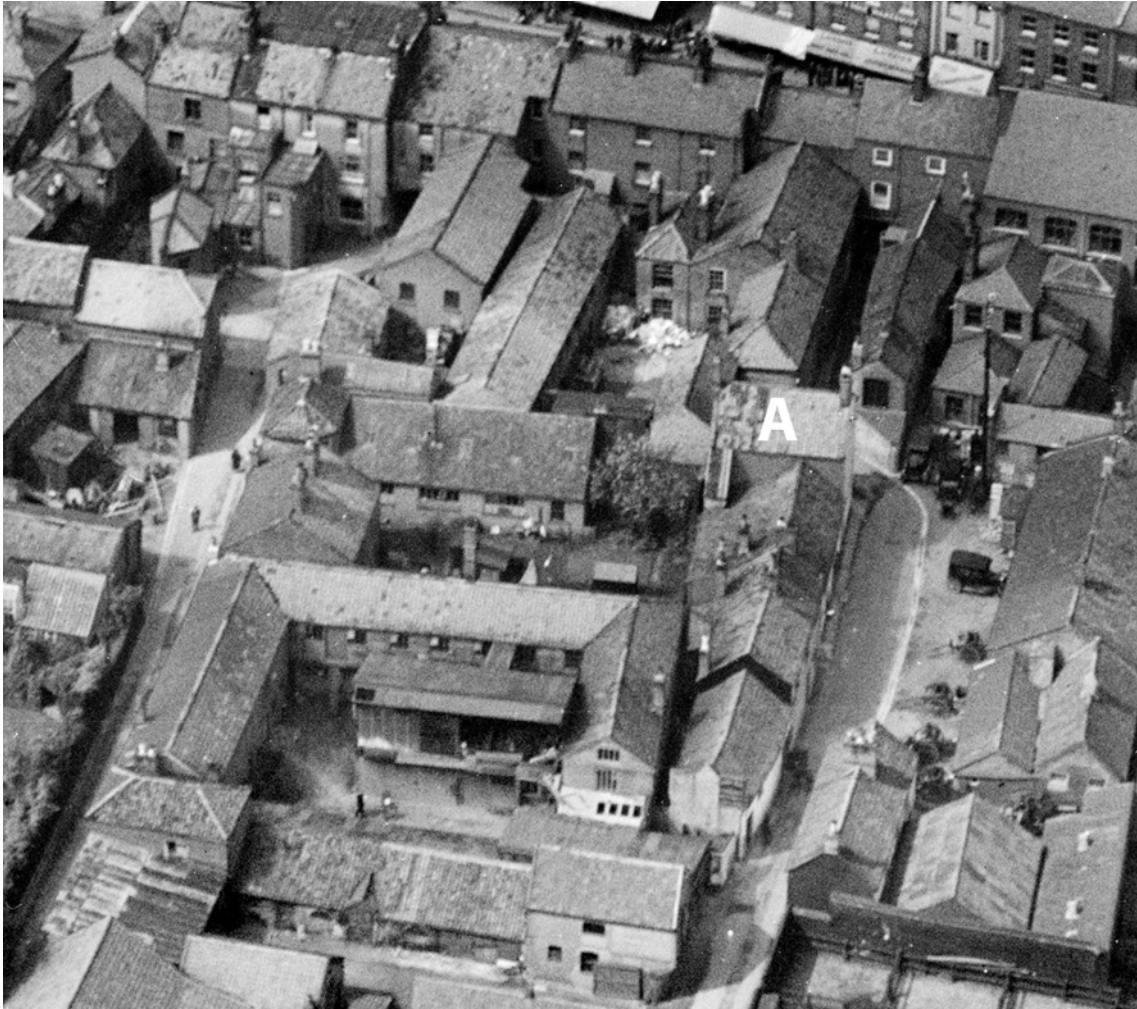
Fig 89: A 1928 view of Bank Loke to the left and Black Swan Loke to the right, looking north. The Black Swan pub is marked A. Detail of EPW021290 MAY 1928 © Historic England (Aerofilms Collection).

Figures 89 and 90 are details of Figure 69 and show in slightly more detail the area to the south of the Market Place including the buildings, penning and yards that formed the town's Cattle Market.

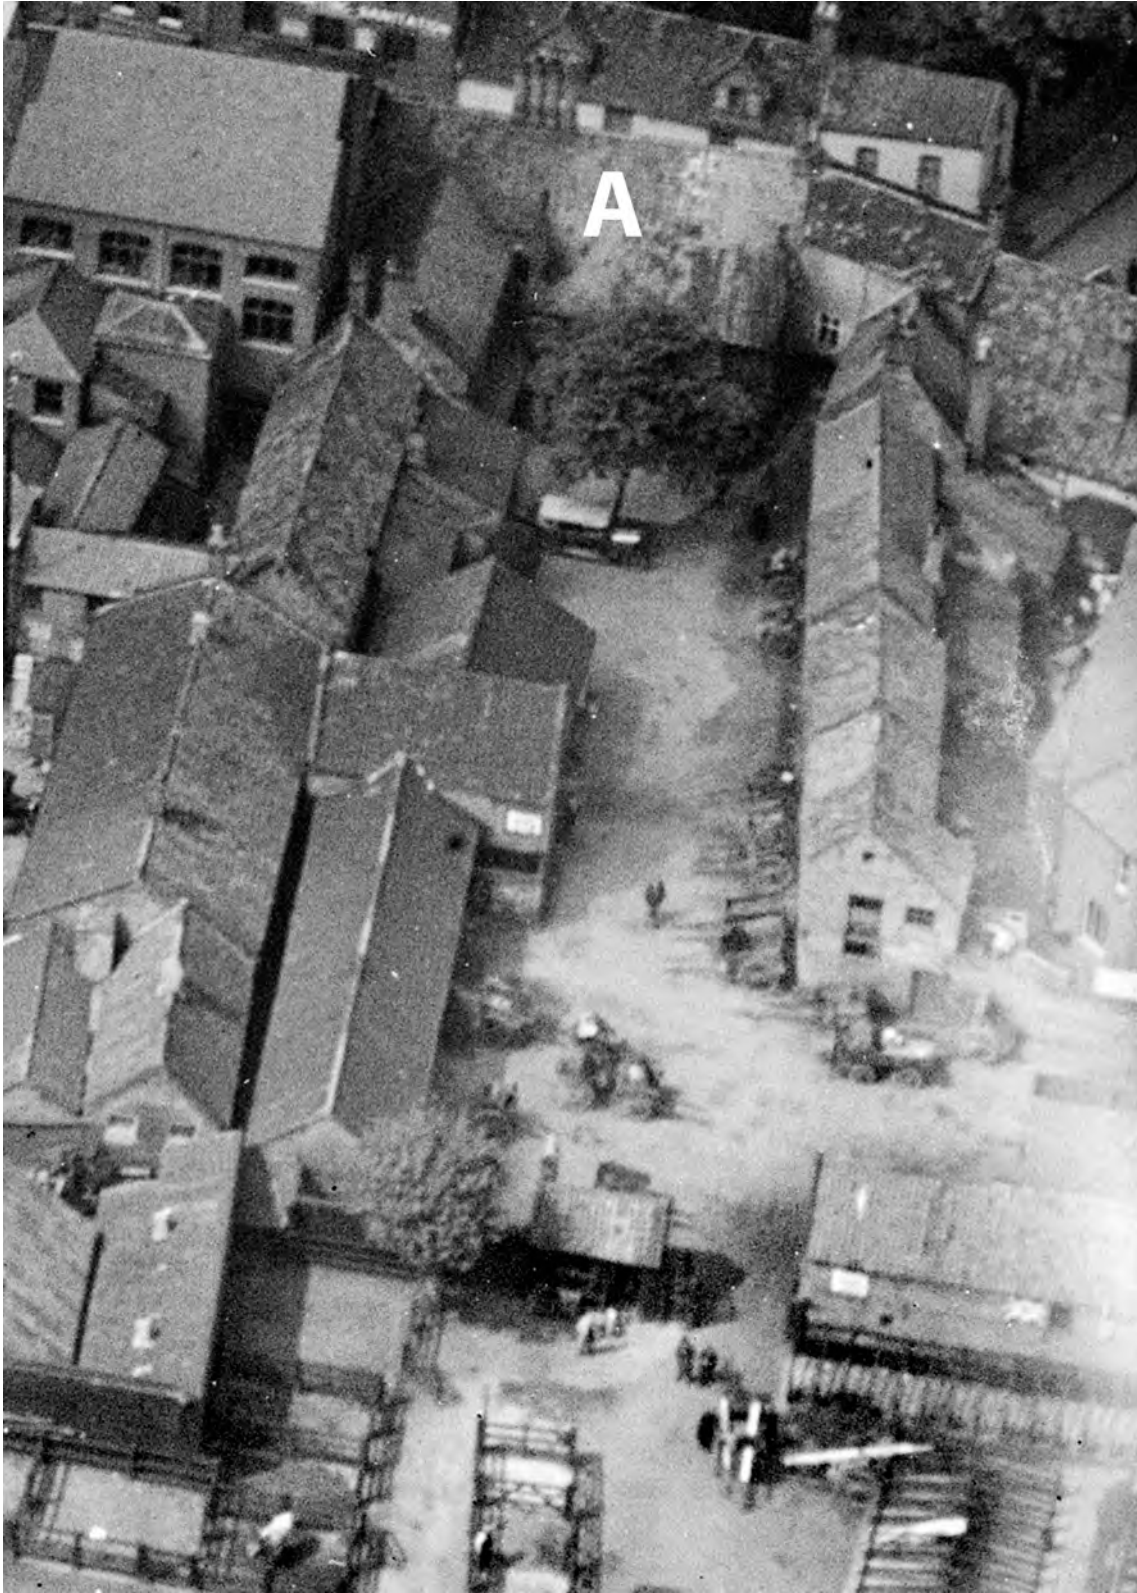
Fig 90: The Cross Keys Hotel yard and the Cattle Yard from the south taken in 1928. The Cross Keys Hotel is marked A. Detail of EPW021290 MAY 1928 © Historic England (Aerofilms Collection).

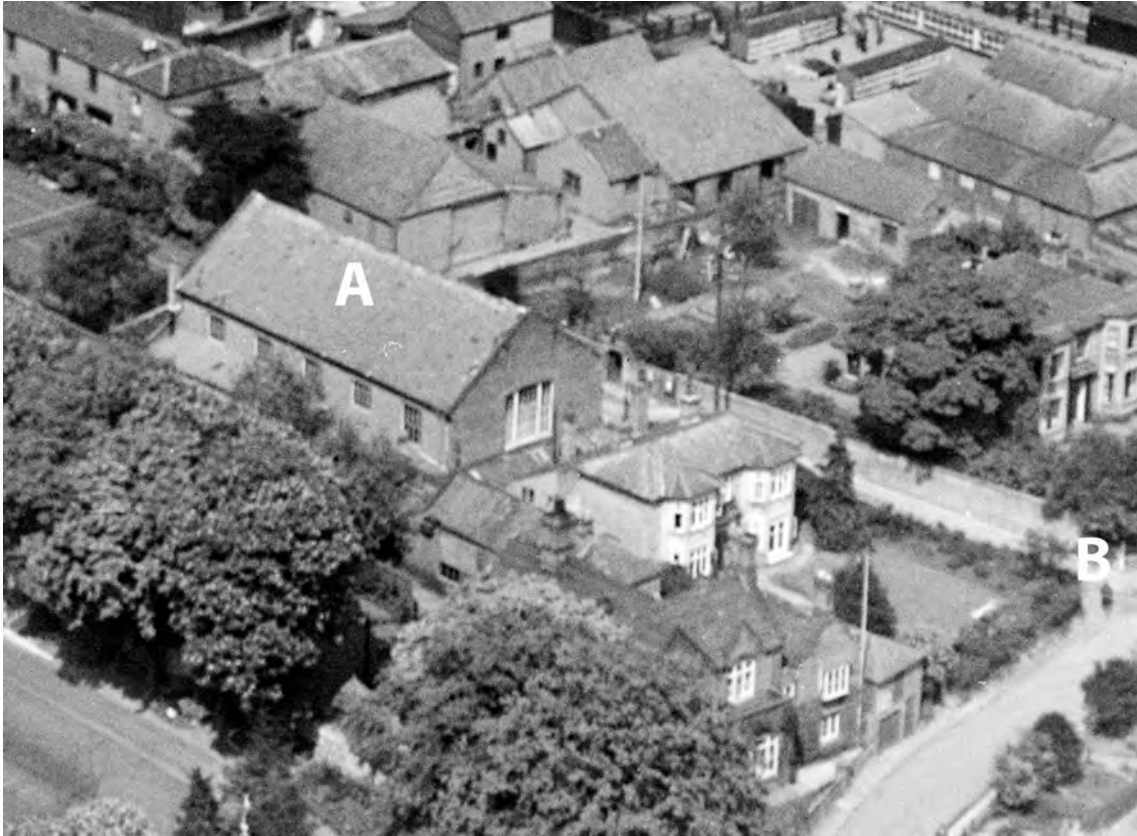
Fig 91: The southern end of Bank Loke in 1928. The letter A marks the hall, B marks the southern entrance to Bank Loke. Grammar School Road is bottom right. Detail of EPW021292 MAY 1928 © Historic England (Aerofilms Collection).

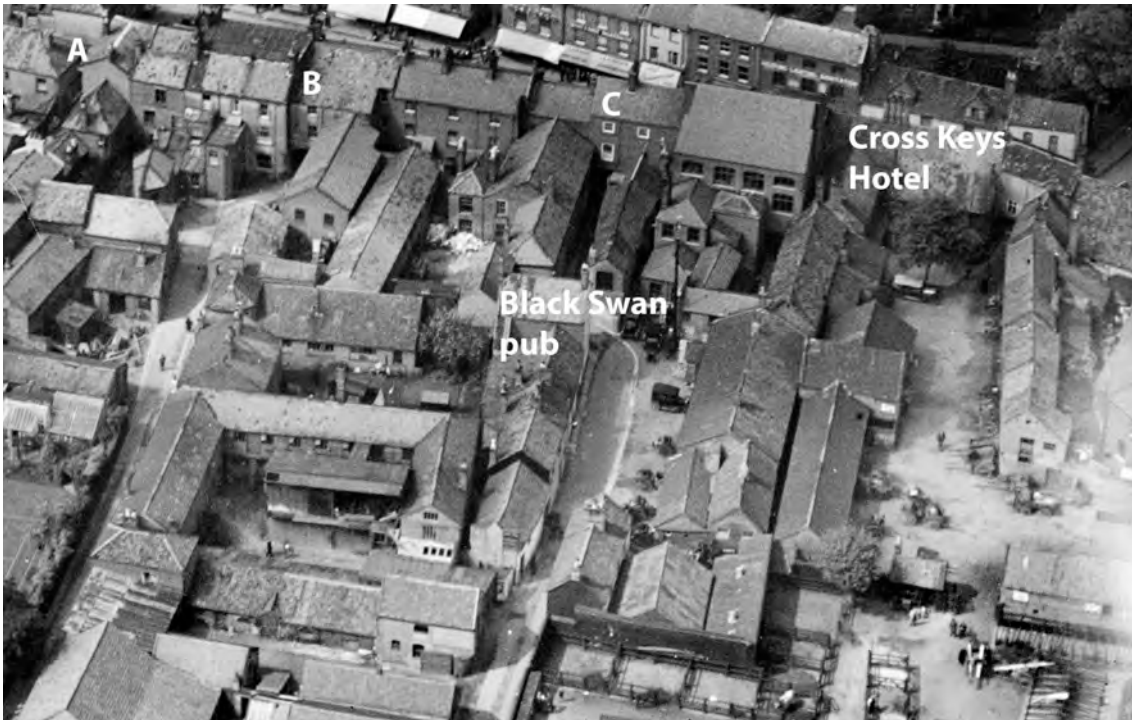
Fig 92: A general view of part of the area south of the Market Place in 1928. The letter A marks the entrance to The Terrace, B to Bank Loke and C to Black Swan Loke. Compare with Fig 93. Detail of EPW021290 MAY 1928 © Historic England (Aerofilms Collection).

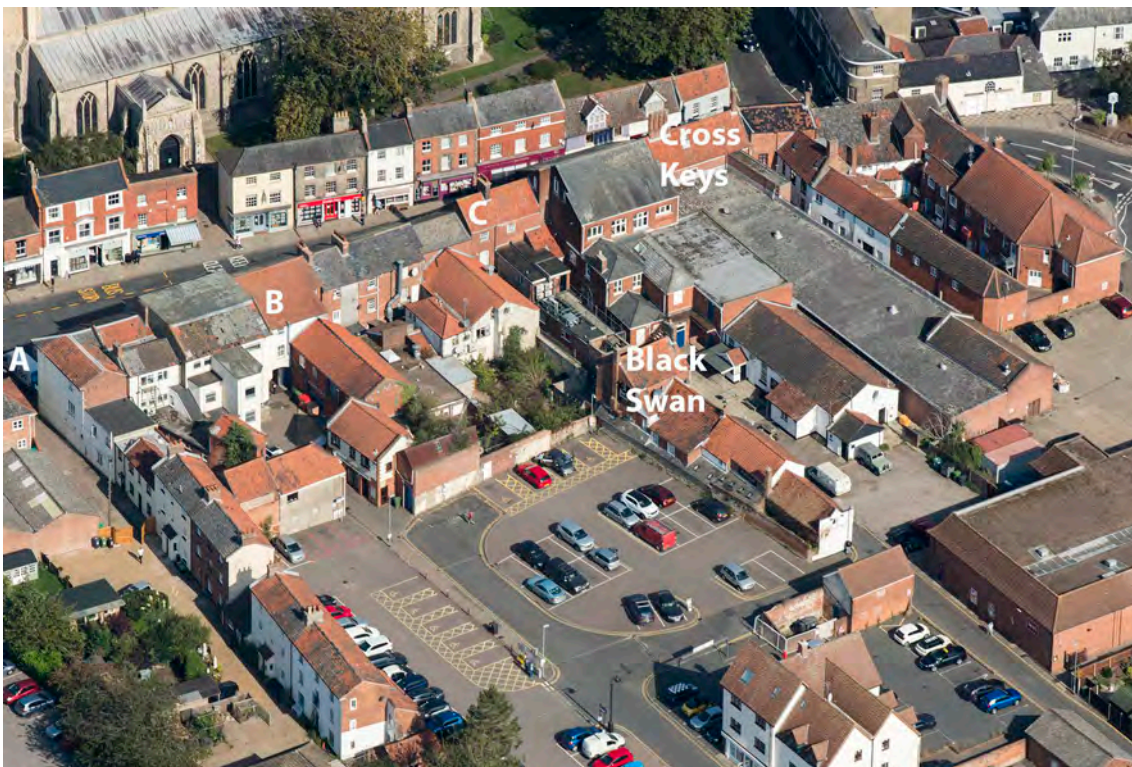
Fig 93: Part of the area south of the Market Place in 2020. The letter A marks the entrance to The Terrace, B to Bank Loke and C to Black Swan Loke. Compare with Fig 92. Detail of 33933_023 22-SEP-2020 © Historic England Archive.

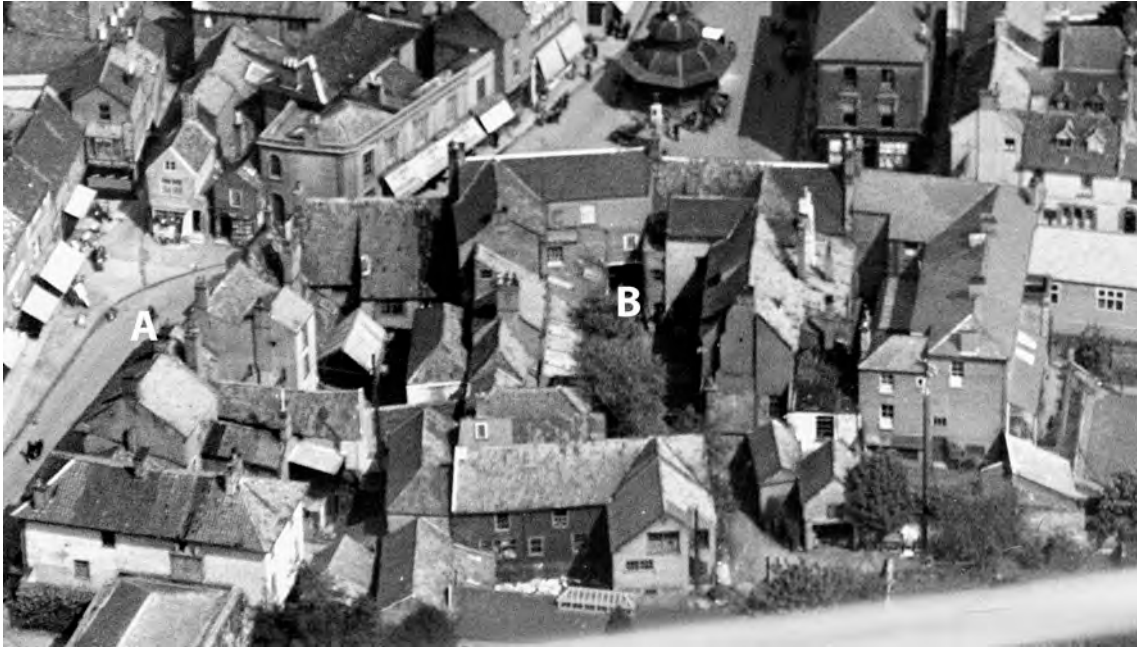
Fig 95: Market Cross Mews from the west. The entrance to the Feathers Inn yard is marked A, the entrance to the Mews is marked B. Detail of EPW021294 MAY 1928 © Historic England (Aerofilms Collection).

There are two yards to the west of the Market place. Market Cross Mews which is accessed via covered way between 24 and 25 Market Place, and to the north, the yard to the former Feathers Inn accessed from Market Street (Fig 94). The arrangement of buildings seen in 1968 largely matches that shown in the 1928 aerial photographs (Figs 95 and 96).

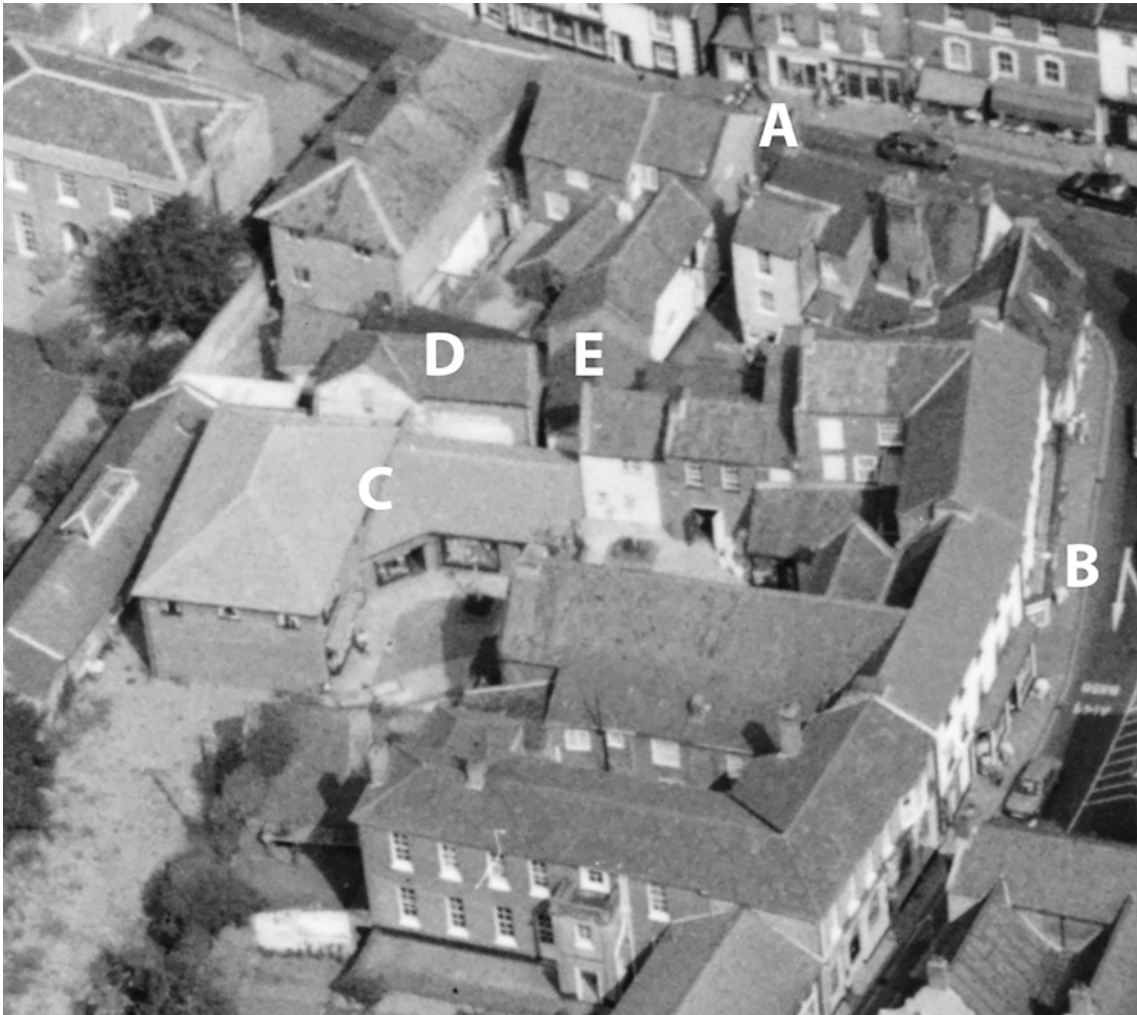
Fig 97: The new building in Market Cross Mews in 1988 is marked C. This replaced the buildings marked C in Figure 96. The letters D and E indicate buildings since demolished. The entrance to the Feathers Inn yard is marked A, the entrance to the Mews is marked B. Detail of TG2830/G/DTV11 17-AUG-1988. Photo by D. Edwards Copyright Norfolk County Council.

1986 photograph but had been demolished and replaced with a new building by August 1988 (Fig 97).

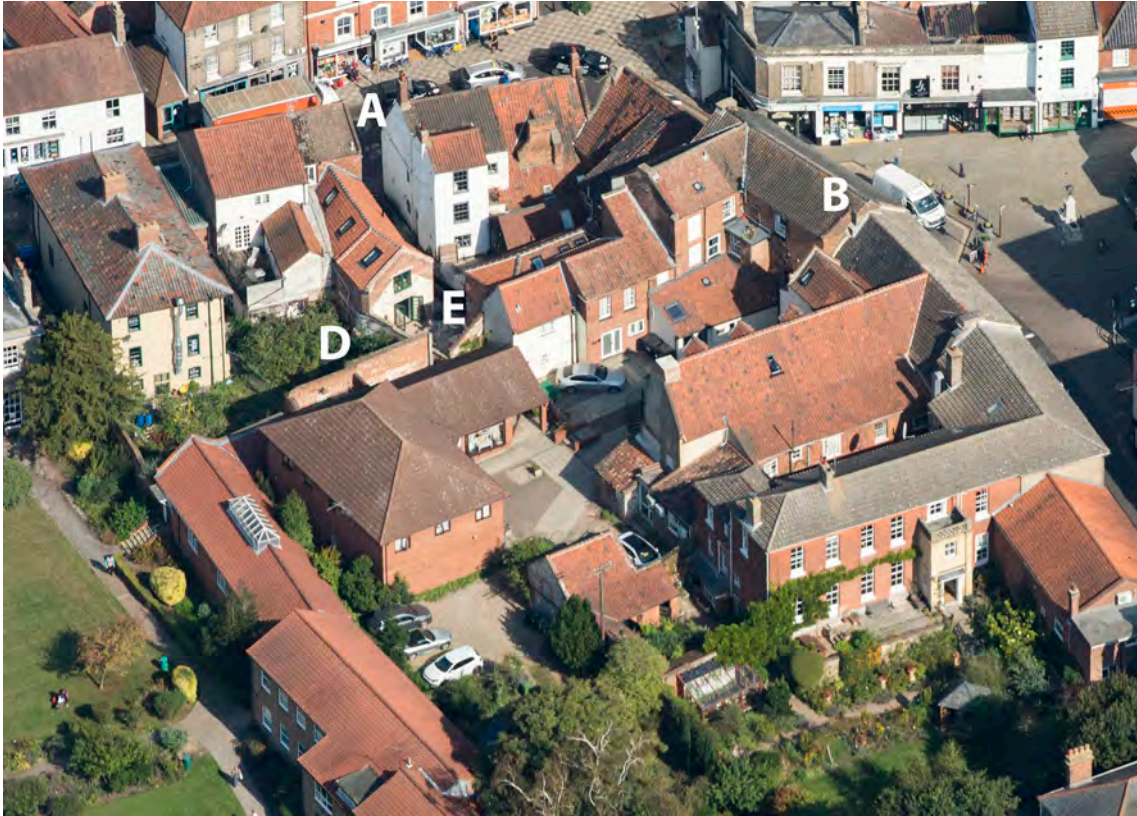
Fig 98: Market Cross Mews in 2020. The letters D and E mark walls retained during demolition of these two buildings. Each letter corresponds to the features shown in Figure 97. Detail of 33933_020 22-SEP-2020 © Historic England Archive.

Buildings D and E in Figure 97 were subsequently demolished, but parts of their walls were retained as property boundaries (Fig 98).

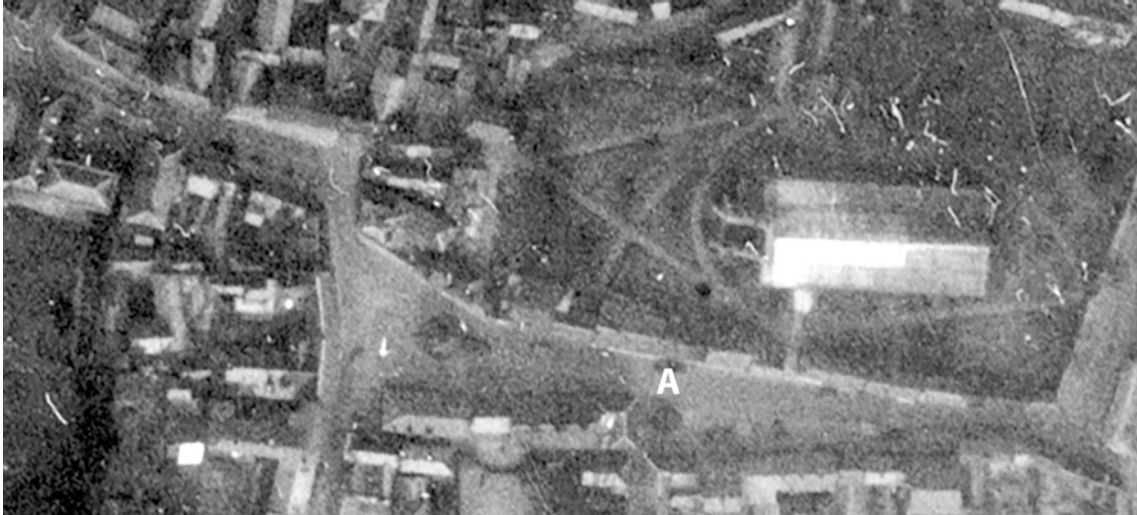
Fig 101: The Market Place in 1945. The dark circle below A is a wartime Emergency Water Supply (EWS). Detail of RAF/106G/UK/LA 1090 13-MAR-1945 Historic England Archive RAF Photography.

During the Second World War a circular reservoir for fighting fires (an Emergency Water Supply or EWS) was constructed for the fire brigade in the Market Place (Fig 101). A second possible EWS was located (outside the project area) at the corner of Pound Road and Manor Road. Shop fronts (partially obscured by awnings) along the northern side of the Market Place and Market Street are shown in Figures 104-107.

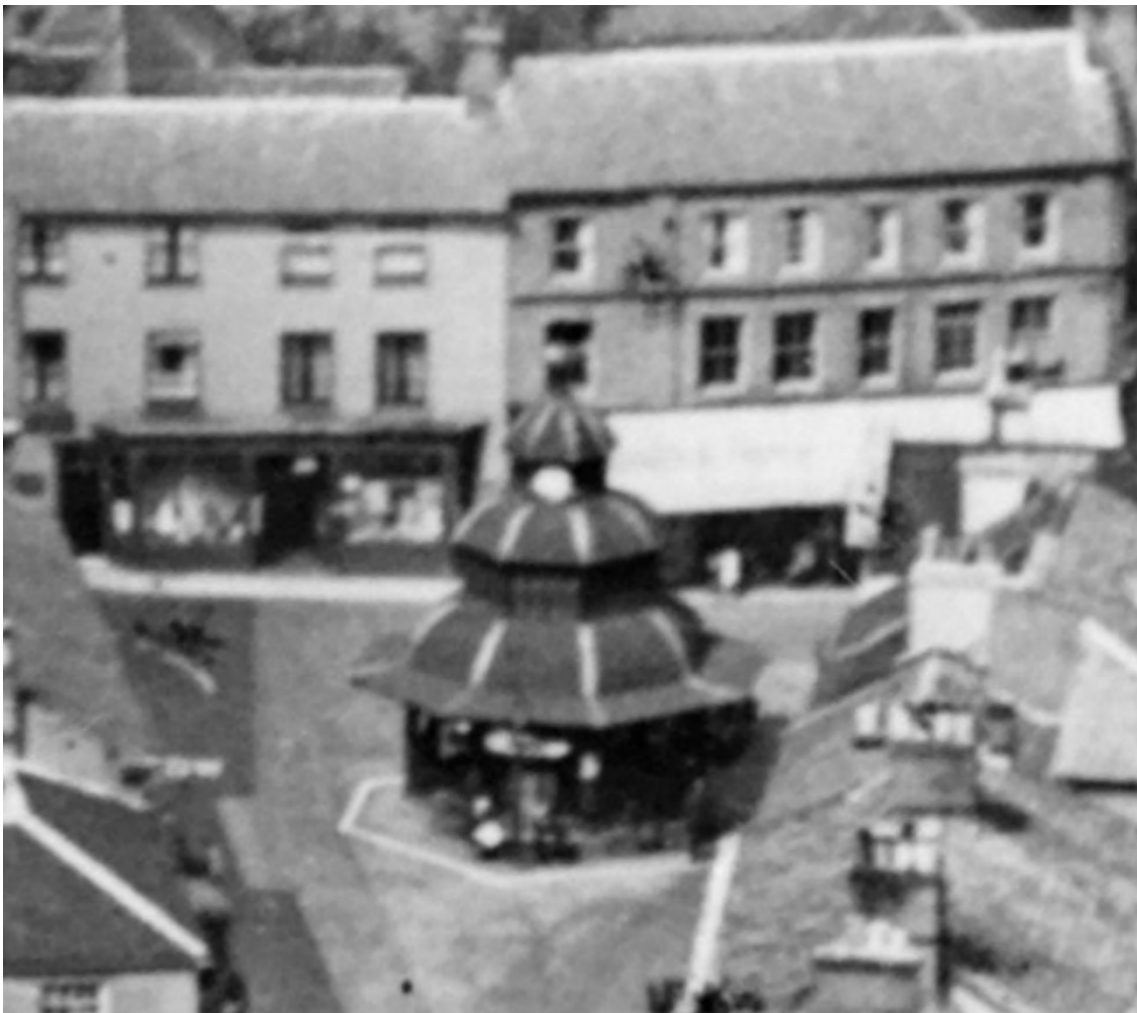
Fig 102: The Market Cross in 1932. Detail of EPW039256 JUL 1932 © Historic England (Aerofilms Collection).

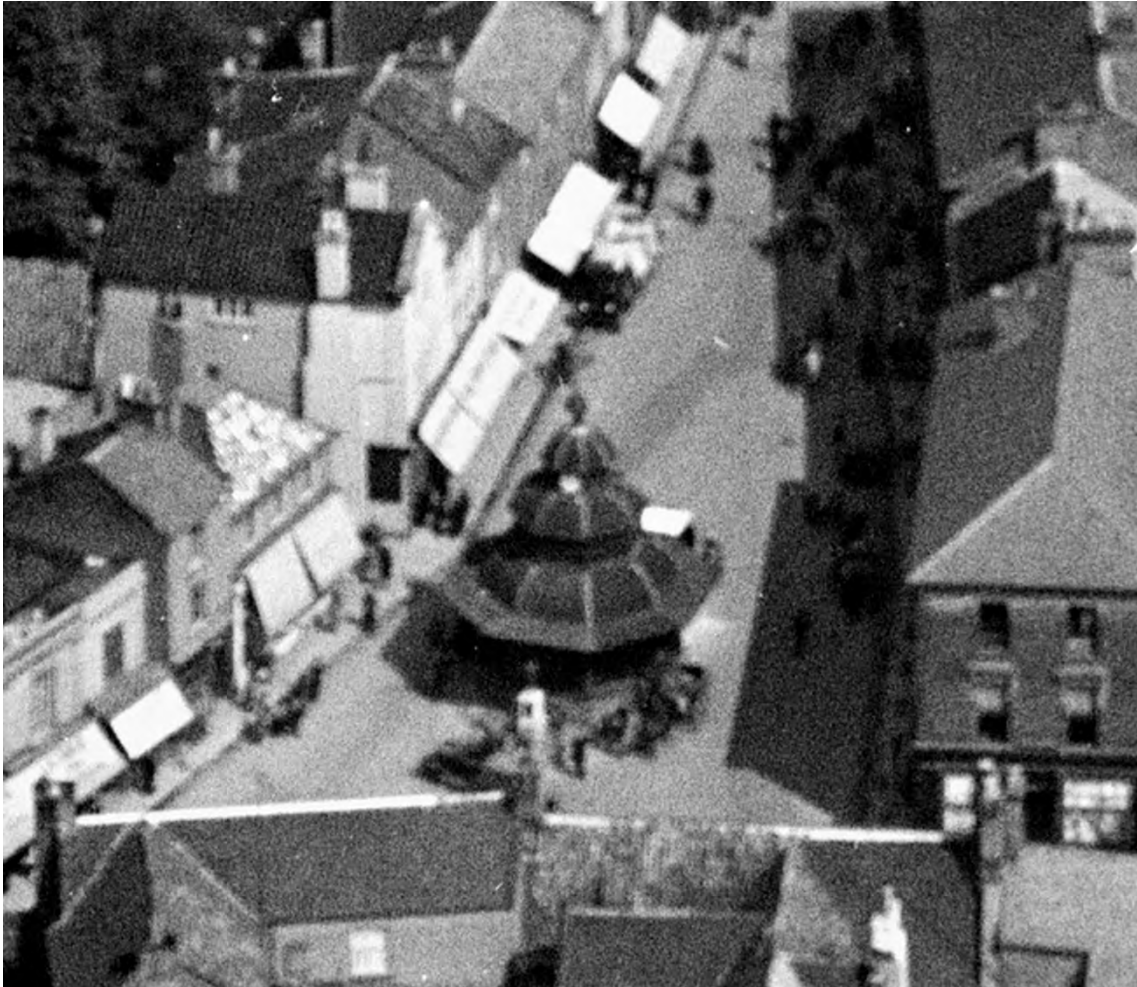
Fig 103: The Market Cross in 1928. Detail of EPW021294 MAY 1928 © Historic England (Aerofilms Collection).

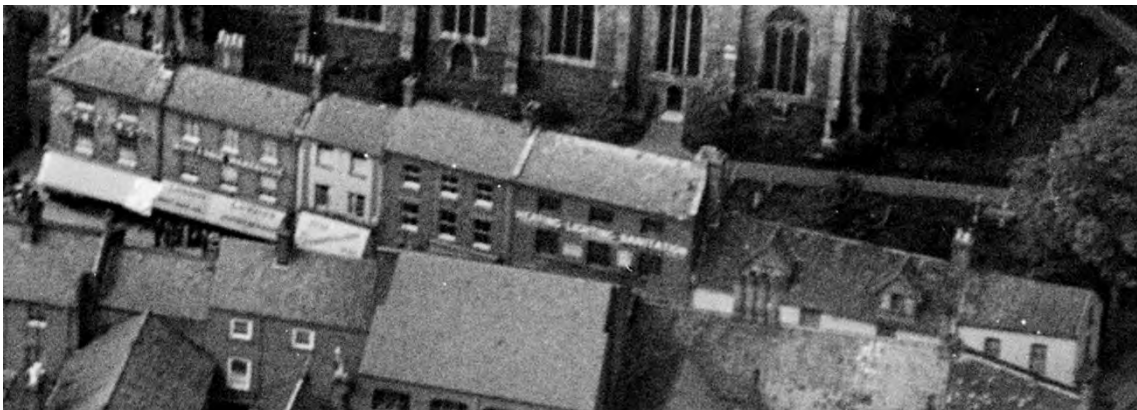
Fig 104: The eastern end of the Market Place from the south-east. Detail of EPW021290 MAY 1928 © Historic England (Aerofilms Collection).

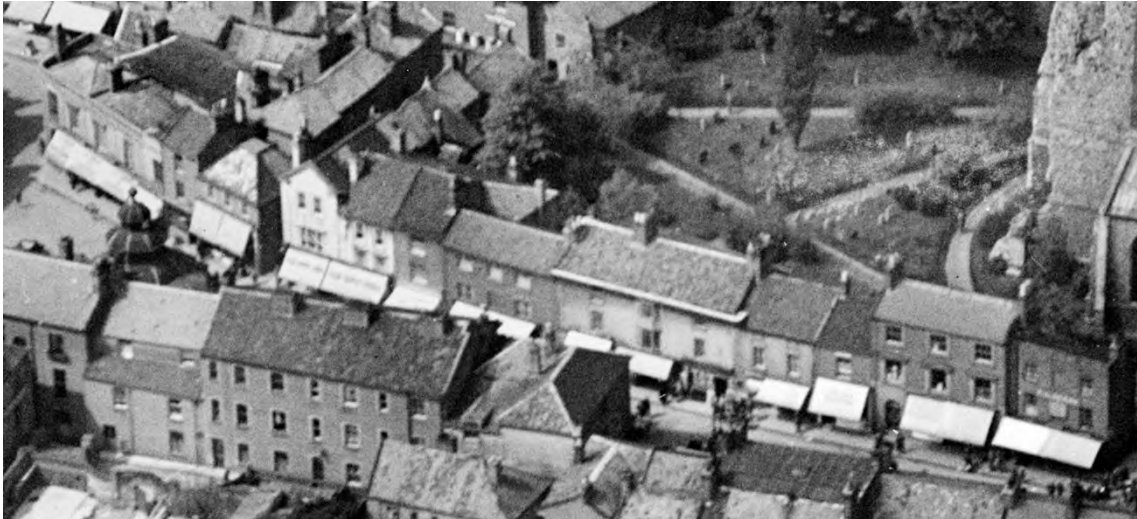
Fig 105: The central and western end of the Market Place from the south-east. Detail of EPW021290 MAY 1928 © Historic England (Aerofilms Collection).

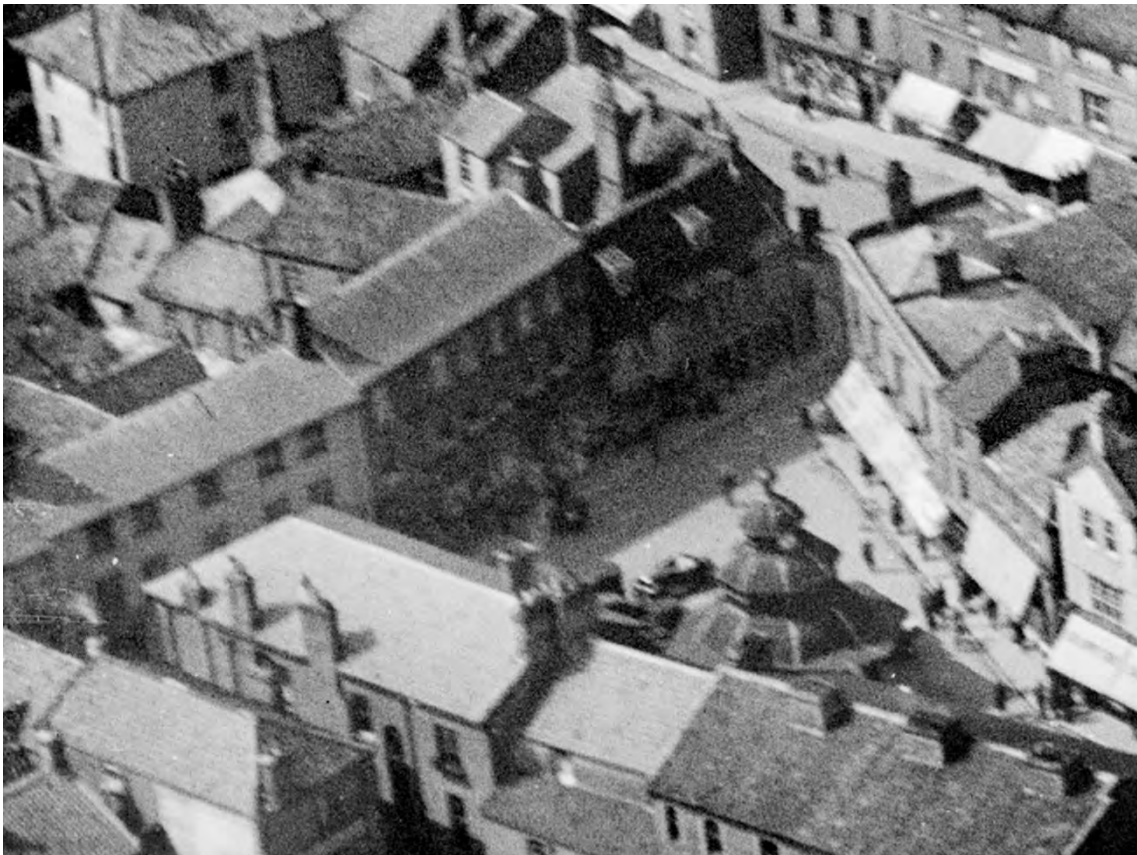
Fig 106: The western end of the Market Place from the south-east. Detail of EPW021289 MAY 1928 © Historic England (Aerofilms Collection).
