North Walsham High Street Heritage Action Zone Aerial Investigation

Edward Carpenter

North Walsham
Norfolk

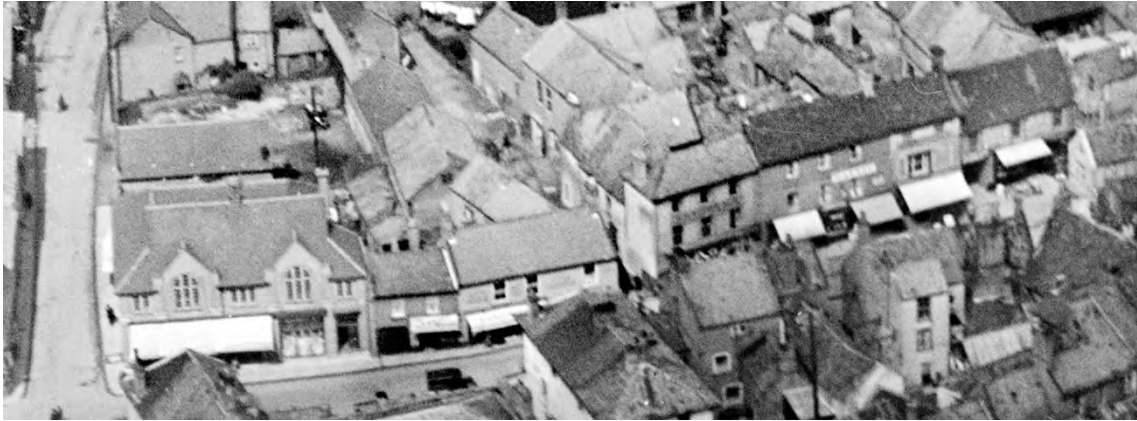
Fig 107: Shops on Market Street seen from the south in 1928. Detail of EPW021293 MAY 1928
© Historic England (Aerofilms Collection).

During the Second World War a circular reservoir for fighting fires (an Emergency Water Supply or EWS) was constructed for the fire brigade in the Market Place (Fig 101). A second possible EWS was located (outside the project area) at the corner of Pound Road and Manor Road. Shop fronts (partially obscured by awnings) along the northern side of the Market Place and Market Street are shown in Figures 104-107.

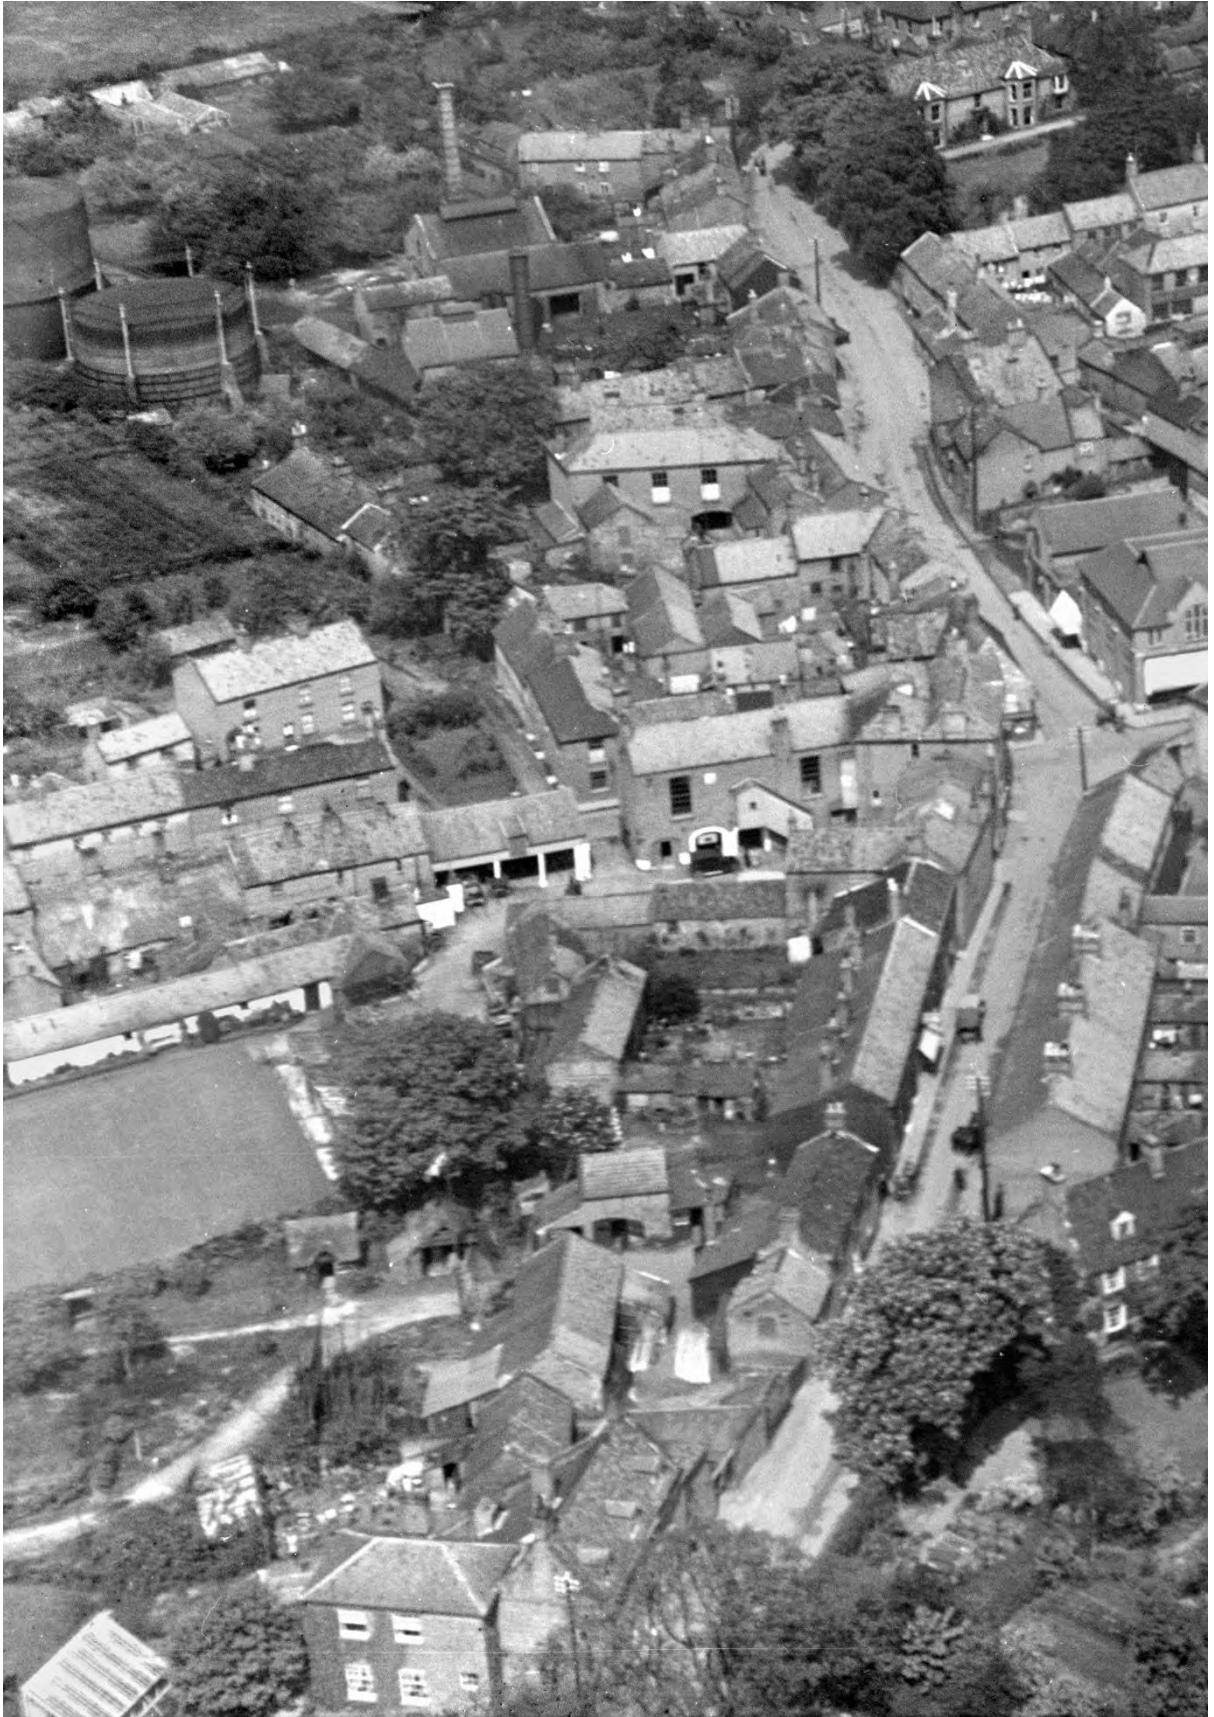
Fig 110: Aylsham Road and Mundesley Road in 1928. The town gas works can be seen top left. Detail of EPW021295 MAY 1928 © Historic England (Aerofilms Collection).

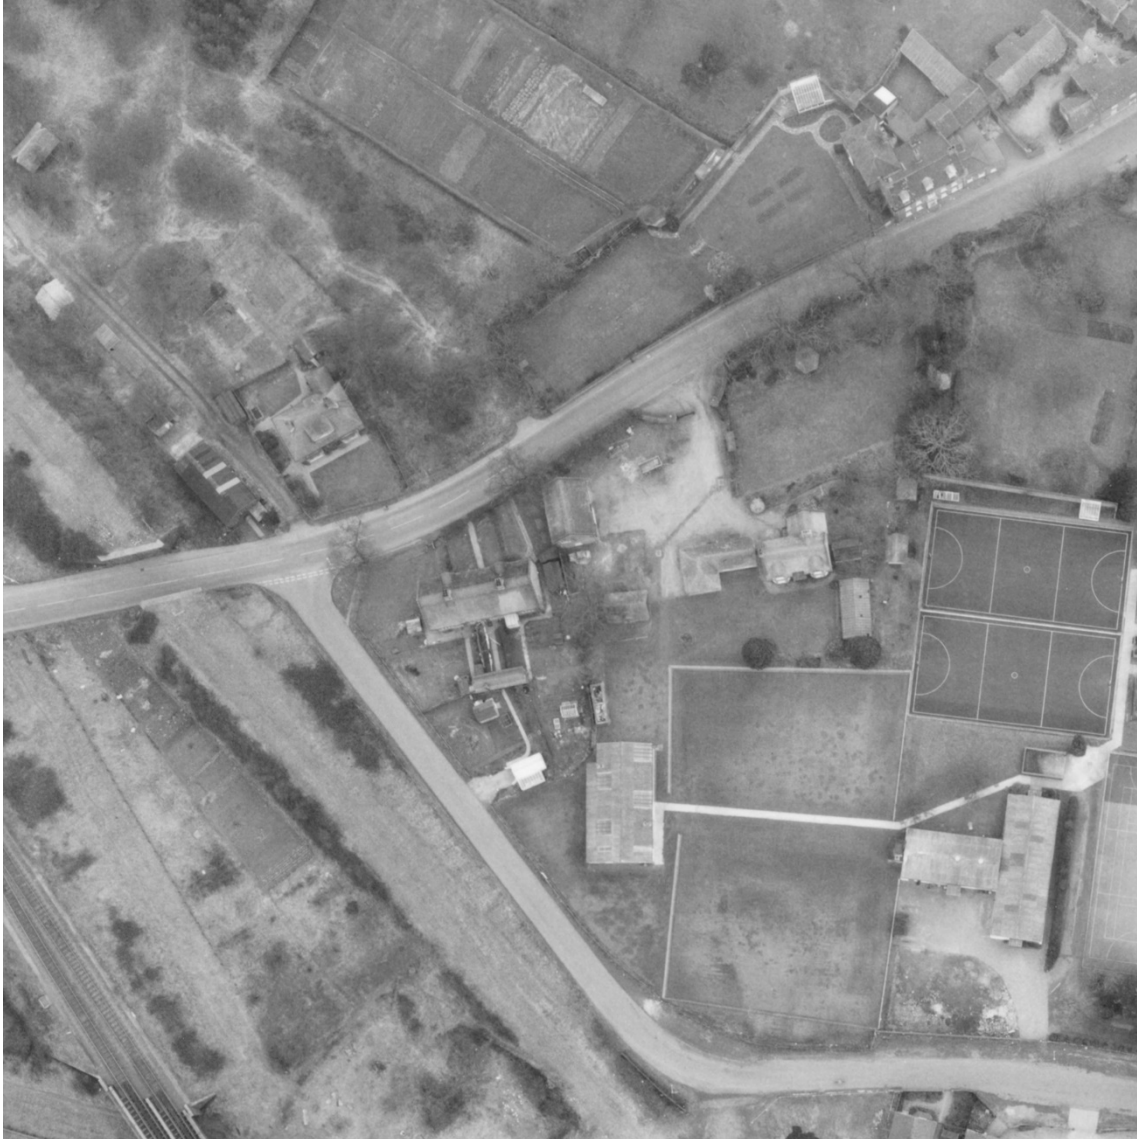
Fig 111: The southern end of Aylsham Road running left to right seen in 1968. Park Lane extends toward the bottom right corner of the photo. The open space along the northern (top) side of Aylsham Road has since been built upon. Detail of MAL/68006 157 24-FEB-1968. Photo by Meridian Airmaps Ltd. Copyright Norfolk County Council.
