Kirby Hall, Gretton, North Northamptonshire Report on Geophysical Survey, July 2021

KIRBY HALL, GRETTON,
NORTH NORTHAMPTONSHIRE
REPORT ON GEOPHYSICAL SURVEY, JULY 2021

A Ground Penetrating Radar (GPR) survey was conducted at Kirby Hall, Gretton, North Northamptonshire, to investigate the immediate vicinity of a collapsed flagstone in a small storeroom adjacent to the Great Hall. The collapse occurred following substantial waterlogging of the ground floor of the building over the previous winter and the survey was extended to cover the whole flagstone floor of the Great Hall. Additional GPR coverage was conducted over the South Lawn beyond the building to determine the location and condition of drainage conduits serving the building known from a previous earth resistance survey. The GPR survey was conducted in response to a request from the English Heritage Trust in advance of works to address the flagstone collapse. A combined area of 0.4ha was surveyed with the data from within the storeroom suggesting the voiding in the immediate area of the flagstone collapse is relatively localised. Areas of high amplitude response within the Great Hall may require further invasive investigat

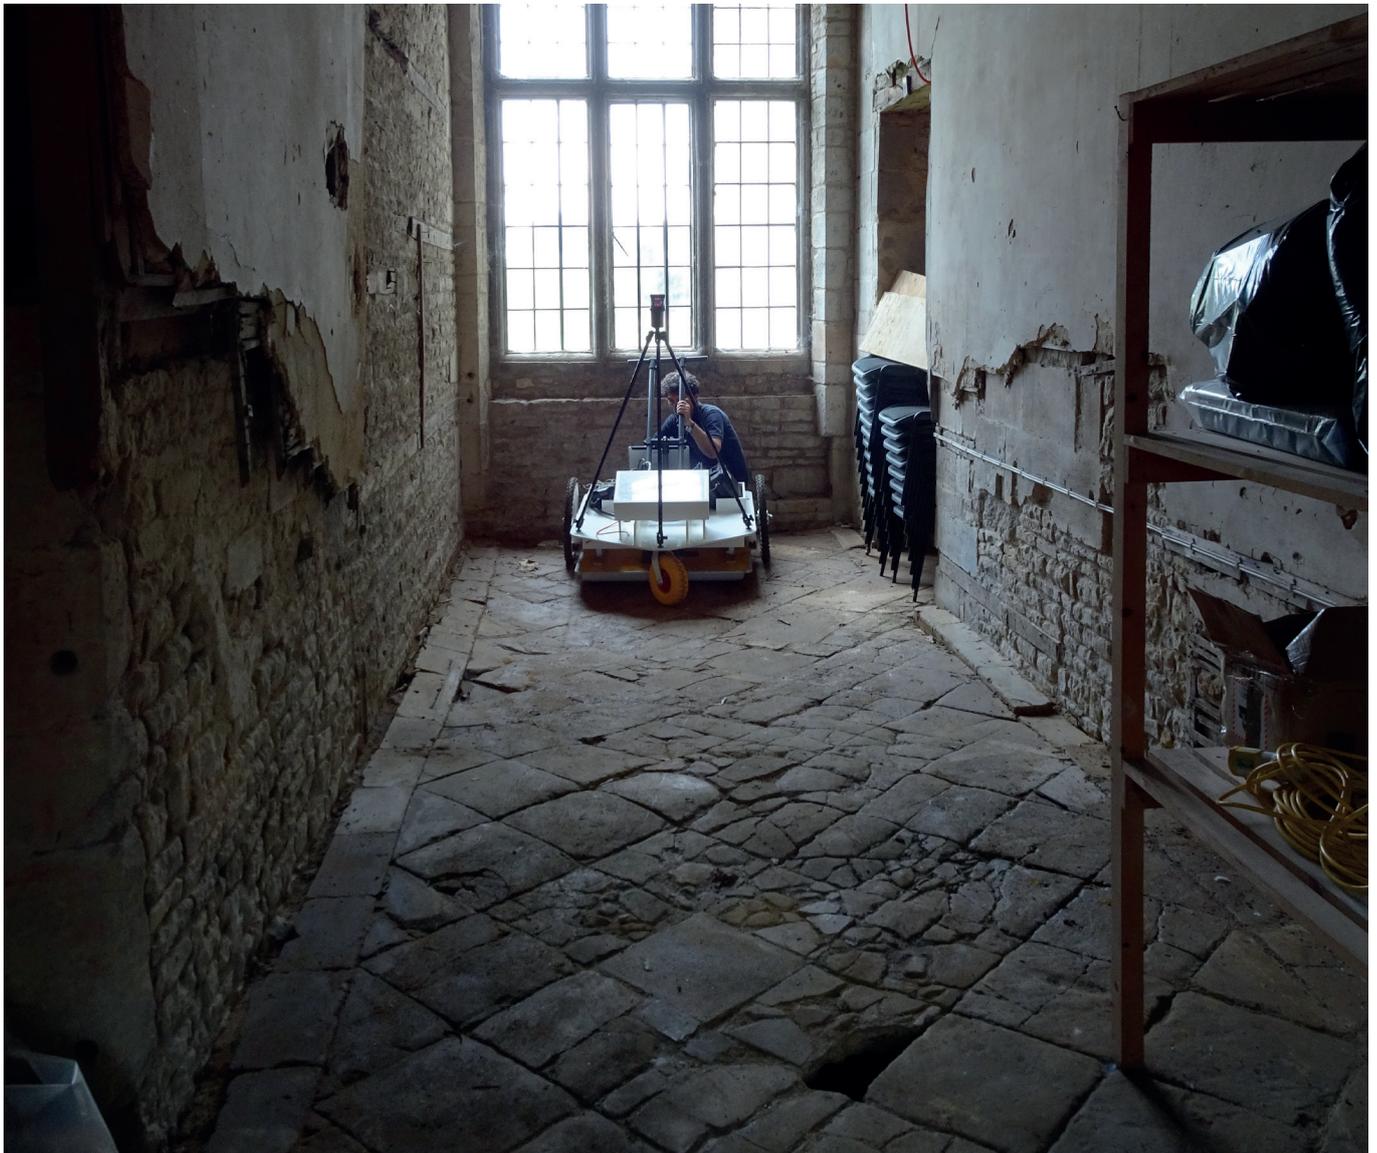
The fieldwork was conducted on 26-30th July 2021 and the report was completed on 7th March 2022. The cover image shows the survey of the storeroom adjacent to the Great Hall in progress with the collapse flagstone visible in the foreground (photograph taken by A Payne).

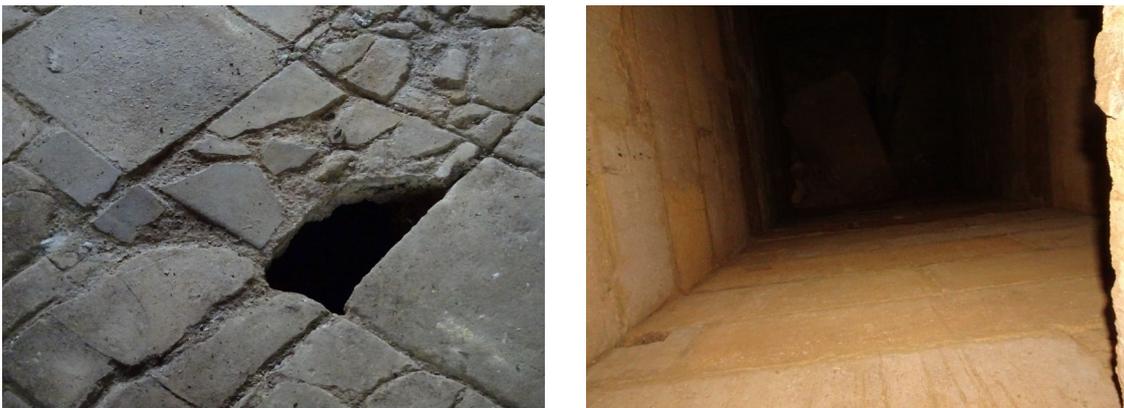
The GPR survey has identified two areas of high amplitude response, most likely associated with subsurface voids, in the area immediately adjacent to the visible collapse of the flagstone floor in the storeroom. Both anomalies appear to be relatively discrete and, in the case of collapsed flagstone, the extent of the voiding correlates with the limited observation possible from the surface (Figure

11). It is difficult to suggest the cause of the collapse from the geophysical data although it seems likely that the recent flooding events have weakened the grouting between the flagstones allowing them to collapse into the underlying voids. Results from the Great Hall suggest a number of areas of similar high amplitude response that may either be associated with subsurface voiding or settling where further invasive investigation and monitoring would be advisable.

Figure 11 Partially collapsed flagstone (left) in the storeroom together with a view of through the opening to reveal the underlying void space (right). It would appear that the flagstone floor is suspended between structural walls with no additional packing material to stabilise the void.

- Figure 11* Photographs of the partially collapsed flagstone (left) in the storeroom together with a view of through the opening to reveal the underlying void space (right). It would appear that the flagstone floor is suspended between structural walls with no additional packing material to stabilise the void (inline photographs, not to scale).

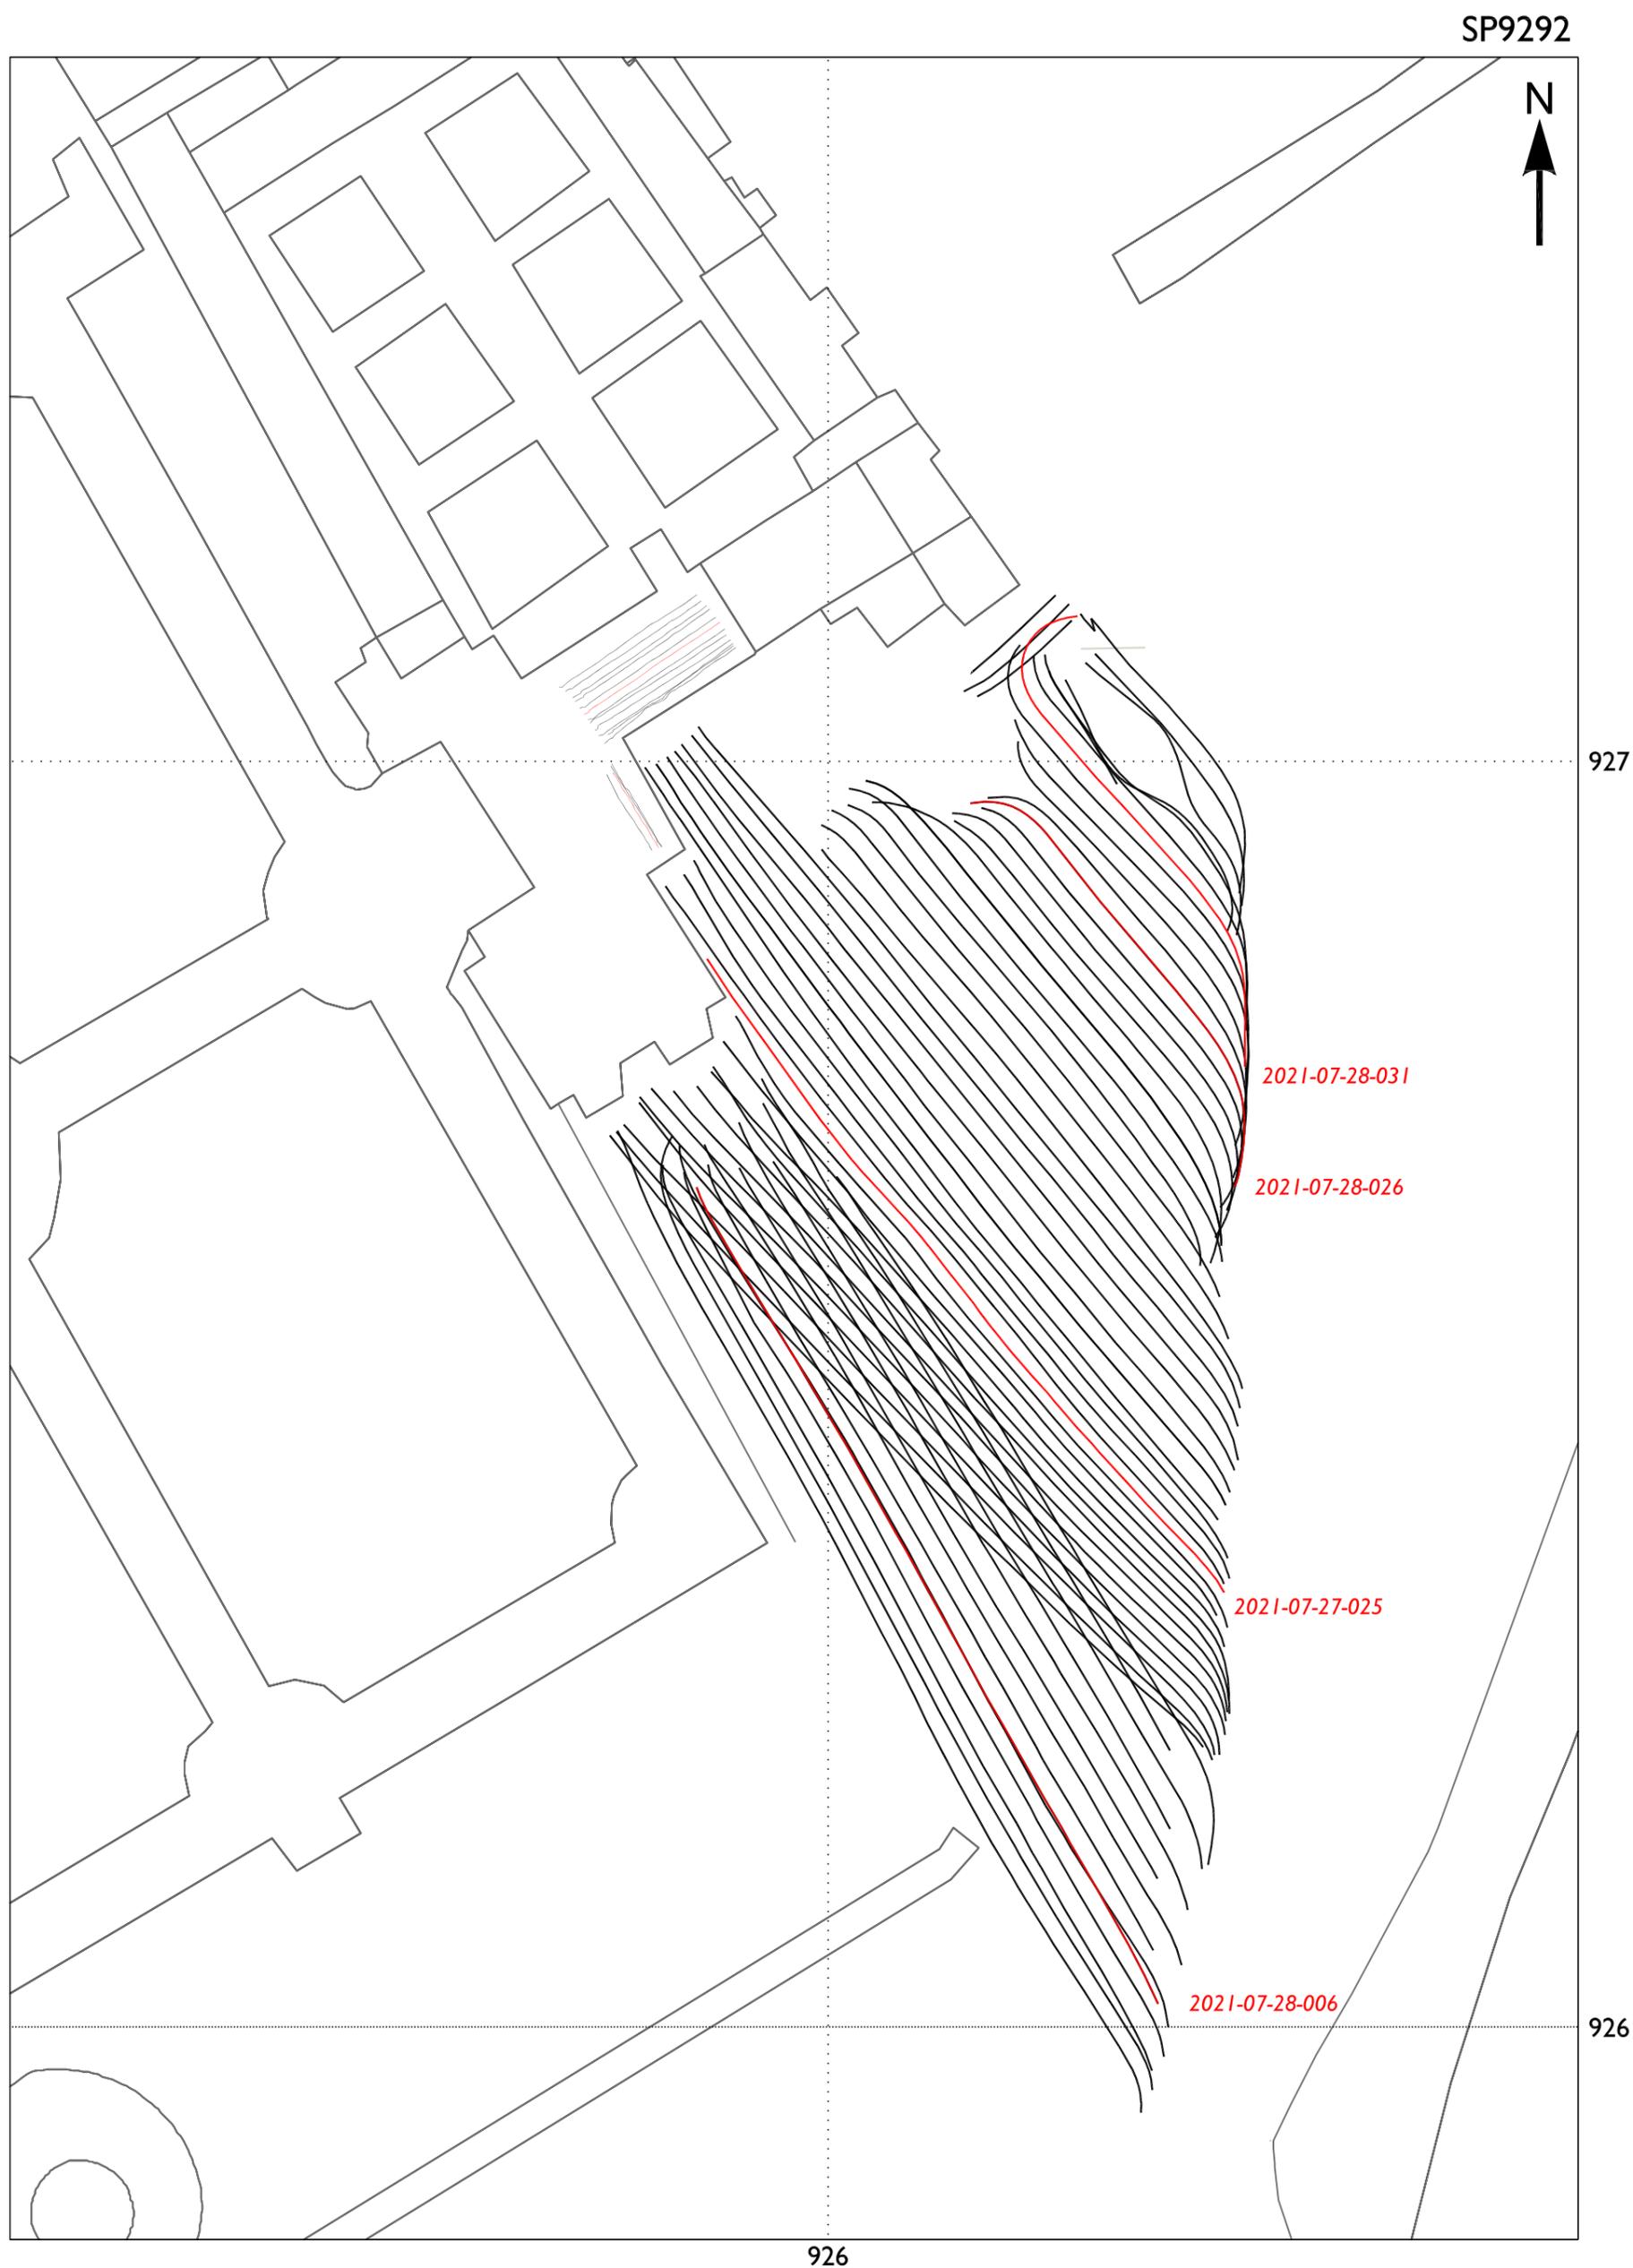
Figure 1

mounted on the GPR array was used to provide continuous positional control for the survey collected along the instrument swaths shown on Figure 1. Control points for the total station were established using a Trimble R8s Global Navigation Satellite System (GNSS) receiver adjusted to the National Grid Transformation OSTN15 using the Trimble VRS Now Network RTK delivery service. This uses the Ordnance Survey's GNSS correction network (OSNet) and gives a stated accuracy of 0.01-0.015m per point with vertical accuracy being half as precise.

Location of GPR instrument swaths, July 2021

Ground Penetrating Radar survey swaths

- Figure 1* Location of the GPR instrument swaths superimposed over the base OS mapping data (1:500).
- Figure 2* Greyscale image of the GPR amplitude time slice over the south lawn from between 22.5 and 25.0ns (1.16-1.29m) superimposed over the base OS mapping data. The location of representative GPR profiles shown on Figure 3 are also indicated (1:500).

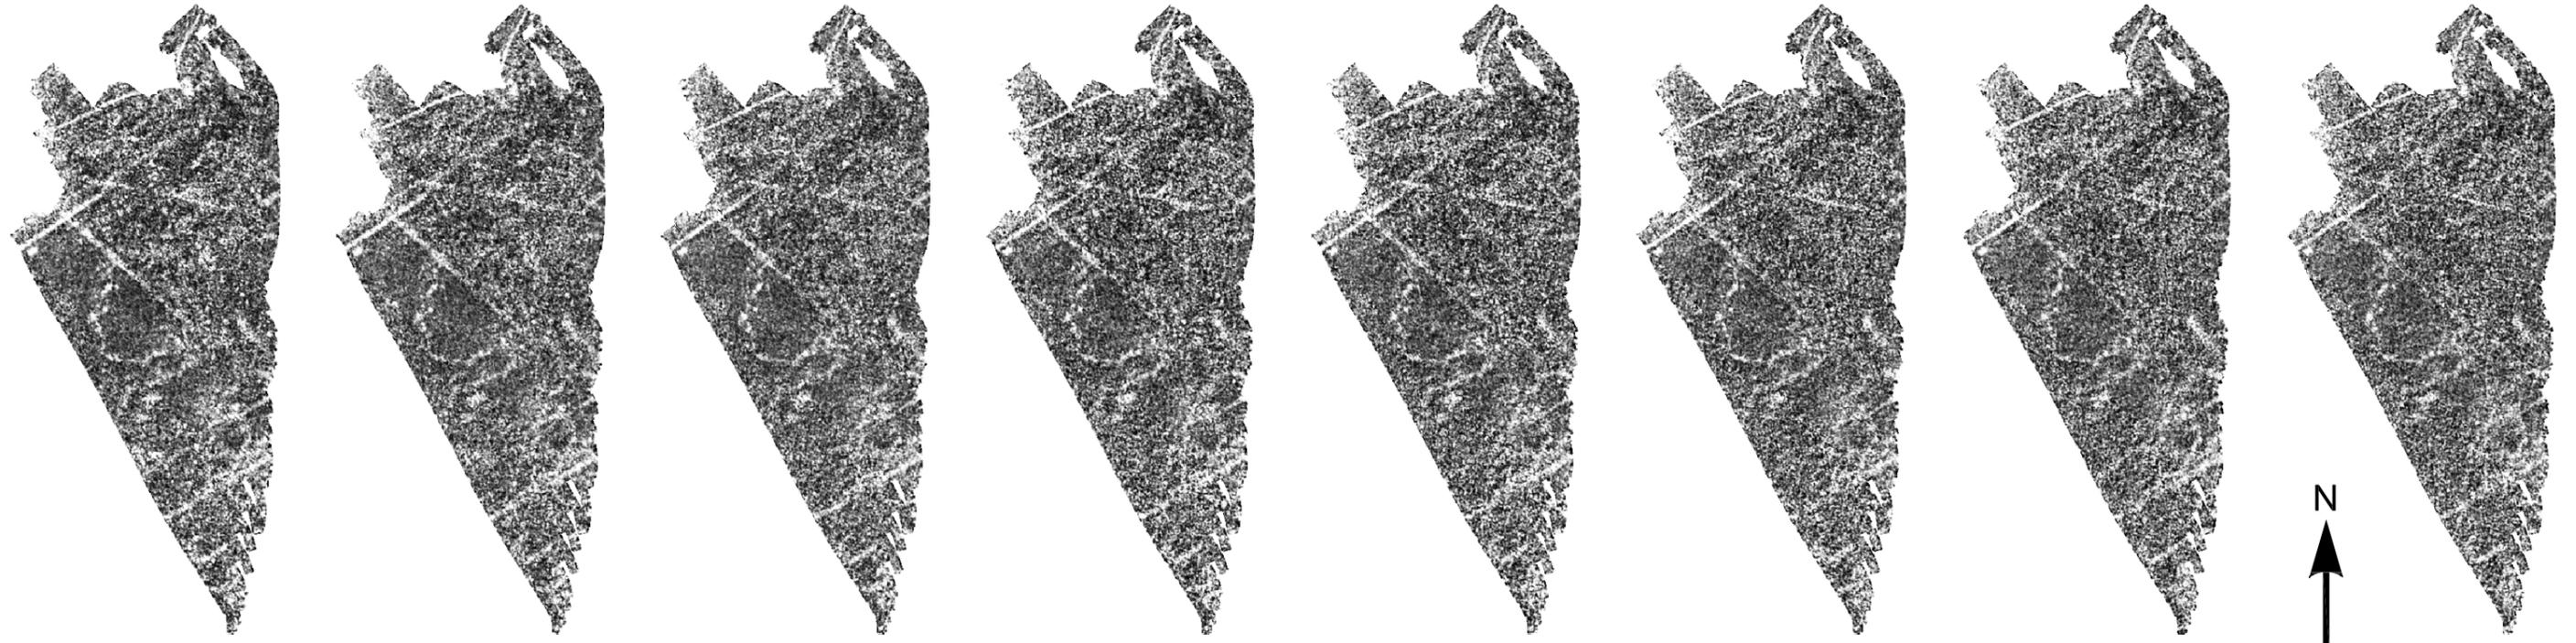
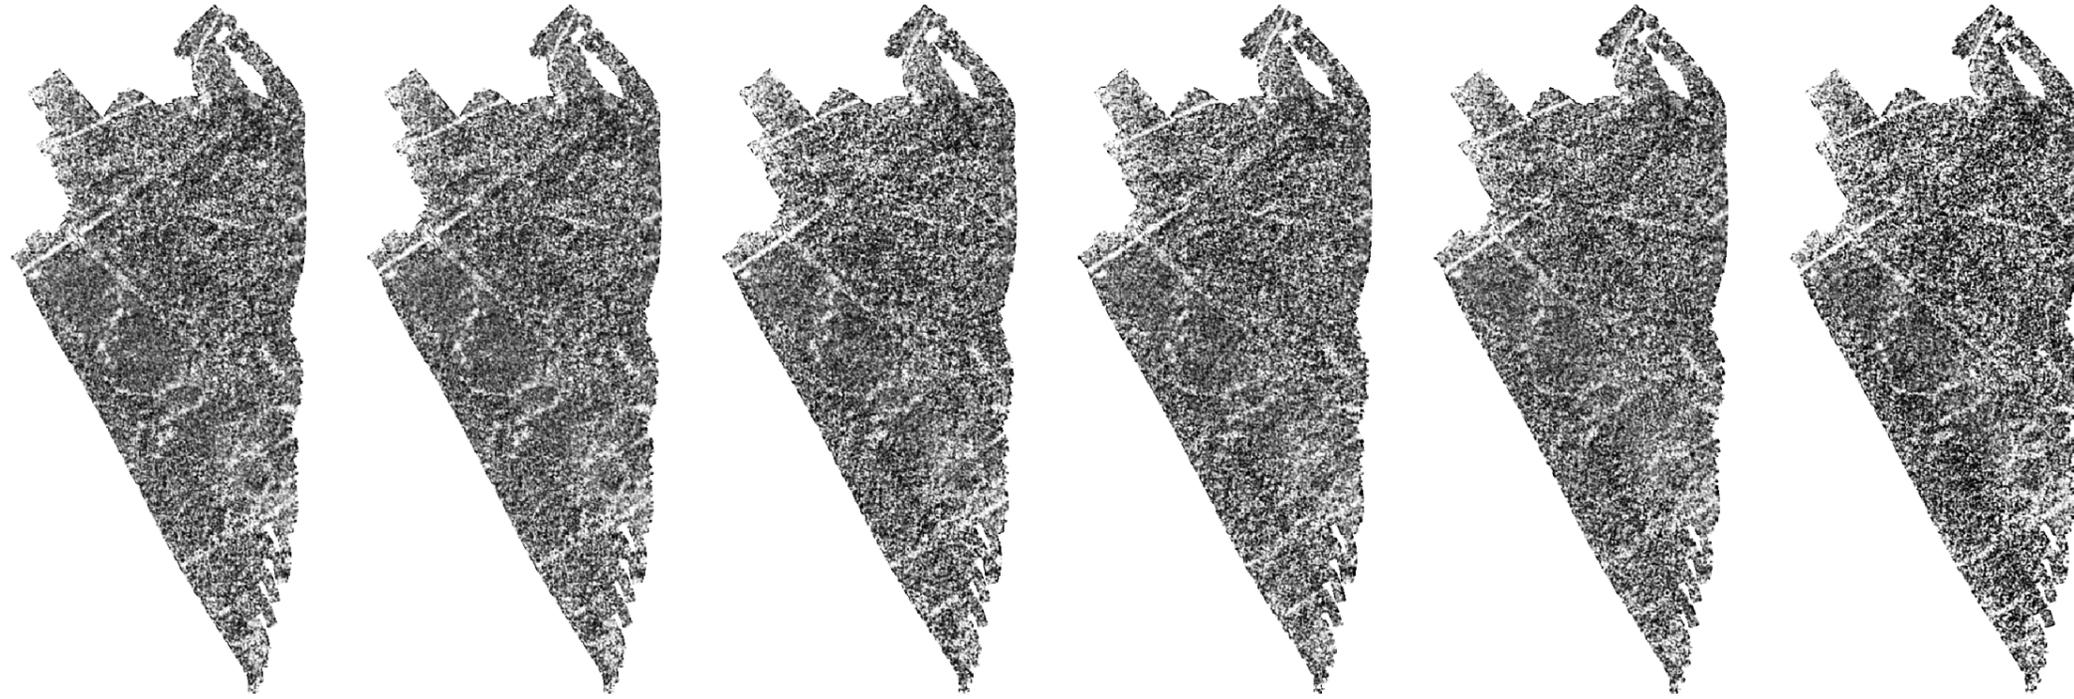
GPR amplitude time slices between 40.0 and 75.0ns (2.64 to 4.95m), South Lawn, July 2021

40.0 - 42.5ns (2.64 - 2.81m) 42.5 - 45.0ns (2.81 - 2.97m) 45.0 - 47.5ns (2.97 - 3.14m) 47.5 - 50.0ns (3.14 - 3.3m) 50.0 - 52.5ns (3.3 - 3.47m) 52.5 - 55.0ns (3.47 - 3.63m) 55.0 - 57.5ns (3.63 - 3.8m) 57.5 - 60.0ns (3.8 - 3.96m)

60.0 - 62.5ns (3.96 - 4.13m) 62.5 - 65.0ns (4.13 - 4.29m) 65.0 - 67.5ns (4.29 - 4.46m) 67.5 - 70.0ns (4.46 - 4.62m) 70.0 - 72.5ns (4.62 - 4.79m) 72.5 - 75.0ns (4.79 - 4.95m)

- Figure 5* GPR amplitude time slices between 0.0 and 40.0ns (0.0 to 2.64m), South Lawn, July 2022 (1:1250).
- Figure 6* GPR amplitude time slices between 40.0 and 75.0ns (2.64 to 3.??m), South Lawn, July 2022 (1:1250).
