# Cleeve Abbey Frater Pavement cleaning analyses

## Cleeve Abbey Frater Pavement cleaning analyses

NGR: ST 047 408

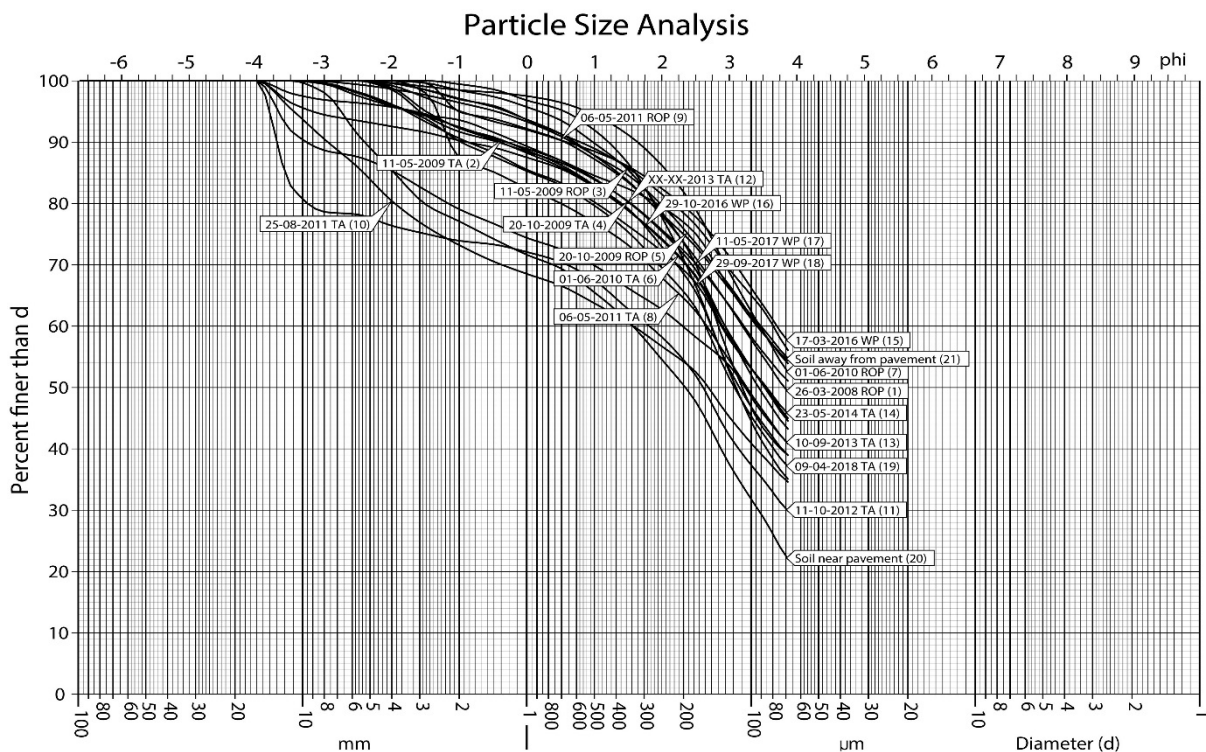
**Figure 1:** Particle size analyses of all the cleaning and soil samples. Sample labels consist of cleaning date, pavement area (TA = trial area; ROP = rest of pavement; WP = whole pavement), followed by laboratory number in brackets (see Table 1).

Figure 1 shows the complete set of particle size analyses. The cleanings and soil samples all have similar slopes in the 2 mm to 63  $\mu\text{m}$  sector, i.e., the fine, medium, and coarse sand component. This is to be expected, as the bulk of the cleaned material must be local soil. Four of the curves are, however, positioned significantly below the main group indicating a greater stone content. Two others within the upper main group show some crossing over of the curves between 2 and 3 mm, again indicating additional stones.

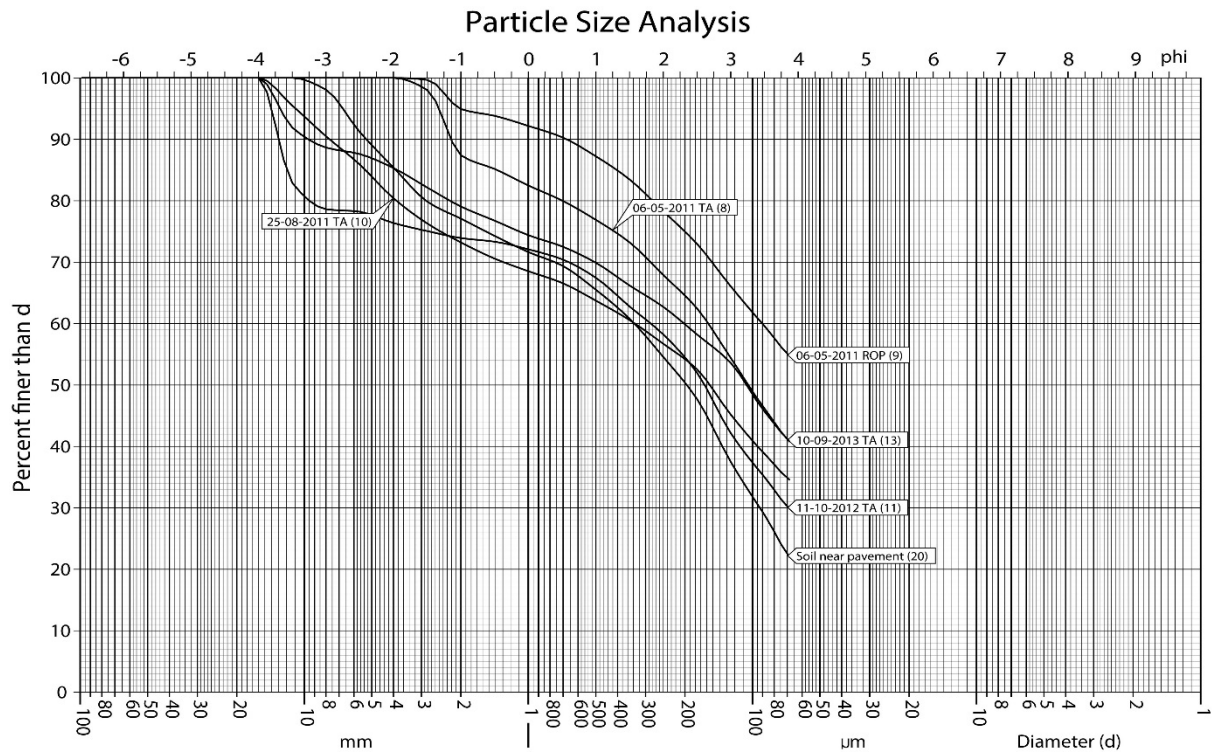
**Figure 2:** Particle size analyses of the six samples with higher stone contents. Sample labels consist of cleaning date, pavement area (TA = trial area; ROP = rest of pavement; WP = whole pavement), followed by laboratory number in brackets (see Table 1).

One of the samples with higher stone content (see Figure 2) is the local soil from near the pavement. However, the remainder (cleaning samples) are nearly all from the trial area and are all dated 2011-2013. The stone content most likely represents inputs from local soil or construction waste, via extreme weather, feet, accidents, or suchlike.

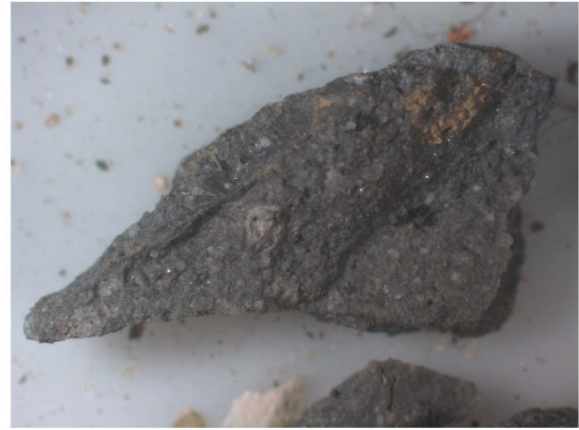
**Figure 4:** Frater Pavement reduced ceramic body: (a) same as Figure 2 (a and b) except grey; (b) with occasional light brown patches.

The reduced part of the ceramic body is the same as the oxidised part except grey (Figure 4a), with occasional light brown patches (Figure 4b). The slip decoration is a very pure white (Figure 5a and b) with only a few additional grains of different types. The pavement also has a brown/yellow transparent glaze which can adhere to any of the different parts of the body or slip (Figure 6a, b and c).

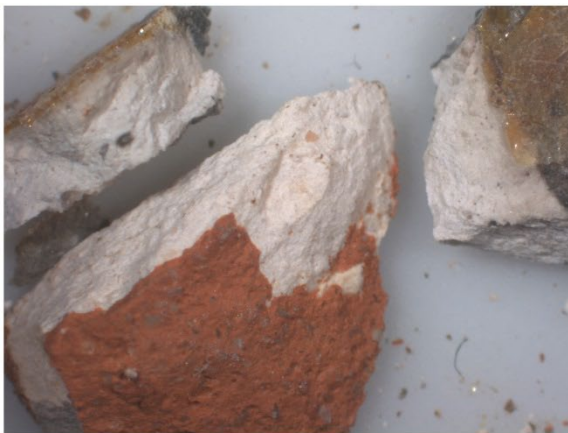
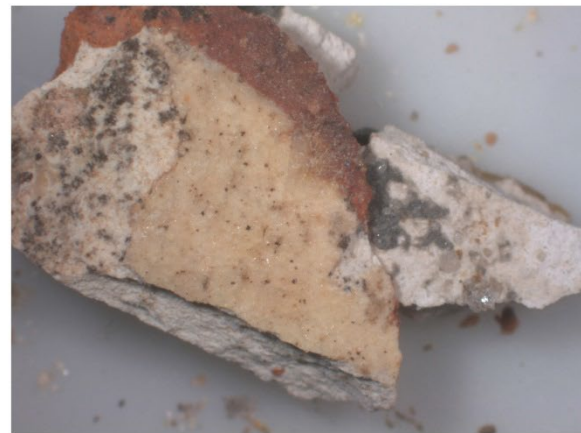
**Figure 5:** White slip decoration - generally a very pure white with few additional grains of different types.

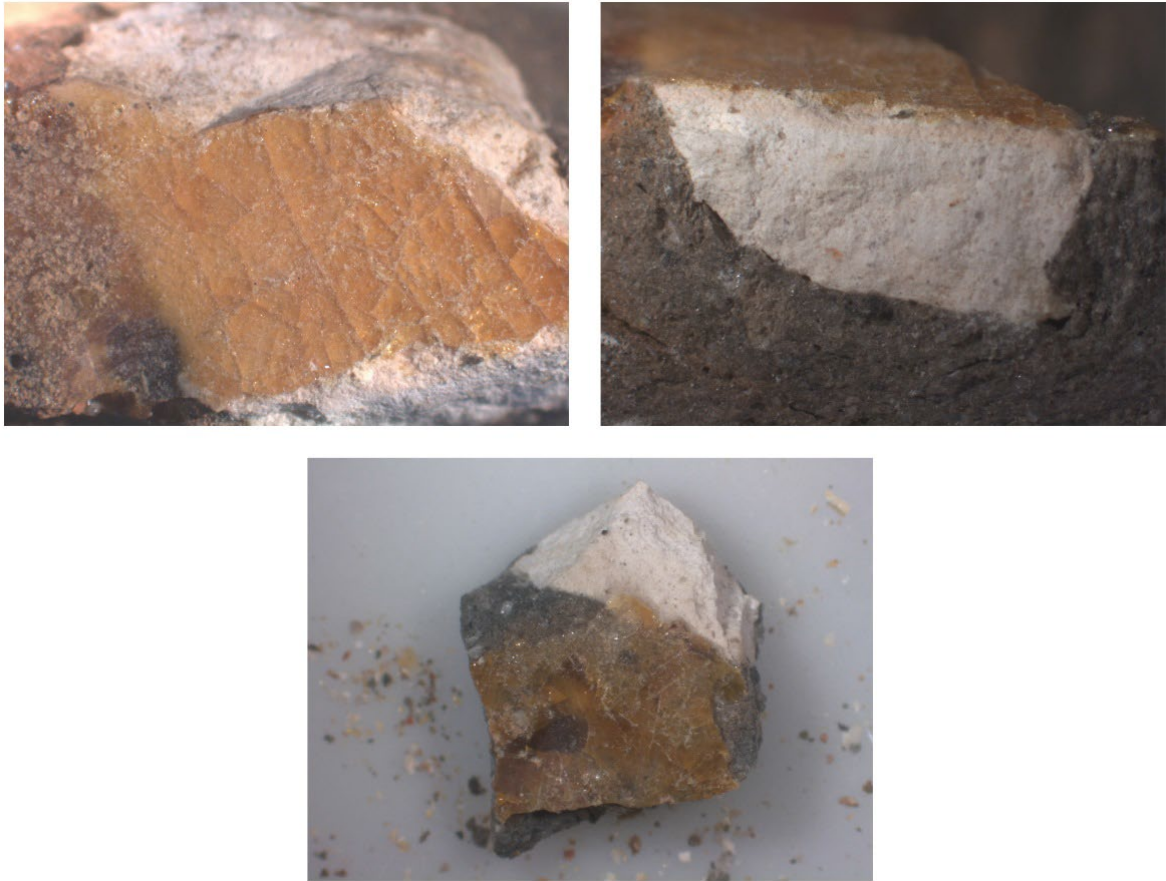
**Figure 6:** Frater Pavement brown/yellow transparent glaze which can be found adhering to any of the different parts of the body or slip.
