MIDSUMMER HILL CAMP

SURVEY REPORT

## **A survey of the earthworks on Midsummer and Hollybush Hills, Eastnor, Hereford & Worcs**

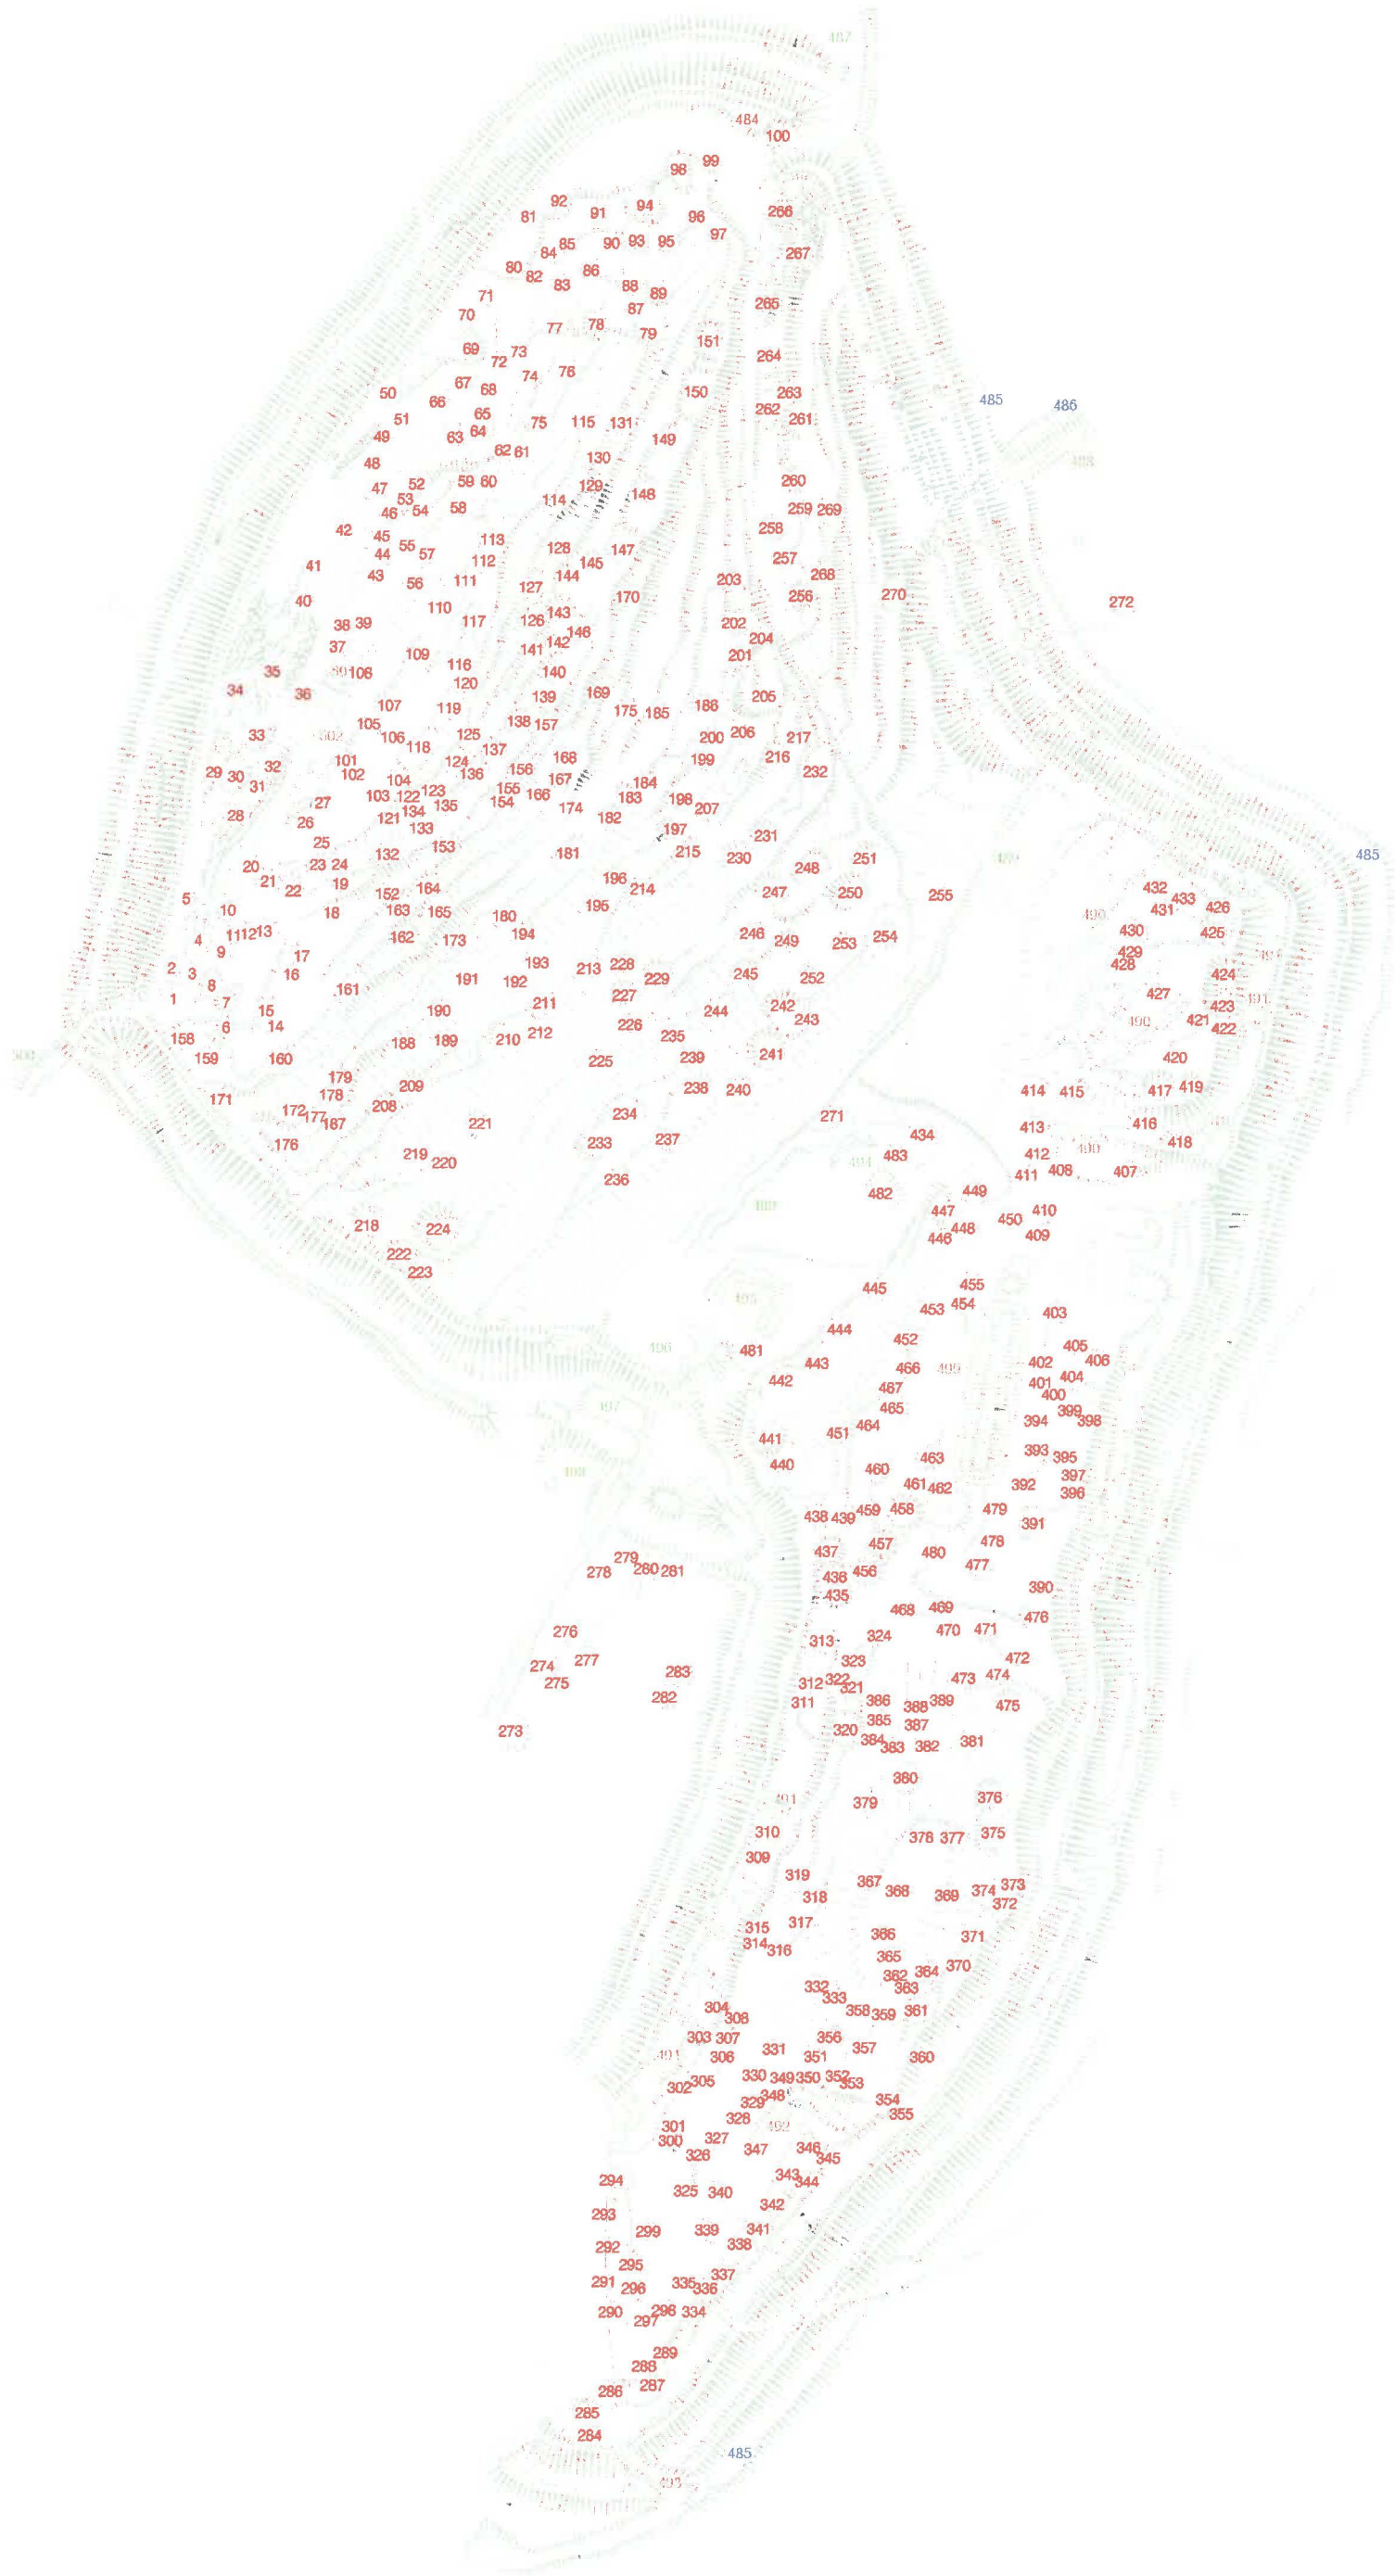
There are some indications of the presence of a line of defence pre-dating the hillfort. At the northern entrance part of what appears to be an earlier phase of rampart is revealed (Fig 2: 484). Traced as a ledge c 1m in height this curves inside the rampart to the west of the north entrance and appears to underlie it. The 'guard chamber' (Fig 2: 100) appears to have cut into it. Around much of the circuit on Hollybush Hill are remnants of a similar ledge that may mark the line of the same feature (Fig 2: 485). In places on the steep eastern slopes it is missing but may have eroded downslope. In the south the scarp becomes stronger and appears to curve uphill around the southern end of the hillfort but is obscured by a track cutting through the ramparts and leading to a small quarry. Despite some obscurity at the northern end the feature almost certainly originates from under the ramparts. Importantly, where the Shire Ditch approaches the hillfort in the north, one element lies over both the ledge and the hillfort counterscarp (Fig 2: 486). H H Lines appears to have observed part of this feature in 1869, notably in the north-east of Hollybush Hill where the ramparts change direction. While on Stanford's version of the plan this area is missing due to damage, the version published by Lines (nd) makes it clear that after rounding the southern end of Hollybush the feature disappeared beneath the counterscarp bank.

A few hut stances are situated outside the hillfort entrance in the ravine, three of which overlie the counterscarp bank (Fig 2: 279-281). The extent of these, however, is not great and the '*British Town*' marked on plans as being located in this area was not traced. If it existed at all it may have succumbed to quarrying. A few large depressions in this area appear to represent precursors of the Hollybush quarry, and it seems likely that they may have been the features noted by earlier investigators.

A series of four narrow linear trenches with traces of a fifth are arranged over the northern part of Hollybush Hill oriented slightly east of north (Fig 2: 490). These are quite uniform, invariably 1.5m wide with the spoil placed alongside, usually to the west, and their sharp

Four cisterns, part of a series that descends the ravine towards the Hollybush Pass, were recorded (Fig 2: 495-498). These are placed at the southern entrance of the hillfort and in part utilise the rampart terminal to pond back water. The first and uppermost is partly demarcated on three sides by a bank 3m wide with external ditch. The bank and inward curving entrance terminal provides a dam to a second pond, while the former line of the counterscarp has been adapted to dam a third, with the counterscarp forming a fourth.

Having traversed the summit of the Malvern Hills, the Shire Ditch, approaches from the north, less than 100m to the east of the northern hillfort entrance (Fig 2: 486, 488). There are evidently two phases of construction: a prominent but narrow ditch c 3m wide with a corresponding bank to the east; and mirroring this a bank and ditch of shallow profile parallel

A second linear runs along the narrow ridge to the south of Midsummer Hill (Fig 2: 500). and together with the linear noted above was once thought to form an outer enclosure to the hillfort. It is clearly later in date than the hillfort defences for it overlies the ditch. In places it is rock cut, and on its east side a number of hollows appear in the rock adjacent to the ditch. These are probably those depicted by Lines and referred to subsequently as hut dwellings. Investigation here, however, suggests that they represent no more than localised quarries, perhaps in part for the linear, but more probably of a later period.

A bank, a property boundary 4m wide, separates Midsummer and Hollybush Hills, being placed just above the ravine floor and can be traced for over 150m (Fig 2: 489). A series of shallow banks placed at right angles to the hillfort rampart lie within the quarry ditch around Hollybush Hill (Fig 2: 501). Separated by little distance, c 10m, they form small units. They are clearly later than the hillfort, invariably surmounting the rampart and they appear to represent Medieval or post-Medieval land-use of the interior.

Certainly a former line of the hillfort enclosure itself can be traced on the surface (Fig 2: 484, 485). Not only does this underlie the main hillfort defences in a number of places, but chronology is assisted by the presence of the Shire Ditch (Fig 2: 486, 488), one element of which appears to underlie and the other overlie the hillfort defences. Assuming the element that underlies the hillfort to be Late Bronze Age, analogous to linear ditches in Wessex, the earliest phase of hillfort enclosure might have been constructed as early as the Late Bronze Age. However, while Stanford's excavations at the south entrance revealed seventeen distinct phases (1981, 58), none produced pottery or other artefact evidence of such an early build.

487	Bank and ditch. Bank 0.6m high from bottom of ditch. Present on Lines map 1870
488	Shire Ditch. Ditch 0.4m deep with bank 0.8m high. Probably Medieval
489	Bank 0.7m high dividing Midsummer and Hollybush Hills. Probably Medieval.
490	Banks 0.15 high with corresponding ditches alongside. Probably post-Medieval
491	Series of short banks up to 0.2m in height. Probably medieval.
492	Bank 0.2m in height with corresponding ditch. Probably post-Medieval
493	Trackway to quarry. Probably post-medieval.
494	Right angled bank 0.4m high together with other evidently recent disturbance.
495	Shallow bank 0.15 in height with ditch evidently demarcating pond.
496	Pond
497	Pond
498	Pond

499	Pillow Mound 1m in height with 0.15 deep surrounding ditch & counterscarp
500	Linear Ditch, 0.7m above land surface in E, 1.5m in W.
501	Stone foundation of rectangular structure. Probably post-Medieval.
