Fort Cumberland, Eastney, City of Portsmouth

Report on Geophysical Surveys, May 2017 to May 2023

Summary

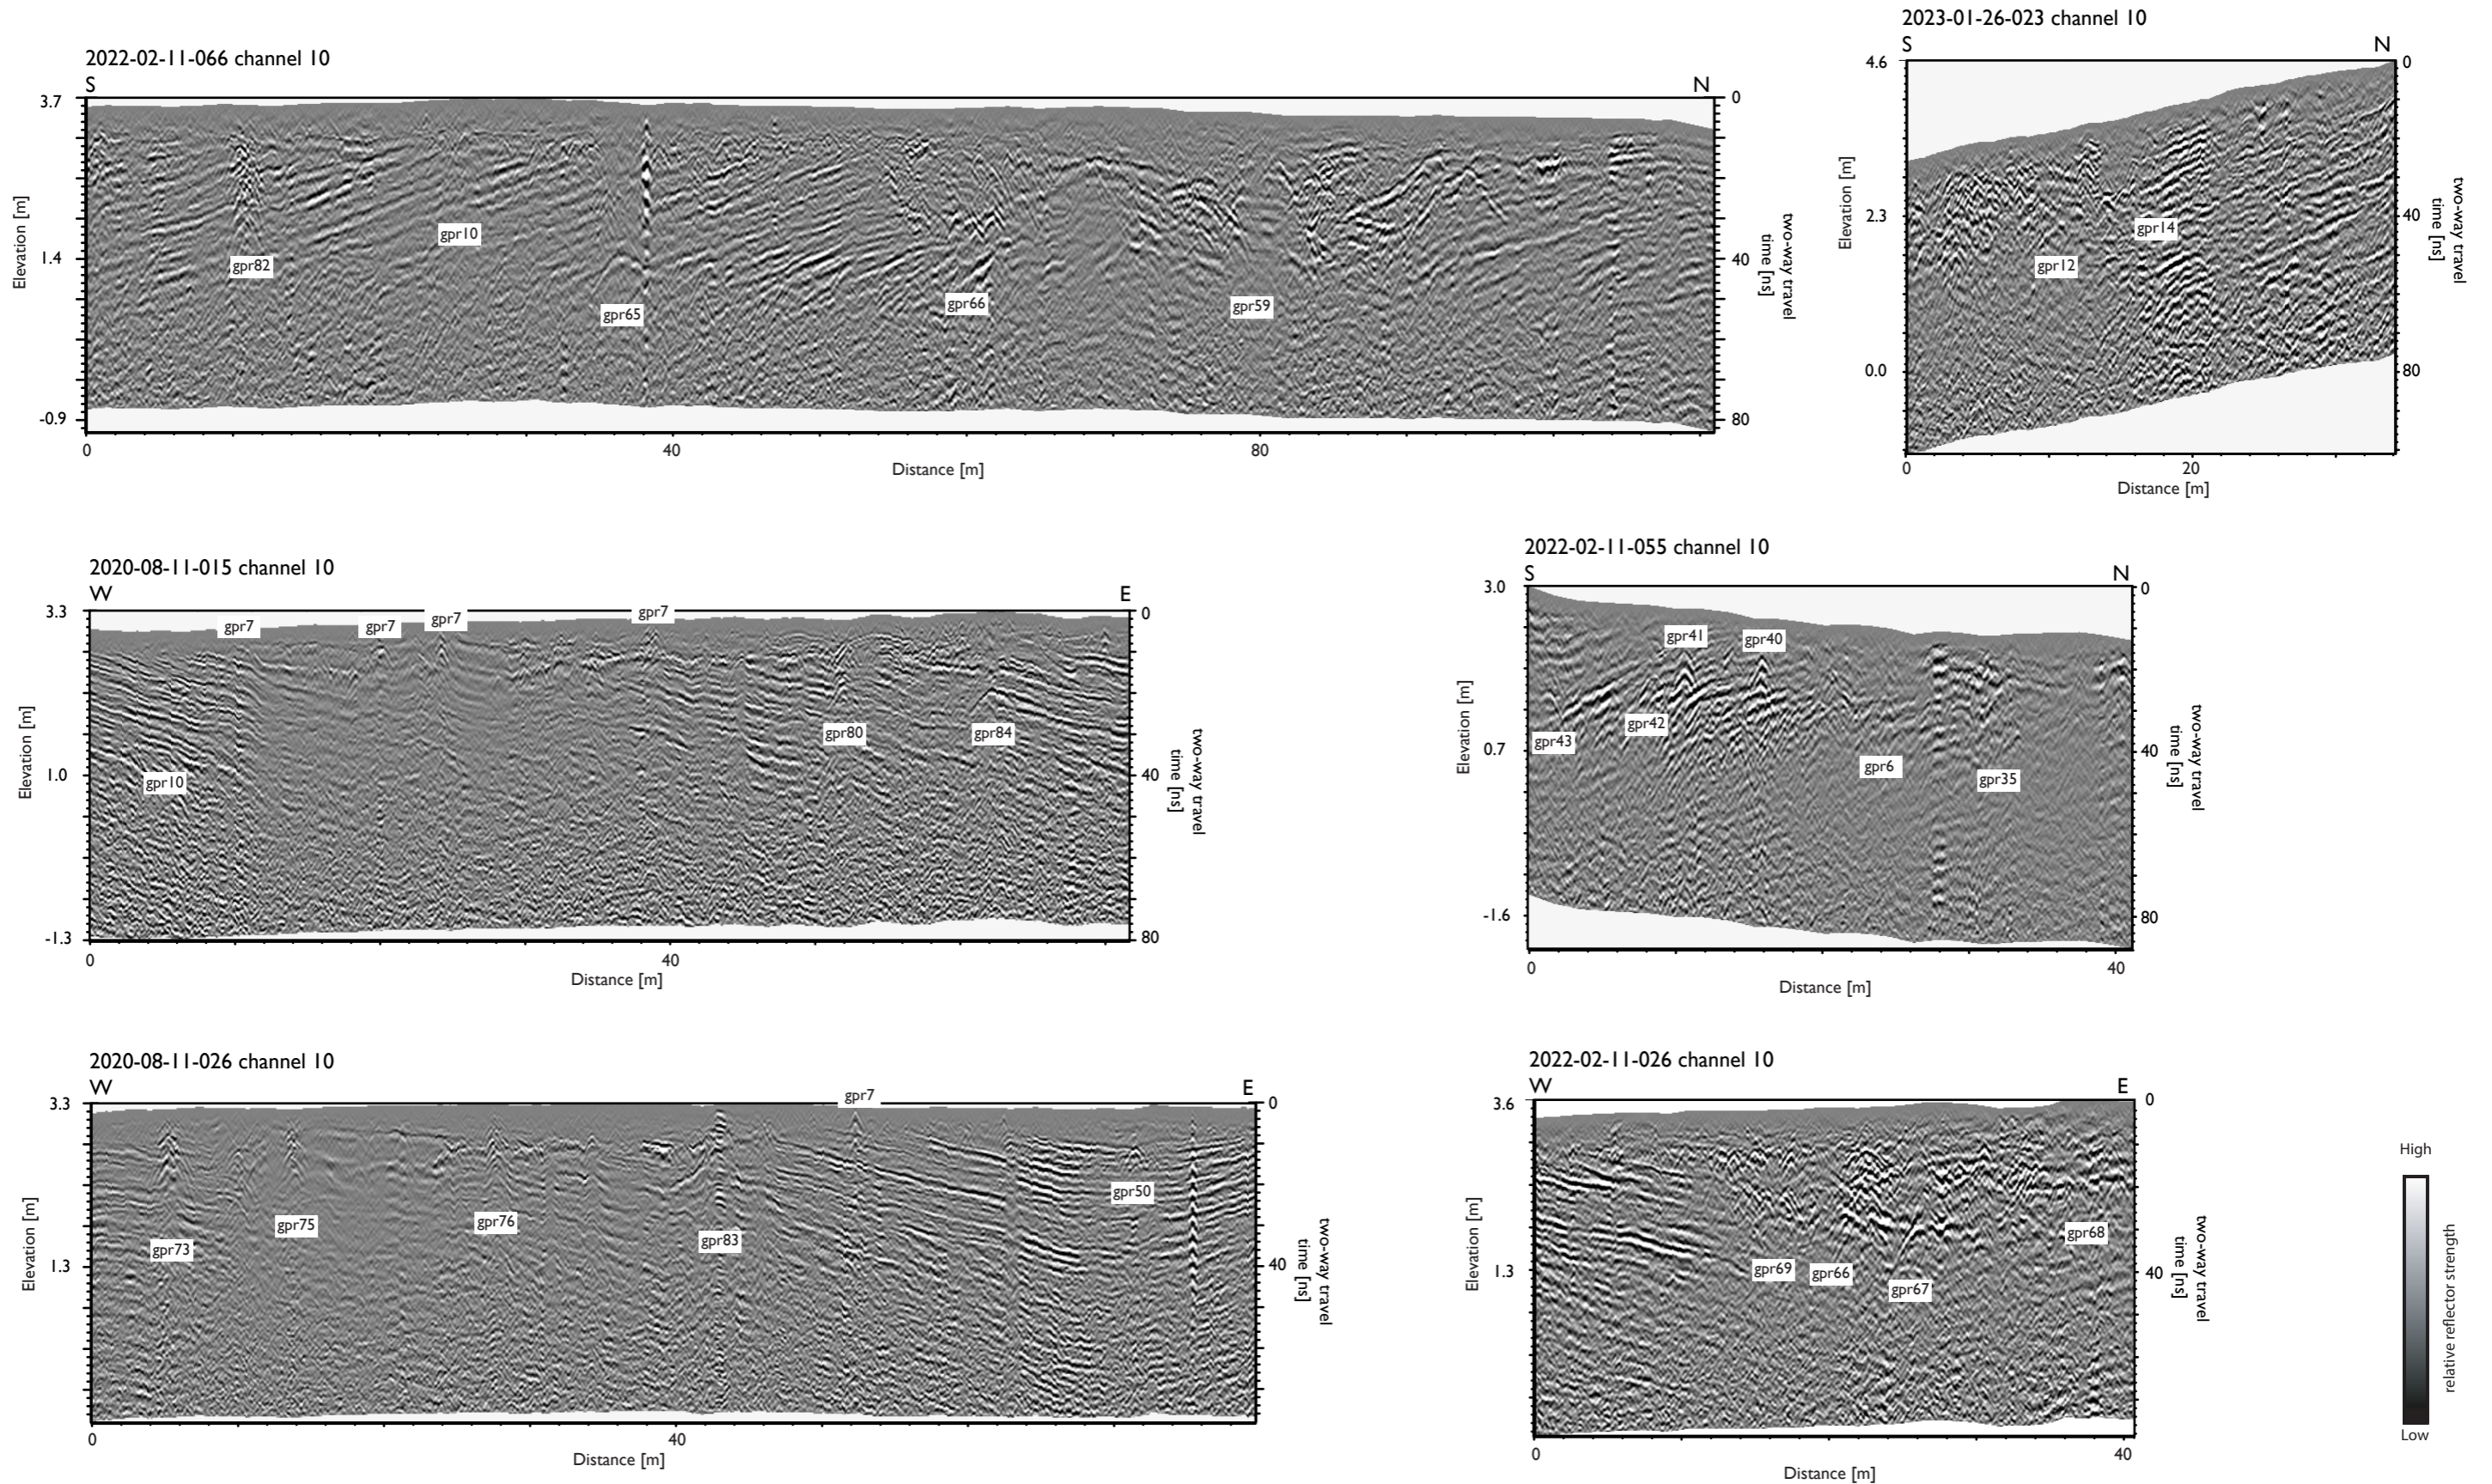
Figure 6

FORT CUMBERLAND, EASTNEY, CITY OF PORTSMOUTH
 Representative topographically corrected GPR profiles, May 2017 to May 2023

The underlying beach gravel deposits across the site appear as dipping reflectors within the GPR profiles (Figure 6) and are evident as high-amplitude anomalies [gpr10] following an approximate south-west to north-east alignment. In places, this geological response obscures the interpretation of more significant anomalies, although interventions such as service trenches can be identified where these disturb the dipping deposits.

- Figure 5: (A) Trace plot and (B) linear greyscale image of the minimally processed fluxgate magnetometer data (1:1000).
- Figure 6: Representative topographically corrected profiles from the GPR survey shown as greyscale images with annotation denoting significant anomalies. The location of the selected profiles can be found on Figures 3, 4 and 12.

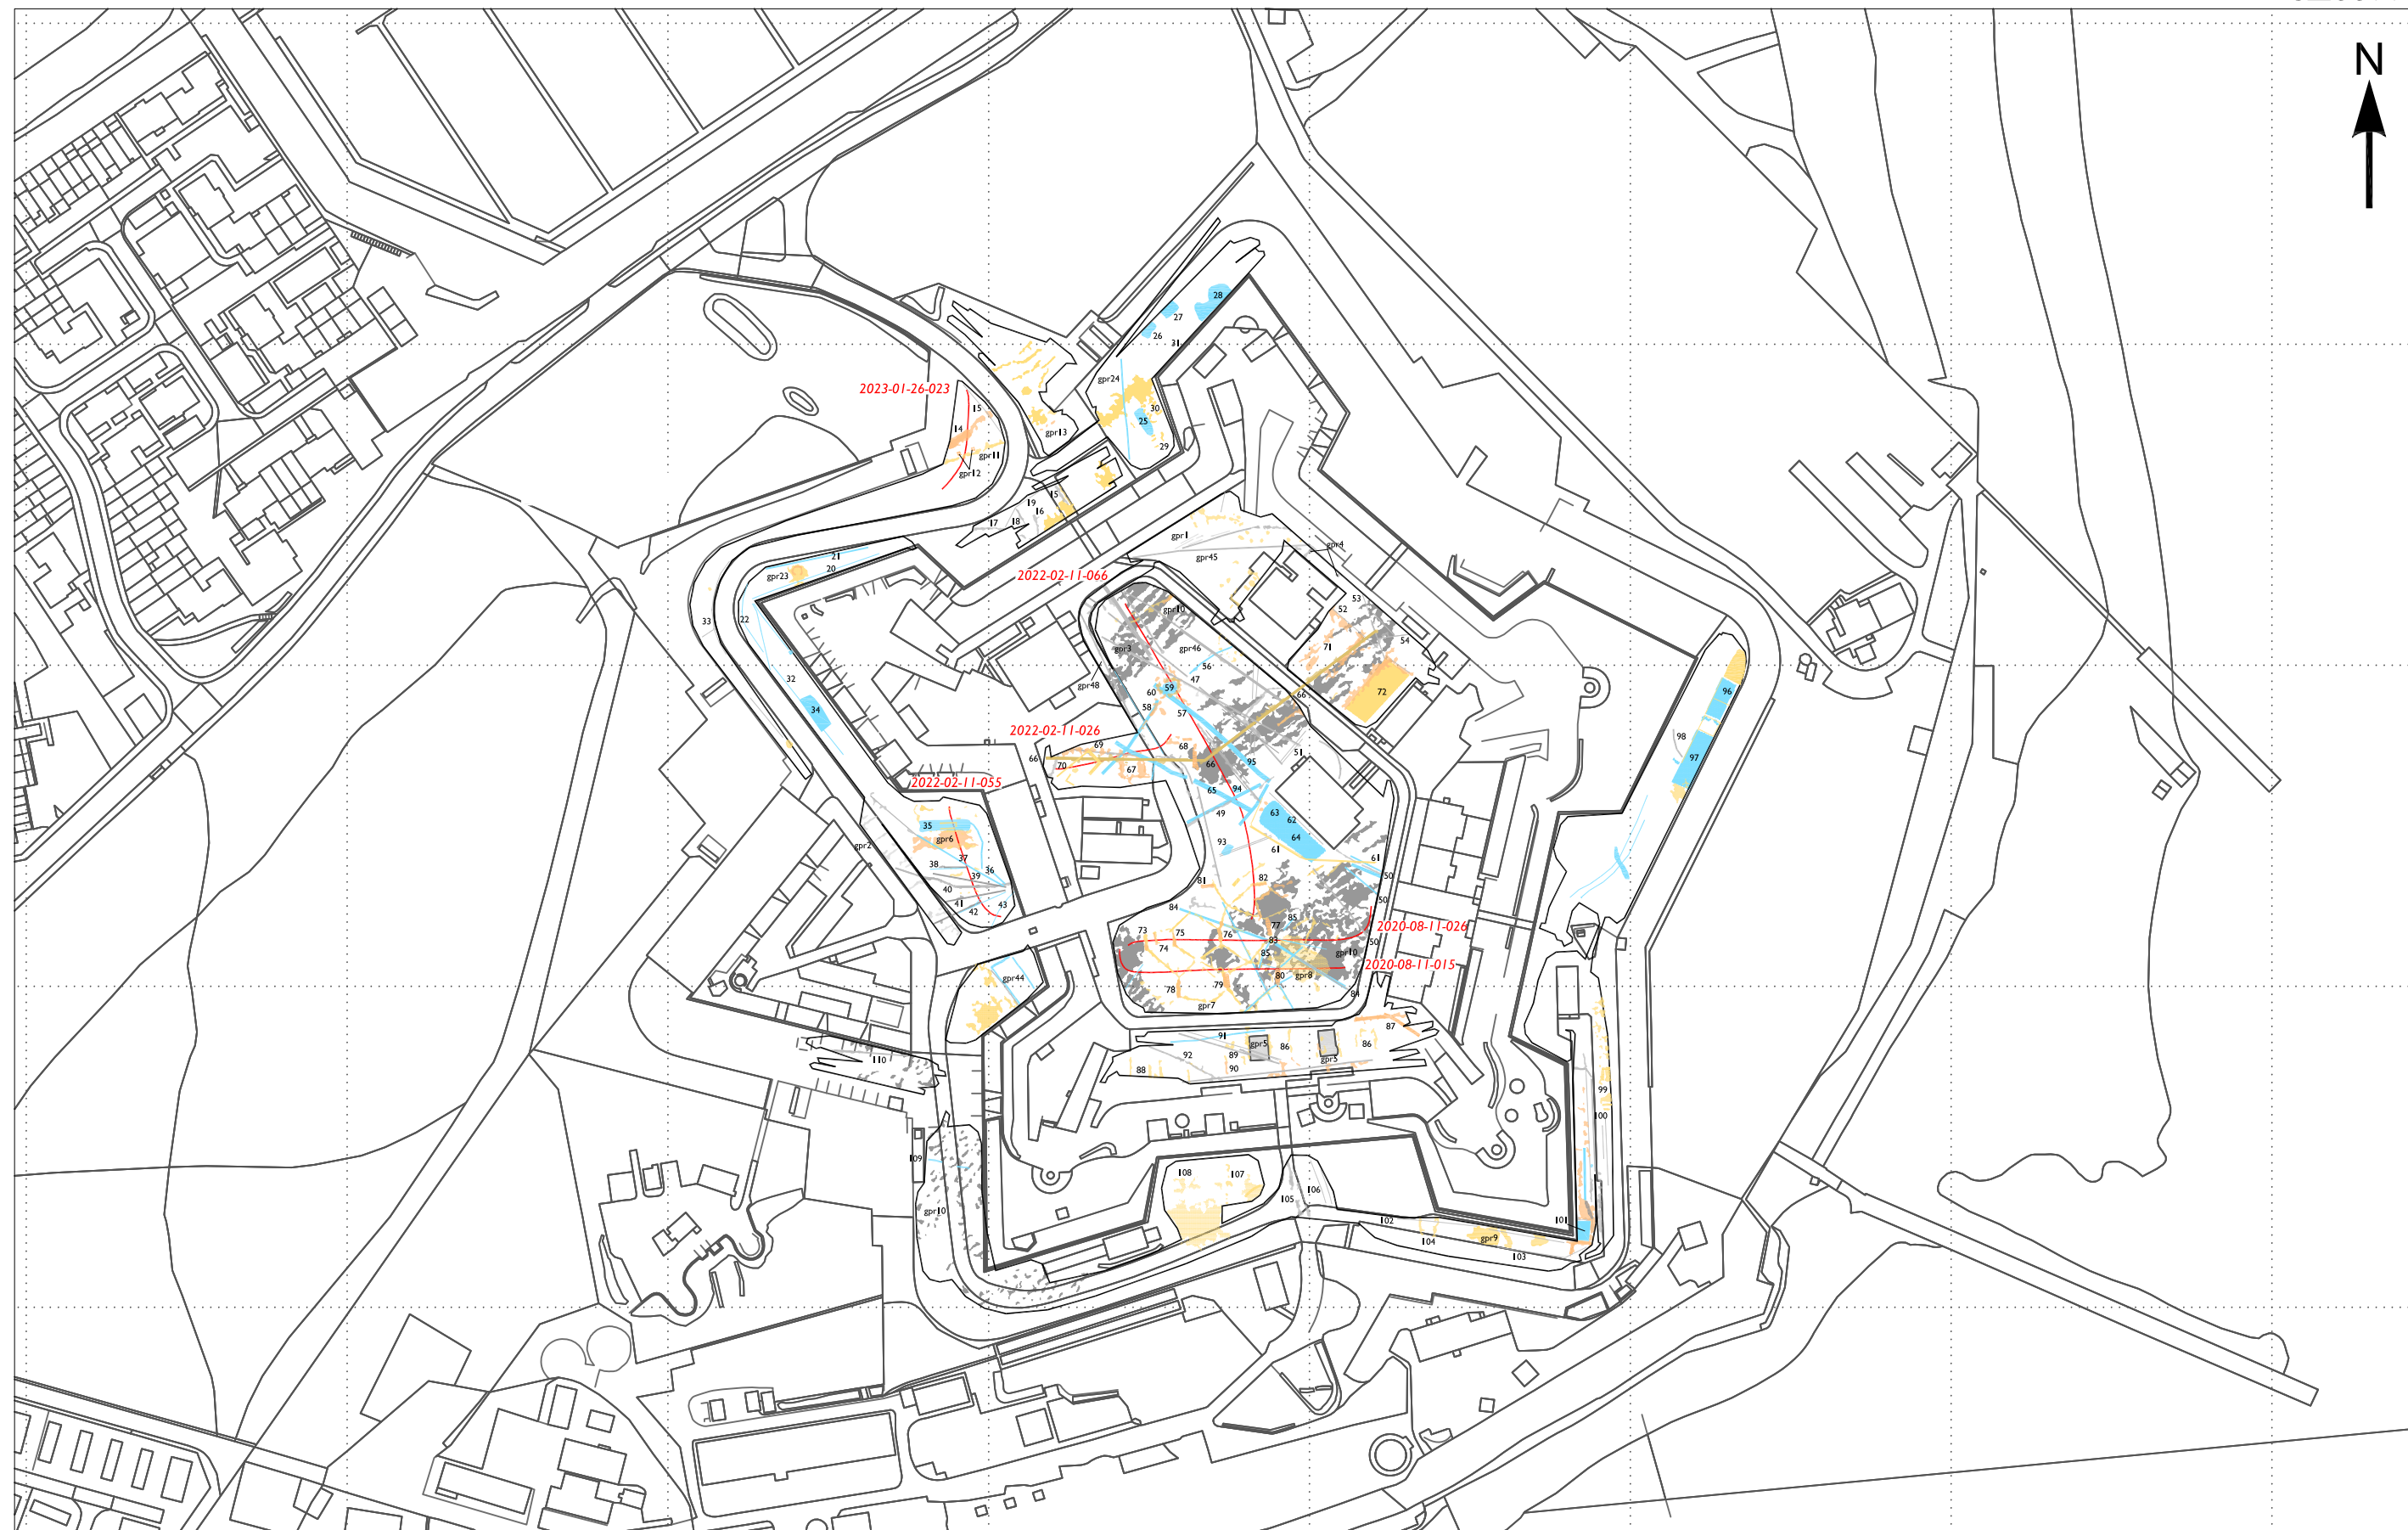
Graphical summary of significant GPR anomalies, May 2017 to May 2023

- low amplitude reflectors
- high amplitude reflectors
- anomalies of known or recent origin

Due to the size of the resultant data set a semi-automated algorithm has been employed to extract the vector outline of significant anomalies shown on Figure 11. The algorithm uses edge detection to identify bounded regions followed by a morphological classification based on the size and shape of the extracted anomalies. For example, the location of possible pits is made by selecting small, sub circular anomalies from the data set (Linford and Linford 2017).

A graphical summary of the significant GPR anomalies, [gpr1-110] discussed in the following text, superimposed on the base OS map data, is provided in Figure 11.

The very near-surface data shows responses to visible surface features including vehicle tracks to the works compound [gpr1] immediately to the north of the garage cookhouse block, concrete expansion joints [gpr2] in the access road by the Ravelin shed, compacted foot paths across the parade ground [gpr3], ferrous service inspection covers for example at [gpr4] and extant concrete building platforms [gpr5]. More significant anomalies show the outline of former huts, for example at [gpr6], and a curious network of polygonal high amplitude responses [gpr7], both also visible from aerial photography (Google Earth image labelled April 2022 accessed October 2023). Some amorphous areas of high-amplitude response are also found at [gpr8], in the vicinity of [gpr7], and along the southern branch of the dry moat at [gpr9].

- Figure 11: Graphical summary of significant GPR anomalies superimposed over the base OS mapping (1:2000).
