Helmsley Castle, Helmsley, North Yorkshire

Report on Geophysical Survey, June 2023

Megan Clements and Neil Linford

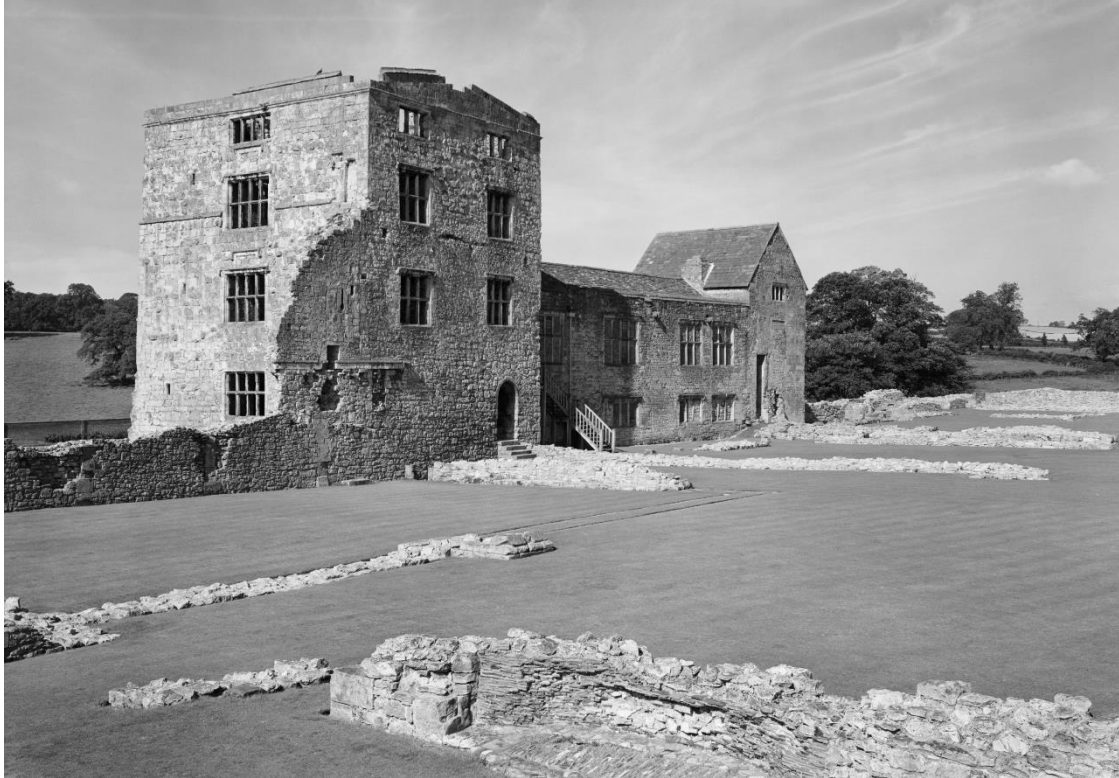
Plate 1: photo looking towards the Hall and the West Range from the Kitchen Range. The outer wall and MoW concrete marker [gpr9] is evident in the centre of the photo (Source: Historic England Archive 1970).

the location of graves. A high-amplitude anomaly [gpr9] bisects [gpr7] and is visible in the data between 15.0 and 30.0ns (0.84 to 1.85m). The course of [gpr9] follows the Ministry of Works (MoW) concrete surface marker indicating the location of the outer wall of the late 13th to early 14th century Hall.

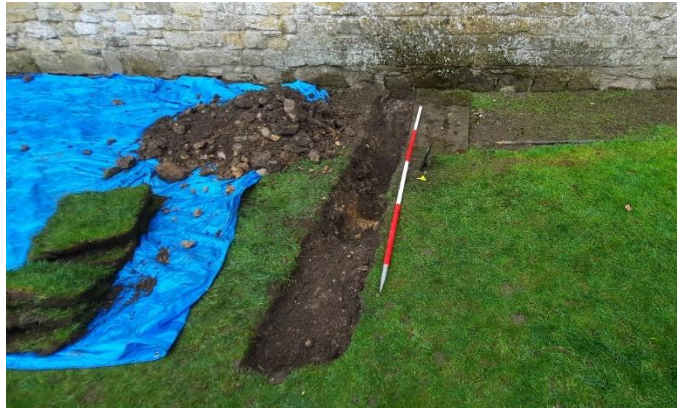
Plate 2: exploratory excavation trench in the vicinity of [gpr67] facing south-west towards the West Range Chamber Block with the grooved paving stone to the immediate right of the ranging rod receiving discharge from water chute S1 above (Source: Historic Property Restoration Ltd 2022).

The water chute to the north, S2, is associated with a less well-defined high-amplitude anomaly [gpr69] and a smaller low-amplitude response [gpr70]. It is possible that [gpr67] and [gpr68] represent a response to the underlying hardcore supporting the perforated drain and were constructed to remove water away from the West Range while avoiding surviving masonry remains shown in the photograph of the site Figure 14(A). Photographs showing limited invasive investigation conducted in March 2022 suggest the trial trench did not, necessarily, extend over the location and depth of the relevant anomalies (Plate 2).

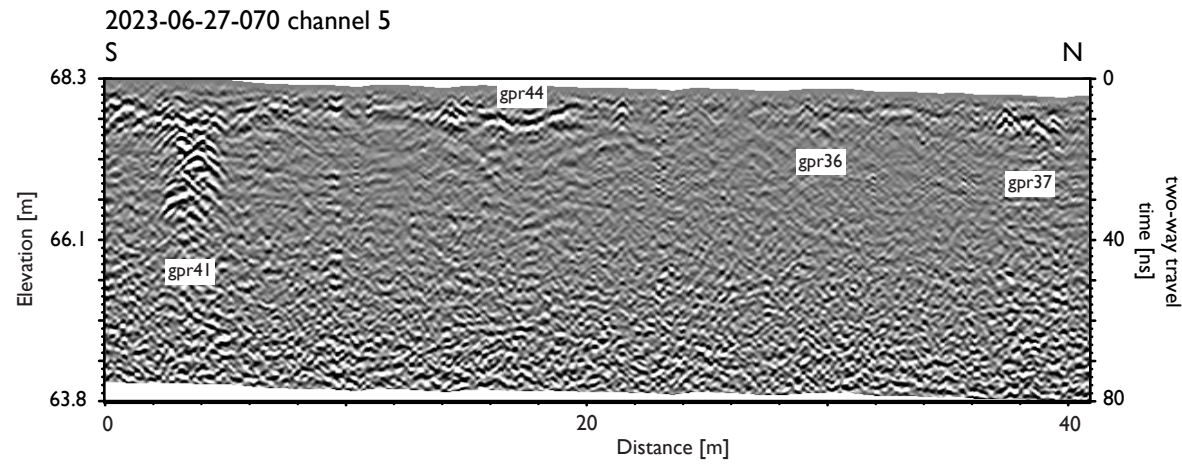
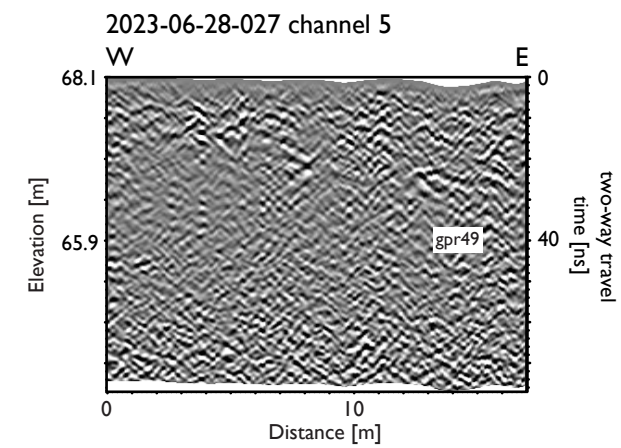
Representative topographically corrected GPR profiles, July 2023

- Figure 3: GPR amplitude time slice between 27.5 and 30.0ns (1.57 to 1.71m) and location of selected GPR profiles shown on Figure 4 (1:750).
- Figure 4: Representative topographically corrected profiles from the GPR survey shown as greyscale images with annotation denoting significant anomalies. The location of the selected profiles can be found on Figures 2, 3 and 12.

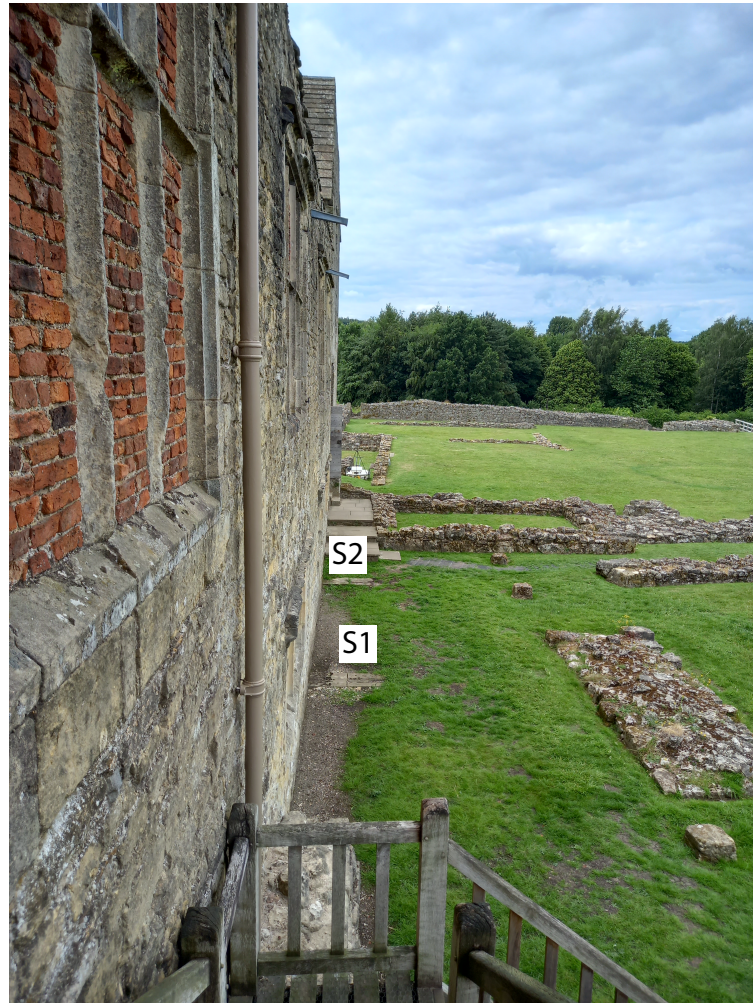
(A) West Range facing north showing location of water chutes

Figure 14 shows a detail of the site in the vicinity of the West Range Chamber Block, including an extract from the plan view of the proposed soakaways drawn in May 1988 scaled with the OS mapping data (Fenton 1988). The presumed location of the two soakaways are shown as grey hachured boxes on the graphical summary of significant GPR anomalies (Figure 14(B)).

There are significant anomalies associated with both water chutes from the roof (marked S1 and S2 on Figures 14(A) and 14(B)) at the approximate location and expected depth of the soakaways proposed on the design plan. However, the anomalies do not appear to match the dimensions or orientation of the proposed soakaways. To the south, a mixed amplitude anomaly [gpr67] heads due east from the West Range from a depth of approximately 0.6m with an adjacent low-amplitude response [gpr68] immediately to the north-west.

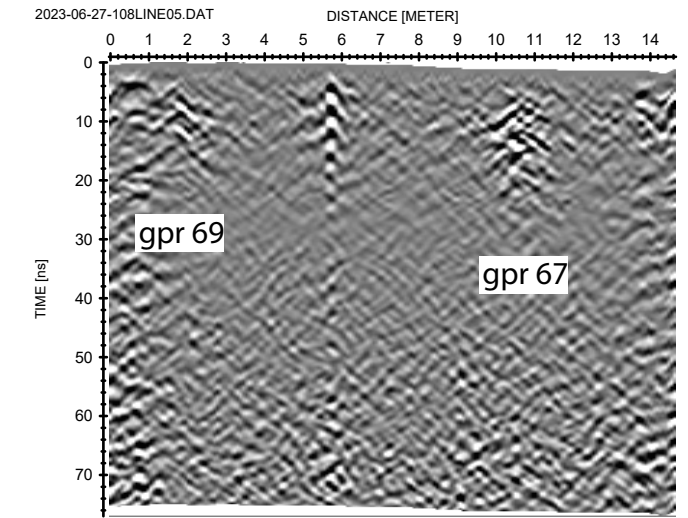
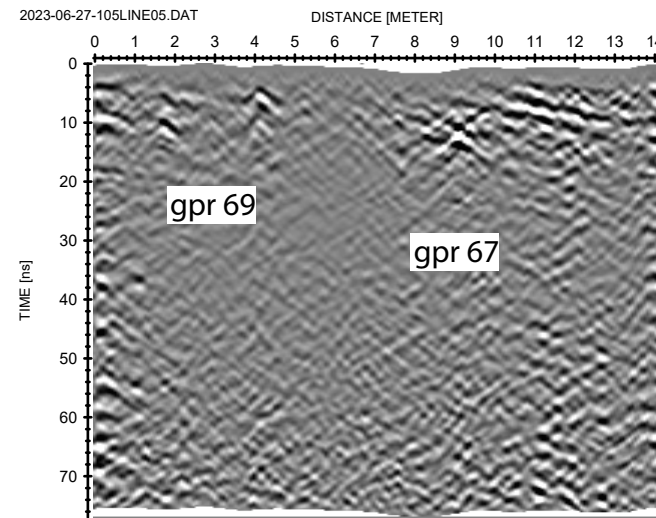
Figure 14

West Range soakaway GPR profiles, June 2023

(B) Graphical summary of significant GPR anomalies
