Archaeological Investigation
Archaeological Projects

WREST PARK, BEDFORDSHIRE

Analytical earthwork survey in the southwest quarter and evaluation trenches in the Mithraic Glade, Duke's Square, and Lady Duchess Square, November 2019

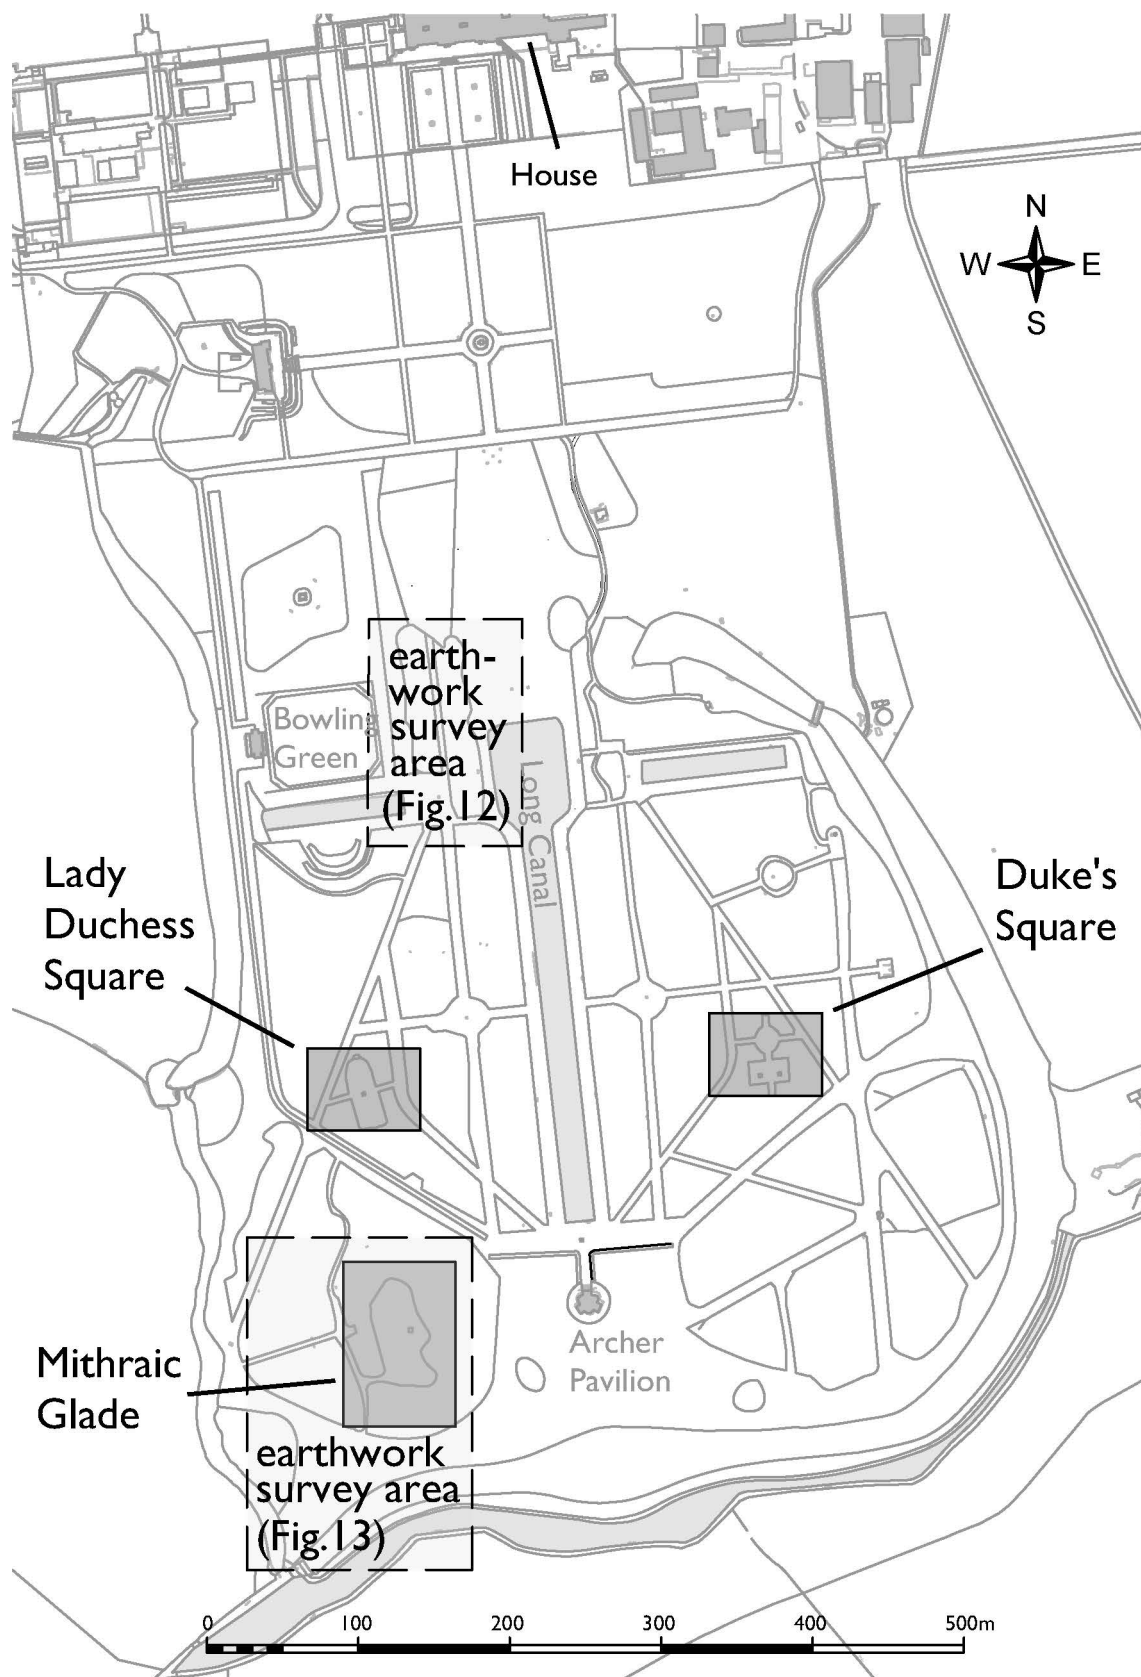
Fig 1: Plan of gardens showing areas of earthwork survey and areas targeted for excavation trenches.
(Base map © Crown Copyright and database rights 2019. OS 100024900.)

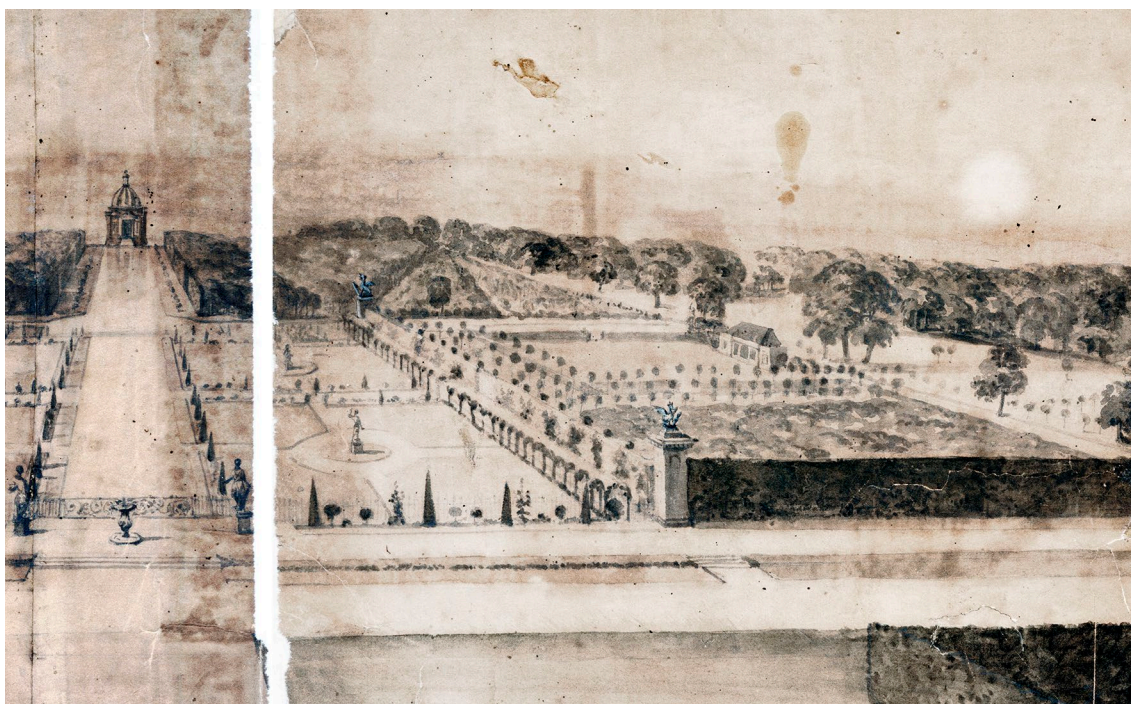
Fig 4: Detail of the early 1720s Angelis view of the gardens from the north (Bedfordshire Archive L33/128A © Historic England Archive e850345/7/8)

The Angelis' view of the gardens from the north, from the early 1720s (Figure 4), shows the survey area much as on the Laurence map but in little detail. The west garden wall was substantial with large piers at either end surmounted by statues of griffins but the south side of the garden appears to be open; it may have been so in 1719 though this is unclear. In the south-west corner the rectangular block of planting noted above can be seen, with a north/south path somewhat to the east of centre; based upon alignments with known features, this path probably lay to the immediate east of the survey area. The Bowling Green is also shown (with Bowling Green House for the first time) with four rows of small, relatively well spaced trees to its east.

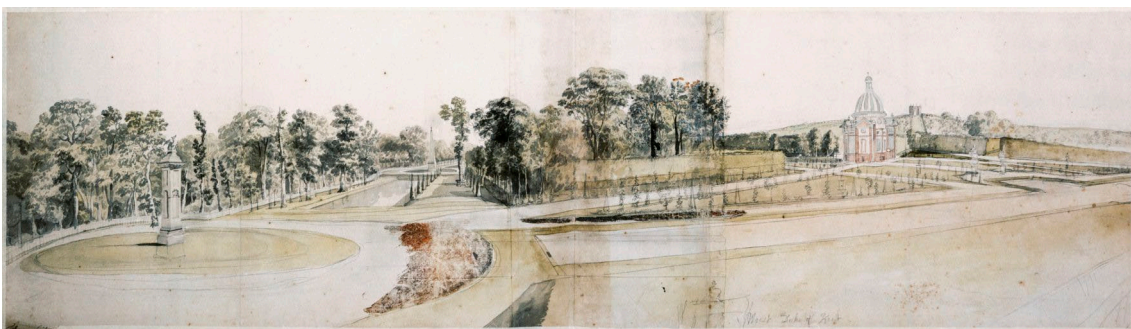
Fig 10: Tillemans' sketch from the southwest circle looking north along a now-infilled canal (© Historic England Archive, e850328)

In contrast, several sketches of the area were produced by Tillemans in the late 1720s, which show the south of the gardens in some detail. One from the very south-west (Figure 10), shows that the south-west of the garden was dominated by a roundel formed by a circular path with a central obelisk. A path ran from this to the Archer Pavilion on approximately the same line as the avenue depicted by Laurence, but probably slightly to the north. There was no sign of the small north/south watercourse or the narrow north-east/south-west channel both of which must have been filled in apparently replaced by formal canals which ran away to the north and east with paths alongside. Much of the associated planting appears recent, though the area of the Mithraic Glade was occupied by a block of well-established woodland enclosed by a mature hedge.

The 1735 Rocque map (Figure 5) depicts the roundel, avenue to the pavilion and eastern canal shown on the Tillemans sketch. It makes it clear that the roundel was in the south-west of the surveyed area and that the canal ran on the same line as the straighter, approximately east/west section of the water to the south-east of the survey area and this continued straight a little further westwards than the point at which the current water curves to the south-west. To the north however, the northern canal and associated paths, had been removed, and the gardens had expanded westwards into the parkland as far as a broad sinuous waterway, the north end of which was on much the same line as the present Serpentine Water, though to the south it ran further to the west. The woodland to the east appears fairly uniform with some straight paths on various intersecting lines, some of which appear to be gravel, notably that around the roundel and to the pavilion, but most were probably grassed. There was no sign of the Mithraic Glade, but a small feature would appear to be in approximately the same location as Hutton's Monument. The monument bears an inscription stating that it was erected by Henry, Duke of Kent, to his friend Thomas Hutton, and as Henry died in 1740 it is likely this is the same feature. The 1737 Rocque map (Figure 6) shows the same basic plan but in the area of the Mithraic Glade the straight paths have been replaced by sinuous paths, apparently gravelled. The feature thought to be Hutton's Monument is not shown and one of the new paths starts in the same location so perhaps this wasn't the monument or perhaps some elements of the map were planned but never executed. The Root House, altar and glade are all thought to have been the creation of Jemima, Marchioness Grey, in 1748 (Alexander et al 2013, 71) and consequently are not shown on the Rocque maps.

In the north-east of this area, a slightly irregular, but generally straight scarp [51] was surveyed within dense vegetation defining the glade. This appears to continue to the north-east but could not be surveyed within increasingly dense growth. To the south-west it merges with the outer scarp of the ditch associated with platform [49] which curves away to the west. A low flat-topped bank [52] appears to continue the alignment of the straight section of [51] but is on a slightly different line. This overlies another scarp to the south-west [53] that may more closely match the alignment of [51], but this is uncertain; in both cases the discrepancy is minor. A further scarp [54] appears to continue this alignment and a smaller scarp [54a] beyond this is also on approximately the same line. It appears likely that scarps [51], [53], and [54] represent a single linear feature ([54a] less certainly so), at least 90m long, and that bank [52] is later, though very similarly aligned. From an examination of the mapping it seems likely that the earlier scarps mark the edge of a path/ride shown on the 1730s Rocque maps (Figures 5 and 6), as well as the 1720s Tillemans view (Figure 10). The date of [52] is uncertain but

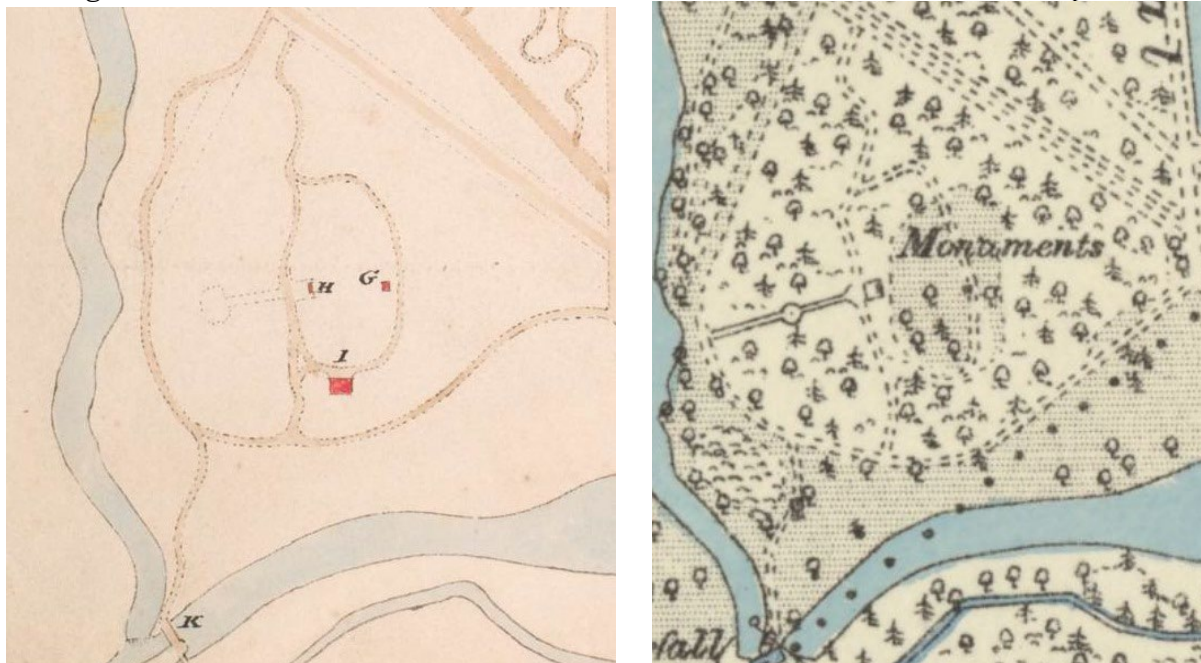
Fig 11: Excerpts from 1831 plan (left) showing Root House (I) and Altar (G), (© Historic England DP110018), and 1881/1887 OS map (right) (National Library of Scotland, CC-BY-NC-SA)

Late 19th- and early 20th-century OS maps show the layout much as on the 1831 album map, though more accurately. By the time of the first edition 6 inch and 25 inch to the mile maps (surveyed 1881, published 1887) the Root House had been demolished. It is clear that the path to the west of the glade is on the line of the existing path as is the path running west from this. The path around the south and east sides of the glade is also shown but to the north it does not run on the same line as the modern path, initially running to its west, following its course for a short distance but continuing directly west to meet the other path rather than curving to the north. To the south and south-west, the survey area is generally shown as featureless apart from the path curving around the edge of the woodland first shown on the early 19th century enclosure maps, though a path from this to the far south-west corner of the grounds, as seen in 1831, is shown curving east around the small isolated block of woodland on the first edition maps.

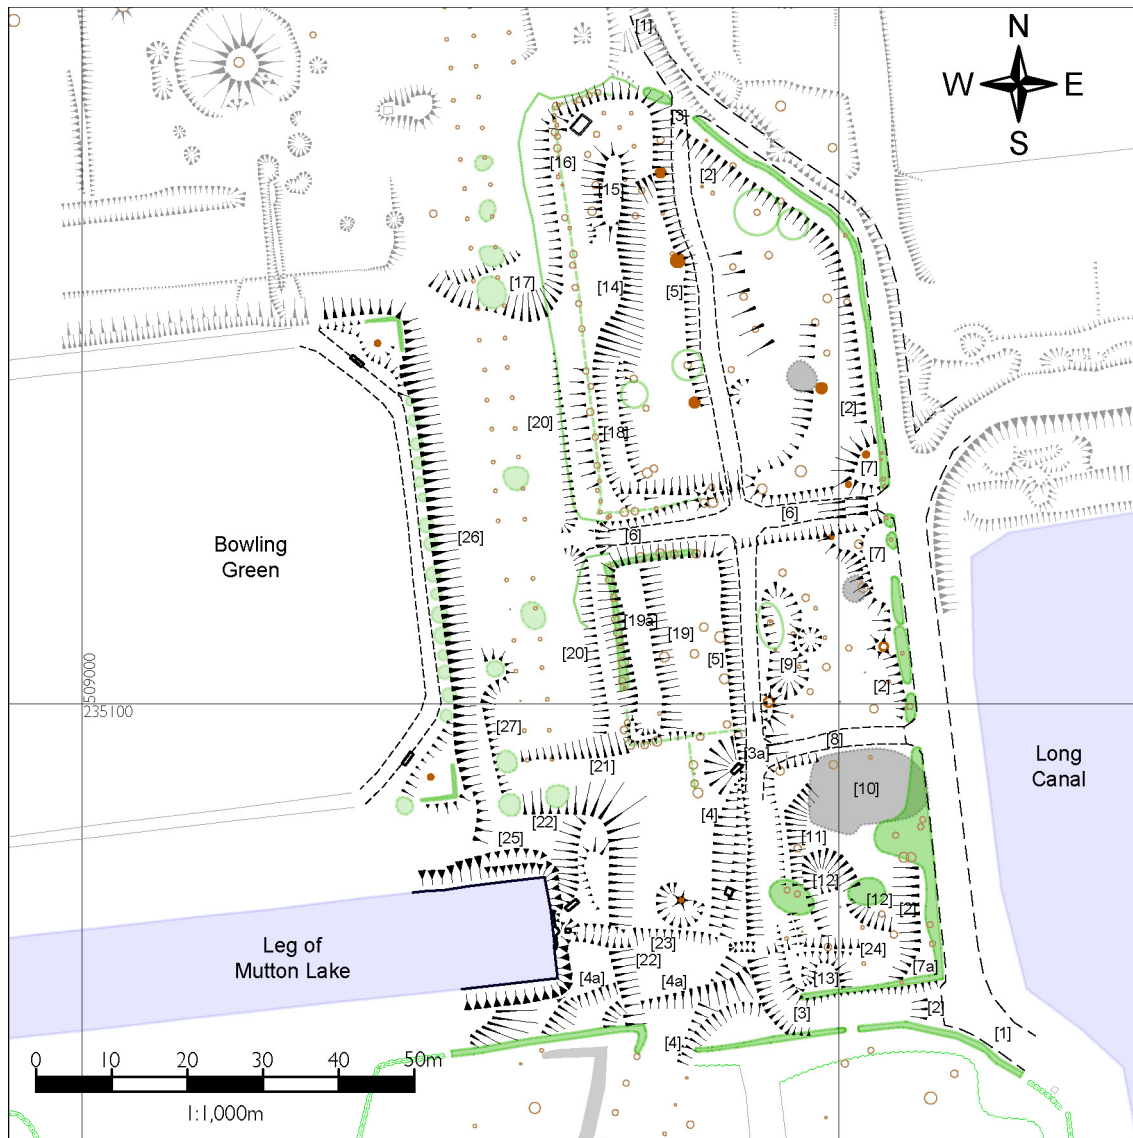
Fig 12: Earthwork Survey of the western Yew Quarter, 1:1000 at A4

As noted above, scarp [5] curves to the west to run to the north of this area and then turns south to run along the west side of the quarter [16], where it appears to be related to the grown-out yew hedge along this side of the quarter. The area to the north and west of mound [15] is slightly higher than that immediately outside the quarter, possibly related to the insertion of a service of some sort in the north-west corner of the quadrant.

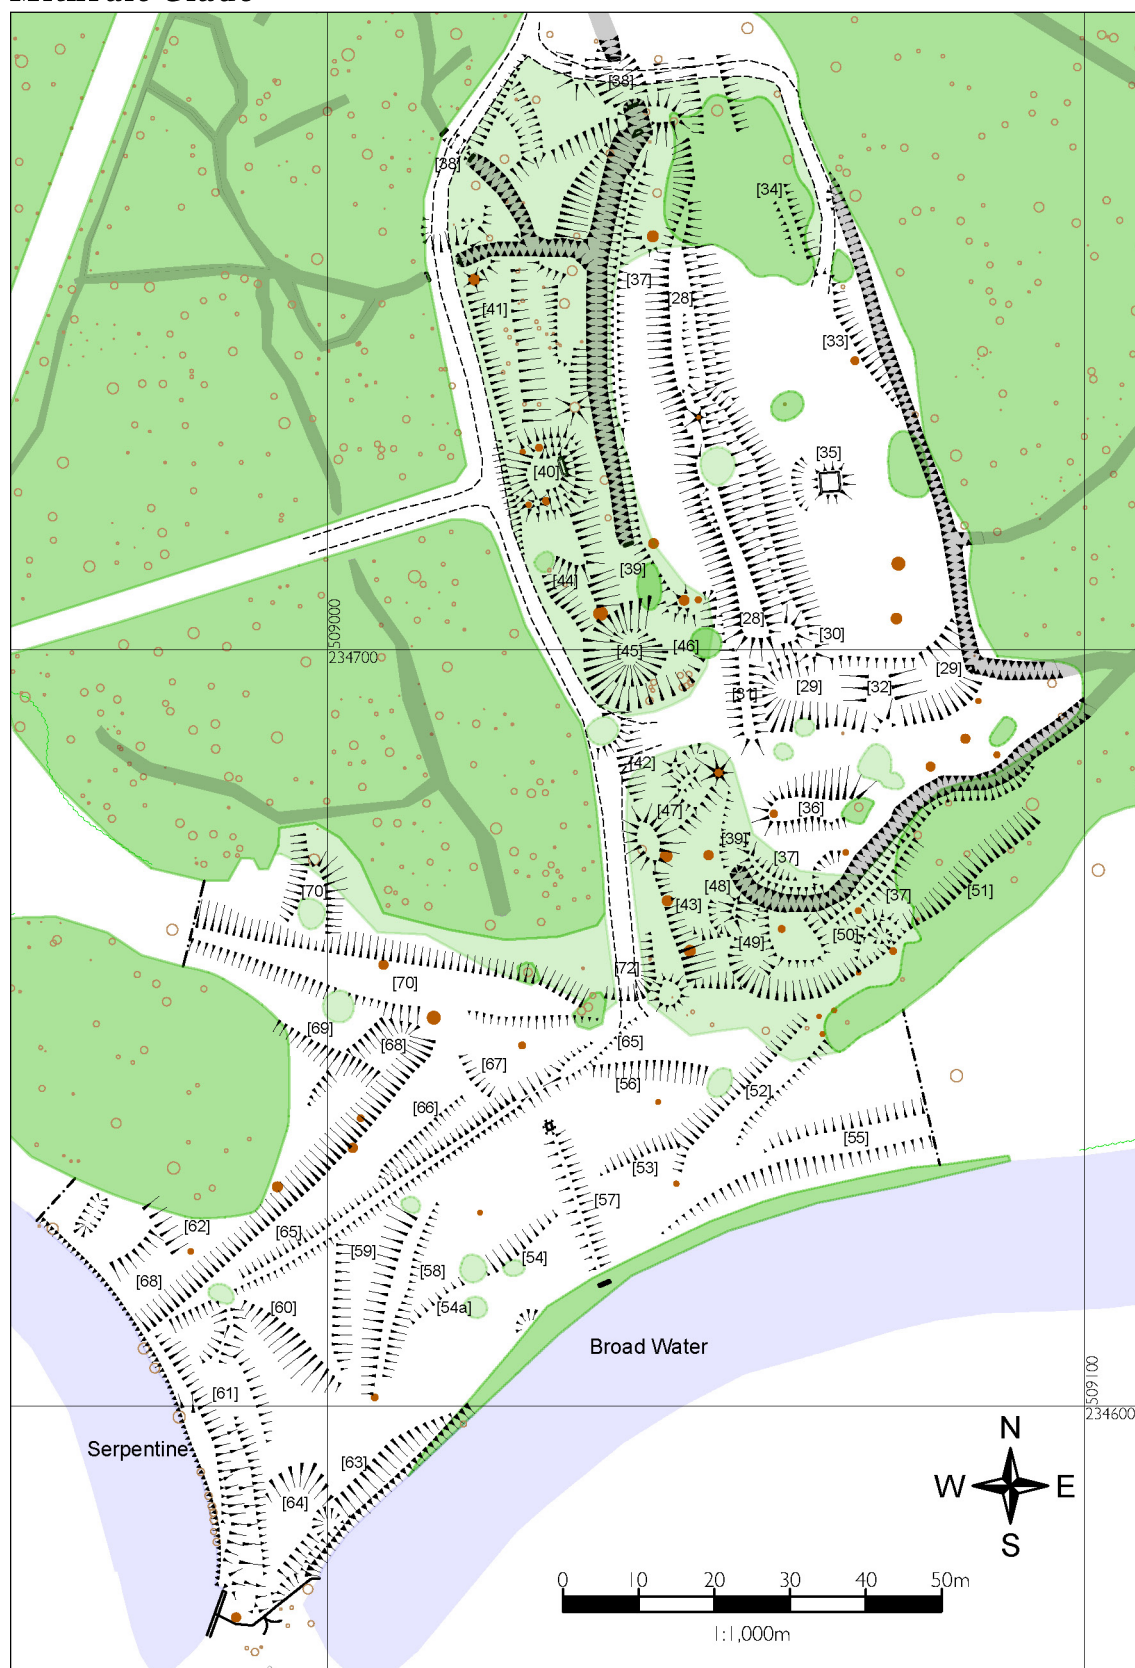
Fig 13: Earthwork survey of the Mithraic Glade and area to the south-west, 1:1000 at A4

south to north narrowing slightly as it loses height. Though a tree and a tree throw break up its form somewhat, it is otherwise quite uniform. It has a slightly lobed southern terminus, from which it runs straight to the NNW for a little over 35m, turns to the north for almost 20m and then runs more to the NNE for a further 6m. Its western scarp is relatively short, steep and uniform, which contrasts with the eastern, which is much broader and more broken. The terminus appears to be similar to the western scarp, but several adjacent features make it difficult to be sure and a broad gully to the south and east [29] suggests the ridge could have been truncated somewhat. At its north end the western scarp curves to the NNE before curving back more to the NNW but the eastern scarp peters out to the south of this, with the west scarp running across its line. It is unclear if the ridge has been truncated by a separate feature that merges with it or if it simply loses form as the ground level rises slightly towards the path. The latter is perhaps more likely.

South of this is a sub-circular hollow [45], set within a second broader, shallower, flat bottomed hollow [46]. The former appears to be secondary to the latter and may have been a tree throw, its larger than average size perhaps due to soft ground. The original shape of hollow [46] is unclear due in part to tree growth to the north-east but its west side is steeper and aligns with scarps [41]-[44], so may originally have been associated with the straight ride of the 1730s. Geophysical survey noted a high resistance anomaly to the immediate south and south-east (Linford and Payne 2019, Fig 21, gpr38) so perhaps the south side of the hollow is in fact part of a ramp created to allow easier access into the glade from the ride, perhaps around 1748 when many of the features here were created. An area of recent earthworks to the south [47], comprising several irregular mounds and hollows, prevents the identification of the south side of this possible ramp. The east side of the hollow was difficult to see due to vegetation but could just be a continuation of scarp [39] thought to mark a sub-surface continuation of the drainage ditch to the north, though with the eye of faith it is possible to suggest that perhaps gully [29] originally continued WNW and curved northwards through this area. Overall however, it seems most likely that the apparent hollow is the conflation of several features.

To the north a low ridge [65] runs WSW/ENE for almost 75m across most of the open survey area and is clearly one of the latest features here as it appears to overlie all other features surveyed. A flattened section suggests it was cut by a continuation northwards of the service indicated by [57] and its north end is also low and spread, perhaps by modern traffic associated with scarp [56] as noted above. Ridge [65] also appears to overlie scarps [66] and [67] to its north, but these are isolated features and it is difficult to say

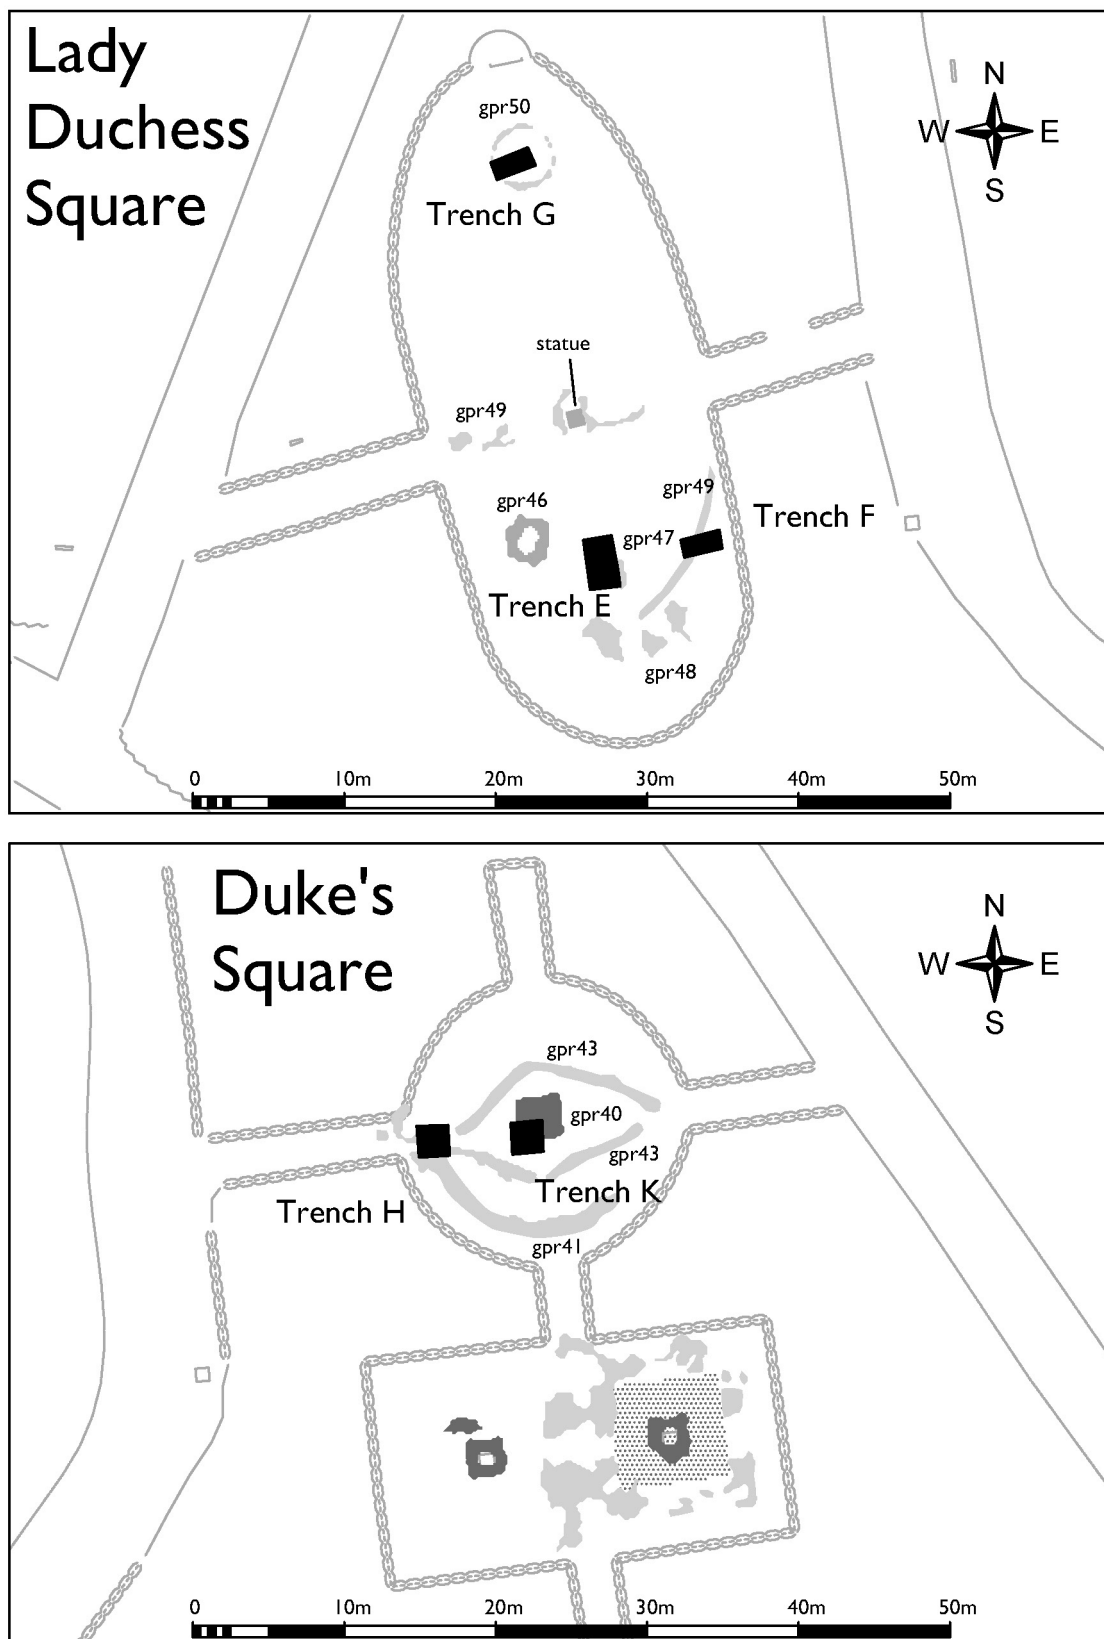
Fig 14: Lady Duchess Square (top) and Duke's Square (bottom) at 1:500 scale, with geophysical anomalies and trench locations. (Base map © Crown Copyright and database rights 2019. OS 100024900.)

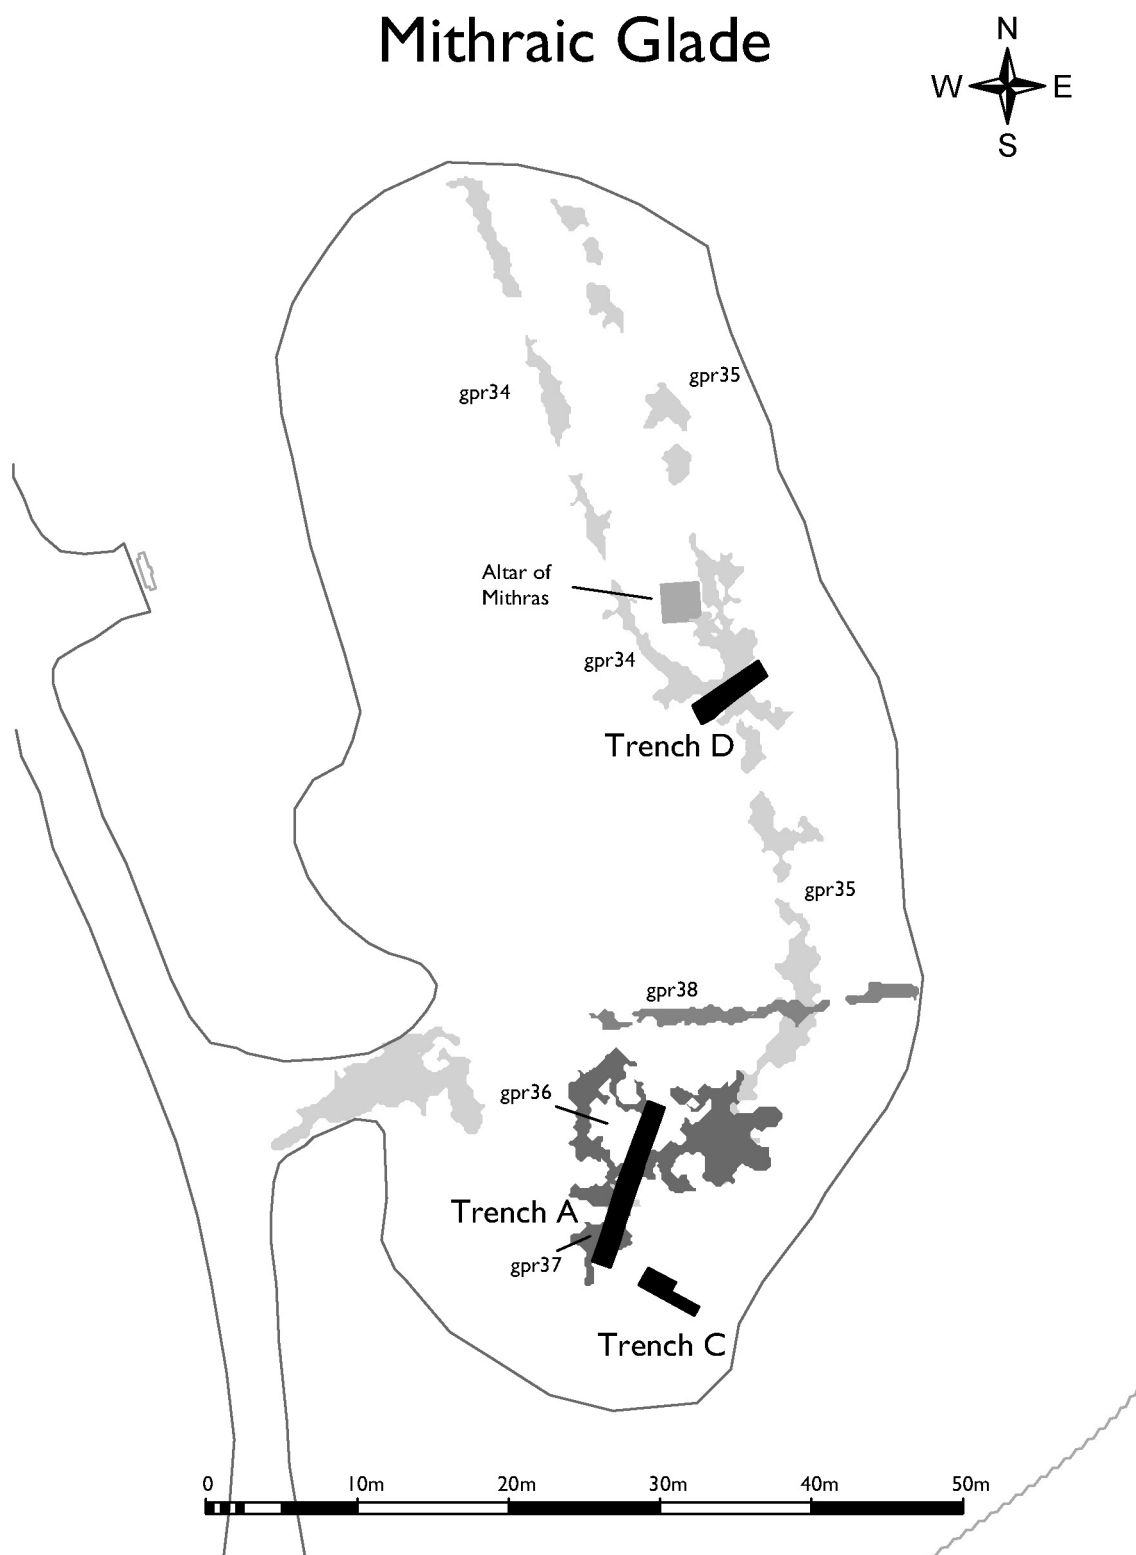
Fig 15: Plan of Mithraic Glade at 1:500 scale, with geophysical anomalies and trench locations. (Base map © Crown Copyright and database rights 2019. OS 100024900.)

Below that at the north end of the trench natural clay was found, ruling out any structure causing the northern anomaly [gpr36]. Cutting across the trench was a thin gravel spread [90104] pressed into the surface of the clay, approximately 1m wide, containing a sheep metatarsal (two fragments, SF3005 and SF30118, with SF3005 having a radiocarbon date, 228 +/-21 BP, or 1773-1815calAD) and a further large mammal longbone fragment (also recovered as SF3005). This gravel also overlaid a deposit of clean orange sand [90113] running south across the central section of the trench, varying in thickness up to 0.10m at its southern extent. This was interpreted as the path seen in early mapping and the 1830s sketches.

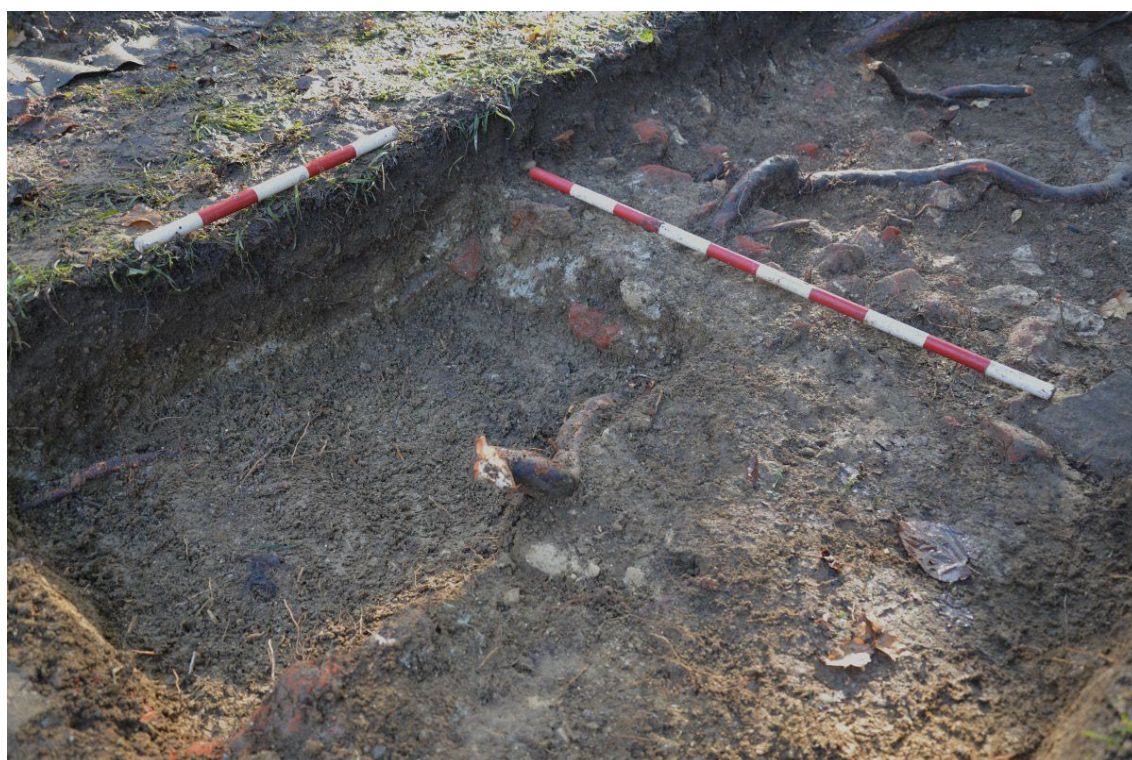
Fig 16: Wall foundation 90105 in Trench A.

It appears that trench A had brick foundations for a structure that then had a sand path running in front, with some gravel added as a separate episode at the edges of the sand path. The rubble at the south between the sand and the structure may tie in with maps that show the building set back from the path with an apron leading to the door.

Confirmation of a building defined by the walls in trenches A & C was a surprise given that a mature yew tree now stands in what must be the centre of the structure, and a more promising GPR shadow was seen at the north end where trenches A & B crossed. Several young yews appear in the 1830s sketches of the root house, with one still standing west of the building as a veteran tree and a second one represented by the stump of a tree throw to the east. Whether the tree in the house was a deliberate planting post-demolition or a self-seeded child of these older trees is a matter of debate, but it must have taken root not long after the building was demolished.

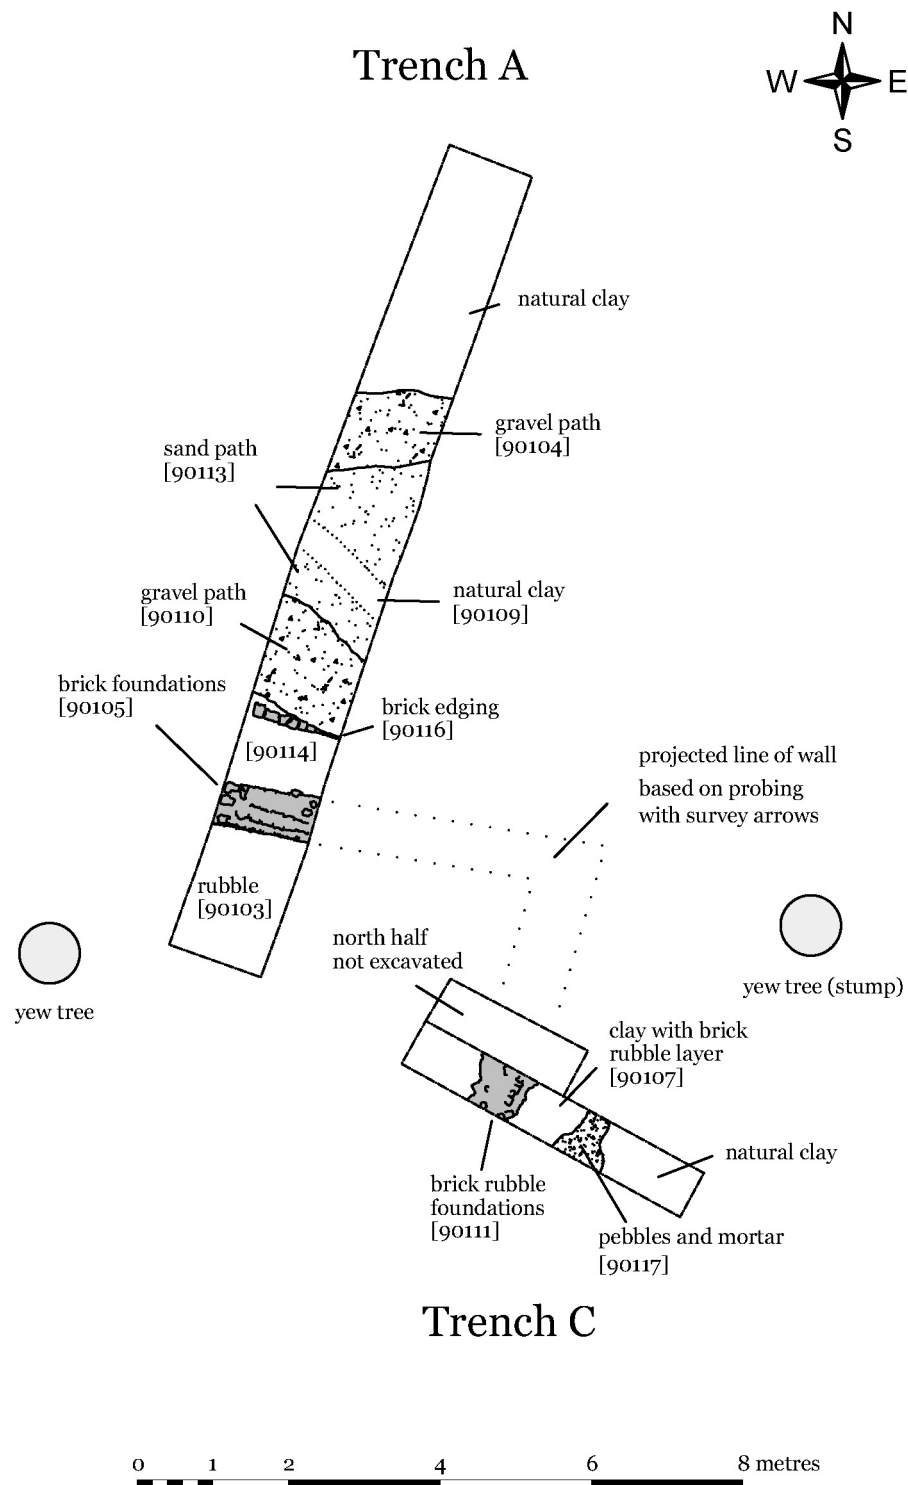
Fig 17: Plan of Trenches A & C at 1:100 scale.

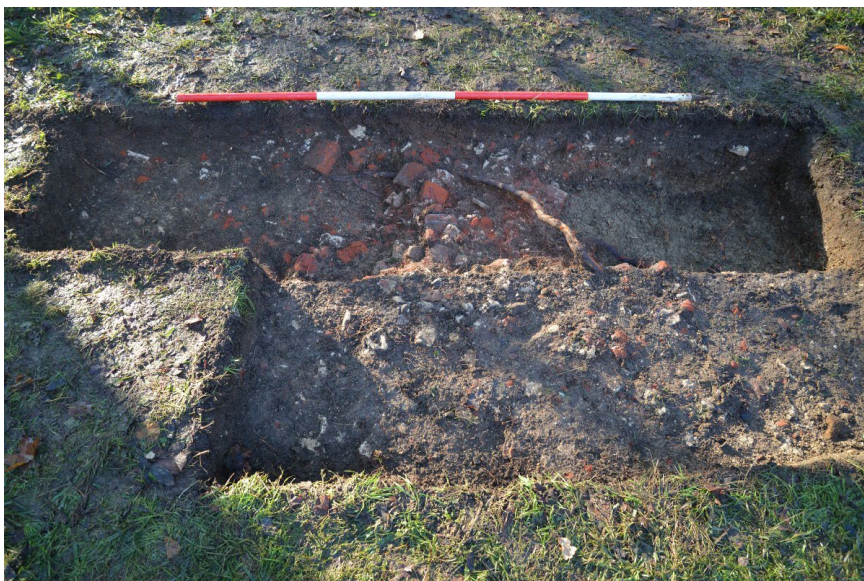
Fig 18: Wall foundation 90111 in Trench C.

Below the topsoil [90101], from which a large iron nail (SF3003), a fragment of glass, a fragment of industrial debris, a pebble (SF30121), a fragment of tile with mortar, and two animal bones including a fallow deer metatarsal (SF30120, radiocarbon date 127 +/-21 BP or 1874-1916calAD) and medium mammal longbone fragment (SF3006) were collected, a thick layer of rubble [90107] was uncovered, containing 11 fragments of glass and a fragment of cream stoneware pottery. It faded out to the west, where it was overlain by a brown silty soil with mortar fragments [90108], from which were collected two fragments of glass. Excavation of the rubble revealed it sealed a brick-rubble linear structure [90111] running north-south, interpreted as a foundation for a wall. The west side of the structure was distinct, but the east face was a jumble of brick and mortar fragments, suggesting at least partial robbing during demolition. West of the wall was a clay layer [90112] that underlay the rubble and filled the lower part of the trench at its west end – from here was collected a cream stoneware base sherd, and 11 fragments of glass – some of which may be as early as 17th century. This came down to natural clay approximately 0.5m below the turf. East of the wall a surface of decayed mortar with pebbles [90117] was found sitting on the natural clay, extending approximately 1.25m from the wall, although the exact distance from the wall is impossible to judge due to the damaged east face. A thick deposit of silty clay [90118] covered the surface [90117] and extended east to the end of the trench, getting thicker as it went. This was possible evidence for landscaping after the building had been demolished. It contained ten fragments of glass, a fragment of brown stoneware pottery (a fragment of probable flowerpot was also found in this context), a single animal bone fragment (SF3008 identified as probably red/fallow deer through ZooMS analysis, Presslee (2023), radiocarbon date 237 +/- 22 BP or 1763-1807calAD), and six pebbles; one pebble with mortar SF30119 from [90117] was also collected – these may all be from a possible floor surface.

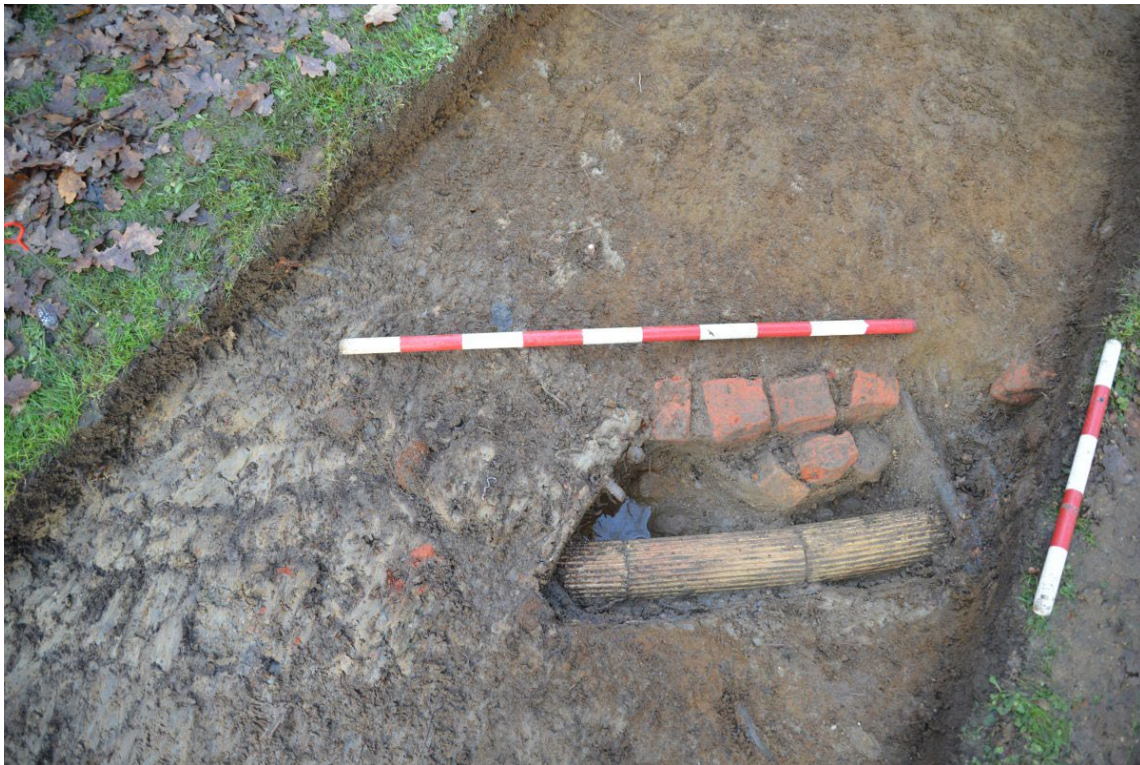
Fig 19: Ceramic land drain and sand path in Trench D.

Placed south of the Mithraic Altar to examine the intersection of two linear features, this trench started with 0.15m of topsoil [90401] that came down onto a layer of clean orange sand [90403] across the east half and natural clay [90404] across the west half. This coincided with the north-south linear anomaly [gpr35] that turned out to be a sandy path with no made edging of any kind. Cutting across the clay and sand running NW-SE was the cut of a pipe trench [90405, gpr34] filled with a mix of clay, gravel, and brick fragments [90402] to aid drainage and a fluted extruded ceramic land-drain pipe [90406] taking water across into the “goose foot” lawn south of the Archer Pavilion. No finds were collected from within Trench D.

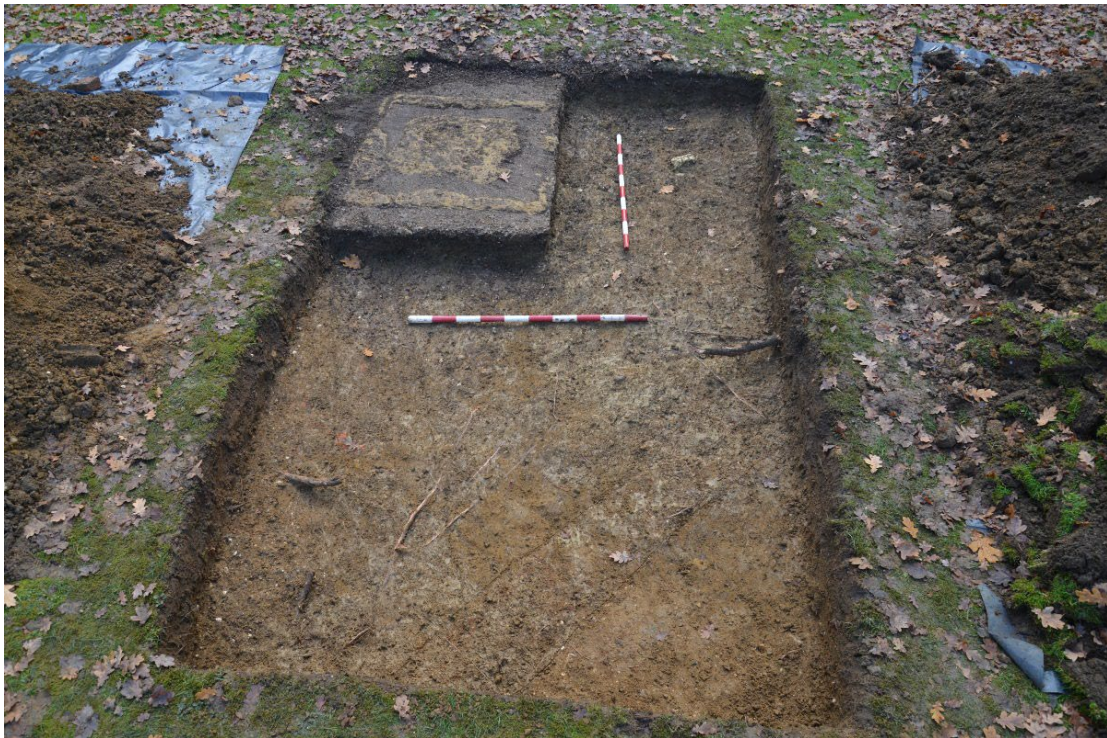
Fig 20: Land drains and concrete base in Trench E.

to reveal a smooth ceramic drain pipe [90512] of likely late 19th/early 20th century origin. 876g of industrial debris was collected from backfill [90506], probably used as packing around the drain pipe.

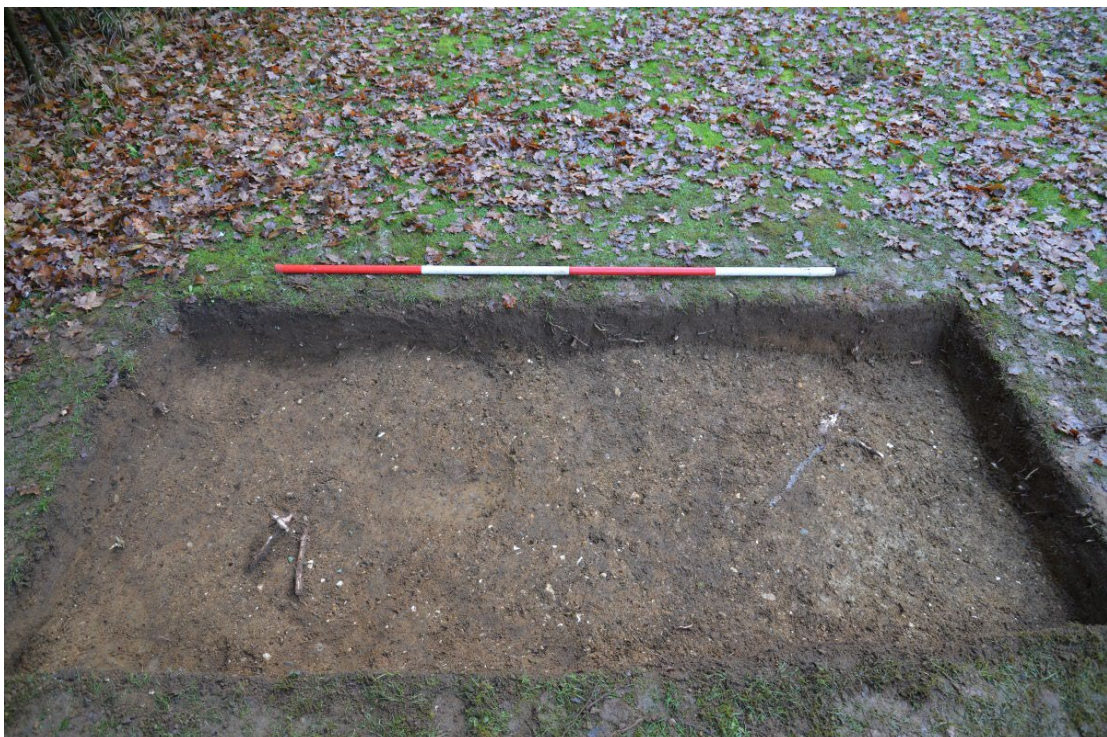
Fig 21: Sand path in Trench F.

This was intended to test the path-like anomaly [gpr49] running down the east side of the Square. Early plans and sketches showed a path around the inside of the perimeter hedging. Below the turf a layer of orange sand [90603] similar to the sand in trenches A, D, G, and H was found, again with no made edging between it and the natural clay. This was clearly a perimeter path. No finds were collected from within Trench F.

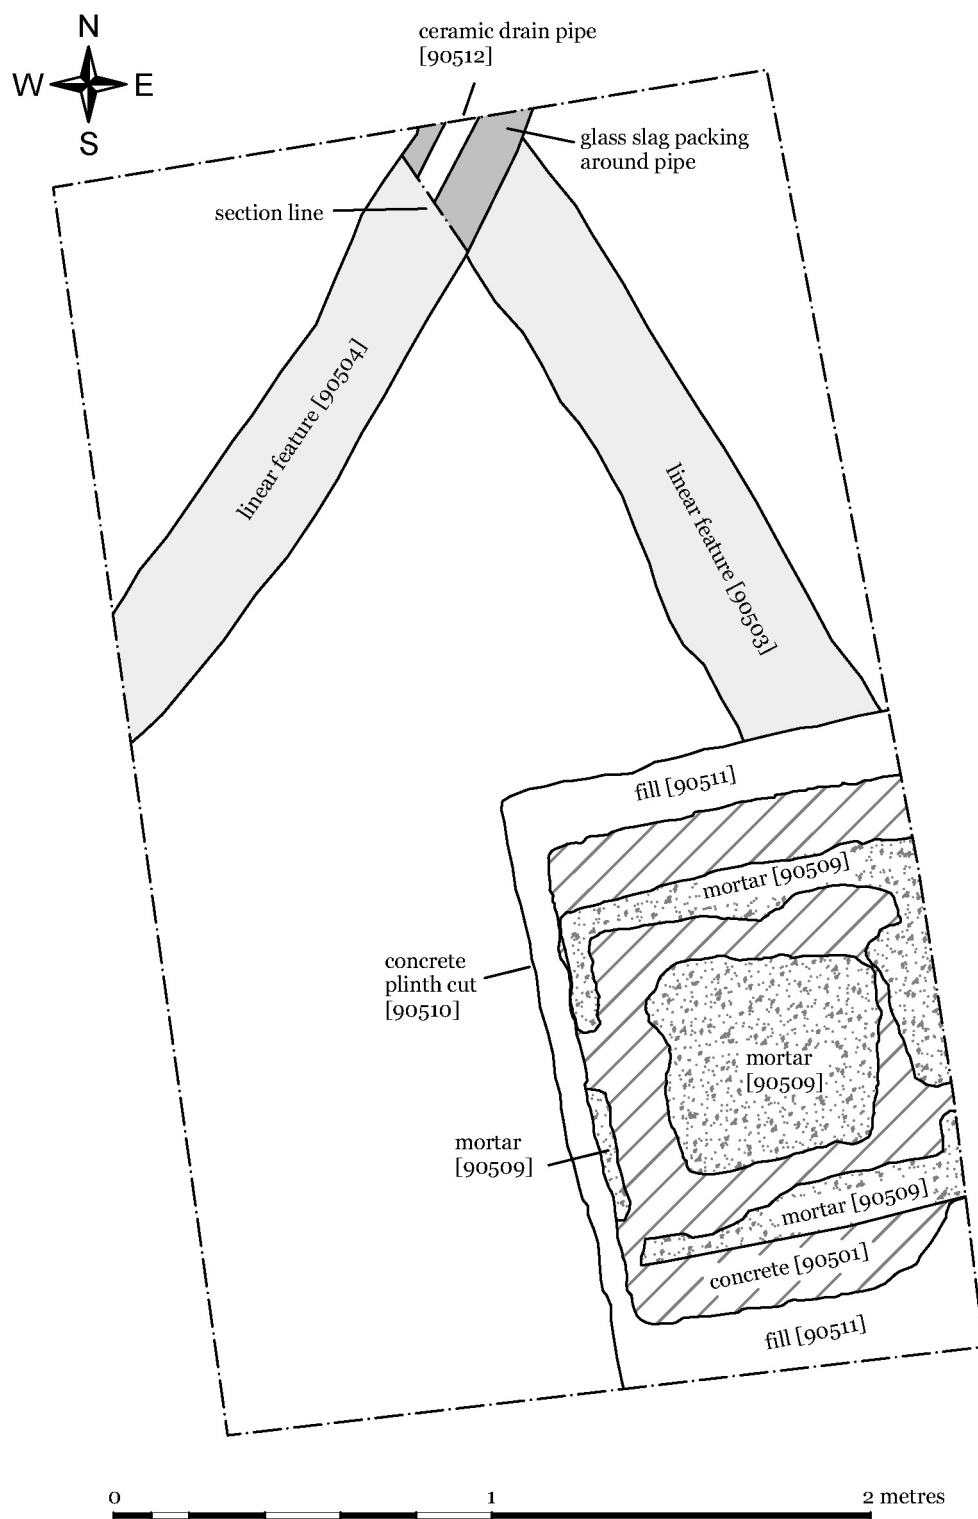
Fig 22: Plan Trench D at 1:20 scale.
