Archaeological Investigation
Archaeological Projects

WREST PARK, BEDFORDSHIRE

Analytical earthwork survey in the southwest quarter and evaluation trenches in the Mithraic Glade, Duke's Square, and Lady Duchess Square, November 2019

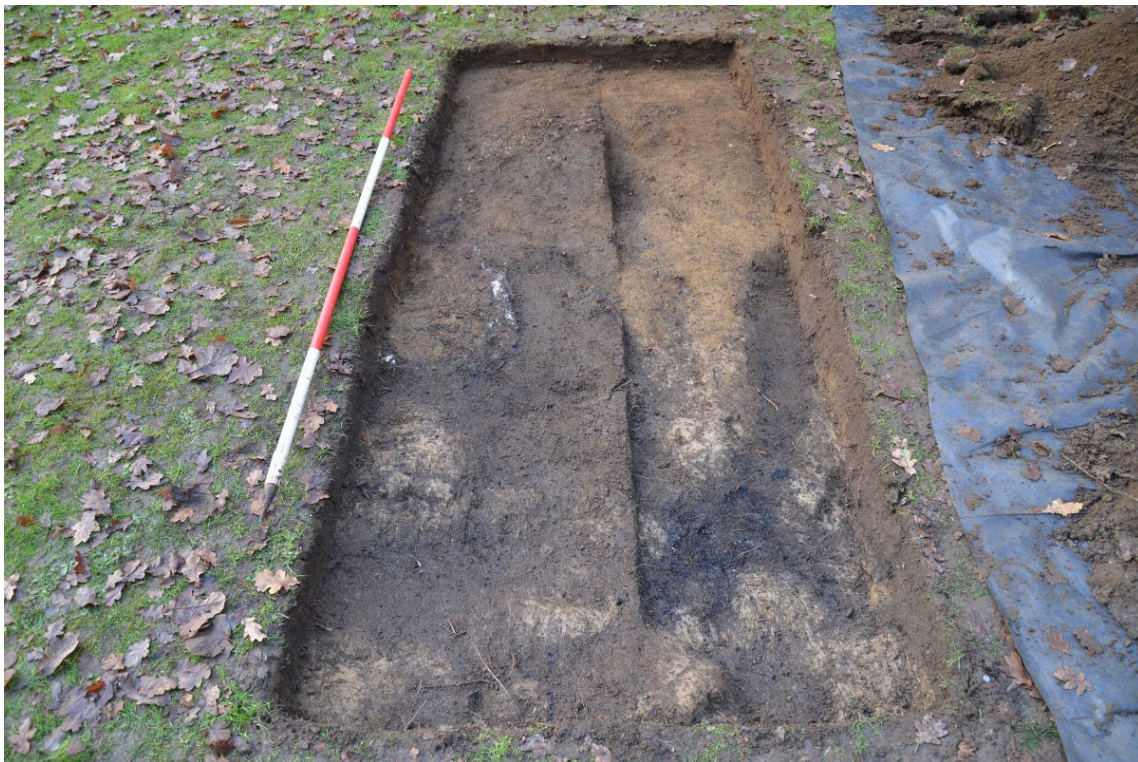
Fig 23: Tree root stains and sand deposit (top) in Trench G.

Anomaly [gpr50] showed as a ring in front of the enclosed curved seat at the north end of the Lady Duchess Square, and this trench was placed to examine it. On arrival it was clear the ring feature was the edge of a circular depression in the lawn, possibly from an old tree throw. Following the line of the anomaly there was a gravel deposit [90706] running across the west end of the trench. The centre of the trench was mottled by irregular linear dark features [90705] interpreted as rotted and decayed tree roots, set in a sandy deposit [90703] that overlay the natural yellow clay. It appears a tree was planted in front of the bench, surrounded by a gravel surface, and then removed presumably after falling over. There were patches of what appeared to be burnt wood within the root features, suggesting the tree stump may have been burned out to facilitate removal. A charcoal sample from within the roots was identified as mature holly (*Ilex aquifolium* L.) No finds were collected from within Trench G.

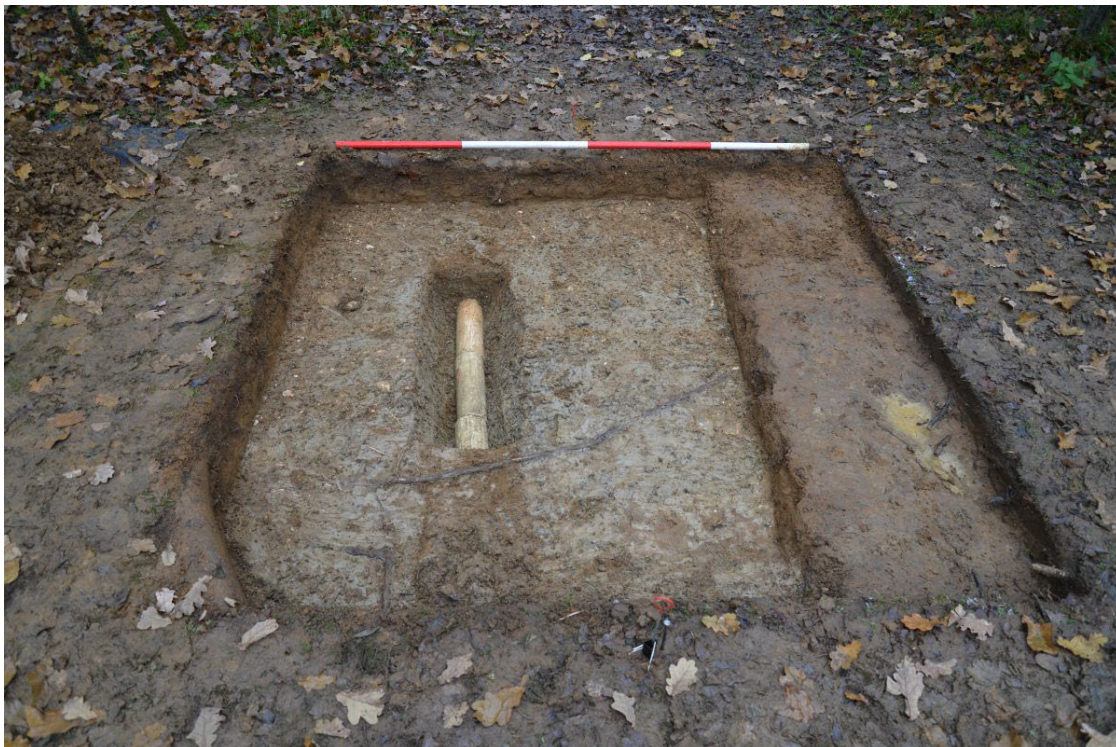
Fig 24: Ceramic land drain in Trench H.

central plinth base [gpr40] in a lozenge shape. Below 0.15m of topsoil [90801], within which was found a single flint, was a layer of orange sand [90802] covering most of the trench, with natural clay exposed at the east side where the sand ran out. There was no edging material to contain the sand despite having a clear edge, implying it was deposited onto the clay in an area already stripped of turf, with the edge of the turf removal forming a boundary. This was interpreted as the circular perimeter path seen in 1830s sketches of the Square. Cutting through the clay, and running under the sand, was a linear clay-filled [90803] cut feature [90806] containing a land drain [90805] made of segments of ceramic pipe. 1265g of industrial debris was collected from [90803], probably used as packing around the drain pipe. Below the sand, and cut by the drain, was a thin layer of gravel [90804] pressed into the natural clay – this was interpreted as an earlier path material.

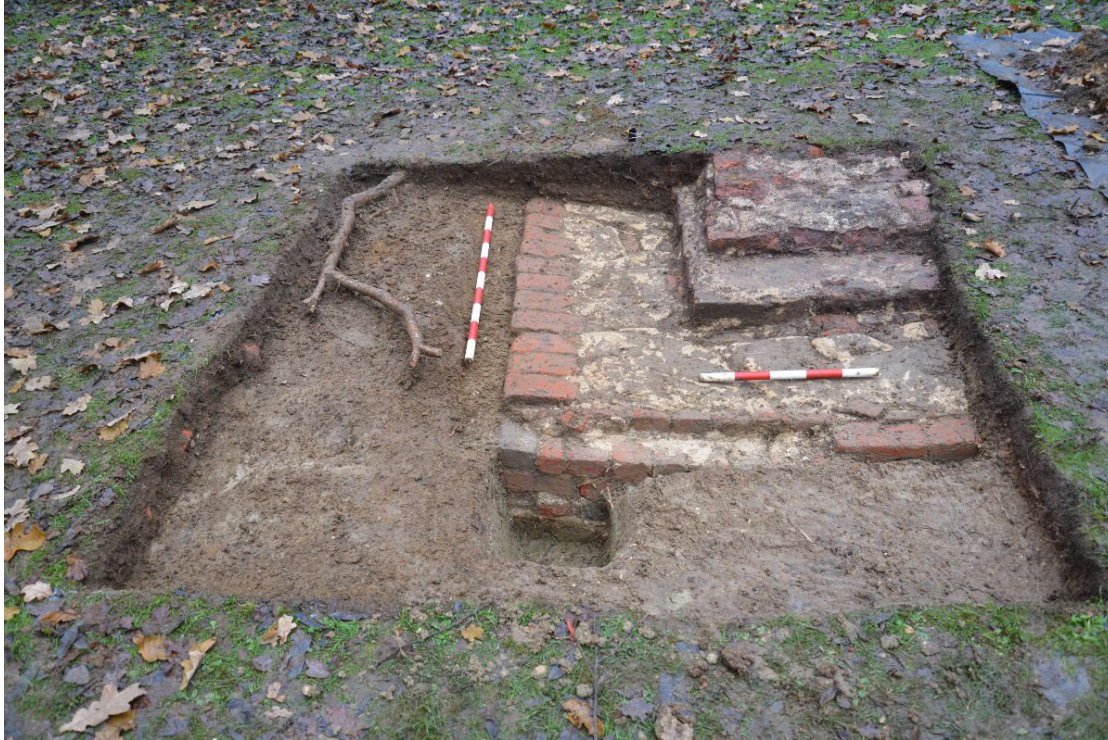
Fig 25: Brick footings in Trench K.

Placed in the centre of the circular northern part of the Duke's Square, this trench exposed the foundations of the plinth that stood here in early sketches, before the plinth and the obelisk on top were removed. The brick base [90904] was visible through the turf, so the trench was intended to examine its form. Below the usual 0.15m of turf [90901] a layer of brick and mortar rubble fragments [90903] sealed the foundations as well as the natural clay into which the foundations were cut. This appears to be demolition from something nearby, but it was not possible to tell if it came from the monument that once stood on the spot. Rubble dump deposit [90902] contained four fragments of white china pottery, two fragments of glass, and a single flint. The foundation cut [90905] was filled by the brick structure and then by clay [90906]. The brick structure appears to have been two separate episodes of construction, with a large square base four courses high that was only exposed in part – the part in the trench was 1.5m x 1.5m, but extended out and may be 2.5-3m square overall. This was well-built, with alternating courses of headers and stretchers. Set back 0.5m from the edges was a

second stage consisting of a single layer of bricks, and it was square on to the edges of the base. This was no doubt the foot of an original plinth rising off the foundations. In turn it was capped by two courses of brick forming a rectangular pad that was off-centre to the underlying structure, suggesting it was a later addition during a re-modelling of whatever stood on top.

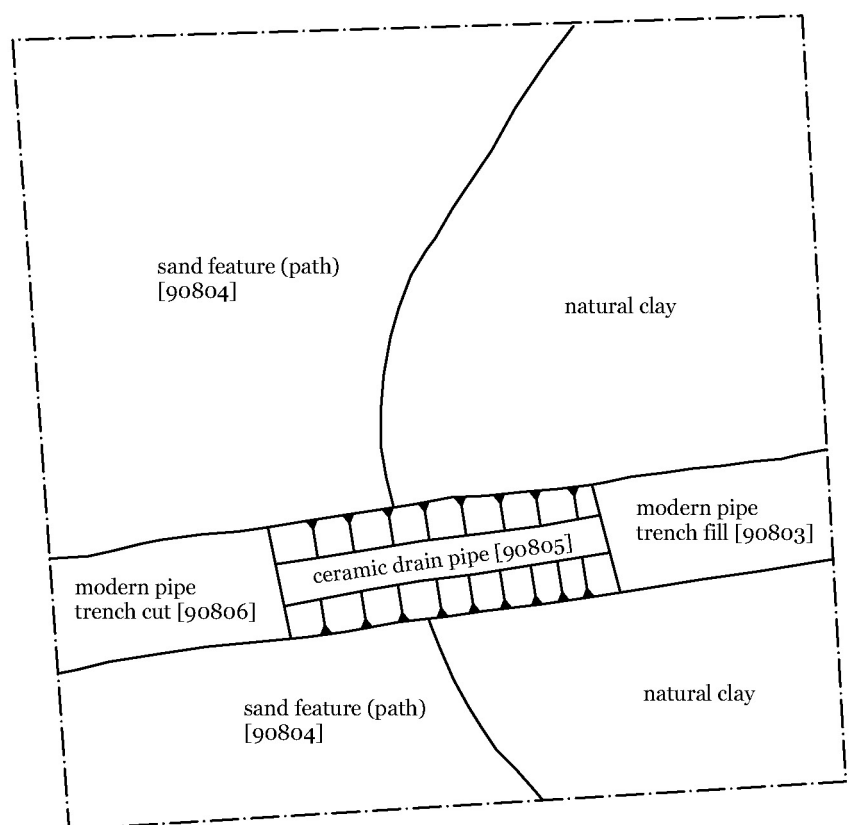
Fig 26: Plan of Trench H at 1:20 scale.

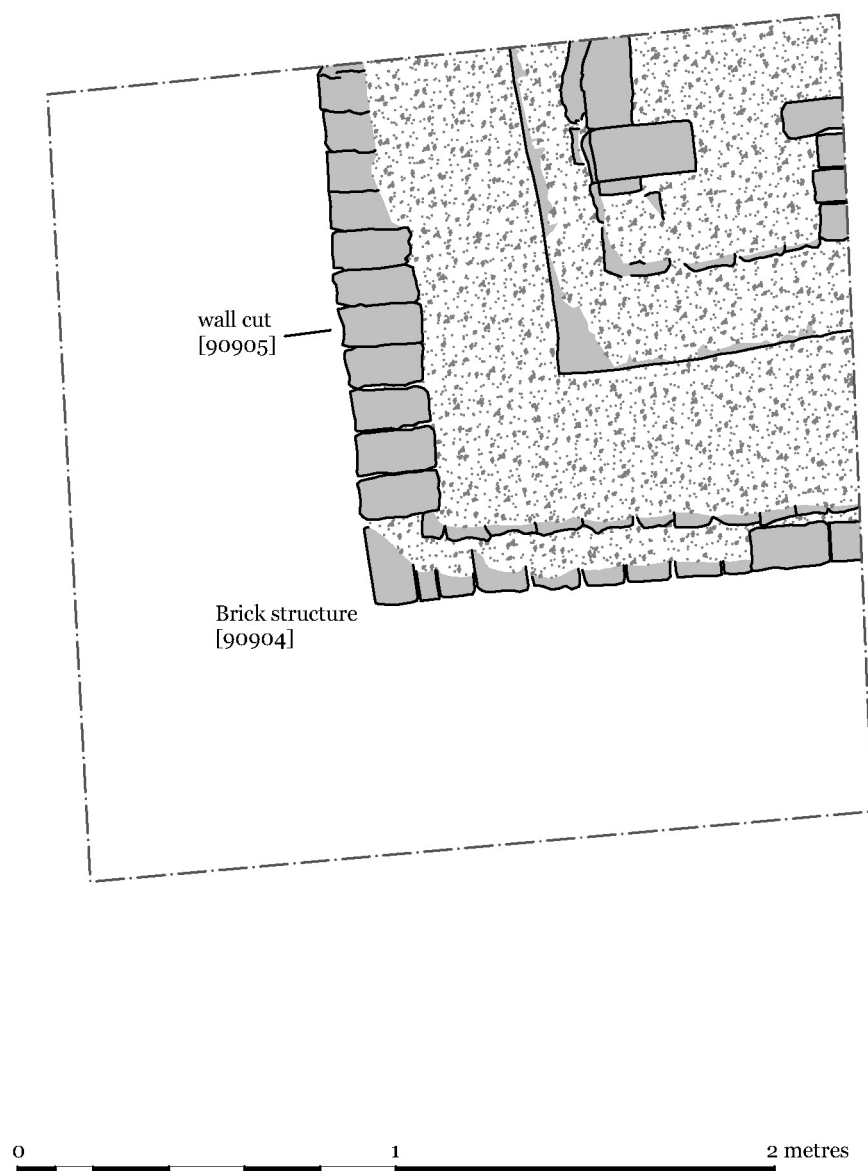
Fig 27: Plan of Trench K at 1:20 scale.

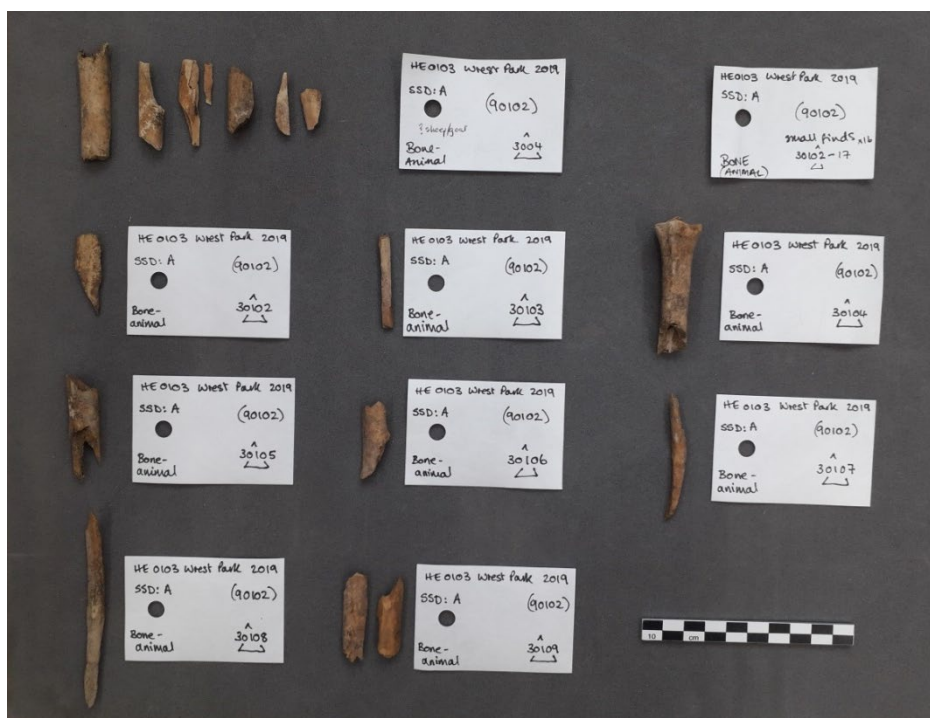
Fig 28: Animal bone assemblage Context [90102] SF 3004-30109. Photo P Baker ©Historic England

Trench A yielded 37 bones, 32 of which are from topsoil [90102] (SF3004, SF30102-17, Table 2, Figs 28-29). [90102] includes two sheep/goat (*Ovis aries/Capra hircus*) right proximal metatarsals (SF 30104, SF 30115 Fig 31) and one *cf.* sheep/goat (*Ovis aries/Capra hircus*) metapodial fragment (SF3004) representing a minimum number of two individuals. [90102] also yielded 29 non-countable medium mammal bones including possible proximal or distal metapodial shaft fragments (SF3004, SF 30105, SF 30112). Most other fragments are consistent with the size of sheep/goat but in some cases, they may derive from large deer size bones. Many of the splinters are very straight or have surface features suggestive of metapodials. Some could also derive from other straight shafted elements such as tibias (Table 5).

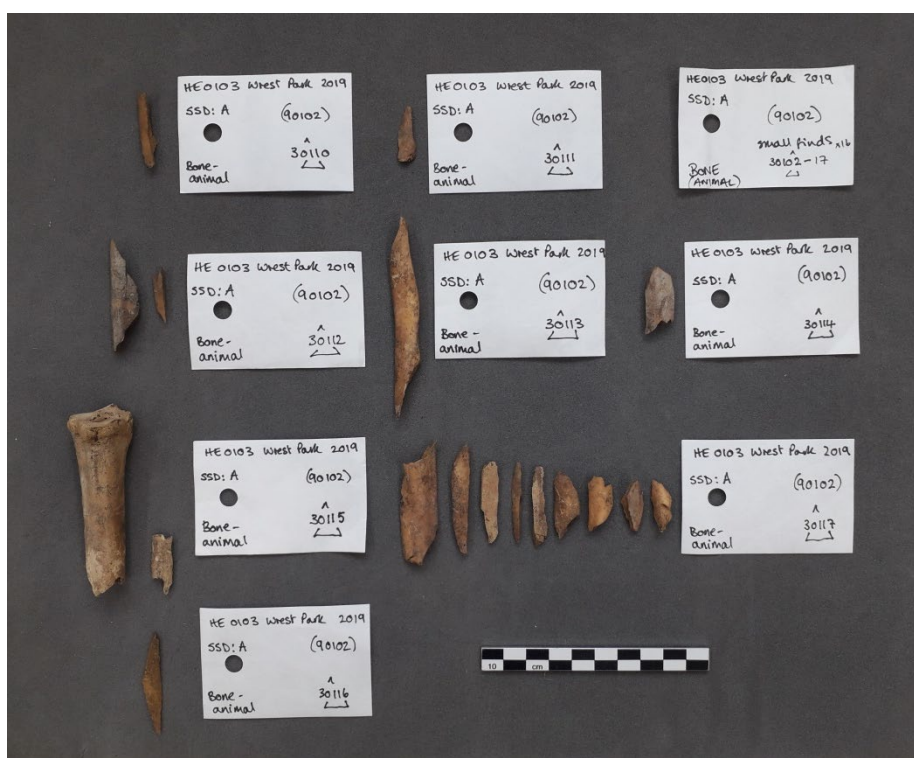
Fig 29: Animal bone assemblage Context [90102] SF 30110-30116. The fragments from SF 30115 are conjoining. Photo P Baker ©Historic England

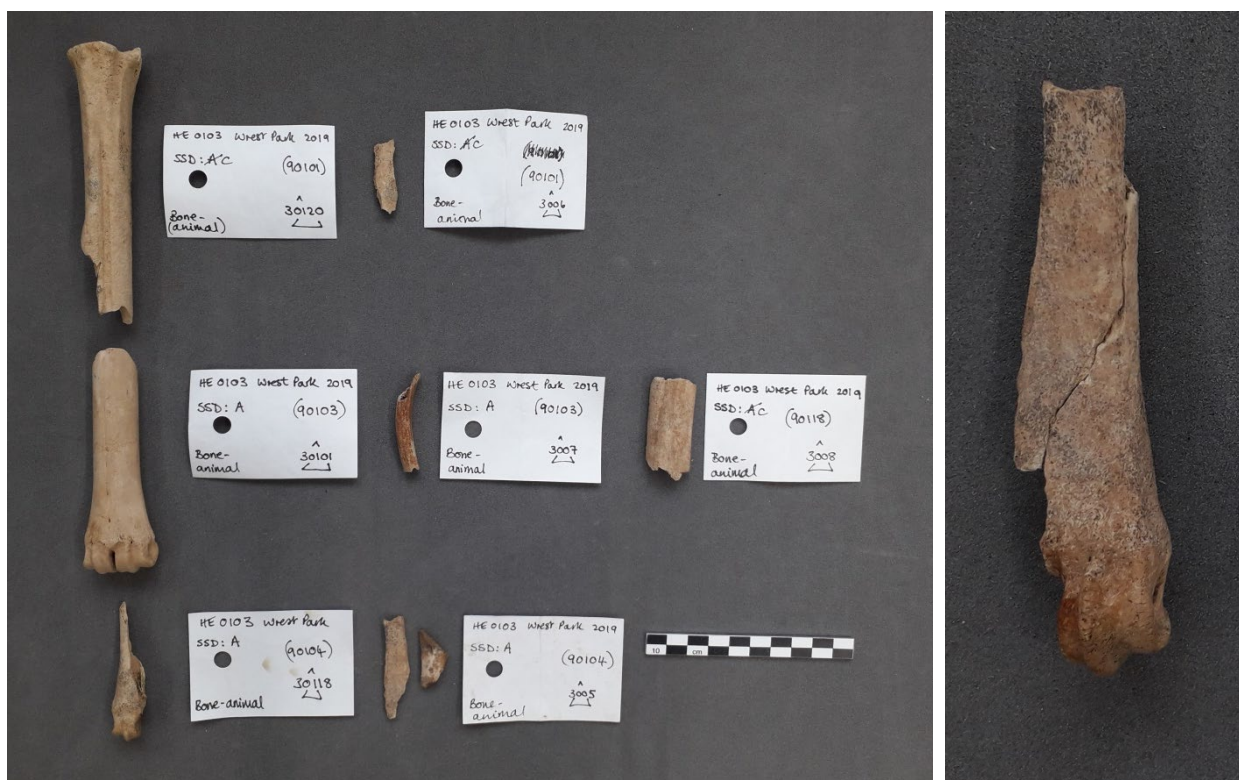
Fig 30: Animal bone assemblage. Left: Contexts [90101] SF 3006, 30120; [90103] SF 3007, 30101; [90104] SF 3005, 30118; [90118] SF 3008. Right: Conjoining fragments from context [90104] SF 30118 and 3005. Photos P Baker ©Historic England

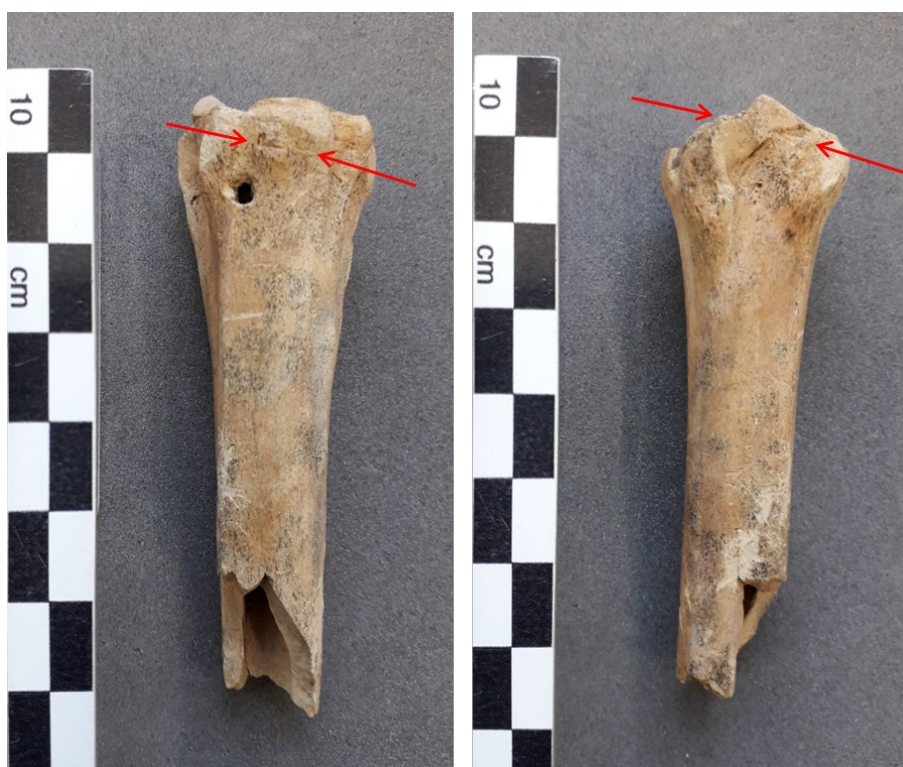
Fig 31: Sheep/goat right metatarsal with cut marks, and hole of indeterminate origin Context [90102] SF 30115. Left: lateral view. Right: posterior view. Arrows indicate location of cut marks. Photos P Baker ©Historic England

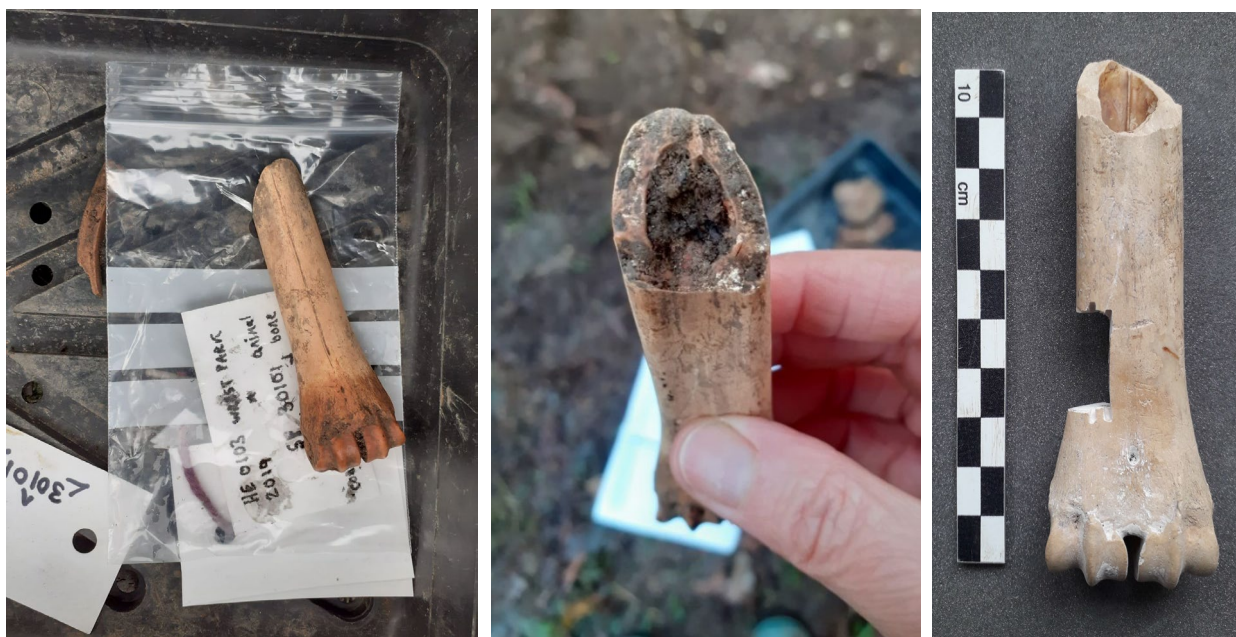
Fig 32: Fallow deer metacarpal Context [90103] SF 30101. Left and middle: as excavated, with mortar adhering to the broken shaft cross-section. Right: after cleaning and sampling for radiocarbon, showing mortar on distal posterior shaft and distal articulation. Photos: left and middle S Hawke, right P Baker ©Historic England

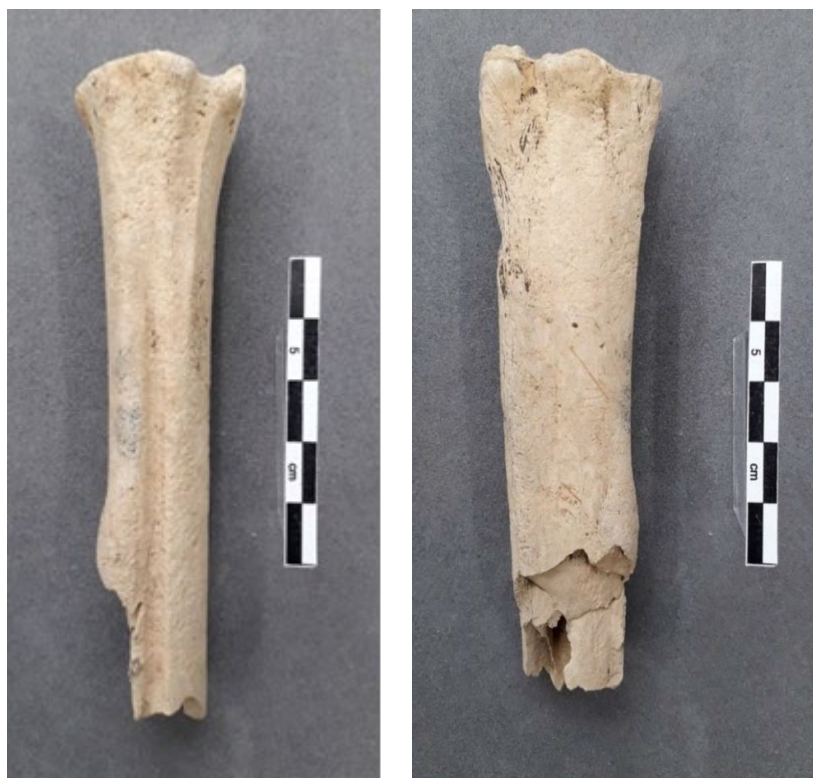
Fig 33: Fallow deer metatarsal with remodelled bone on medial side of the vascular groove Context [90101] SF 30120. Left: dorsal view; Right: medial view. Photos P Baker ©Historic England

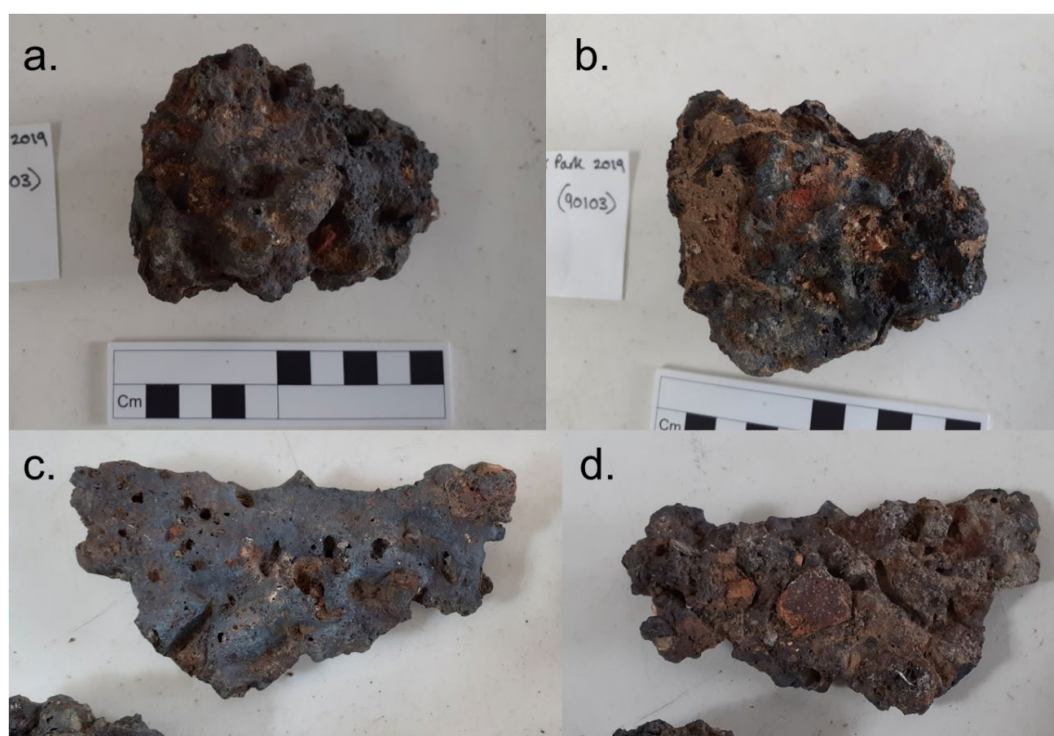
Fig 35: Samples collected from context 90103 (a. and b.) and 90506 (c. and d.). Small inclusions of ceramic, stone and clay can be observed at the bottom of the slags (b. and d.).

Industrial debris was found during the excavation, used as packing around land drains in order to percolate water in the absence of local gravel. There would likely have been a blacksmith somewhere on the estate.

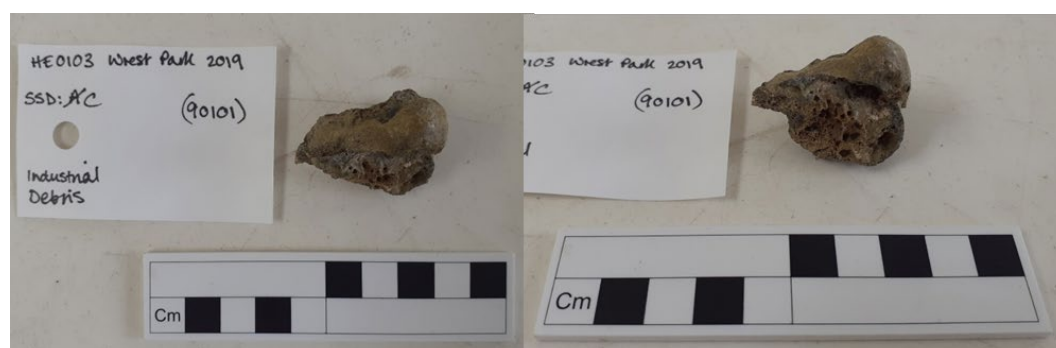
Fig 36: Sample collected from context 90101.

The exception is the sample collected from context 90101 (topsoil), which shows bubbly-spongy features, plus it has a lighter colour, and it is less dense compared to the other slags (Figure 36). This sample is rich in SiO₂, Al₂O₃ and CaO, with an FeO content lower than 6 (wt%) (Table 7). It is not diagnostic of a metalworking process, and it is probably a fuel ash slag, produced by reaction of ash from a fuel with clay.

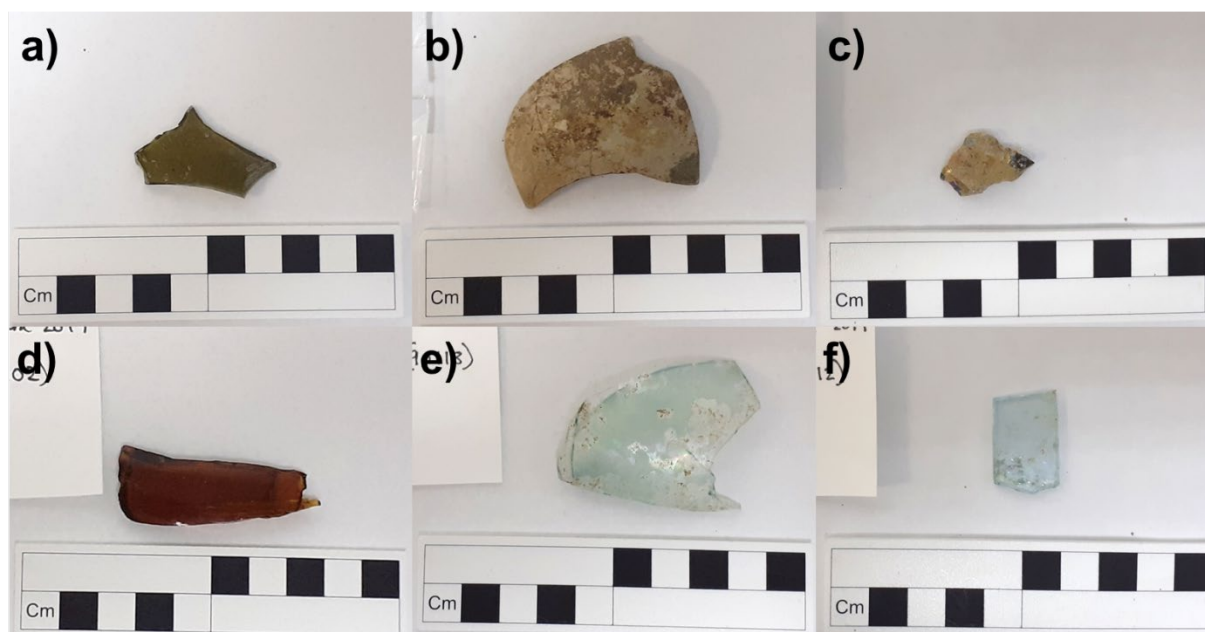
Fig 37: The glass samples can be divided in to six main groups according to the colour, shape and weathering conditions: a) dark green glass fragments; b) very decayed dark green glass fragments; c) green glass fragments with a golden weathering patina; d) brown glass fragment; e) light blue/colourless fragments from bottles or vessels; f) light blue/colourless window glass.

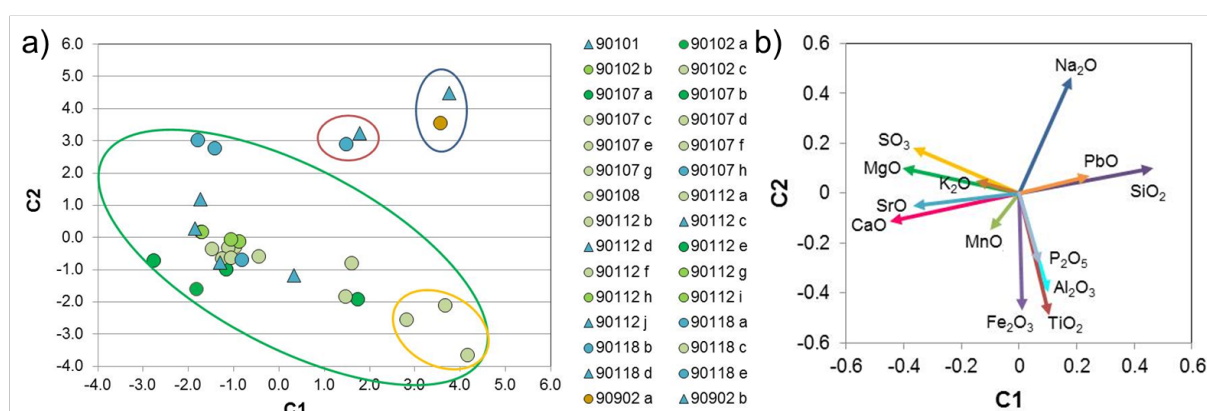
Fig 38: Principal component analysis (PCA) of the glass samples.

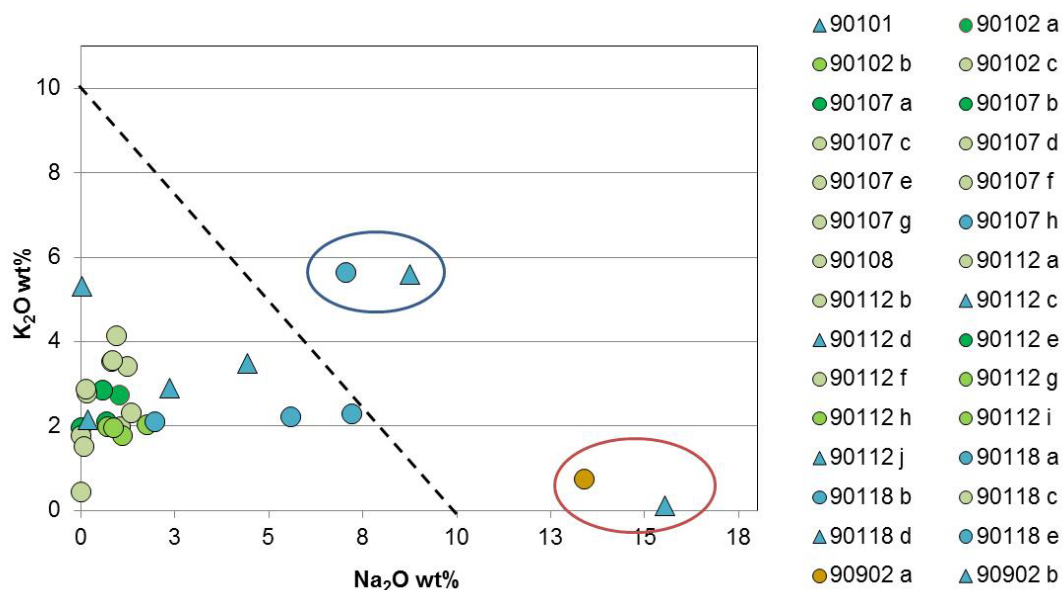
Fig 39: Correlation of Na_2O and K_2O wt% in the glass fragments.

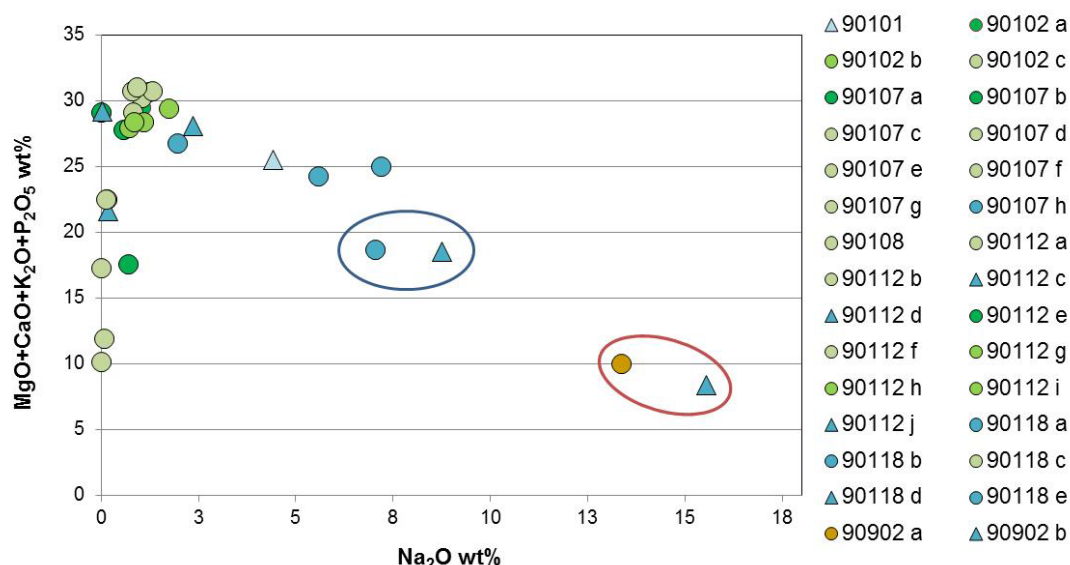
Fig 40: Correlation of Na_2O and the sum of MgO , CaO , K_2O , and P_2O_5 wt% in the glass fragments.

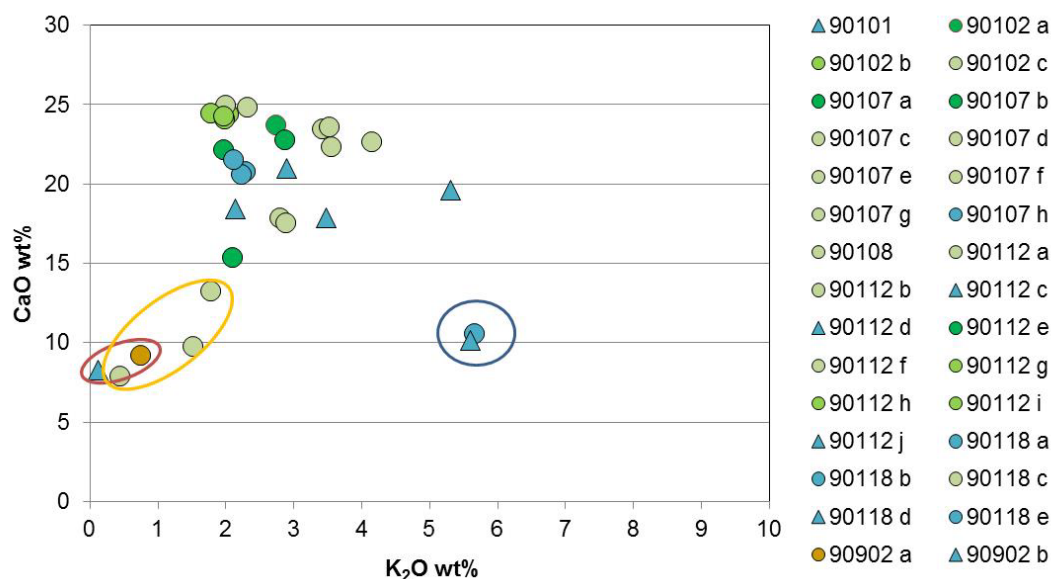
Fig 41: Correlation of K_2O and CaO wt% in the glass fragments.

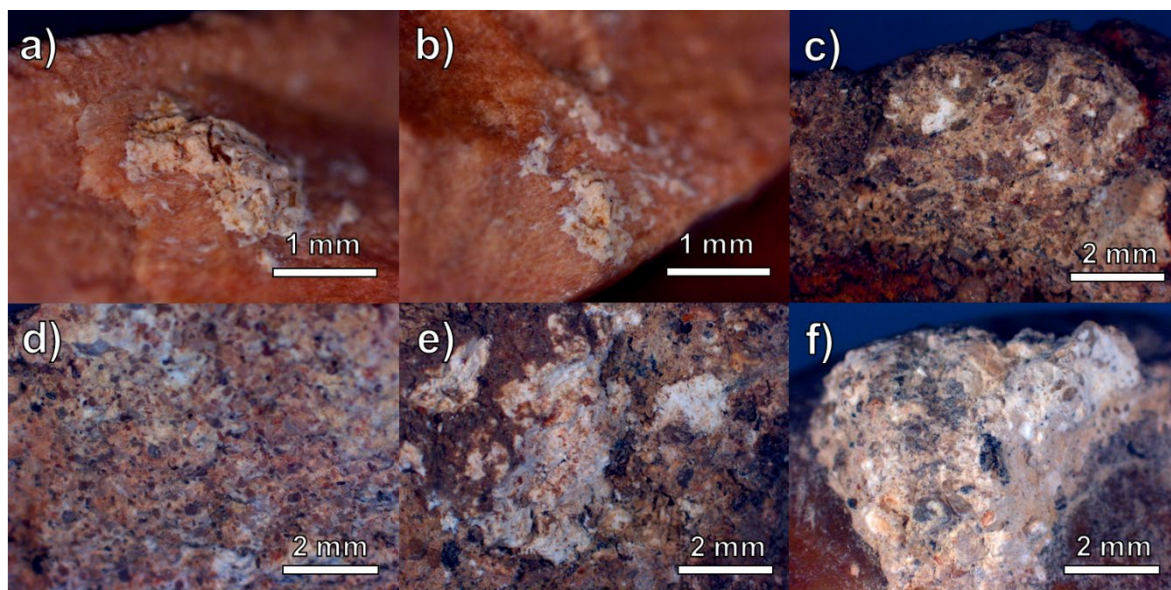
Fig 42: Stereomicroscopy images of mortar residues on animal bone (a. and b.), flat iron bar (c. and d.), curved iron bar (e.), and pebble (f.).

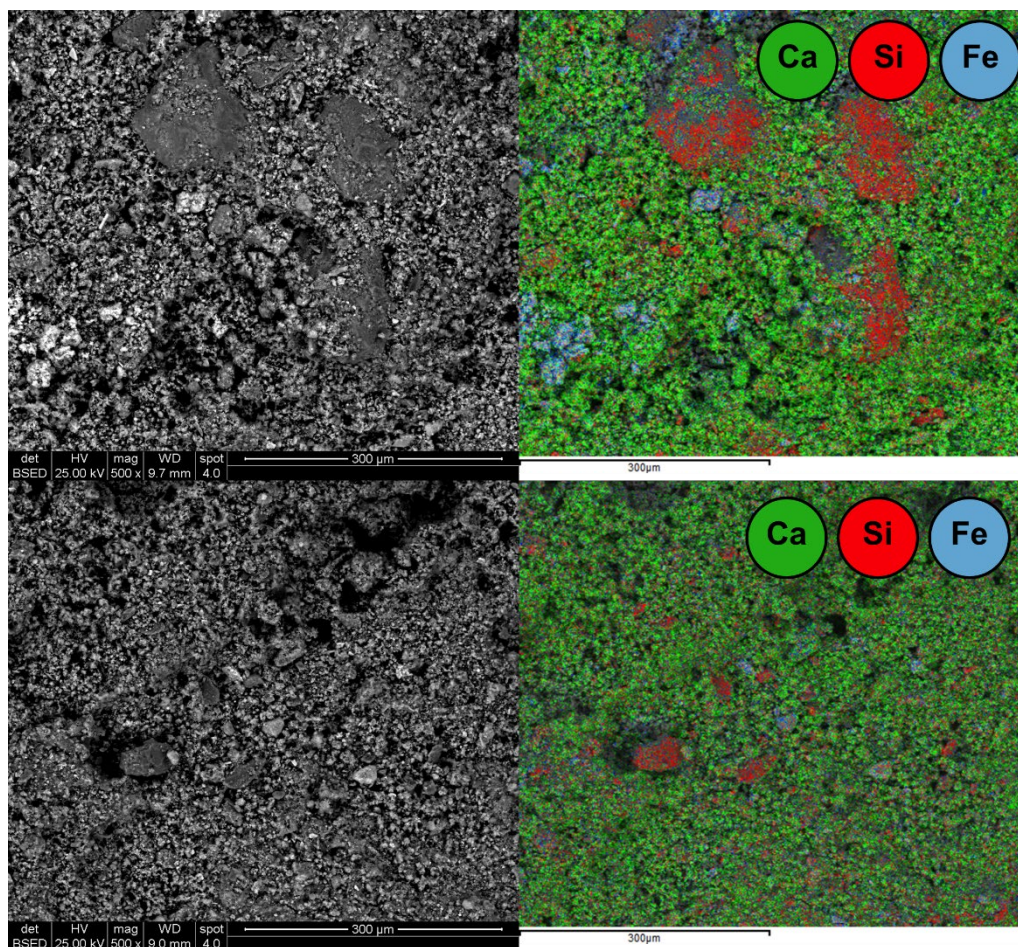
Fig 43: SEM images (BSE detector) and coloured maps of the main elements (calcium-Ca, silicon-Si and iron-Fe) of mortar collected from an iron bar (3002).

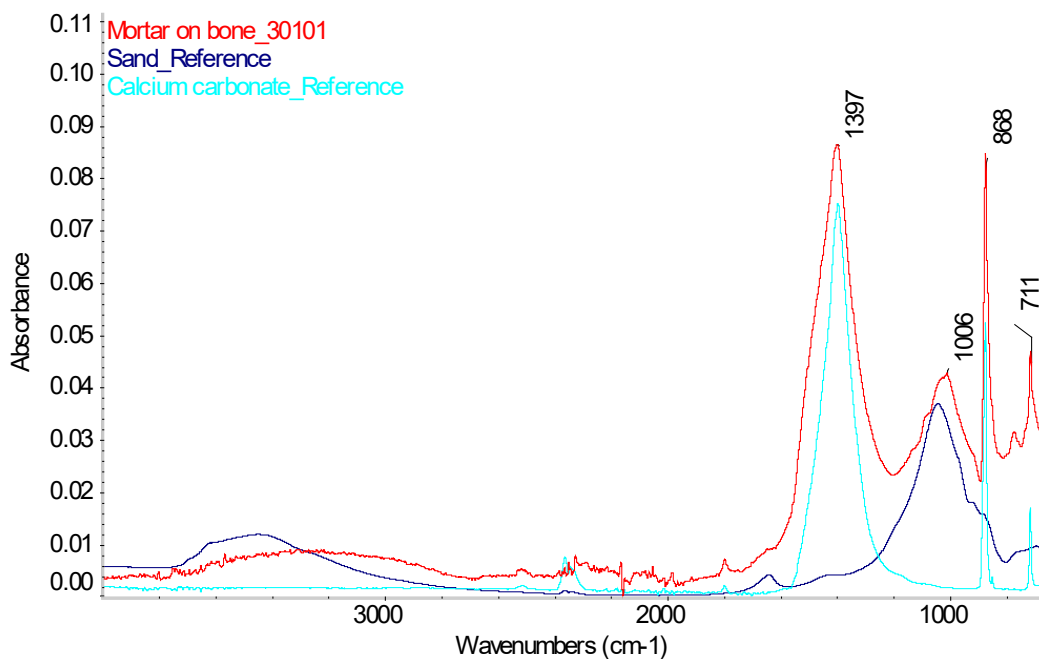
Fig 44: ATR-FTIR spectrum collected from the mortar attached to the animal bone (30101), and the FTIR spectra of reference samples of calcium carbonate and sand.

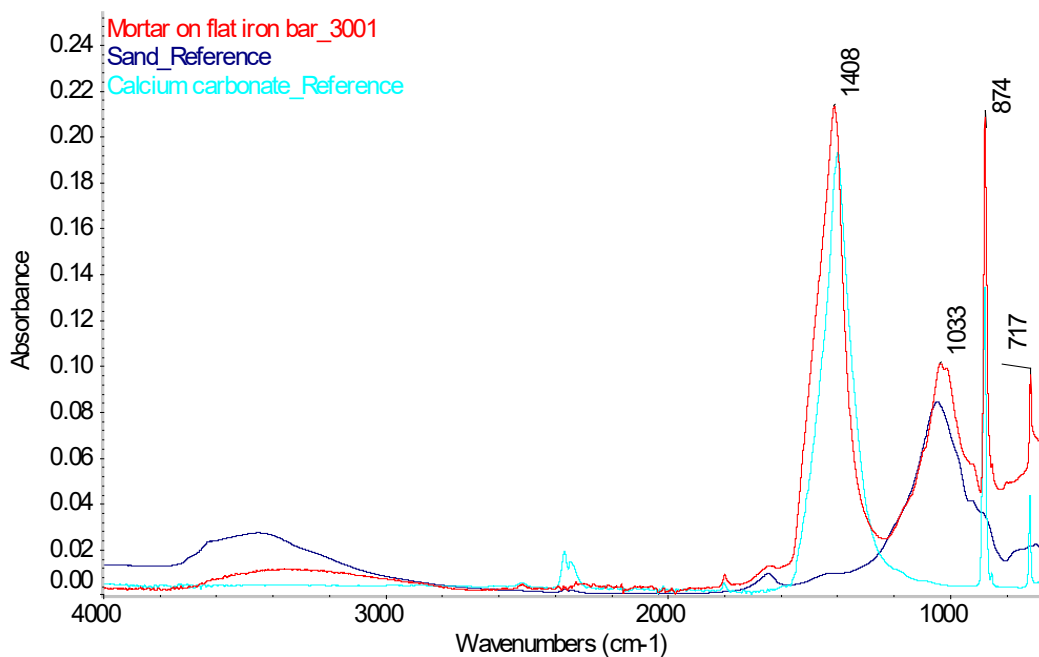
Fig 45: ATR-FTIR spectrum collected from the mortar attached to the flat iron bar (3001), and the FTIR spectra of reference samples of calcium carbonate and sand.

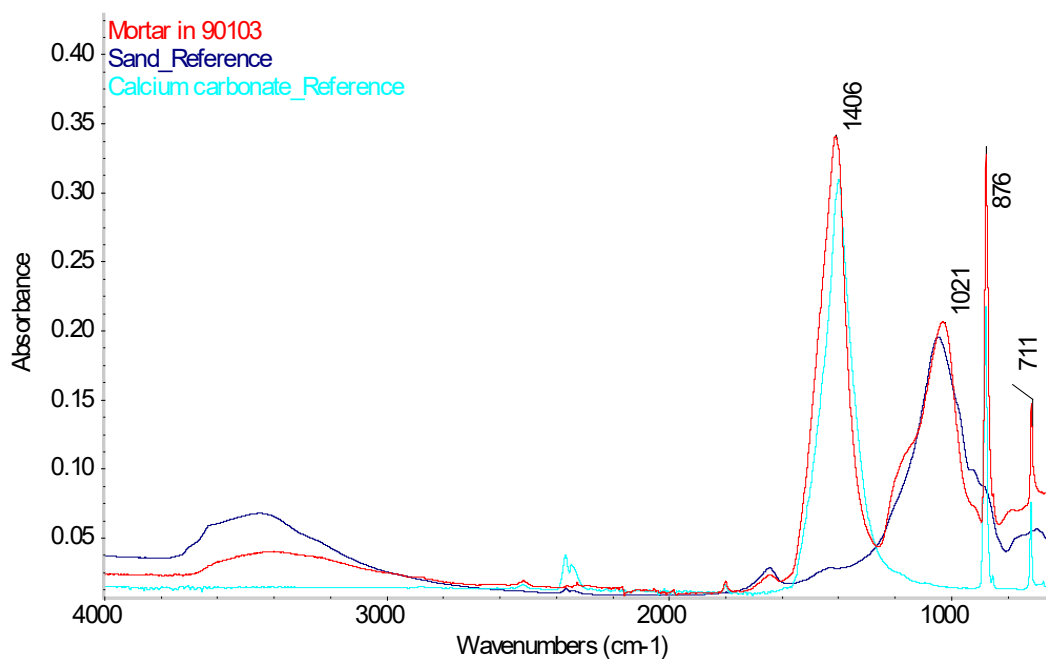
Fig 46: ATR-FTIR spectrum collected from the mortar residues from flat iron bar (3001), and the FTIR spectra of reference samples of calcium carbonate and sand.

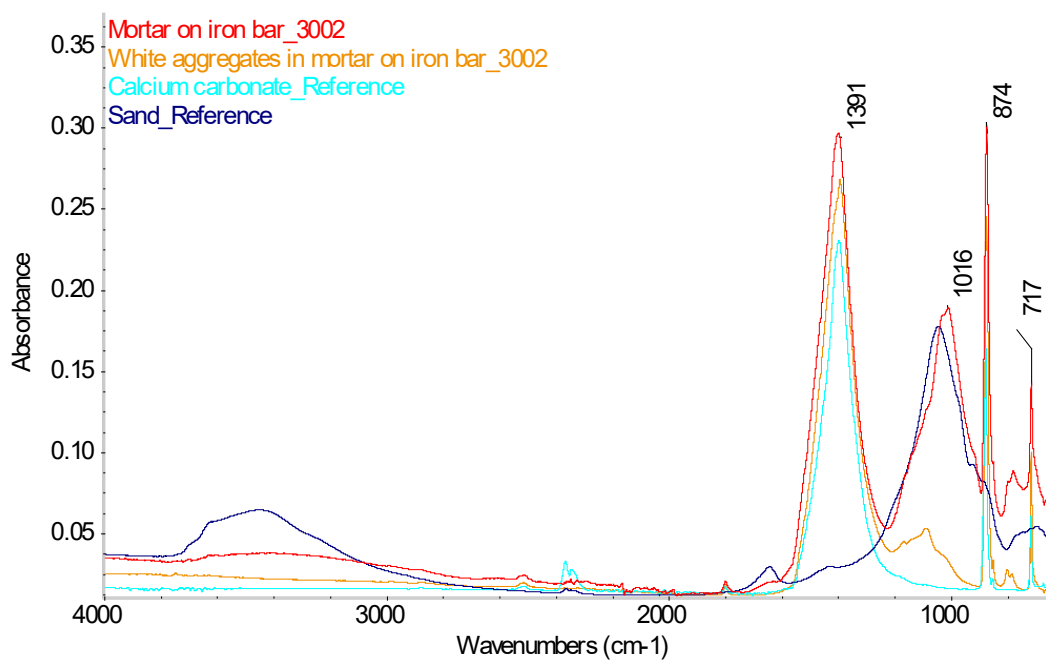
Fig 47: ATR-FTIR spectra collected from the mortar residues attached to the curved iron bar (3002) and white lumps in the mortar. For comparison, FTIR spectra of reference samples of calcium carbonate and sand are reported.

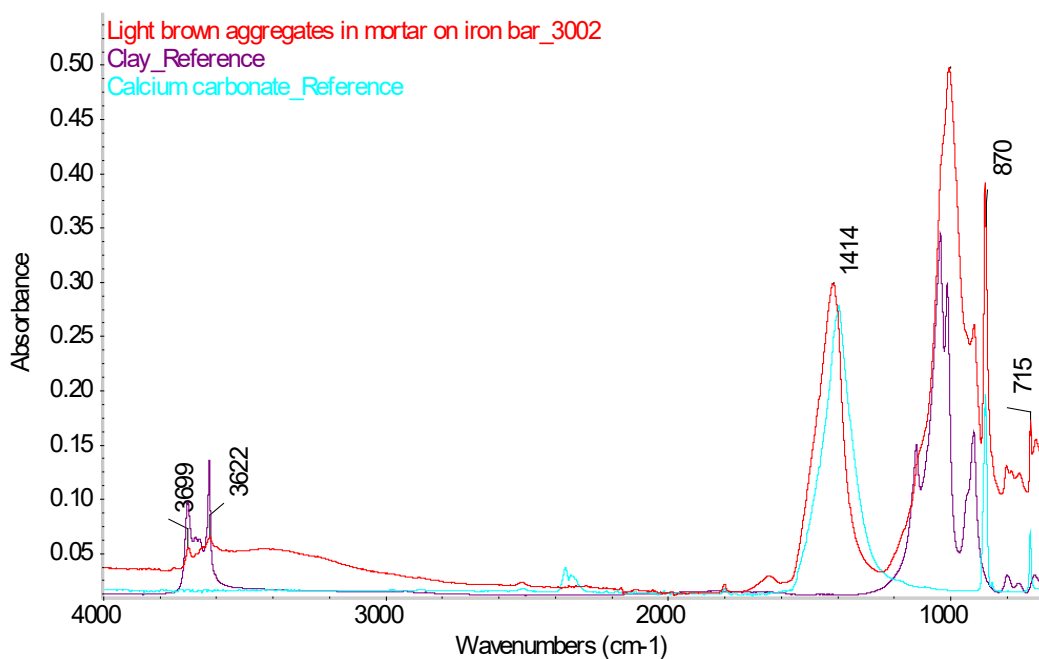
Fig 48: ATR-FTIR spectra collected from light brown aggregates in the mortar residues attached to the curved iron bar (3002), and the FTIR spectra of reference samples of calcium carbonate and clay.

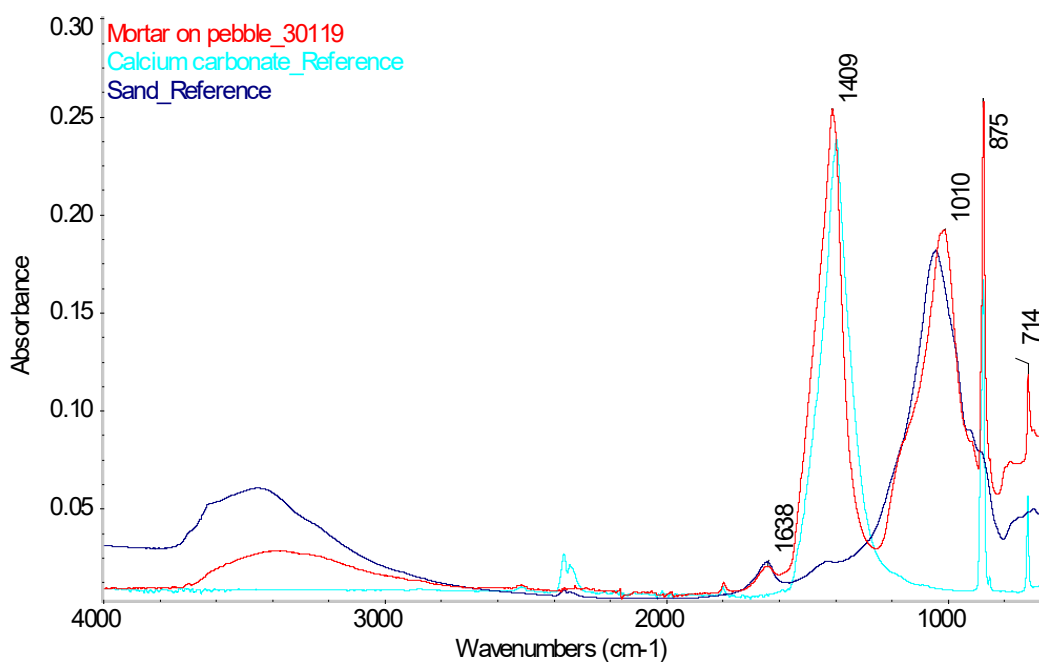
Fig 49: ATR-FTIR spectrum collected from the mortar attached to the pebble and the FTIR spectra of reference samples of calcium carbonate and sand.

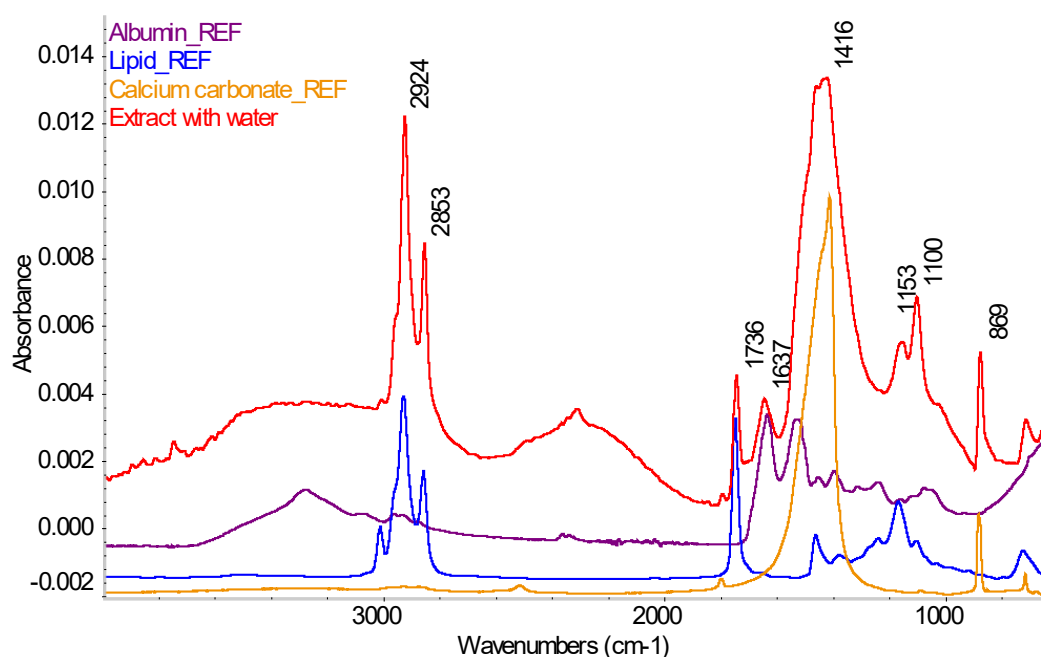
Fig 50: FTIR spectrum of the extract with water from the mortar attached to the pebble and the FTIR spectra of reference samples of a calcium carbonate, a lipid, and the albumin protein.

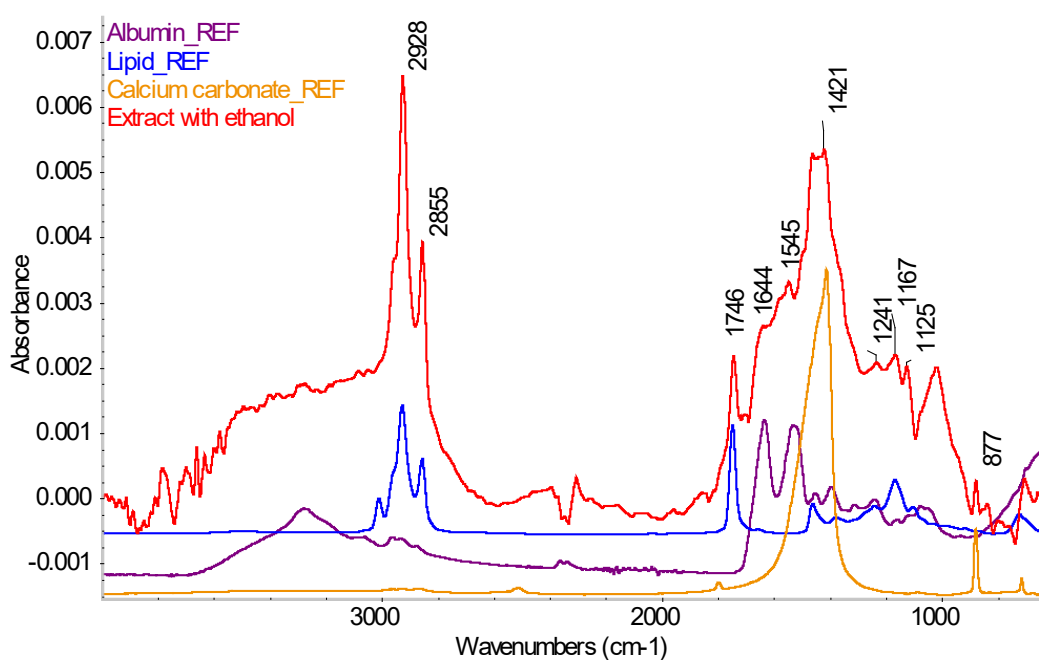
Fig 51: FTIR spectrum of the extract with ethanol from the mortar attached to the pebble and the FTIR spectra of reference samples of a calcium carbonate, a lipid, and the albumin protein.
