The Fleece Hotel, 19, 19A and 21 Westgate Street, Gloucester

Historic Building Investigation

Rebecca Lane

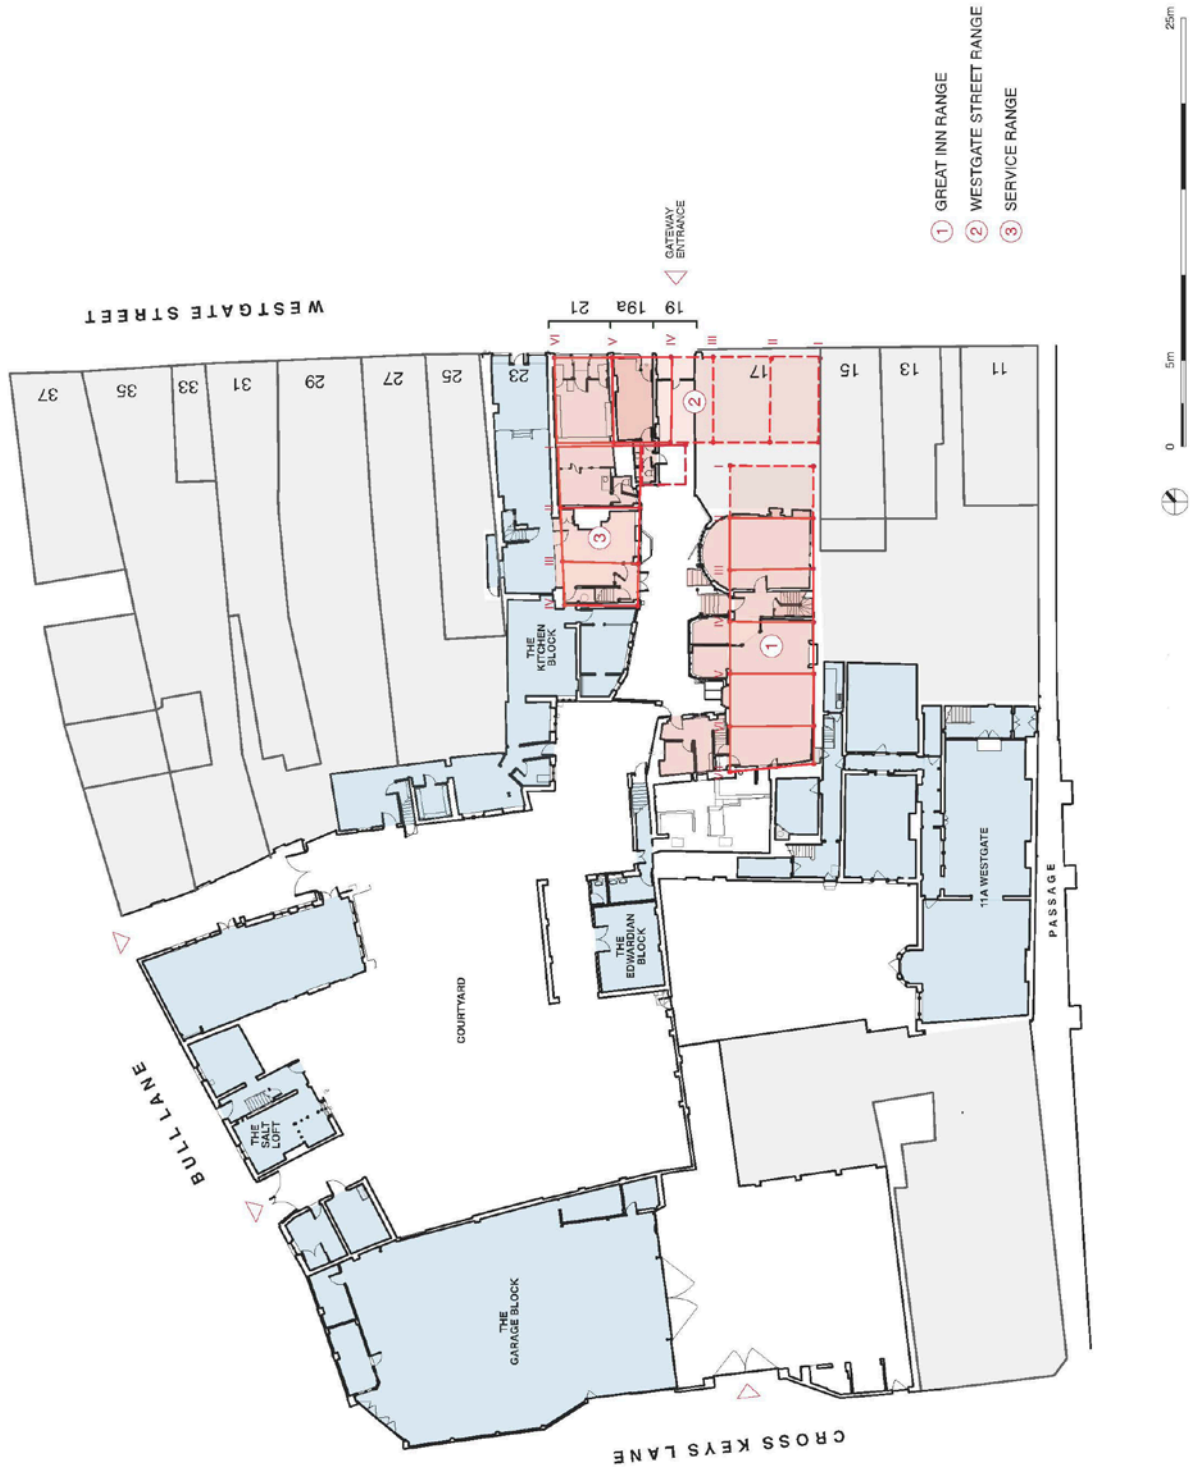
Figure 2: Site plan showing the three main ranges in red and other ancillary structures in blue. North is to the top left of the image. [© Butler Hegarty Architects. Reproduced with permission.]

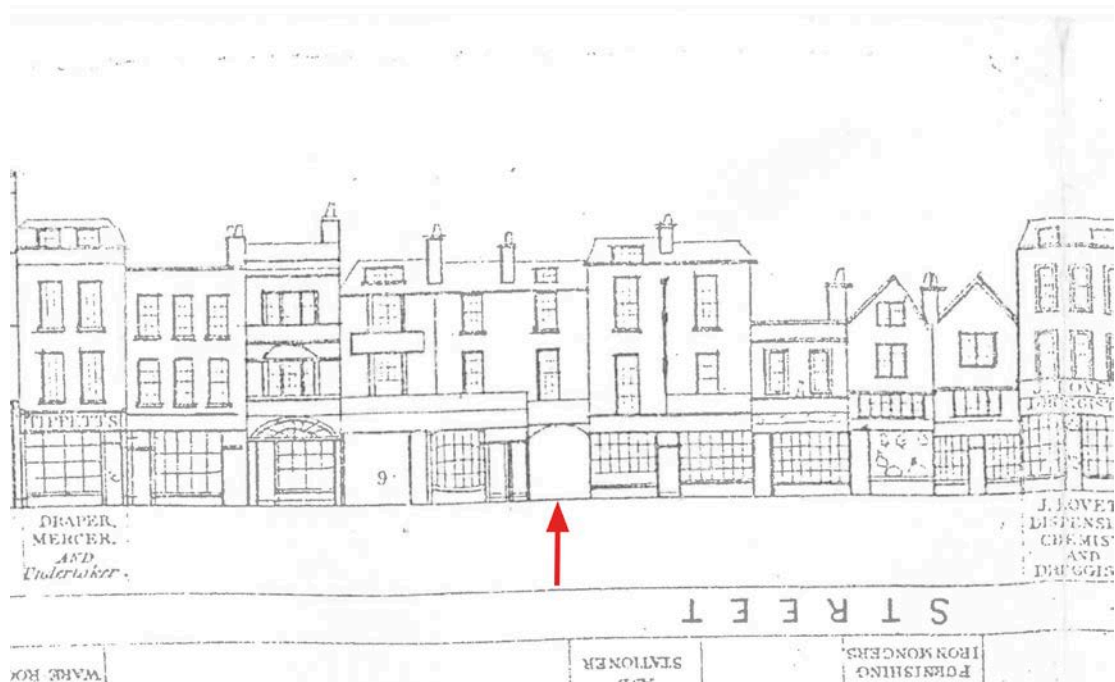
Figure 9: Detail of the east side of Westgate Street from the 1841 street view of Gloucester. The arched entrance to the Fleece is indicated with an arrow. [From the *Historical, pictorial and topographical illustrations of the counties of Gloucestershire, Somerset, Wiltshire and Monmouthshire: with specimens of the architecture and street views of Gloucester, Cheltenham, Bath, Bristol, Wells, Salisbury, Monmouth, etc.*]

A street view of 1841 shows the street-front range associated with the Fleece at this date, although none of the buildings are identified (Figure 9).¹⁴⁸ The archway through to the Fleece is recognisable, however, with a segmentally arched head. To the west of this the shops which are now Nos 19A and 21 appear to have been in use as a single shop unit with a central doorway flanked by two large-paned glass windows. Above this the upper floors are shown as being lit by sash windows (although one of these is partially obscured, possibly by an additional fascia board). No. 19A has a small garret window lighting the attic level. The garret window and the raised ceiling level (compared to No. 17 to the left) indicate that by this date the façade had been refaced and a parapet added to give the building the impression of greater height. The western part of No. 17 (just to the east of the passageway) is shown with paired doorways immediately adjacent to the archway, presumably giving separate access to the ground-floor shop and the rooms above. The shop appears to have had a bow window projecting out into the street. Above the shop the

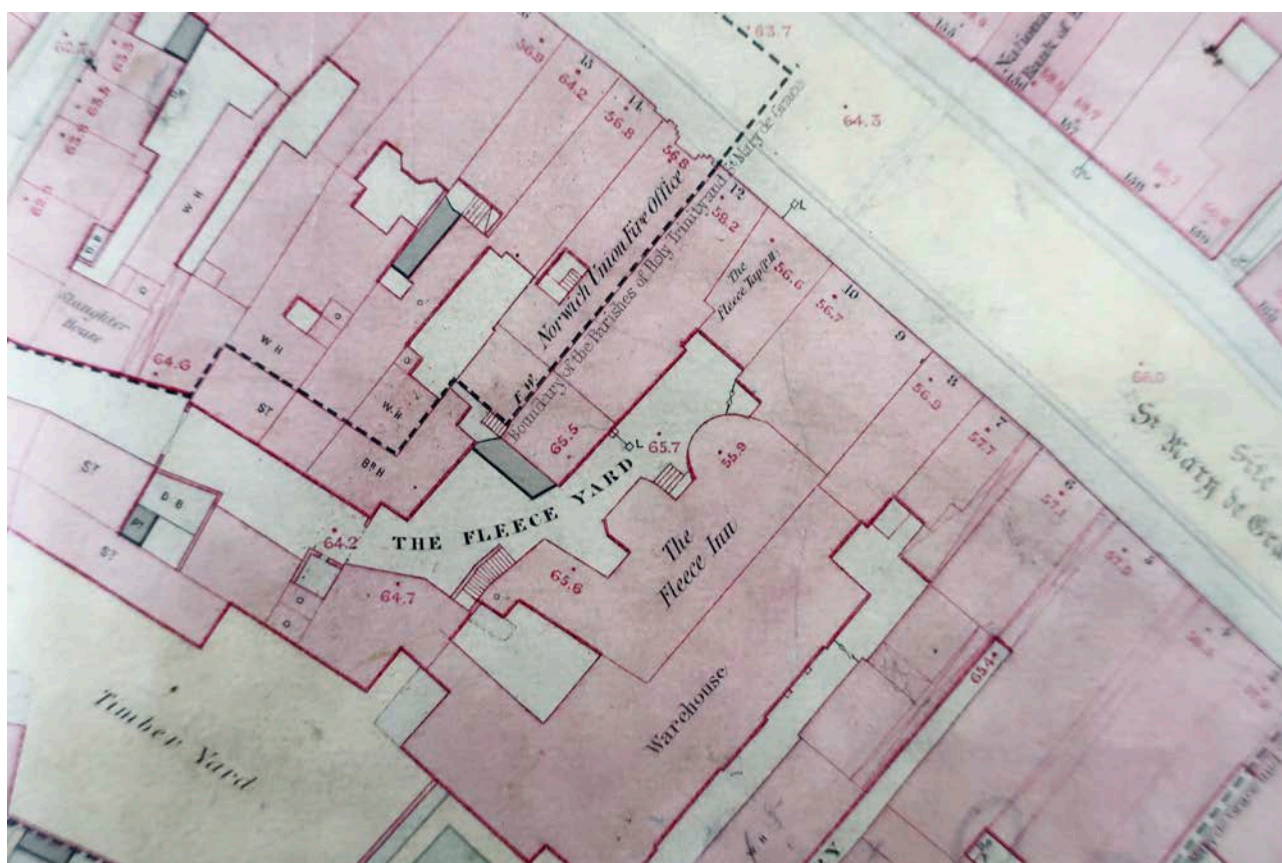
Figure 11: Detail from the 1852 Board of Health map of Gloucester, showing the footprint of the Fleece ranges in detail and the warehouse on the adjacent plot. [Reproduced with the permission of Gloucestershire Archives: GBR/L10/1/2]

The 1852 Board of Health map shows the same arrangement as Causton's map of 1843, although with greater detail about the subdivision of some of the buildings (Figure 11). The great inn range is shown with a stair leading up to the entrance in the same position as that surviving today. Further south a stair is also shown running along the west elevation of the south-west wing of the great inn range, perhaps providing access to the building to the south of this. The west range is shown with a subdivision towards its southern end,

suggesting that the rear area of the building was in a distinct use from the front part of the range. No. 19A is labelled as 'The Fleece Tap P.H.' and was presumably in use with the main inn. No. 21 is also shown with no division between it and the west range to the rear – perhaps also suggesting a shared use. Notwithstanding the separate sales of both these units in 1800, it appears that by this date they had become part of the Fleece, at least at ground-floor level, and were used as such. An irregular series of buildings is shown running along the entrance passage from Bull Lane.

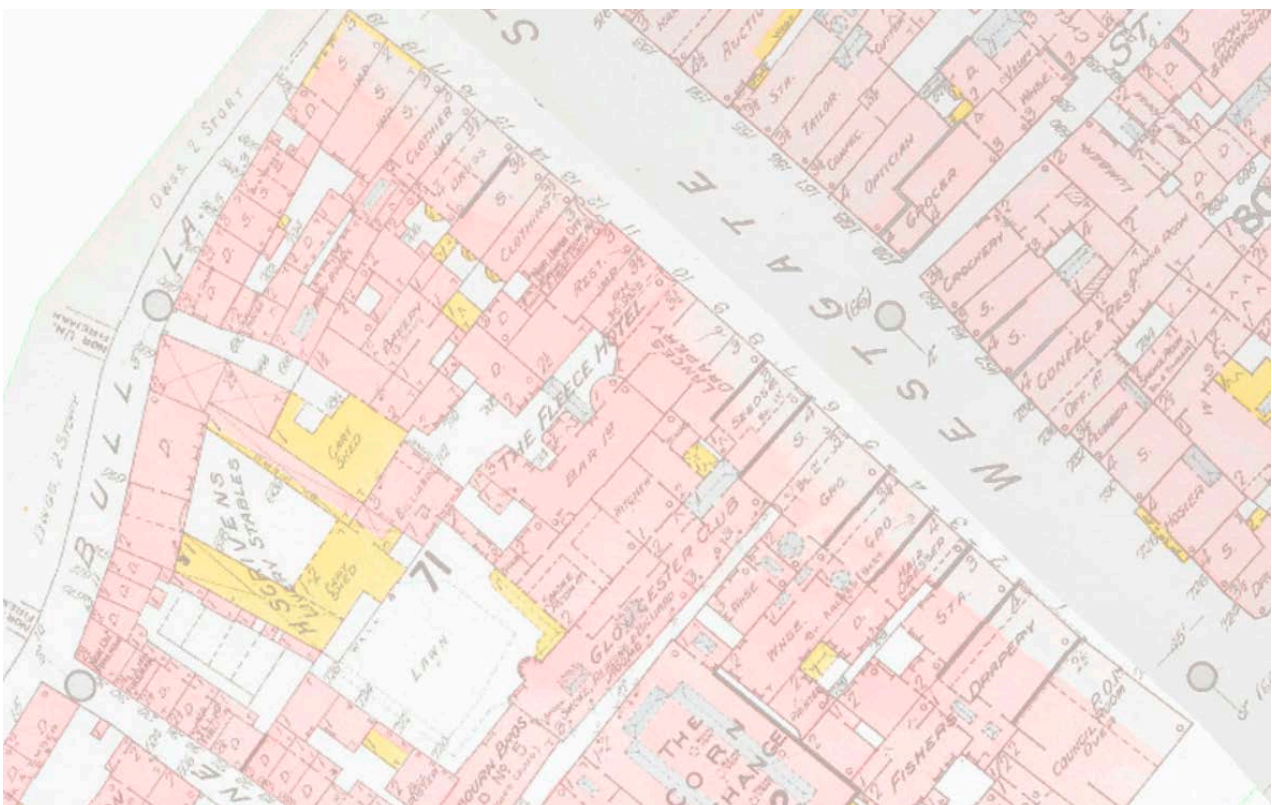
Figure 12: Detail from the 1877 Goad map of Gloucester showing the basic internal layout of the Fleece Hotel. [© Landmark Information Group Ltd. Licence No. GD0003]

The 1887 Goad Insurance mapping shows the Fleece in some detail, including some of the uses of different parts of the complex (Figure 12). It also makes clear the complexity of the ranges of buildings to the rear of Westgate Street, with many buildings which span the main plot divisions. The great inn range is shown as a single space at ground-floor level, labelled as a bar. The western range is subdivided with the southern end labelled as D (dwelling), perhaps suggesting this was the section occupied by the innkeeper (as was certainly the case in the 20th century). The front two units also appear to be in use in conjunction with the inn at ground-floor level. No. 21 is labelled as a restaurant, with a door connecting to the rear part of the west range. No. 19A is labelled PH for public house. To the south of these main ranges the relationship between the inn and the further ranges is less clear, and some areas of the plot appear to have been owned and/or used

in conjunction with the properties to the east, maintaining the relationship shown on the earlier mapping of 1843 and 1852. To the south the ranges running along the south side of the Fleece's entrance passage off Bull Lane are identified as stables (indicated by diagonal crossed lines) and a cart shed. These must have provided stabling for the inn. A square building housing the billiard room (saved in the fire of 1874) is shown at the eastern end of this range of buildings, in the approximate location of the later garage building, with a narrow corridor connecting it to the building on the rear part of No. 15 to the east.

To the south of this the separate yard developed at the start of the 19th century is labelled as 'H Scrivens livery stables'. This appears to have provided some sort of domestic accommodation in the two-storey block adjacent to Bull Lane (as it is marked D for dwelling on the map), with two long stable ranges marked to the rear and then an attached cart shed. The cart shed had been added some time after the 1884 map, perhaps when the site was converted from a timber yard into a livery stables.

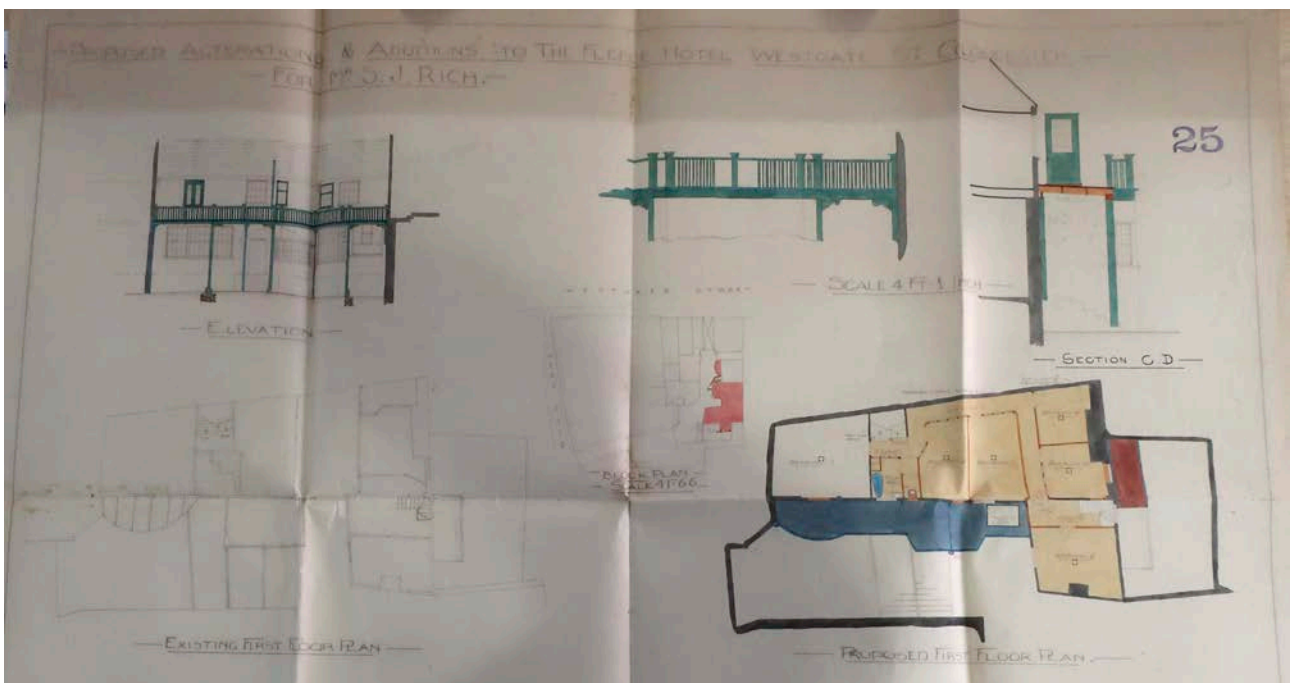
Figure 15: Designs for alterations to the great inn range by architect A. W. Probyn, 1919. [Reproduced with the permission of Gloucestershire Archives: GBR/L20/2/1919/25]

Five years later, in 1919, an application was submitted for alterations to the great inn range, also designed by A. W. Probyn (Figure 15).¹⁶⁵ This appears to have comprised changes in the subdivision of the first-floor area to provide a corridor to link a series of bedrooms. This area seems previously to have had interconnecting rooms. An extension to the rear was intended to provide additional toilets at first-floor level, with some additional windows to light a bathroom immediately over the main entrance. Externally a gallery was to be built sitting over the existing ground-floor bay windows accessed via a doorway in the north elevation of the south-west wing of the great inn range. The gallery does not appear to have provided access to any further rooms, and perhaps was intended largely to elaborate the front of the building and create a more historic inn-like look.

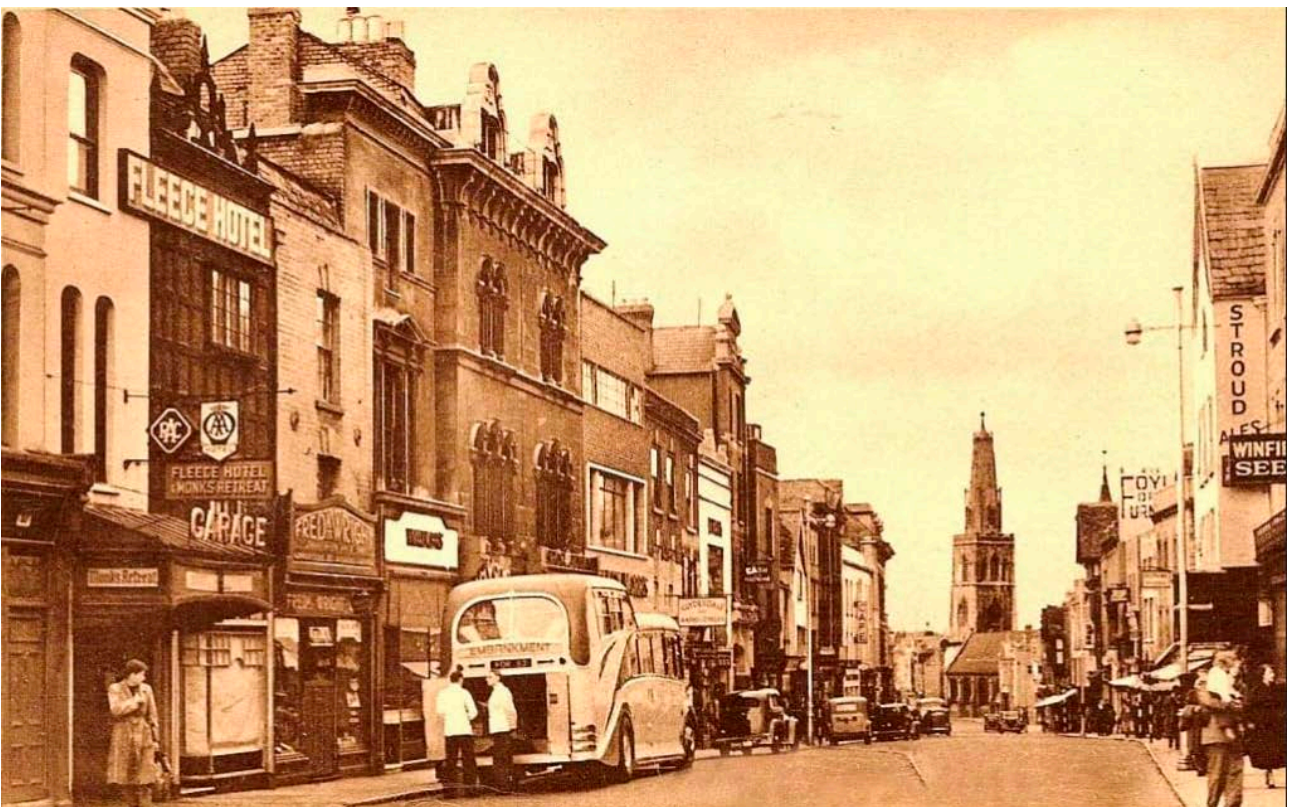
Figure 19: Undated (1930s?) photograph looking west along Westgate Street, showing the entrance to the Fleece Hotel and Nos 19A and 21, with No. 23 beyond, prior to its reconstruction. [https://www.facebook.com/103431487713746/posts/1126432691290479/?substory_index=1126432691290479&app=fbl. Original image source not identified]

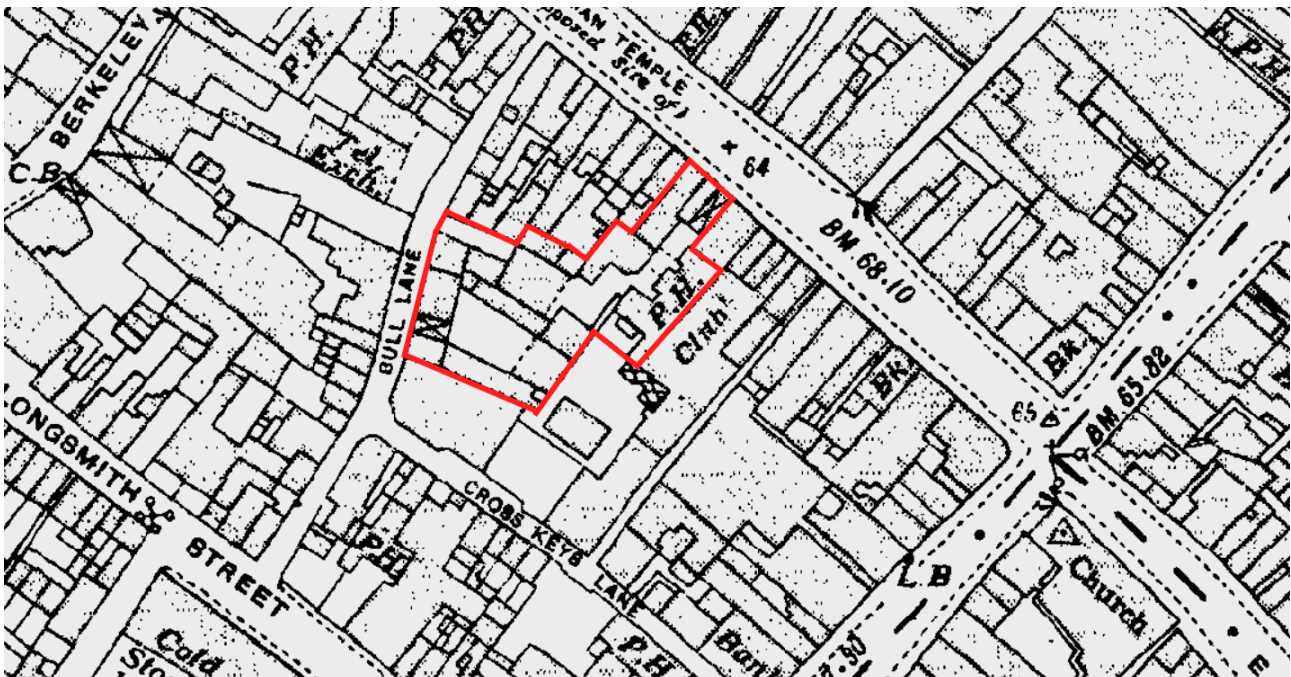
Figure 21: 1:2,500 Ordnance Survey map of 1936 showing the presumed extent of the Fleece Hotel outlined in red. [© and database right Crown Copyright and Landmark Information Group Ltd (All rights reserved 2023.) Licence numbers 000394 and TP0024]

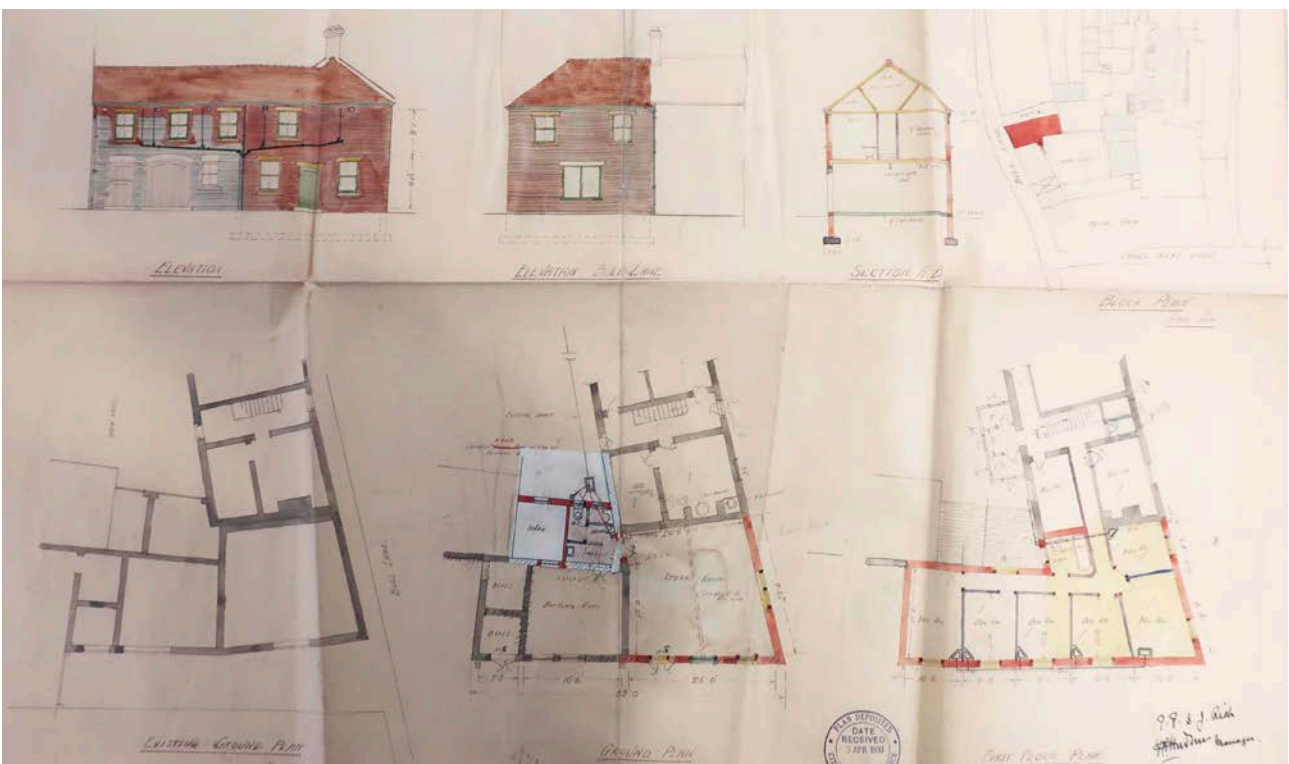
Figure 23: Plans for alterations to the range adjacent to Bull Lane, 1939. [Reproduced with the permission of Gloucestershire Archives: GBR/L20/2/1930/39]

In the block adjoining Bull Lane the accommodation was listed as a double bedroom, a single bedroom, a boiler house and various stores. The outbuildings are listed as ‘six lockup garages now used for storage purposes, a bacon store, a covered yard forming a garage, an unenclosed garage situate beneath the lounge and bedrooms adjoining. A concrete yard with a petrol pump’. In the discussion over the rating the owner stated:

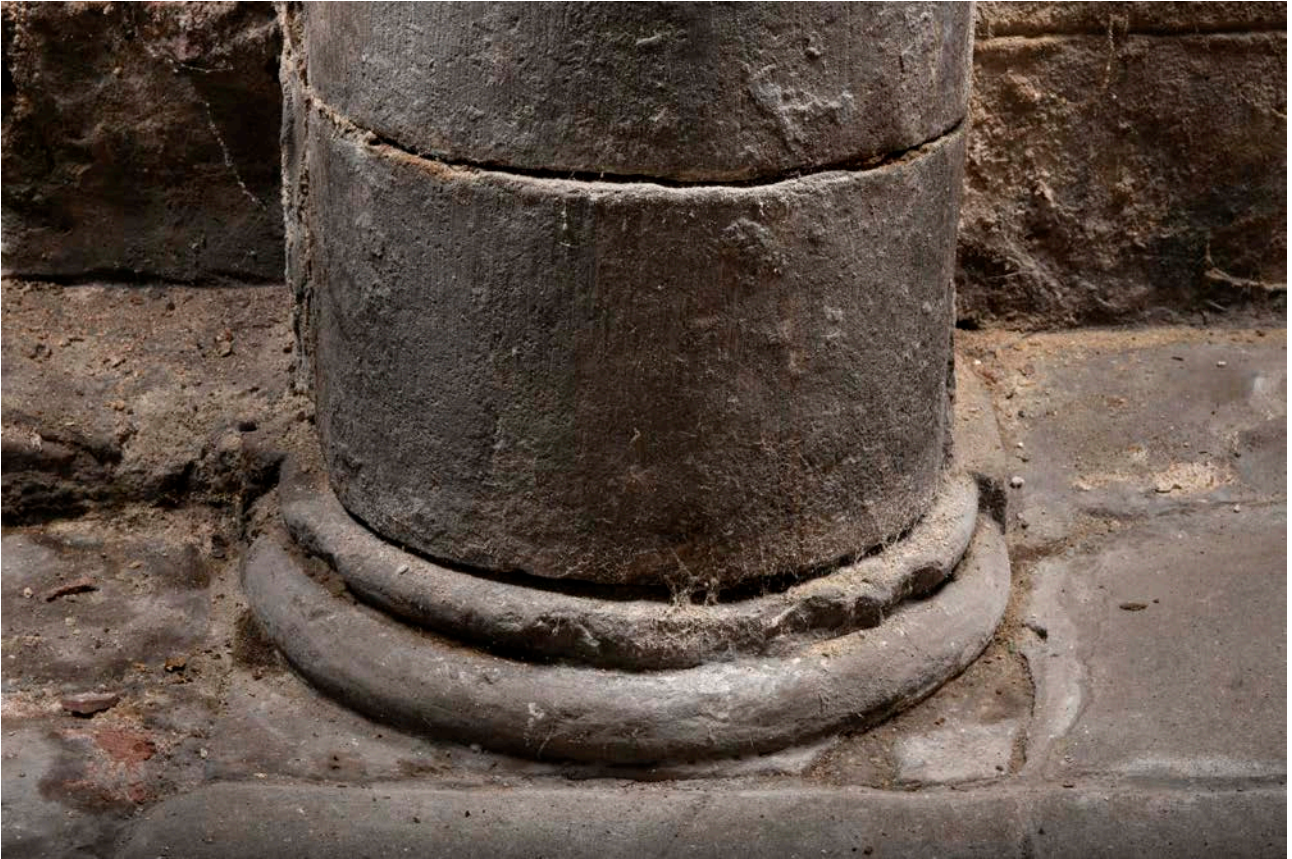
Figure 28: The base of one of the engaged columns in the undercroft, looking west. [James O.Davies © HEA DP435623]

The columns and associated walling and the ribs of the vault are formed of finely cut stone. The columns have a semicircular profile characteristic of the 12th century. Some columns still have their worked bases, indicating that the original floor level was similar to that which survives today (Figure 28). Others appear to have had theirs removed or cut back, possibly when the later floor was inserted. The column heads are all of the same form, with a roll-moulded neck at the top of the shaft. The capital is of an unusual form; its concave profile is similar to a bell capital but with defined corners rather than a rounded shaft (Figure 29). This may be an attempt to reconcile the rounded form of the columns below with the square form of the ribs. Above the capital is a chamfered impost.

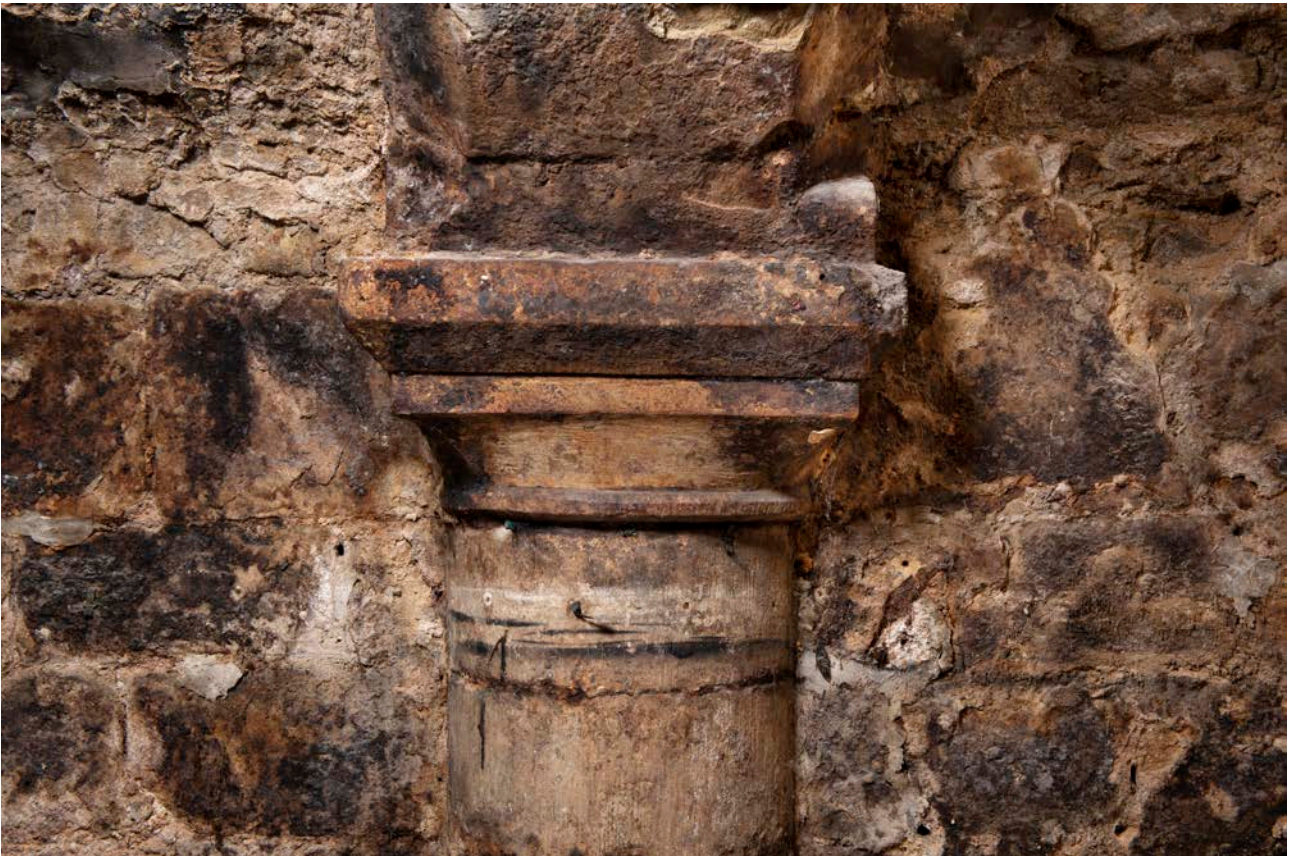
Figure 29: The capital of one of the engaged columns in the undercroft, looking east. [James O.Davies © HEA DP435621]

The base of the ribs generally sit slightly in from the outer edge of the impost, although their rectangular bases are of the same proportions as the top of the impost. The base stones of the ribs have angled corners forming what are effectively chamfer stops for the chamfered profile of the ribs. The form of the capitals may indicate a specific date of after 1170 and probably in the 1180s.¹⁸⁶

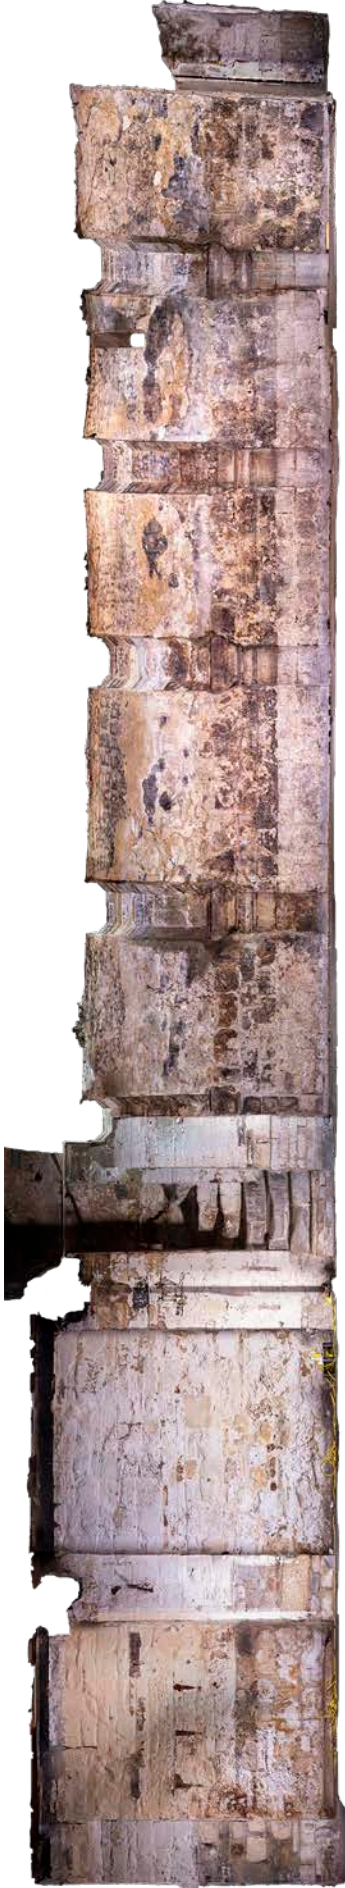
Figure 30: Rectified photograph of the east elevation of the undercroft. [Geospatial Survey © HEA DP364811]

The east wall is formed of squared blocks of stone, with no indication of any features or openings (Figure 30). The west wall, however, has a recess in each of the surviving bays (Figure 31). These have all been blocked later, to a greater or lesser degree. However, it is clear that in four out of the six bays for which there is surviving evidence the recesses form splayed openings. In the fifth bay from the south, where there has been less in the way of later blocking, it is clear that the splay runs back at least 0.5m to create what must originally have been a small opening in the upper part of the wall. Given the identical proportions of the openings in the three other bays, it is likely that all had the same overall form. The angled corners of the splay are formed of finely cut stonework, with rougher squared stone forming the sides of the splays. Originally these appear to have represented window openings, as they are at a level high enough to have sat above the contemporary ground level.

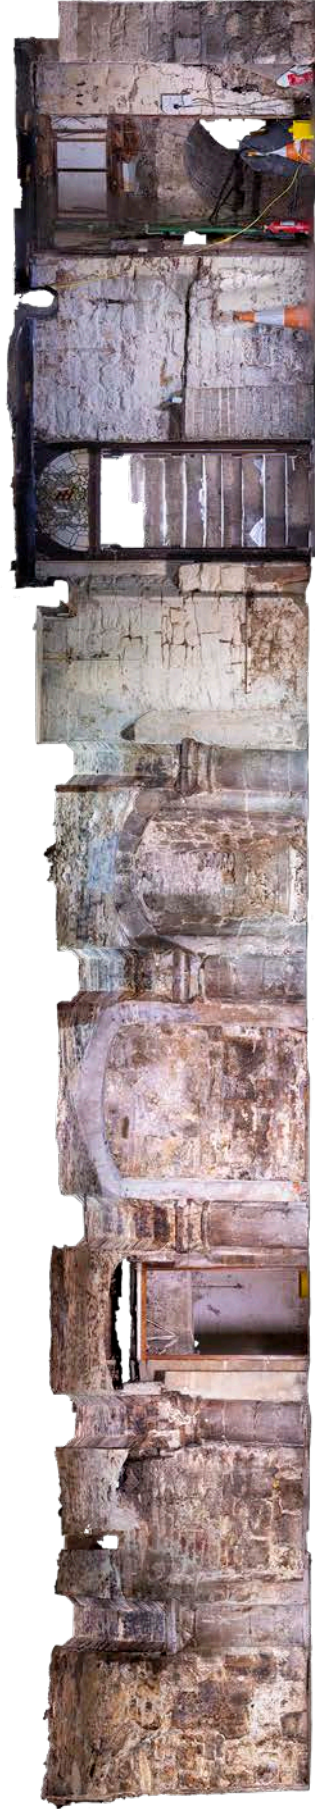
Figure 31: Rectified photograph of the west elevation of the undercroft. [Geospatial Survey © HEA DP364810]

The wider fourth bay from the south has a different original form to its western side. Although much modified, it appears that the western wall of the bay had a much wider opening, defined by walls at right-angles to the main wall line. Although the rear of this opening is now blocked, it seems likely that this represented the original access point into the undercroft, via a wide doorway. As with the windows this indicates that the area west of the undercroft was open, presumably as part of a courtyard arrangement similar to that which survives today.

It is evident that the undercroft originally continued further to the north and has been truncated at a later date. The northernmost surviving rib has a splayed angle on the western side to its north for a further window opening, indicating there was at least one further bay (see Figure 31). Its full extent is unknown, but it seems unlikely that it ever ran to the street – partly as that would have made it 26m long, which would have made it an extraordinarily large structure. Mainly, though, it is likely that, as in later phases, the street-front area of the plot was in use as separate commercial units, behind which the undercroft would have sat. It may originally have been similar in length to the extent of the 15th-century range, running a further 10m north from the northern extent of the surviving structure. That would still have made it a very long structure, however. Perhaps more likely is that it may have had two additional bays, which would have provided a symmetrical layout with the wider entrance bay placed centrally. This is speculation, though, and at present there is no evidence to indicate whether that was the original extent of the undercroft.

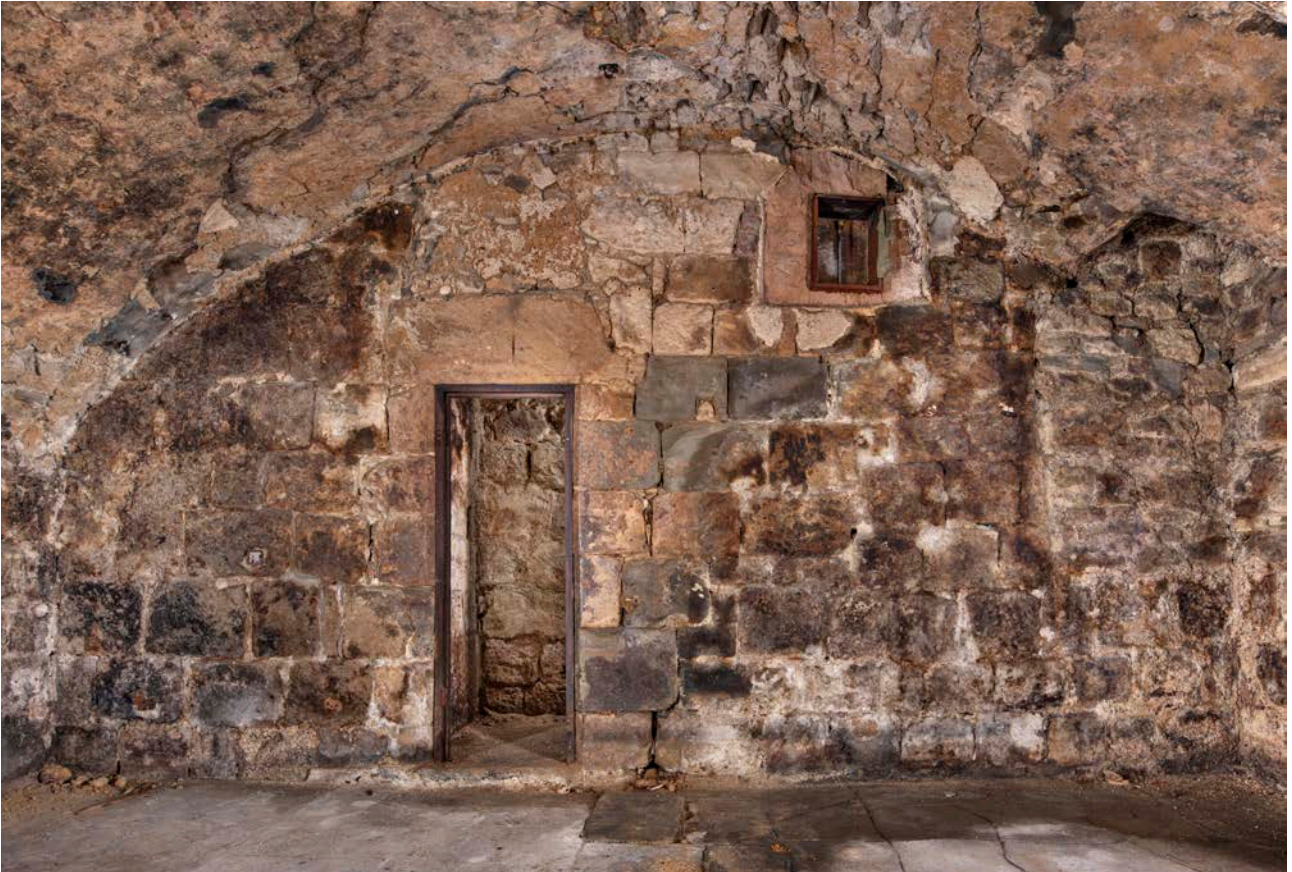
Figure 32: The south elevation of the undercroft, looking south, showing the original doorway to the intra-mural stair. [James O. Davies © HEA DP435614].

To the south, the original end wall survives (Figure 32). This is again of squared stone blocks laid in courses. Just to the east of the centre point is an extant doorway opening which provides access to a narrow intramural stair. This opening is again formed of finely cut stone, with a large stone lintel chamfered on its lower edge. It seems likely therefore that the doorway is an original feature, as the quality of the stonework is comparable to the other original features. Within the narrow stairwell four steps survive, also formed of stone (Figure 33). The south wall of the stairwell is formed of the same type of squared stone seen in the side walls of the undercroft. This all appears to confirm that, although later modified, the stair is an original feature. Given the likely presence of an original wide entranceway on the western side of the undercroft, the cramped nature of the stair makes it unlikely that it formed the principal access route into the cellar. The narrow proportions of the stair and its associated doorway would not have facilitated the movement of goods into and out of the undercroft. Instead it seems likely that this stair communicated with the upper floors of the building.

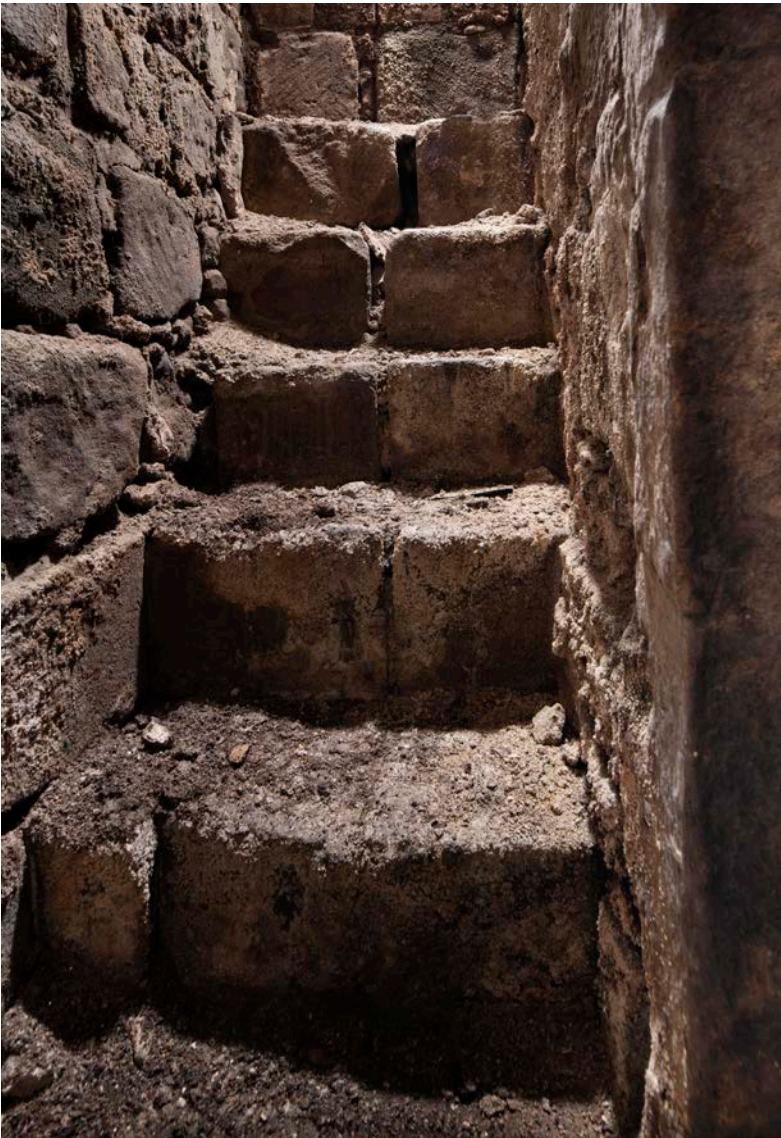
Figure 33: The original intra-mural stair in the south wall of the undercroft, looking west. [James O. Davies © HEA DP435615].

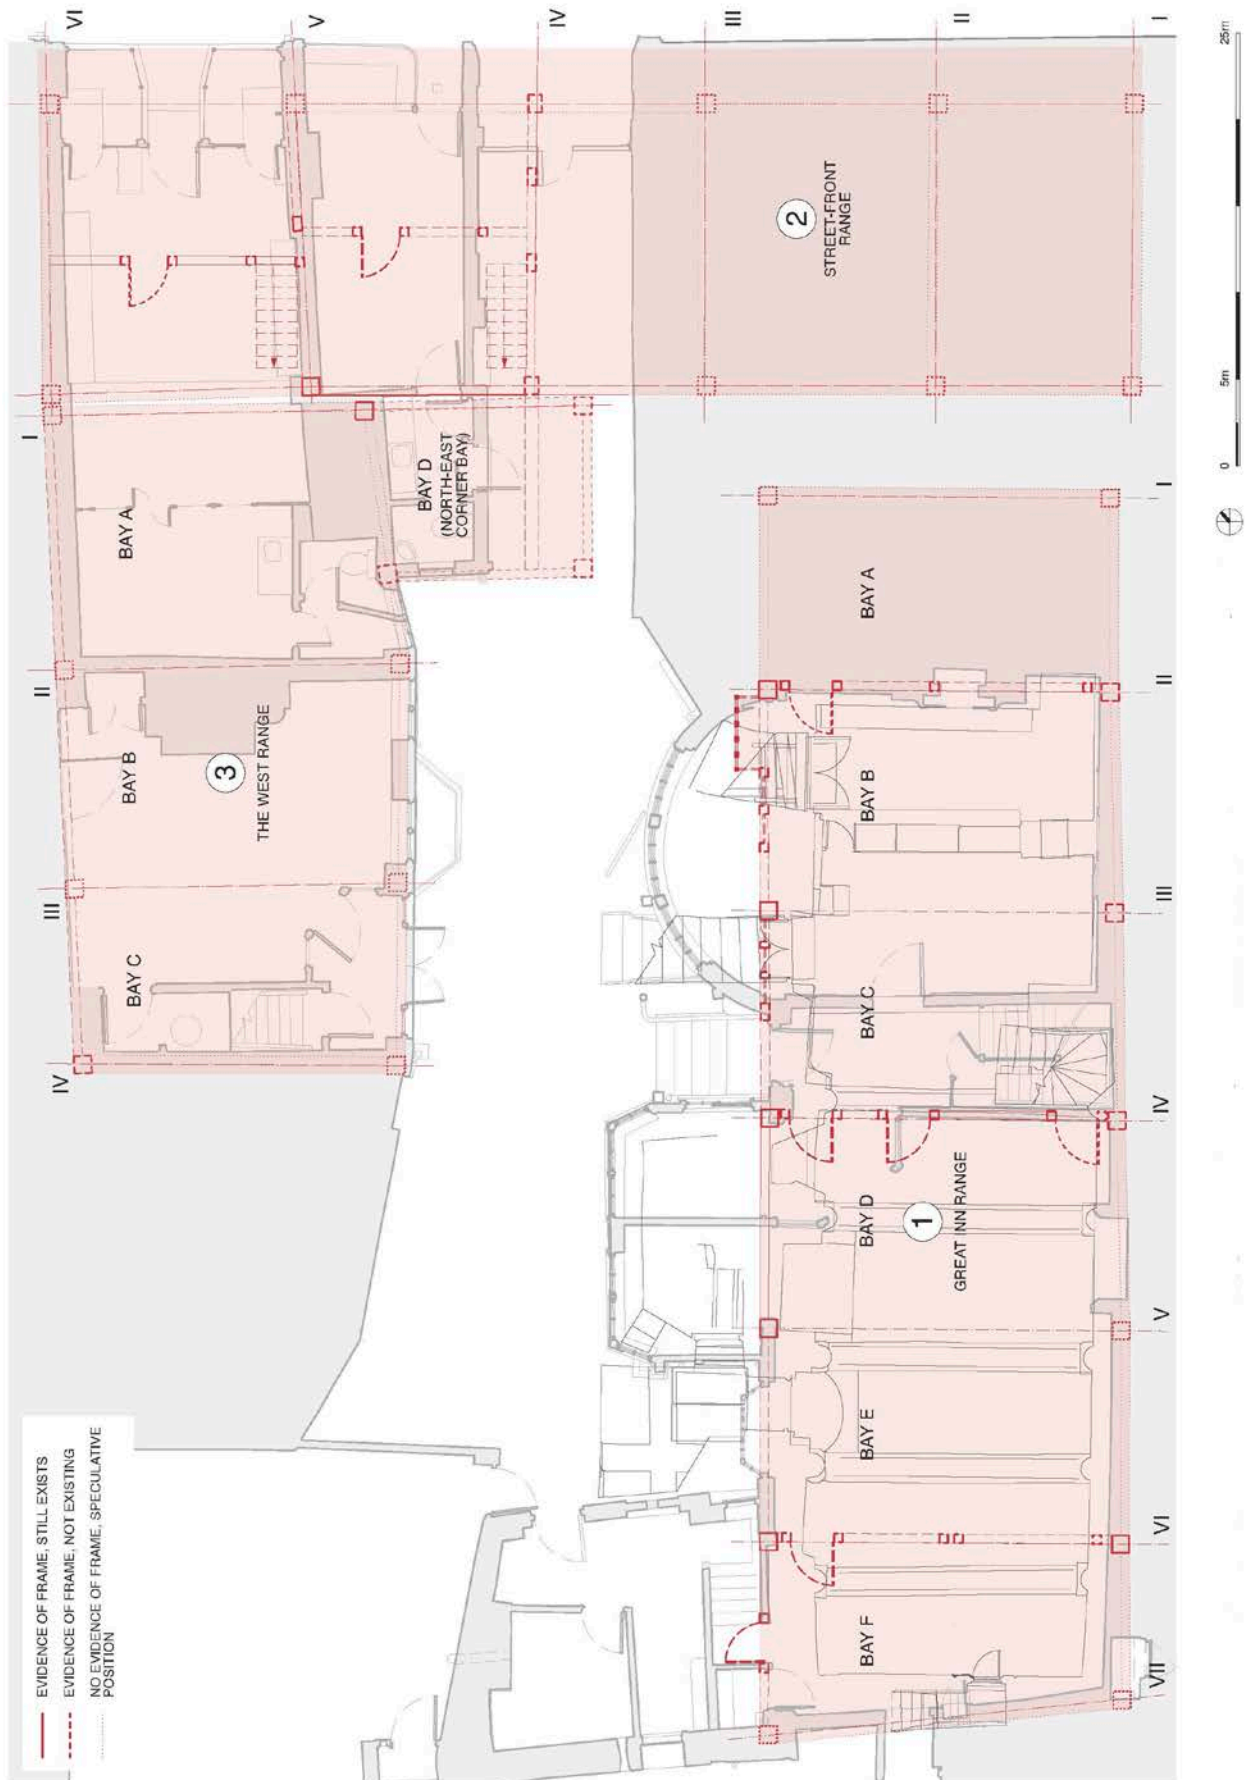
Figure 37: Plan of the three main ranges, showing the ground-floor plan as reconstructed from surviving evidence. [© Butler Hegarty Architects. Reproduced with permission.]

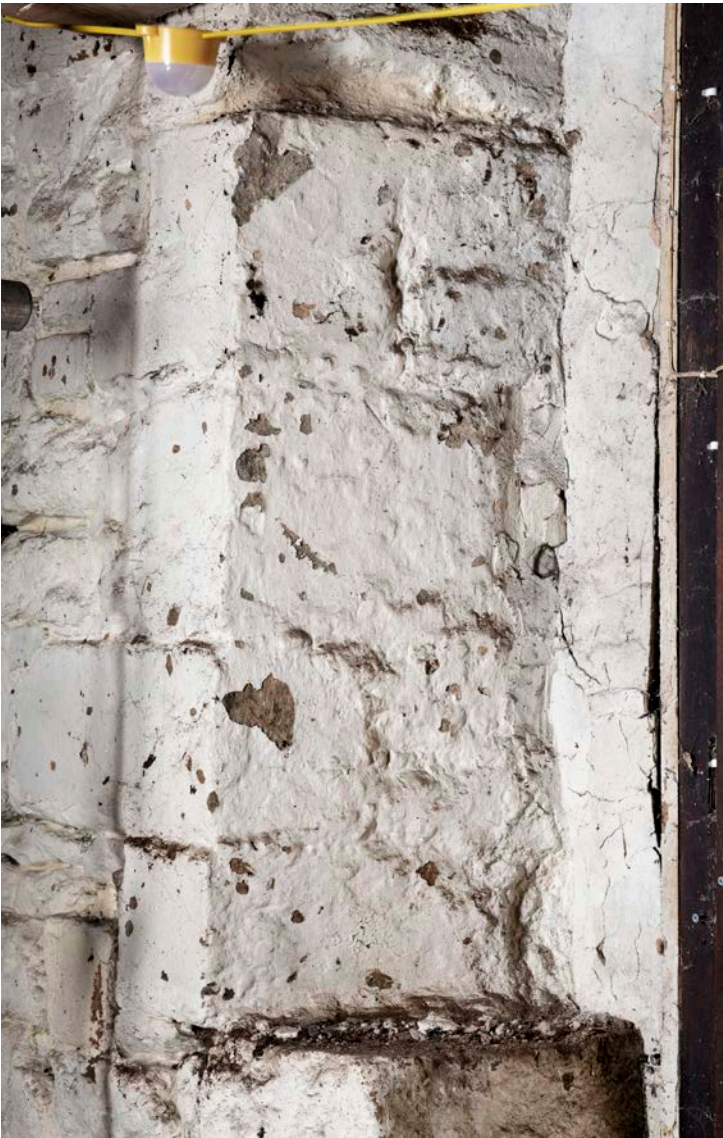
Figure 38: Splayed window opening in the north end of the undercroft, looking south-west, possibly dating from the 15th century. [James O. Davies © HEA DP435624]

As discussed above (see Phase One), the undercroft as it survives today is truncated from its original extent, with an unknown number of bays missing from its northern end. It seems likely that this partial demolition was undertaken as part of the redevelopment of the site in the 15th century, although it is possible that it happened at some stage prior to this (between the 12th and the 15th centuries). It certainly did not happen any later than the construction of the 15th-century timber frame, as the northern half of the frame was constructed to work with a lower level towards that end of the building.

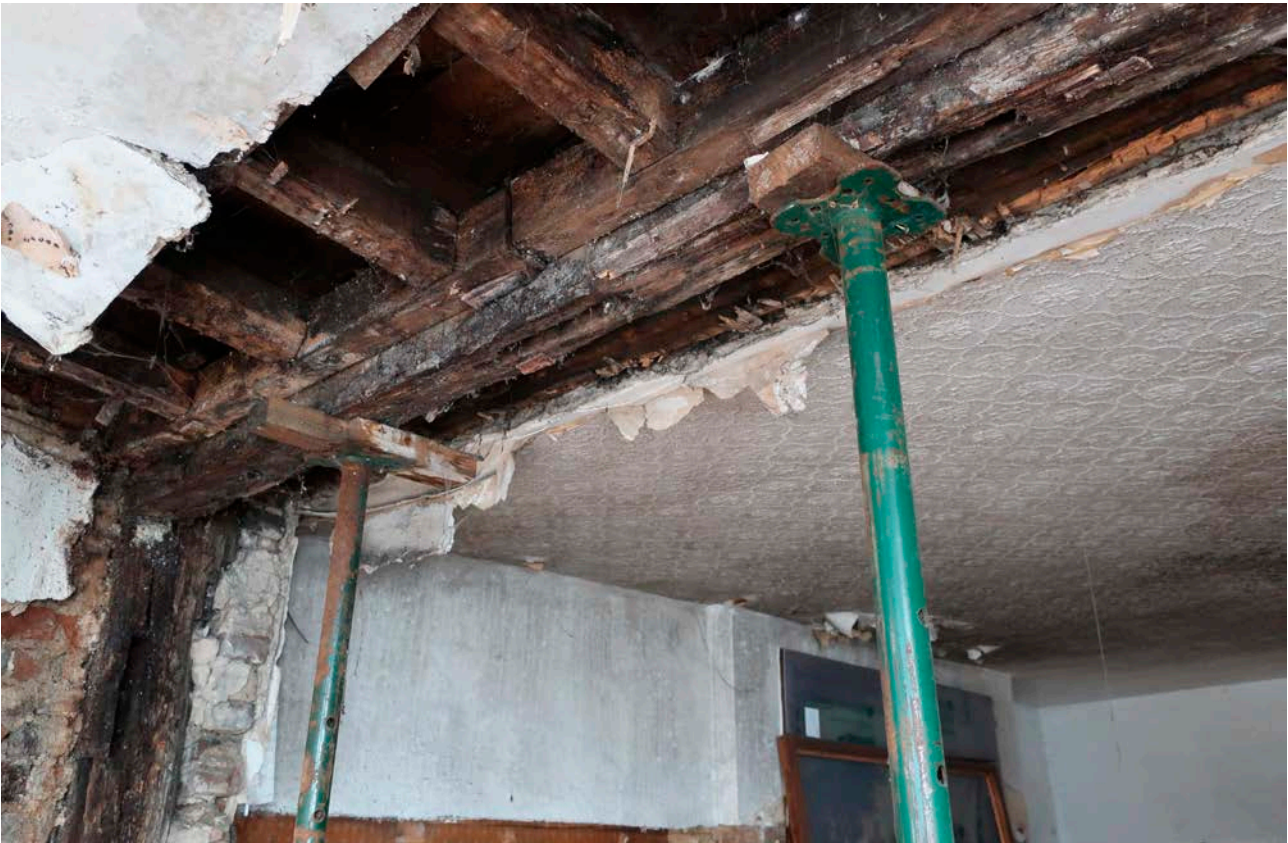
Figure 39: Girding beam forming part of the west elevation of the great inn range, looking north-east, with empty mortices showing the position of studs and window openings. [Rebecca Lane © Historic England]
