The Fleece Hotel, 19, 19A and 21 Westgate Street, Gloucester

Historic Building Investigation

Rebecca Lane

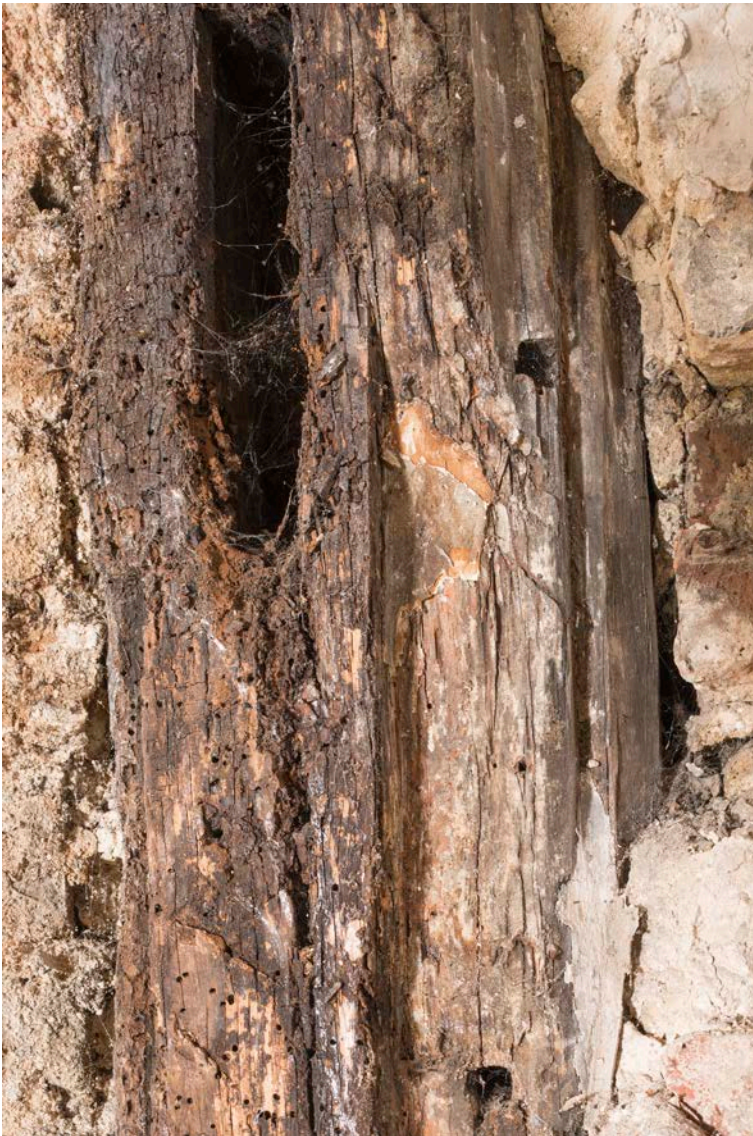
Figure 40: The west post of frame II of the great inn range, looking north, showing the moulding on the inner face of the post. [Steve Baker © HEA DP325691]

On the western side much of the girding beam survives (in bay B and part of Bay C), as well as the west post of frame II (as noted above). The post is moulded with an ogee moulding, possibly originally with a roll on its inner edge although this has been cut back (see Figure 40). This contrasts with the plain chamfer mouldings seen in the rest of the rooms in the great inn range. As well as the moulding on the inner face, on the southern side of this post three redundant mortices are visible. Two of these sit towards the top of the post, some 2.4m from ground level (Figure 42). The upper one of these two sits in the centre of the post and is angled to take a timber running horizontally along the elevation at high level. The lower one sits on the western edge of the post and is angled outwards, most likely for a timber which would have formed the lintel of a projecting bay or oriel window. Below this, just 0.7m above the ground level, is a further large mortice orientated along the wall line (Figure 43). The top of this lowest mortice coincides with a deep cut in the side of the post, running its full depth. This appears to form part of the same feature as the adjacent mortice and in fact to indicate the former position of a sill forming the base of

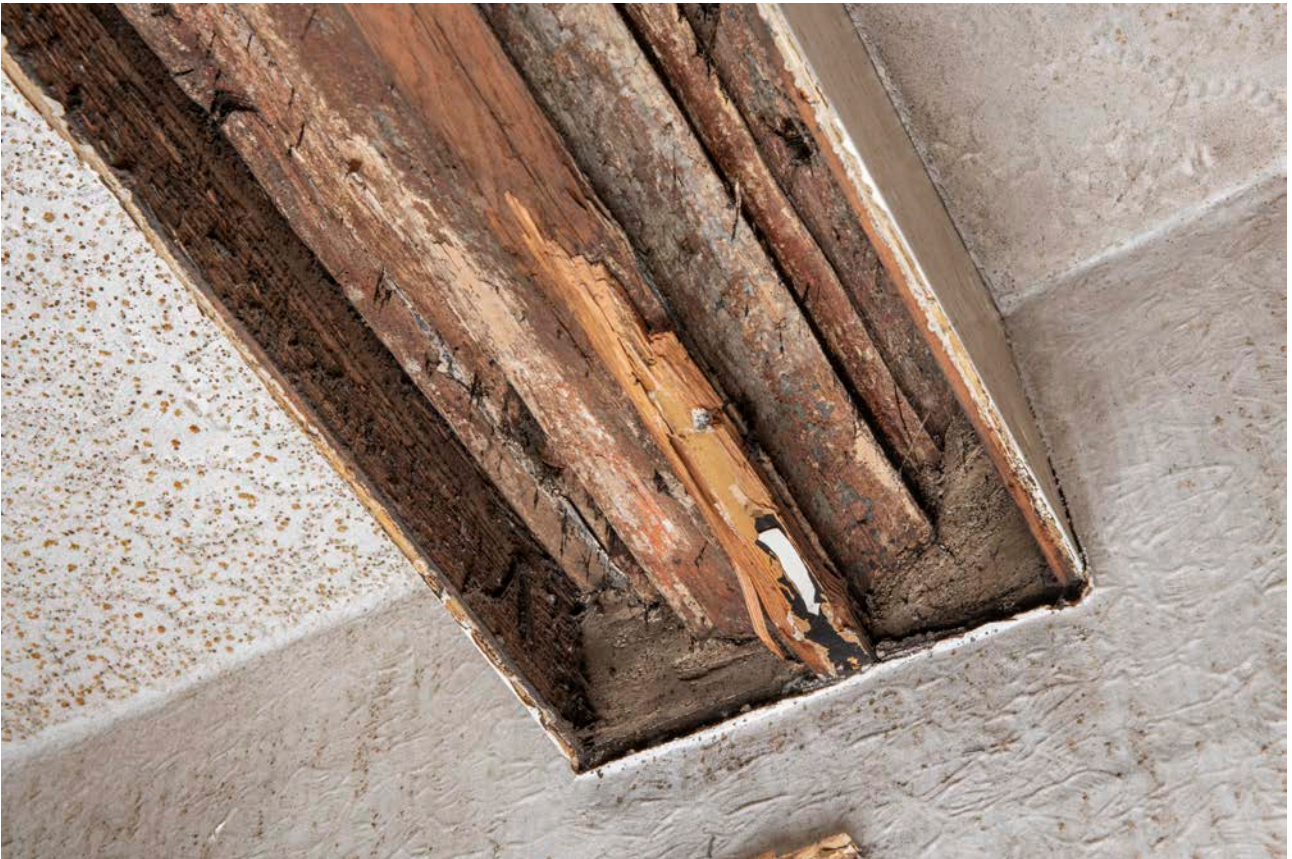
Figure 41: The cross beam of frame III, looking north-east, showing the moulding on the underside of the beam. [James O. Davies © HEA DP435628]

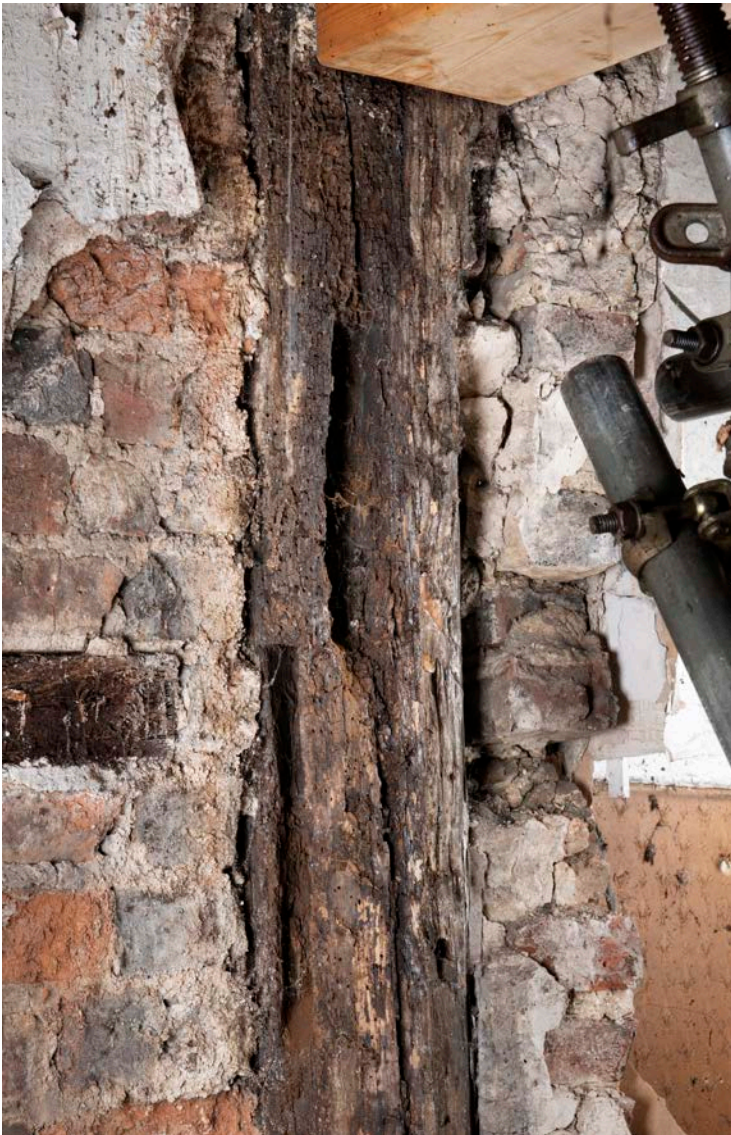
Figure 42: The west post of frame II showing the mortices which indicate the position of an oriel window, looking north-east. [James O. Davies © HEA DP435633]

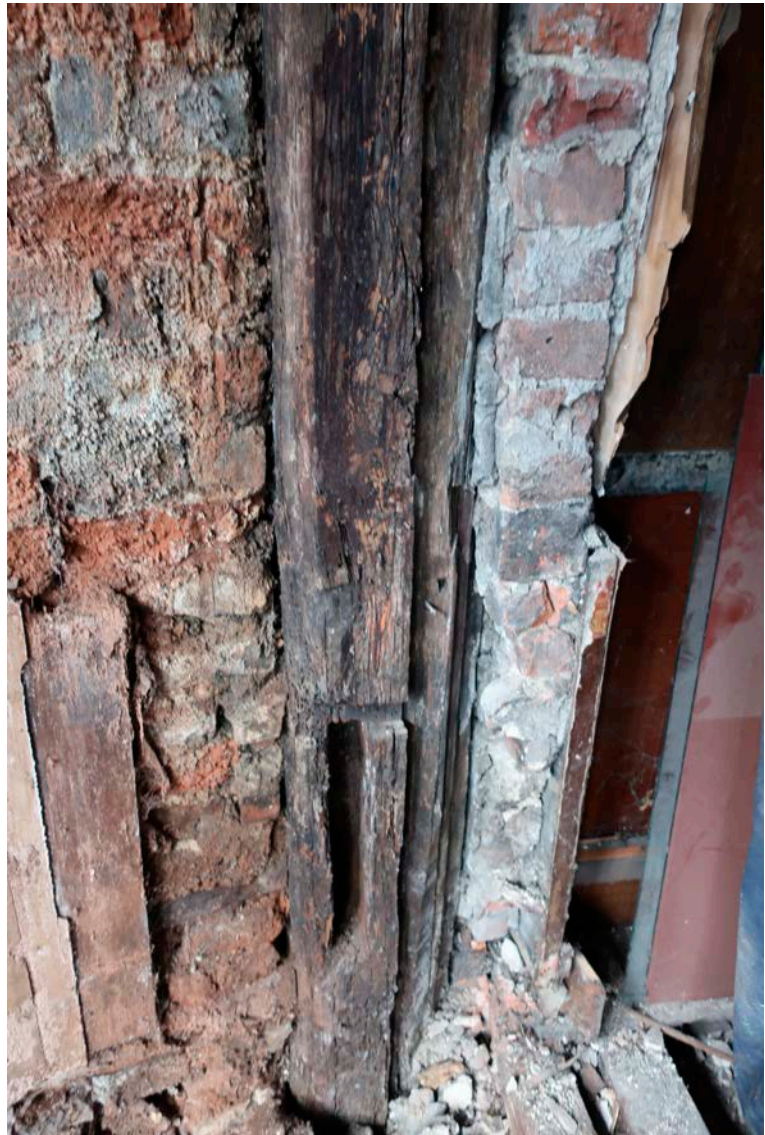
Figure 43: Lower part of the west post of frame II showing the mortice and slot which indicate the base of the oriel window, looking north.
[Rebecca Lane © Historic England]

the wall line. This is indicated by a smaller mortice for a central mullion and then a further mortice for a stud forming the southern side of the window (the stave hole cut just to the north of this mortice is a later feature). As this window evidently sat directly underneath the girding beam, it must have sat at a relatively high level within the room. It is possible it was part of a further full-height window opening or that it was a high-level window designed to provide more light. The remainder of the girding beam in this bay has stave holes as far as frame III, suggesting that there were no further windows in the bay. The western post of frame III was cut off below the girding beam in a later phase (see Phase Three below), although it is still in situ at higher level, as the joint between the cut off beam and the cross beam of frame III is still extant (Figure 44). It is likely that in its original form it would have had the same moulding pattern as that seen on the posts of frame II, which would have continued around to the corresponding moulding on the cross beam itself. The cross beam, later boxed in, is also cut back at its western end, but towards the east more of the moulding survives (see Figure 41). Only the northern part of the west girding beam in bay C is visible, but any features are hidden by a later timber attached to the underside of the

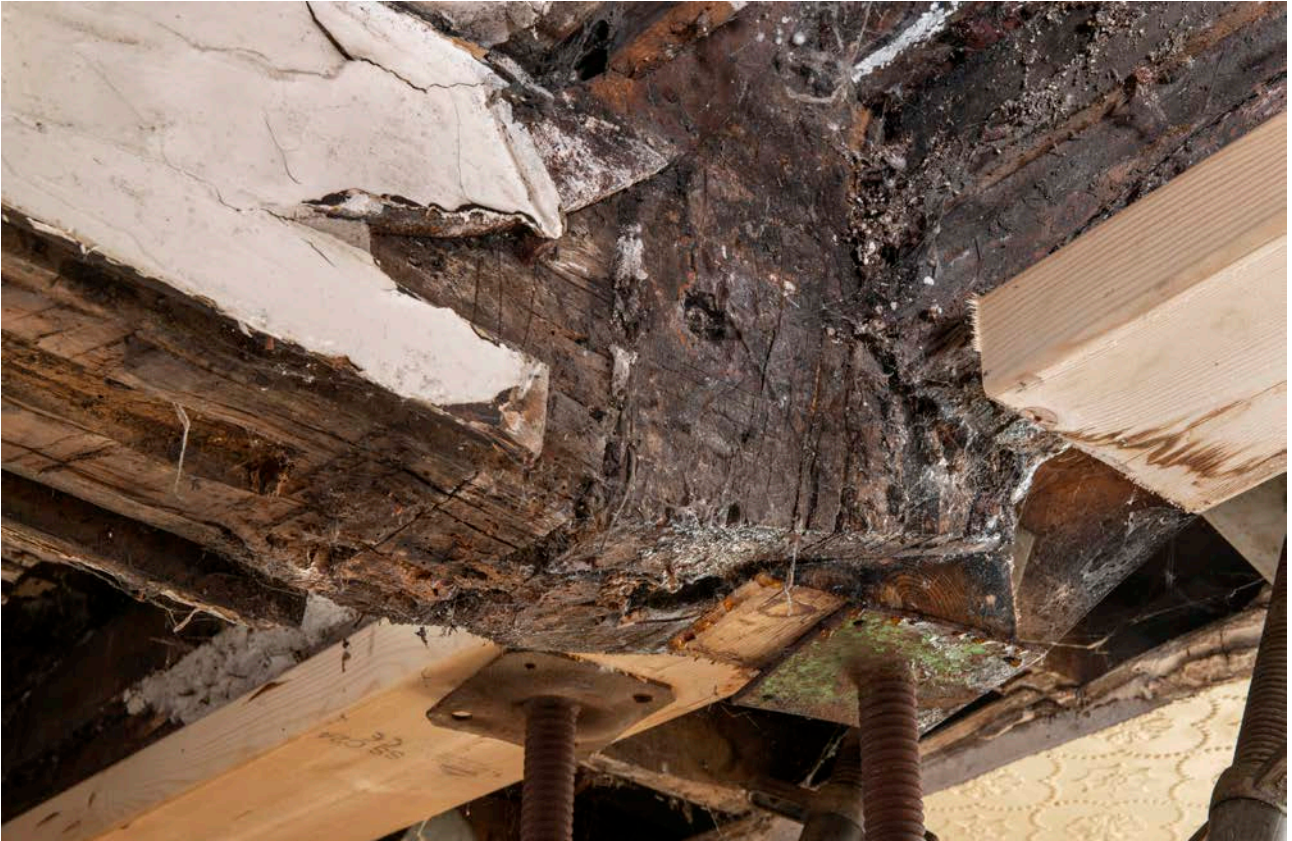
Figure 44: The western post of frame III, cut off below the cross beam, looking south-west. [James O. Davies © HEA DP435643]

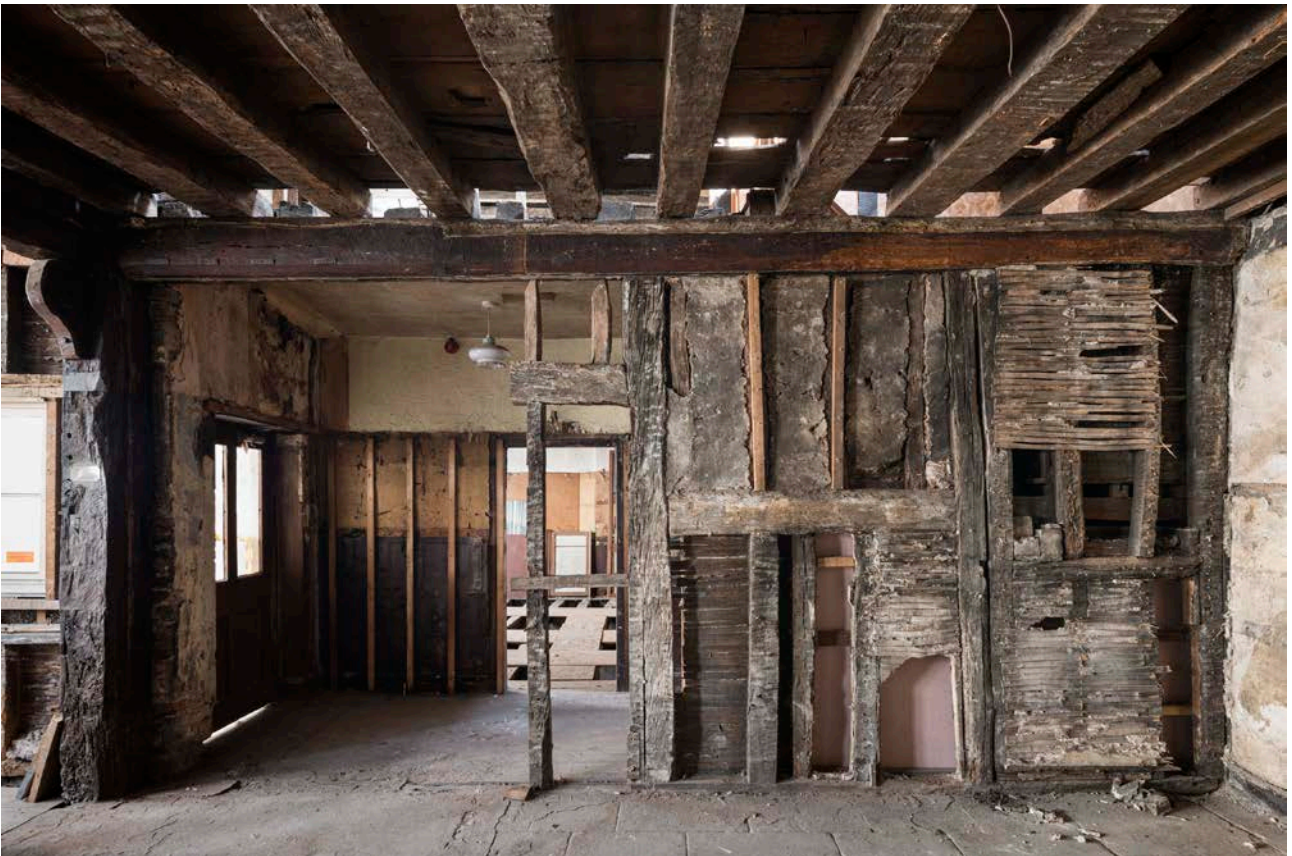
Figure 45: The ground-floor partition forming part of frame IV, looking north. [Steve Baker © HEA DP325620]

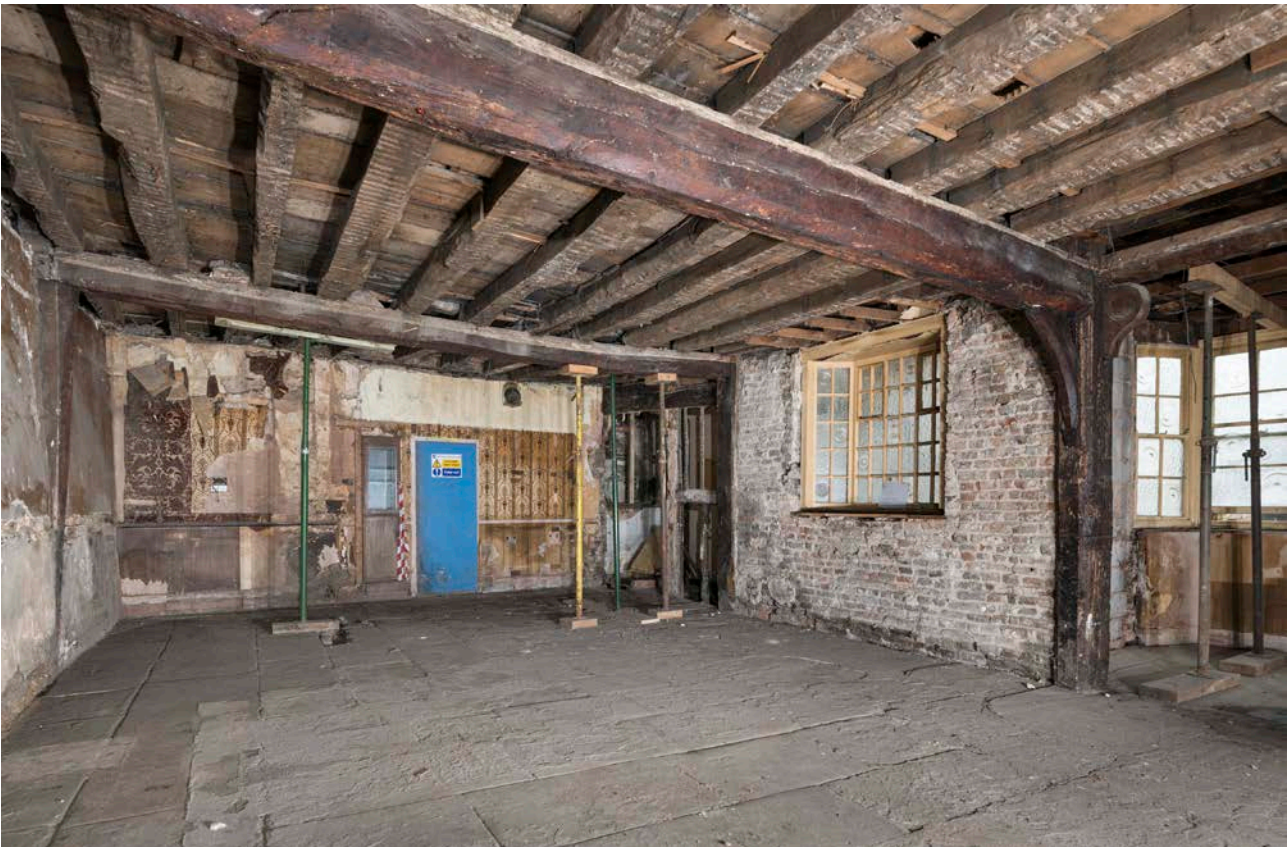
Figure 47: The southern part of the ground-floor area of the great inn range, looking south-west. [Steve Baker © HEA DP325600]

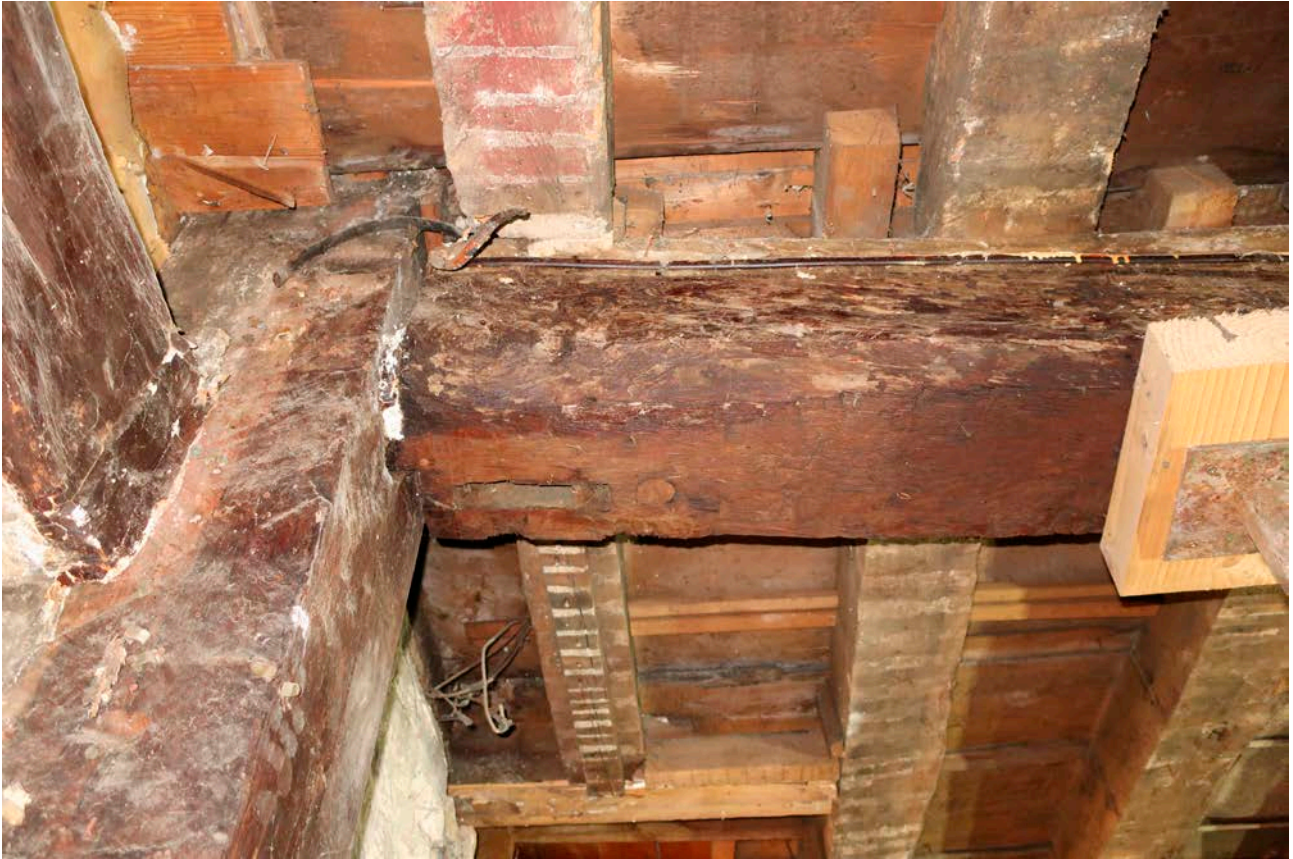
Figure 49: The cross beam of frame VI, looking north, showing the mortice for the western jamb of the doorway. [Rebecca Lane © Historic England]

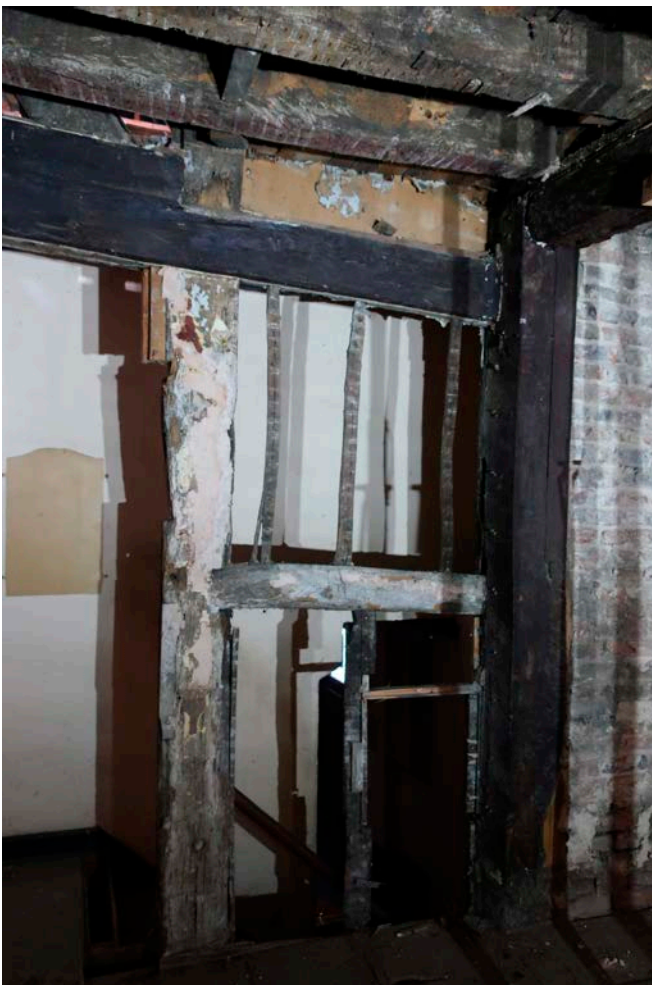
Figure 50: The western elevation of the great inn range in bay F, looking west, showing surviving timber framing of the west wall. [Rebecca Lane © Historic England]

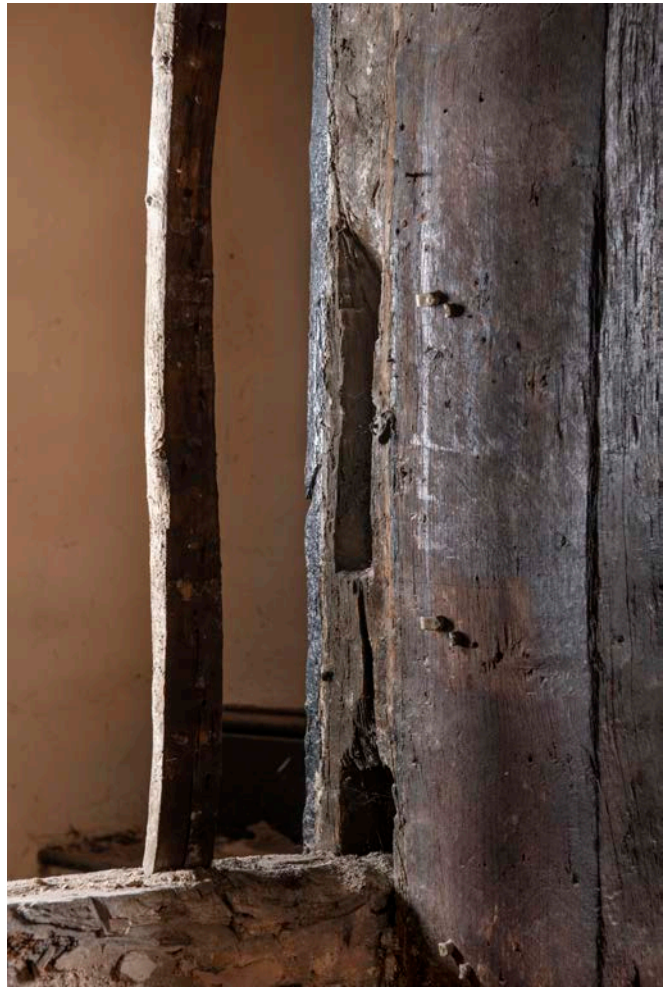
Figure 51: The west post of frame VI, looking north-west, showing the empty mortice for an up-brace. [James O. Davies © HEA DP435641]

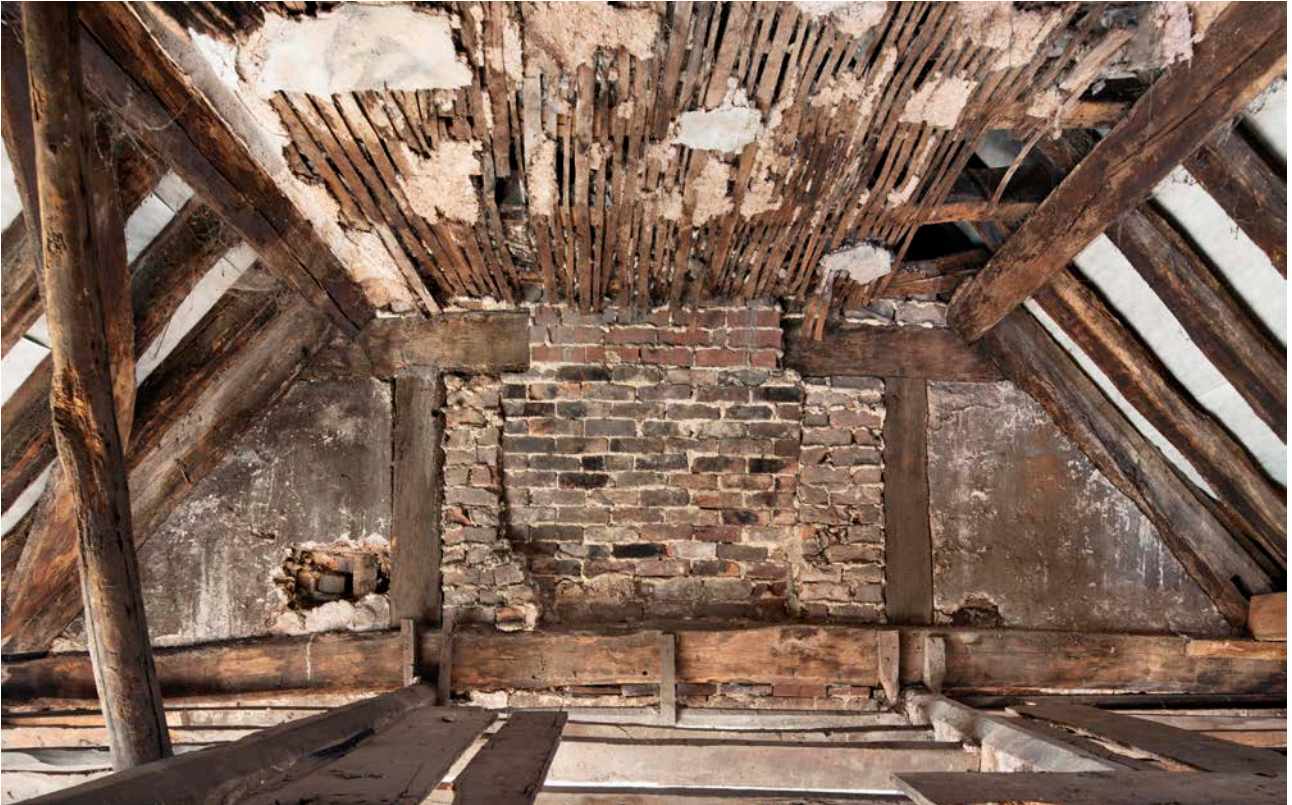
Figure 55: The upper part of frame II, looking north, showing the form of the original timber truss with later brick infill. [James O. Davies © HEA DP435635]

As at ground-floor level, the northernmost bay of the original building has been completely replaced in the reconstruction of No. 17, but the original western post and tie beam of frame II survives and much of the truss above, although the collar has been cut for the insertion of a later chimney (Figure 55). The western post has the pegging for the original mid-rail running to the south; the northern side cannot be seen. At the top of the post a large section of later infill probably conceals the position of a mortice for a down-brace, suggesting that the frame was closed at first-floor level. The tie beam is chamfered on both sides, but the underside has the stave holes for a partition, further indicating that the northern bay, to the north of frame II, was divided from the bays to the south. The pattern of mortices indicates there was a larger central full-height stud, with a smaller secondary stud towards the west, with intermediate stave holes. There are no mortices for jambs at the western end for a doorway like those in the partition trusses further south. The eastern part of the tie beam is not currently visible. There may have been an interconnecting doorway towards the east of the wall, although this would mean it was out of alignment with the doorways to the south (see below). Alternatively it is possible that the northern bay was accessed separately either via an external stair or possibly via the street-front range.

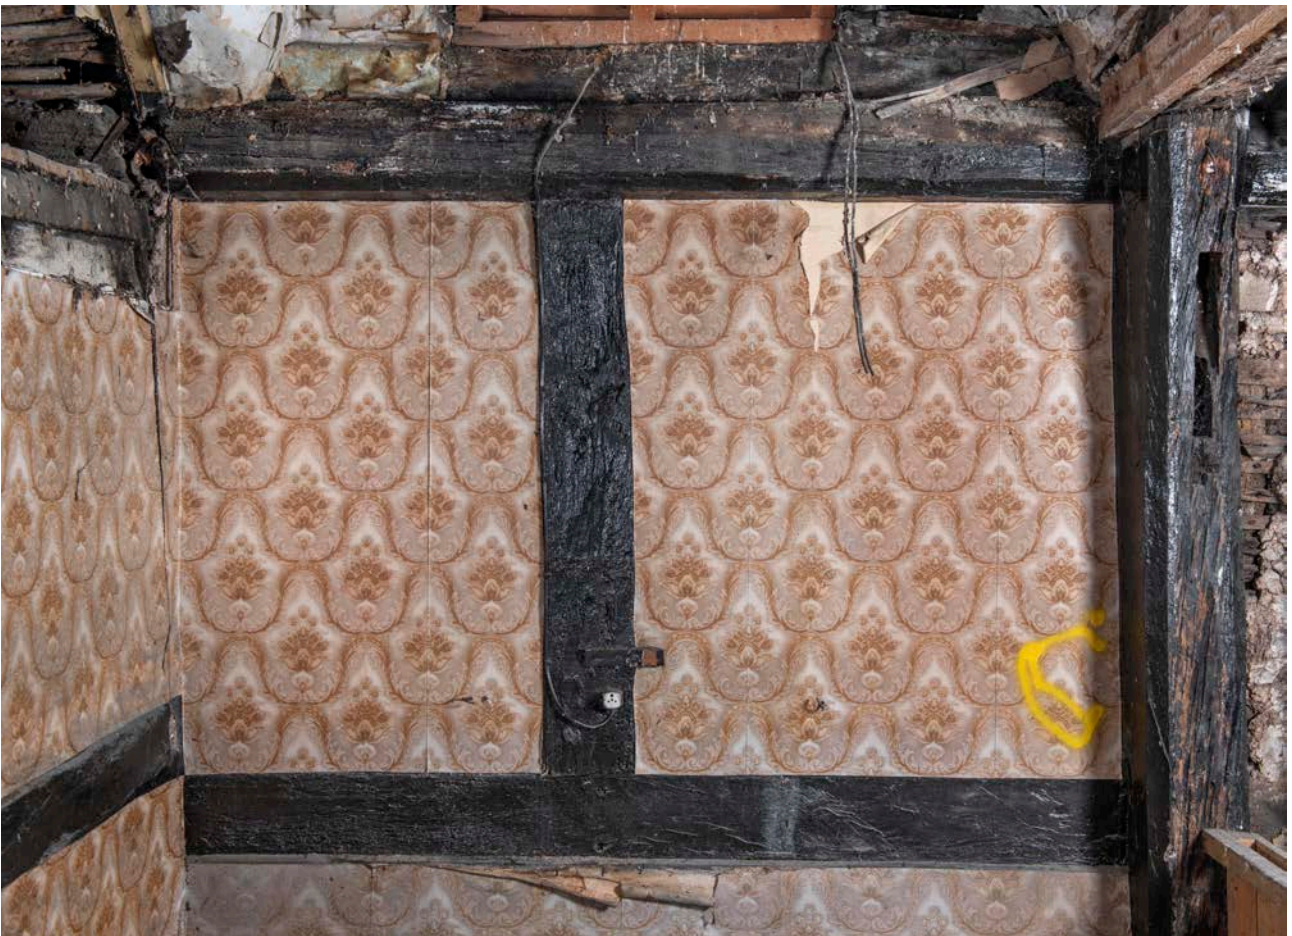
Figure 56: The timber framing of the east elevation of bay C, looking east, showing the mid-rail and stud arrangement. [James O. Davies © HEA DP435653]

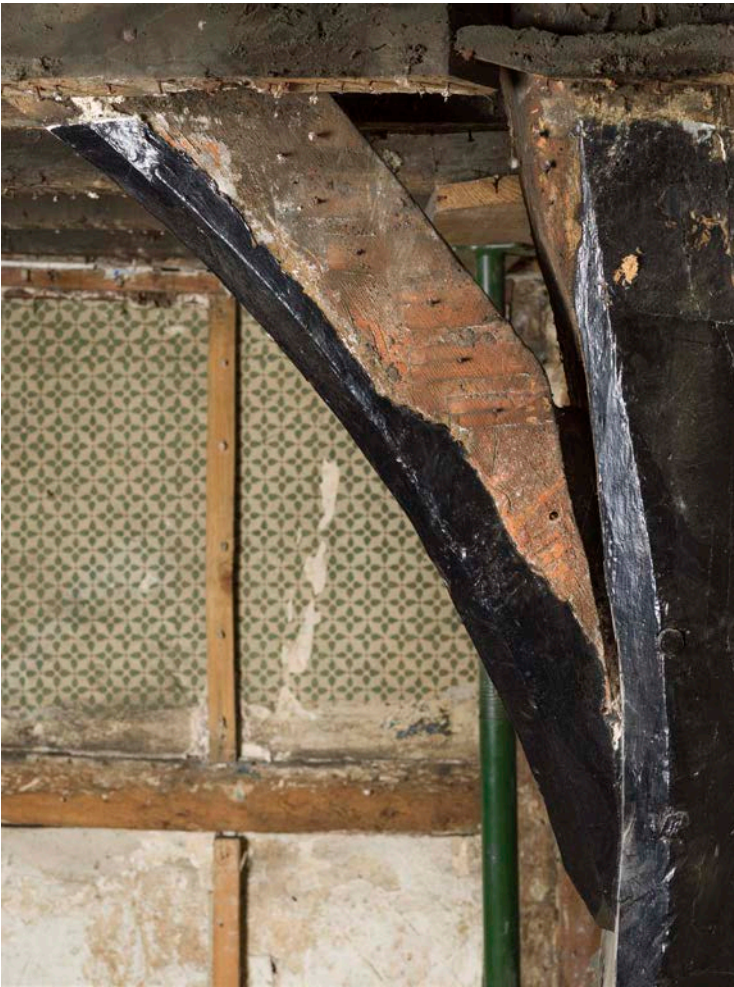
Figure 57: The up-brace and western post of frame III, looking south, showing surviving fragments of a red paint. [Steve Baker © HEA DP325669]

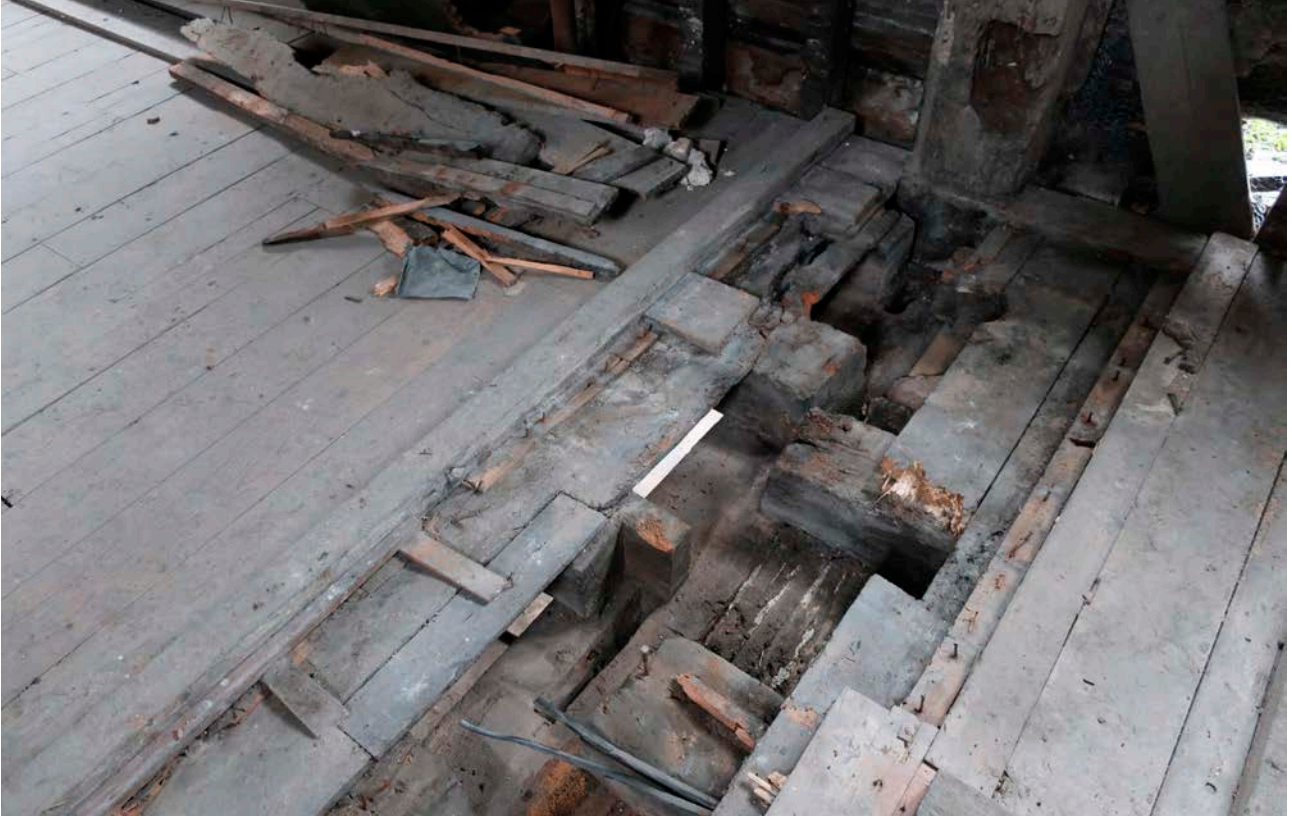
Figure 58: The upper edge of the cross beam in frame IV, looking south-west, showing empty mortices for the partition at first-floor level and the floor joists resting on top of the beam. [Rebecca Lane © Historic England]

The other notable feature of frame IV is that the joists of the ground-floor ceilings to the north and south of the frame are currently visible where they meet over the cross beam. Both sets of joists are in fact simply resting on the upper side of the cross beam, not jointed into it (see Figure 58). The joists of the floor over bay C (to the north of frame IV) only project very slightly over the cross beam, an overlap of about 0.05m. The joists of the southern bay (bay D) are more deeply set on the beam but have been cut around the studs of the partition, including one joist which is cut to form a right-angled corner to accommodate one of the studs. As the studs of the partition were properly jointed into both the cross beam and the tie beam they must be contemporary with the erection of the frame. The joists therefore must either also be contemporary or a later insertion carefully designed to accommodate the partition. The possibility of the floor being a later insertion must be considered, but as both sets of joists have the same structural relationship with the cross beam, it seems likely they are contemporary with each other and with the rest of the frame. There is also other evidence to suggest that the building never had an open hall – including the lack of smoke blackening on the roof and the evidence that the cross beam of truss V at ground-floor level appears to be an original feature.

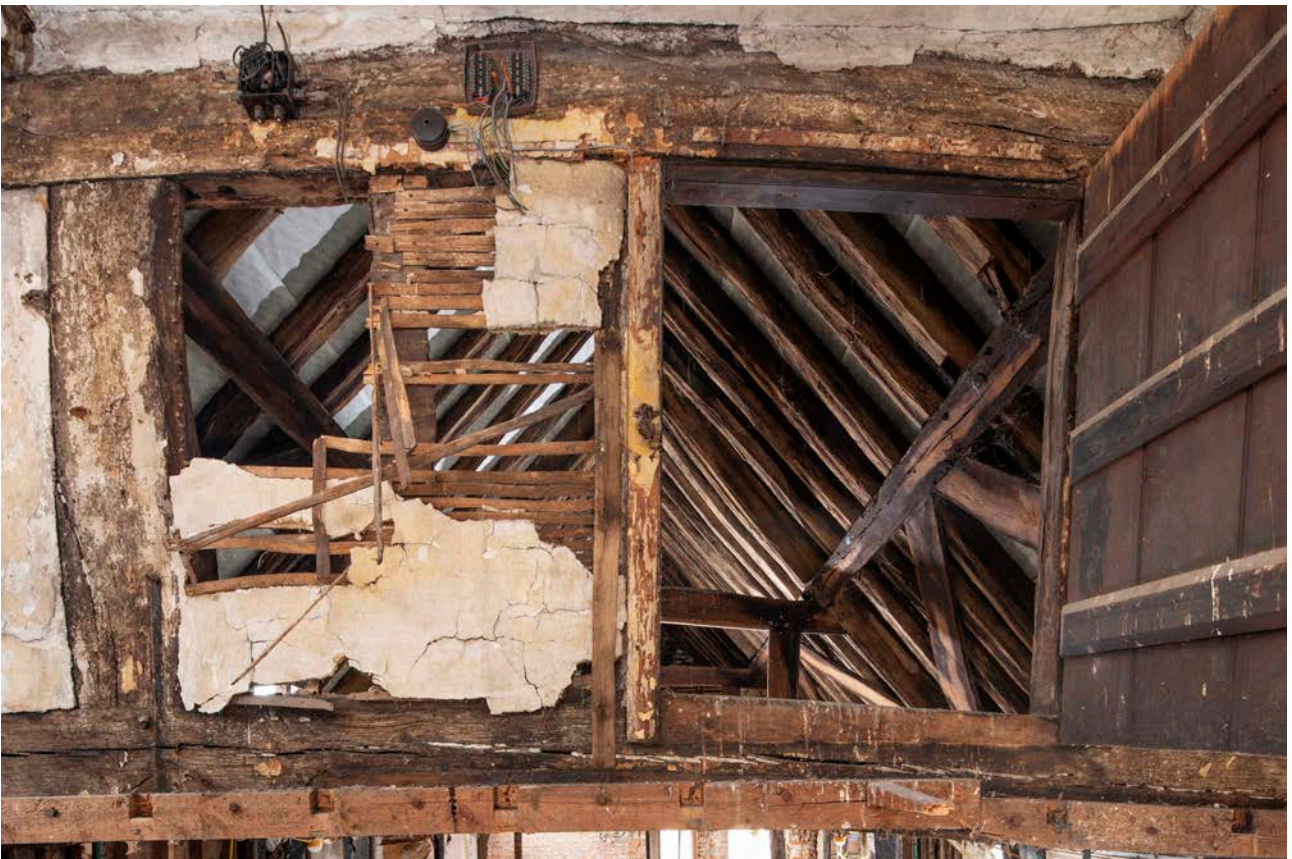
Figure 59: The central part of the truss of frame IV, looking south, showing the original stave positions on the underside of the collar. [James O. Davies © HEA DP435636]

Frame IV formed a partition, which ran the full height of the first floor. Although this partition has subsequently been removed, on the upper side of the cross beam and the lower side of the tie beam the pattern of mortices and stave holes indicates that originally the partition was fully closed, apart from a gap in the stave holes at the western end indicating the position of a doorway (see Figure 46). A large redundant mortice on the eastern post indicates that there was a curving down-brace at this end running into the cross beam. As with the evidence for the other closed partitions (in frame II and frame VI), there appears to have been a large central stud rising between the cross beam and the tie beam. The position of a further stud towards the west is also clear, with a smaller mortice right at the western end of the cross beam indicating a narrower stud adjacent to the west post, which must have formed the western door jamb (Figure 58). At high level a IIII can be seen scribed on one of the queen struts of the truss. At roof level some surviving original stave holes and one surviving stave are visible between the tie beam and the collar (with later laths adhering to the outside), indicating that the truss was also closed at roof level (Figure 59 and see Figure 46).

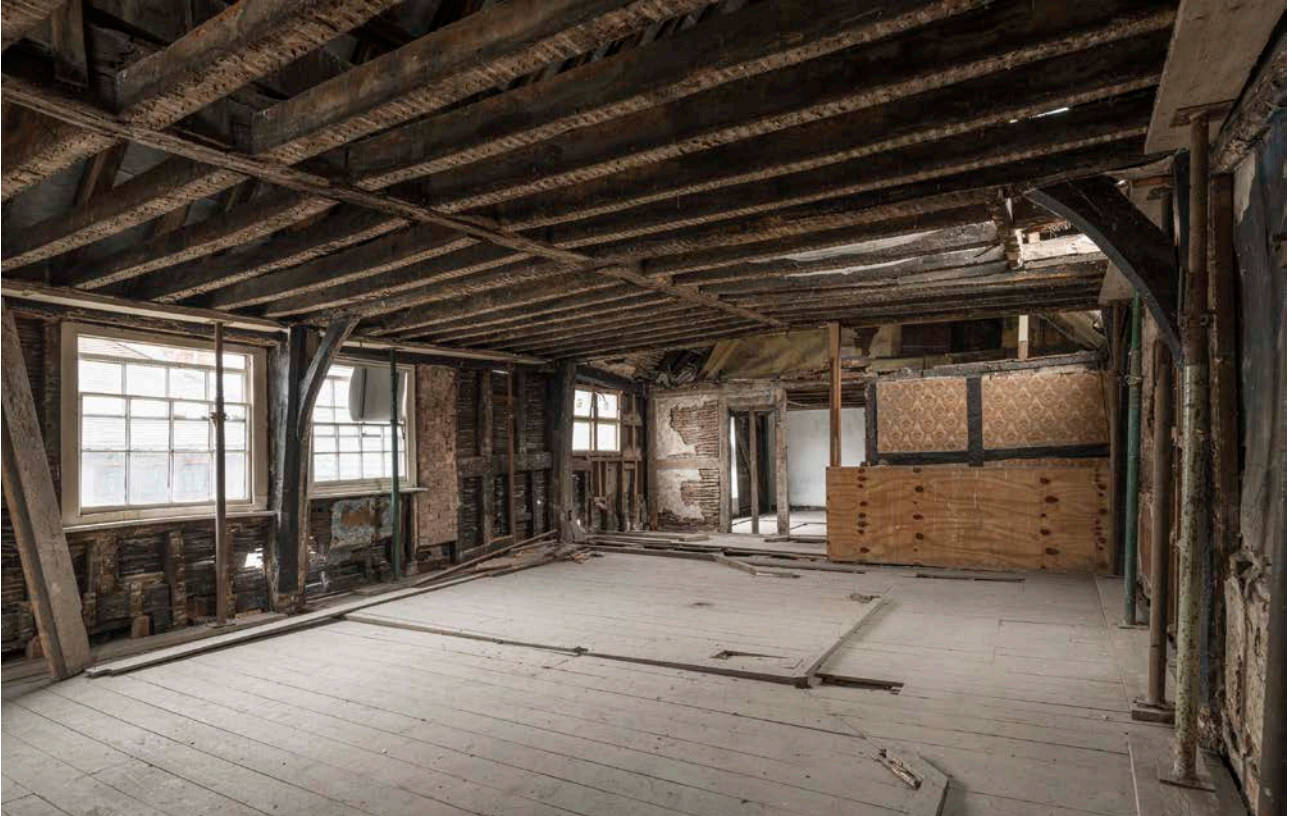
Figure 60: The central area of the first floor of the great inn range, including frame V, looking north-west. [Steve Baker © HEA DP325595]

South of frame IV there was a further two-bay room of similar form and proportions as that immediately north of it (Figure 60 and see Figure 54). This ran from frame IV to frame VI and had direct access into the rooms directly north and south of it. The eastern side of bay D has one of the few sections of surviving framing on the eastern side of the range. The southern part has been infilled with a much later partition (which has also seen the removal of the associated wall plate) but to the north the mid-rail and the upper part of one of the studs survive (Figure 61). North of the stud, running up to the eastern post of truss IV, there are some apparently early laths surviving with plaster still adhering to the inner face. South of the surviving stud three small mortices are visible in the underside of the wall plate, indicating a possible window position in the centre of the bay. This has been infilled with later studding. On the western side of bay D further framing survives in the form of the northern half of the mid-rail and the northern stud. The southern part has been altered by the insertion of a later window, but the lower part of the southern stud survives below the window and pegging in the northern side of the post of frame V indicates that the mid-rail originally ran through to the post. In the northern third of the bay, the wall plate and mid-rail both show the redundant mortices of a two-light window. There is a small rectangular mortice for the central mullion, with two smaller diamond-shaped mortices for bars set either side of this. In the southern side of the post of frame IV a redundant mortice immediately below the wall plate appears to indicate the position of a timber which must have provided an arched head to the window. This is matched by a corresponding redundant mortice in the side of the stud forming the south side of the window (Figure 62). No other original window positions have evidence for such an arch-headed feature, which suggests this window may have been more elaborate than other examples. Grooves cut into the mid-rail appear to be later, presumably to block the window in a later phase.

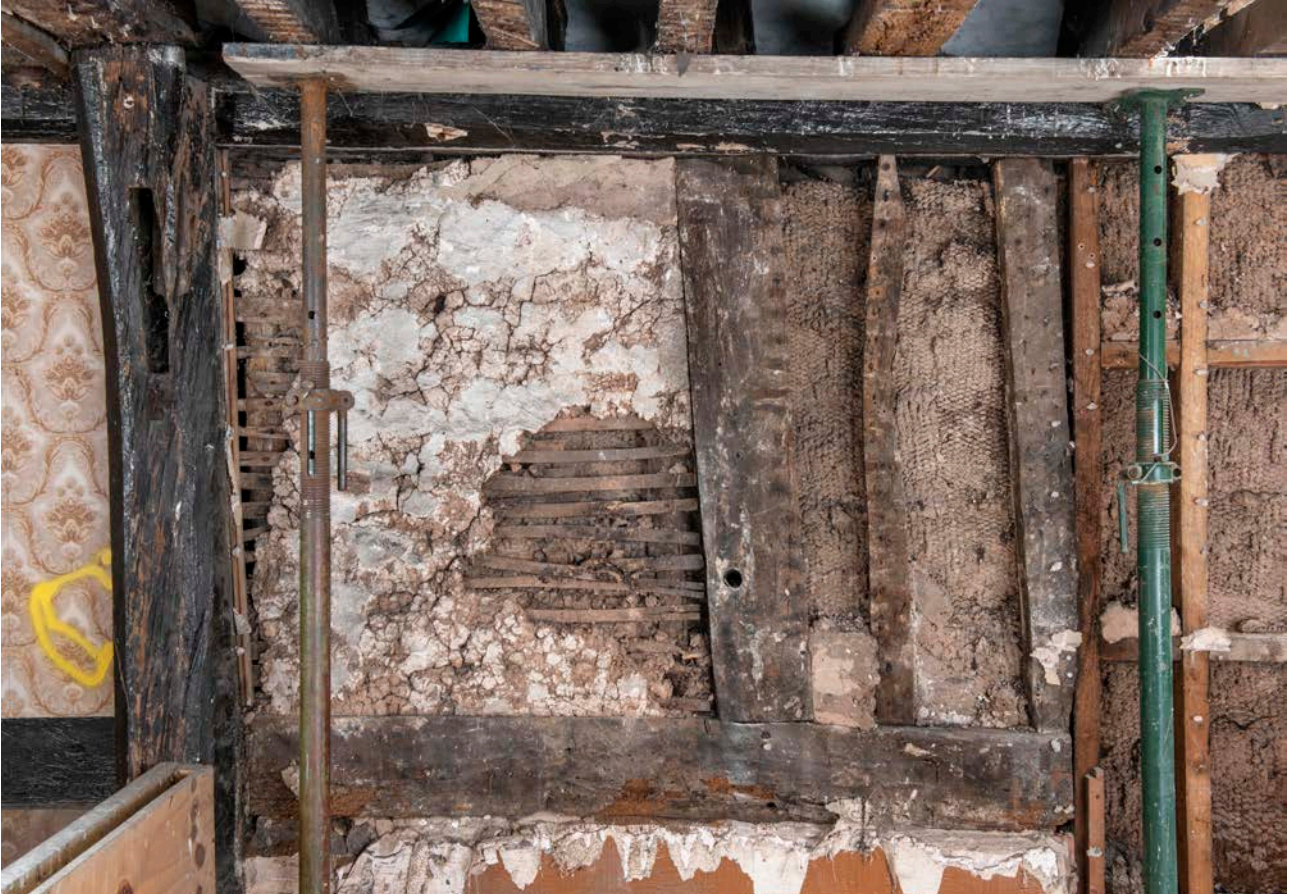
Figure 61: Surviving framing of the east elevation of bay D, looking east, with surviving wattle and daub infill. [James O. Davies © HEA DP435652]

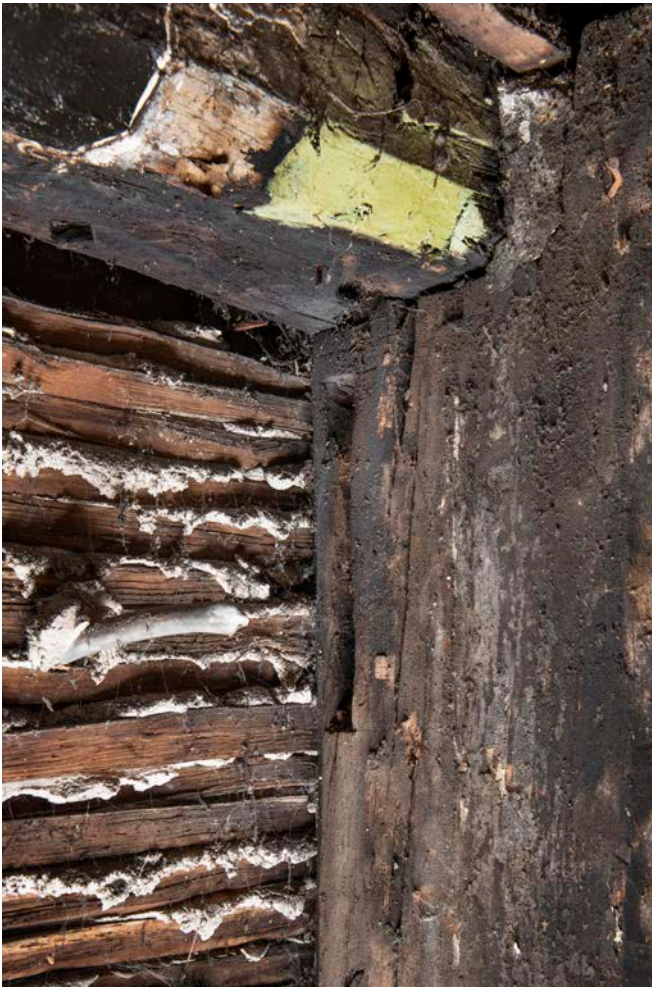
Figure 62: The west post of frame IV and the framing in bay D, looking north-west, showing the mortice for a window head and the diamond-shaped hole in the wall plate for an iron bar. [James O. Davies © HEA DP435629]

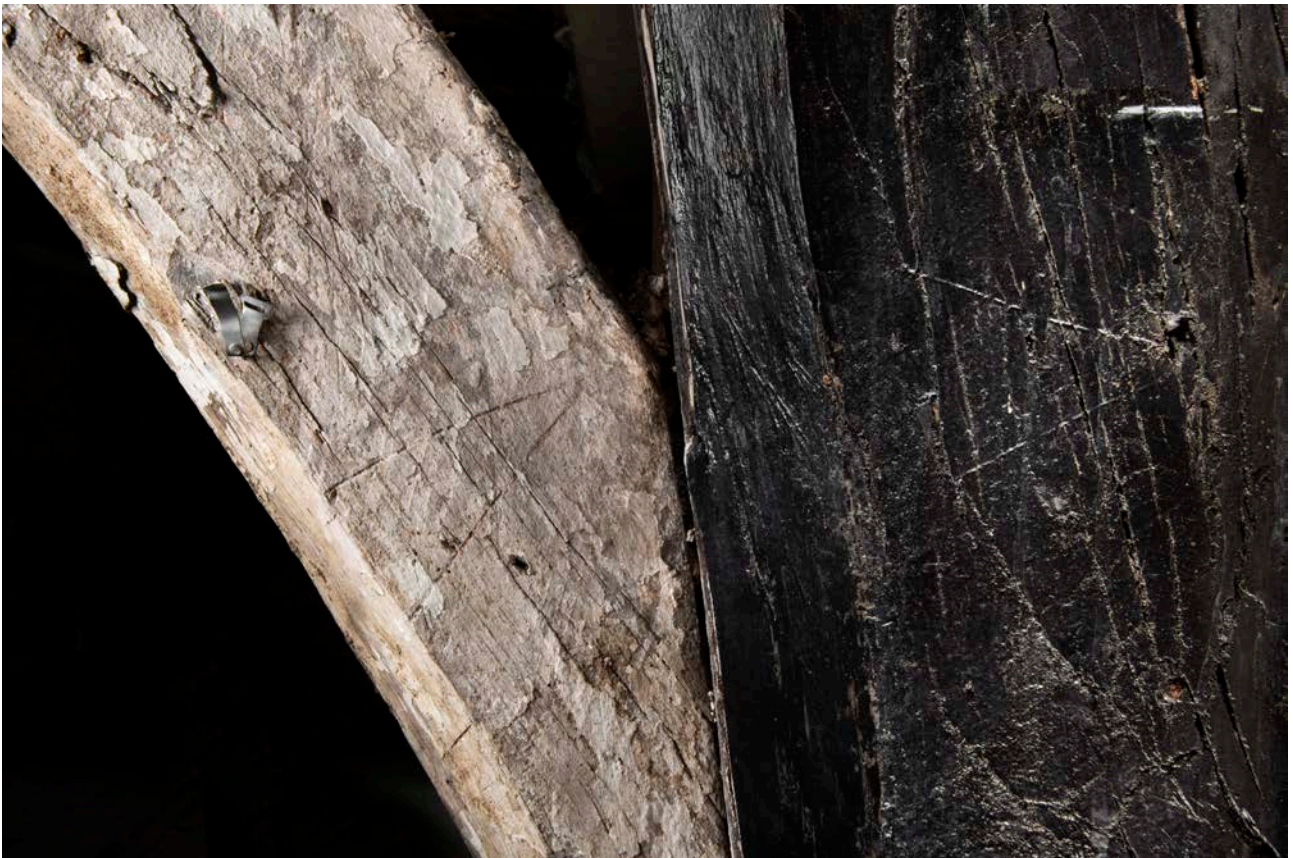
Figure 63: The up-brace of frame V, showing the carpenters' assembly mark on the brace and the adjacent west post, looking south. [James O. Davies © HEA DP435645]

Frame V formed an open truss in the centre of this two-bay room. The tie beam is chamfered on both sides and supported by curved braces rising from the posts which are also chamfered. On the western up-brace a scribed V is visible, with a fainter corresponding mark on the adjacent west post (Figure 63). Above the tie beam the roof
