The Fleece Hotel, 19, 19A and 21 Westgate Street, Gloucester

Historic Building Investigation

Rebecca Lane

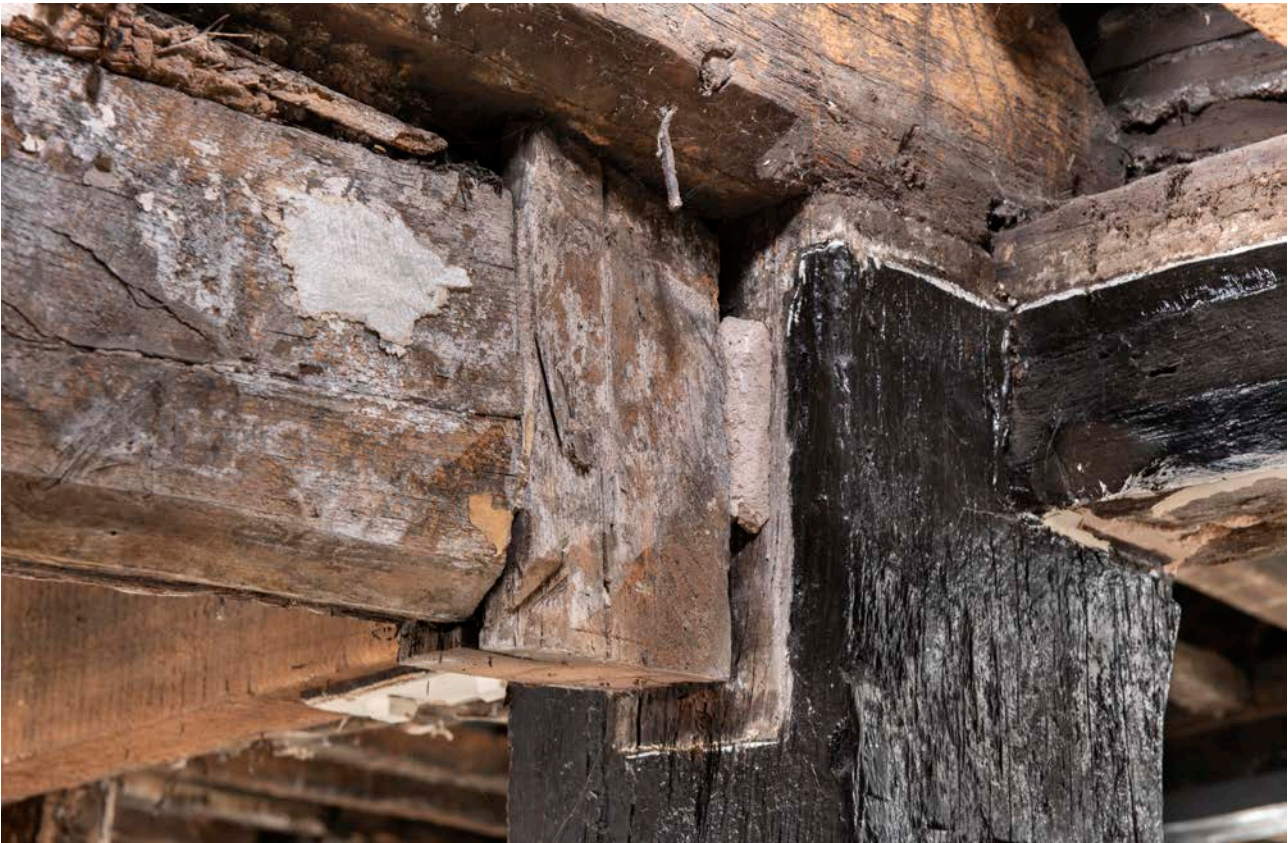
Figure 65: Detail of doorhead in frame VI, showing the chamfered lintel and the cut off jamb, looking south-west. [James O. Davies © HEA DP435646]

below the door head (Figure 65). The door head itself is also in situ. It has a simple square profile with a chamfer on the underside, visible returning on the surviving section of the western jamb. A VI is visible scribed onto the tie beam, where it meets the western post, and the studs and rails have the same number scribed on them consistently, always close to joint positions, with the addition of a circle sitting within the V (Figure 66). Above the tie beam the truss survives, with clear indications that it originally formed a closed truss. Stave holes are visible on the underside of the collar for example, and some sections of original wattle and daub may still be in situ (see Figure 48).

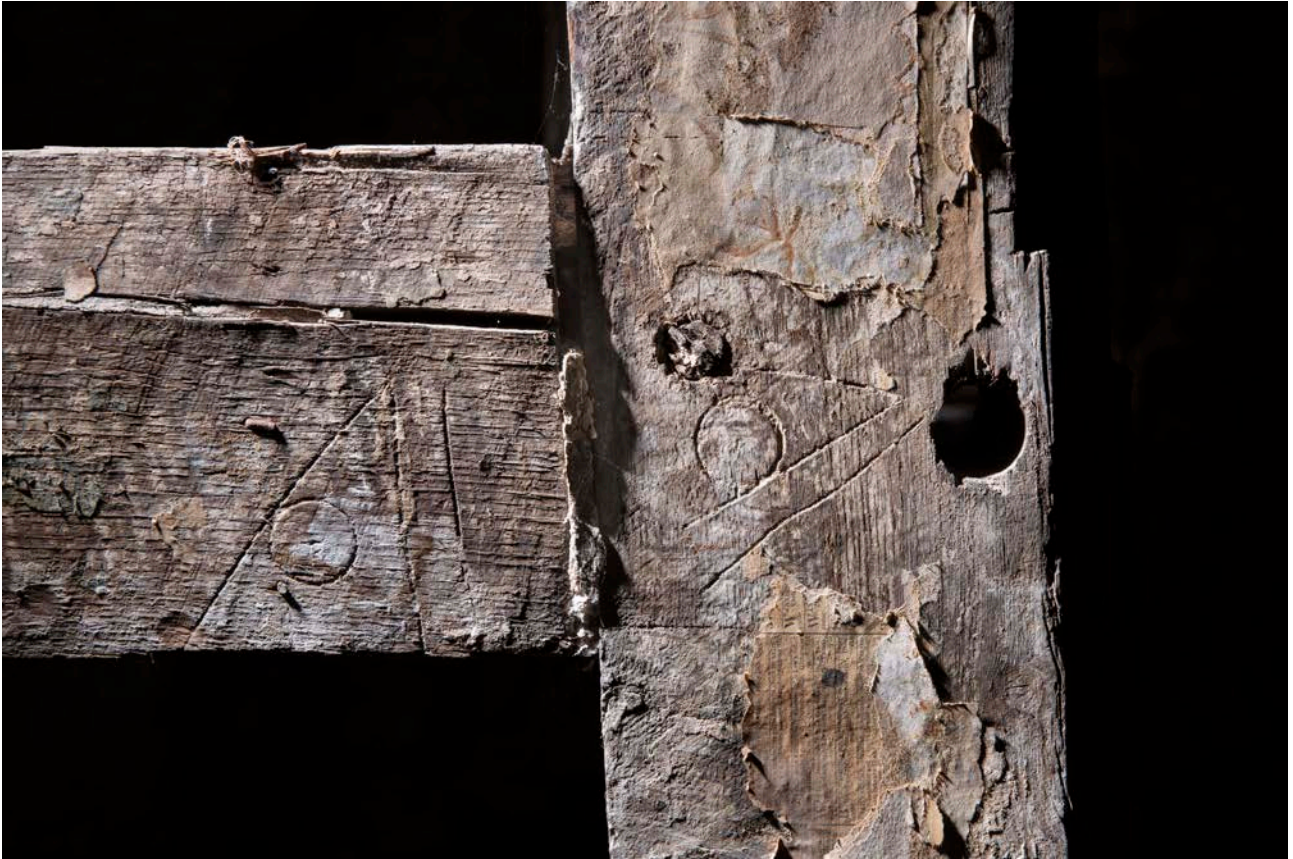
Figure 66: Detail of carpenters' assembly mark on the partition stud of frame VI, looking south. [James O. Davies © HEA DP435647]

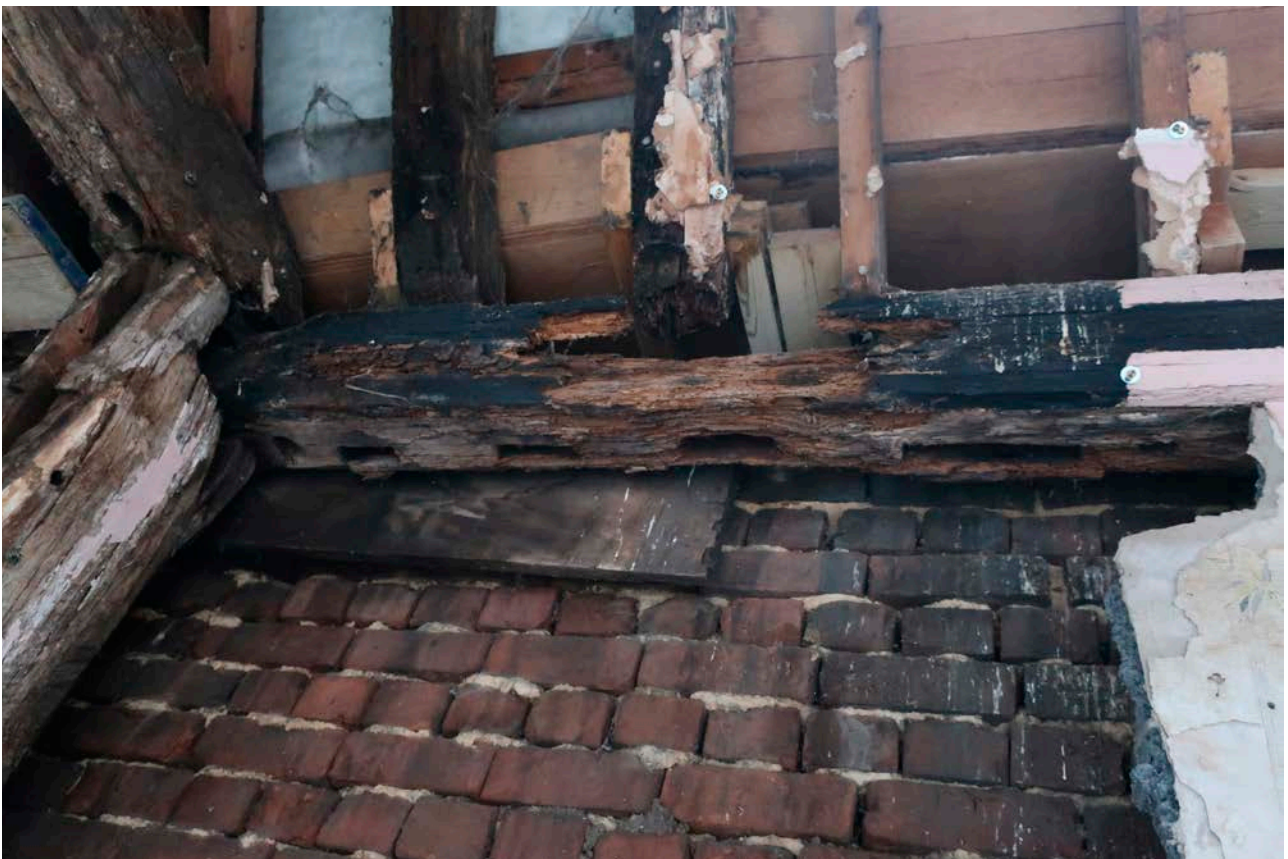
Figure 67: Underside of the wall plate of the eastern elevation in the south bay (bay E), looking north-east showing the mortice for a window position. [Rebecca Lane © Historic England]

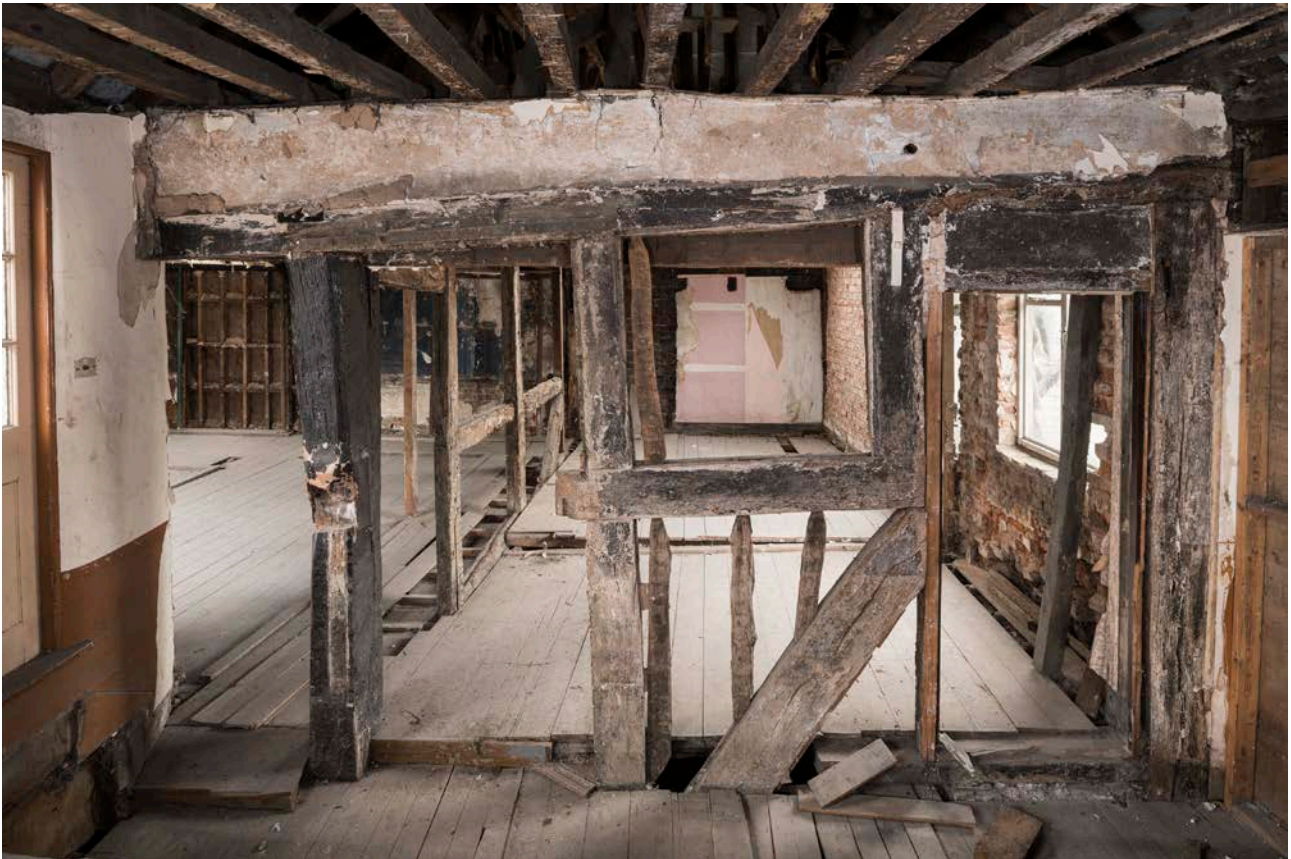
Figure 69: The west elevation of the south bay (bay E) at first-floor level, looking east. [Steve Baker © HEA DP325591]

The western side of the southern bay has considerable evidence for its original framing arrangement, although slightly confused by later alterations. It is also currently the only bay where the form of the frame can be observed externally (that is, on the eastern side of the frame), due to access via the adjacent south-west wing (Figure 69). The pattern of the framing is slightly different from the other bays, apparently because it formed the end bay of the building. At the southern end therefore there is a large down-brace curving down from the post of frame VII (the end frame) to the girding beam. Although the brace has been later truncated, and the northern side of the post is still concealed, pegging visible on the outer side of the post shows the position of the original joint with the post, and the lower part of the brace remains in situ. The central part of the mid-rail survives. It is clear that originally the mid-rail ran across the bay, from the northern post (frame VI) until it met the down brace at its southern end, although it has been cut by the insertion of doorways at the north and south ends. The northern stud is in its typical position roughly a third of the way along the bay, but the southern stud sits above the lower part of the down-brace and slightly further south than is typical in the other bays, creating a slightly wider central part to the bay and a narrower panel to the south.

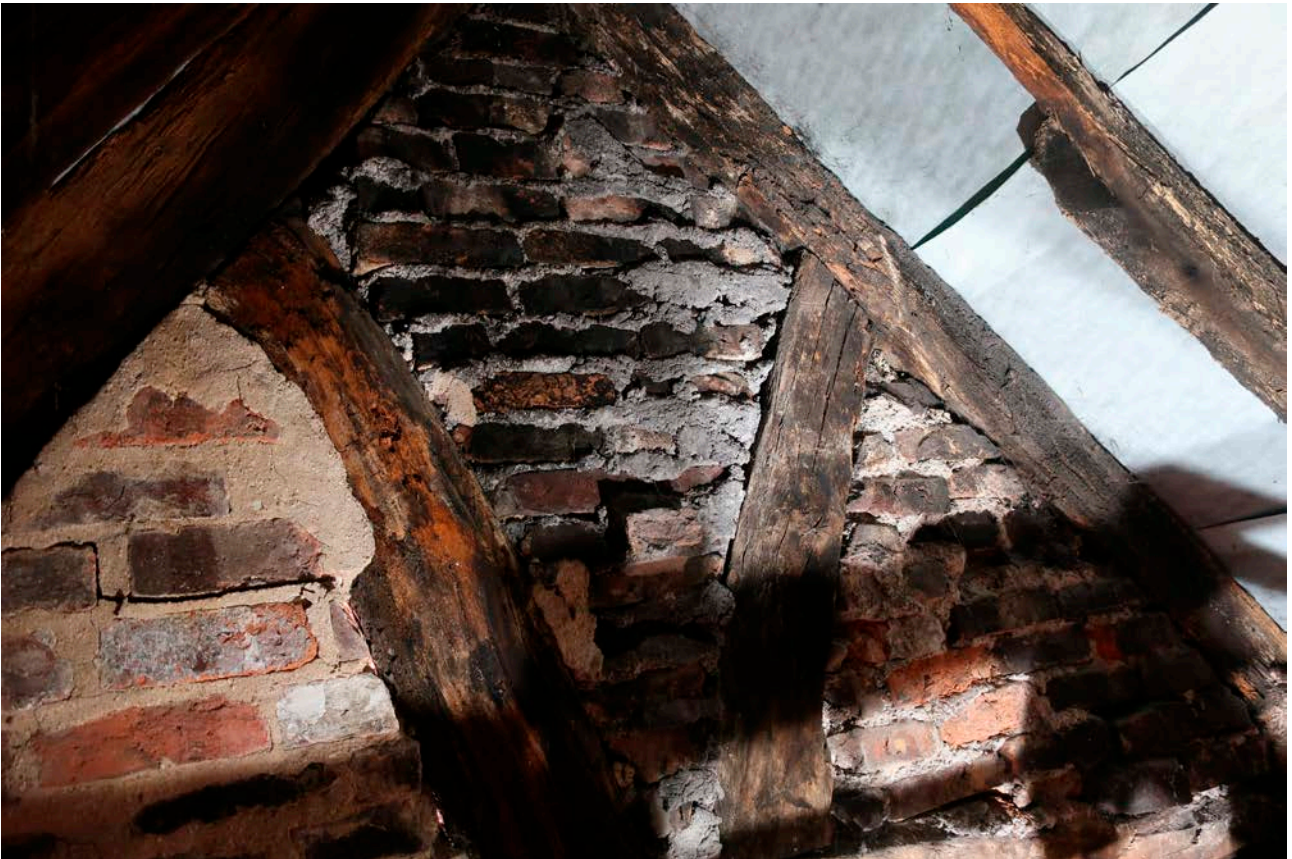
Figure 71: Upper part of the truss of frame VII, looking south-west, showing curved struts running from the collar to the principal rafters. [Rebecca Lane © Historic England]

Frame VII appears to have formed the end frame of the building. Although the external south elevation cannot currently be examined (as it is concealed behind a temporary membrane cover), its position as the original end of the building is suggested by the different form of the frame as visible internally. Much of the wall has been rebuilt in later brick, but the east and west posts survive (the latter still largely concealed), as do the eastern and western ends of the tie beam, the collar and the principal rafters (Figure 70). The brickwork built around these surviving timbers means that seeing the form of the original closure and framing is not currently possible; however, above the collar two curving struts survive, rising to support the principal rafters (Figure 71). This arrangement is not seen on the internal trusses of this range and is a typical decorative feature seen on external gable ends in Gloucester.

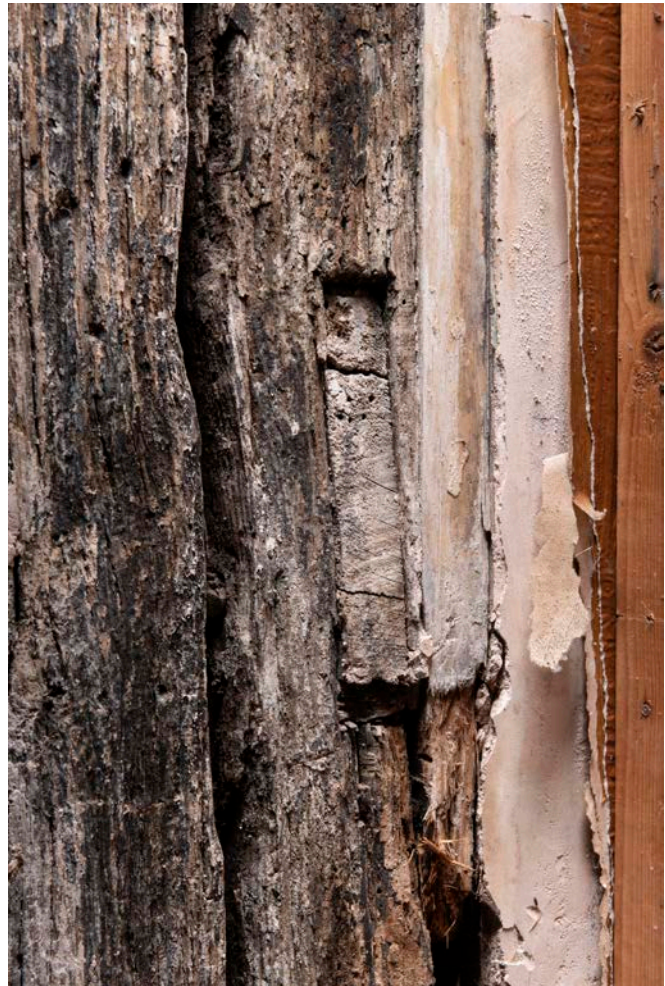
Figure 72: Detail of the mortice on the outer (western) face of the west post of frame VII, looking east, possibly indicating some form of structure originally attached to western side of the range. [James O. Davies © HEA DP435651]

Although the west post of frame VII is largely concealed, its western face is visible, where it now sits within the south-west wing. As noted above, this face appears from the weathering to have been external. However, at a low first-floor level (0.6m above the girding beam) is a single mortice sitting towards the outer (southern) edge of the post (Figure 72). In isolation this feature is difficult to interpret. It may be that if further framing along the west elevation is exposed, it will be possible to establish if it forms part of a pattern of features which may relate to some form of structure in the position of the later south-west wing or running along the southern part of the east elevation more generally.

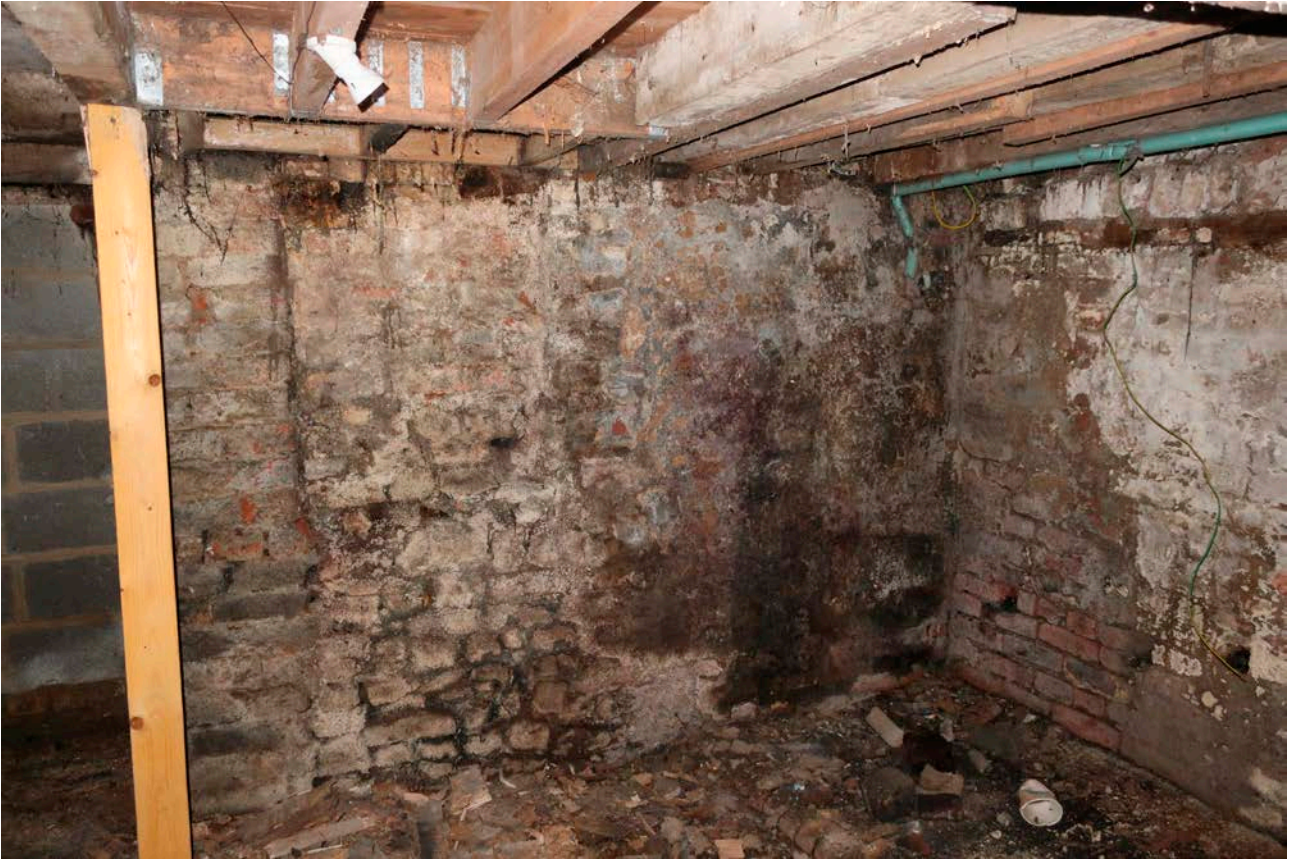
Figure 76: The cellar under No. 21 (bay E), looking north-east, showing the rubble stone walling of the north elevation. [Rebecca Lane © Historic England]

In the western bay (bay E), the north and south walls of the cellar are formed of rubble stonework which is likely to be original to the range (Figure 76). The west wall has been heavily rebuilt in brick. The east wall of the bay is, somewhat surprisingly, formed of timber-framing and in fact forms an integral part of the framework of frame V. The base is formed of rubble stone, although much of this has been replaced in brick. Much of the frame has also been replaced. All that is currently visible of the original framework is a short section of the sill plate, with a central post rising from it (Figure 77). This post in fact appears to rise through the building as far as first-floor ceiling level, indicating the extent to which the framing of the cellar wall was an integral part of the 15th-century framework. It seems, therefore, that stone was used for the outer perimeter of the cellars of the range, with timber-framing used for the subdivisions within this.

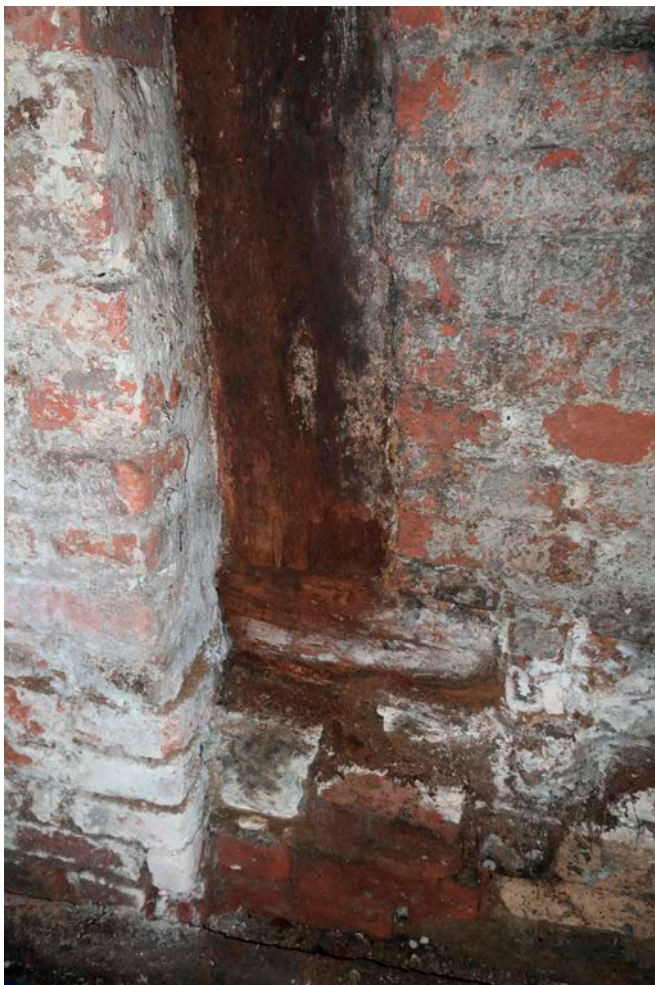
Figure 77: The cellar under No. 21 (bay E), showing timber frame in the east wall (the partition wall between Nos 21 and 19A), looking east, with part of the sill beam and a post in situ. [Rebecca Lane © Historic England]

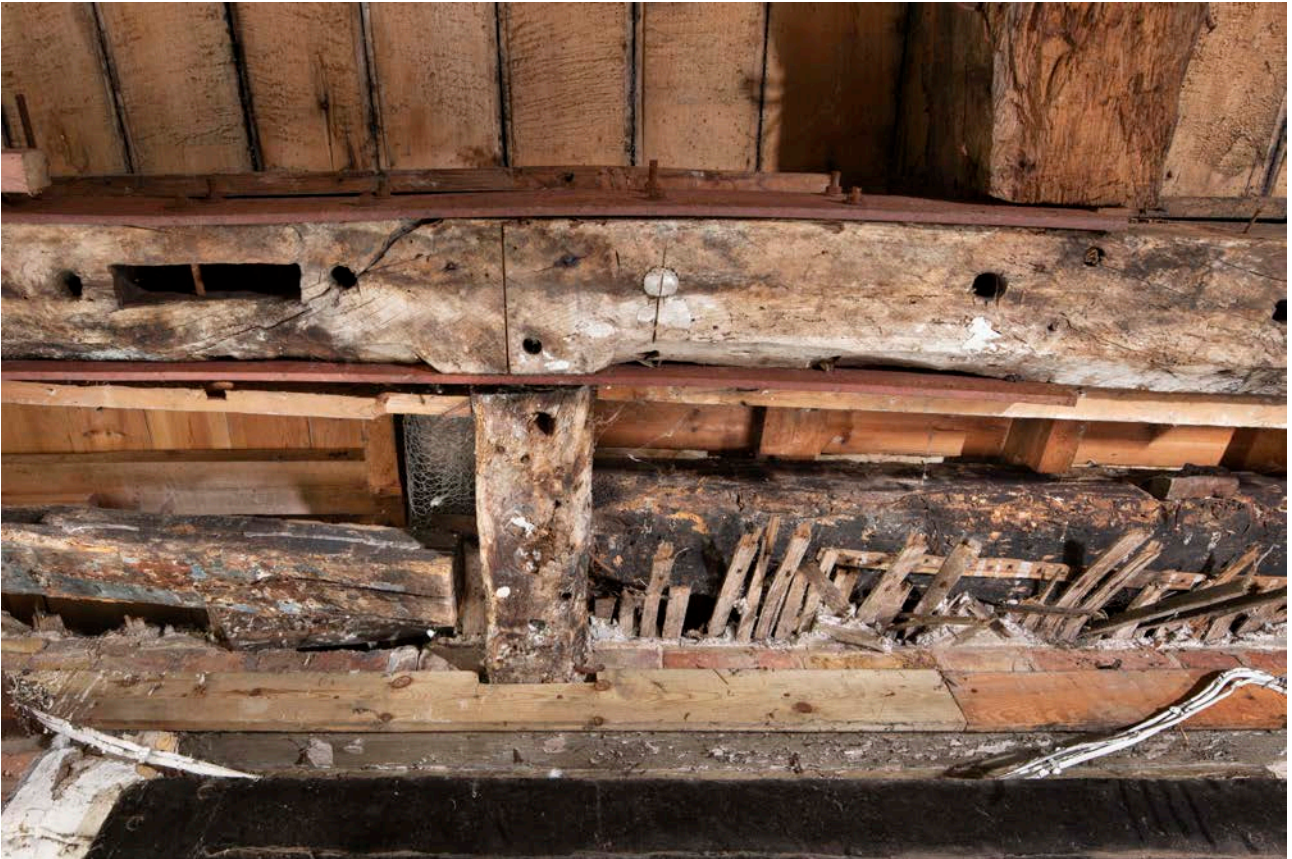
Figure 78: The underside of the central part of the cross beam of frame III, now visible in the passageway through the street-front range, showing the empty mortices for the original partition. [James O. Davies © HEA DP435637]

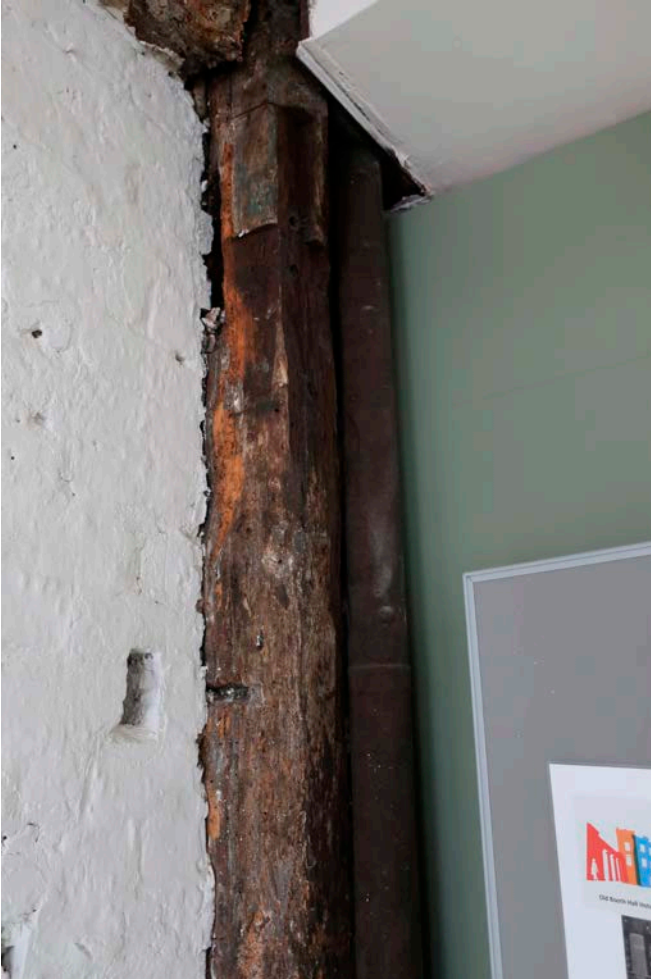
Figure 79: South post of frame V, now visible in the shop at ground-floor level in No. 21 (bay E), looking south-east. [Rebecca Lane © Historic England]

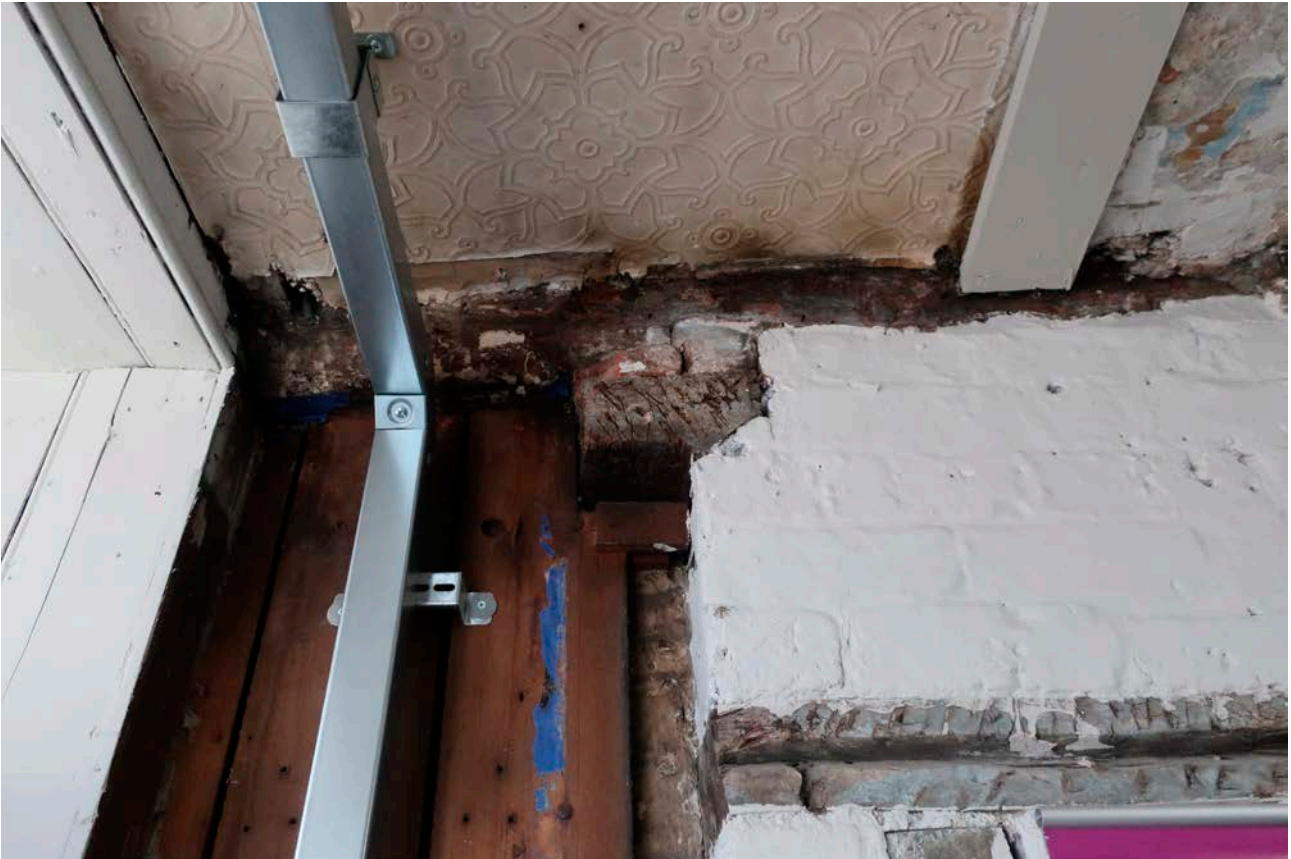
Figure 80: East wall of No. 21 (bay E), looking east, showing the cut off jetty plate adjacent to frame V. [Rebecca Lane © Historic England]

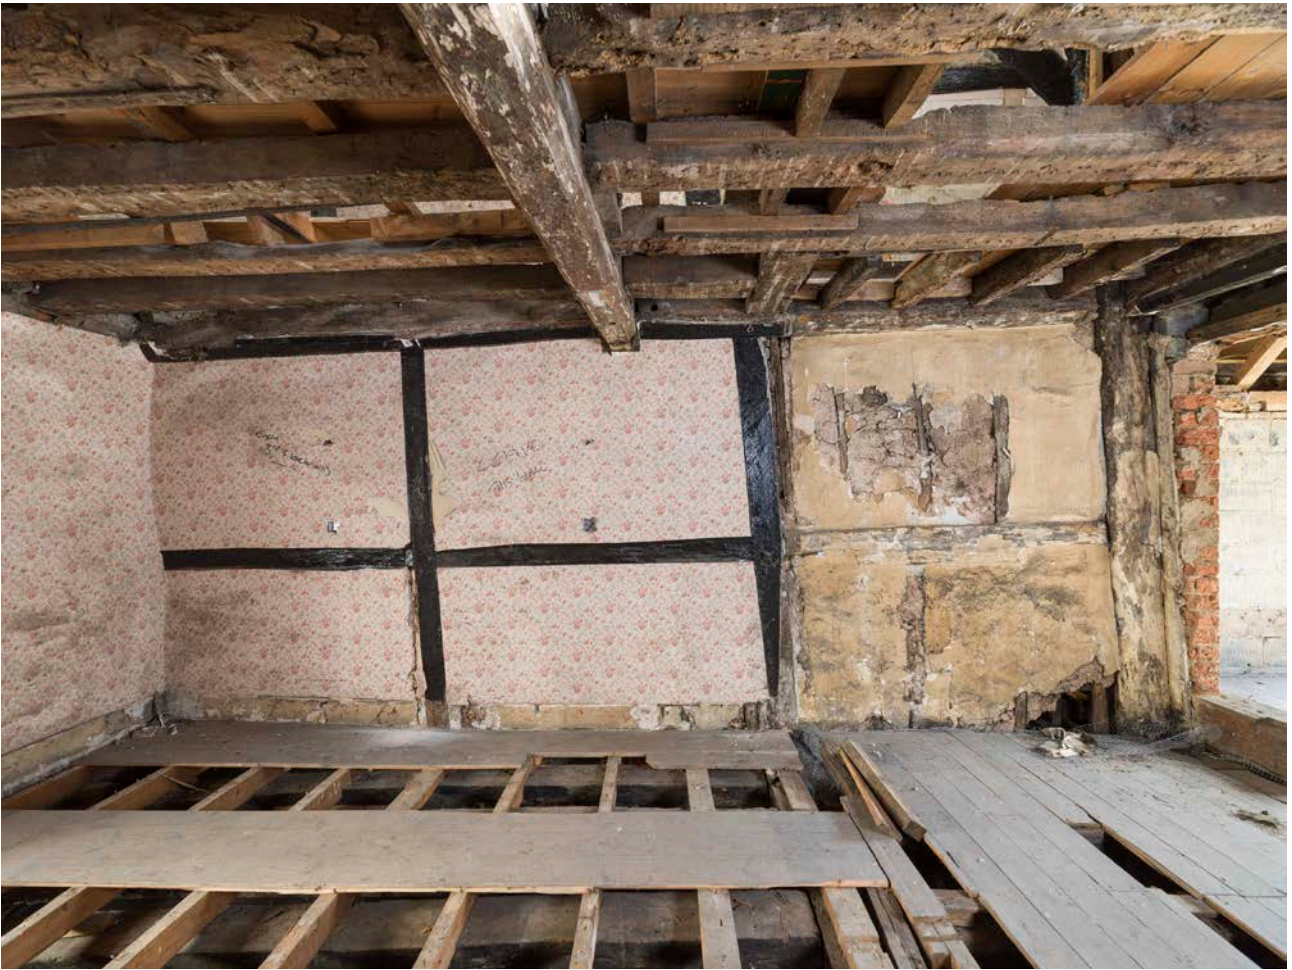
Figure 82: Framing of frame IIII of the street-front range at first-floor level, looking east. [Steve Baker © HEA DP325632]

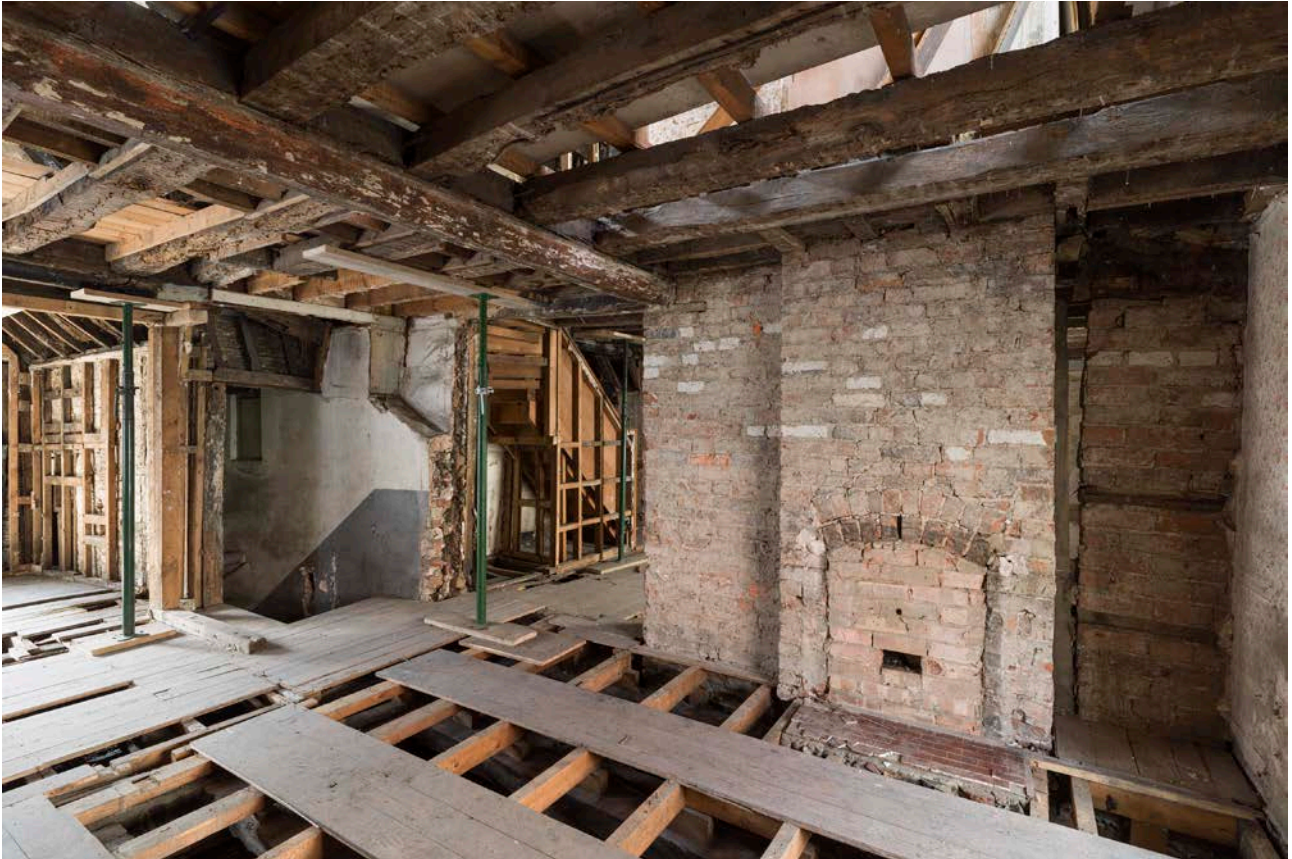
Figure 83: Bay D (No. 19A) at first-floor level, looking south-west, showing the surviving girding beam of the south wall towards the left-hand side. [Steve Baker © HEA DP325631]

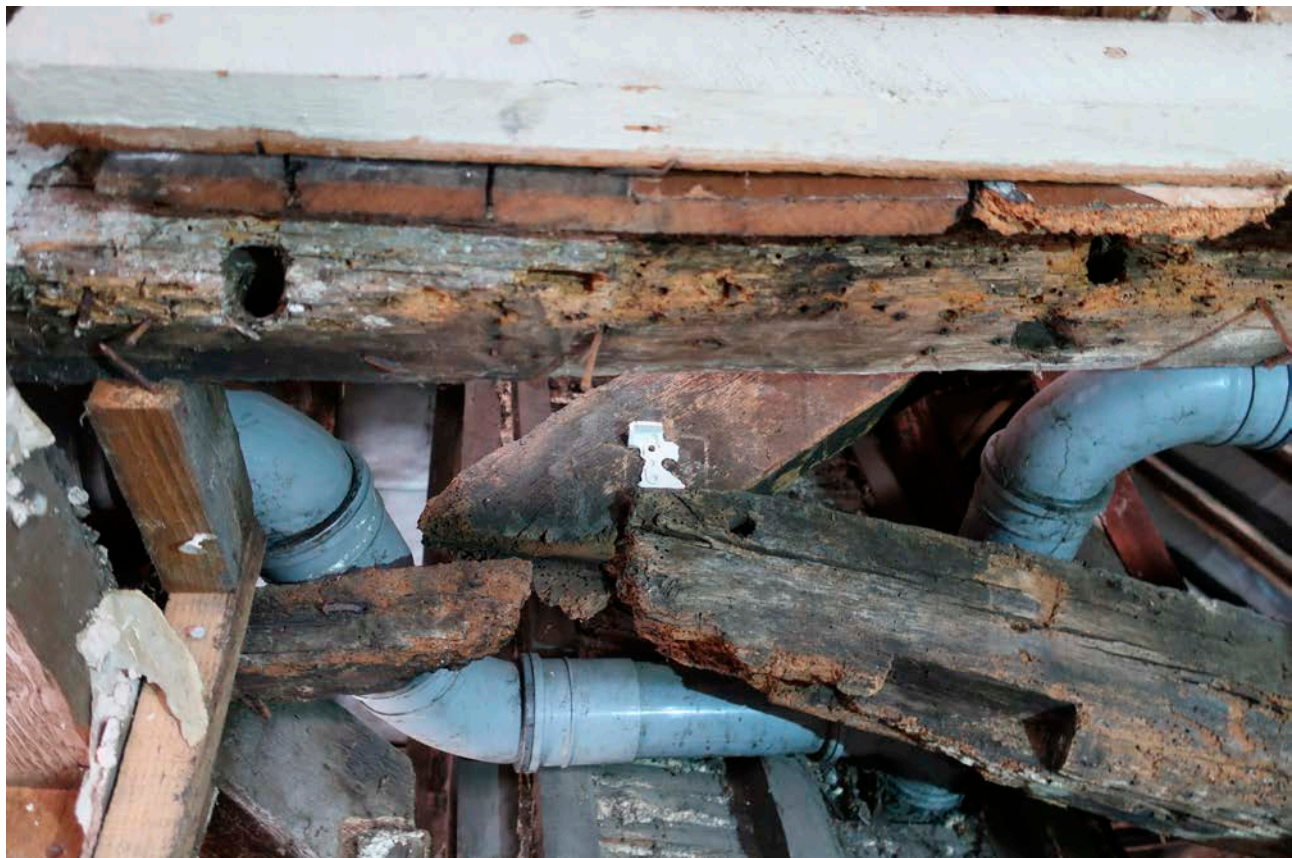
Figure 84: Girding beam in the south elevation of bay D (No. 19A) showing peg holes which may indicate the position of a window opening. [Rebecca Lane © Historic England]

Of the south wall at first-floor level in bay D, therefore, there is only the girding beam between ground- and first-floor level and that between first- and second-floor level surviving (Figure 83). That between ground- and first-floor level has only a residual mortice for the central stud visible, although the eastern part is cut back. The upper girding beam has the corresponding residual mortice for the central stud (the mortice to the east is later). Either side of the original mortice for the stud are regular stave holes indicating that the partition was fully closed. The only exception to this is towards the western end, close to frame V. Here in the girding rail there is a gap in the regular stave-hole arrangement and instead there are two peg holes, on the inner edge of the frame, around 0.5m apart (Figure 84). At present the interpretation of this feature is unclear, but it may represent some form of opening.

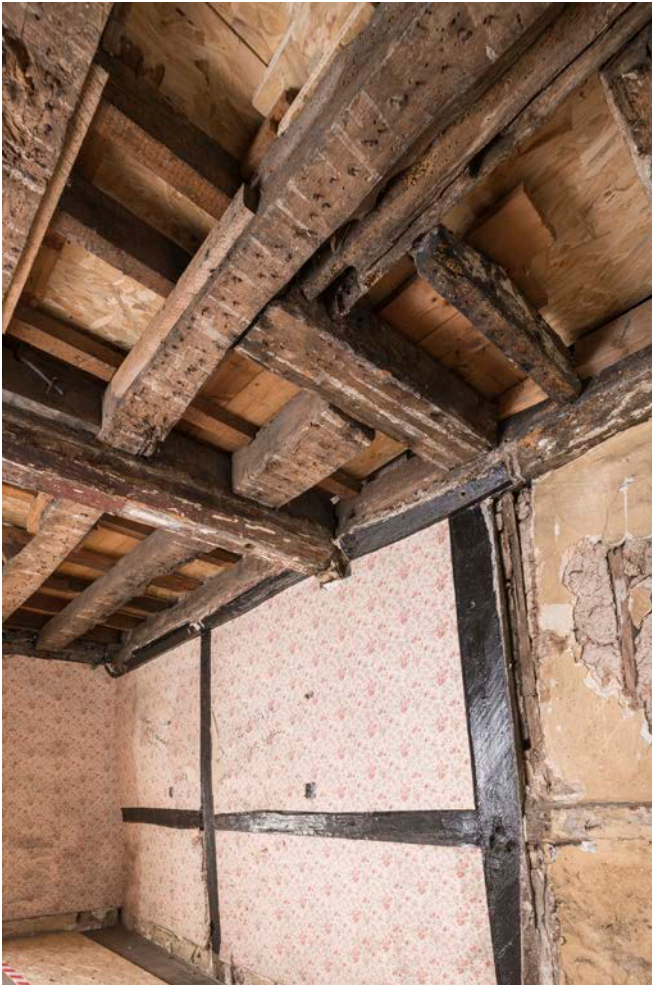
Figure 85: Ceiling at first-floor level in bay D (No. 19A), looking north-east, showing the position of a partial partition running along the central lateral beam, partly indicated by the paintwork pattern. [Steve Baker © HEA DP325686]

Bay D has the original joists between the ground and first floor in situ, although these are largely concealed. Similarly the joists between first- and second-floor level survive. These are currently exposed from above and below. The lateral beam running through the bay at this level has no indication of a full-length partition, indicating the first-floor bay formed a single room. Towards the west of the beam, however, there is evidence of a short length of partition projecting westwards from frame IIII for around 0.7m (Figure 85). This consists of a mortice for a stud and some associated stave holes. It appears to correspond to the position of the stair rising in the southeast corner of the bay and must have formed part of a partition to box in the stair.

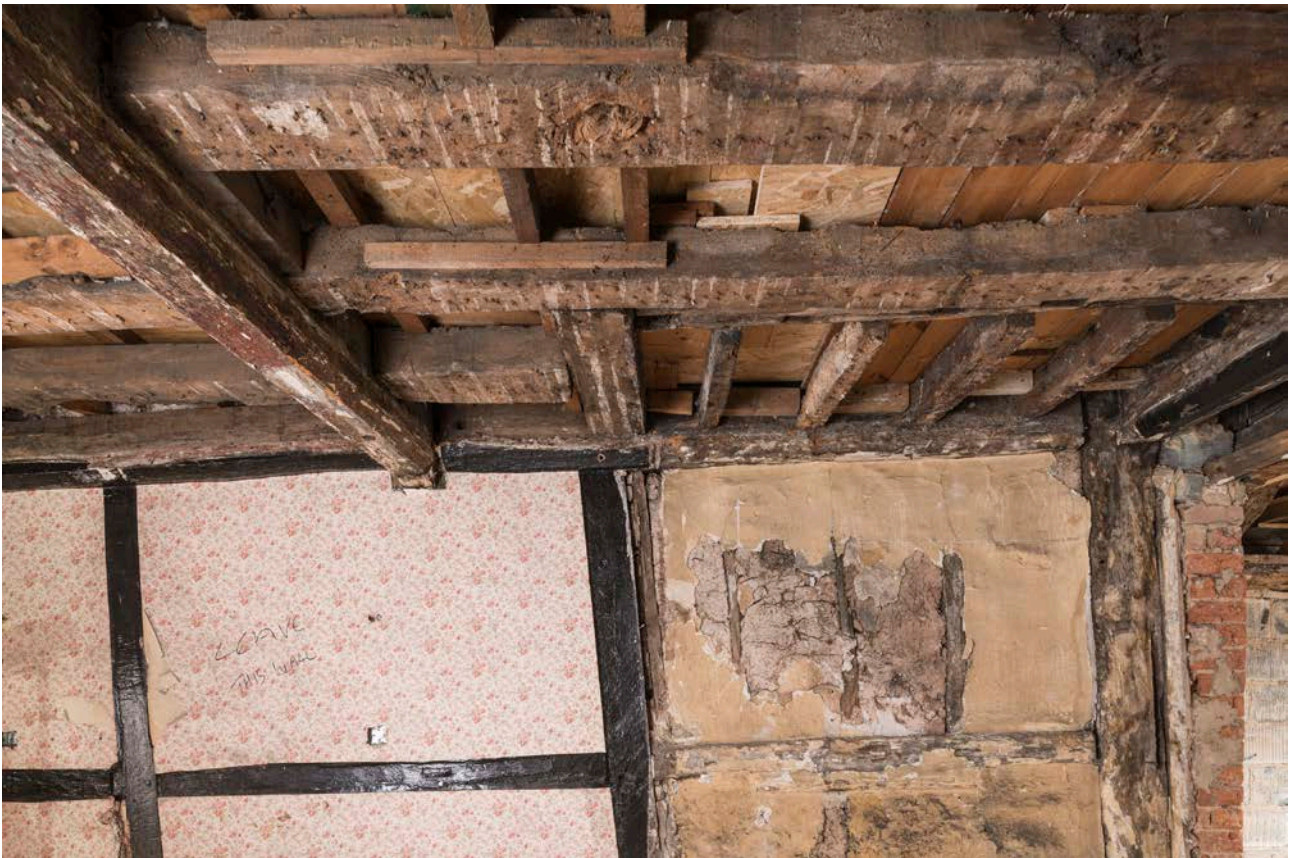
Figure 86: Ceiling at first-floor level in bay D (No. 19A), looking east, showing the stair trimmer indicating the position of the stair in the south-east corner of the bay. [Steve Baker © HEA DP325687]

A stair trimmer arrangement is extant in the south-east corner (Figure 86). The evidence of this feature is somewhat ambiguous as the trimmer has been tenoned into the eastern joist but lapped onto frame IIII, which might be seen to imply that it is a later insertion. There is also a redundant mortice in the girding beam to the south, as though originally a joist was intended to run through to the beam. However, as all of the original joists survive, and there is no other position for a stair identifiable, it seems likely that this was the original stair position. The reason for the residual mortice feature appears to be that the stair position was chosen after the framework was laid out, with the joist then cut to allow the position of the stair to be created.

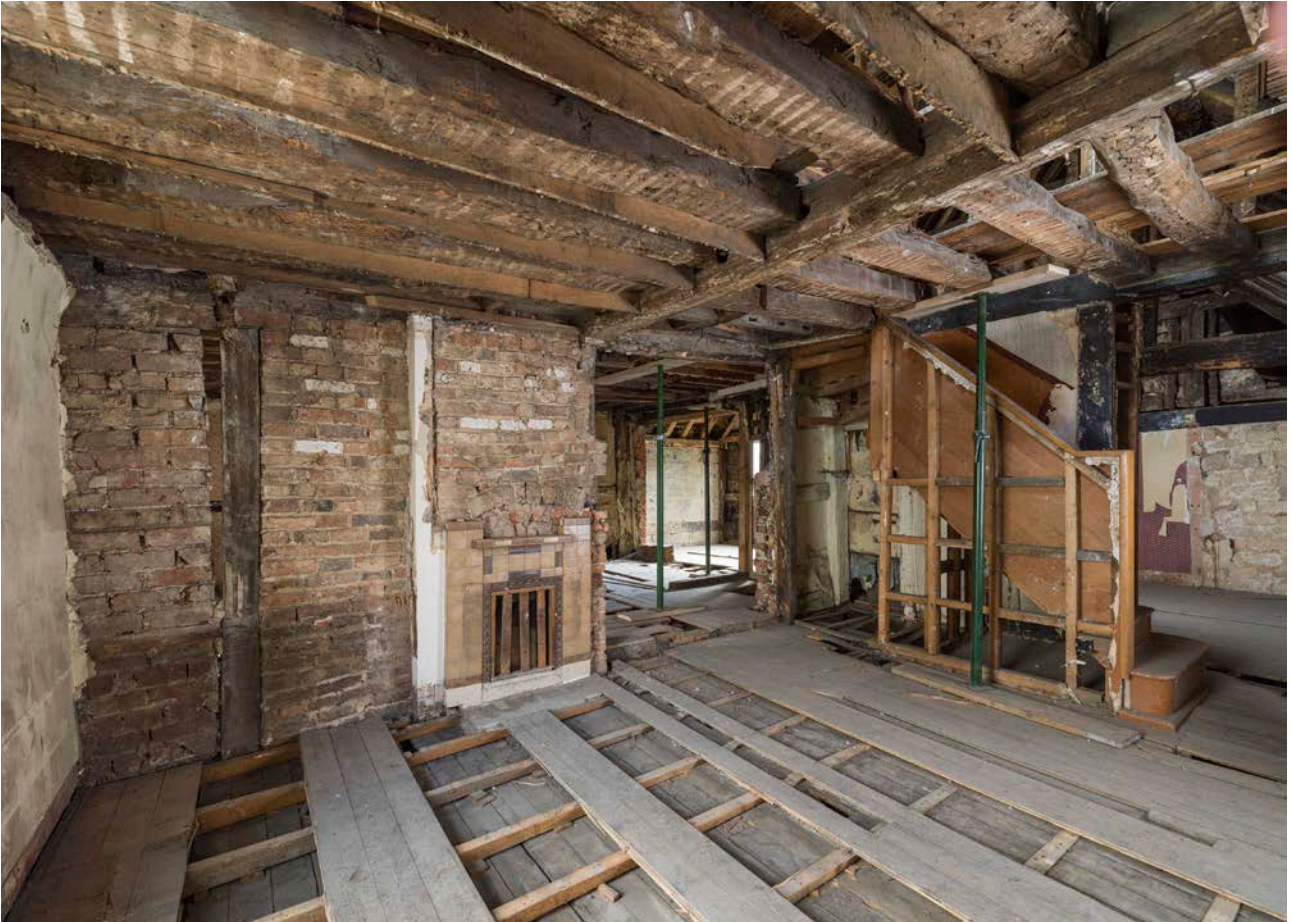
Figure 87: First floor of bay E (No. 21), looking south-east, showing the remaining framing of frame V. [Steve Baker © HEA DP325627]

At first-floor level frame V is largely intact towards the south, although to the north it has been truncated by the insertion of a later chimney stack. The southern post, which was visible at ground-floor level, rises through this level (Figure 87 and see Figure 75). The cross beams between ground- and first-floor level and first- and second-floor level survive as far as the central stud of the frame, but the northern part has been rebuilt. A mortice on the side of the south post and another on the central post indicates that a mid-rail originally ran across the frame, matching that surviving on frame IIII. Although the north part of the partition does not survive it is likely that the partition continued and the two bays formed completely separate units as at ground-floor level. This is further confirmed by the stair evidence (see below).

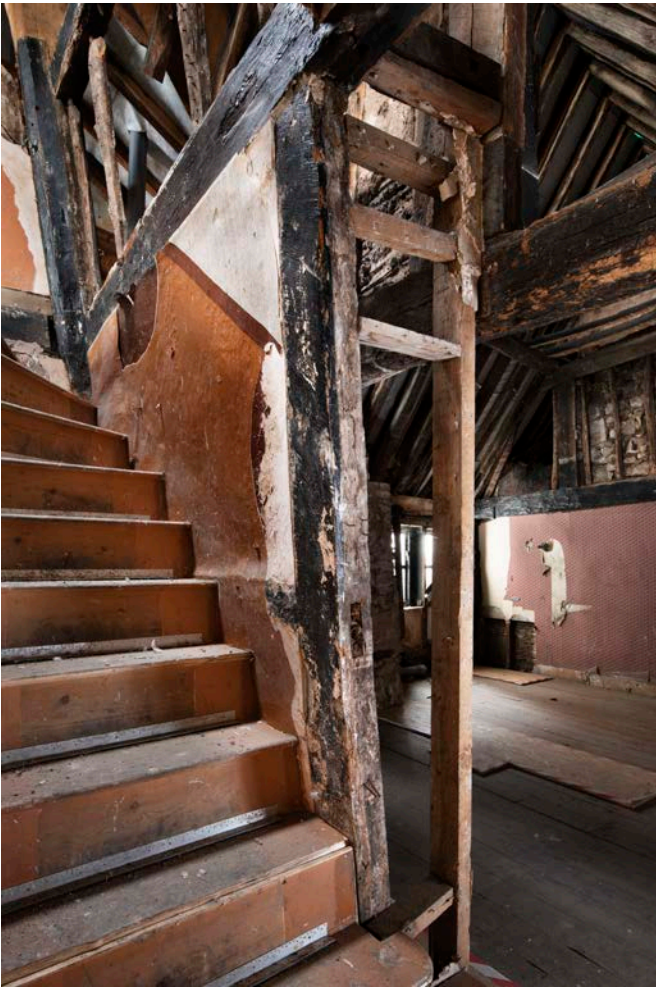
Figure 89: South elevation of the street-front range in bay E (No. 21), looking south east, showing the girding beam, stud and infill of the elevation at first-floor level. [James O. Davies © HEA DP435637]

At first-floor level bay E (west of frame V; No. 21) appears originally to have formed a single room. To the south the surviving framing of the south wall makes it clear that there was originally no access between this room and the first floor of the west range, as the framing of the street-front range is separate, with a clear gap between the south wall of the street-front range and the north wall of the west range at this level (Figure 88). Within bay E much of the south wall survives at first-floor level, including a central stud and the remains of a mid-rail forming the main framing elements of the wall (Figure 89 and see Figure 83). The stud runs the full height of the floor level between the two girding beams. The timber mid-rail is still partly in situ to the east of the central stud, although truncated at the east end by a later doorway. Originally, however, it appears to have run across the bay as there is a corresponding mortice in the post to the east, with no provision for any doorway between the street-front range and the west range. The north wall does not survive, but the floor joists indicate that its original position was on a similar alignment to the extant brick wall which now forms the front elevation.

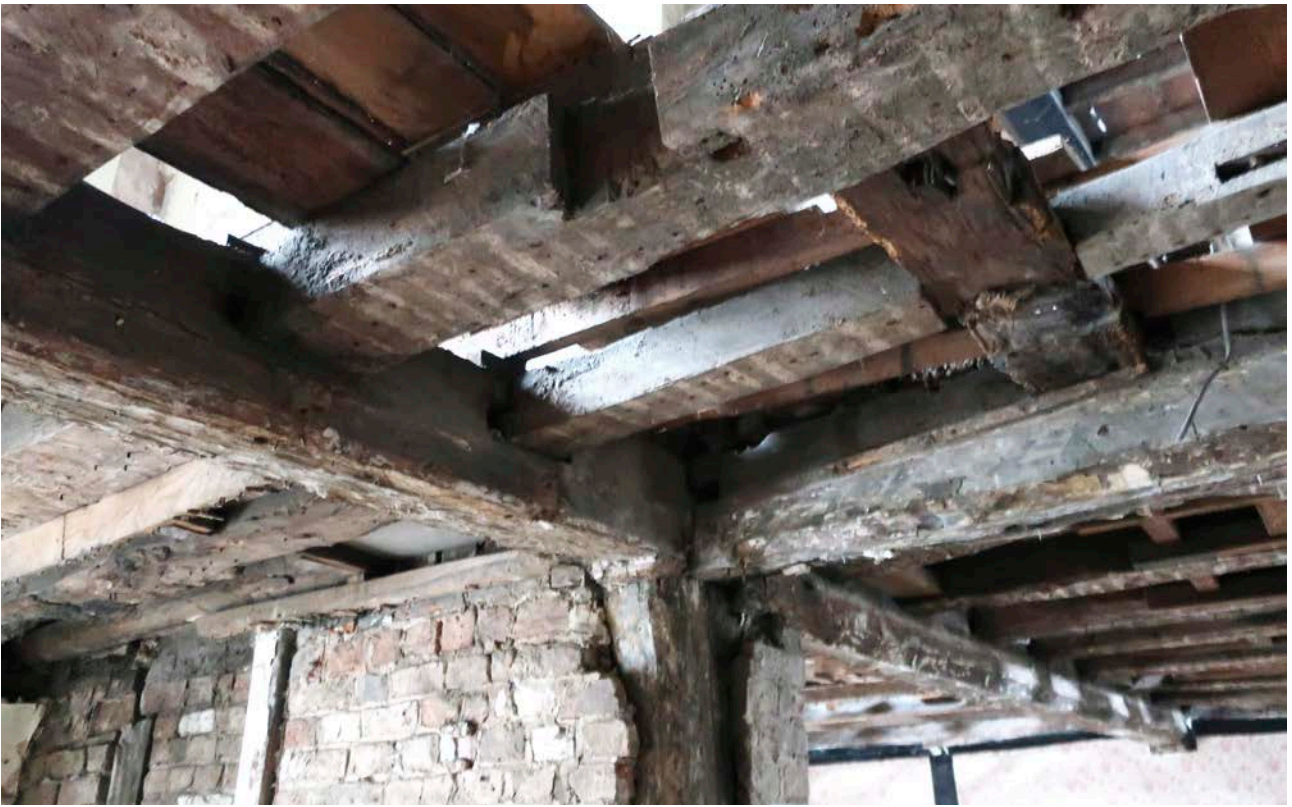
Figure 90: First floor of bay E (No. 21) showing the stair trimmer beam in the ceiling and the possible stair position in the south-east corner, looking north east. [Rebecca Lane © Historic England]

At the western end of the bay some of the joists are still jointed into the lateral beam, but those to the east have been cut back to create a later stair. At the south-eastern corner of the bay a small trimmer can be observed (Figure 90). This is a short beam running at right-angles to the joists and appears to indicate the position of an original ladder stair, which would have run between first- and second-floor levels. The trimmer beam is tenoned into the joist to the west but lapped onto the cross rail in frame V, an arrangement which suggests that it was formed after the main floor was framed (as with the trimmer in bay D to the east). There is a redundant mortice visible in the eastern end of the southern girding beam at this level (with other redundant mortices for further joists also visible to its west, where further joists have been cut for the later stair in this position). As in bay D, it seems likely that this stair position was cut after the main frame had been formed, but that it is an original feature. It is notable that both bays have their original stair sitting in the same position within their respective bays, and the fact that there are two stairs further confirms that the two bays formed separate units.
