The Fleece Hotel, 19, 19A and 21 Westgate Street, Gloucester

Historic Building Investigation

Rebecca Lane

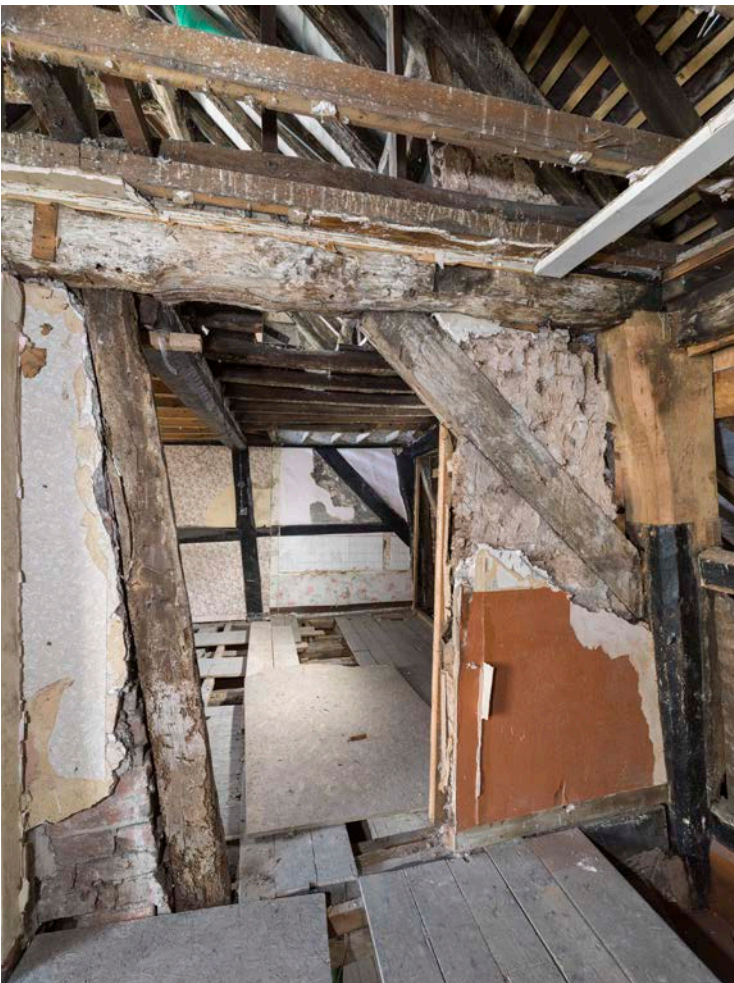
Figure 91: Frames III and V at second-floor level, looking east, showing the pattern of framing in the partitions. [Steve Baker © HEA 325636]

At second-floor level frame III has the jowled head of the south post surviving intact (Figure 91 and see Figure 74). There are two studs rising between the cross beam and the tie beam at this level, reflecting the greater width of the frame due to the jetty arrangement to the north. A straight up-brace rises from the south post to the tie beam. The ceiling above second-floor level is a later insertion, but above this elements of the original truss of frame IV survive intact, including the tie beam, collar and queen struts (Figure 92 and see Figure 74). The position of the original clasped purlins is still evident, and redundant mortices indicate the former position of windbraces which would originally have risen to the purlins.

At second-floor level frame V survives largely intact (Figure 94 and see Figure 75). The head of the south post has been recently replaced but is probably a like-for-like copy, as the replacement matches the original head of the post of frame IIII. From the south post rises a straight up-brace running into the tie beam above. One stud survives further to the north, with the position of a further stud identifiable from the mortice in the tie beam. The northern section has been truncated by the cutting back of the original wall line, which was originally jettied out over the first-floor wall line below. At roof level the tie beam and principal rafters of the truss remain, although the collar has been removed.

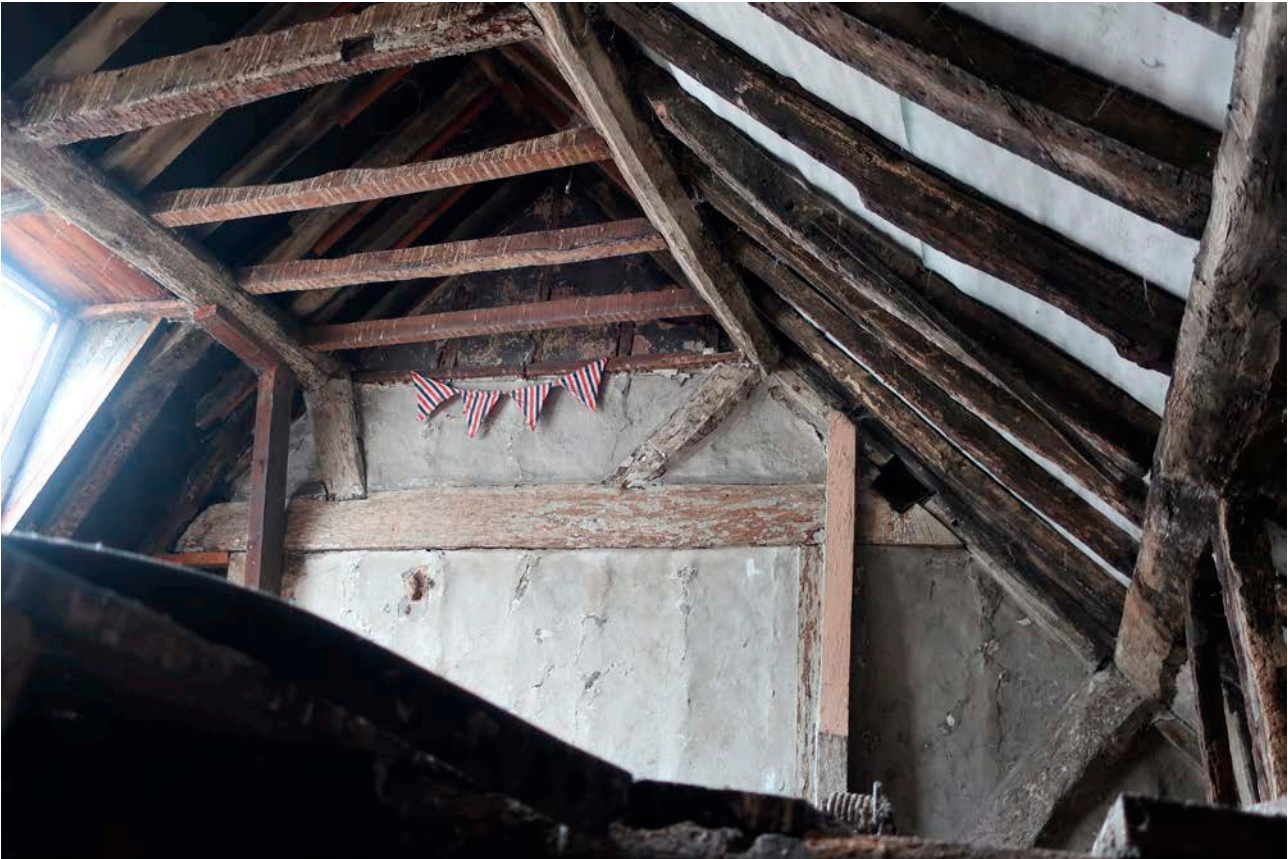
Figure 92: Frame IIII at roof level, looking north-east, showing the surviving elements of the roof truss, looking north east. [Rebecca Lane © Historic England]

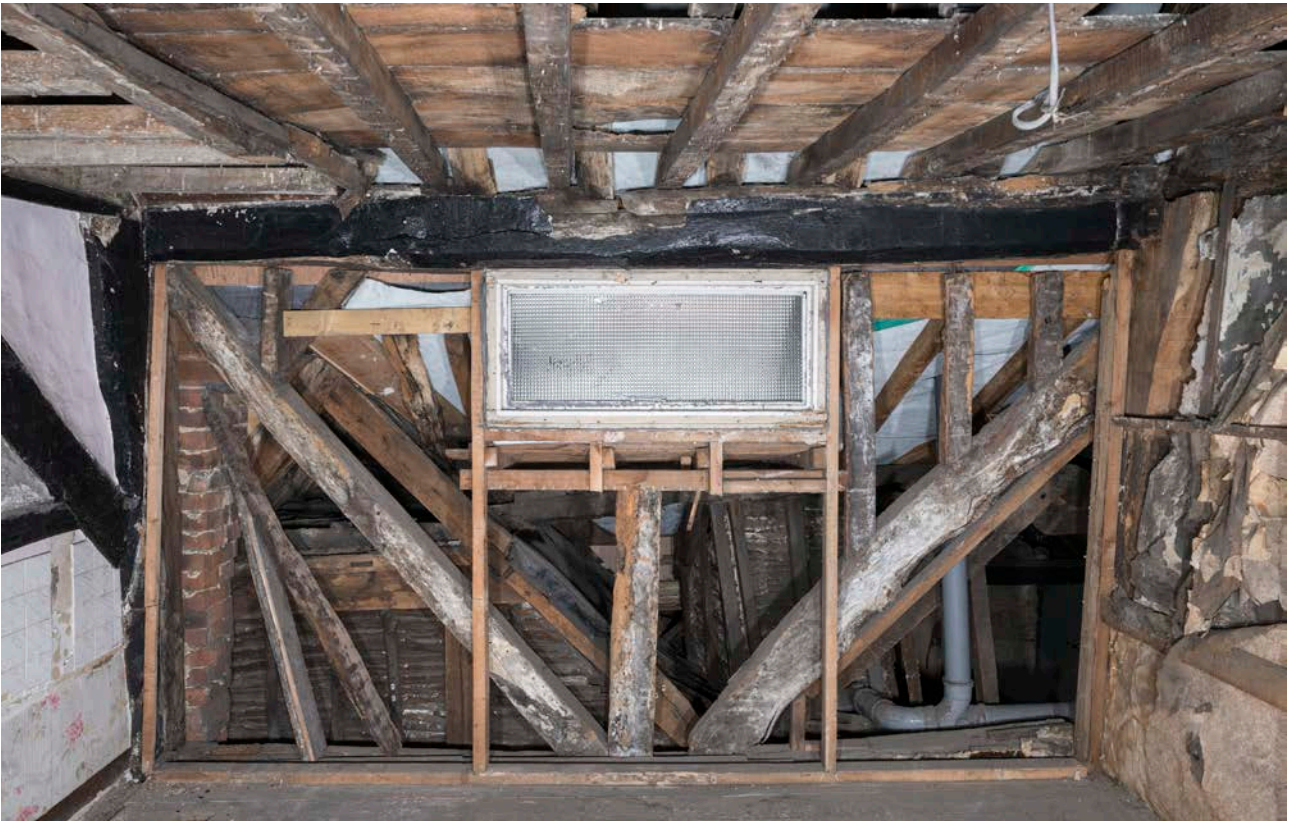
Figure 93: South elevation of bay D (No. 19A) at second-floor level showing the original timber framing, looking south, including curved brace to the west (right-hand) side and later inserted straight brace on the east (left-hand) side. [Steve Baker © HEA DP325641]

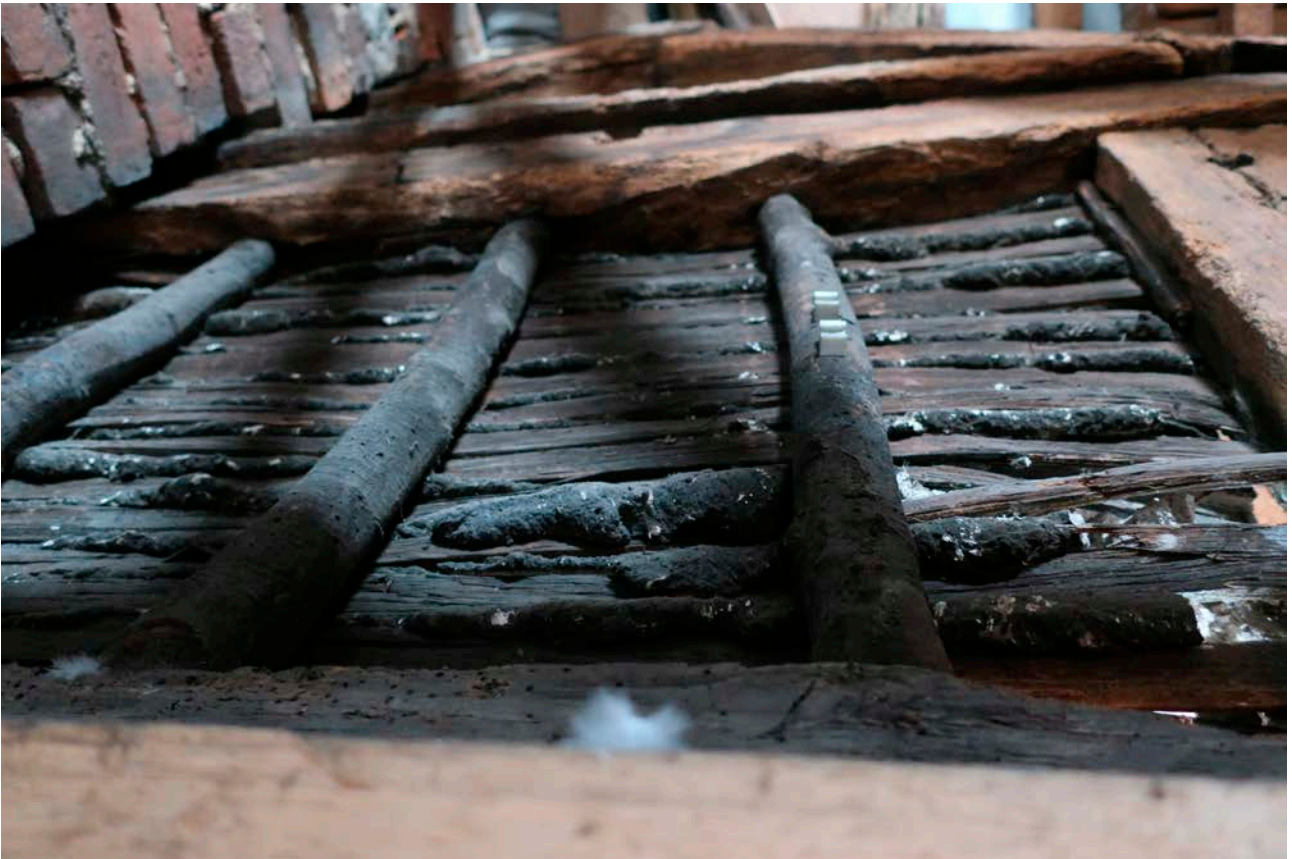
Figure 95: The north frame of the north-east corner bay, showing the northern (outer) face with the original staves with no indication of any original plaster on this side of the truss. [Rebecca Lane © Historic England]

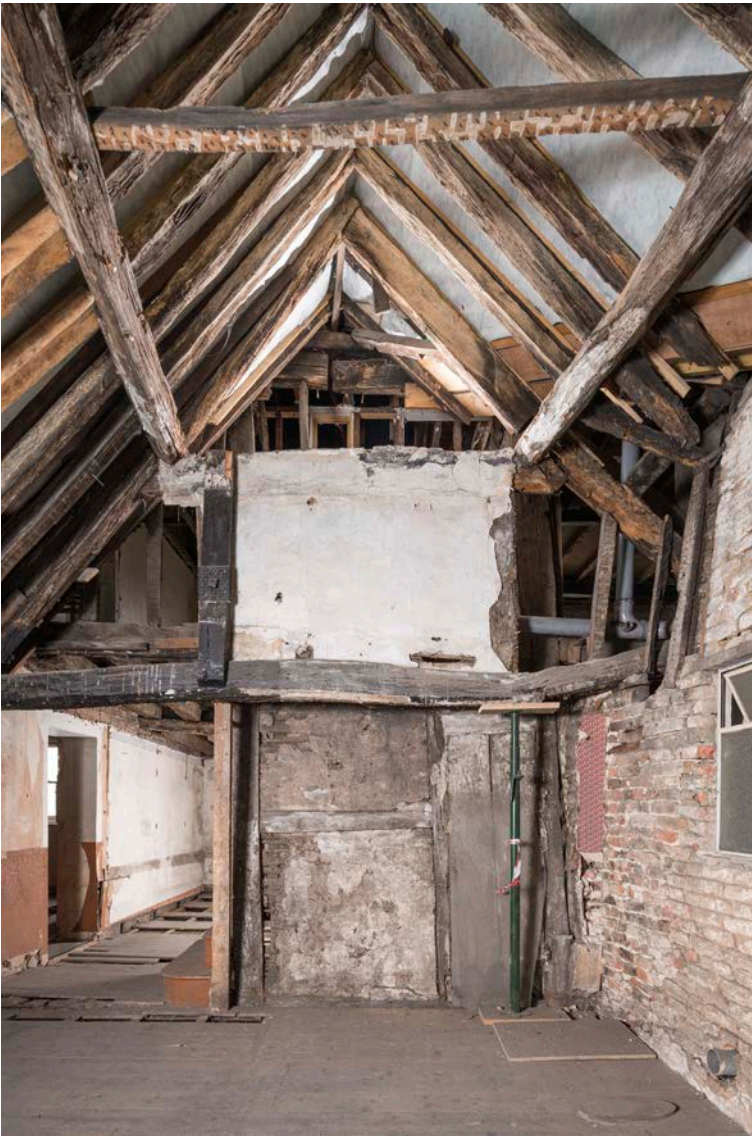
Figure 97: The southern side of frame I of the west range, looking north-west. [Steve Baker © HEA DP325611]

Of the main western range, frame I was clearly originally a closed frame (Figure 96). Both its east and west posts have been removed, but the tie beam and the roof structure remain in situ (Figure 97). At first-floor level, below the tie beam, its framing has been removed to facilitate later access between the street-front range and the west range, but the underside of the tie beam shows the stave holes of a partition. At either end are larger mortices for up-braces which would originally have risen from the posts to the tie beam. Above the tie beam the roof structure has the same arrangement as the street-front range (and the great inn range), with two vertical queen struts supporting a collar with the purlins clasped between the collar and the principal rafters. Redundant mortices on the south side of the frame show where windbraces would originally have risen to the purlins. Between the tie beam and the collar an original panel of staves with daub still attached survives (see Figure 97). There is no sign of stave holes on the underside of the principal rafters but surviving nail holes may indicate the position of fixings for some form of framework for closing the other sections of the truss.

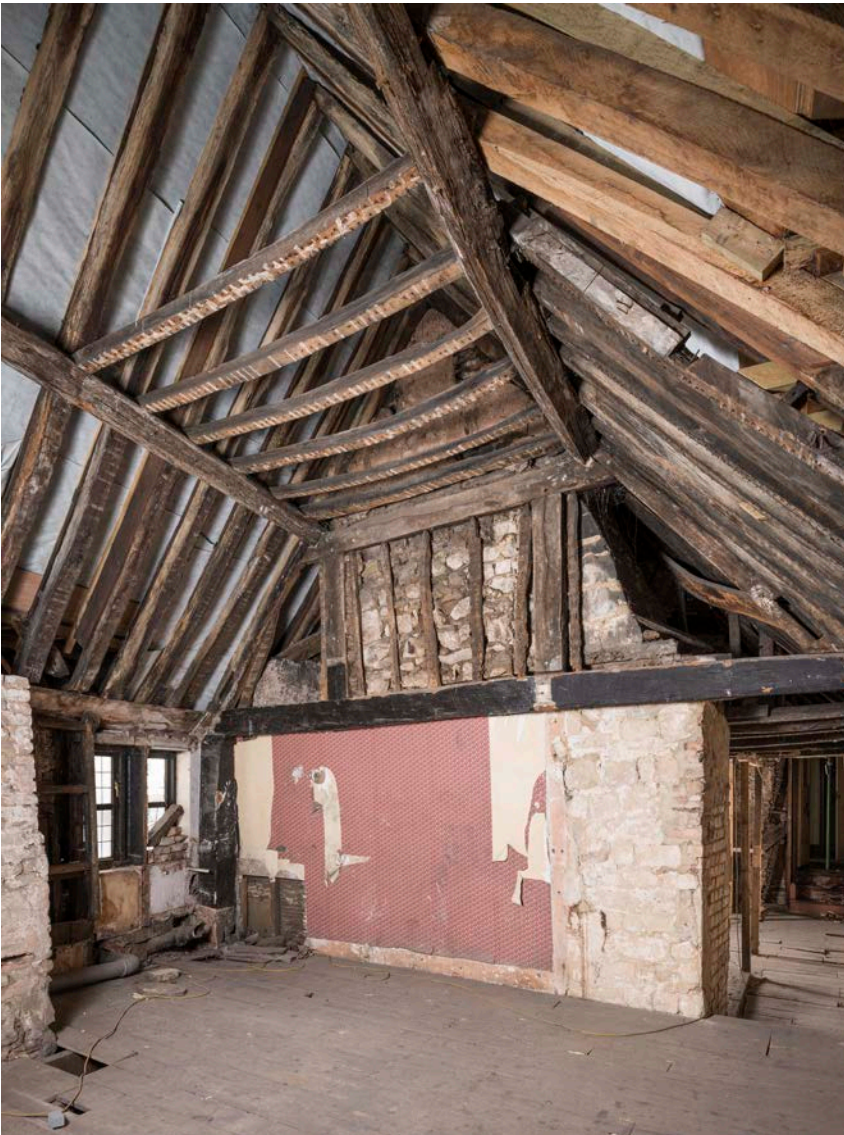
Figure 99: The northern face of frame II of the west range, looking south-east, with the stonework of the inserted chimney sitting against the southern side. [Steve Baker © HEA DP325613]

Frame II also appears to have represented a closed frame, creating a partition within the building (Figure 98). The east post of the frame survives, at least at first-floor level, although it is heavily painted over and little detail could be observed. As with frame I the roof truss survives intact (Figure 99). Below the tie beam the partitioning has again been removed, but the same pattern of stave holes can be observed as that on the underside of the tie beam of frame I, with a mortice towards the eastern end for an up-brace. There is no corresponding mortice on the western side (there is a small mortice but it appears to be secondary), which may indicate that there was originally some form of doorway on this side of the space, providing access between the two bays at first-floor level. Above the tie beam the truss originally had the same arrangement as that to the north, and again there are indications of surviving staves in the central panel between the queen struts, although other areas have been affected by the insertion of a large chimney breast (see Phase Three below). Redundant mortices on the northern sides of the principal rafters indicate further wind-bracing which has been removed. Above the collar some apparently original daub still adheres to the staves of the partition, indicating that the truss was closed up to the apex of the roof.

An alteration to the west range which might also be tentatively be ascribed to this phase is the insertion of a large stone chimney stack (see Figure 99). This now sits against frame II, at the north end of bay B. Frame II has elements of an original partition surviving within the truss, particularly above the tie beam where an early partition survives. The upper part of the chimney stack has been built up against this, suggesting that the stack is not original. The stack originally occupied almost the whole width of the bay, although it has been later truncated at its western end. To the east there is a narrow gap between the stack and the east wall which may have provided a means of access between the two first-floor bays, after the insertion of the chimney. The chimney itself is formed of squared blocks of stone, some of which may be reused. It appears to have provided a fireplace only at ground-floor level, as there is no indication of any first-floor fireplace on either side of the stack. The stack survives at ground-floor level but it is largely plastered over on its northern face. It still provides a (later) fireplace for what was originally the northern bay of the west range (now the rear bay of the shop in No. 21). The south side is currently plastered over, so could not be examined closely. The size of the stack suggests that it may have had a service function. It is possible that it superseded the original smoke bay, one bay further to the south. Although it is not clear when this fell out of use, the level of smoke blackening within the smoke bay is relatively light, perhaps suggesting it was not in use for a long period of time. The most frequent alteration to smoke bays was to insert a chimney within the bay, but there is no evidence that this happened here. It may be that instead the smoke bay was superseded by this later stack, with the former smoke bay used for different purposes from the 16th century onwards. Alternatively, it is possible that the smoke bay and chimney were in use at the same time, providing different functions within the service arrangement for the tenement.

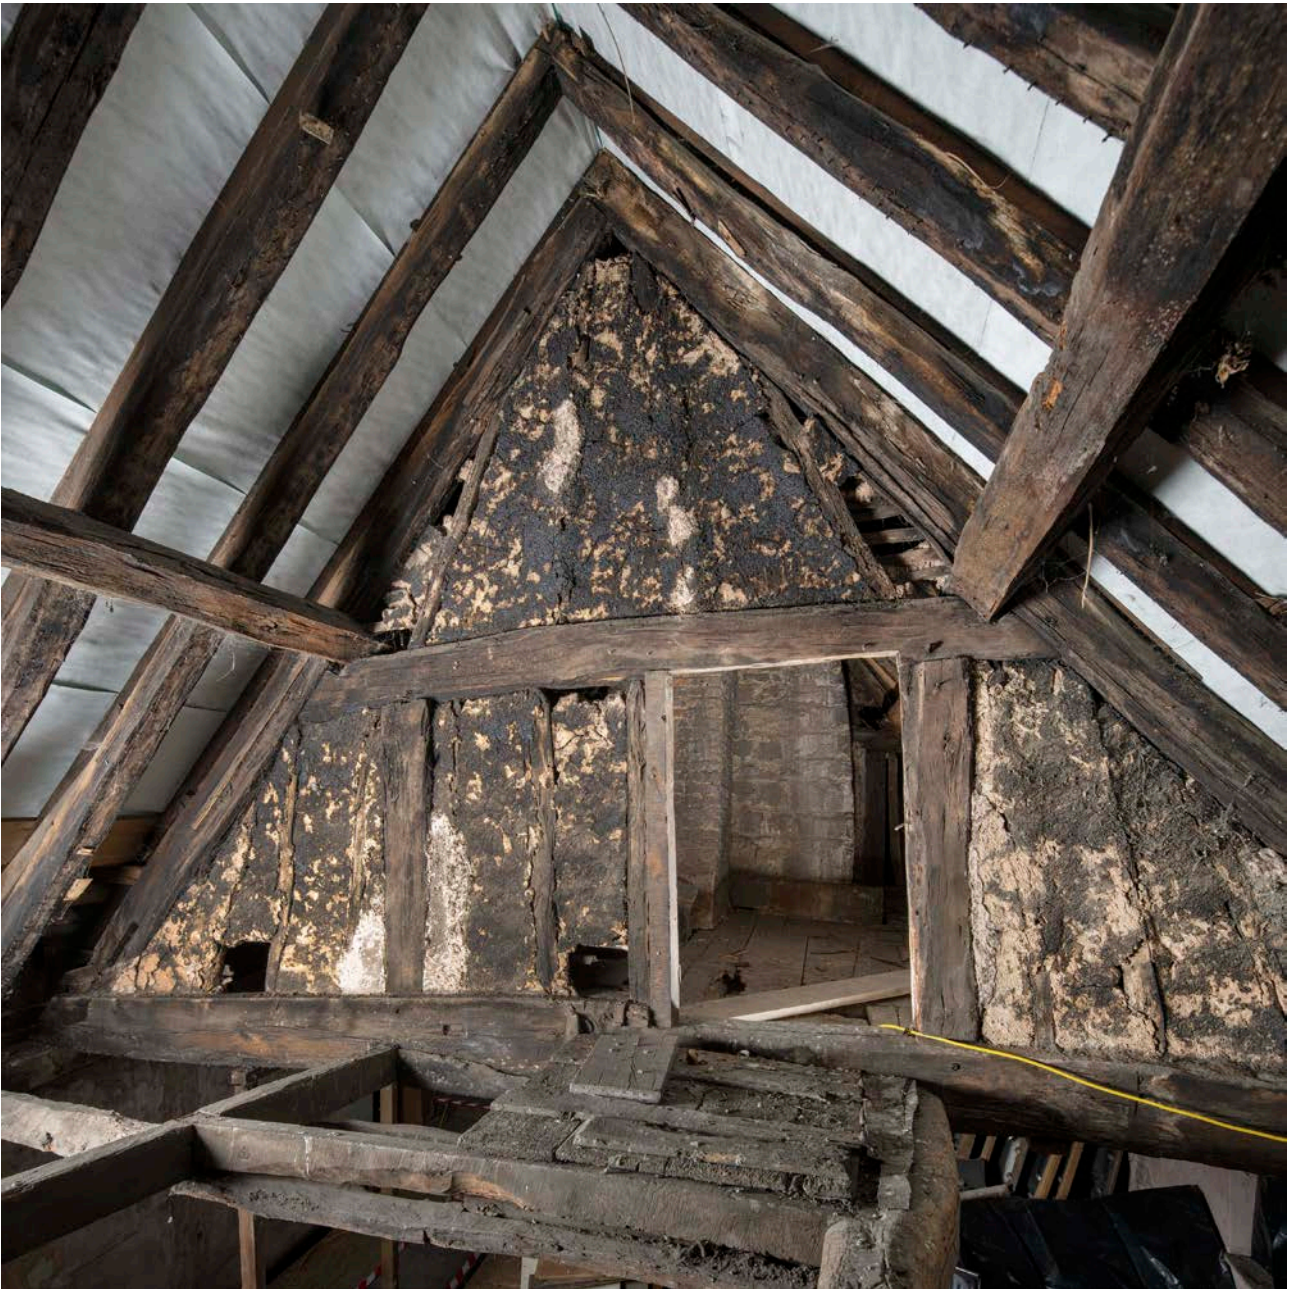
Figure 101: The southern face of the roof truss of frame III, looking north-west, showing the smoke blackening on the in situ wattle and daub panels and the timber frame. [Steve Baker © HEA DP325677]

Frame III originally formed the northern side of the smoke bay and originally took a slightly different form to those to the north (Figure 100). Again the framing has been removed below the tie beam. There is a large central mortice in the tie beam for a stud with stave holes to either side, but there are no mortices for up-braces or any doorway positions. It is possible that originally the frame had two down braces like that to the south (see frame IV below), although there is no evidence visible to confirm this. Above the tie beam the original partitioning of the bay is still in situ, apart from one small section which has been removed to create a later access hatch. The truss is of the same form as those to the north, with the same staves used to infill the various panels, with most of the daub still adhering to them. On the north side, facing into the central bay, the daub is clean, with some sections of limewash still adhering to the surface. On the south side the partition is smoke blackened (Figure 101).

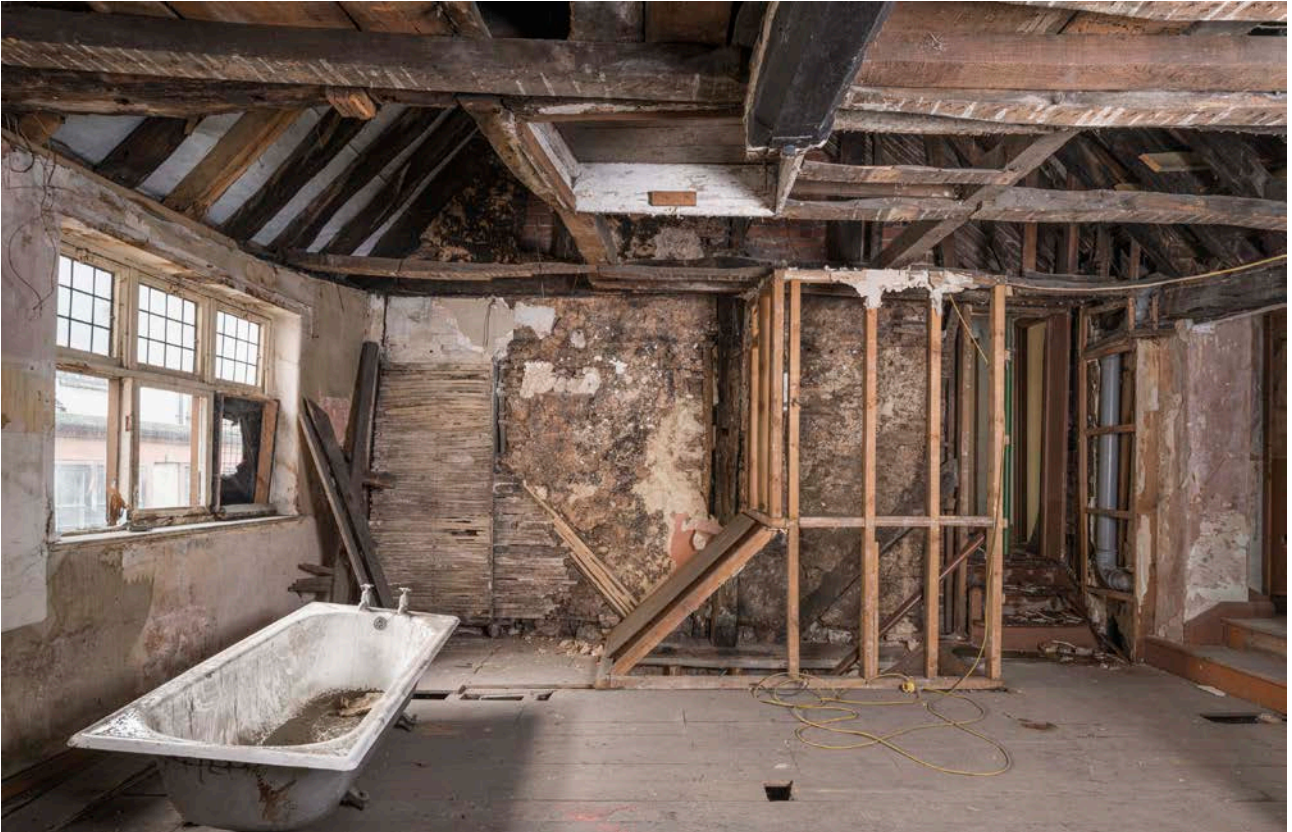
Figure 103: The northern face of frame IIII, looking south, showing smoke blackening on the frame and infill panels at first-floor level and in the roof. [Steve Baker © HEA DP325606]

Above the cross beam of frame IV the framing is still in situ and comprises a central stud (like that in frame III immediately to the north) and two down braces running from the east and west posts to the cross beam (Figure 103). Above the tie beam the roof truss is again closed, with some original staves and daub left in situ. This is again heavily smoke blackened (Figure 104). Above the collar the truss is now infilled with a later partition; however, the top of the collar has a groove for the base of an original partition. There is no indication of any original fixing on the underside of the principal rafters in this position, although this is also seen on some of the trusses to the north. It is possible that there was a smoke vent arrangement provided in this area, but if so this has later been removed.

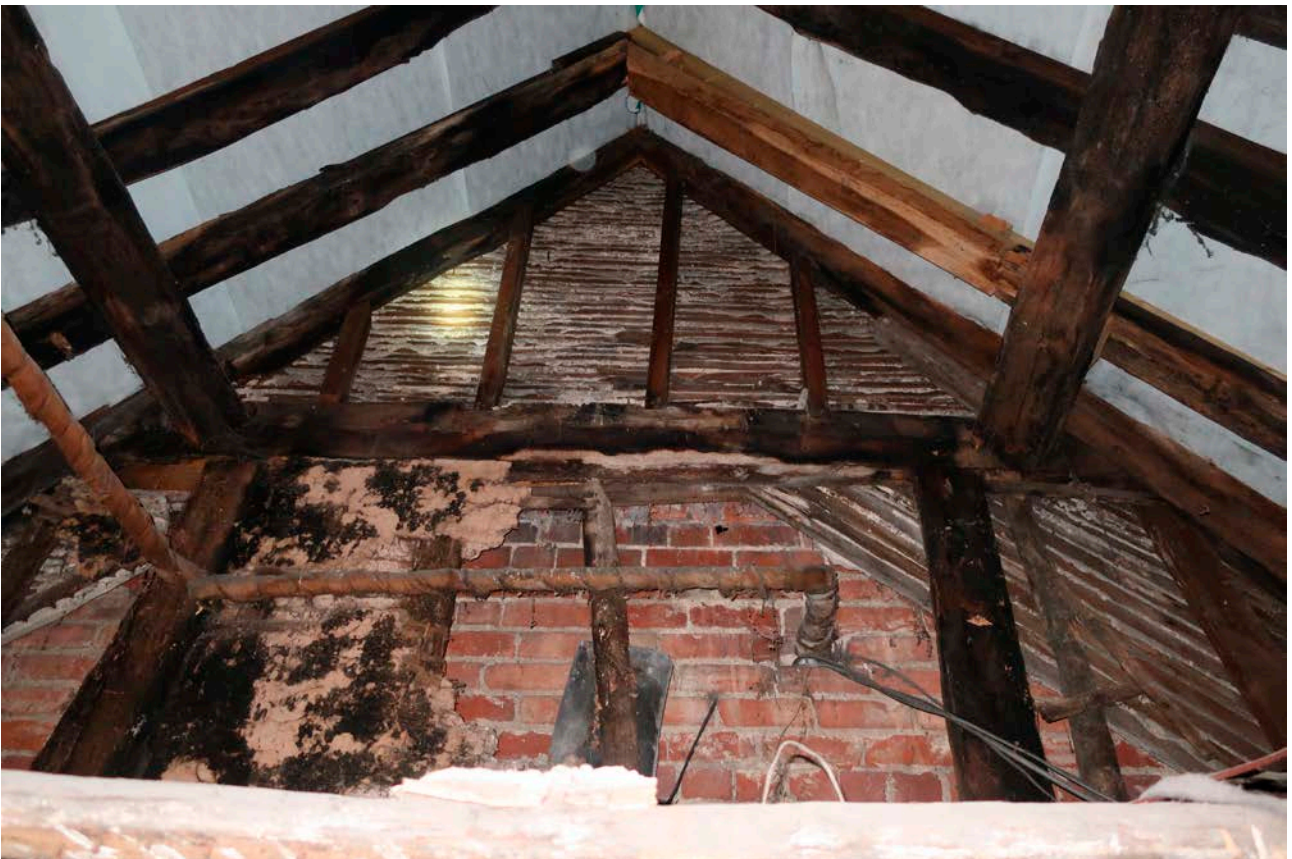
Figure 104: The roof truss of frame IIII, showing smoke blackening, and later stud infill above the collar. [Rebecca Lane © Historic England]

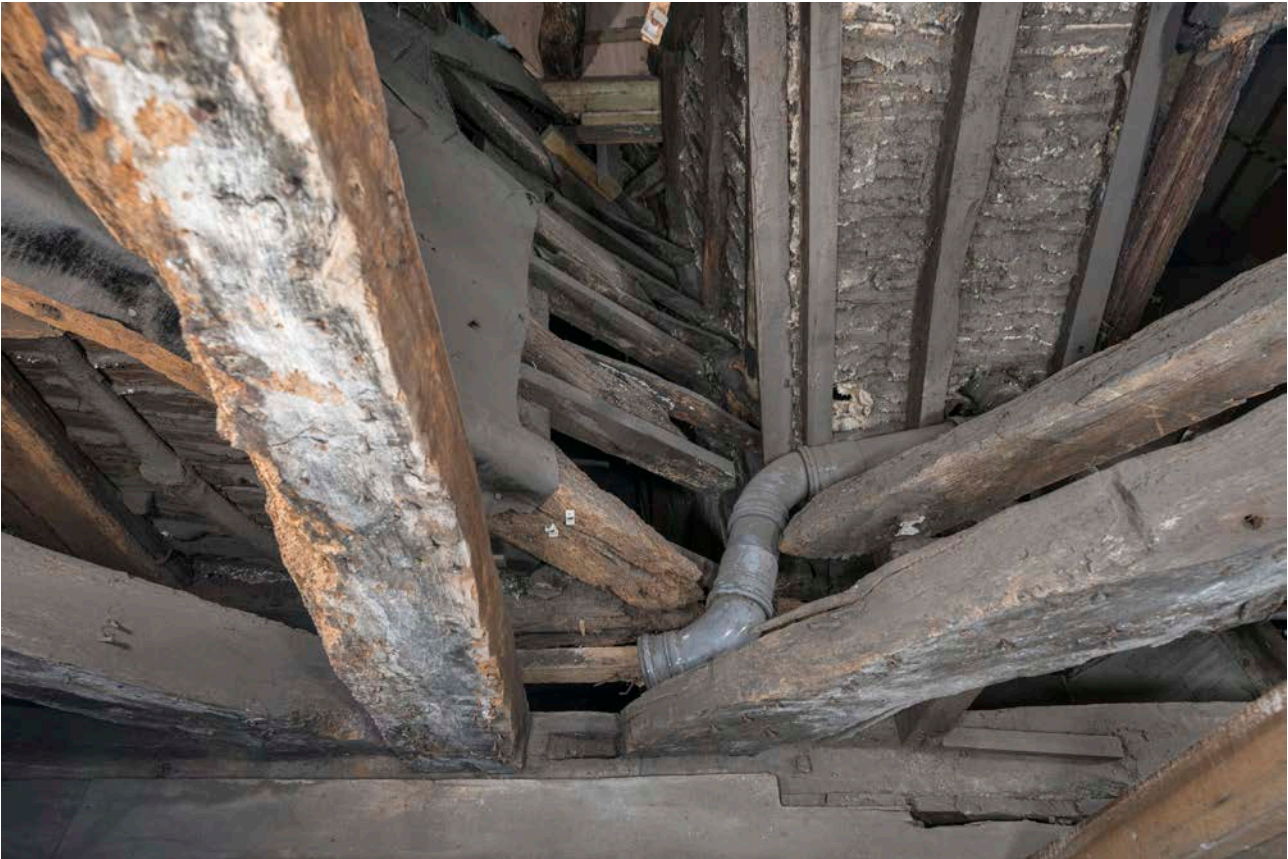
Figure 105: The junction between the main west range and the north-east corner bay, showing the rafters of both running down to the shared wall plate. [Steve Baker © HEA DP325643]

As described above, the small two-storey north-east corner bay between the west range and the street-front range is apparently contemporary with the construction of the west range as they share a corner post and a wall plate along the junction between the two (Figure 105). The ground floor of this bay has been completely reconstructed, but its original extent can be deduced from the surviving evidence in the first-floor frame. The bay measures only 3.6m by 2.7m, which means its full depth was not as much as a single bay of the west range, nor was its full width that of a bay of the street-front range, giving it a very limited footprint. At first-floor level it was slightly larger, as the eastern side of the first floor was jettied out over the passageway (Figure 106). The passageway has later been widened to the west, although the original ground-floor west wall line is indicated on the underside of the jetty joists. The northernmost joist has a cut on the underside which must originally have supported a north-eastern ground-floor post, with the shadow of the jetty plate visible on all of the joists to the south of this (see Figure 106). All the evidence suggests that this jetty is part of the original frame, with consistent marking for the jetty plate, but one of the joists shows signs of reuse, with a mortice and a groove in its southern face suggesting that it was originally part of a wall frame. However, it is of the same overall width and form as the other jetty joists, including having a rounded end. As it seems likely that the ranges were built over a number of years, it is possible that this represented the reuse of a piece of timber which had not been used for its original framing purpose for some reason.

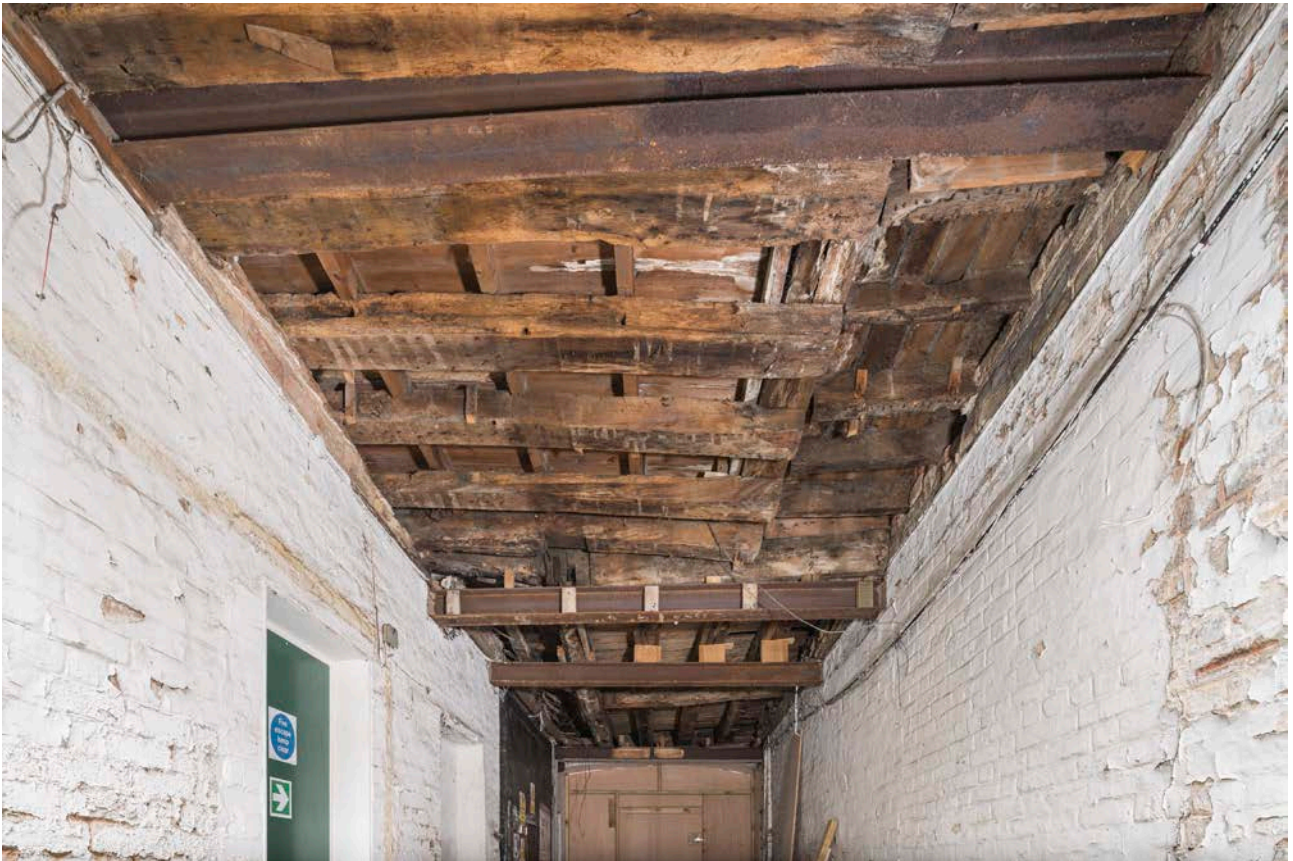
Figure 106: The jetty of the north-east corner bay, as visible from the passageway below, looking north. [Steve Baker © HEA DP325688]

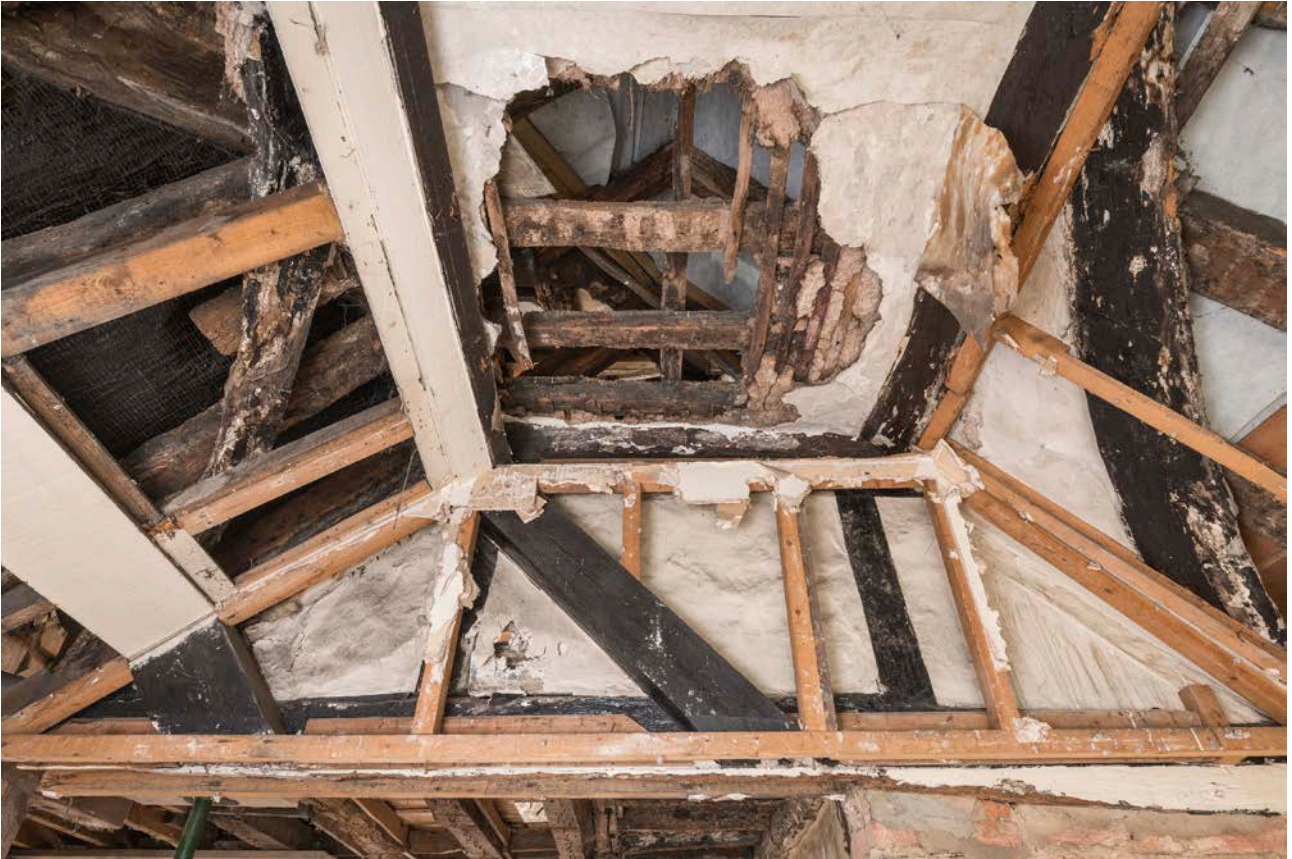
Figure 108: The roof truss arrangement of the northern frame of the north-east corner bay, looking north, with later timber and plaster ceiling inserted. [Steve Baker © HEA DP325683]

The form of the northern cross frame indicates that at first-floor level the north-east corner bay functioned separately from the street-front range as there are mortices in the underside of the tie beam indicating the position of studs. The underside of the eastern part of the tie beam is concealed, but the western part has a single original mortice for a stud, with stave holes to the west of this (there are other smaller mortices which appear to be secondary). Above the tie beam the truss is of a form corresponding to those in the rest of the west range (and the other ranges on the site), with two queen struts rising to a collar (Figure 108). Between the tie beam and the collar the truss is closed with what appears to be original staves, although the laths which form the plaster surface on its southern face appear to be later (see Figure 95). There is no indication of any original laths, and the original staves appear clean with no residual daub. There is no indication it was ever rendered or plastered on its northern face. It seems likely therefore that when constructed the bay was built up against the street-front range. This may reflect the phased approach to the construction of the different ranges.

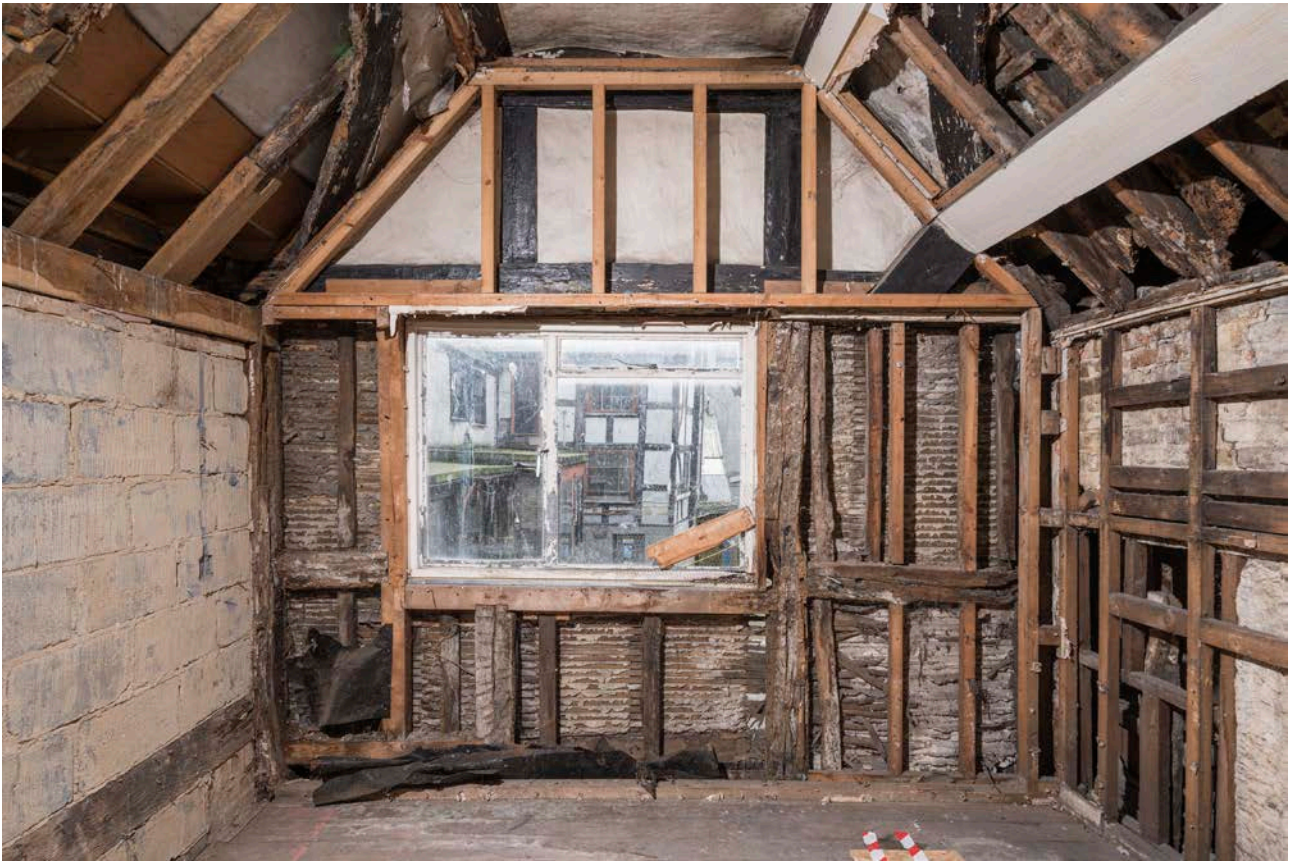
Figure 109: The first-floor room of the north-east corner bay, looking south, showing the framing of the south elevation. [Steve Baker © HEA DP325678]

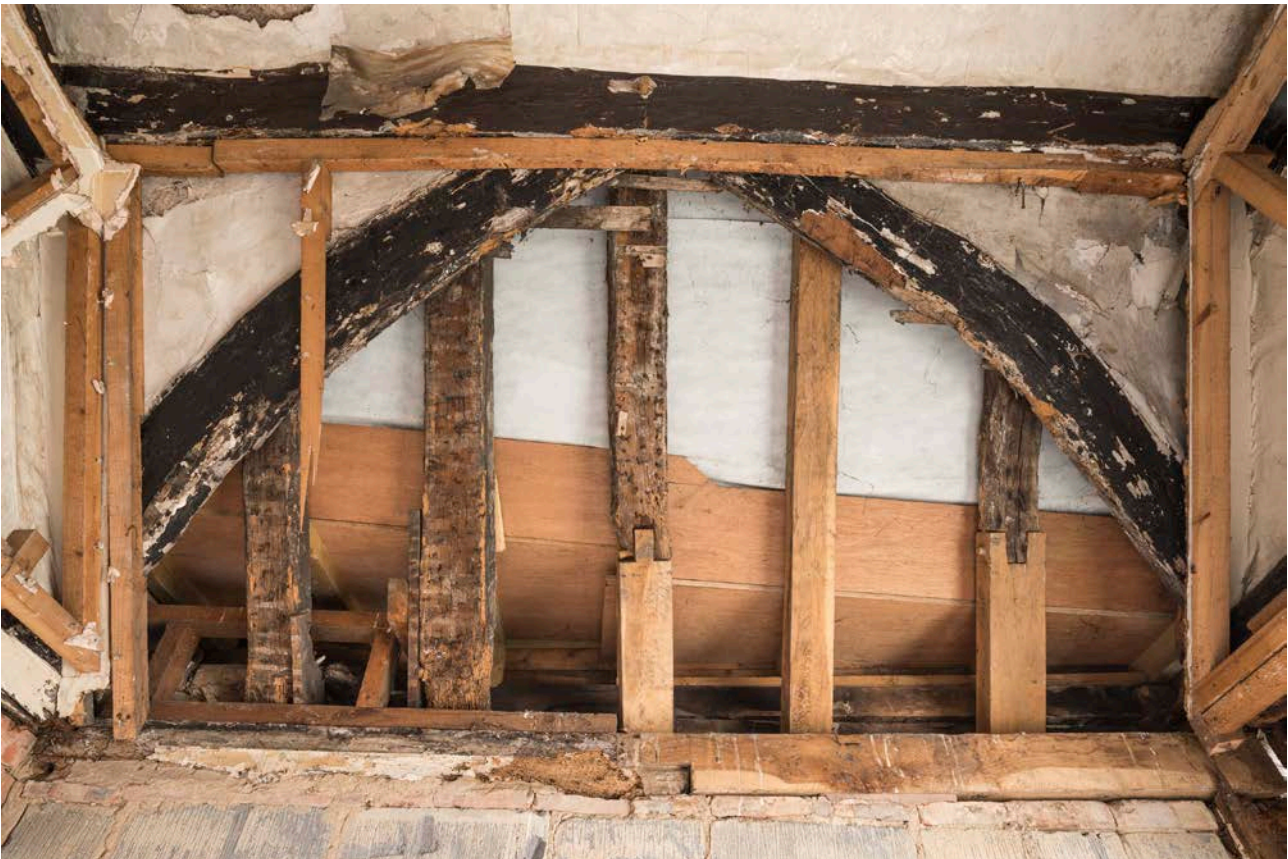
Figure 110: The eastern part of the roof structure of the north-east corner bay, looking east, showing the curved wind braces and original rafters. [Steve Baker © HEA DP325684]

slightly to the east of centre. Between the two a smaller mortice with part of a residual peg hole indicate the position of a mullion. Above the tie beam the truss takes the same form as that to the north, with queen strut and collar arrangement. Between the two trusses curved windbraces survive, rising to the purlin (Figure 110). The common rafter pairs also appear original.

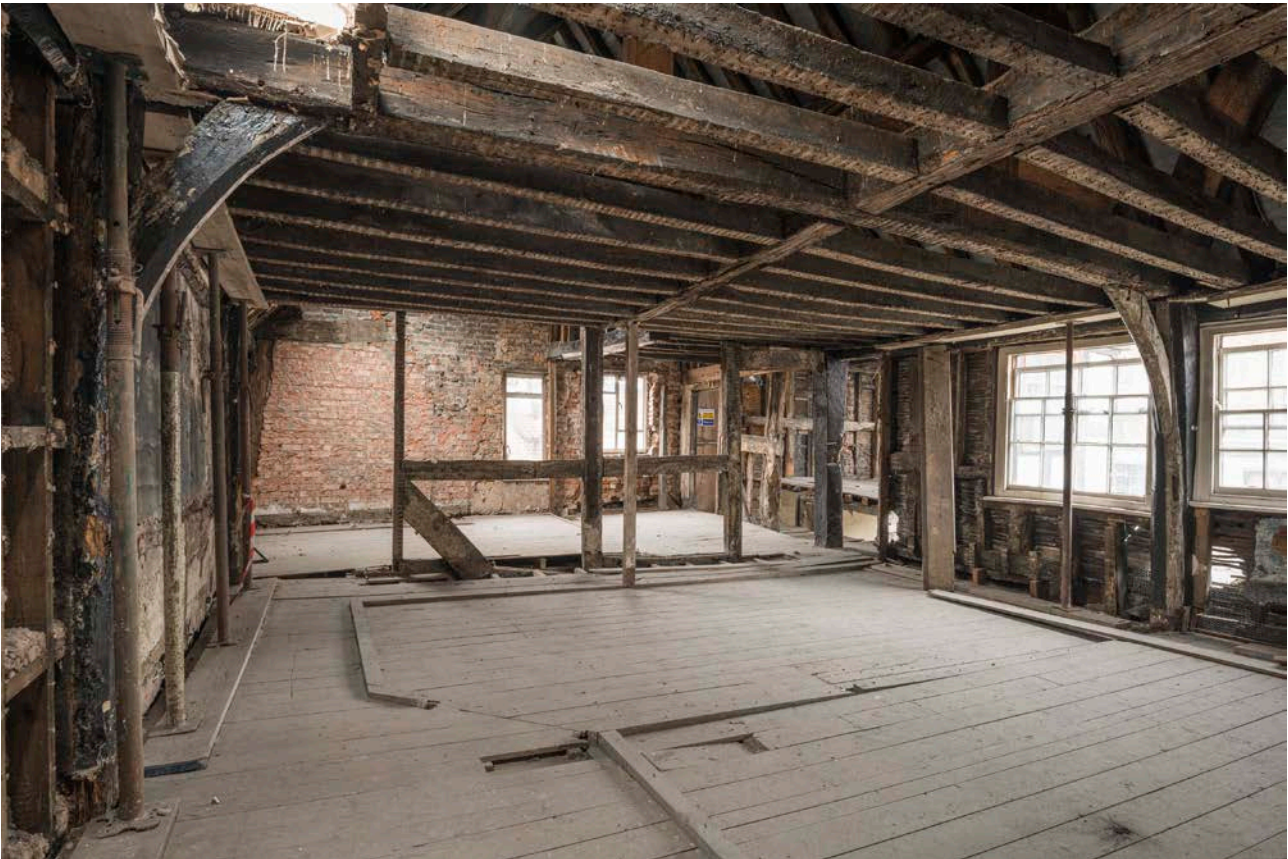
Figure 111: The first-floor central room of the great inn range, looking south-west, showing the ceiling inserted over the room, possibly in the 16th century. [Steve Baker © HEA DP325588]

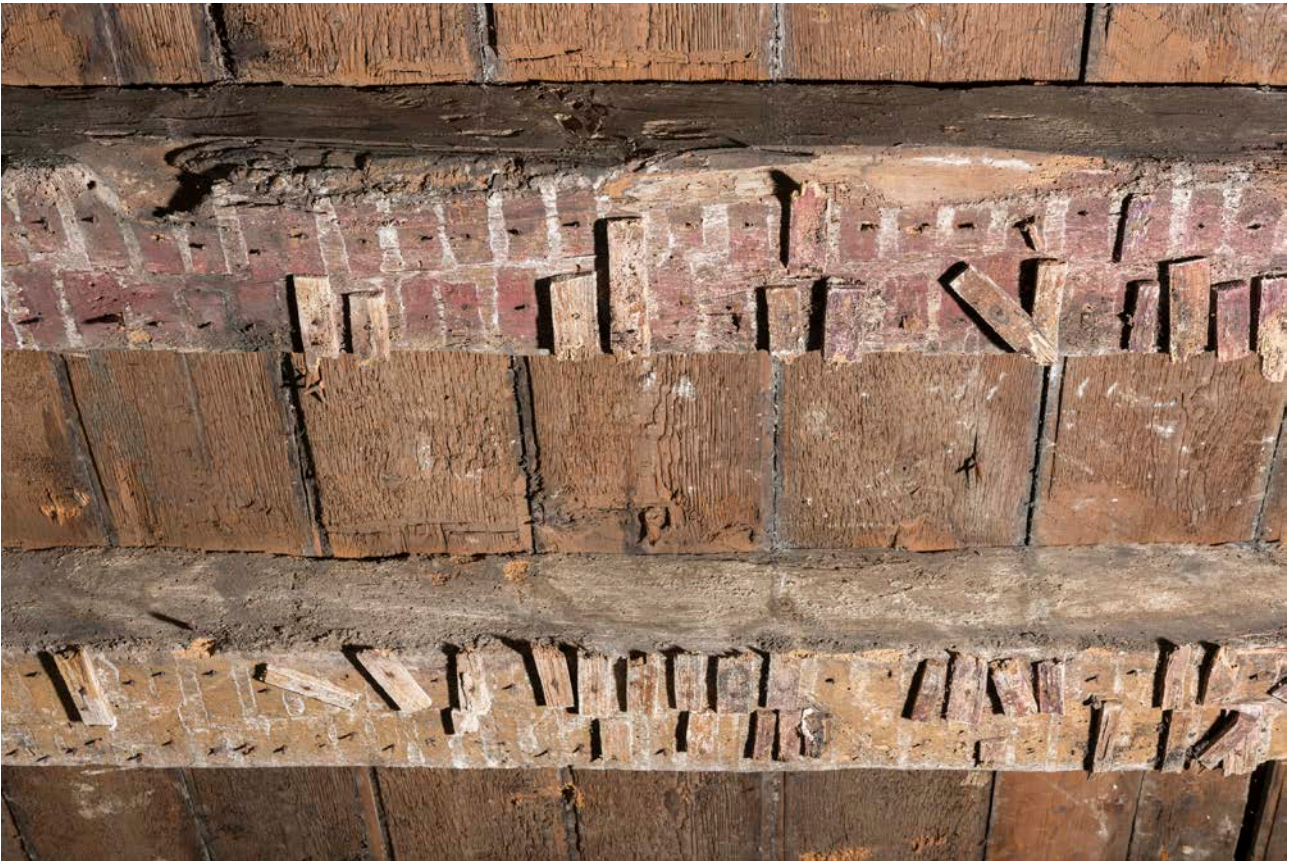
Figure 112: The ground-floor southern bay (bay F) of the great inn range, showing the possible use of alternating red and yellow paint on the ceiling joists. [Steve Baker © HEA DP325692]

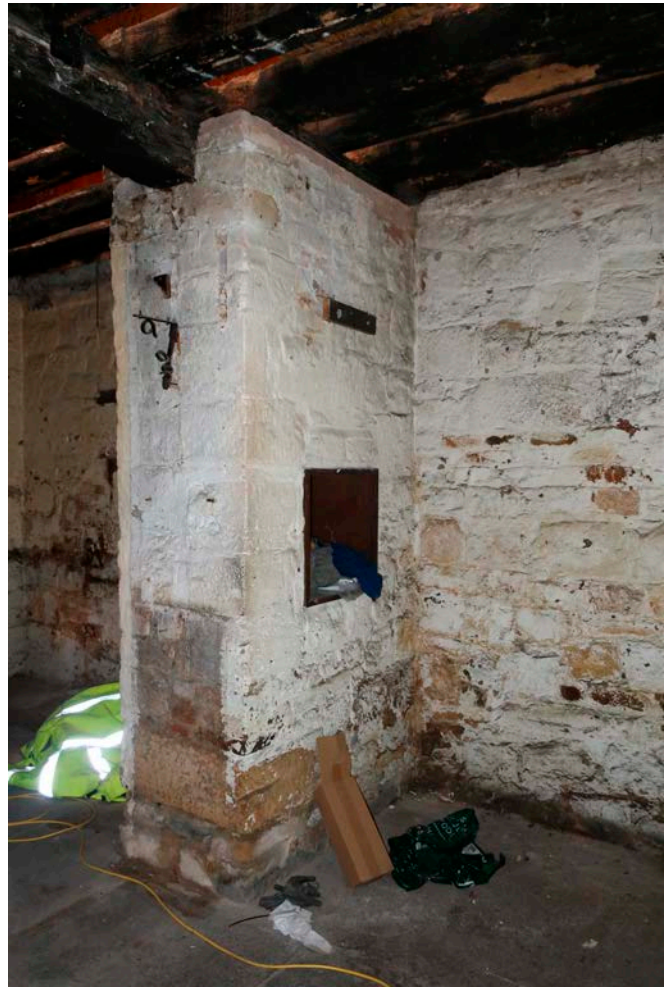
Figure 113: The undercroft in the great inn range, looking north-east, showing the inserted stone piers and timber beams of the raised floor at the northern end of the building. [Rebecca Lane © Historic England]

saw the more extensive reconstruction of a greater proportion of the cellar walls in this northern area. The raised floor itself is formed of two squared timber beams which span the undercroft supported on projecting masonry piers (Figure 113). These are chamfered on their undersides with stepped run out stops. It is likely that there was originally a further beam to the north of this, but this has been lost in the later truncation of the range. The cross beams supported joists which ran between them. Originally these were tenoned into the side of the beams, although the 17th-century joists have been removed and replaced by later joists resting on top of the cross beams.
